## **JOURNEY RISK MANAGEMENT (JRM) STUDY**

**Salem Terminal TO Tiruchengodu Rig Urimayalargal  
Sang**

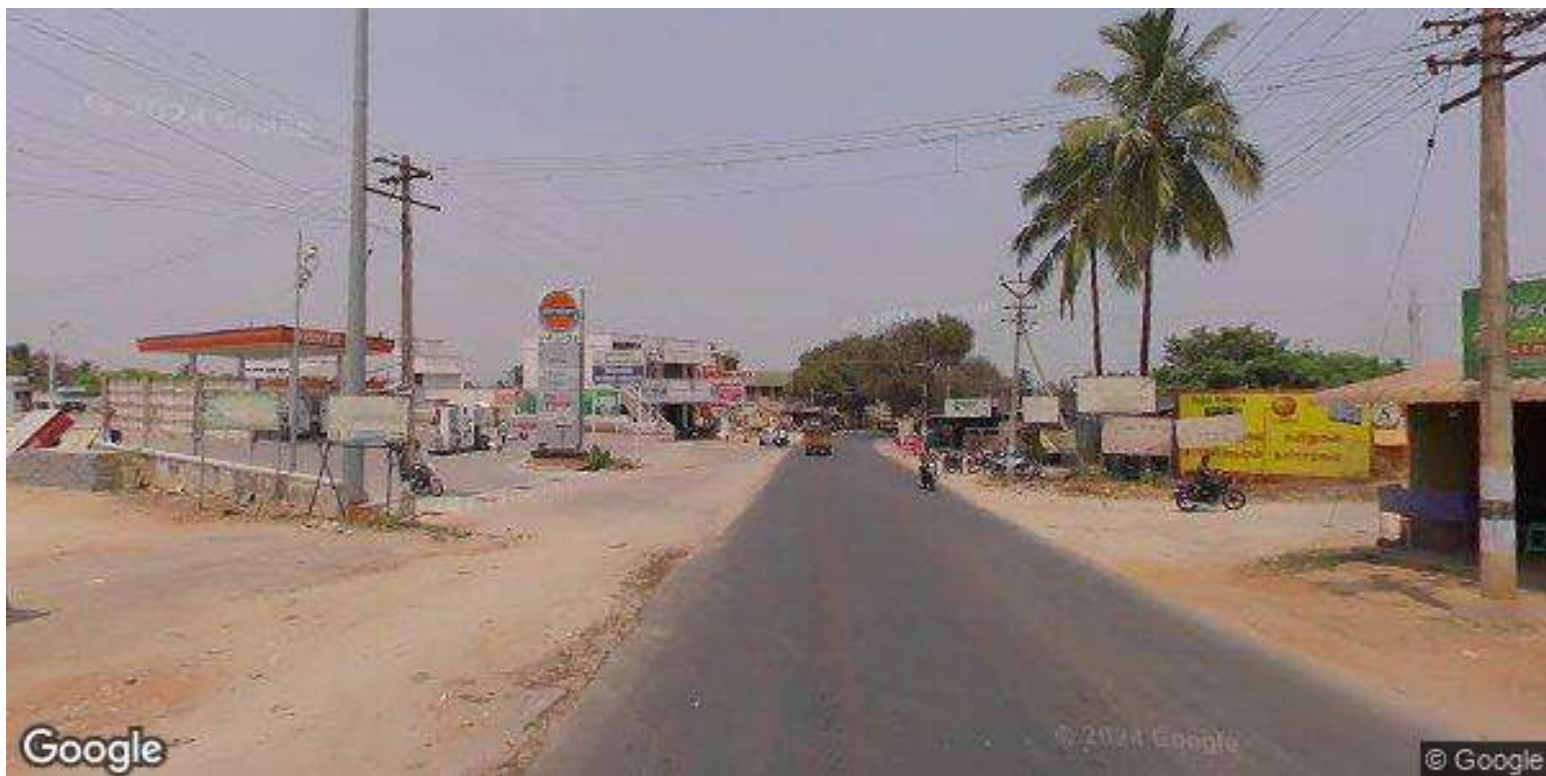
**Coordinates:** 11.40452, 77.88181

**Risk Type:** Blind Spot

**Risk Level:** Blind Spot

**Speed Limit:** 10 KM/Hr
