# IndianOil

## JOURNEY RISK MANAGEMENT (JRM) STUDY

### Salem Terminal to TIRUCHENGODU AGRO PDT CO- OP MKTG SO

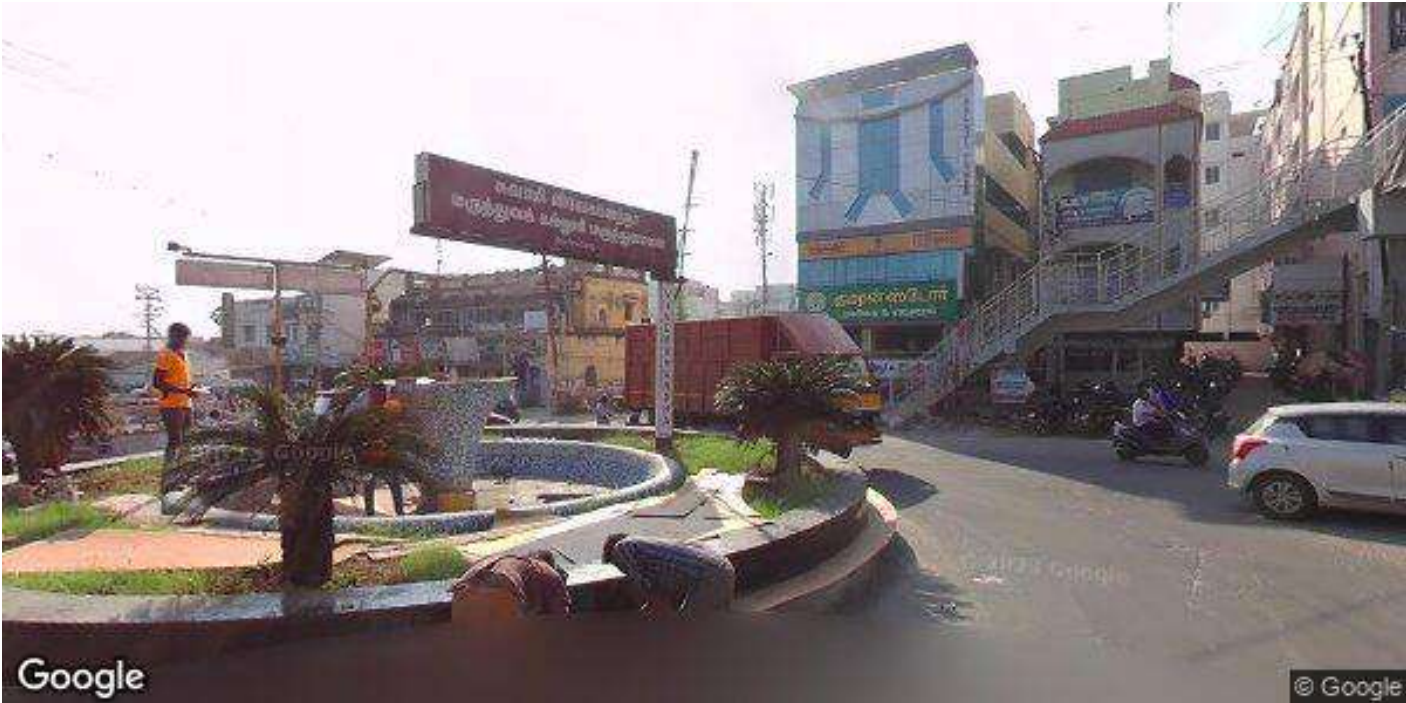
Coordinates: 11.38395, 77.89480

Risk Type: Roundabout

Risk Level: High

Speed Limit: 15 KM/Hr

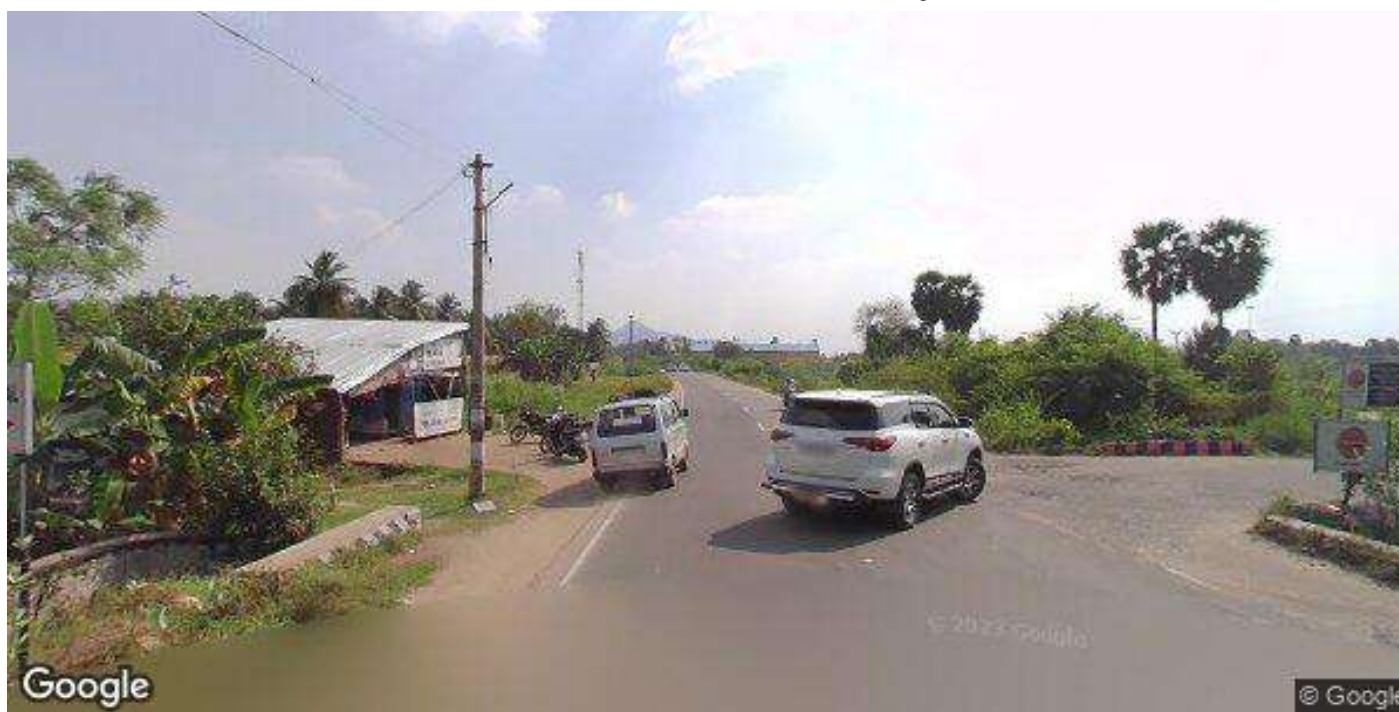
**Risk Type:** Blind Spot  
**Risk Level:** Blind Spot  
**Speed Limit:** 10 KM/Hr  
**Coordinates:** 11.44029, 77.87544

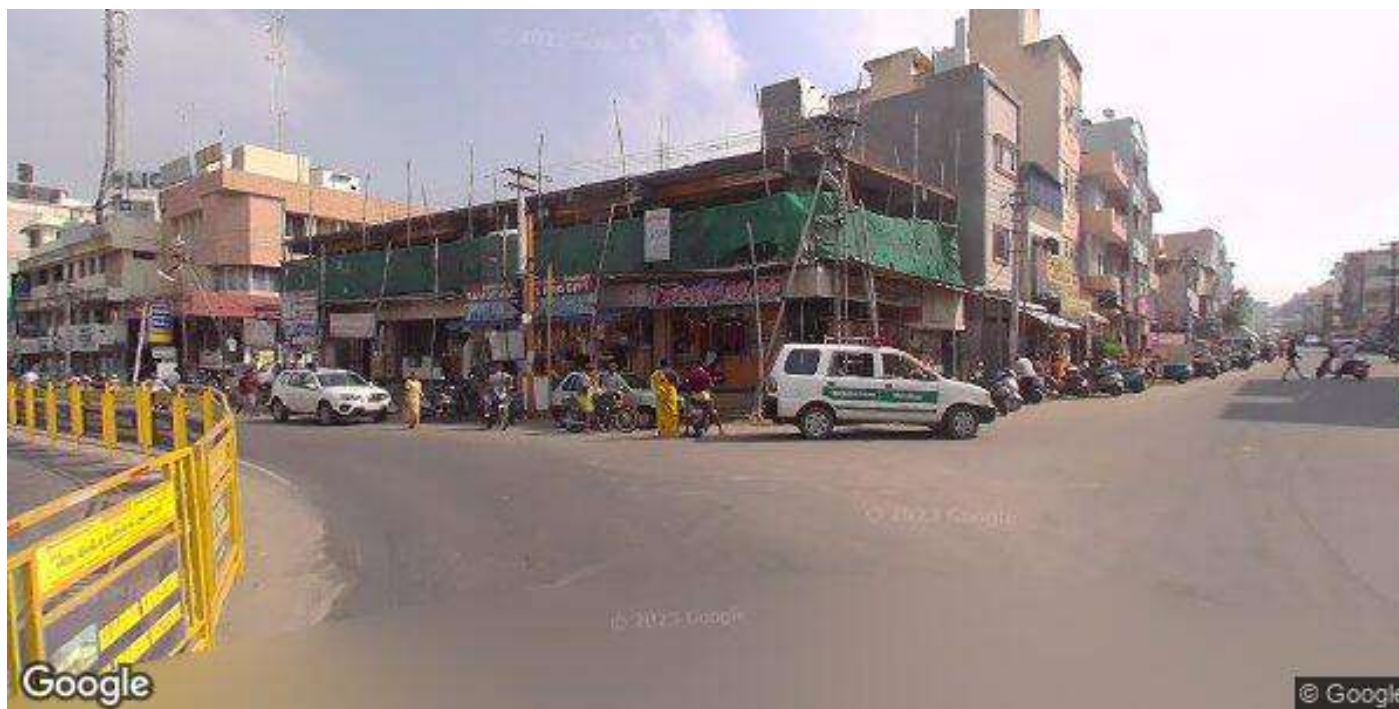
**Risk Type:** Turn  
**Risk Level:** High  
**Speed Limit:** 15 KM/Hr  
**Coordinates:** 11.37868, 77.89498

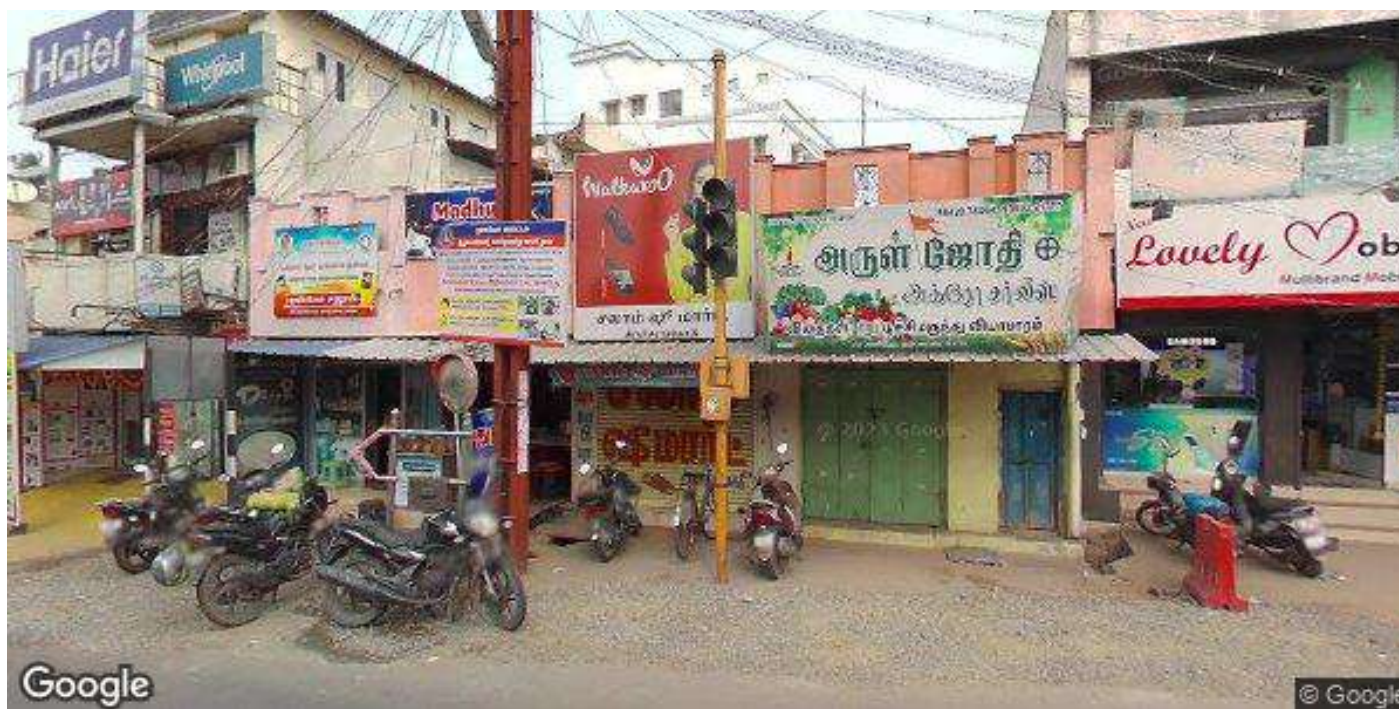
**Risk Type:** Turn  
**Risk Level:** High  
**Speed Limit:** 15 KM/Hr  
**Coordinates:** 11.37850, 77.89453
