## JOURNEY RISK MANAGEMENT (JRM) STUDY

### Salem Terminal to Sri Hari Agencies

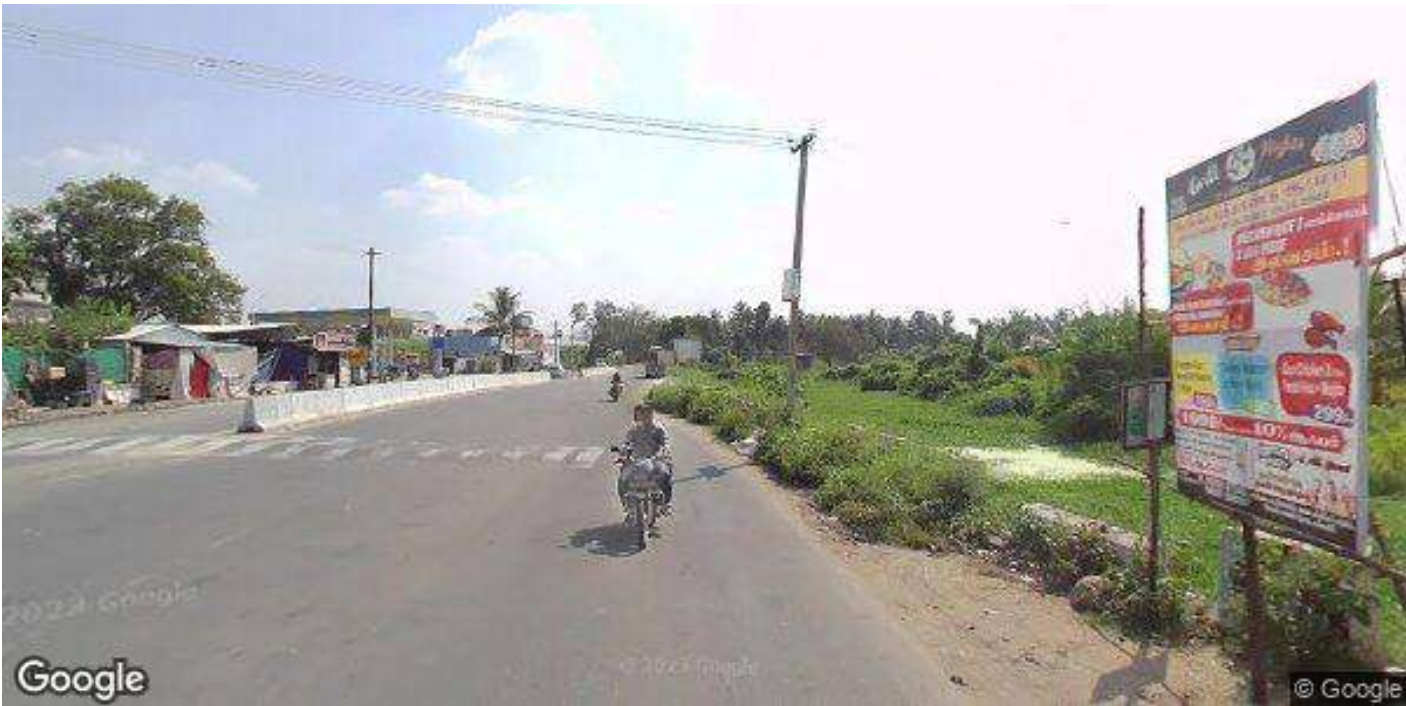
| | Risk Type | Risk Level | Coordinates | Speed Limit |
|---|---|---|---|---|
| 4 | Blind Spot | Blind Spot | 11.44861, 77.87429 | 10 KM/Hr |

Risk Type: Blind Spot  
Risk Level: Blind Spot  
Speed Limit: 10 KM/Hr  
Coordinates: 11.44861, 77.87429

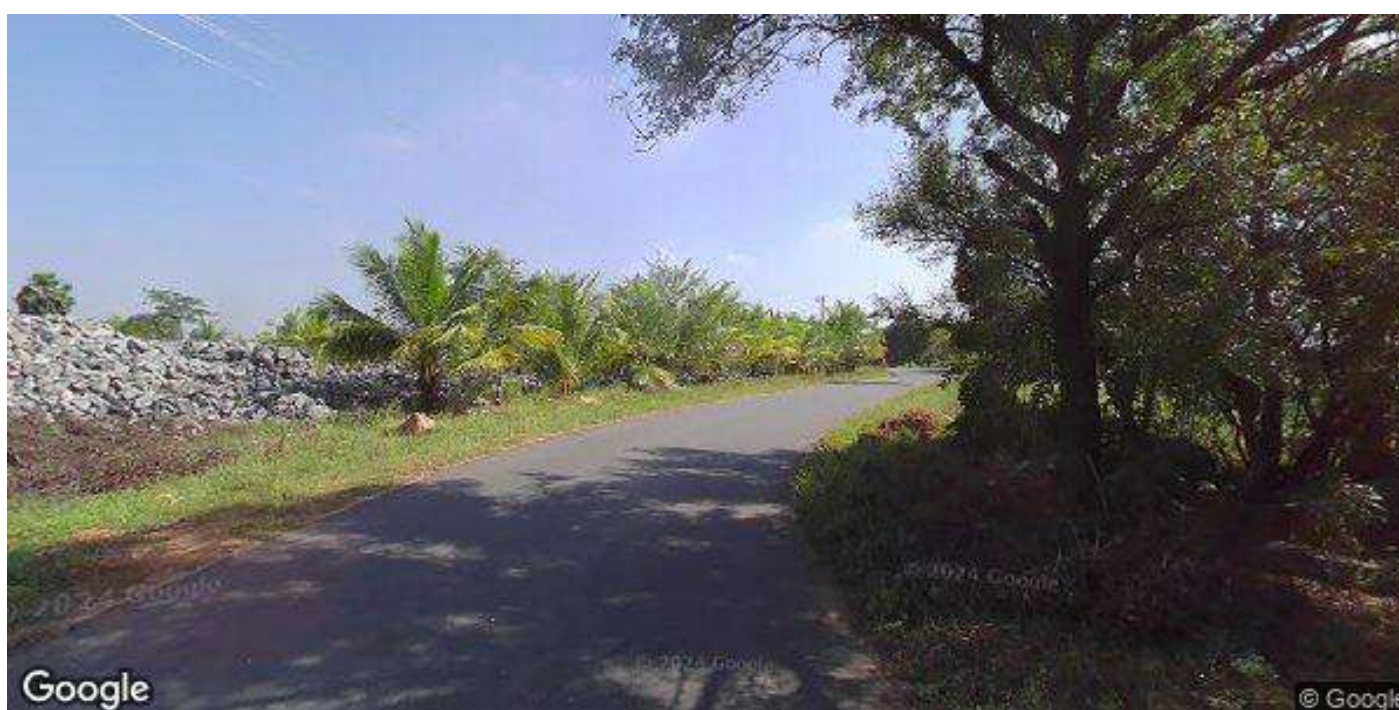
| | Risk Type | Risk Level | Coordinates | Speed Limit |
|---|---|---|---|---|
| 7 | Turn | Medium | 11.44030, 77.93066 | 30 KM/Hr |

**Risk Type:** Turn  
**Risk Level:** Medium  
**Speed Limit:** 30 KM/Hr  
**Coordinates:** 11.44030, 77.93066

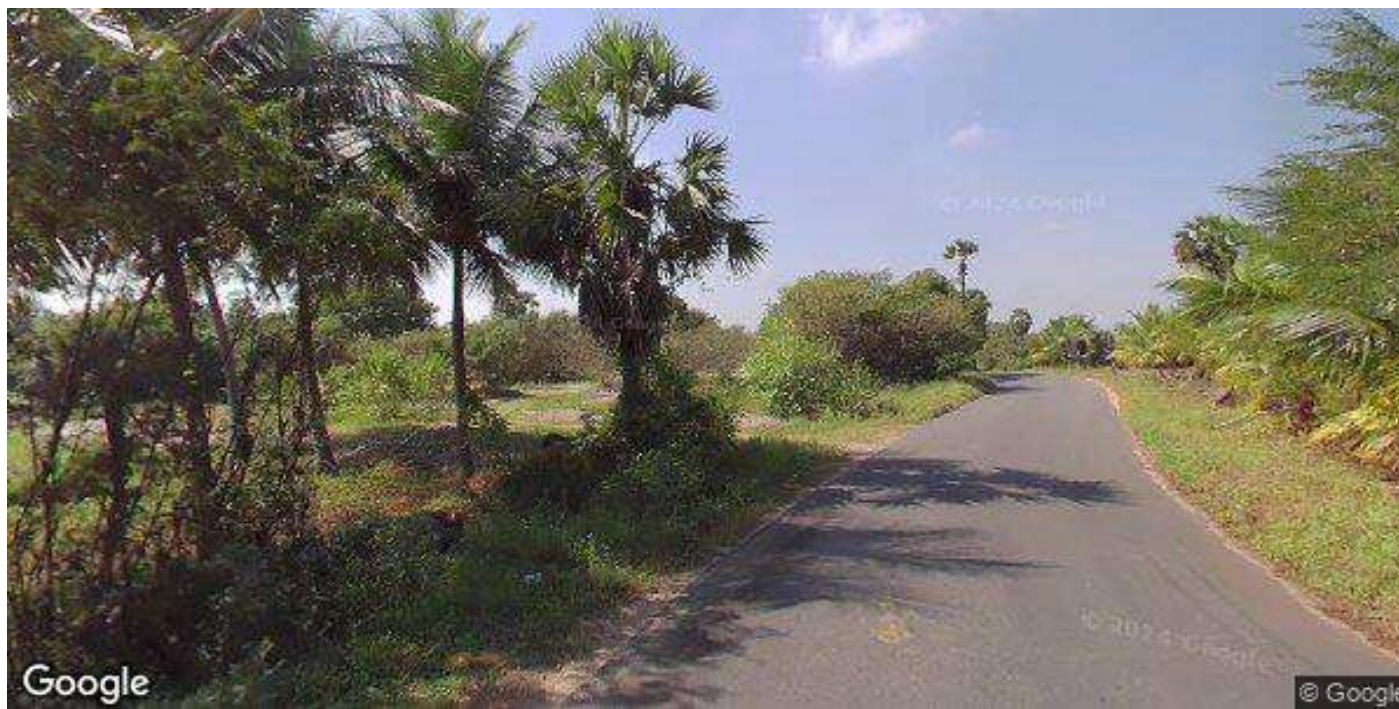
| | Risk Type | Risk Level | Coordinates | Speed Limit |
|---|---|---|---|---|
| 8 | Turn | Medium | 11.44075, 77.93216 | 30 KM/Hr |

**Risk Type:** Turn  
**Risk Level:** Medium  
**Speed Limit:** 30 KM/Hr  
**Coordinates:** 11.44075, 77.93216

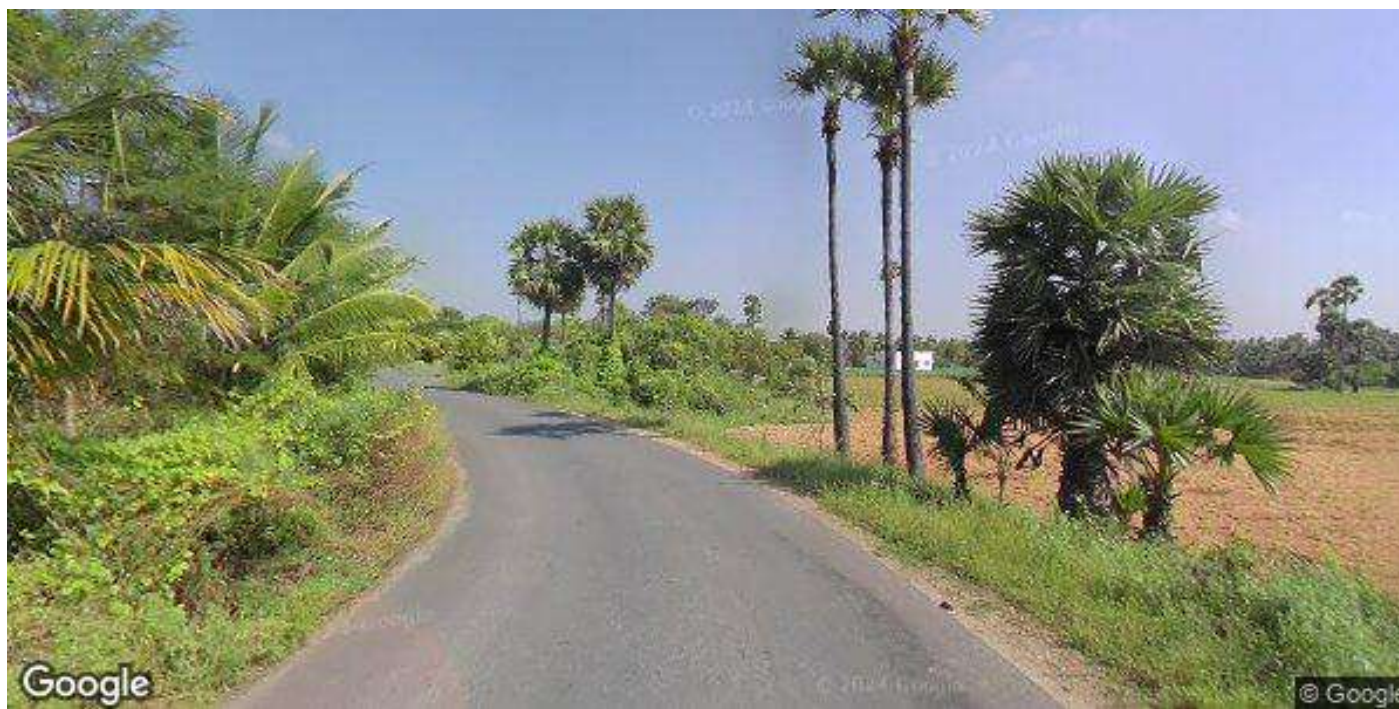
| | Risk Type | Risk Level | Coordinates | Speed Limit |
|---|---|---|---|---|
| 9 | Turn | Medium | 11.44088, 77.93223 | 30 KM/Hr |

**Risk Type:** Turn  
**Risk Level:** Medium  
**Speed Limit:** 30 KM/Hr  
**Coordinates:** 11.44088, 77.93223

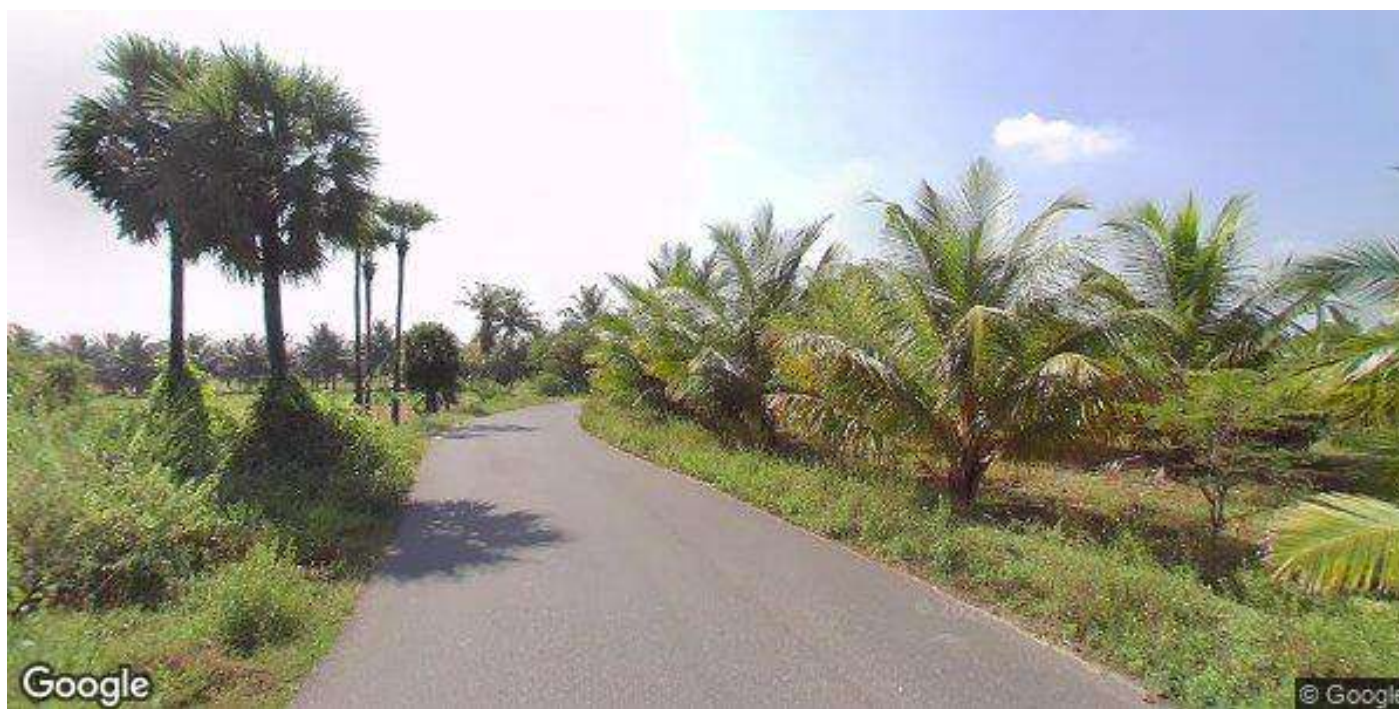
| | Risk Type | Risk Level | Coordinates | Speed Limit |
|---|---|---|---|---|
| 10 | Turn | Medium | 11.44127, 77.93218 | 30 KM/Hr |

**Risk Type:** Turn  
**Risk Level:** Medium  
**Speed Limit:** 30 KM/Hr  
**Coordinates:** 11.44127, 77.93218

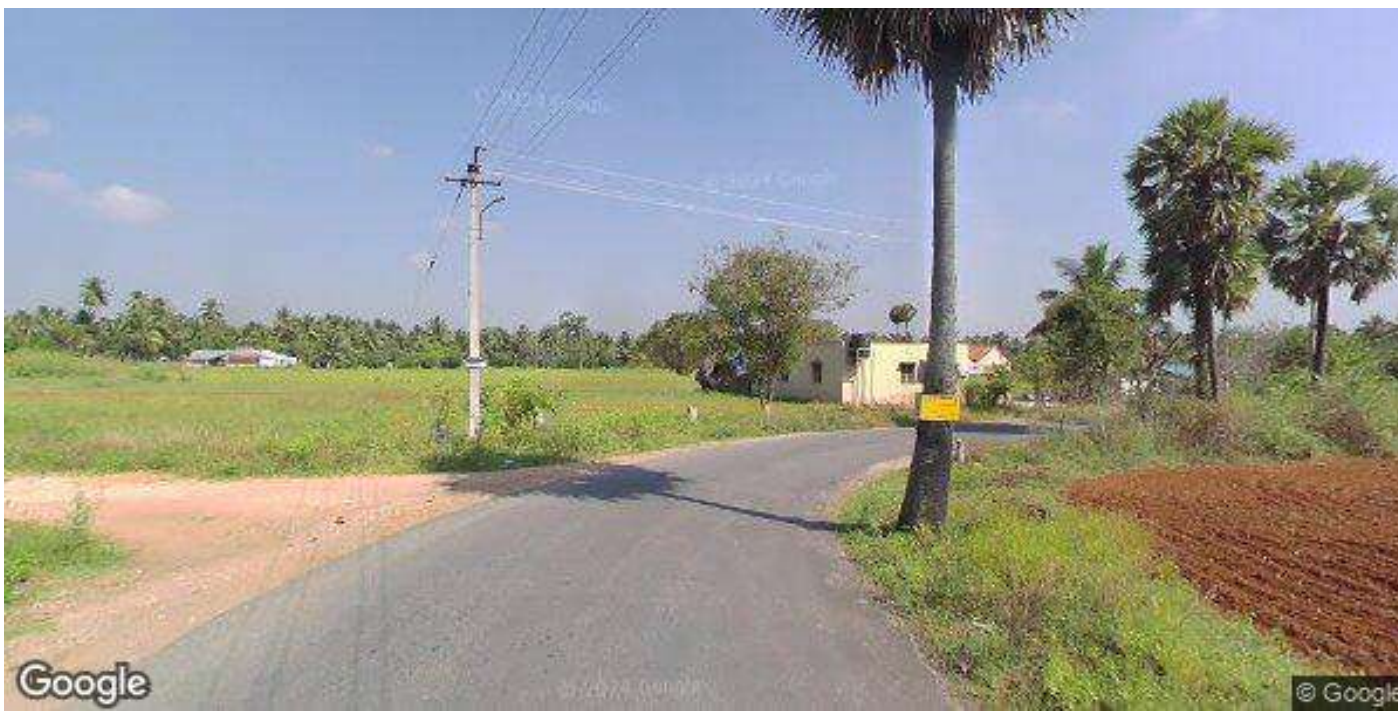
| | Risk Type | Risk Level | Coordinates | Speed Limit |
|---|---|---|---|---|
| 11 | Turn | Medium | 11.44243, 77.93244 | 30 KM/Hr |

**Risk Type:** Turn  
**Risk Level:** Medium  
**Speed Limit:** 30 KM/Hr  
**Coordinates:** 11.44243, 77.93244

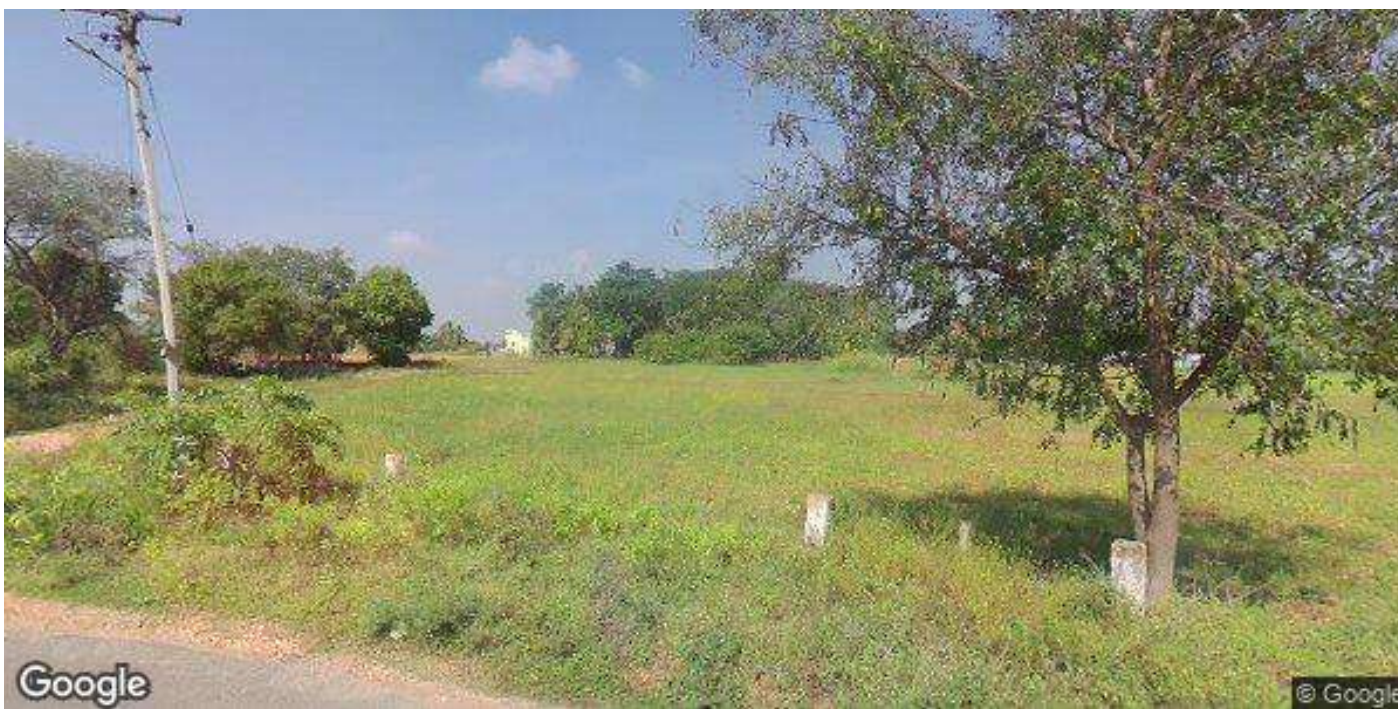
| | Risk Type | Risk Level | Coordinates | Speed Limit |
|---|---|---|---|---|
| 12 | Turn | Medium | 11.44254, 77.93256 | 30 KM/Hr |

**Risk Type:** Turn  
**Risk Level:** Medium  
**Speed Limit:** 30 KM/Hr  
**Coordinates:** 11.44254, 77.93256

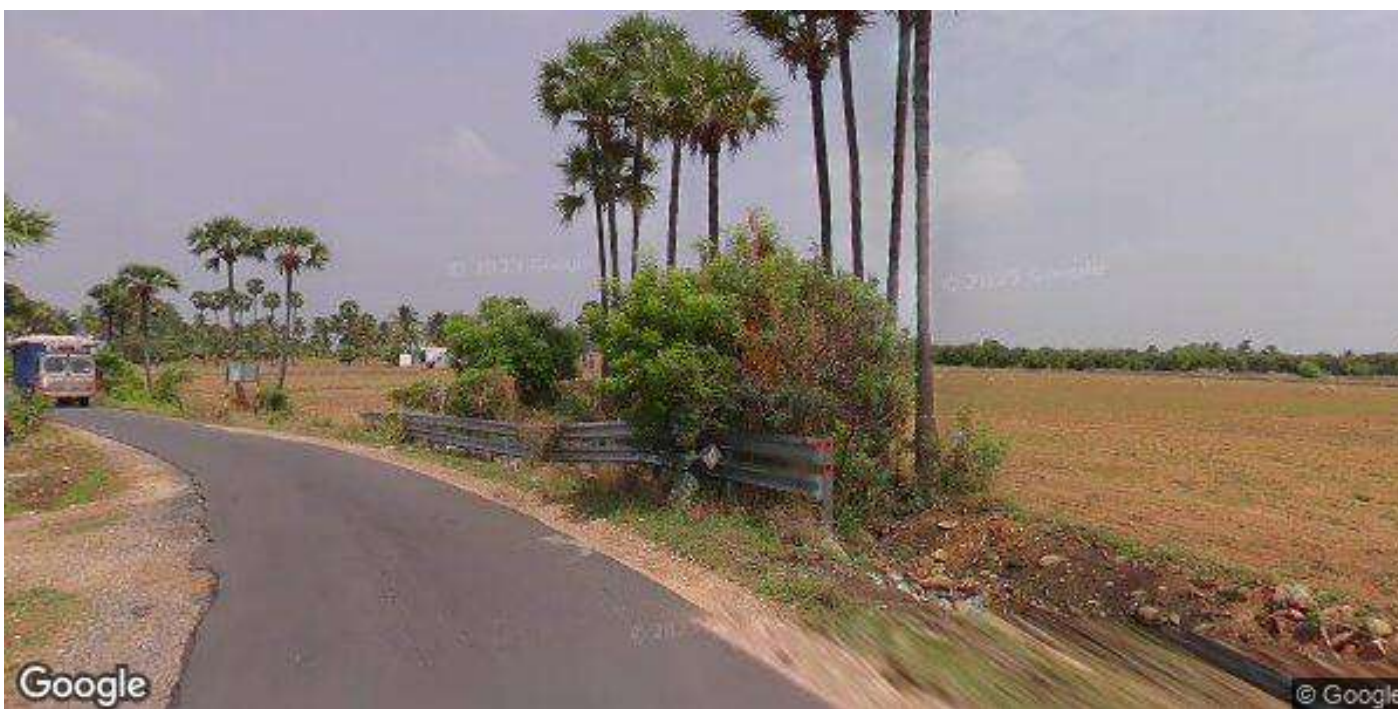
| | Risk Type | Risk Level | Coordinates | Speed Limit |
|---|---|---|---|---|
| 13 | Turn | Medium | 11.44550, 77.95329 | 30 KM/Hr |

**Risk Type:** Turn  
**Risk Level:** Medium  
**Speed Limit:** 30 KM/Hr  
**Coordinates:** 11.44550, 77.95329

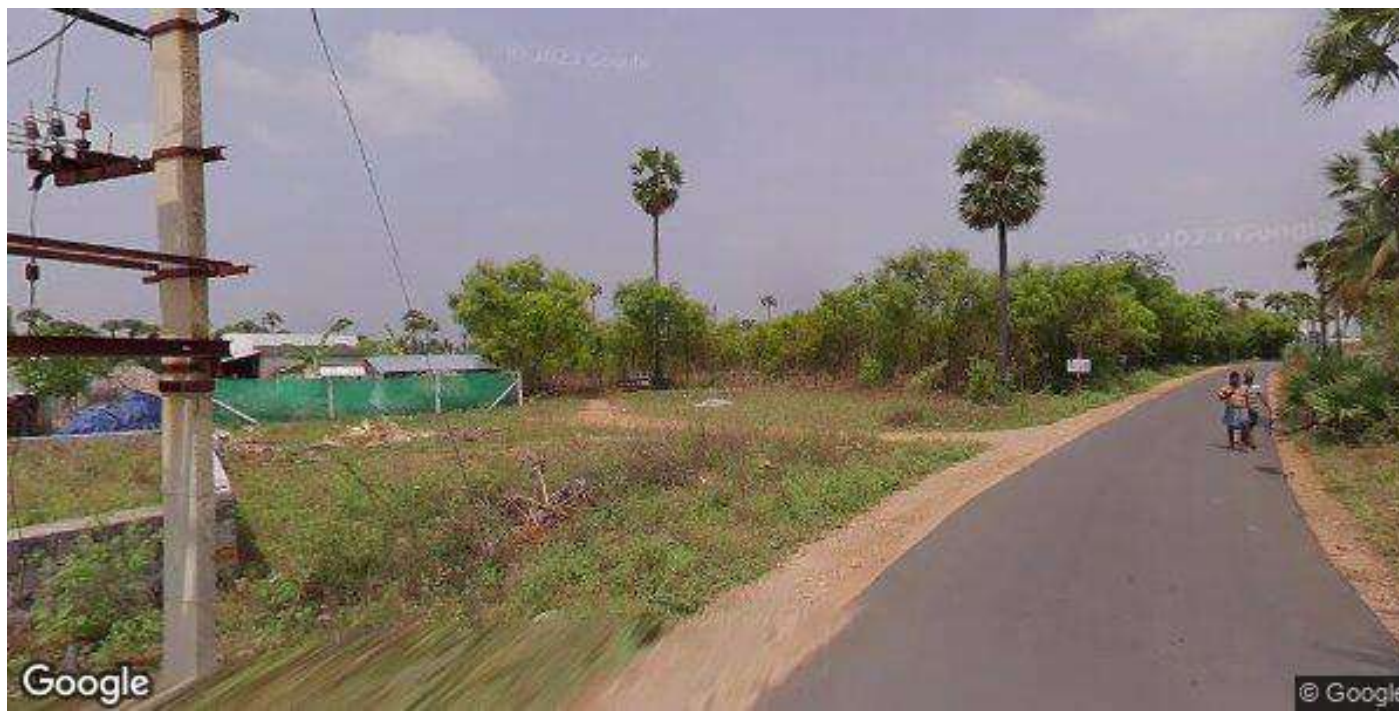
| | Risk Type | Risk Level | Coordinates | Speed Limit |
|---|---|---|---|---|
| 14 | Turn | Medium | 11.44369, 77.96036 | 30 KM/Hr |

**Risk Type:** Turn  
**Risk Level:** Medium  
**Speed Limit:** 30 KM/Hr  
**Coordinates:** 11.44369, 77.96036

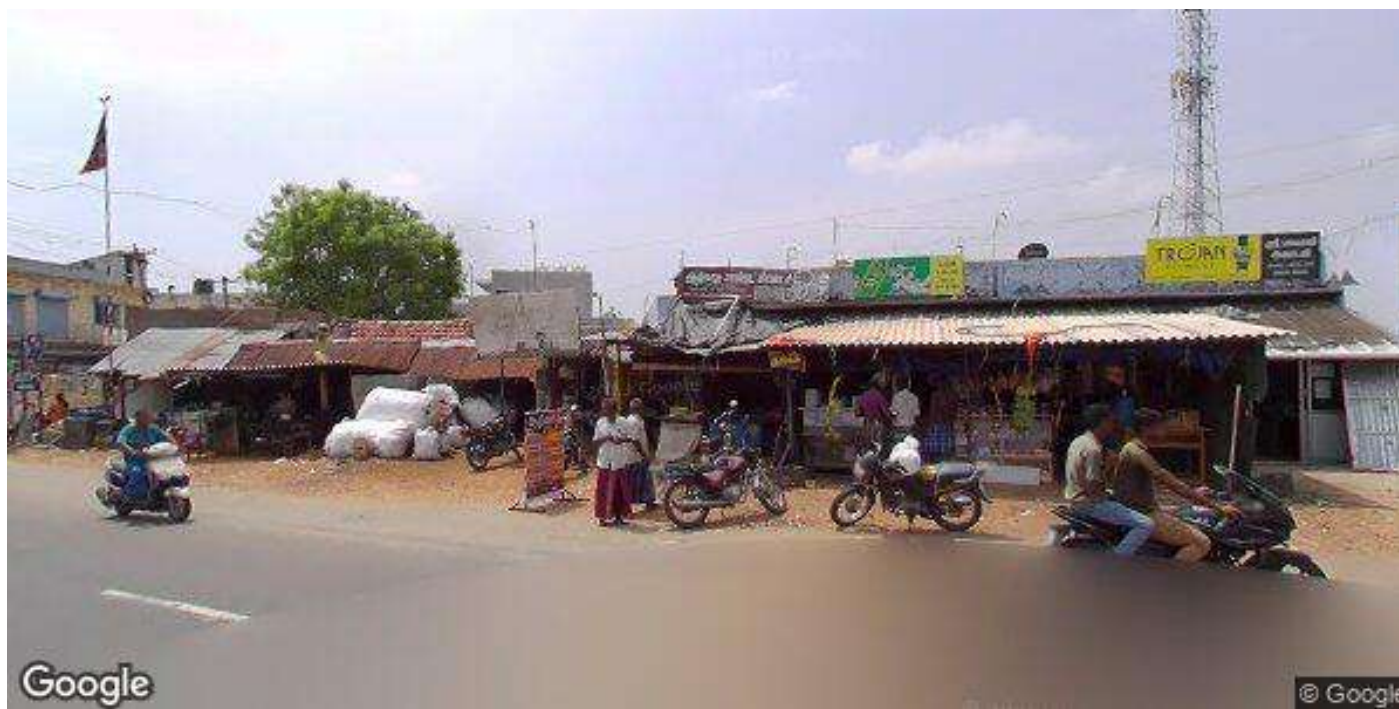
| | Risk Type | Risk Level | Coordinates | Speed Limit |
|---|---|---|---|---|
| 15 | Turn | High | 11.44387, 77.96283 | 15 KM/Hr |

**Risk Type:** Turn  
**Risk Level:** High  
**Speed Limit:** 15 KM/Hr  
**Coordinates:** 11.44387, 77.96283

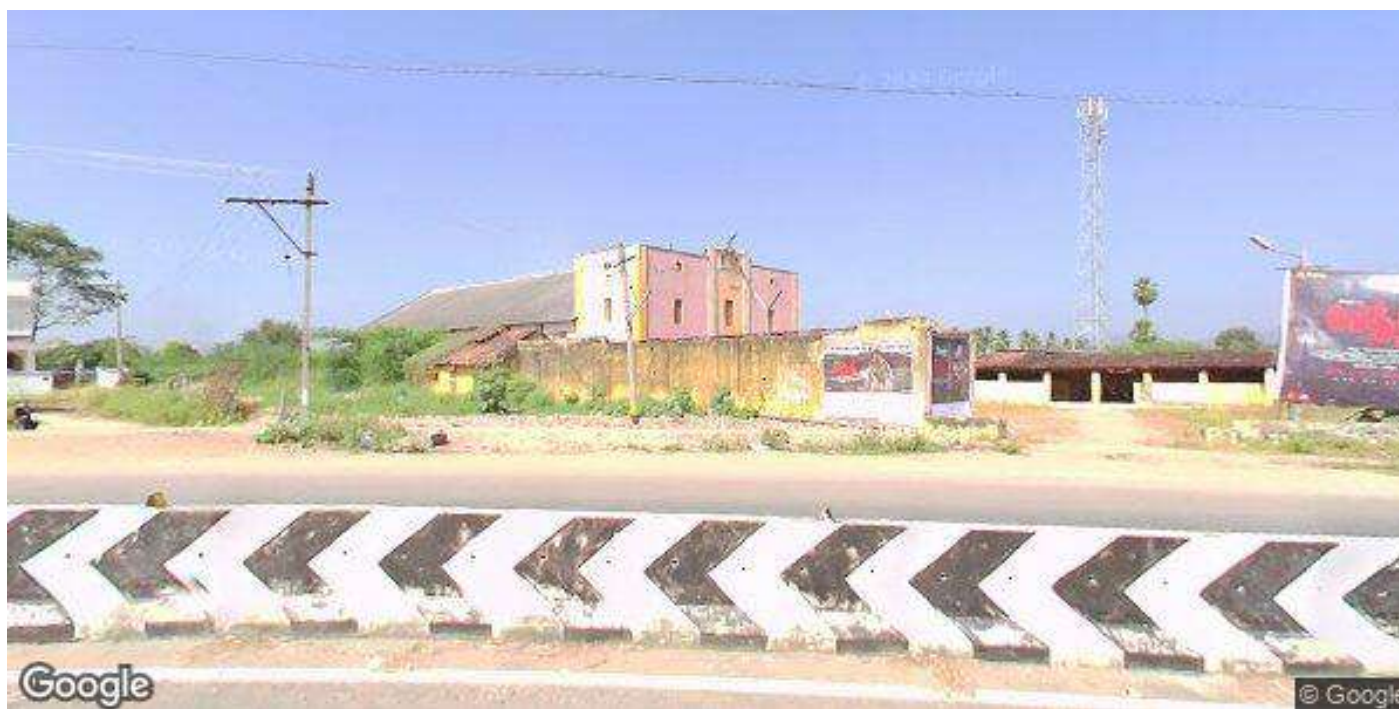
| | Risk Type | Risk Level | Coordinates | Speed Limit |
|---|---|---|---|---|
| 16 | Turn | Medium | 11.53064, 78.04684 | 30 KM/Hr |

**Risk Type:** Turn  
**Risk Level:** Medium  
**Speed Limit:** 30 KM/Hr  
**Coordinates:** 11.53064, 78.04684

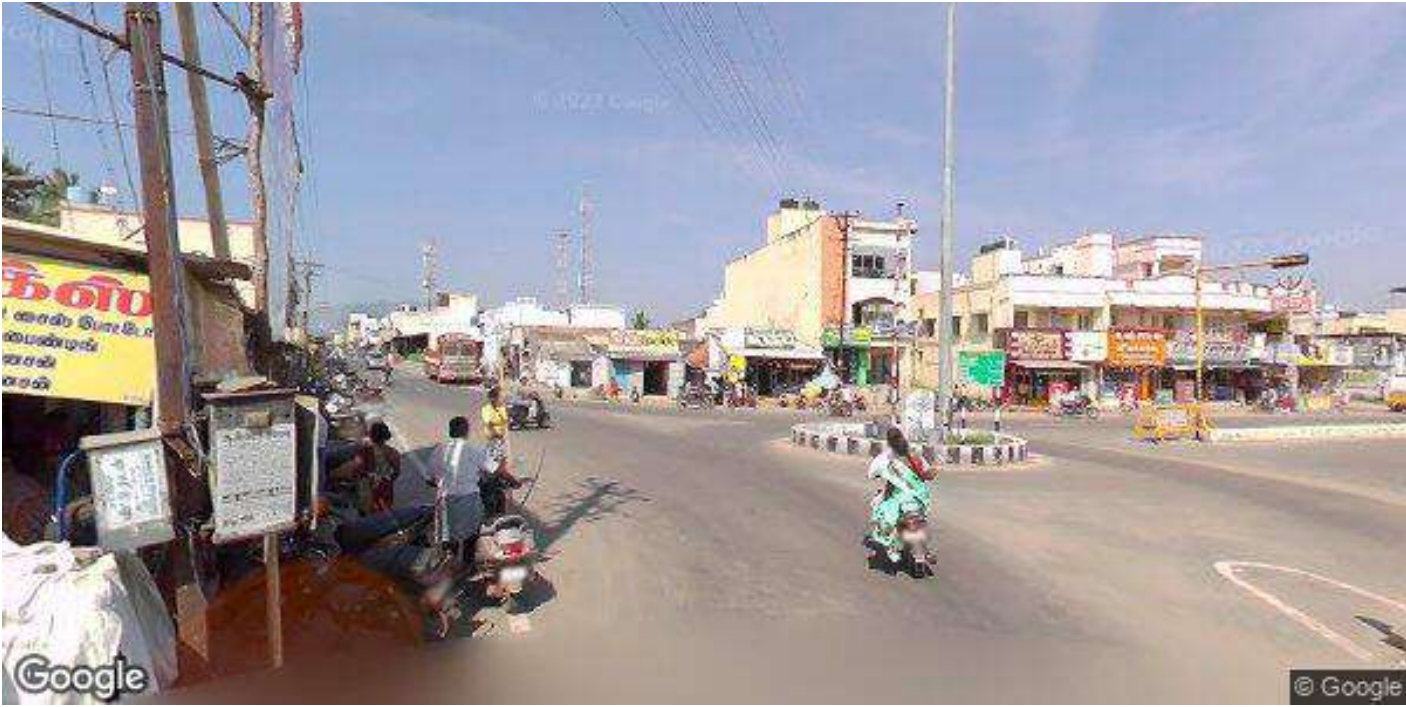
| | Risk Type | Risk Level | Coordinates | Speed Limit |
|---|---|---|---|---|
| 17 | Turn | Medium | 11.53170, 78.05073 | 30 KM/Hr |

**Risk Type:** Turn  
**Risk Level:** Medium  
**Speed Limit:** 30 KM/Hr  
**Coordinates:** 11.53170, 78.05073
