# IndianOil

## JOURNEY RISK MANAGEMENT (JRM) STUDY

**Salem Terminal TO NAMAKKAL TAL. RIG  
URIMAIYALARGAL SA**

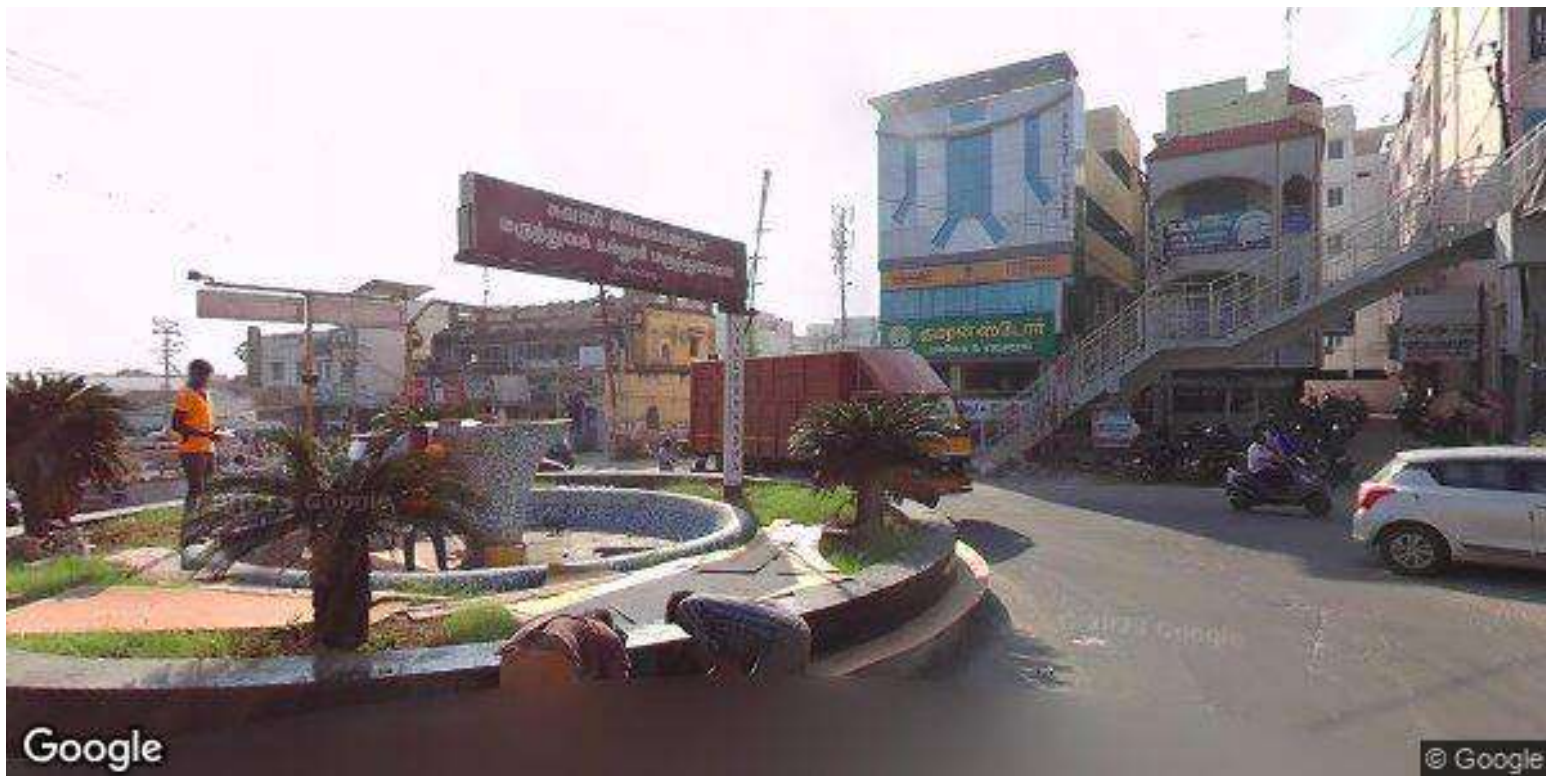
**Coordinates:** 11.38395, 77.89480

**Risk Type:** Roundabout

**Risk Level:** High

**Speed Limit:** 15 KM/Hr

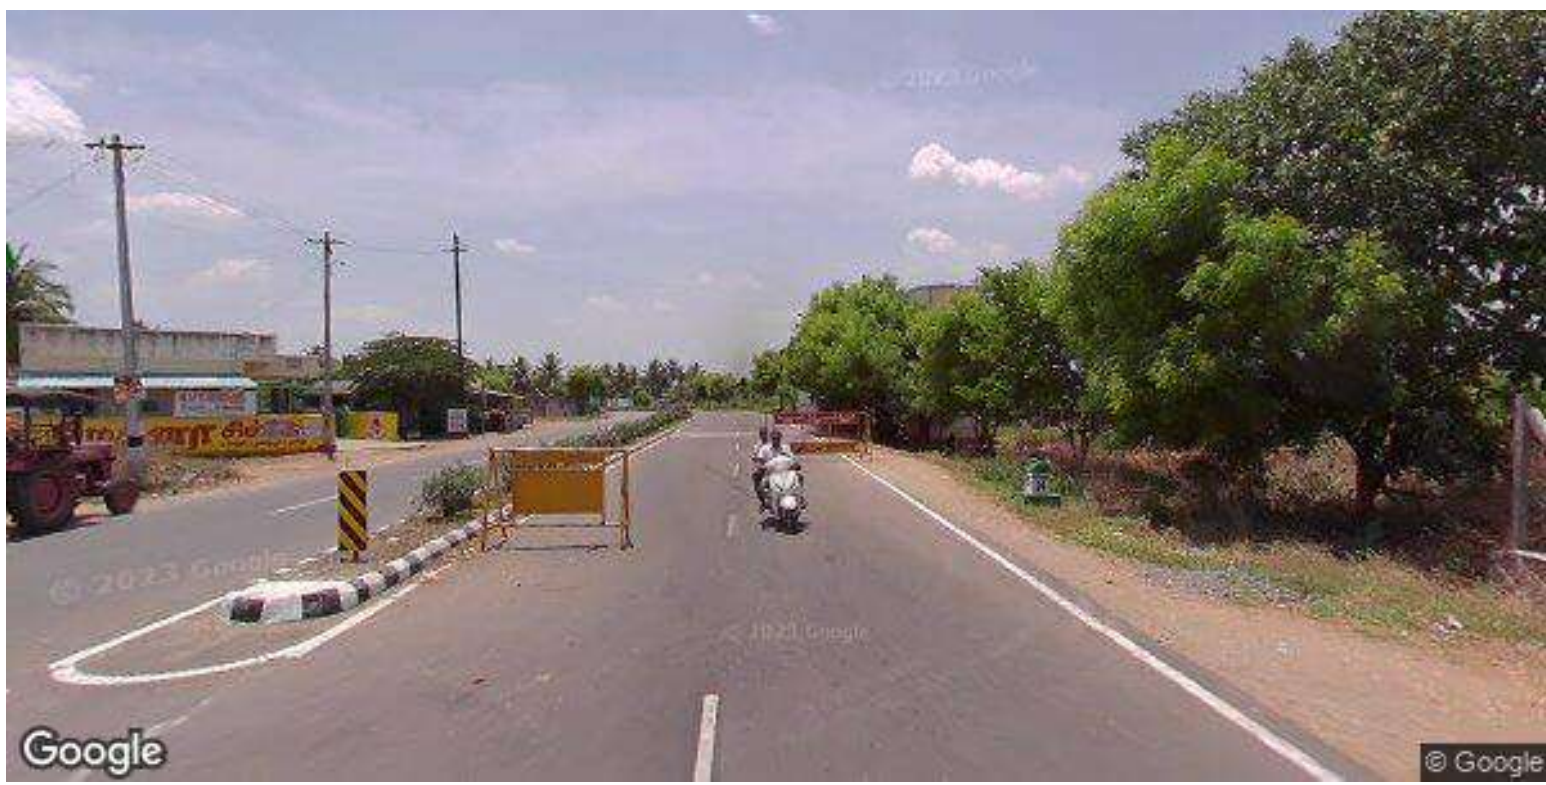
**Coordinates:** 11.27732, 78.08017

**Risk Type:** Turn

**Risk Level:** High

**Speed Limit:** 15 KM/Hr
