# IndianOil

## JOURNEY RISK MANAGEMENT (JRM) STUDY

### Salem Terminal TO SHRI SHANMUGA ENTERPRISES

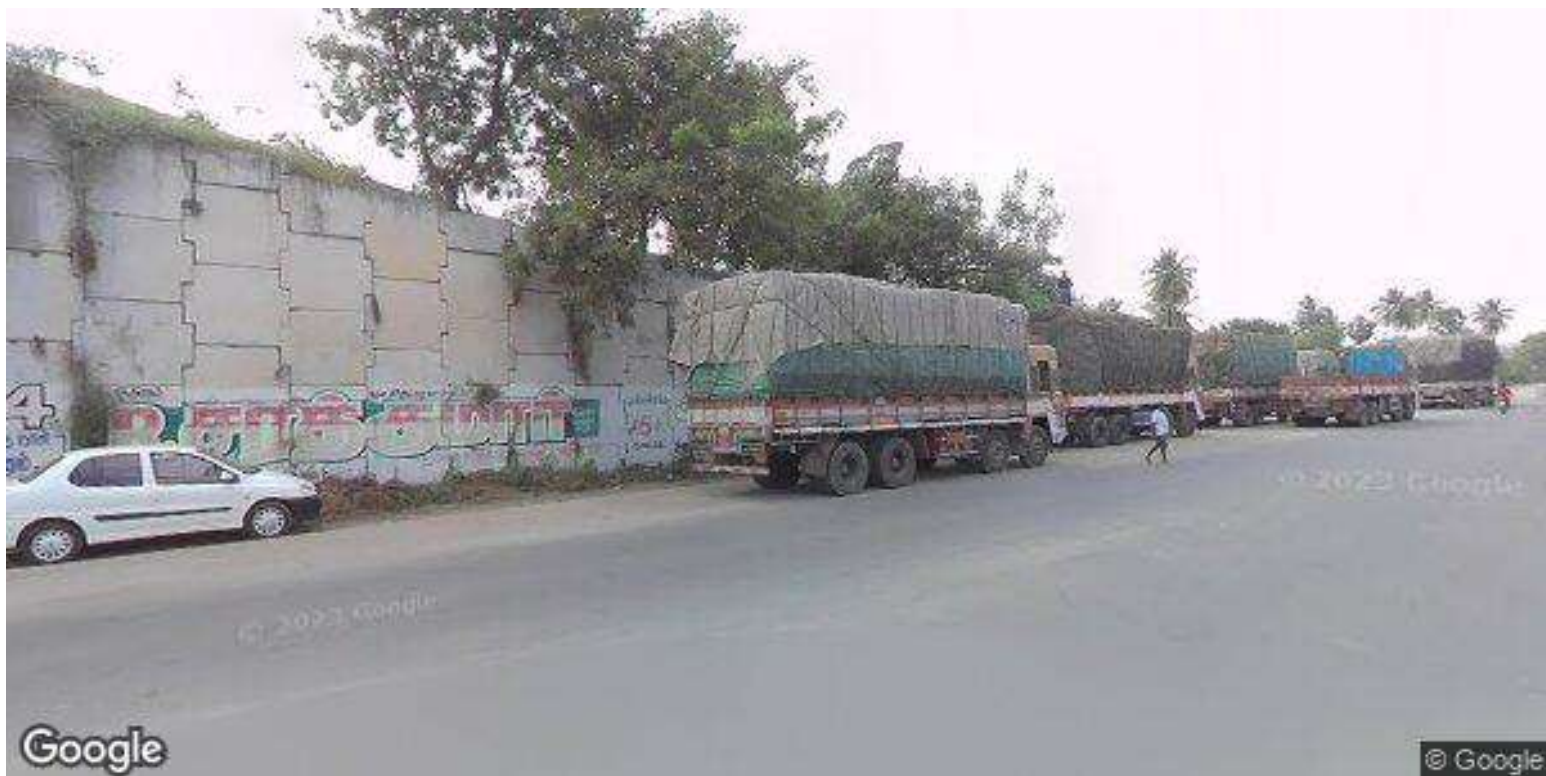
**Coordinates:** 11.49365, 77.88596

**Risk Type:** Turn

**Risk Level:** Medium

**Speed Limit:** 30 KM/Hr

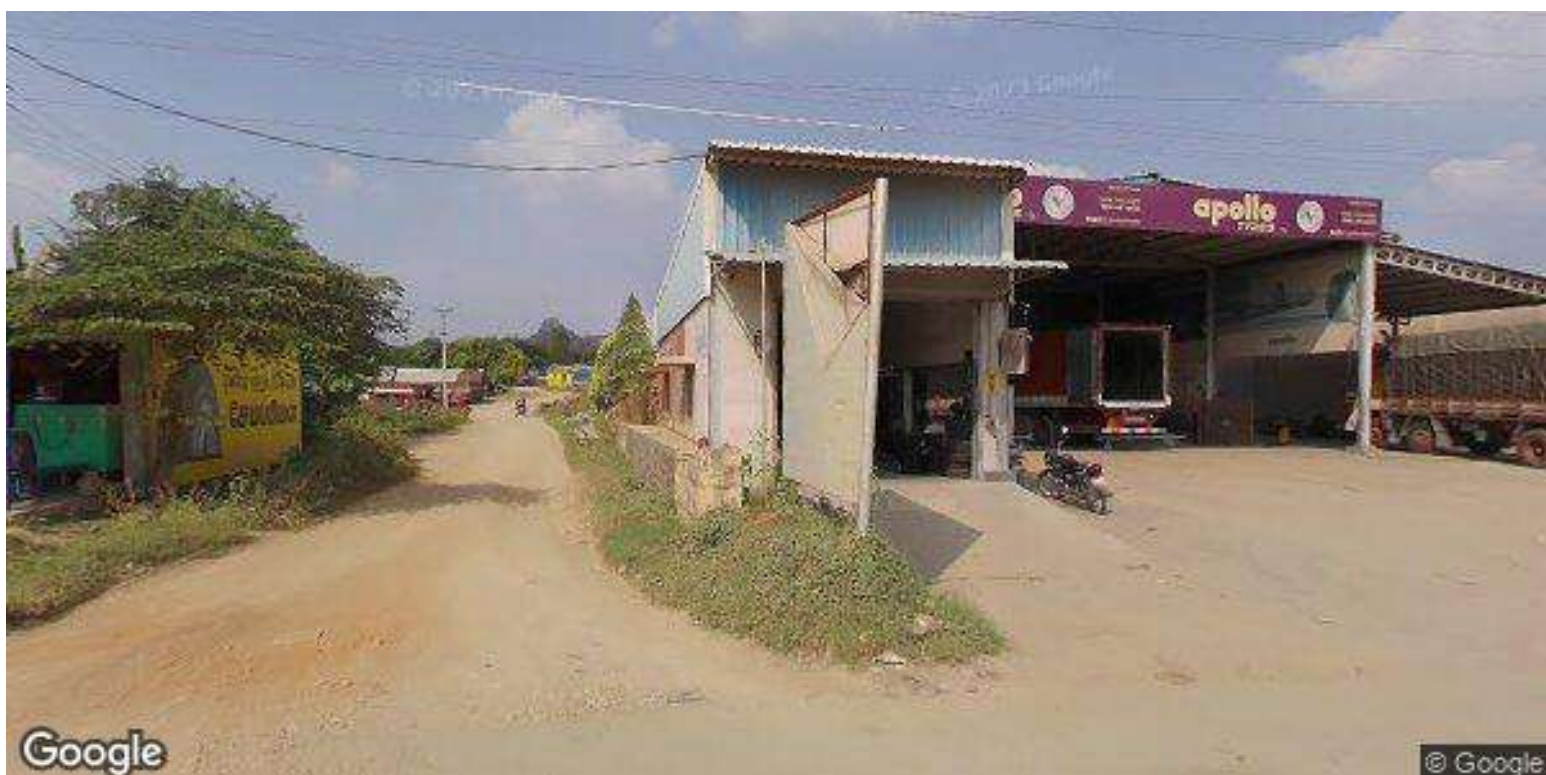
**Coordinates: 11.49235, 77.89561**

**Risk Type: Turn**

**Risk Level: High**

**Speed Limit: 15 KM/Hr**

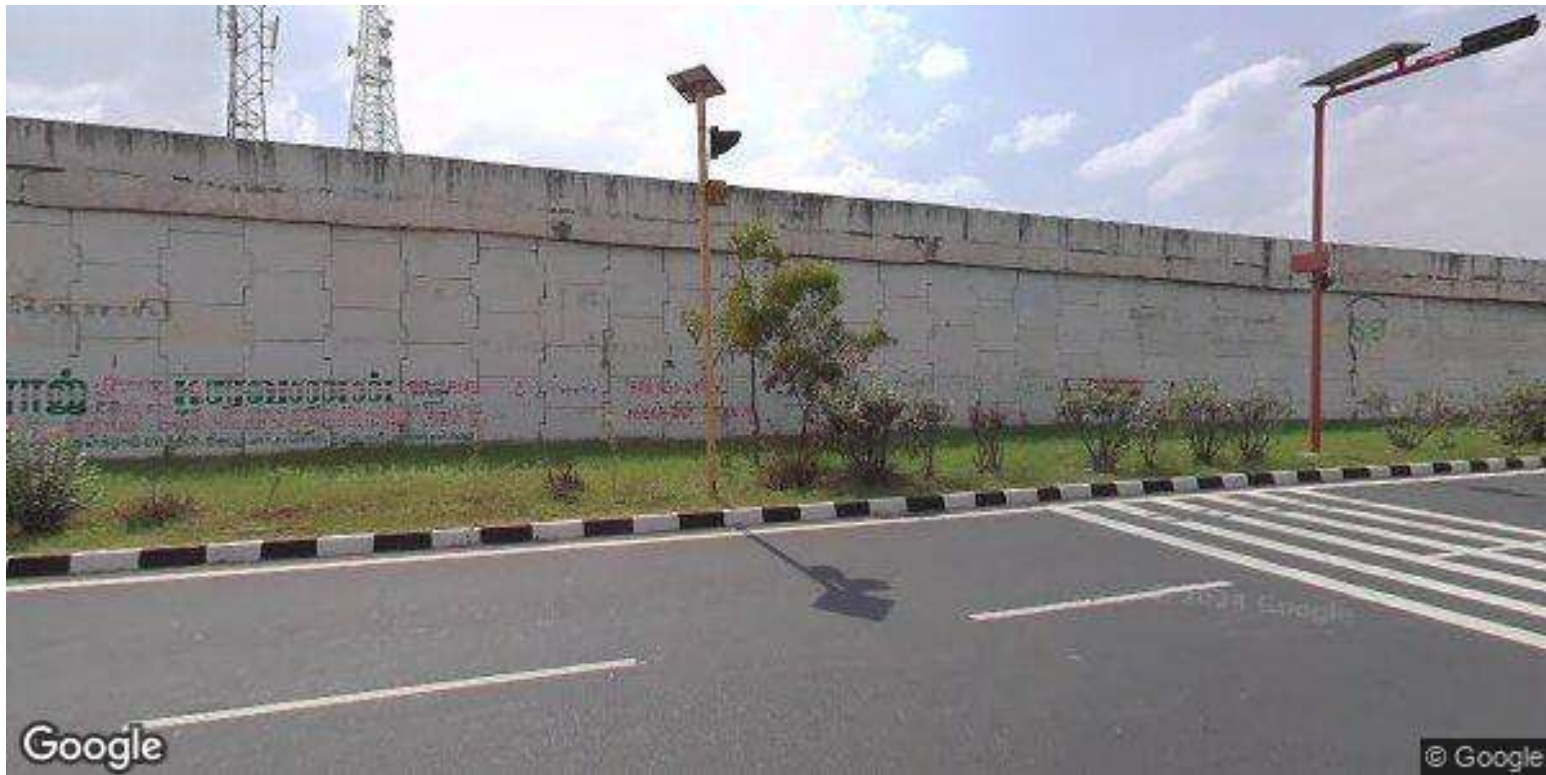
**Coordinates: 11.49225, 77.89560**

**Risk Type: Blind Spot**

**Risk Level: Blind Spot**

**Speed Limit: 10 KM/Hr**

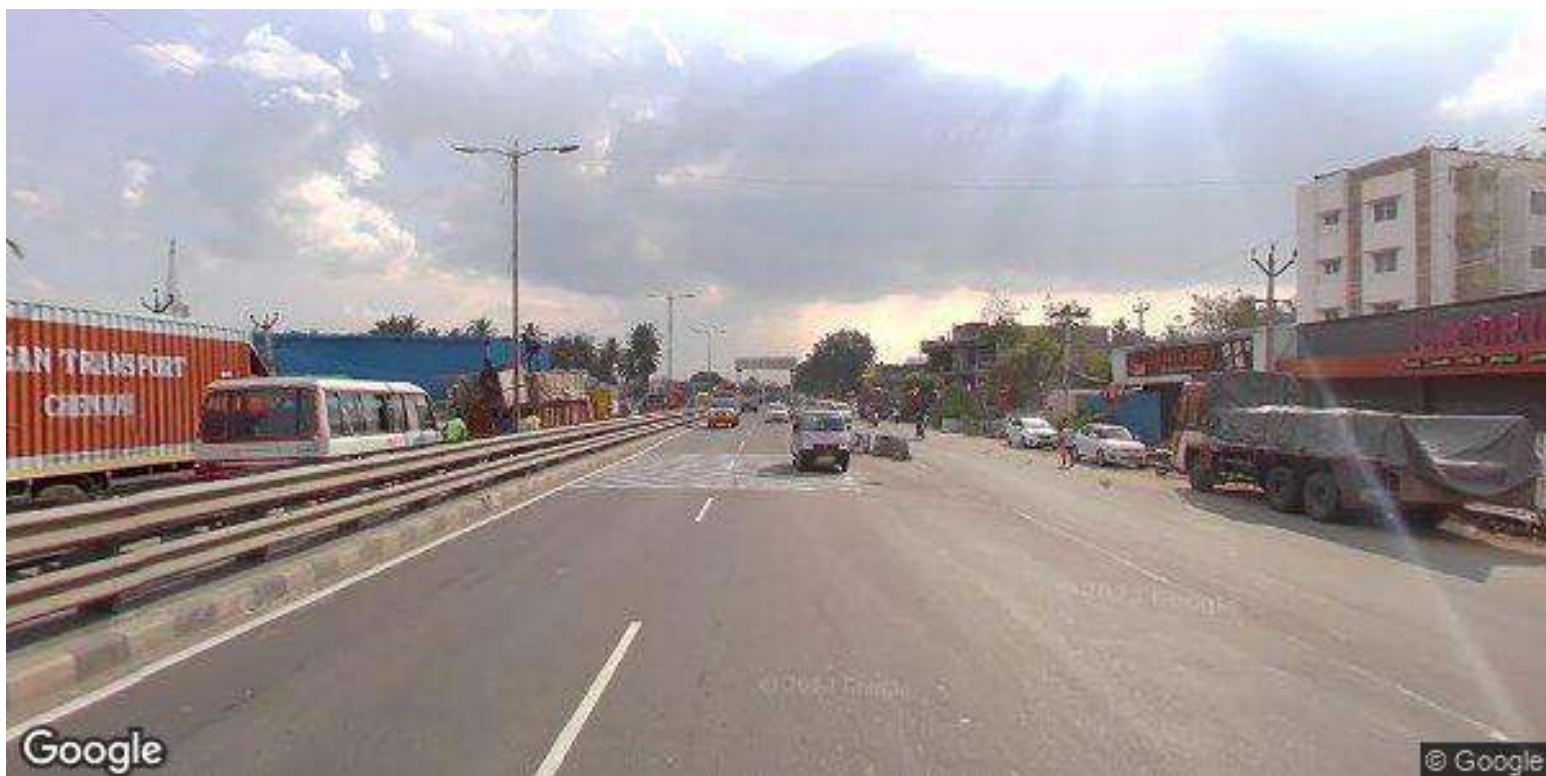
**Coordinates: 11.67074, 78.12668**

**Risk Type: Turn**

**Risk Level: High**

**Speed Limit: 15 KM/Hr**

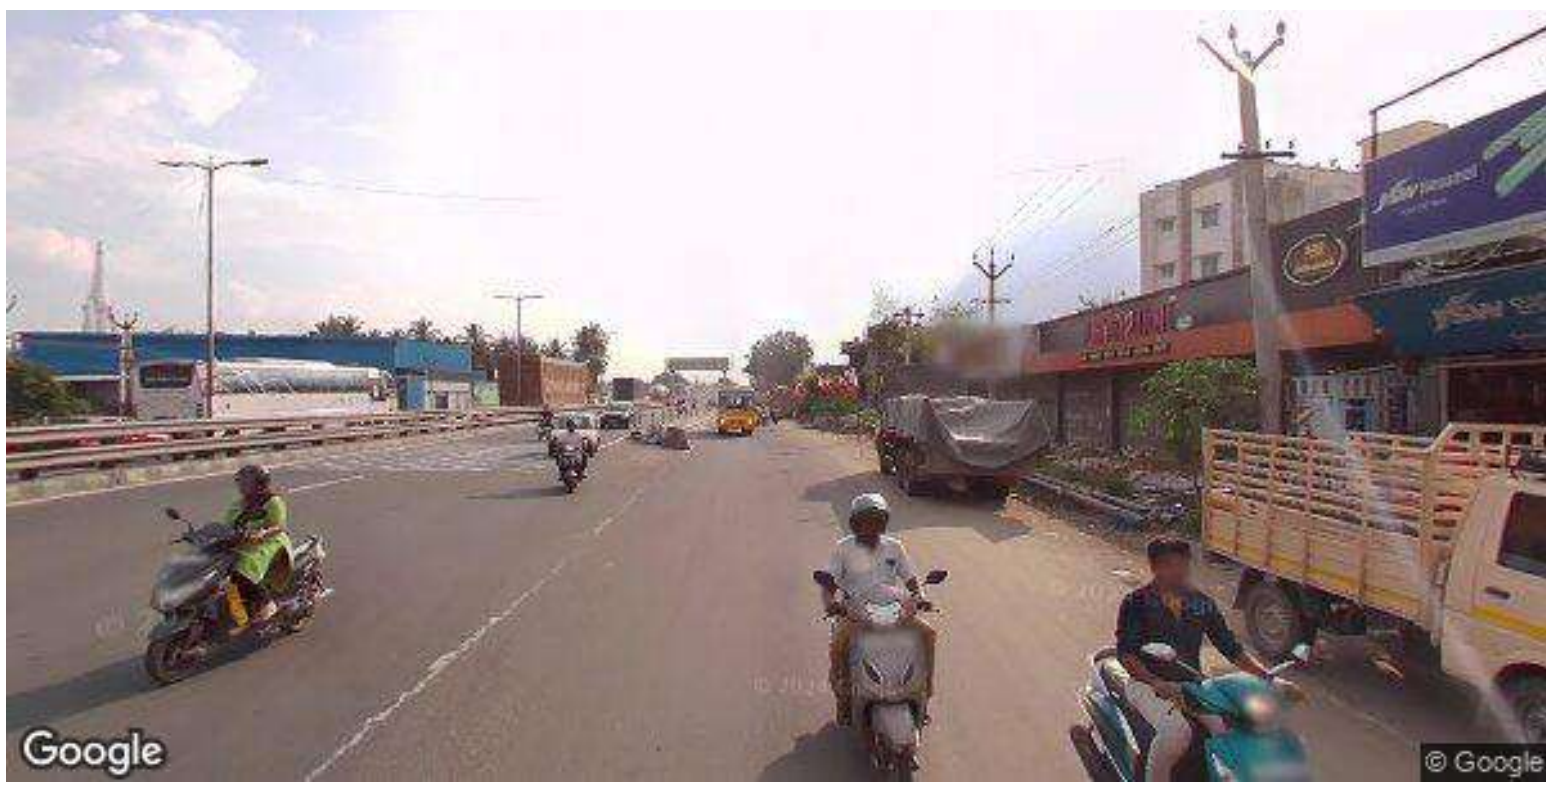
**Coordinates:** 11.67081, 78.12661

**Risk Type:** Turn

**Risk Level:** High

**Speed Limit:** 15 KM/Hr

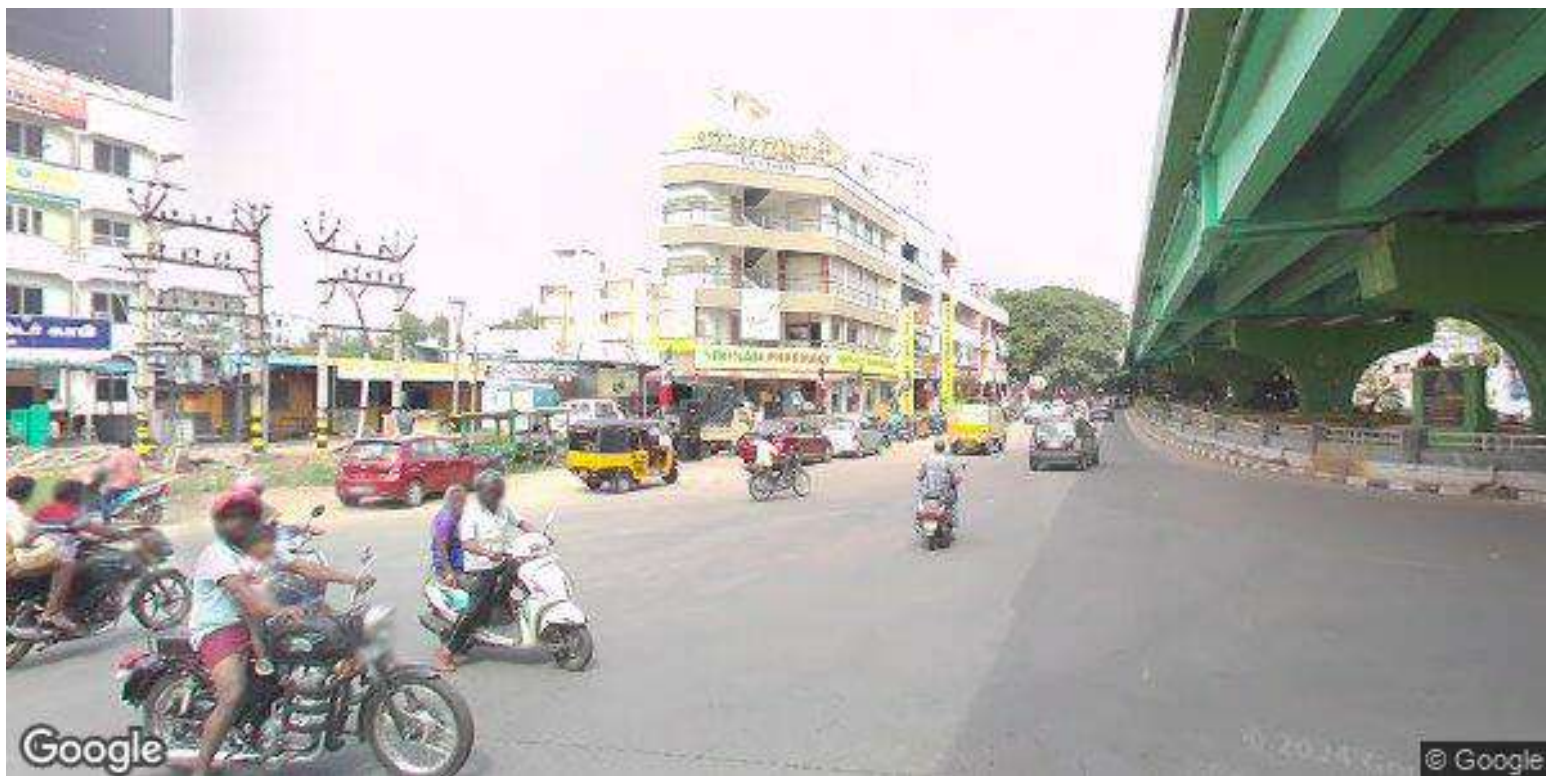
**Coordinates:** 11.67582, 78.12786

**Risk Type:** Turn

**Risk Level:** High

**Speed Limit:** 15 KM/Hr

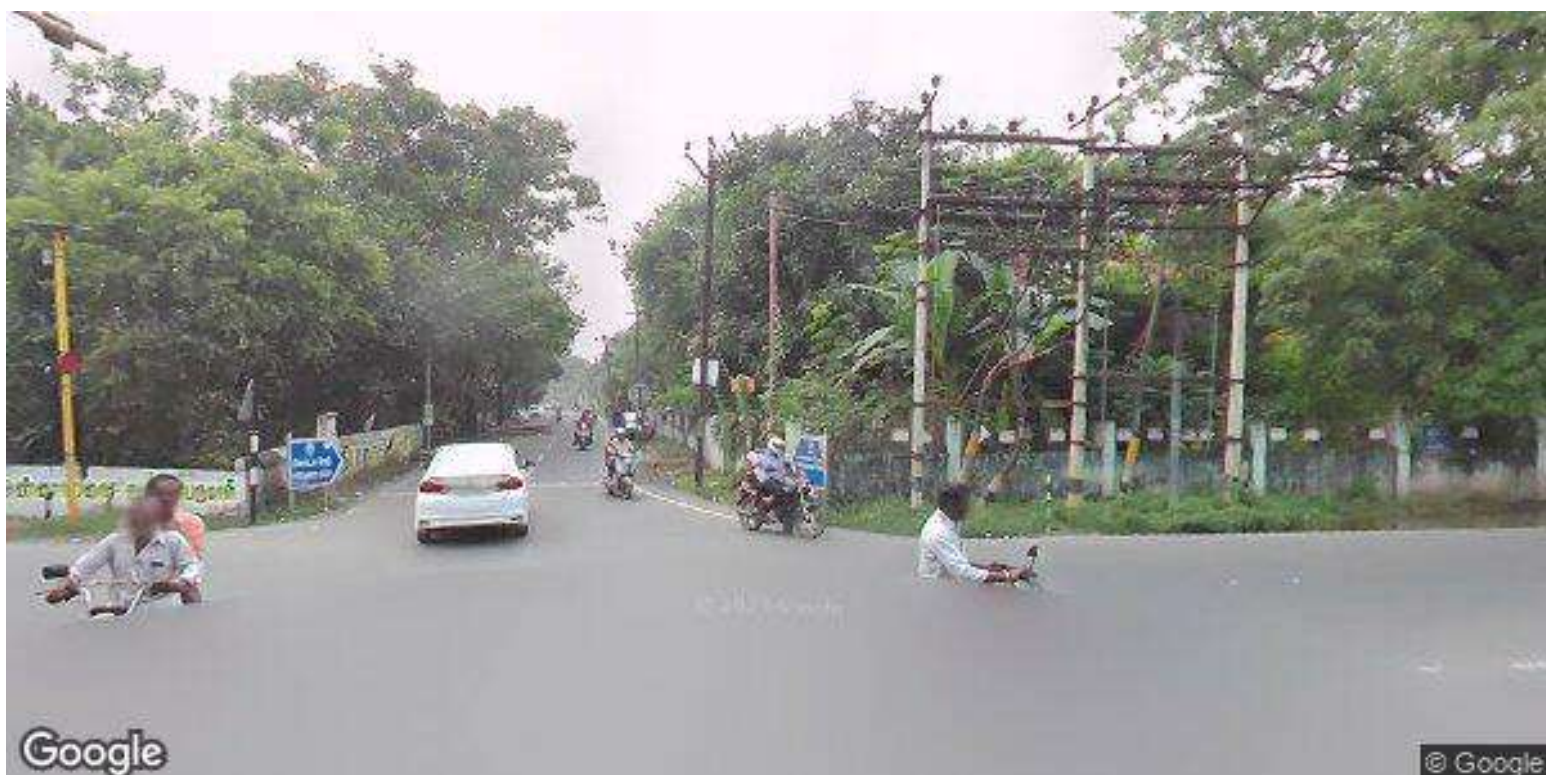
**Risk Type:** Turn  
**Risk Level:** High  
**Speed Limit:** 15 KM/Hr  
**Coordinates:** 11.67623, 78.15755

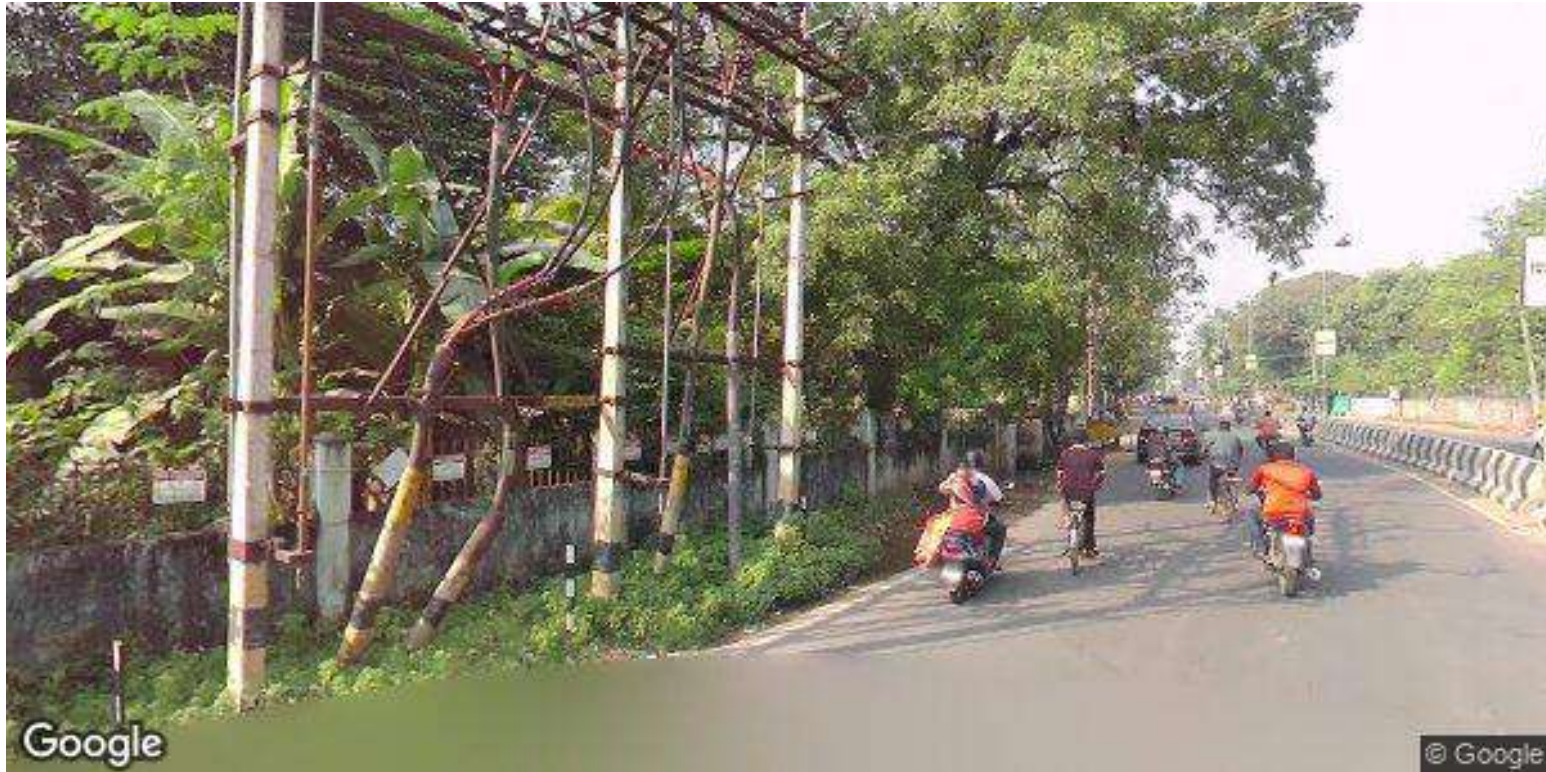
**Risk Type:** Blind Spot  
**Risk Level:** Blind Spot  
**Speed Limit:** 10 KM/Hr  
**Coordinates:** 11.67615, 78.15756

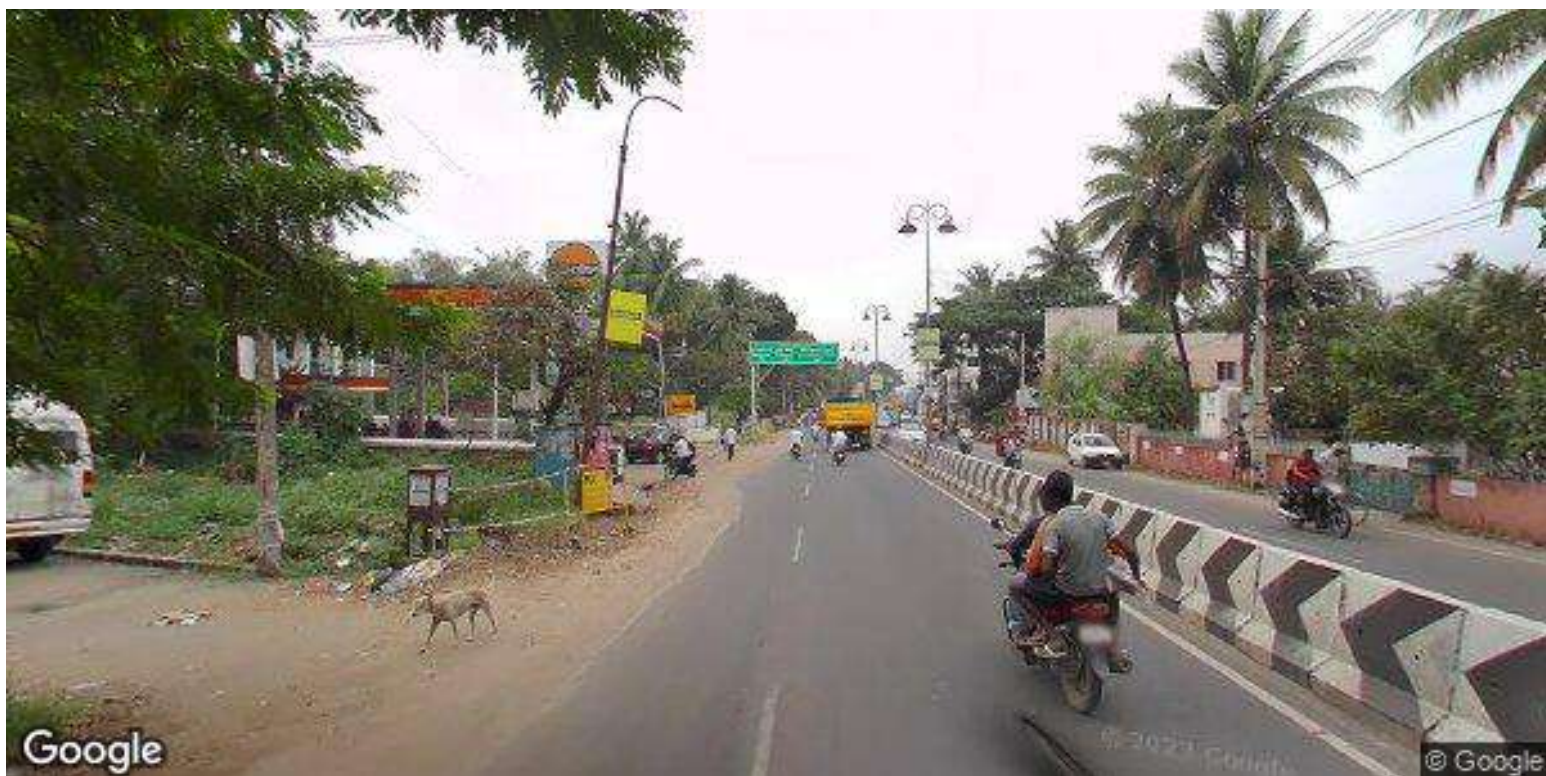
**Risk Type:** Turn  
**Risk Level:** High  
**Speed Limit:** 15 KM/Hr  
**Coordinates:** 11.67603, 78.15558
