# IndianOil

## JOURNEY RISK MANAGEMENT (JRM) STUDY

### Salem Terminal to CHERAN PETROLEUMS

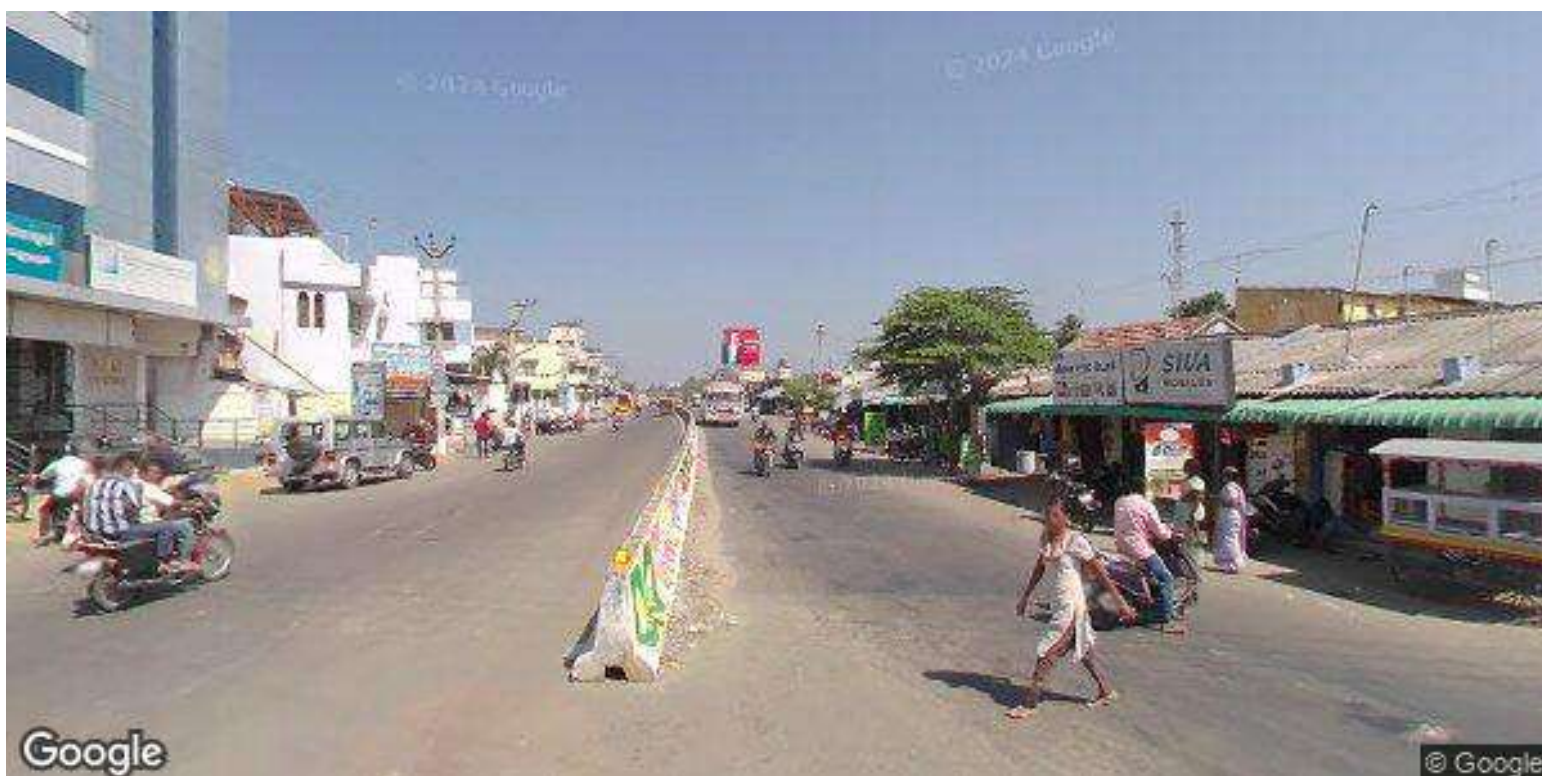
**Coordinates: 11.37086, 77.74828**

**Risk Type: Roundabout**

**Risk Level: High**

**Speed Limit: 15 KM/Hr**

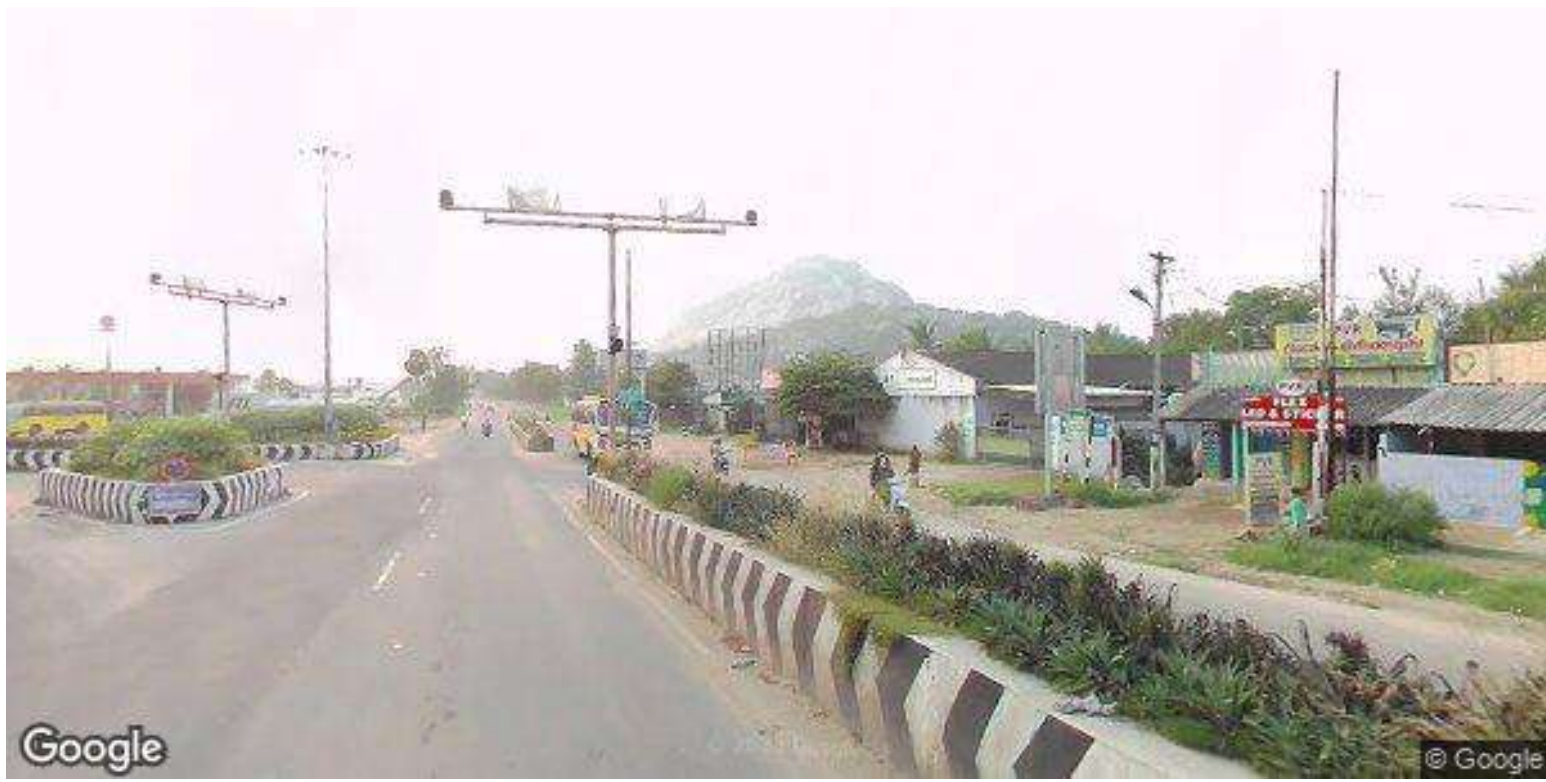
**Coordinates:** 11.46312, 77.84886

**Risk Type:** Turn

**Risk Level:** Medium

**Speed Limit:** 30 KM/Hr

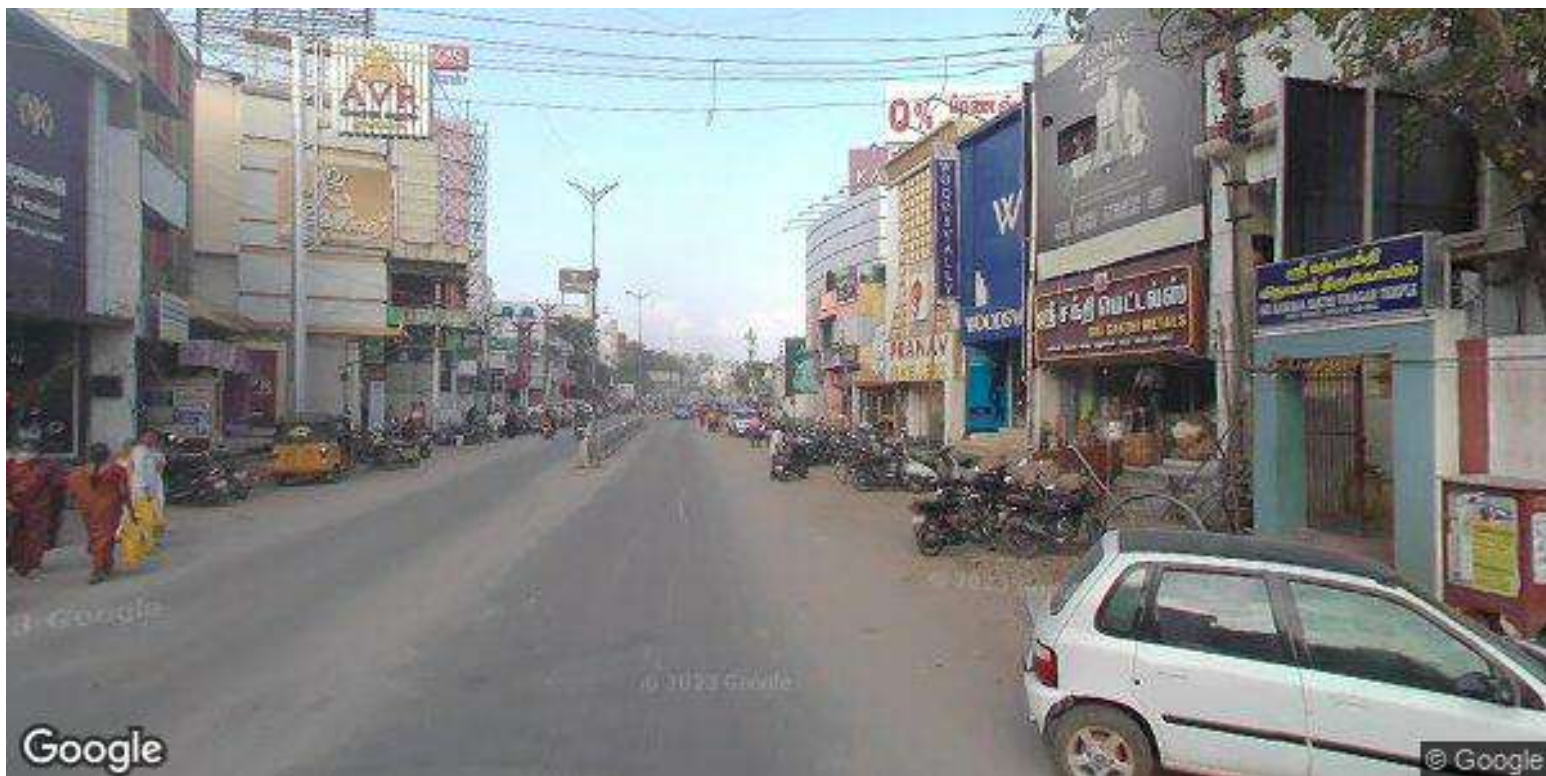
**Coordinates:** 11.34532, 77.73047

**Risk Type:** Turn

**Risk Level:** High

**Speed Limit:** 15 KM/Hr

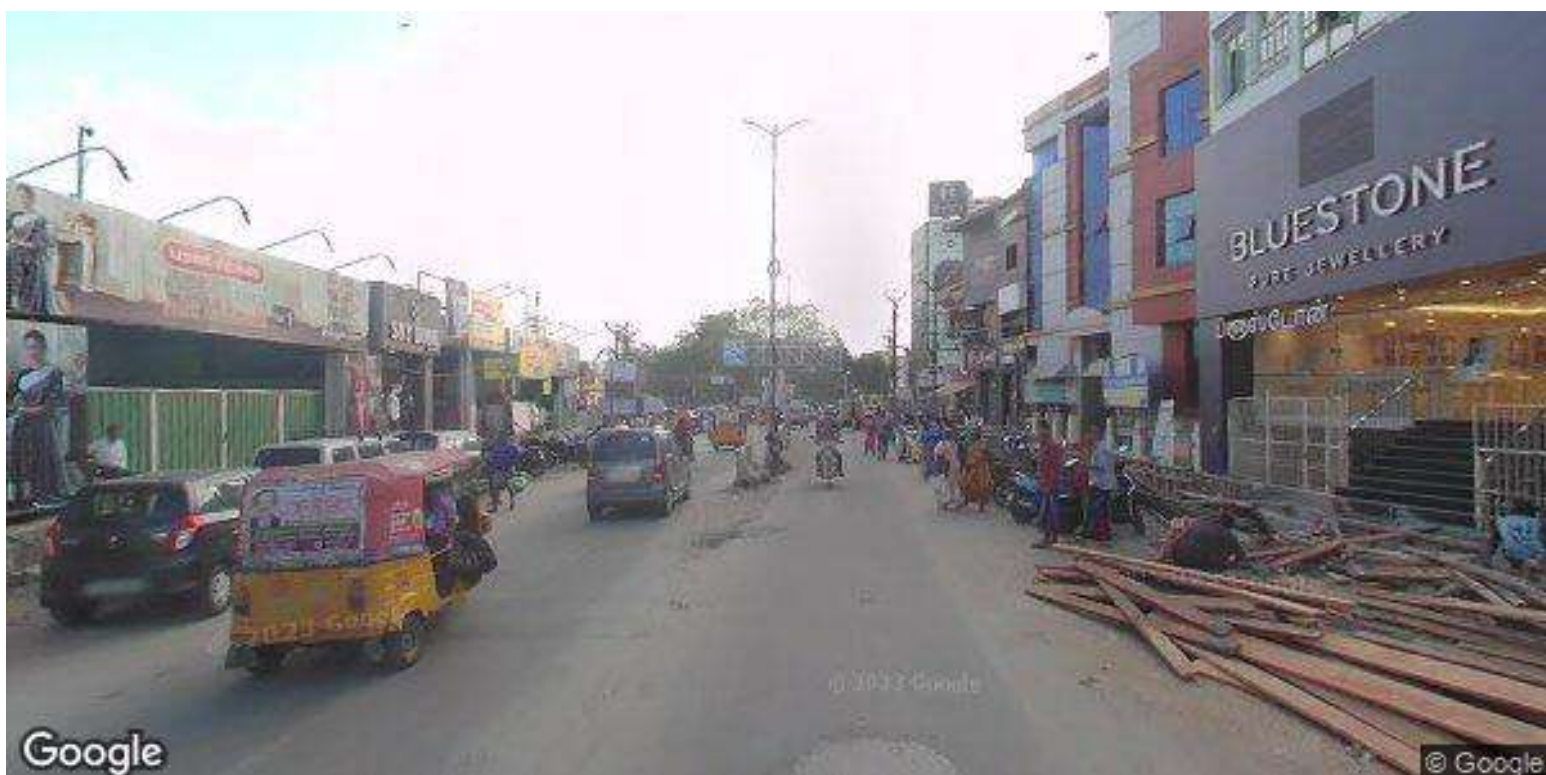
**Risk Type:** Blind Spot  
**Risk Level:** Blind Spot  
**Speed Limit:** 10 KM/Hr  
**Coordinates:** 11.34535, 77.73036

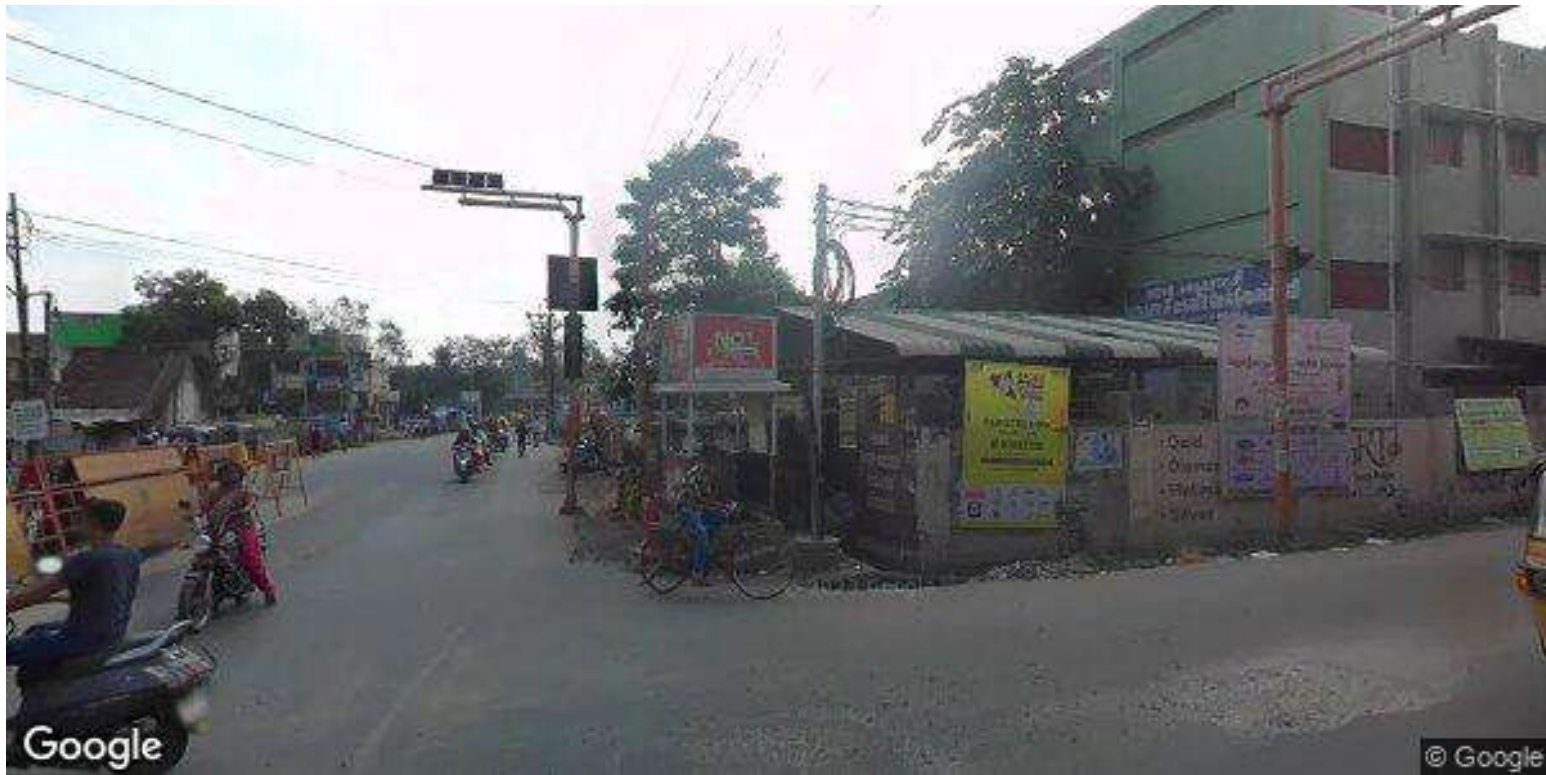
**Risk Type:** Blind Spot  
**Risk Level:** Blind Spot  
**Speed Limit:** 10 KM/Hr  
**Coordinates:** 11.34964, 77.73257

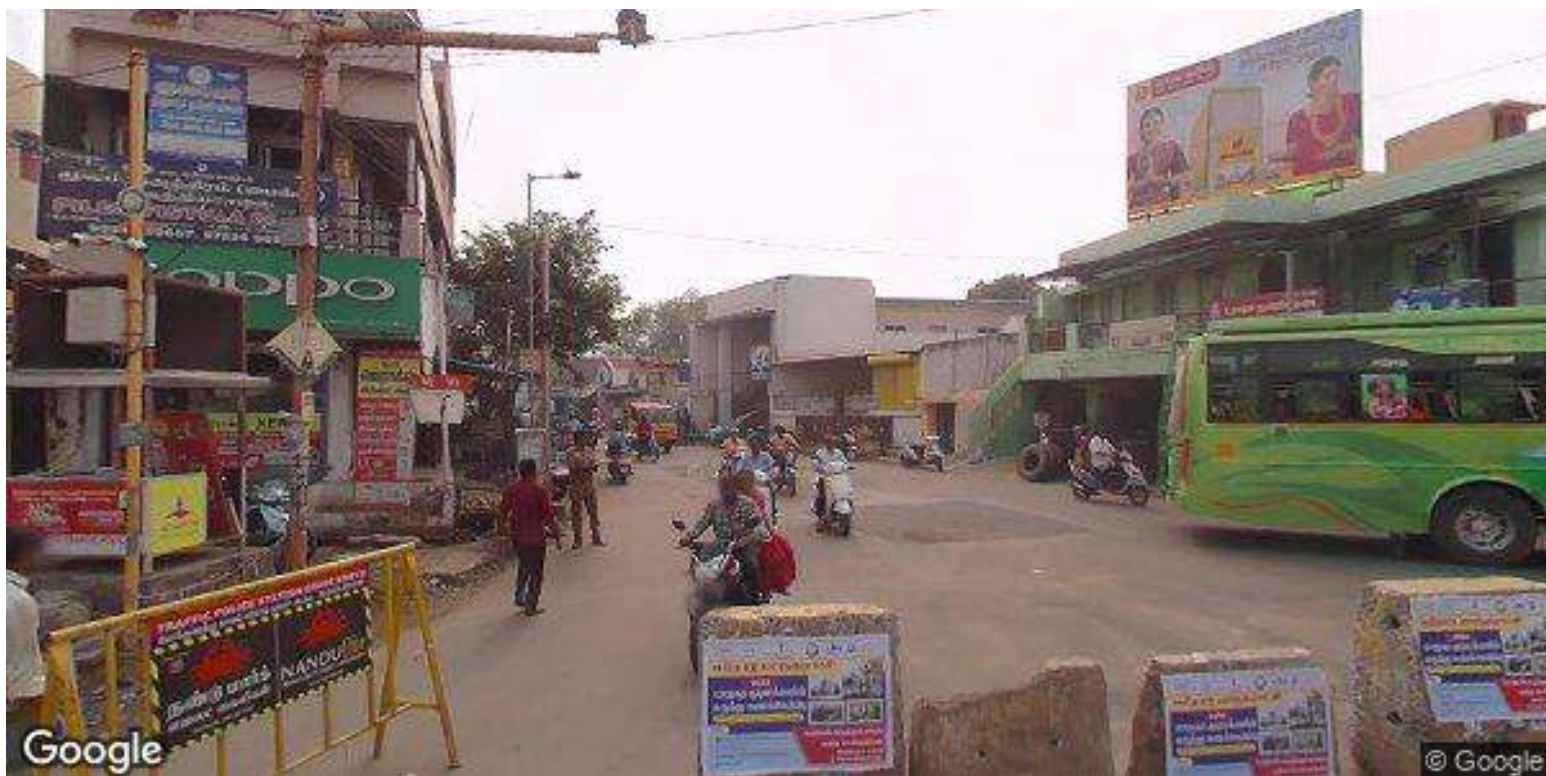
**Risk Type:** Turn  
**Risk Level:** High  
**Speed Limit:** 15 KM/Hr  
**Coordinates:** 11.35072, 77.72261

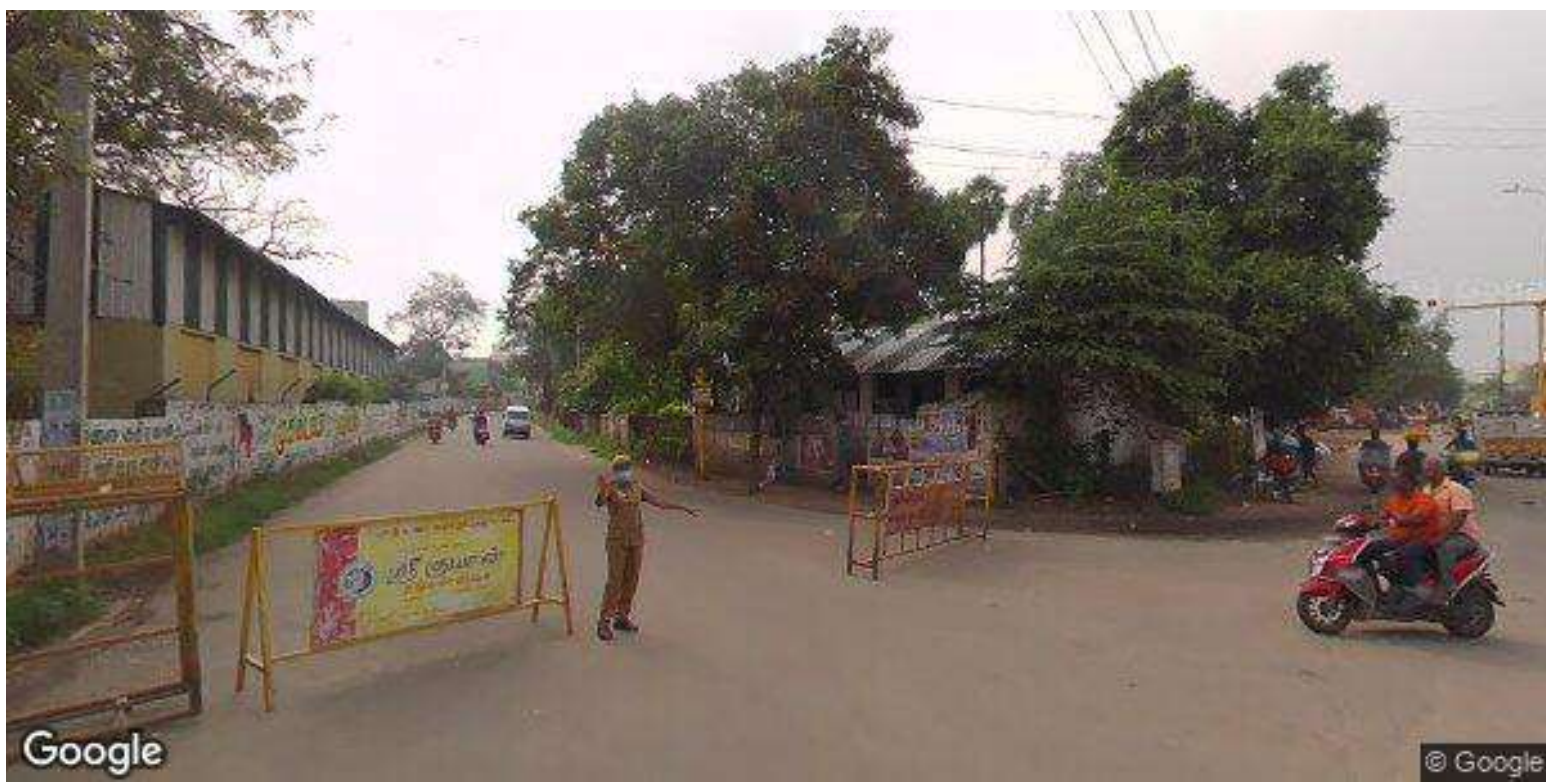
**Coordinates:** 11.35306, 77.71961

**Risk Type:** Turn

**Risk Level:** High

**Speed Limit:** 15 KM/Hr

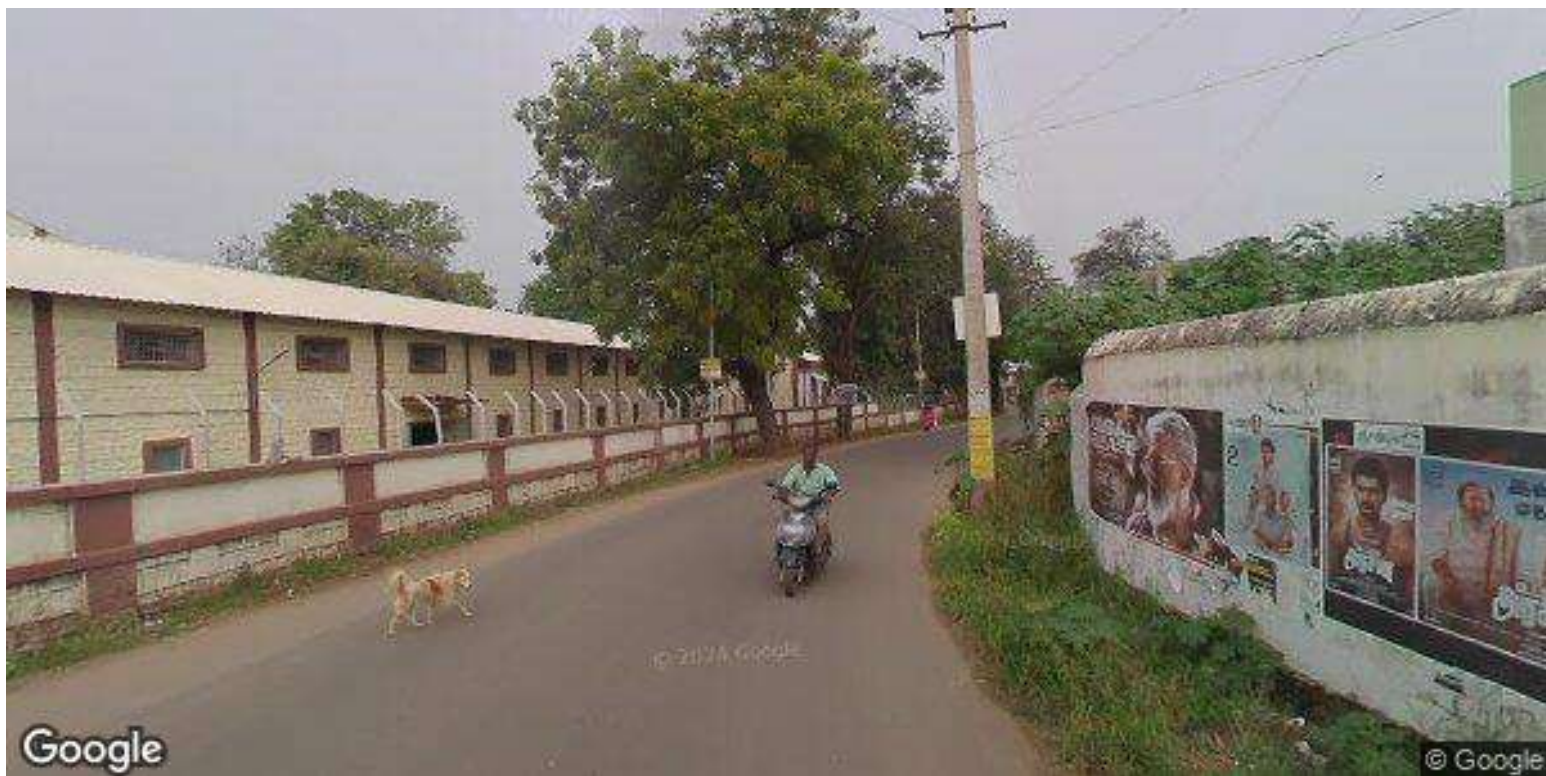
**Coordinates:** 11.35269, 77.71811

**Risk Type:** Turn

**Risk Level:** Medium

**Speed Limit:** 30 KM/Hr

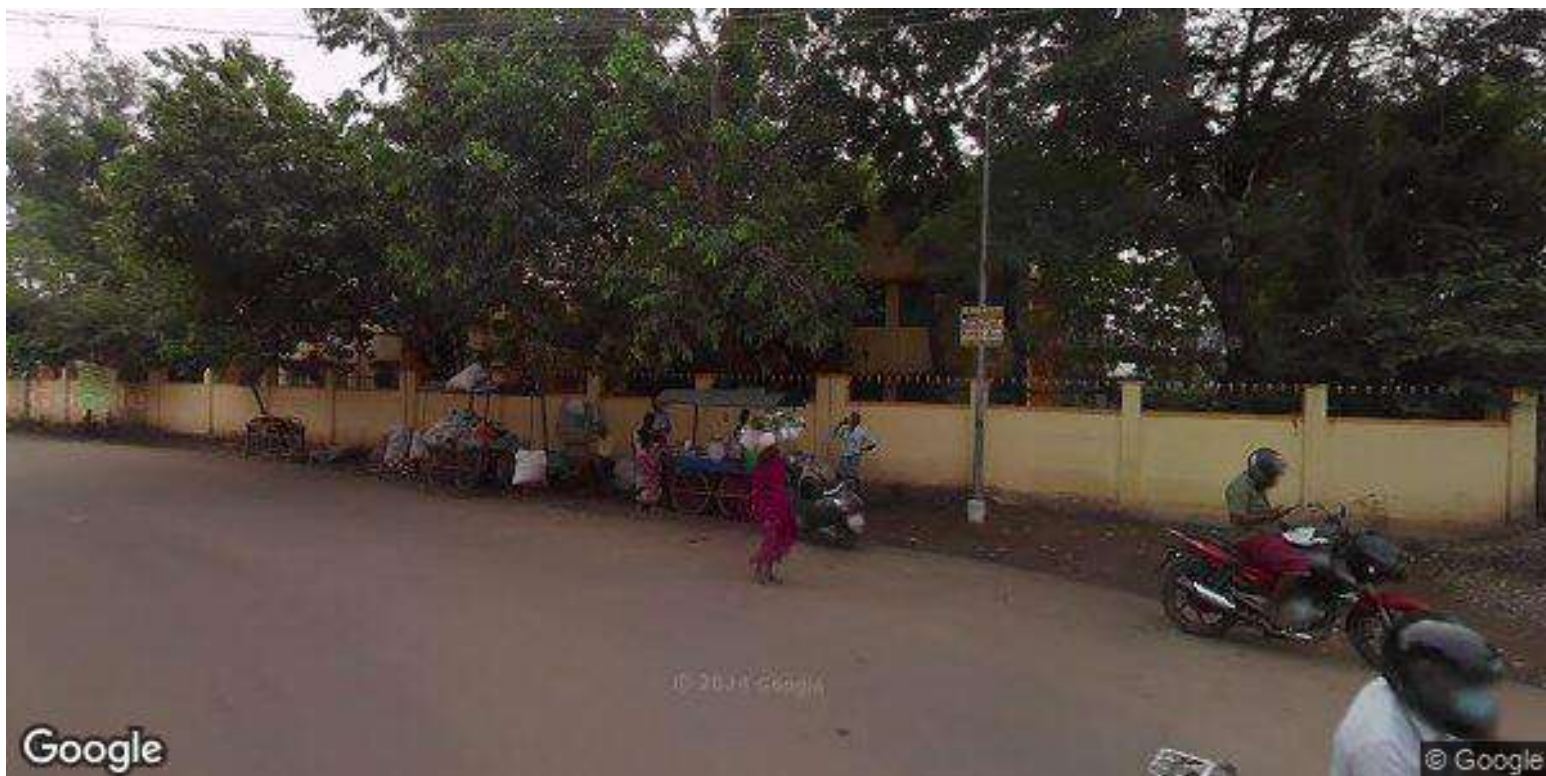
**Coordinates:** 11.35173, 77.71753

**Risk Type:** Turn

**Risk Level:** Medium

**Speed Limit:** 30 KM/Hr

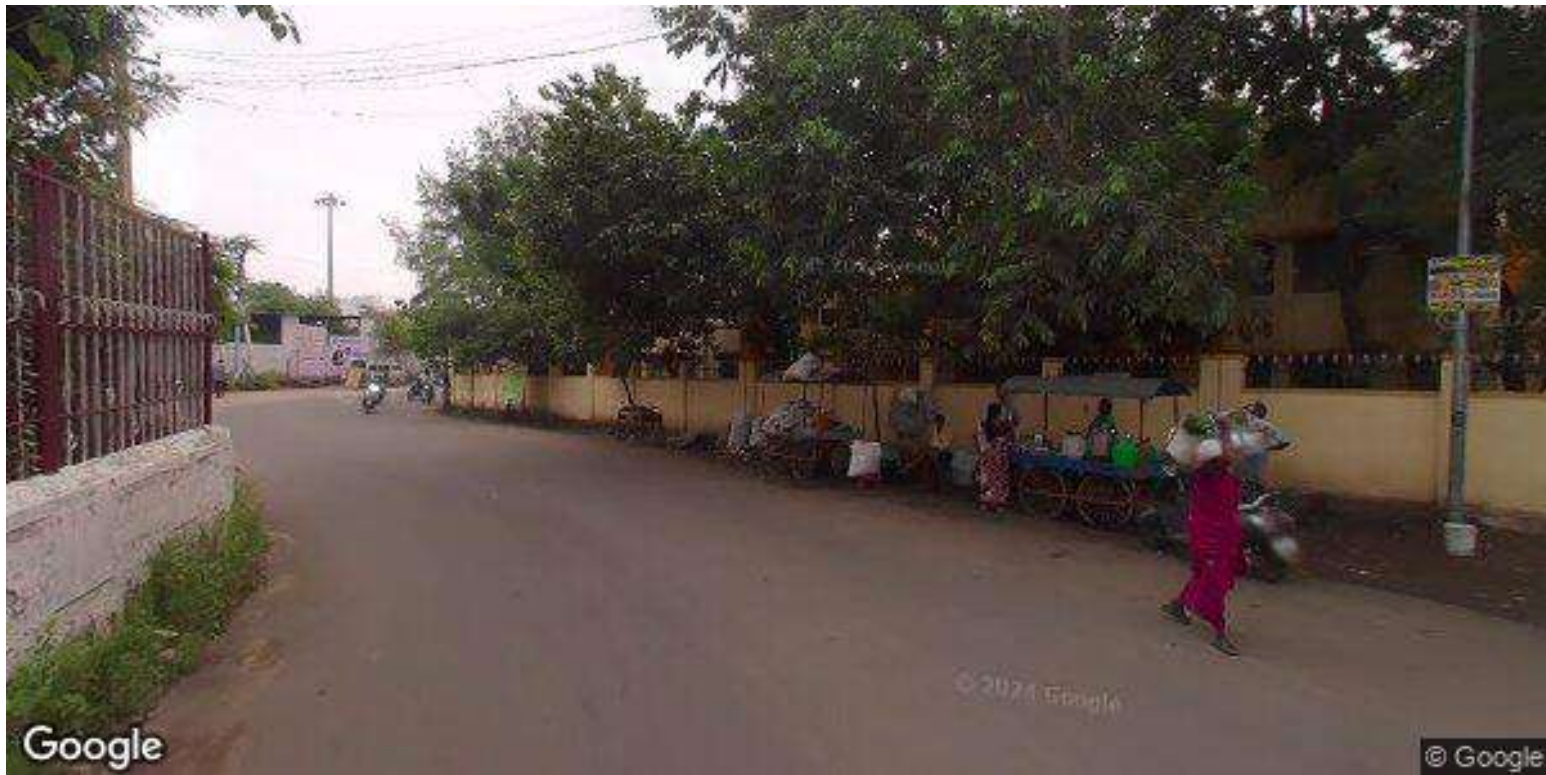
**Coordinates:** 11.35167, 77.71753

**Risk Type:** Turn

**Risk Level:** Medium

**Speed Limit:** 30 KM/Hr

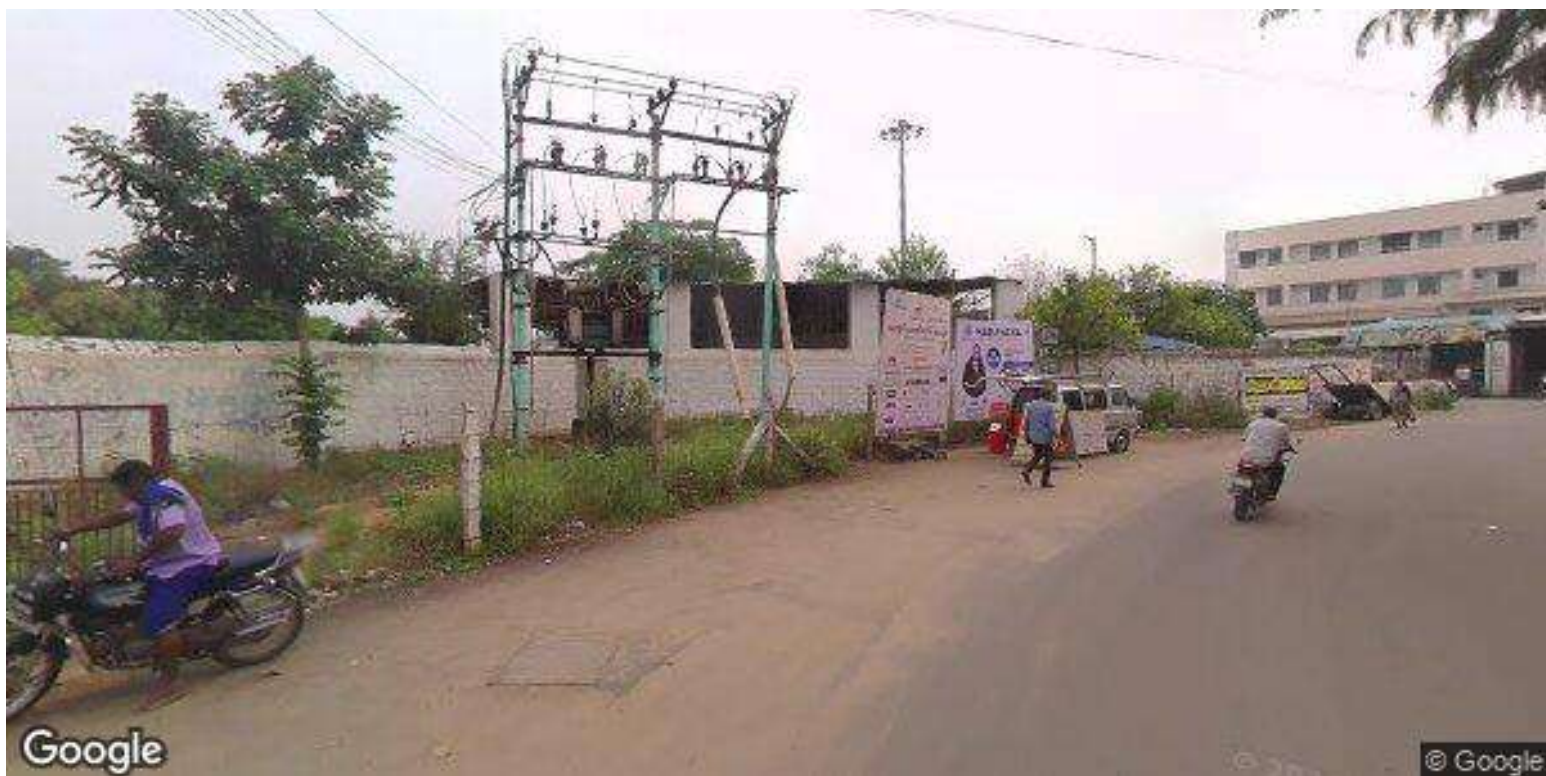
**Coordinates:** 11.35138, 77.71774

**Risk Type:** Turn

**Risk Level:** Medium

**Speed Limit:** 30 KM/Hr

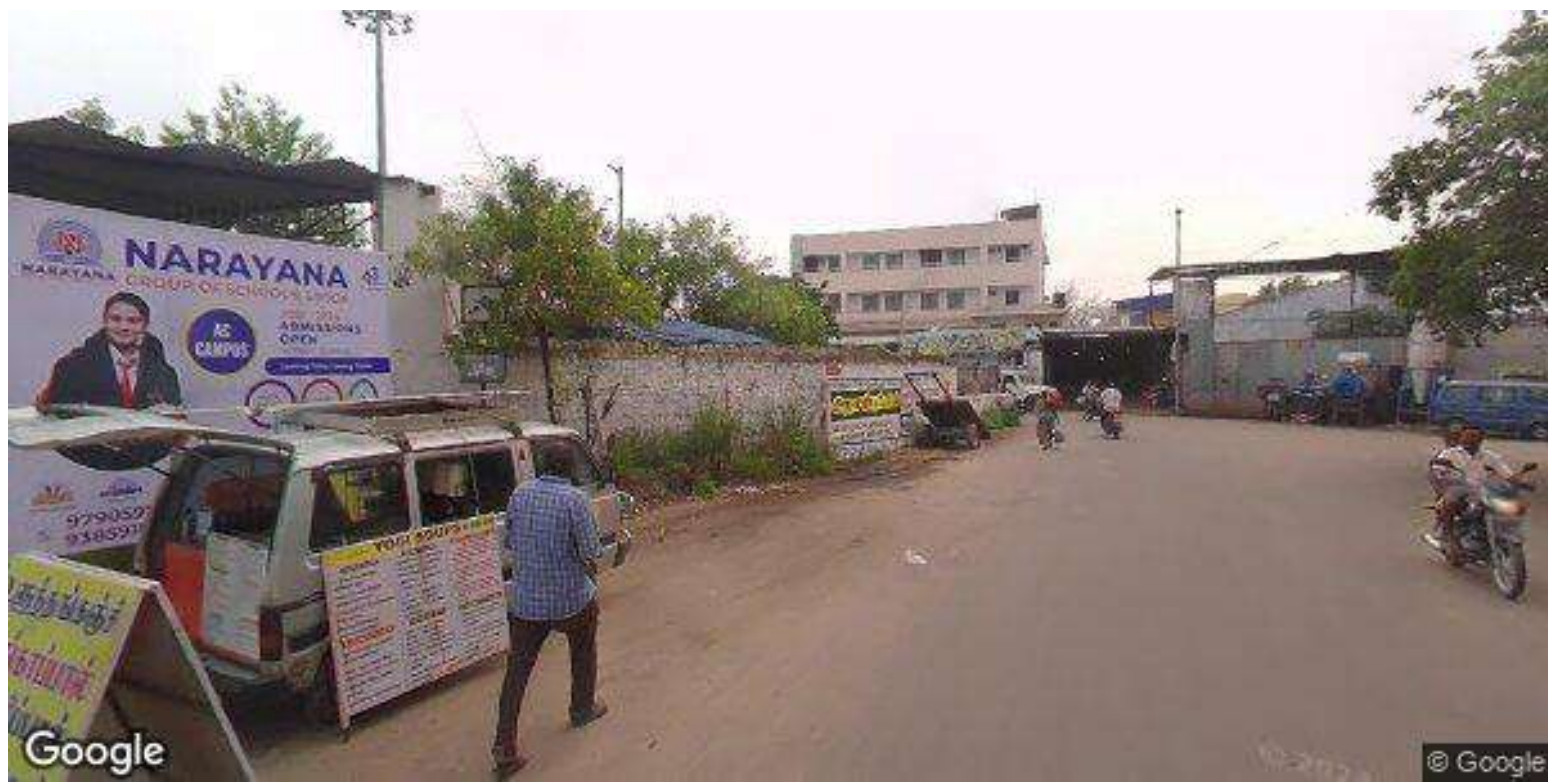
**Coordinates:** 11.35129, 77.71775

**Risk Type:** Turn

**Risk Level:** Medium

**Speed Limit:** 30 KM/Hr

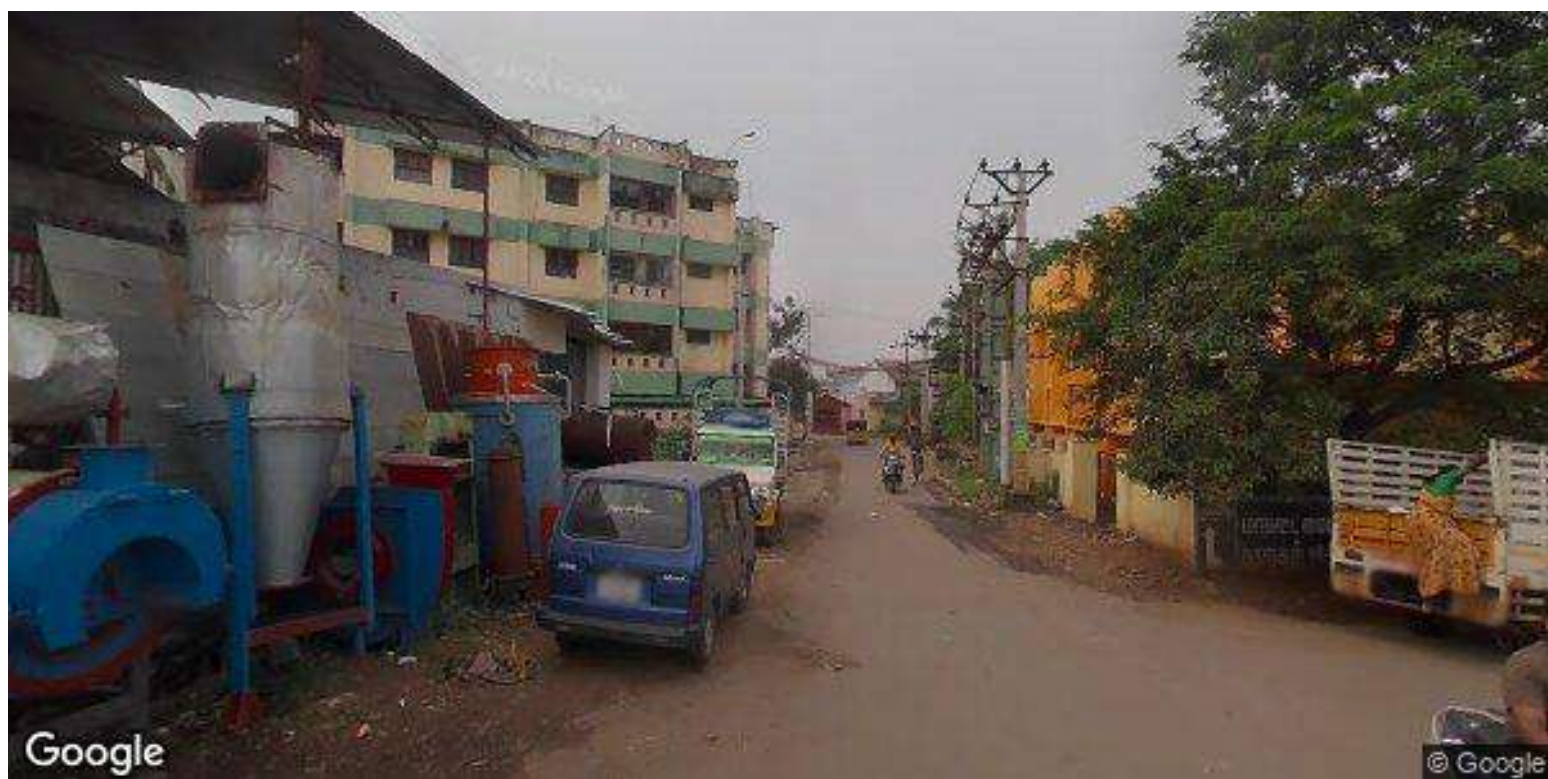
**Coordinates:** 11.35101, 77.71764

**Risk Type:** Turn

**Risk Level:** High

**Speed Limit:** 15 KM/Hr

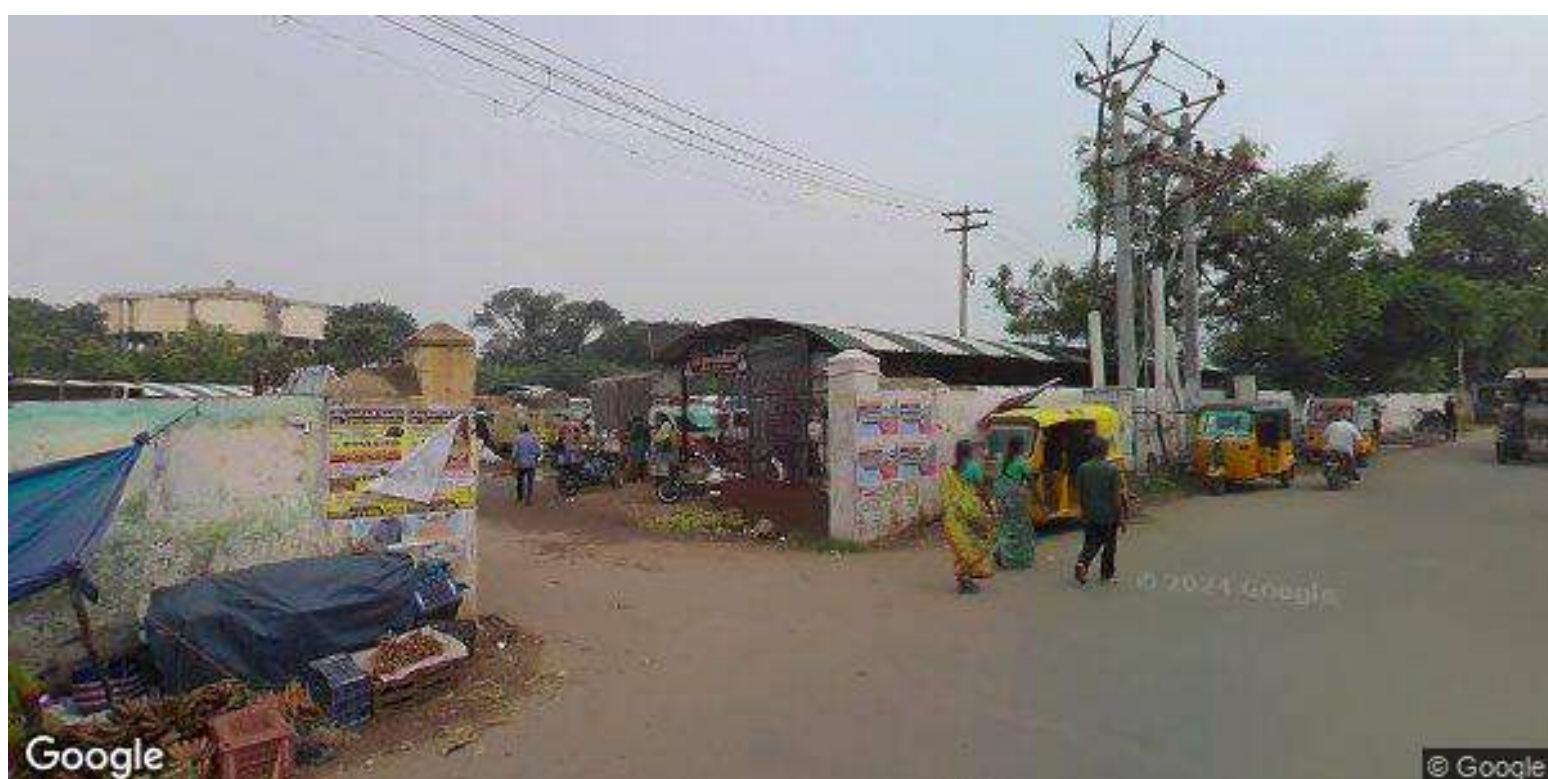
**Risk Type:** Turn  
**Risk Level:** High  
**Speed Limit:** 15 KM/Hr  
**Coordinates:** 11.35076, 77.71790

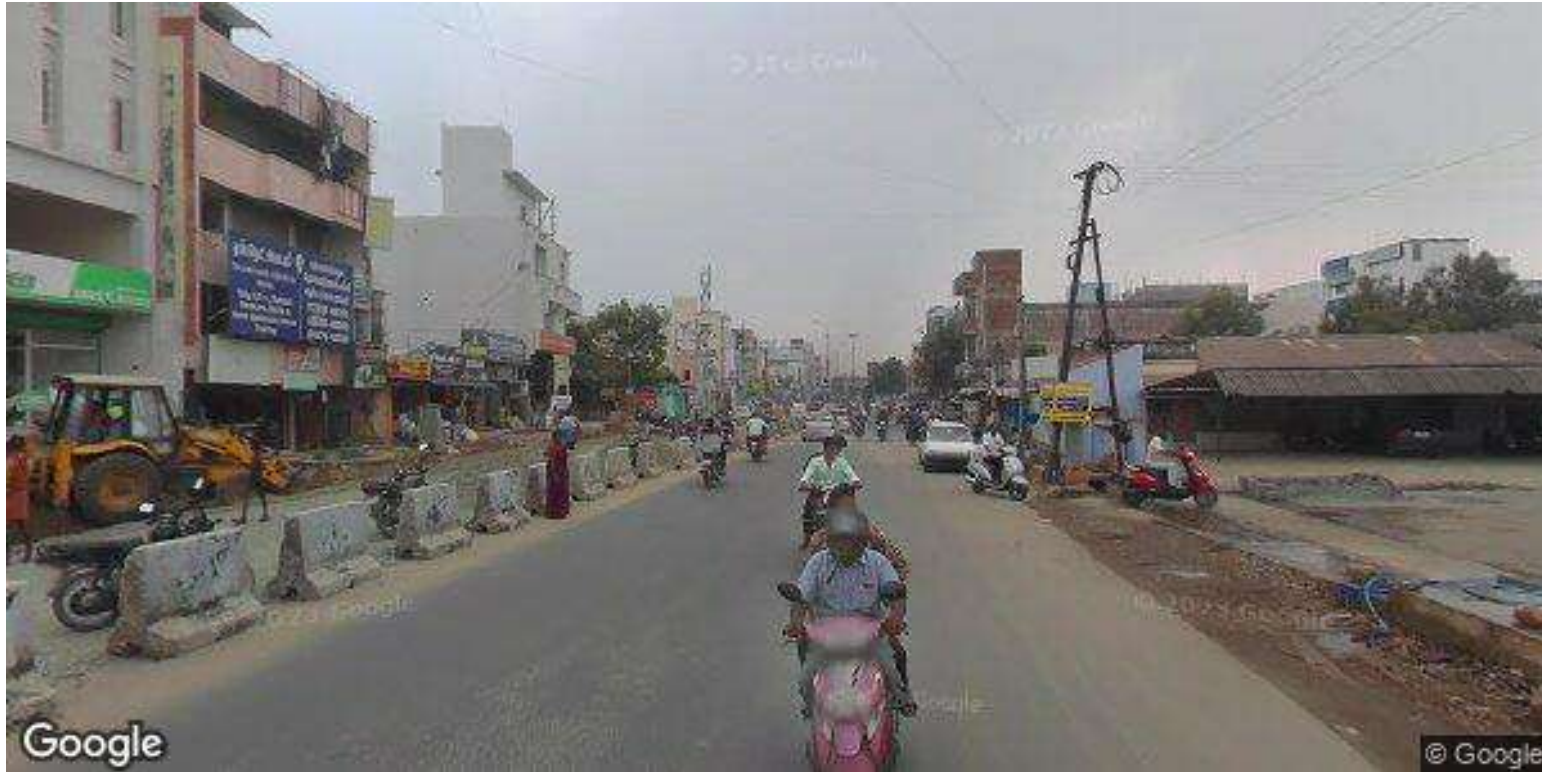
**Risk Type:** Turn  
**Risk Level:** High  
**Speed Limit:** 15 KM/Hr  
**Coordinates:** 11.34859, 77.71744

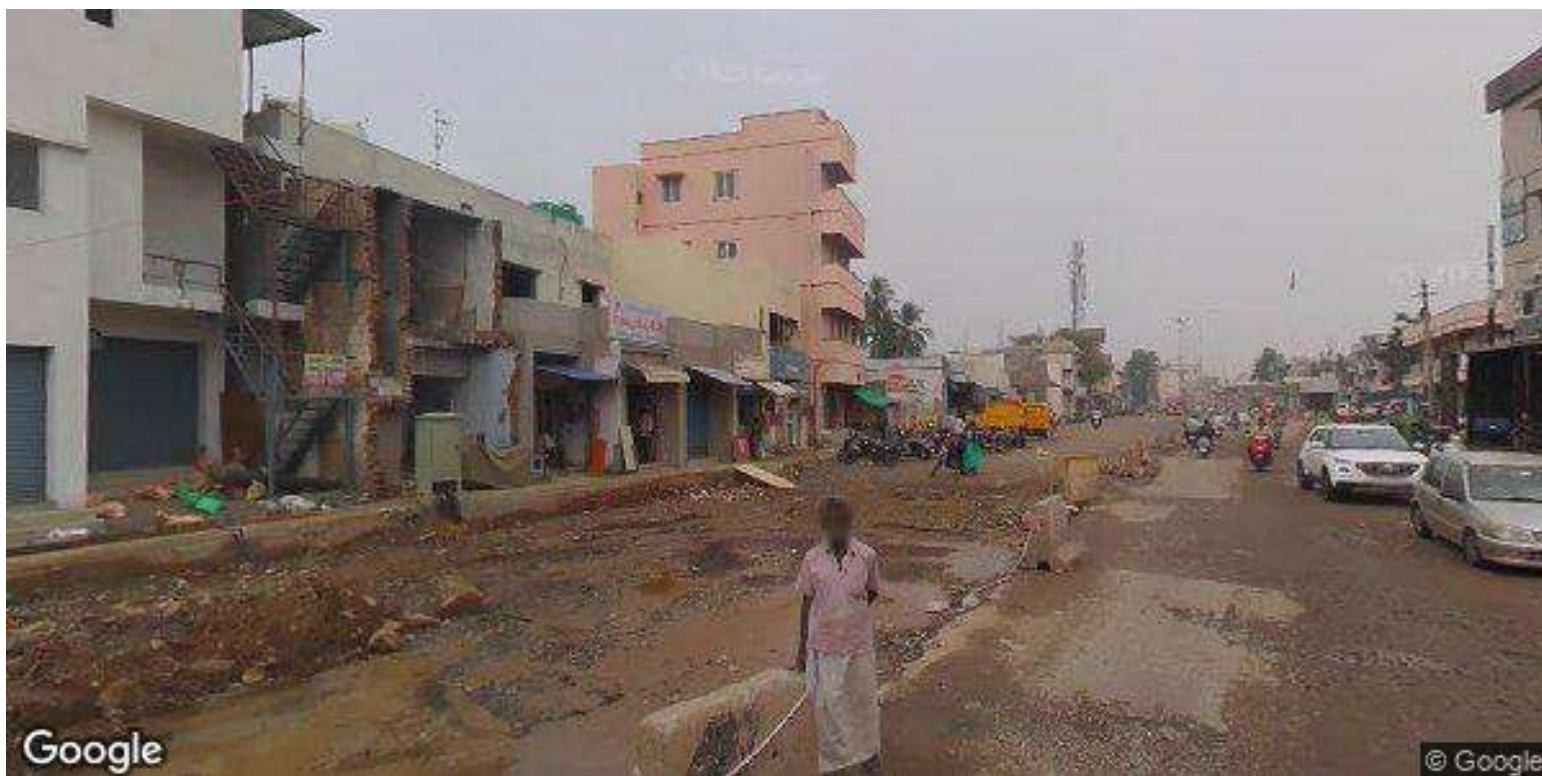
**Risk Type:** Turn  
**Risk Level:** Medium  
**Speed Limit:** 30 KM/Hr  
**Coordinates:** 11.35250, 77.71083

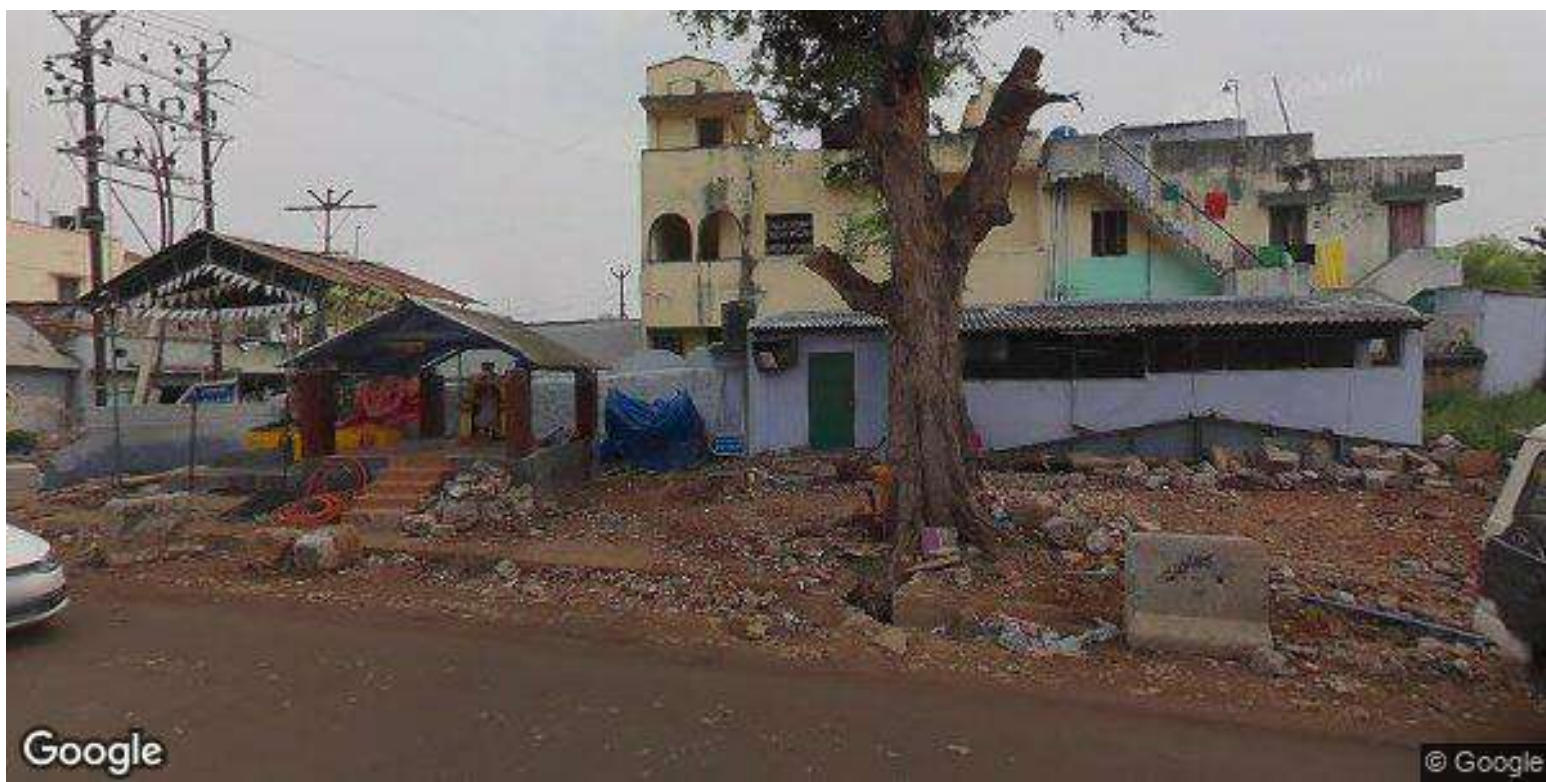
**Coordinates:** 11.35249, 77.71072

**Risk Type:** Turn

**Risk Level:** Medium

**Speed Limit:** 30 KM/Hr

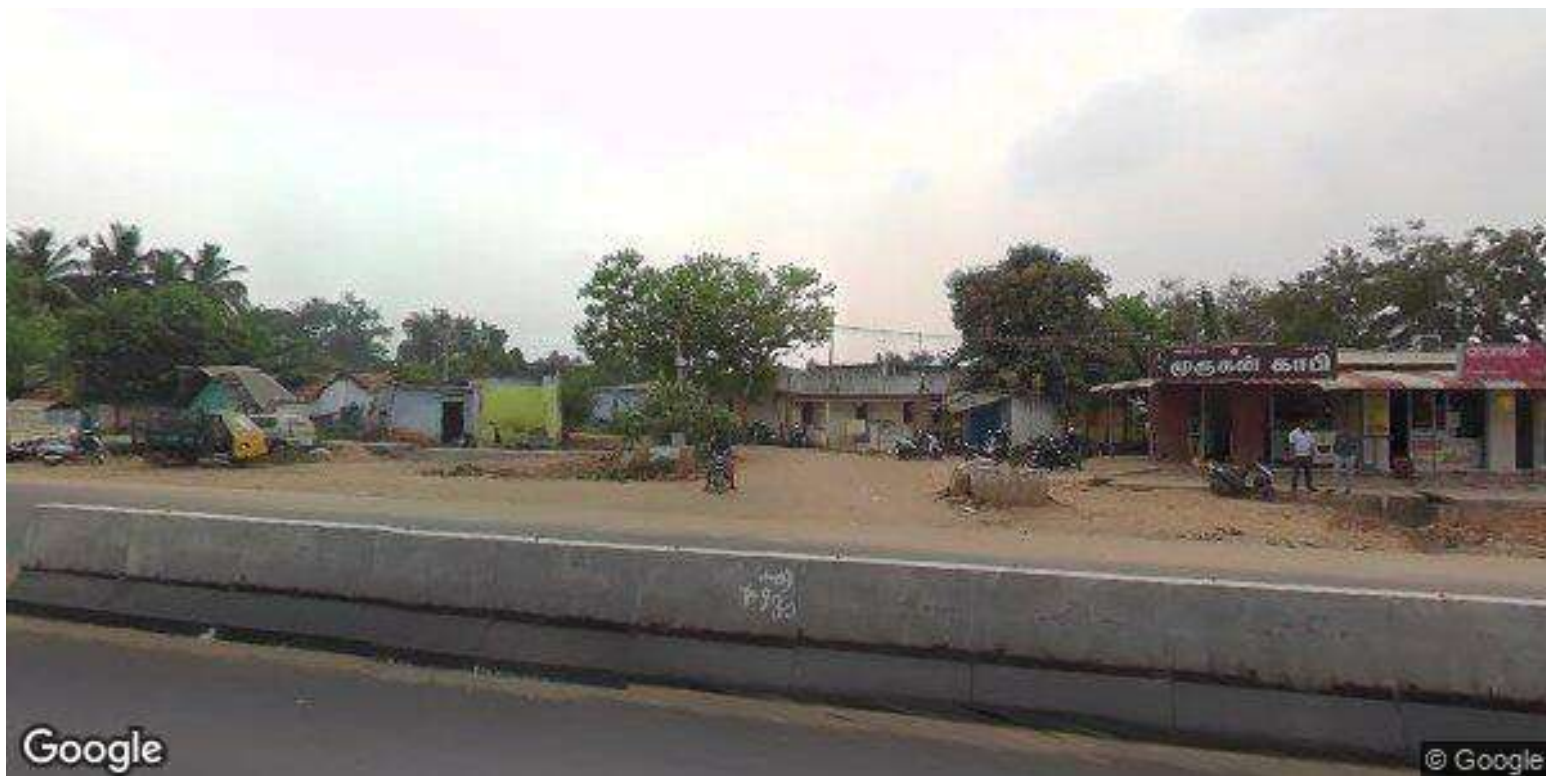
**Coordinates:** 11.35664, 77.70582

**Risk Type:** Turn

**Risk Level:** High

**Speed Limit:** 15 KM/Hr

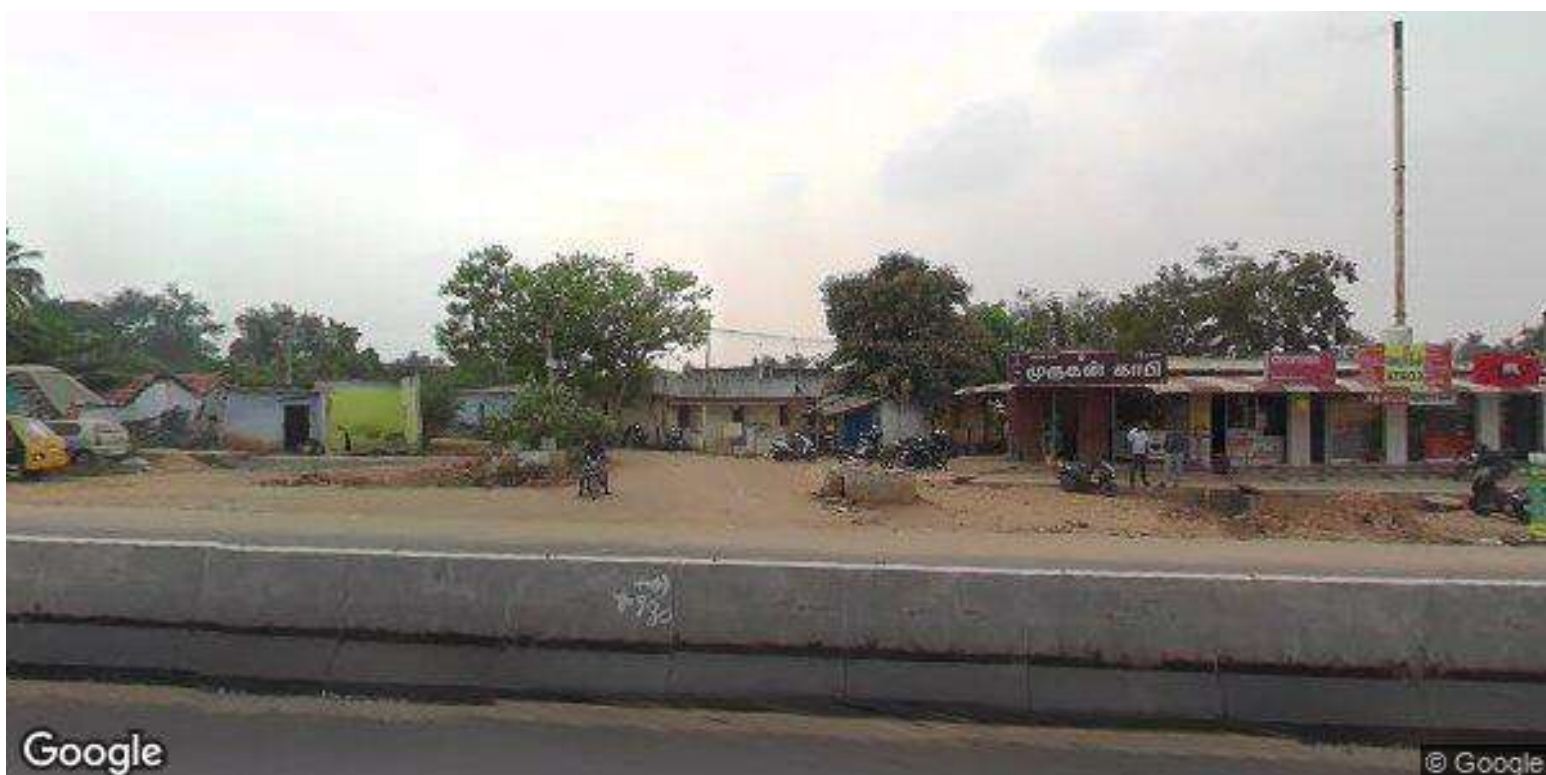
**Coordinates:** 11.35658, 77.70571

**Risk Type:** Turn

**Risk Level:** Medium

**Speed Limit:** 30 KM/Hr
