## JOURNEY RISK MANAGEMENT (JRM) STUDY

### Salem Terminal TO THE SALEM CO.OP.SUGAR MILLS

Route Safety Analysis: CVQF+23W, Sangagiri to 34GG+39P, Velur Rd, Tamil Nadu, India

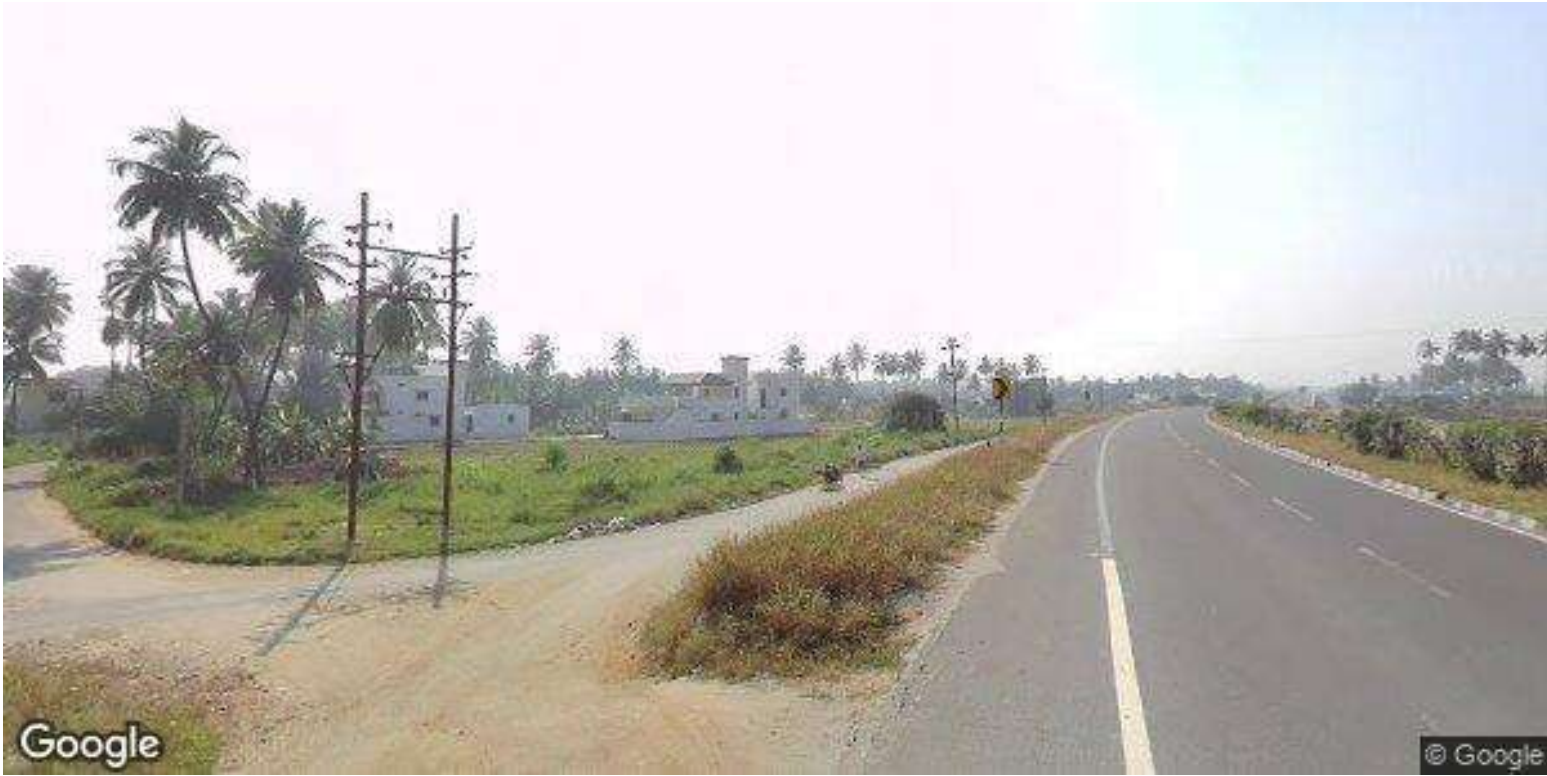
**Risk Type:** Turn  
**Risk Level:** High  
**Speed Limit:** 15 KM/Hr  
**Coordinates:** 11.11887, 78.01758

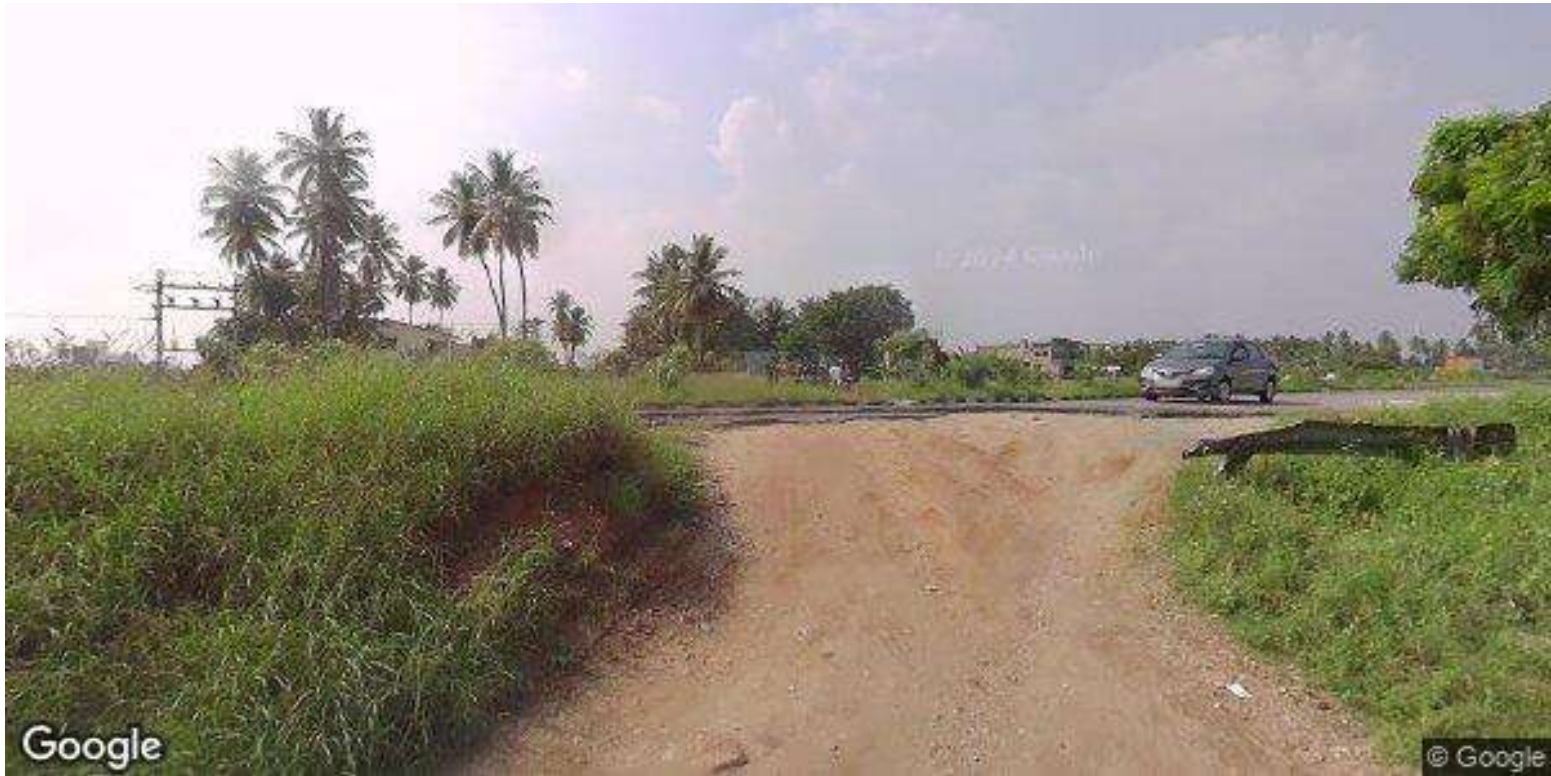
**Risk Type:** Turn  
**Risk Level:** High  
**Speed Limit:** 15 KM/Hr  
**Coordinates:** 11.11883, 78.01771

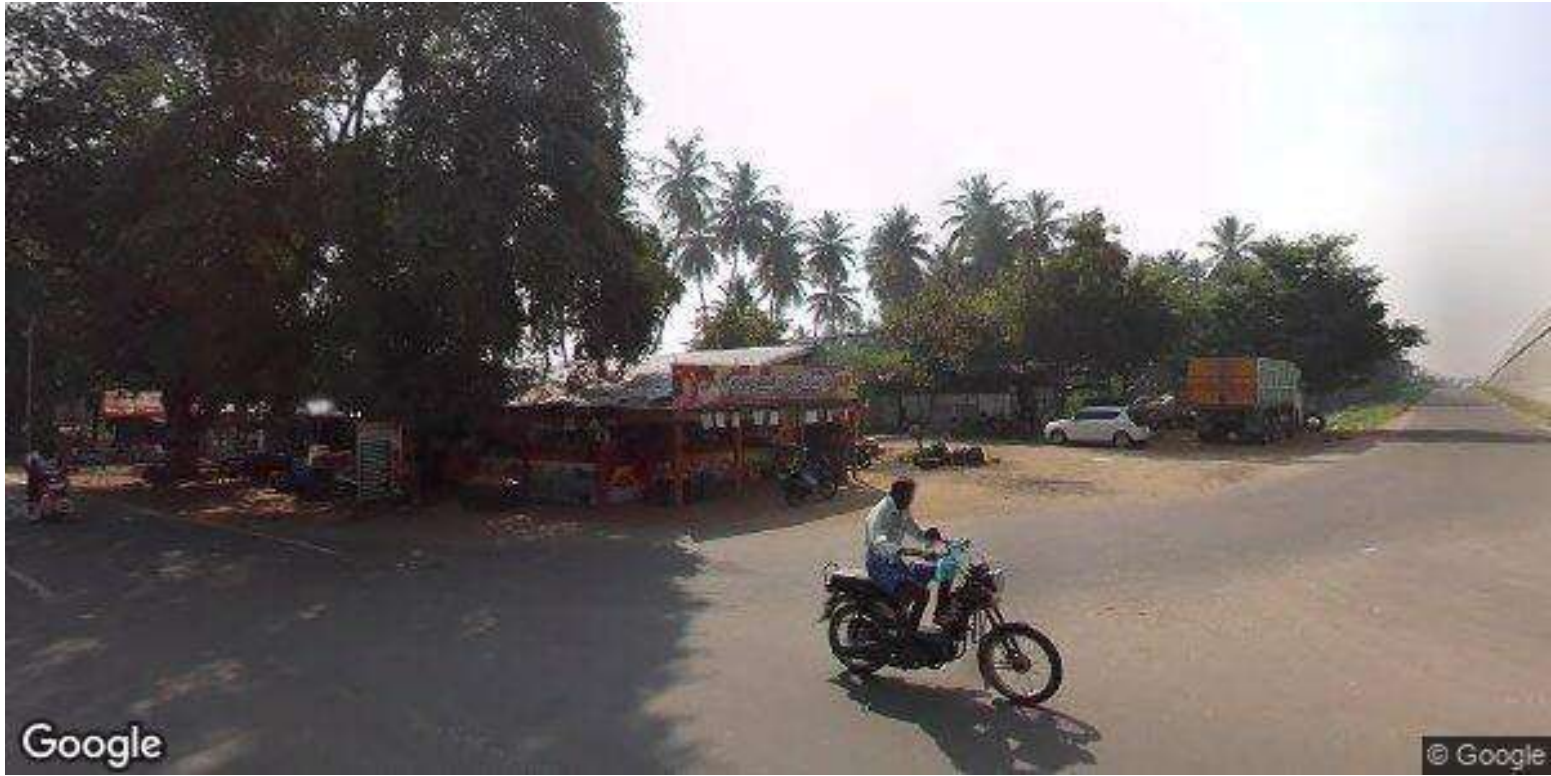
**Risk Type:** Blind Spot  
**Risk Level:** Blind Spot  
**Speed Limit:** 10 KM/Hr  
**Coordinates:** 11.11397, 78.01722

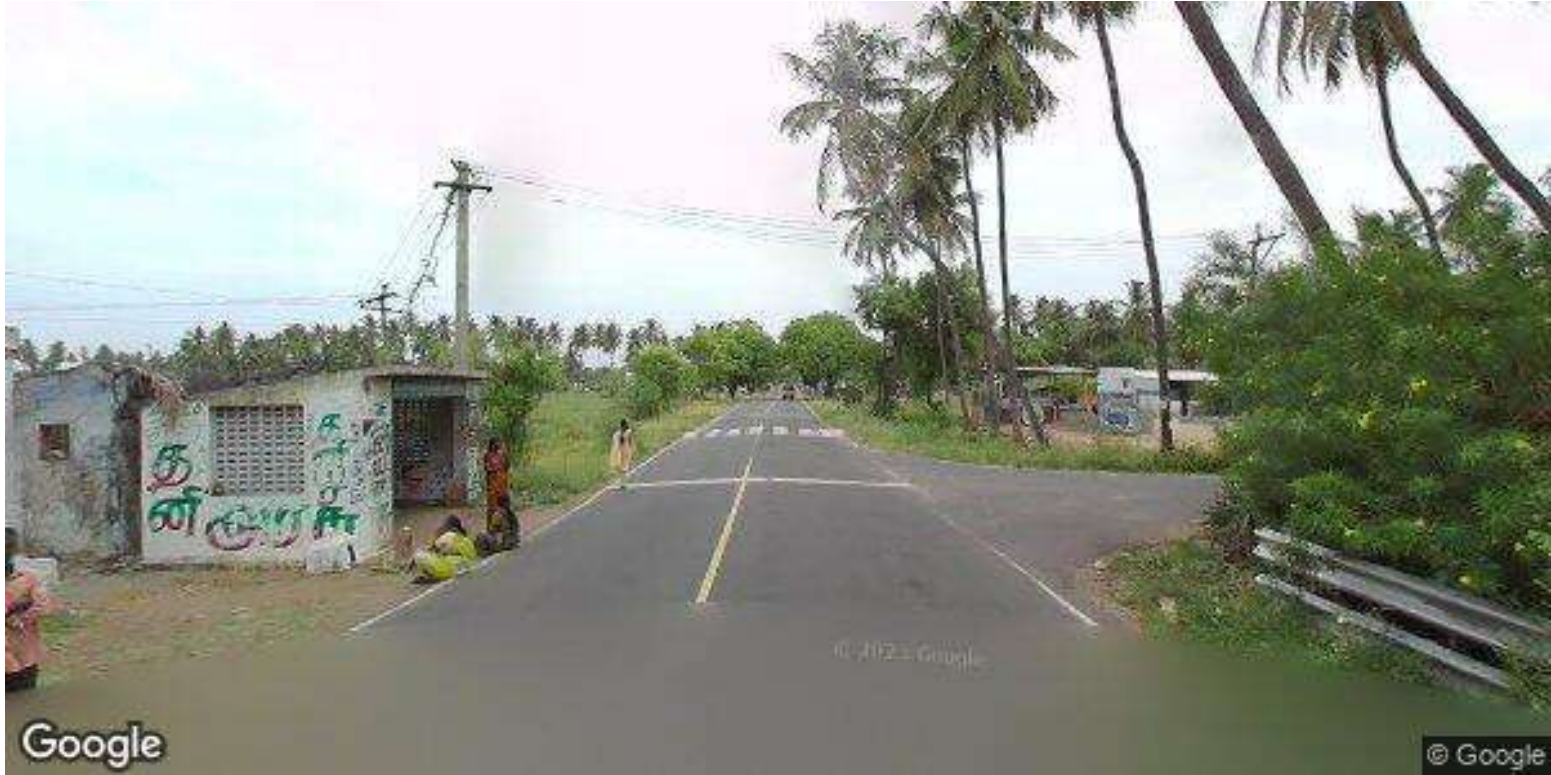
**Risk Type:** Turn

**Risk Level:** Medium

**Speed Limit:** 30 KM/Hr

**Coordinates:** 11.10418, 78.04796
