# IndianOil

## JOURNEY RISK MANAGEMENT (JRM) STUDY

### Salem Terminal TO K.M. FUEELS

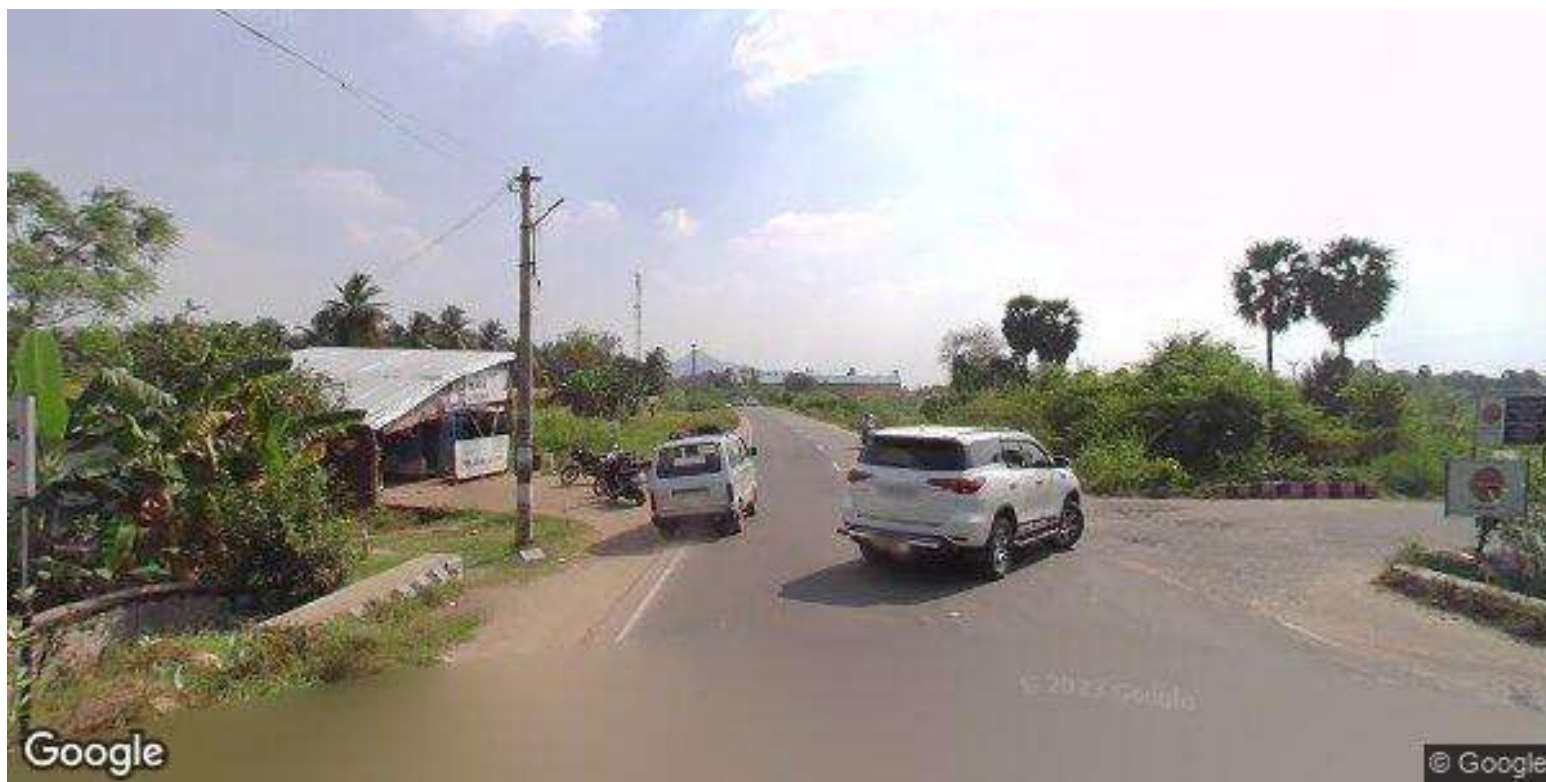
**Coordinates: 11.44029, 77.87544**

**Risk Type: Turn**

**Risk Level: High**

**Speed Limit: 15 KM/Hr**

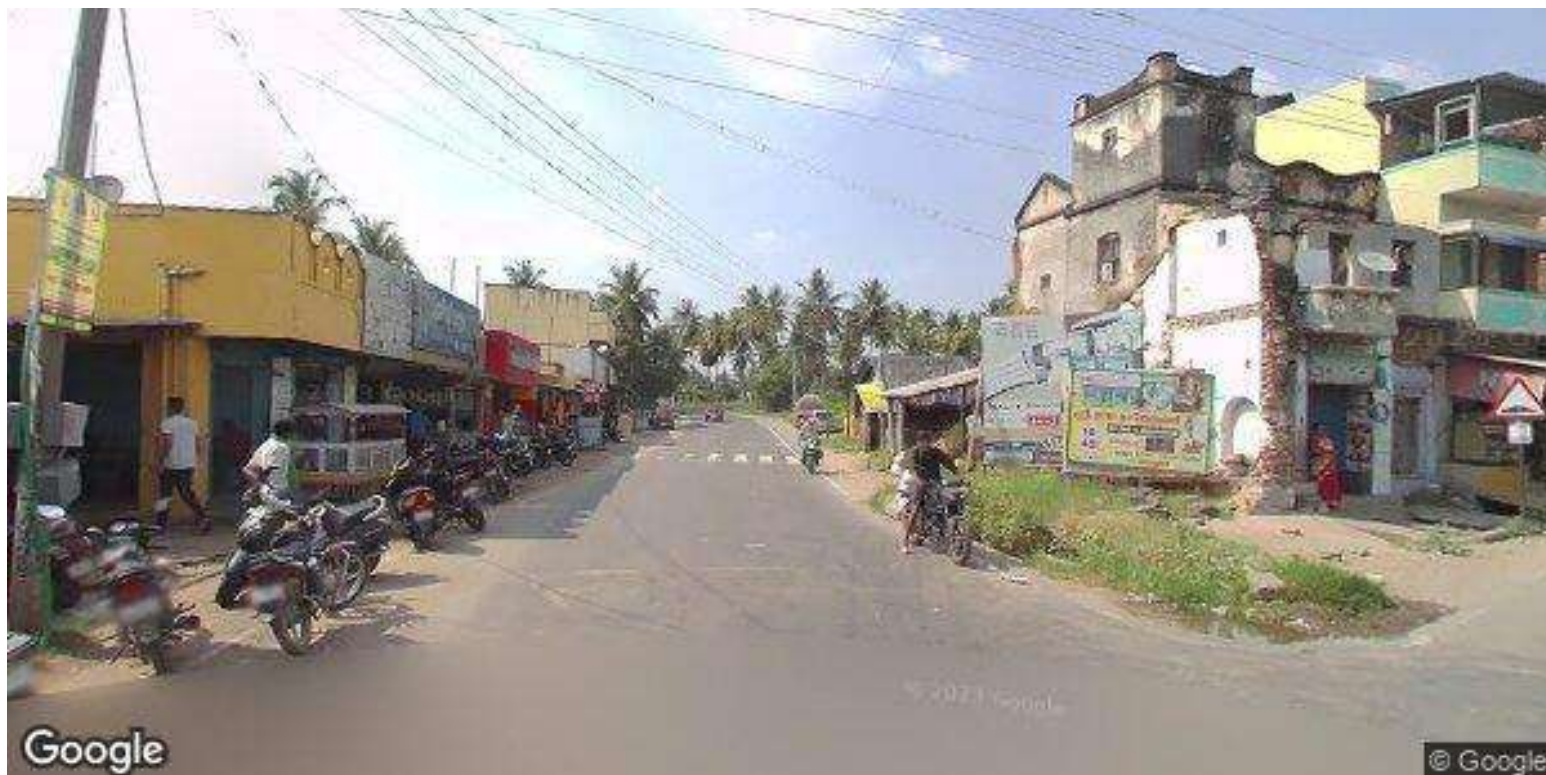
**Coordinates: 11.45007, 77.87201**

**Risk Type: Turn**

**Risk Level: High**

**Speed Limit: 15 KM/Hr**

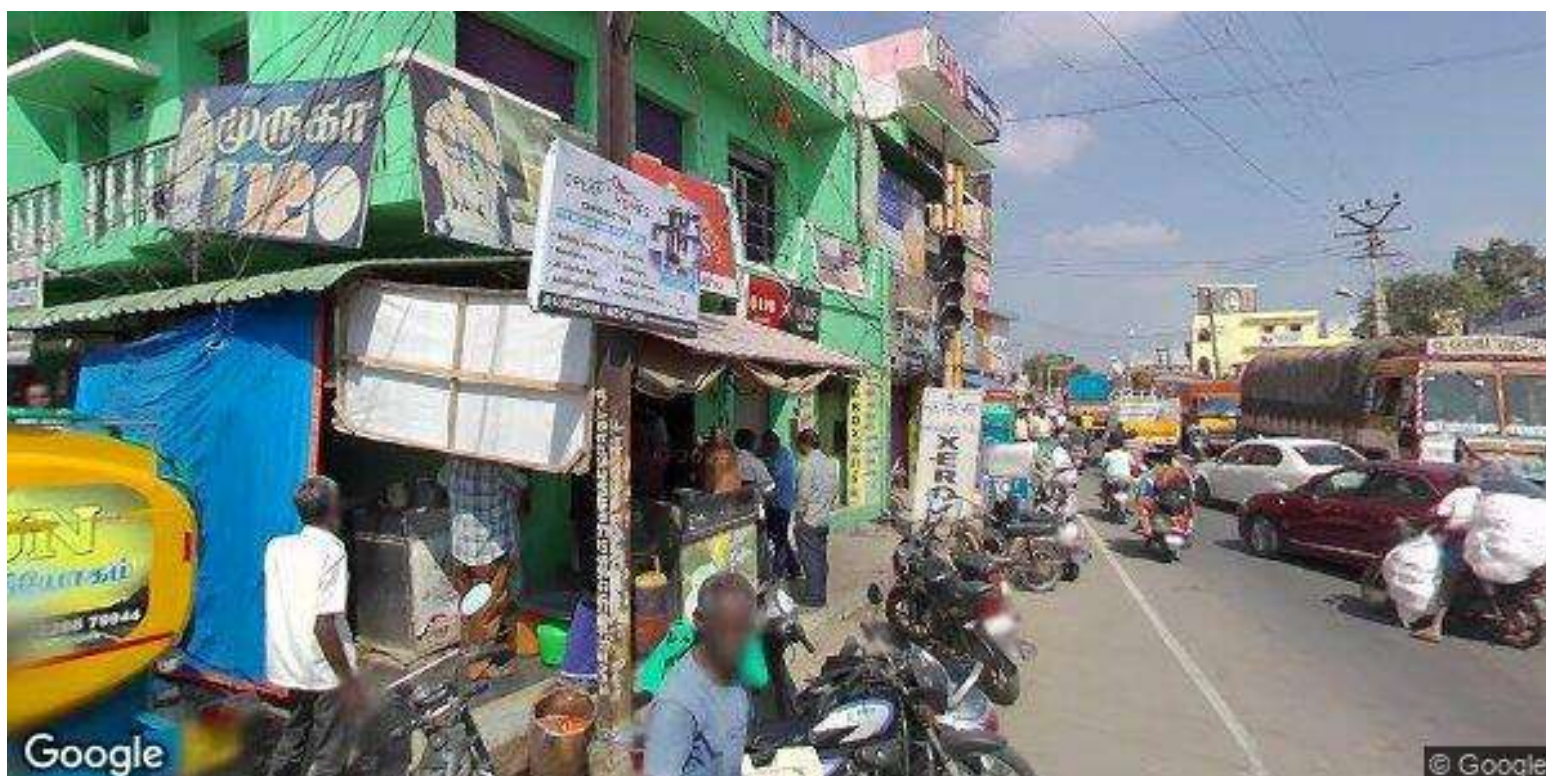
**Risk Type:** Turn  
**Risk Level:** High  
**Speed Limit:** 15 KM/Hr  
**Coordinates:** 11.47407, 77.86839

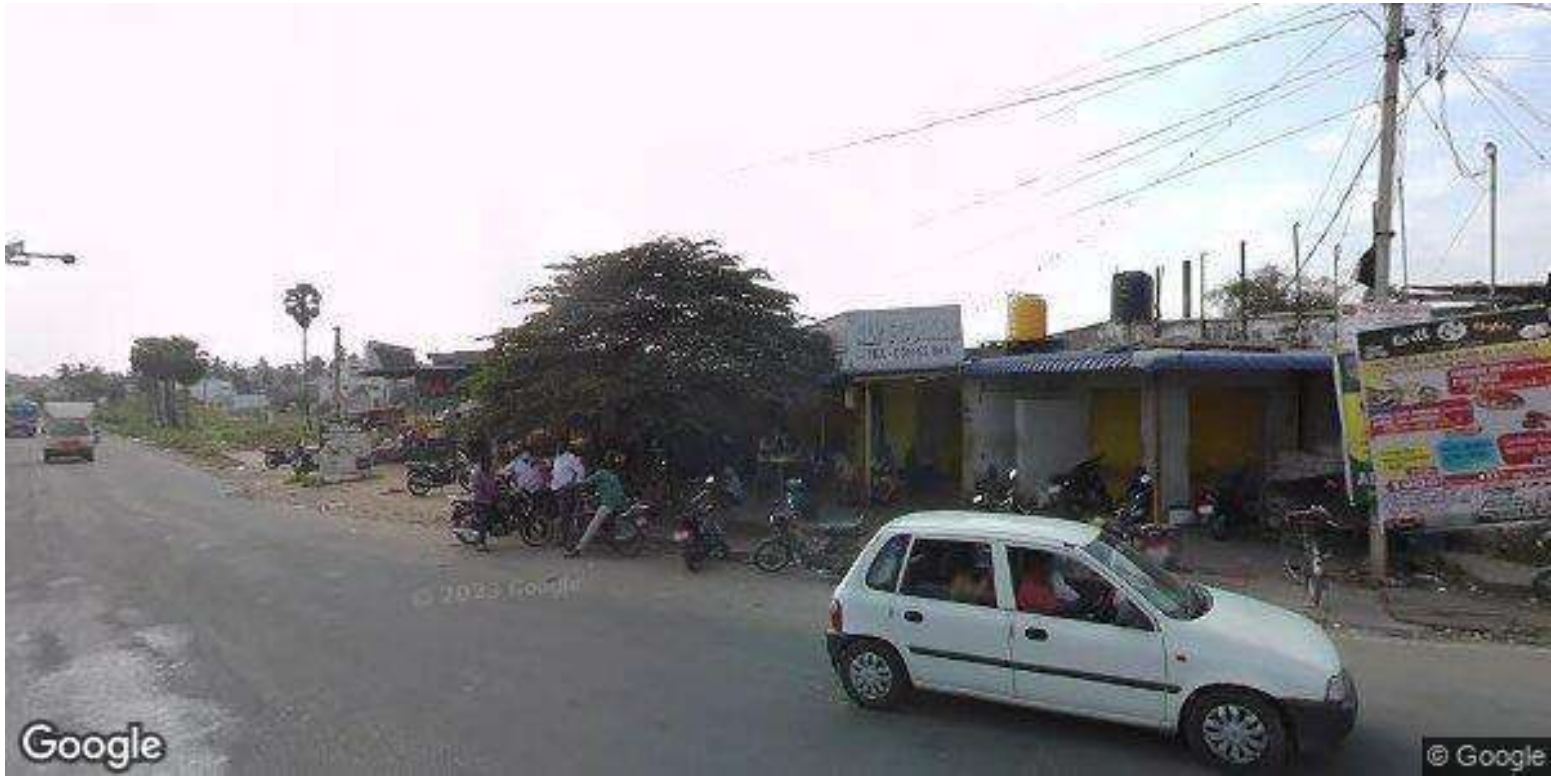
**Risk Type:** Turn  
**Risk Level:** High  
**Speed Limit:** 15 KM/Hr  
**Coordinates:** 11.48369, 77.88781

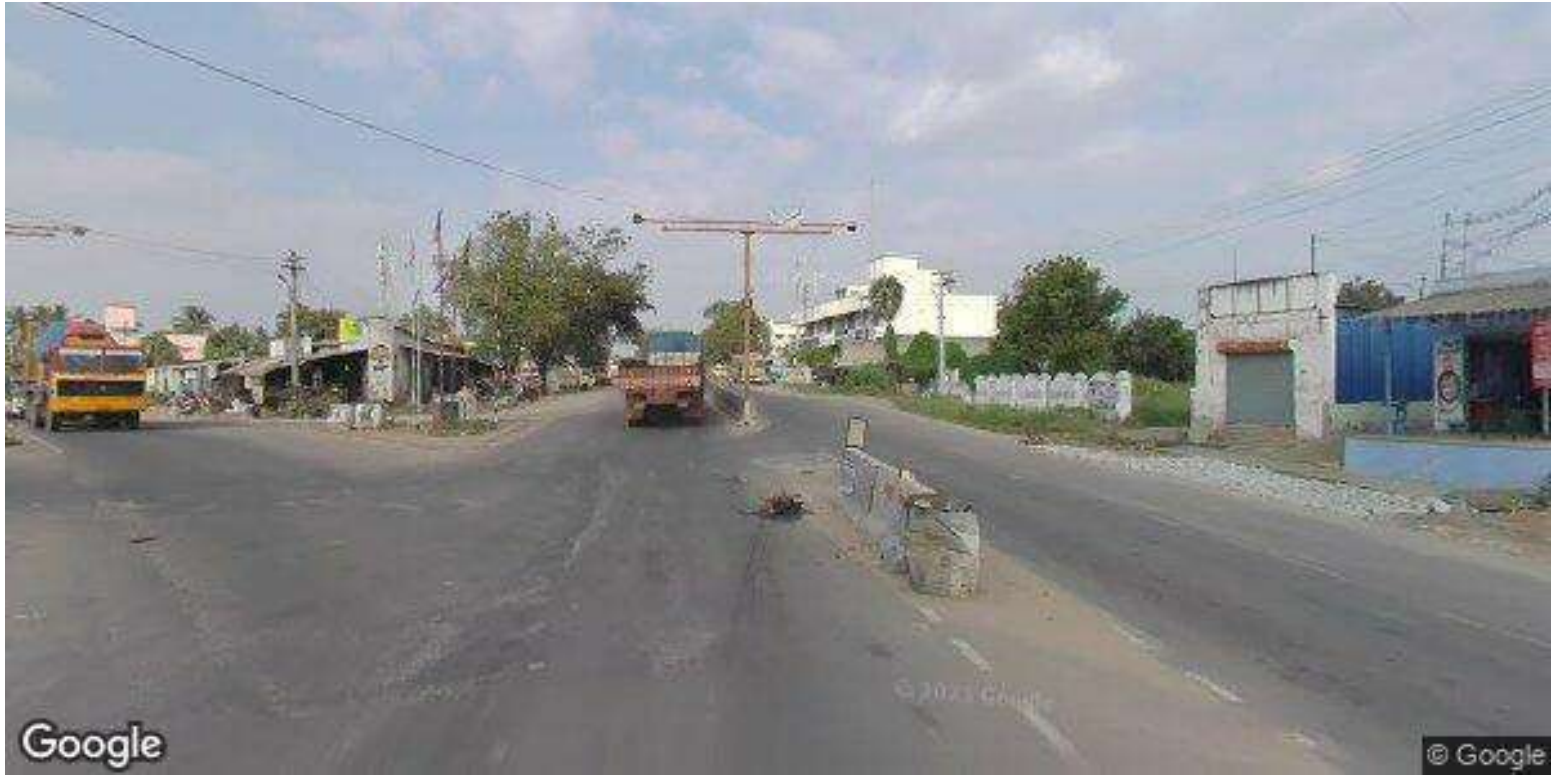
**Risk Type:** Turn  
**Risk Level:** Medium  
**Speed Limit:** 30 KM/Hr  
**Coordinates:** 11.48370, 77.88787

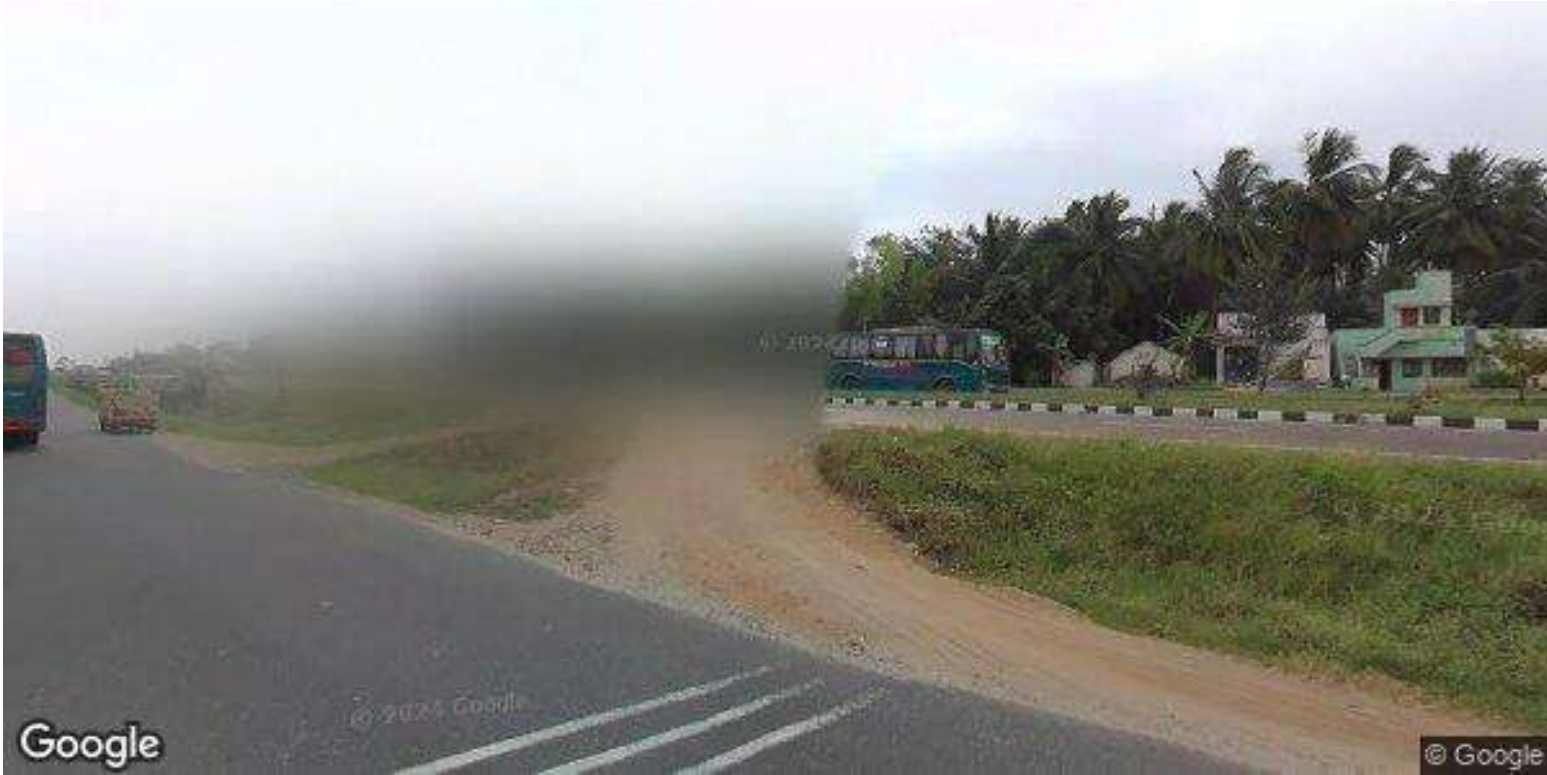
**Coordinates:** 11.55622, 78.00774

**Risk Type:** Turn

**Risk Level:** Medium

**Speed Limit:** 30 KM/Hr
