# IndianOil

## JOURNEY RISK MANAGEMENT (JRM) STUDY

### Salem Terminal to AMR FUELS

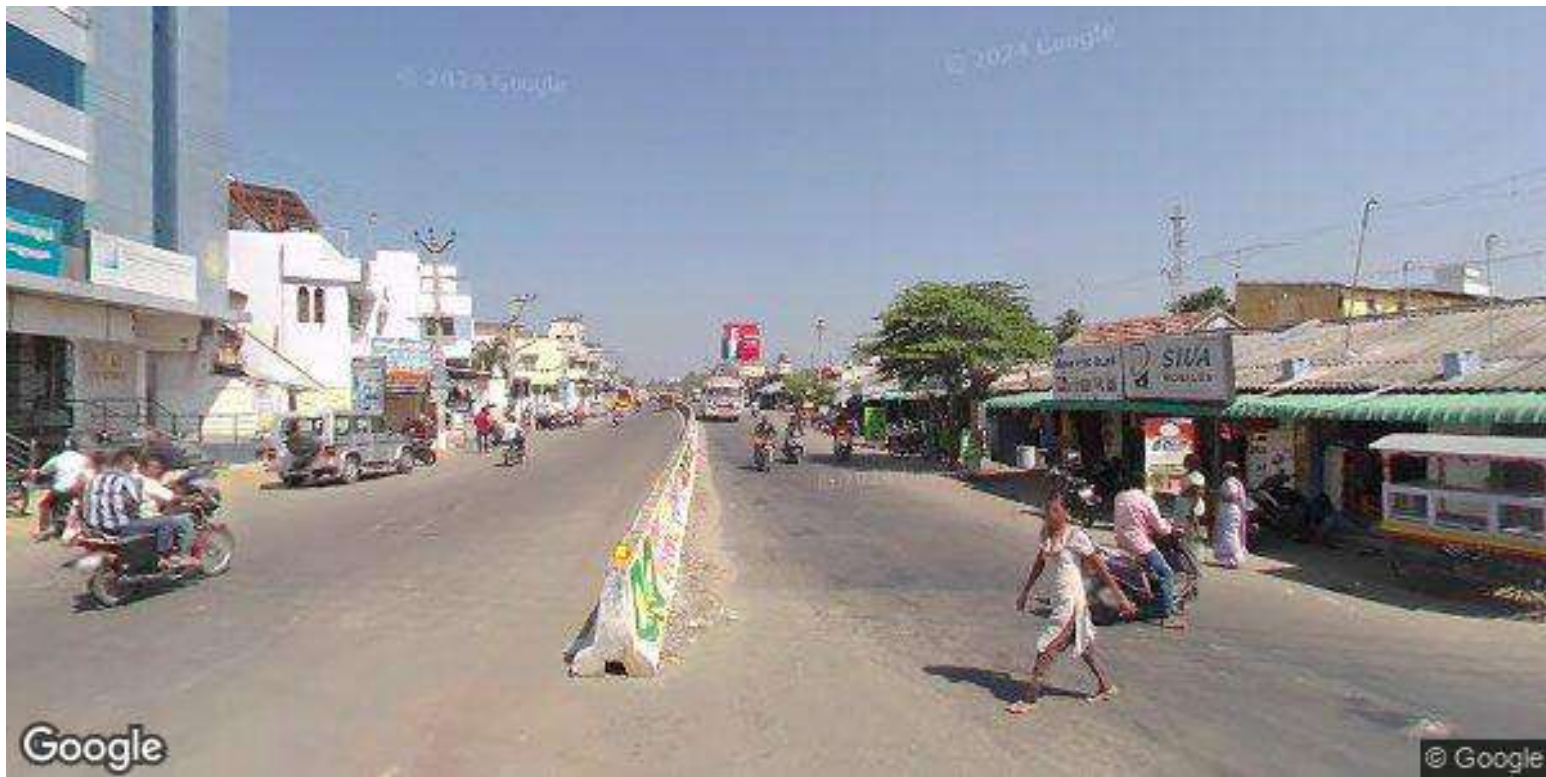
**Coordinates:** 11.37086, 77.74828

**Risk Type:** Roundabout

**Risk Level:** High

**Speed Limit:** 15 KM/Hr

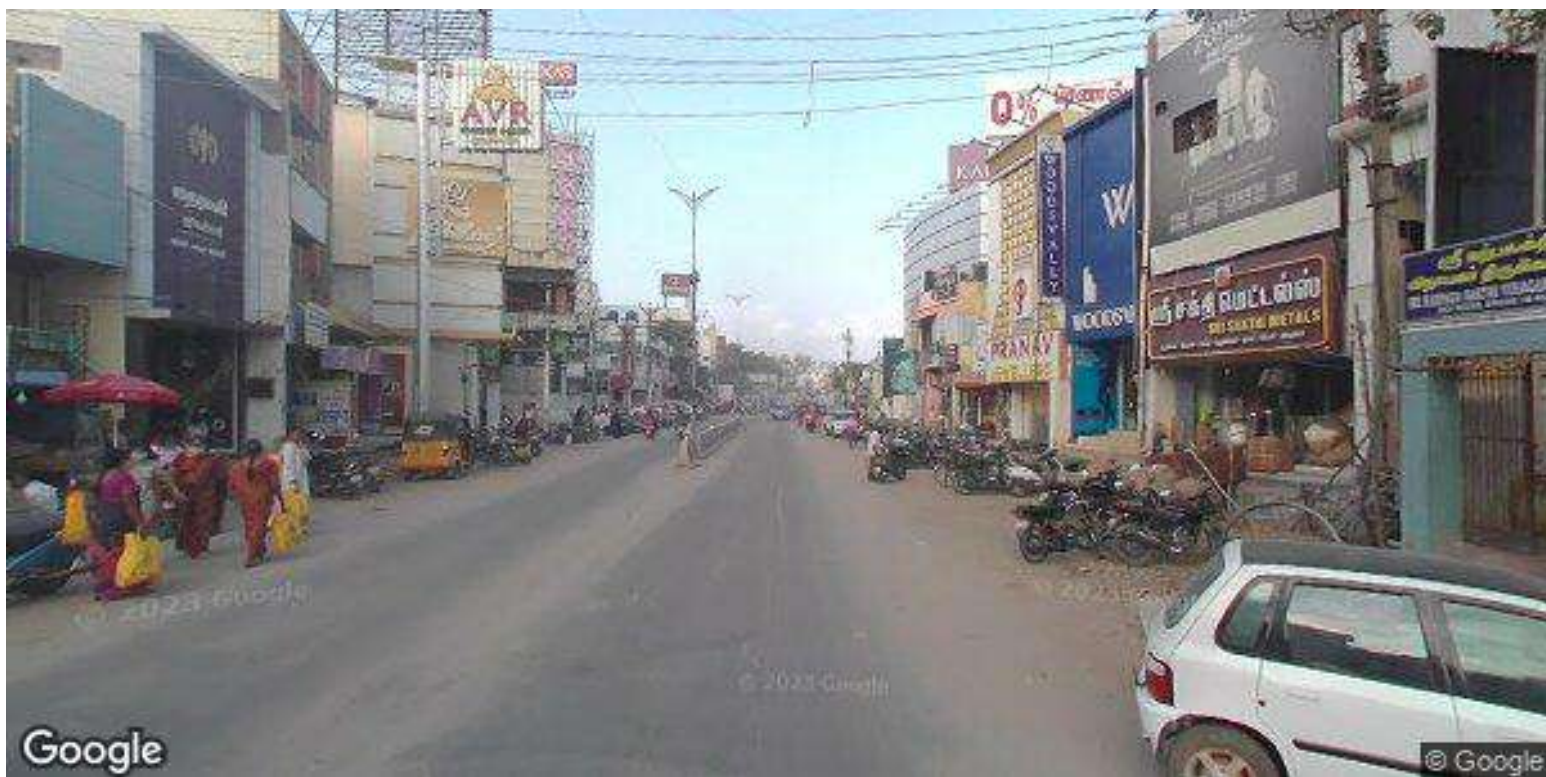
**Coordinates:** 11.3453211, 77.7304652

**Risk Type:** U-Turn

**Risk Level:** High

**Speed Limit:** 10 KM/Hr

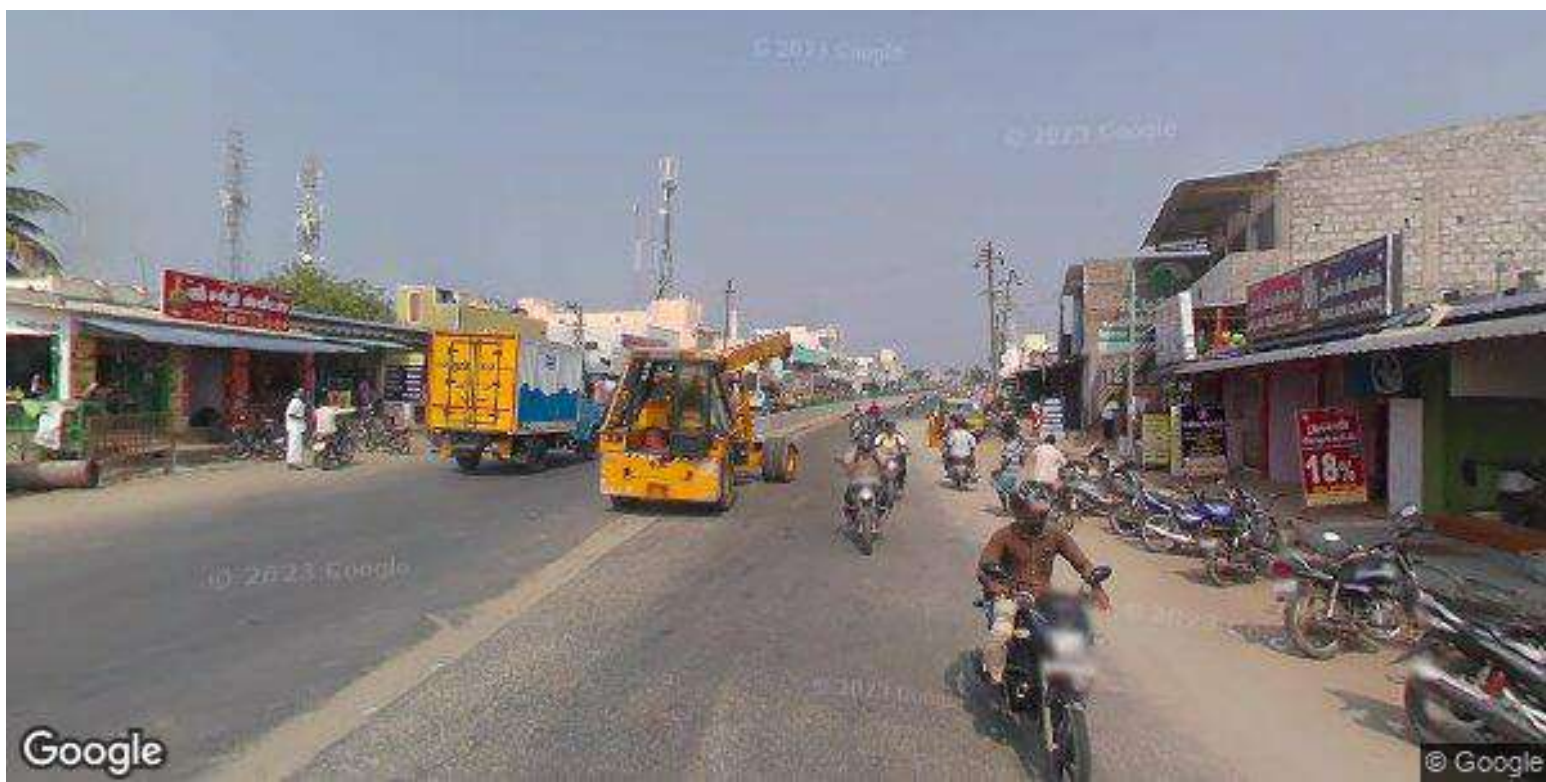
**Coordinates:** 11.3663553, 77.6968024

**Risk Type:** U-Turn

**Risk Level:** High

**Speed Limit:** 10 KM/Hr

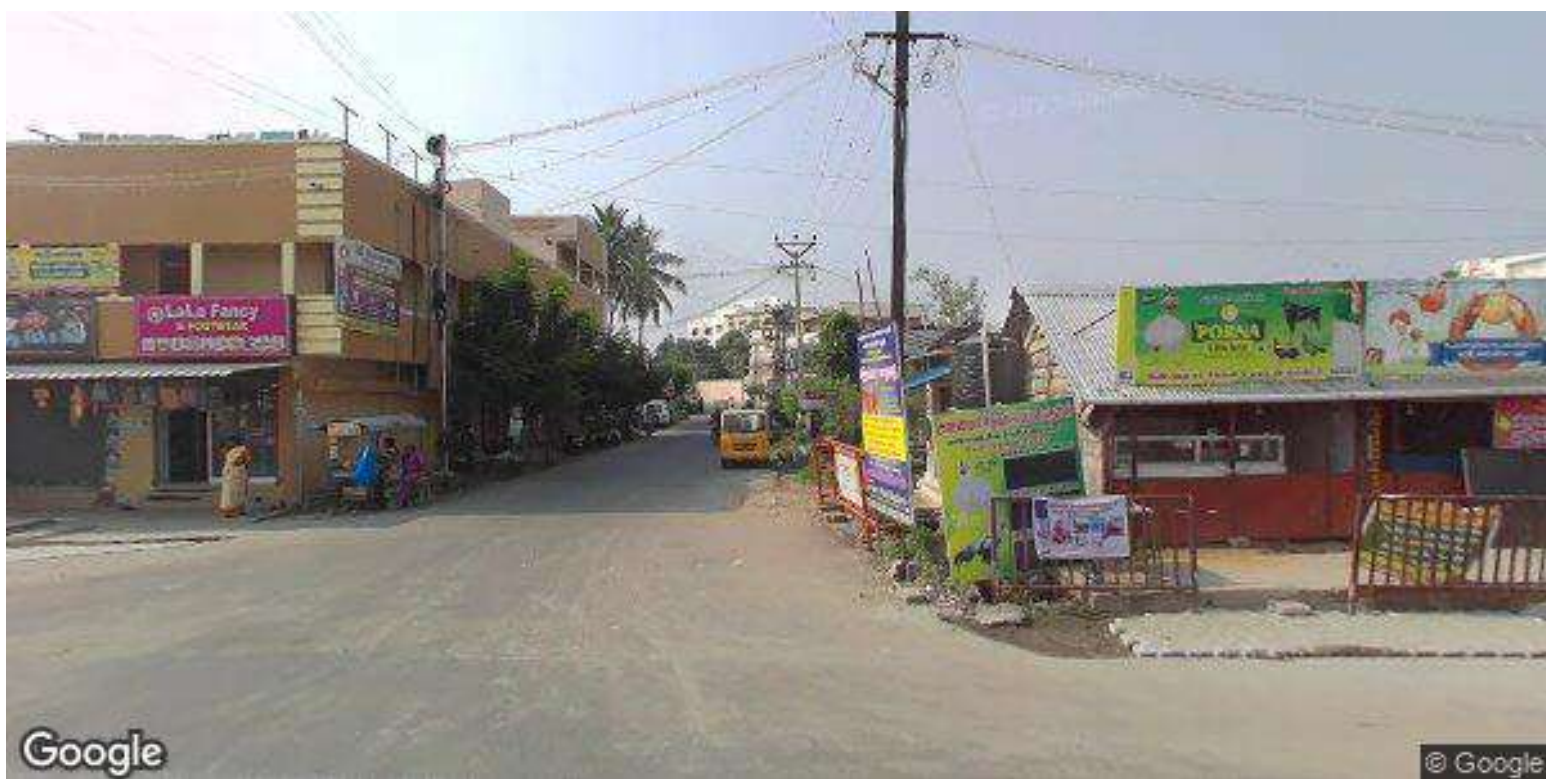
**Coordinates:** 11.3770605, 77.68412

**Risk Type:** U-Turn

**Risk Level:** High

**Speed Limit:** 10 KM/Hr

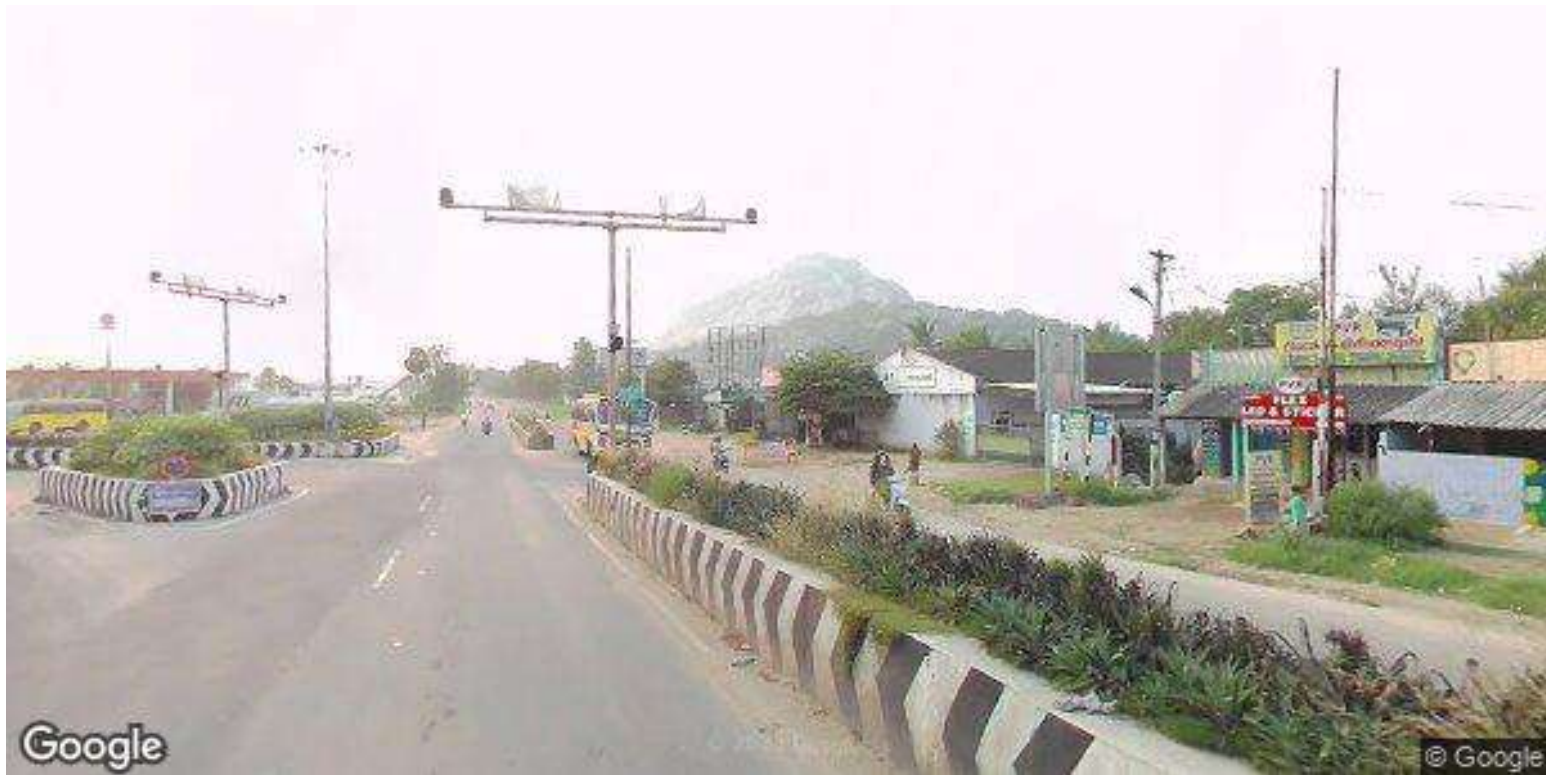
**Coordinates: 11.46312, 77.84886**

**Risk Type: Turn**

**Risk Level: Medium**

**Speed Limit: 30 KM/Hr**

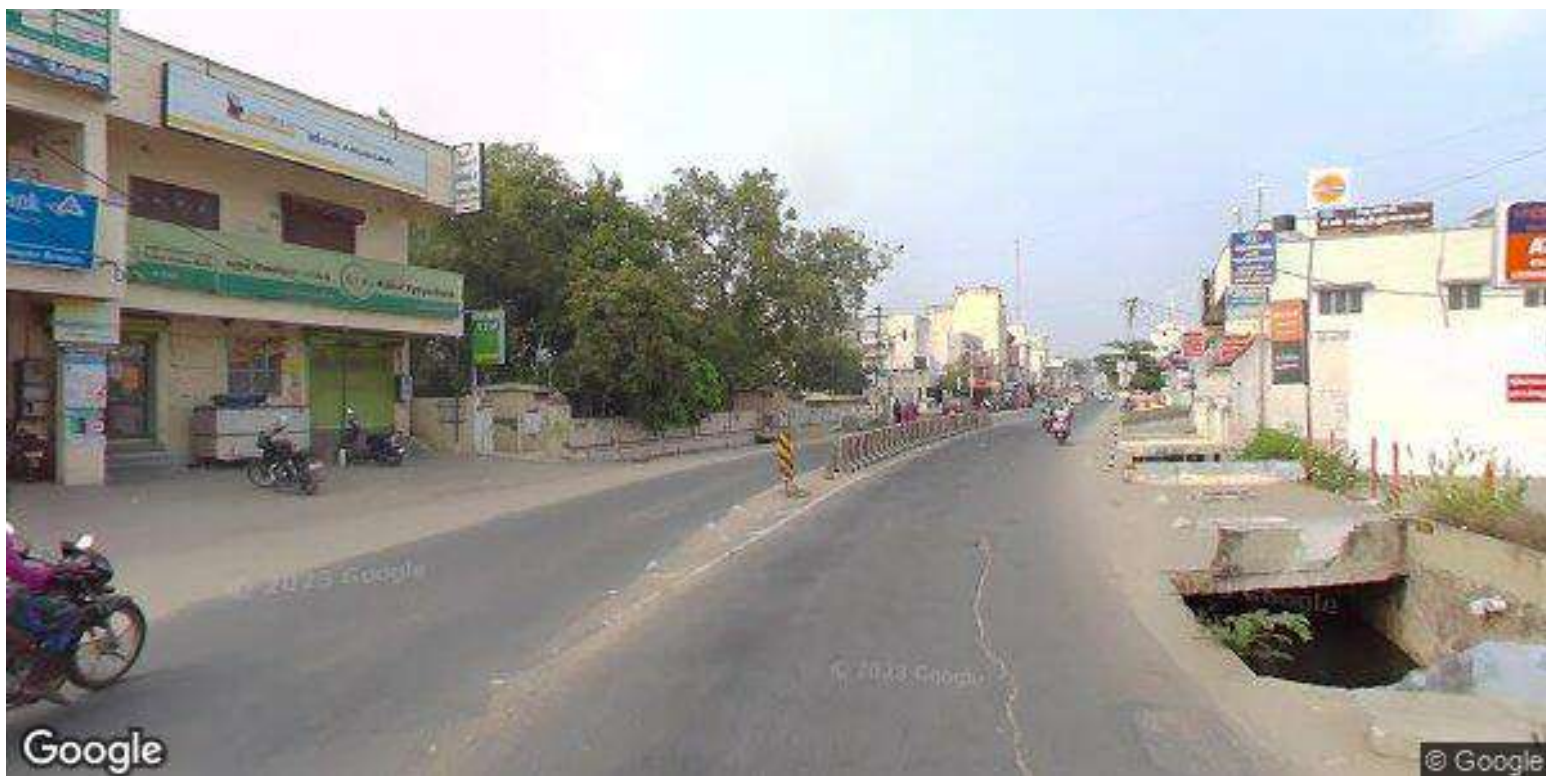
**Coordinates: 11.36622, 77.74789**

**Risk Type: Turn**

**Risk Level: Medium**

**Speed Limit: 30 KM/Hr**

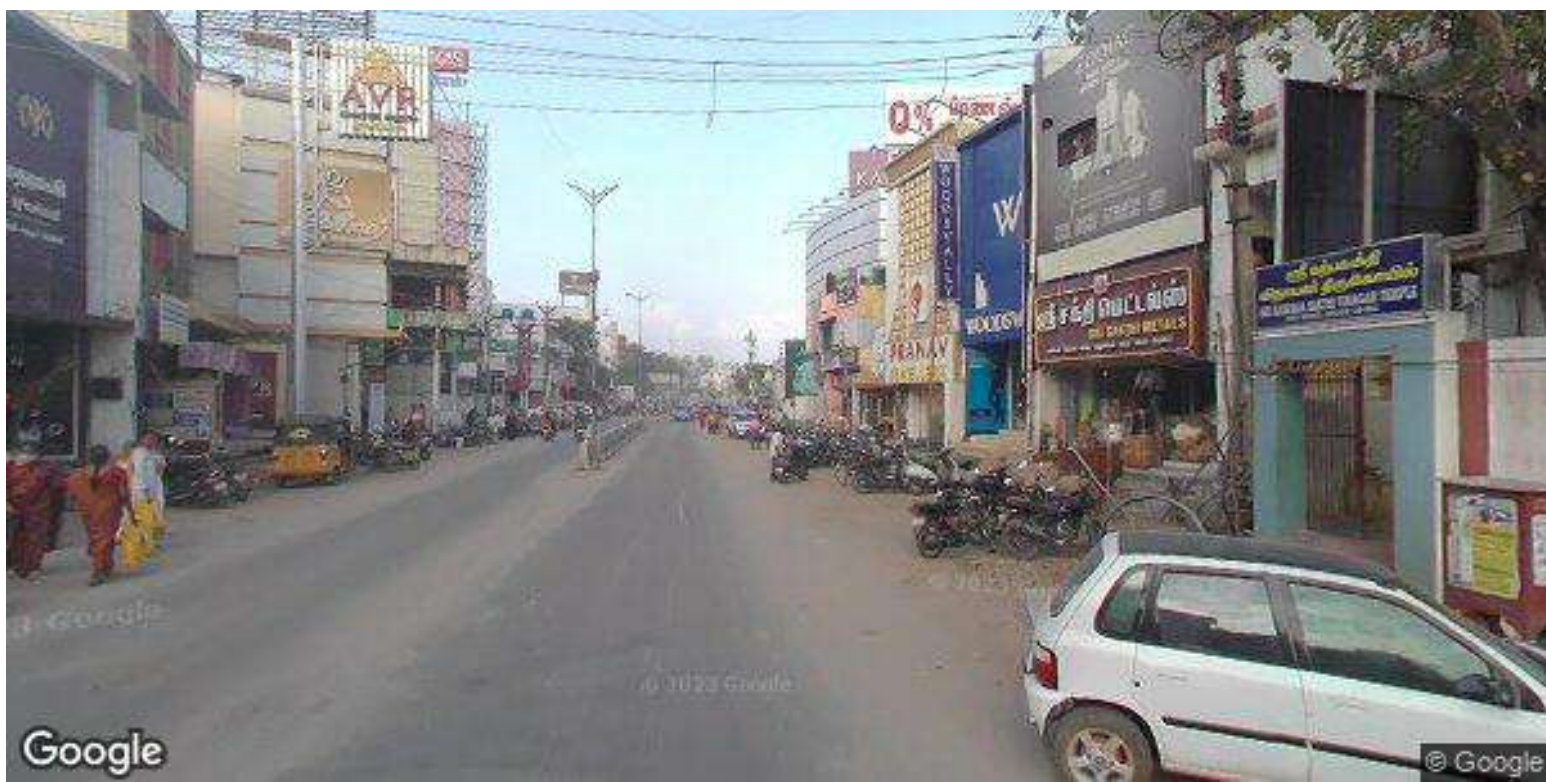
**Coordinates:** 11.34532, 77.73047

**Risk Type:** Turn

**Risk Level:** High

**Speed Limit:** 15 KM/Hr

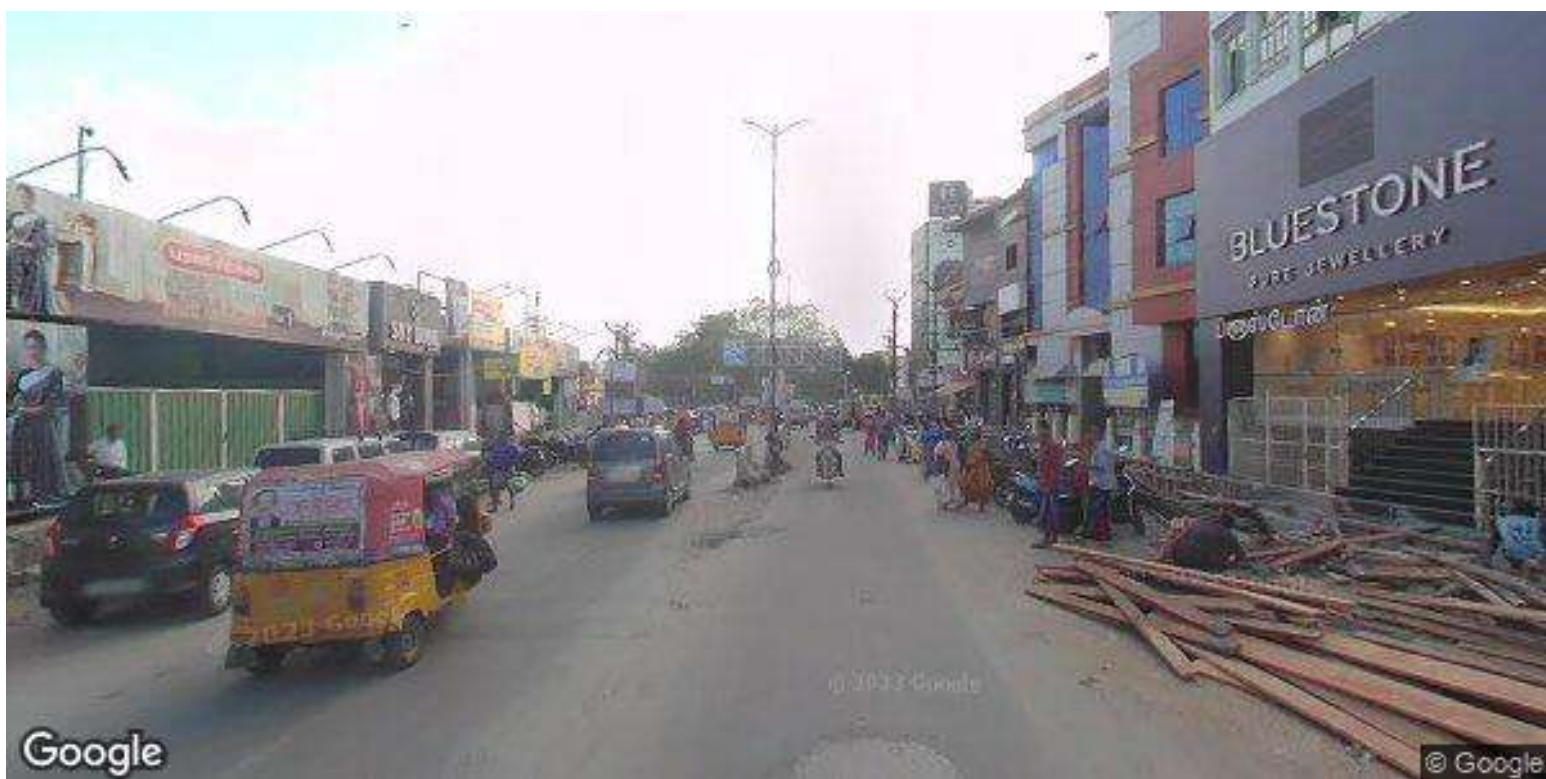
**Coordinates:** 11.34535, 77.73036

**Risk Type:** Blind Spot

**Risk Level:** Blind Spot

**Speed Limit:** 10 KM/Hr

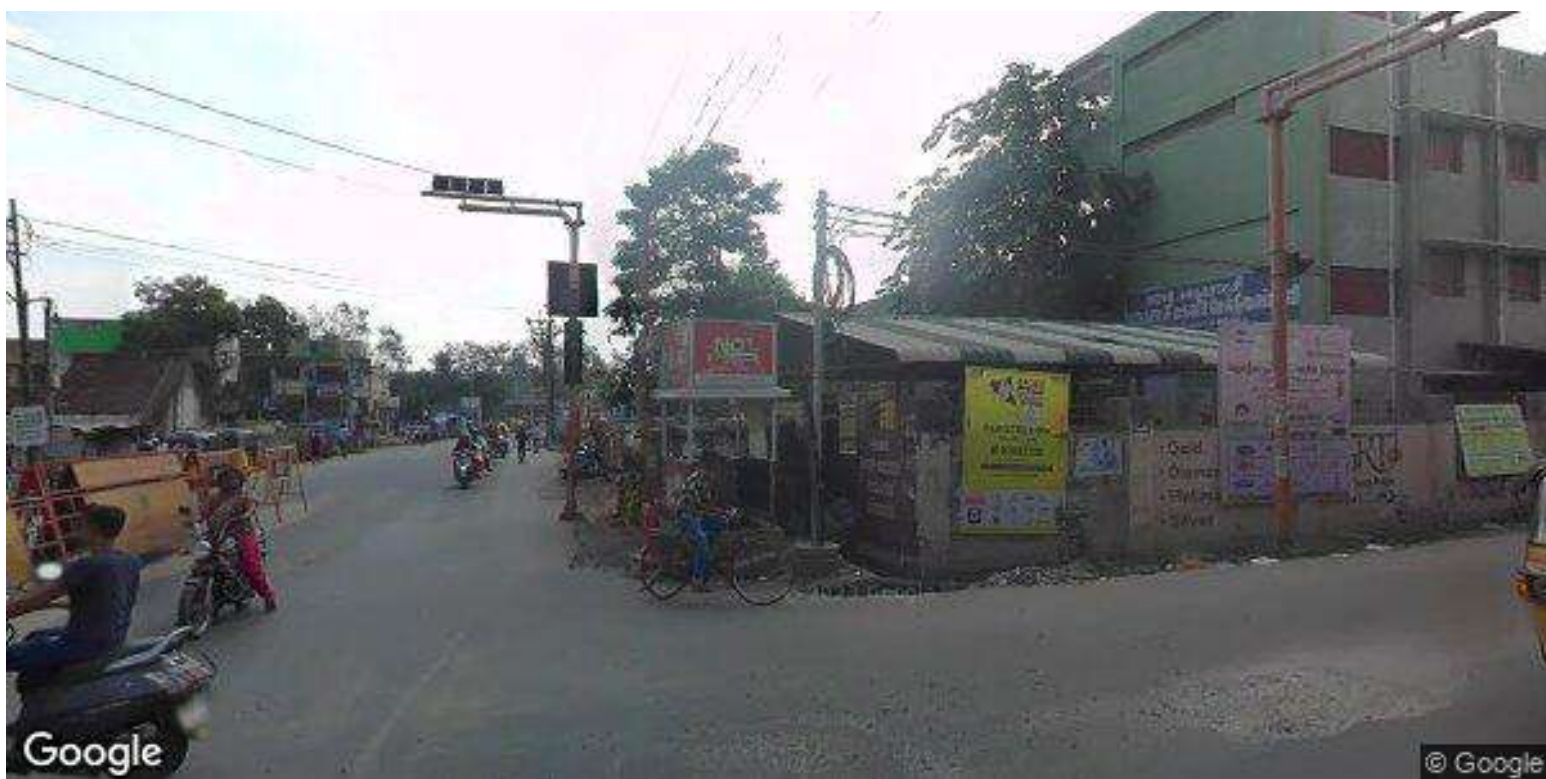
**Risk Type:** Blind Spot  
**Risk Level:** Blind Spot  
**Speed Limit:** 10 KM/Hr  
**Coordinates:** 11.34964, 77.73257

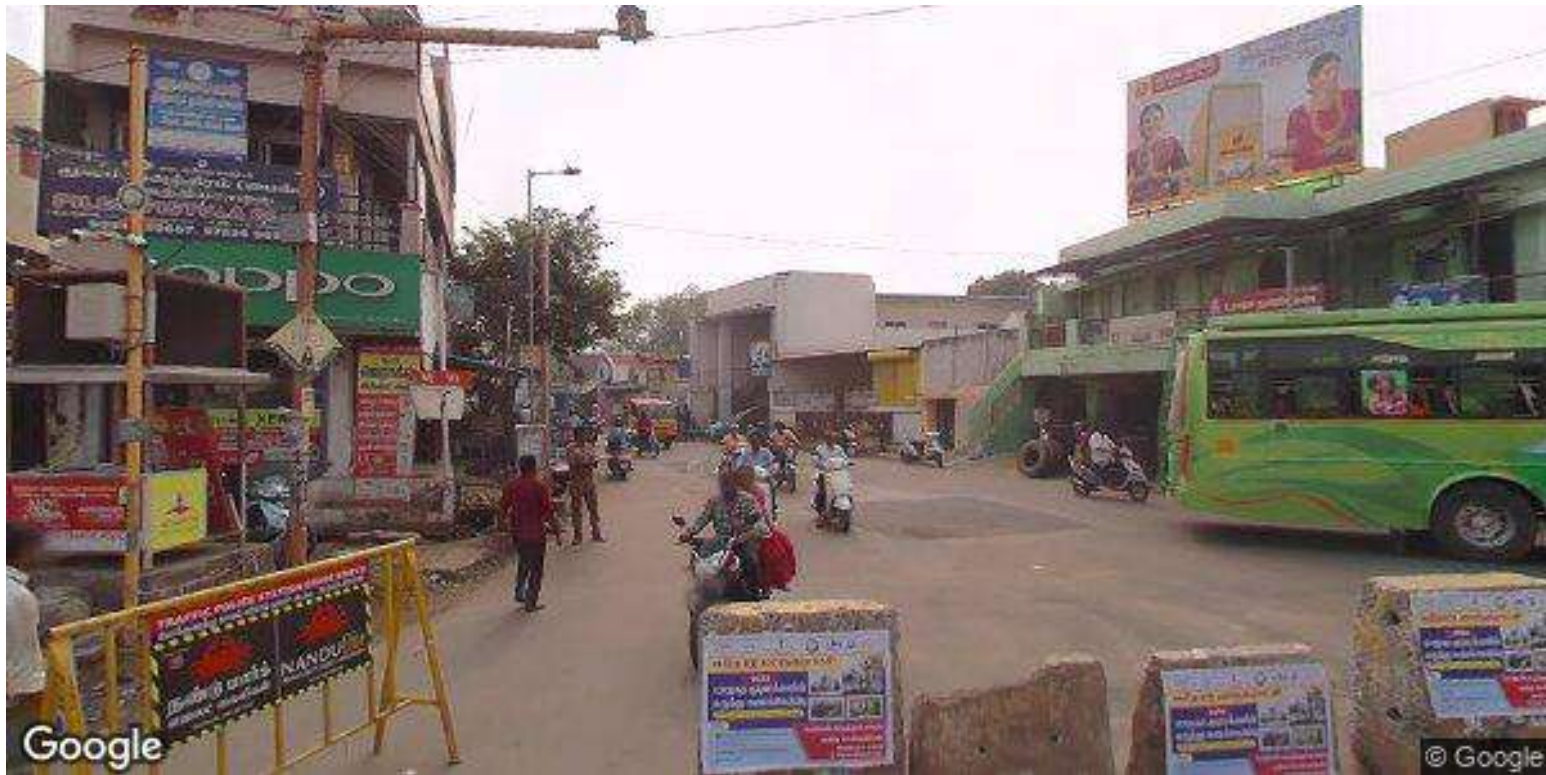
**Risk Type:** Turn  
**Risk Level:** High  
**Speed Limit:** 15 KM/Hr  
**Coordinates:** 11.35072, 77.72261

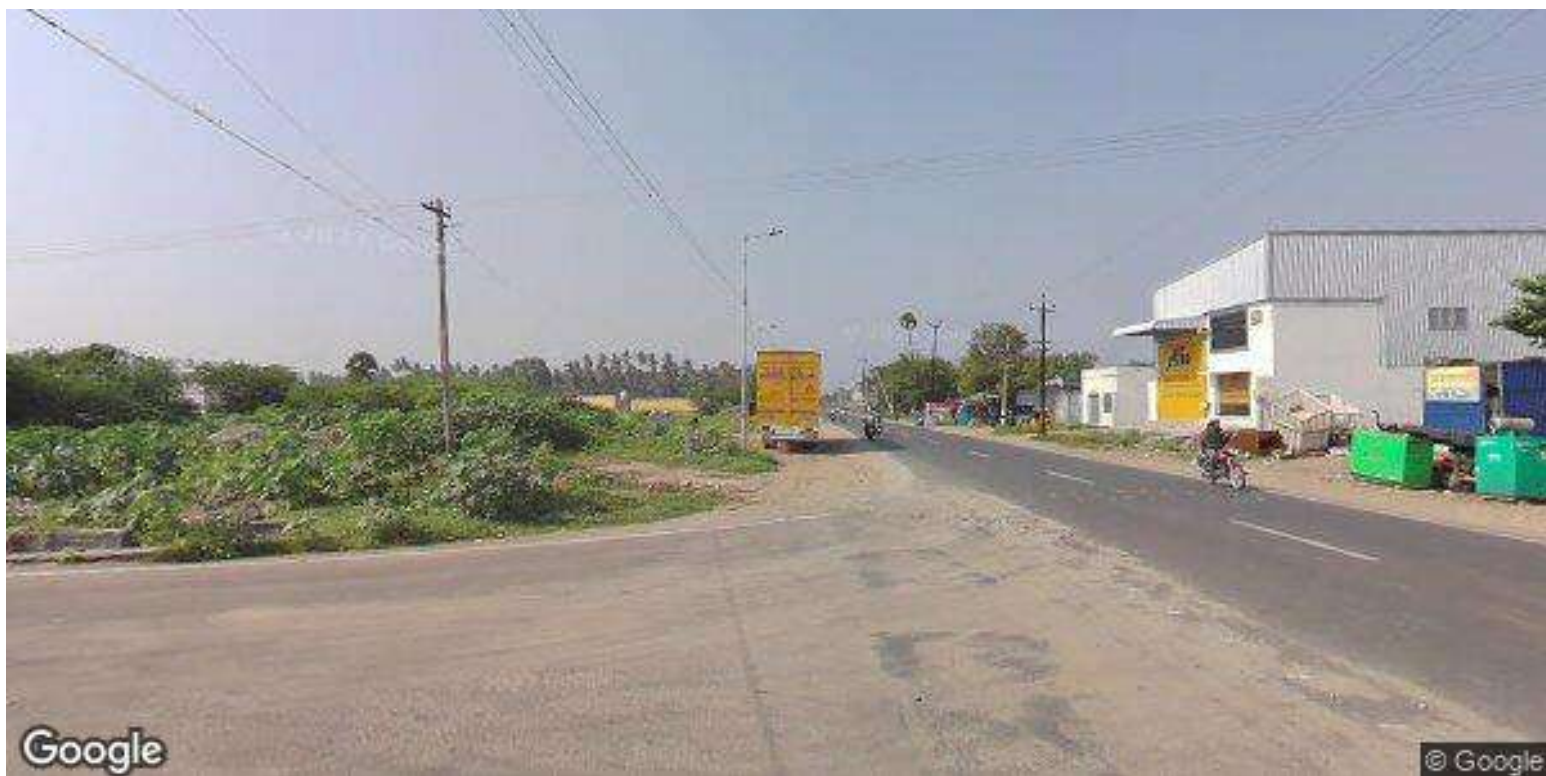
**Risk Type:** Turn  
**Risk Level:** High  
**Speed Limit:** 15 KM/Hr  
**Coordinates:** 11.37396, 77.70396

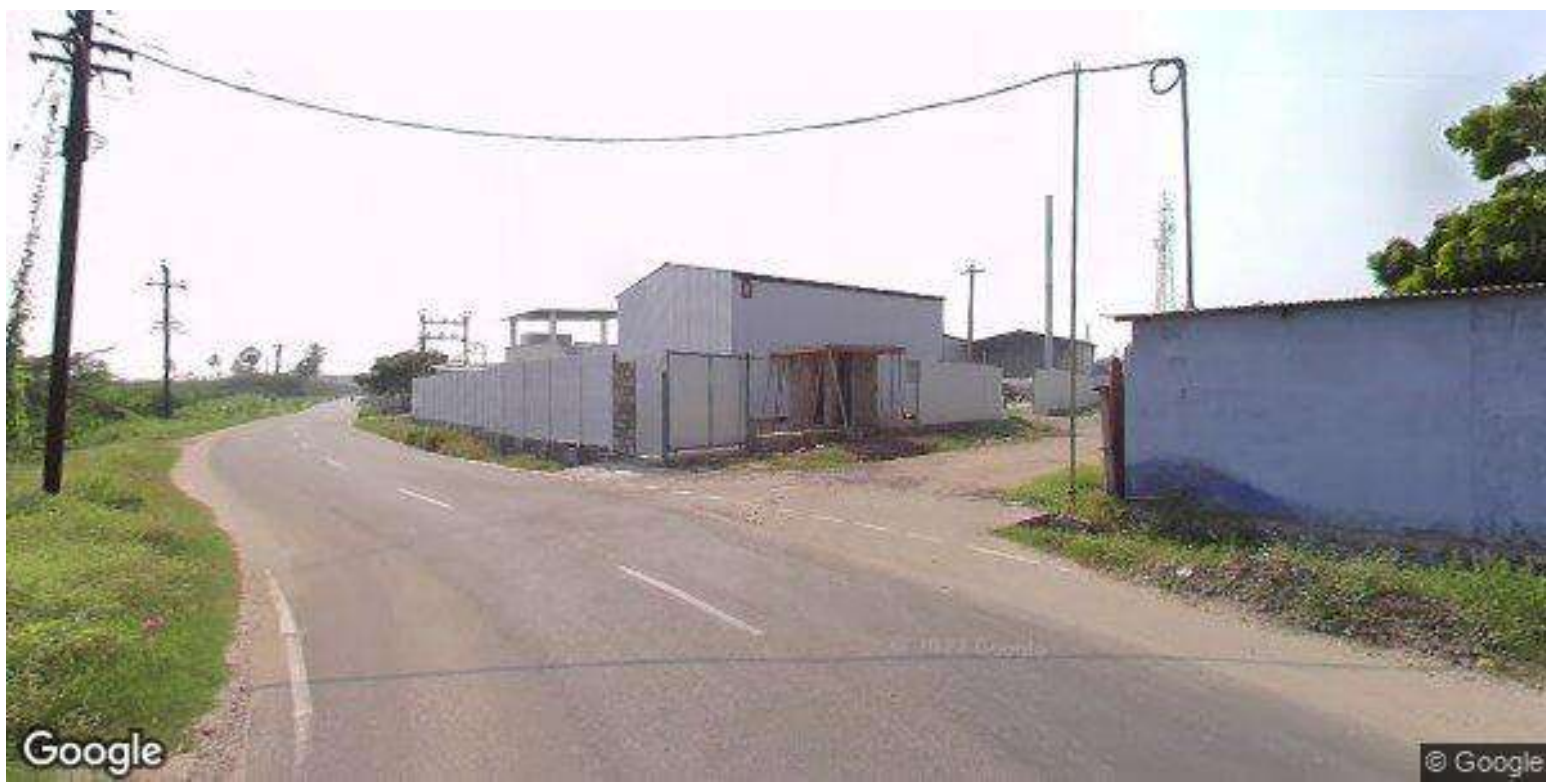
**Coordinates:** 11.37309, 77.70214

**Risk Type:** Turn

**Risk Level:** Medium

**Speed Limit:** 30 KM/Hr

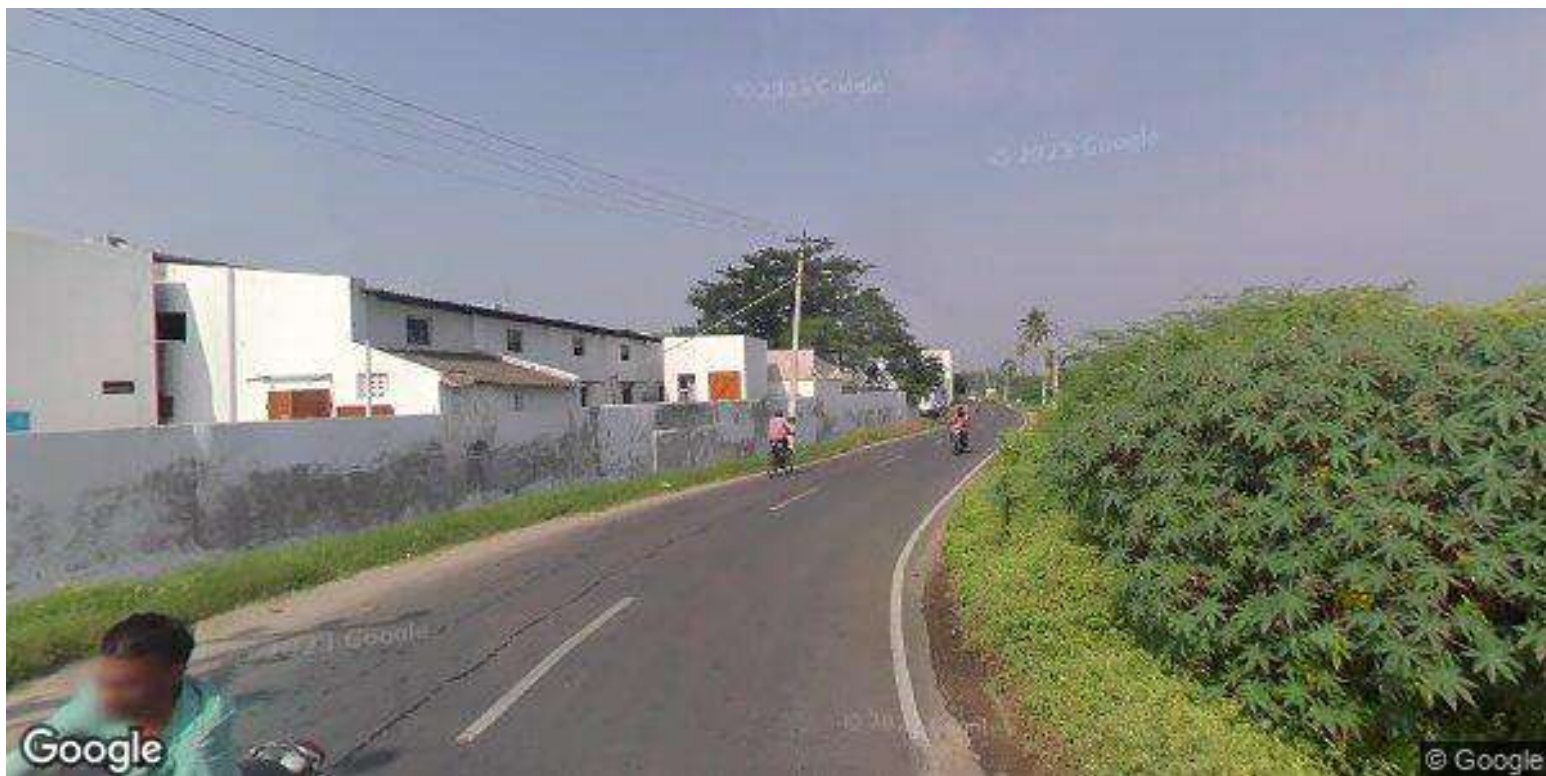
**Coordinates:** 11.37055, 77.70037

**Risk Type:** Turn

**Risk Level:** Medium

**Speed Limit:** 30 KM/Hr

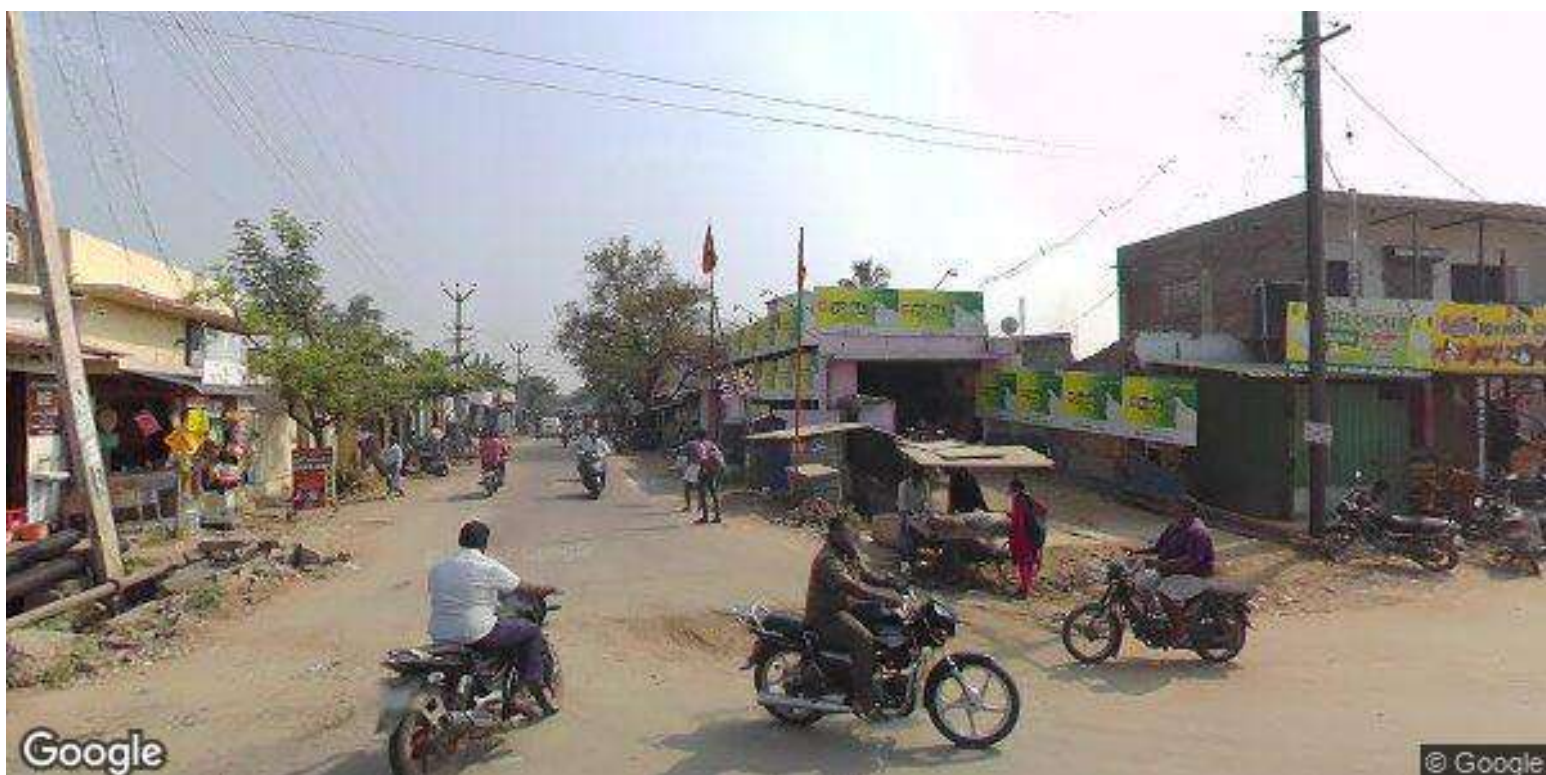
**Risk Type:** Blind Spot  
**Risk Level:** Blind Spot  
**Speed Limit:** 10 KM/Hr  
**Coordinates:** 11.36677, 77.69653

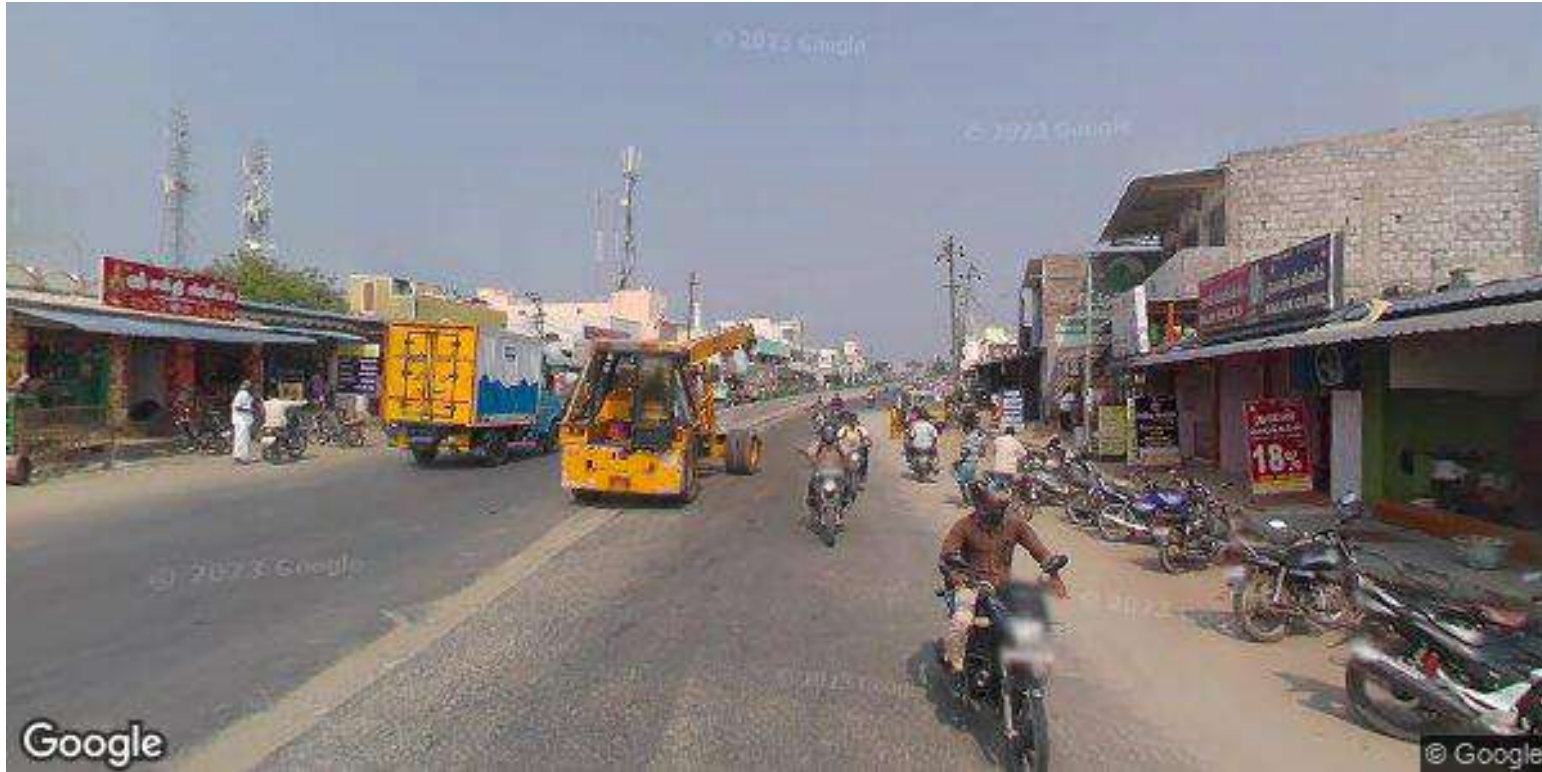
**Risk Type:** Blind Spot  
**Risk Level:** Blind Spot  
**Speed Limit:** 10 KM/Hr  
**Coordinates:** 11.36636, 77.69680

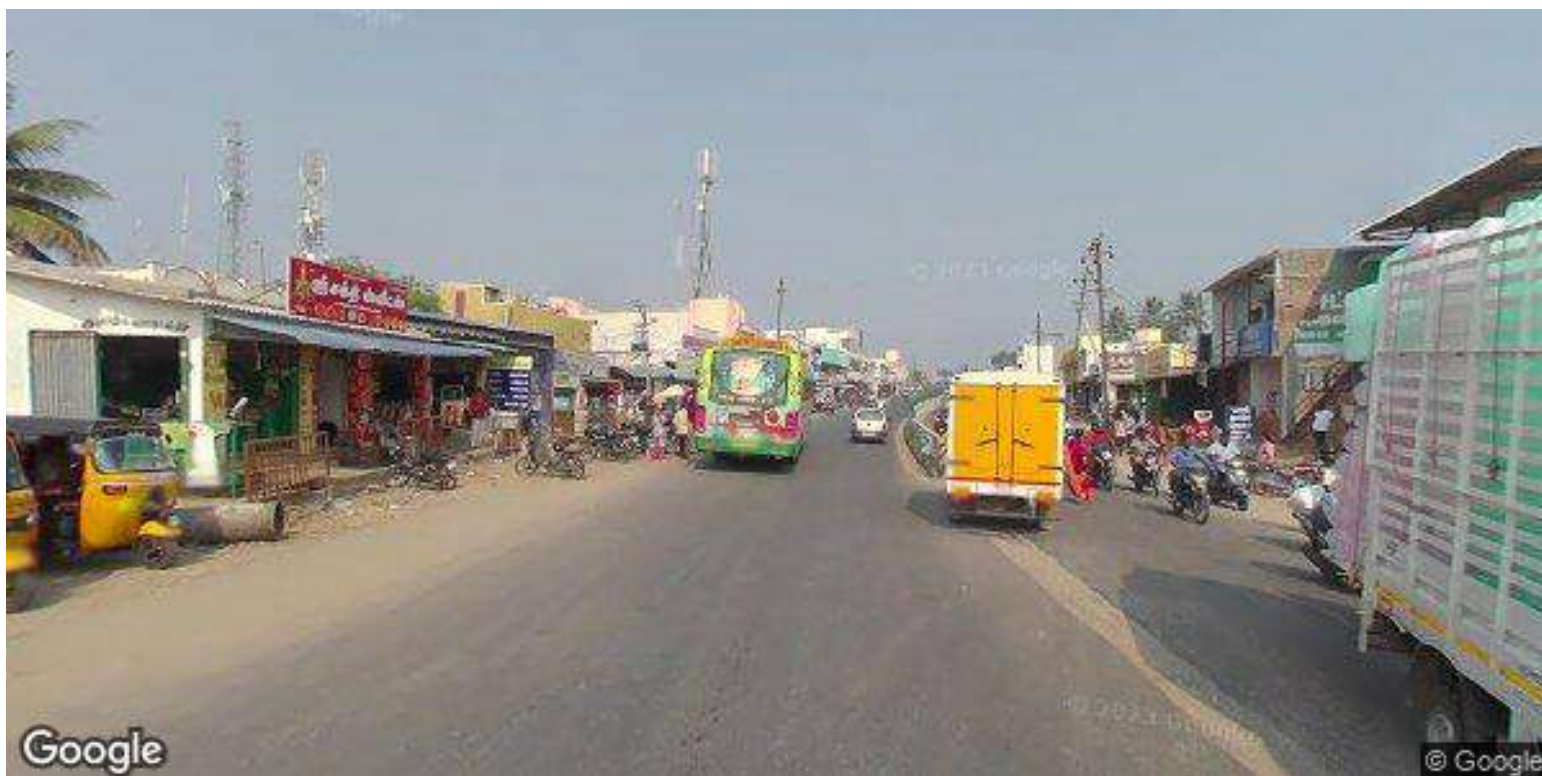
**Risk Type:** Turn  
**Risk Level:** High  
**Speed Limit:** 15 KM/Hr  
**Coordinates:** 11.36633, 77.69674

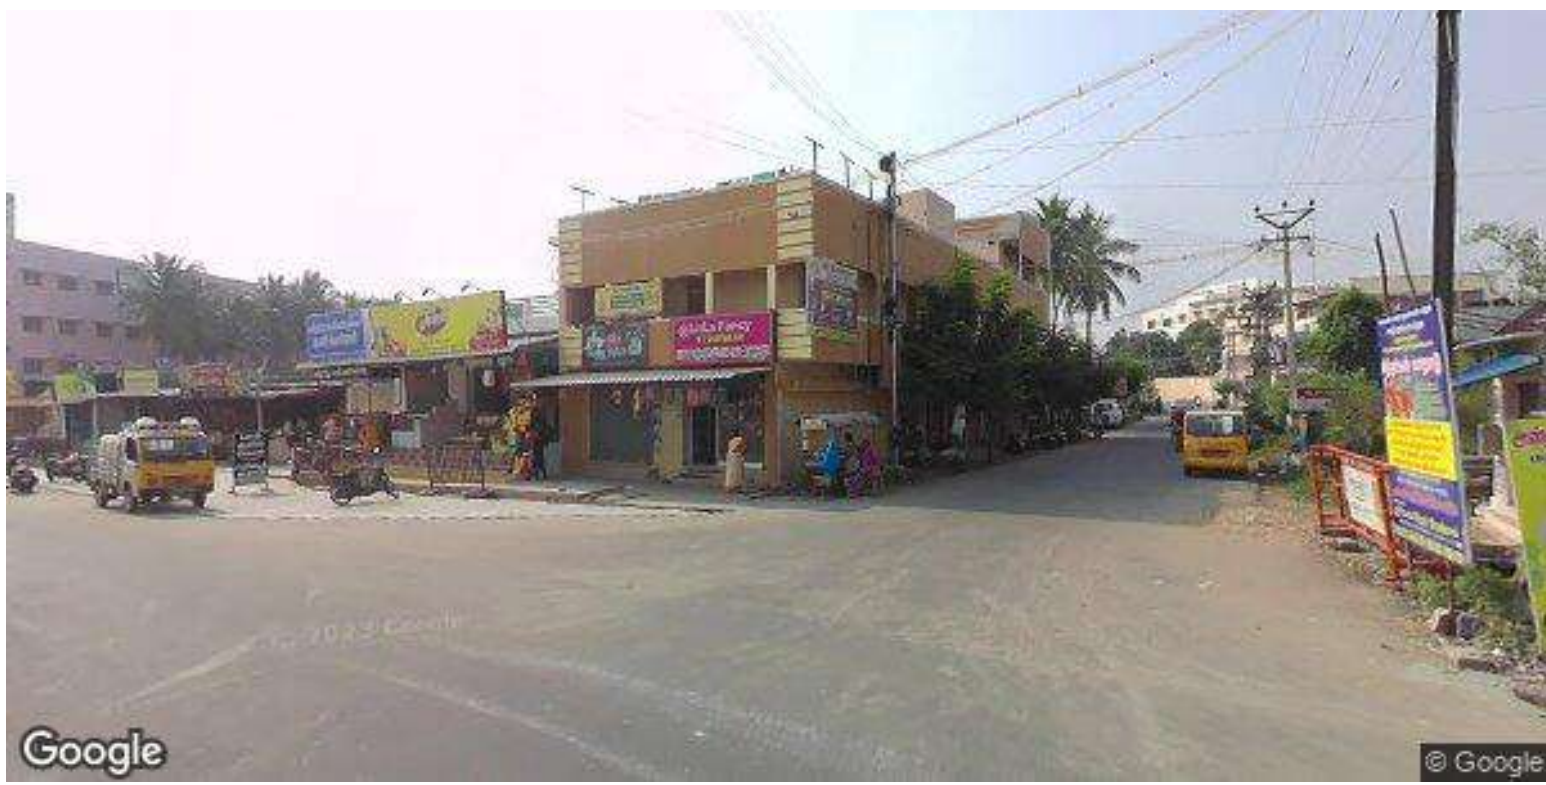
**Coordinates:** 11.37706, 77.68412

**Risk Type:** Turn

**Risk Level:** High

**Speed Limit:** 15 KM/Hr

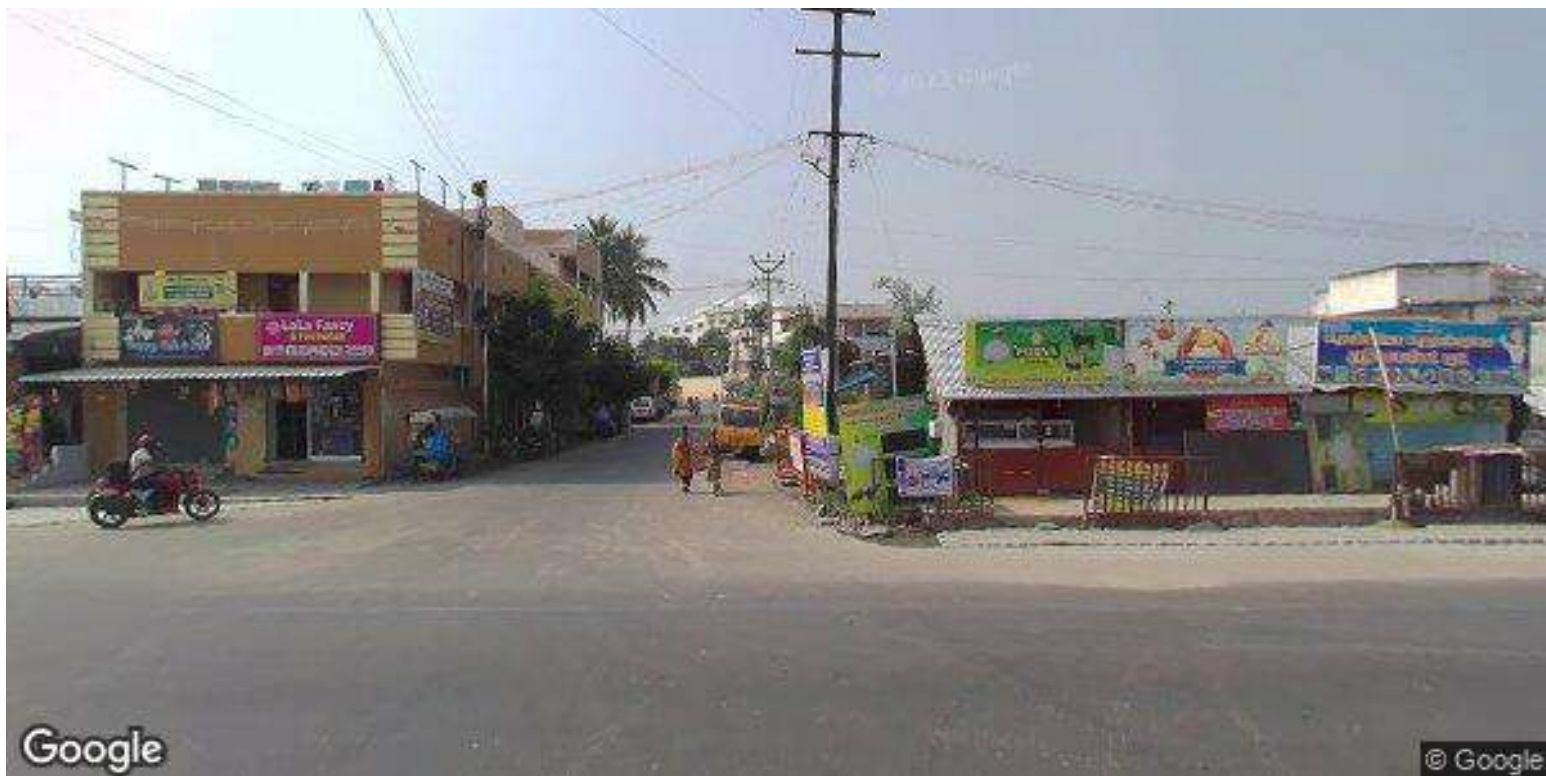
**Coordinates:** 11.37712, 77.68416

**Risk Type:** Blind Spot

**Risk Level:** Blind Spot

**Speed Limit:** 10 KM/Hr
