## JOURNEY RISK MANAGEMENT (JRM) STUDY

### Salem Terminal to SARAVANA AGENCY

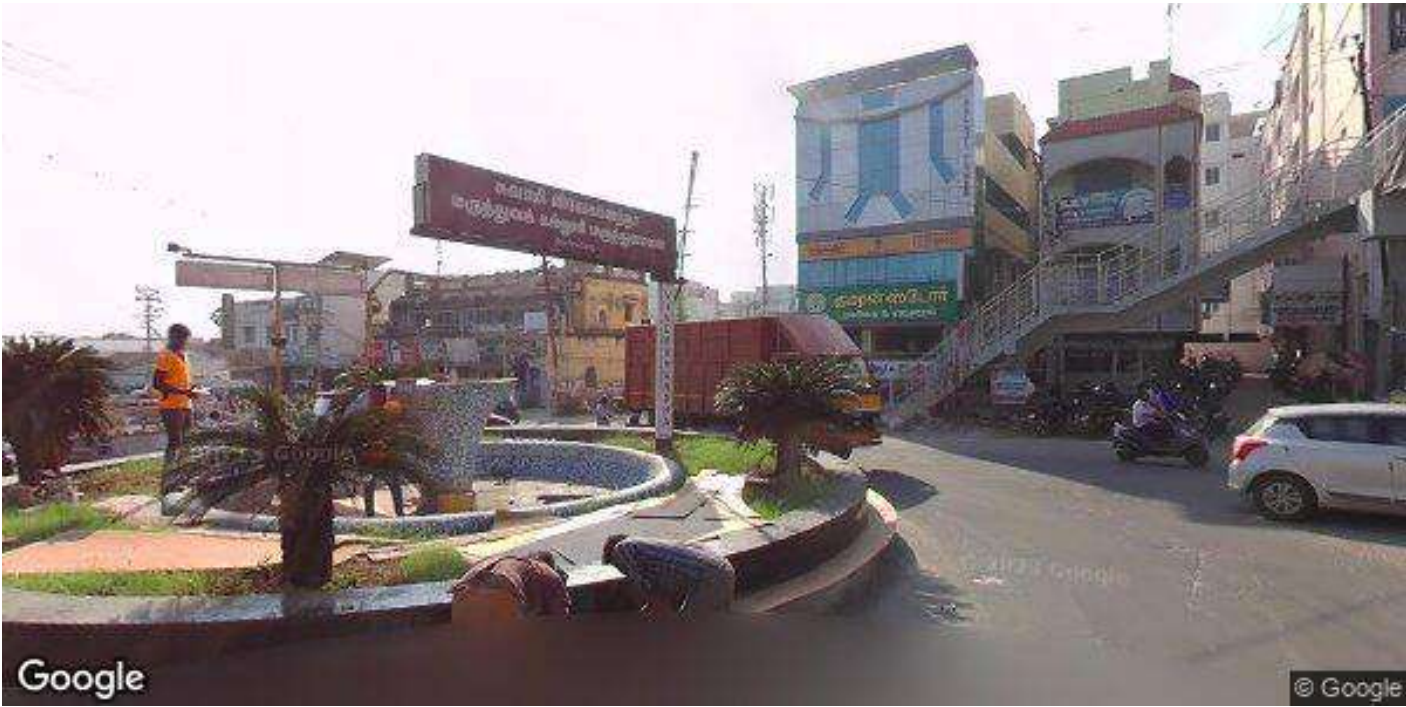
Coordinates: 11.38395, 77.89480

Risk Type: Roundabout

Risk Level: High

Speed Limit: 15 KM/Hr

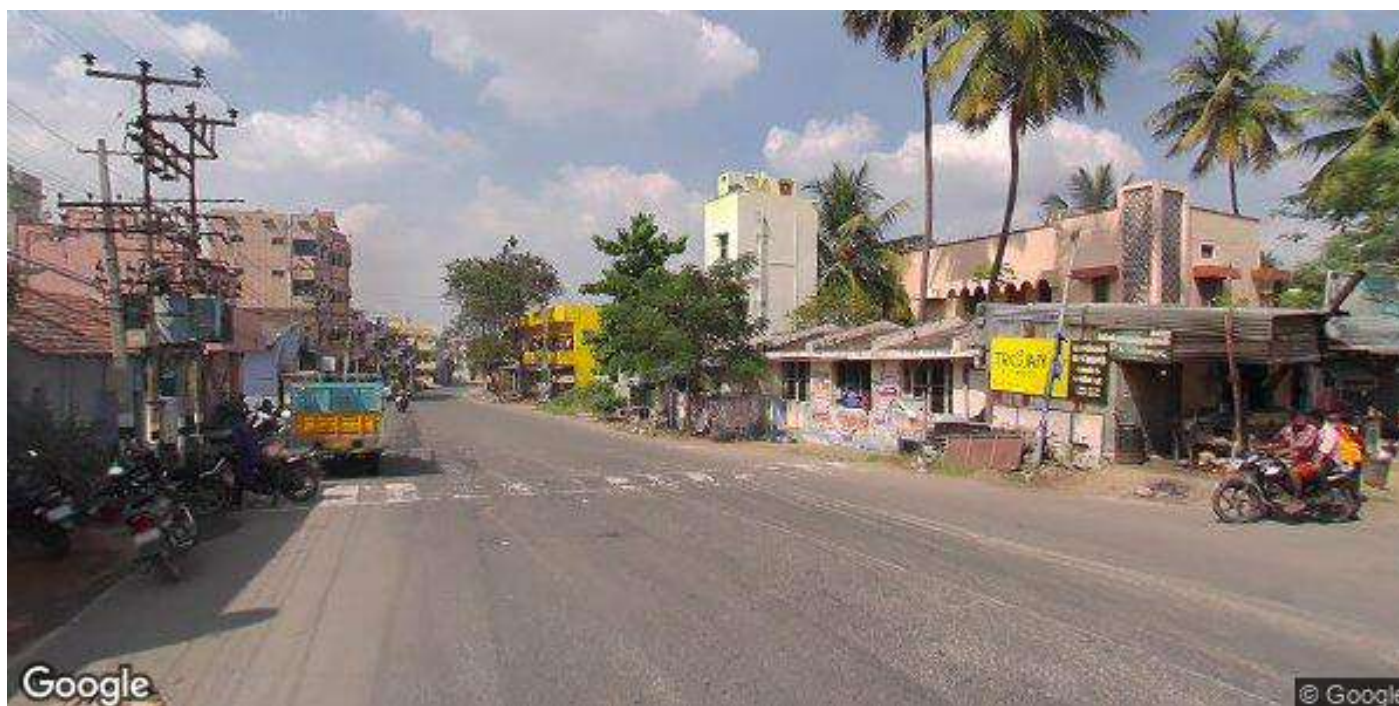
**Risk Type:** Turn  
**Risk Level:** Medium  
**Speed Limit:** 30 KM/Hr  
**Coordinates:** 11.38190, 77.90254

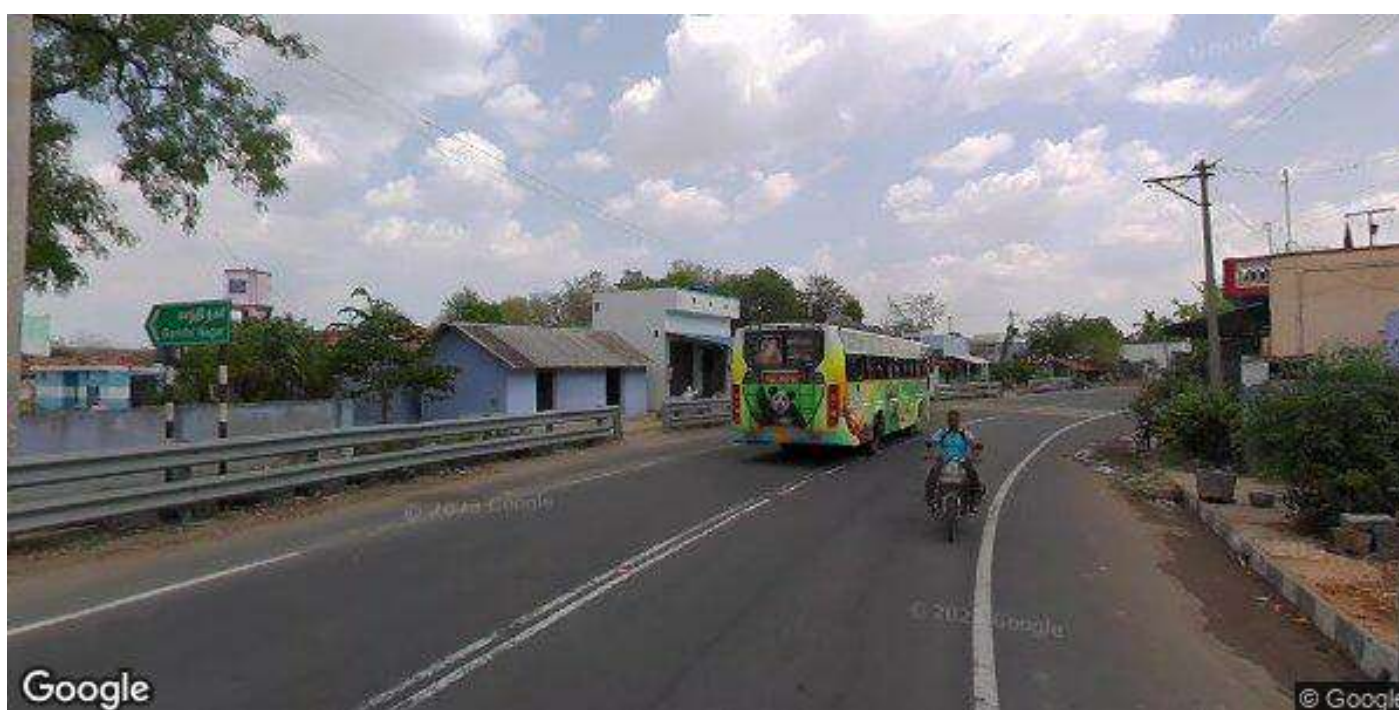
**Risk Type:** Turn  
**Risk Level:** Medium  
**Speed Limit:** 30 KM/Hr  
**Coordinates:** 11.41354, 78.08075

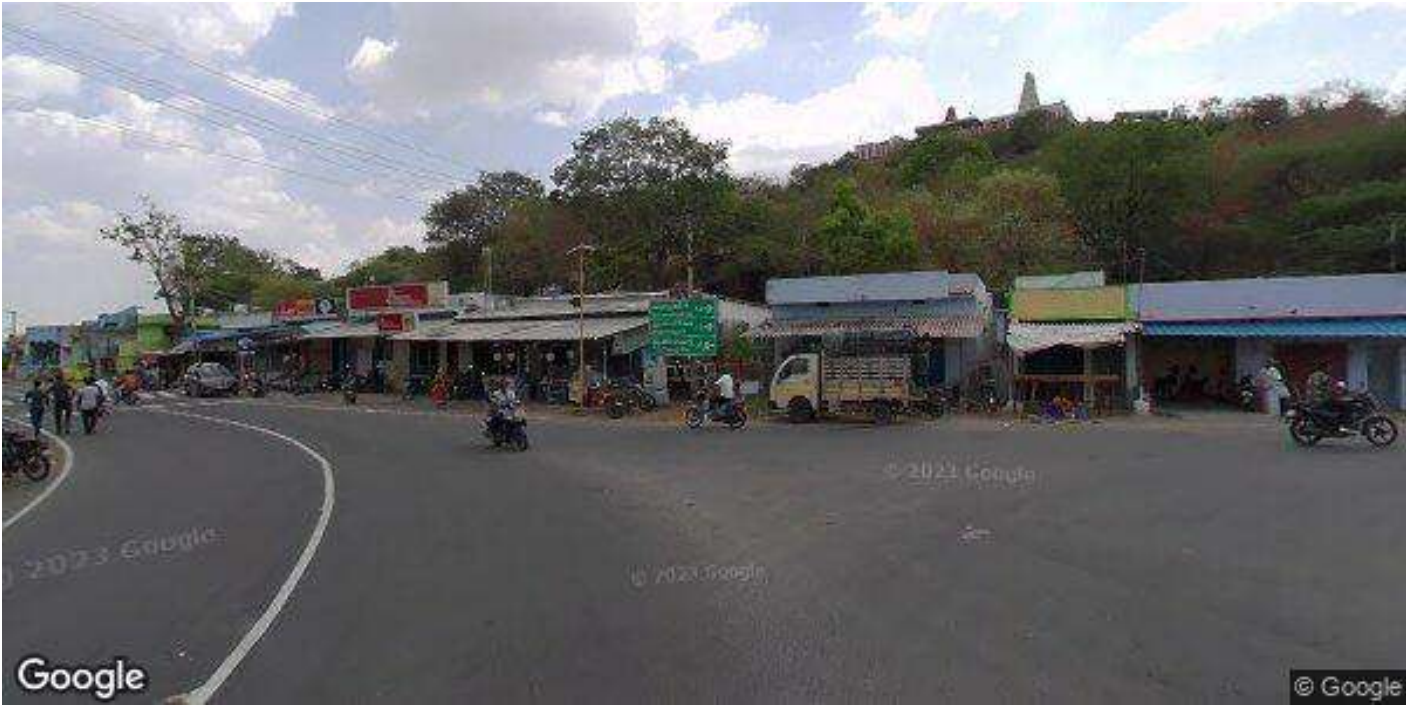
**Risk Type:** Turn  
**Risk Level:** Medium  
**Speed Limit:** 30 KM/Hr  
**Coordinates:** 11.41463, 78.08067

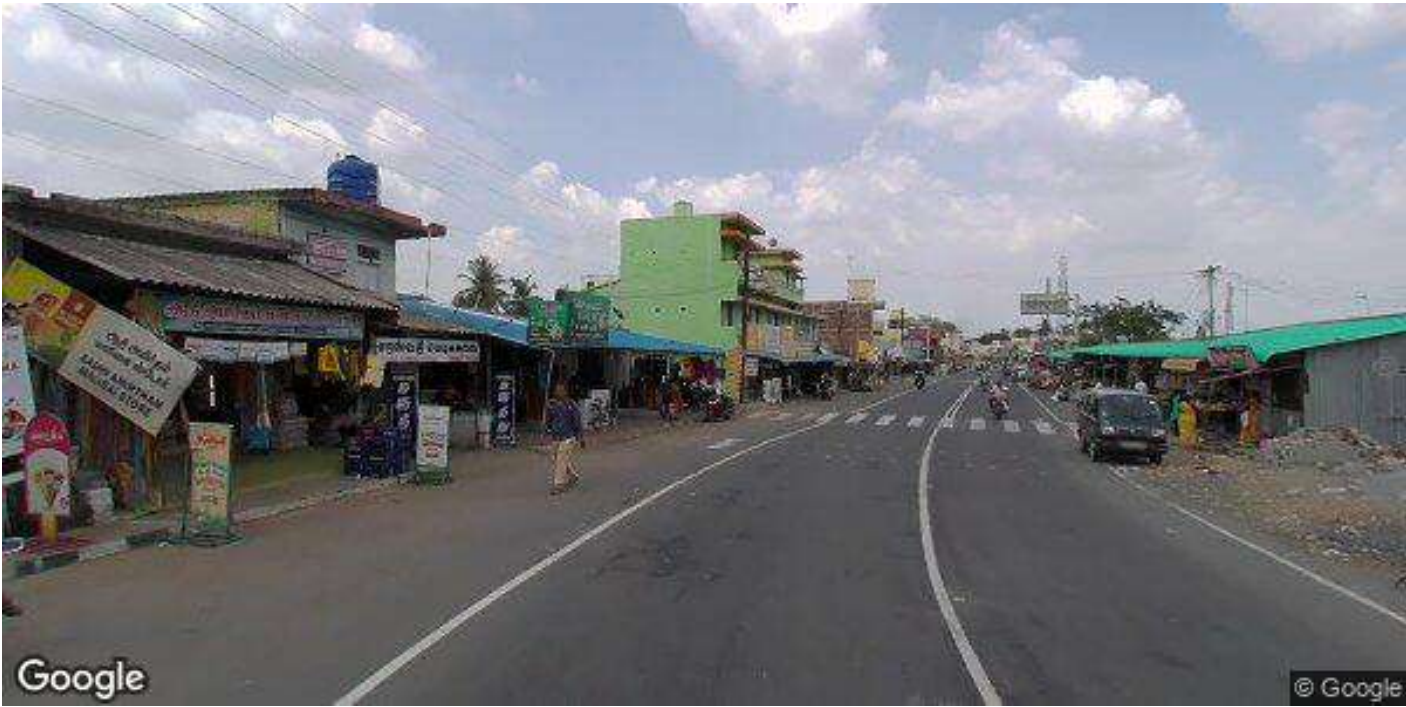
**Risk Type:** Turn  
**Risk Level:** Medium  
**Speed Limit:** 30 KM/Hr  
**Coordinates:** 11.41475, 78.08087

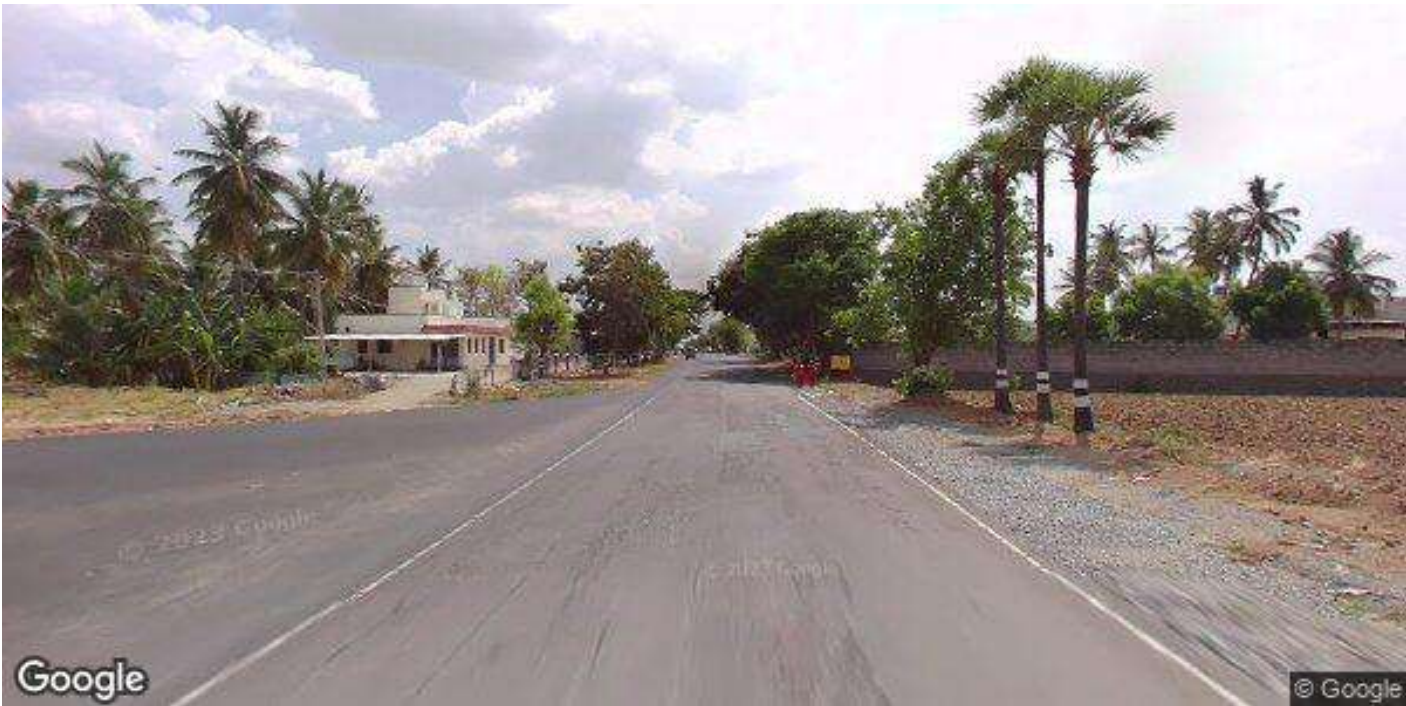
**Risk Type:** Turn  
**Risk Level:** High  
**Speed Limit:** 15 KM/Hr  
**Coordinates:** 11.42964, 78.11587

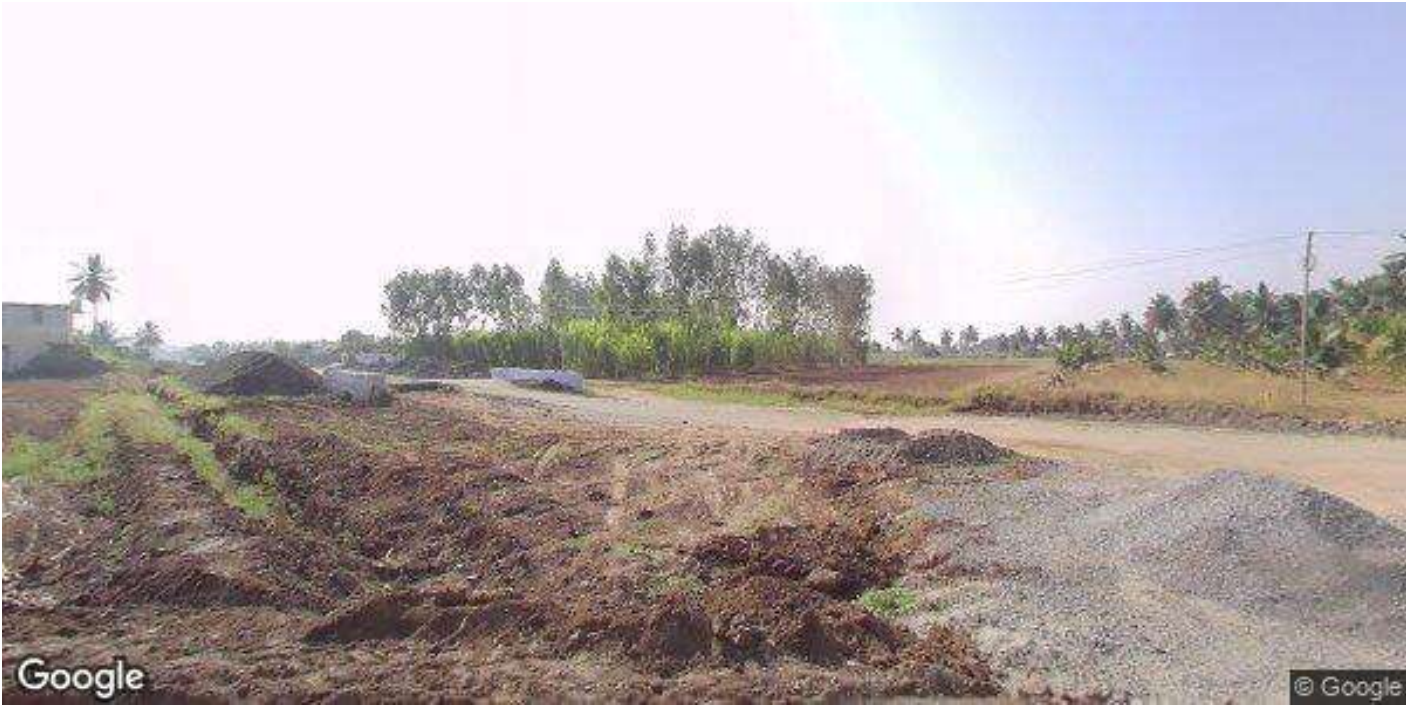
**Risk Type:** Turn  
**Risk Level:** Medium  
**Speed Limit:** 30 KM/Hr  
**Coordinates:** 11.42945, 78.11606

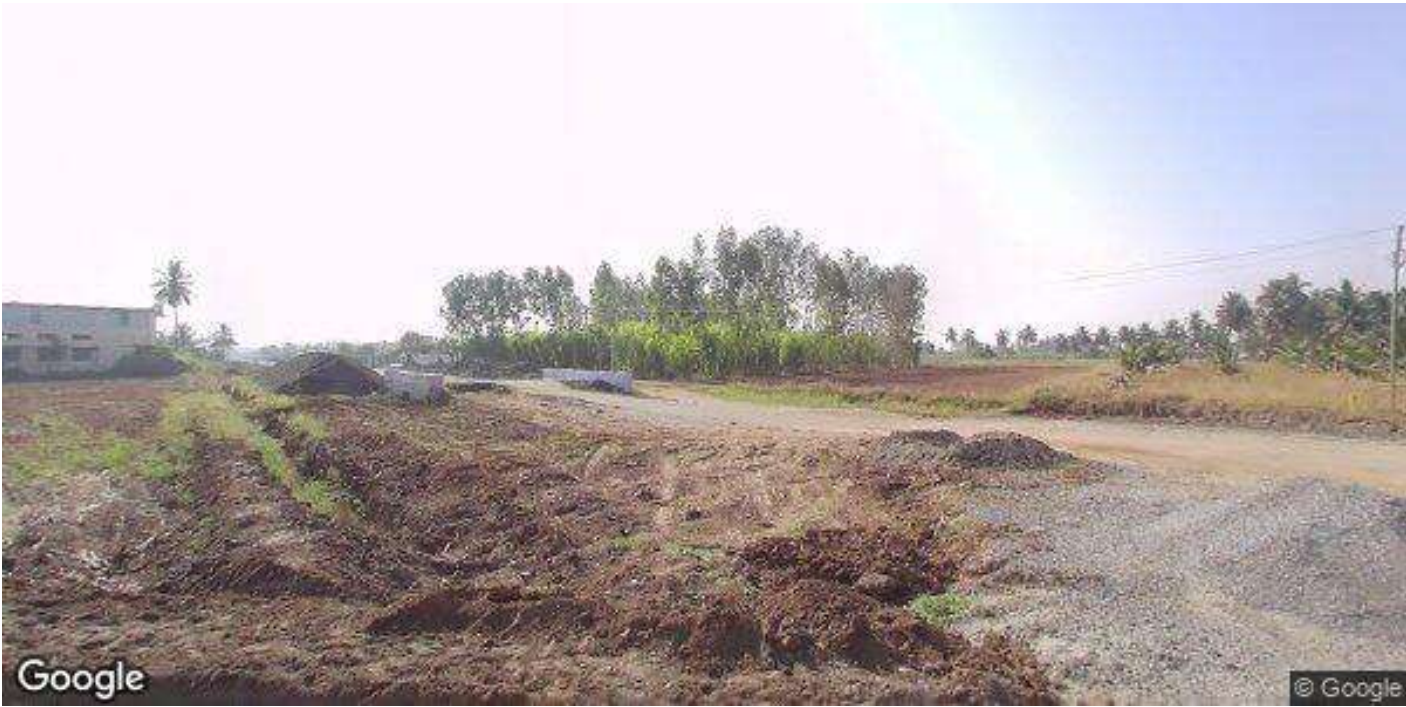
**Risk Type:** Turn  
**Risk Level:** Medium  
**Speed Limit:** 30 KM/Hr  
**Coordinates:** 11.42940, 78.11609

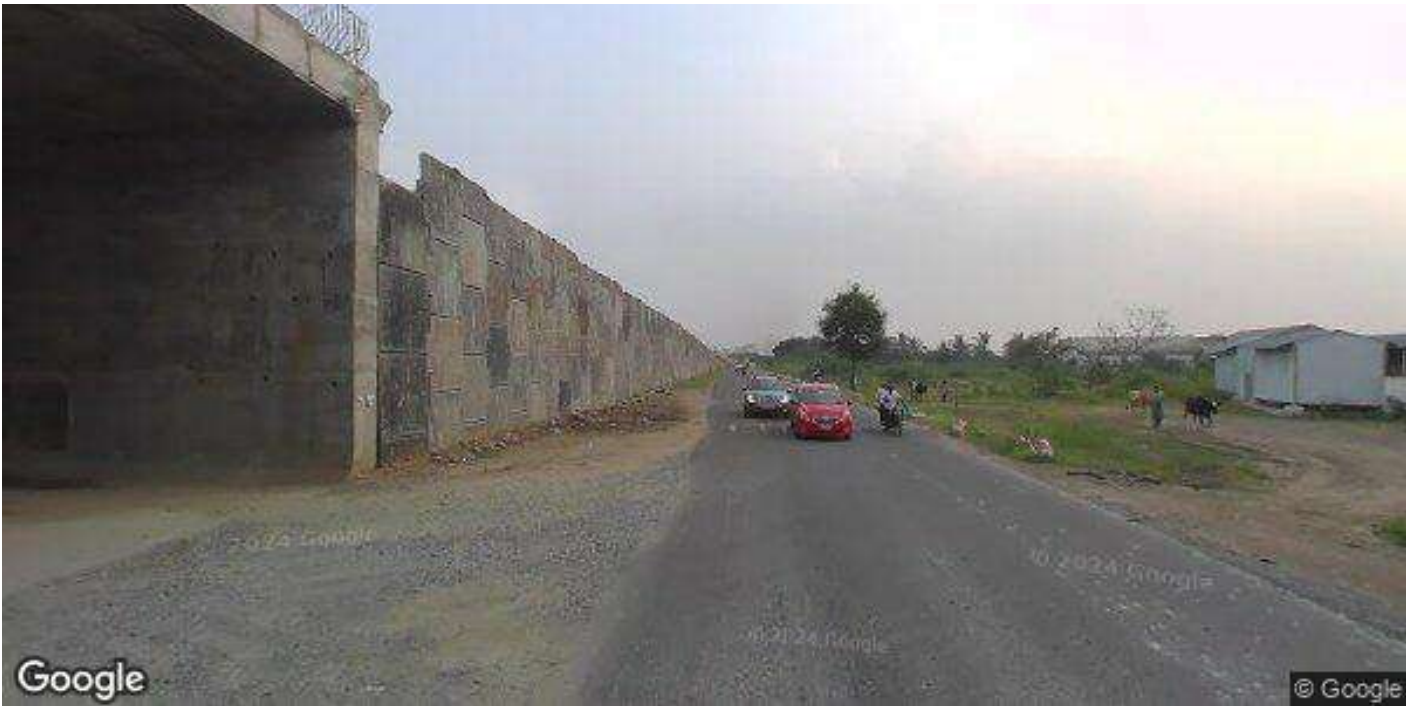
**Risk Type:** Turn  
**Risk Level:** High  
**Speed Limit:** 15 KM/Hr  
**Coordinates:** 11.42622, 78.15562

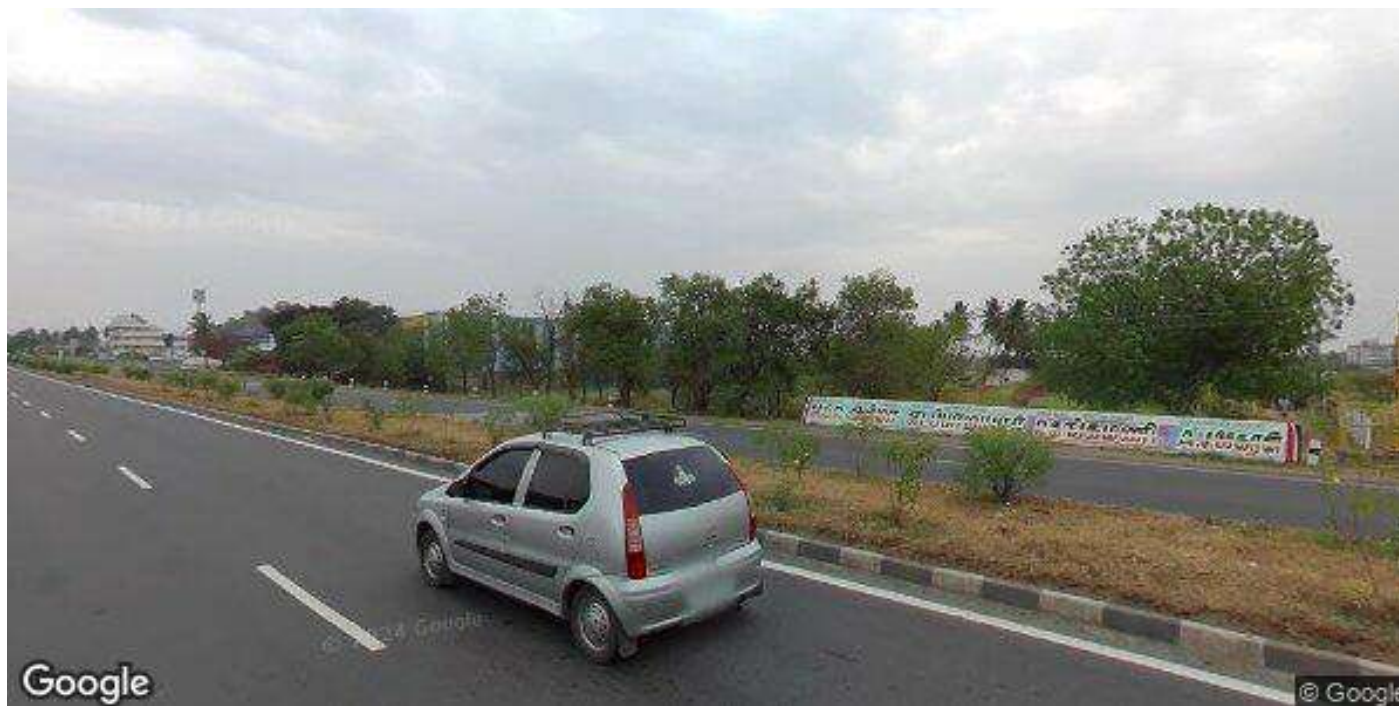
**Risk Type:** Turn  
**Risk Level:** Medium  
**Speed Limit:** 30 KM/Hr  
**Coordinates:** 11.43096, 78.15617

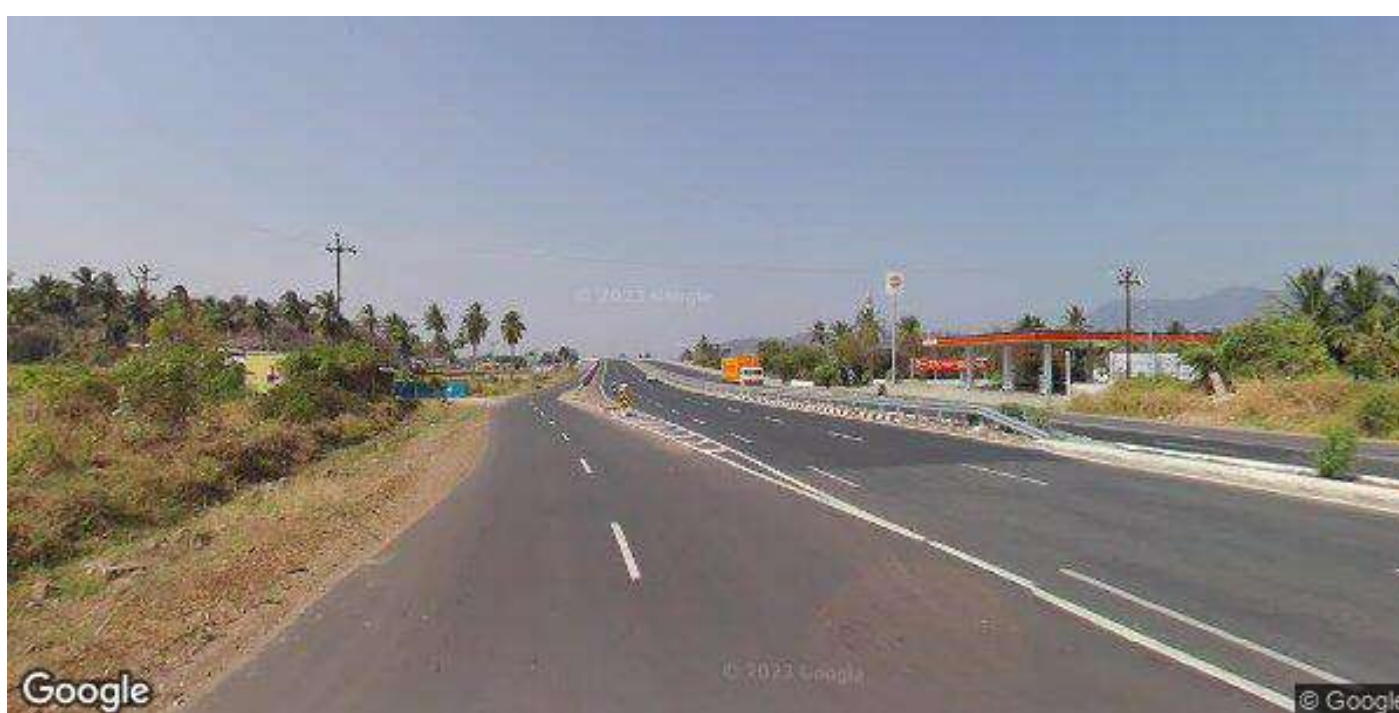
**Risk Type:** Turn  
**Risk Level:** Medium  
**Speed Limit:** 30 KM/Hr  
**Coordinates:** 11.46786, 78.15750

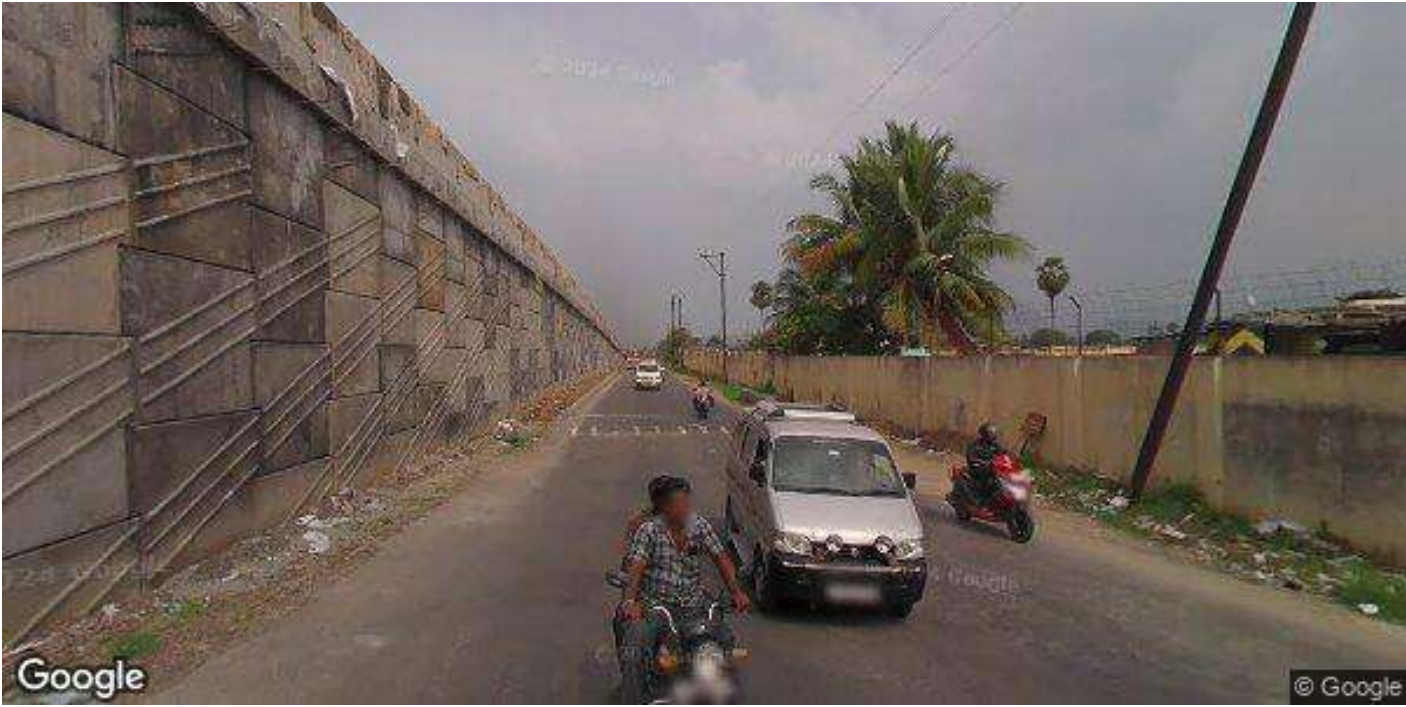
**Risk Type:** Blind Spot  
**Risk Level:** Blind Spot  
**Speed Limit:** 10 KM/Hr  
**Coordinates:** 11.47225, 78.15722
