# IndianOil

## JOURNEY RISK MANAGEMENT (JRM) STUDY

### Salem Terminal to SALEM DISTRICT LORRY OWNERS

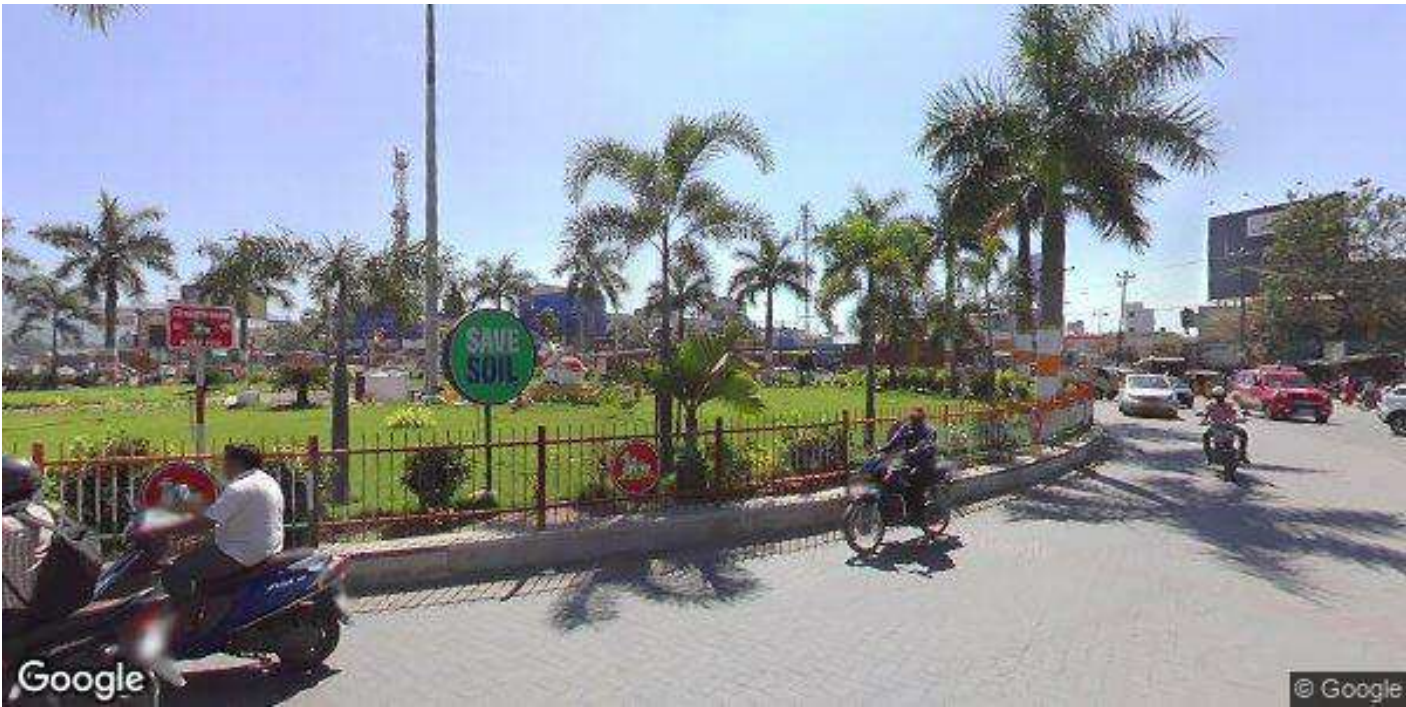
| | Risk Type | Risk Level | Coordinates | Speed Limit |
|---|---|---|---|---|
| 0 | Roundabout | High | 11.63303, 78.12713 | 15 KM/Hr |

Risk Type: Roundabout

Risk Level: High

Speed Limit: 15 KM/Hr

Coordinates: 11.63303, 78.12713

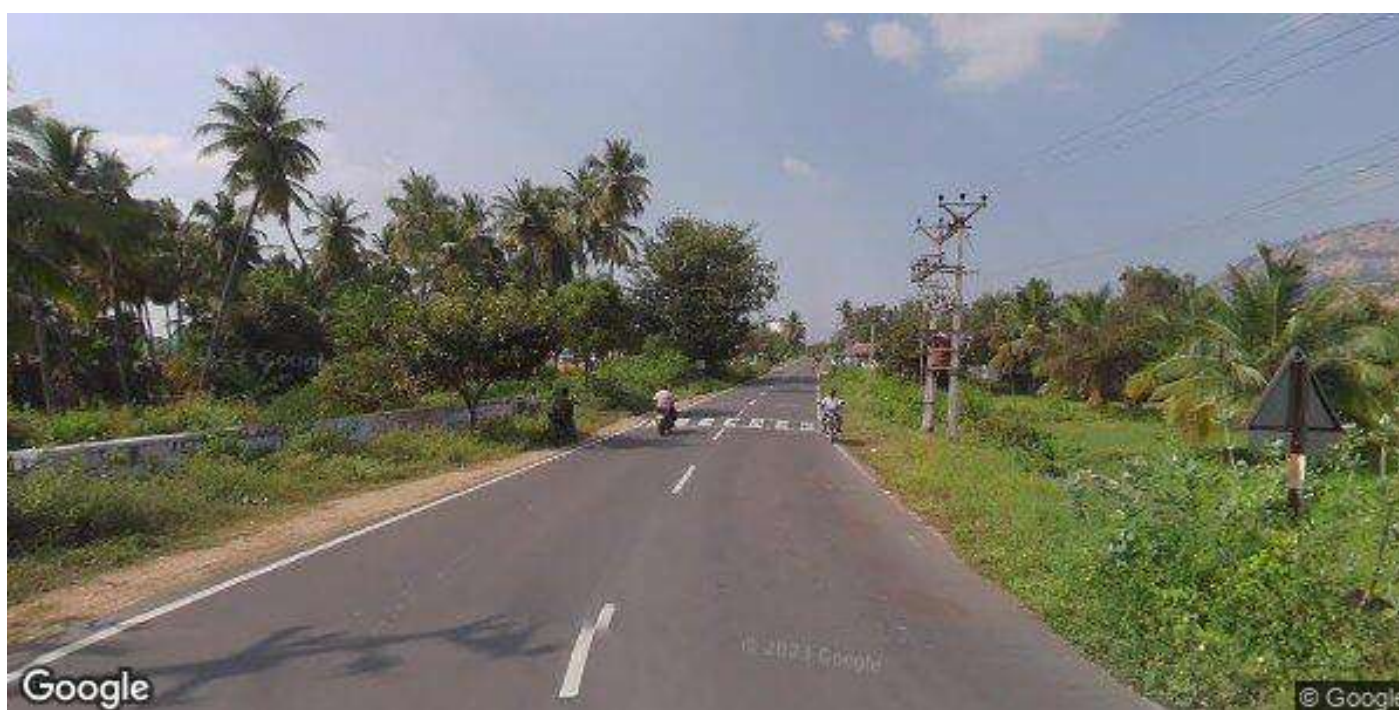
| | Risk Type | Risk Level | Coordinates | Speed Limit |
|---|---|---|---|---|
| 5 | Turn | Medium | 11.45353, 77.85697 | 30 KM/Hr |

**Risk Type:** Turn  
**Risk Level:** Medium  
**Speed Limit:** 30 KM/Hr  
**Coordinates:** 11.45353, 77.85697

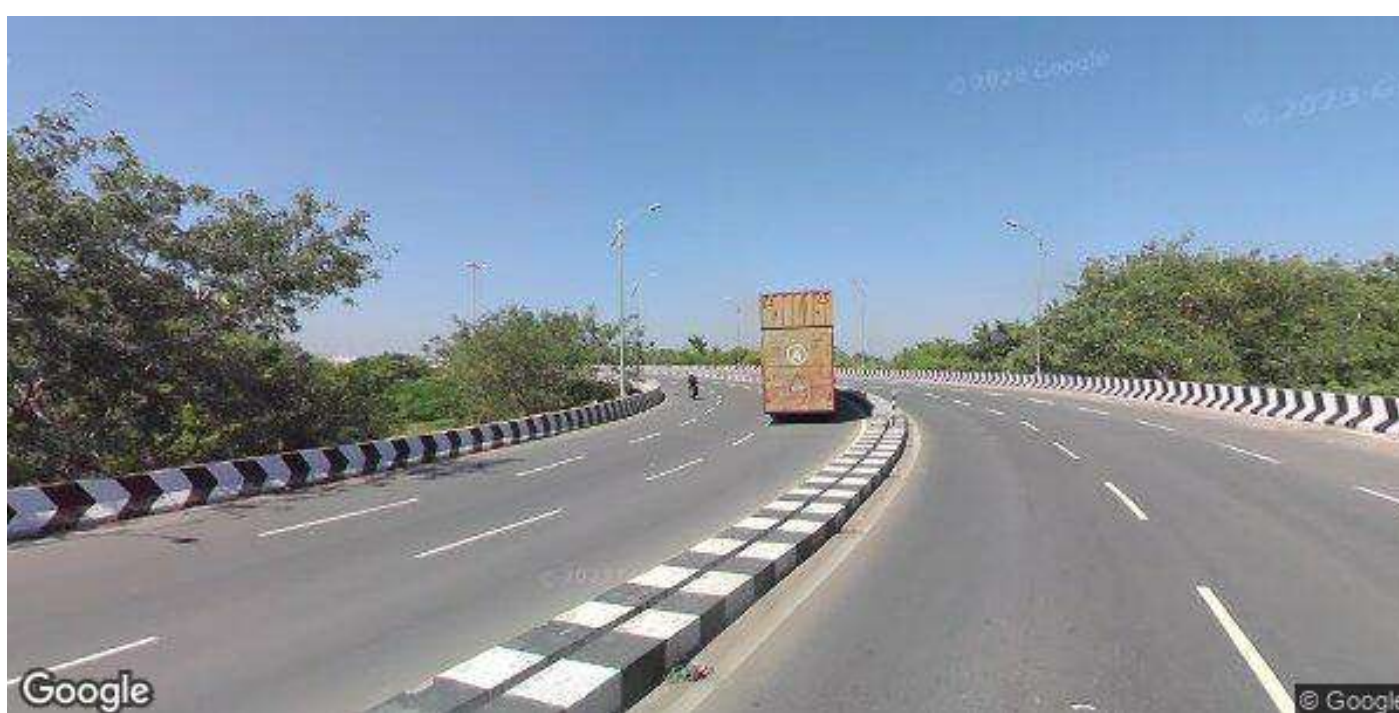
| | Risk Type | Risk Level | Coordinates | Speed Limit |
|---|---|---|---|---|
| 11 | Turn | Medium | 11.64156, 78.12162 | 30 KM/Hr |

**Risk Type:** Turn  
**Risk Level:** Medium  
**Speed Limit:** 30 KM/Hr  
**Coordinates:** 11.64156, 78.12162

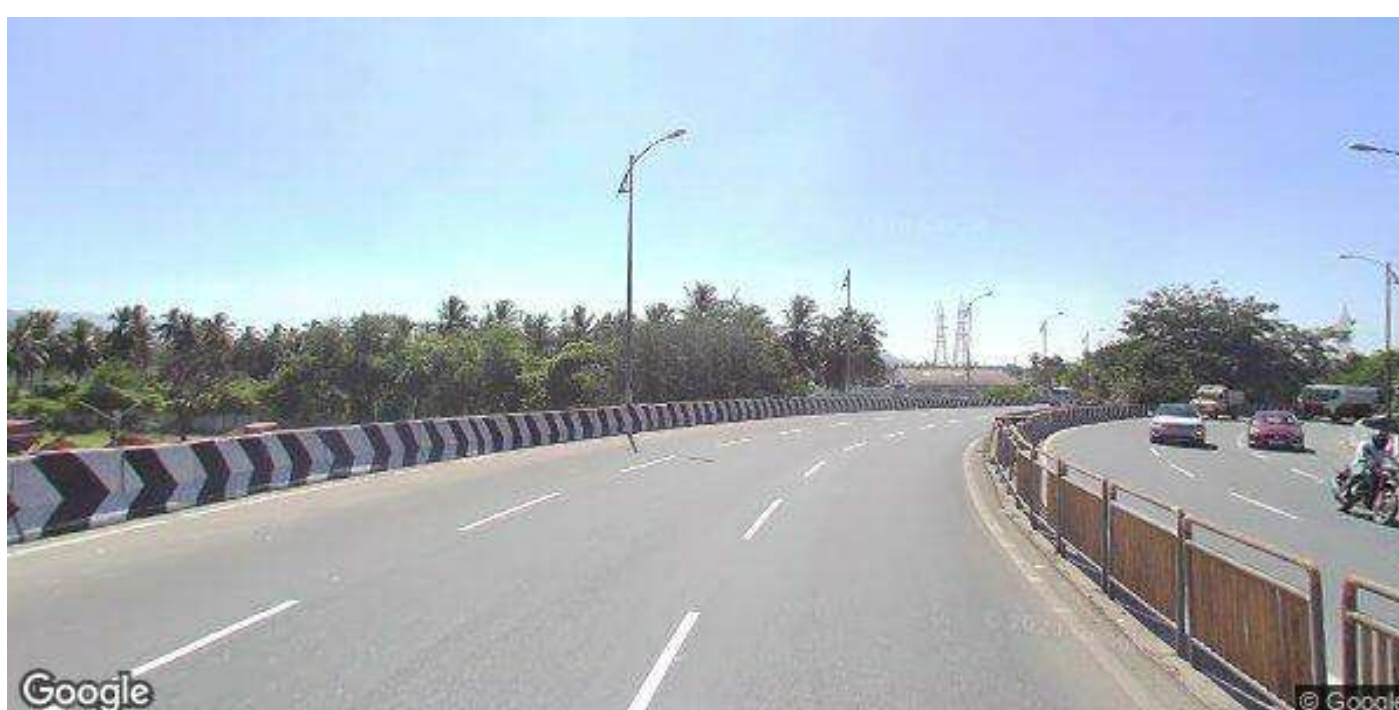
| | Risk Type | Risk Level | Coordinates | Speed Limit |
|---|---|---|---|---|
| 12 | Turn | Medium | 11.64116, 78.12168 | 30 KM/Hr |

**Risk Type:** Turn  
**Risk Level:** Medium  
**Speed Limit:** 30 KM/Hr  
**Coordinates:** 11.64116, 78.12168

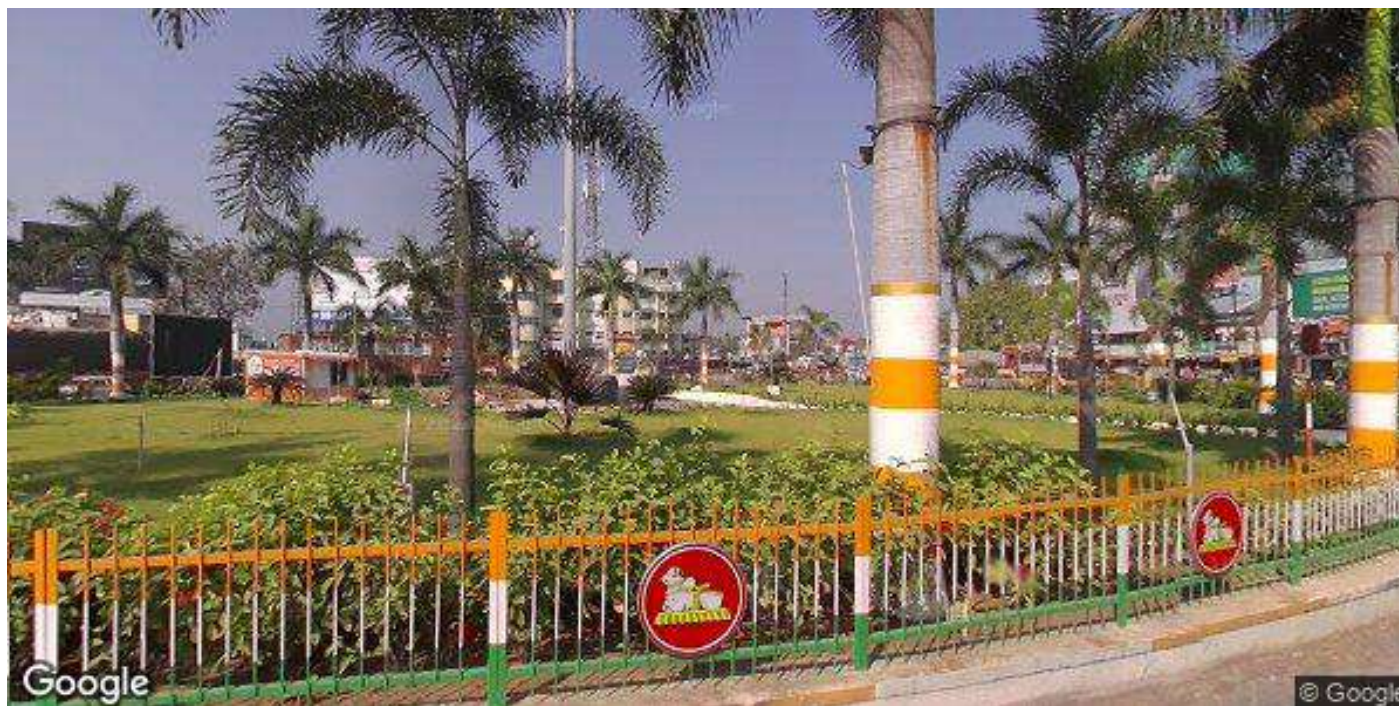
| | Risk Type | Risk Level | Coordinates | Speed Limit |
|---|---|---|---|---|
| 13 | Turn | Medium | 11.63270, 78.12757 | 30 KM/Hr |

**Risk Type:** Turn  
**Risk Level:** Medium  
**Speed Limit:** 30 KM/Hr  
**Coordinates:** 11.63270, 78.12757

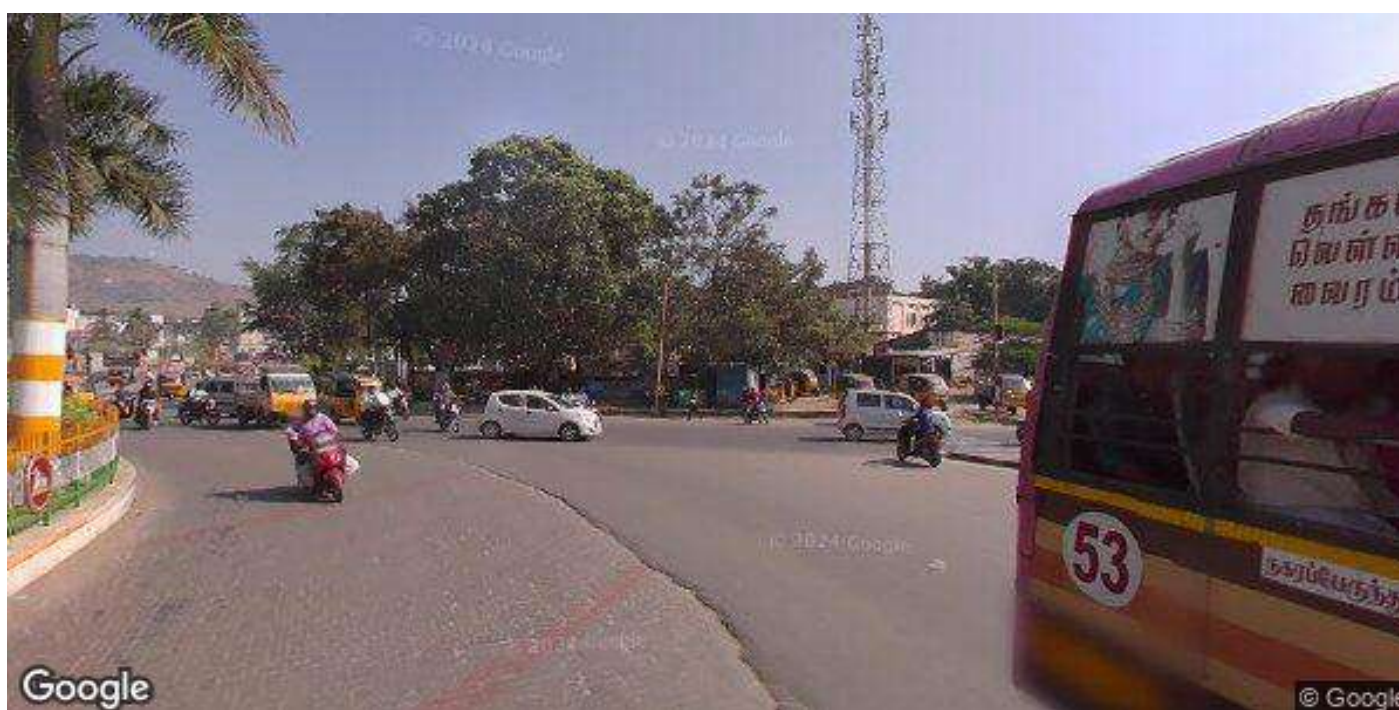
| | Risk Type | Risk Level | Coordinates | Speed Limit |
|---|---|---|---|---|
| 14 | Turn | Medium | 11.63256, 78.12749 | 30 KM/Hr |

**Risk Type:** Turn  
**Risk Level:** Medium  
**Speed Limit:** 30 KM/Hr  
**Coordinates:** 11.63256, 78.12749

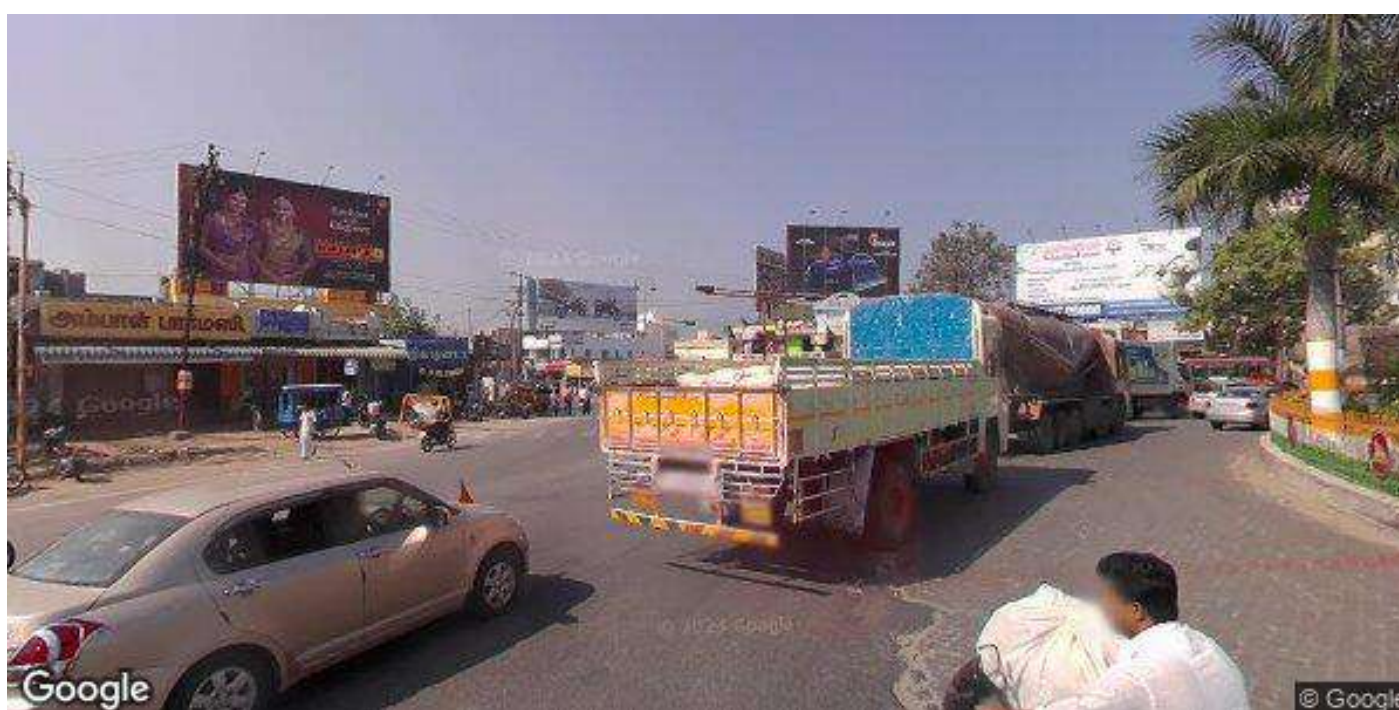
| | Risk Type | Risk Level | Coordinates | Speed Limit |
|---|---|---|---|---|
| 15 | Turn | Medium | 11.63247, 78.12734 | 30 KM/Hr |

**Risk Type:** Turn  
**Risk Level:** Medium  
**Speed Limit:** 30 KM/Hr  
**Coordinates:** 11.63247, 78.12734

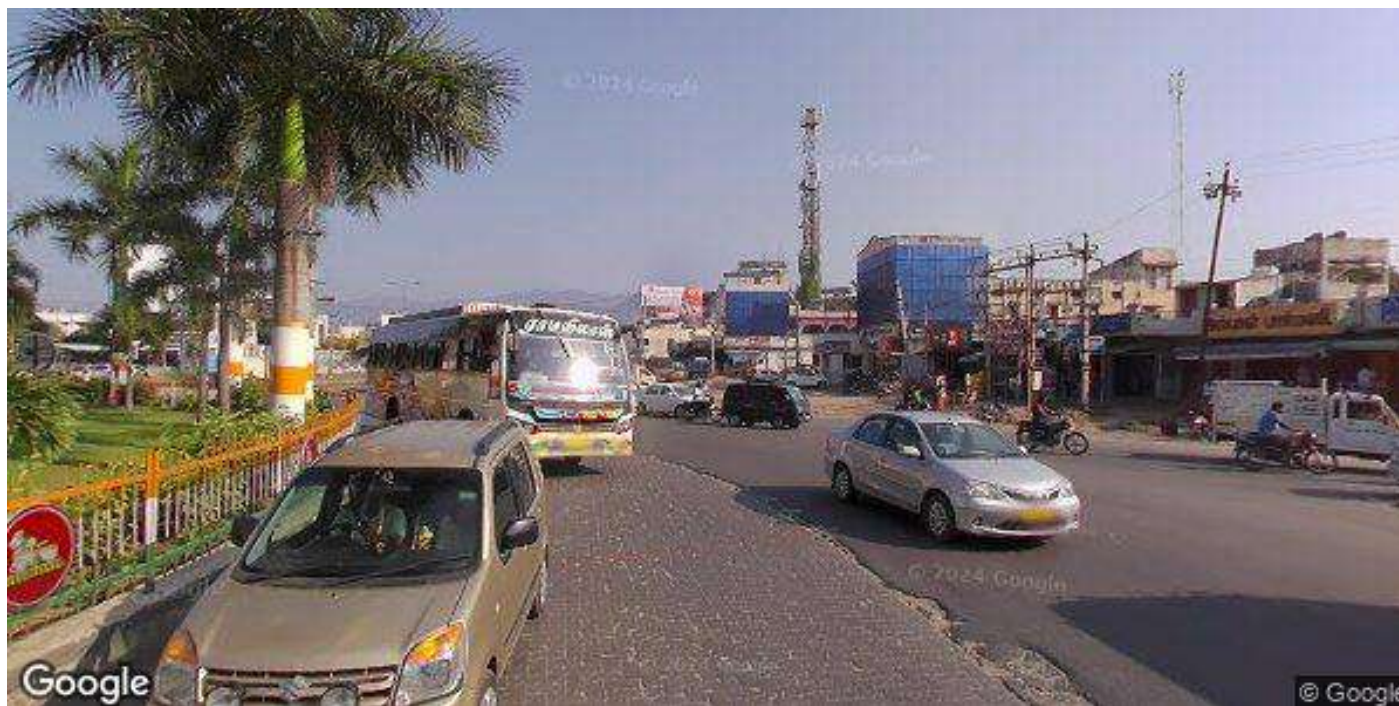
| | Risk Type | Risk Level | Coordinates | Speed Limit |
|---|---|---|---|---|
| 16 | Turn | Medium | 11.63252, 78.12712 | 30 KM/Hr |

**Risk Type:** Turn  
**Risk Level:** Medium  
**Speed Limit:** 30 KM/Hr  
**Coordinates:** 11.63252, 78.12712

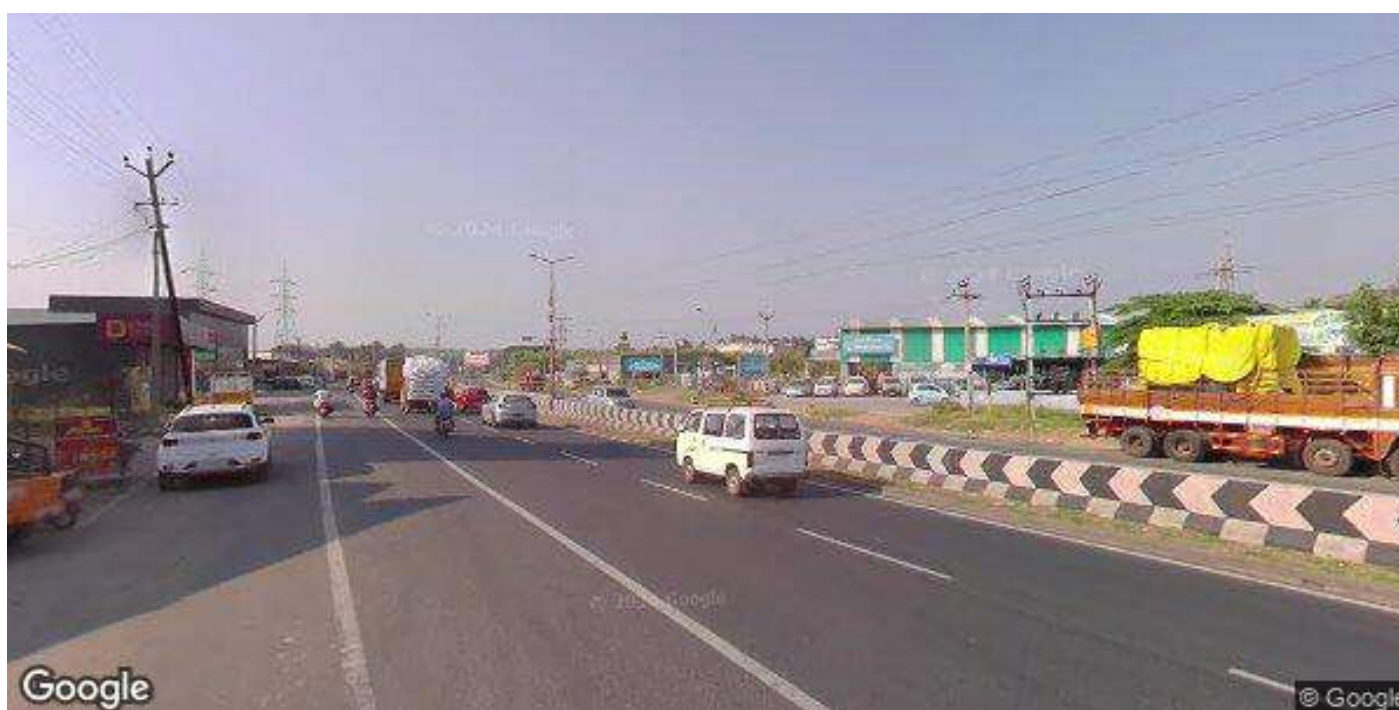
| | Risk Type | Risk Level | Coordinates | Speed Limit |
|---|---|---|---|---|
| 17 | Turn | High | 11.63640, 78.12244 | 15 KM/Hr |

**Risk Type:** Turn  
**Risk Level:** High  
**Speed Limit:** 15 KM/Hr  
**Coordinates:** 11.63640, 78.12244
