# IndianOil

## JOURNEY RISK MANAGEMENT (JRM) STUDY

### Salem Terminal to SRI SIVASELVI AGENCIES

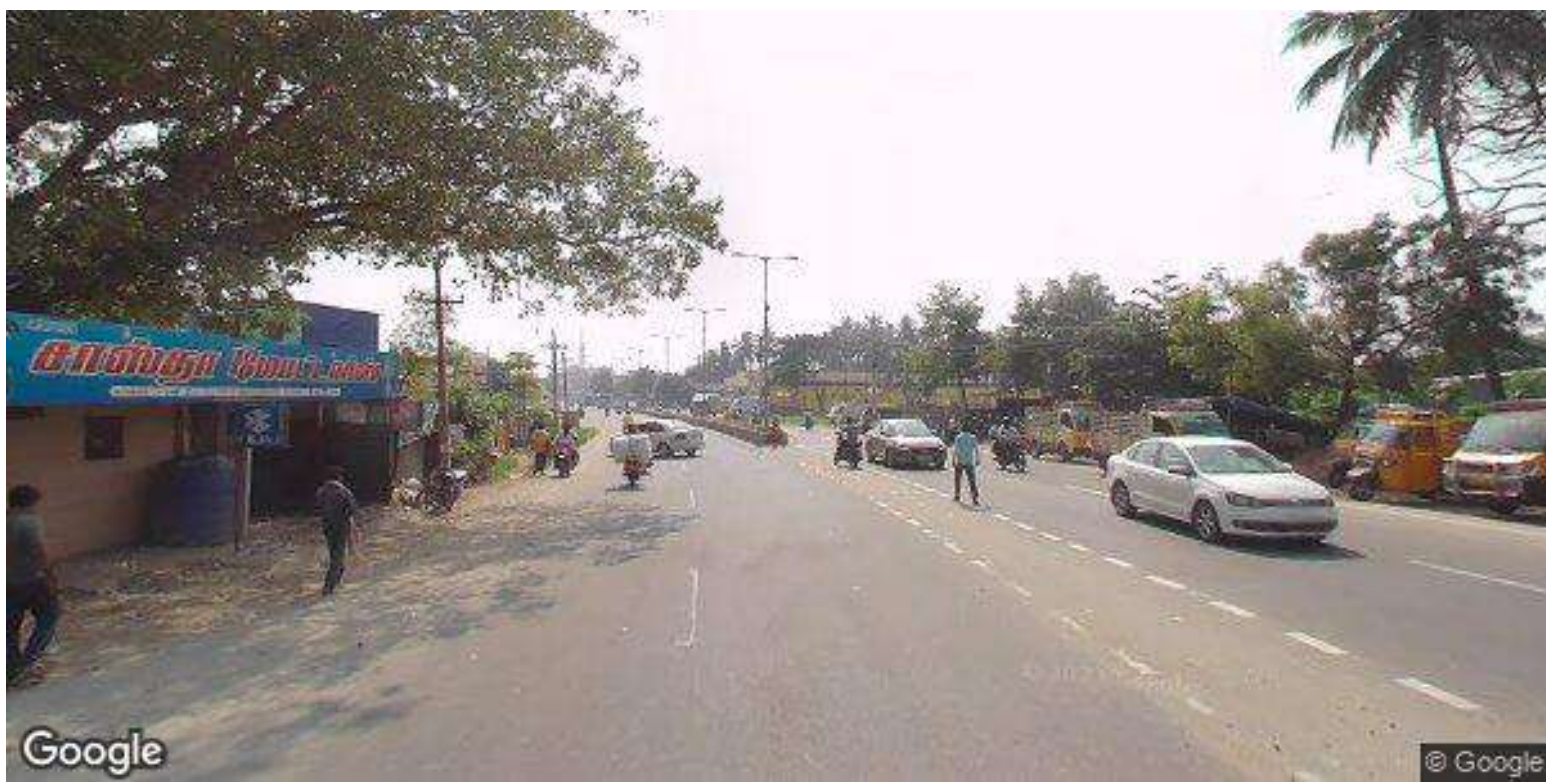
**Coordinates:** 11.1485866, 77.3133702

**Risk Type:** U-Turn

**Risk Level:** High

**Speed Limit:** 10 KM/Hr

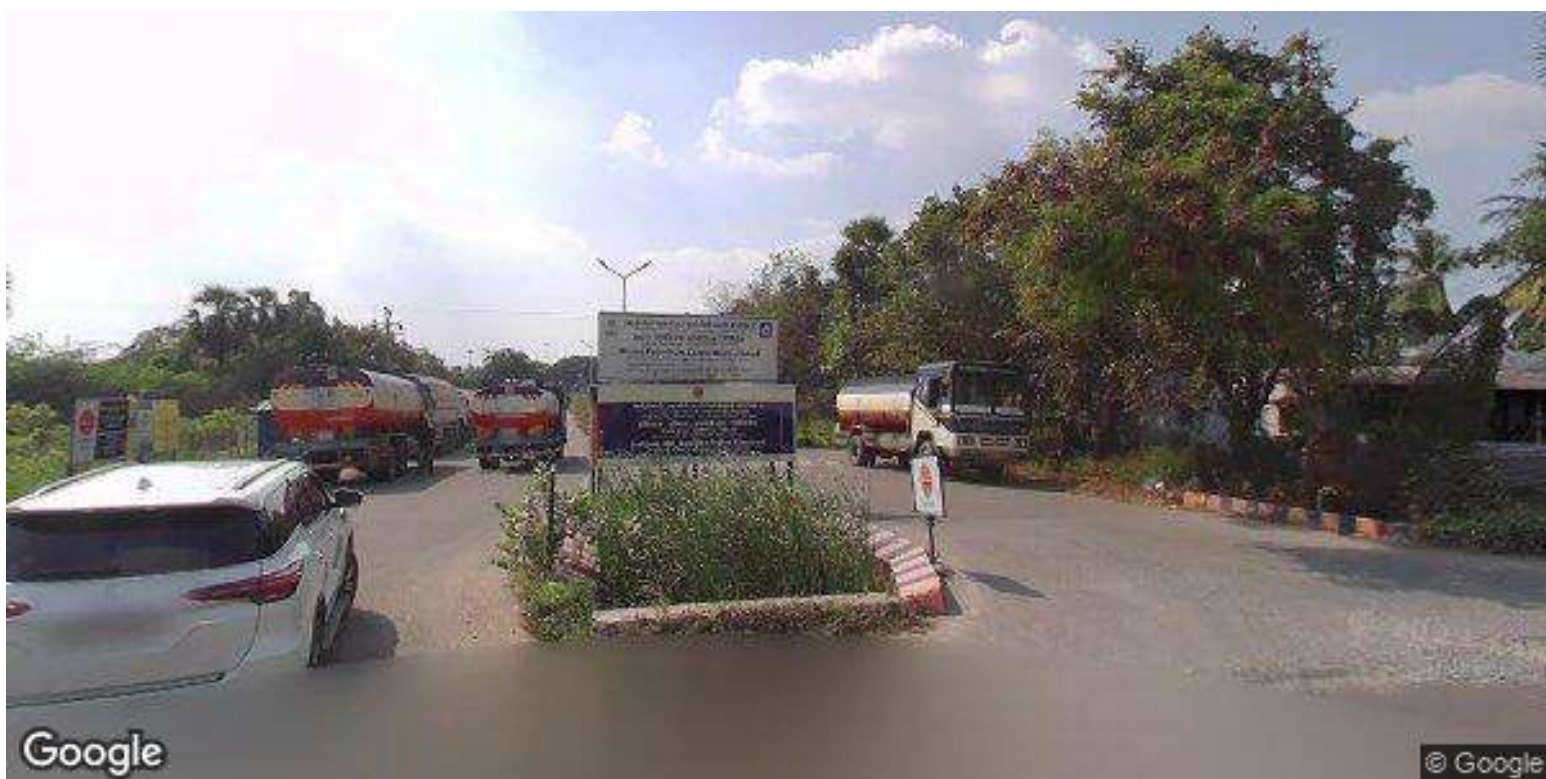
**Coordinates:** 11.44024, 77.87528

**Risk Type:** Turn

**Risk Level:** High

**Speed Limit:** 15 KM/Hr

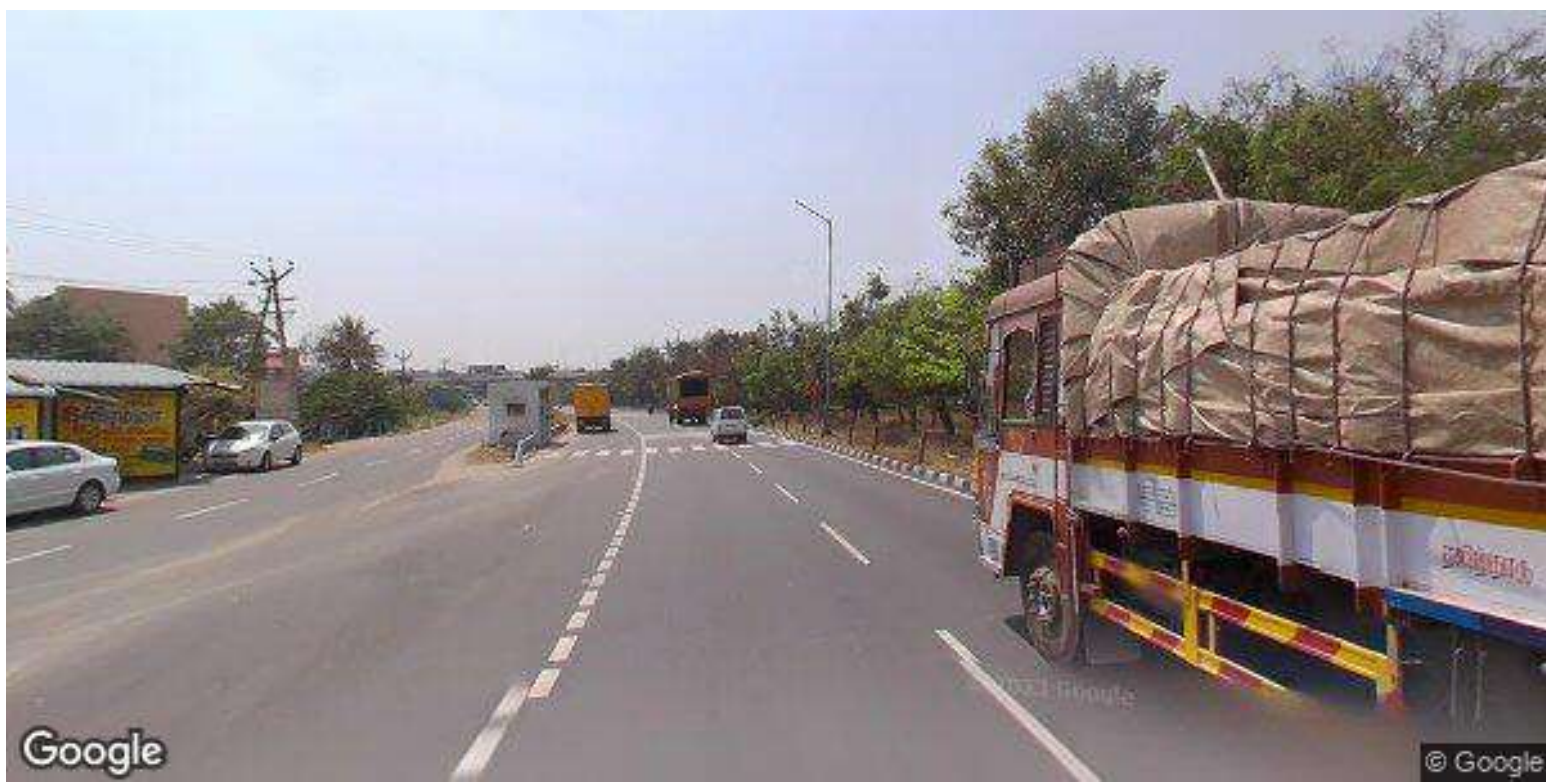
**Coordinates:** 11.43165, 77.67734

**Risk Type:** Turn

**Risk Level:** Medium

**Speed Limit:** 30 KM/Hr

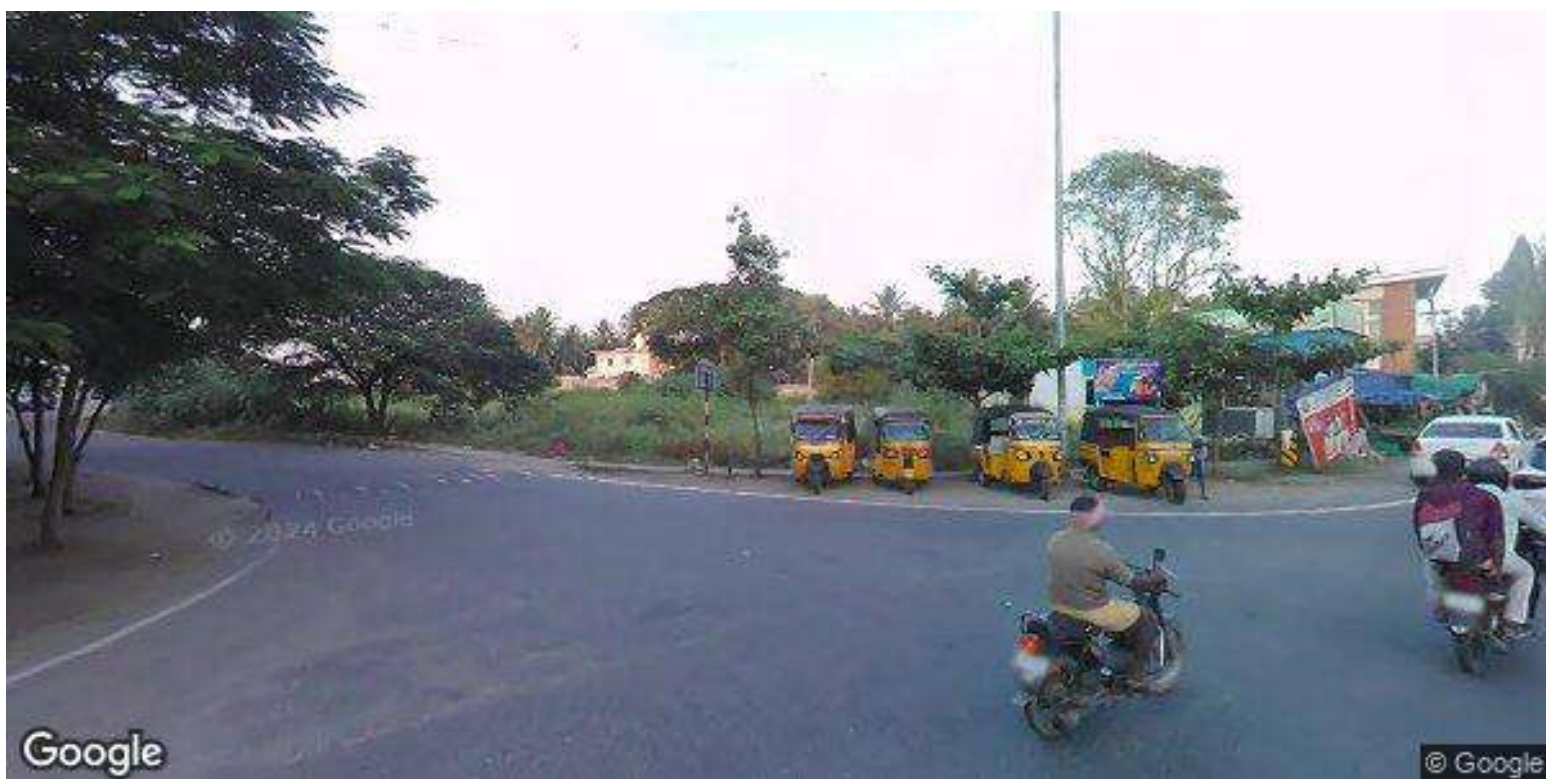
**Coordinates:** 11.18254, 77.28529

**Risk Type:** Turn

**Risk Level:** High

**Speed Limit:** 15 KM/Hr

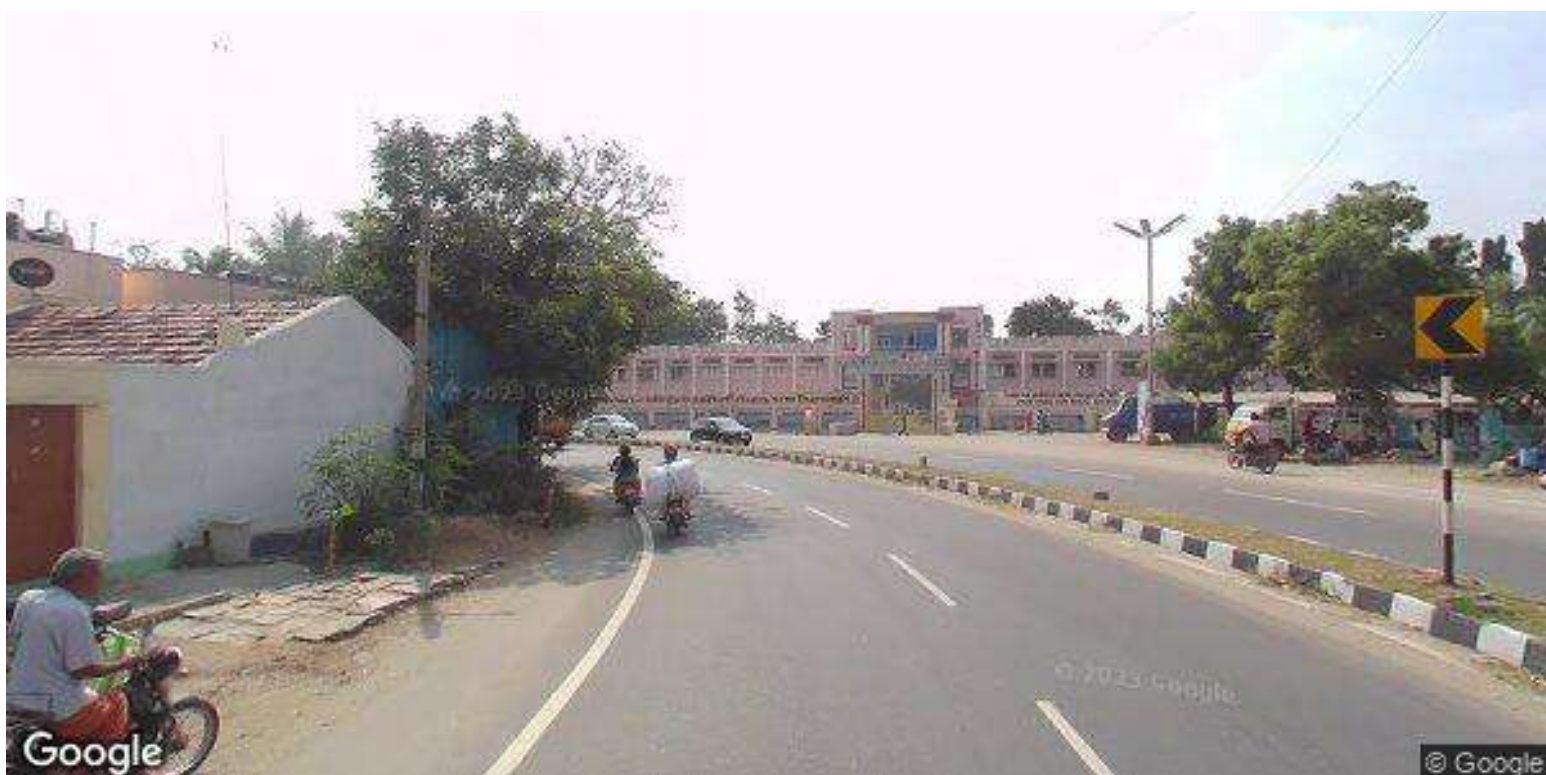
**Risk Type:** Turn  
**Risk Level:** High  
**Speed Limit:** 15 KM/Hr  
**Coordinates:** 11.15202, 77.30879

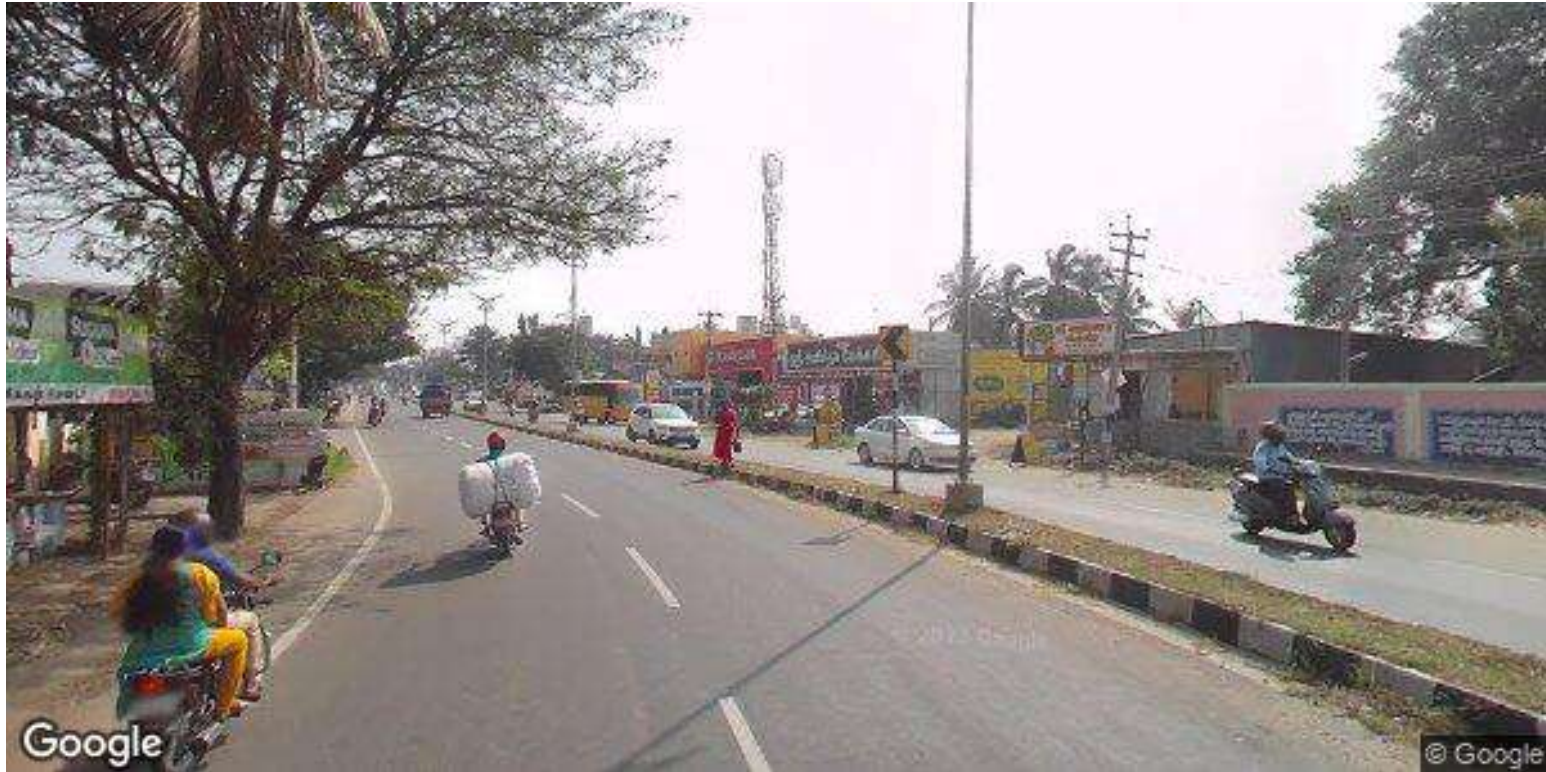
**Risk Type:** Turn  
**Risk Level:** High  
**Speed Limit:** 15 KM/Hr  
**Coordinates:** 11.15167, 77.30915

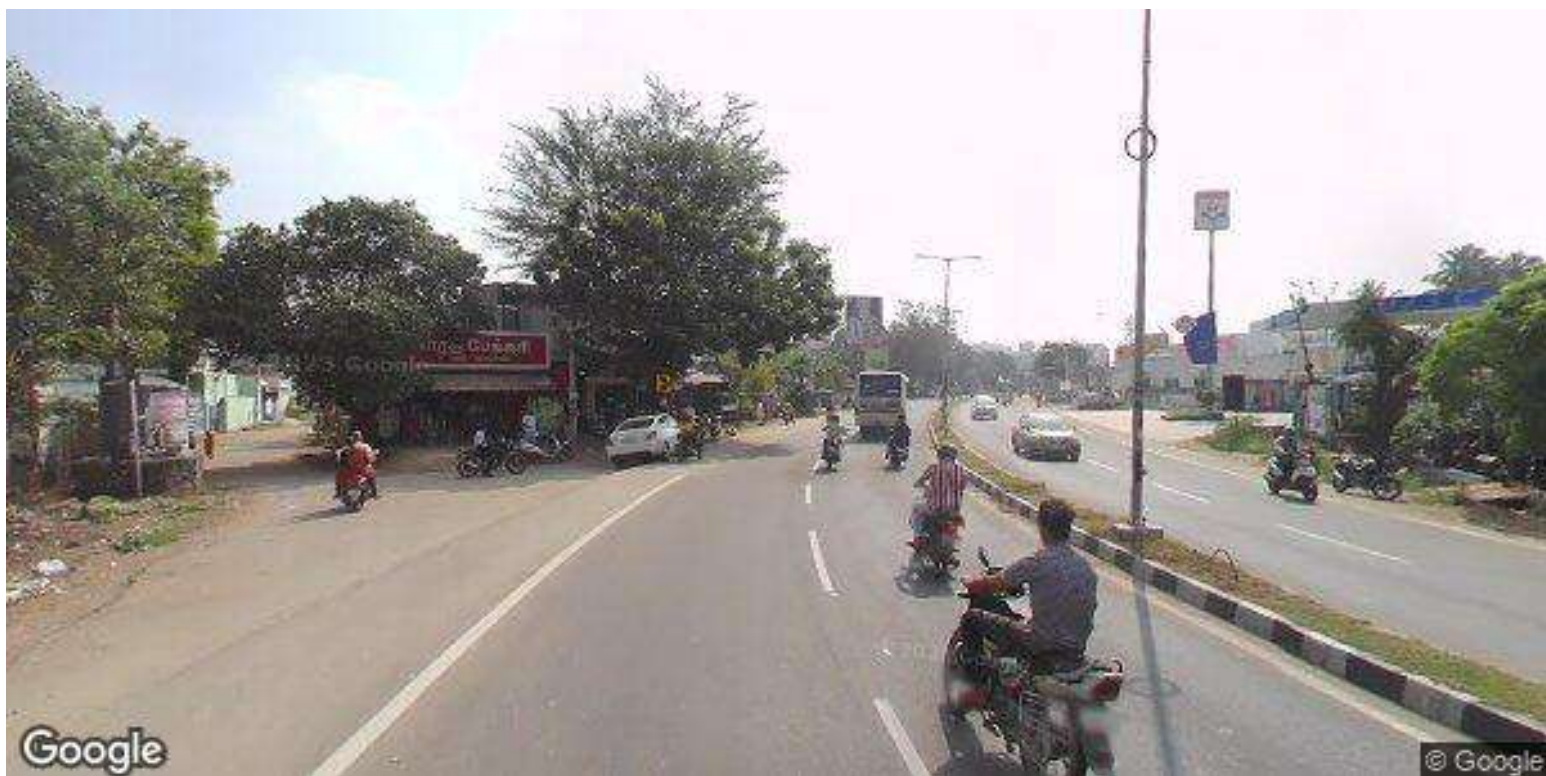
**Risk Type:** Turn  
**Risk Level:** Medium  
**Speed Limit:** 30 KM/Hr  
**Coordinates:** 11.15169, 77.31145
