# IndianOil

## JOURNEY RISK MANAGEMENT (JRM) STUDY

### Salem Terminal TO SRI SAKTHI CORPORATION

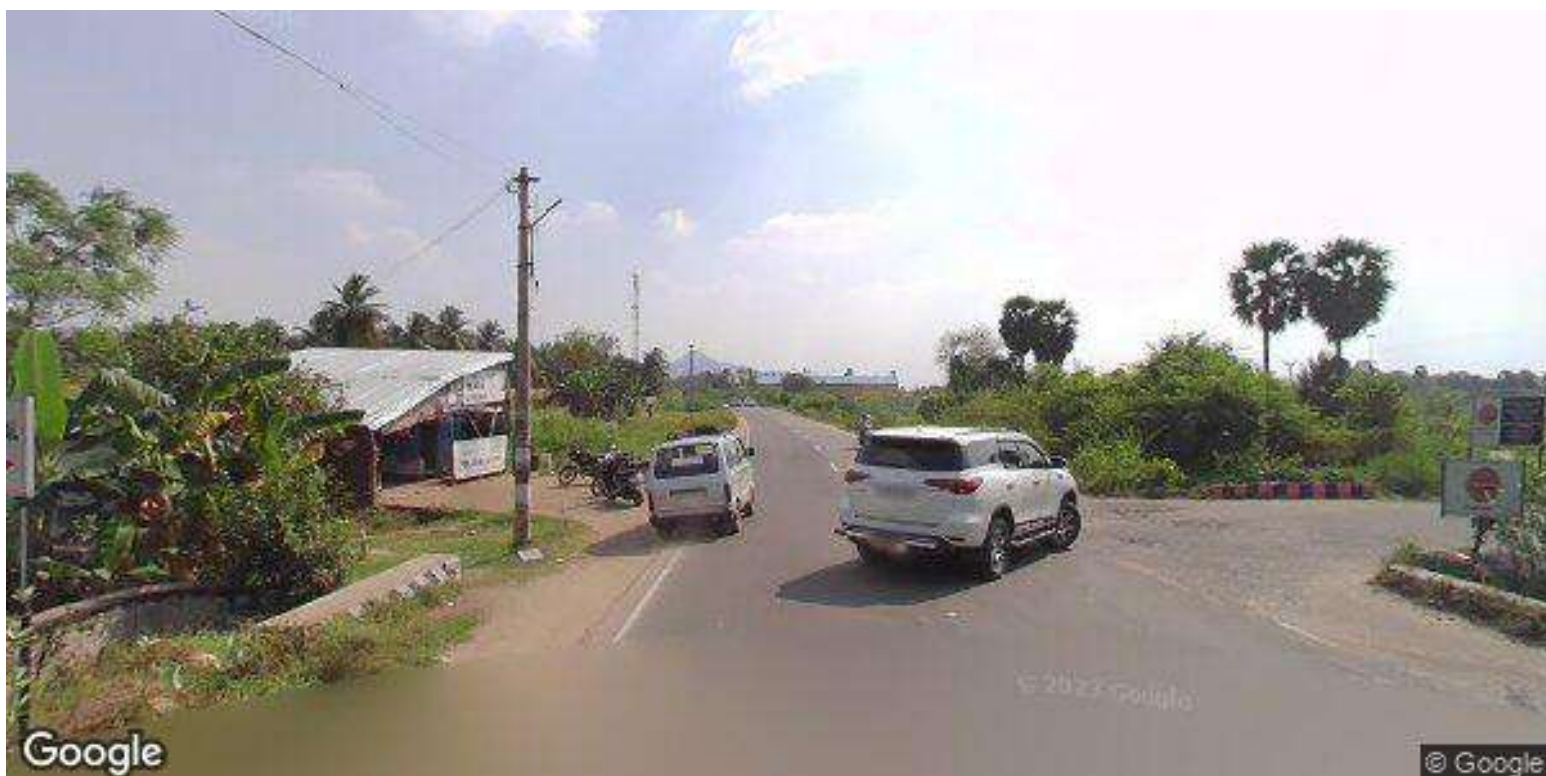
**Coordinates:** 11.44029, 77.87544

**Risk Type:** Turn

**Risk Level:** High

**Speed Limit:** 15 KM/Hr

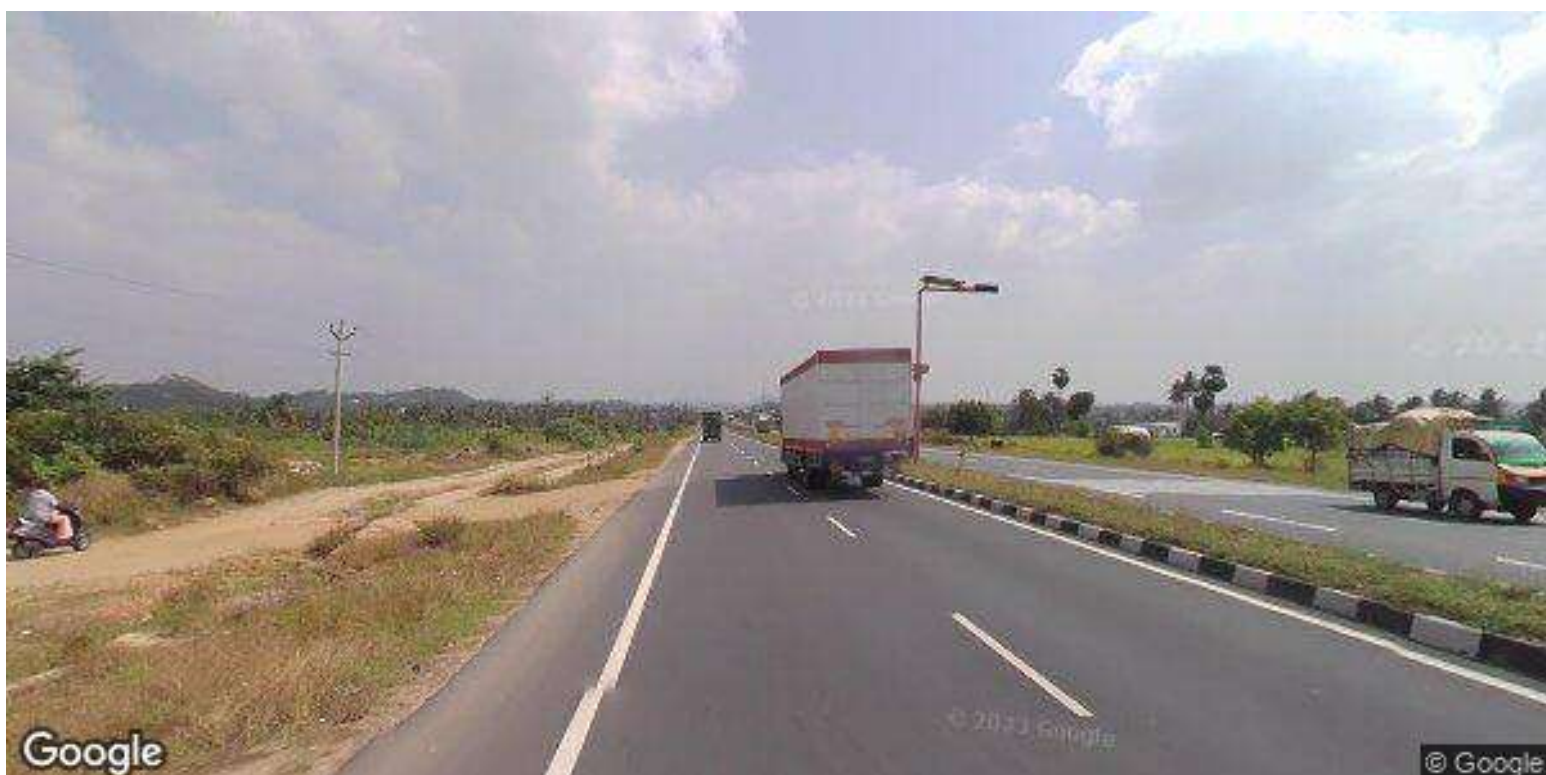
**Risk Type:** Turn  
**Risk Level:** High  
**Speed Limit:** 15 KM/Hr  
**Coordinates:** 11.49409, 77.88004

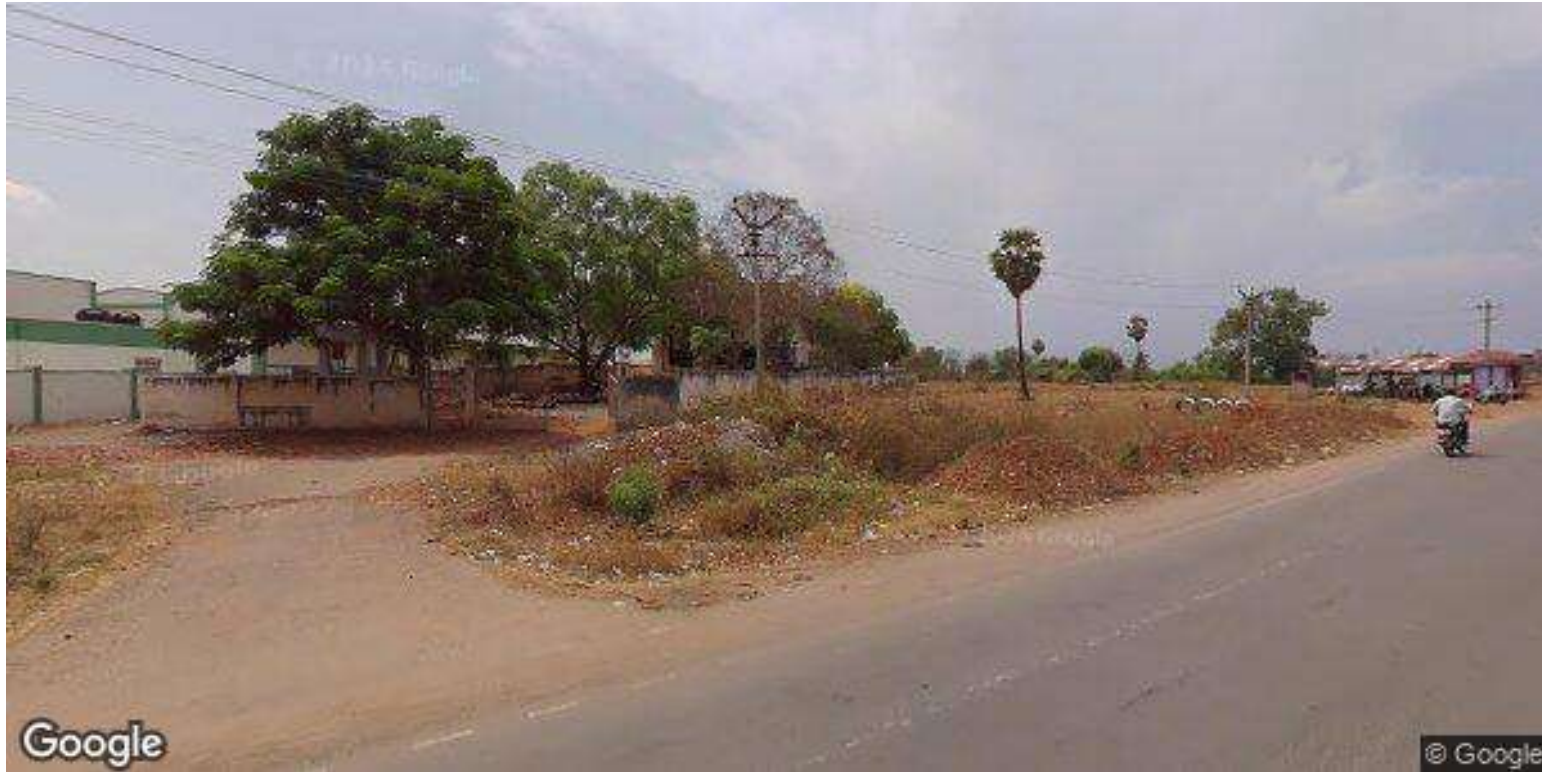
**Risk Type:** Turn  
**Risk Level:** High  
**Speed Limit:** 15 KM/Hr  
**Coordinates:** 11.58320, 77.90646

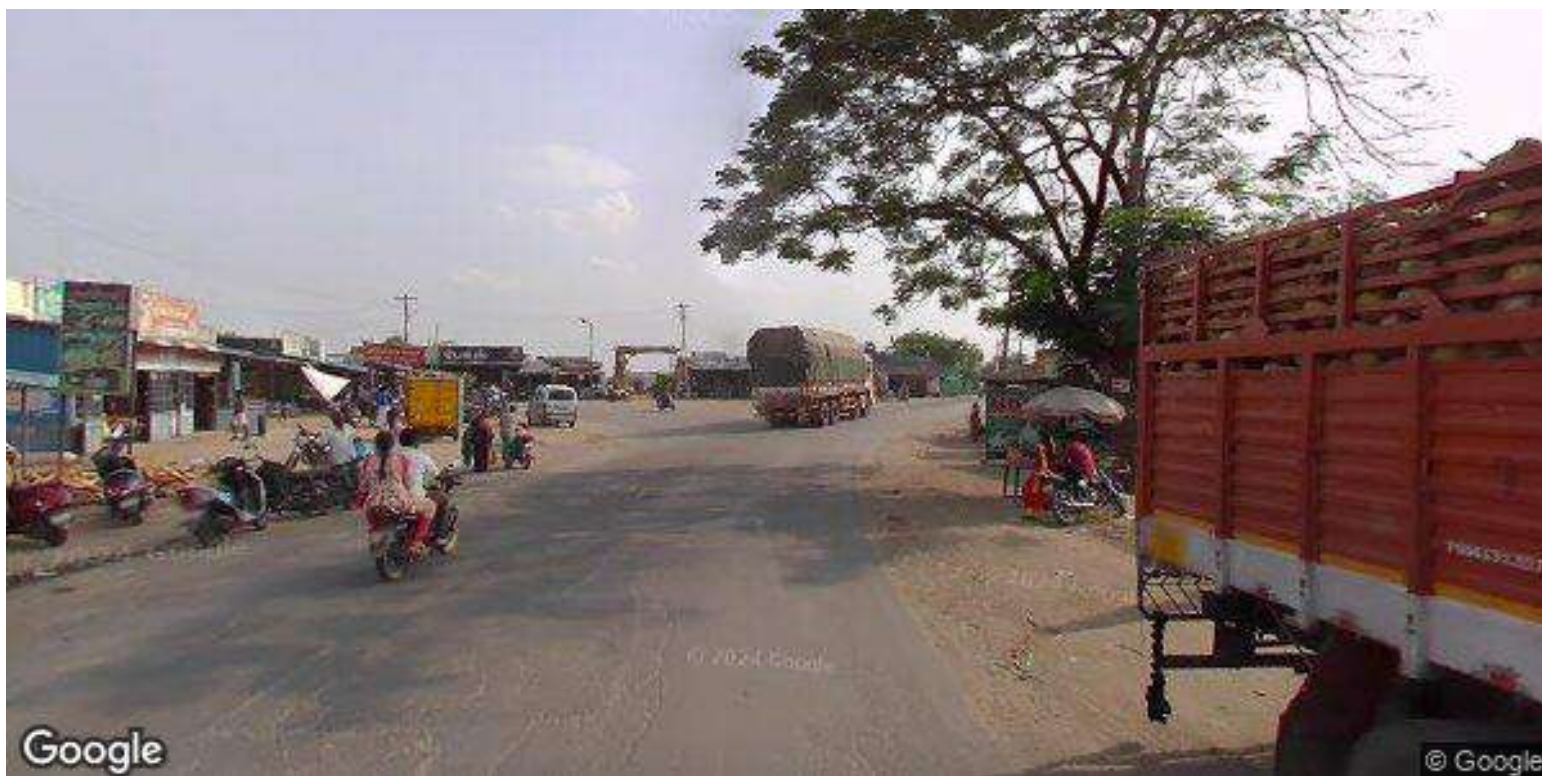
**Risk Type:** Turn  
**Risk Level:** Medium  
**Speed Limit:** 30 KM/Hr  
**Coordinates:** 11.64197, 77.95197
