## **JOURNEY RISK MANAGEMENT (JRM) STUDY**

### **Salem Terminal to PONNI COOPERATIVE PETROLEUM.**

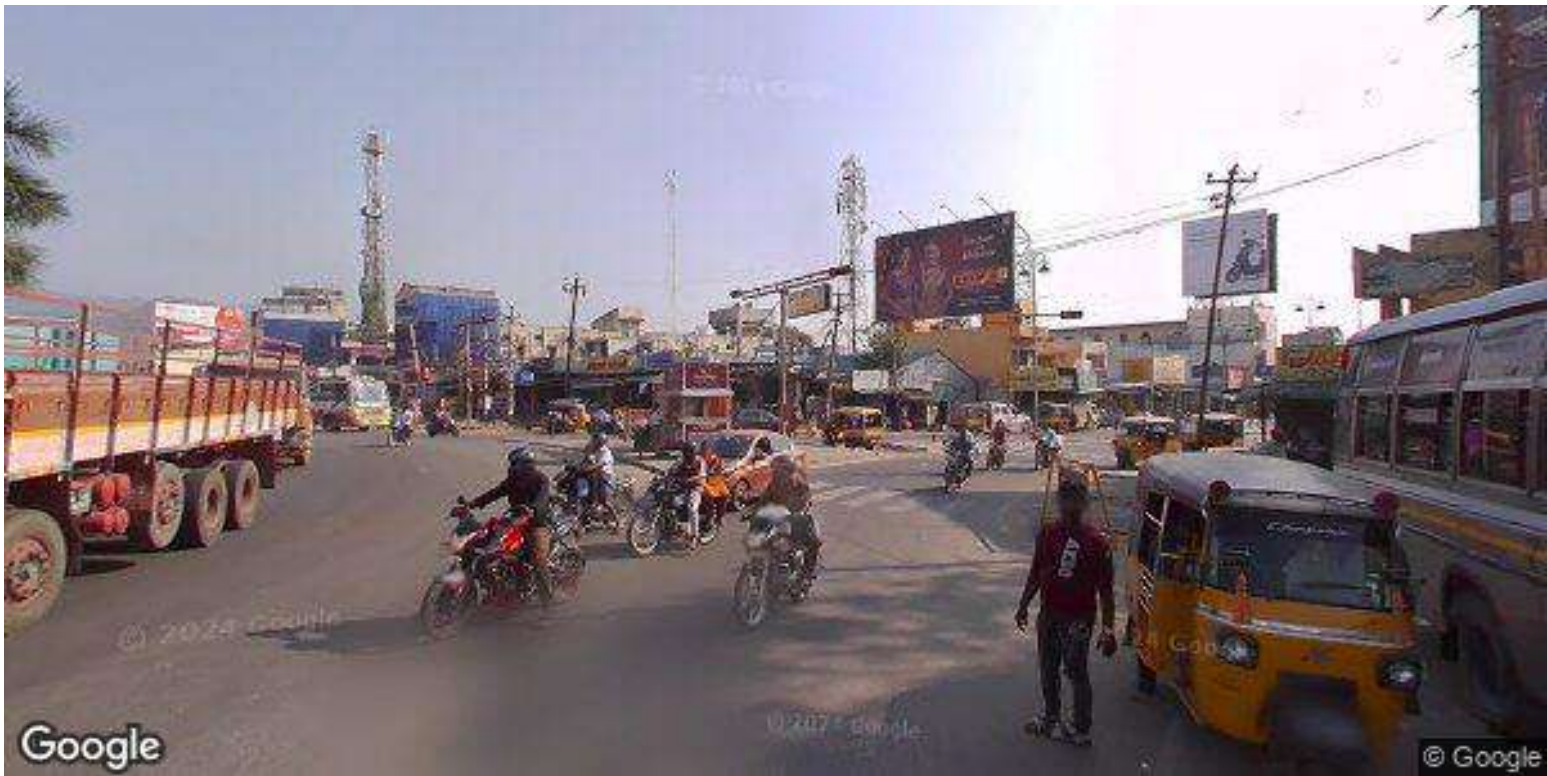
**Risk Type:** Roundabout  
**Risk Level:** High  
**Speed Limit:** 15 KM/Hr  
**Coordinates:** 11.63266, 78.12699

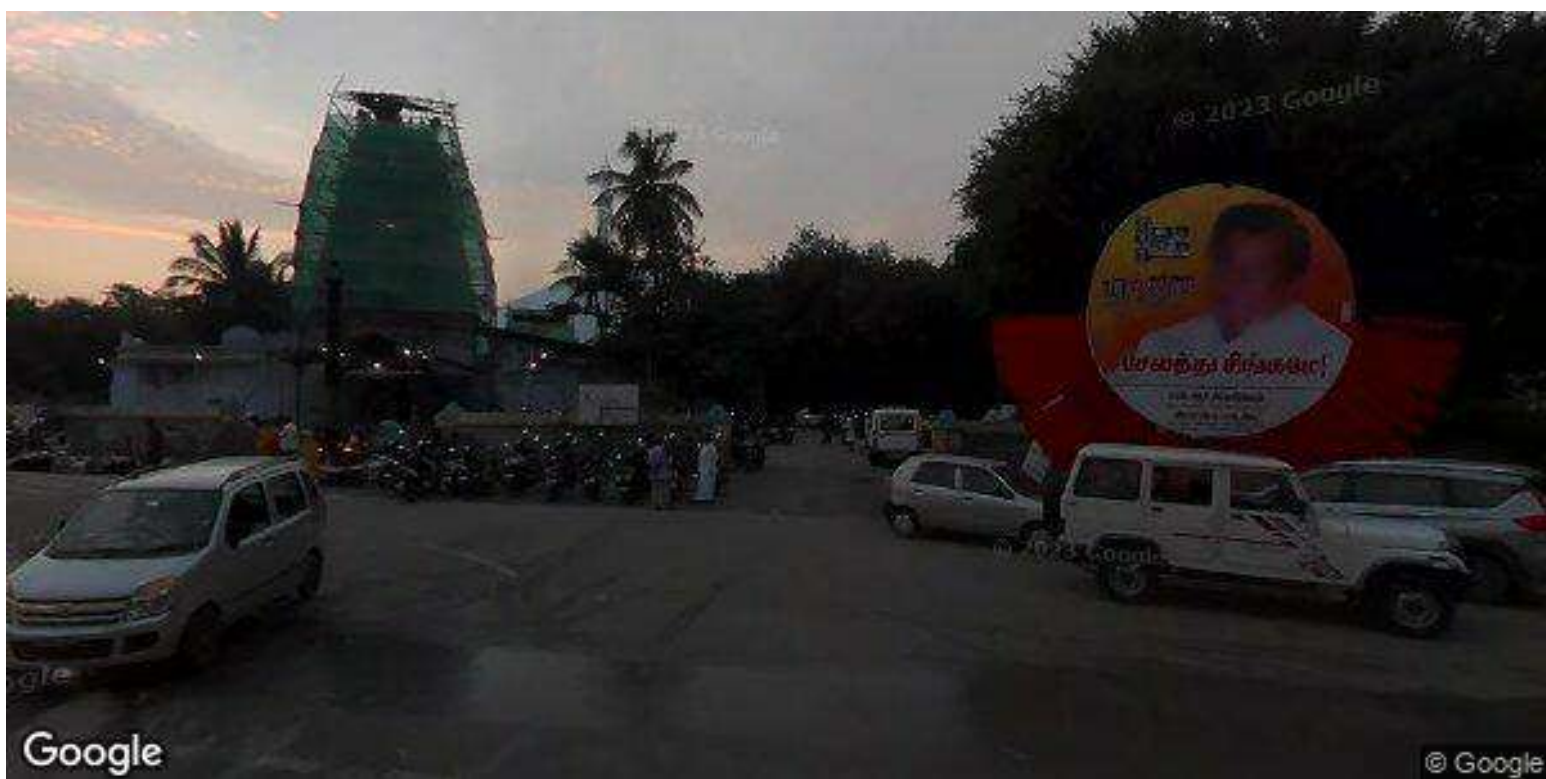
**Coordinates:** 11.61233, 78.10397

**Risk Type:** Turn

**Risk Level:** High

**Speed Limit:** 15 KM/Hr

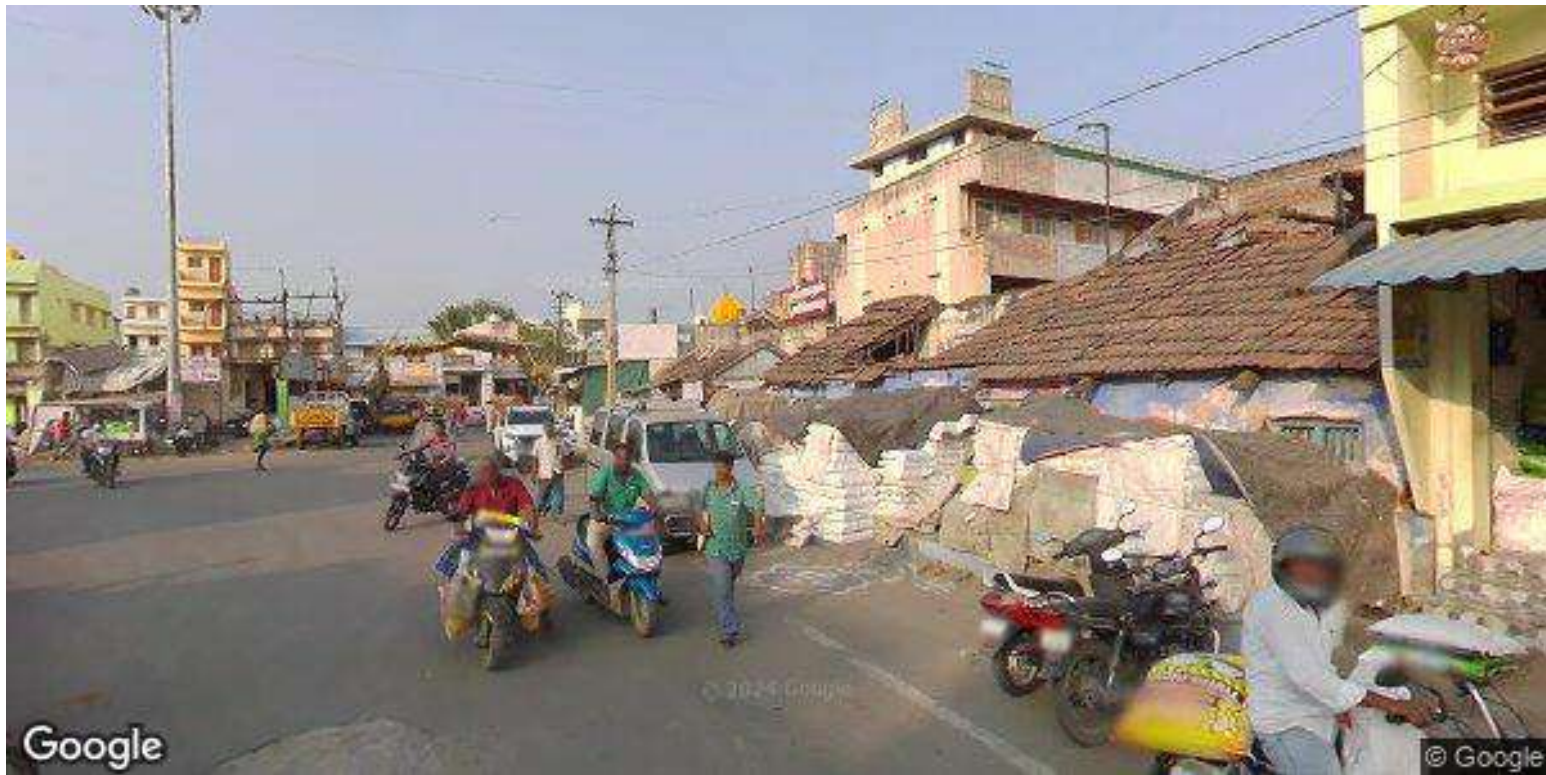
**Coordinates:** 11.65141, 78.14234

**Risk Type:** Turn

**Risk Level:** Medium

**Speed Limit:** 30 KM/Hr

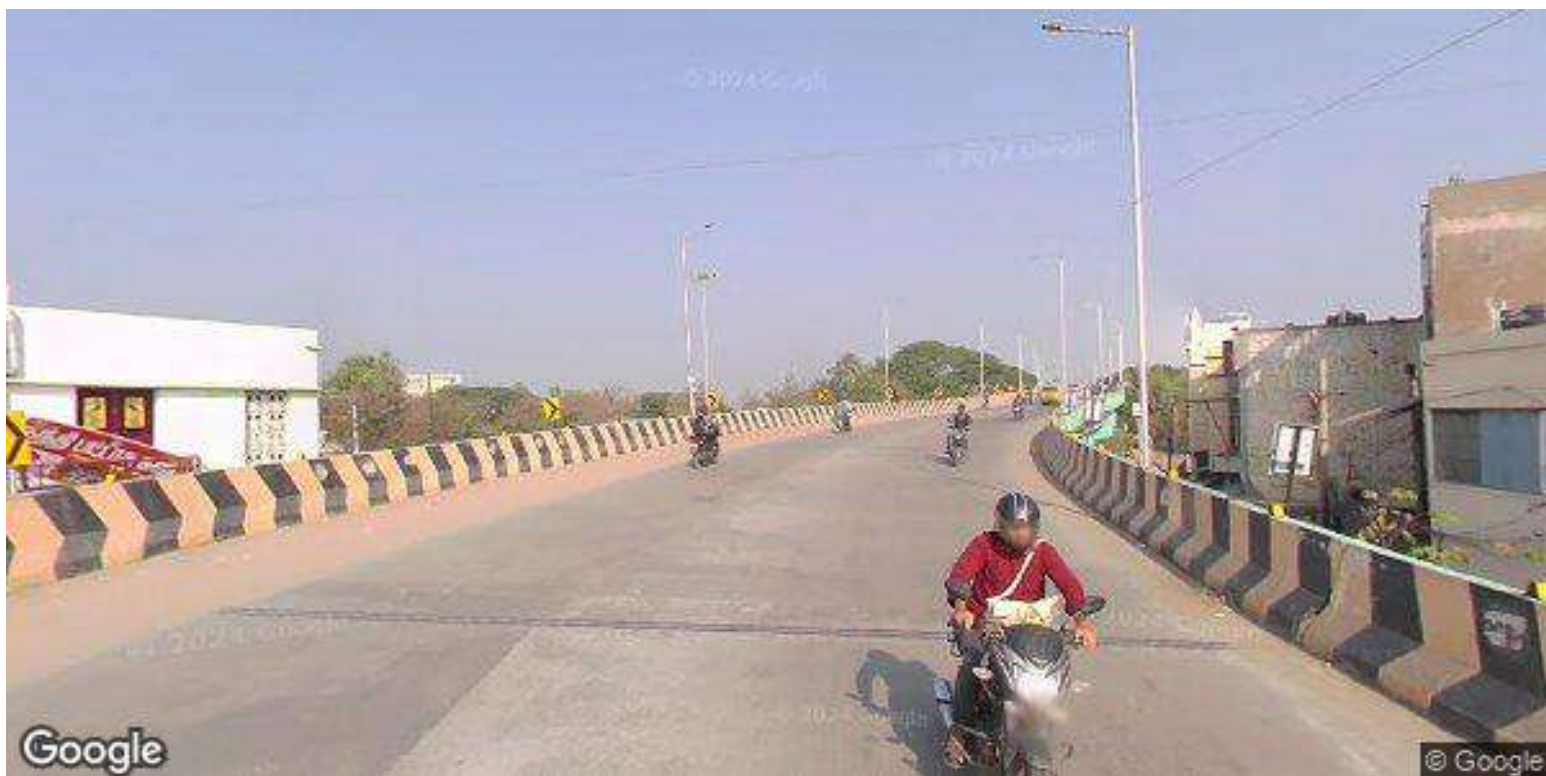
**Coordinates:** 11.65210, 78.14169

**Risk Type:** Turn

**Risk Level:** Medium

**Speed Limit:** 30 KM/Hr

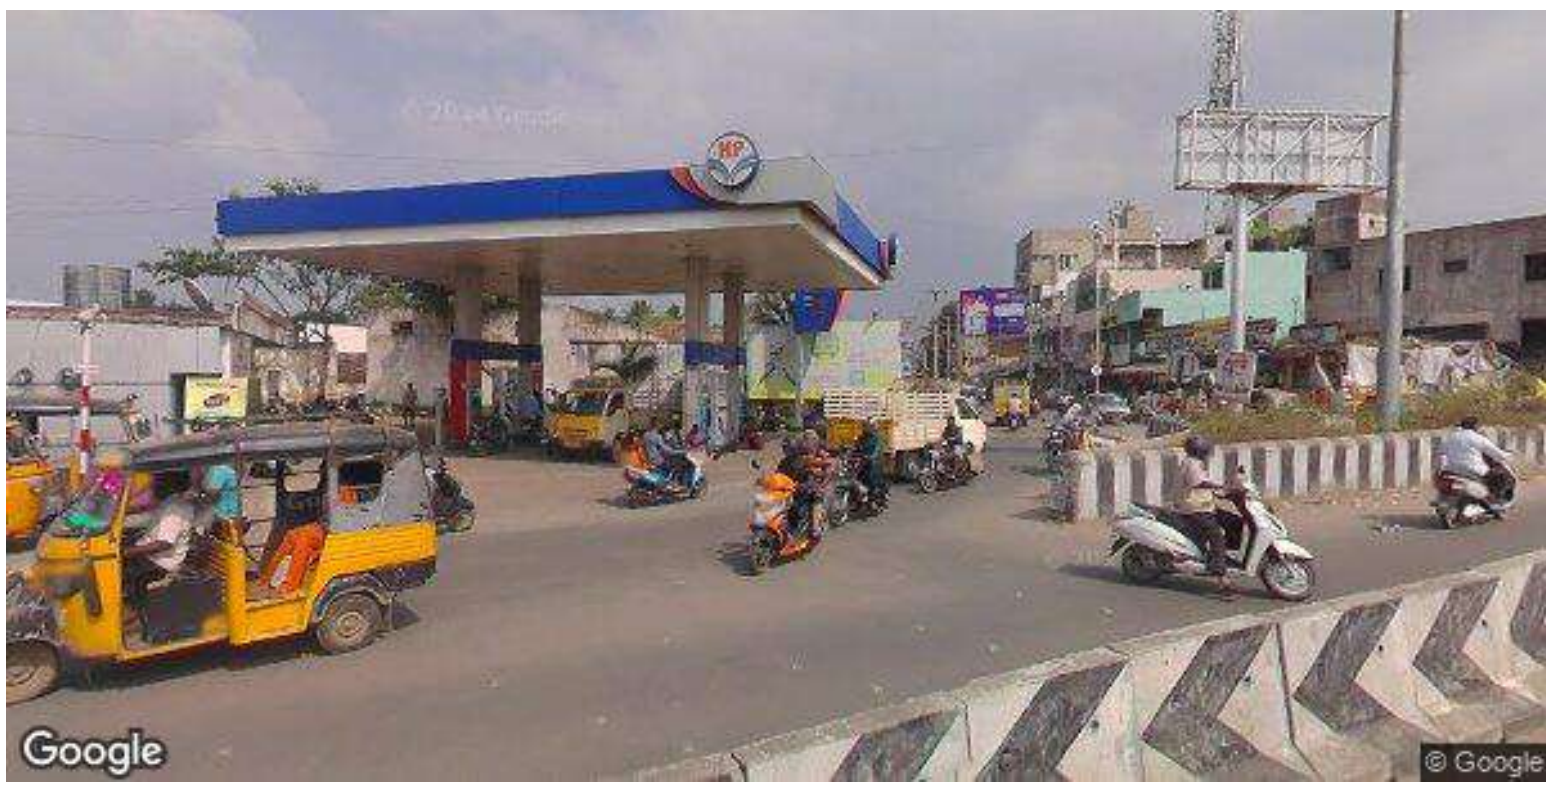
**Coordinates:** 11.65573, 78.13972

**Risk Type:** Blind Spot

**Risk Level:** Blind Spot

**Speed Limit:** 10 KM/Hr

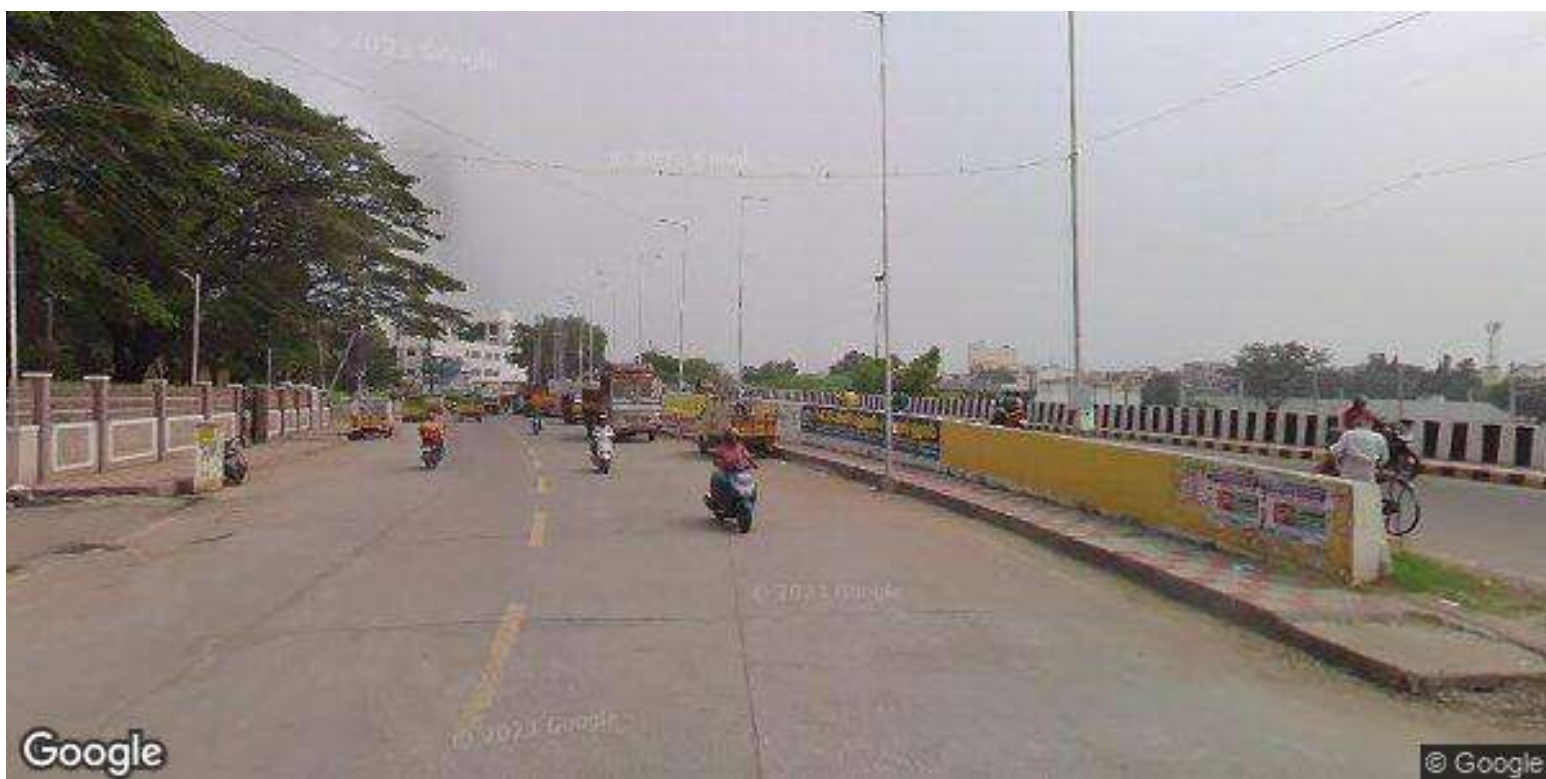
**Coordinates:** 11.65636, 78.14508

**Risk Type:** Turn

**Risk Level:** Medium

**Speed Limit:** 30 KM/Hr

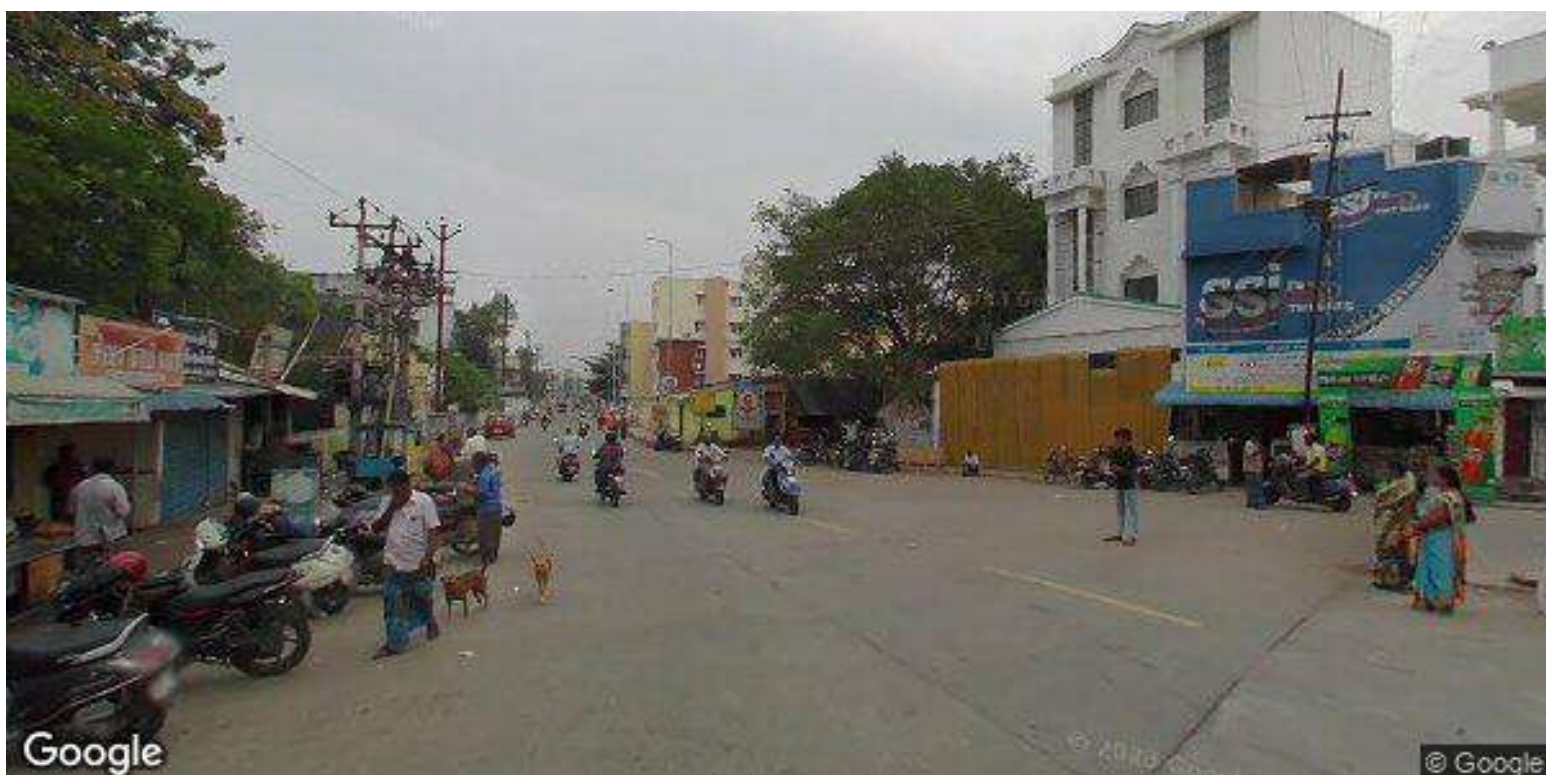
**Coordinates:** 11.65678, 78.14605

**Risk Type:** Turn

**Risk Level:** High

**Speed Limit:** 15 KM/Hr

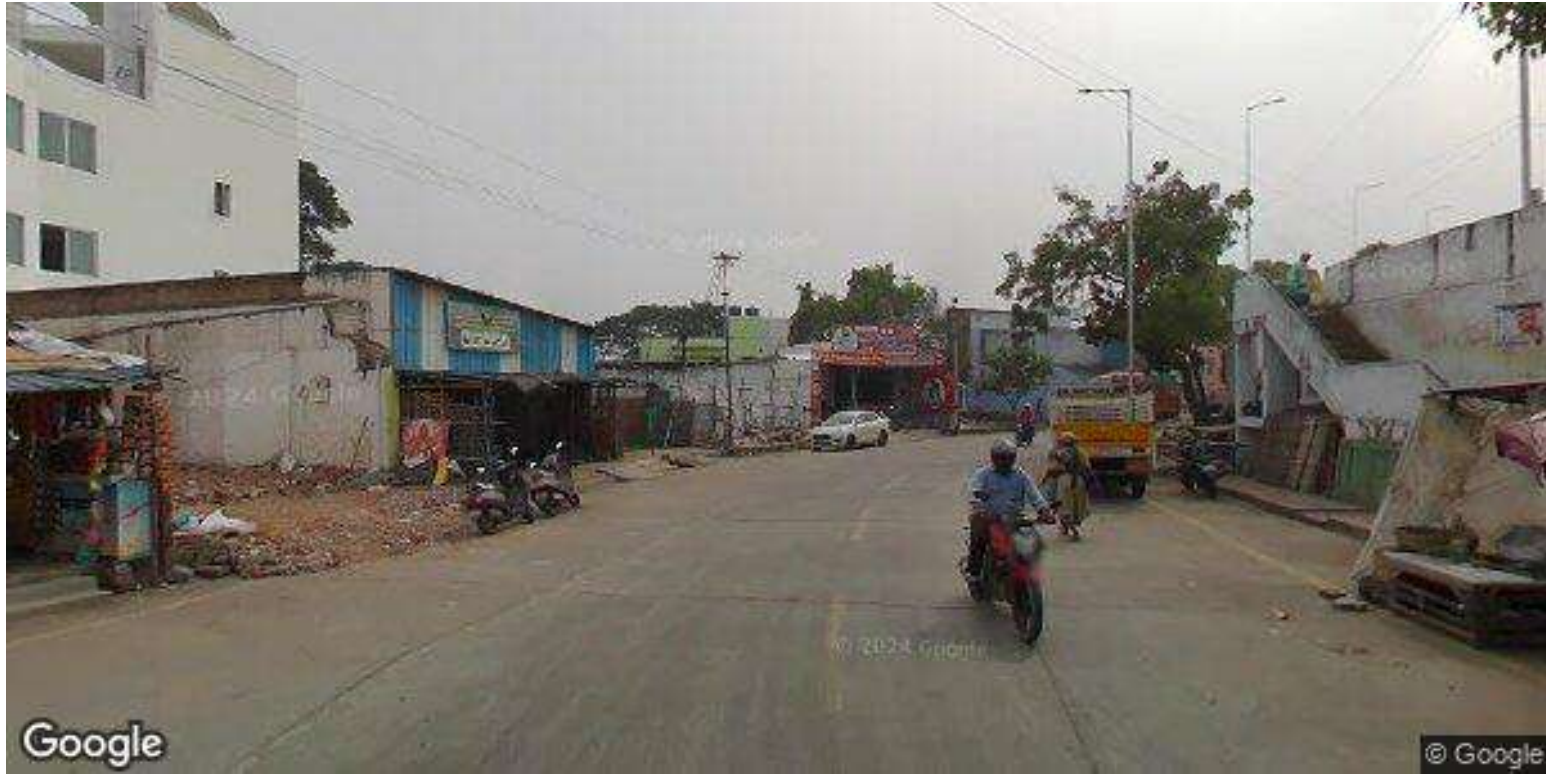
**Coordinates:** 11.65674, 78.14623

**Risk Type:** Turn

**Risk Level:** Medium

**Speed Limit:** 30 KM/Hr

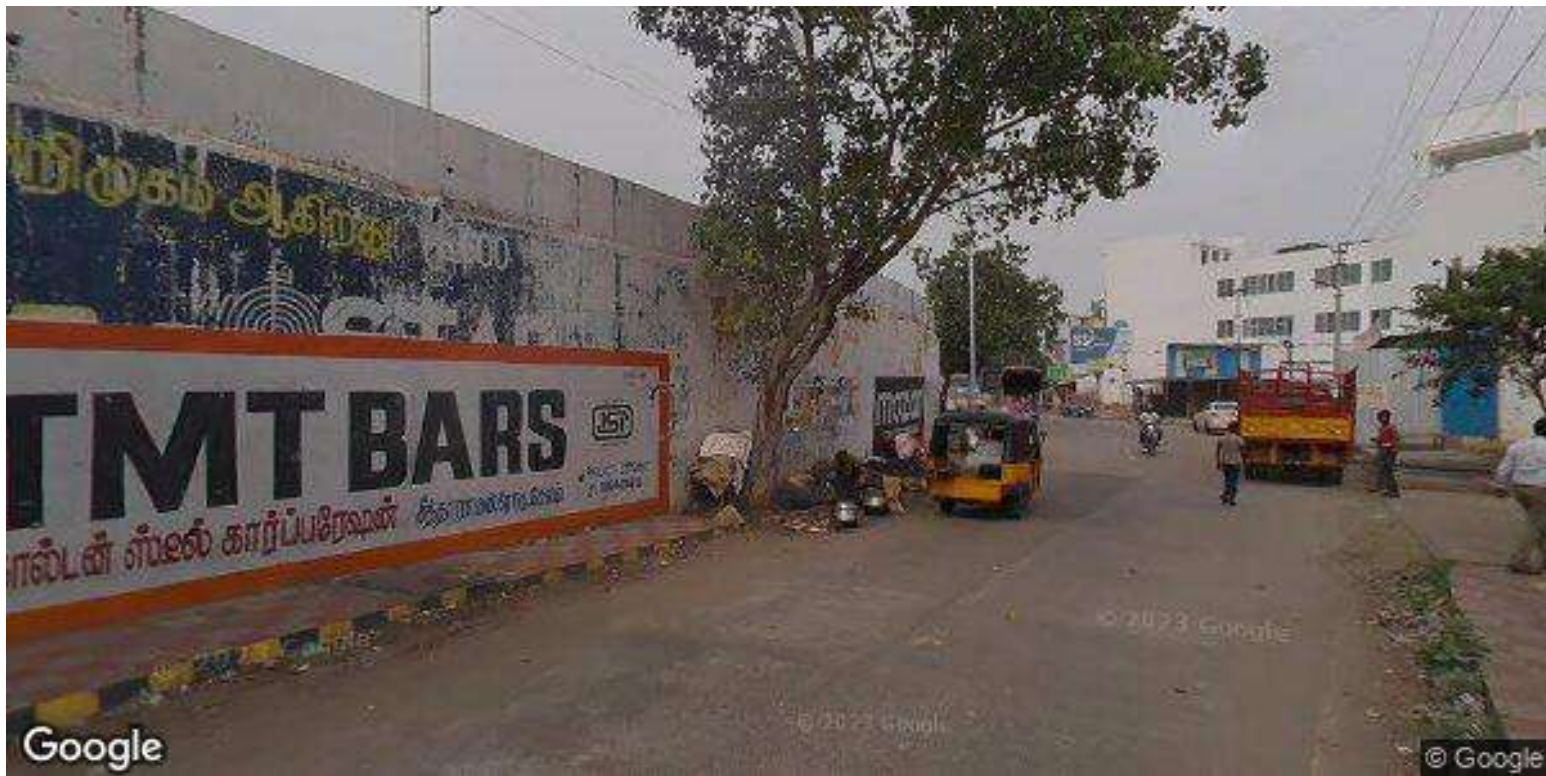
**Coordinates:** 11.65628, 78.14659

**Risk Type:** Turn

**Risk Level:** High

**Speed Limit:** 15 KM/Hr

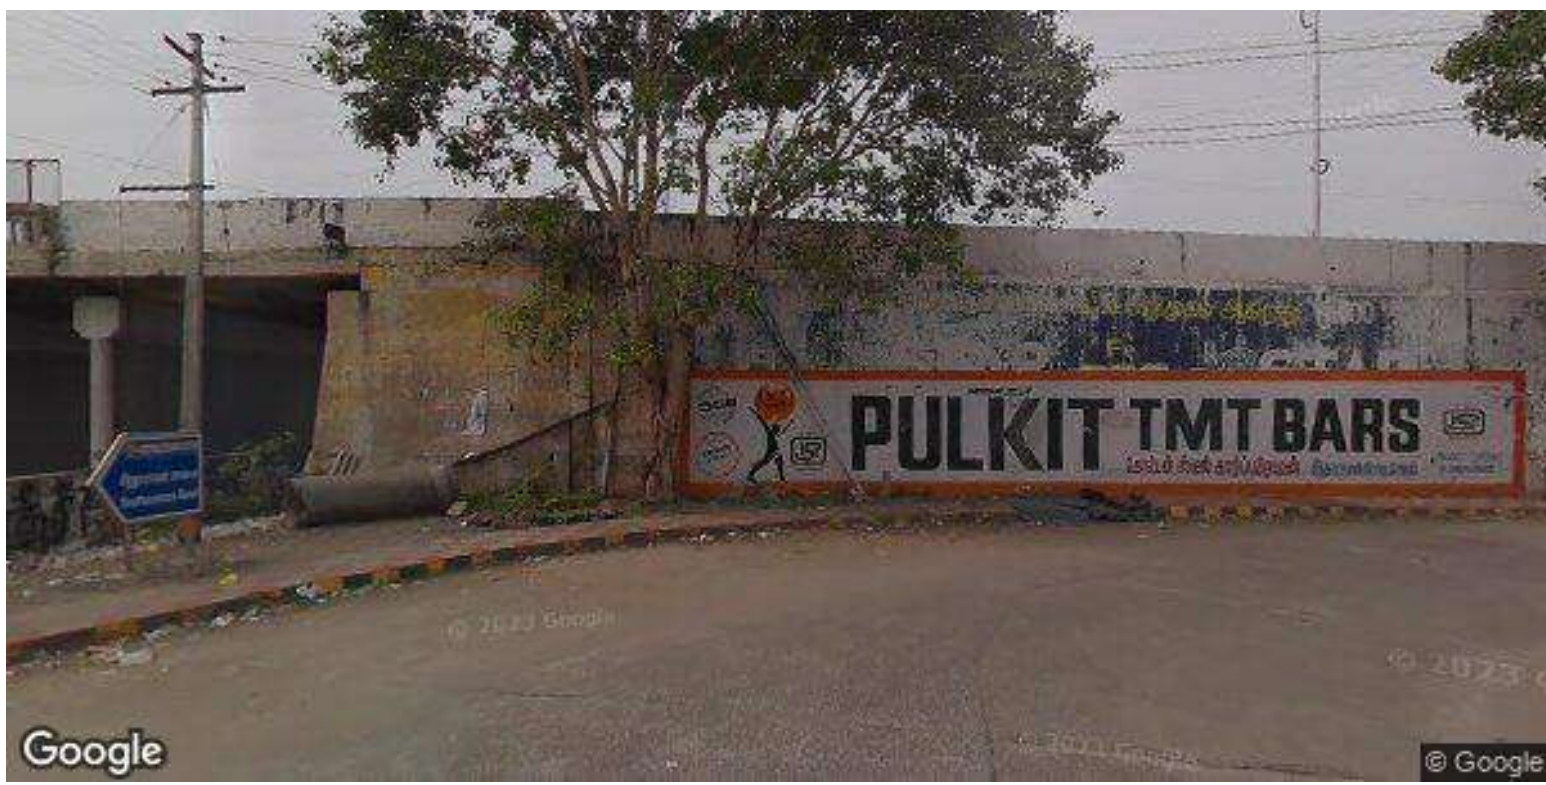
**Coordinates:** 11.65626, 78.14667

**Risk Type:** Turn

**Risk Level:** Medium

**Speed Limit:** 30 KM/Hr
