# IndianOil

## JOURNEY RISK MANAGEMENT (JRM) STUDY

### Salem Terminal to ARS AGENCY - UTHANGARAI

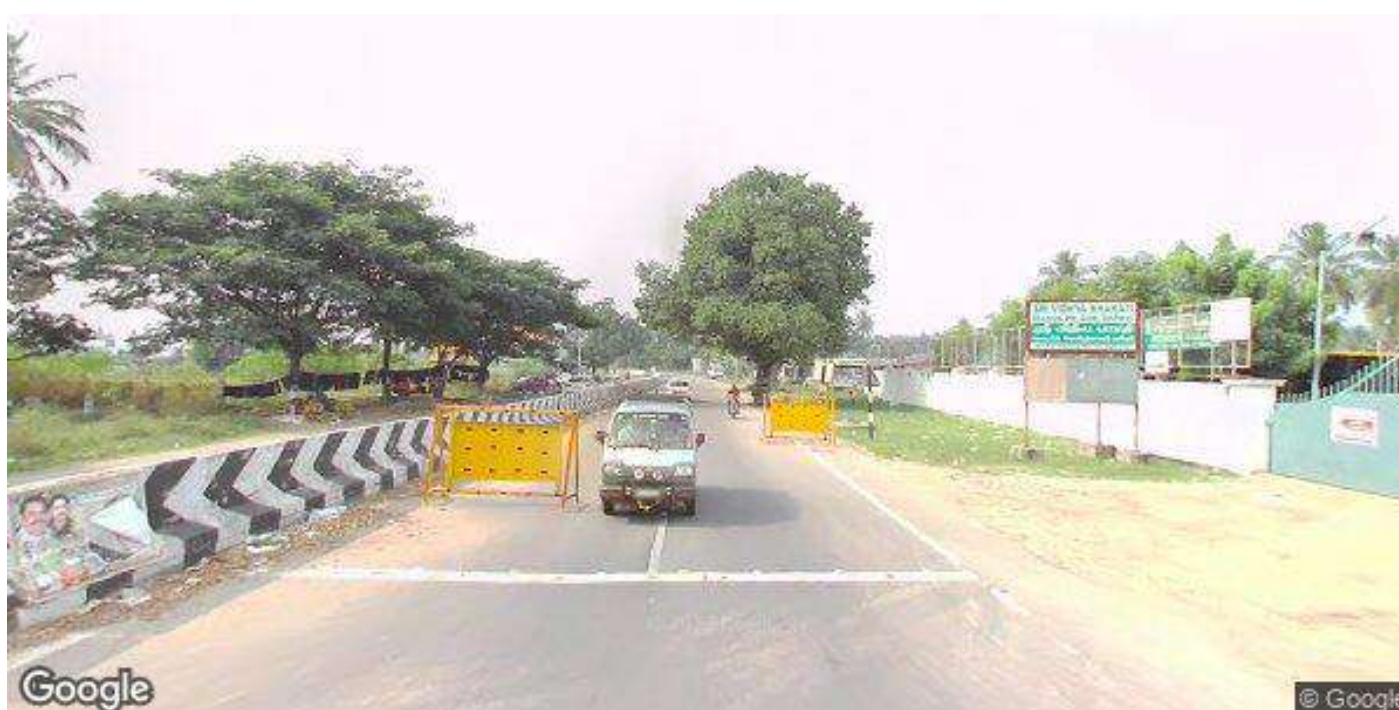
**Risk Type:** U-Turn

**Risk Level:** High

**Speed Limit:** 10 KM/Hr

**Coordinates:** 11.6180669, 78.1109048

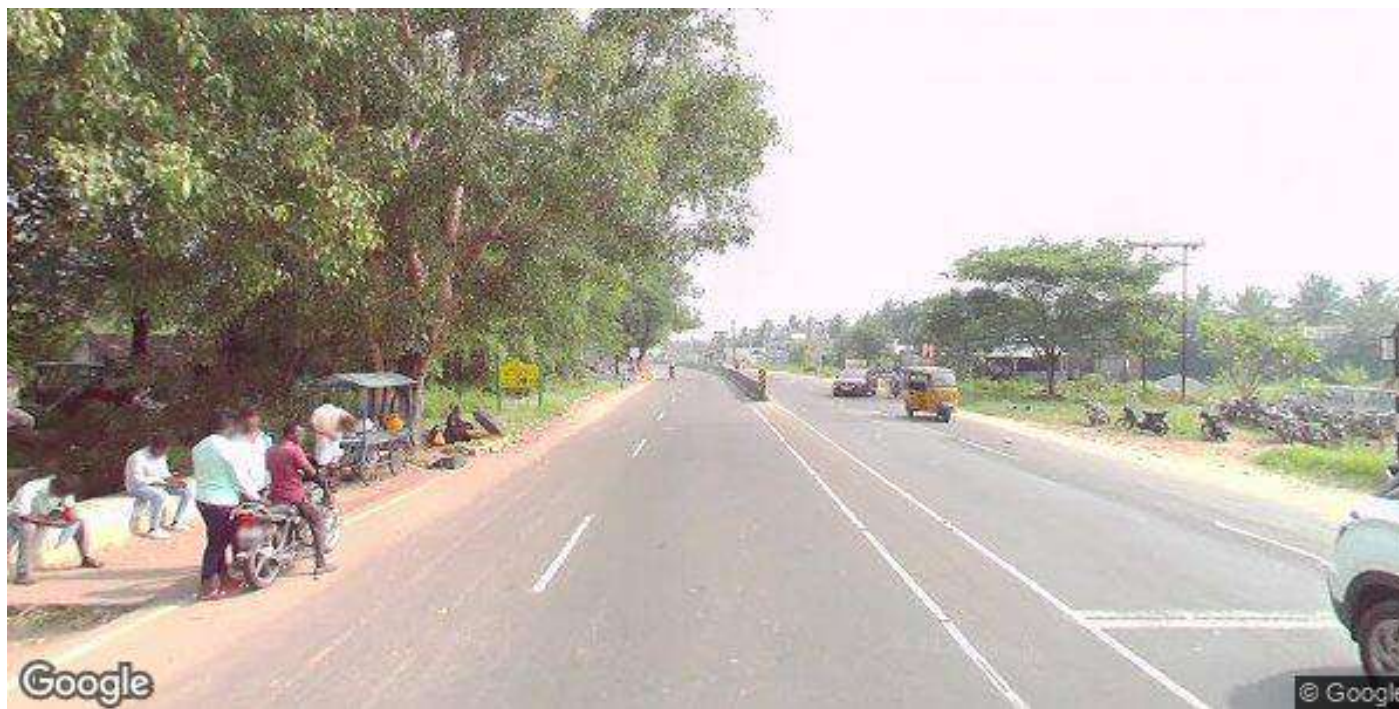
**Risk Type:** U-Turn  
**Risk Level:** High  
**Speed Limit:** 10 KM/Hr  
**Coordinates:** 11.6128439, 78.1059968

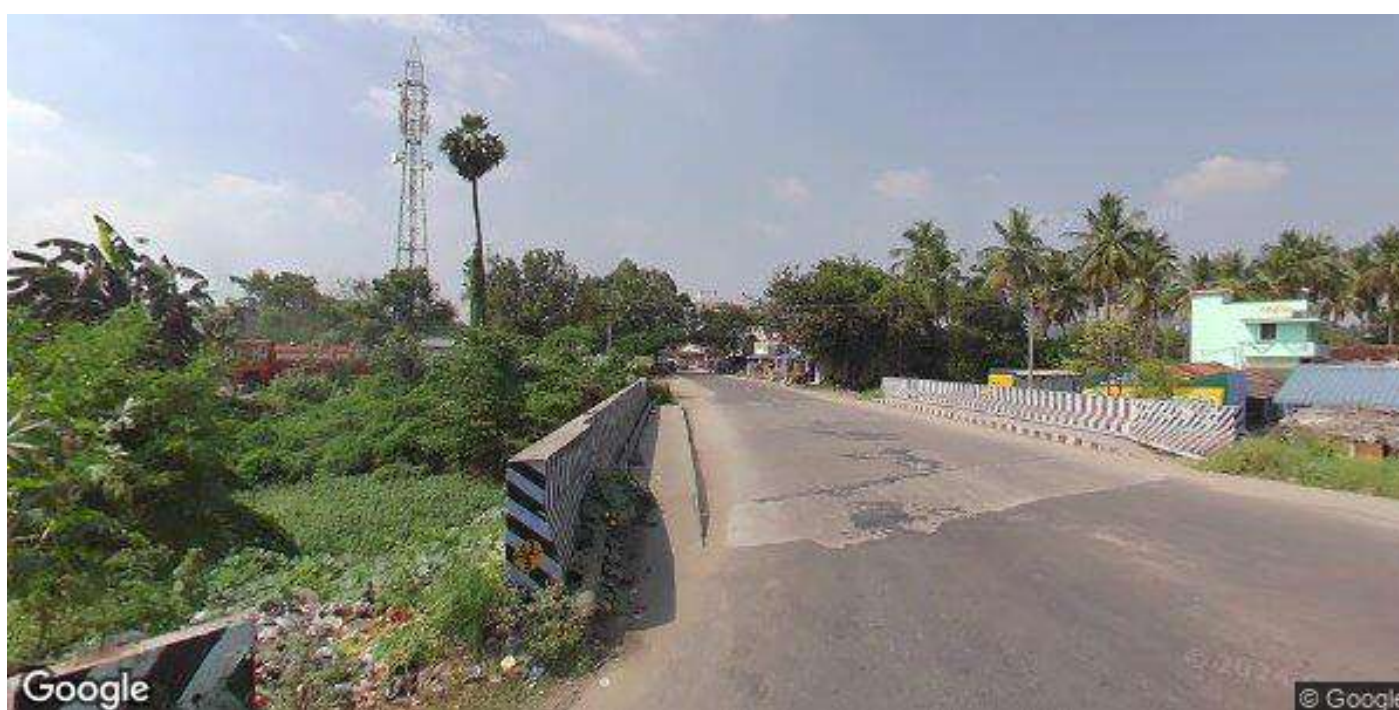
**Risk Type:** Turn  
**Risk Level:** High  
**Speed Limit:** 15 KM/Hr  
**Coordinates:** 11.44900, 77.87406

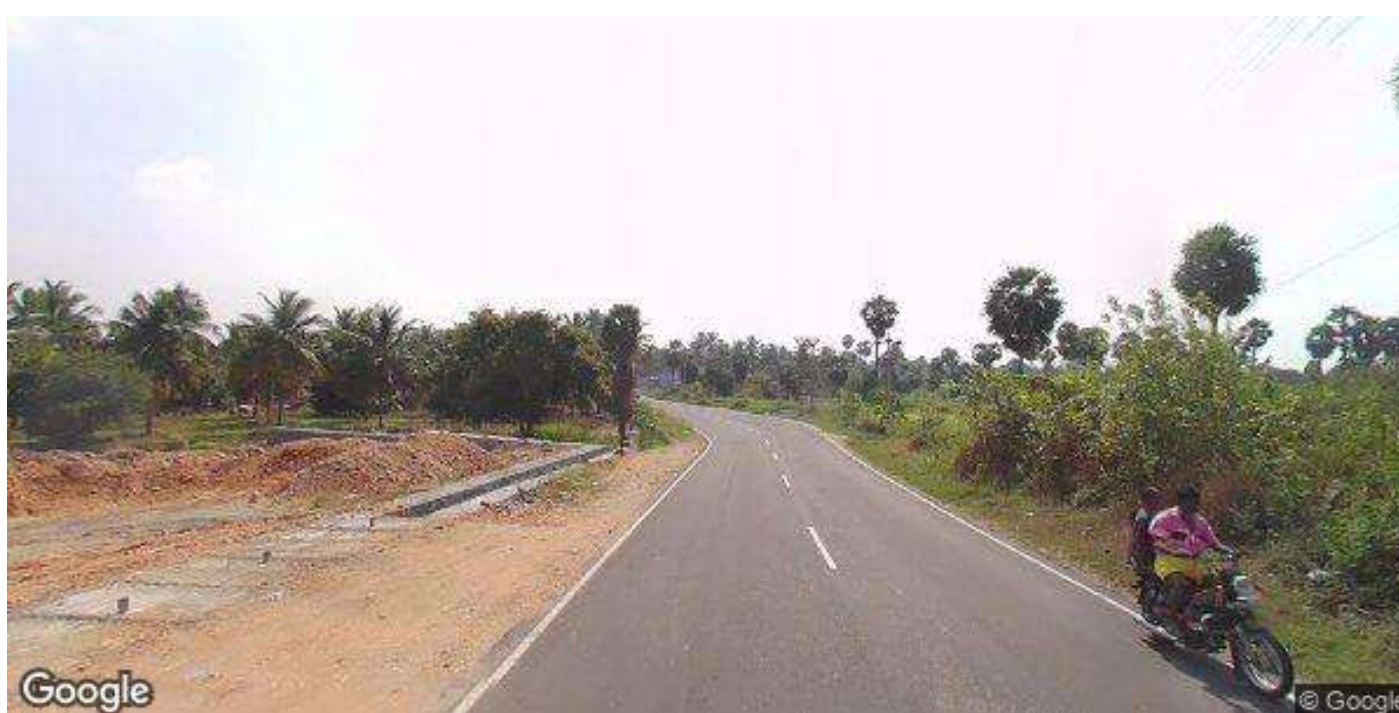
**Risk Type:** Turn  
**Risk Level:** Medium  
**Speed Limit:** 30 KM/Hr  
**Coordinates:** 11.45781, 77.85203

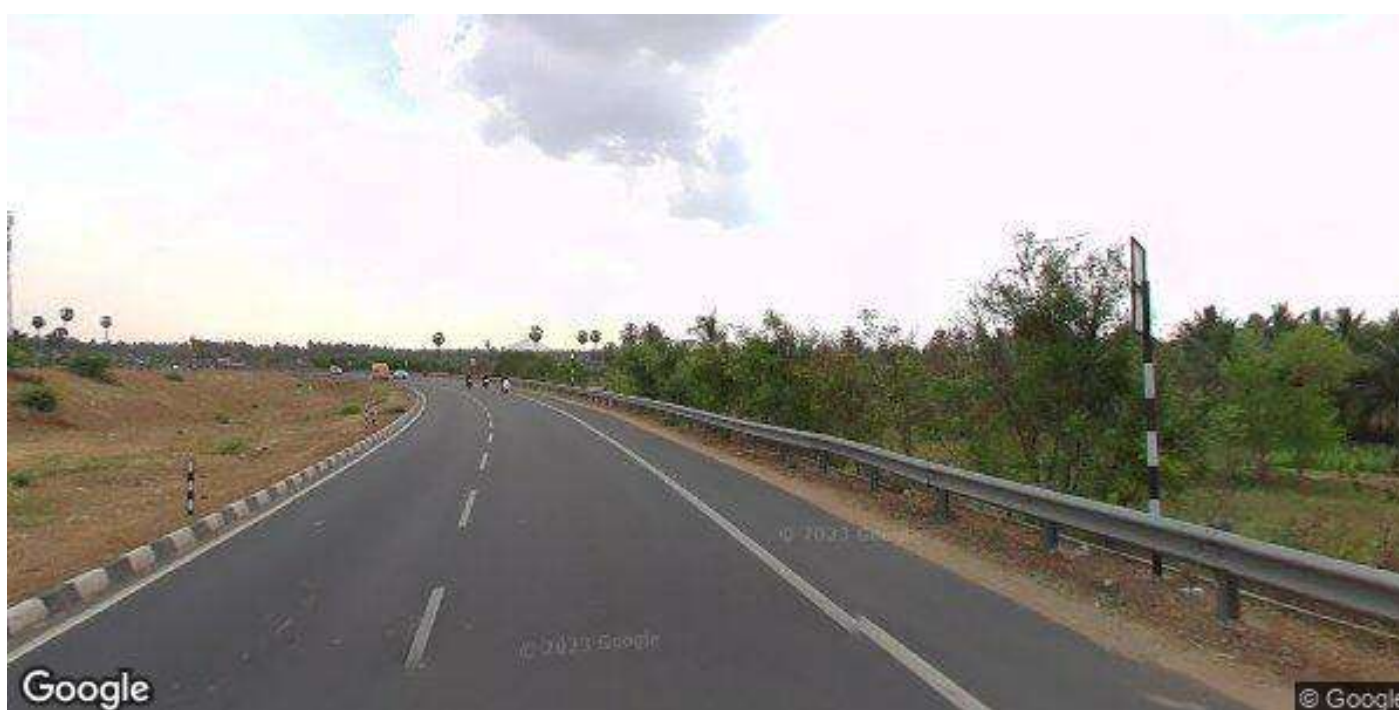
**Risk Type:** Turn  
**Risk Level:** Medium  
**Speed Limit:** 30 KM/Hr  
**Coordinates:** 11.53578, 77.95802

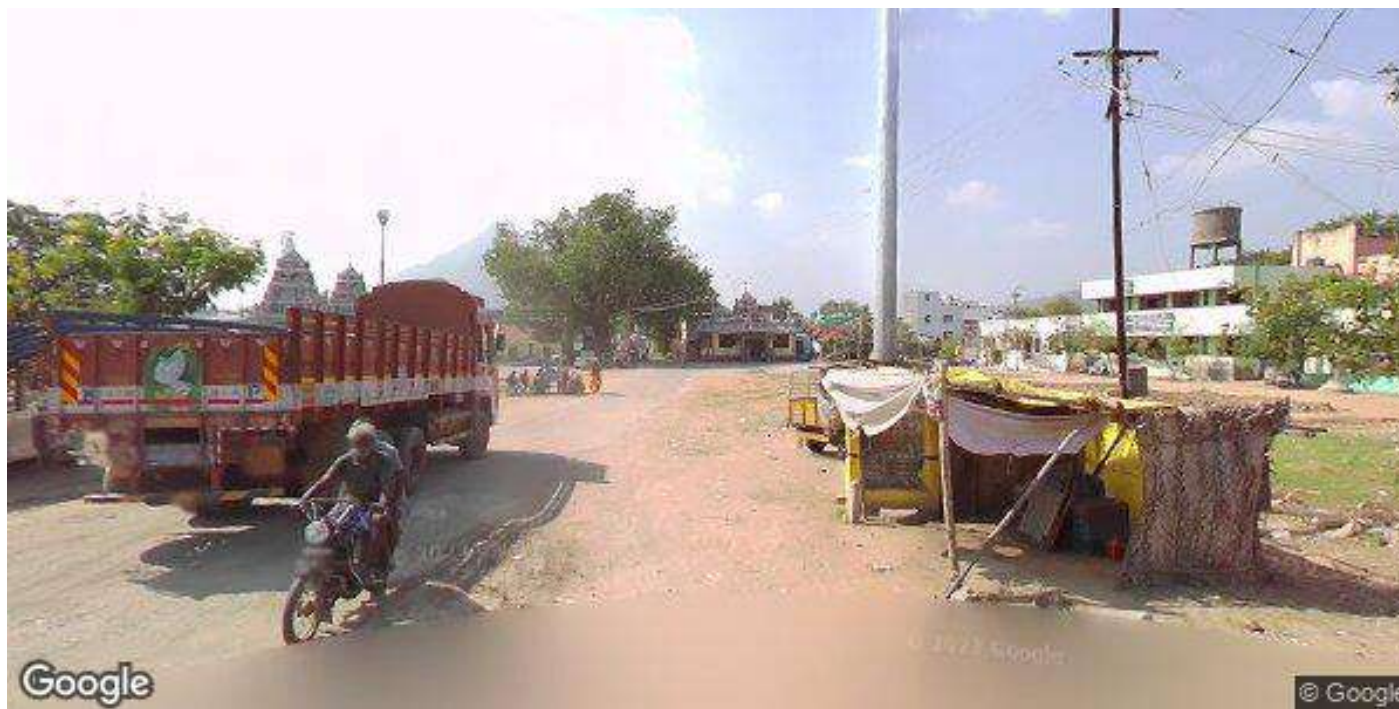
**Risk Type:** Blind Spot  
**Risk Level:** Blind Spot  
**Speed Limit:** 10 KM/Hr  
**Coordinates:** 11.62145, 78.10740

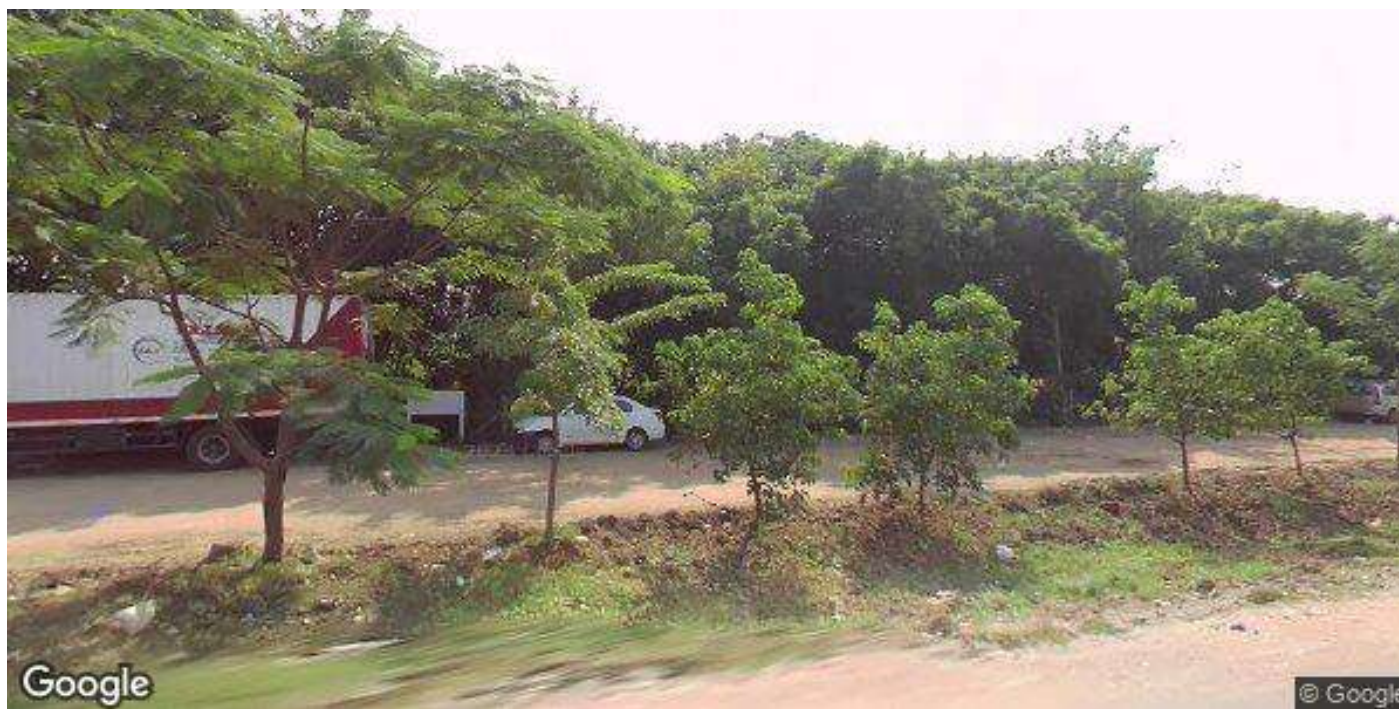
**Risk Type:** Turn  
**Risk Level:** High  
**Speed Limit:** 15 KM/Hr  
**Coordinates:** 11.62106, 78.10767

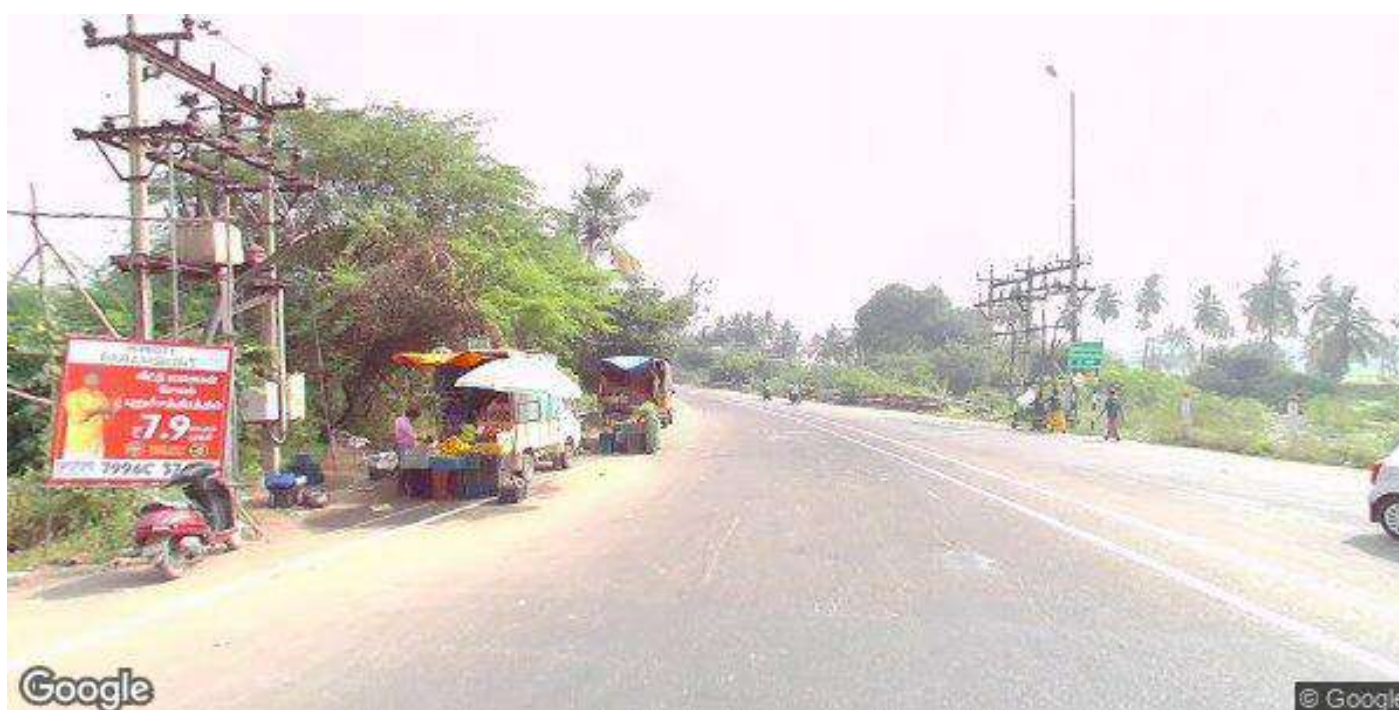
**Risk Type:** Blind Spot  
**Risk Level:** Blind Spot  
**Speed Limit:** 10 KM/Hr  
**Coordinates:** 11.61217, 78.10439

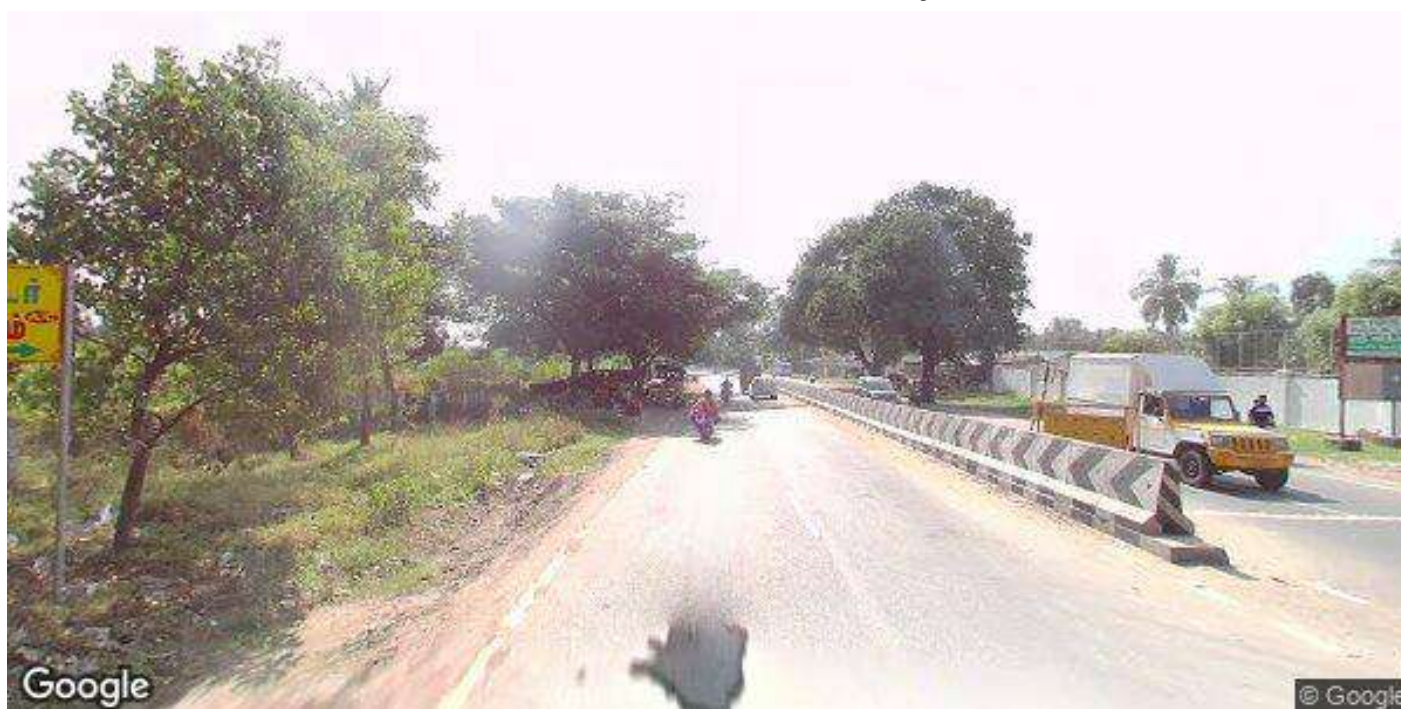
**Risk Type:** Blind Spot  
**Risk Level:** Blind Spot  
**Speed Limit:** 10 KM/Hr  
**Coordinates:** 11.61801, 78.11095

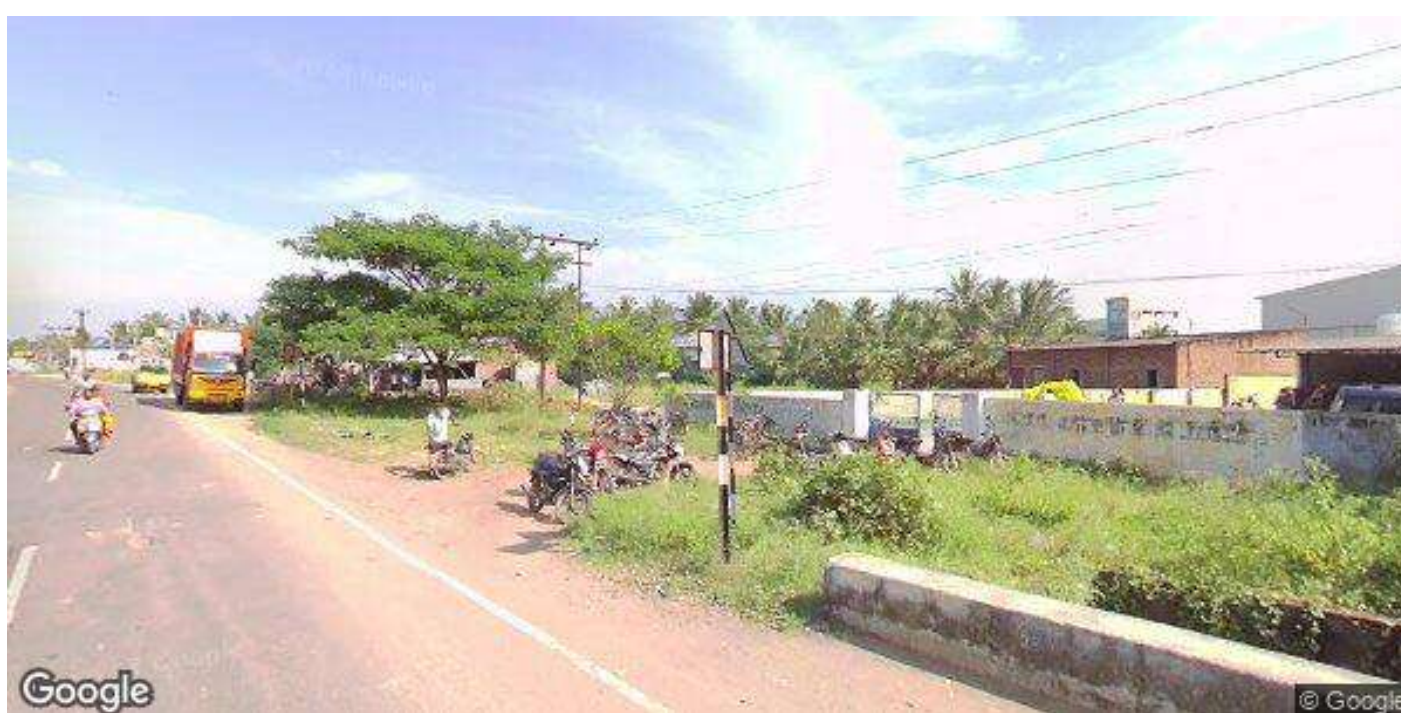
**Risk Type:** Blind Spot  
**Risk Level:** Blind Spot  
**Speed Limit:** 10 KM/Hr  
**Coordinates:** 11.61285, 78.10608

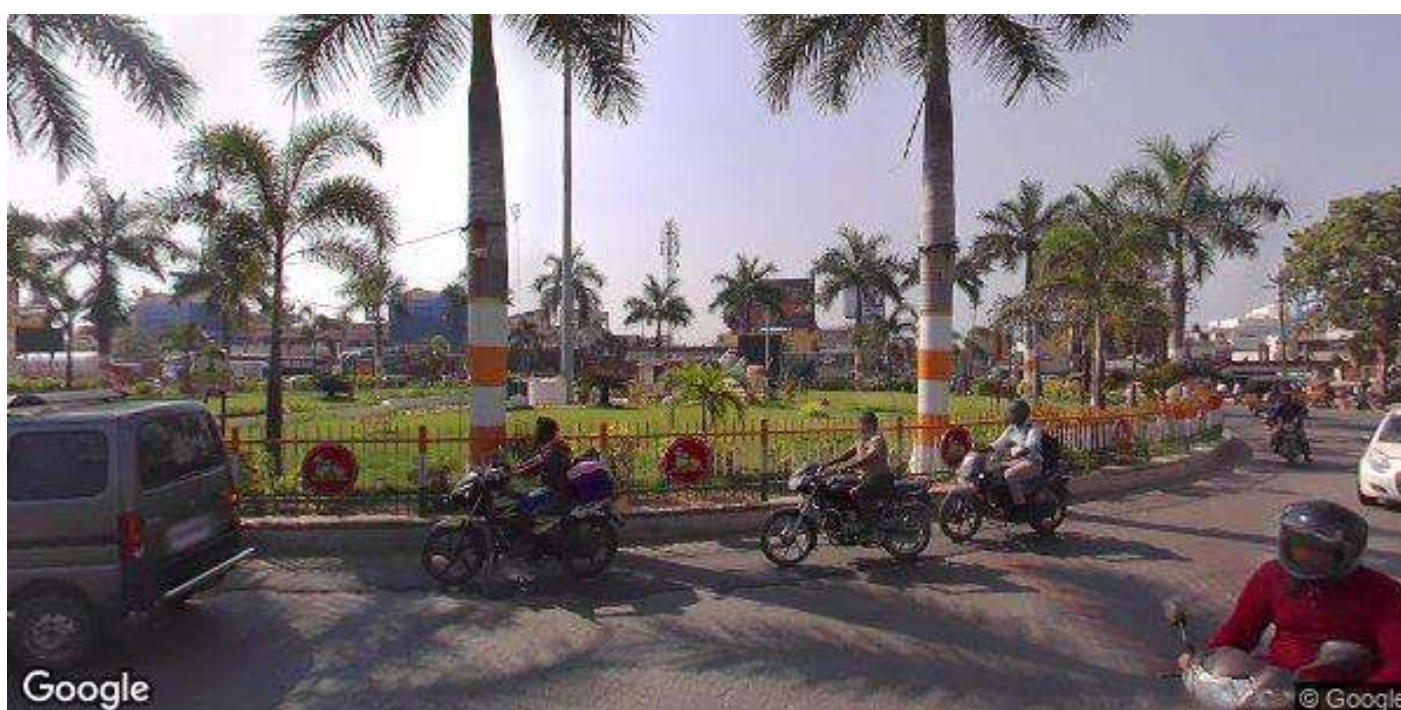
**Risk Type:** Turn  
**Risk Level:** High  
**Speed Limit:** 15 KM/Hr  
**Coordinates:** 11.63306, 78.12728

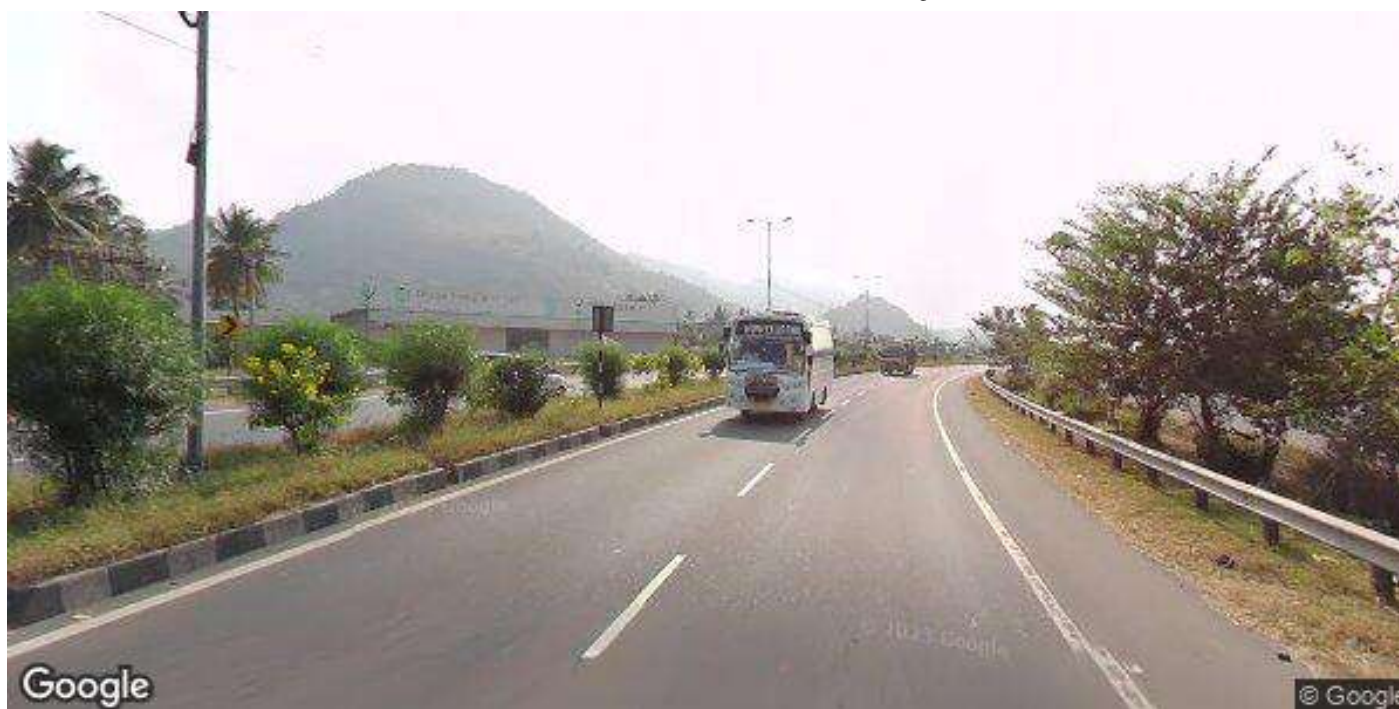
**Risk Type:** Turn  
**Risk Level:** Medium  
**Speed Limit:** 30 KM/Hr  
**Coordinates:** 11.62861, 78.16526

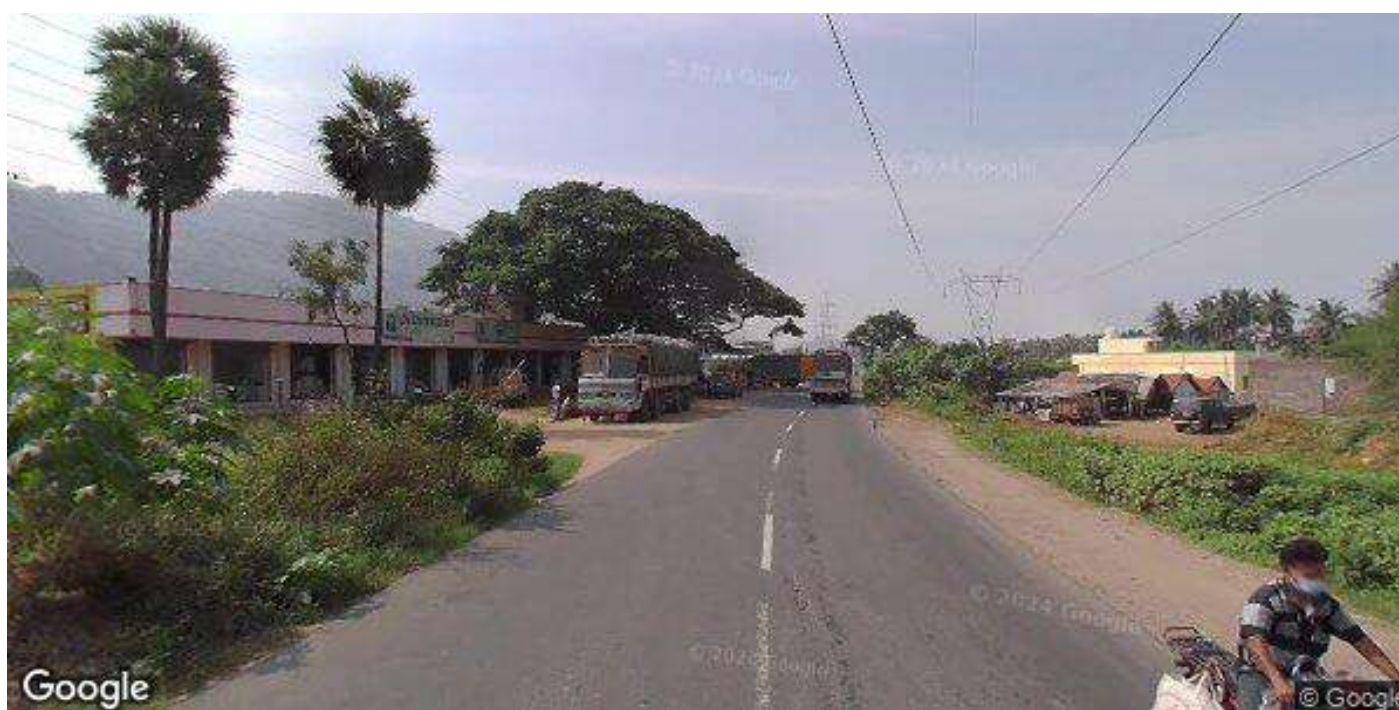
**Risk Type:** Turn  
**Risk Level:** Medium  
**Speed Limit:** 30 KM/Hr  
**Coordinates:** 11.65786, 78.20436

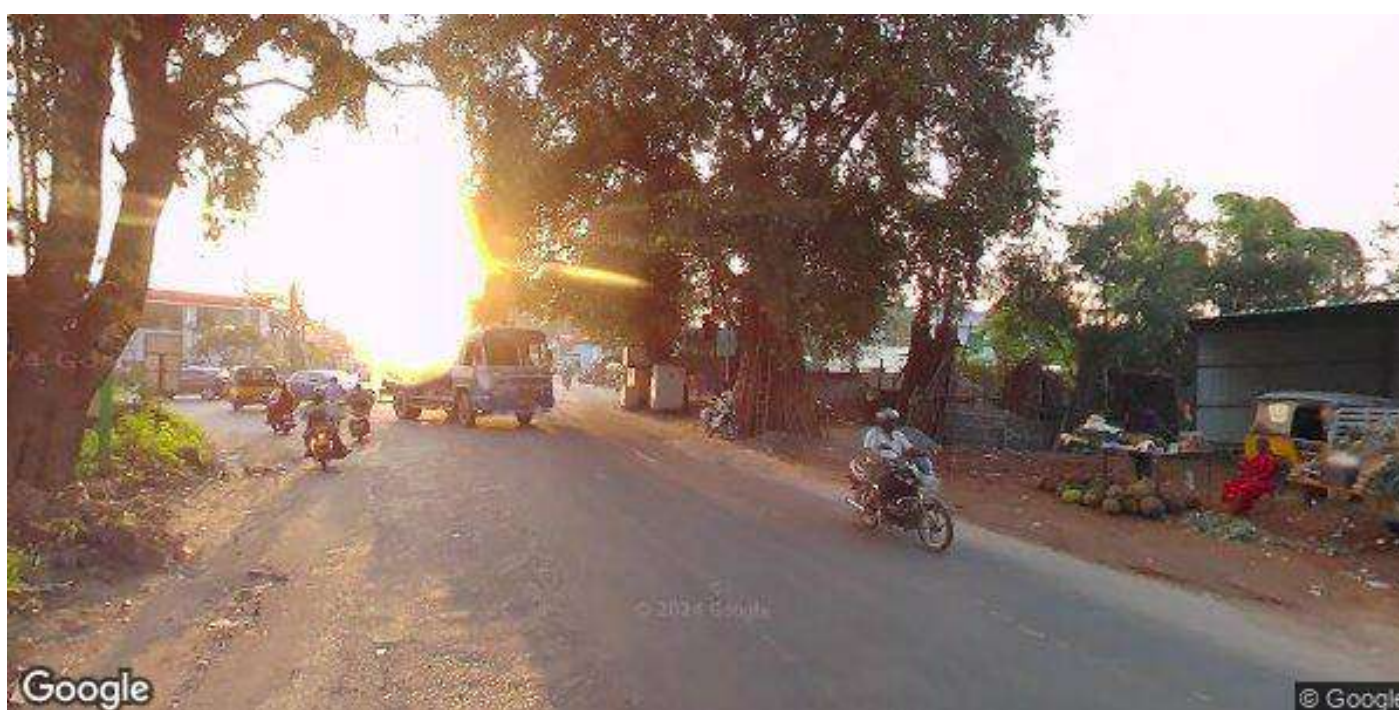
**Risk Type:** Turn  
**Risk Level:** High  
**Speed Limit:** 15 KM/Hr  
**Coordinates:** 11.66388, 78.20672

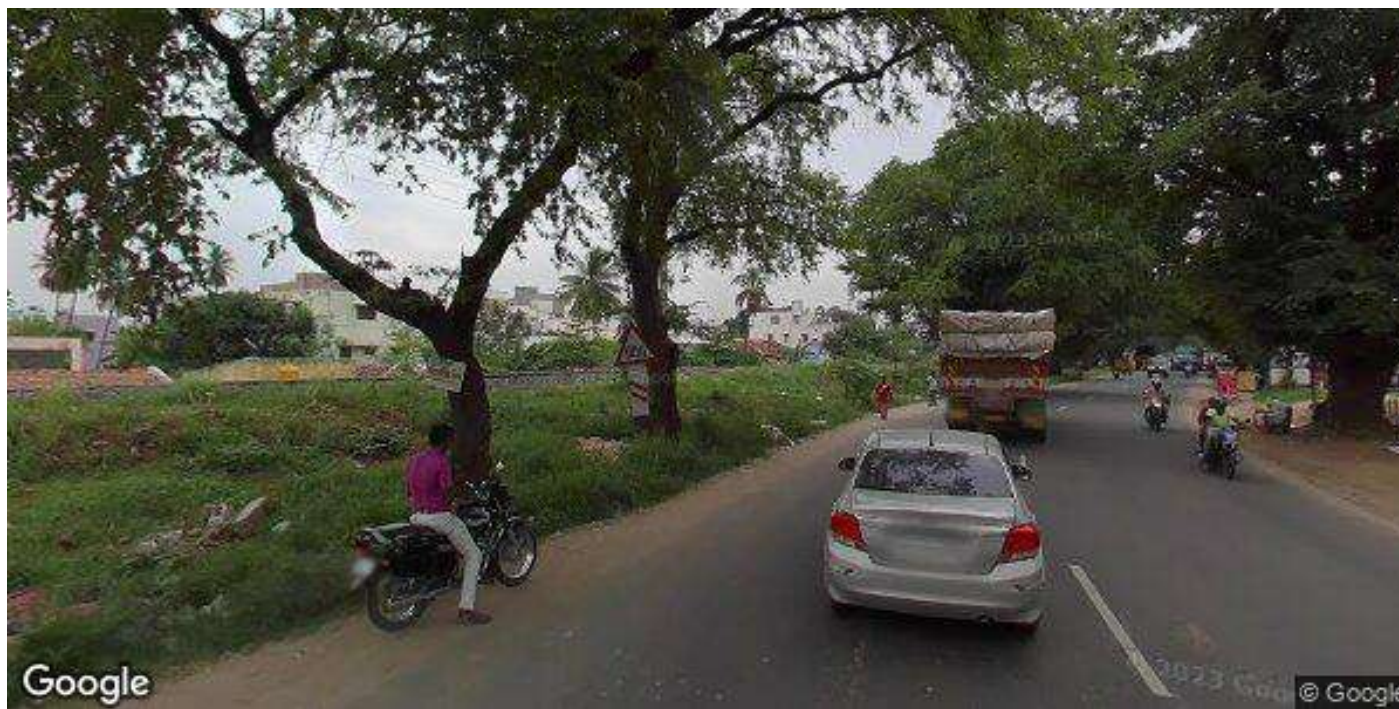
**Risk Type:** Turn  
**Risk Level:** Medium  
**Speed Limit:** 30 KM/Hr  
**Coordinates:** 11.67129, 78.22978

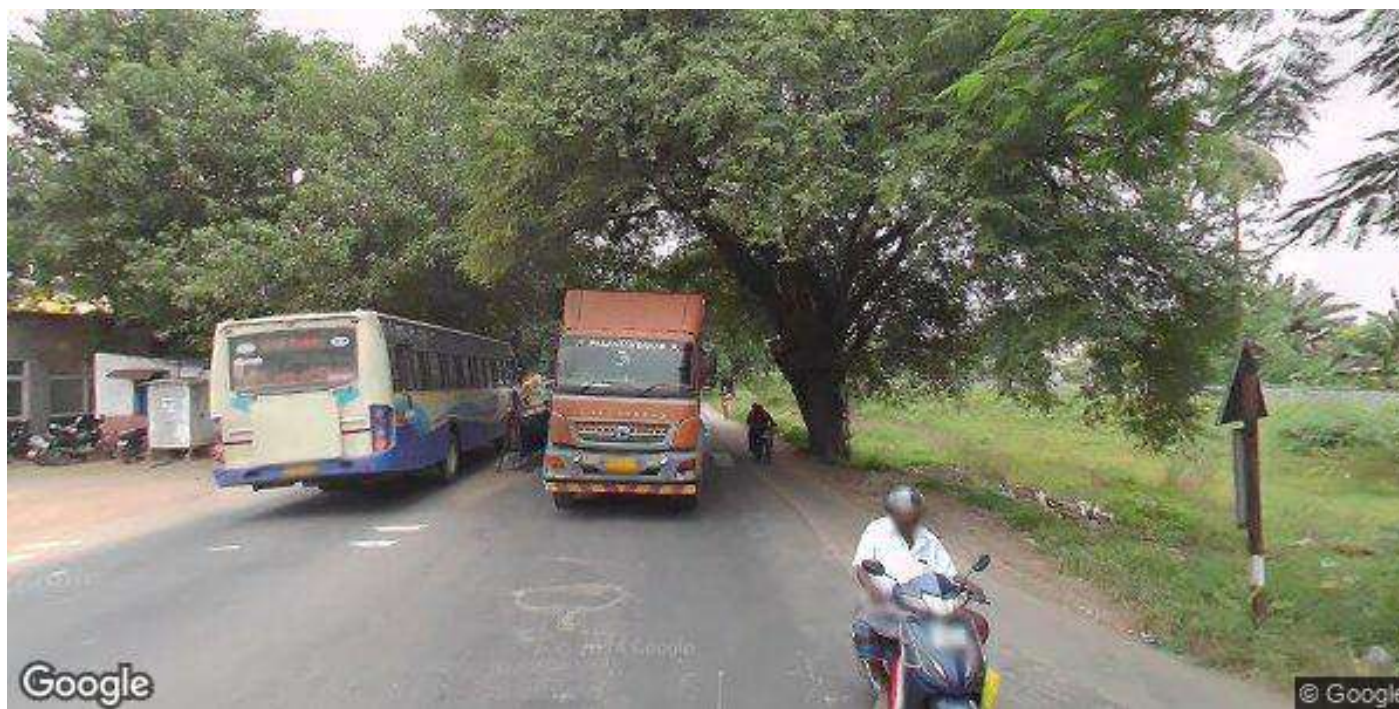
**Risk Type:** Turn  
**Risk Level:** Medium  
**Speed Limit:** 30 KM/Hr  
**Coordinates:** 11.67116, 78.23102

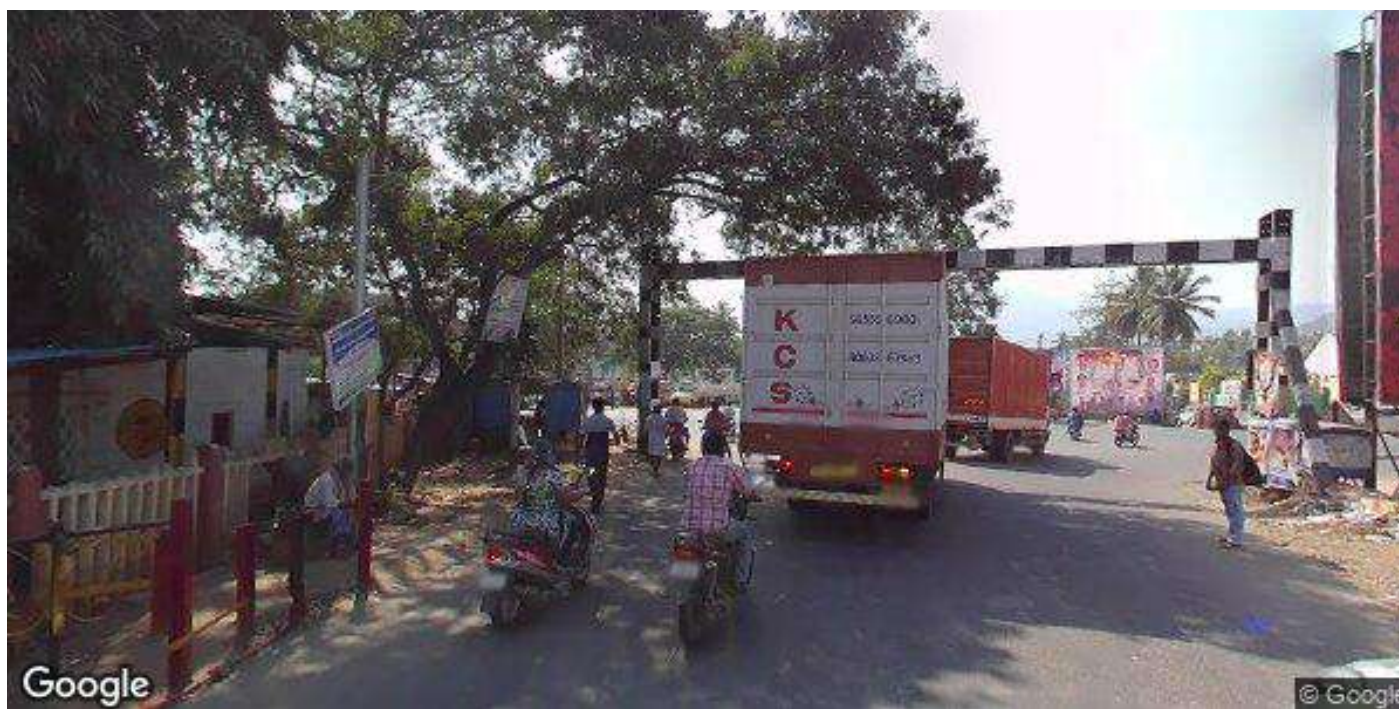
**Risk Type:** Turn  
**Risk Level:** High  
**Speed Limit:** 15 KM/Hr  
**Coordinates:** 11.67145, 78.23141

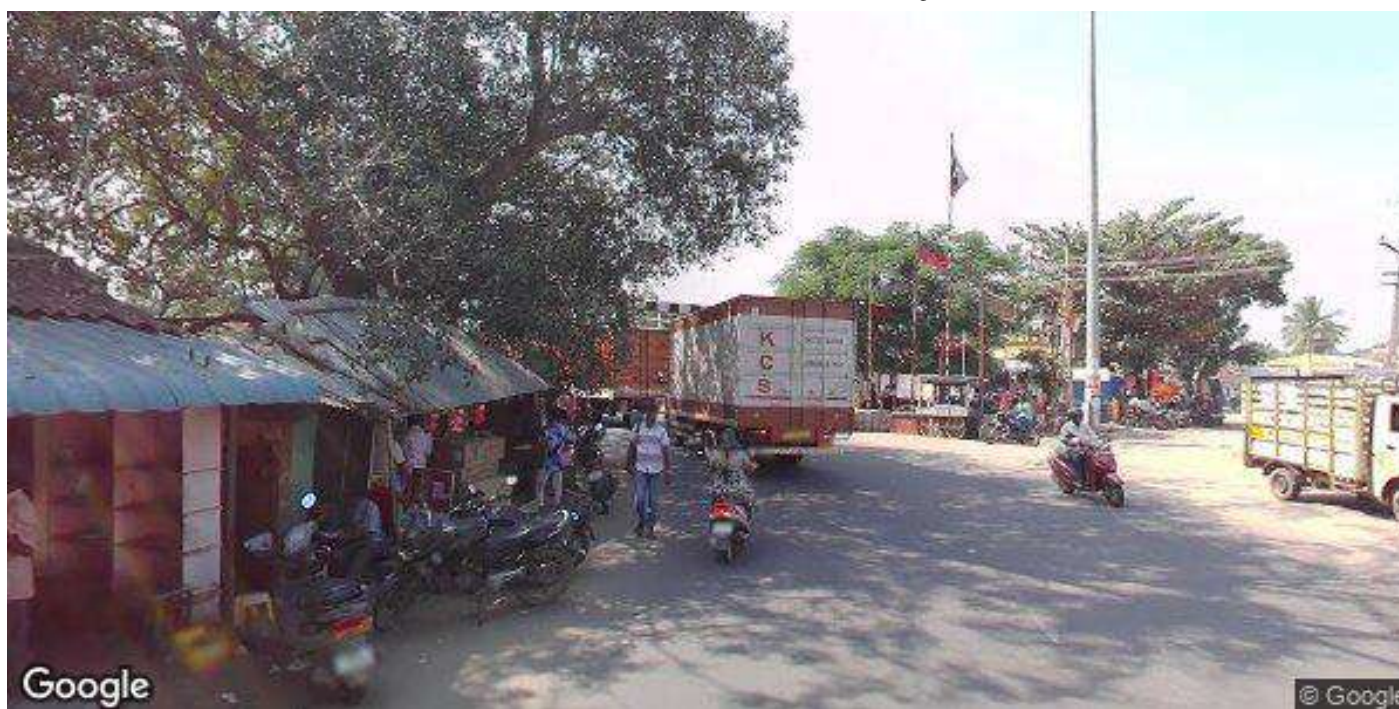
**Risk Type:** Turn  
**Risk Level:** High  
**Speed Limit:** 15 KM/Hr  
**Coordinates:** 11.67198, 78.23148

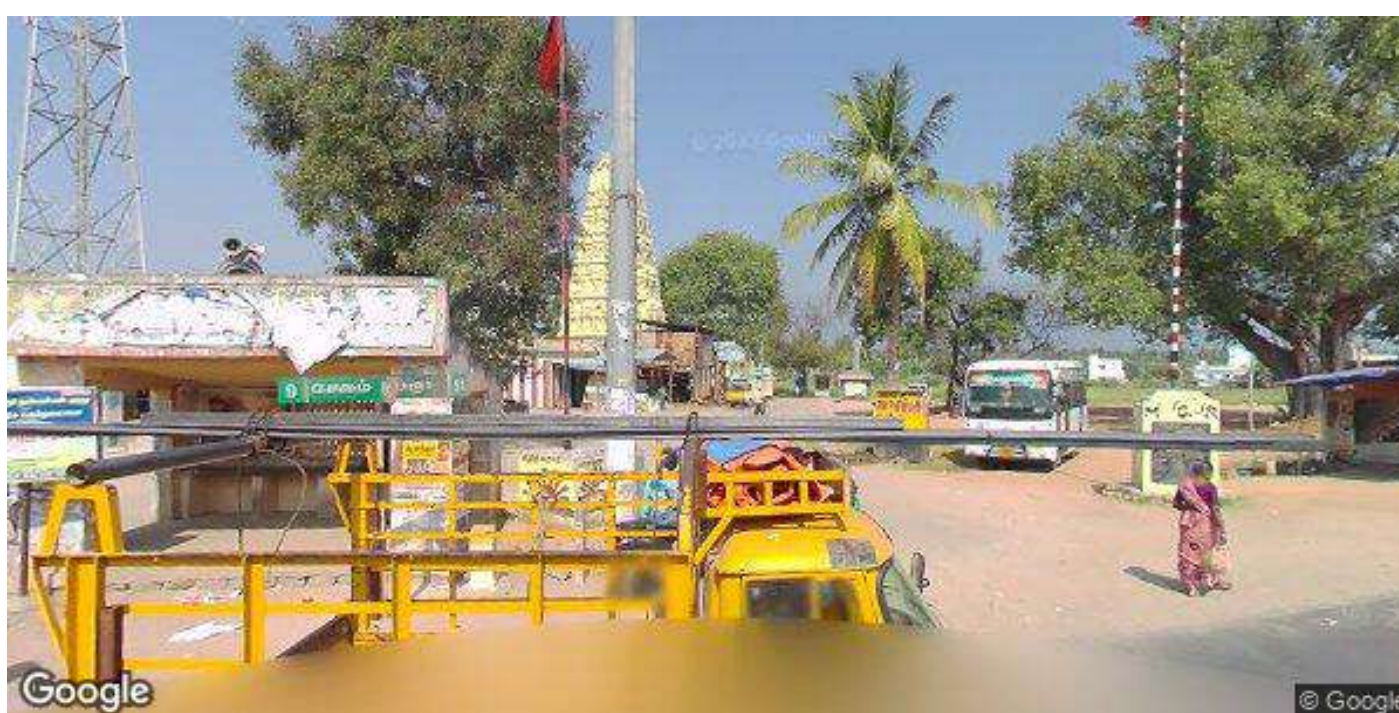
**Risk Type:** Turn  
**Risk Level:** Medium  
**Speed Limit:** 30 KM/Hr  
**Coordinates:** 11.67440, 78.23914

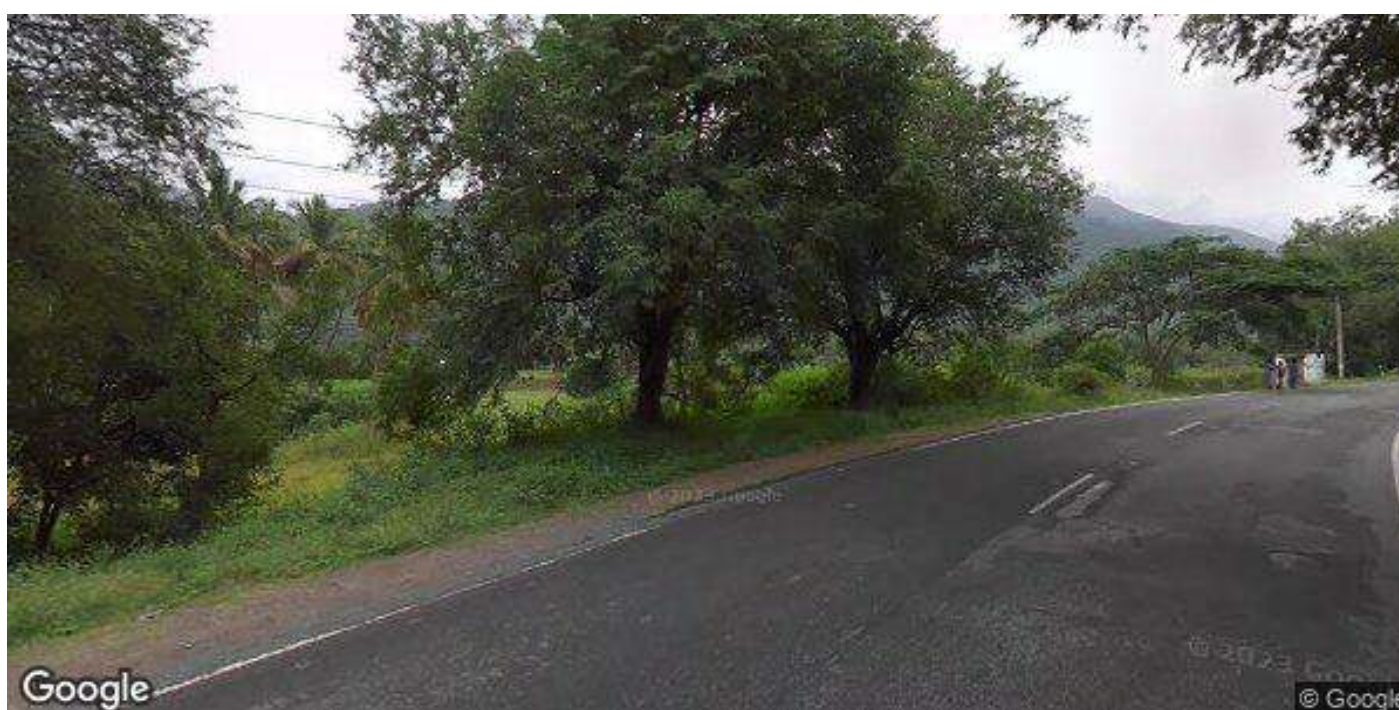
**Risk Type:** Turn  
**Risk Level:** Medium  
**Speed Limit:** 30 KM/Hr  
**Coordinates:** 11.81235, 78.34084

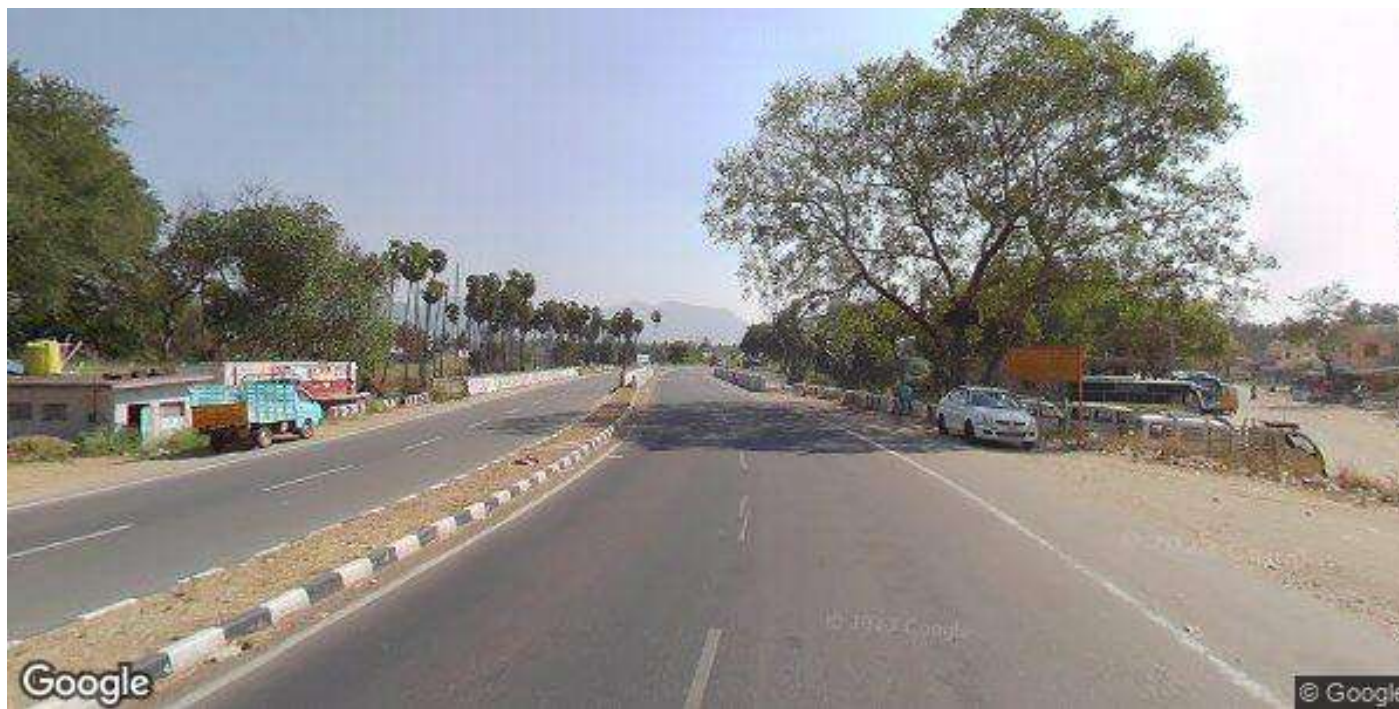
**Risk Type:** Turn  
**Risk Level:** Medium  
**Speed Limit:** 30 KM/Hr  
**Coordinates:** 11.99554, 78.44553

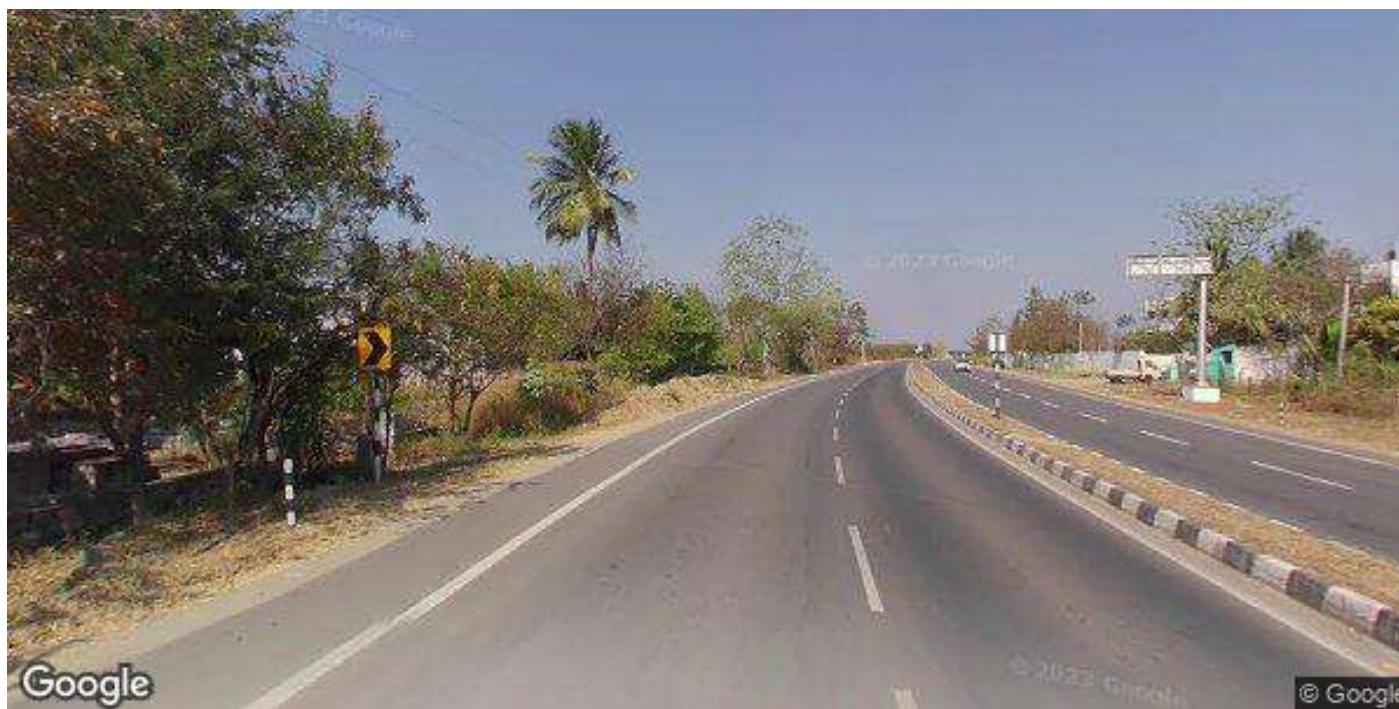
**Risk Type:** Turn  
**Risk Level:** Medium  
**Speed Limit:** 30 KM/Hr  
**Coordinates:** 12.01577, 78.45673
