# IndianOil

## JOURNEY RISK MANAGEMENT (JRM) STUDY

### Salem Terminal to ARS AGENCY - UTHANGARAI

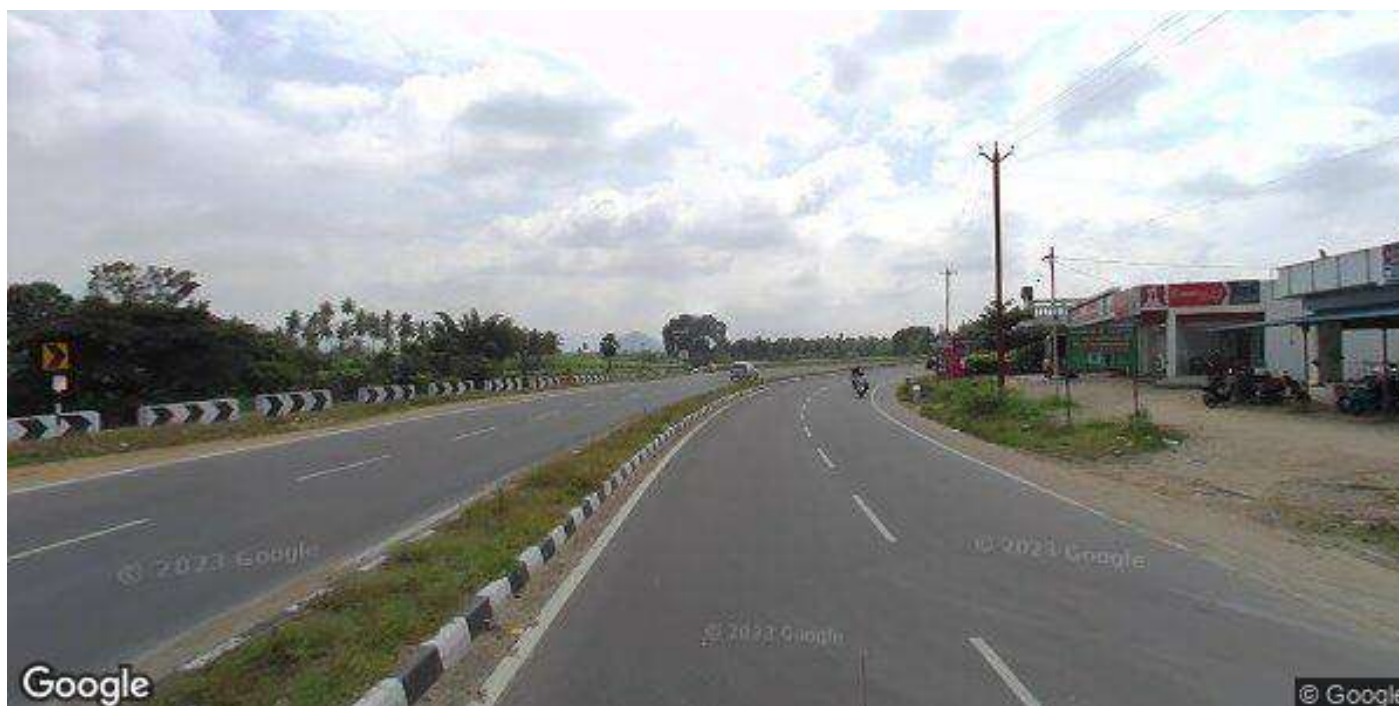
**Risk Type:** Turn  
**Risk Level:** Medium  
**Speed Limit:** 30 KM/Hr  
**Coordinates:** 12.04335, 78.48368

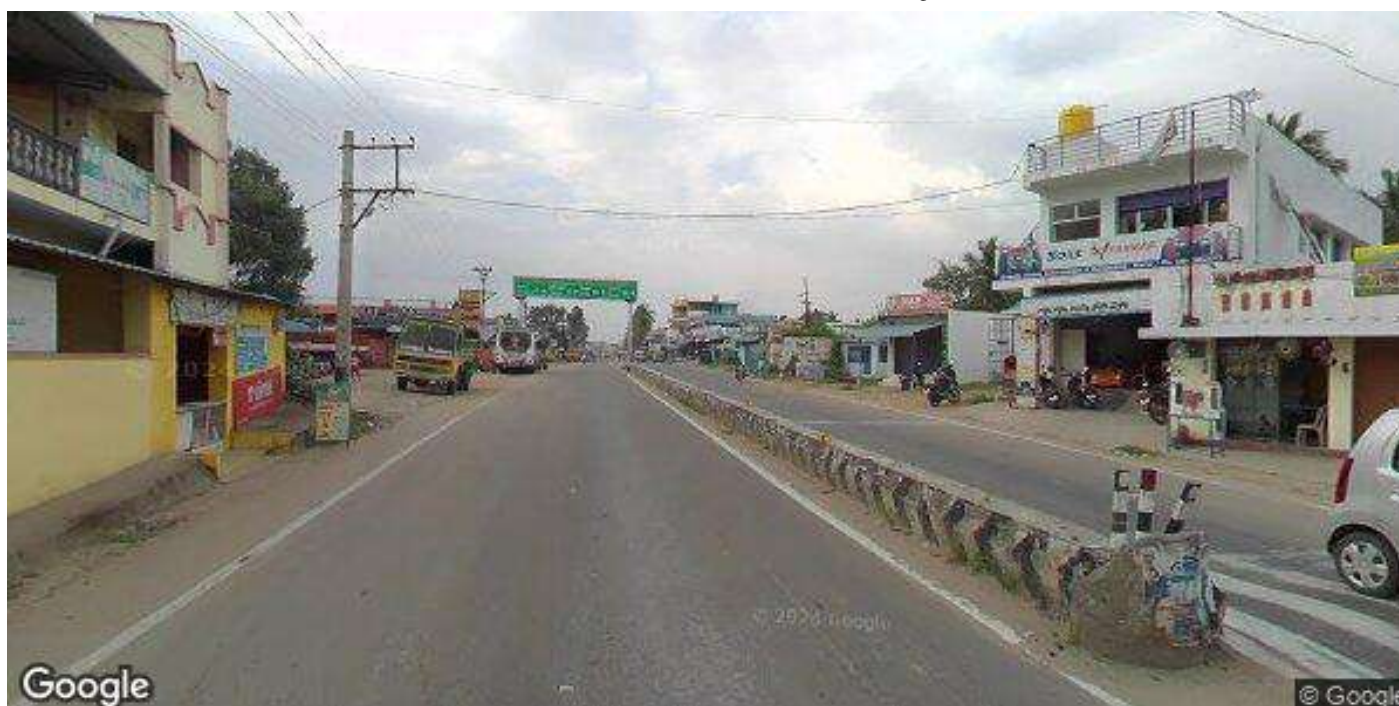
**Risk Type:** Turn  
**Risk Level:** Medium  
**Speed Limit:** 30 KM/Hr  
**Coordinates:** 12.04504, 78.48335

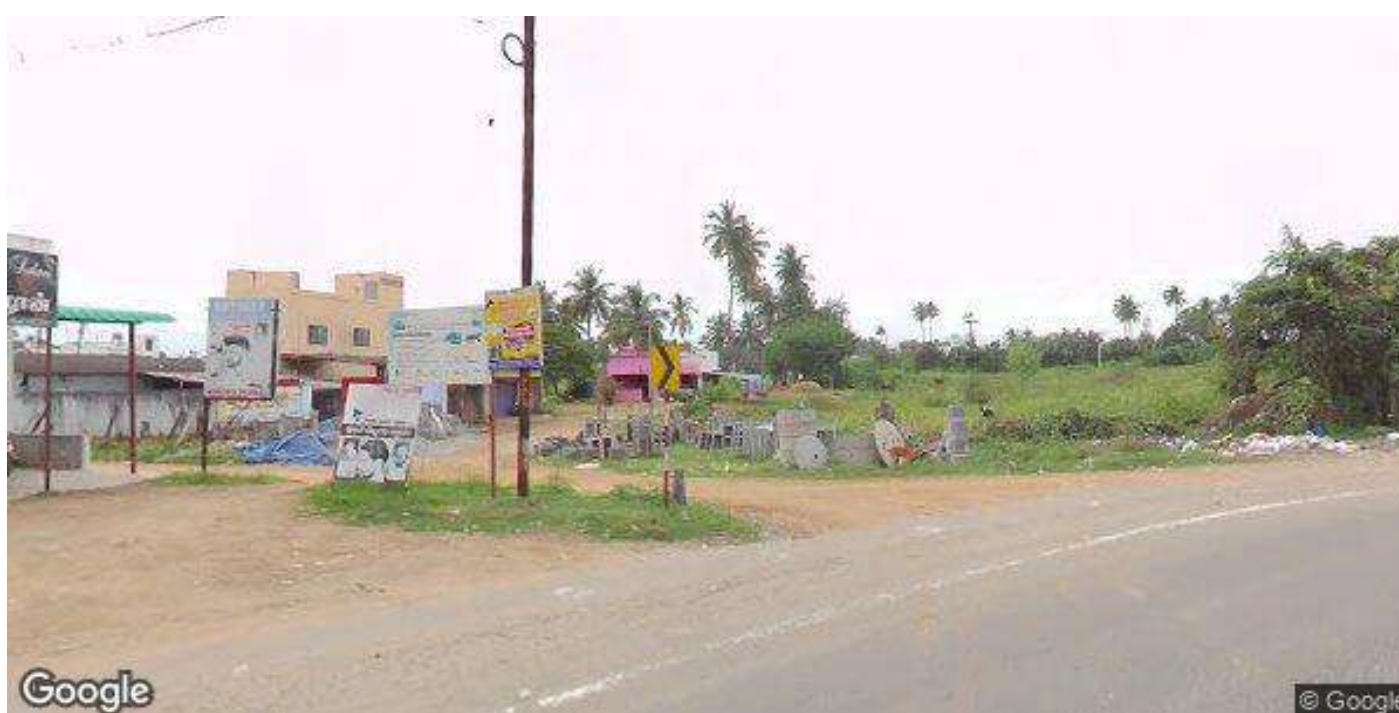
**Risk Type:** Turn  
**Risk Level:** High  
**Speed Limit:** 15 KM/Hr  
**Coordinates:** 12.04990, 78.47475

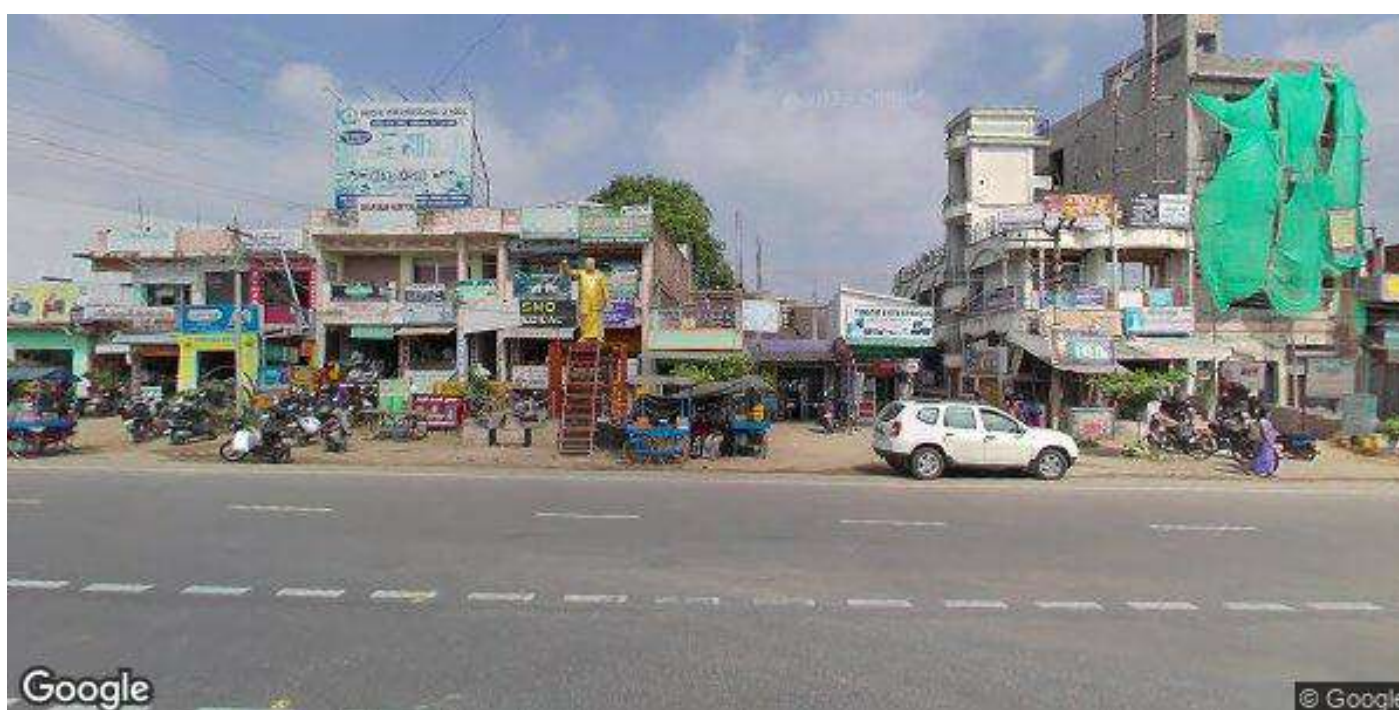
**Risk Type:** Turn  
**Risk Level:** Medium  
**Speed Limit:** 30 KM/Hr  
**Coordinates:** 12.06023, 78.47792

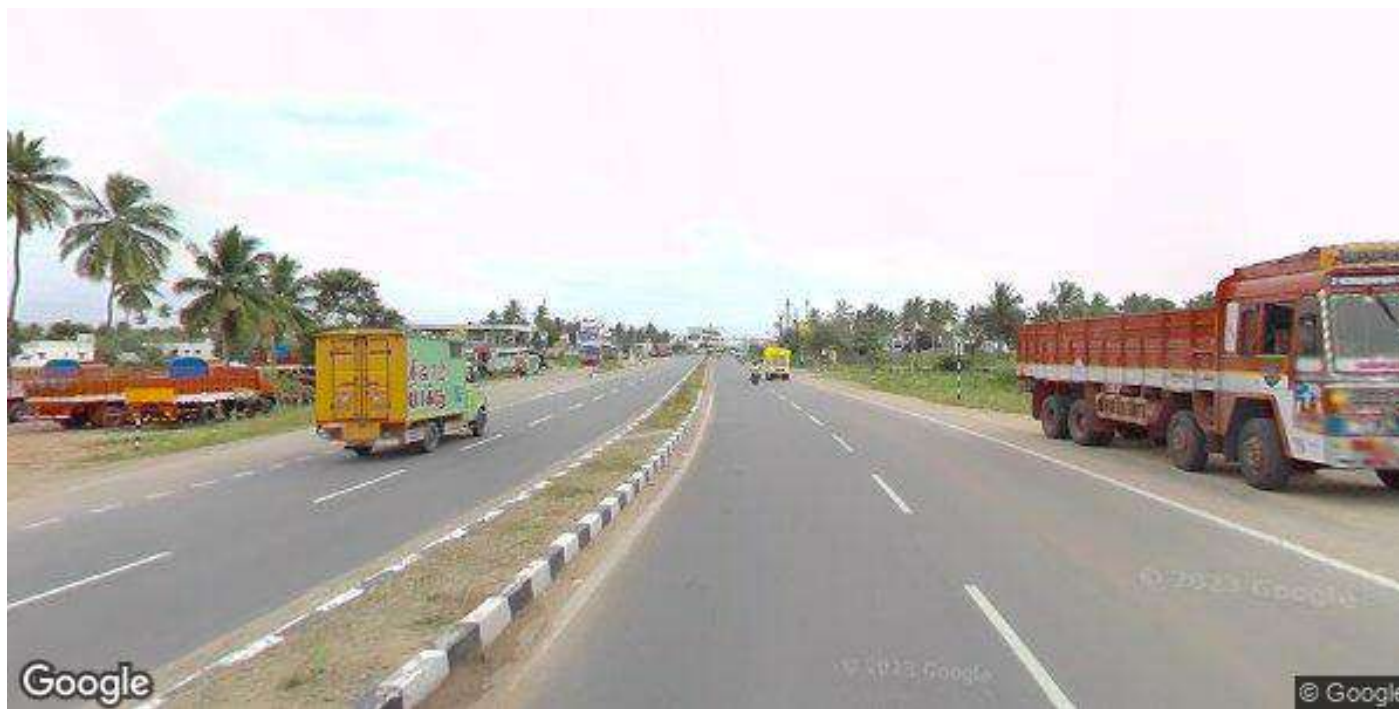
**Risk Type:** Turn  
**Risk Level:** Medium  
**Speed Limit:** 30 KM/Hr  
**Coordinates:** 12.06932, 78.47655

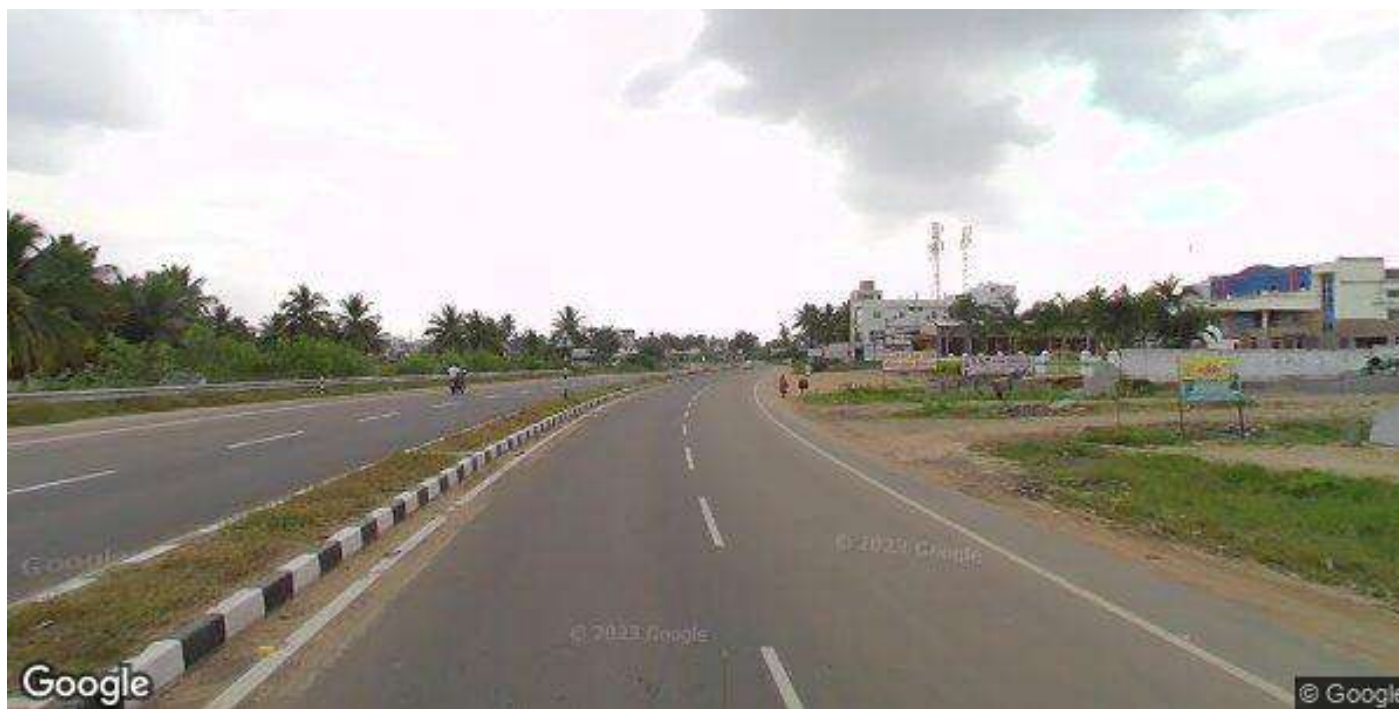
**Risk Type:** Turn  
**Risk Level:** Medium  
**Speed Limit:** 30 KM/Hr  
**Coordinates:** 12.07112, 78.47724

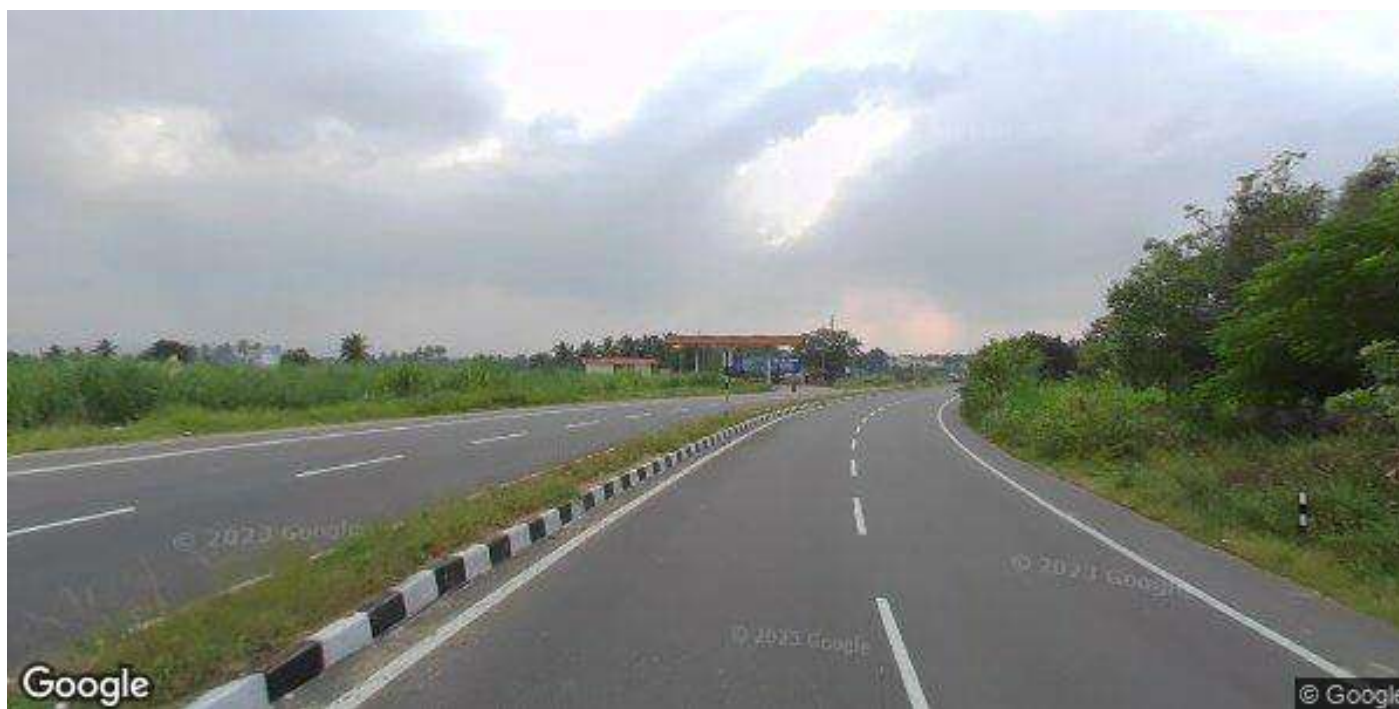
**Risk Type:** Turn  
**Risk Level:** Medium  
**Speed Limit:** 30 KM/Hr  
**Coordinates:** 12.11669, 78.49766

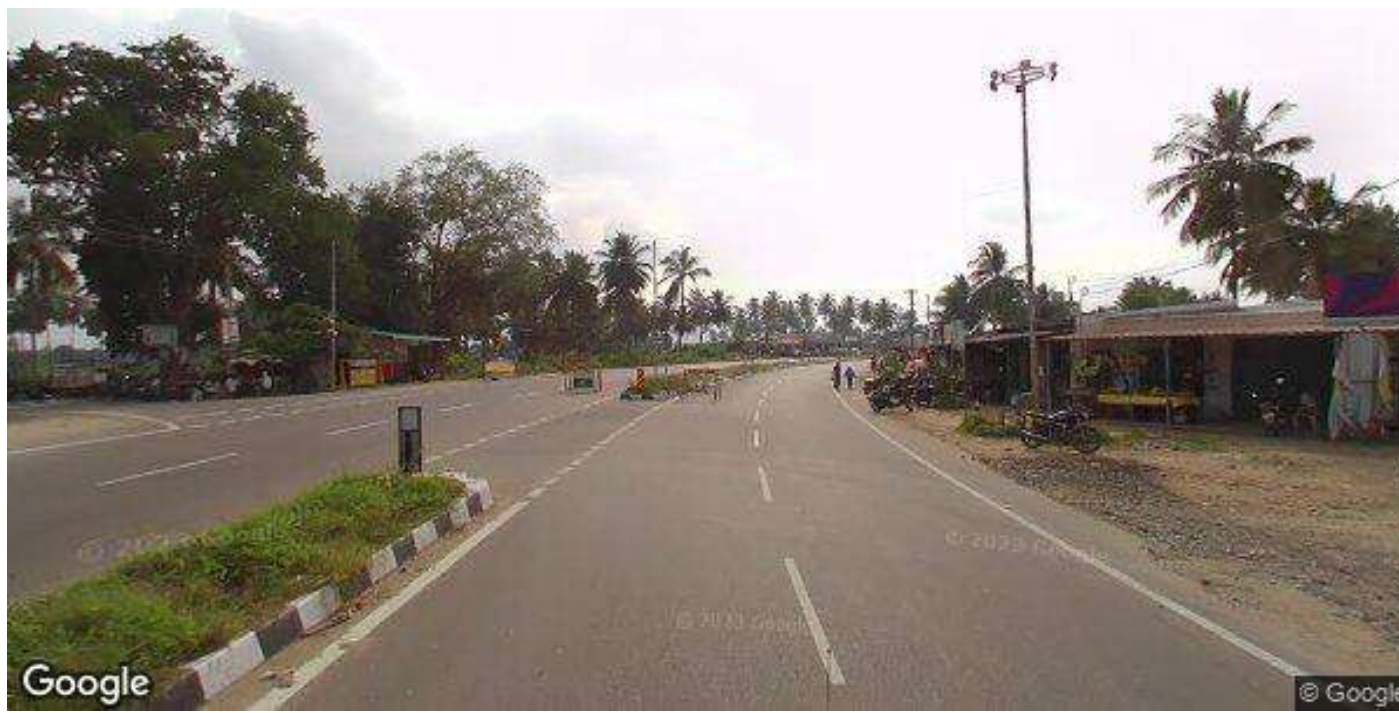
**Risk Type:** Turn  
**Risk Level:** Medium  
**Speed Limit:** 30 KM/Hr  
**Coordinates:** 12.17764, 78.54800

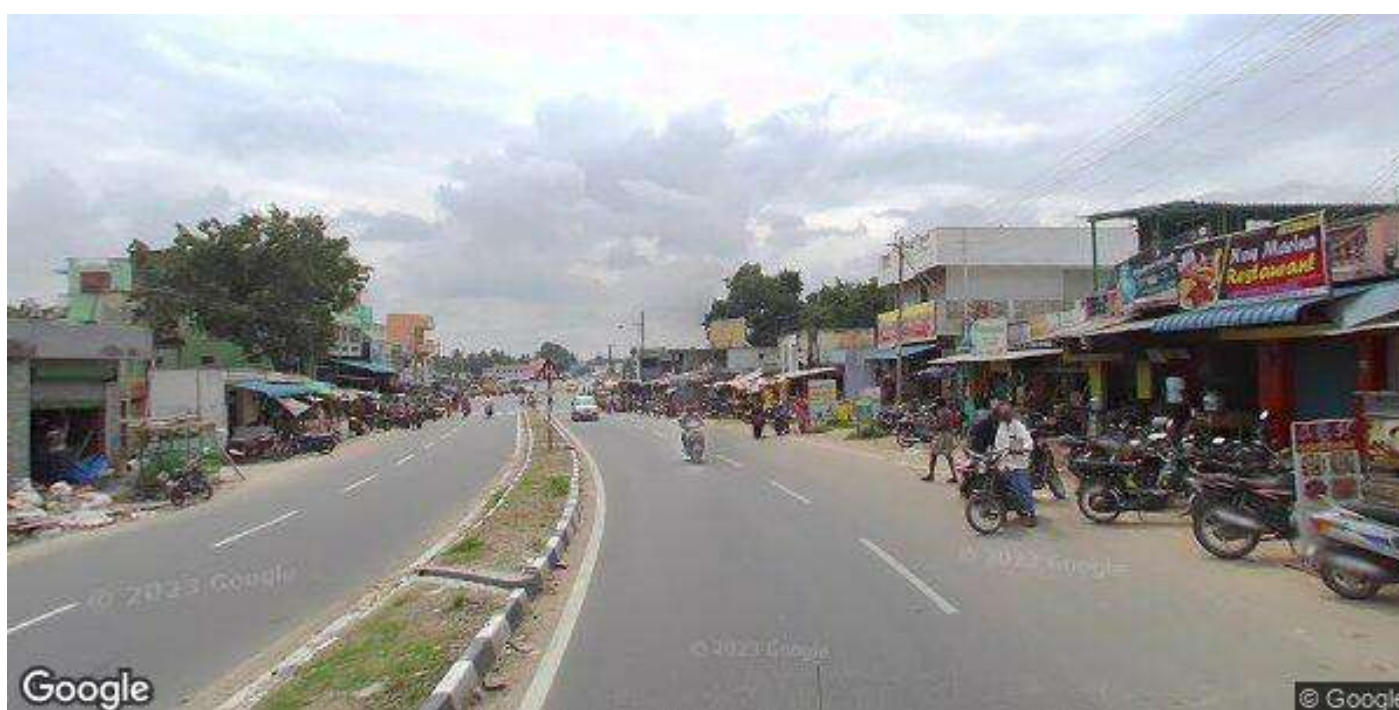
**Risk Type:** Turn  
**Risk Level:** Medium  
**Speed Limit:** 30 KM/Hr  
**Coordinates:** 12.18223, 78.54843

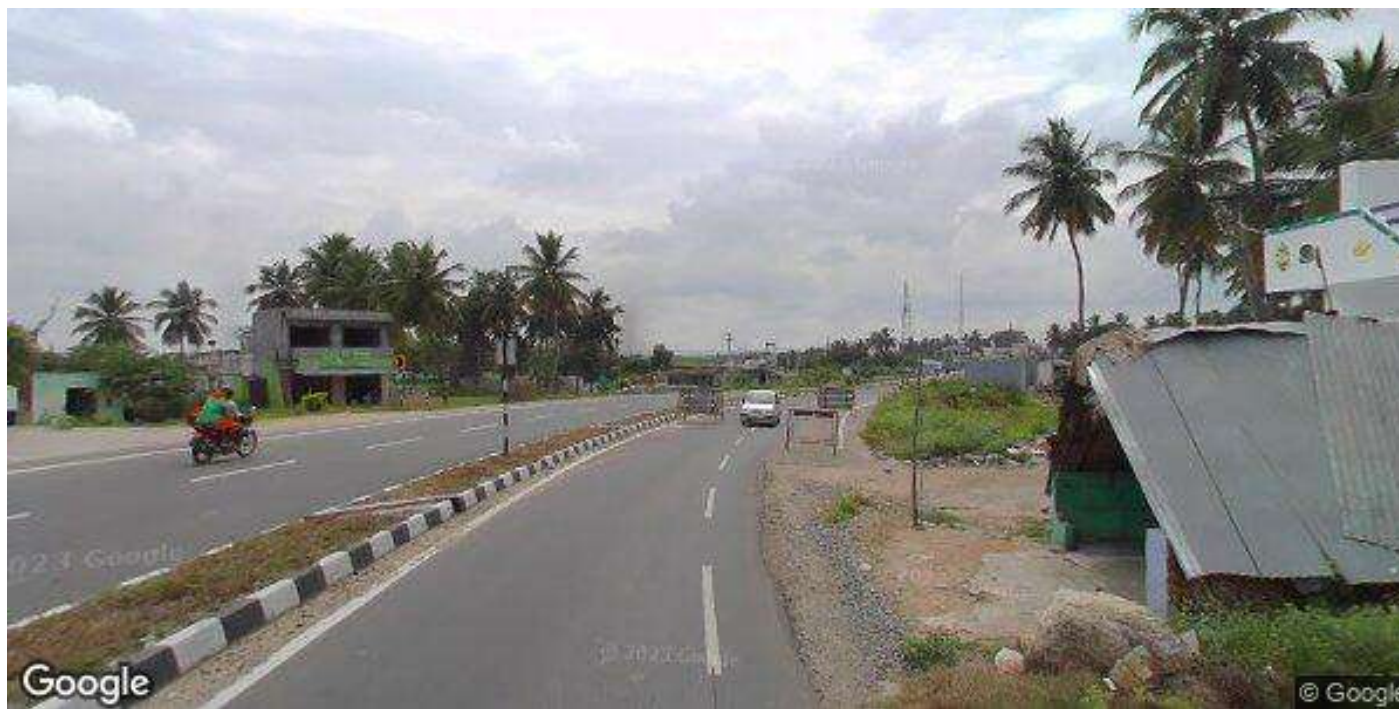
**Risk Type:** Turn  
**Risk Level:** High  
**Speed Limit:** 15 KM/Hr  
**Coordinates:** 12.18614, 78.54962

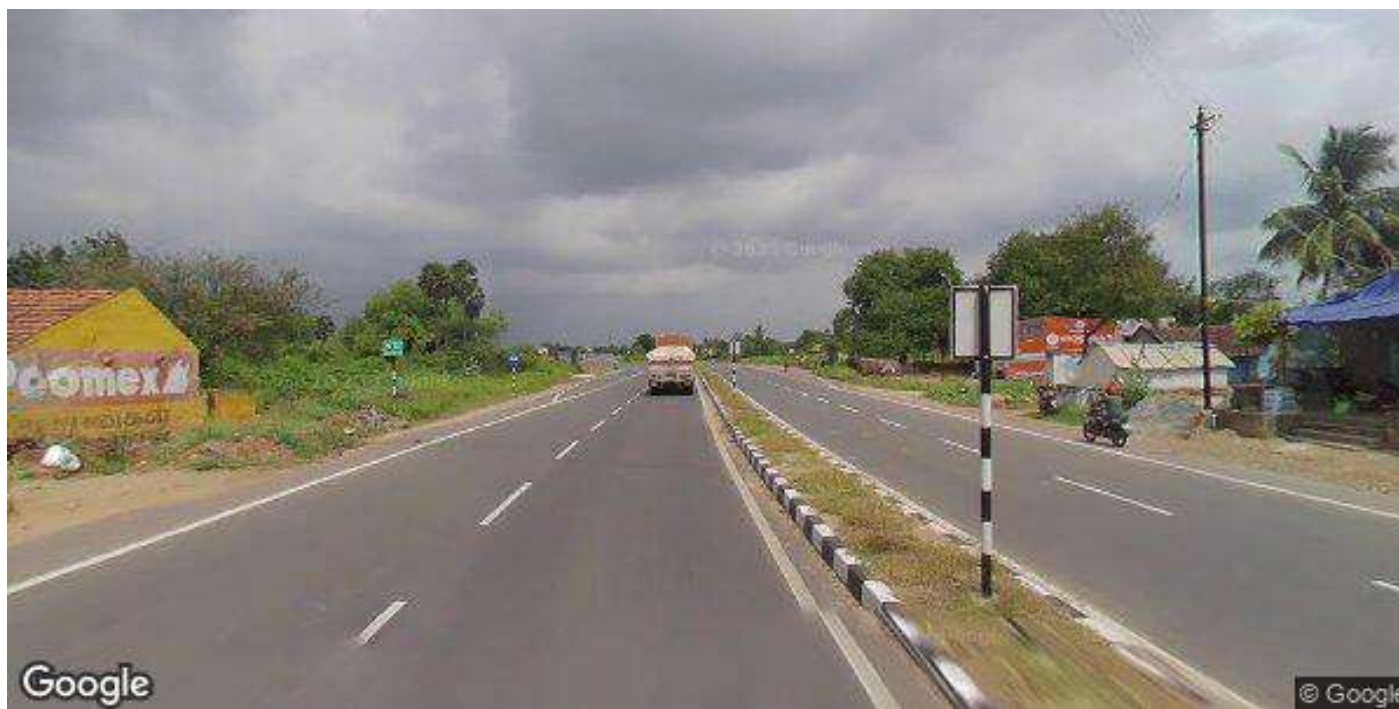
**Risk Type:** Turn  
**Risk Level:** Medium  
**Speed Limit:** 30 KM/Hr  
**Coordinates:** 12.20186, 78.54375

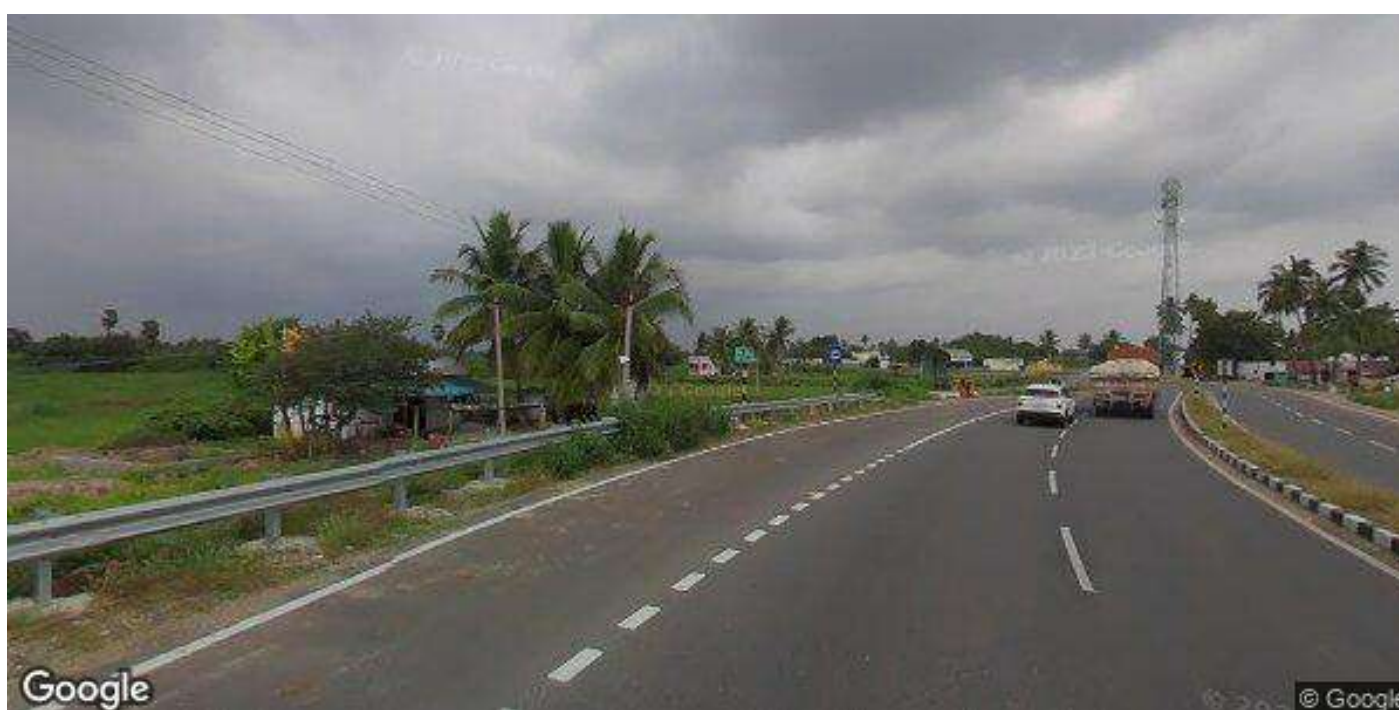
**Risk Type:** Turn  
**Risk Level:** Medium  
**Speed Limit:** 30 KM/Hr  
**Coordinates:** 12.20953, 78.54358

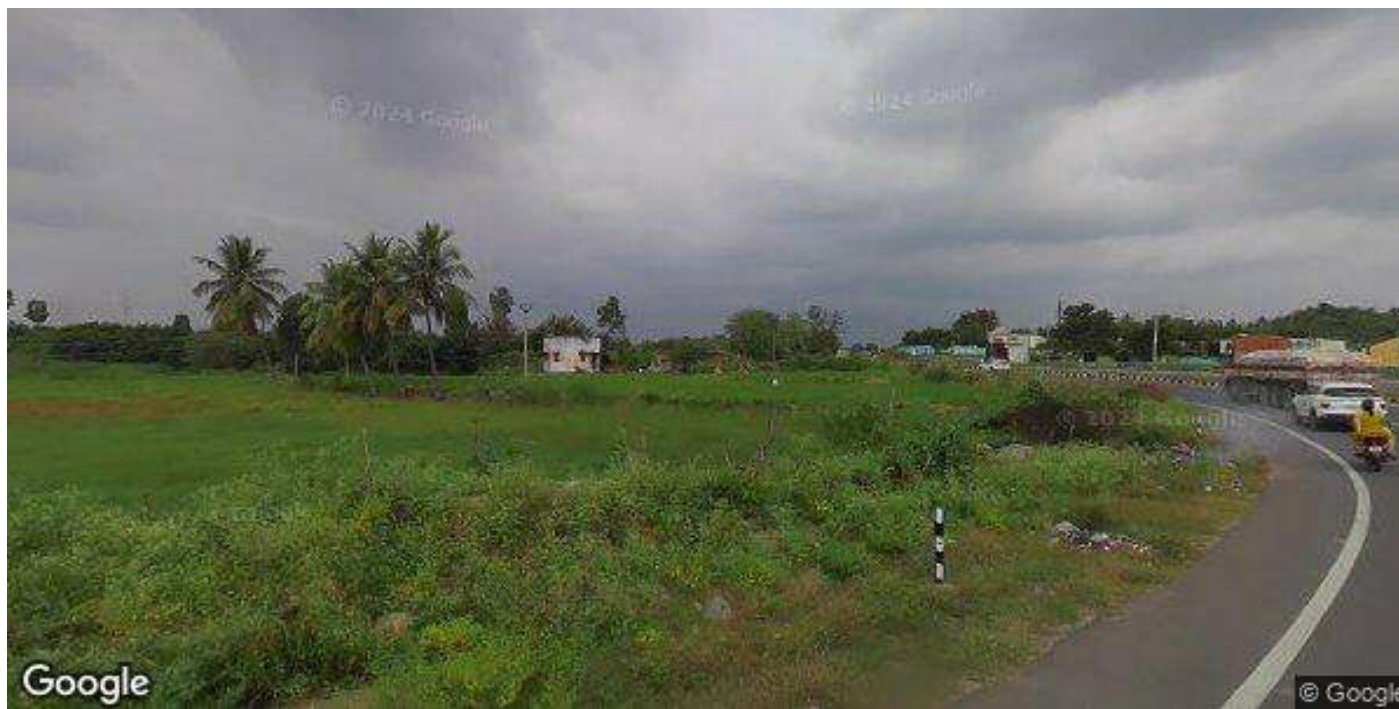
**Risk Type:** Turn  
**Risk Level:** High  
**Speed Limit:** 15 KM/Hr  
**Coordinates:** 12.21030, 78.54402

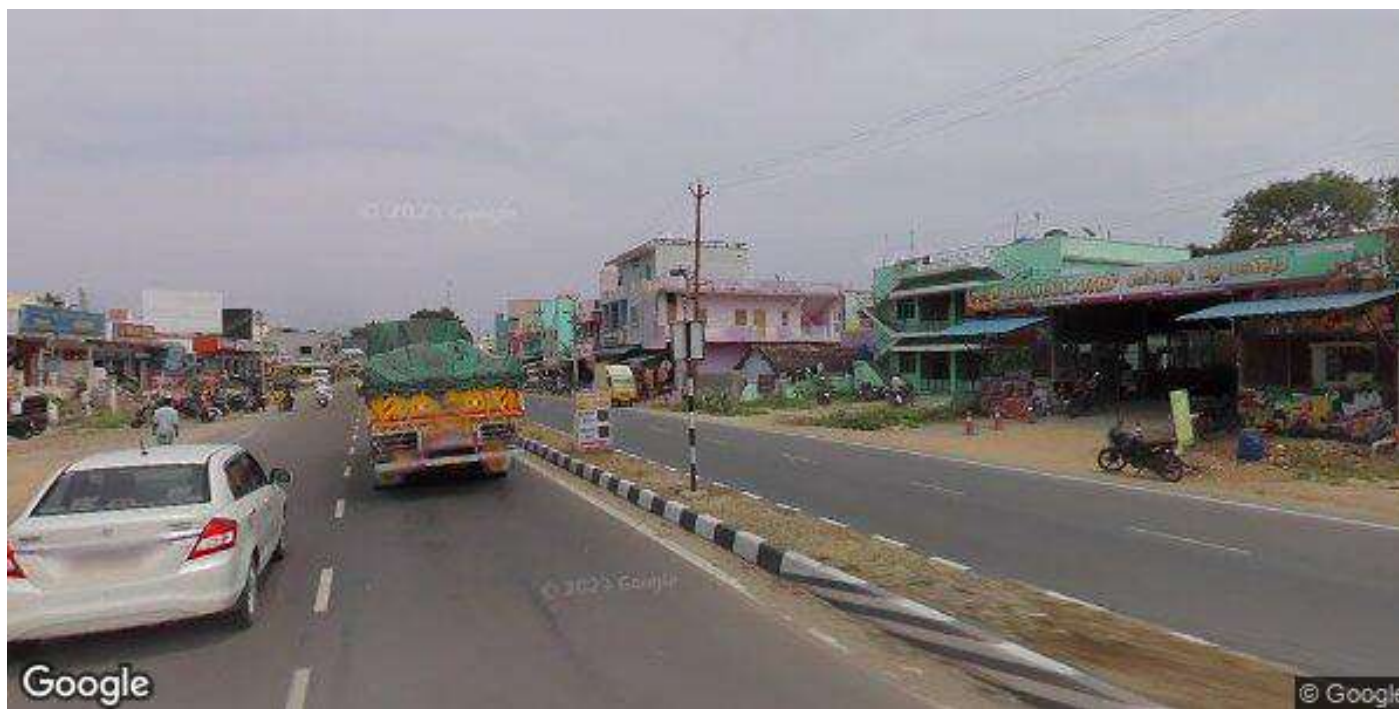
**Risk Type:** Turn  
**Risk Level:** Medium  
**Speed Limit:** 30 KM/Hr  
**Coordinates:** 12.25956, 78.53301

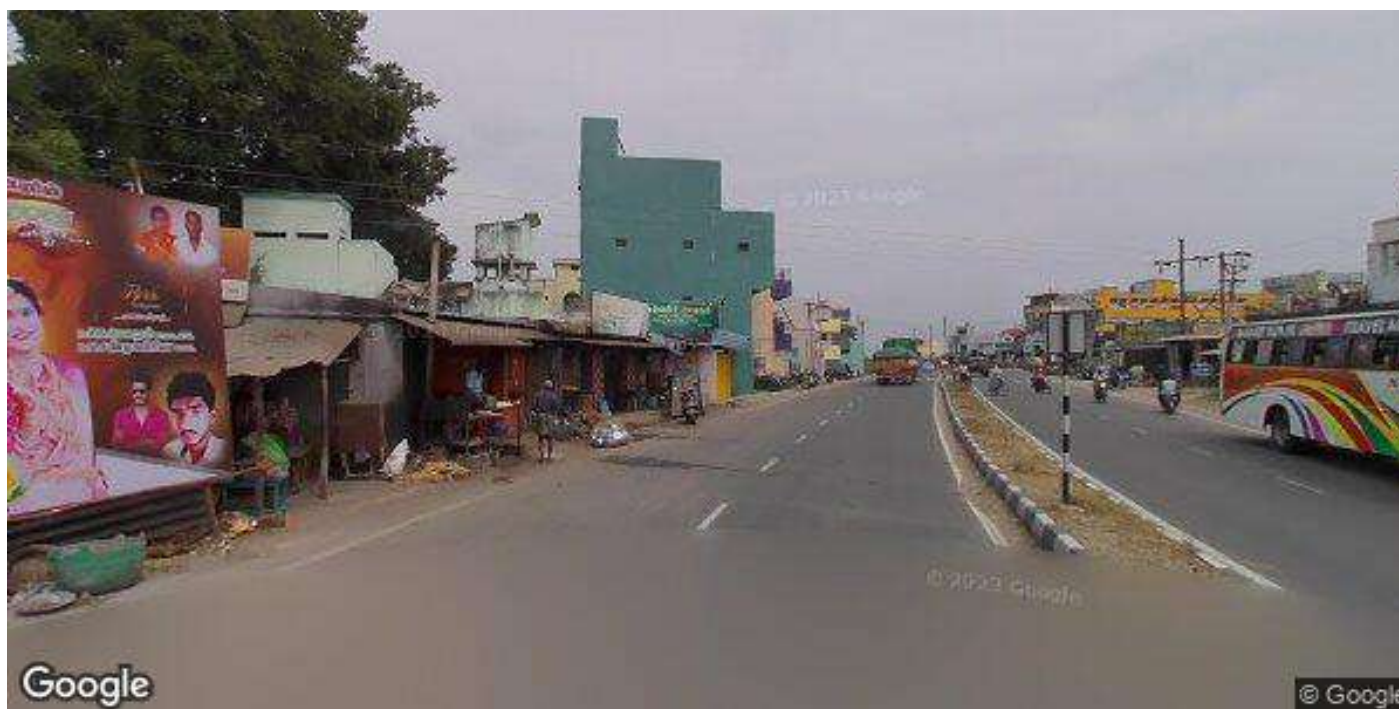
**Risk Type:** Turn  
**Risk Level:** Medium  
**Speed Limit:** 30 KM/Hr  
**Coordinates:** 12.26092, 78.53324

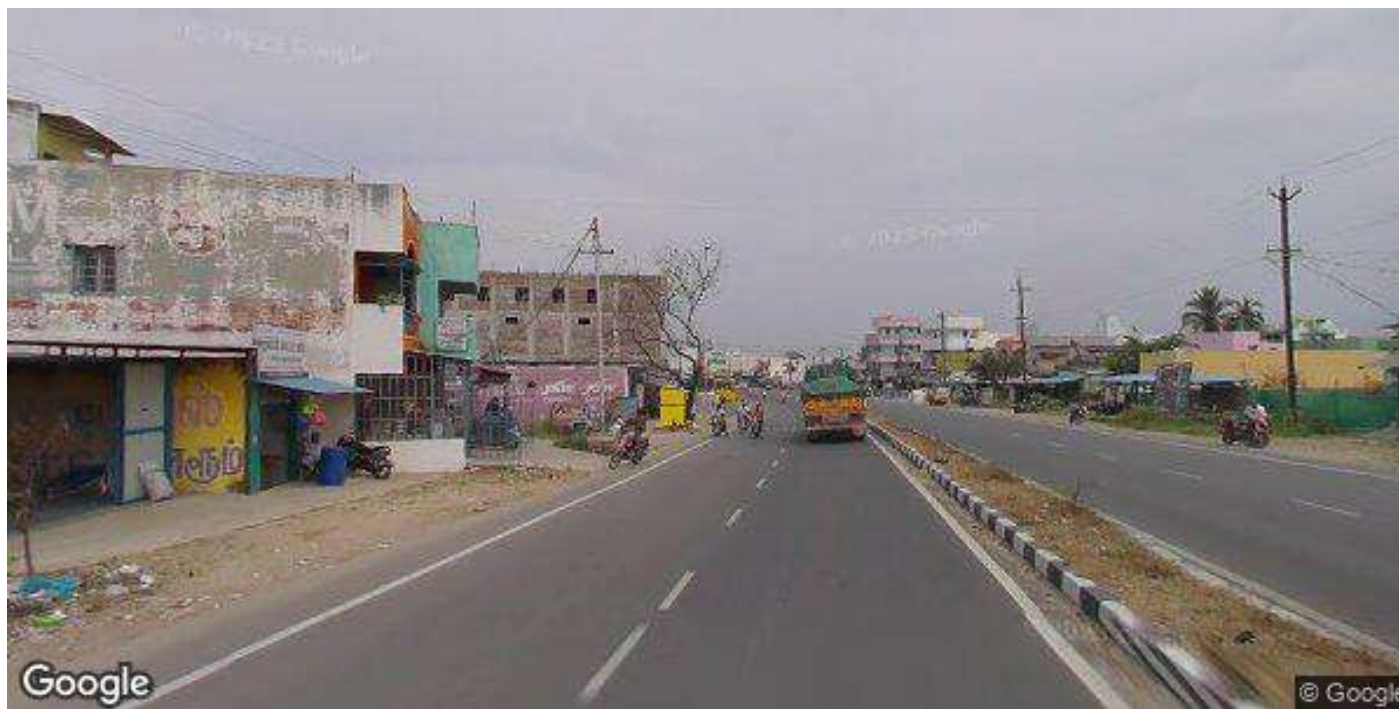
**Risk Type:** Turn  
**Risk Level:** Medium  
**Speed Limit:** 30 KM/Hr  
**Coordinates:** 12.26207, 78.53436

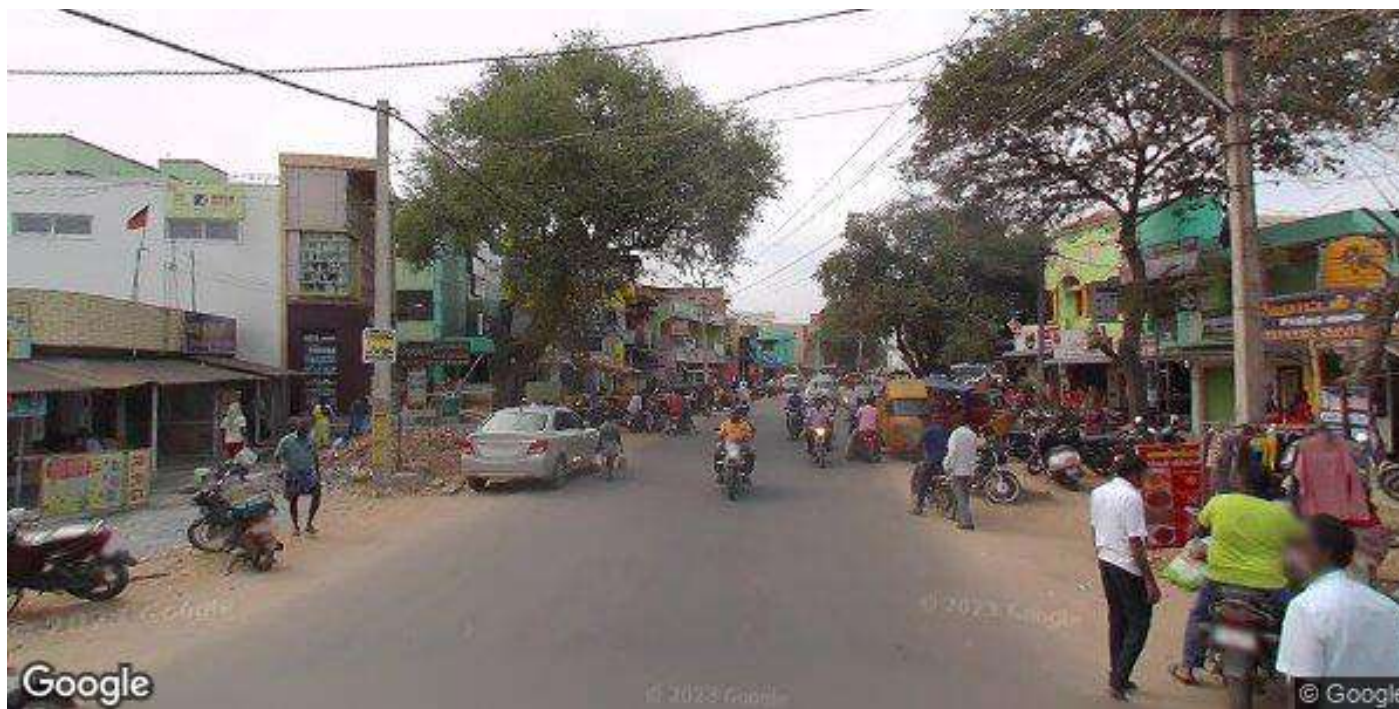
**Risk Type:** Turn  
**Risk Level:** High  
**Speed Limit:** 15 KM/Hr  
**Coordinates:** 12.26689, 78.53108

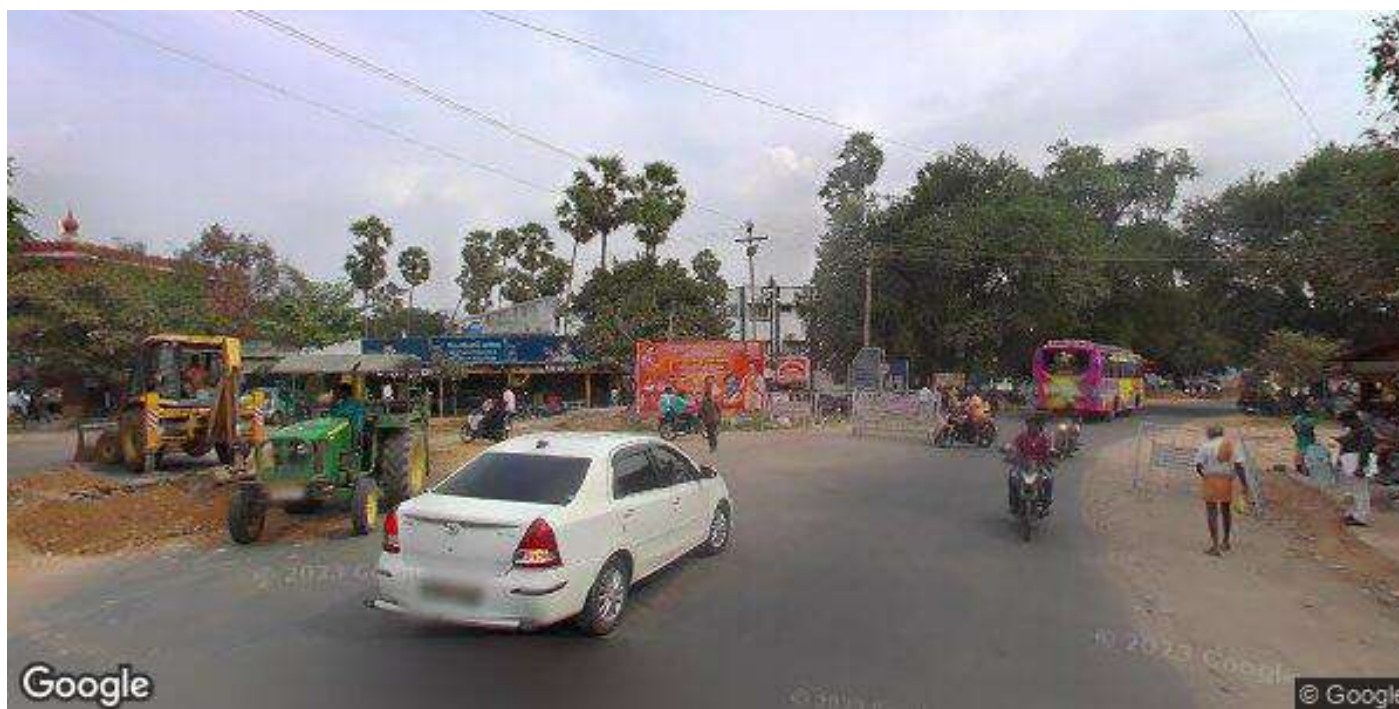
**Risk Type:** Turn  
**Risk Level:** Medium  
**Speed Limit:** 30 KM/Hr  
**Coordinates:** 12.27021, 78.52951

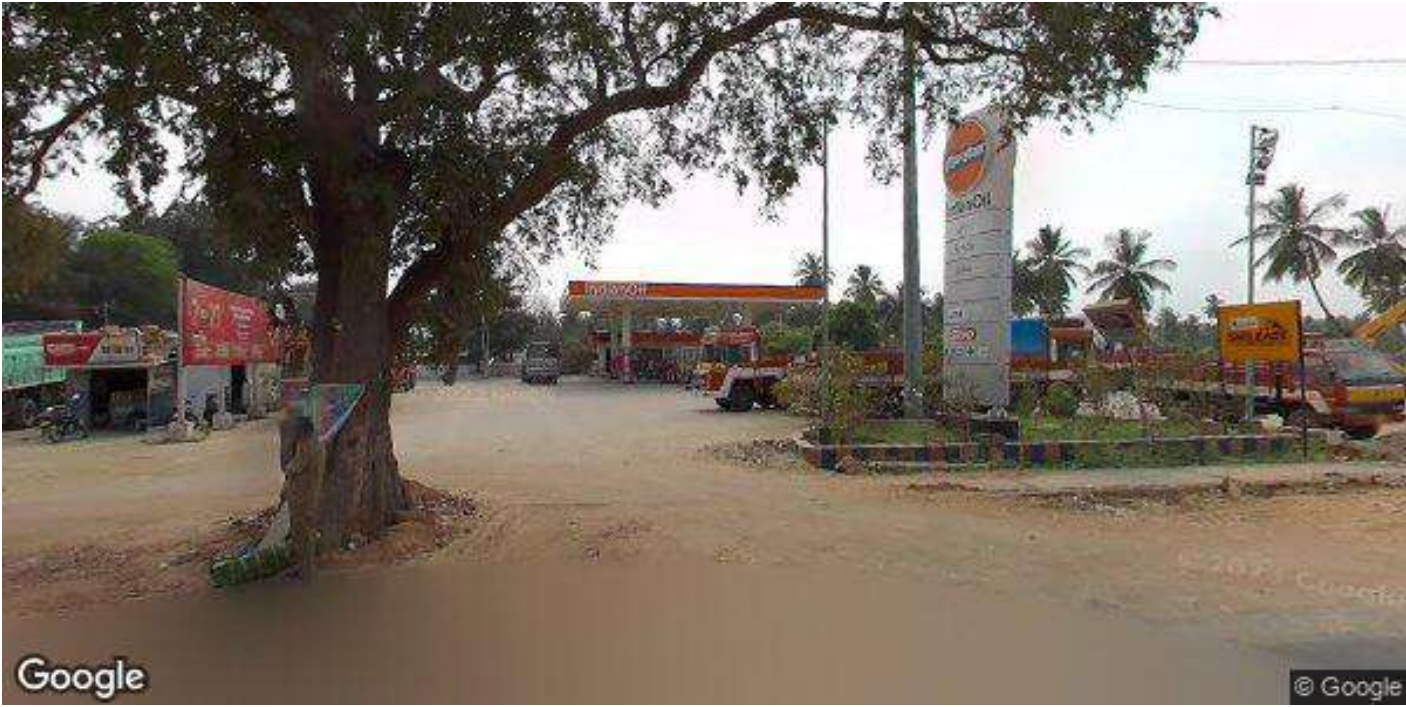
**Risk Type:** Turn  
**Risk Level:** Medium  
**Speed Limit:** 30 KM/Hr  
**Coordinates:** 12.27100, 78.52821
