# IndianOil

## JOURNEY RISK MANAGEMENT (JRM) STUDY

### Salem Terminal to SONASUN TRADERS

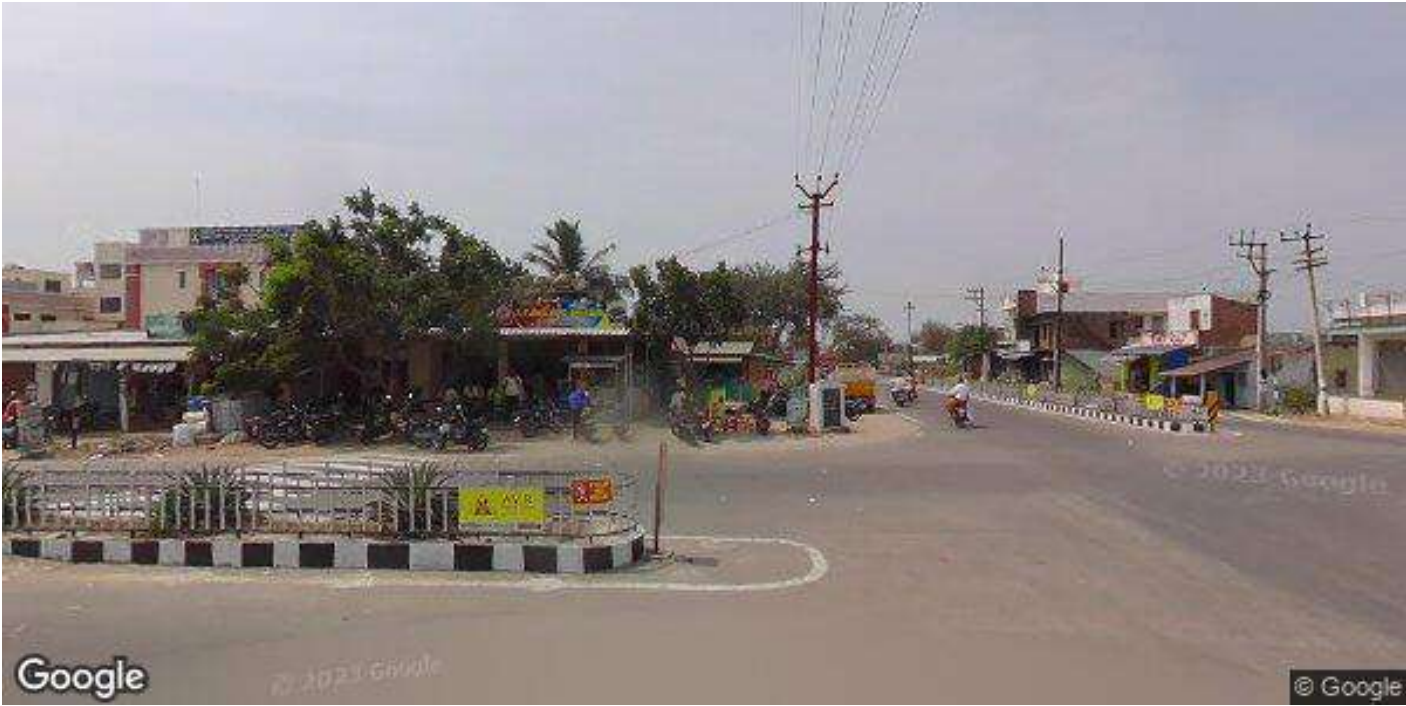
Risk Type: Roundabout

Risk Level: High

Speed Limit: 15 KM/Hr

Coordinates: 11.58300, 77.85813

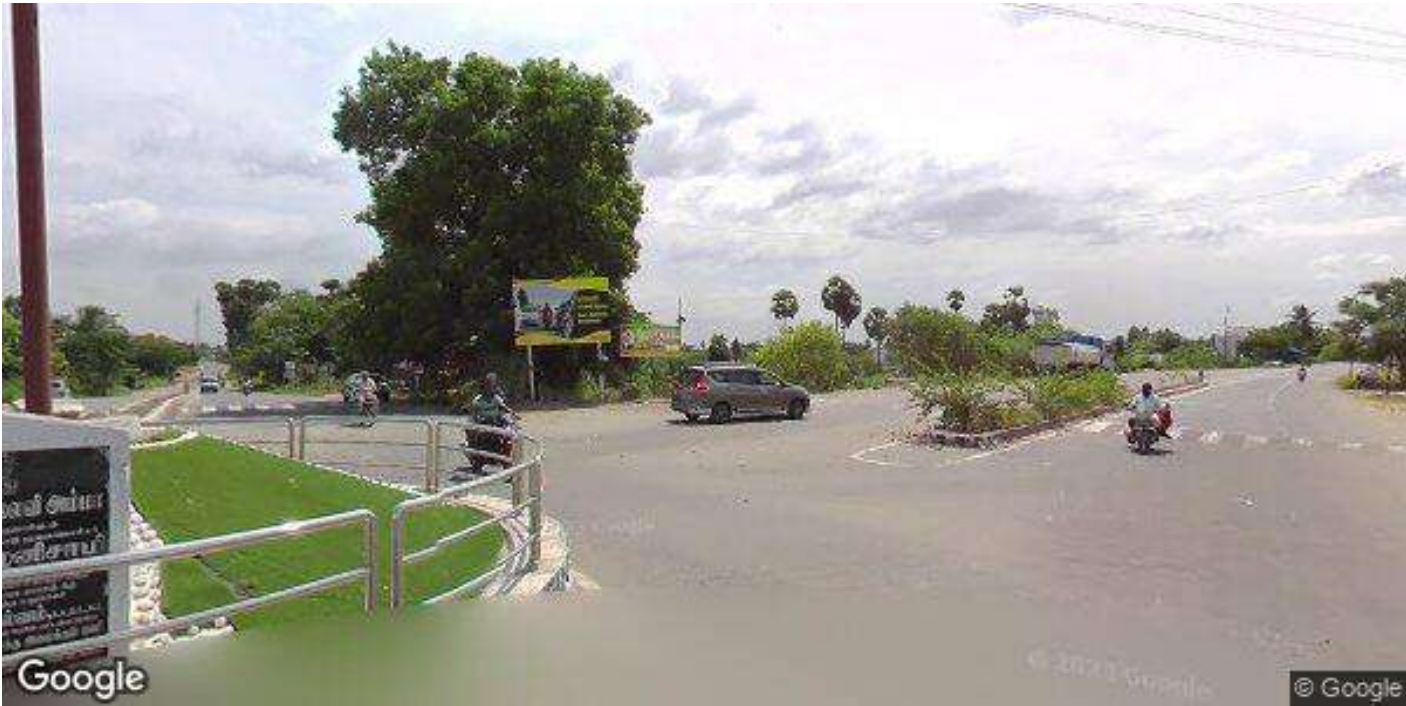
Risk Type: Roundabout

Risk Level: High

Speed Limit: 15 KM/Hr

Coordinates: 11.60348, 77.83967

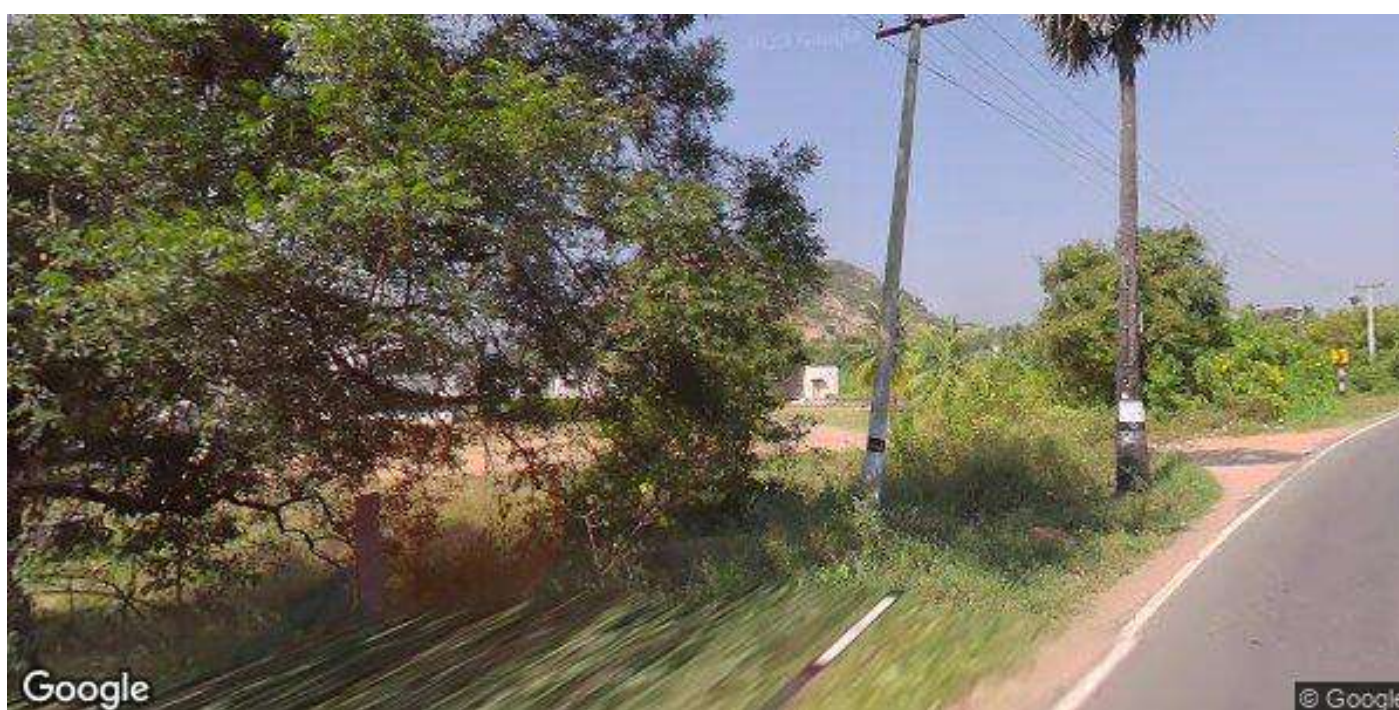
**Risk Type:** Turn  
**Risk Level:** Medium  
**Speed Limit:** 30 KM/Hr  
**Coordinates:** 11.49971, 77.86468

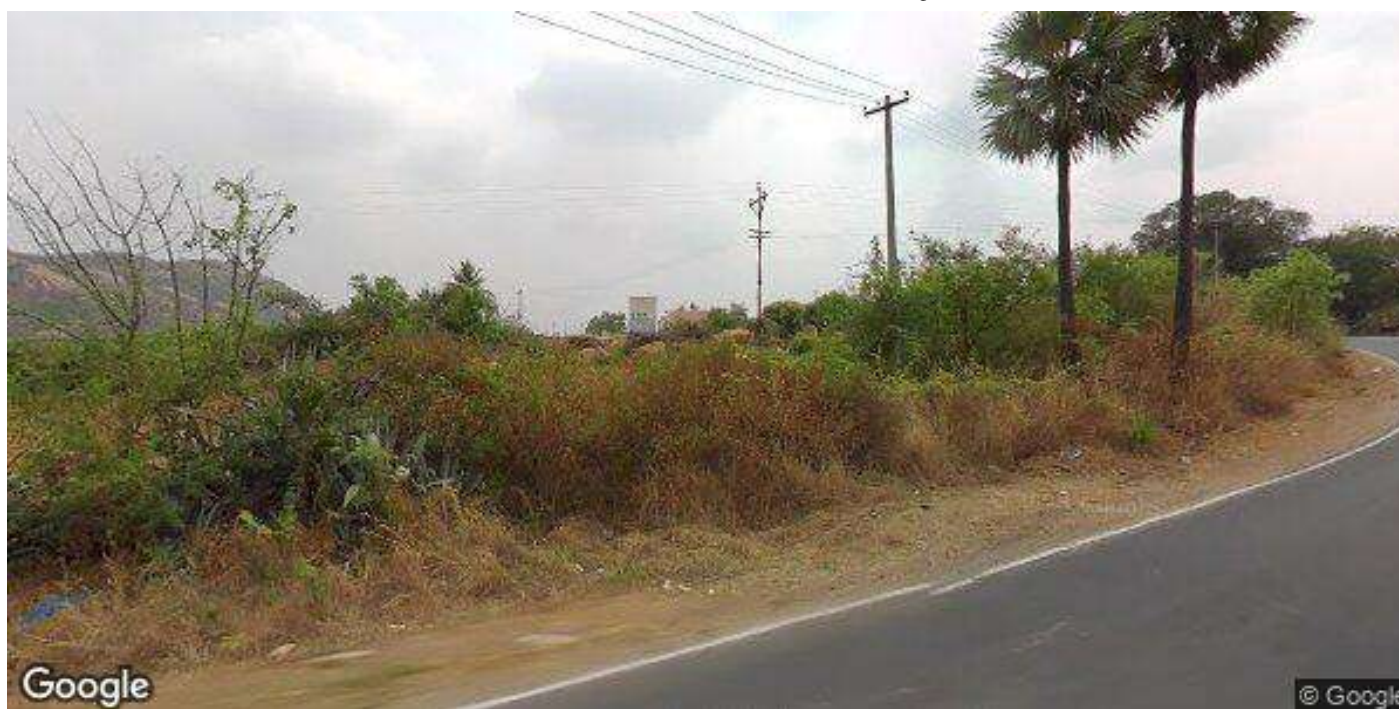
**Risk Type:** Turn  
**Risk Level:** Medium  
**Speed Limit:** 30 KM/Hr  
**Coordinates:** 11.50885, 77.86037

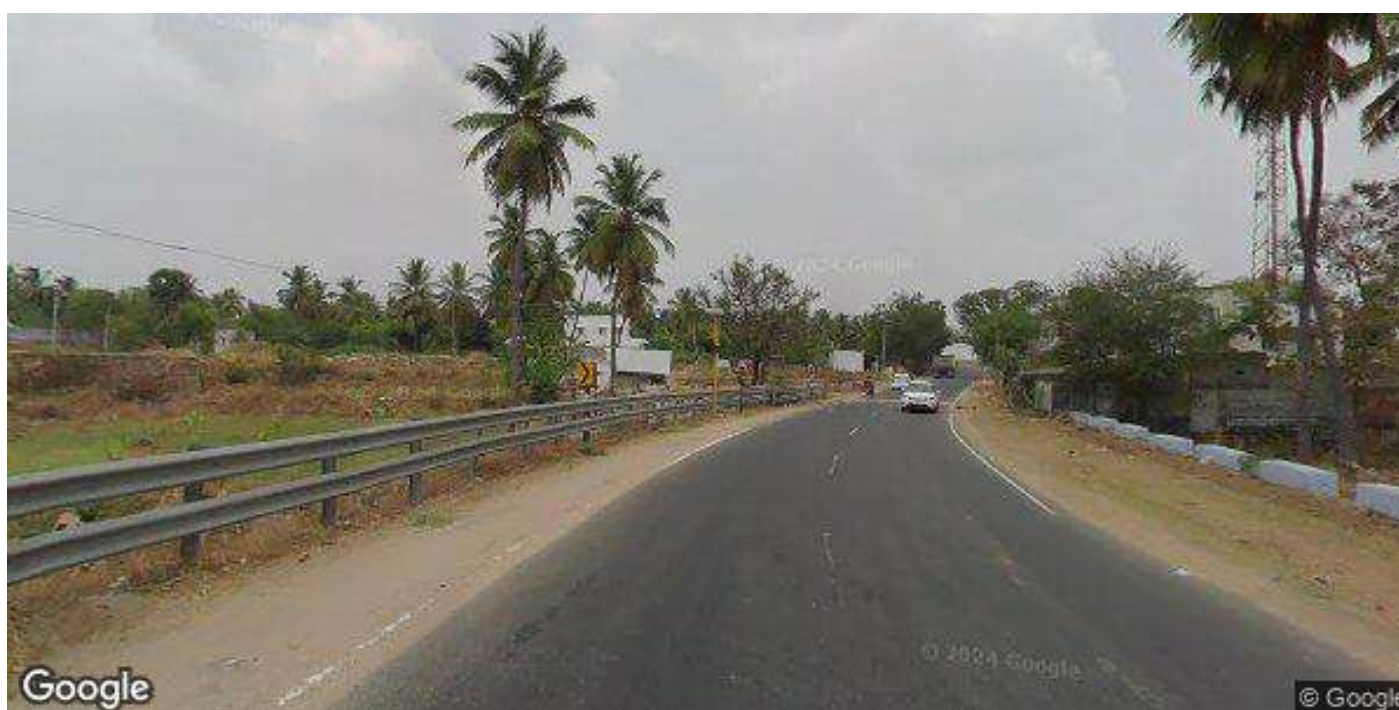
**Risk Type:** Turn  
**Risk Level:** Medium  
**Speed Limit:** 30 KM/Hr  
**Coordinates:** 11.52571, 77.85522

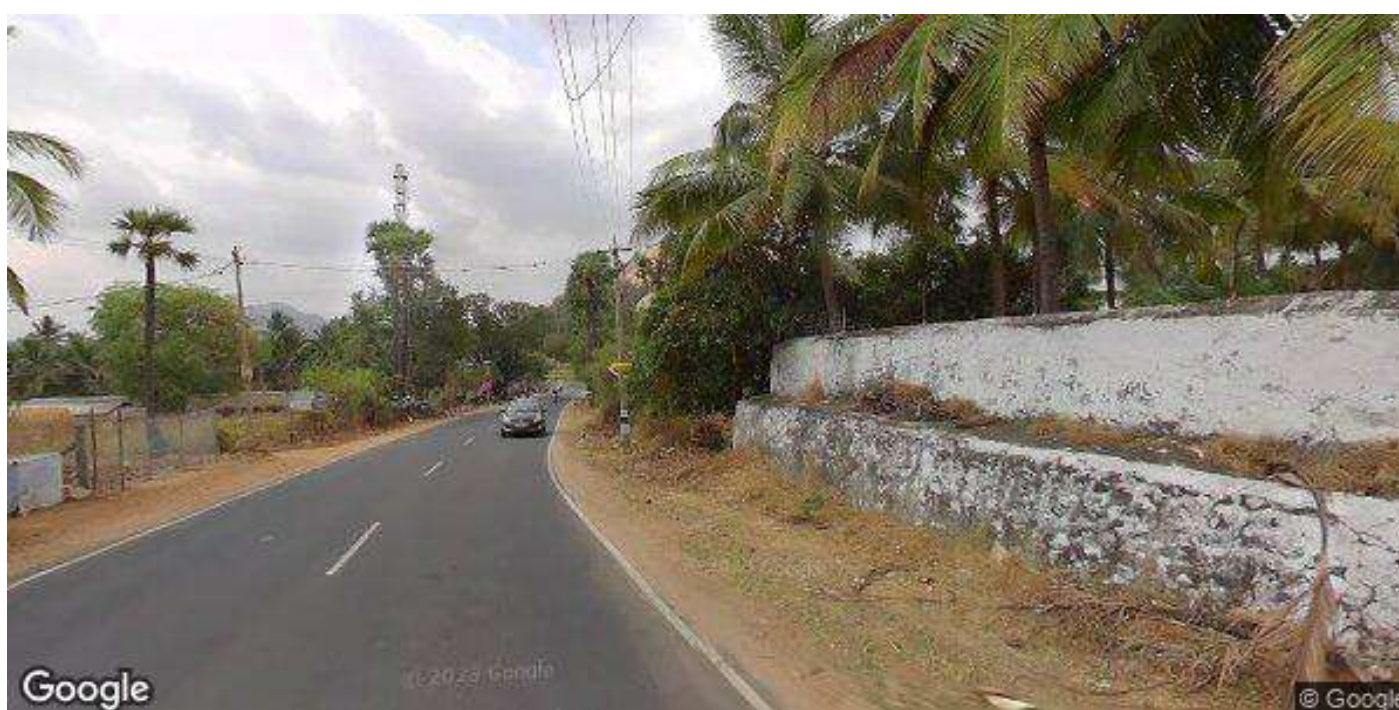
**Risk Type:** Turn  
**Risk Level:** Medium  
**Speed Limit:** 30 KM/Hr  
**Coordinates:** 11.52744, 77.85582

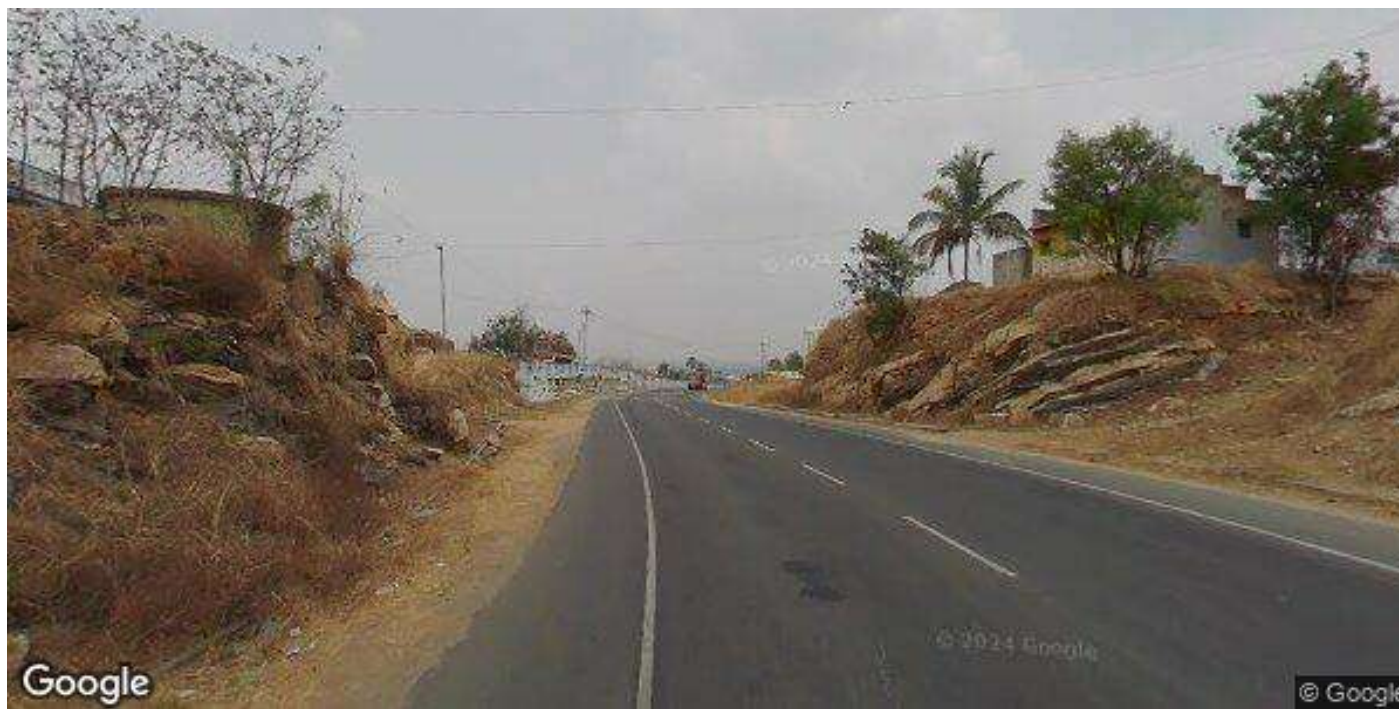
**Risk Type:** Turn  
**Risk Level:** Medium  
**Speed Limit:** 30 KM/Hr  
**Coordinates:** 11.55049, 77.85513

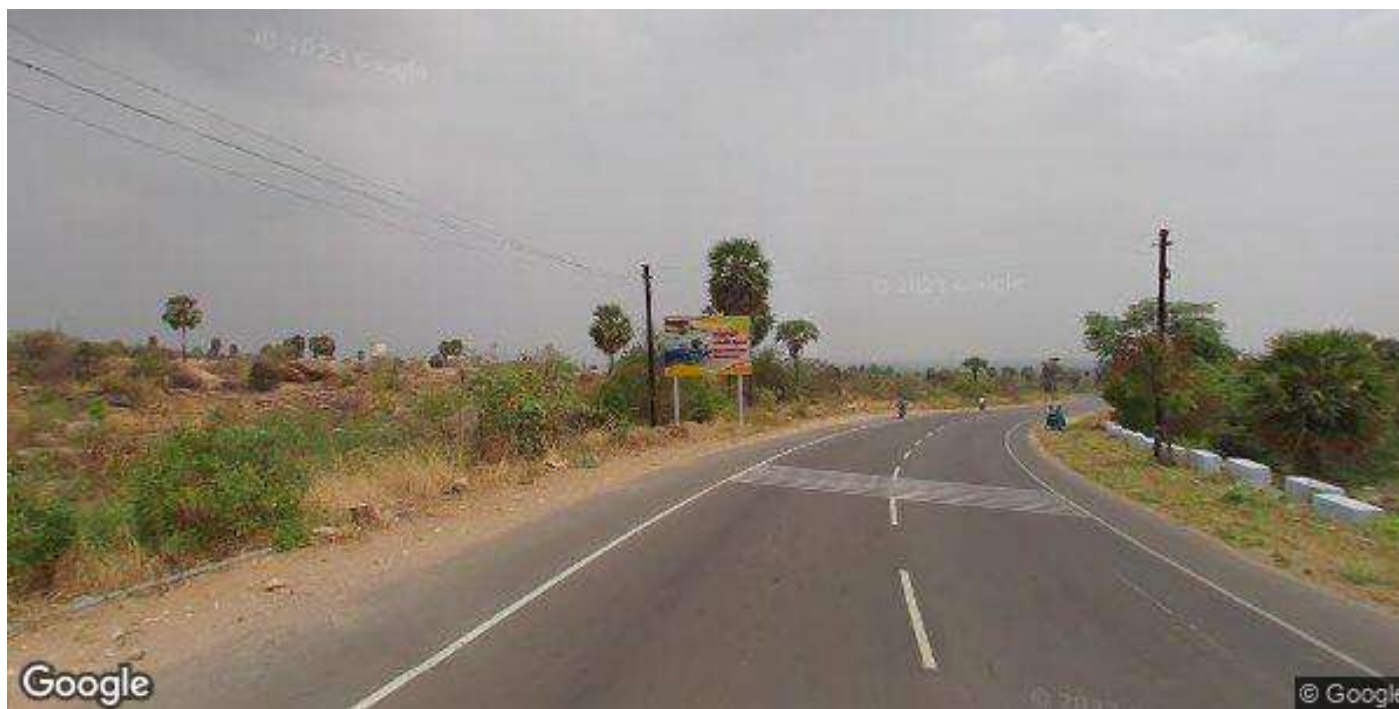
**Risk Type:** Turn  
**Risk Level:** Medium  
**Speed Limit:** 30 KM/Hr  
**Coordinates:** 11.55460, 77.85624

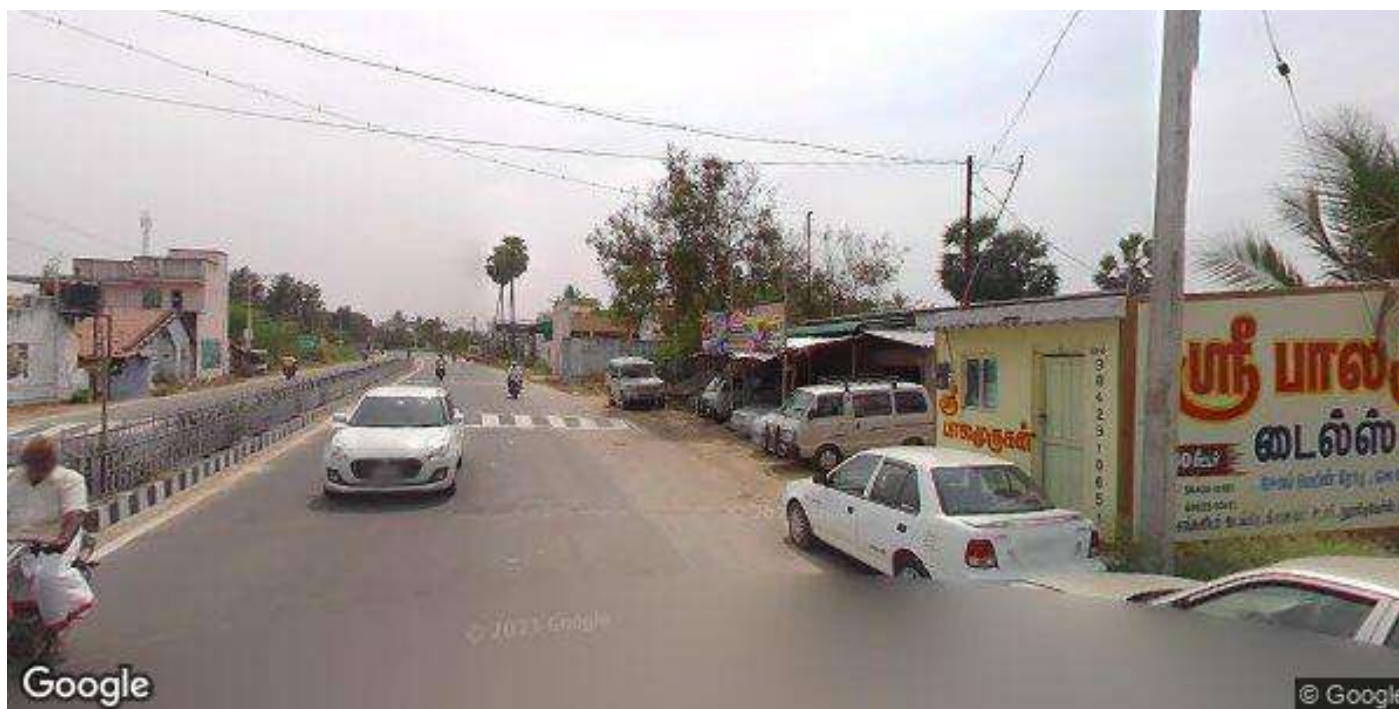
**Risk Type:** Turn  
**Risk Level:** High  
**Speed Limit:** 15 KM/Hr  
**Coordinates:** 11.57893, 77.85430

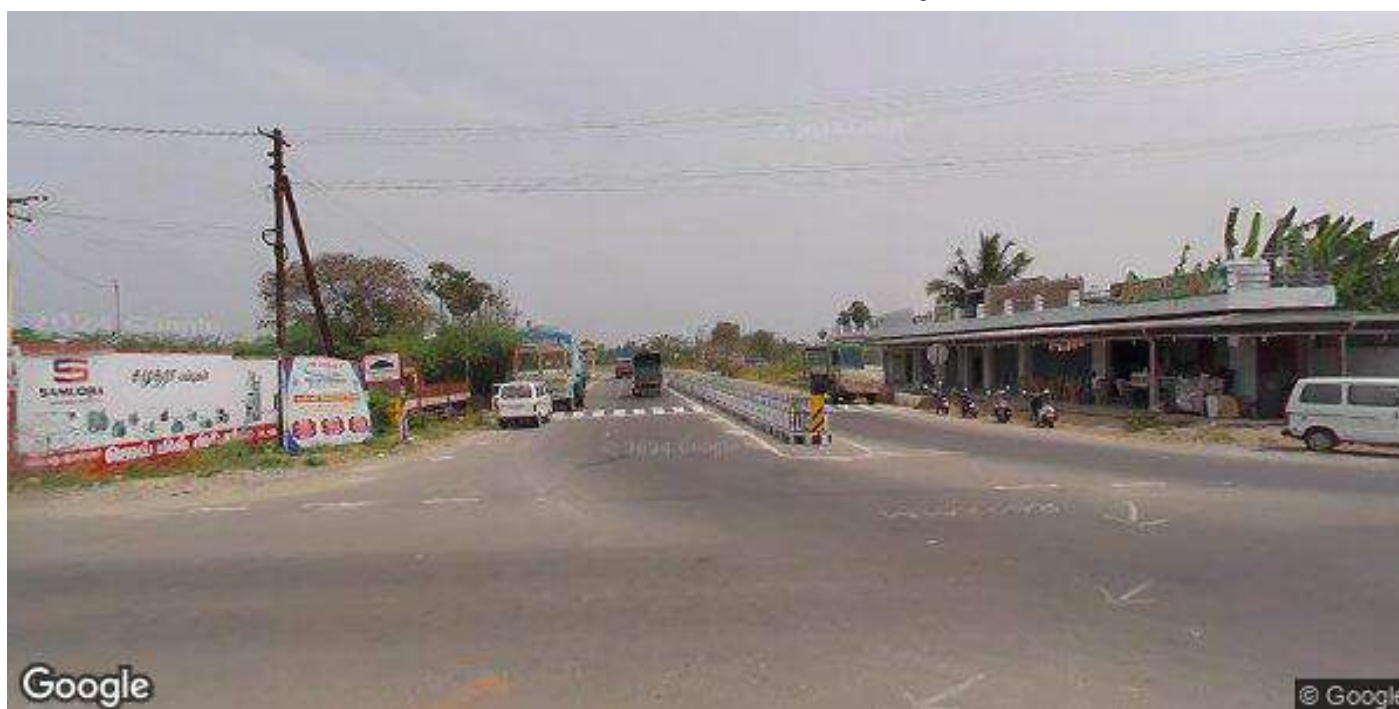
**Risk Type:** Turn  
**Risk Level:** Medium  
**Speed Limit:** 30 KM/Hr  
**Coordinates:** 11.57903, 77.85441

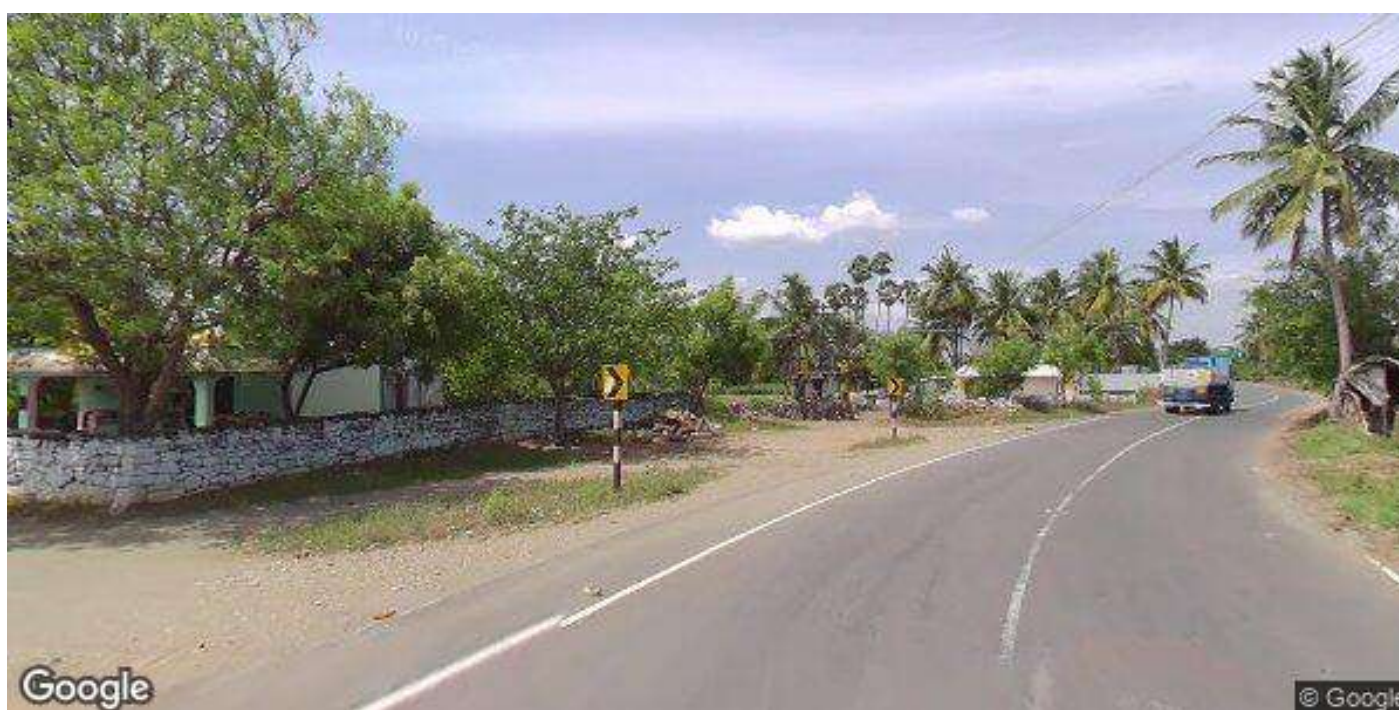
**Risk Type:** Turn  
**Risk Level:** Medium  
**Speed Limit:** 30 KM/Hr  
**Coordinates:** 11.60978, 77.84165

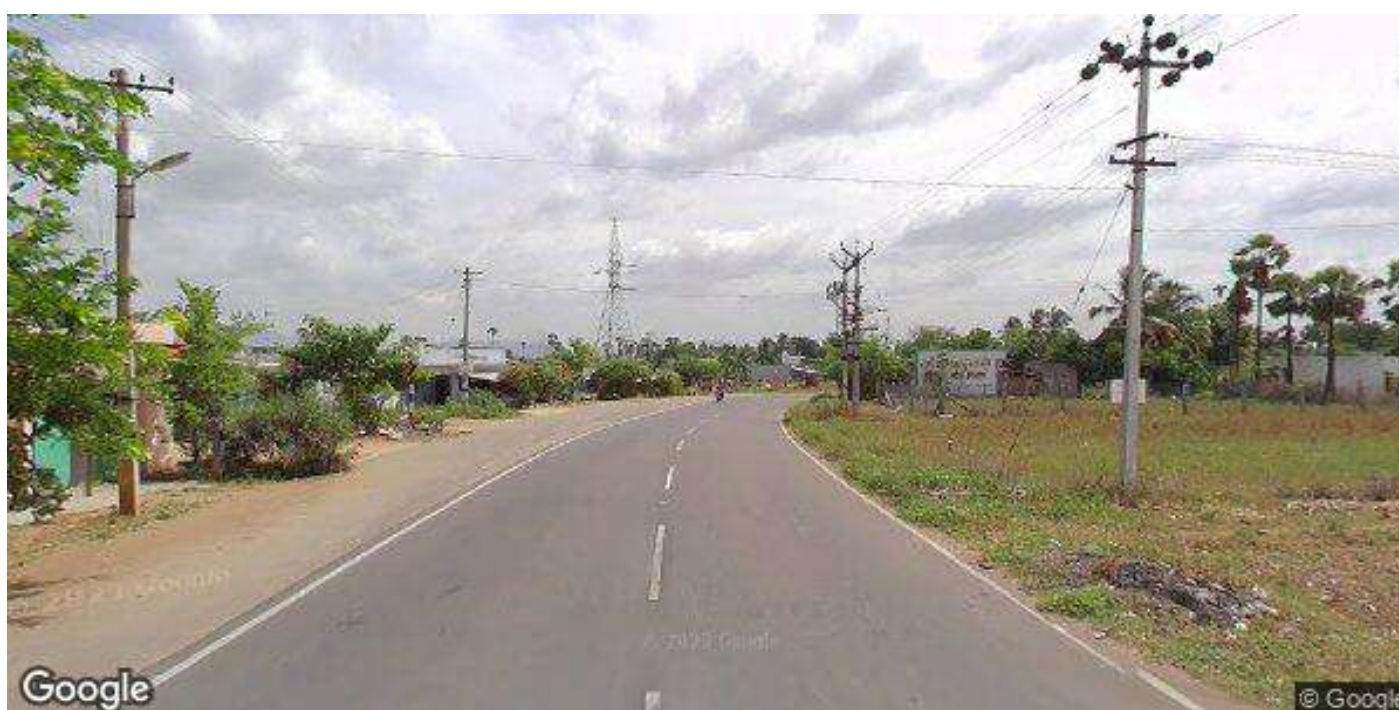
**Risk Type:** Turn  
**Risk Level:** Medium  
**Speed Limit:** 30 KM/Hr  
**Coordinates:** 11.61795, 77.84020

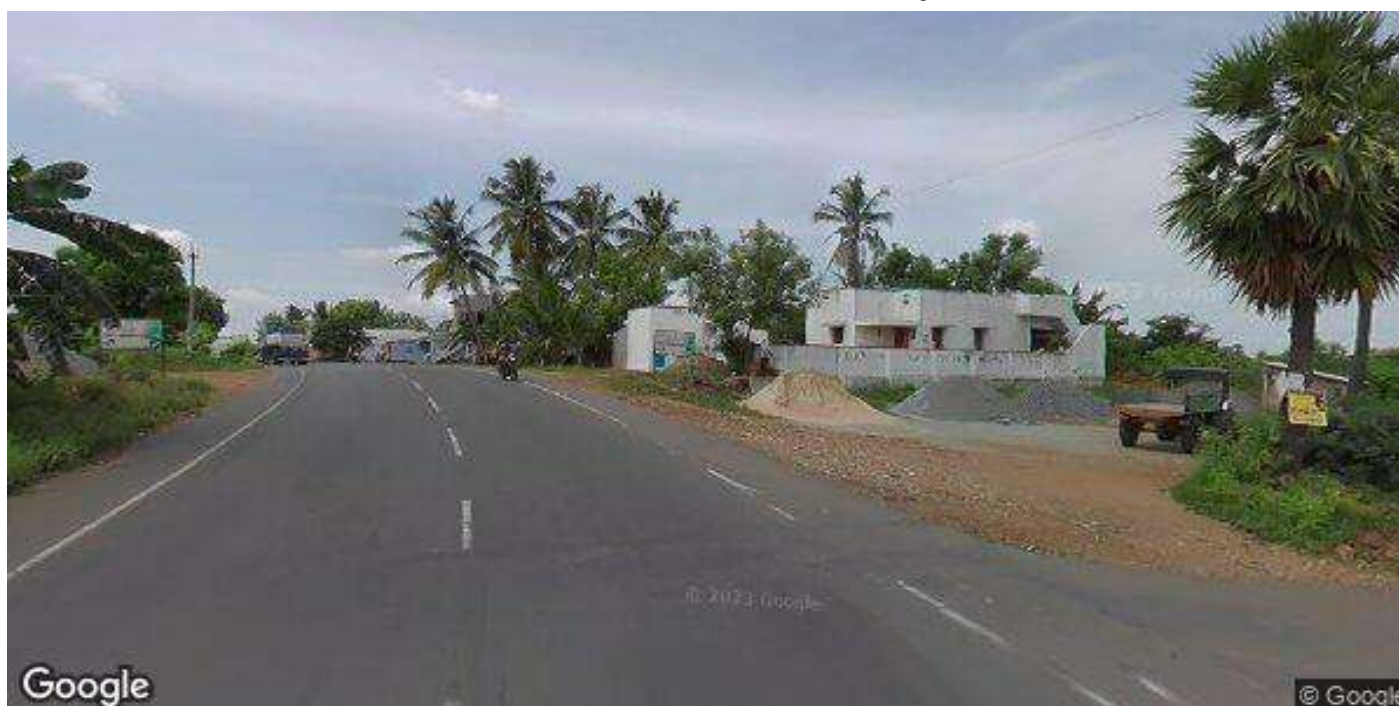
**Risk Type:** Turn  
**Risk Level:** Medium  
**Speed Limit:** 30 KM/Hr  
**Coordinates:** 11.63085, 77.84072

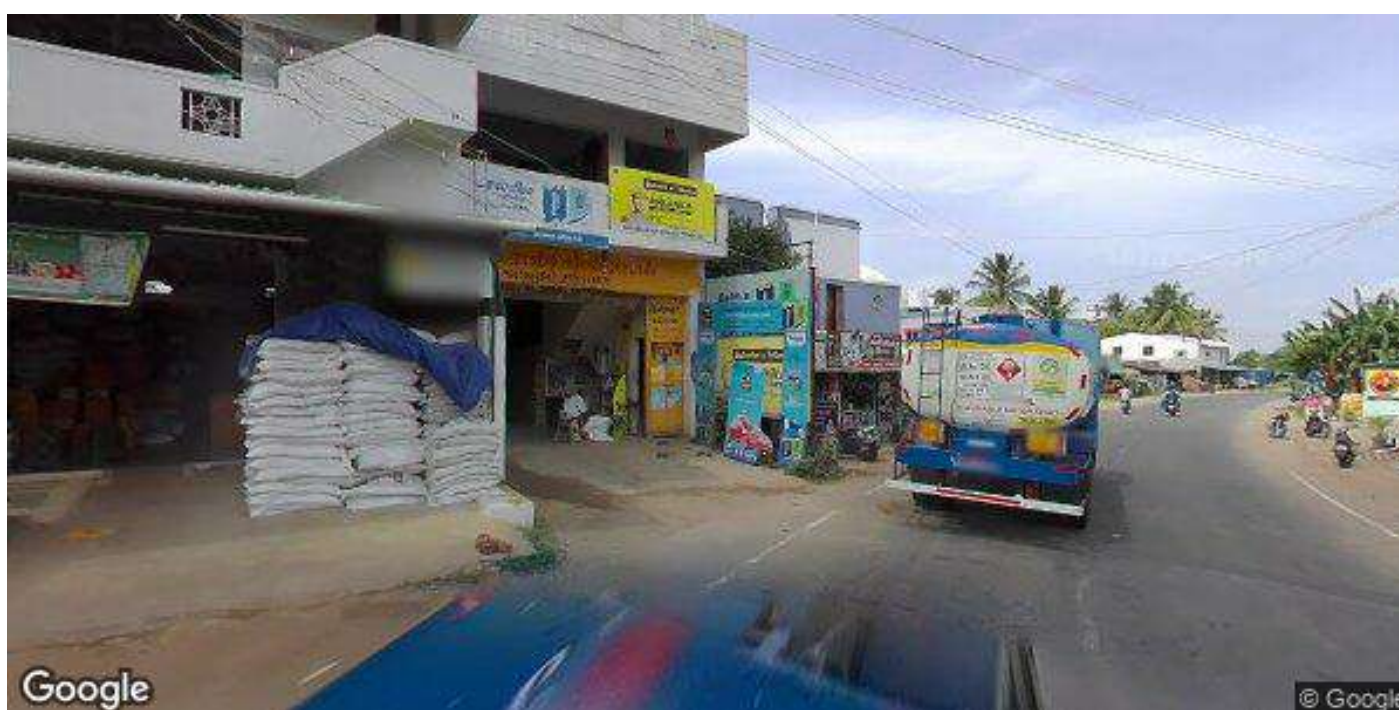
**Risk Type:** Turn  
**Risk Level:** Medium  
**Speed Limit:** 30 KM/Hr  
**Coordinates:** 11.64173, 77.84878

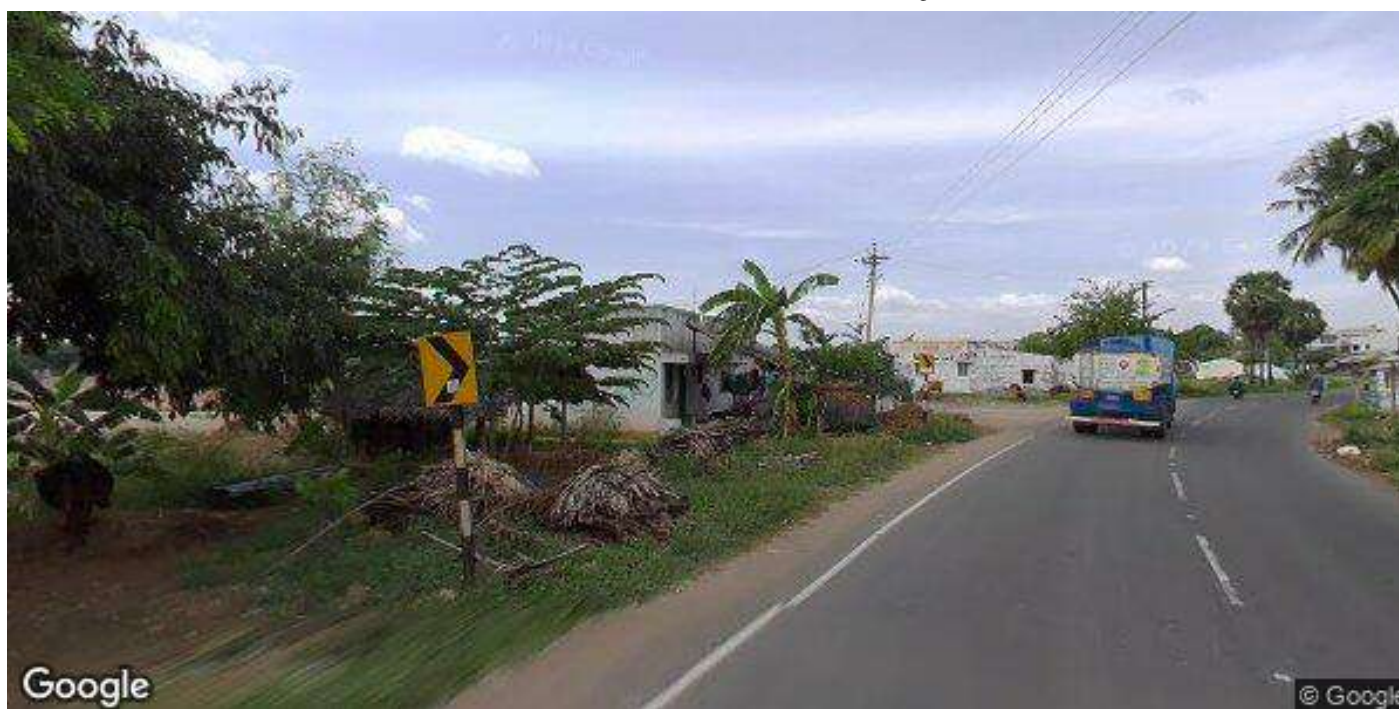
**Risk Type:** Turn  
**Risk Level:** Medium  
**Speed Limit:** 30 KM/Hr  
**Coordinates:** 11.64547, 77.85129

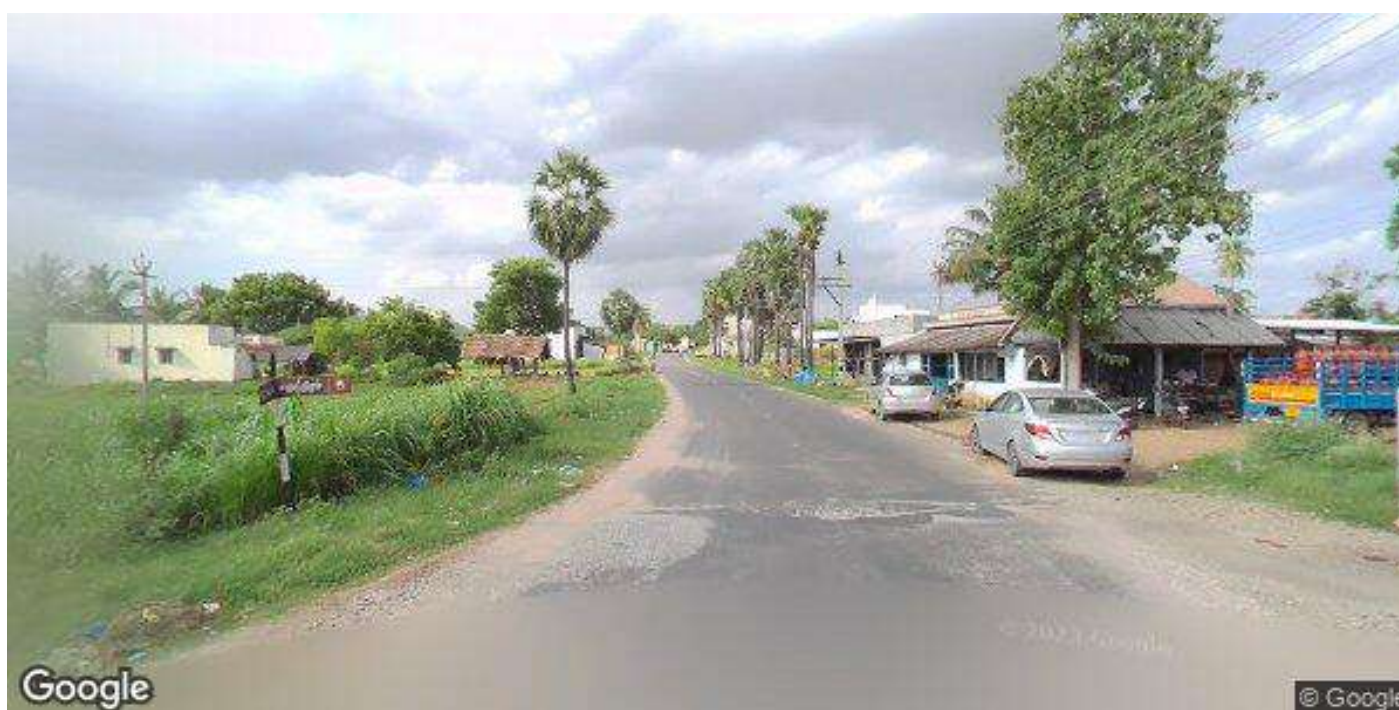
**Risk Type:** Turn  
**Risk Level:** Medium  
**Speed Limit:** 30 KM/Hr  
**Coordinates:** 11.65486, 77.85335

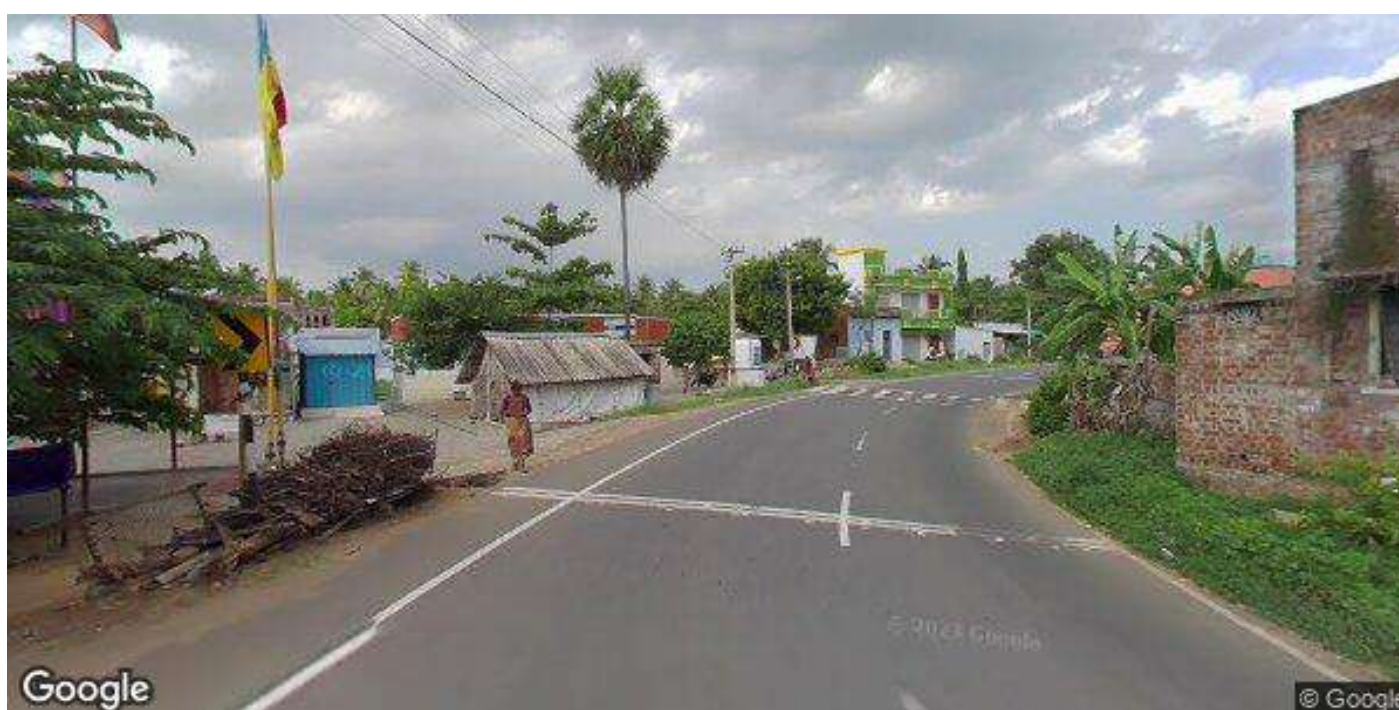
**Risk Type:** Turn  
**Risk Level:** Medium  
**Speed Limit:** 30 KM/Hr  
**Coordinates:** 11.67310, 77.86031

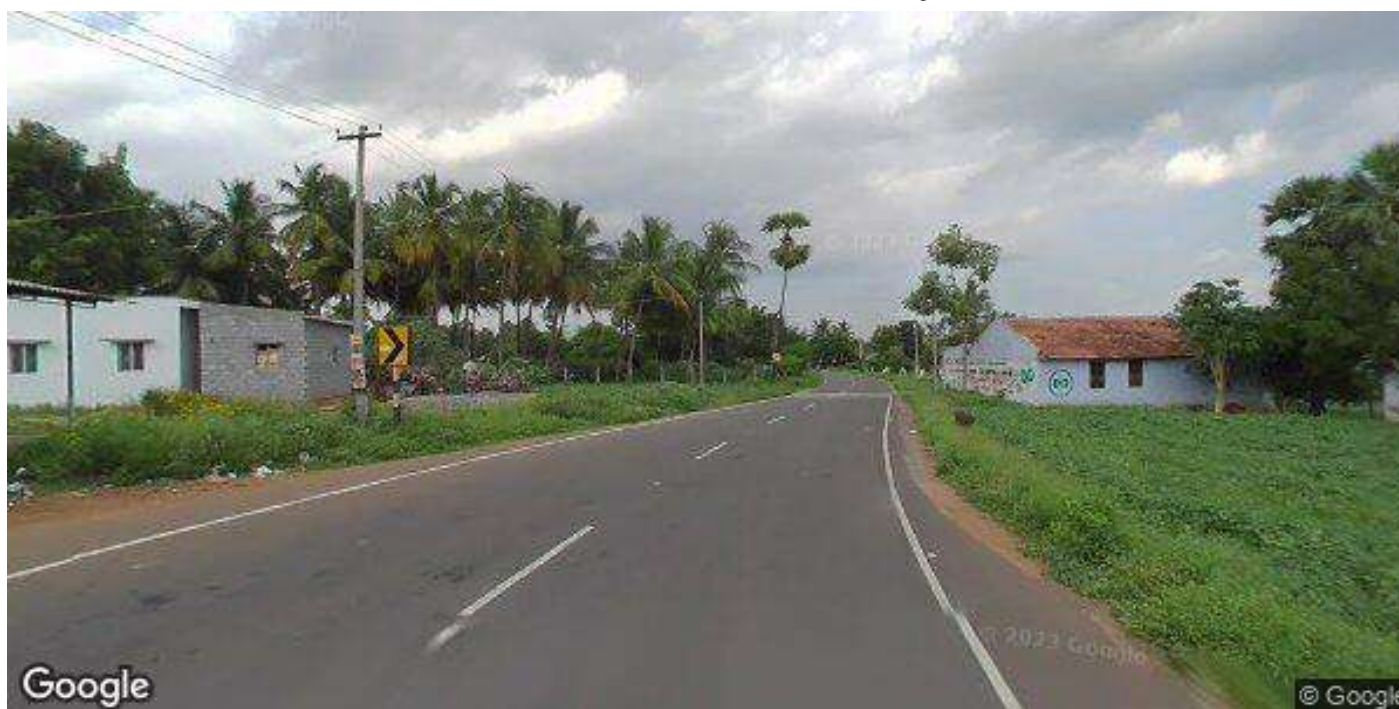
**Risk Type:** Turn  
**Risk Level:** Medium  
**Speed Limit:** 30 KM/Hr  
**Coordinates:** 11.68196, 77.86690

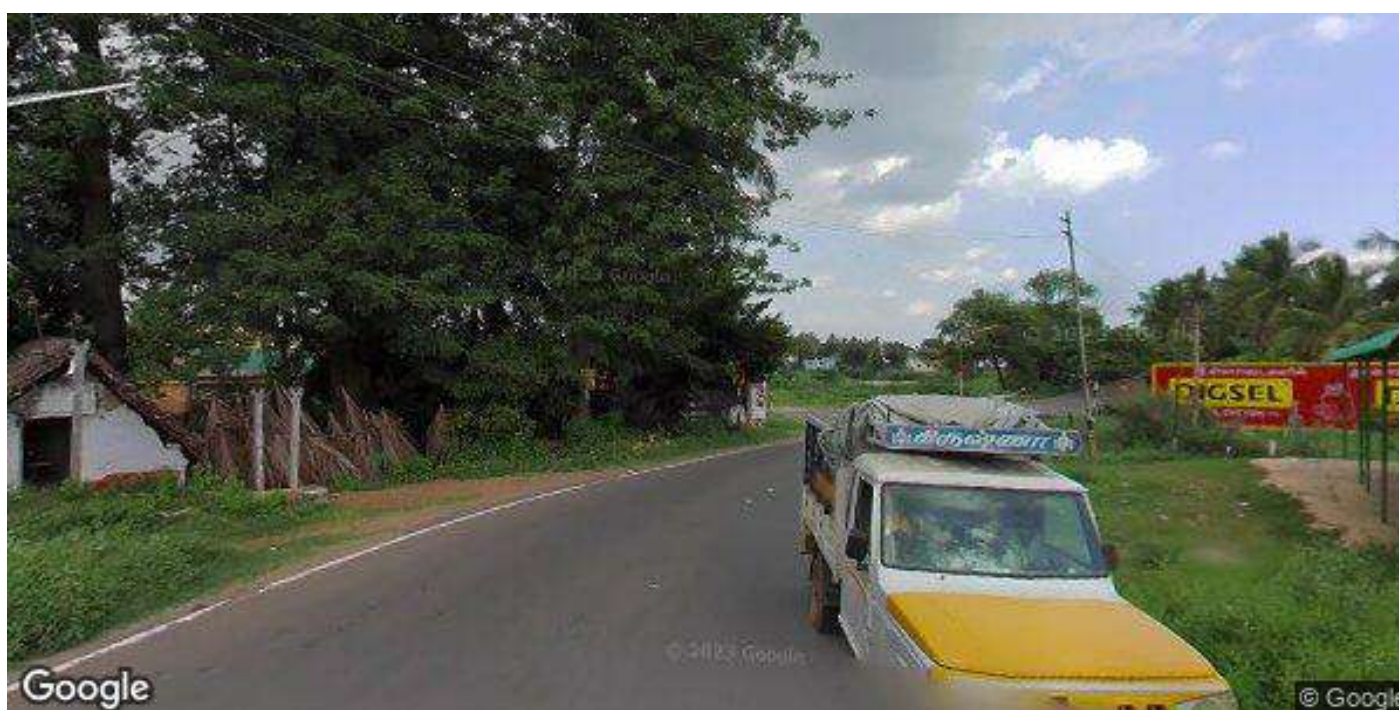
**Risk Type:** Turn  
**Risk Level:** High  
**Speed Limit:** 15 KM/Hr  
**Coordinates:** 11.68492, 77.86898

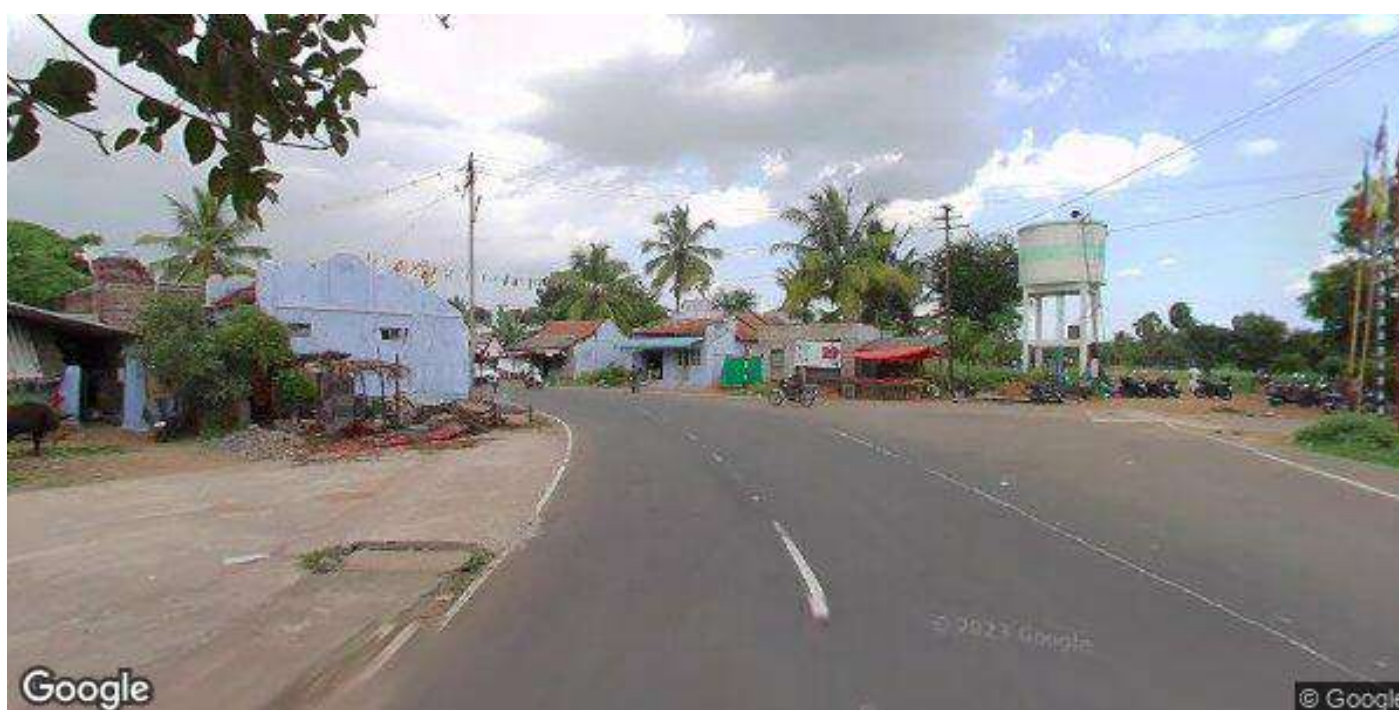
**Risk Type:** Turn  
**Risk Level:** Medium  
**Speed Limit:** 30 KM/Hr  
**Coordinates:** 11.68463, 77.87262

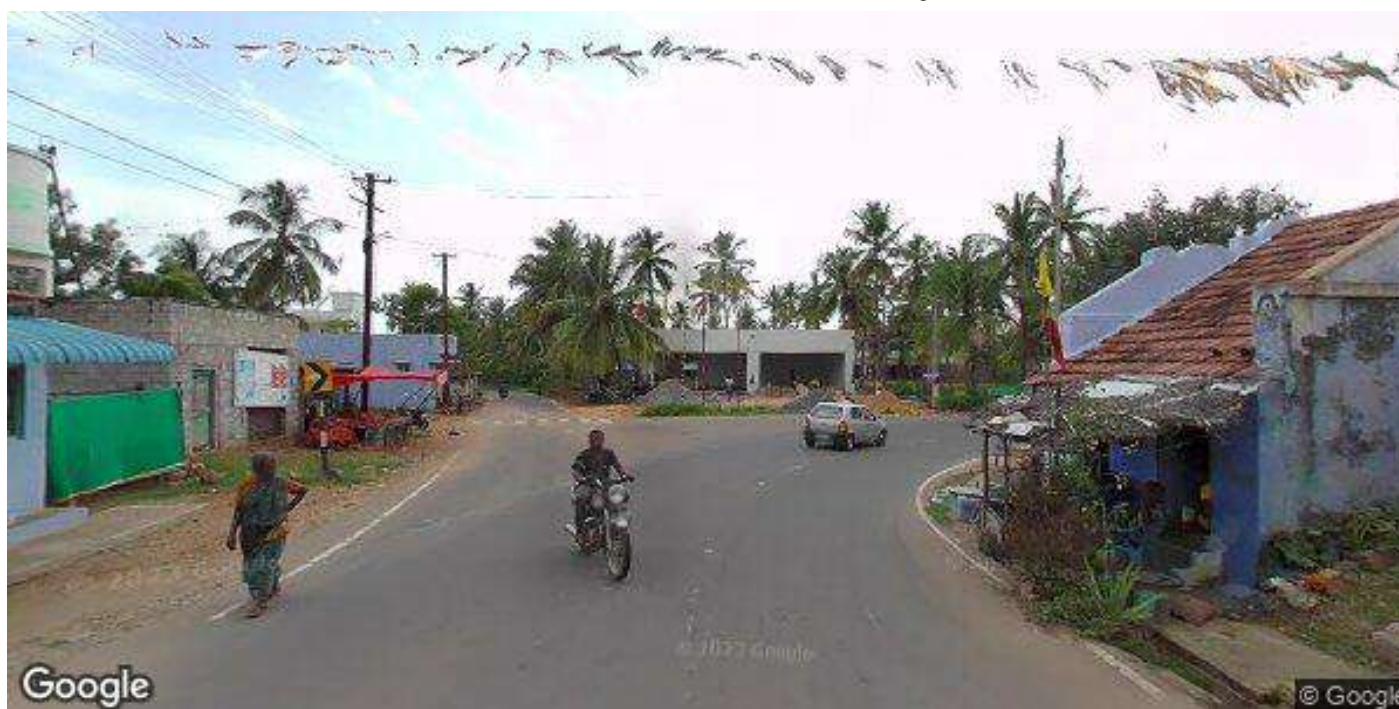
**Risk Type:** Turn  
**Risk Level:** Medium  
**Speed Limit:** 30 KM/Hr  
**Coordinates:** 11.68486, 77.87288

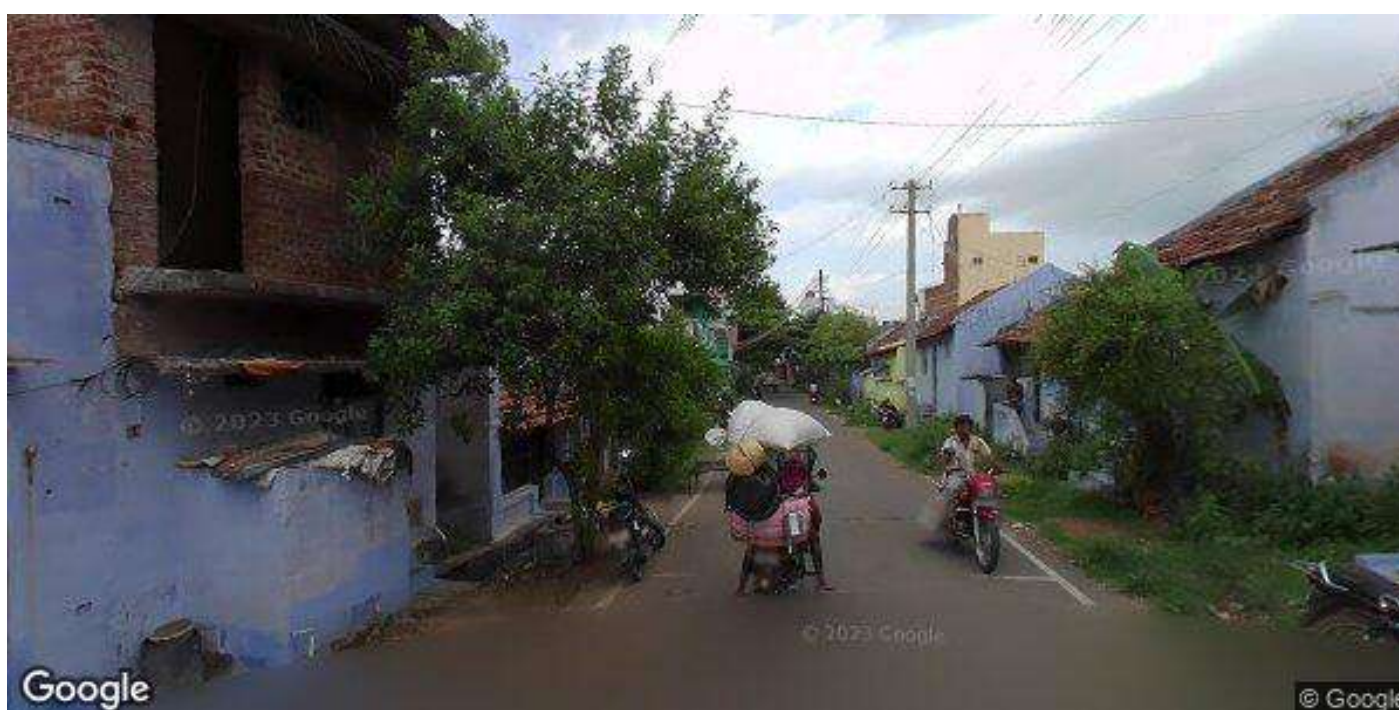
**Risk Type:** Turn  
**Risk Level:** High  
**Speed Limit:** 15 KM/Hr  
**Coordinates:** 11.69558, 77.87439
