# IndianOil

## JOURNEY RISK MANAGEMENT (JRM) STUDY

### Salem Terminal to SONASUN TRADERS

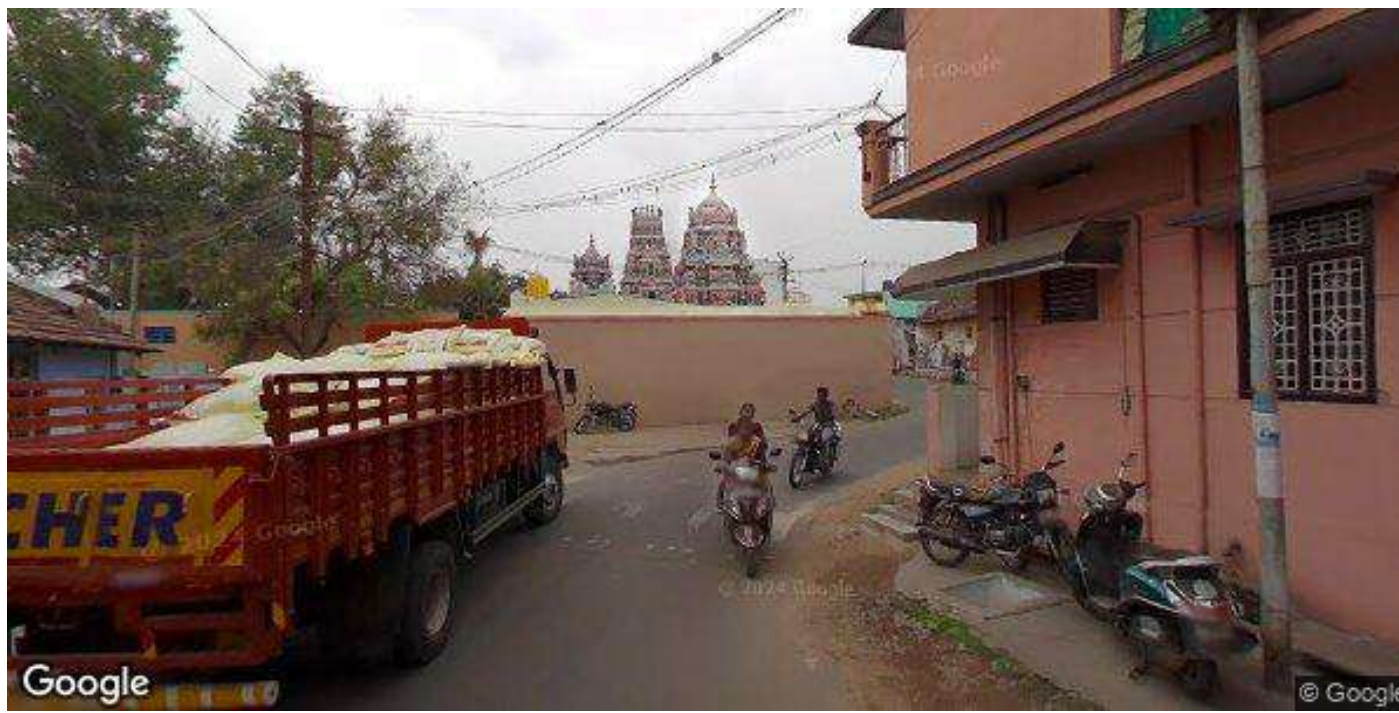
**Risk Type:** Turn  
**Risk Level:** Medium  
**Speed Limit:** 30 KM/Hr  
**Coordinates:** 11.69908, 77.87472

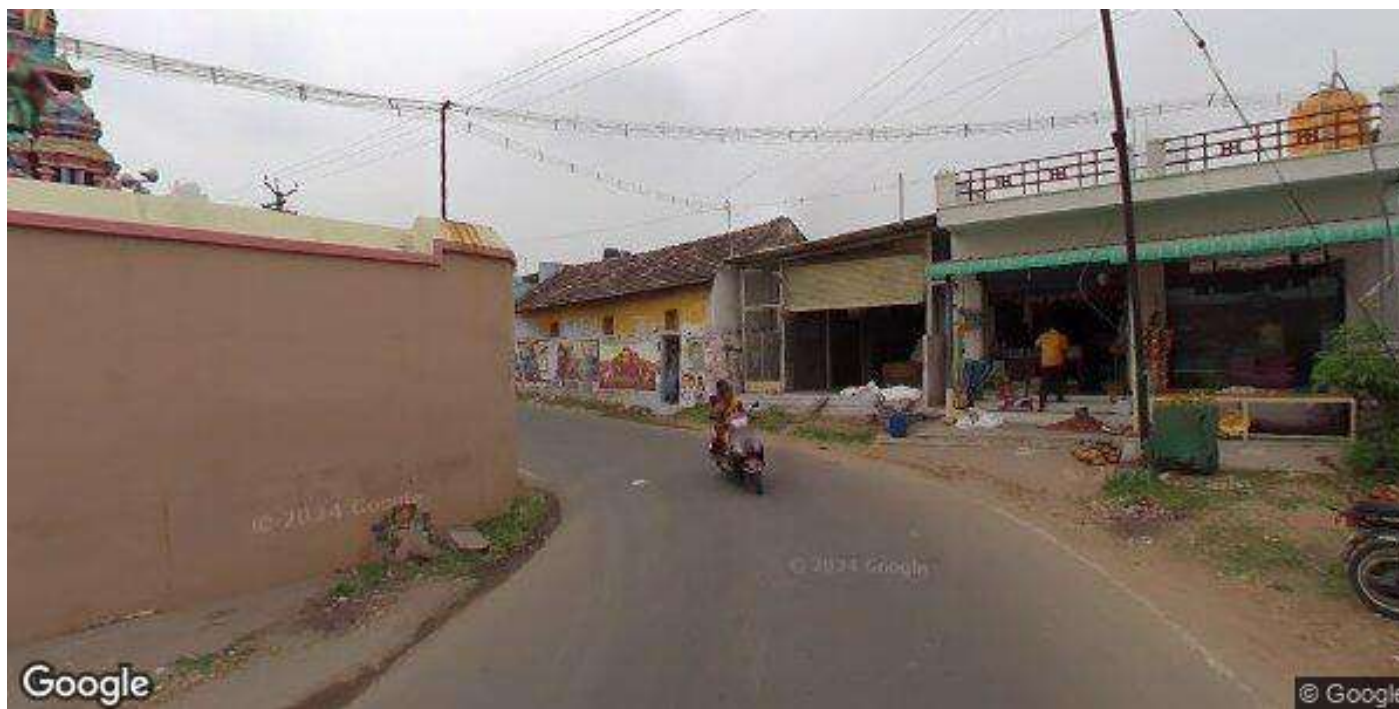
**Risk Type:** Turn  
**Risk Level:** Medium  
**Speed Limit:** 30 KM/Hr  
**Coordinates:** 11.69918, 77.87487

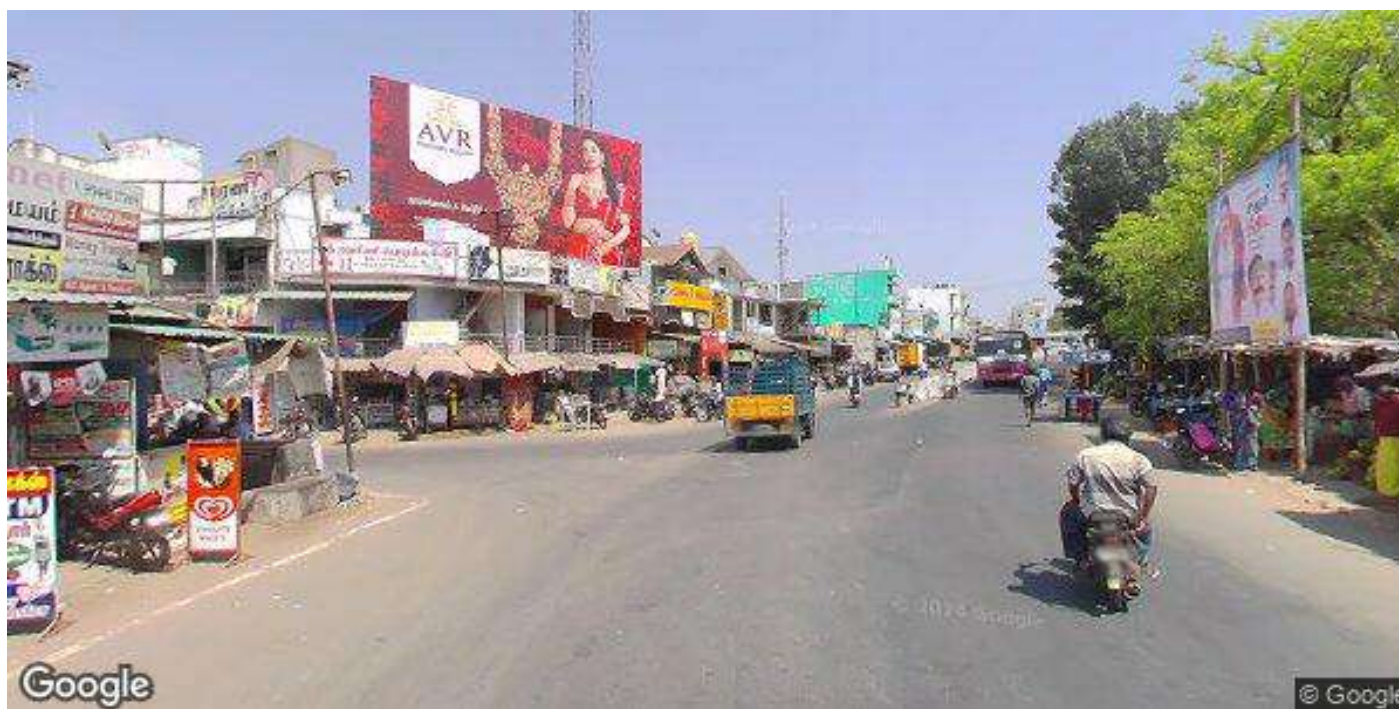
**Risk Type:** Turn  
**Risk Level:** High  
**Speed Limit:** 15 KM/Hr  
**Coordinates:** 11.76019, 77.89047

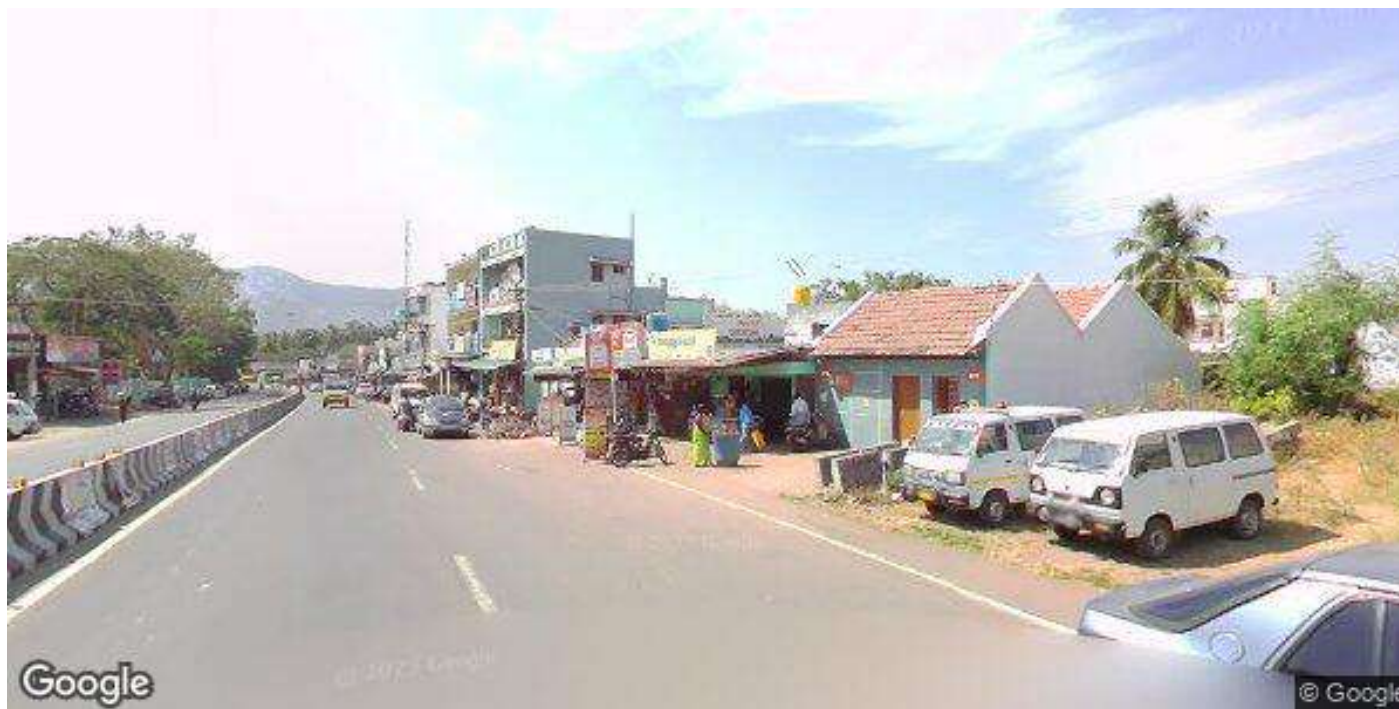
**Risk Type:** Turn  
**Risk Level:** Medium  
**Speed Limit:** 30 KM/Hr  
**Coordinates:** 11.75964, 77.89200

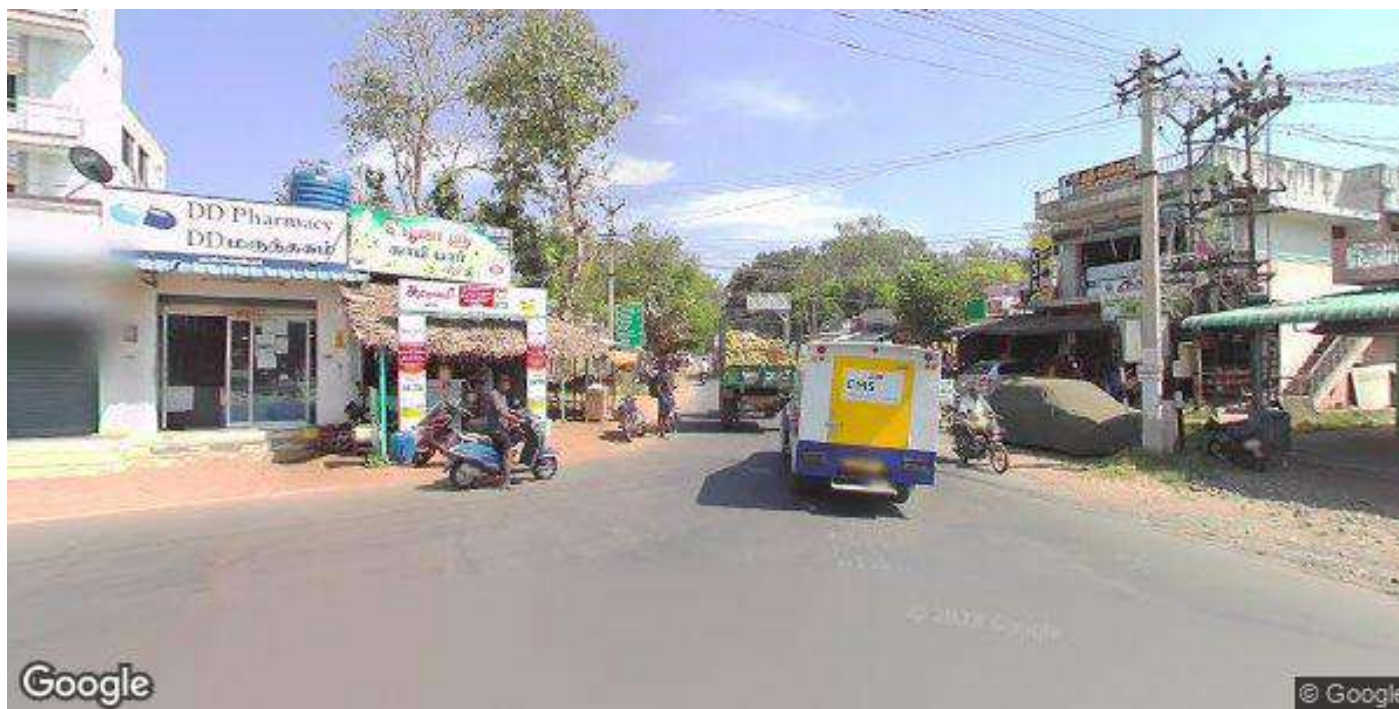
**Risk Type:** Blind Spot  
**Risk Level:** Blind Spot  
**Speed Limit:** 10 KM/Hr  
**Coordinates:** 11.75947, 77.89214

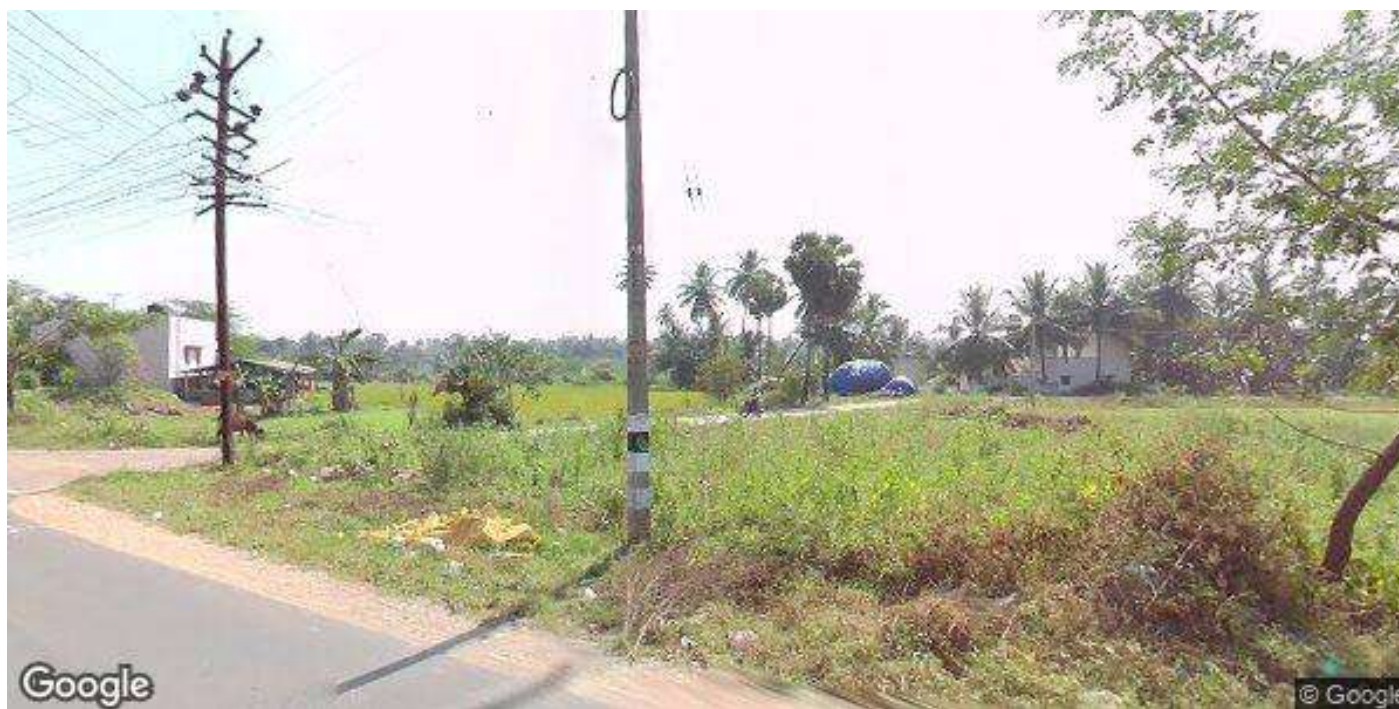
**Risk Type:** Blind Spot  
**Risk Level:** Blind Spot  
**Speed Limit:** 10 KM/Hr  
**Coordinates:** 11.82791, 77.94044

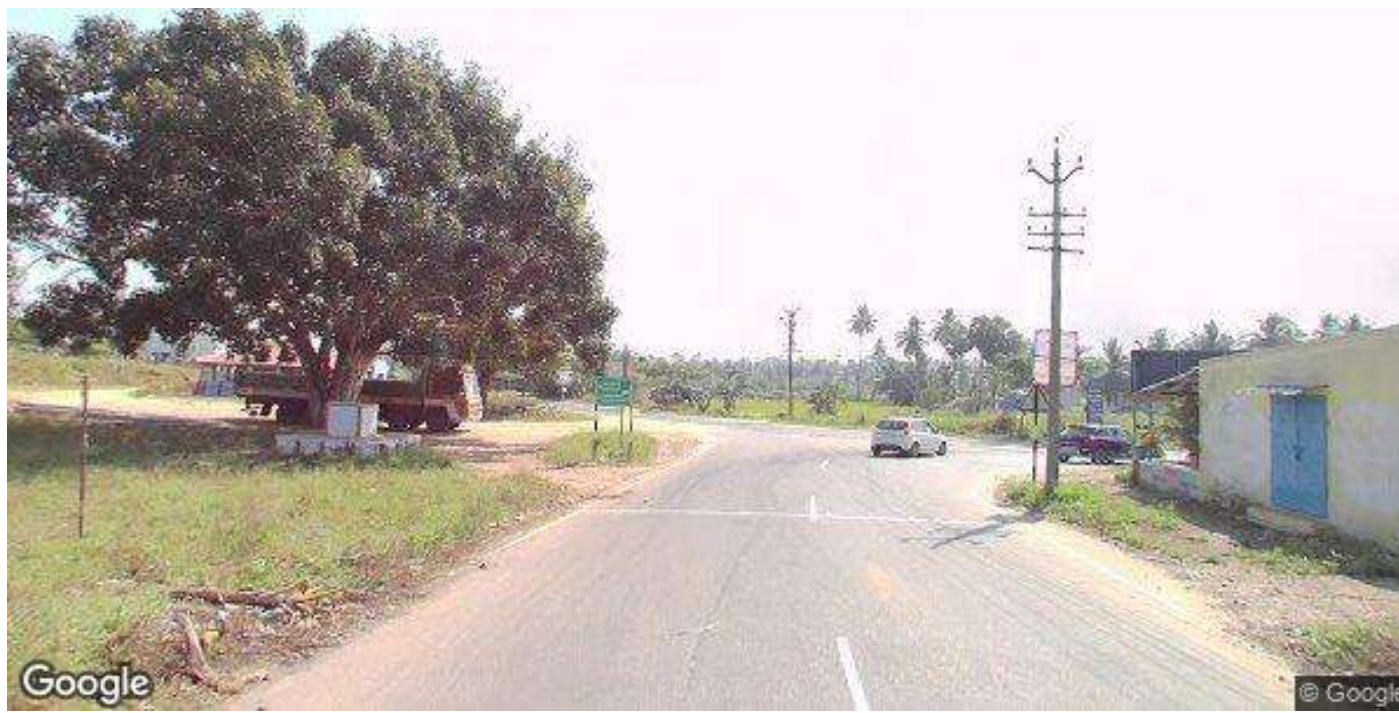
**Risk Type:** Turn  
**Risk Level:** Medium  
**Speed Limit:** 30 KM/Hr  
**Coordinates:** 11.82810, 77.94014

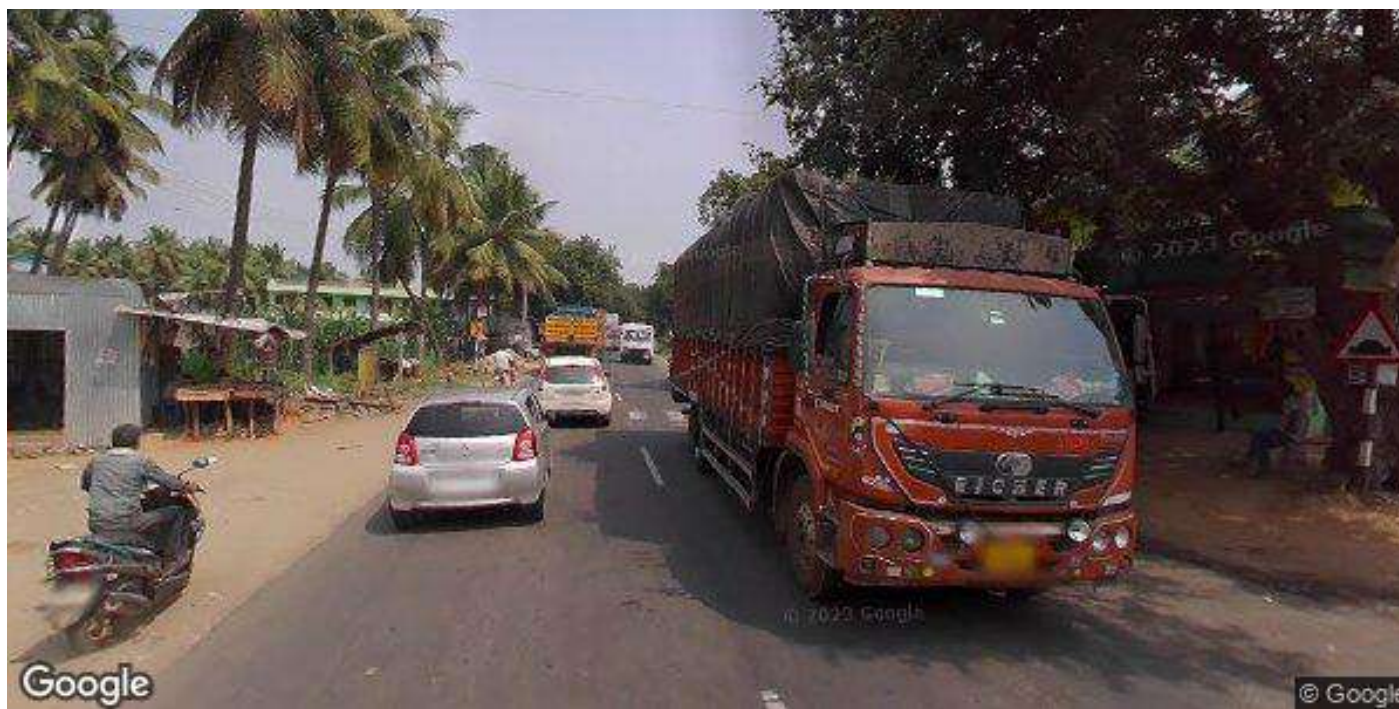
**Risk Type:** Blind Spot  
**Risk Level:** Blind Spot  
**Speed Limit:** 10 KM/Hr  
**Coordinates:** 11.82769, 77.93262

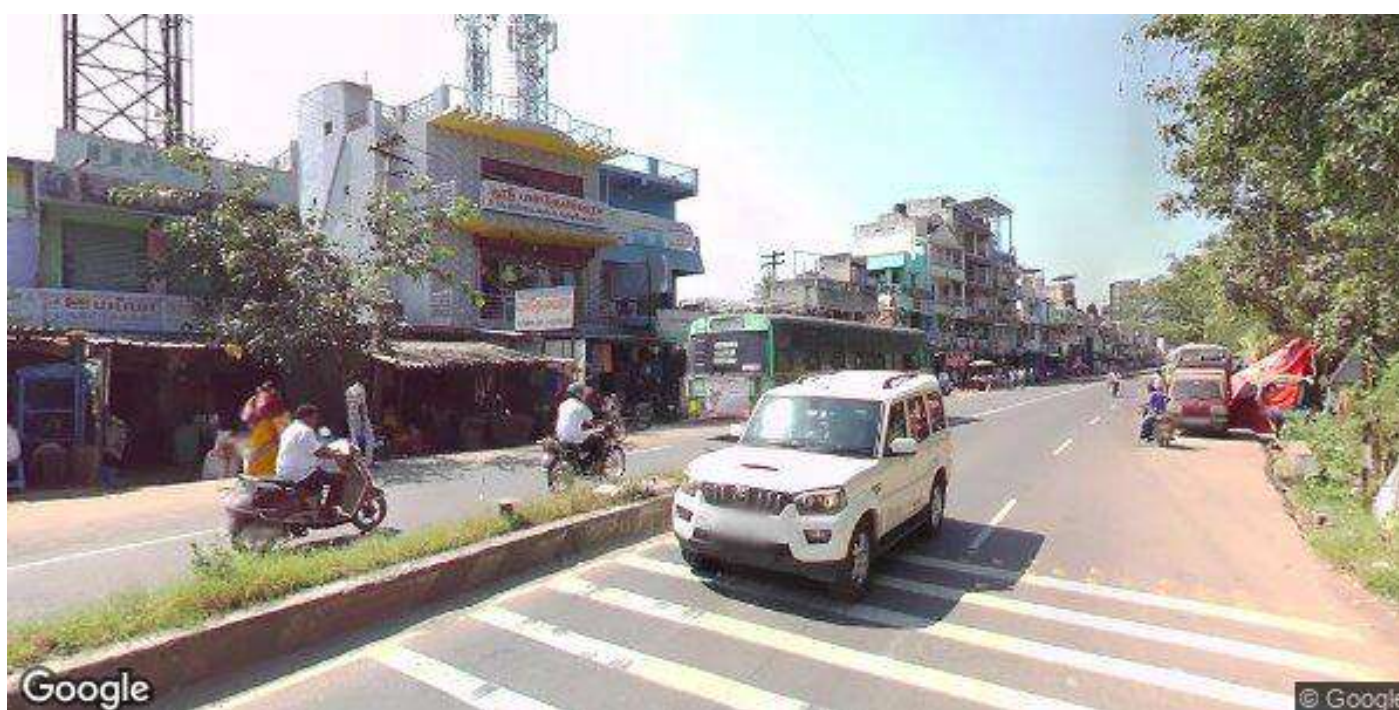
**Risk Type:** Turn  
**Risk Level:** Medium  
**Speed Limit:** 30 KM/Hr  
**Coordinates:** 11.83363, 77.94443

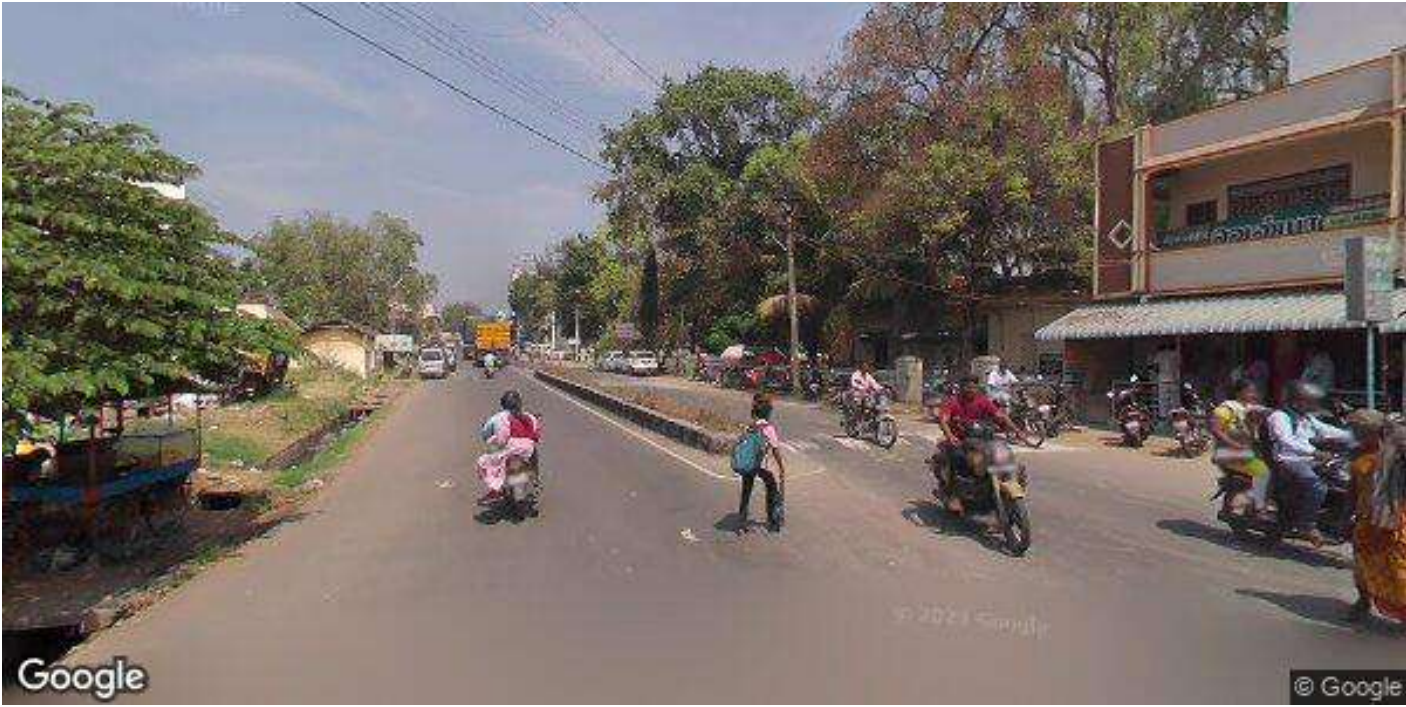
**Risk Type:** Turn  
**Risk Level:** High  
**Speed Limit:** 15 KM/Hr  
**Coordinates:** 11.83386, 77.94485
