# IndianOil

## JOURNEY RISK MANAGEMENT (JRM) STUDY

### Salem Terminal to VR - CO

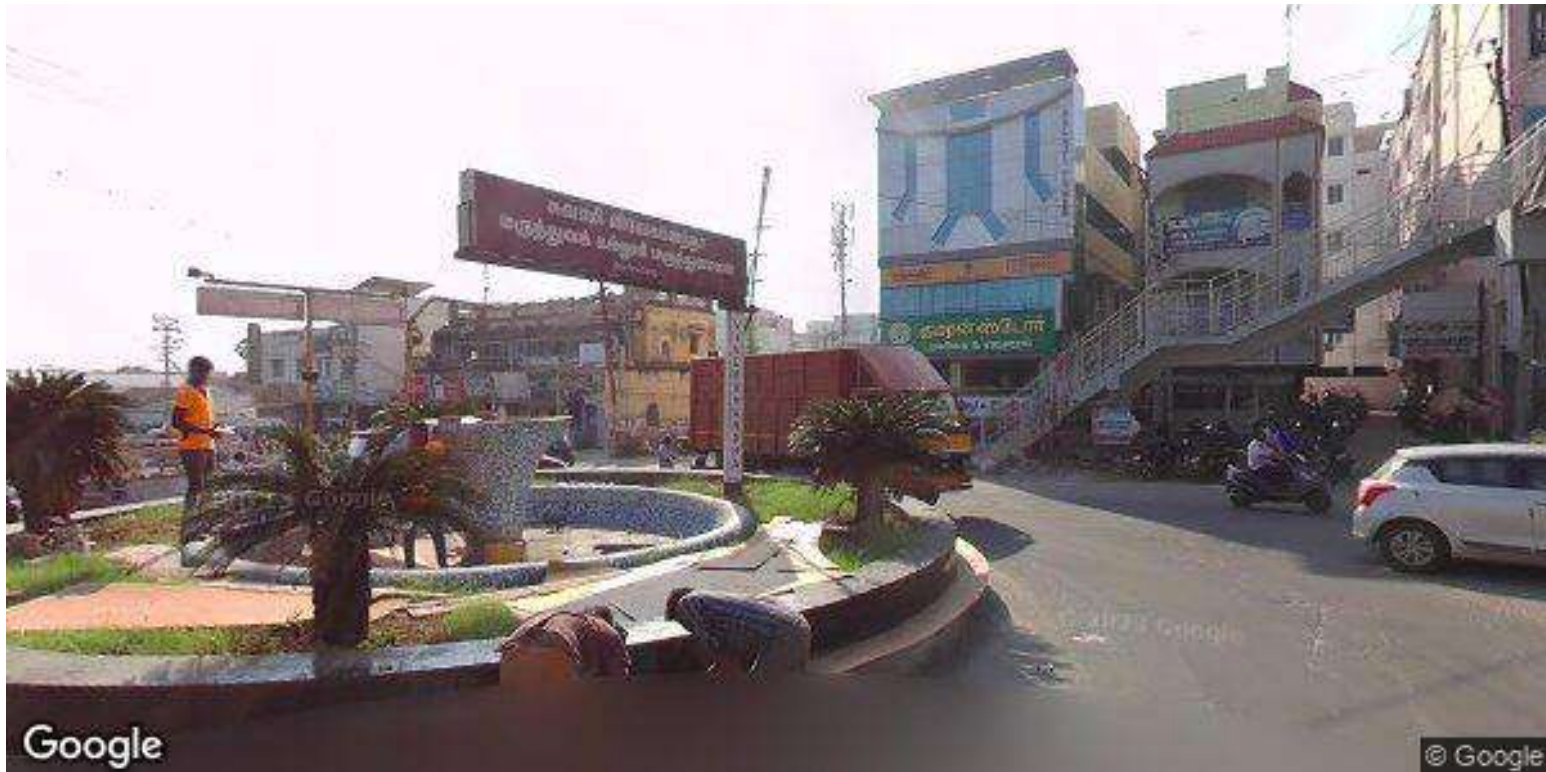
**Coordinates:** 11.38395, 77.89480

**Risk Type:** Roundabout

**Risk Level:** High

**Speed Limit:** 15 KM/Hr

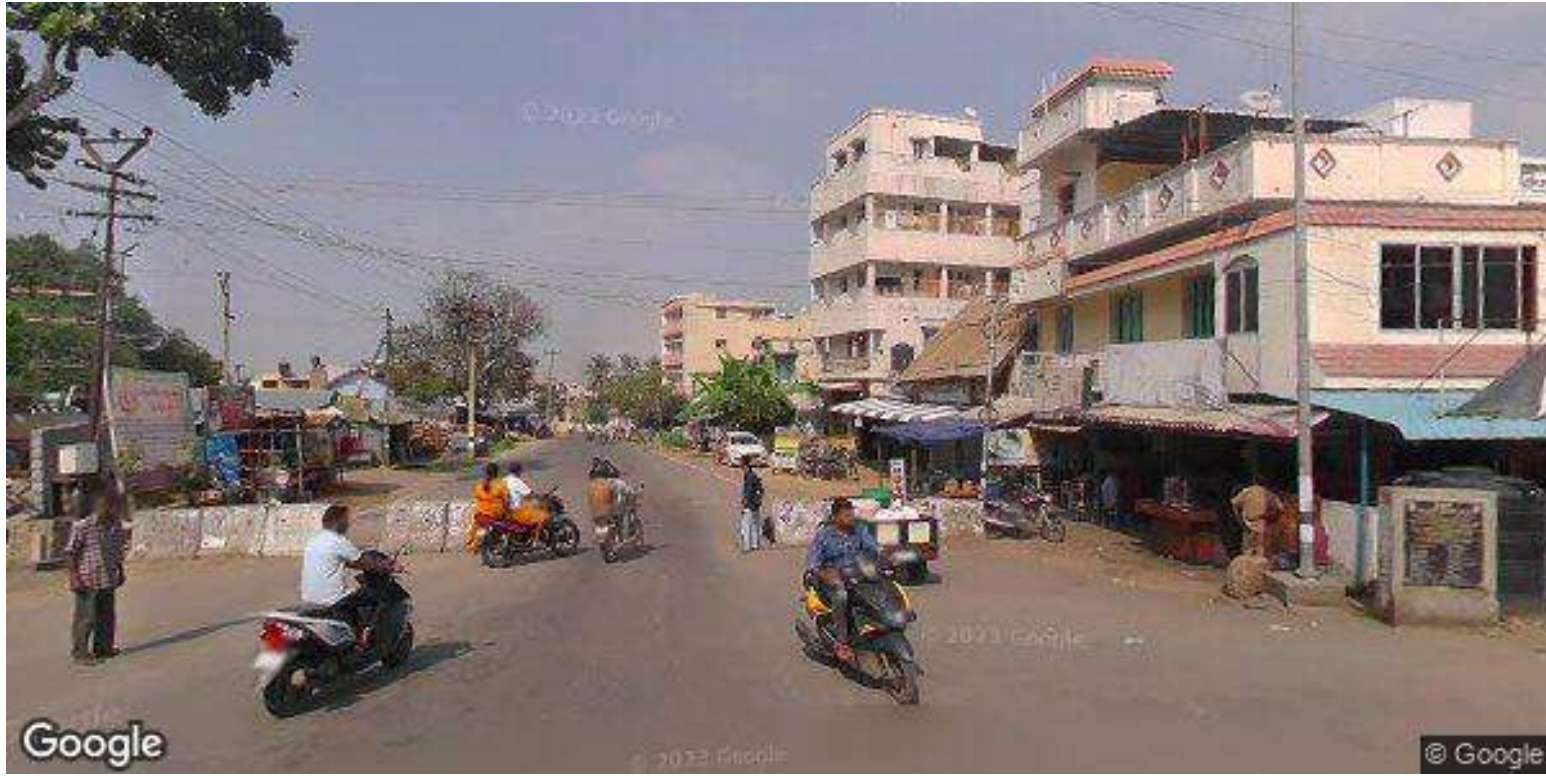
**Risk Type:** Blind Spot  
**Risk Level:** Blind Spot  
**Speed Limit:** 10 KM/Hr  
**Coordinates:** 11.37841, 77.90140

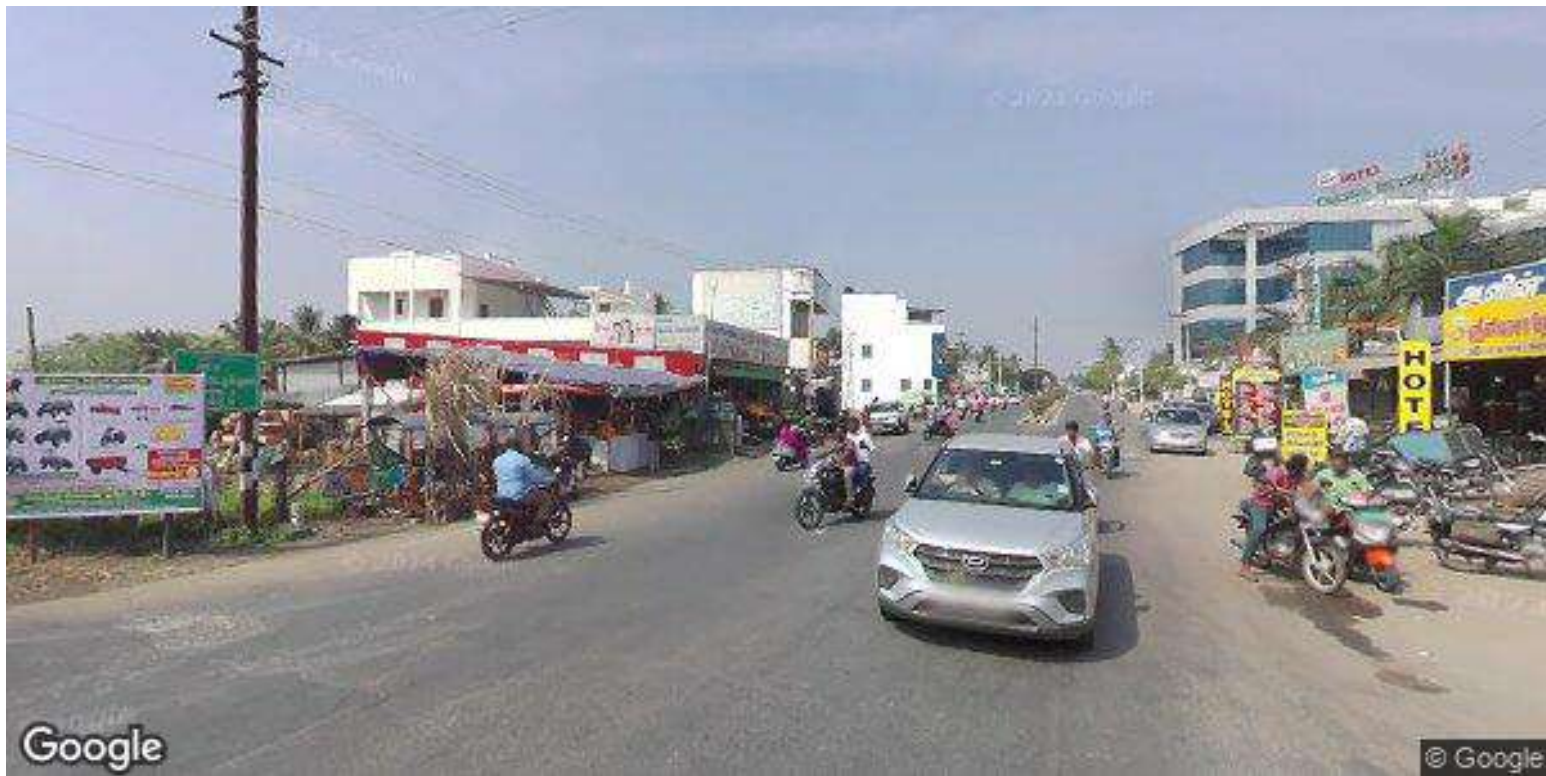
**Risk Type:** Turn  
**Risk Level:** High  
**Speed Limit:** 15 KM/Hr  
**Coordinates:** 11.23961, 78.14223
