# IndianOil

## JOURNEY RISK MANAGEMENT (JRM) STUDY

### Salem Terminal TO S P S MARKETING

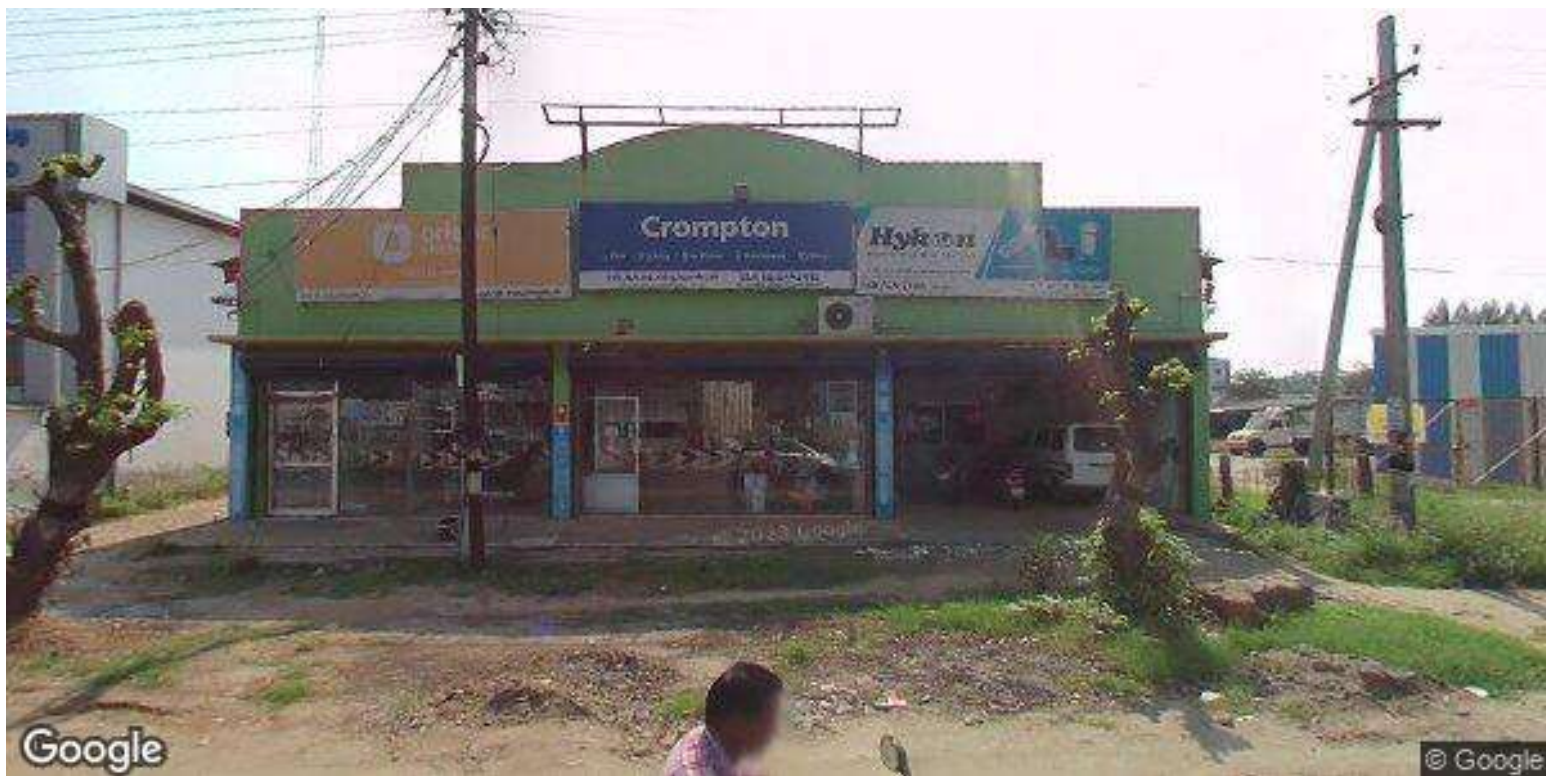
**Coordinates:** 11.0999904, 77.3822943

**Risk Type:** U-Turn

**Risk Level:** High

**Speed Limit:** 10 KM/Hr

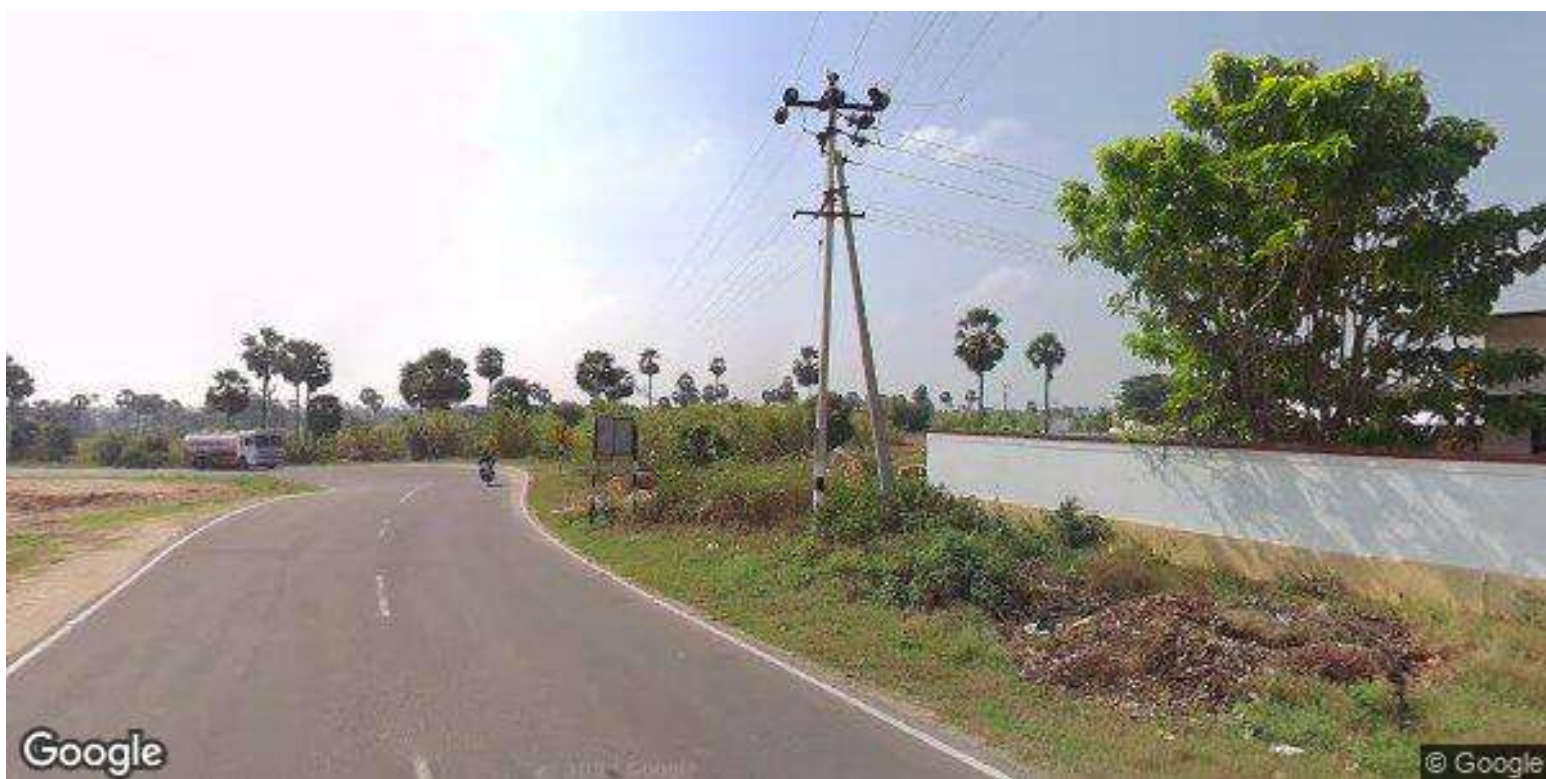
**Coordinates: 11.45889, 77.85136**

**Risk Type: Turn**

**Risk Level: Medium**

**Speed Limit: 30 KM/Hr**

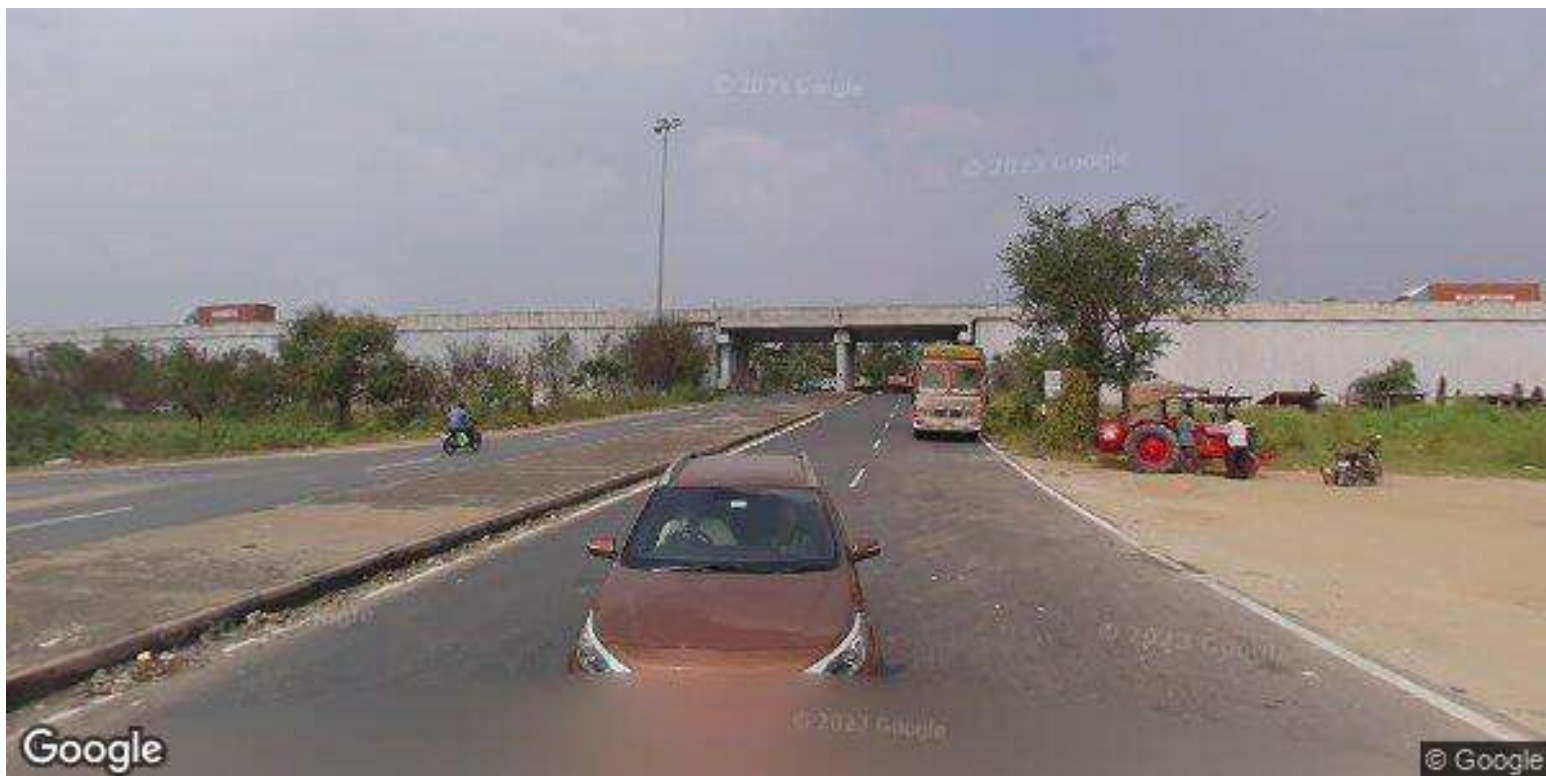
**Risk Type:** Turn  
**Risk Level:** High  
**Speed Limit:** 15 KM/Hr  
**Coordinates:** 11.45556, 77.81729

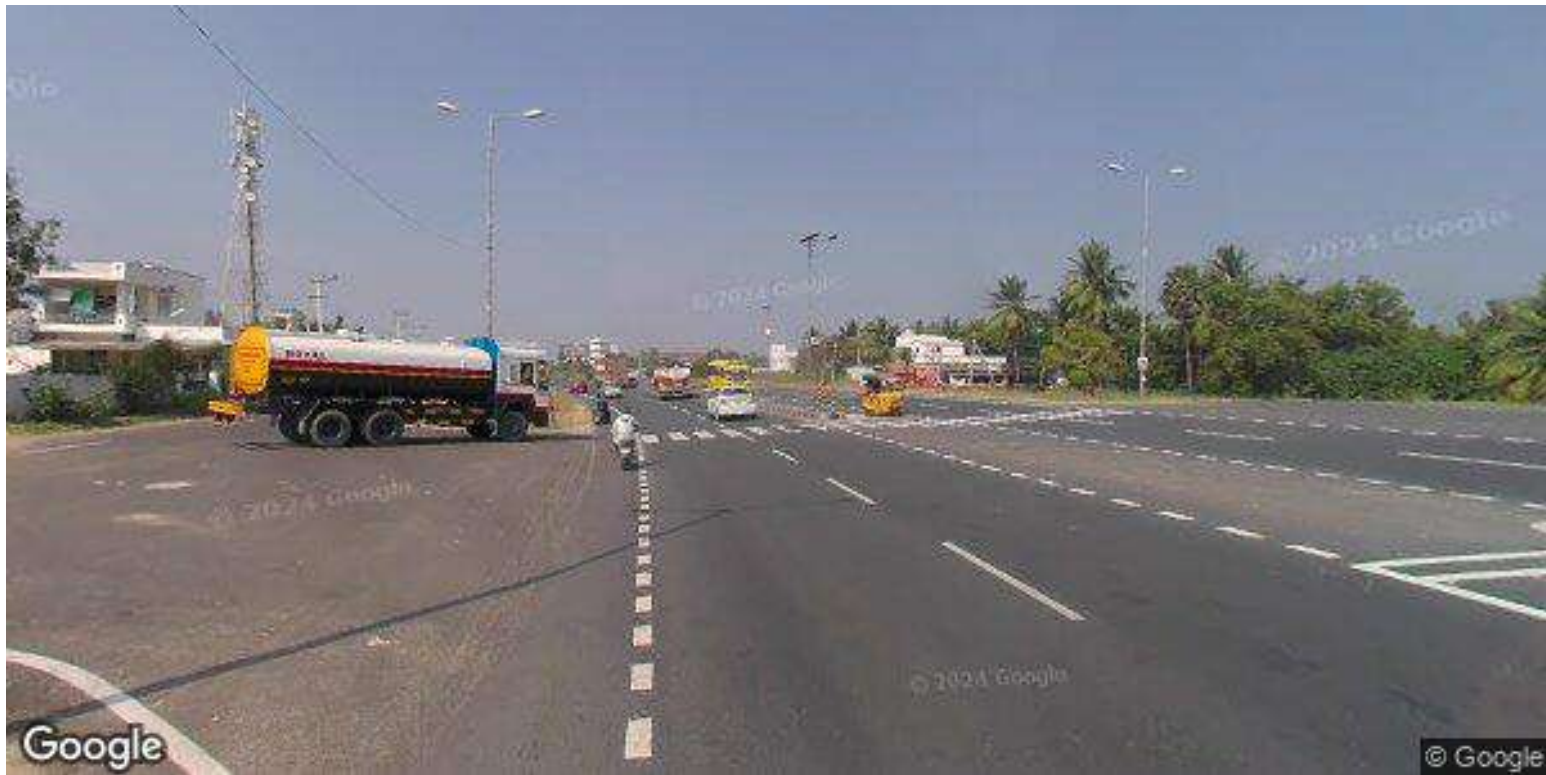
**Coordinates: 11.45081, 77.77034**

**Risk Type: Turn**

**Risk Level: Medium**

**Speed Limit: 30 KM/Hr**

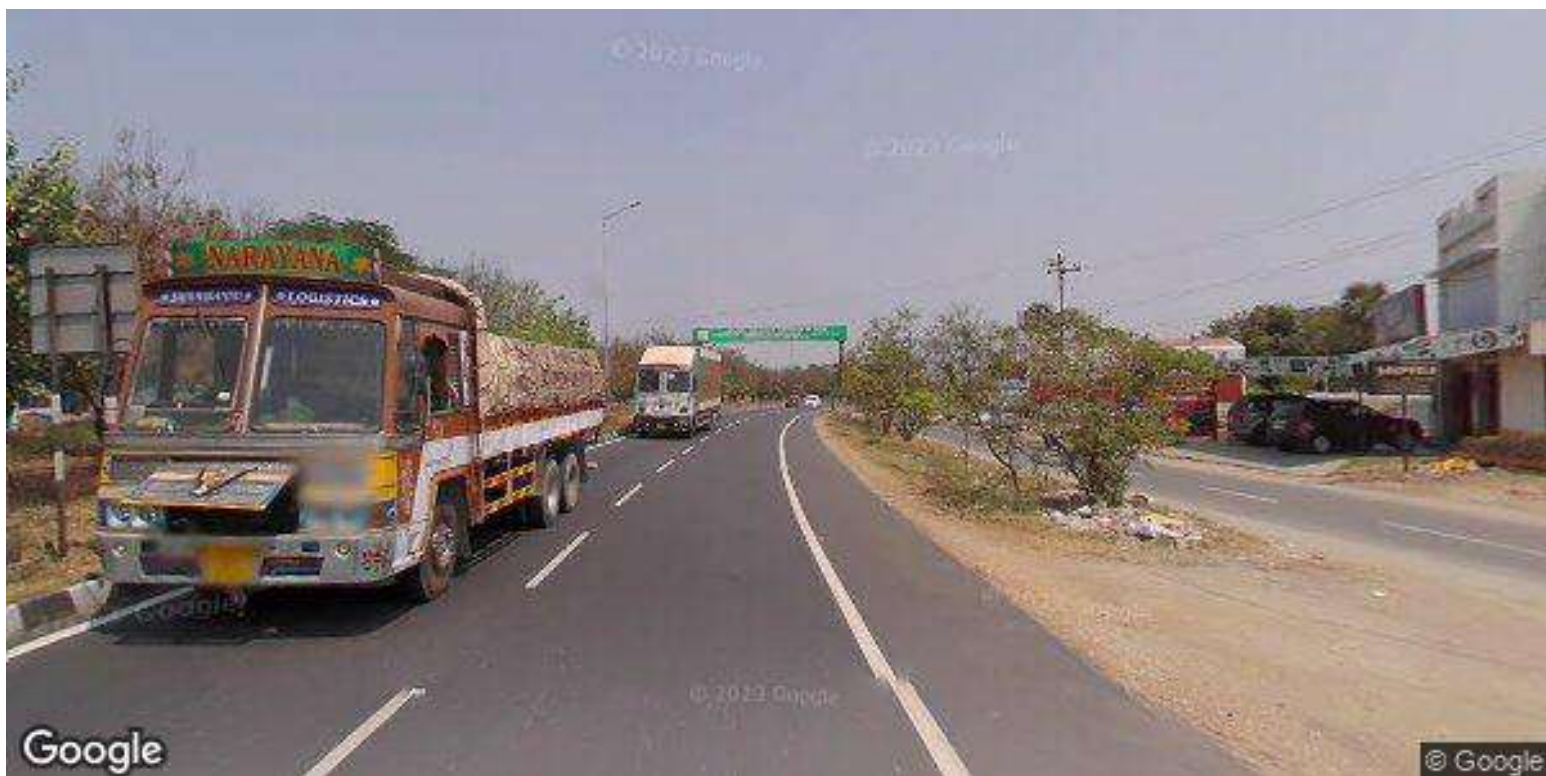
**Coordinates: 11.43192, 77.67803**

**Risk Type: Turn**

**Risk Level: Medium**

**Speed Limit: 30 KM/Hr**

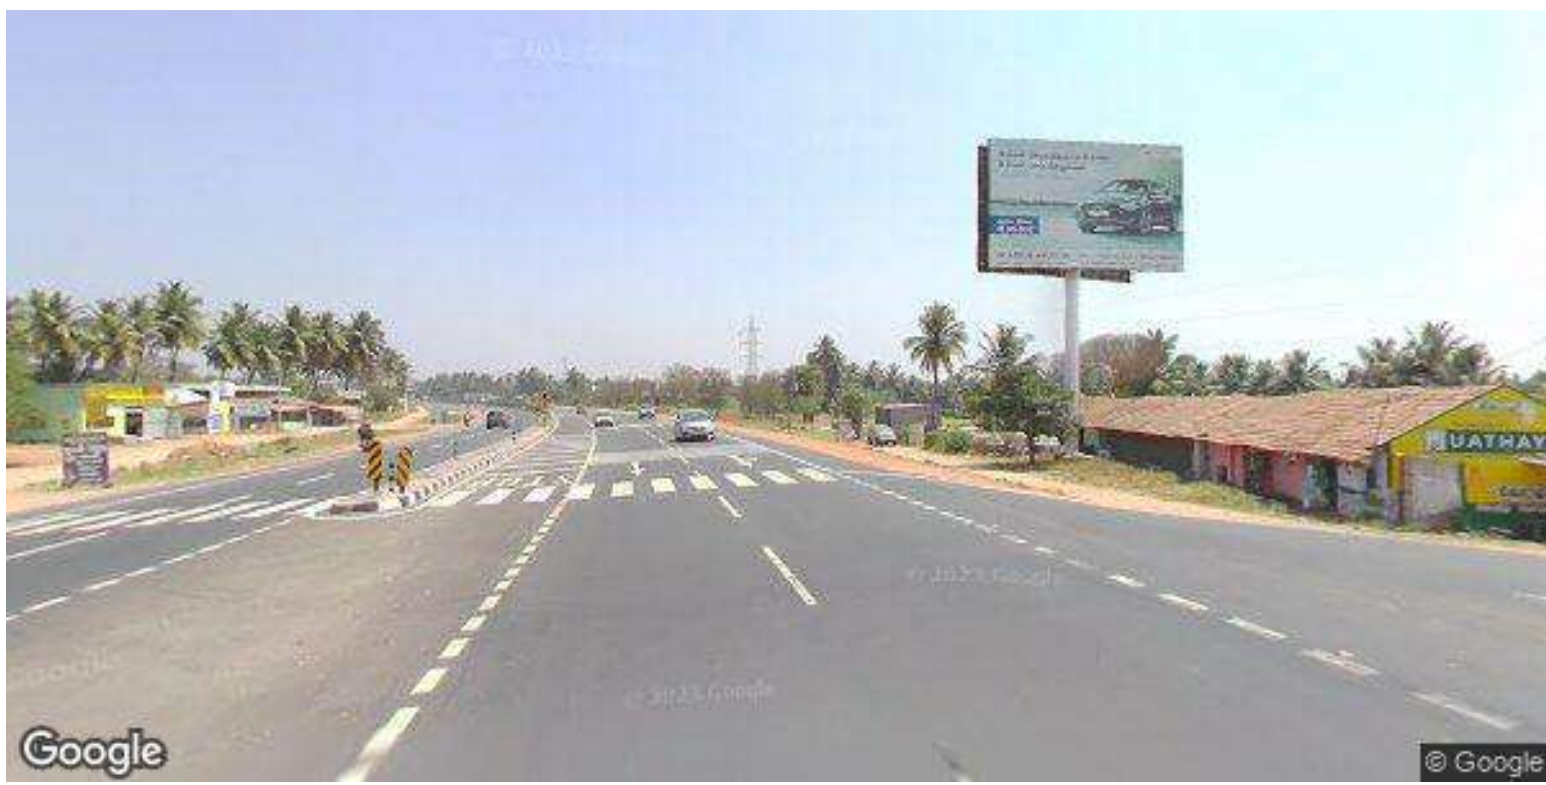
**Coordinates:** 11.23716, 77.50666

**Risk Type:** Turn

**Risk Level:** Medium

**Speed Limit:** 30 KM/Hr

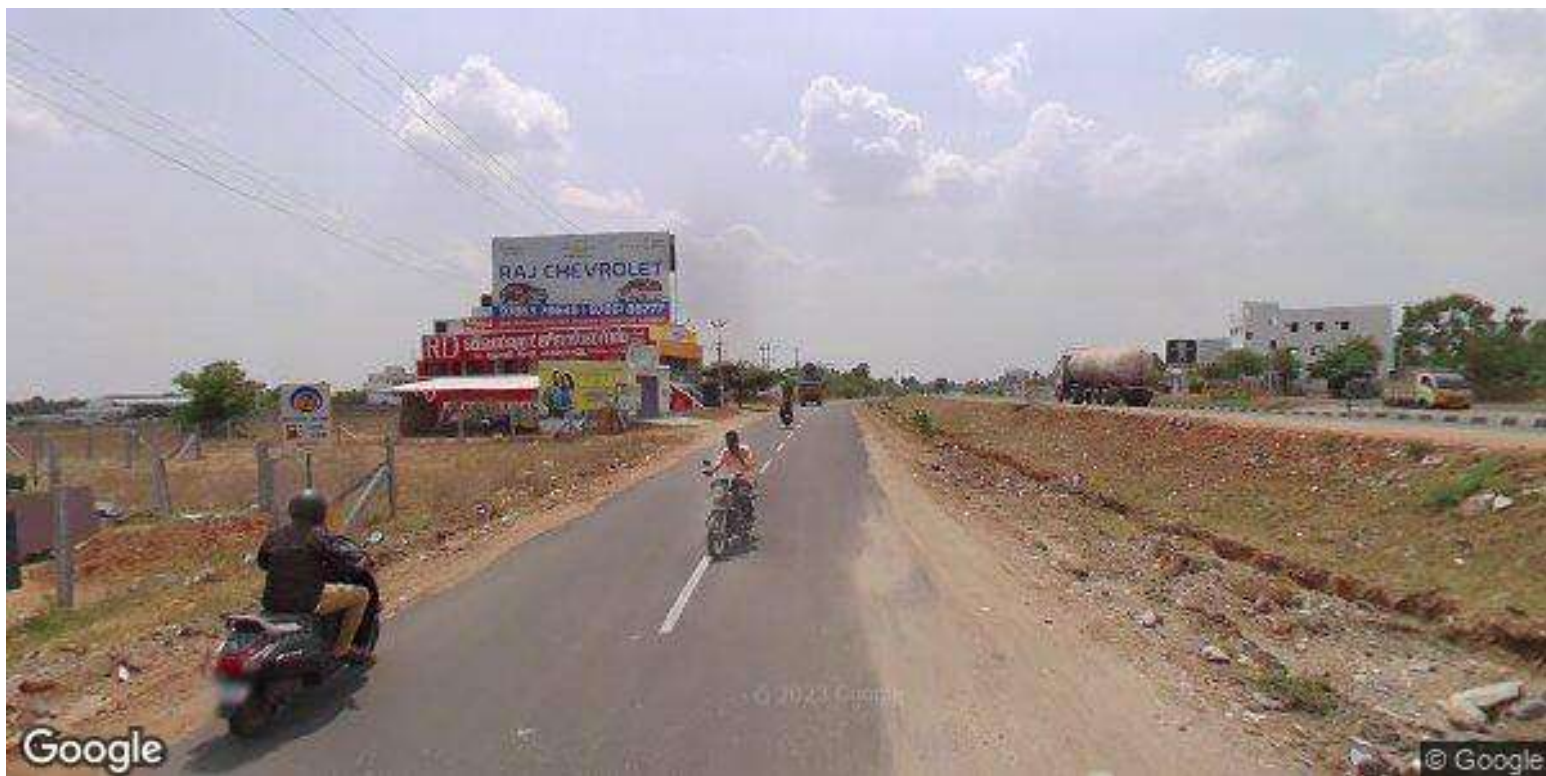
**Coordinates:** 11.23697, 77.50655

**Risk Type:** Turn

**Risk Level:** High

**Speed Limit:** 15 KM/Hr

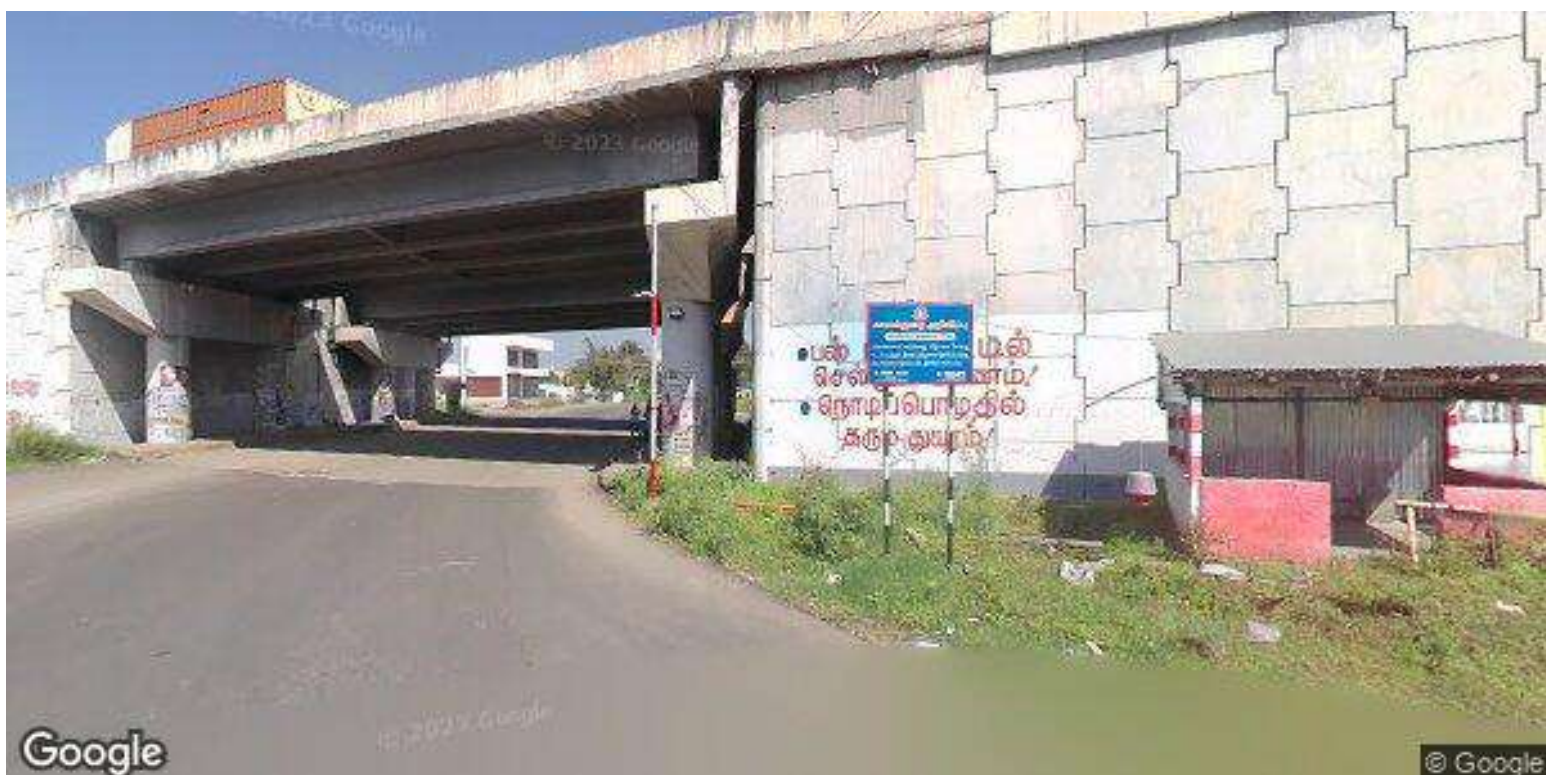
**Risk Type:** Blind Spot  
**Risk Level:** Blind Spot  
**Speed Limit:** 10 KM/Hr  
**Coordinates:** 11.23687, 77.50213

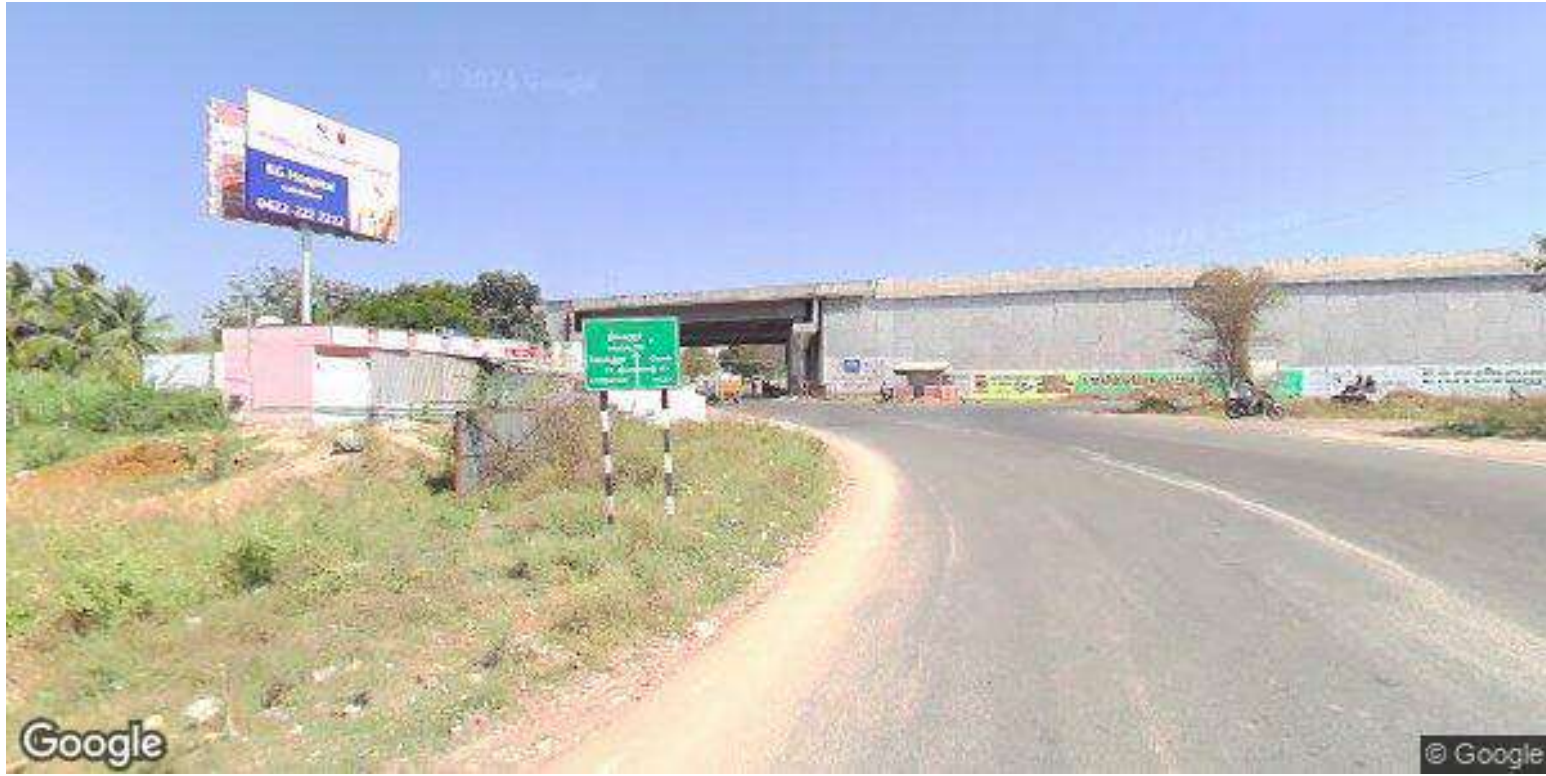
**Risk Type:** Turn  
**Risk Level:** Medium  
**Speed Limit:** 30 KM/Hr  
**Coordinates:** 11.23645, 77.50218

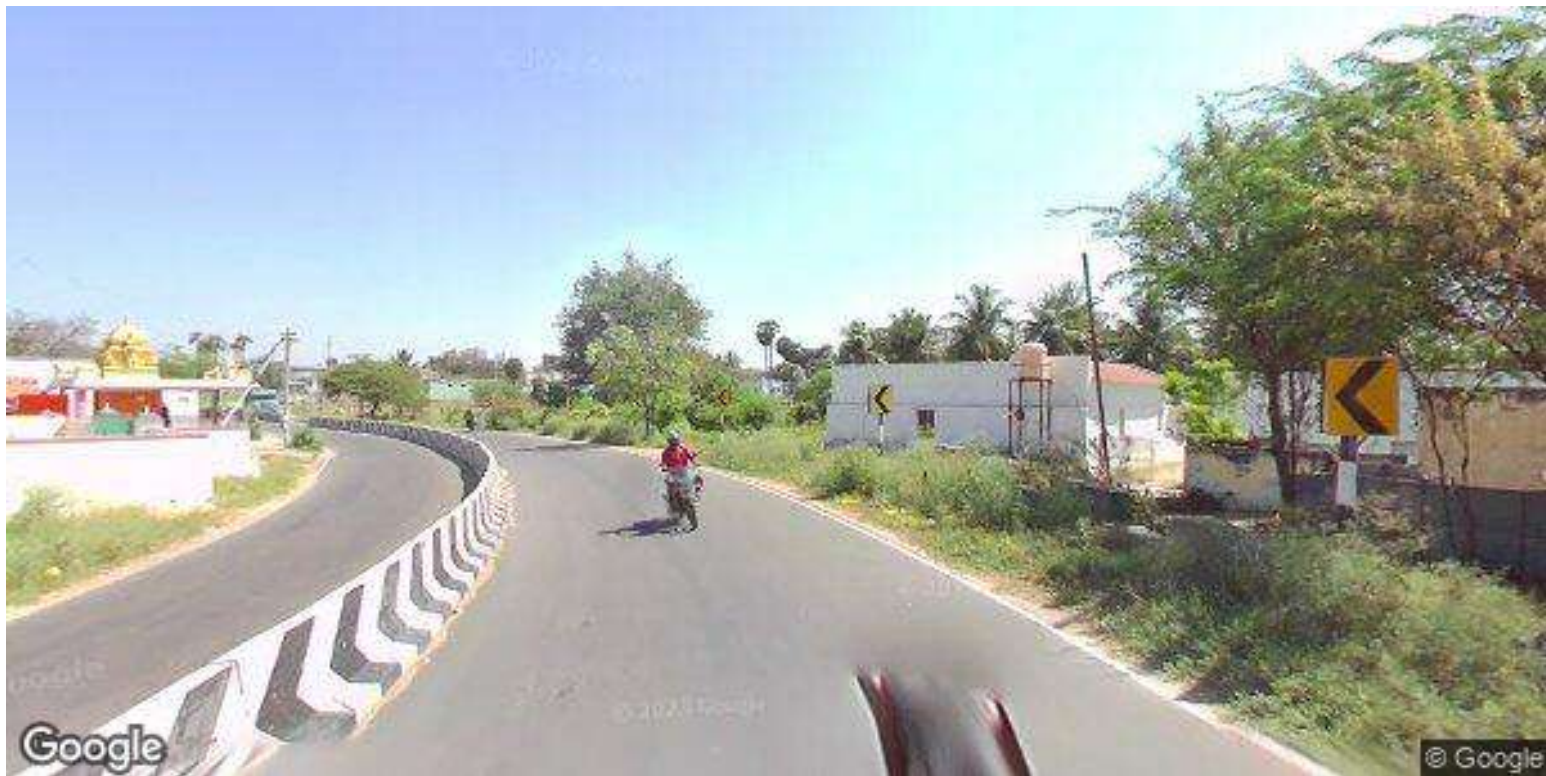
**Risk Type:** Turn  
**Risk Level:** High  
**Speed Limit:** 15 KM/Hr  
**Coordinates:** 11.23386, 77.50098

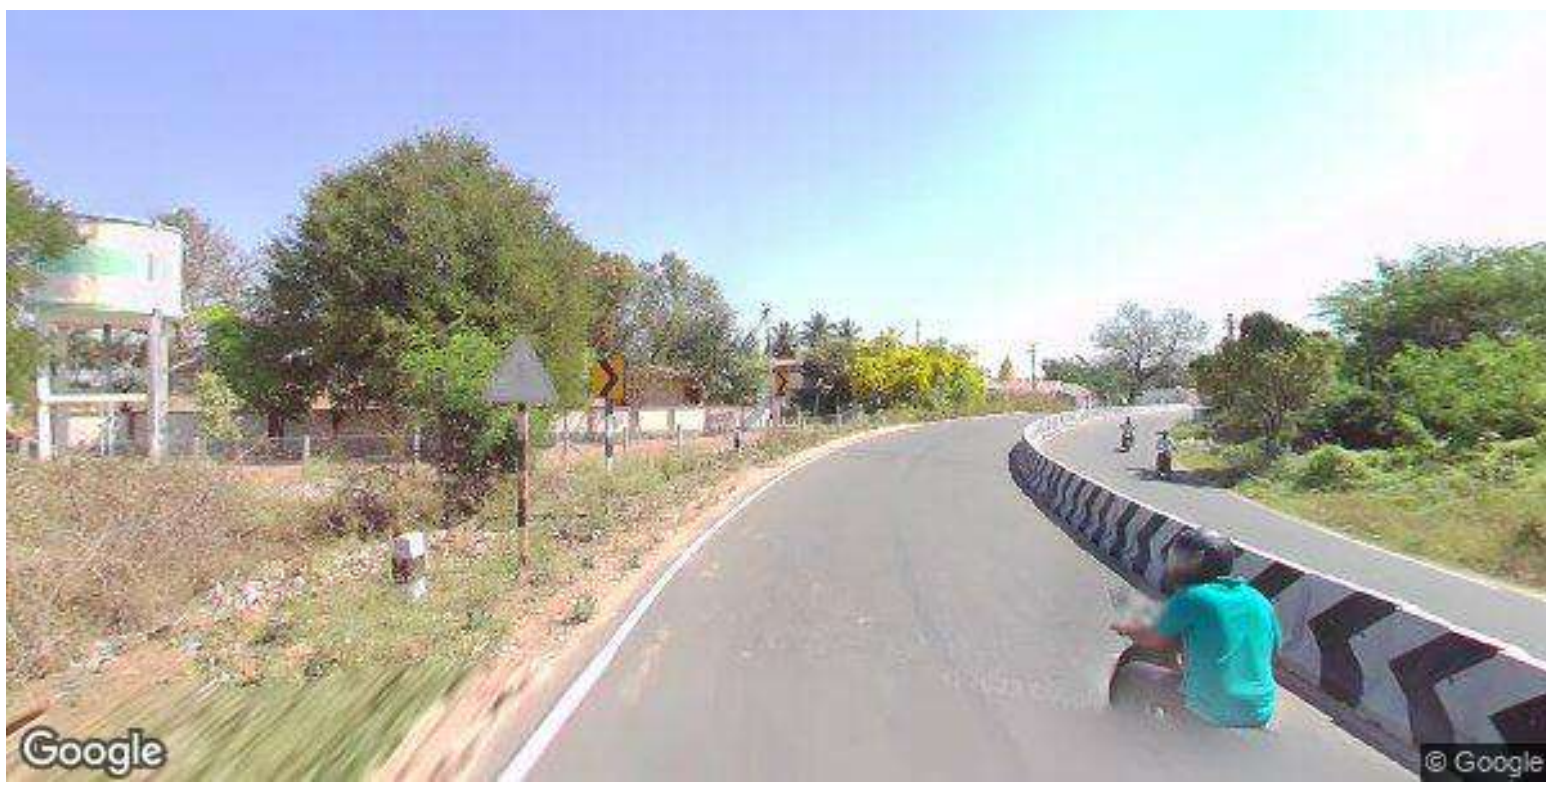
**Coordinates:** 11.23319, 77.49954

**Risk Type:** Turn

**Risk Level:** Medium

**Speed Limit:** 30 KM/Hr

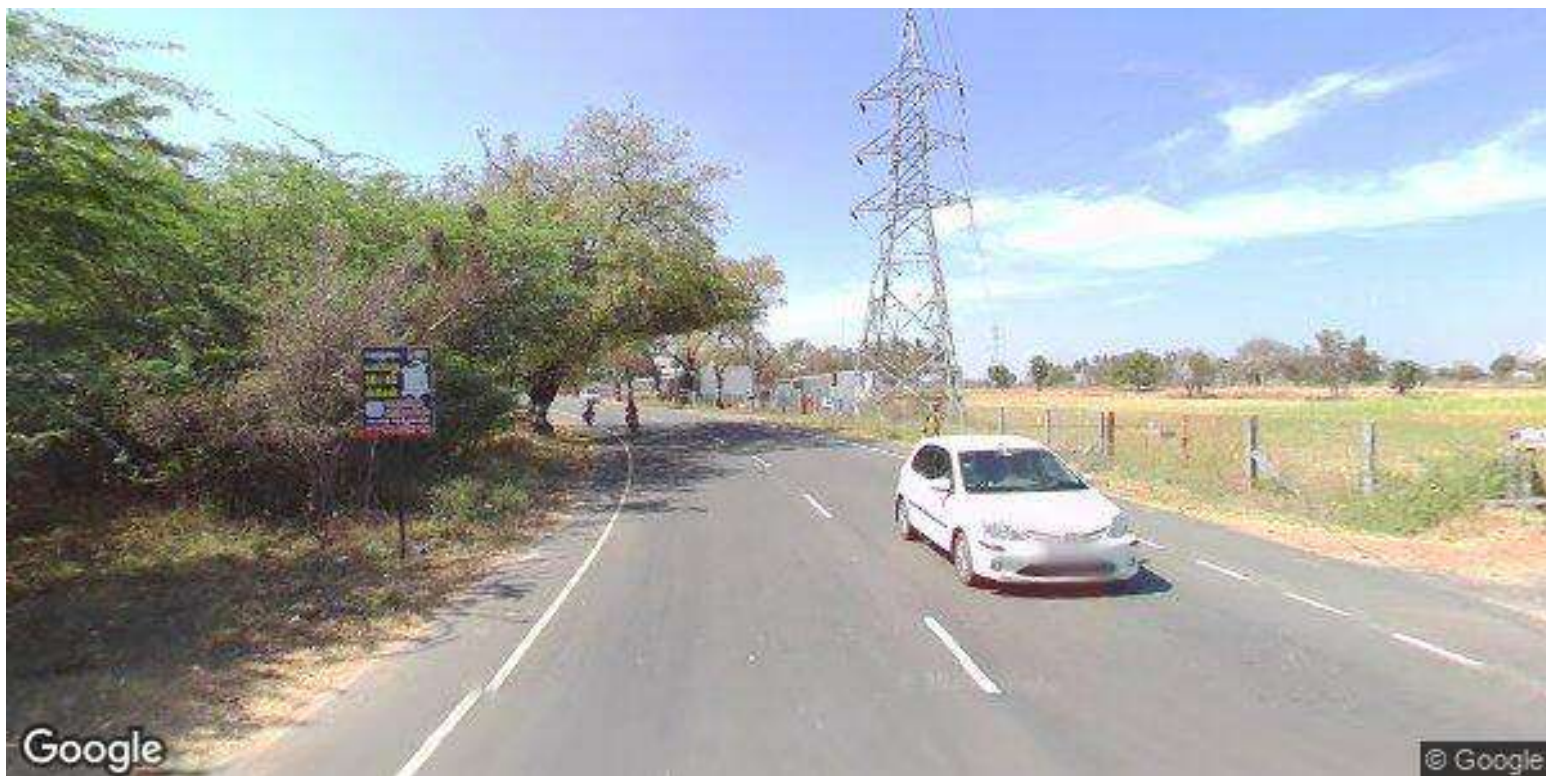
**Coordinates:** 11.23054, 77.49777

**Risk Type:** Turn

**Risk Level:** Medium

**Speed Limit:** 30 KM/Hr

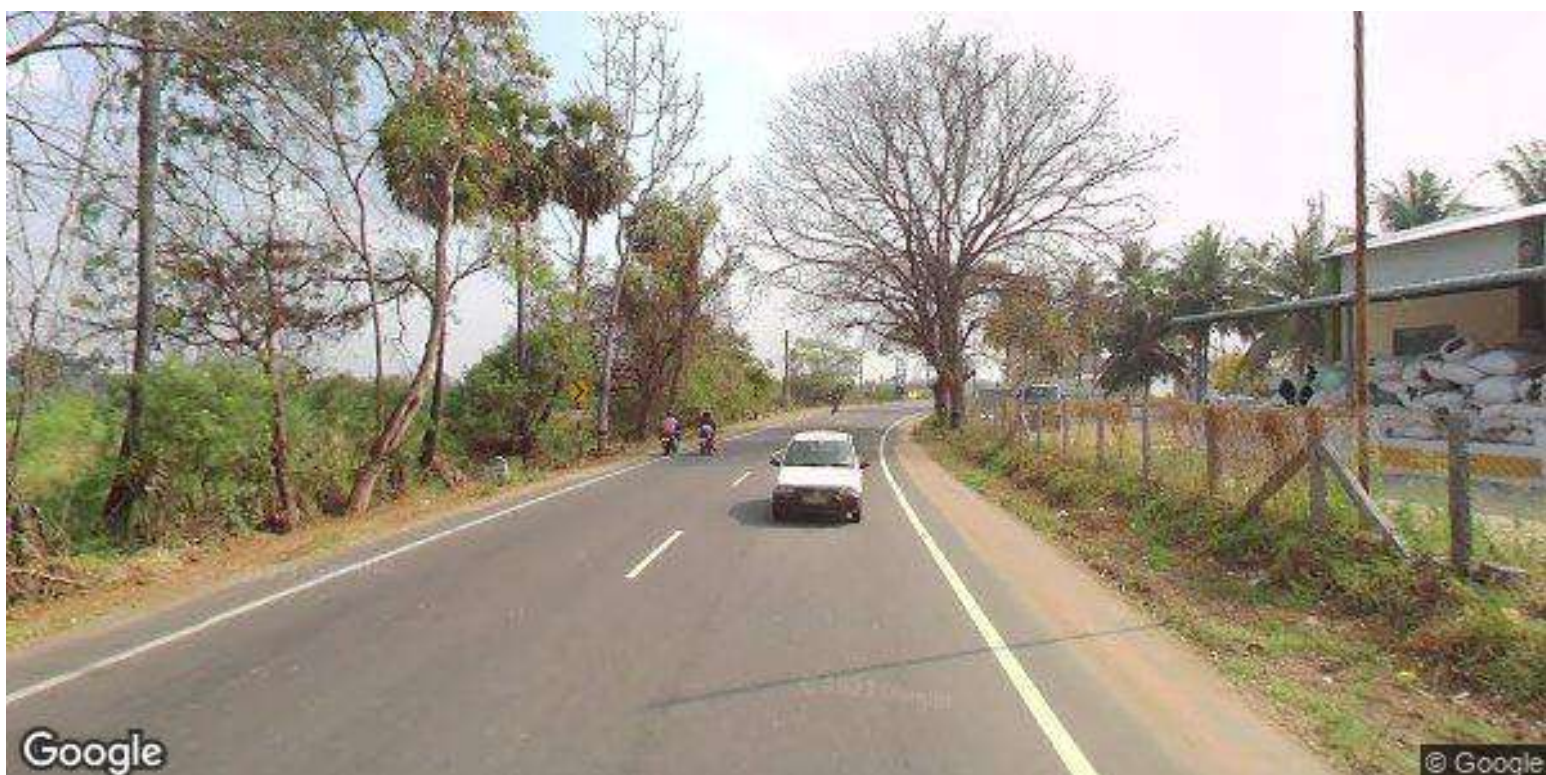
**Risk Type:** Turn  
**Risk Level:** Medium  
**Speed Limit:** 30 KM/Hr  
**Coordinates:** 11.18389, 77.46306

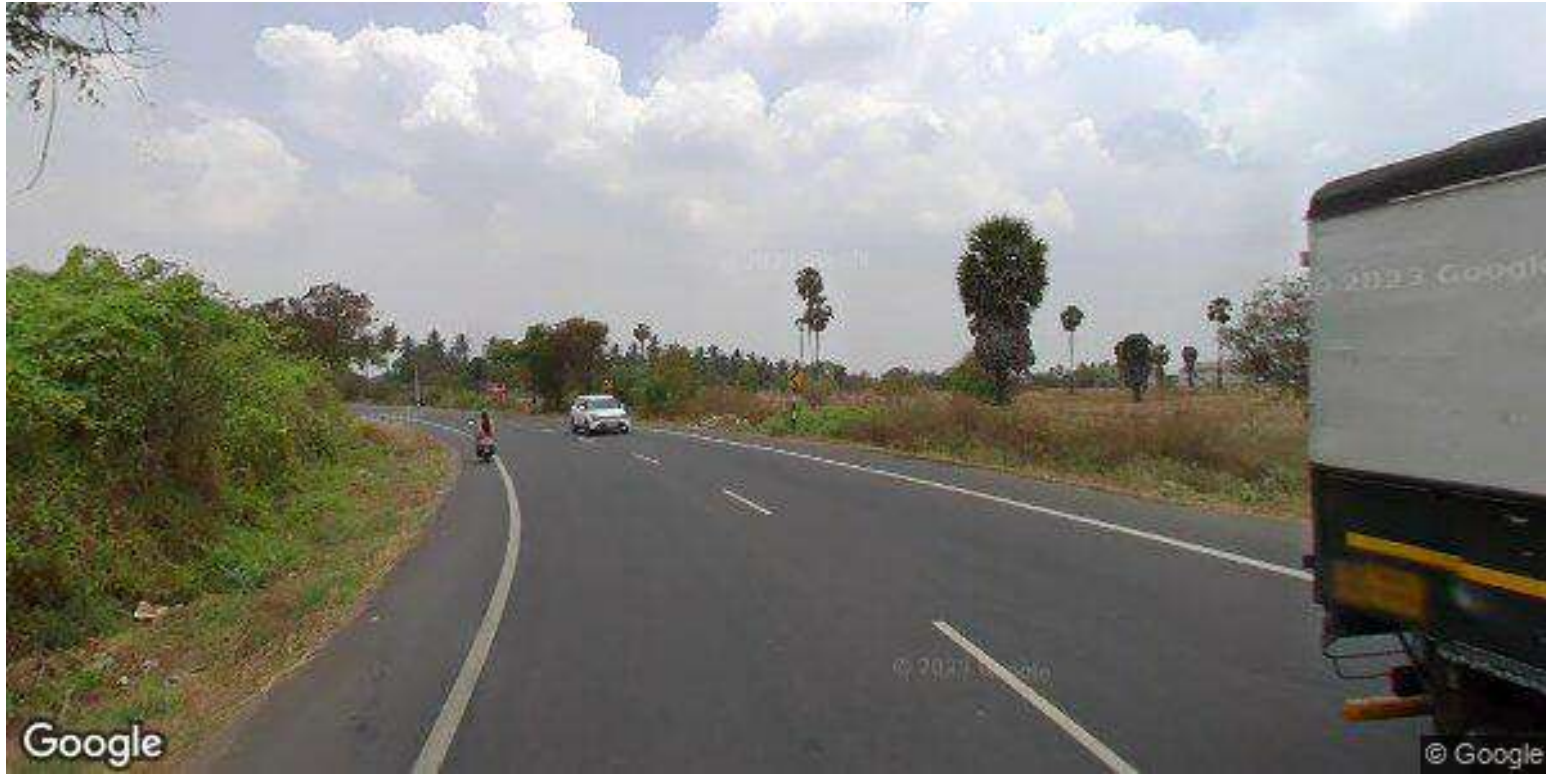
**Risk Type:** Turn  
**Risk Level:** Medium  
**Speed Limit:** 30 KM/Hr  
**Coordinates:** 11.17834, 77.46162

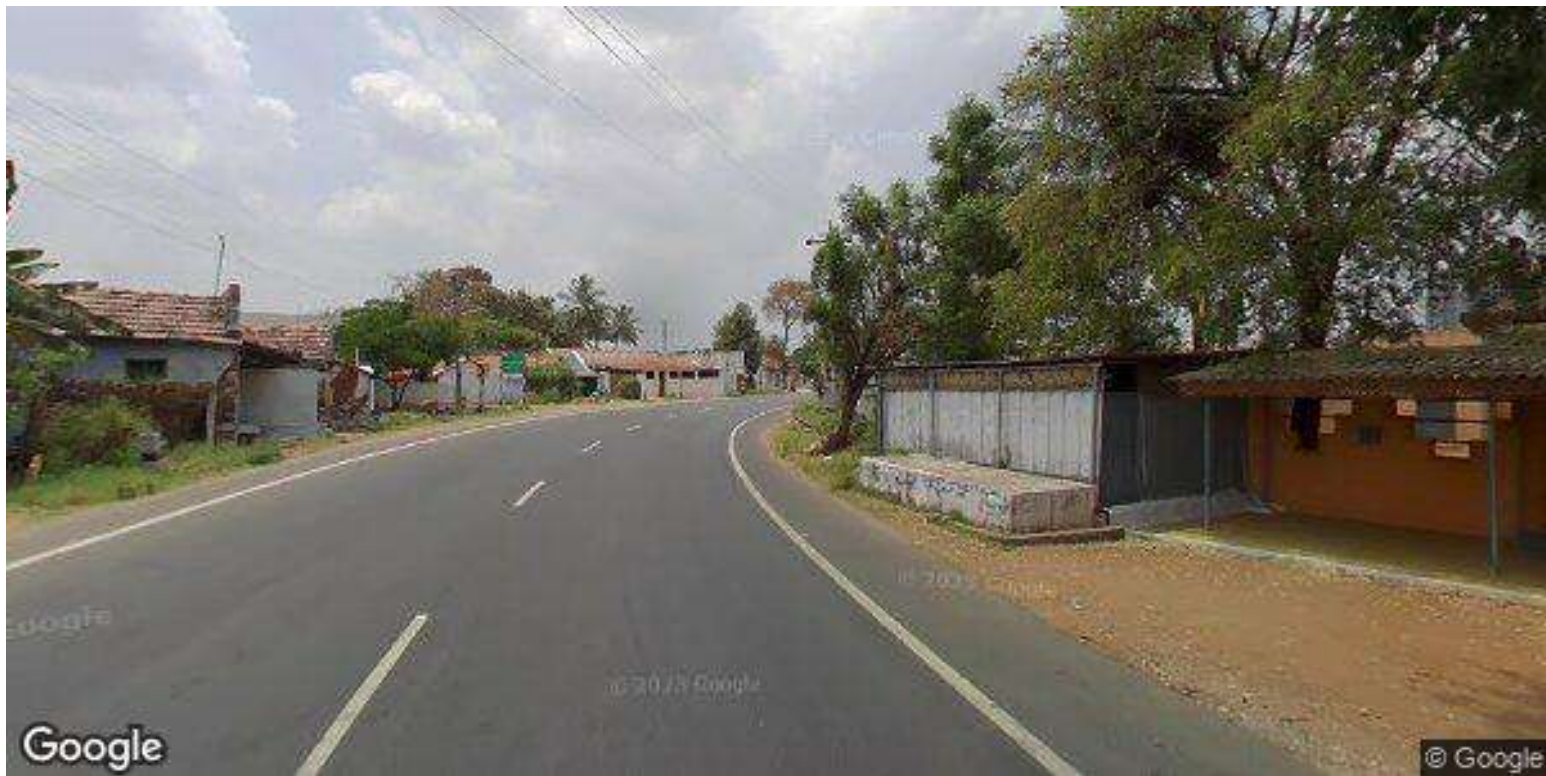
**Risk Type:** Turn  
**Risk Level:** Medium  
**Speed Limit:** 30 KM/Hr  
**Coordinates:** 11.17518, 77.45976

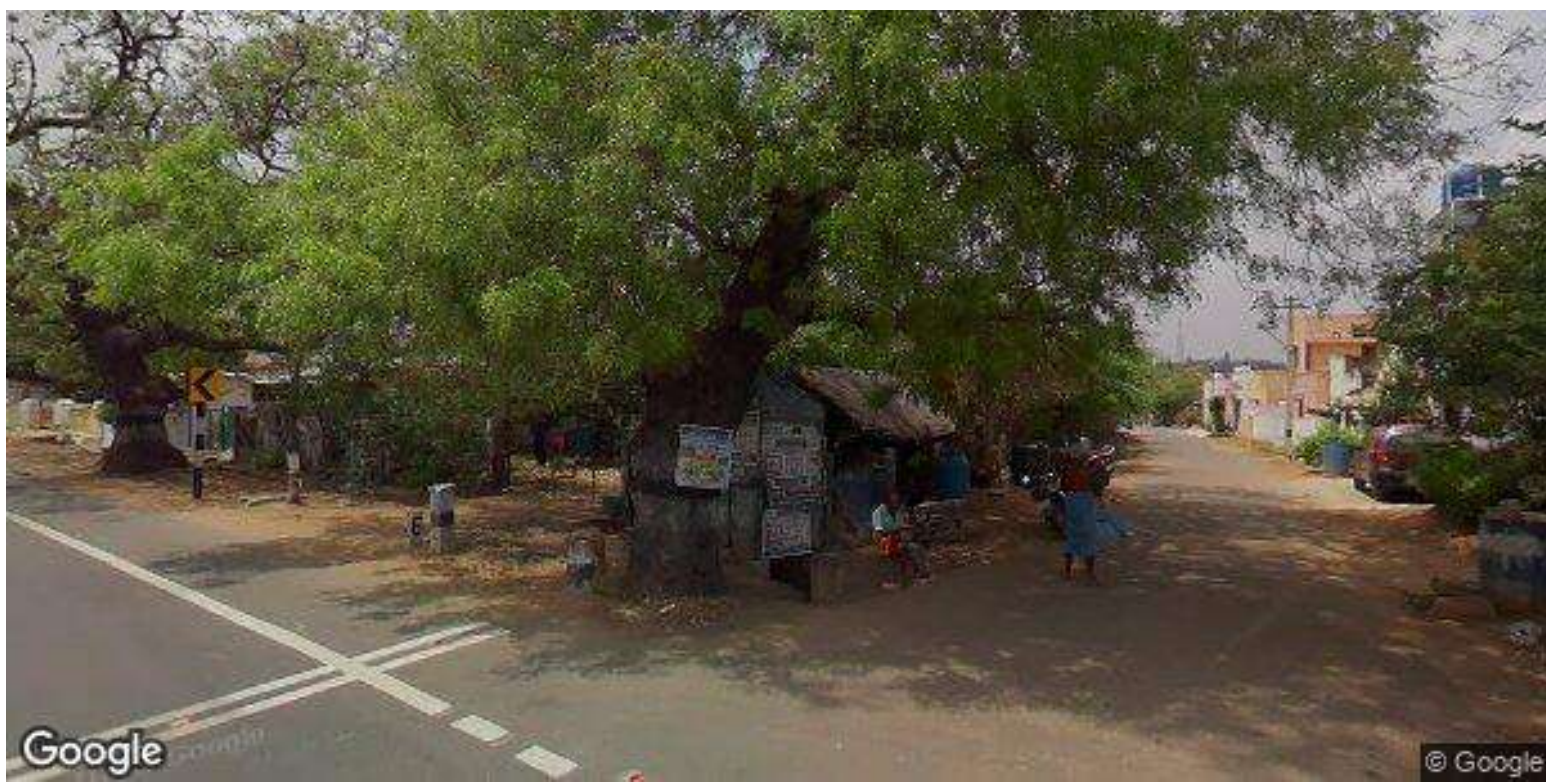
**Coordinates:** 11.17366, 77.45728

**Risk Type:** Turn

**Risk Level:** Medium

**Speed Limit:** 30 KM/Hr

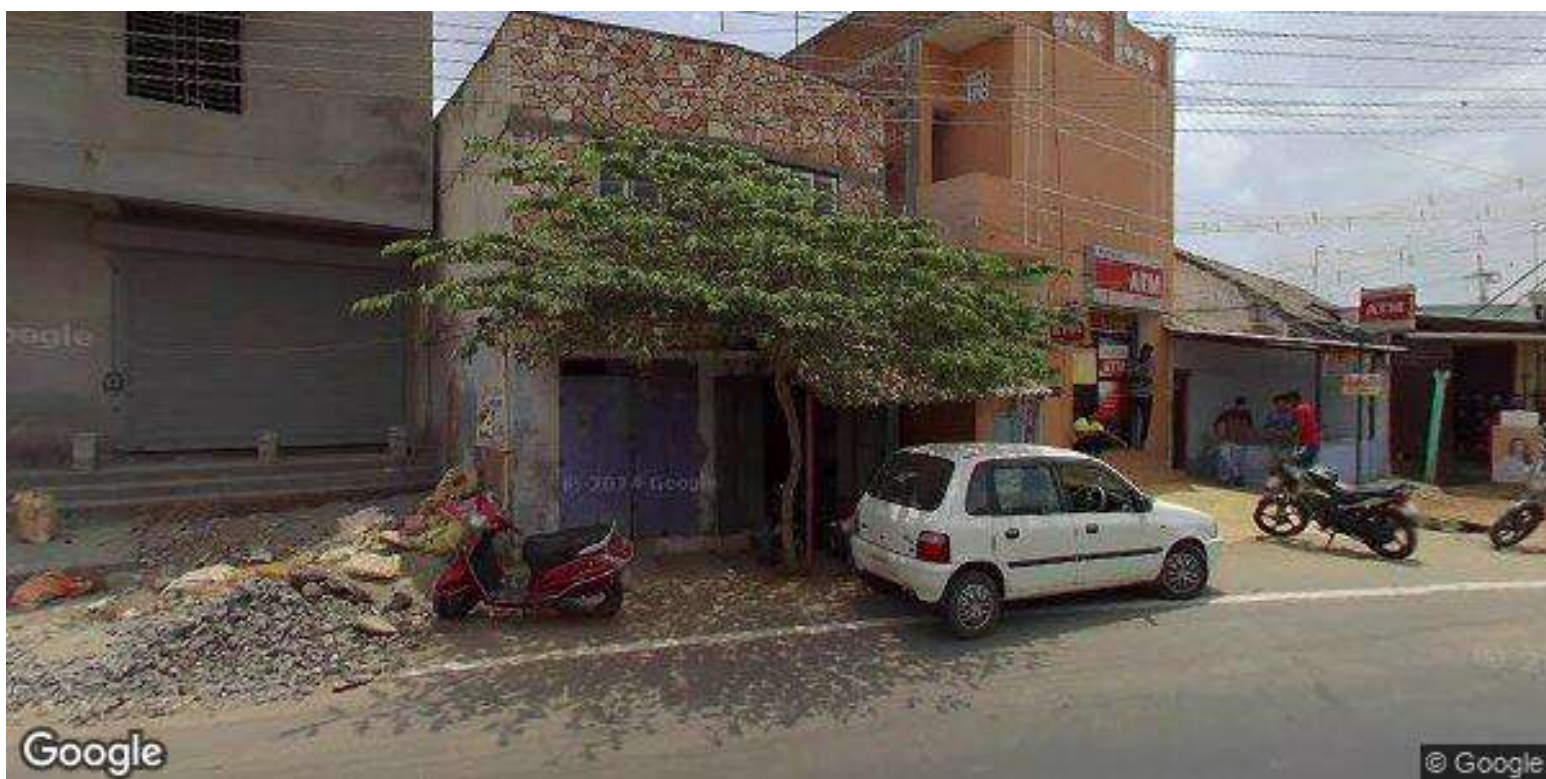
**Coordinates:** 11.17144, 77.45602

**Risk Type:** Turn

**Risk Level:** Medium

**Speed Limit:** 30 KM/Hr

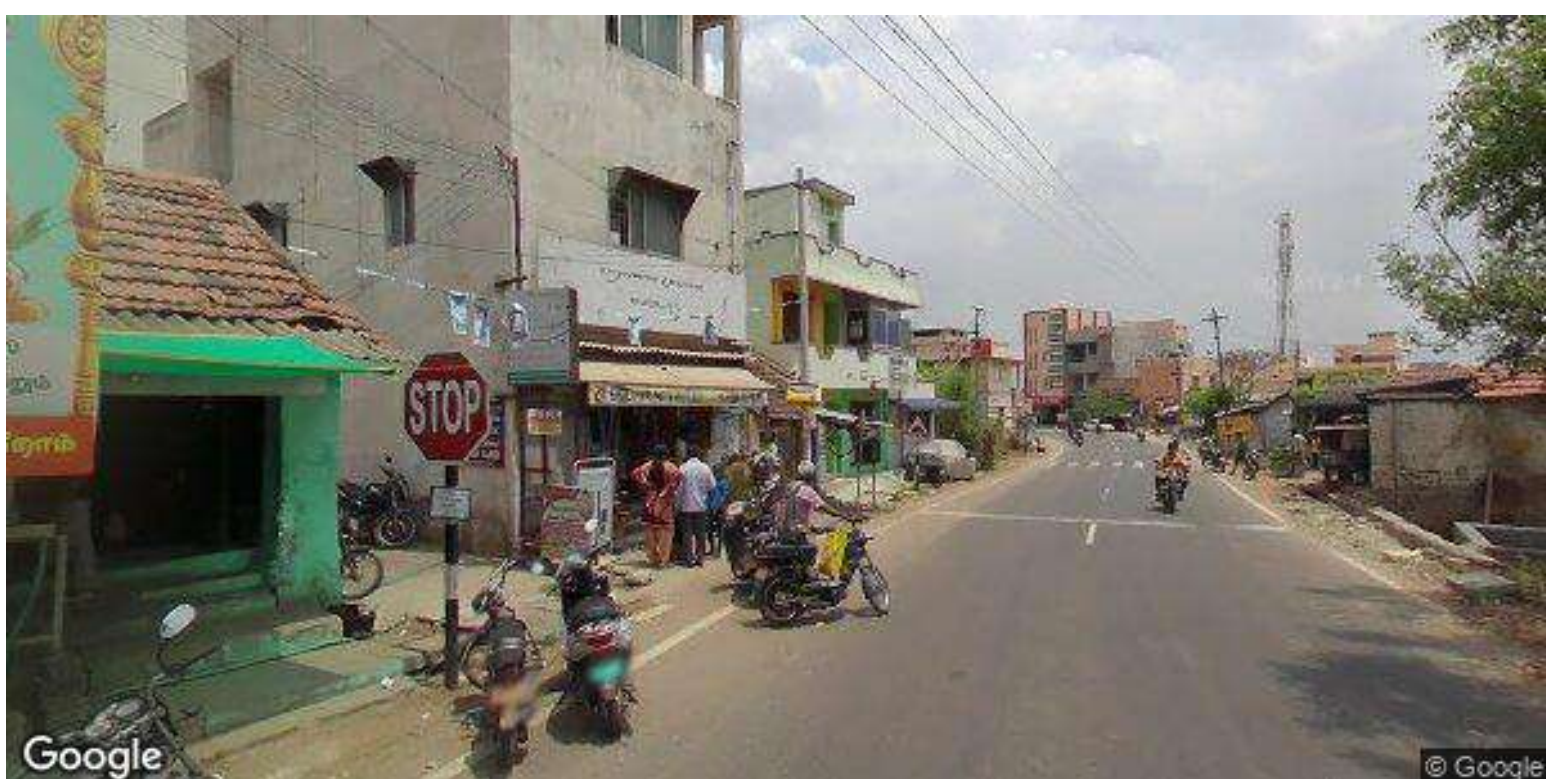
**Risk Type:** Turn  
**Risk Level:** High  
**Speed Limit:** 15 KM/Hr  
**Coordinates:** 11.17103, 77.45527
