# IndianOil

## JOURNEY RISK MANAGEMENT (JRM) STUDY

### Salem Terminal TO S P S MARKETING

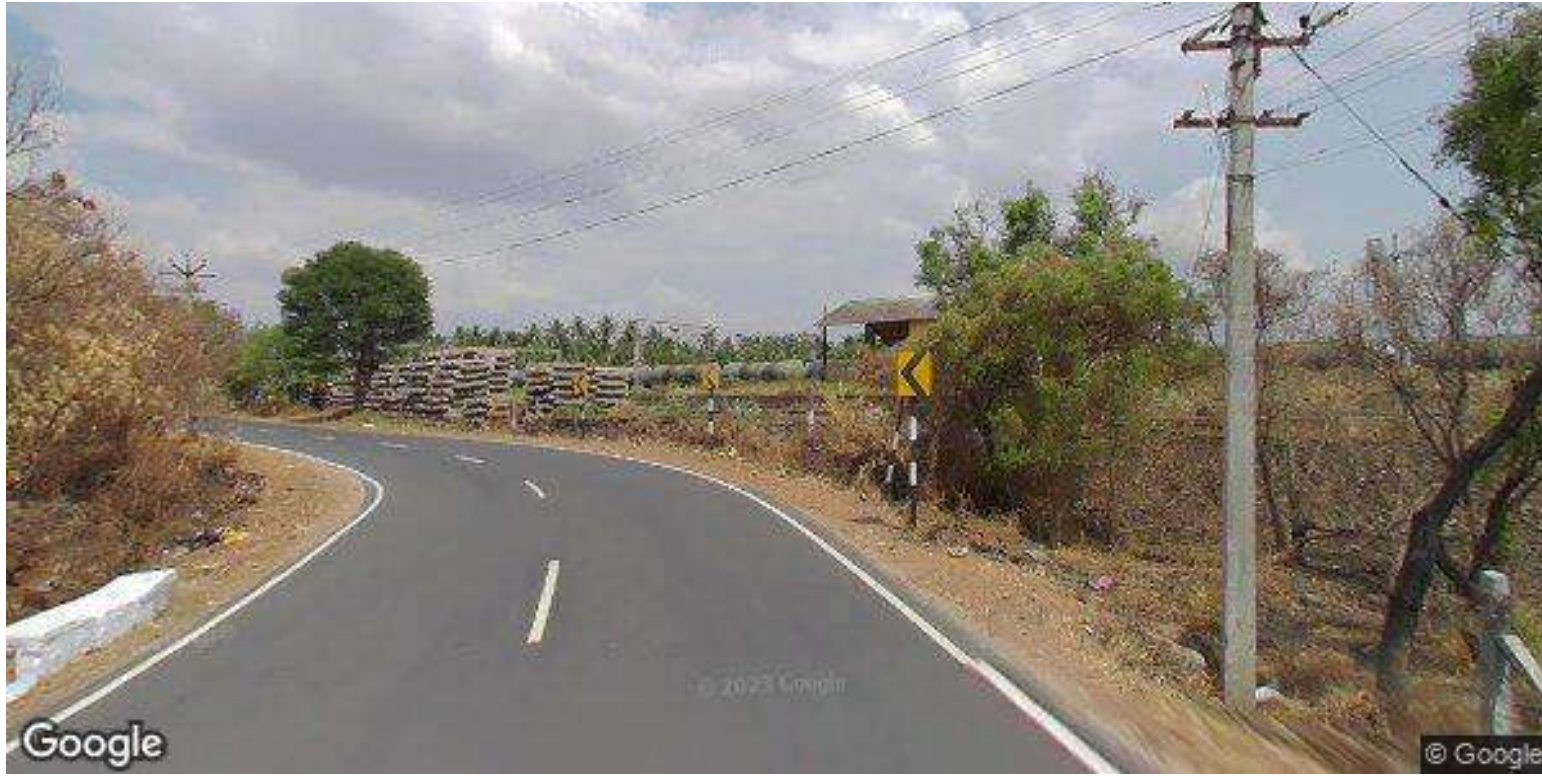
**Risk Type:** Turn  
**Risk Level:** High  
**Speed Limit:** 15 KM/Hr  
**Coordinates:** 11.15693, 77.44742

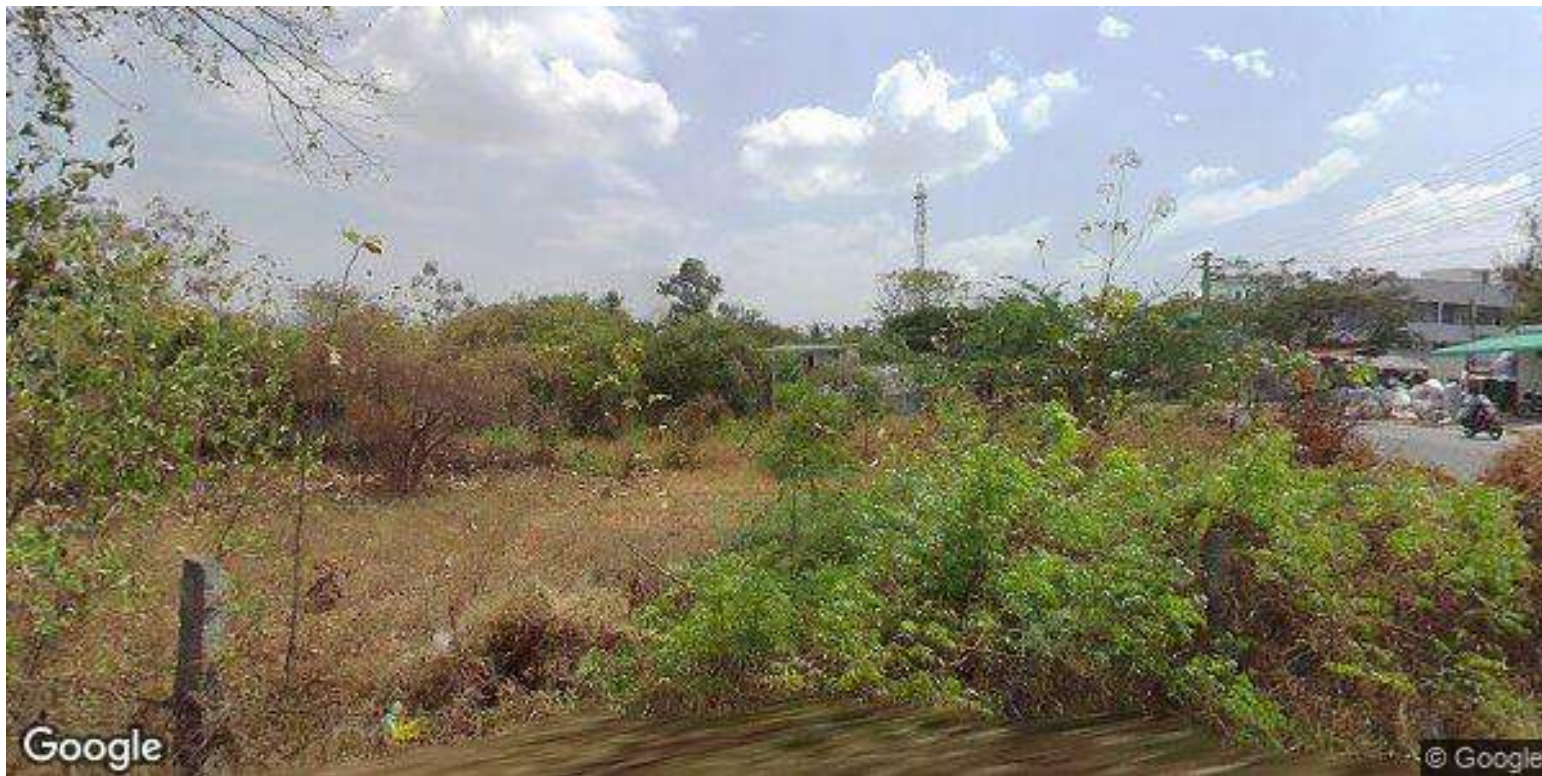
**Risk Type:** Turn  
**Risk Level:** High  
**Speed Limit:** 15 KM/Hr  
**Coordinates:** 11.15727, 77.44546

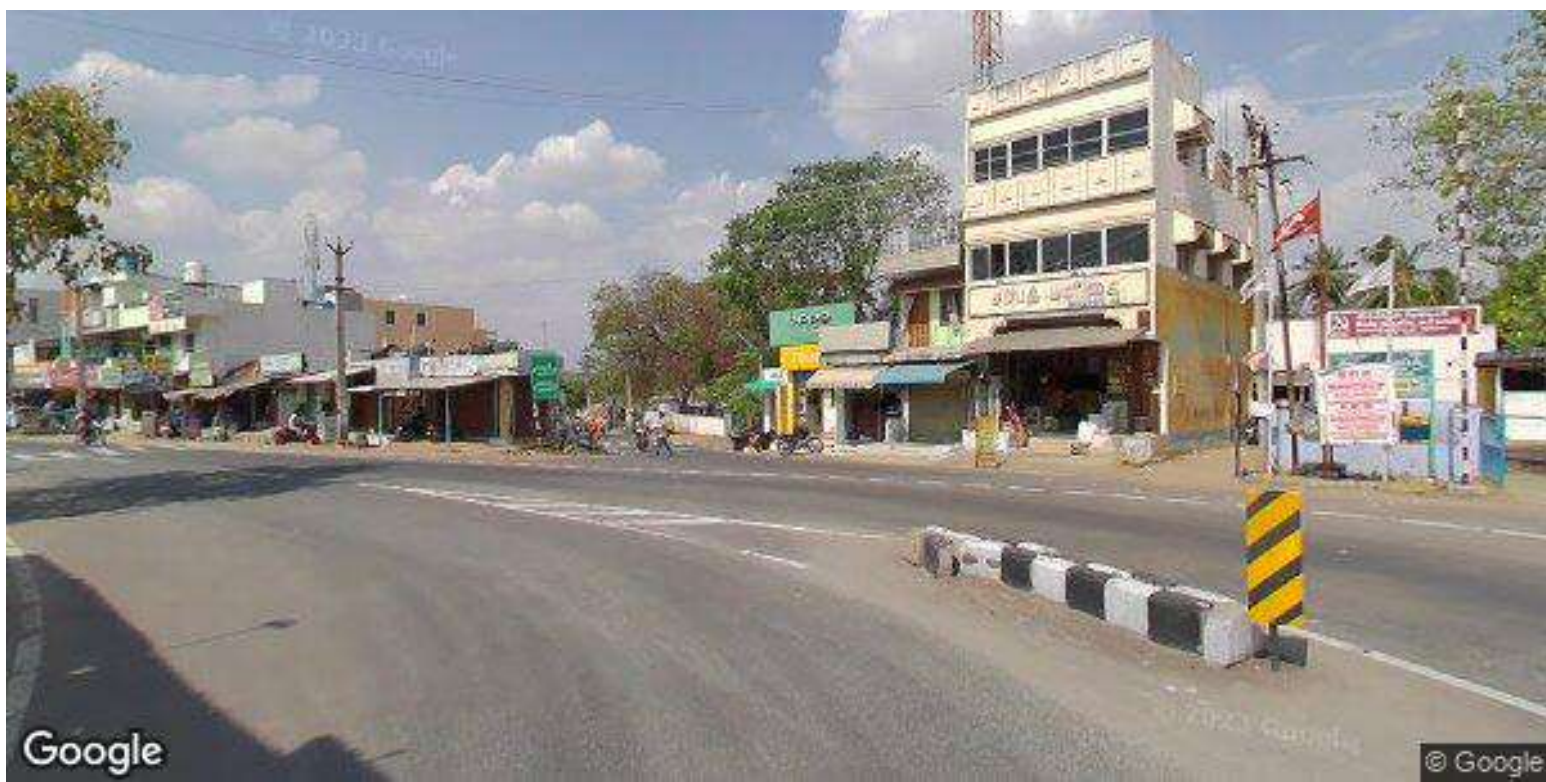
**Coordinates:** 11.15557, 77.44475

**Risk Type:** Turn

**Risk Level:** High

**Speed Limit:** 15 KM/Hr

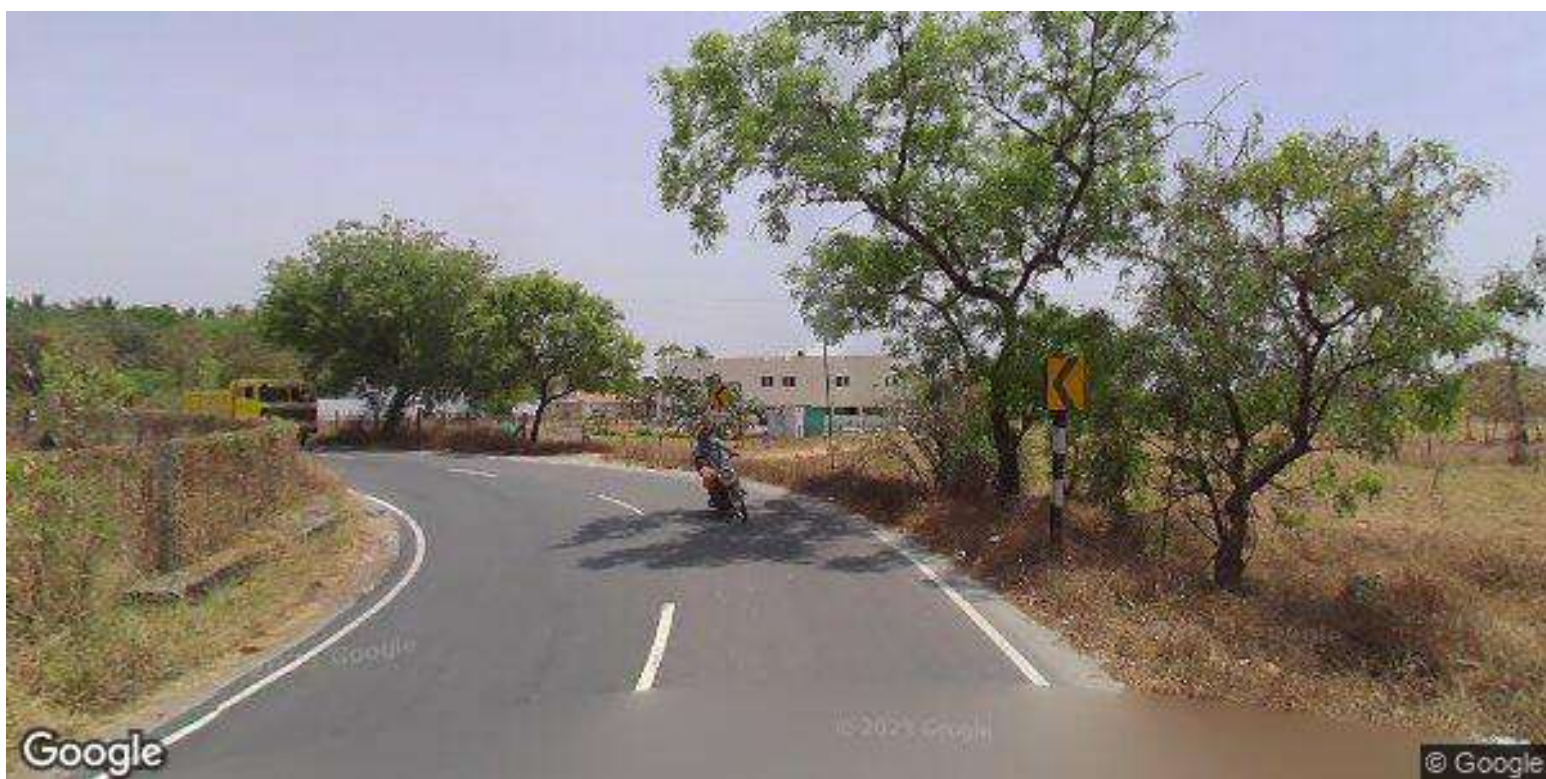
**Coordinates:** 11.15595, 77.43624

**Risk Type:** Turn

**Risk Level:** Medium

**Speed Limit:** 30 KM/Hr

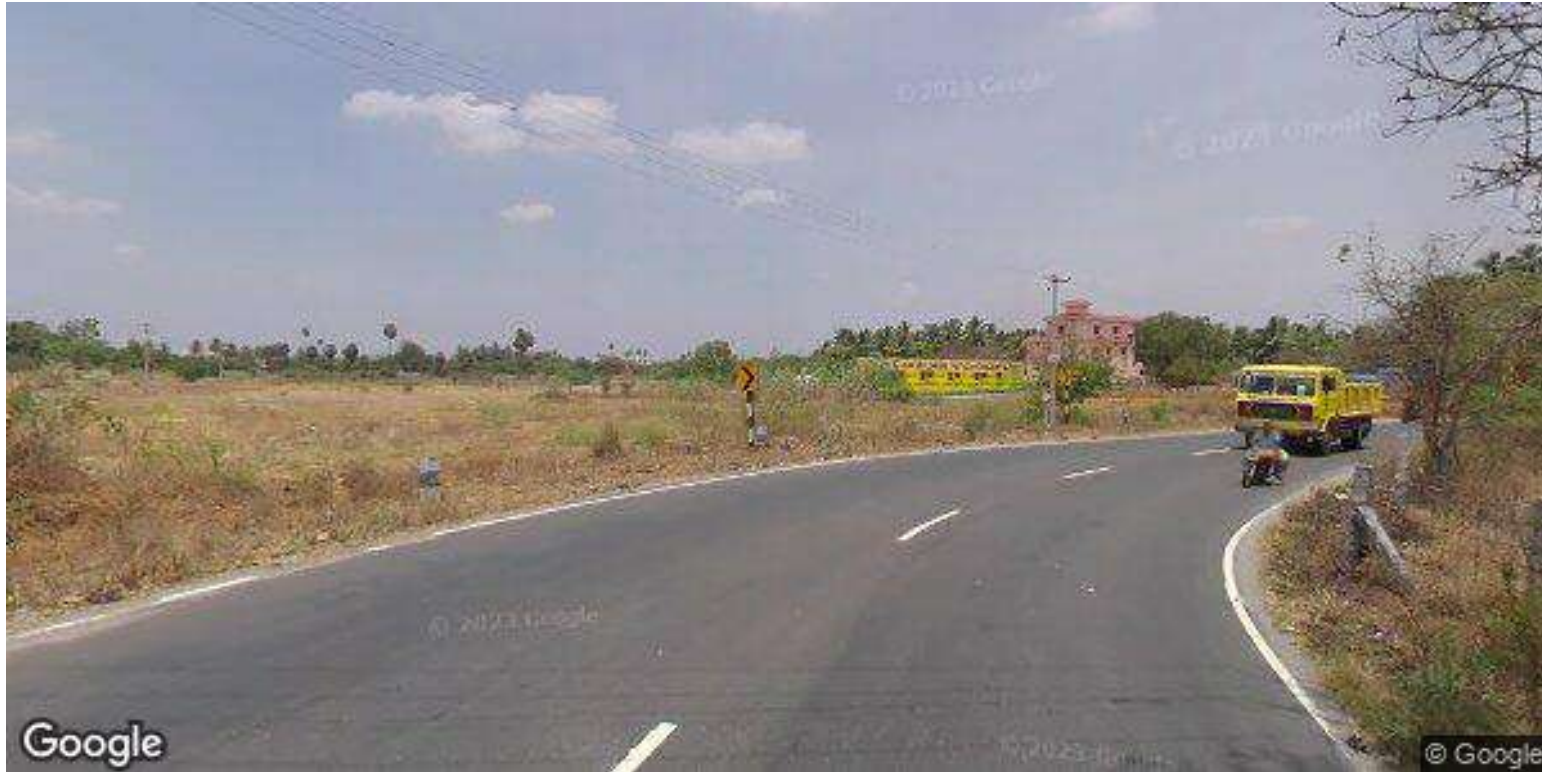
**Risk Type:** Turn  
**Risk Level:** Medium  
**Speed Limit:** 30 KM/Hr  
**Coordinates:** 11.15642, 77.43541

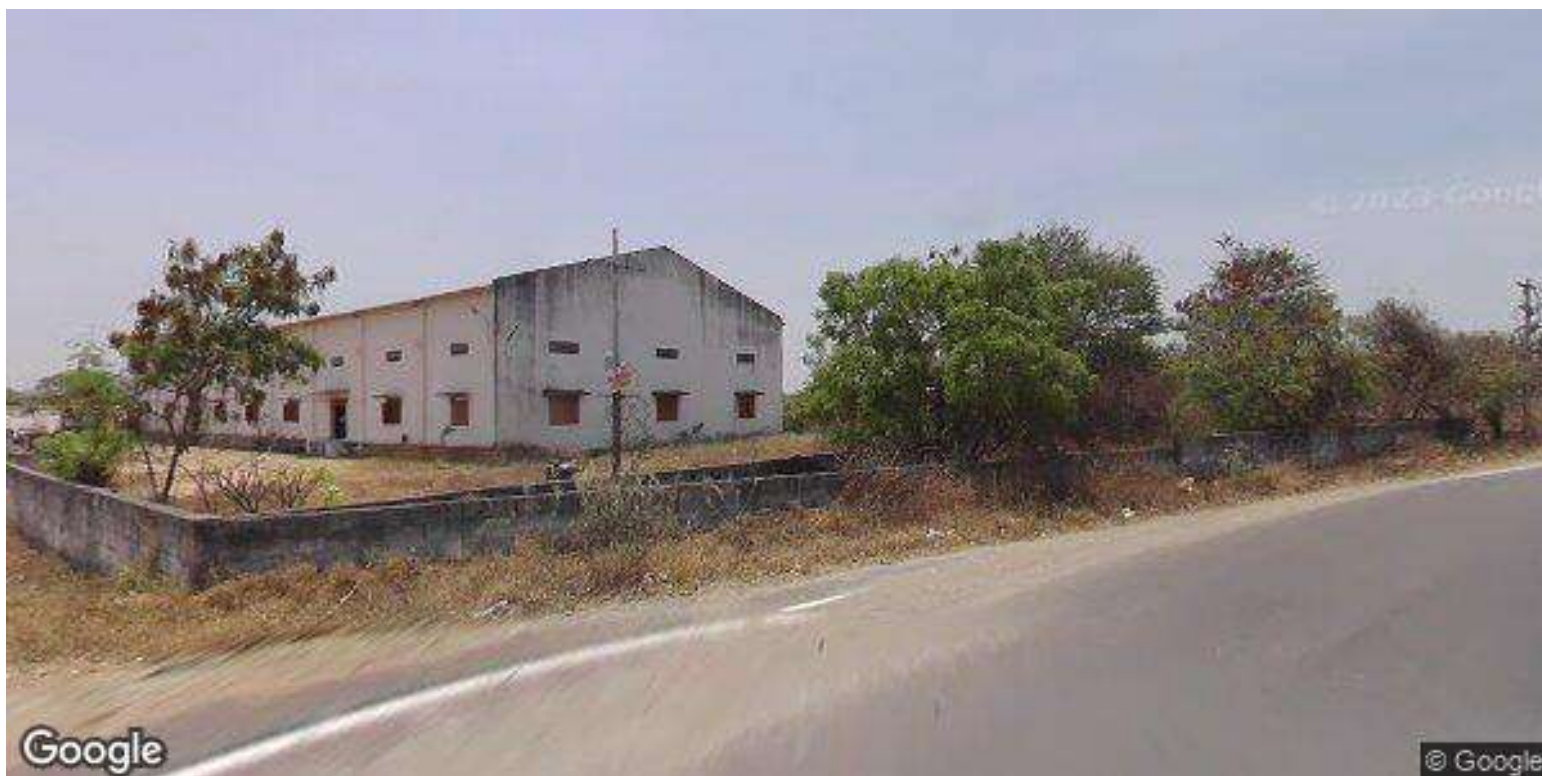
**Risk Type:** Turn  
**Risk Level:** High  
**Speed Limit:** 15 KM/Hr  
**Coordinates:** 11.15606, 77.43505

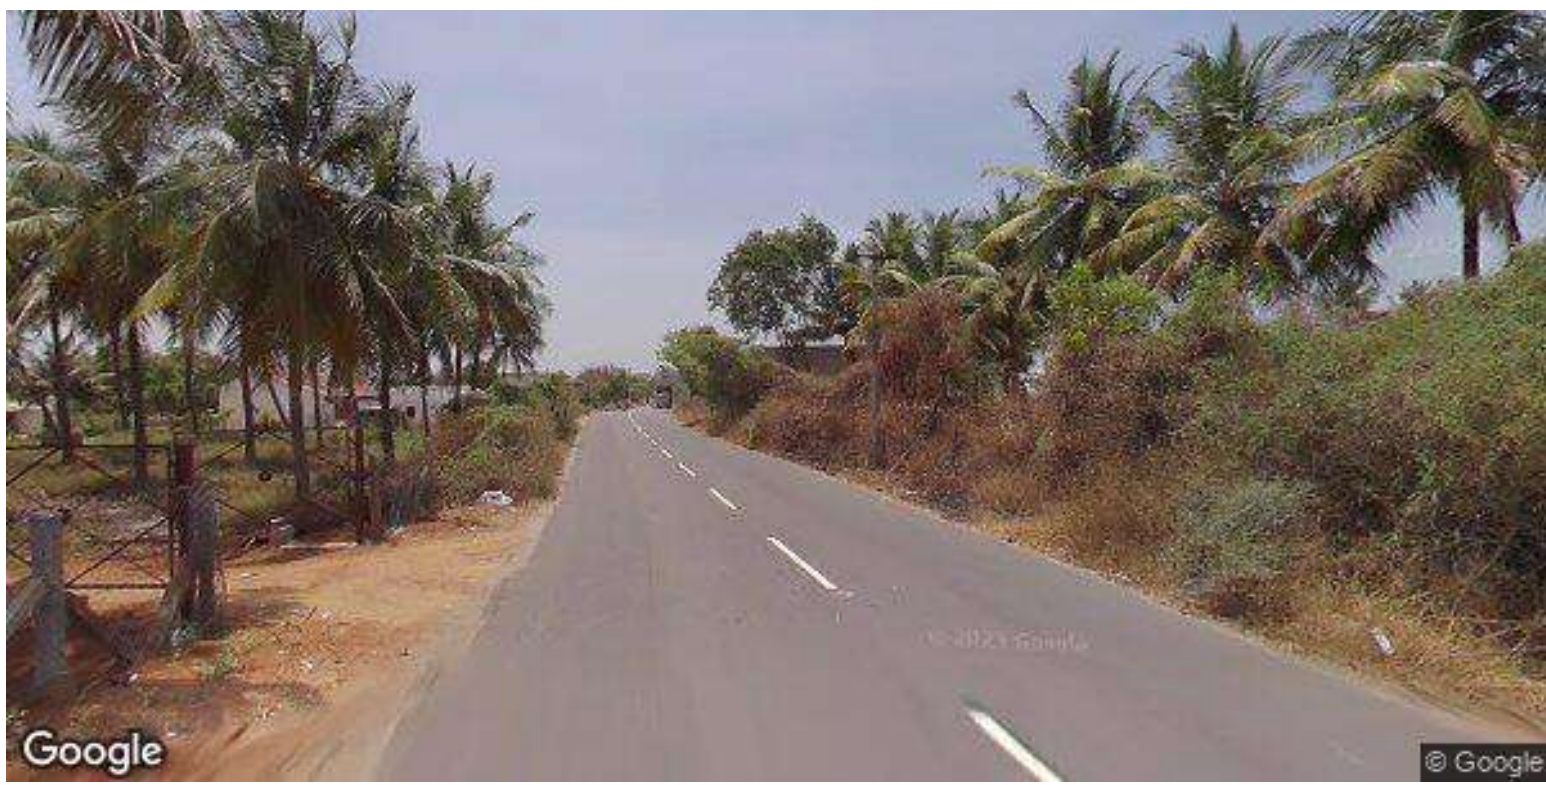
**Coordinates:** 11.15781, 77.43115

**Risk Type:** Turn

**Risk Level:** Medium

**Speed Limit:** 30 KM/Hr

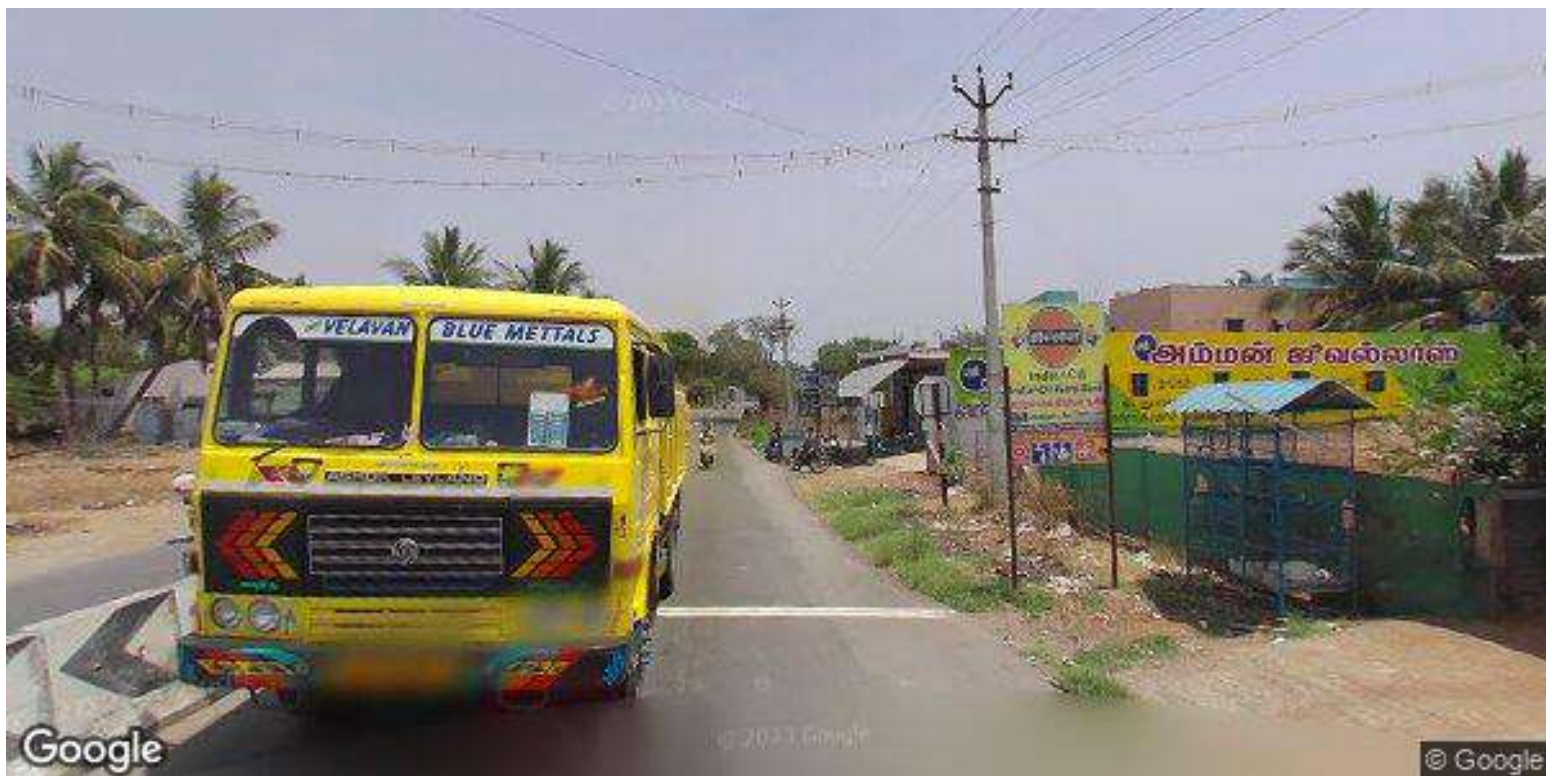
**Coordinates:** 11.15839, 77.42789

**Risk Type:** Turn

**Risk Level:** Medium

**Speed Limit:** 30 KM/Hr

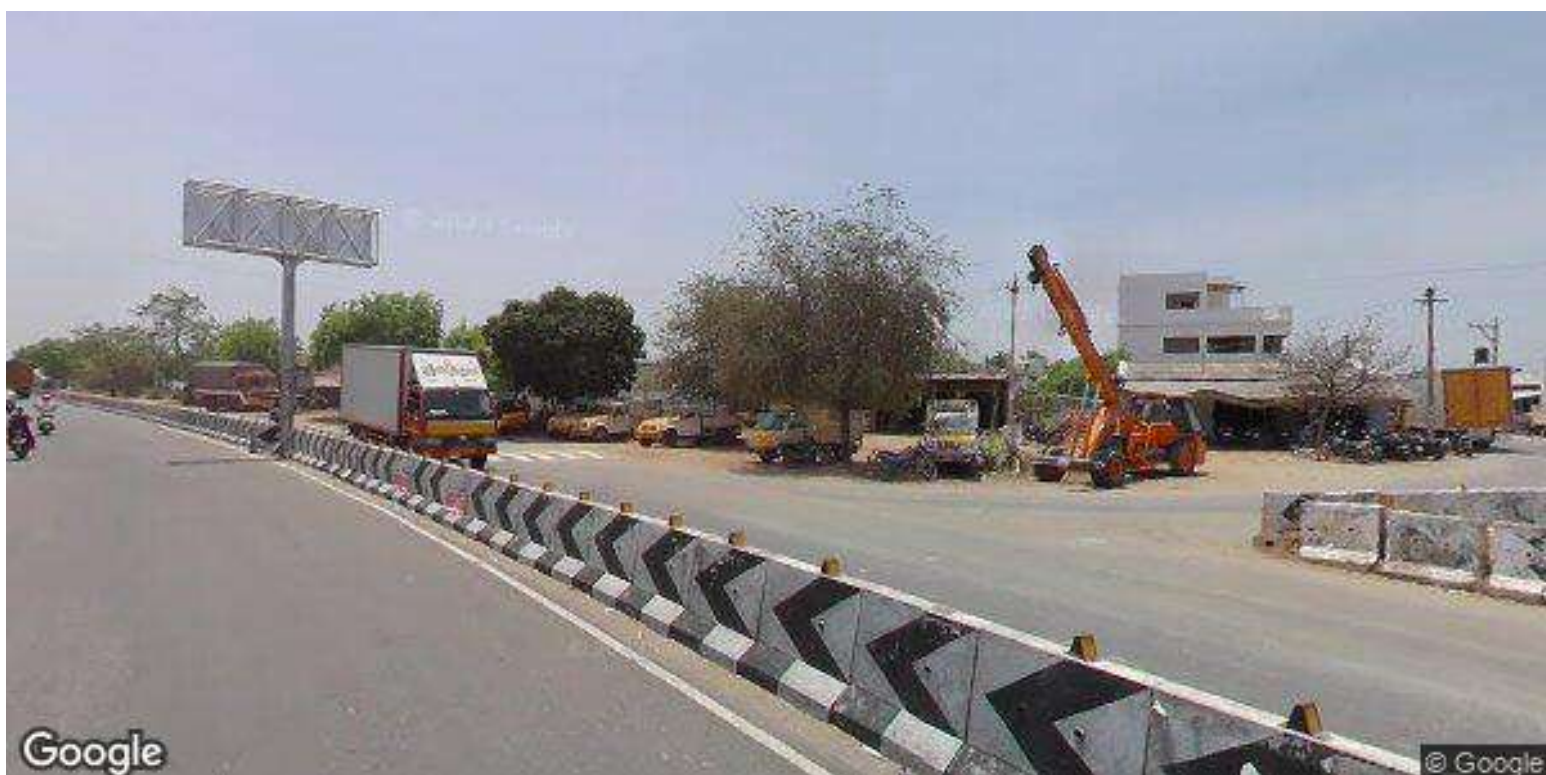
**Risk Type:** Turn  
**Risk Level:** High  
**Speed Limit:** 15 KM/Hr  
**Coordinates:** 11.15833, 77.42740

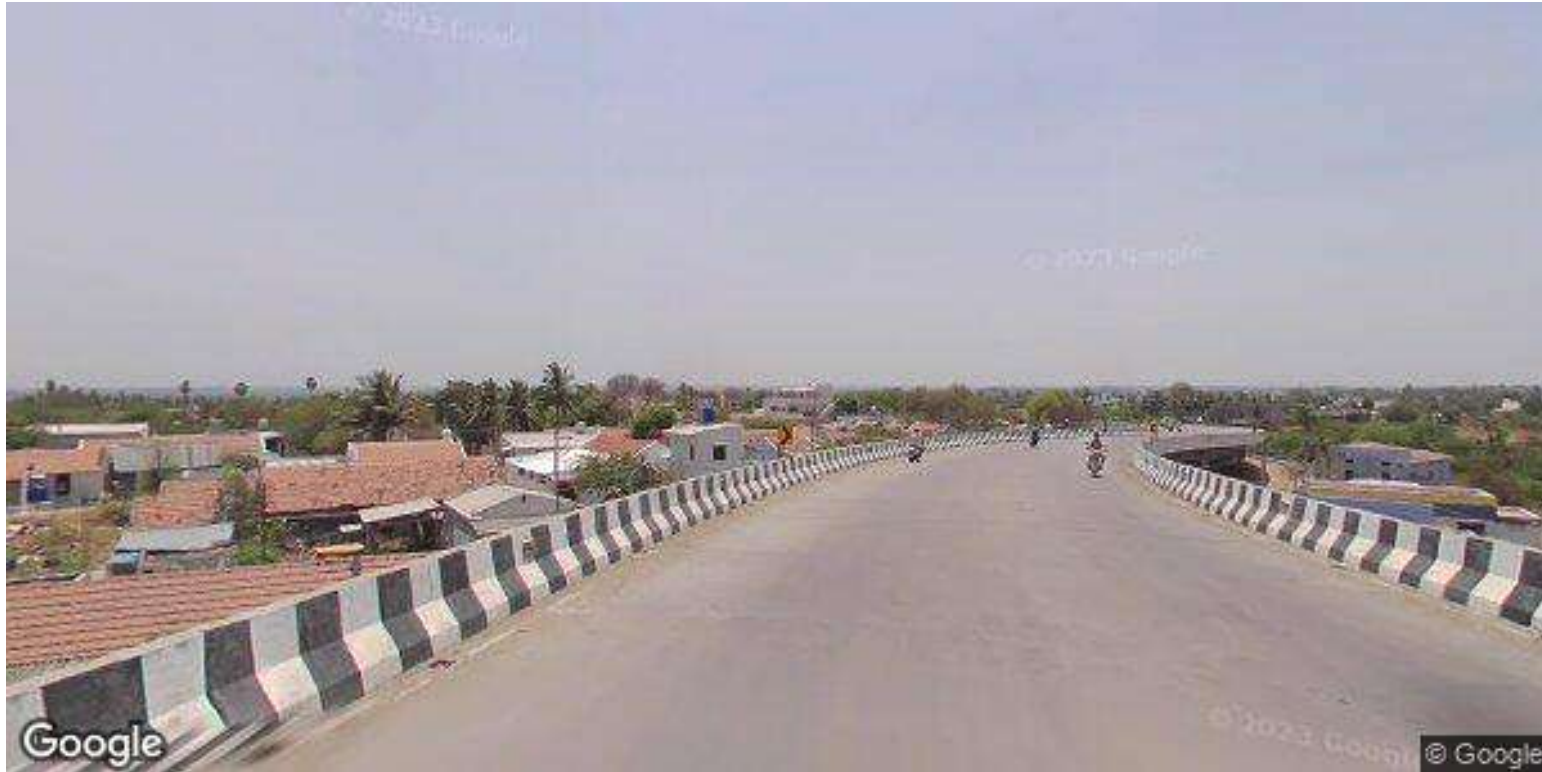
**Risk Type:** Turn  
**Risk Level:** Medium  
**Speed Limit:** 30 KM/Hr  
**Coordinates:** 11.15226, 77.42425

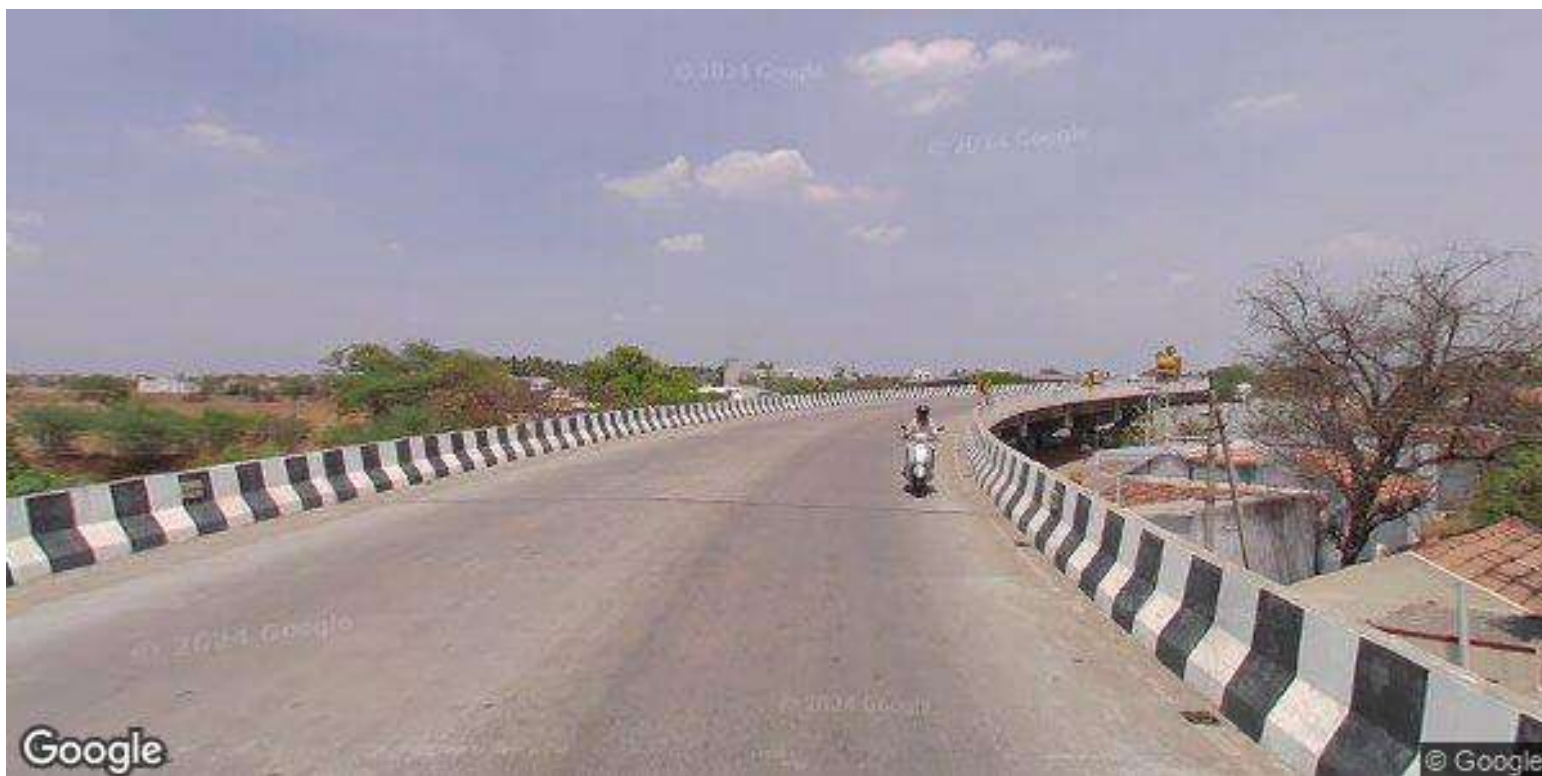
**Risk Type:** Turn  
**Risk Level:** Medium  
**Speed Limit:** 30 KM/Hr  
**Coordinates:** 11.15141, 77.42304

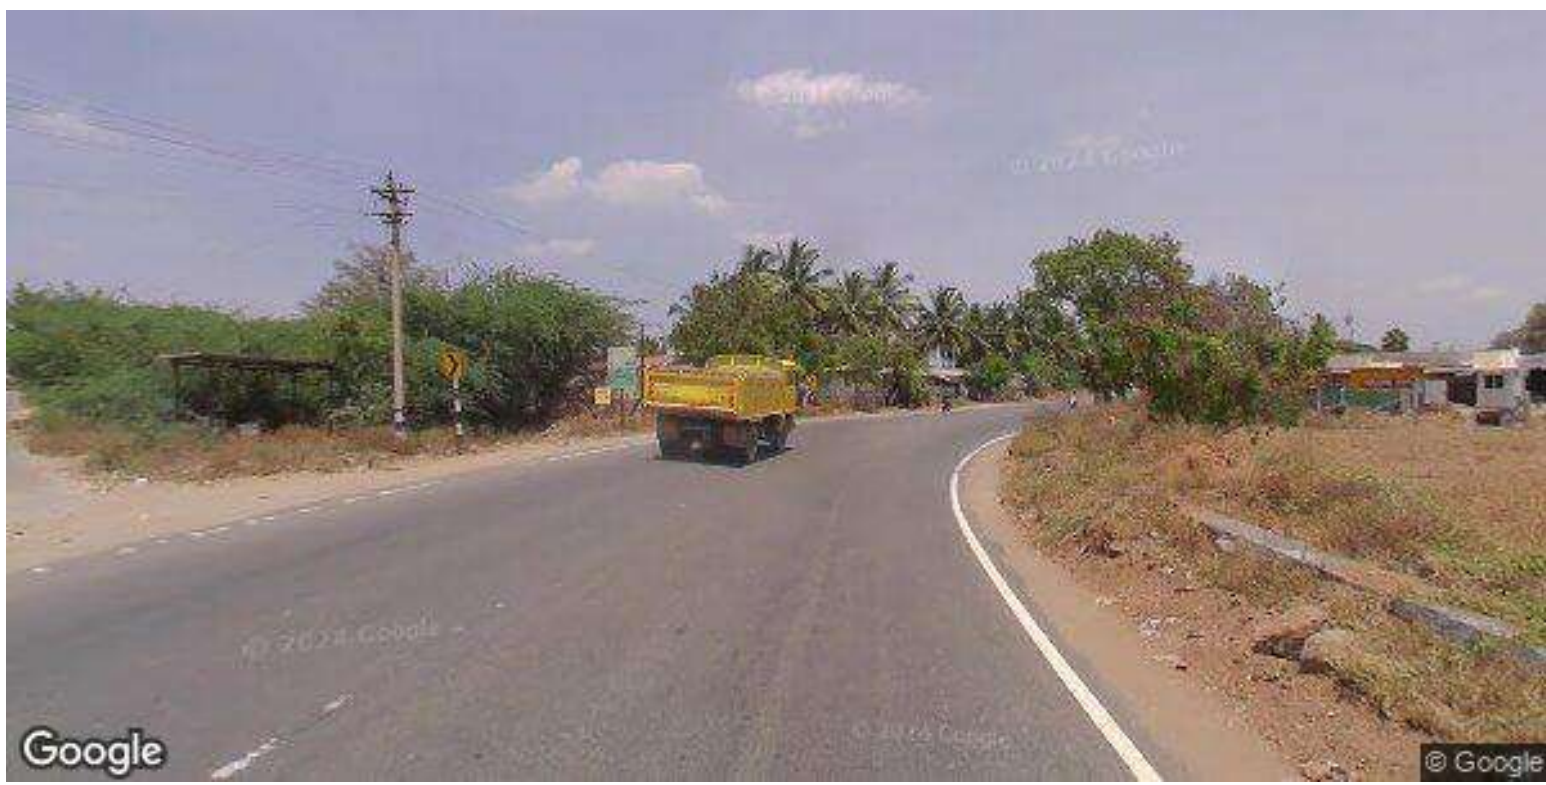
**Coordinates:** 11.14904, 77.42031

**Risk Type:** Turn

**Risk Level:** Medium

**Speed Limit:** 30 KM/Hr

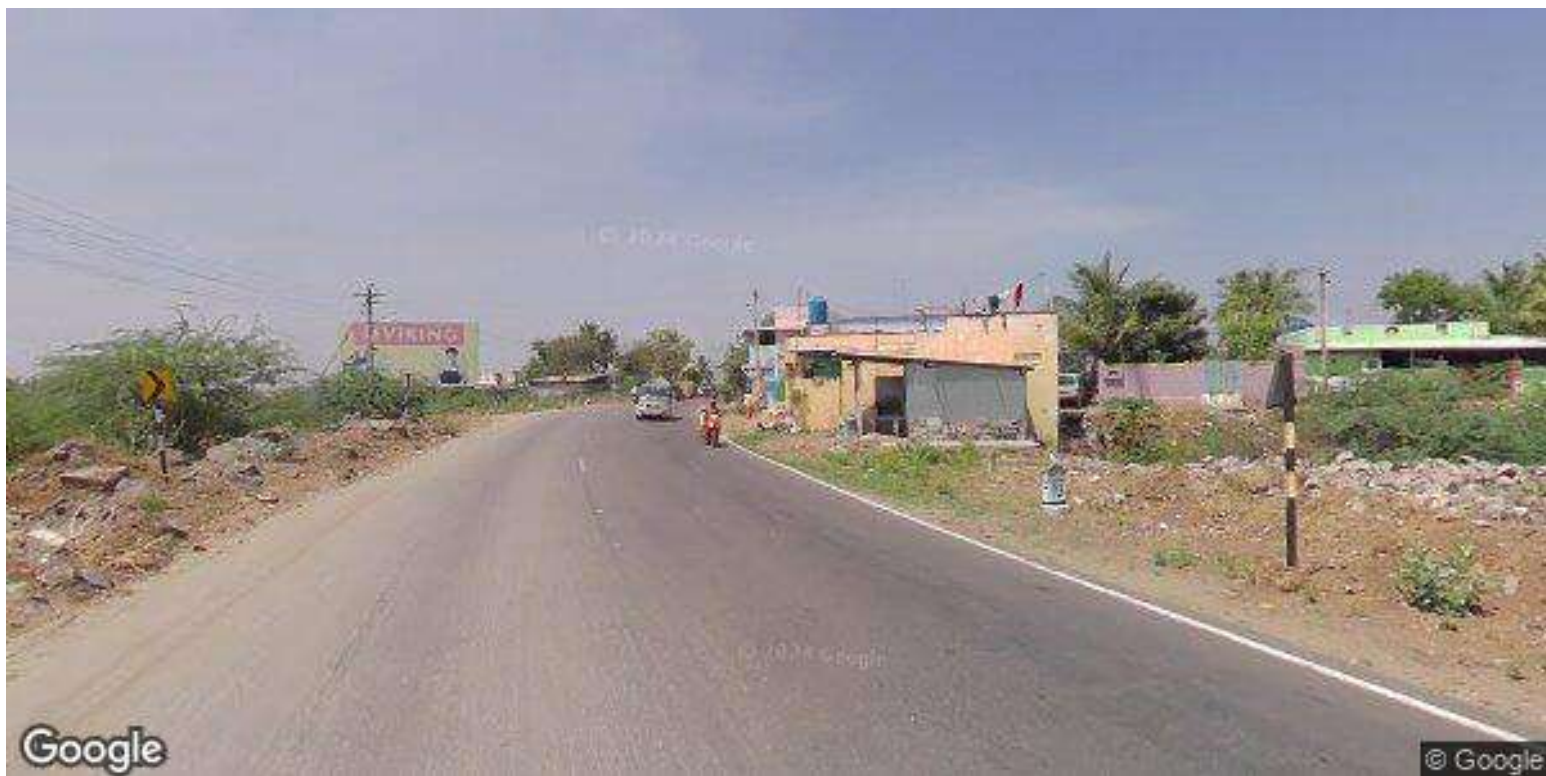
**Coordinates:** 11.13860, 77.41623

**Risk Type:** Turn

**Risk Level:** Medium

**Speed Limit:** 30 KM/Hr

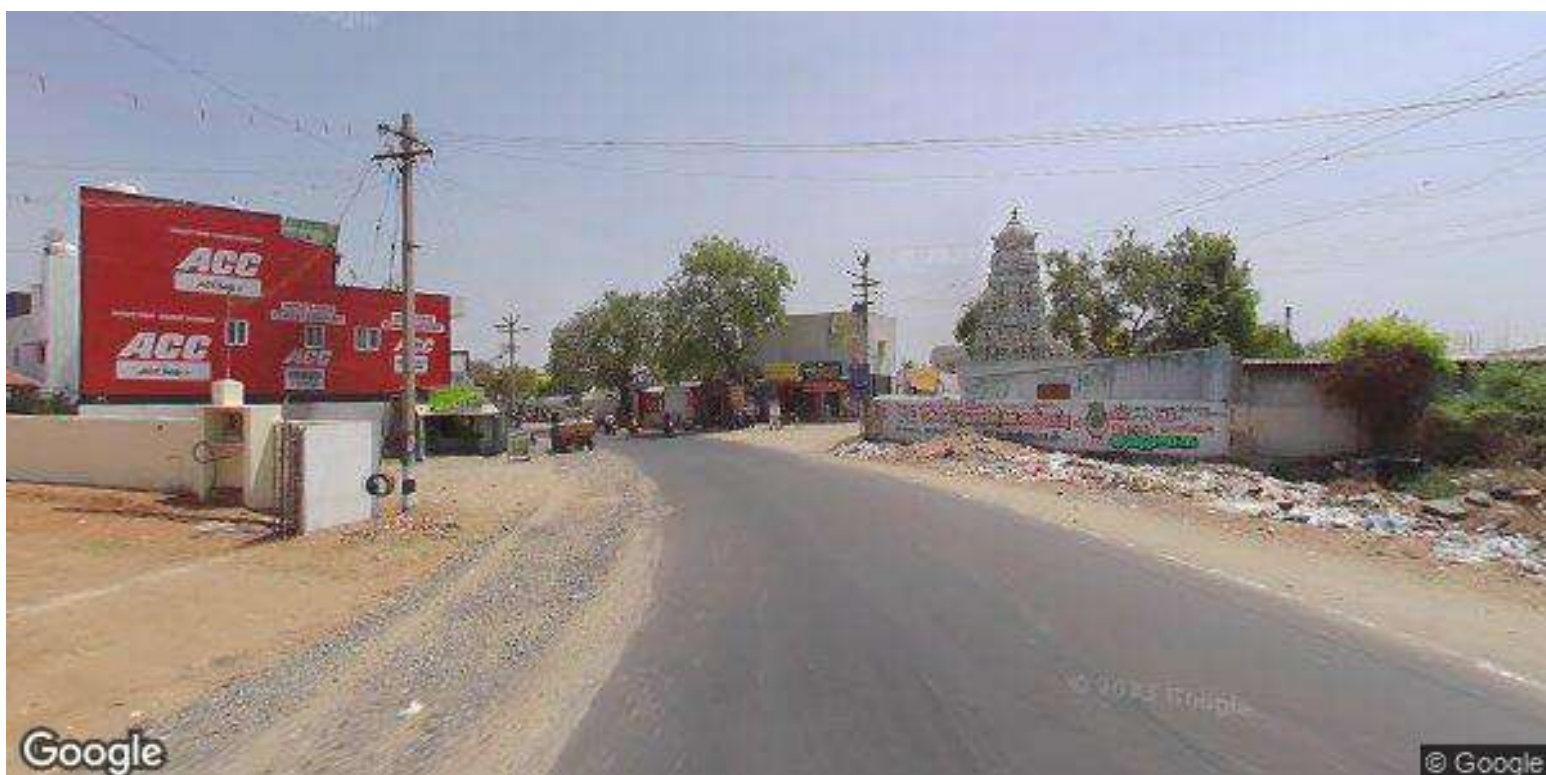
**Risk Type:** Turn  
**Risk Level:** Medium  
**Speed Limit:** 30 KM/Hr  
**Coordinates:** 11.12993, 77.40310

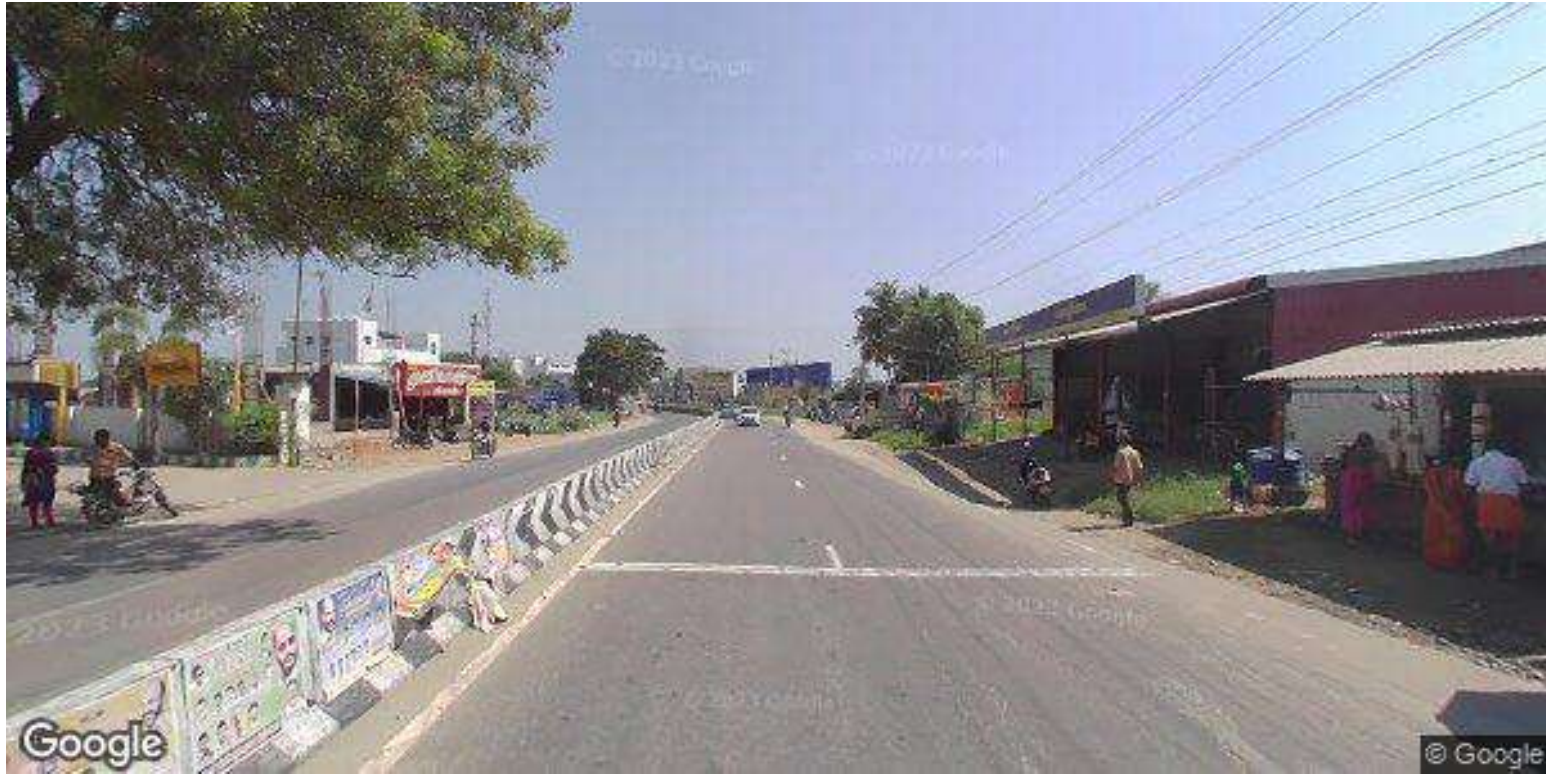
**Risk Type:** Turn  
**Risk Level:** High  
**Speed Limit:** 15 KM/Hr  
**Coordinates:** 11.12780, 77.39364

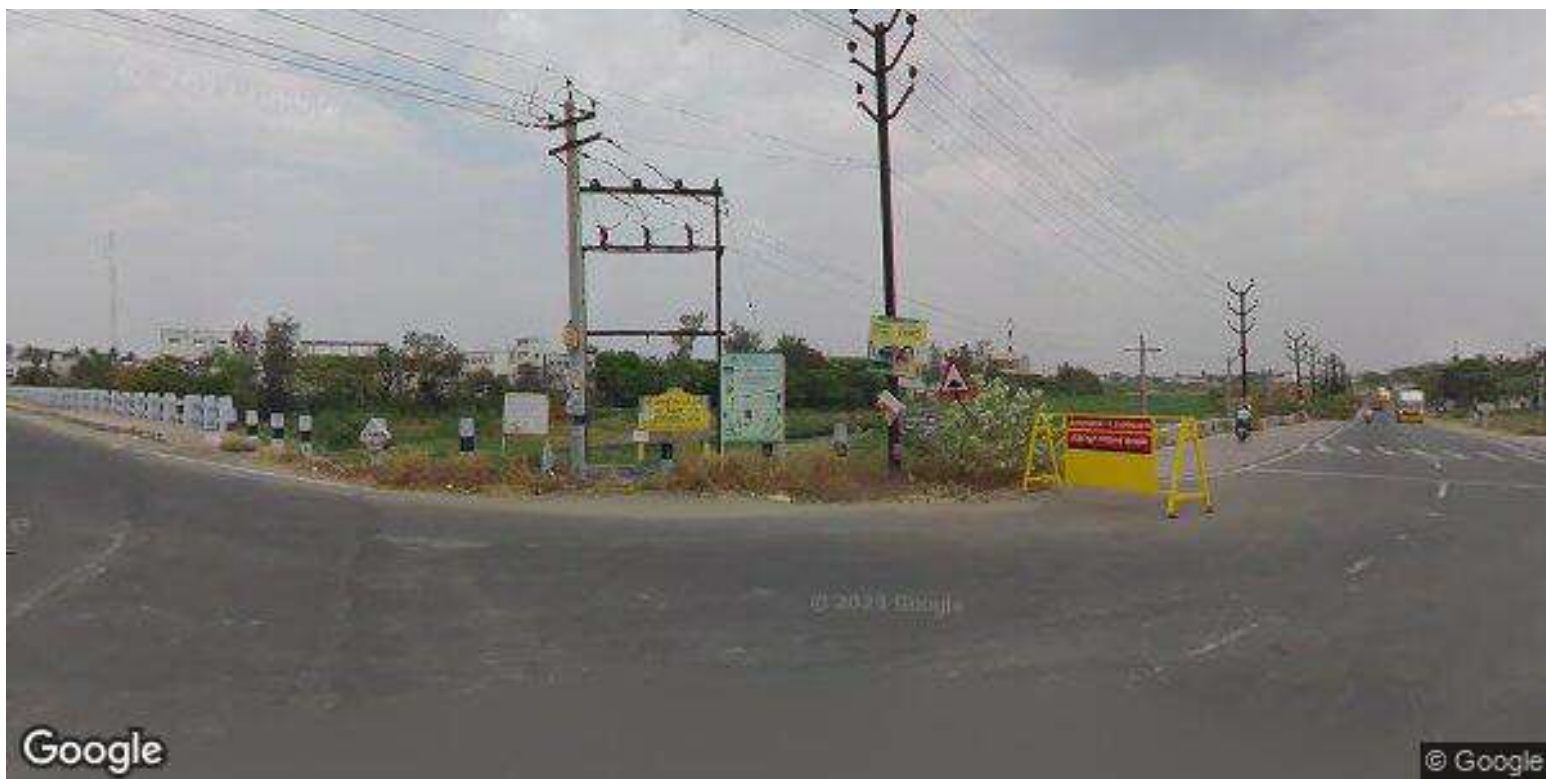
**Risk Type:** Blind Spot  
**Risk Level:** Blind Spot  
**Speed Limit:** 10 KM/Hr  
**Coordinates:** 11.11848, 77.39475

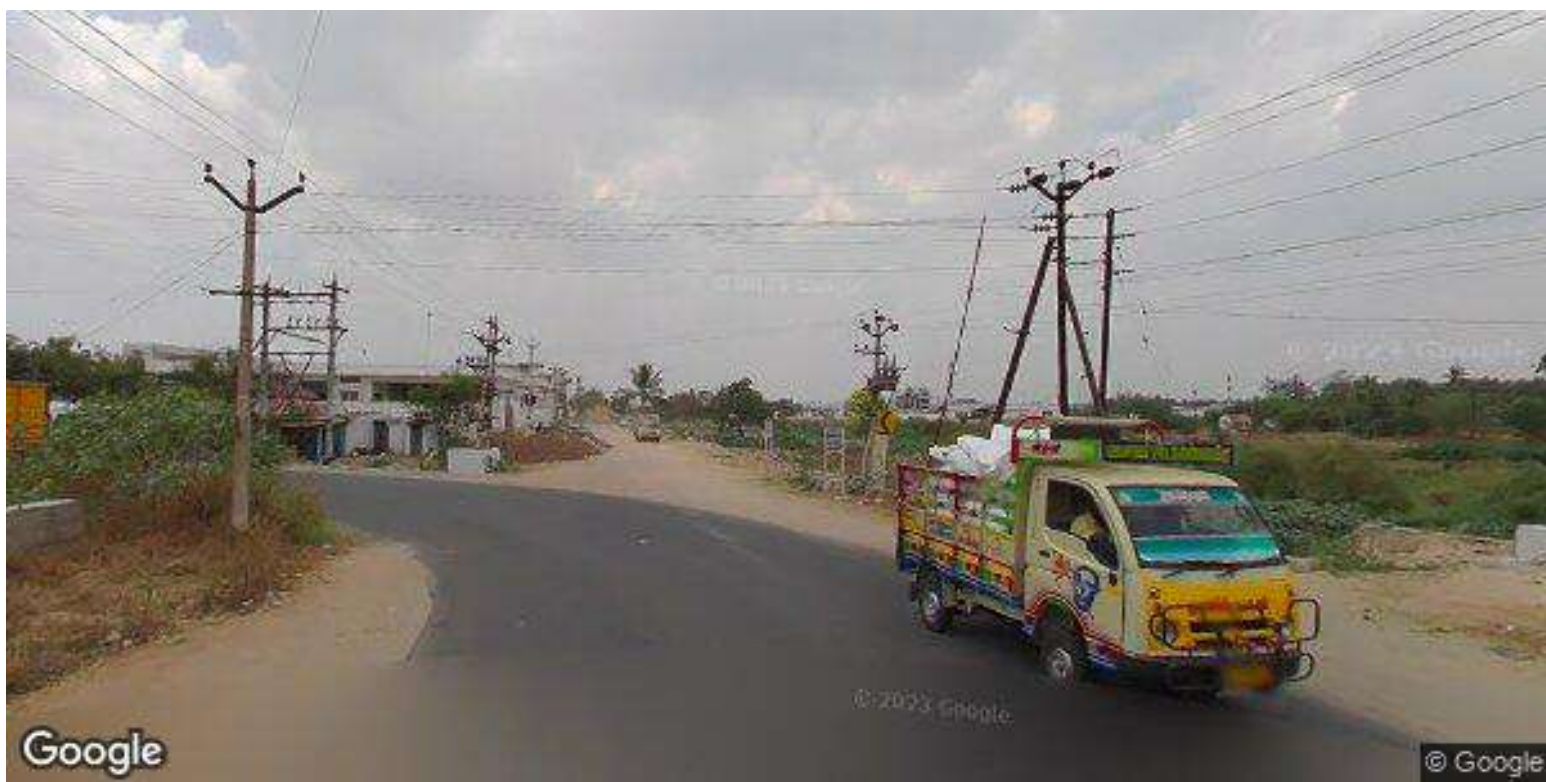
**Coordinates:** 11.11841, 77.39405

**Risk Type:** Turn

**Risk Level:** Medium

**Speed Limit:** 30 KM/Hr

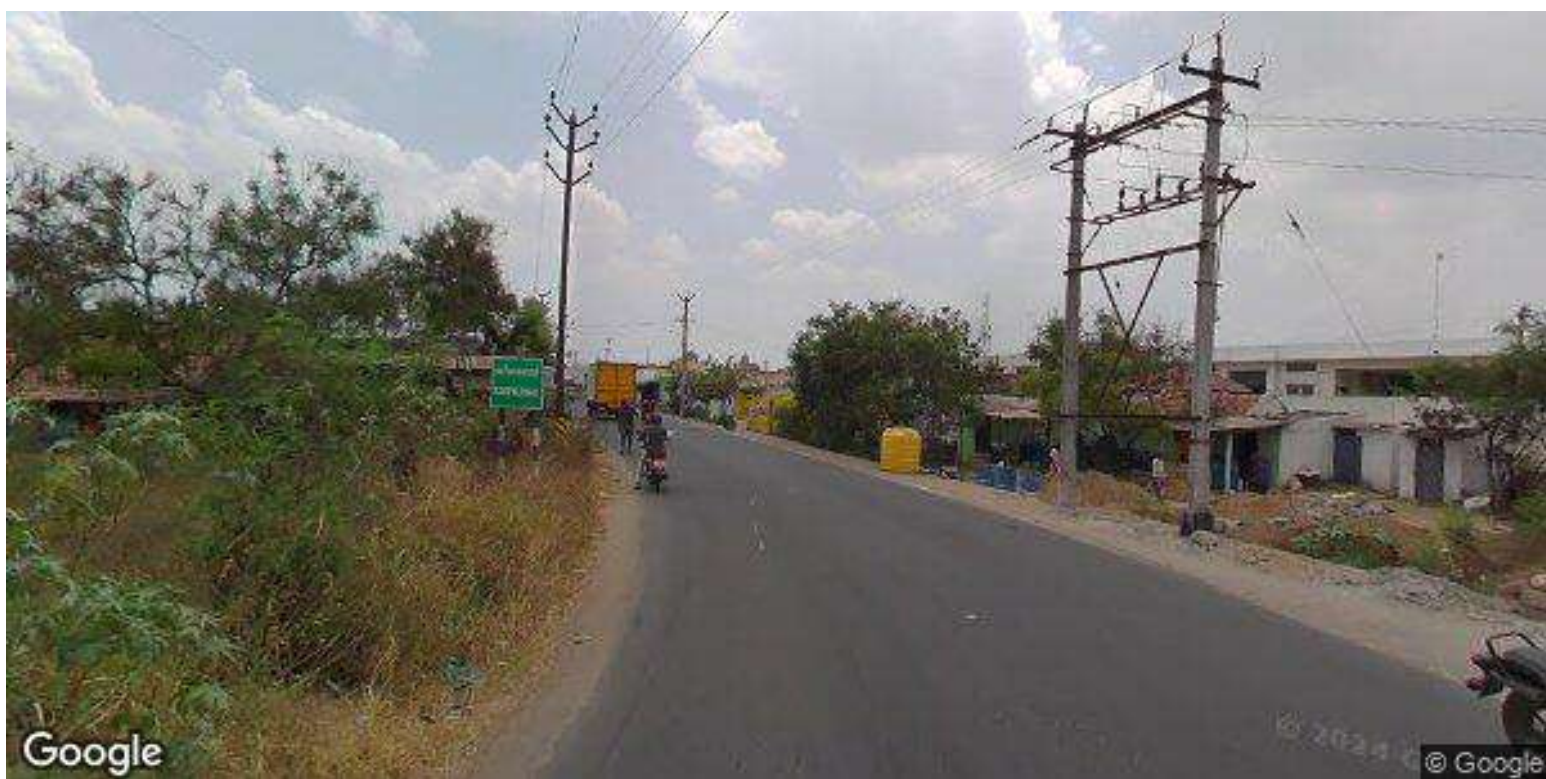
**Coordinates:** 11.11826, 77.39386

**Risk Type:** Turn

**Risk Level:** Medium

**Speed Limit:** 30 KM/Hr

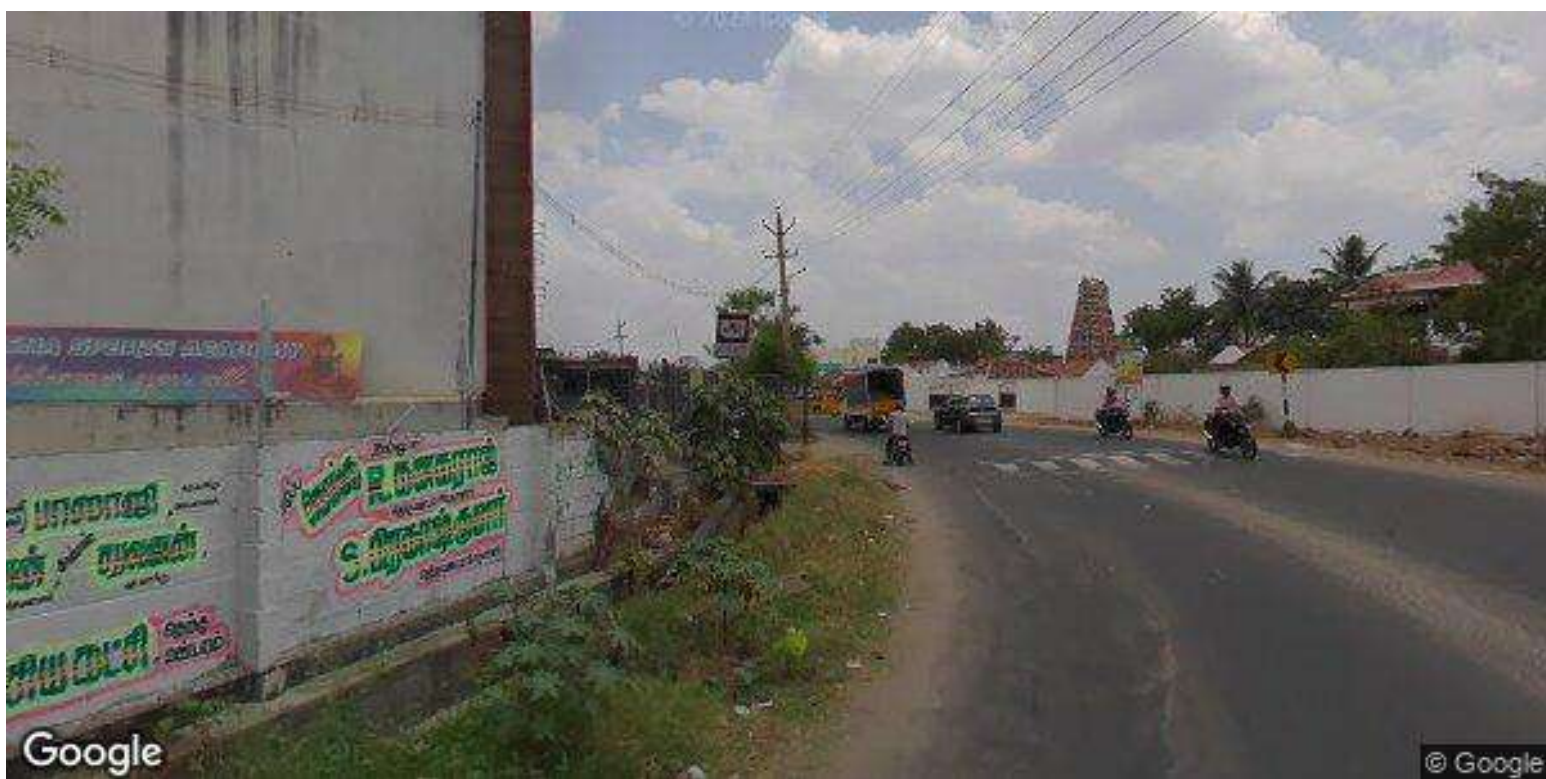
**Risk Type:** Turn  
**Risk Level:** High  
**Speed Limit:** 15 KM/Hr  
**Coordinates:** 11.10290, 77.39189
