# IndianOil

## JOURNEY RISK MANAGEMENT (JRM) STUDY

### Salem Terminal TO S P S MARKETING

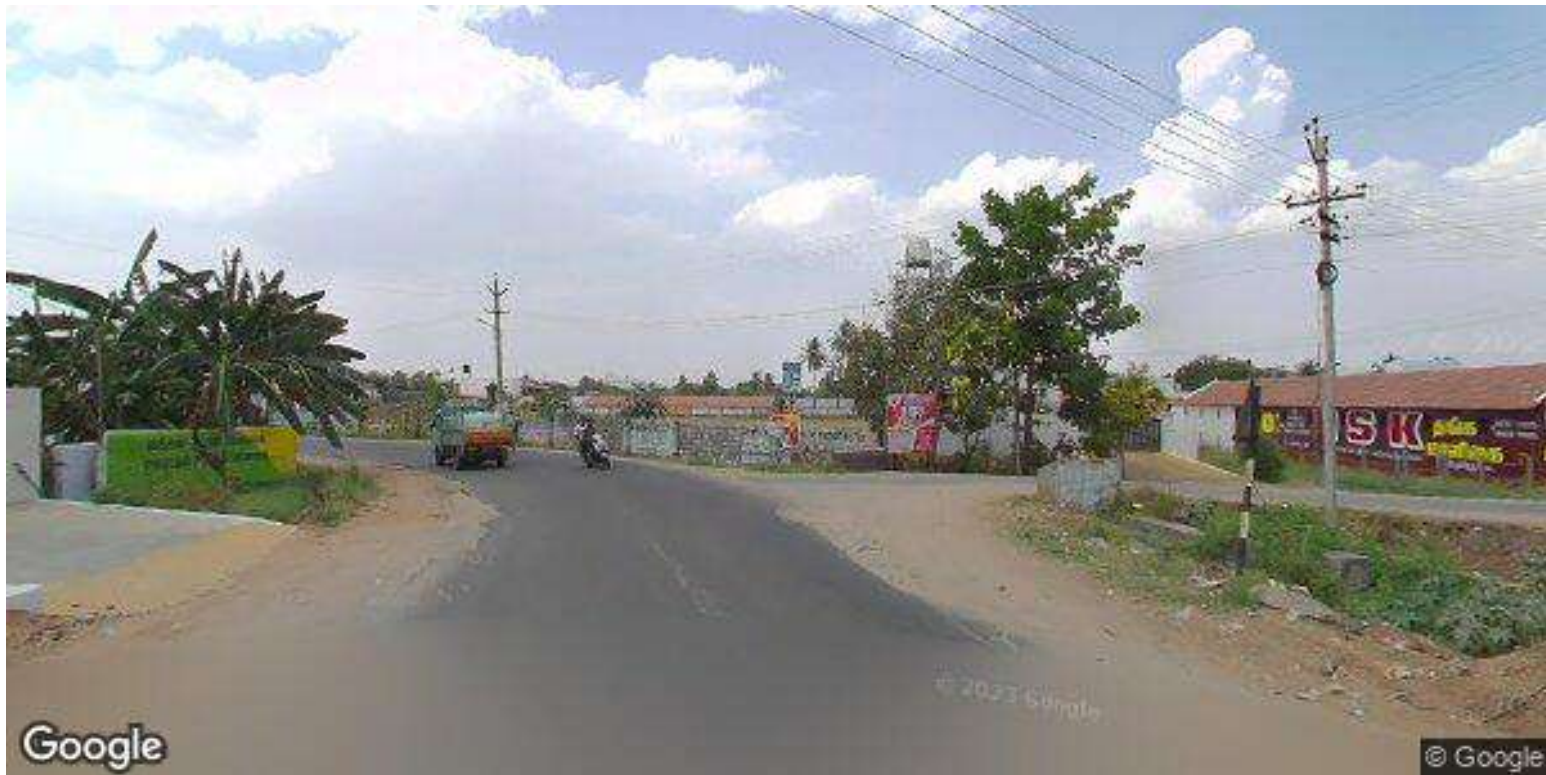
**Risk Type:** Turn  
**Risk Level:** Medium  
**Speed Limit:** 30 KM/Hr  
**Coordinates:** 11.10233, 77.39295

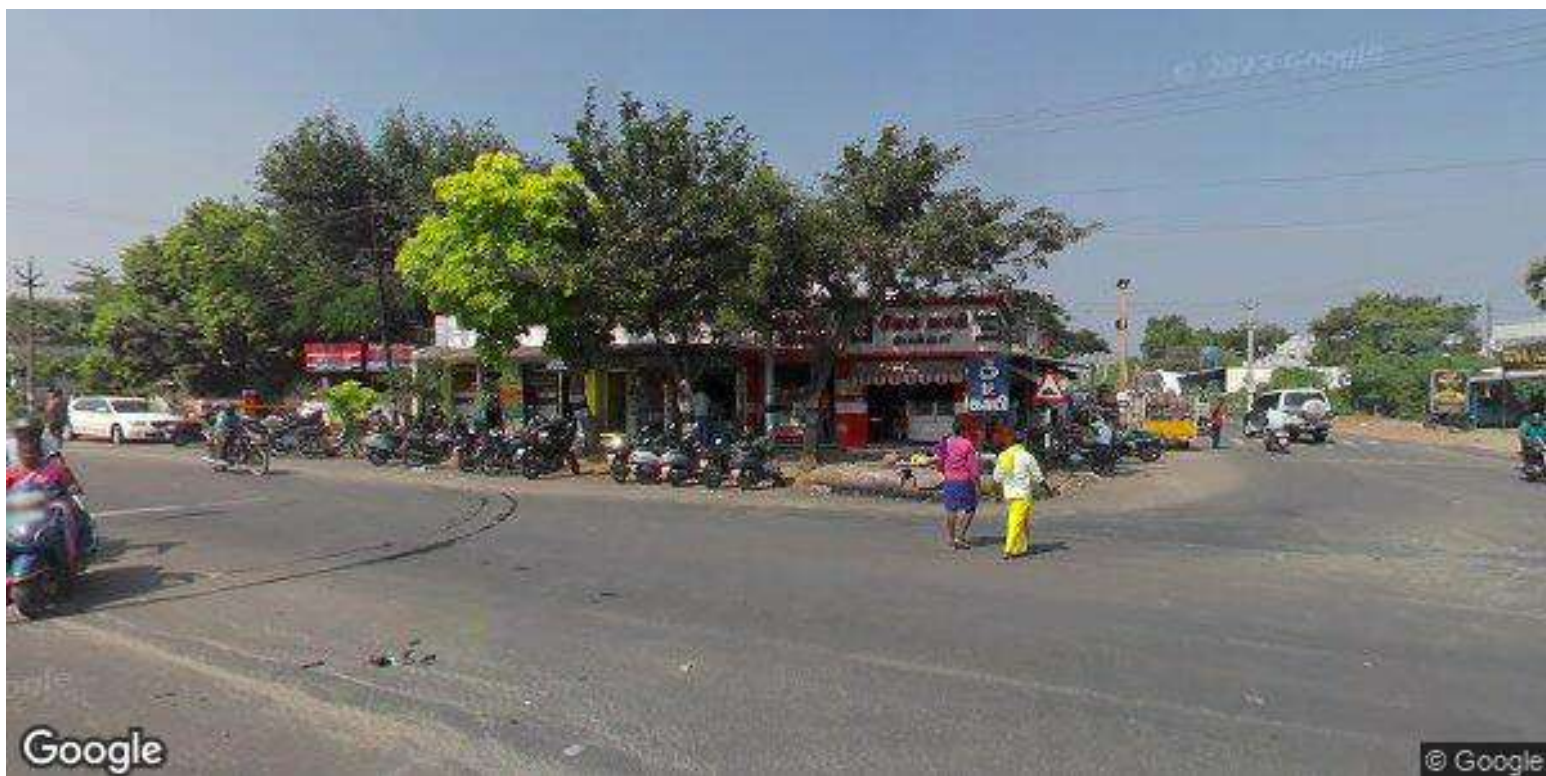
**Risk Type:** Blind Spot  
**Risk Level:** Blind Spot  
**Speed Limit:** 10 KM/Hr  
**Coordinates:** 11.09878, 77.39311

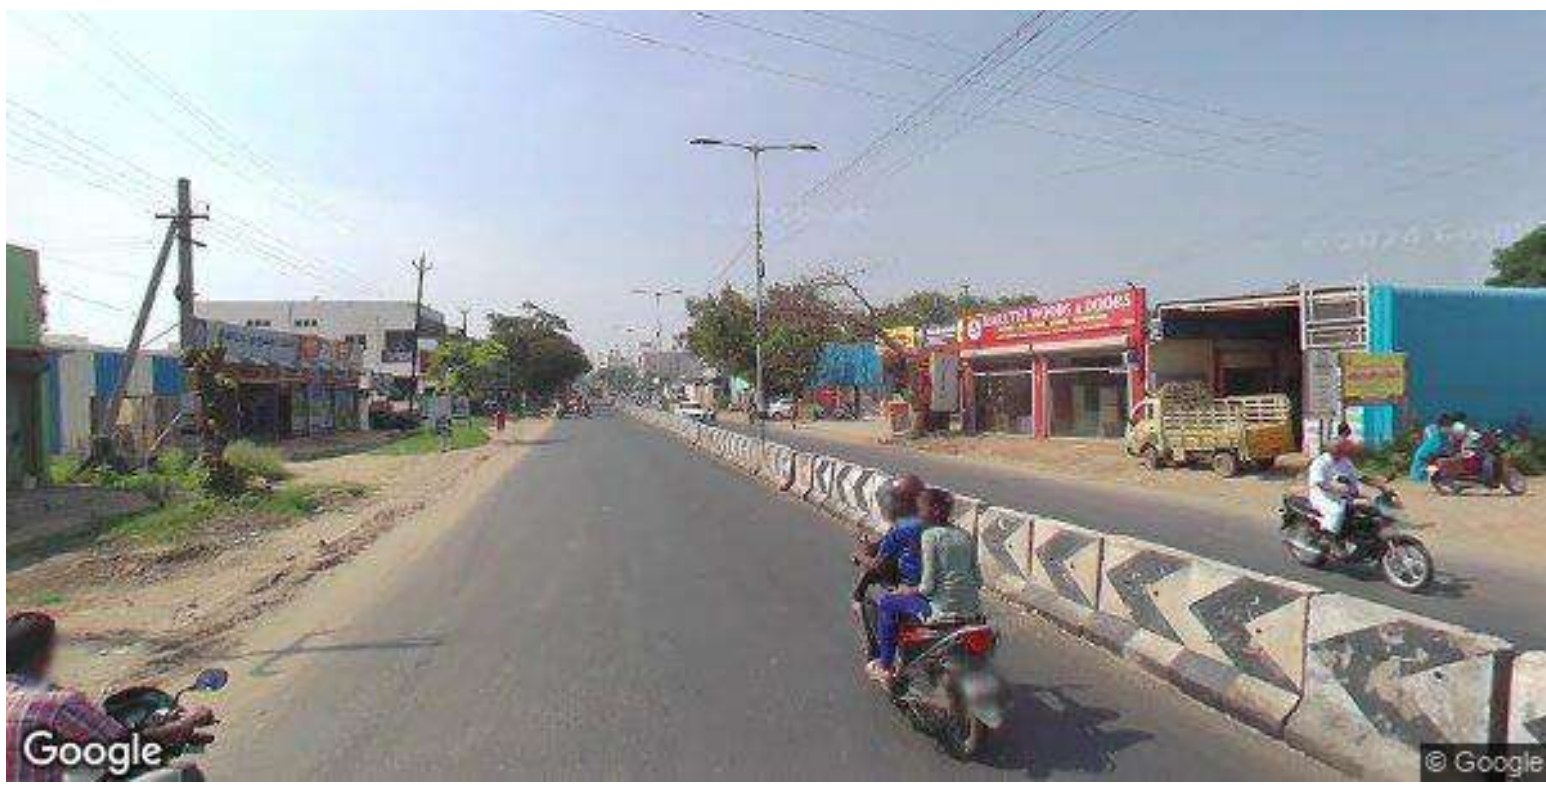
**Coordinates:** 11.09997, 77.38242

**Risk Type:** Blind Spot

**Risk Level:** Blind Spot

**Speed Limit:** 10 KM/Hr
