## **JOURNEY RISK MANAGEMENT (JRM) STUDY**

### **Salem Terminal To SHANTHI AGENCIES**

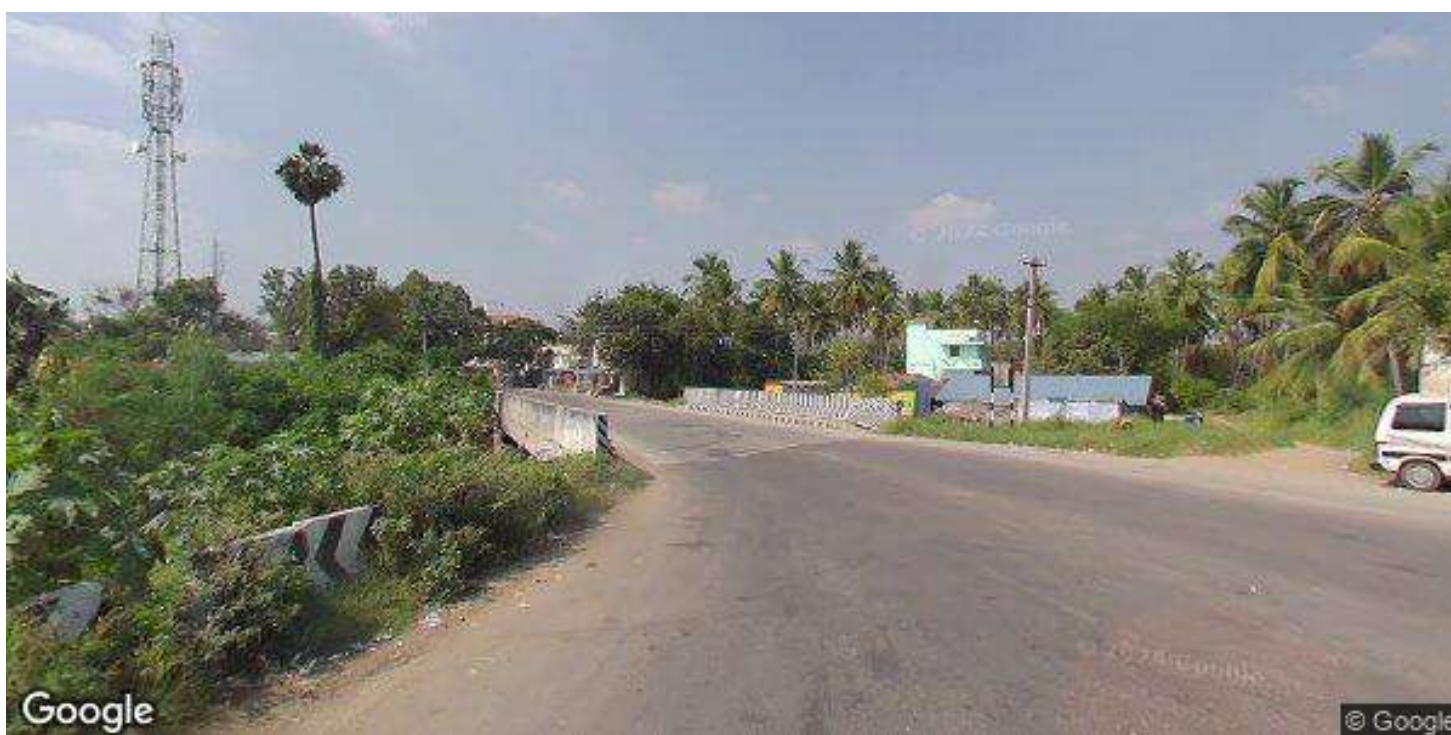
**Risk Type:** Turn  
**Risk Level:** High  
**Speed Limit:** 15 KM/Hr  
**Coordinates:** 11.44893, 77.87413

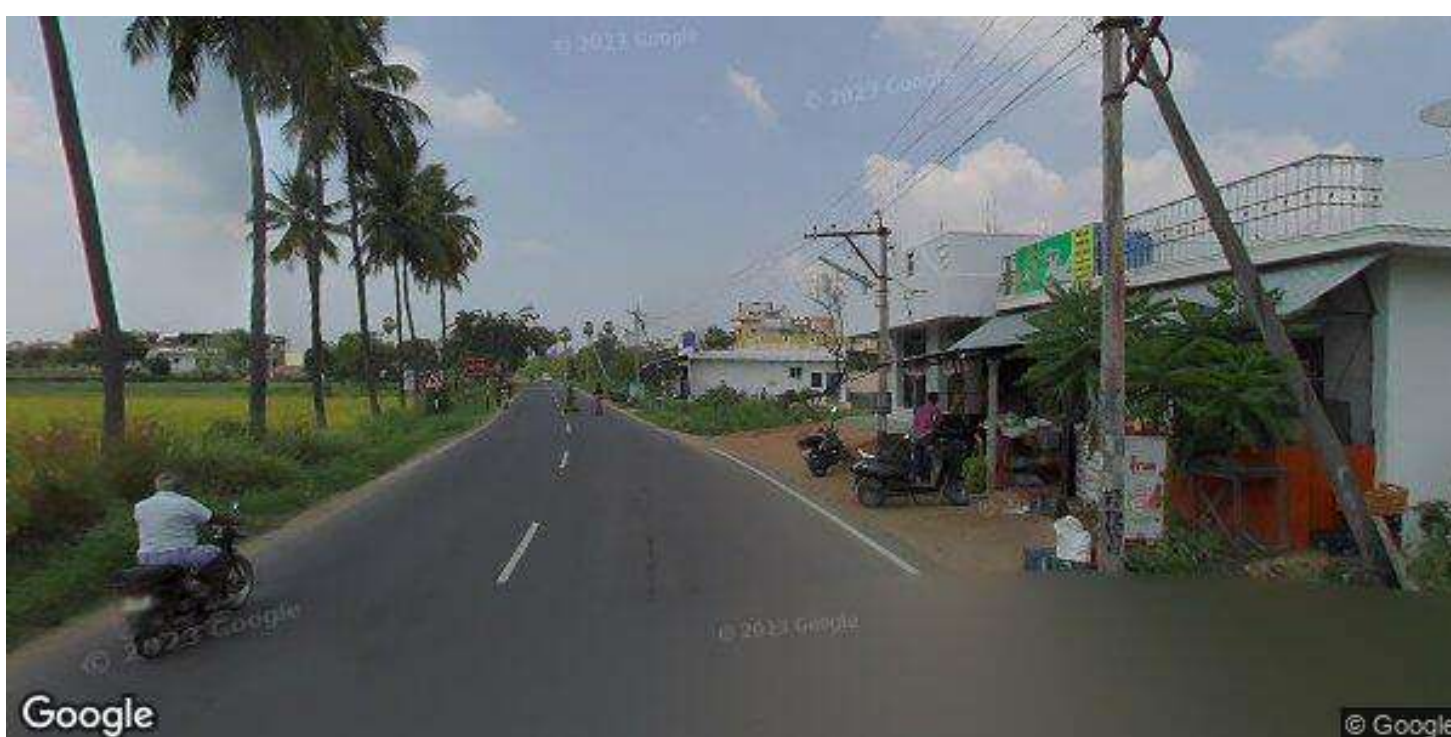
**Coordinates: 11.45127, 77.86734**

**Risk Type:** Turn  
**Risk Level:** Medium

**Speed Limit: 30 KM/Hr**
