# IndianOil

## JOURNEY RISK MANAGEMENT (JRM) STUDY

### Salem Terminal to S. MITRA AGENCY

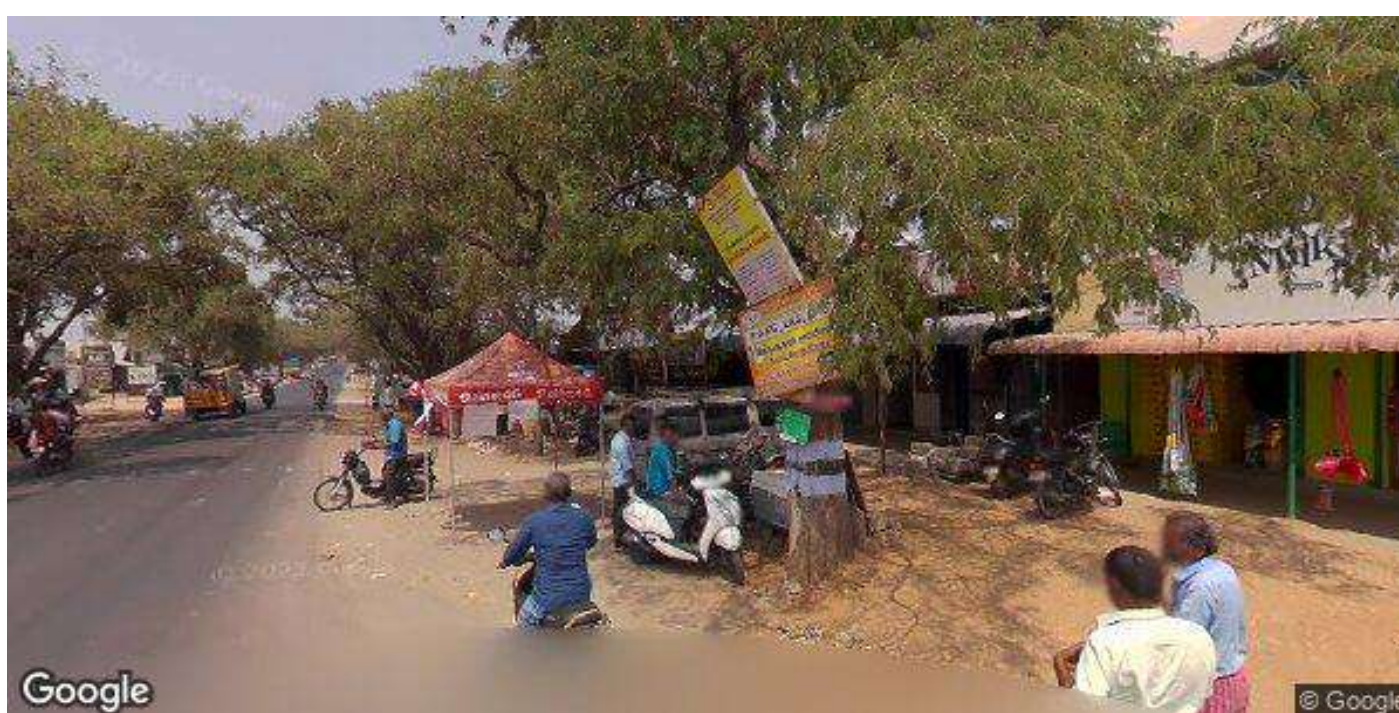
**Risk Type:** Blind Spot  
**Risk Level:** Blind Spot  
**Speed Limit:** 10 KM/Hr  
**Coordinates:** 11.41981, 77.88078

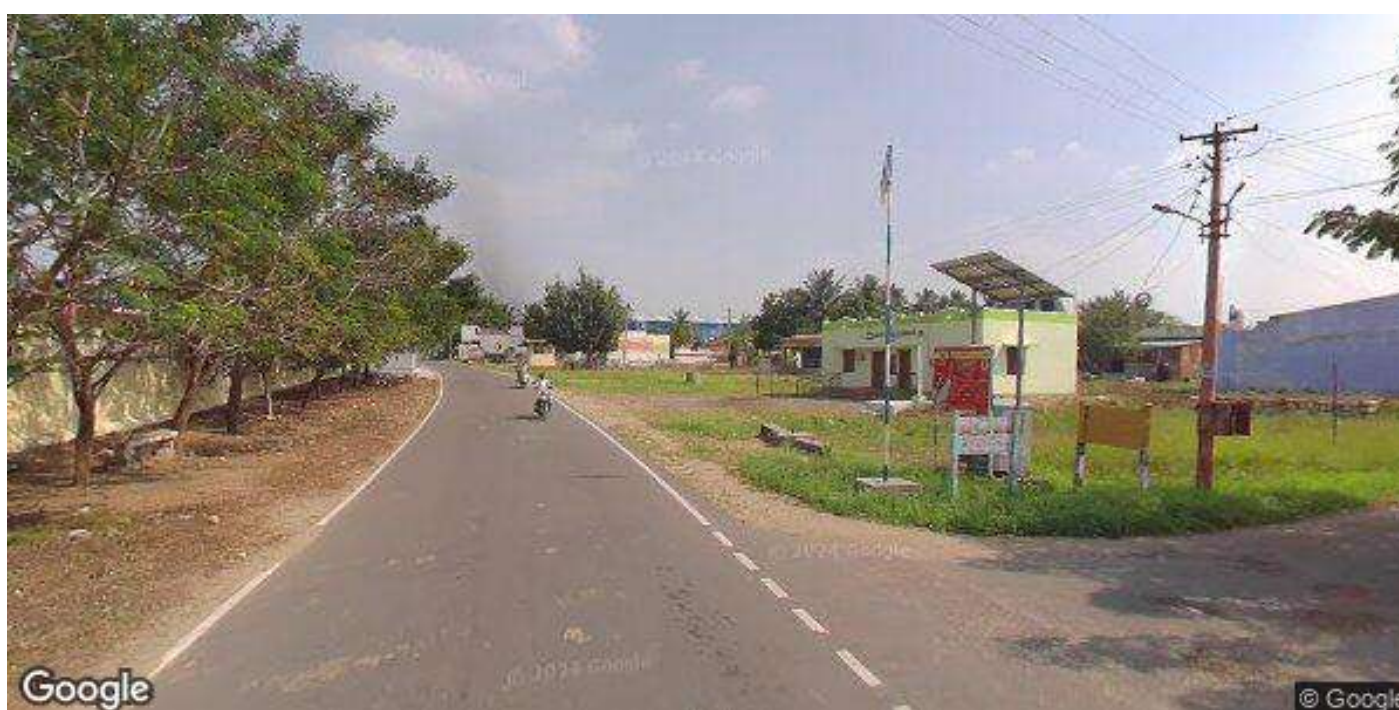
**Risk Type:** Blind Spot  
**Risk Level:** Blind Spot  
**Speed Limit:** 10 KM/Hr  
**Coordinates:** 11.42333, 77.87394

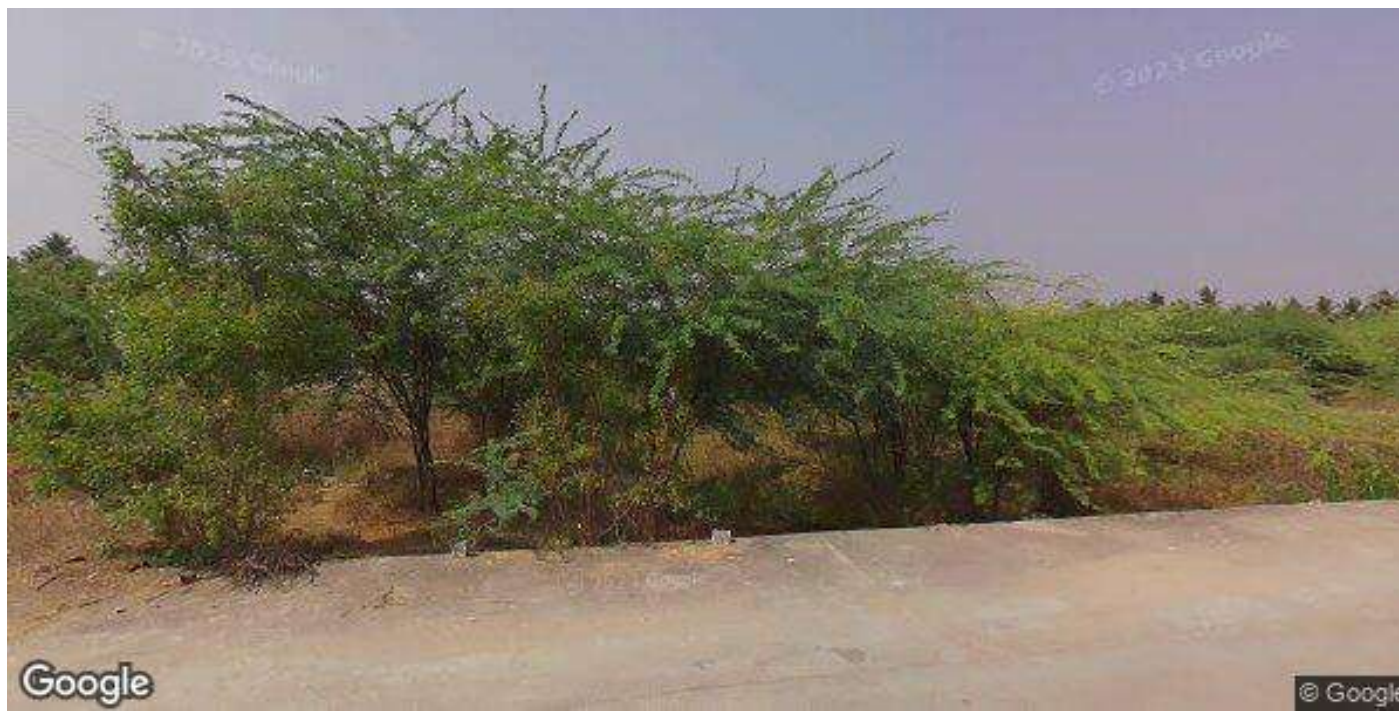
**Risk Type:** Turn  
**Risk Level:** High  
**Speed Limit:** 15 KM/Hr  
**Coordinates:** 11.41917, 77.87022

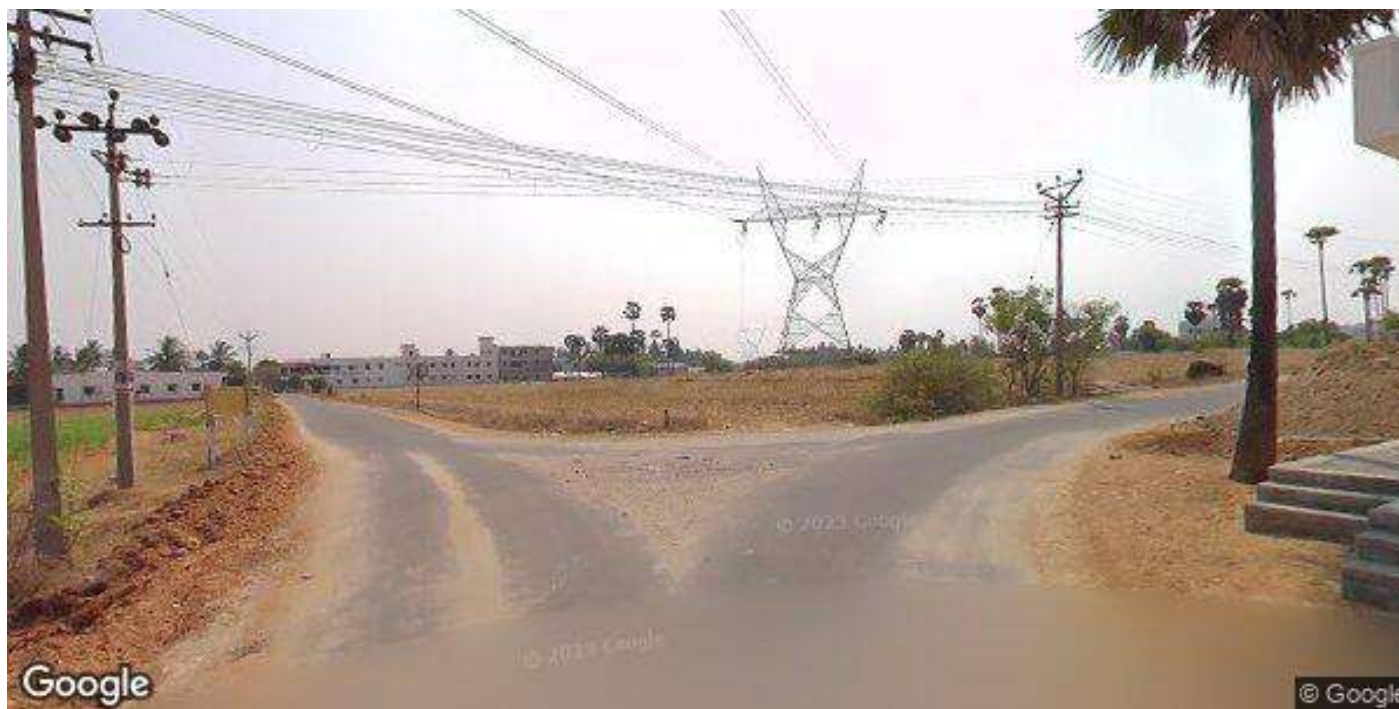
**Risk Type:** Turn  
**Risk Level:** High  
**Speed Limit:** 15 KM/Hr  
**Coordinates:** 11.40476, 77.86017

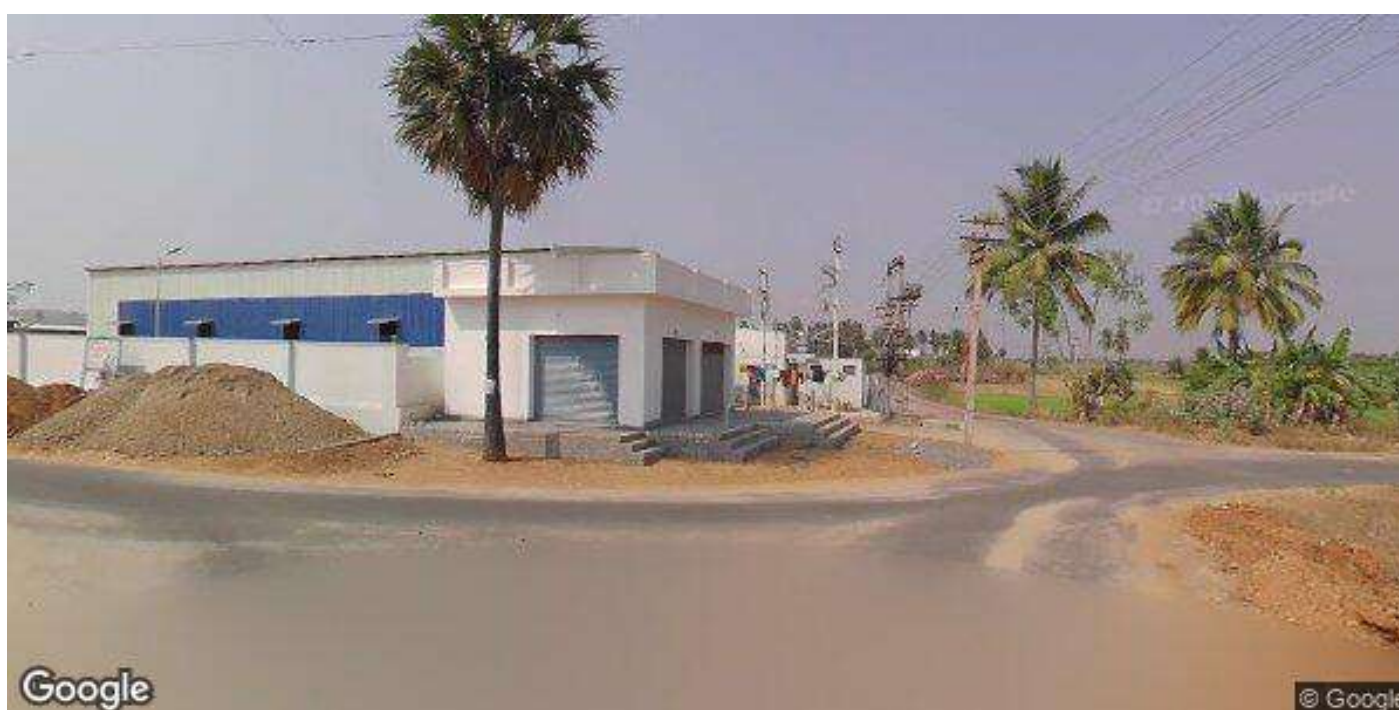
**Risk Type:** Turn  
**Risk Level:** High  
**Speed Limit:** 15 KM/Hr  
**Coordinates:** 11.40471, 77.86004

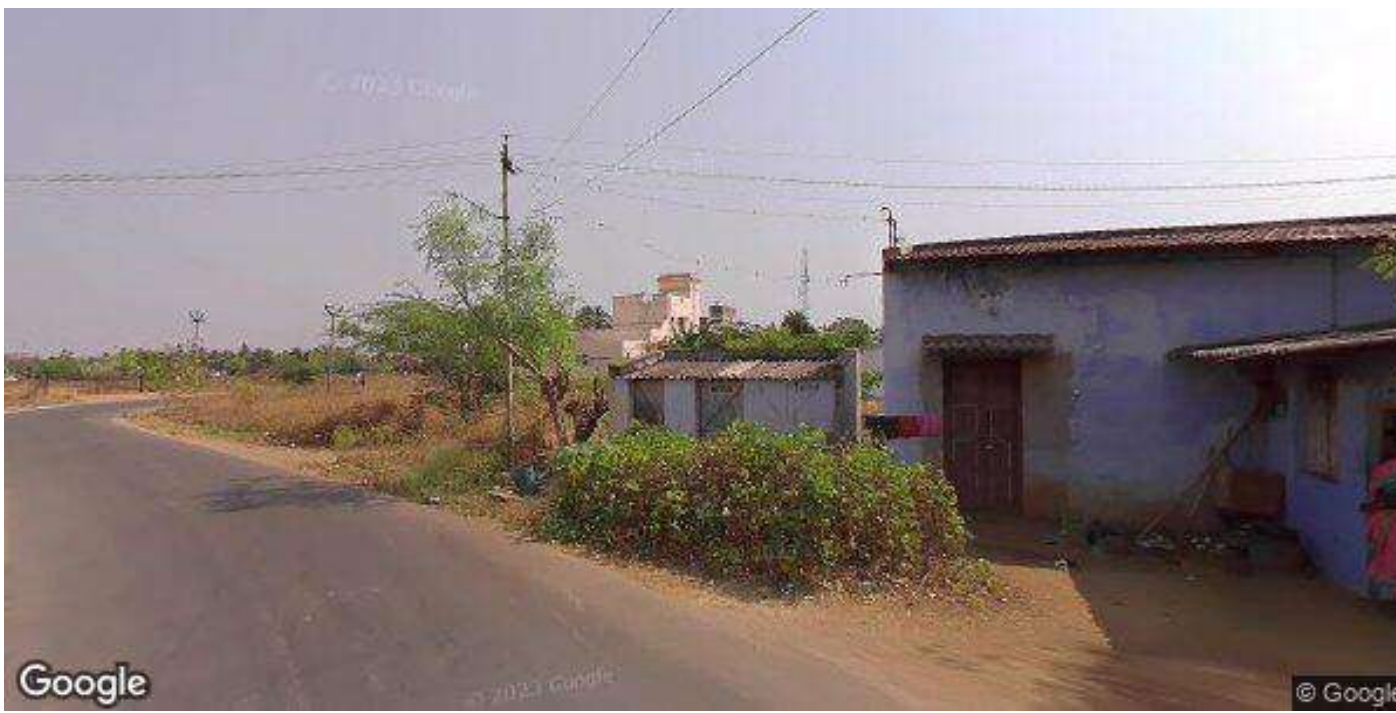
**Risk Type:** Turn  
**Risk Level:** High  
**Speed Limit:** 15 KM/Hr  
**Coordinates:** 11.39361, 77.85502

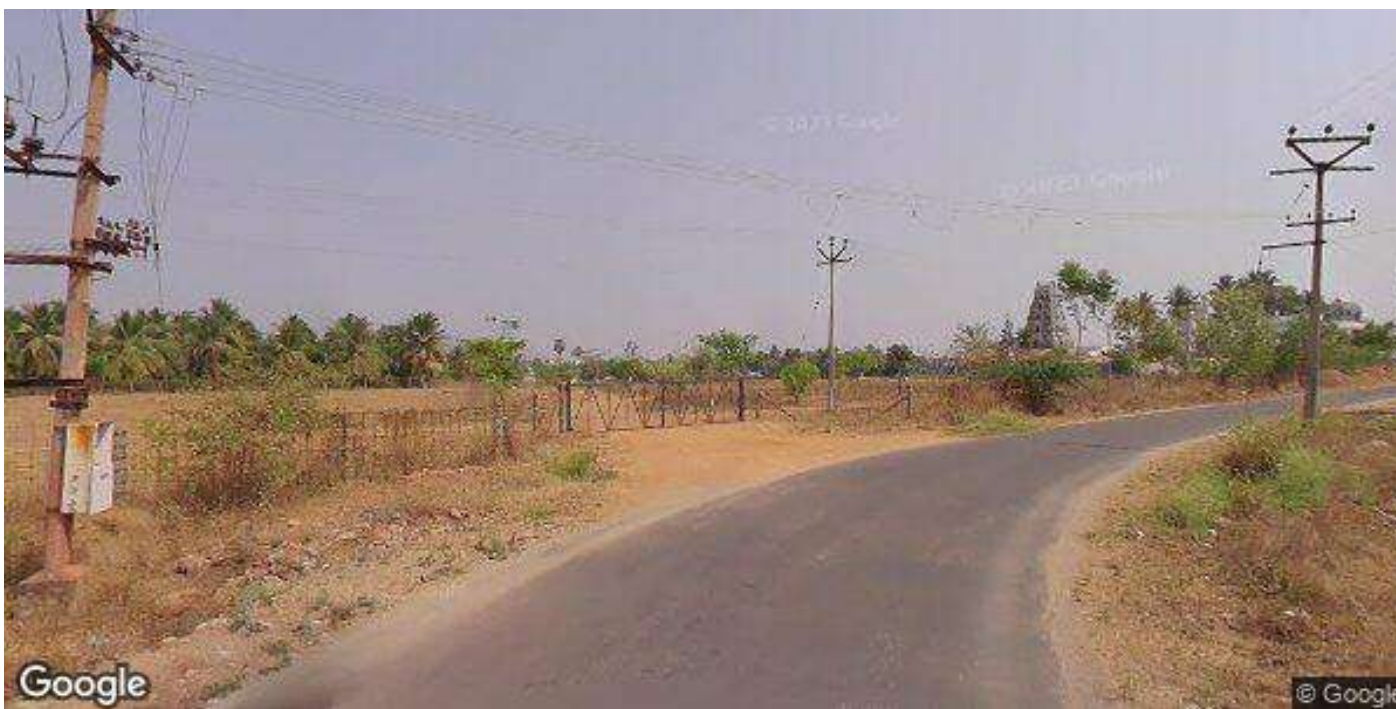
**Risk Type:** Turn  
**Risk Level:** Medium  
**Speed Limit:** 30 KM/Hr  
**Coordinates:** 11.39326, 77.85537

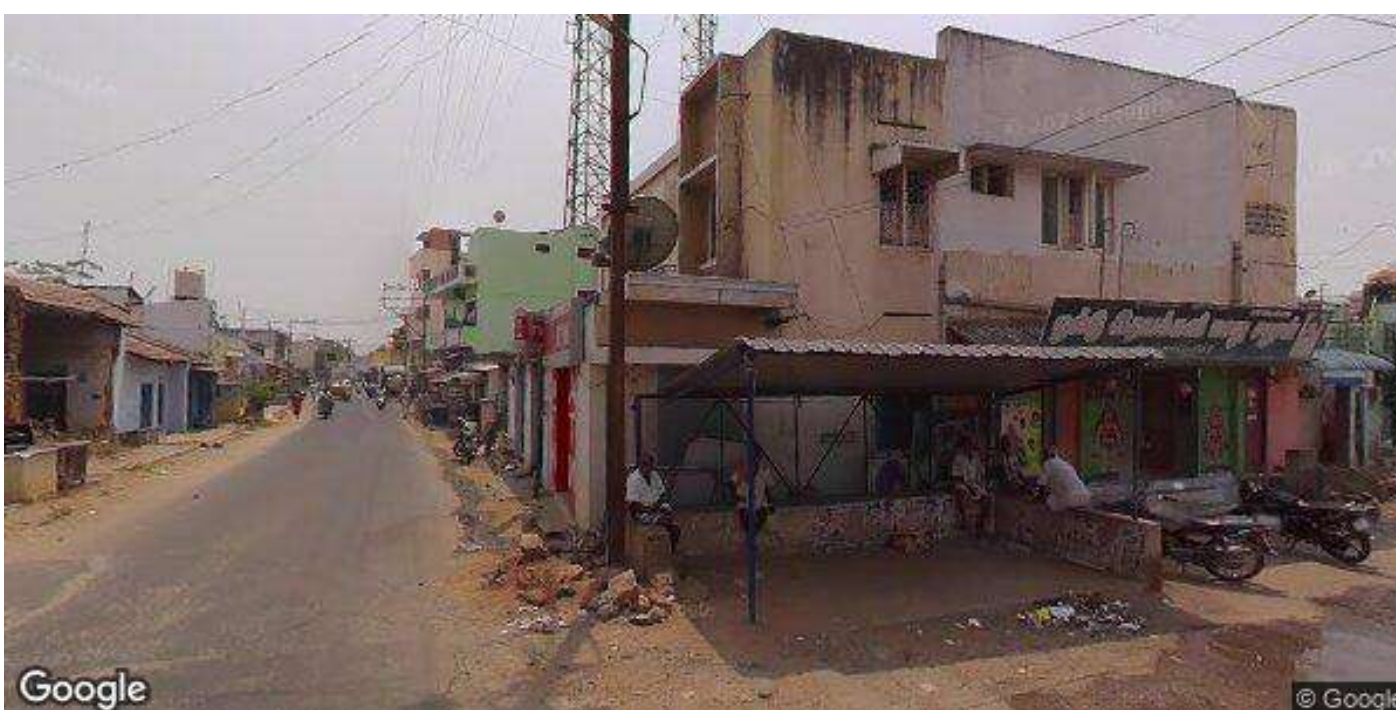
**Risk Type:** Blind Spot  
**Risk Level:** Blind Spot  
**Speed Limit:** 10 KM/Hr  
**Coordinates:** 11.39047, 77.85509

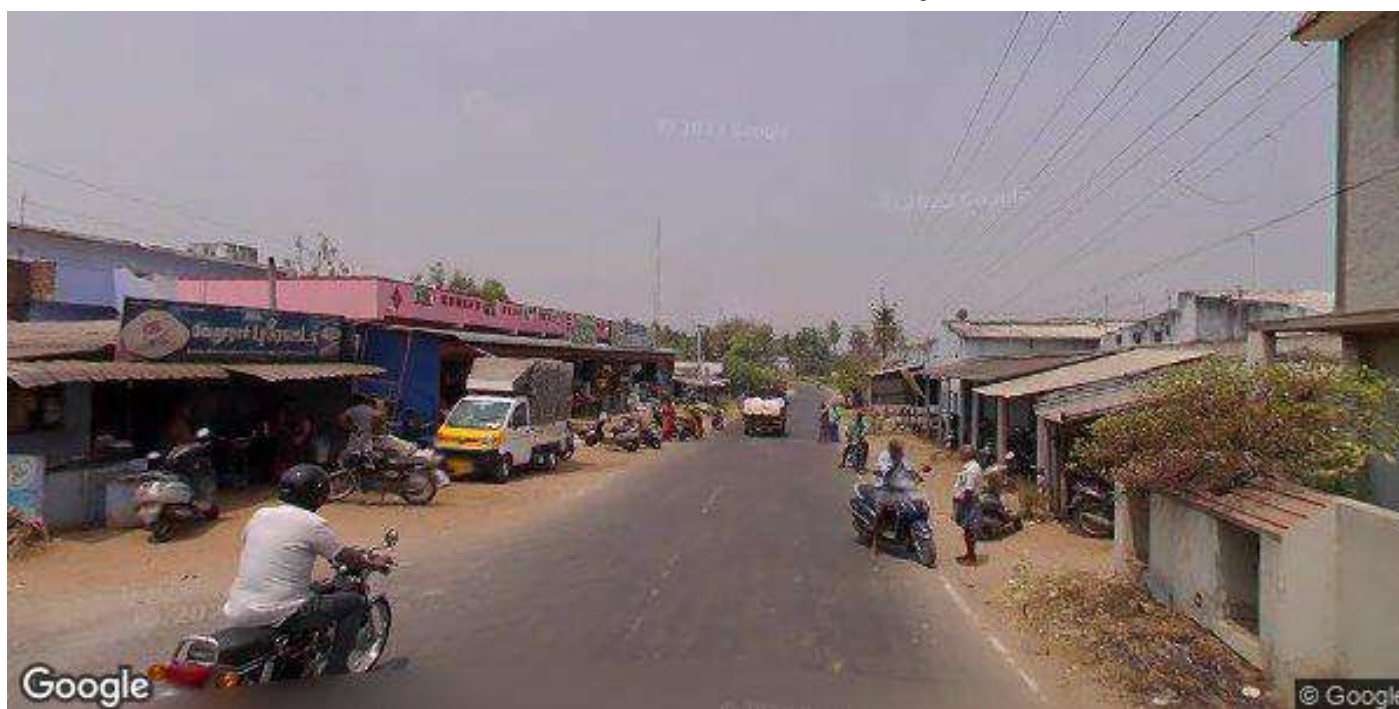
**Risk Type:** Turn  
**Risk Level:** High  
**Speed Limit:** 15 KM/Hr  
**Coordinates:** 11.39076, 77.85379

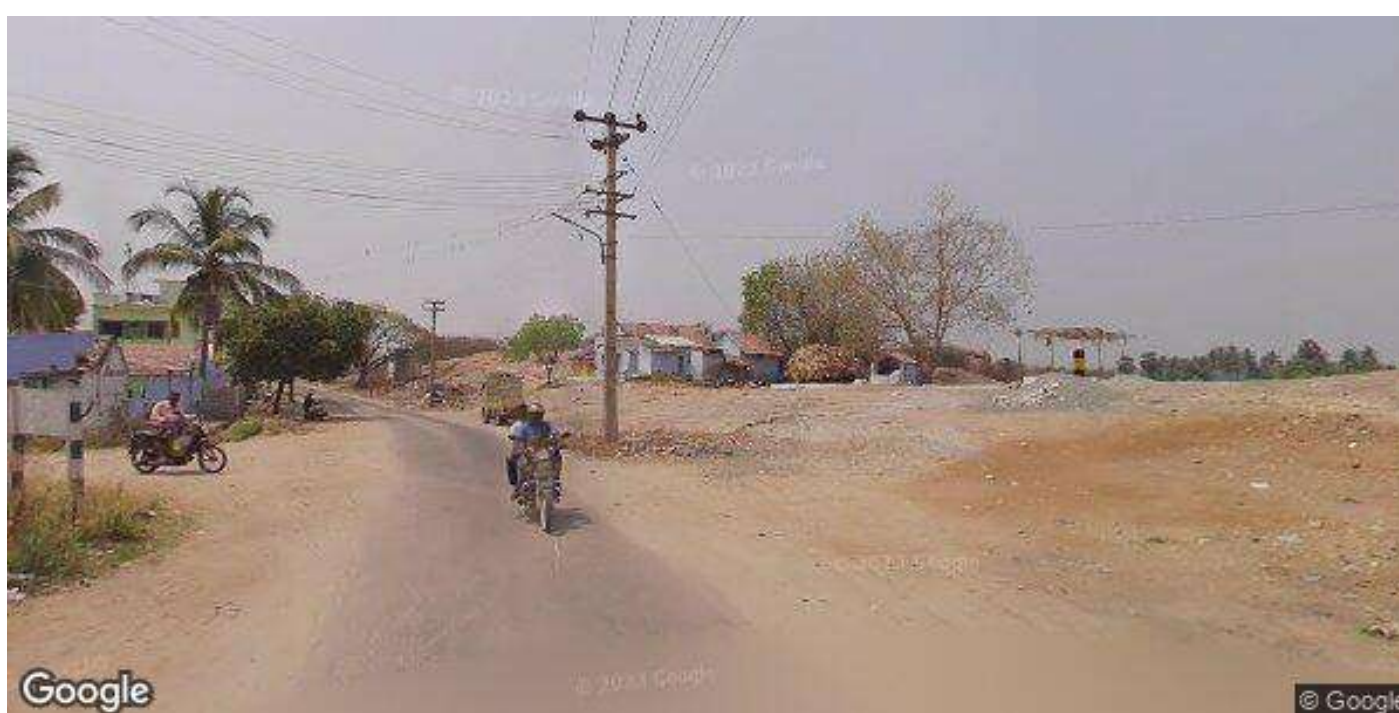
**Risk Type:** Turn  
**Risk Level:** Medium  
**Speed Limit:** 30 KM/Hr  
**Coordinates:** 11.38963, 77.85303

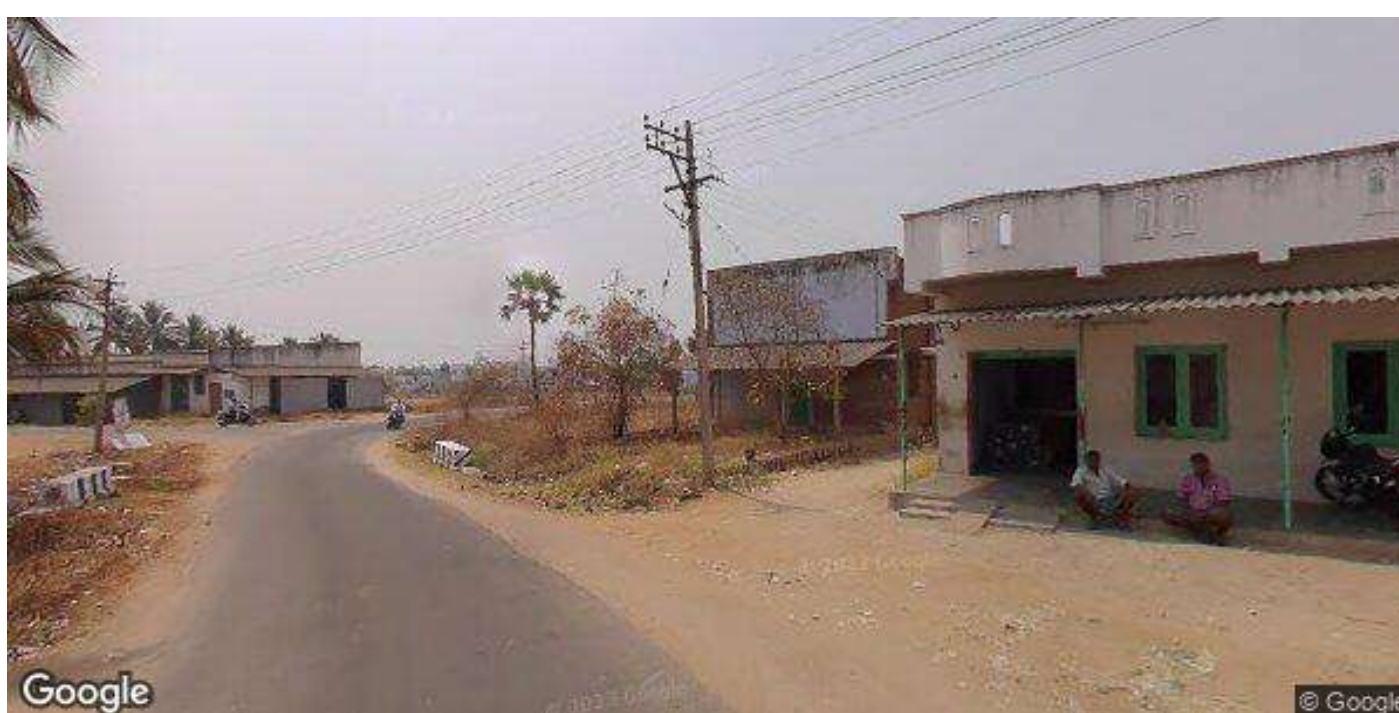
**Risk Type:** Turn  
**Risk Level:** Medium  
**Speed Limit:** 30 KM/Hr  
**Coordinates:** 11.38629, 77.85258

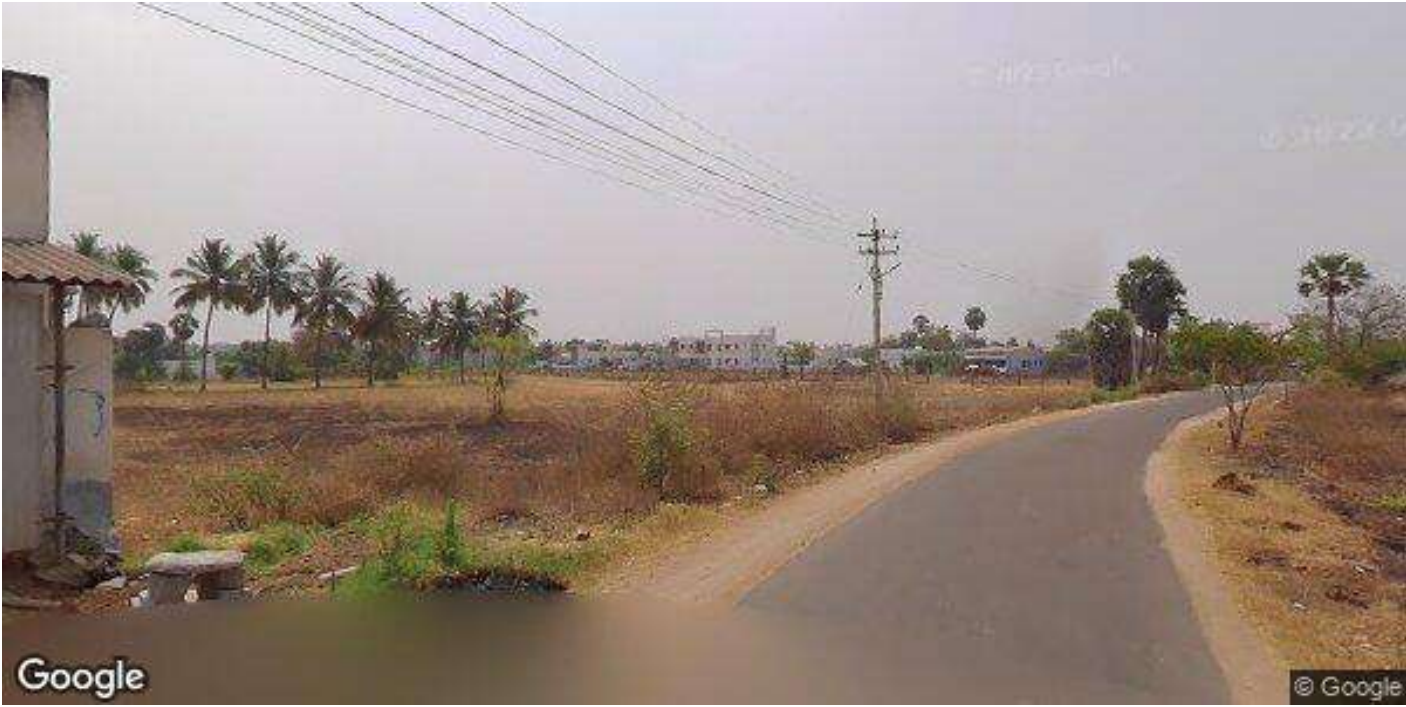
**Risk Type:** Turn  
**Risk Level:** Medium  
**Speed Limit:** 30 KM/Hr  
**Coordinates:** 11.38591, 77.85279

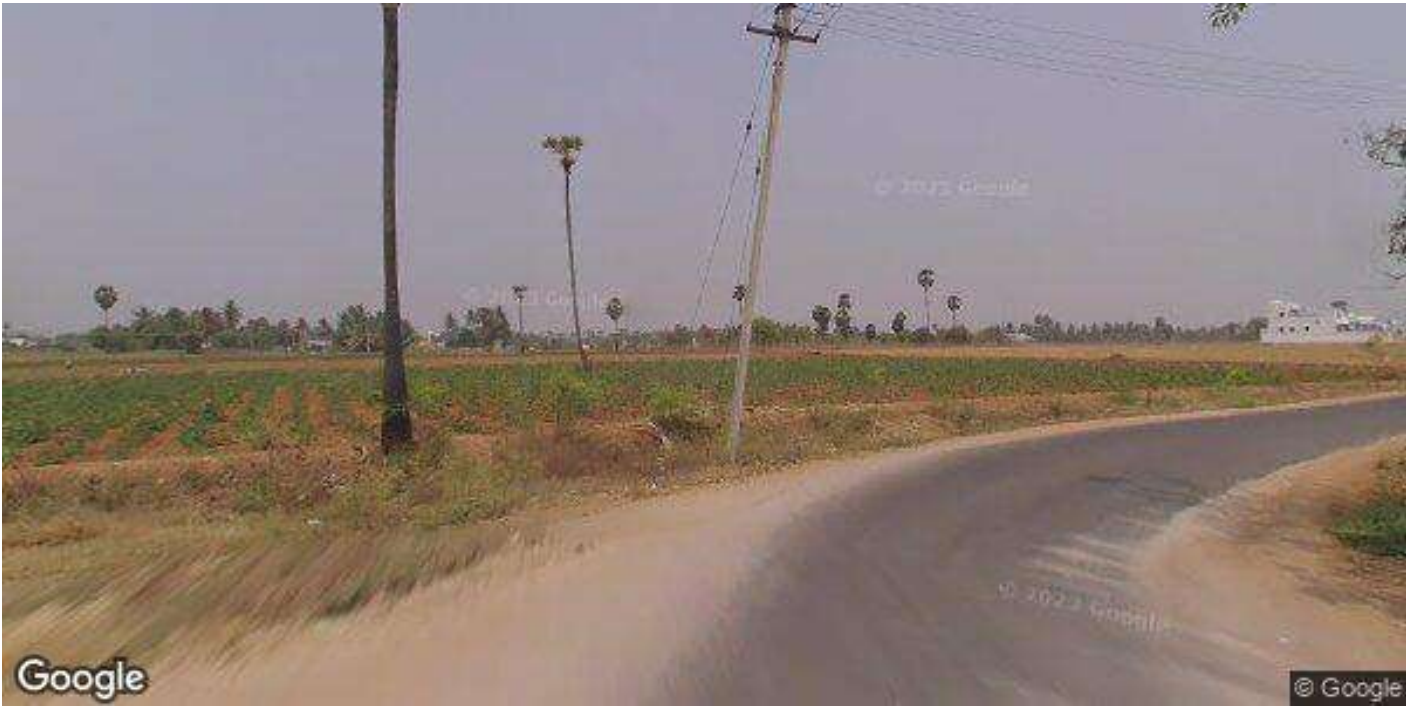
**Risk Type:** Turn  
**Risk Level:** High  
**Speed Limit:** 15 KM/Hr  
**Coordinates:** 11.38248, 77.85174

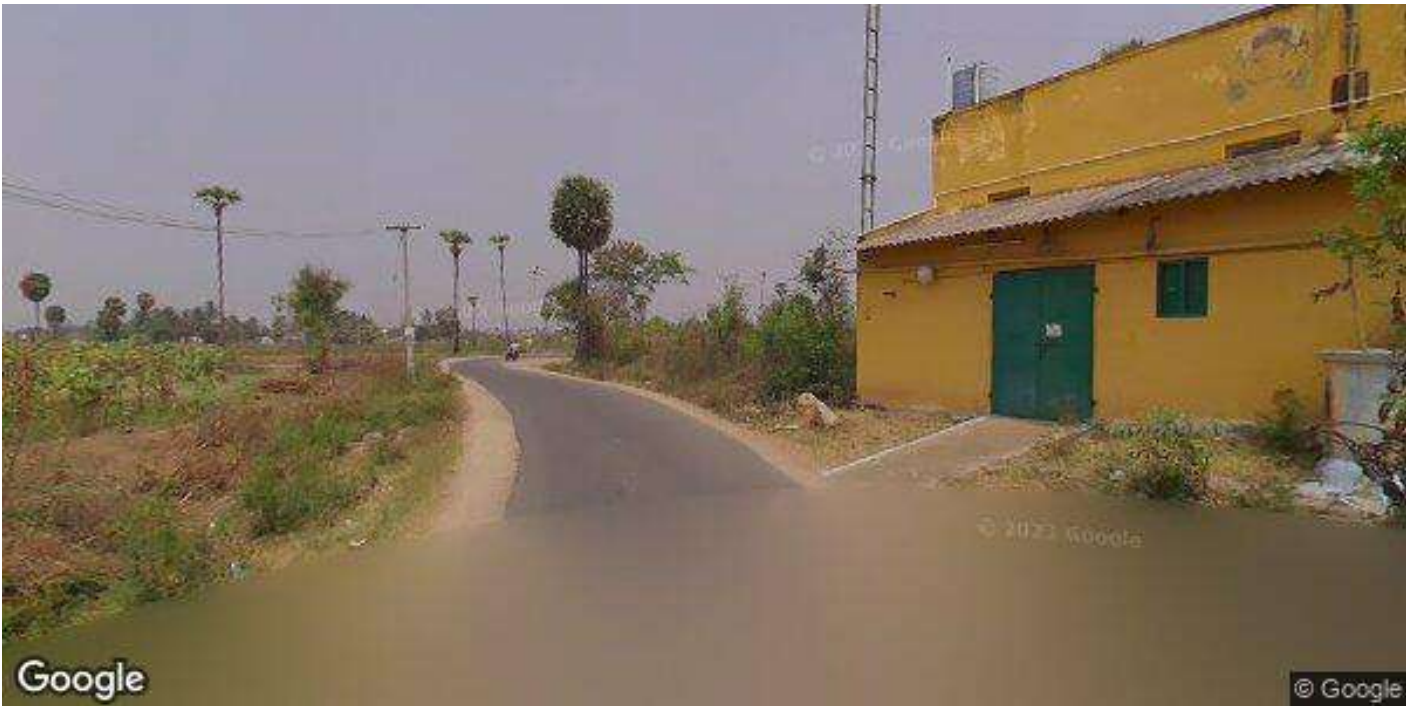
**Risk Type:** Turn  
**Risk Level:** Medium  
**Speed Limit:** 30 KM/Hr  
**Coordinates:** 11.38227, 77.85213

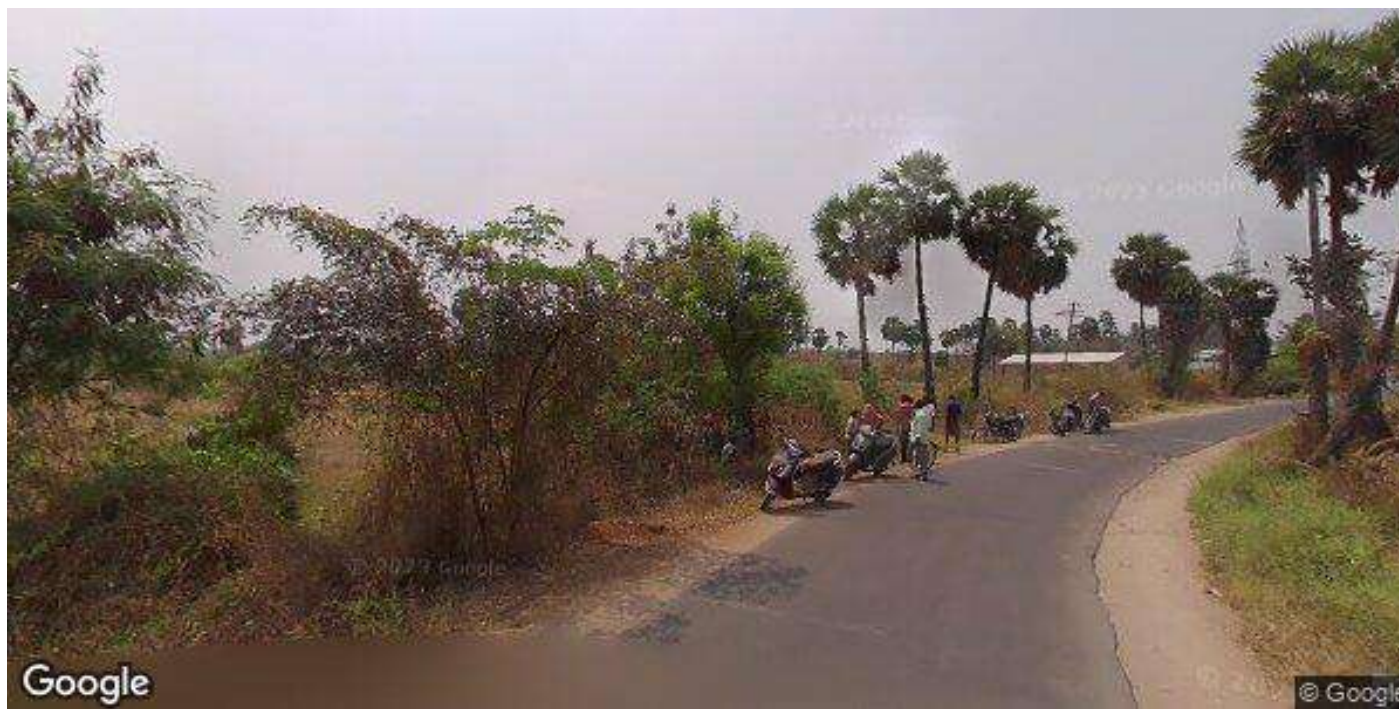
**Risk Type:** Turn  
**Risk Level:** Medium  
**Speed Limit:** 30 KM/Hr  
**Coordinates:** 11.38207, 77.85226

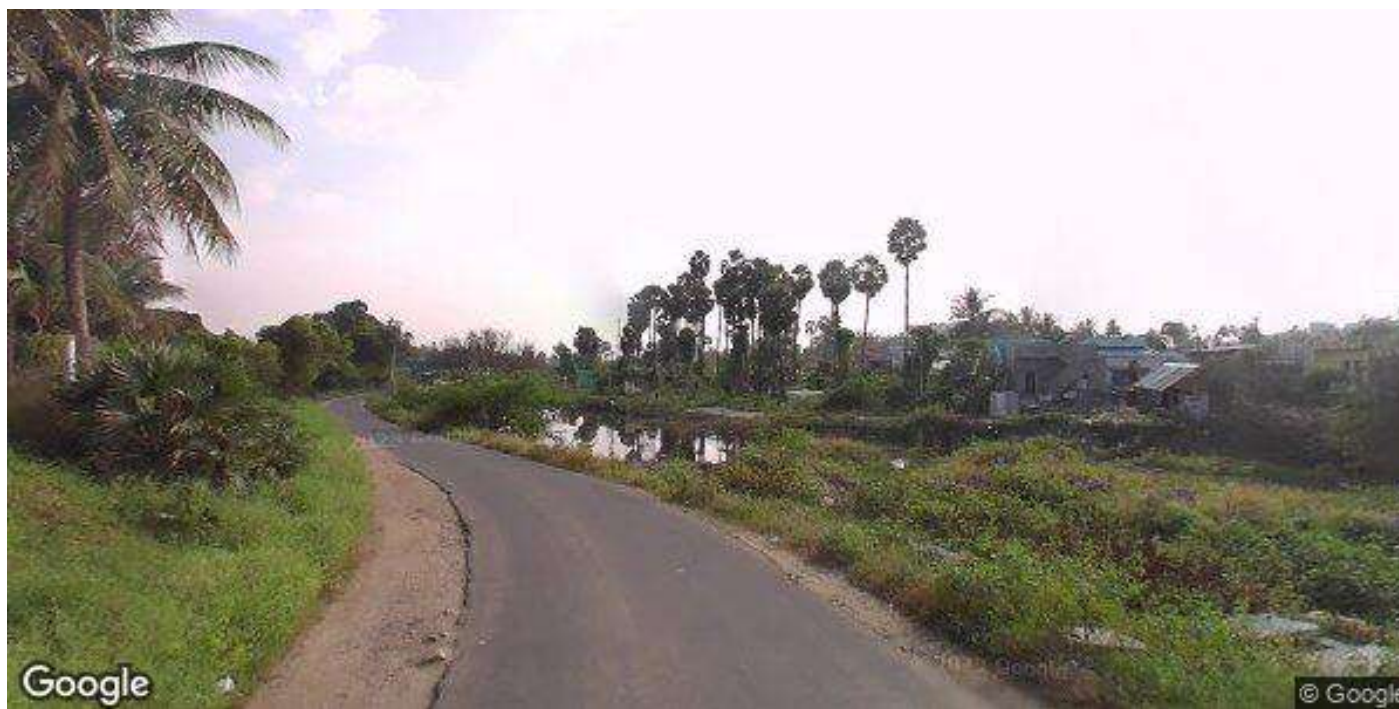
**Risk Type:** Turn  
**Risk Level:** Medium  
**Speed Limit:** 30 KM/Hr  
**Coordinates:** 11.37017, 77.84376

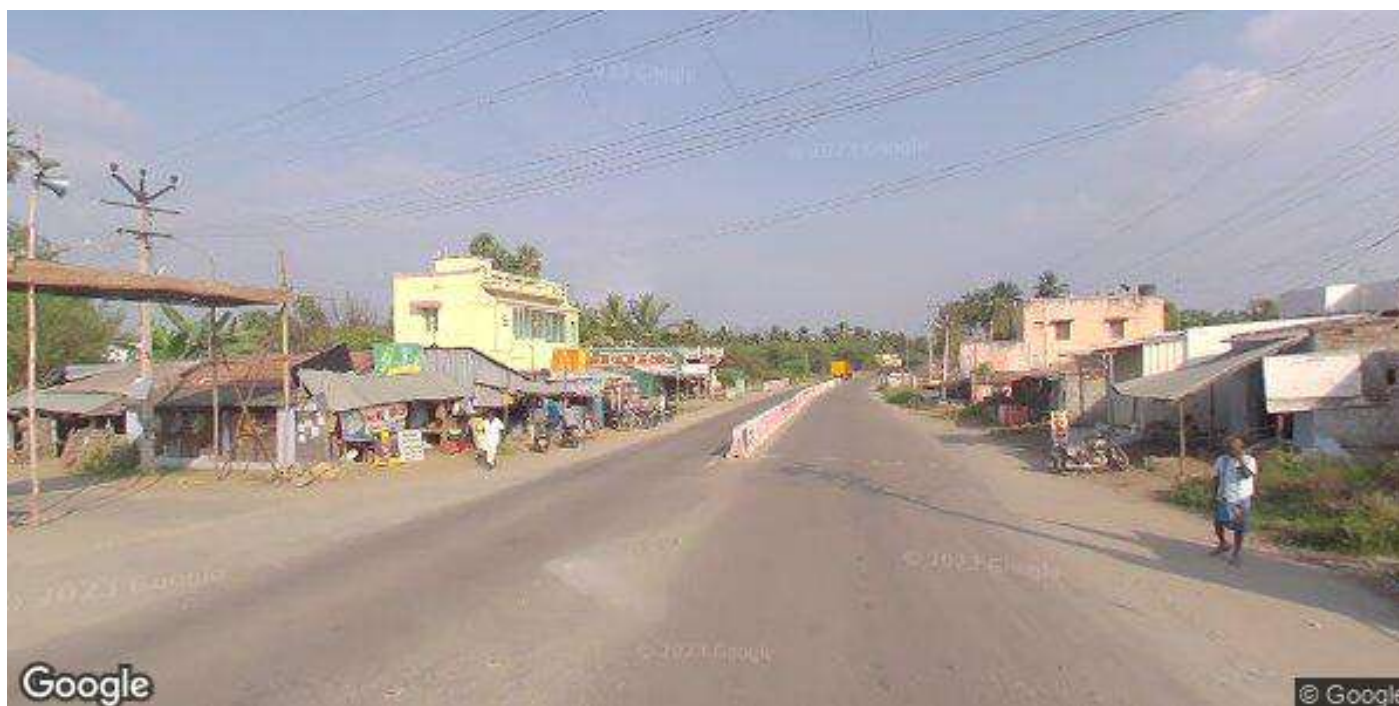
**Risk Type:** Turn  
**Risk Level:** High  
**Speed Limit:** 15 KM/Hr  
**Coordinates:** 11.36568, 77.84272

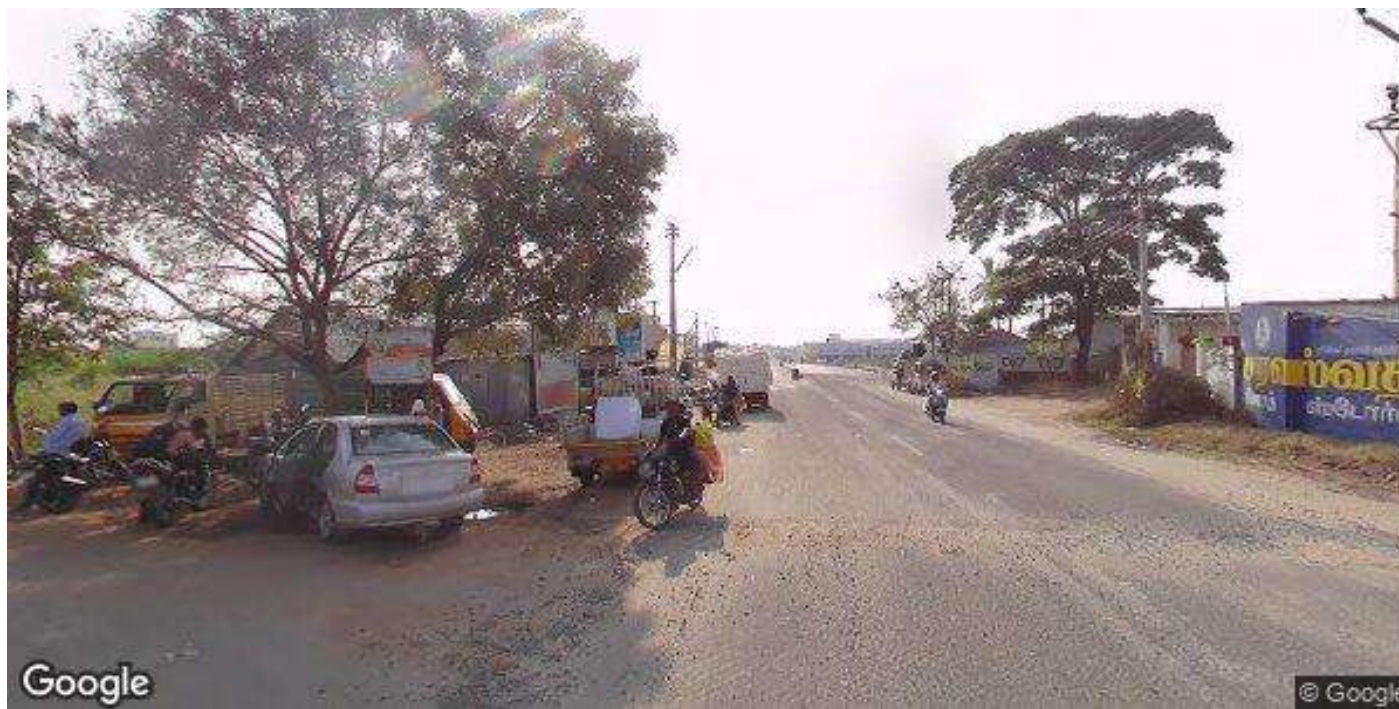
**Risk Type:** Turn  
**Risk Level:** High  
**Speed Limit:** 15 KM/Hr  
**Coordinates:** 11.36551, 77.84183

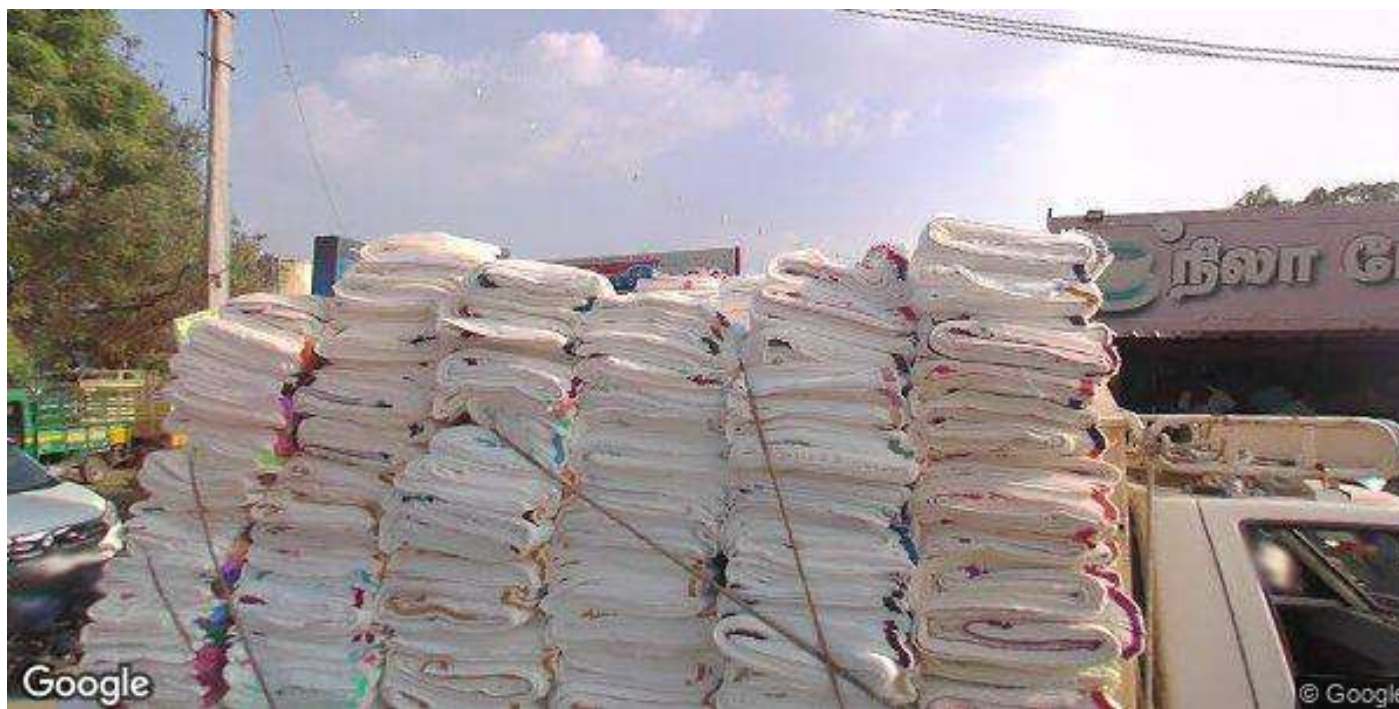
**Risk Type:** Turn  
**Risk Level:** Medium  
**Speed Limit:** 30 KM/Hr  
**Coordinates:** 11.36505, 77.84189

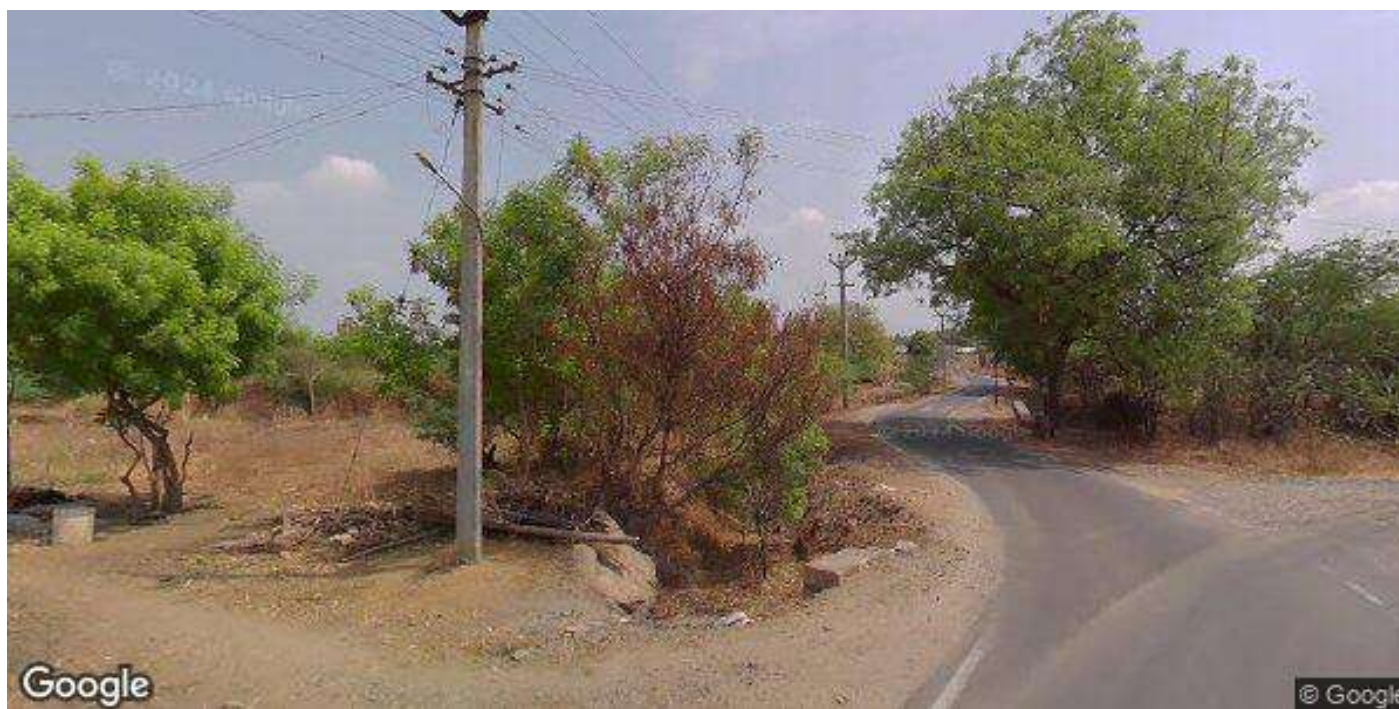
**Risk Type:** Turn  
**Risk Level:** Medium  
**Speed Limit:** 30 KM/Hr  
**Coordinates:** 11.33668, 77.81596

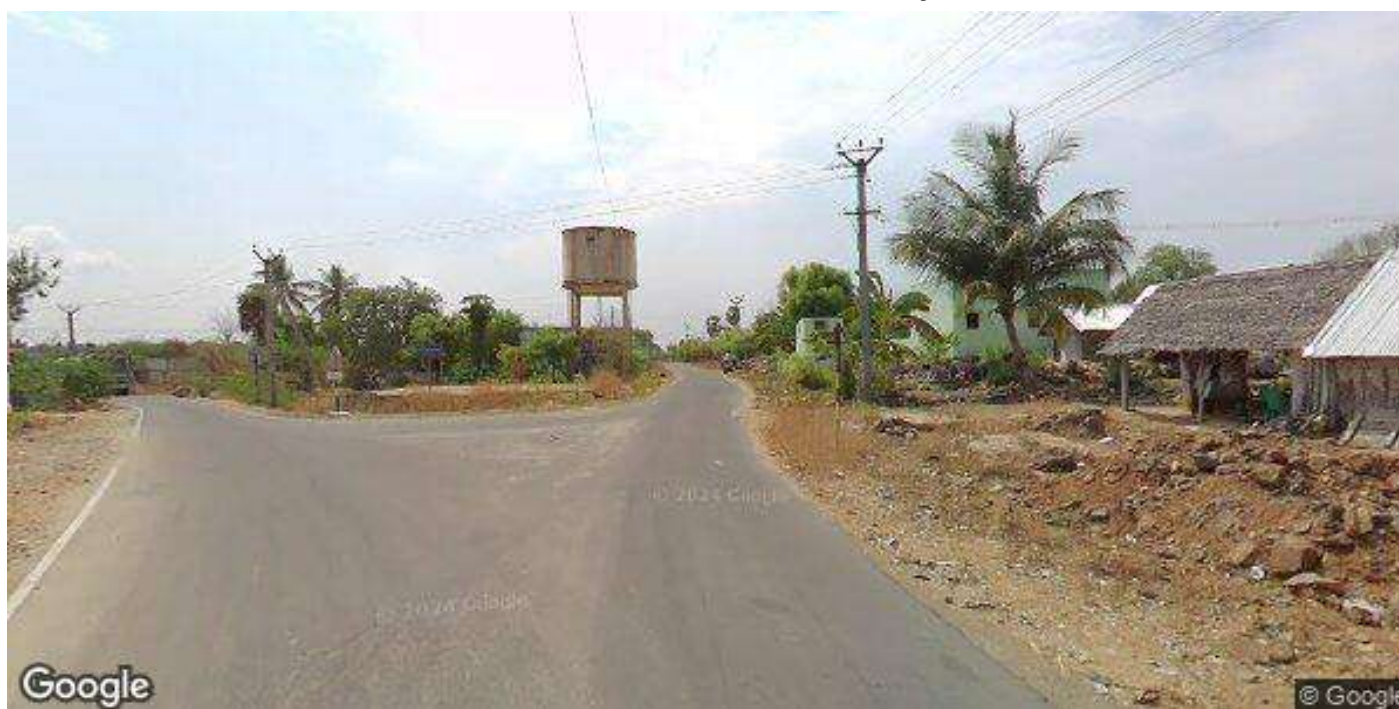
**Risk Type:** Turn  
**Risk Level:** Medium  
**Speed Limit:** 30 KM/Hr  
**Coordinates:** 11.33552, 77.81470

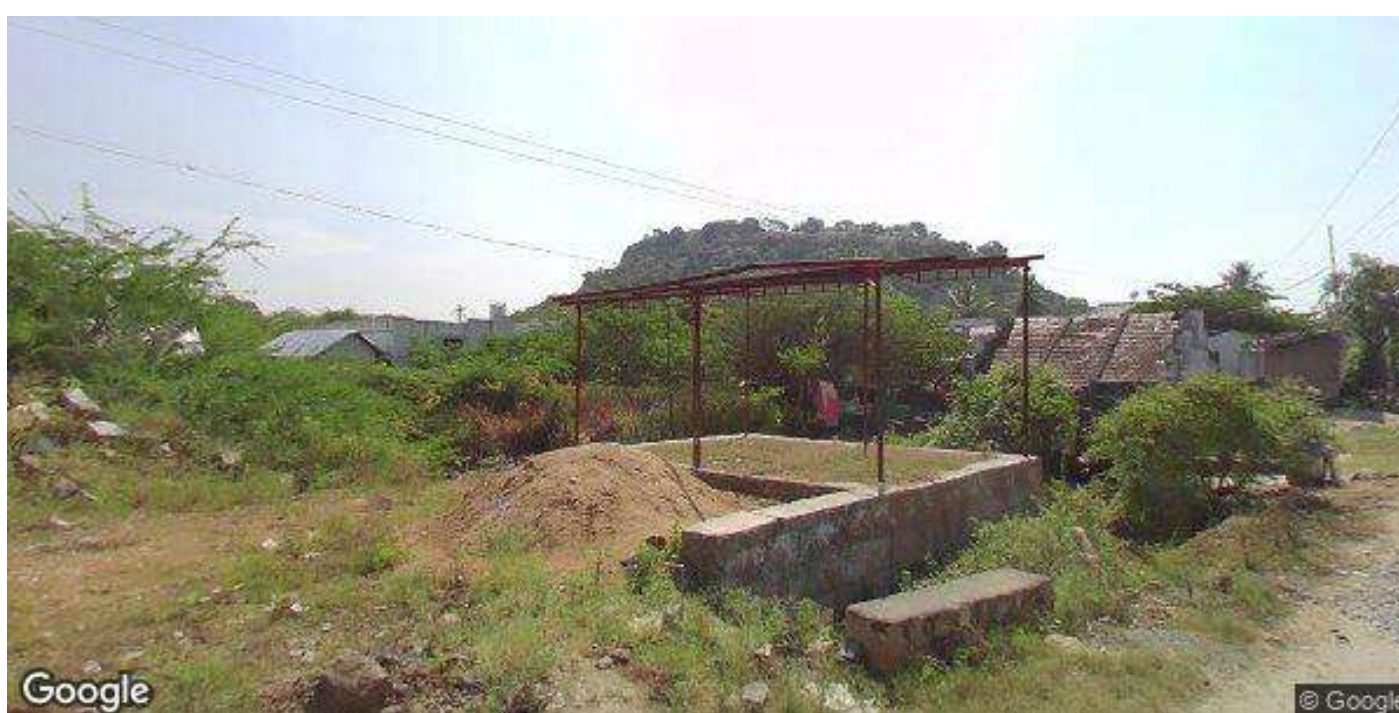
**Risk Type:** Turn  
**Risk Level:** High  
**Speed Limit:** 15 KM/Hr  
**Coordinates:** 11.33554, 77.81355
