# IndianOil

## JOURNEY RISK MANAGEMENT (JRM) STUDY

### Salem Terminal to S. MITRA AGENCY

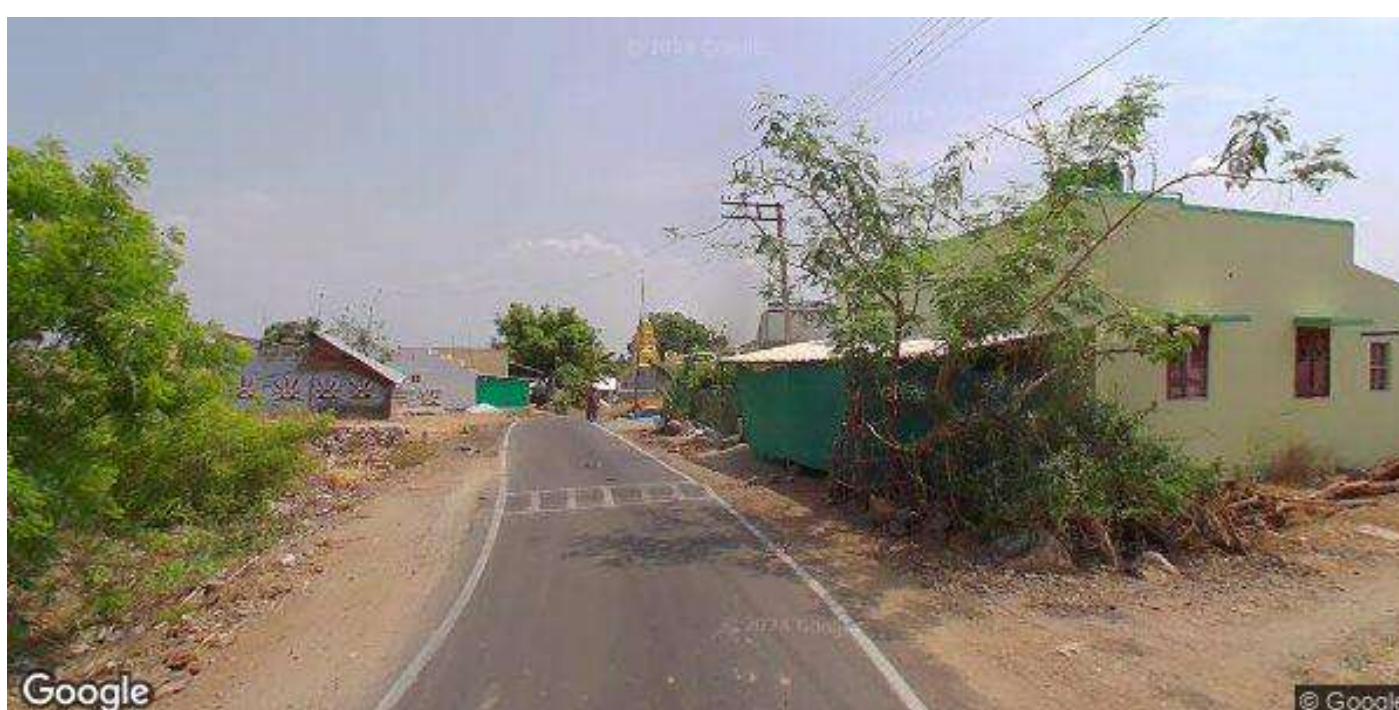
**Risk Type:** Turn  
**Risk Level:** Medium  
**Speed Limit:** 30 KM/Hr  
**Coordinates:** 11.33489, 77.81346

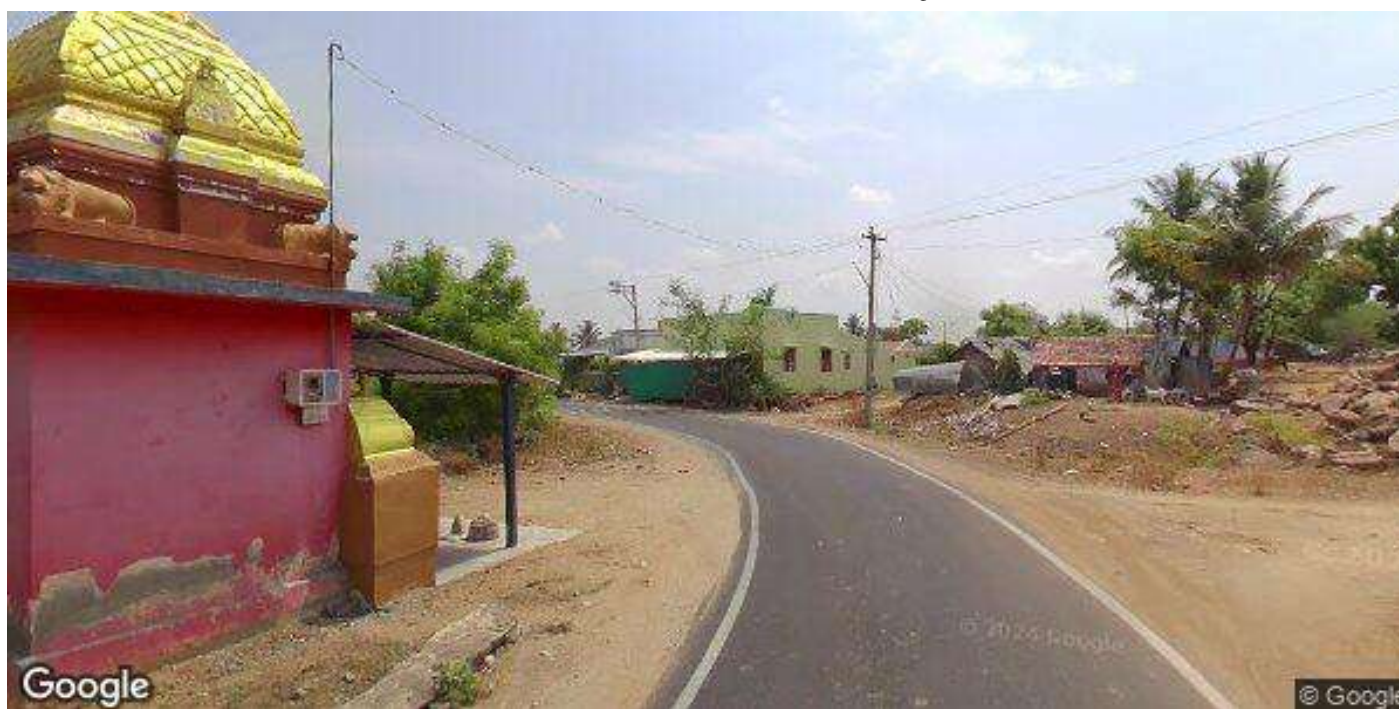
**Risk Type:** Turn  
**Risk Level:** Medium  
**Speed Limit:** 30 KM/Hr  
**Coordinates:** 11.33470, 77.81336

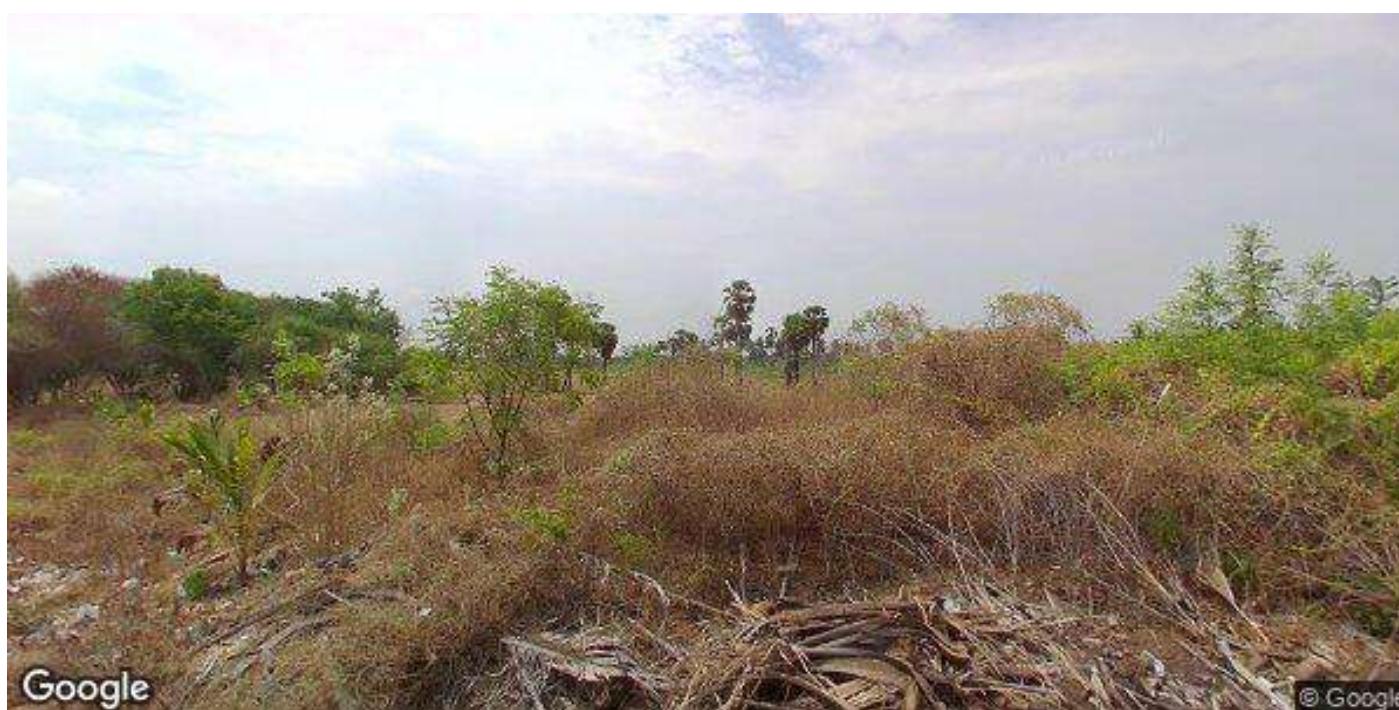
**Risk Type:** Turn  
**Risk Level:** Medium  
**Speed Limit:** 30 KM/Hr  
**Coordinates:** 11.33160, 77.80861

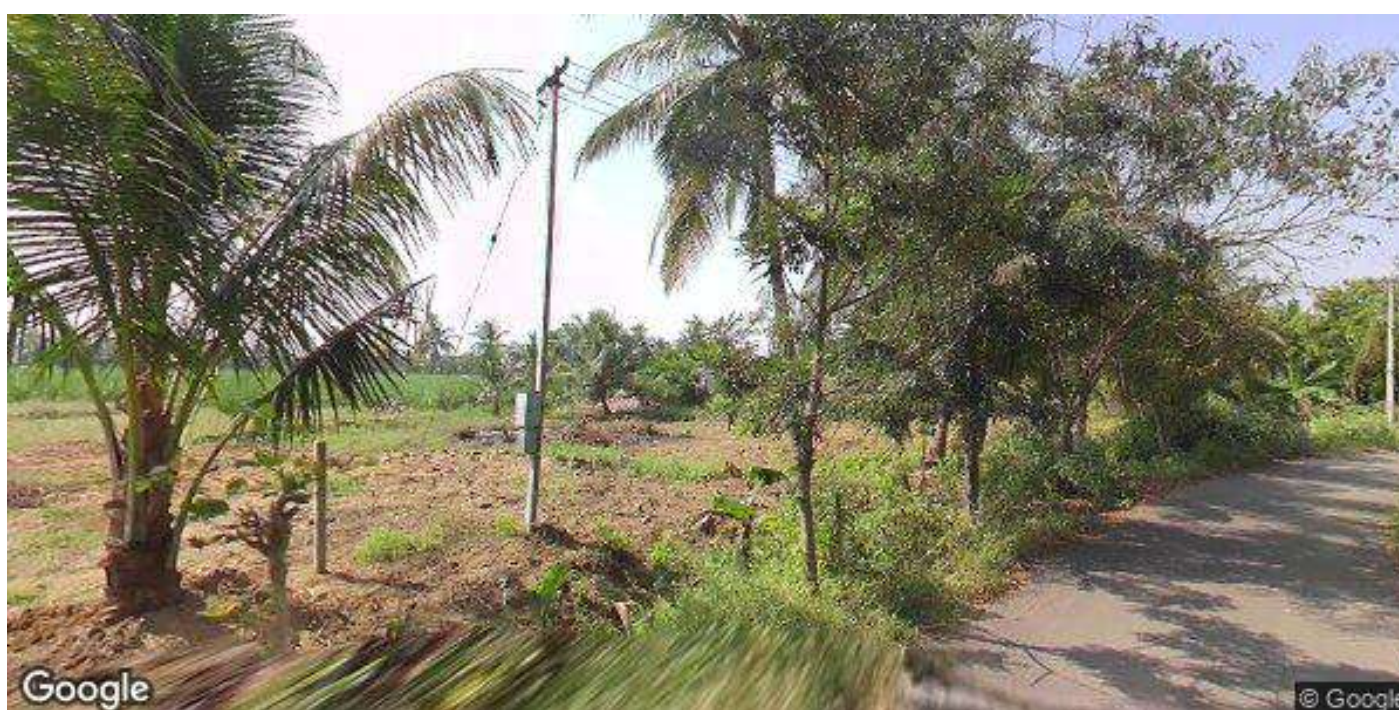
**Risk Type:** Turn  
**Risk Level:** High  
**Speed Limit:** 15 KM/Hr  
**Coordinates:** 11.32143, 77.79174

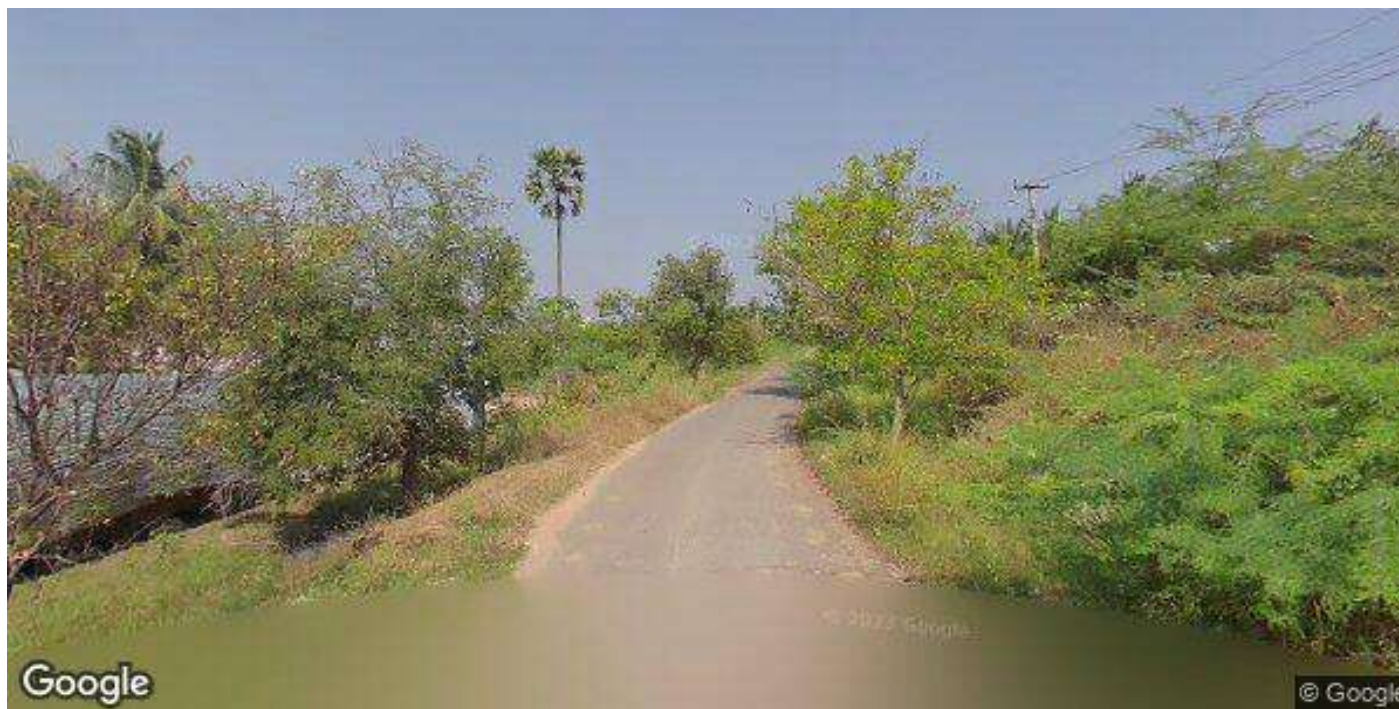
**Risk Type:** Turn  
**Risk Level:** Medium  
**Speed Limit:** 30 KM/Hr  
**Coordinates:** 11.32231, 77.79039

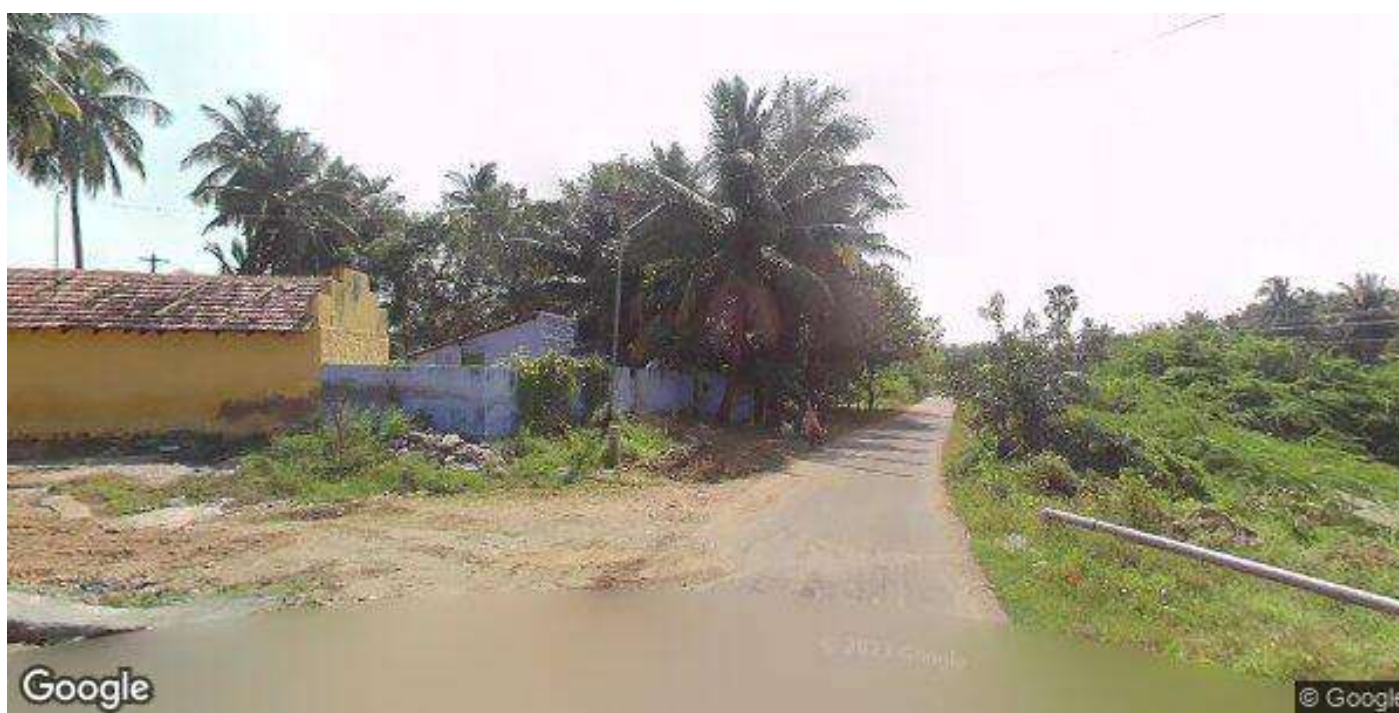
**Risk Type:** Turn  
**Risk Level:** Medium  
**Speed Limit:** 30 KM/Hr  
**Coordinates:** 11.32344, 77.79015

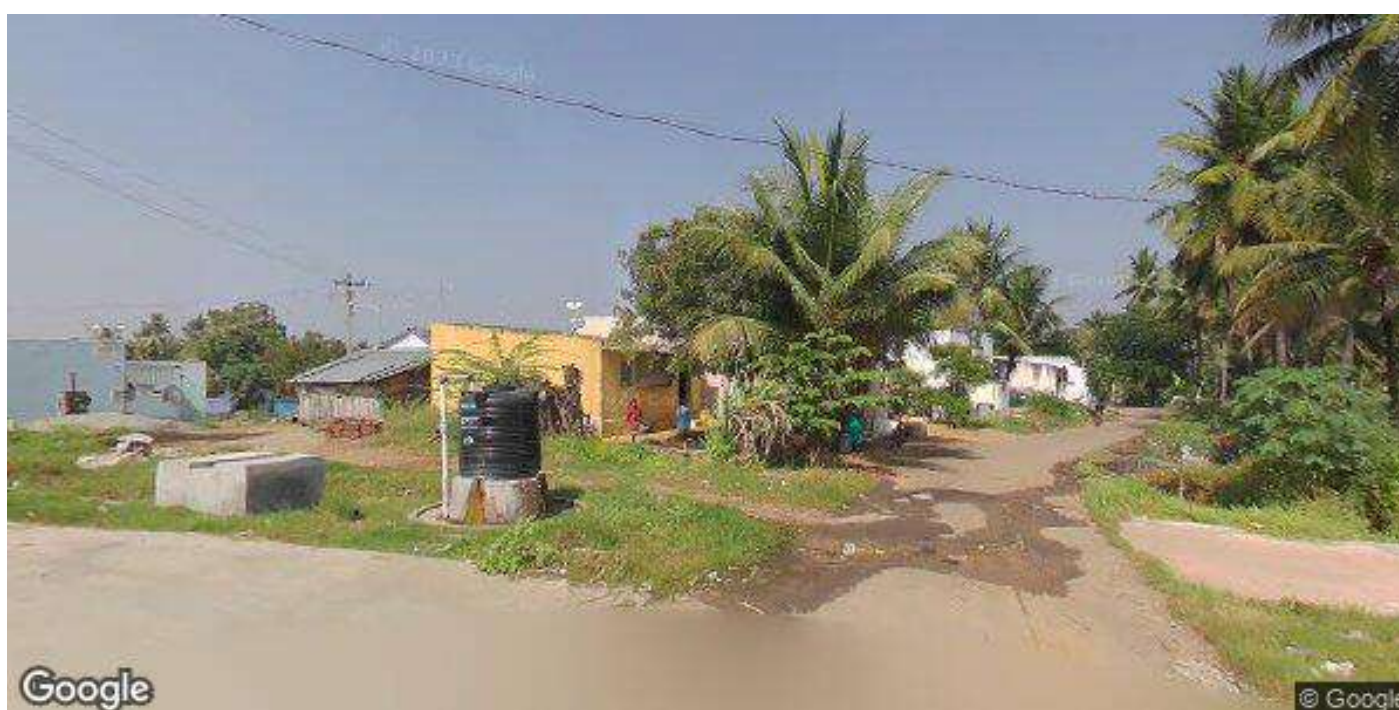
**Risk Type:** Turn  
**Risk Level:** High  
**Speed Limit:** 15 KM/Hr  
**Coordinates:** 11.32376, 77.78976

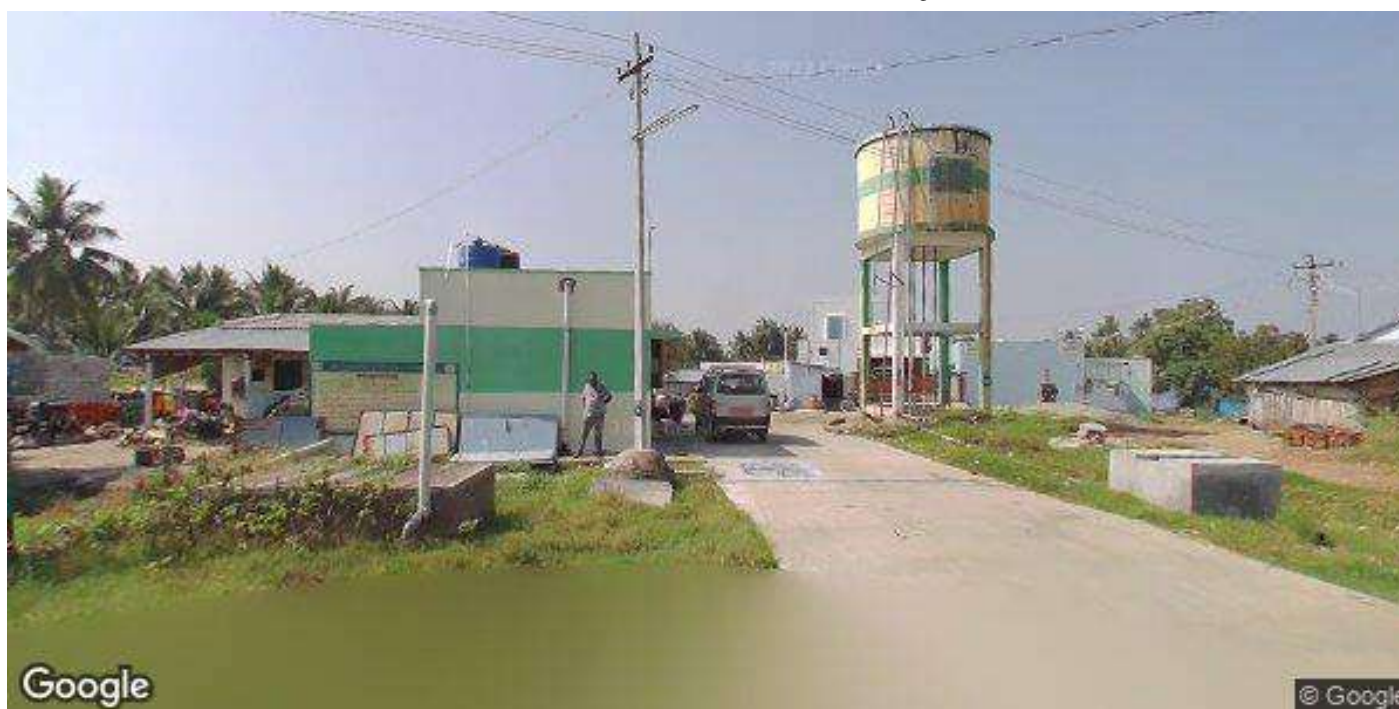
**Risk Type:** Blind Spot  
**Risk Level:** Blind Spot  
**Speed Limit:** 10 KM/Hr  
**Coordinates:** 11.32358, 77.78941

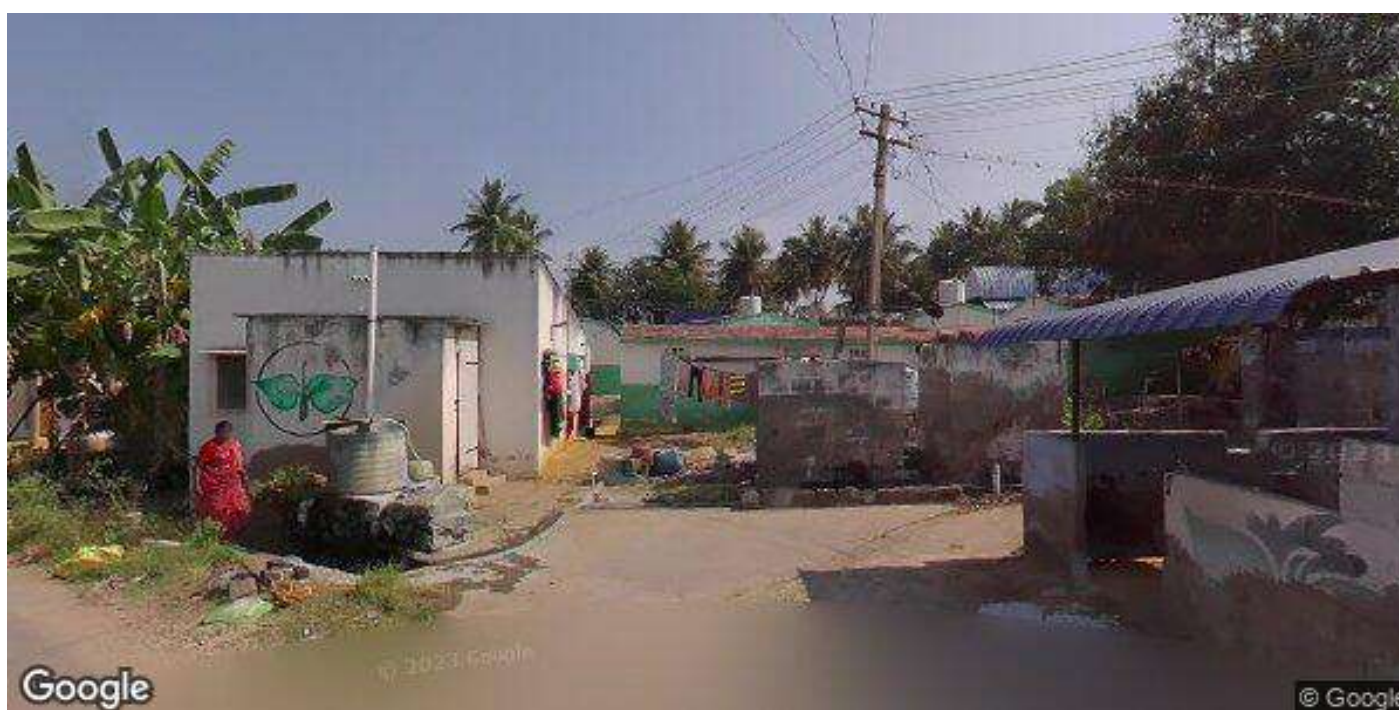
**Risk Type:** Blind Spot  
**Risk Level:** Blind Spot  
**Speed Limit:** 10 KM/Hr  
**Coordinates:** 11.32423, 77.78912

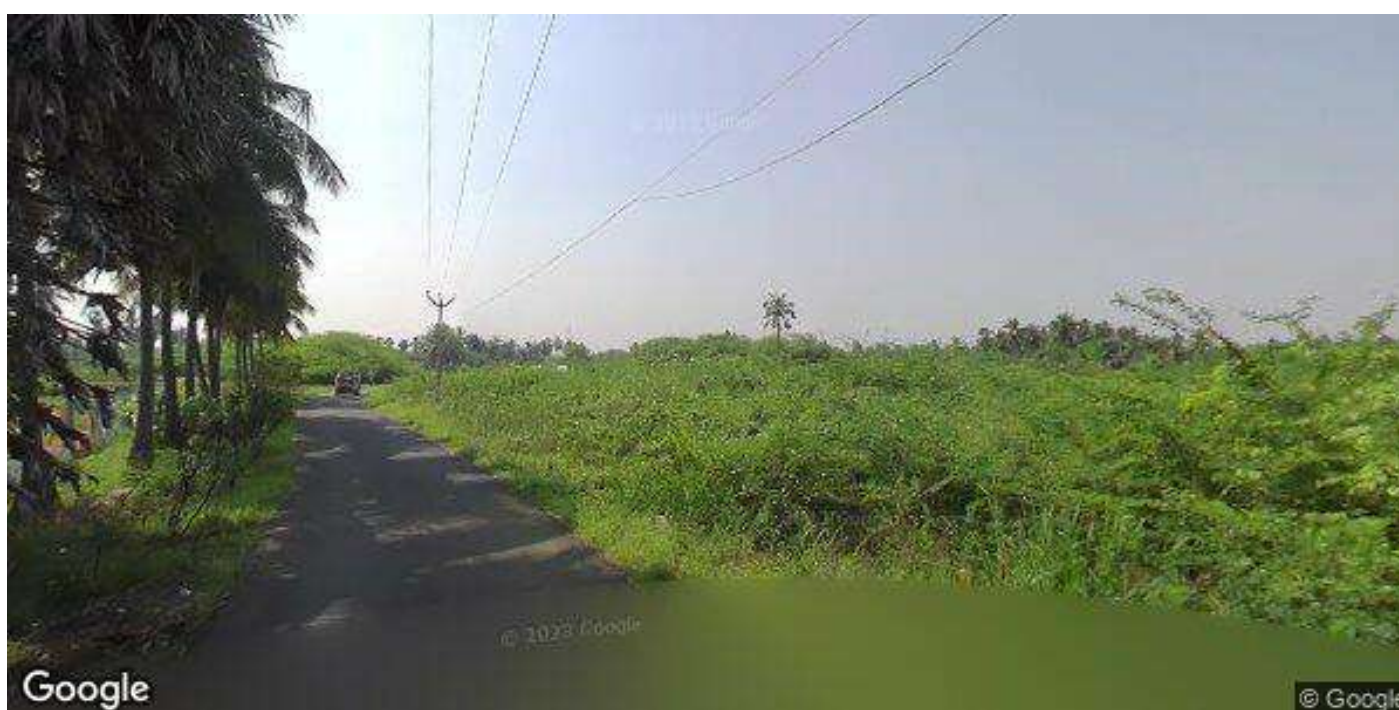
**Risk Type:** Turn  
**Risk Level:** Medium  
**Speed Limit:** 30 KM/Hr  
**Coordinates:** 11.32243, 77.78555

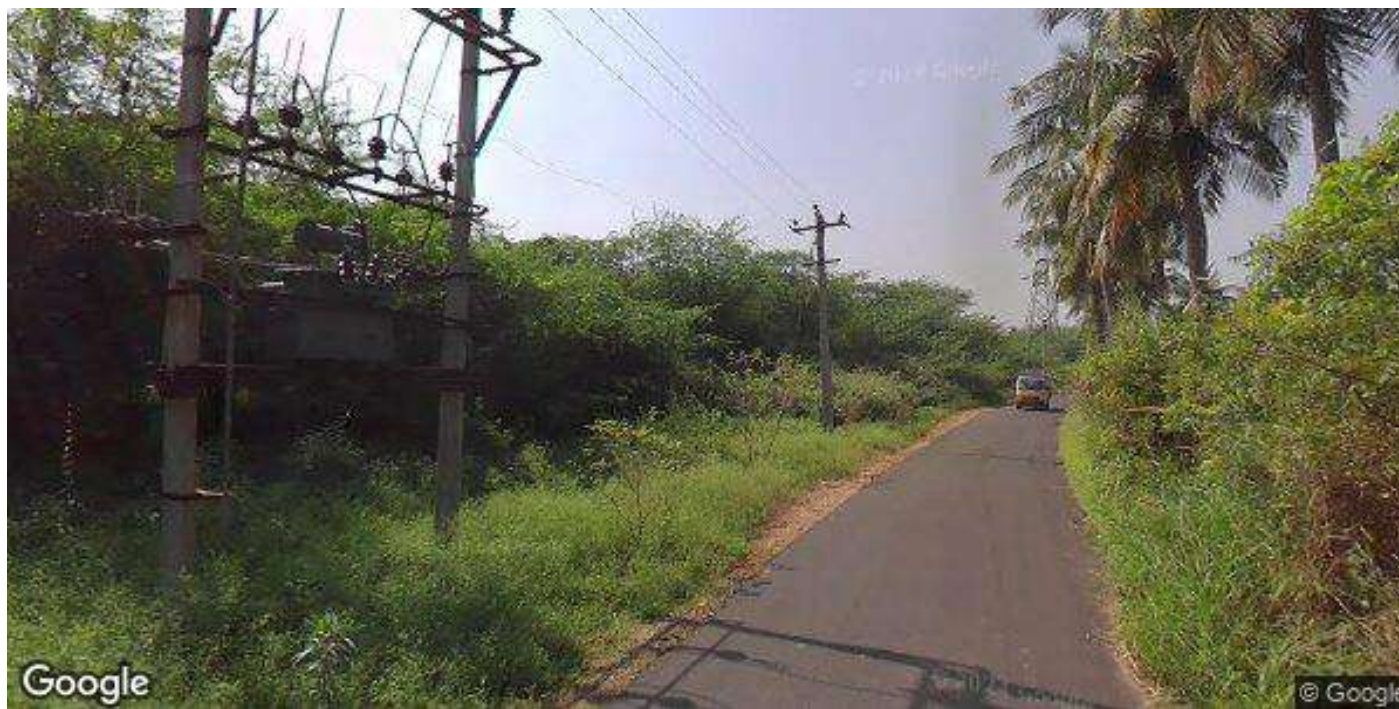
**Risk Type:** Turn  
**Risk Level:** Medium  
**Speed Limit:** 30 KM/Hr  
**Coordinates:** 11.32013, 77.78492

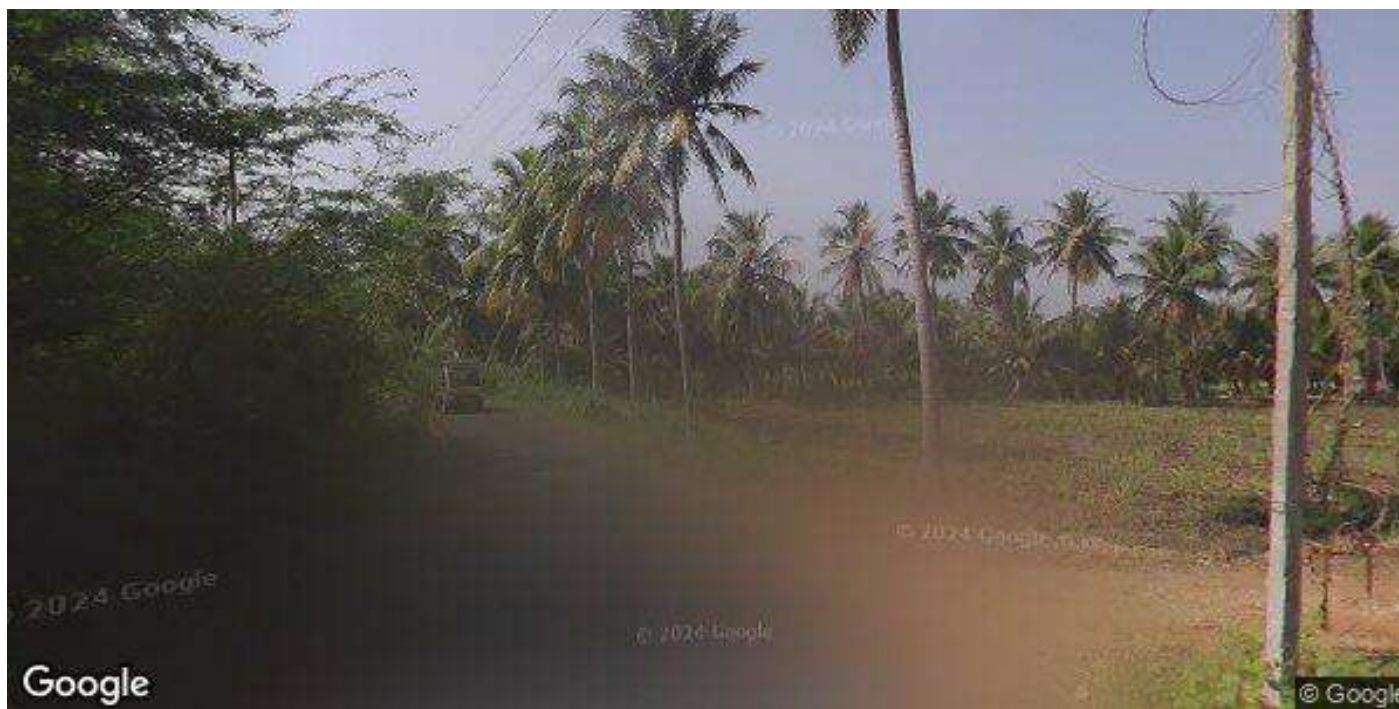
**Risk Type:** Turn  
**Risk Level:** Medium  
**Speed Limit:** 30 KM/Hr  
**Coordinates:** 11.31955, 77.78388

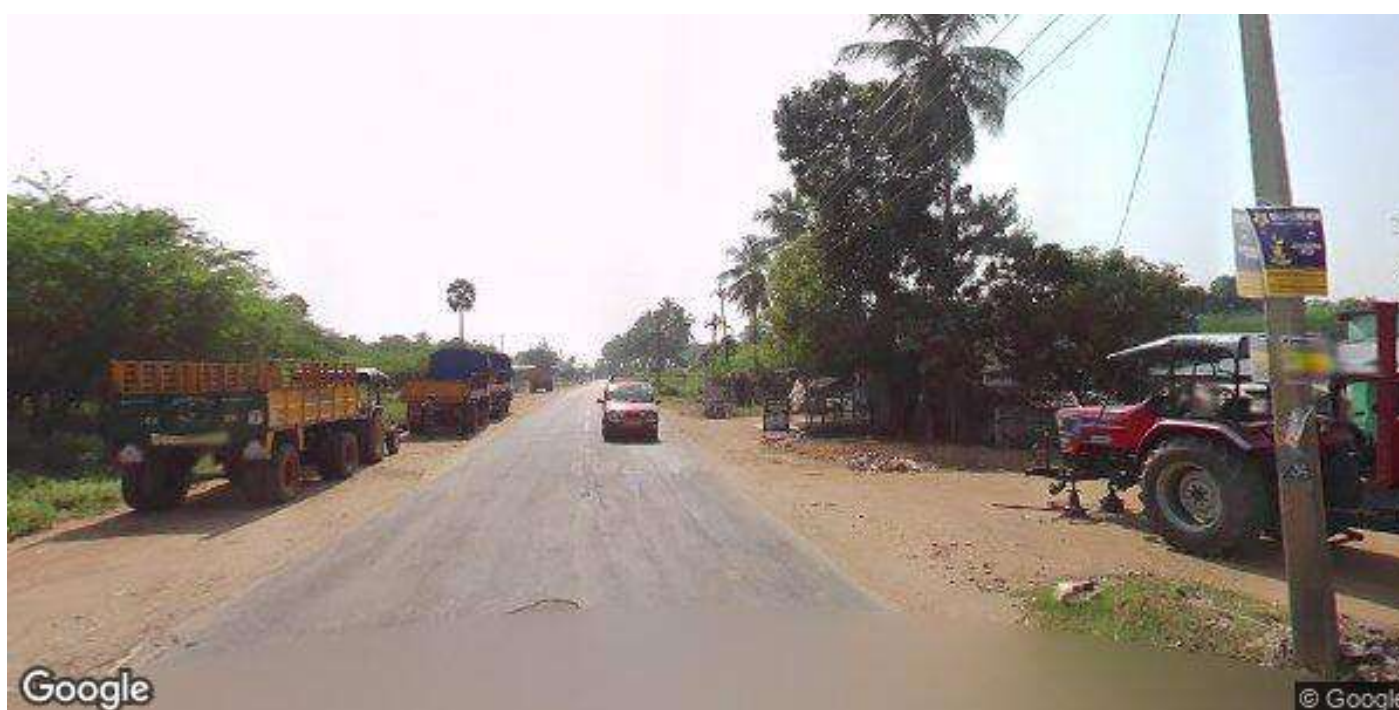
**Risk Type:** Blind Spot  
**Risk Level:** Blind Spot  
**Speed Limit:** 10 KM/Hr  
**Coordinates:** 11.31627, 77.78274

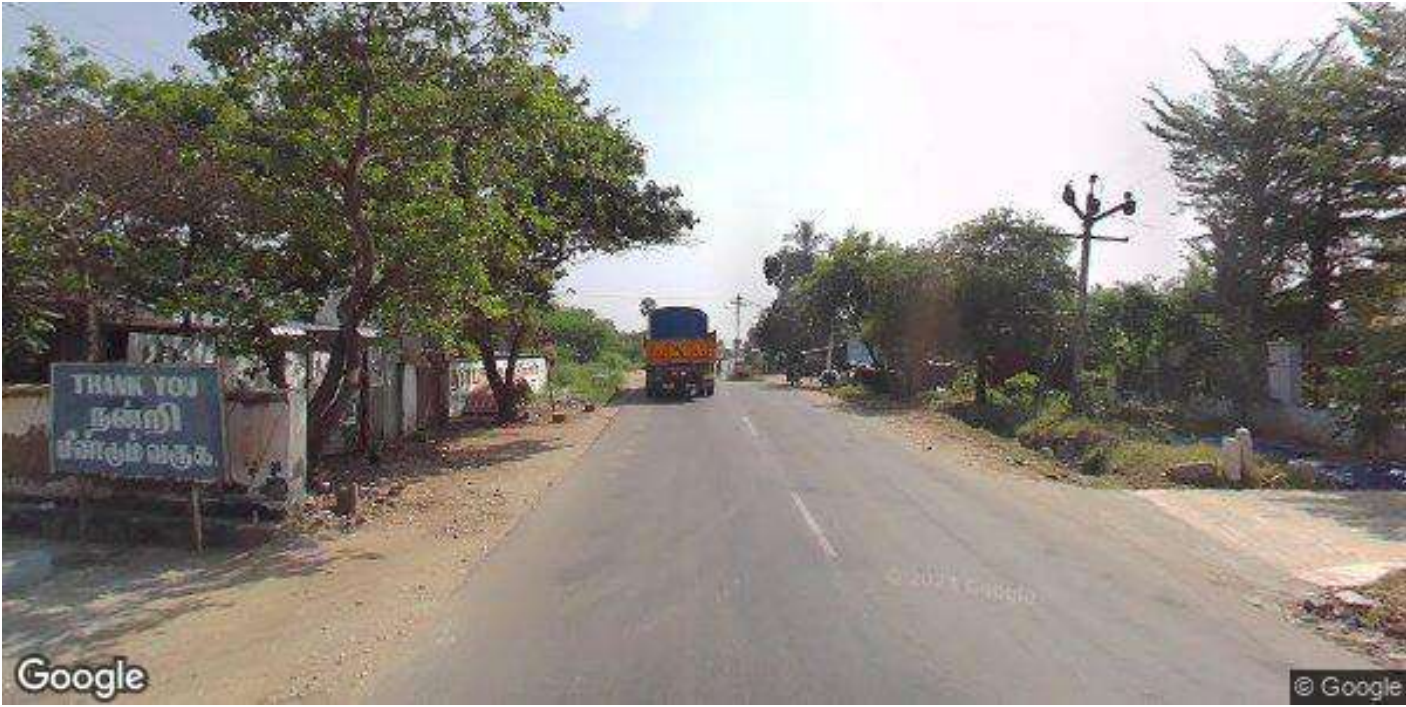
**Risk Type:** Turn  
**Risk Level:** High  
**Speed Limit:** 15 KM/Hr  
**Coordinates:** 11.31664, 77.78249
