# IndianOil

## JOURNEY RISK MANAGEMENT (JRM) STUDY

### Salem Terminal to UDAYAM AGENCY

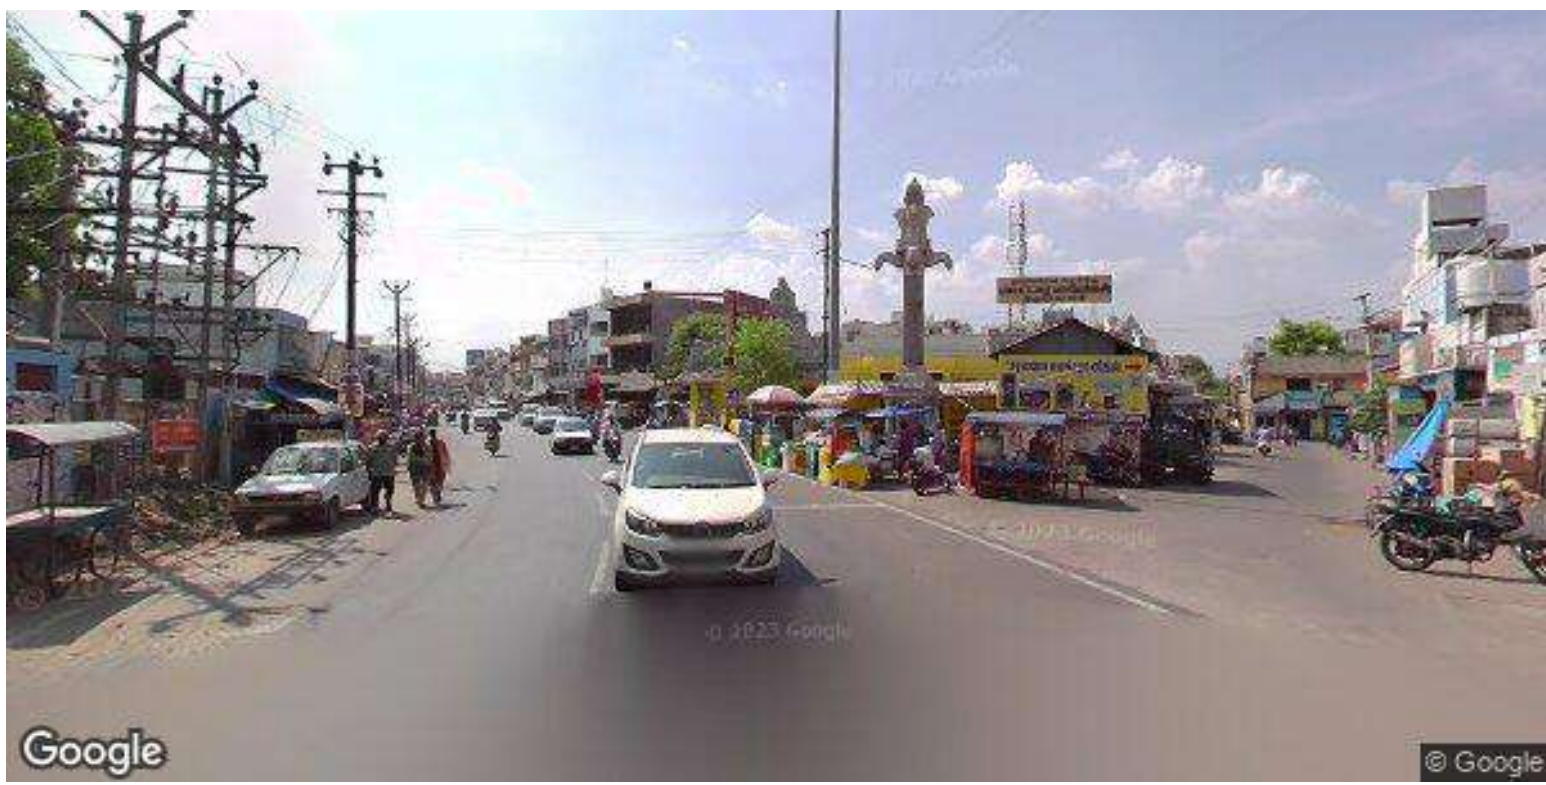
**Coordinates:** 11.22411, 78.16637

**Risk Type:** Turn

**Risk Level:** Medium

**Speed Limit:** 30 KM/Hr
