# IndianOil

## JOURNEY RISK MANAGEMENT (JRM) STUDY

### Salem Terminal to RANJETH AGENCIES

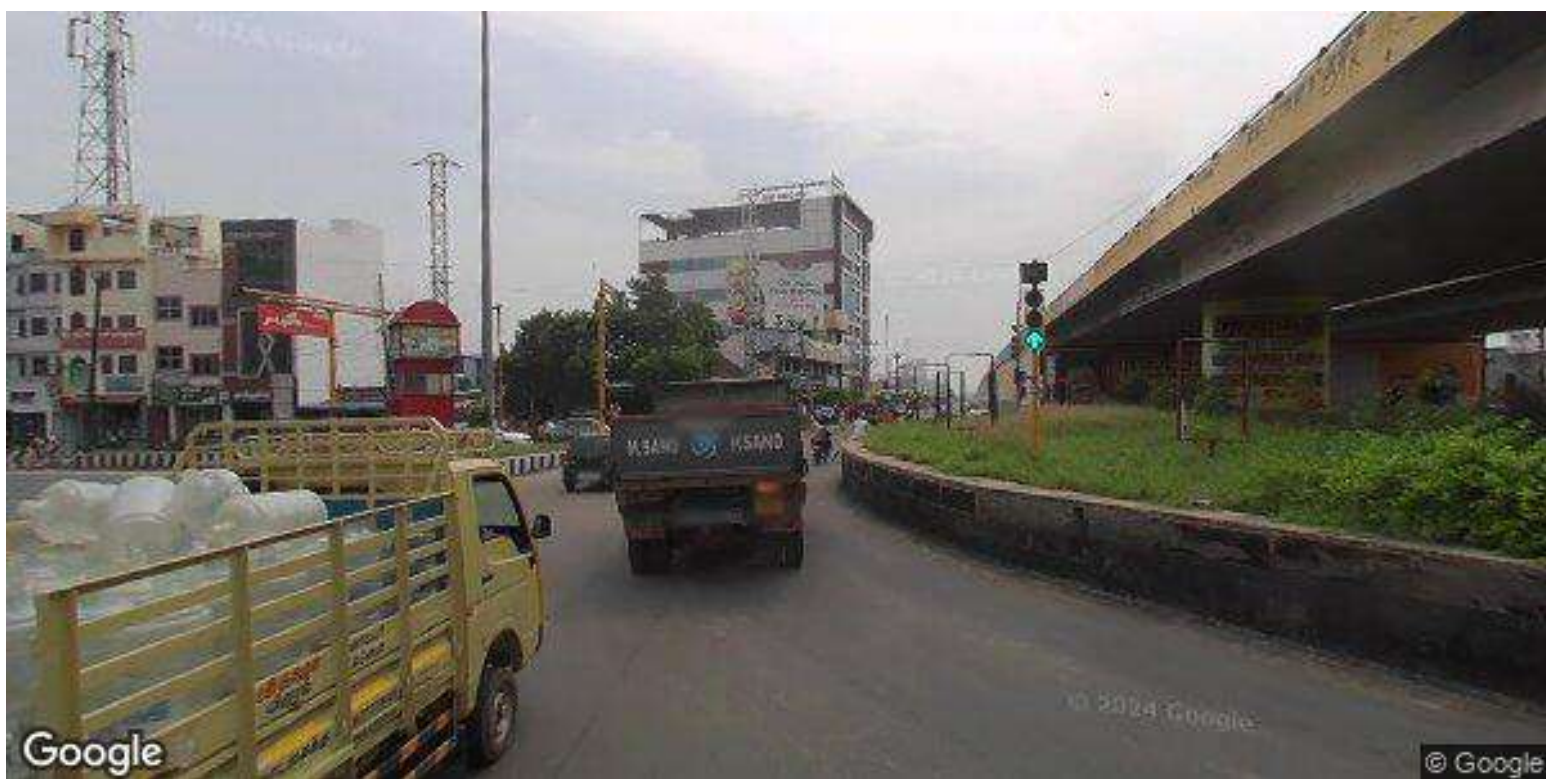
**Coordinates:** 10.96304, 78.06131

**Risk Type:** Roundabout

**Risk Level:** High

**Speed Limit:** 15 KM/Hr

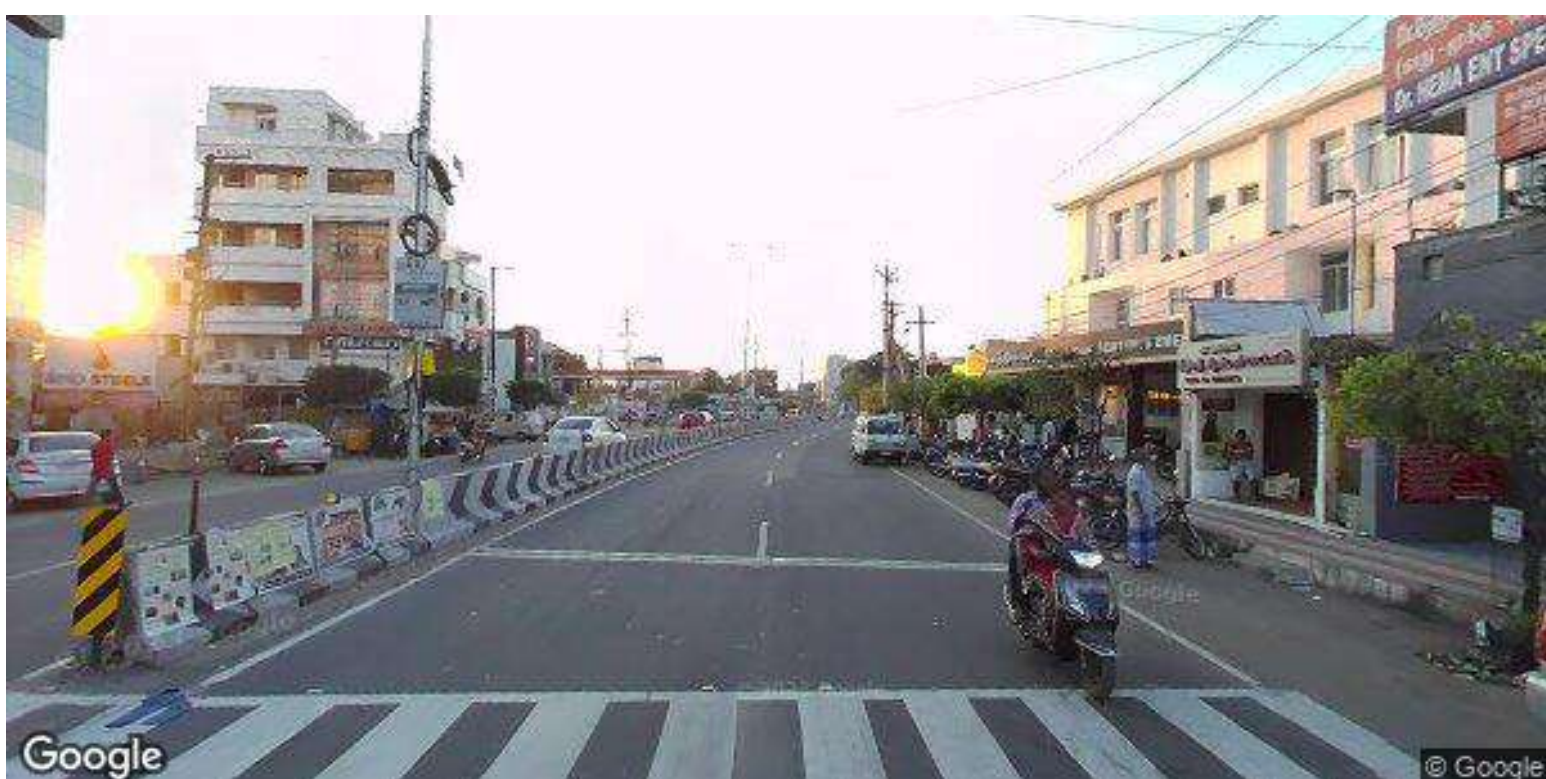
**Coordinates: 10.9617665, 78.0644854**

**Risk Type: U-Turn**

**Risk Level: High**

**Speed Limit: 10 KM/Hr**

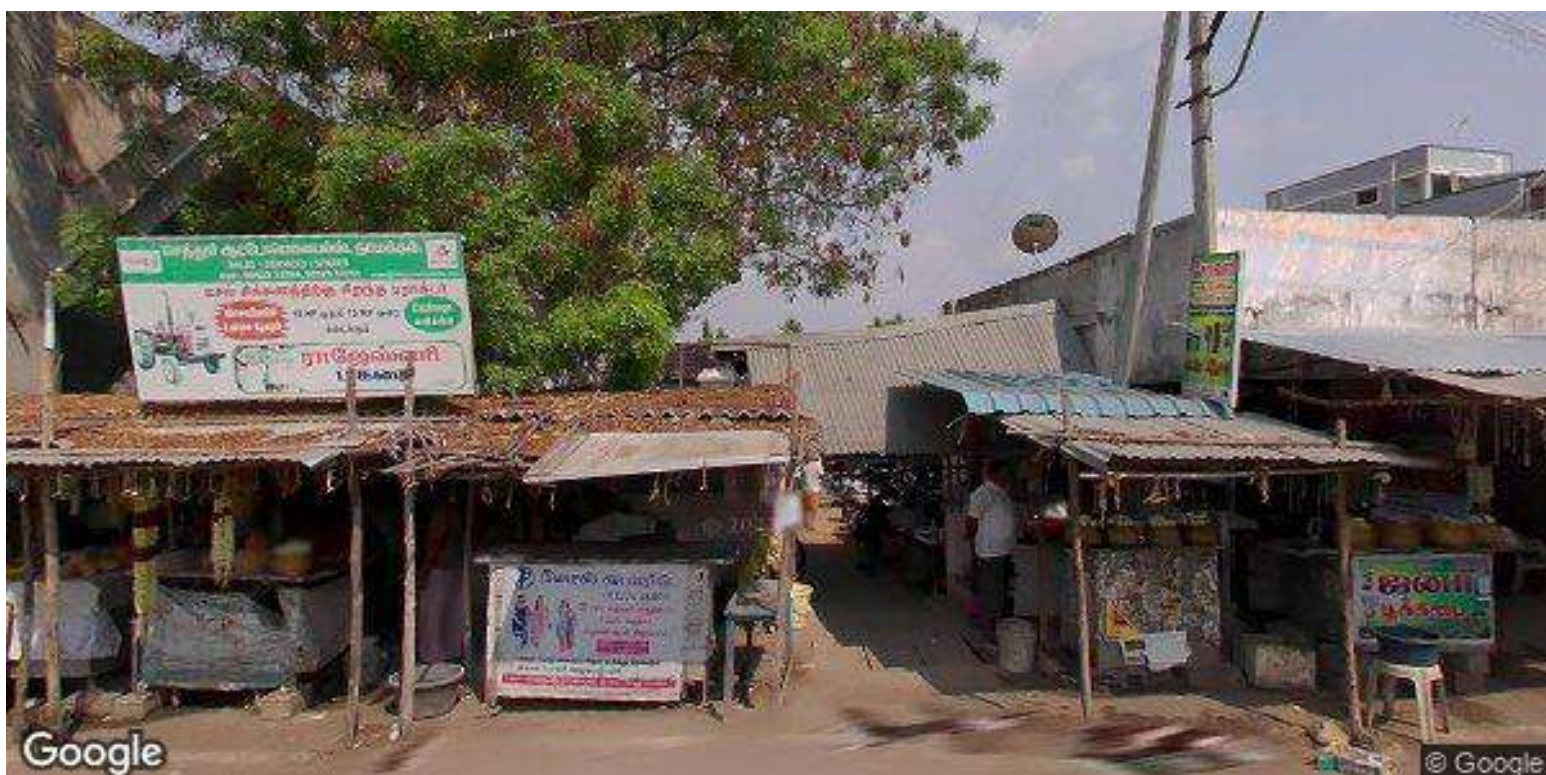
**Risk Type:** Turn  
**Risk Level:** High  
**Speed Limit:** 15 KM/Hr  
**Coordinates:** 11.15573, 78.02176

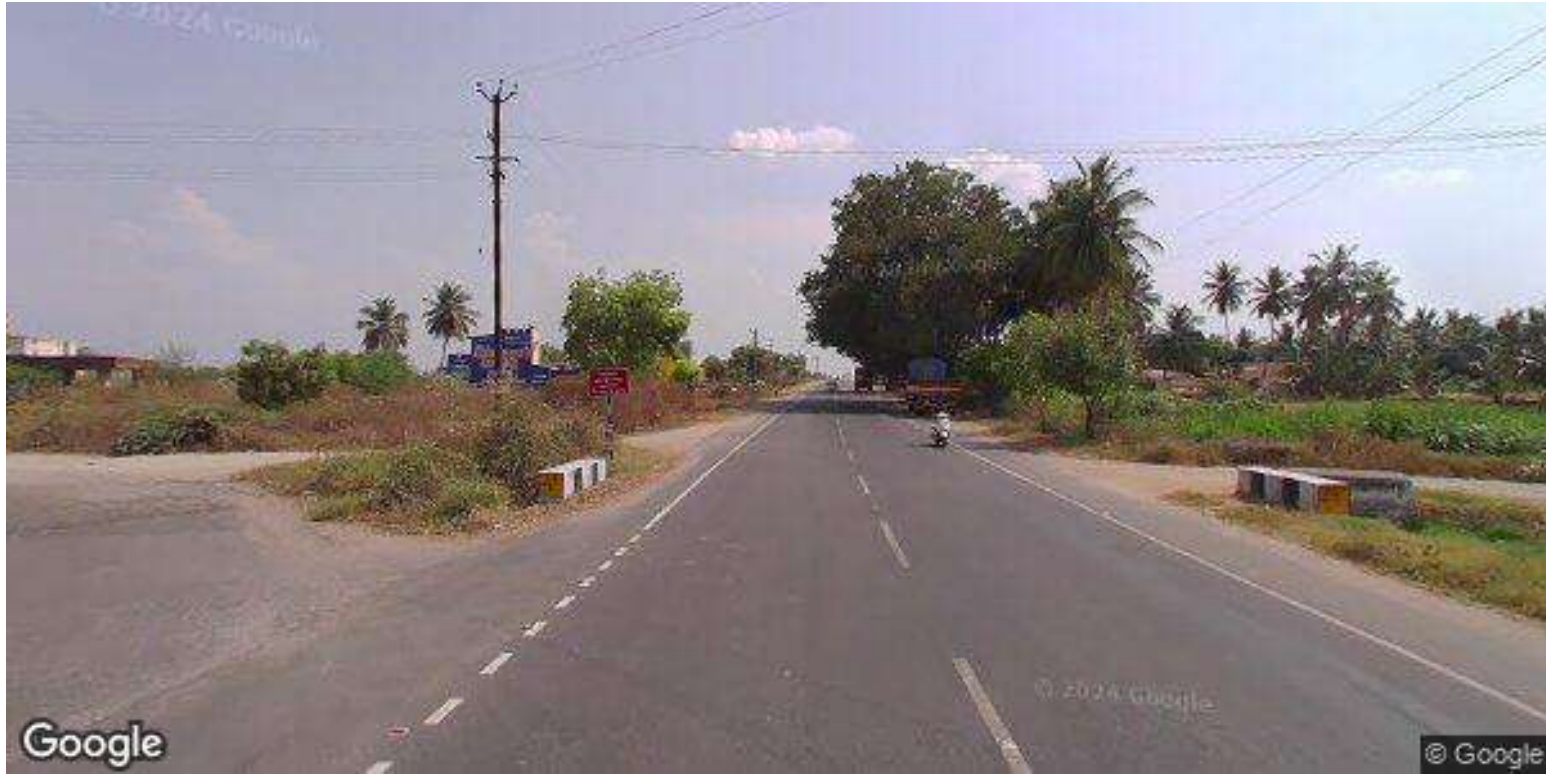
**Risk Type:** Turn  
**Risk Level:** High  
**Speed Limit:** 15 KM/Hr  
**Coordinates:** 11.14545, 78.02208

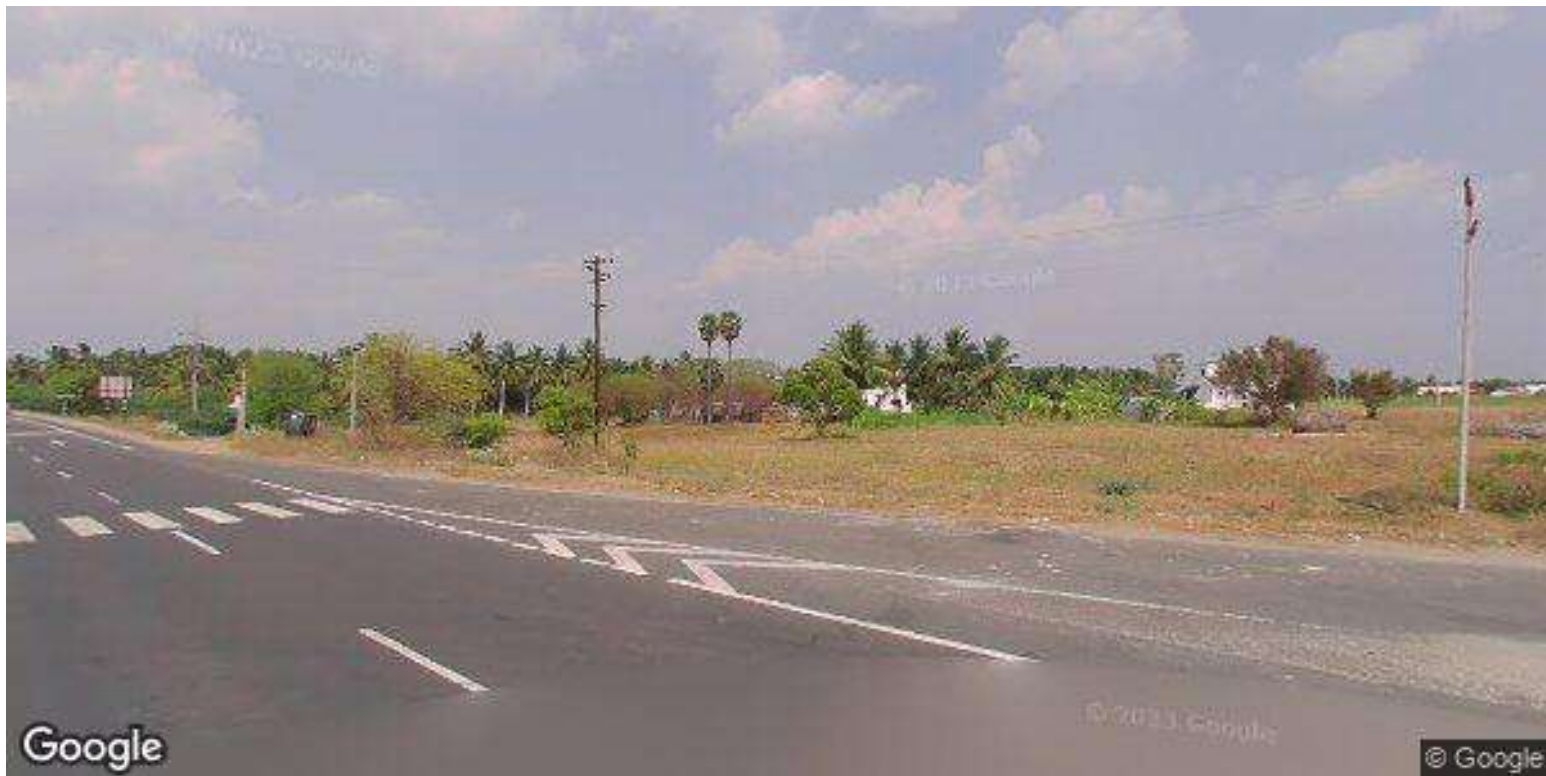
**Risk Type:** Turn  
**Risk Level:** High  
**Speed Limit:** 15 KM/Hr  
**Coordinates:** 11.14480, 78.02291

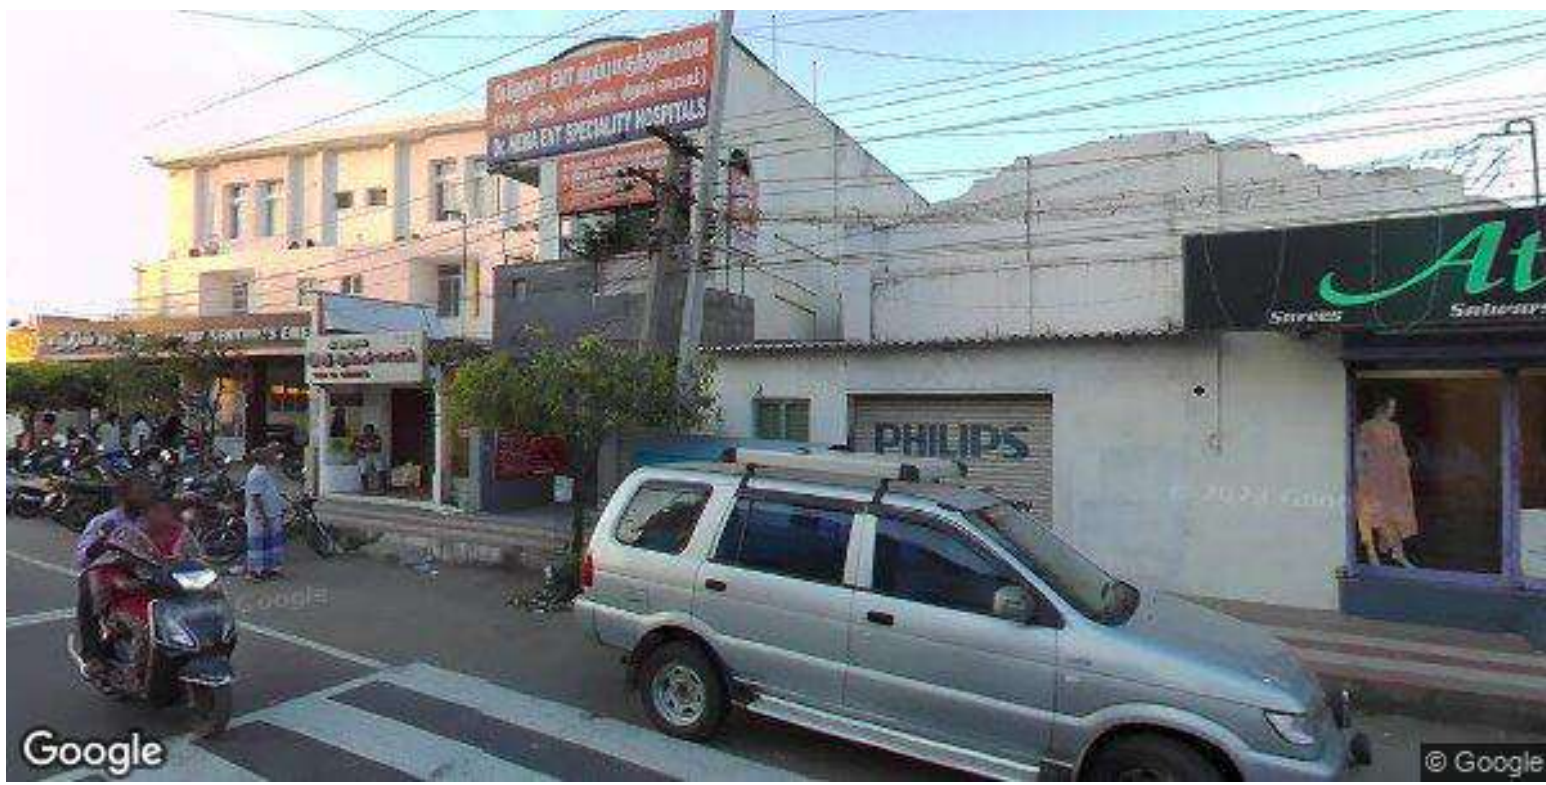
**Coordinates:** 10.96177, 78.06449

**Risk Type:** Turn

**Risk Level:** High

**Speed Limit:** 15 KM/Hr

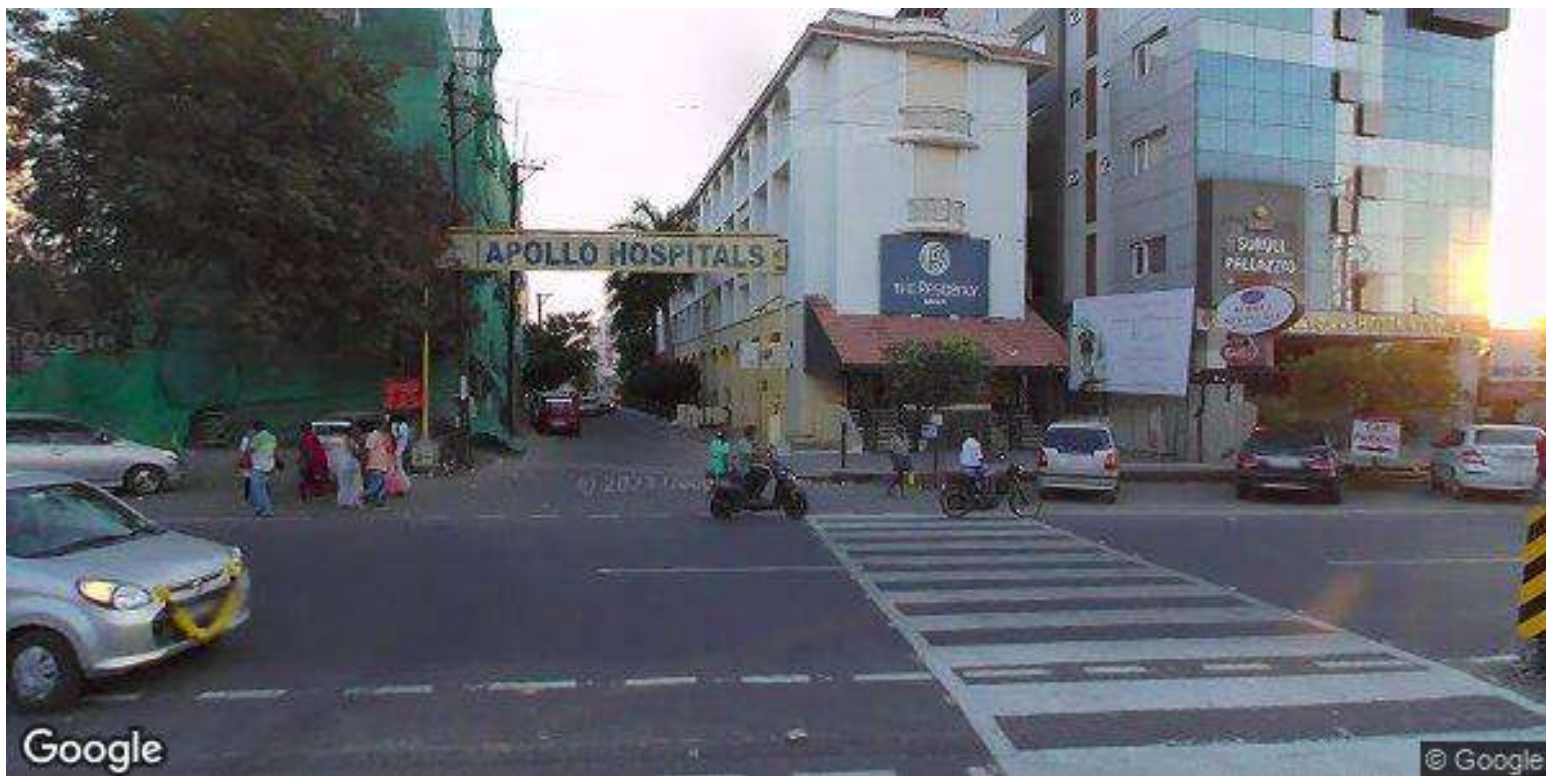
**Coordinates:** 10.96169, 78.06446

**Risk Type:** Blind Spot

**Risk Level:** Blind Spot

**Speed Limit:** 10 KM/Hr
