# IndianOil

## JOURNEY RISK MANAGEMENT (JRM) STUDY

### Salem Terminal to VICTORY AGENCIES

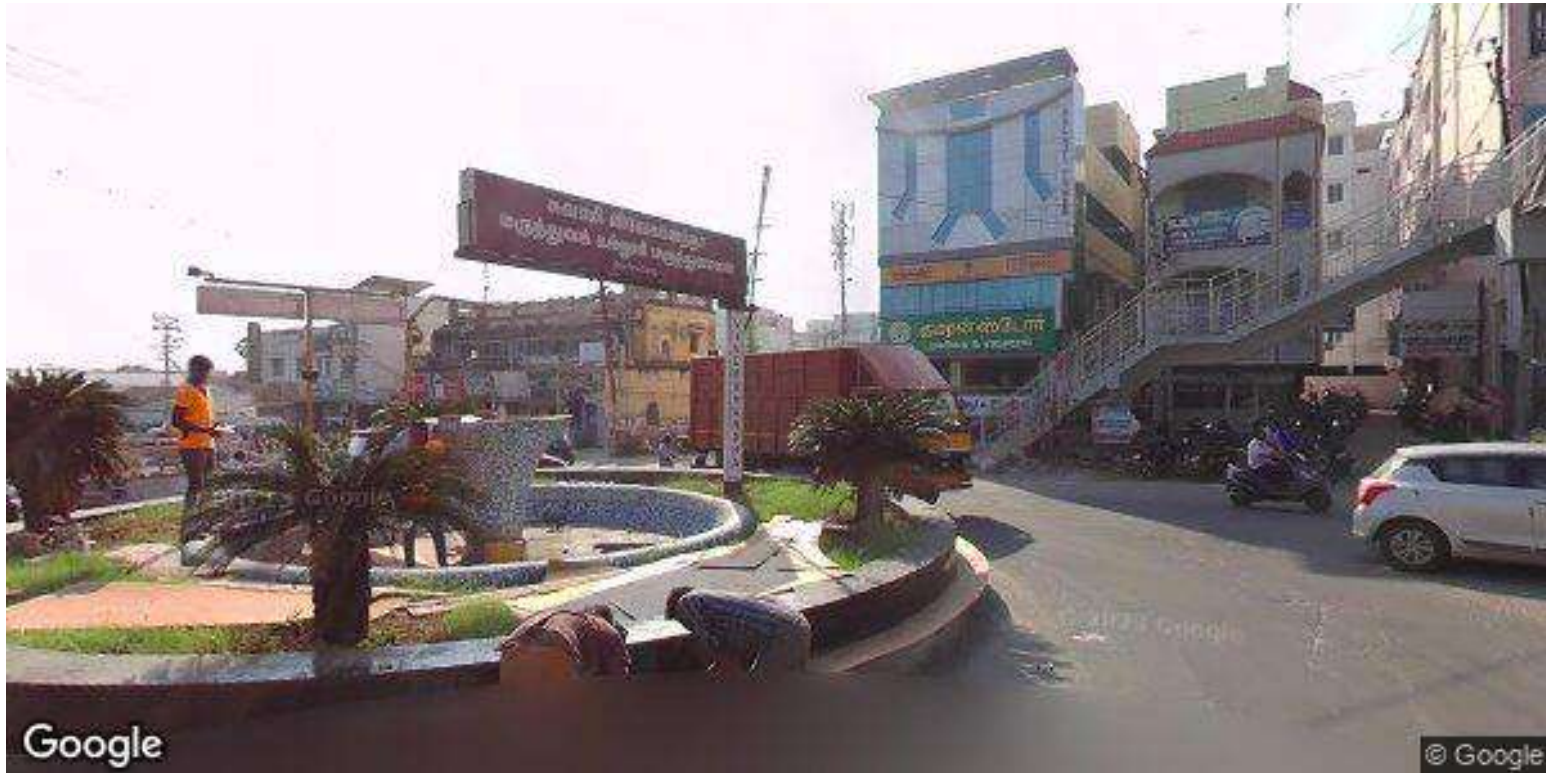
**Coordinates:** 11.38395, 77.89480

**Risk Type:** Roundabout

**Risk Level:** High

**Speed Limit:** 15 KM/Hr

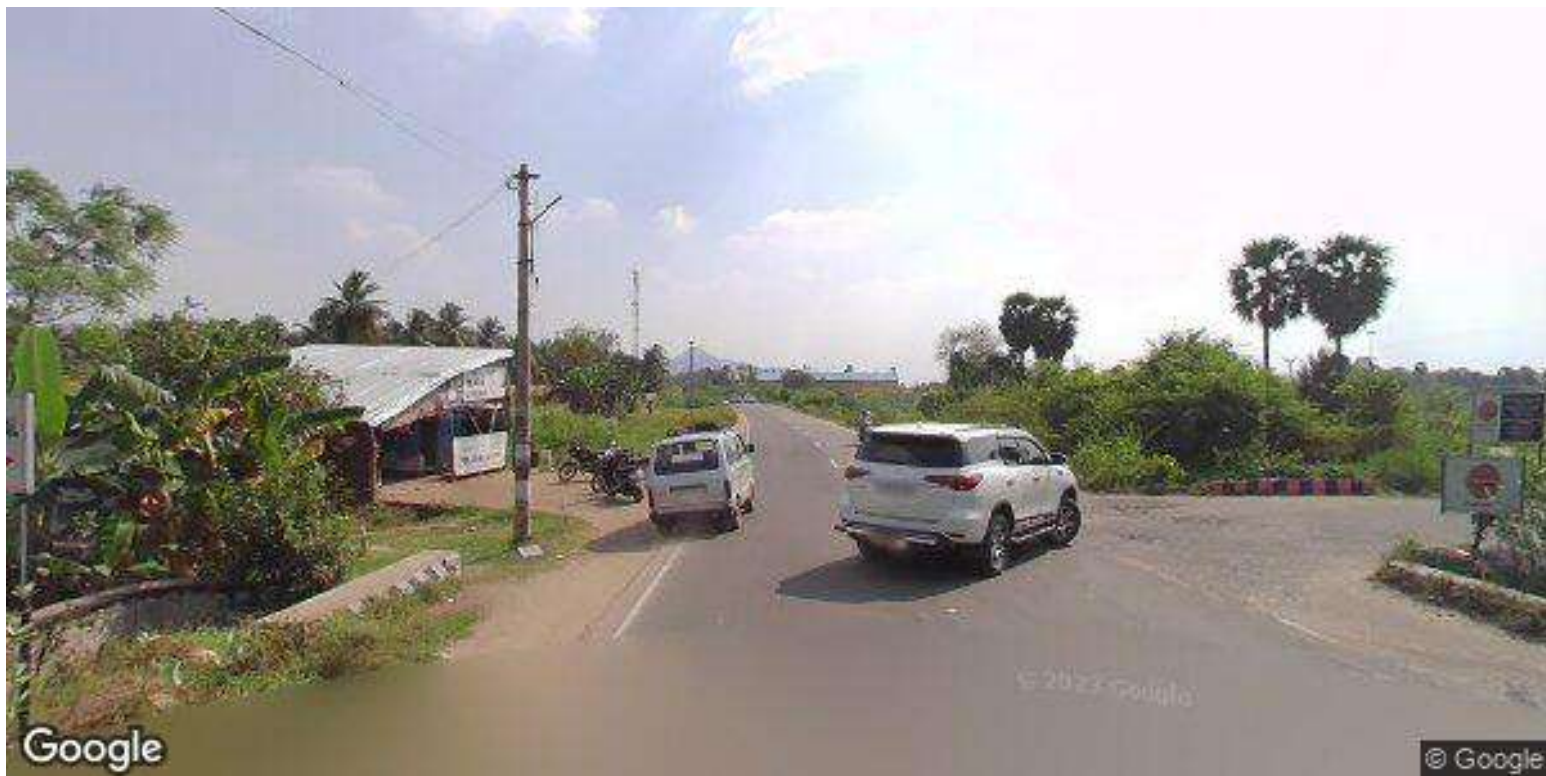
**Coordinates:** 11.44029, 77.87544

**Risk Type:** Blind Spot

**Risk Level:** Blind Spot

**Speed Limit:** 10 KM/Hr

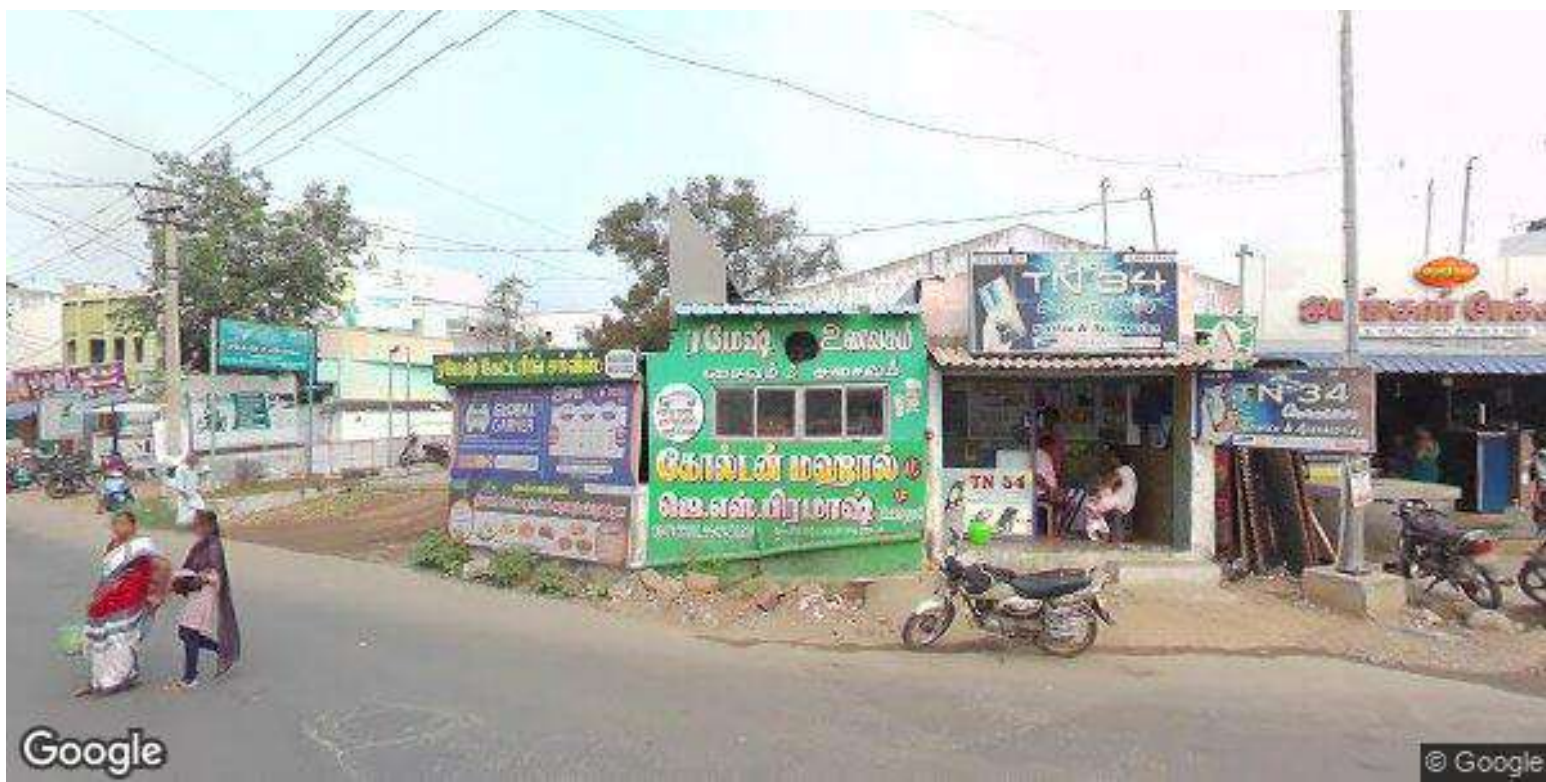
**Coordinates:** 11.38346, 77.89975

**Risk Type:** Turn

**Risk Level:** High

**Speed Limit:** 15 KM/Hr

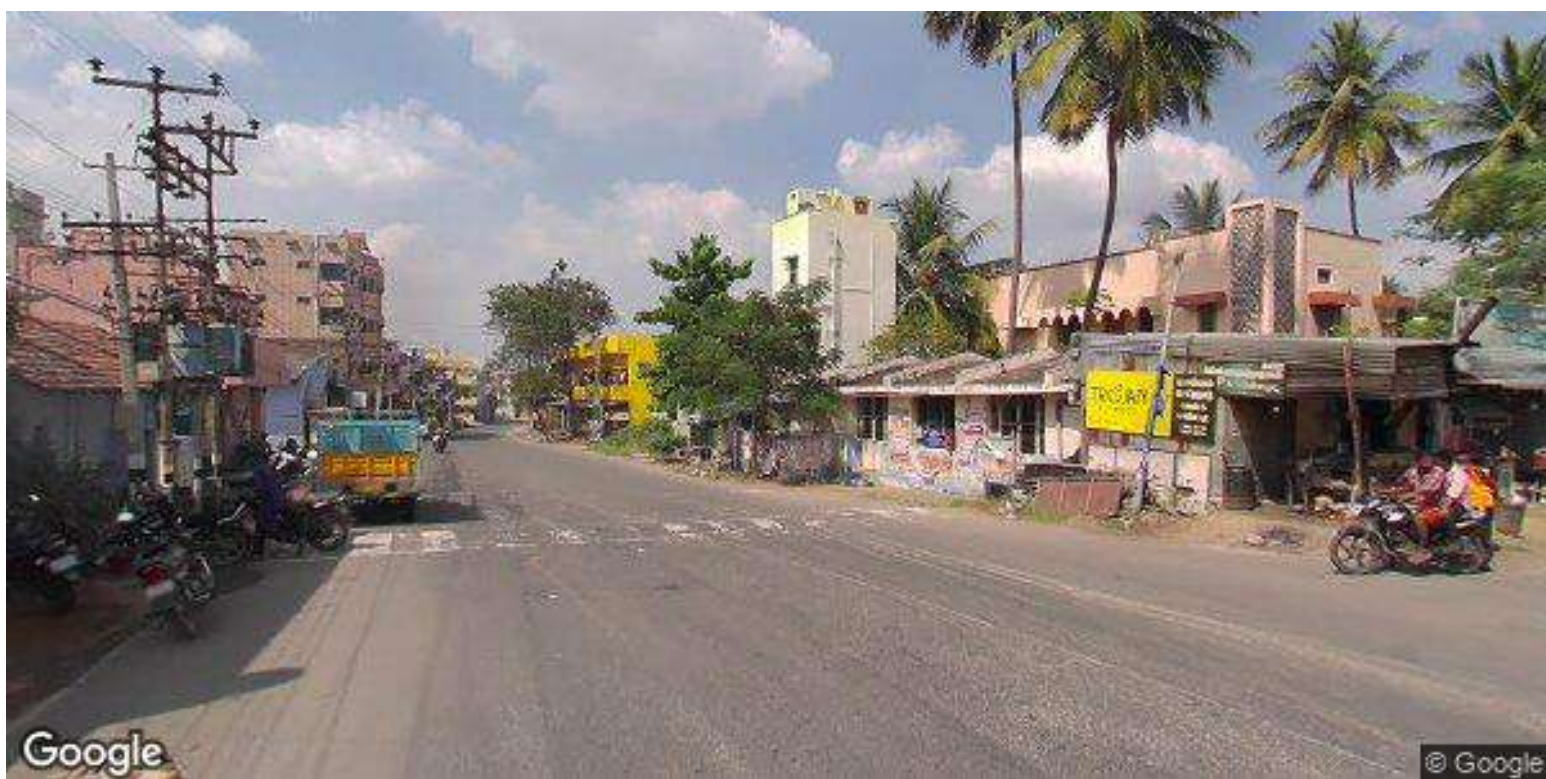
**Coordinates:** 11.38190, 77.90254

**Risk Type:** Turn

**Risk Level:** Medium

**Speed Limit:** 30 KM/Hr

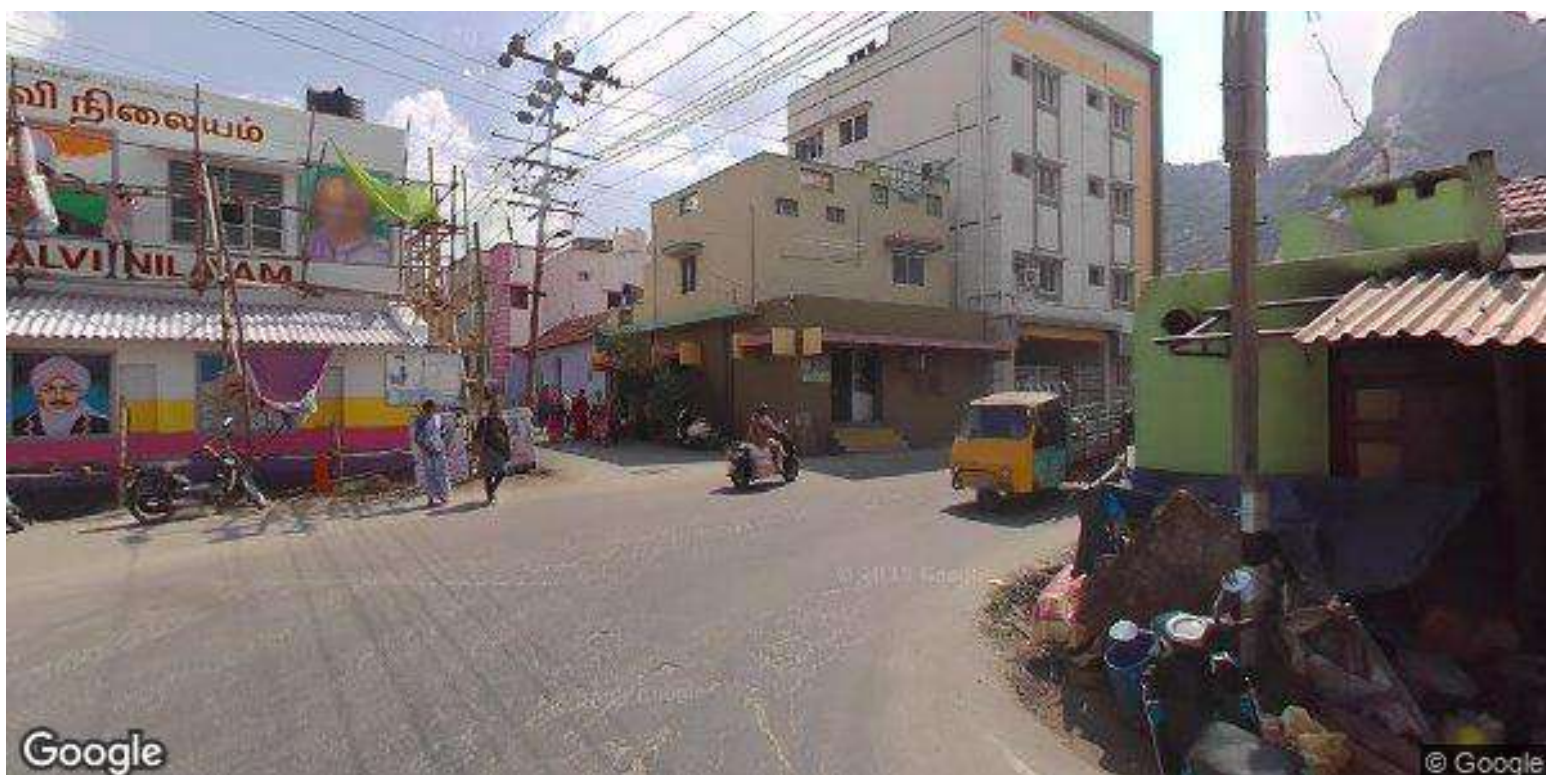
**Coordinates:** 11.38186, 77.90258

**Risk Type:** Turn

**Risk Level:** Medium

**Speed Limit:** 30 KM/Hr

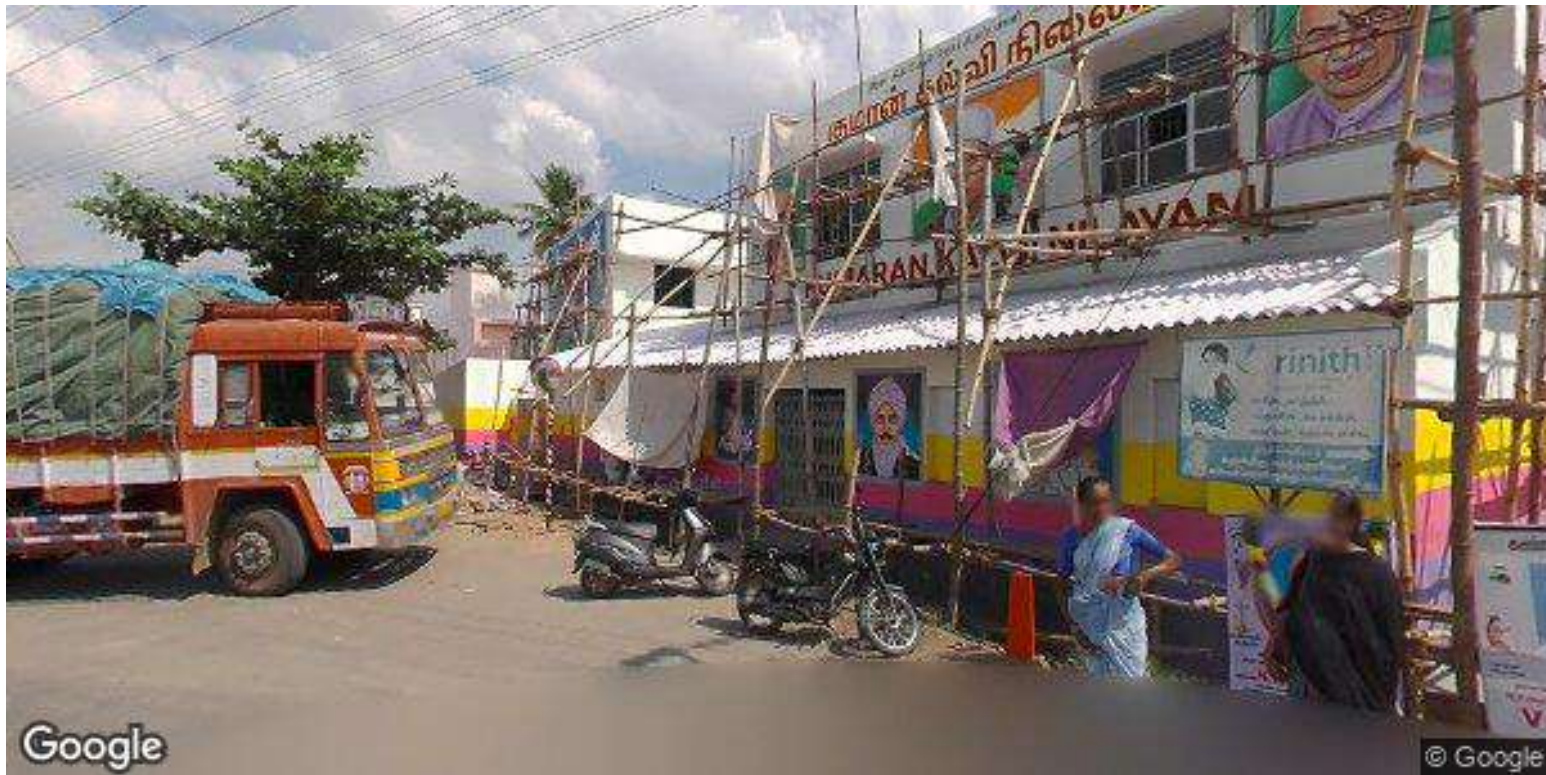
**Coordinates:** 11.38182, 77.90259

**Risk Type:** Turn

**Risk Level:** Medium

**Speed Limit:** 30 KM/Hr

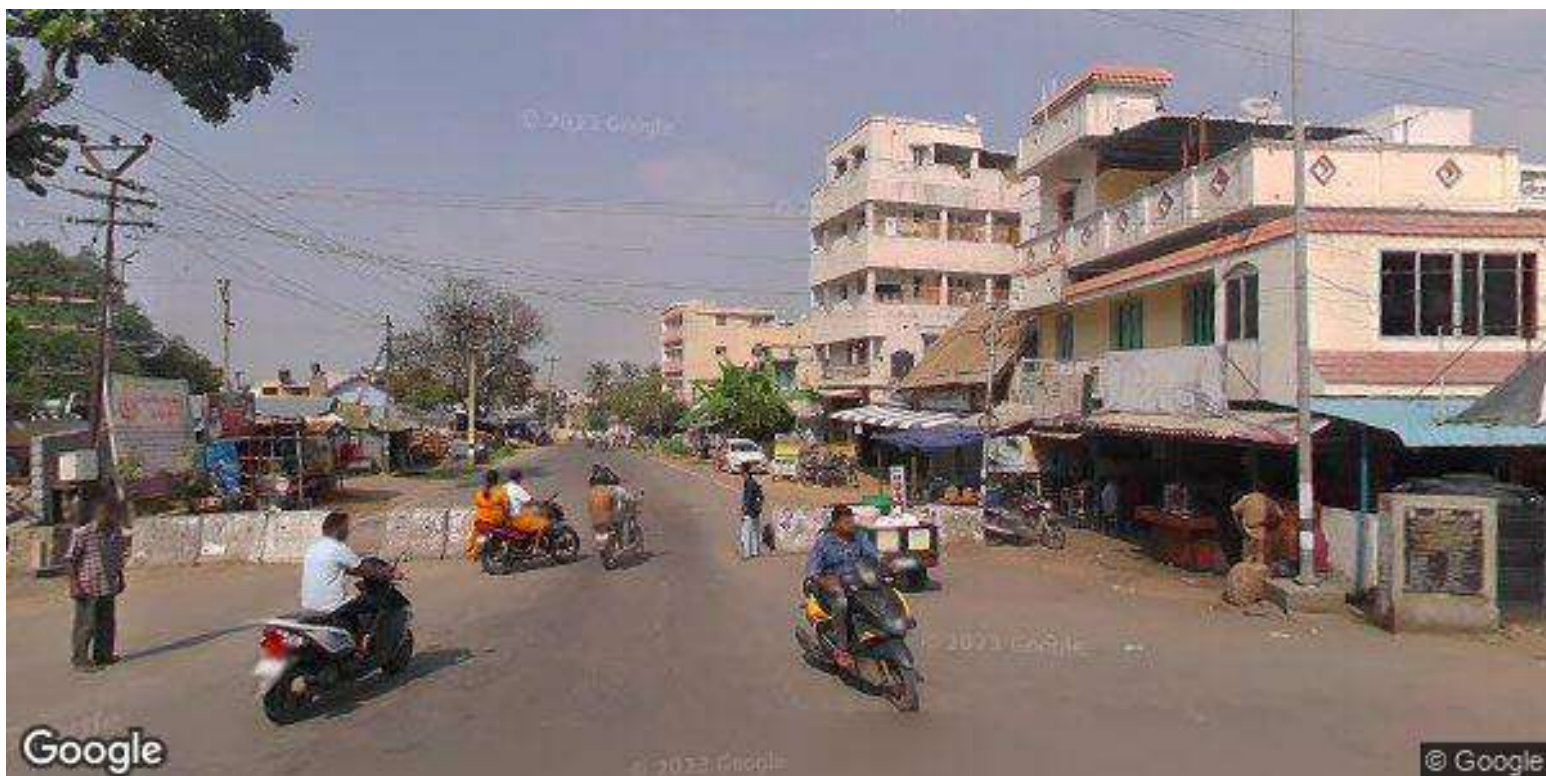
**Coordinates:** 11.37841, 77.90140

**Risk Type:** Blind Spot

**Risk Level:** Blind Spot

**Speed Limit:** 10 KM/Hr
