# IndianOil

## JOURNEY RISK MANAGEMENT (JRM) STUDY

### Salem Terminal to V.V.D. PETRO

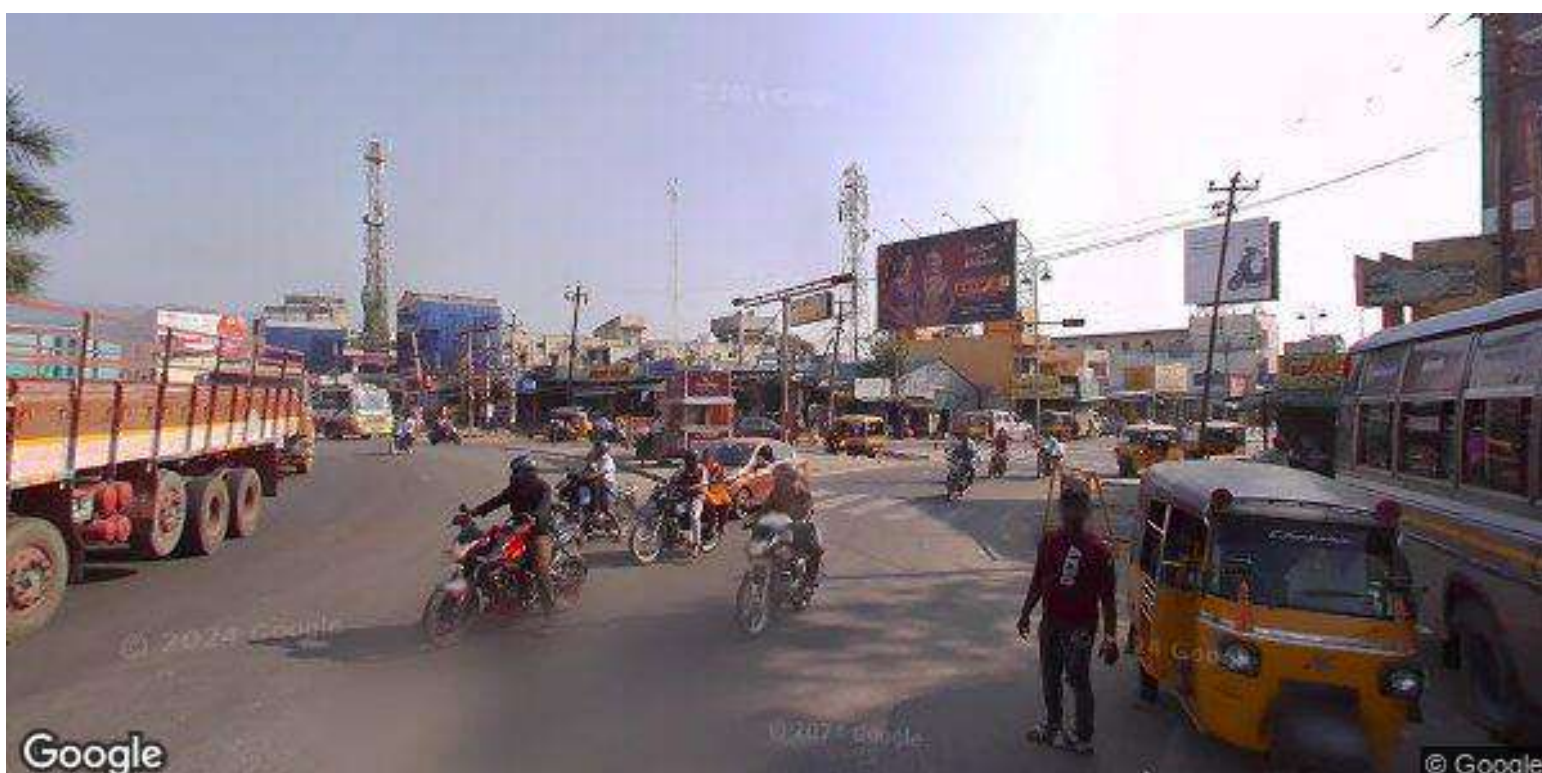
**Risk Type:** Roundabout

**Risk Level:** High

**Speed Limit: 15 KM/Hr**  
**Coordinates: 11.63266, 78.12699**

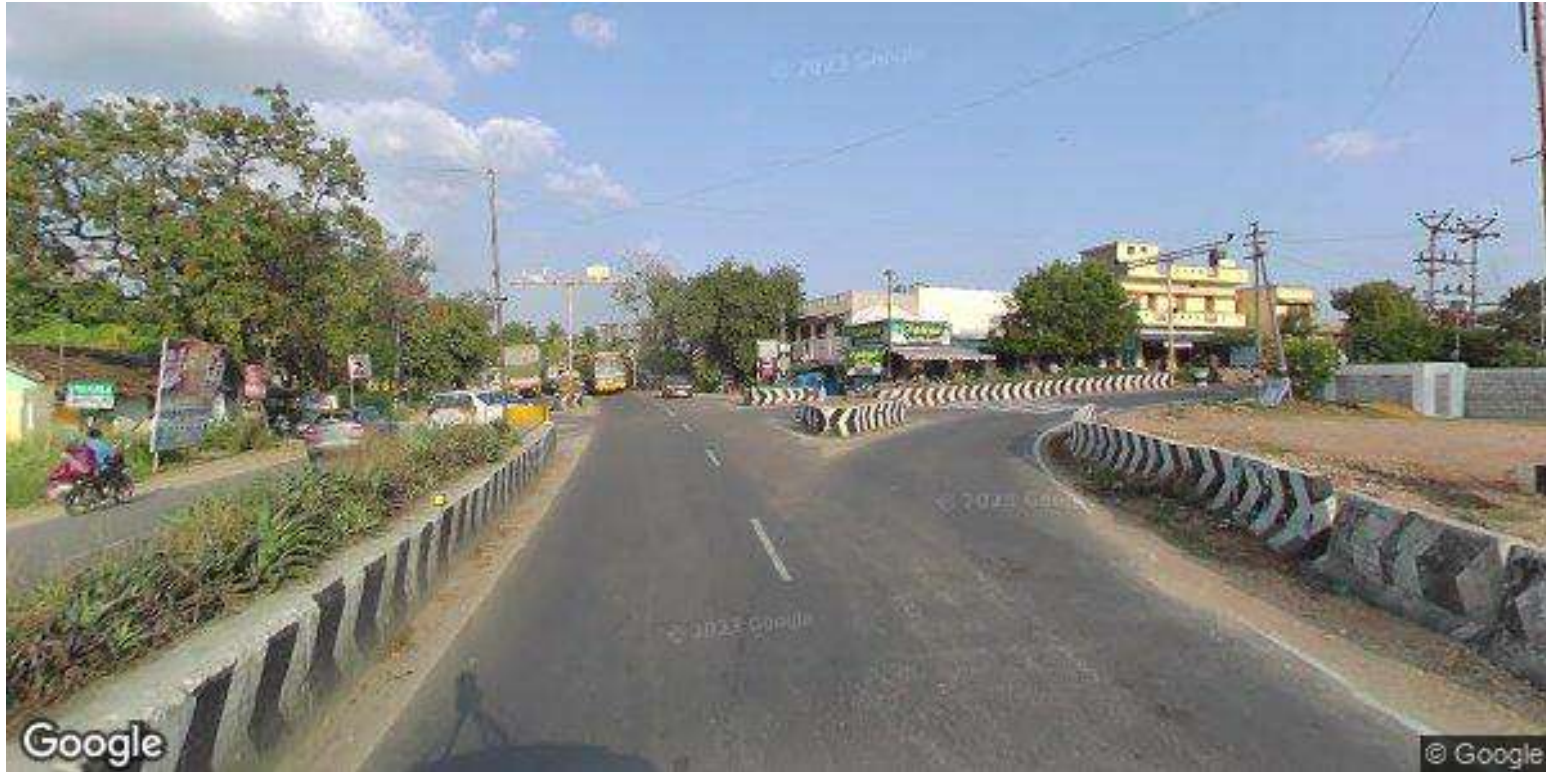
**Risk Type: Turn**

**Risk Level: Medium**

**Speed Limit: 30 KM/Hr**

**Coordinates: 11.46318, 77.84913**

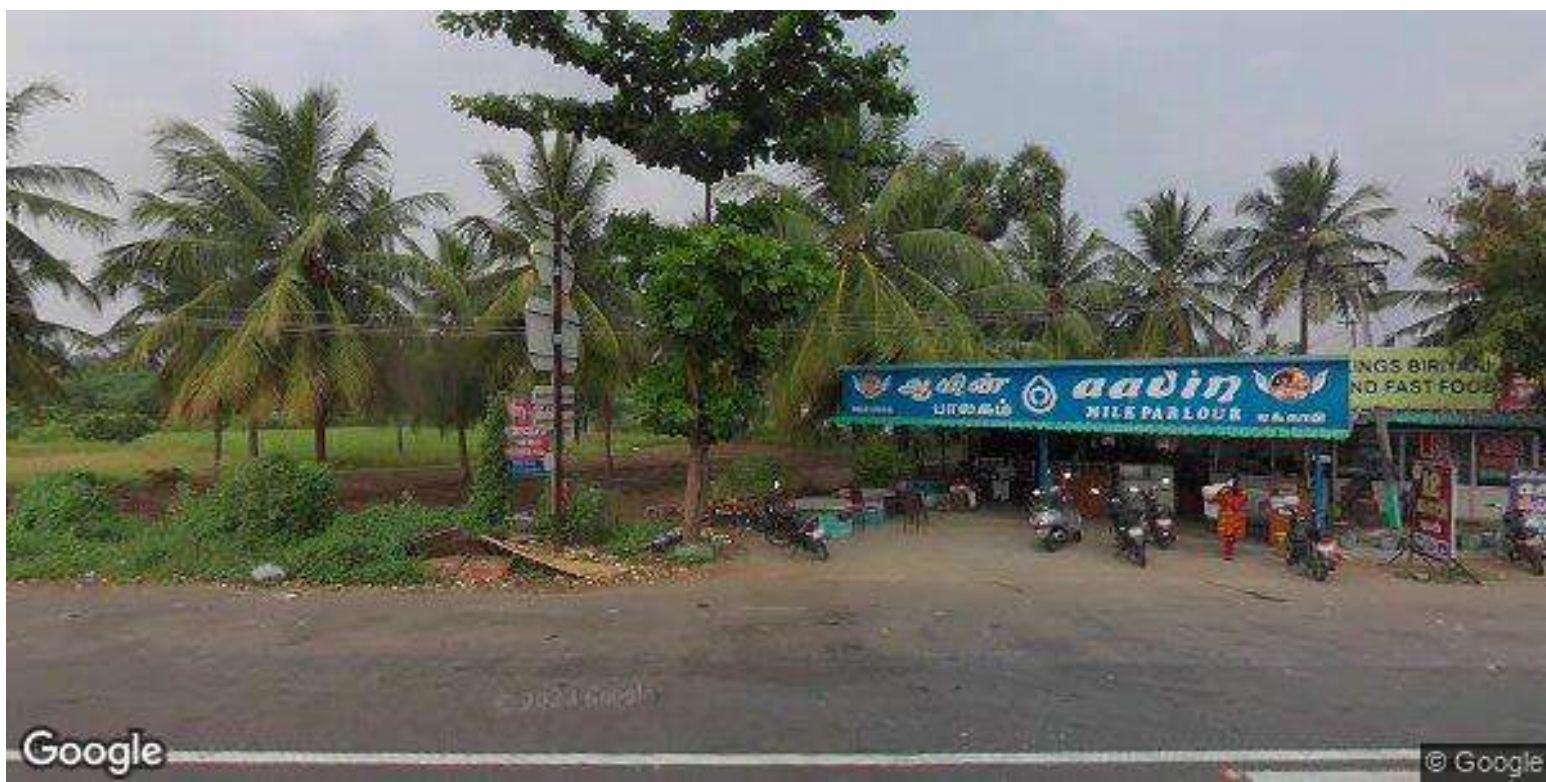
**Risk Type:** Turn

**Risk Level:** High

**Speed Limit:** 15 KM/Hr

**Coordinates:** 11.45631, 77.81668

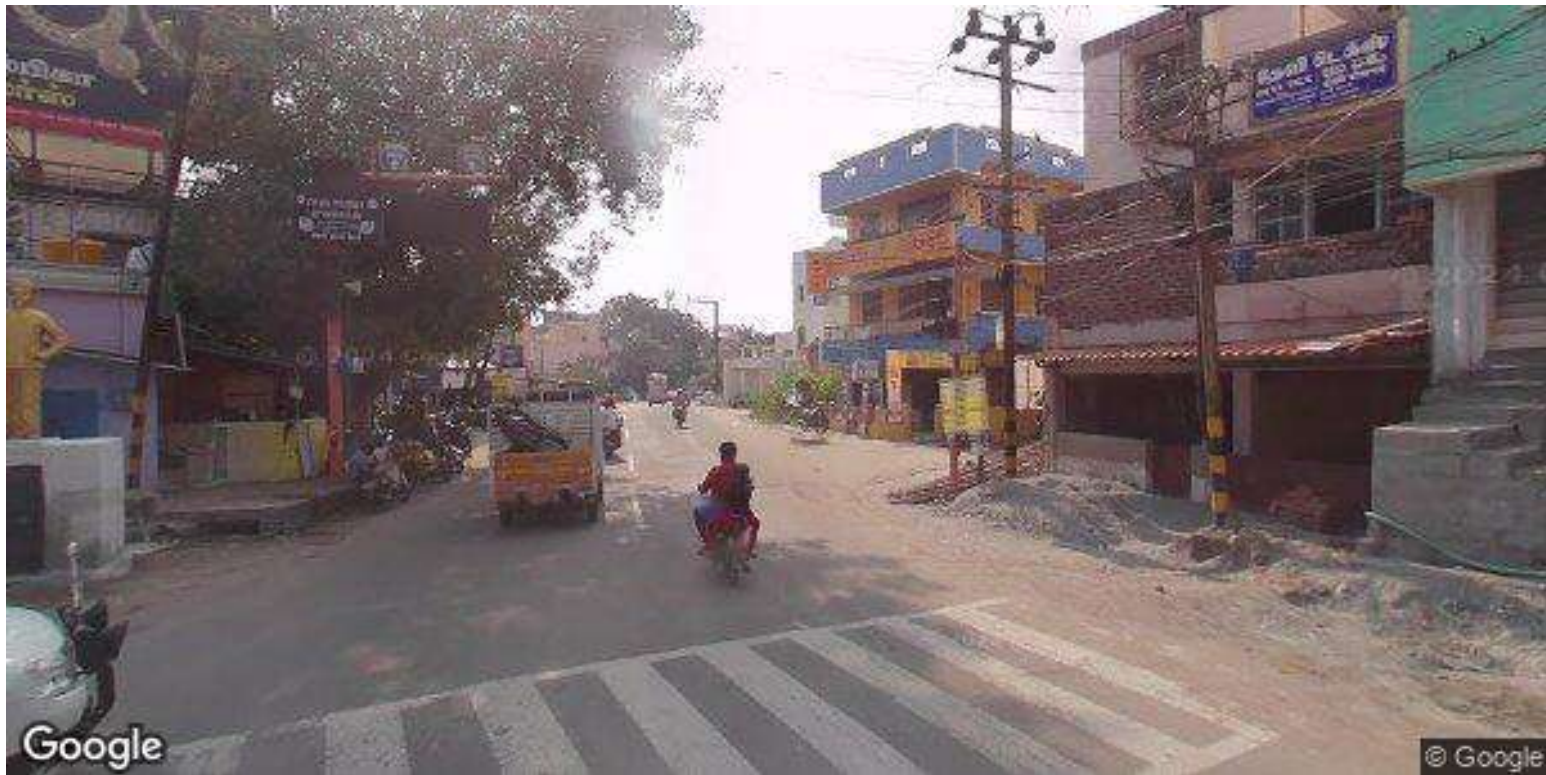
**Risk Type:** Turn

**Risk Level:** Medium

**Speed Limit:** 30 KM/Hr

**Coordinates:** 11.64132, 78.15294

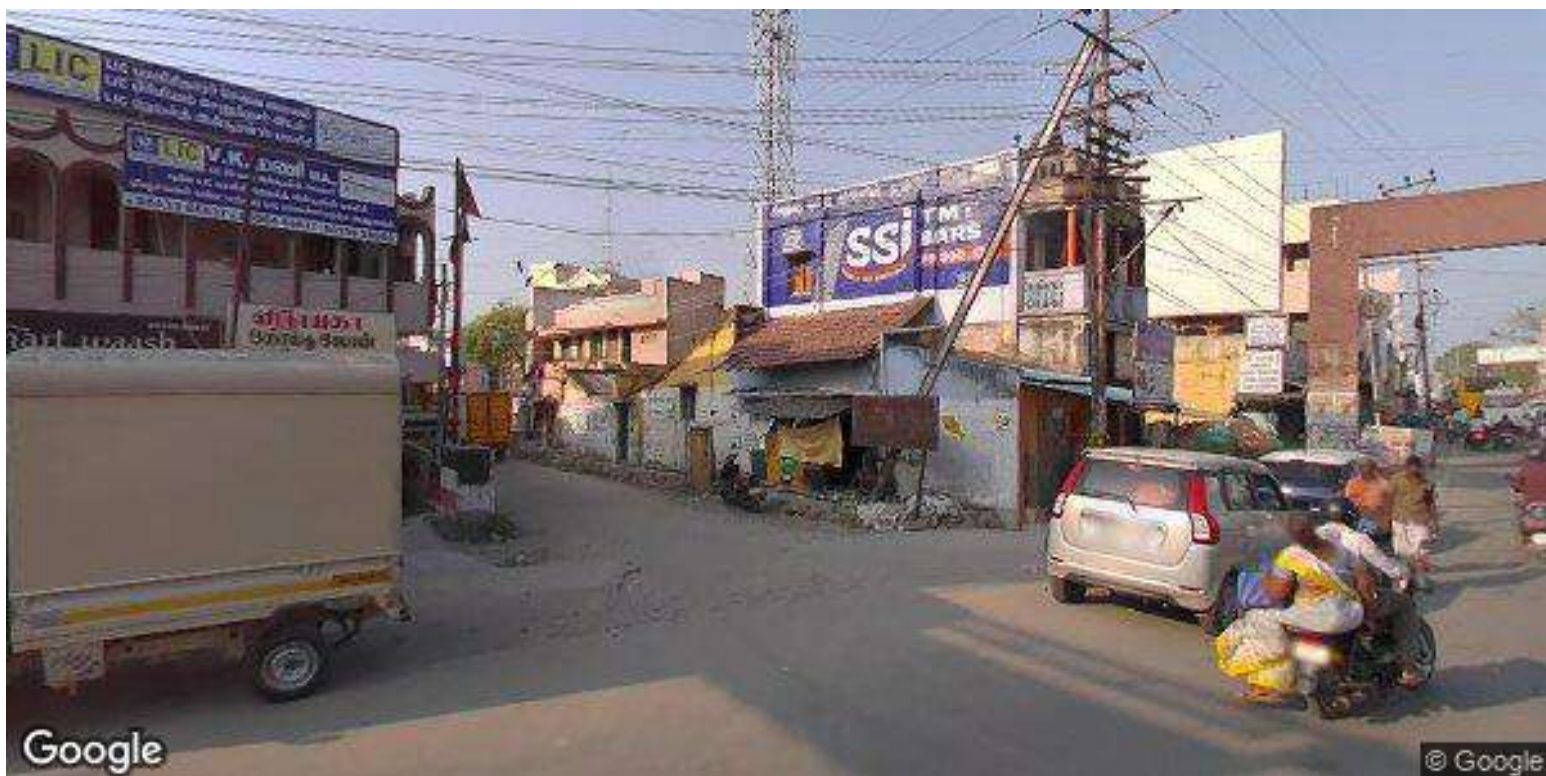
**Risk Type:** Turn

**Risk Level:** High

**Speed Limit:** 15 KM/Hr

**Coordinates:** 11.64134, 78.15304
