## JOURNEY RISK MANAGEMENT (JRM) STUDY

### Salem Terminal TO KANNAN AGENCIES

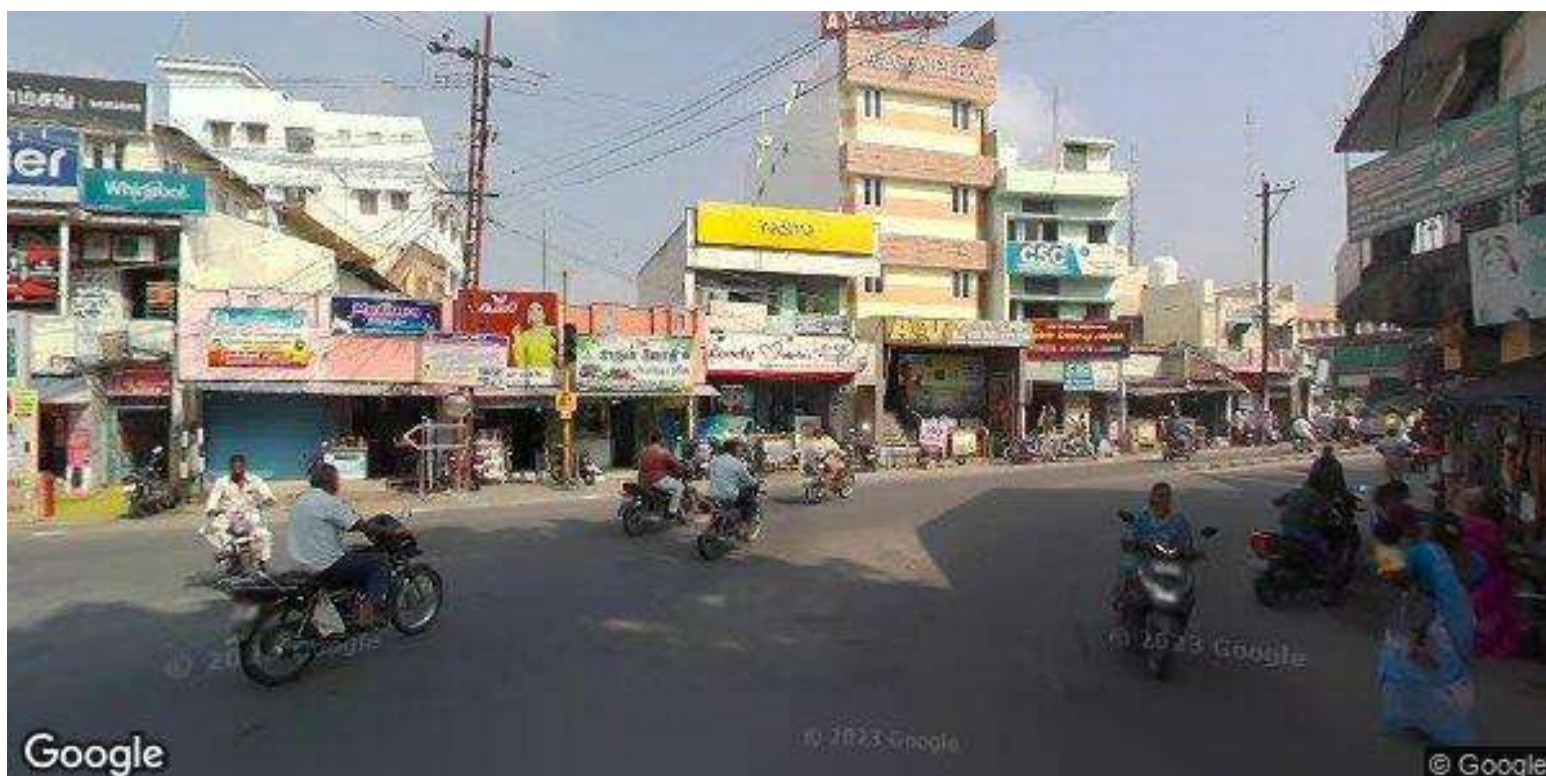
**Risk Type:** Turn  
**Risk Level:** Medium  
**Speed Limit:** 30 KM/Hr  
**Coordinates:** 11.37842, 77.89452

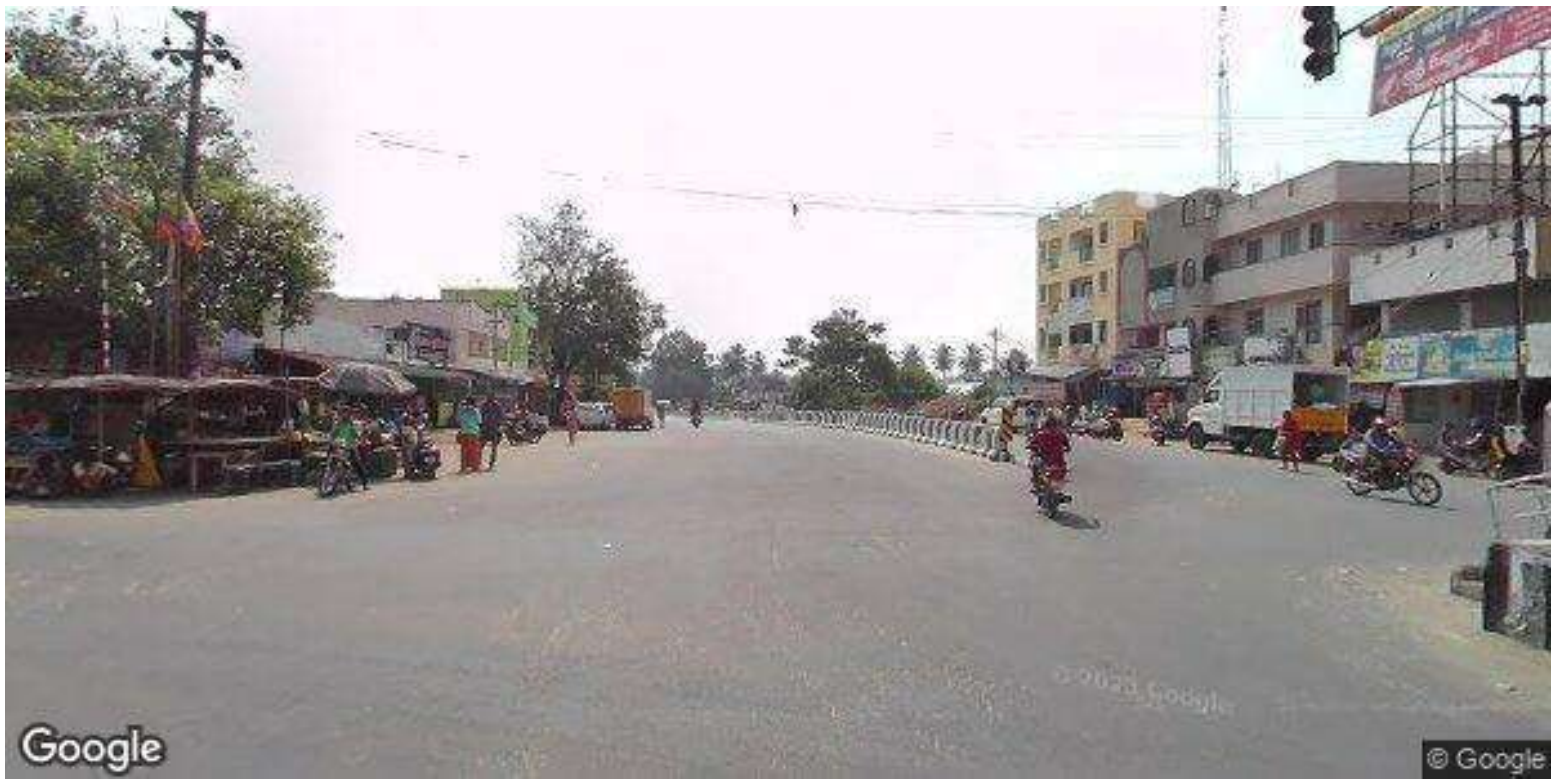
**Risk Type:** Turn  
**Risk Level:** High  
**Speed Limit:** 15 KM/Hr  
**Coordinates:** 11.36604, 77.88887

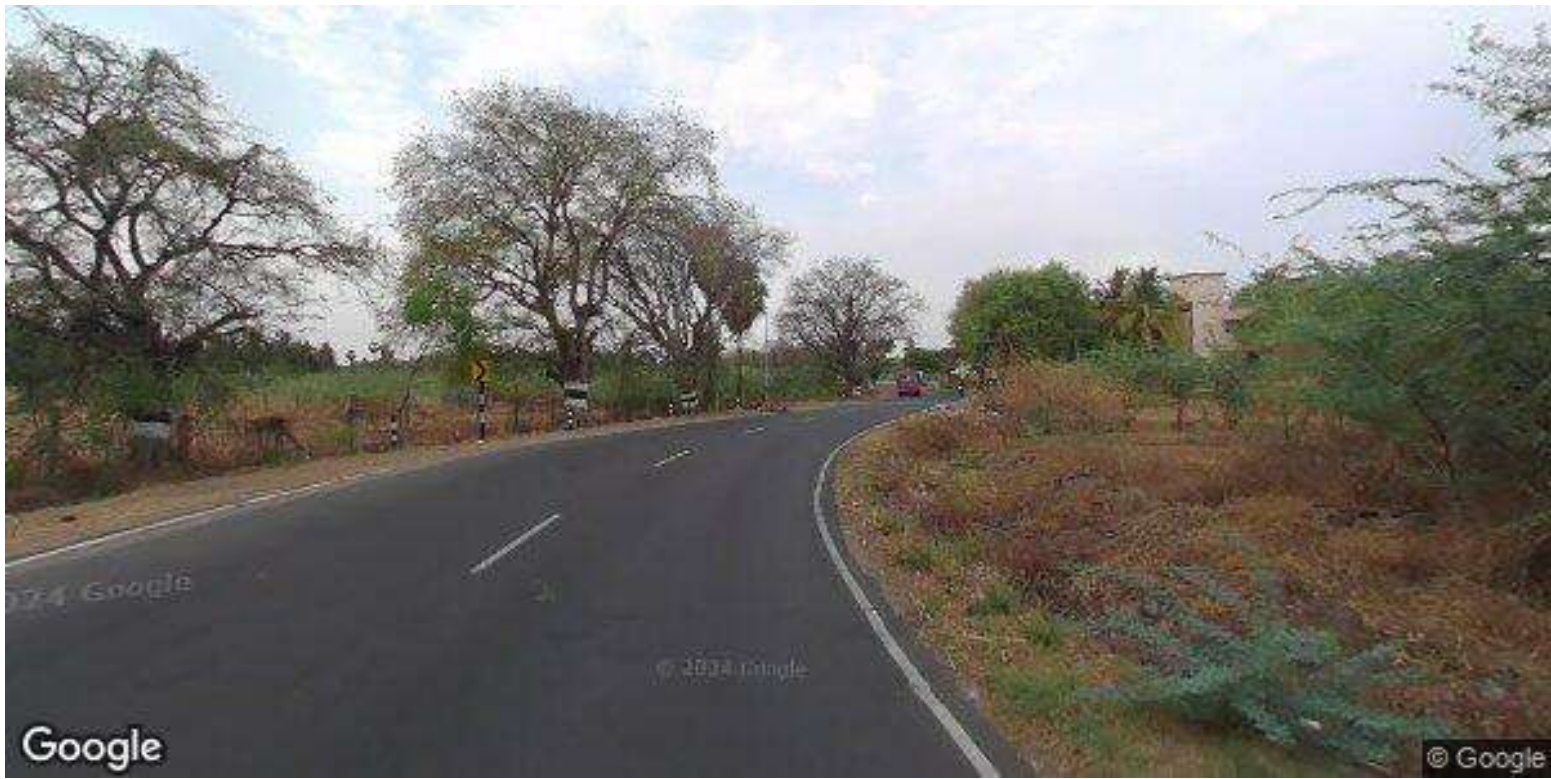
**Risk Type:** Turn  
**Risk Level:** Medium  
**Speed Limit:** 30 KM/Hr  
**Coordinates:** 11.34067, 77.86347

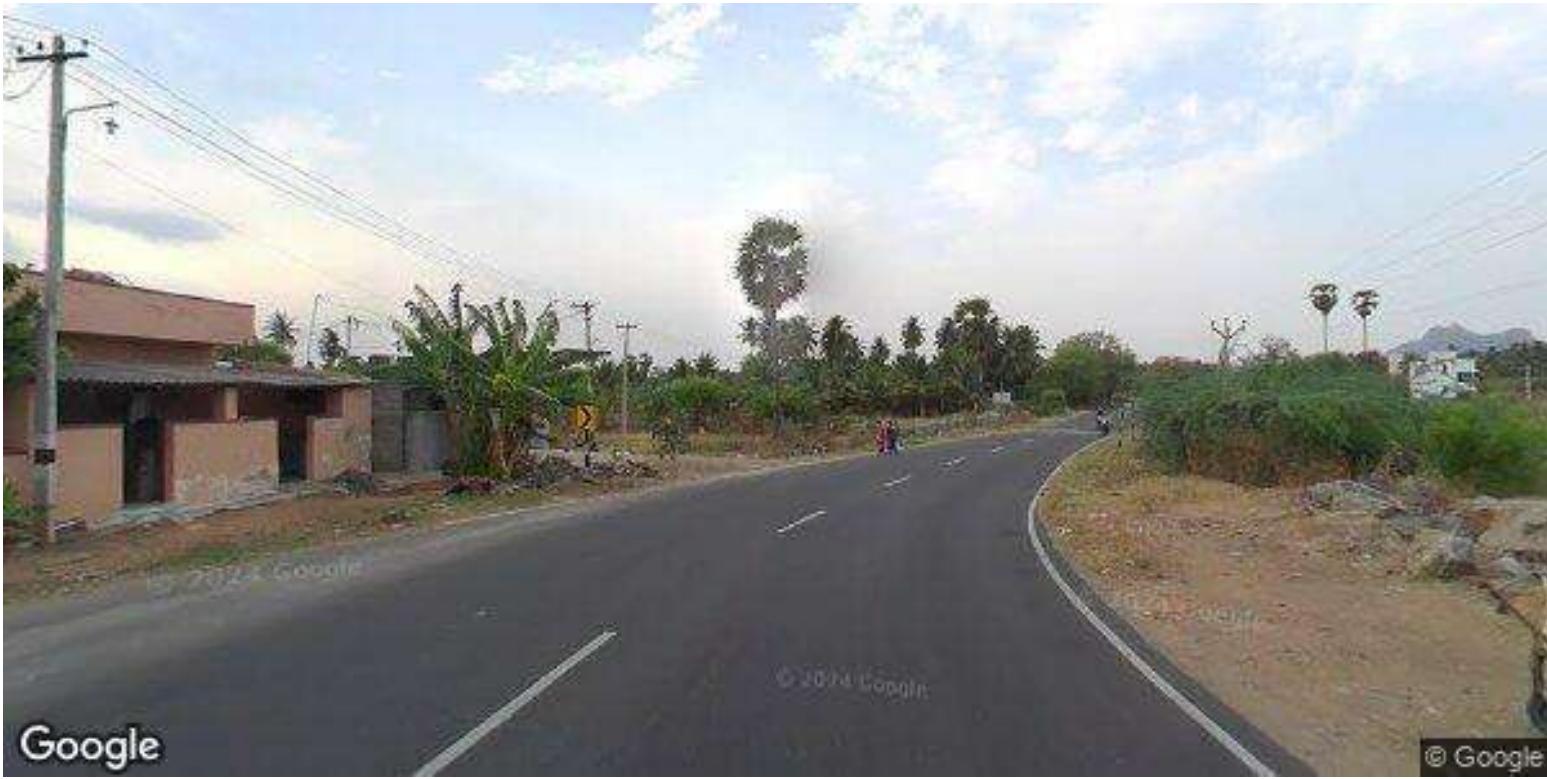
**Risk Type:** Turn  
**Risk Level:** Medium  
**Speed Limit:** 30 KM/Hr  
**Coordinates:** 11.33882, 77.86218

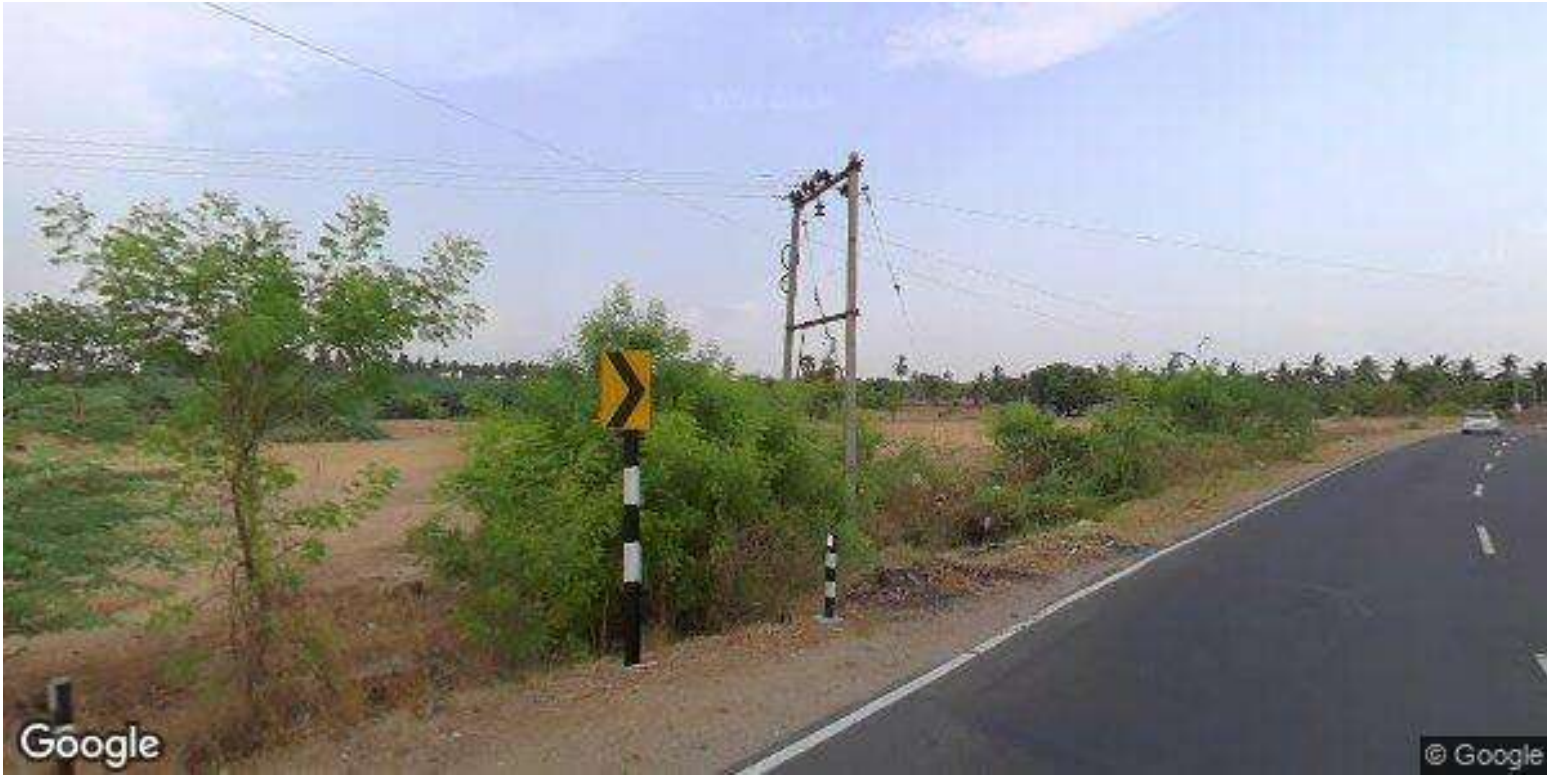
**Risk Type:** Turn  
**Risk Level:** Medium  
**Speed Limit:** 30 KM/Hr  
**Coordinates:** 11.33778, 77.86236

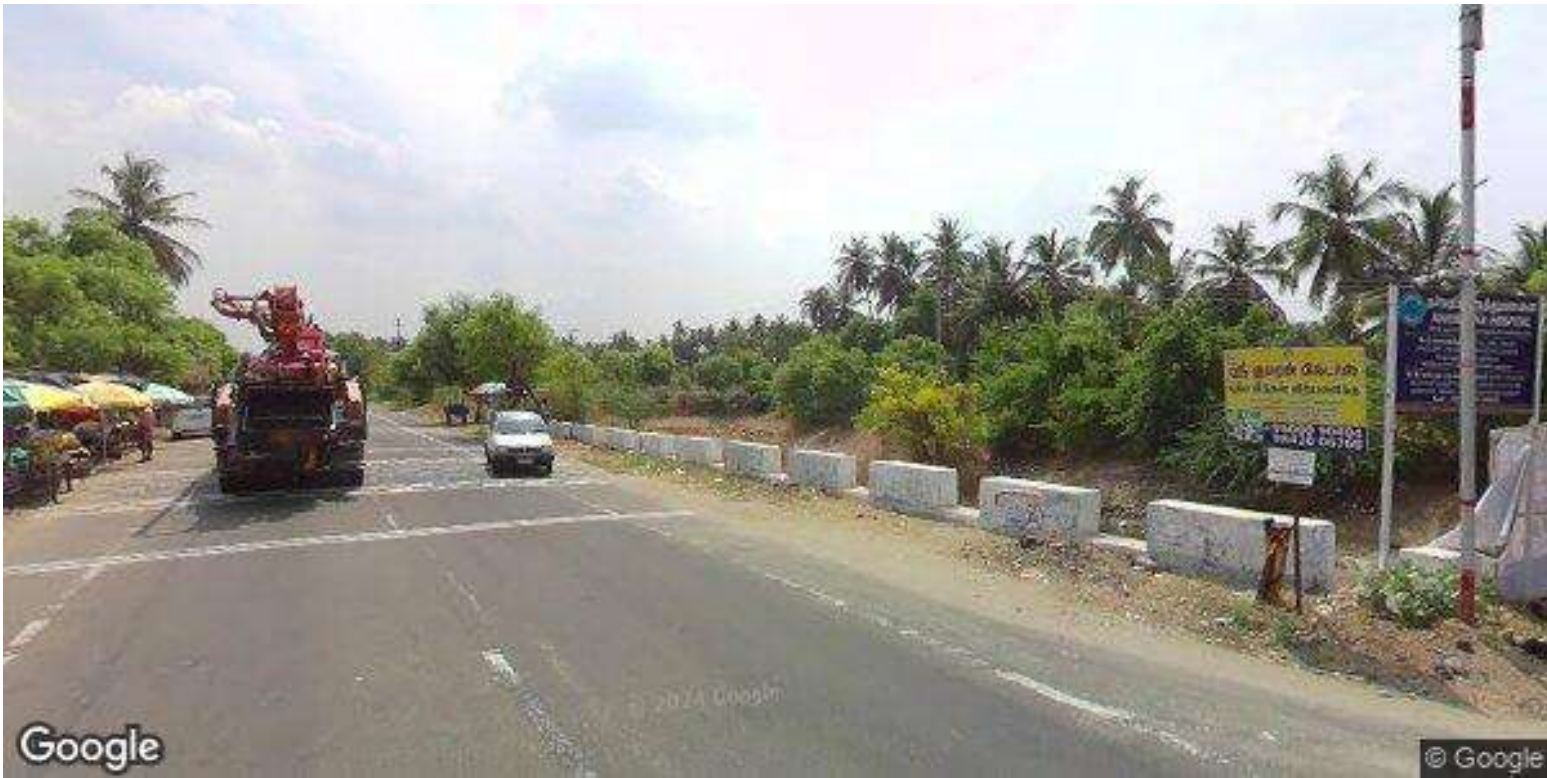
**Risk Type:** Turn  
**Risk Level:** High  
**Speed Limit:** 15 KM/Hr  
**Coordinates:** 11.29490, 77.74685

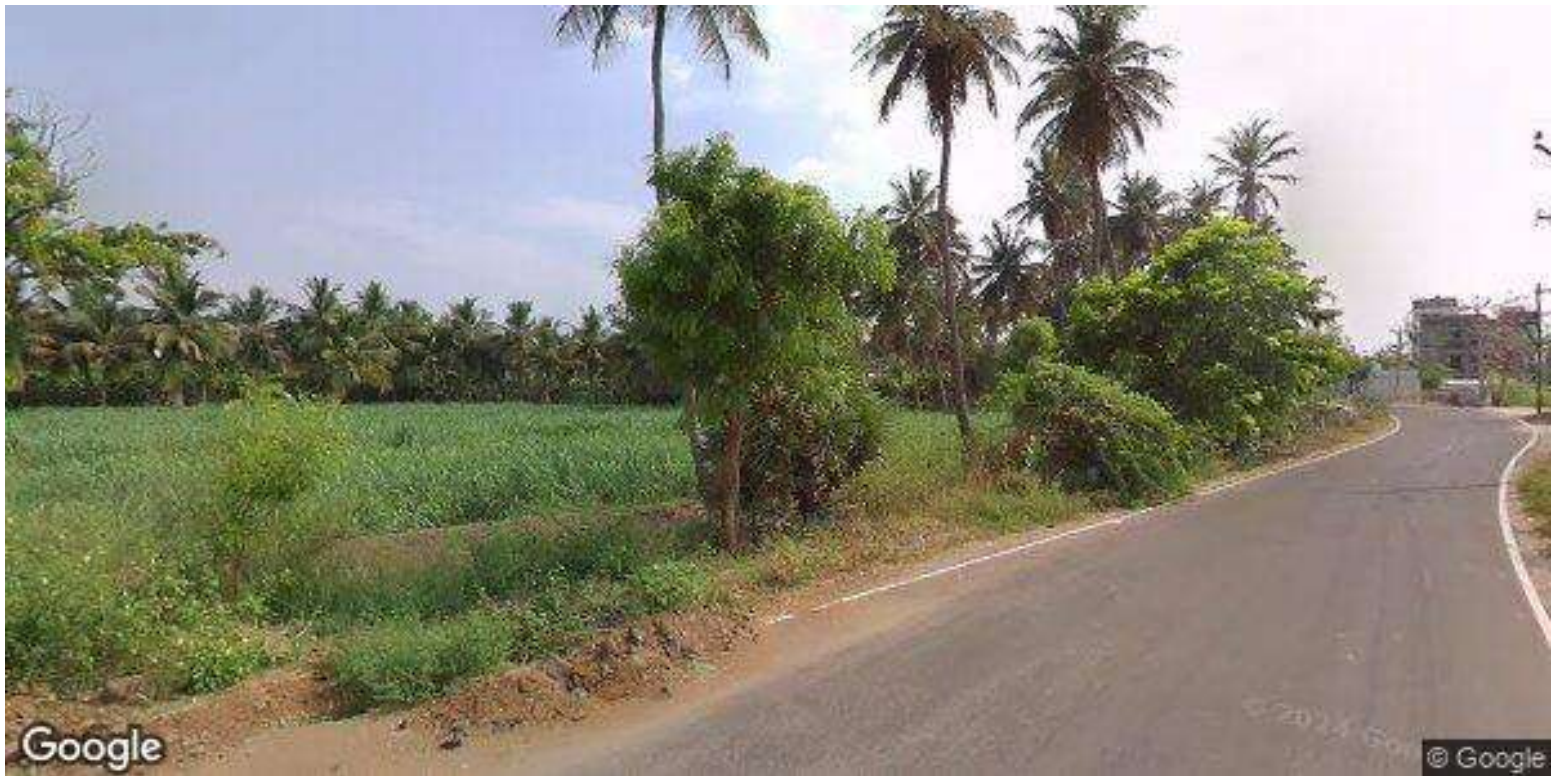
**Risk Type:** Turn  
**Risk Level:** High  
**Speed Limit:** 15 KM/Hr  
**Coordinates:** 11.29129, 77.74657

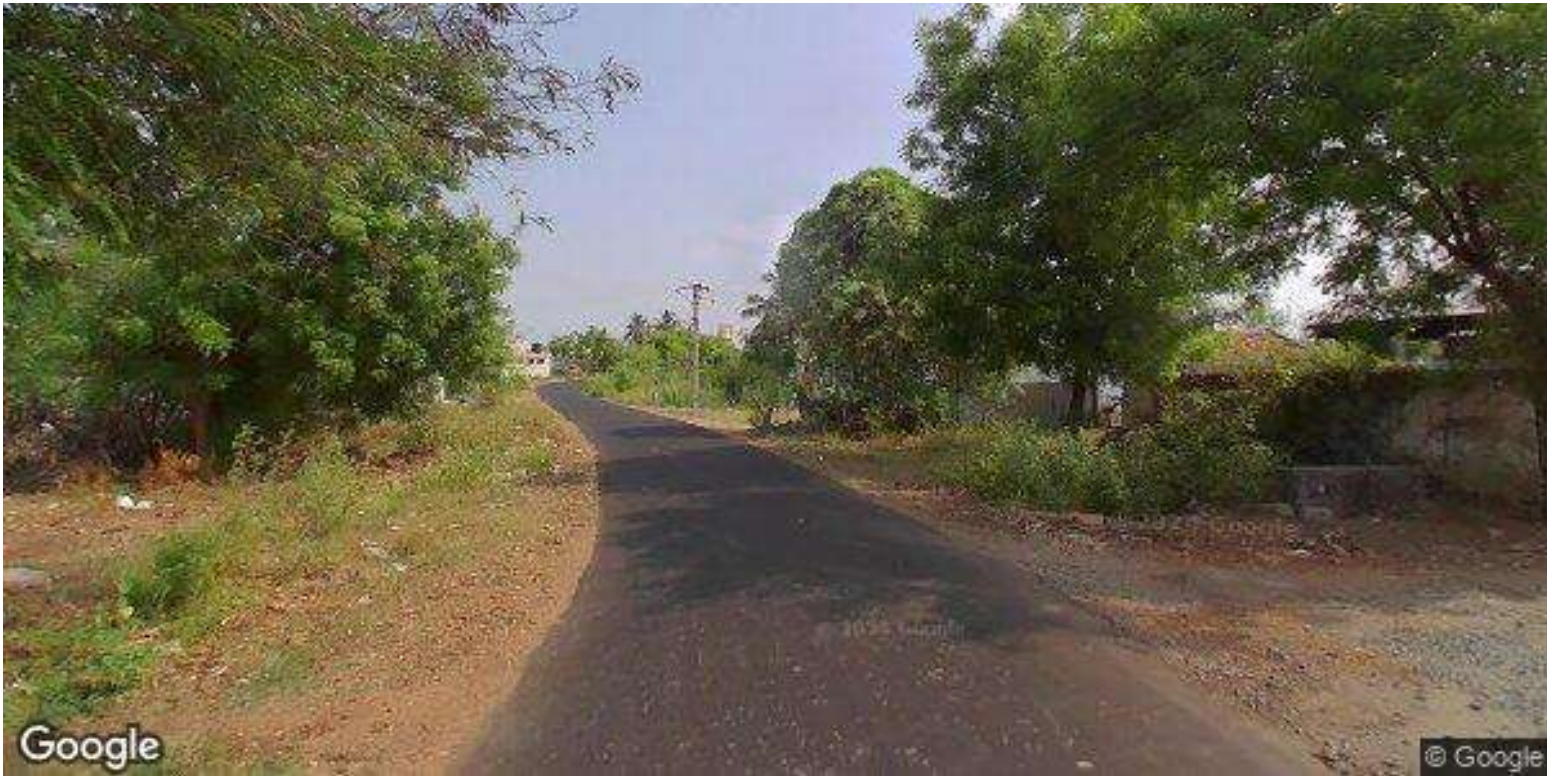
**Risk Type:** Turn  
**Risk Level:** Medium  
**Speed Limit:** 30 KM/Hr  
**Coordinates:** 11.28844, 77.74319

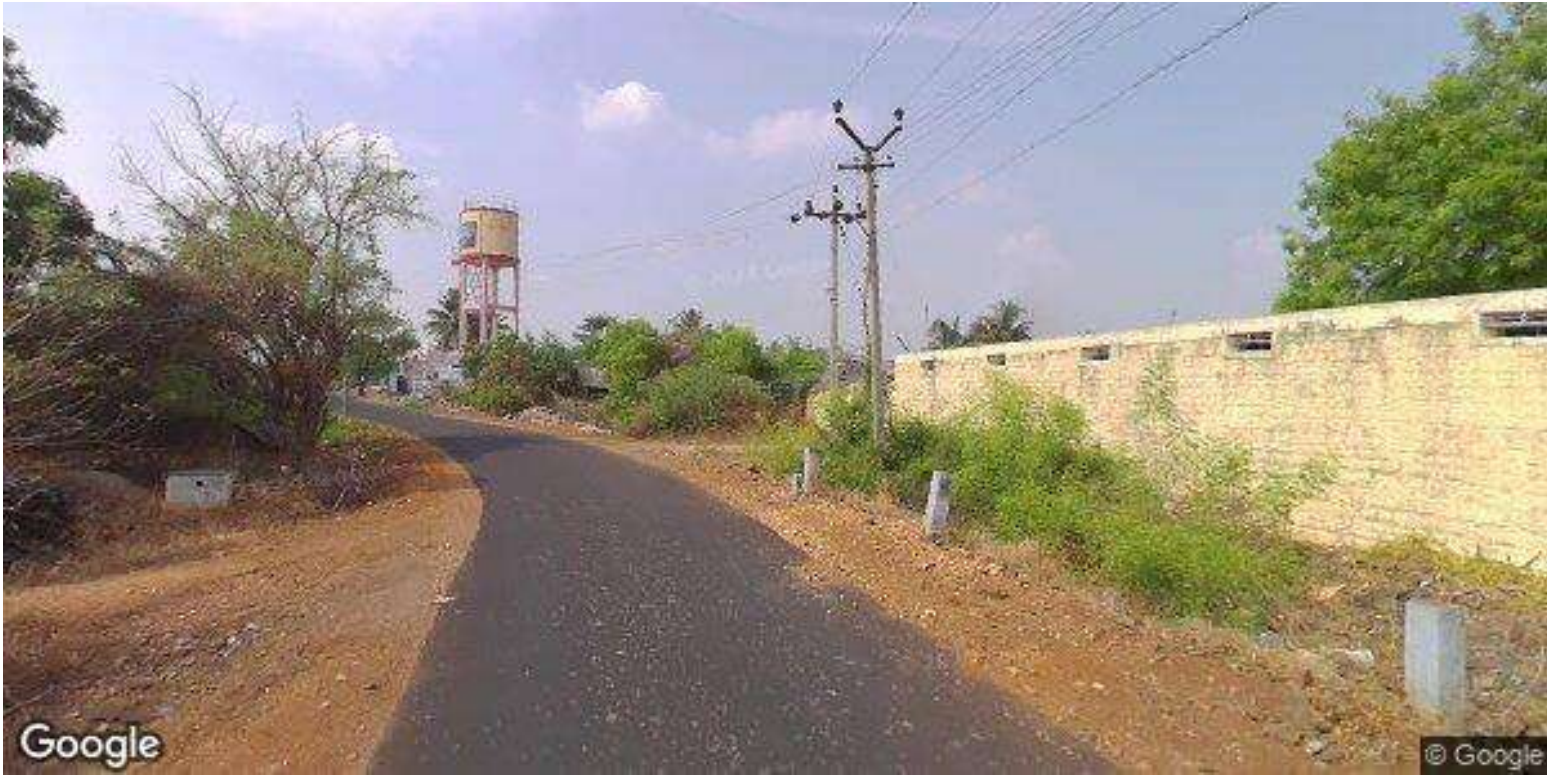
**Risk Type:** Turn  
**Risk Level:** Medium  
**Speed Limit:** 30 KM/Hr  
**Coordinates:** 11.28573, 77.74281

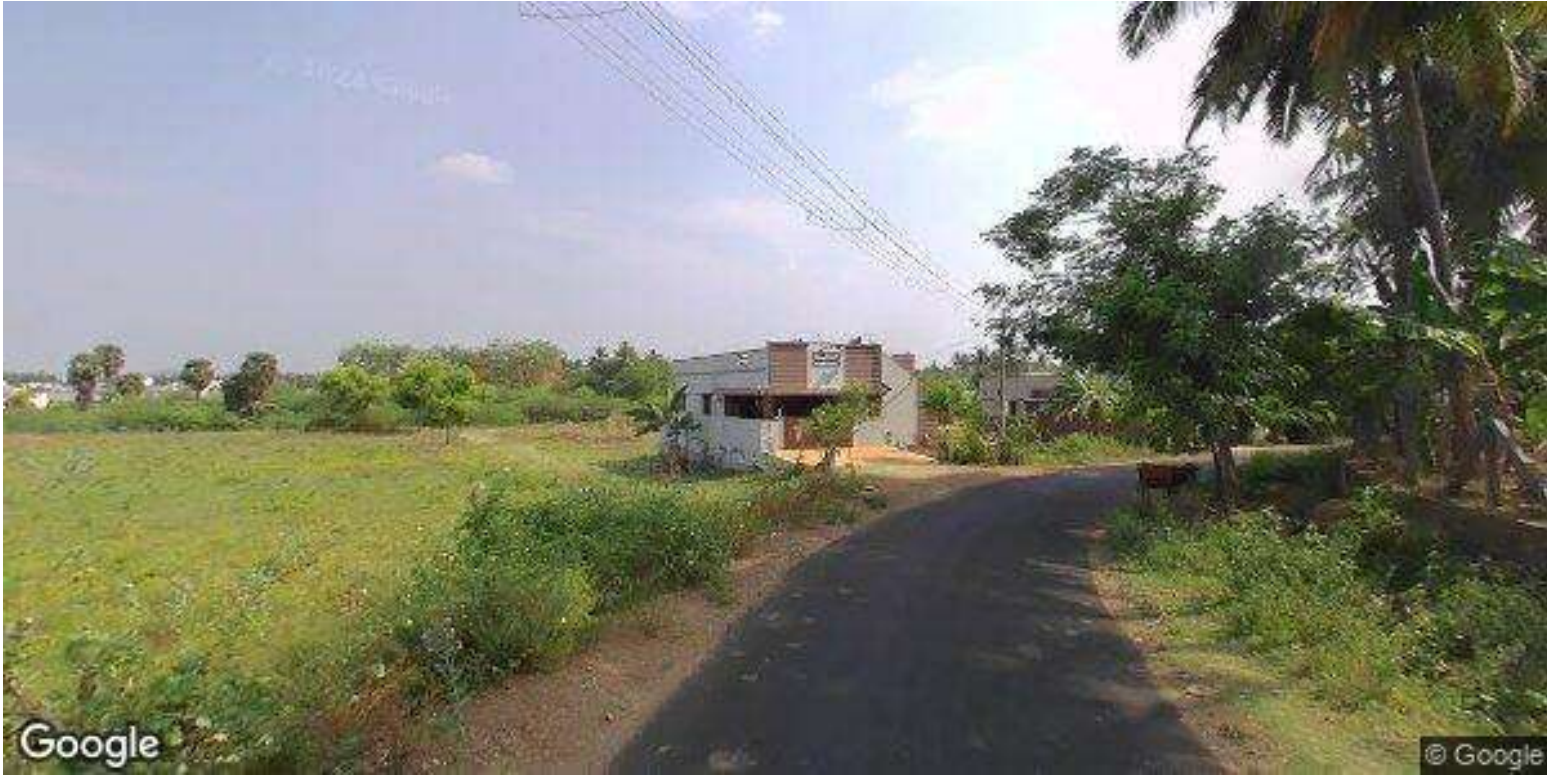
**Coordinates: 11.27336, 77.72999**

**Risk Type: Turn**

**Risk Level: Medium**

**Speed Limit: 30 KM/Hr**

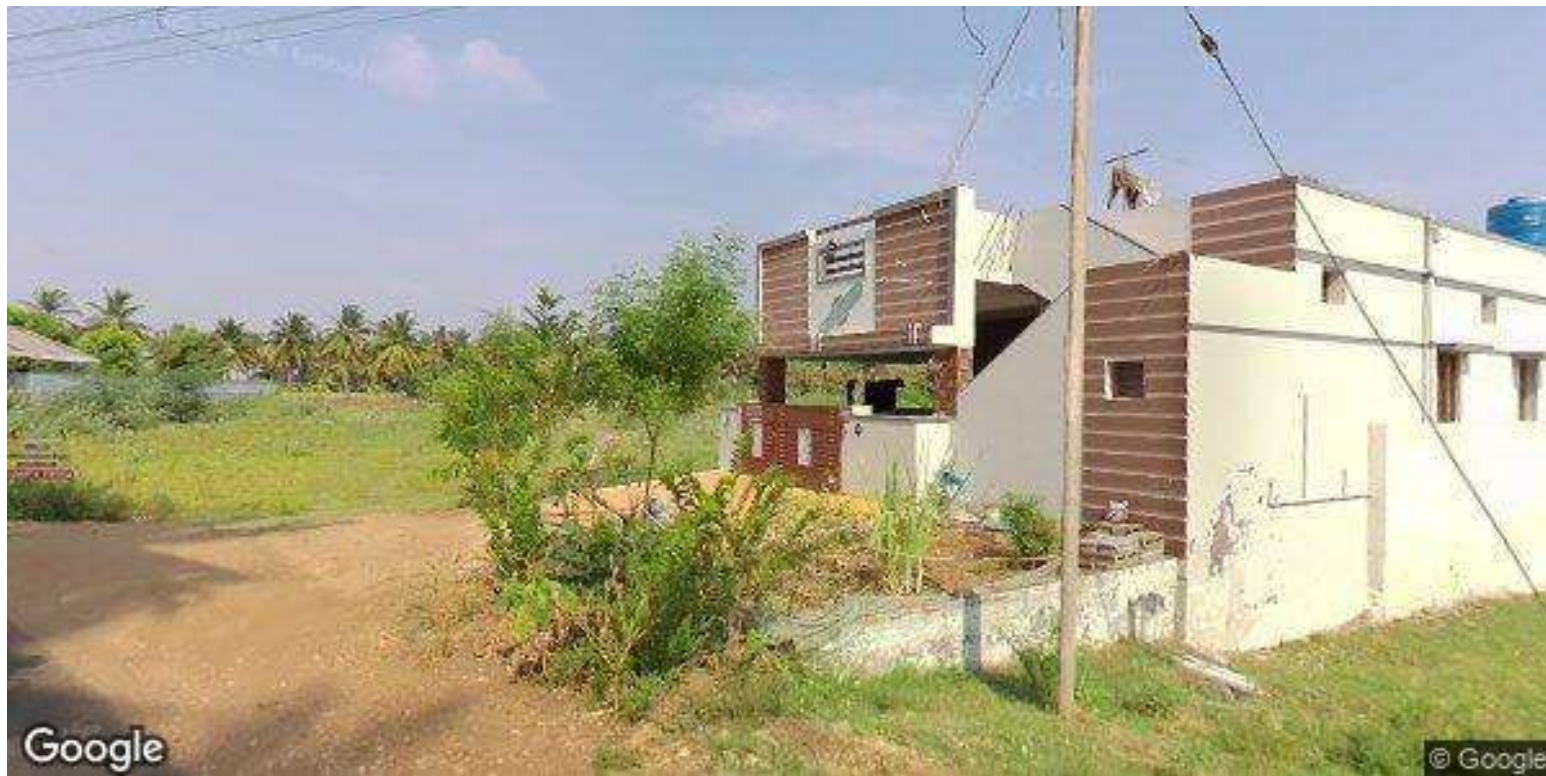
**Coordinates: 11.27319, 77.72981**

**Risk Type: Turn**

**Risk Level: Medium**

**Speed Limit: 30 KM/Hr**

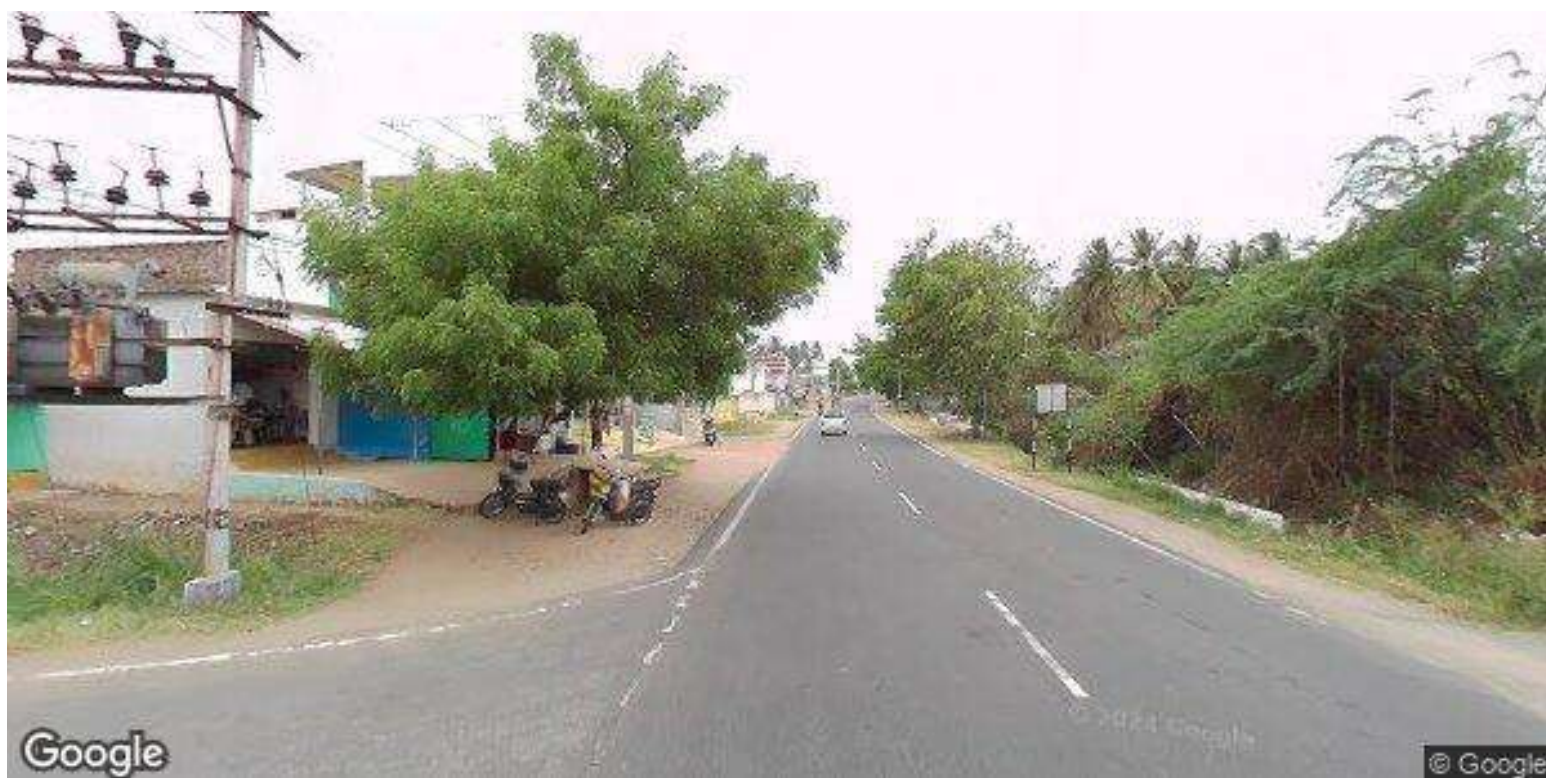
**Coordinates: 11.27328, 77.72705**

**Risk Type: Turn**

**Risk Level: High**

**Speed Limit: 15 KM/Hr**

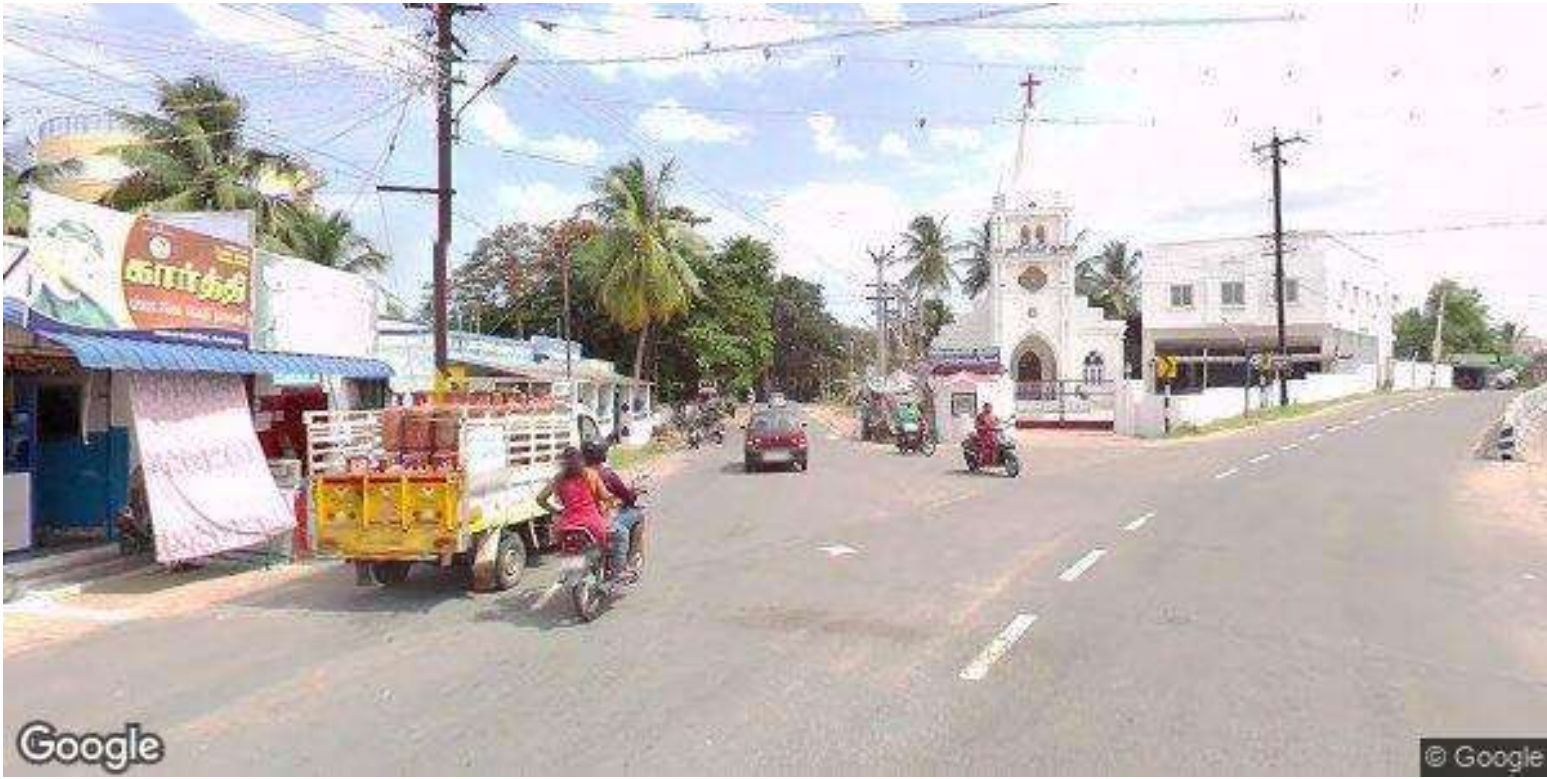
**Risk Type:** Turn  
**Risk Level:** Medium  
**Speed Limit:** 30 KM/Hr  
**Coordinates:** 11.23054, 77.71796

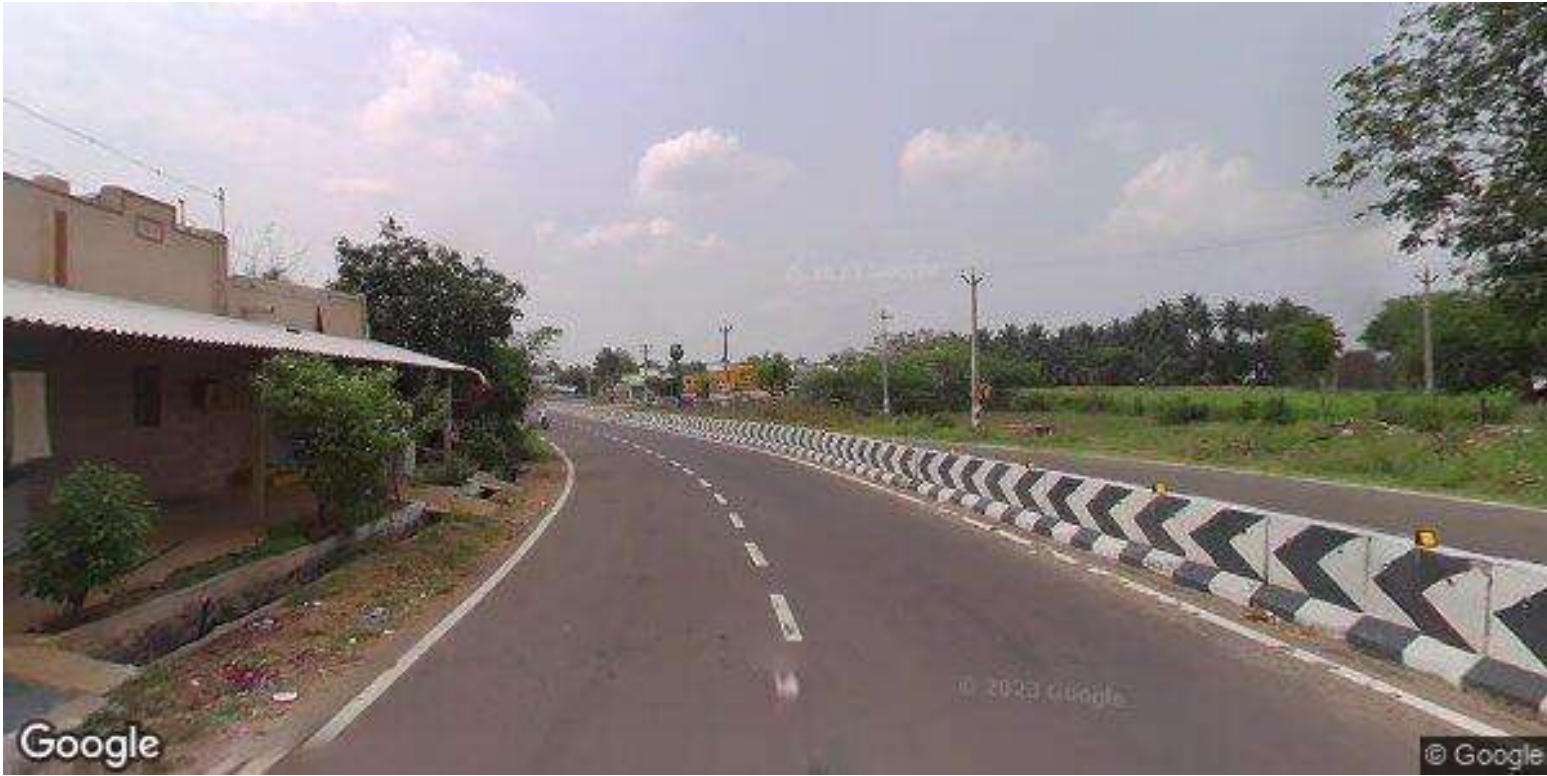
**Risk Type:** Turn  
**Risk Level:** Medium  
**Speed Limit:** 30 KM/Hr  
**Coordinates:** 11.22387, 77.71385

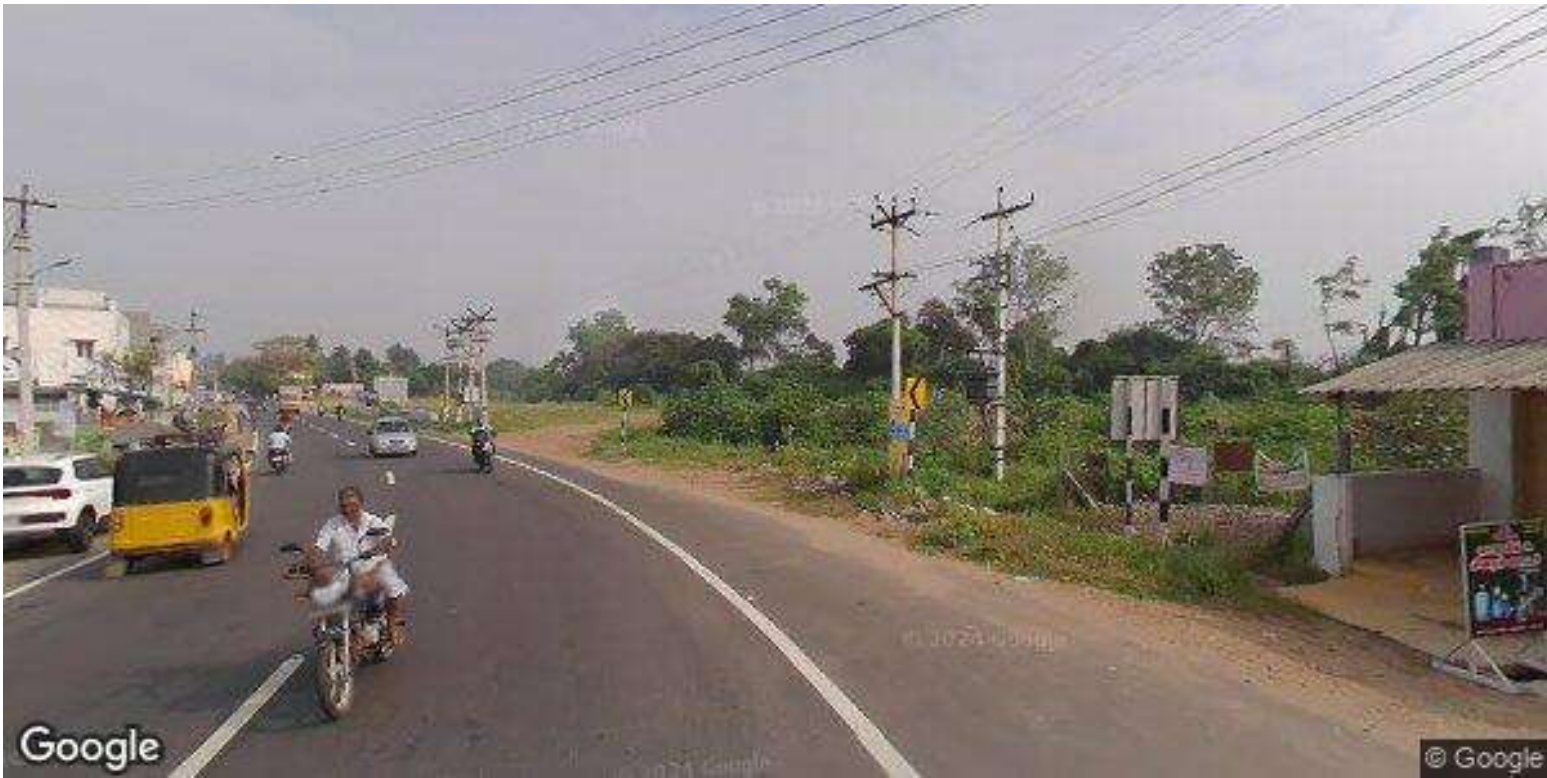
Coordinates: 11.16078, 77.70122

Risk Type: Turn

Risk Level: Medium

Speed Limit: 30 KM/Hr

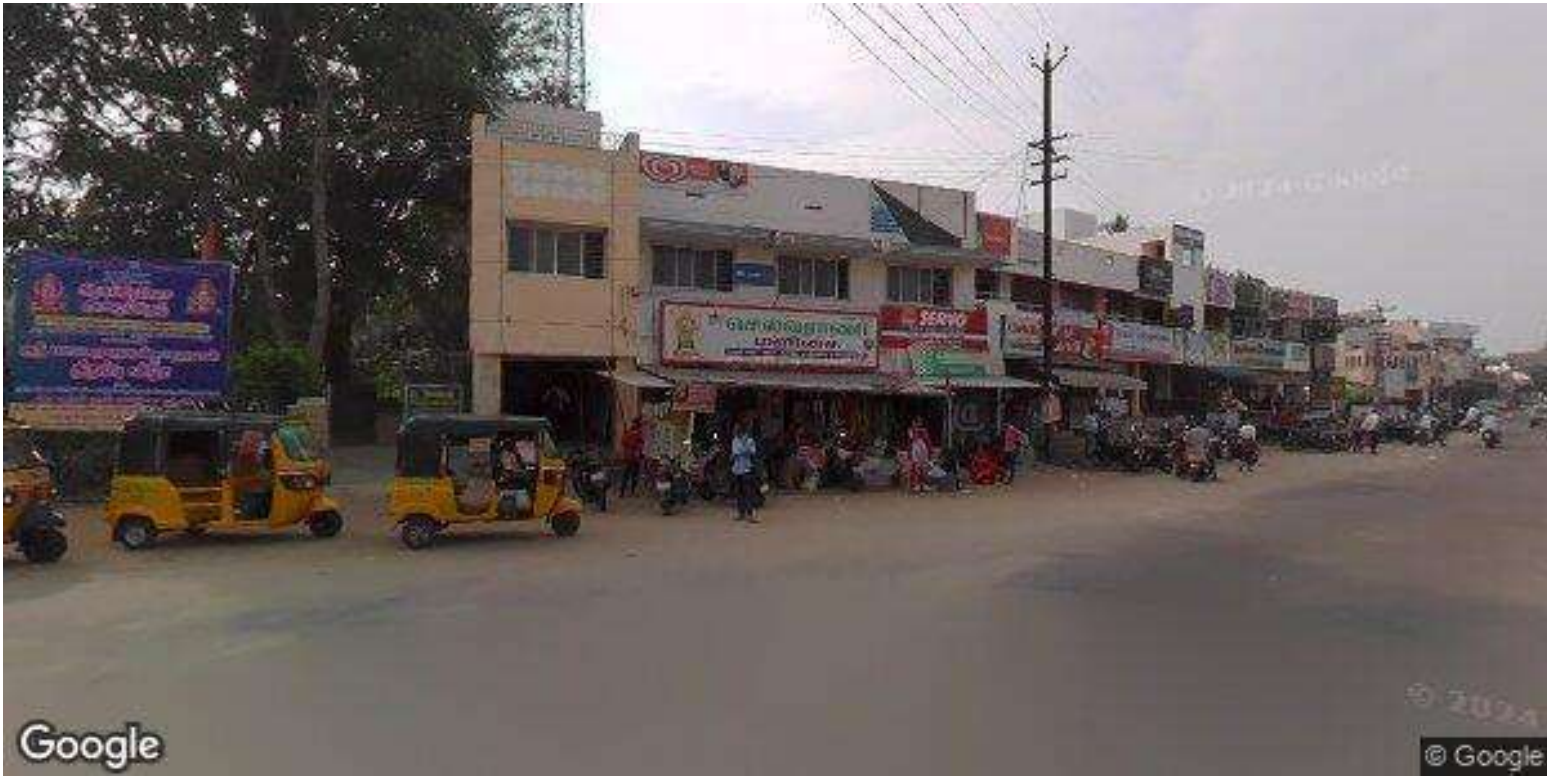
Coordinates: 11.15942, 77.70068

Risk Type: Turn

Risk Level: High

Speed Limit: 15 KM/Hr

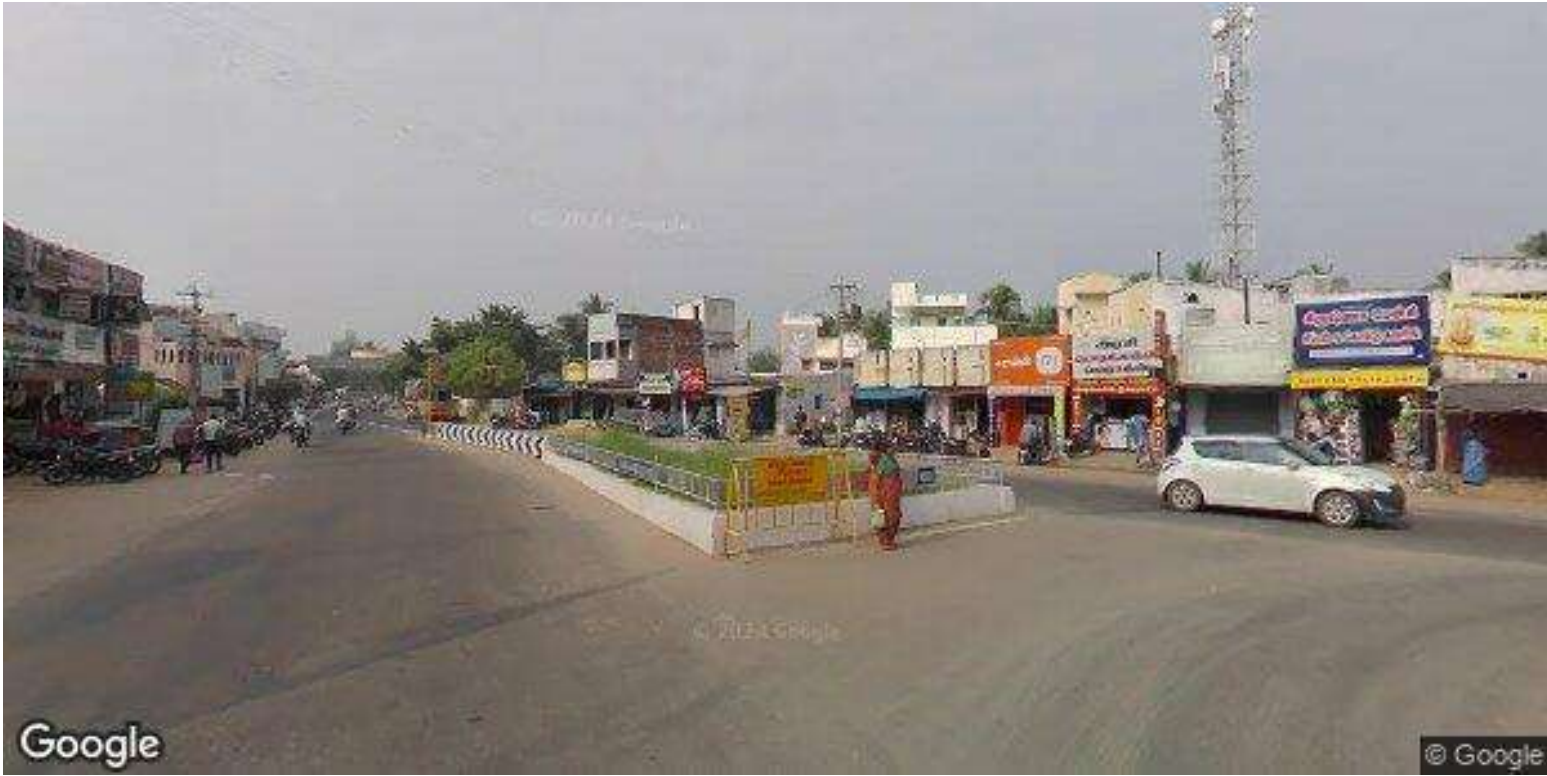
Coordinates: 11.15935, 77.70060

Risk Type: Turn

Risk Level: Medium

Speed Limit: 30 KM/Hr
