# IndianOil

## JOURNEY RISK MANAGEMENT (JRM) STUDY

### Salem Terminal TO KANAGAMANI AGENCIES

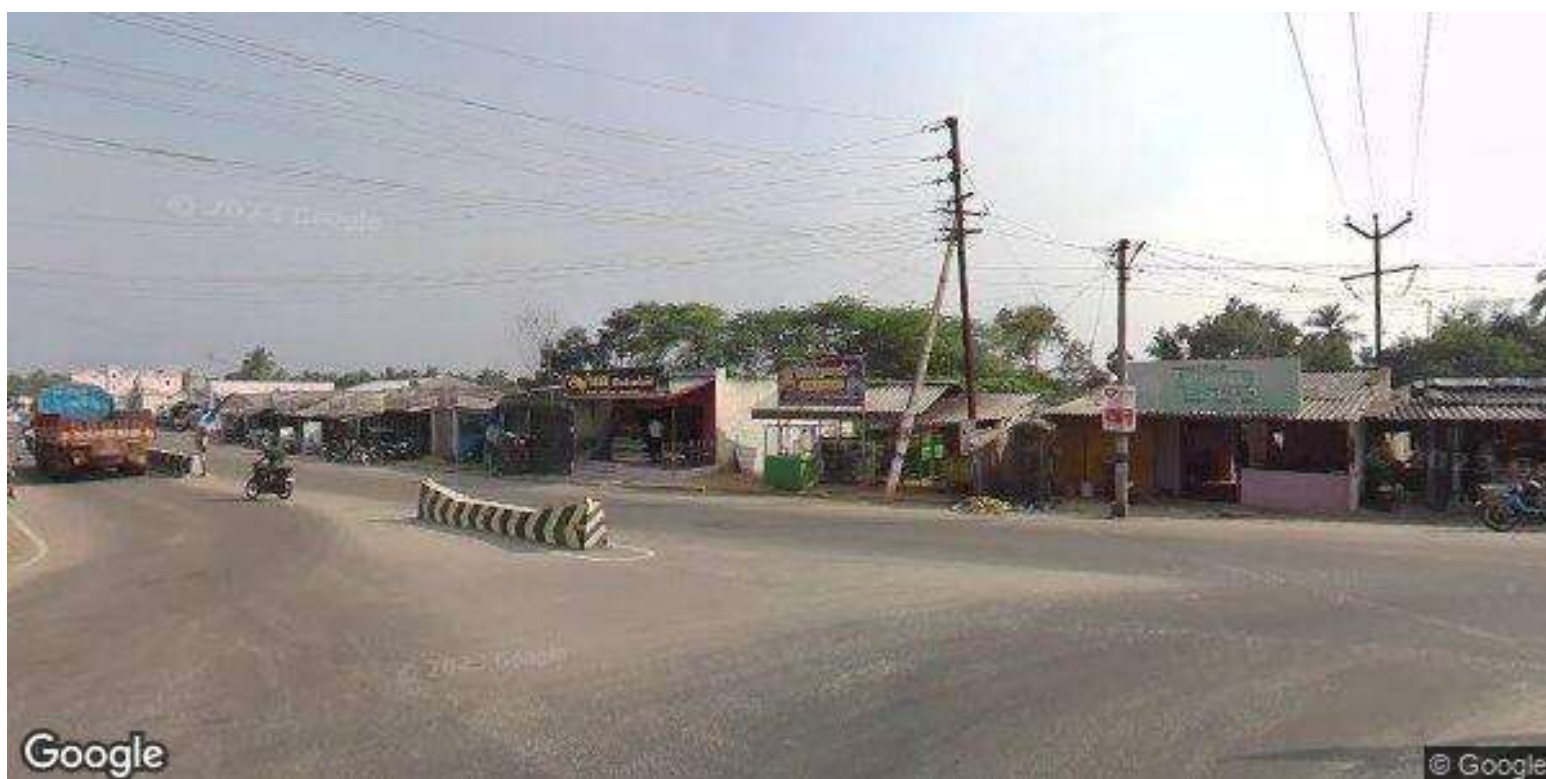
**Risk Type:** Roundabout

**Risk Level:** High

**Speed Limit:** 15 KM/Hr

**Coordinates:** 11.04637, 77.73761

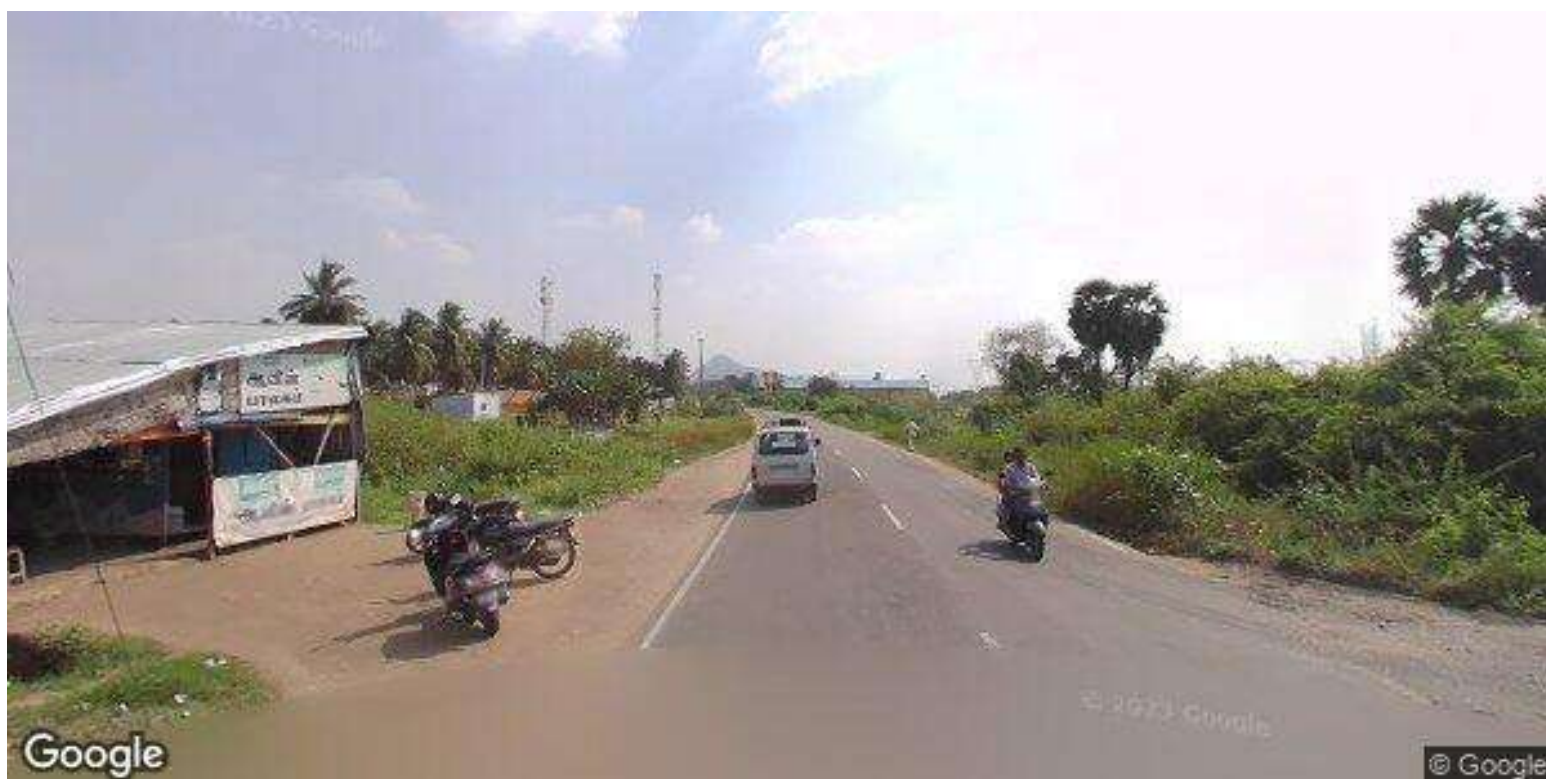
**Risk Type:** Turn  
**Risk Level:** High  
**Speed Limit:** 15 KM/Hr  
**Coordinates:** 11.44022, 77.87546

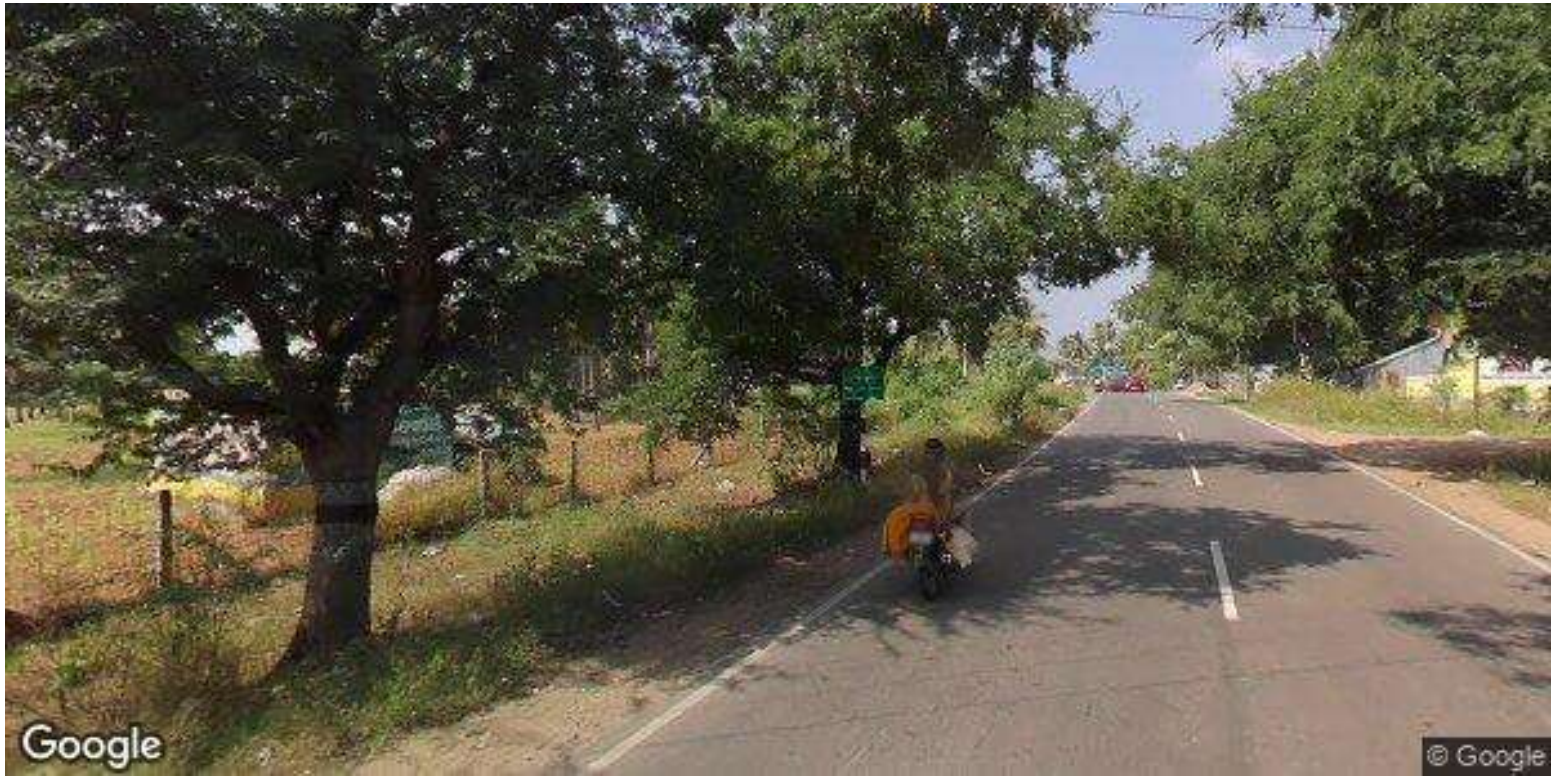
**Risk Type:** Turn  
**Risk Level:** Medium  
**Speed Limit:** 30 KM/Hr  
**Coordinates:** 11.43107, 77.88171

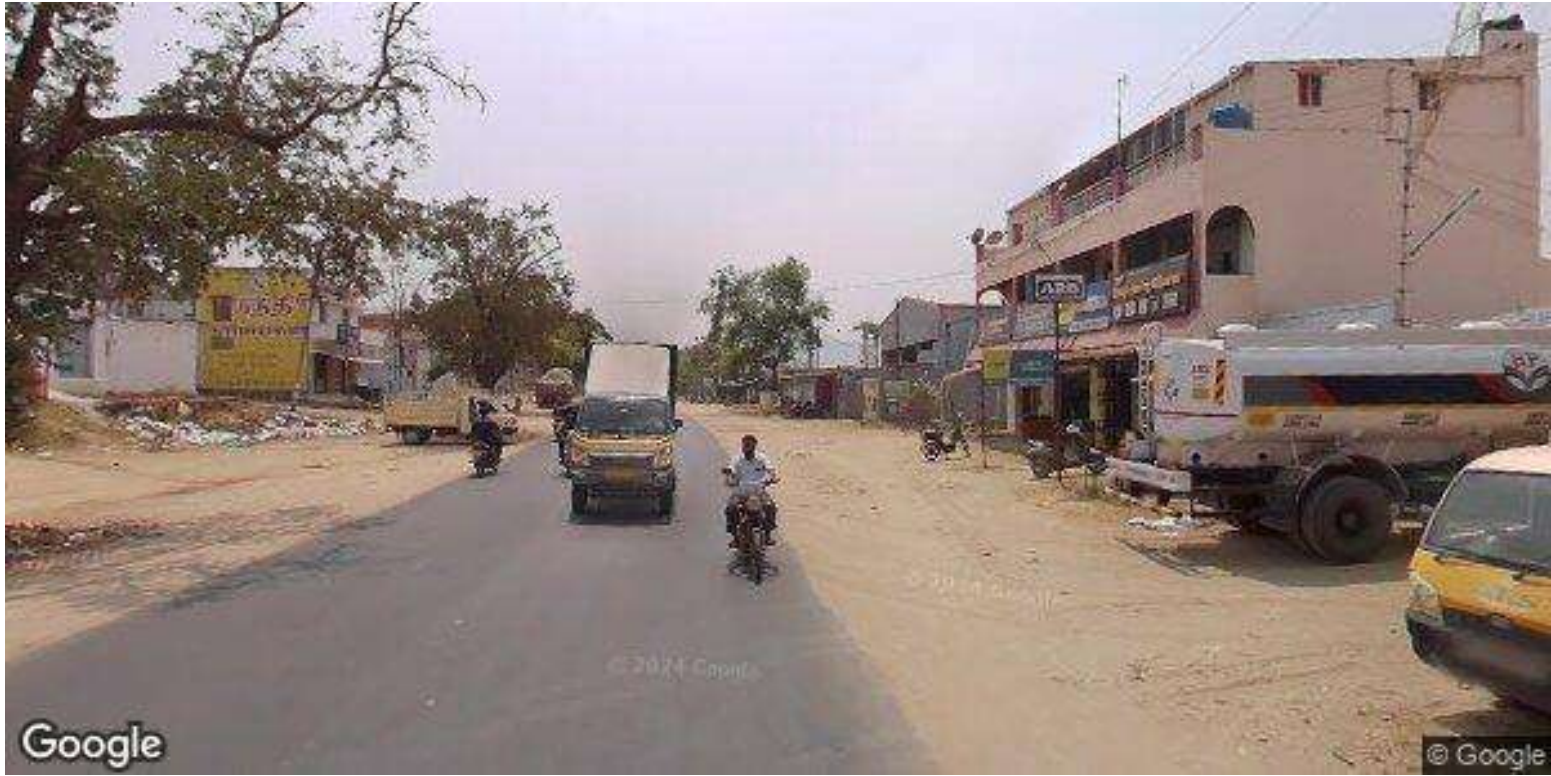
**Risk Type:** Turn  
**Risk Level:** Medium  
**Speed Limit:** 30 KM/Hr  
**Coordinates:** 11.39976, 77.88382

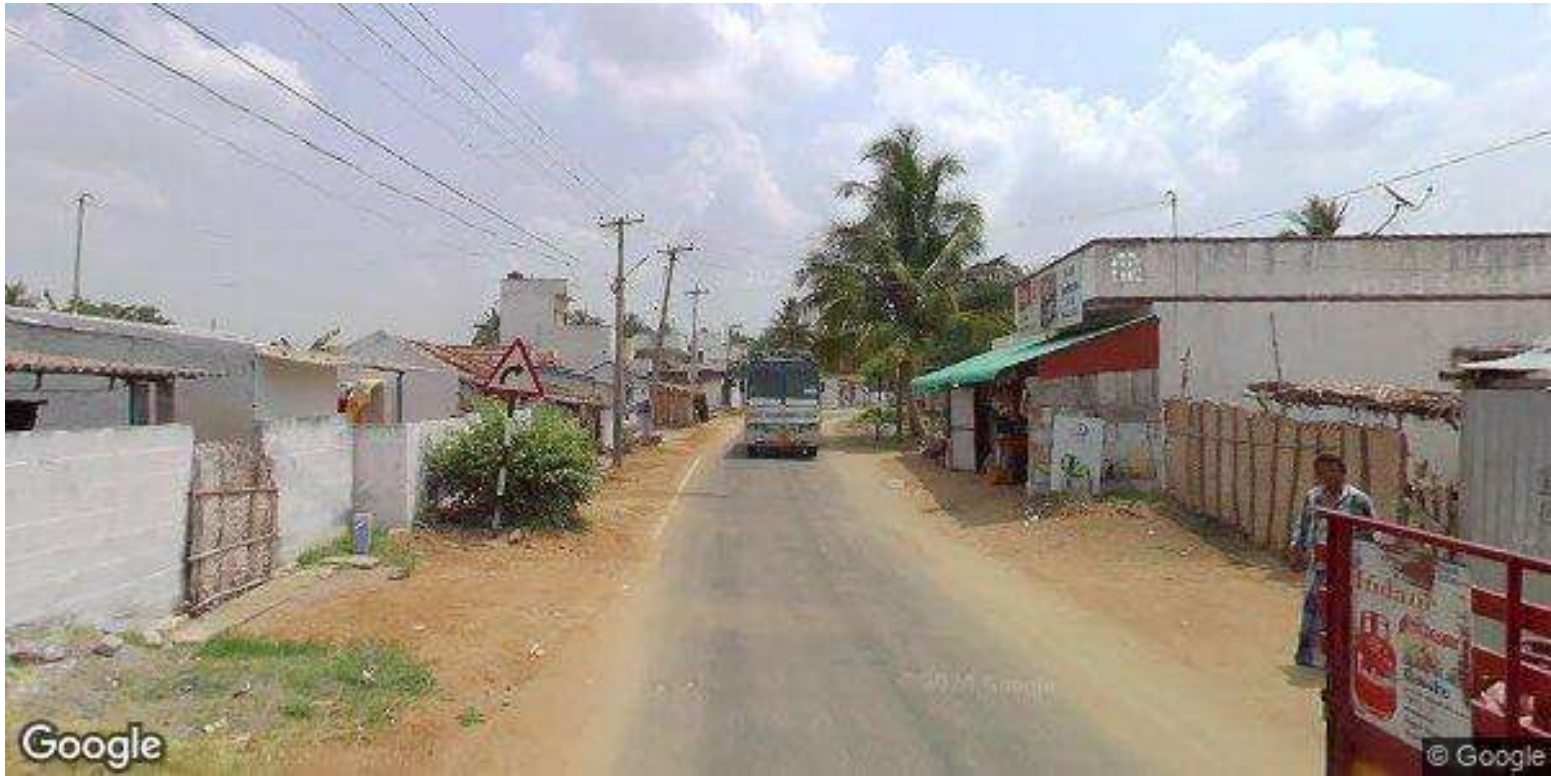
**Risk Type:** Turn  
**Risk Level:** Medium  
**Speed Limit:** 30 KM/Hr  
**Coordinates:** 11.30580, 77.87761

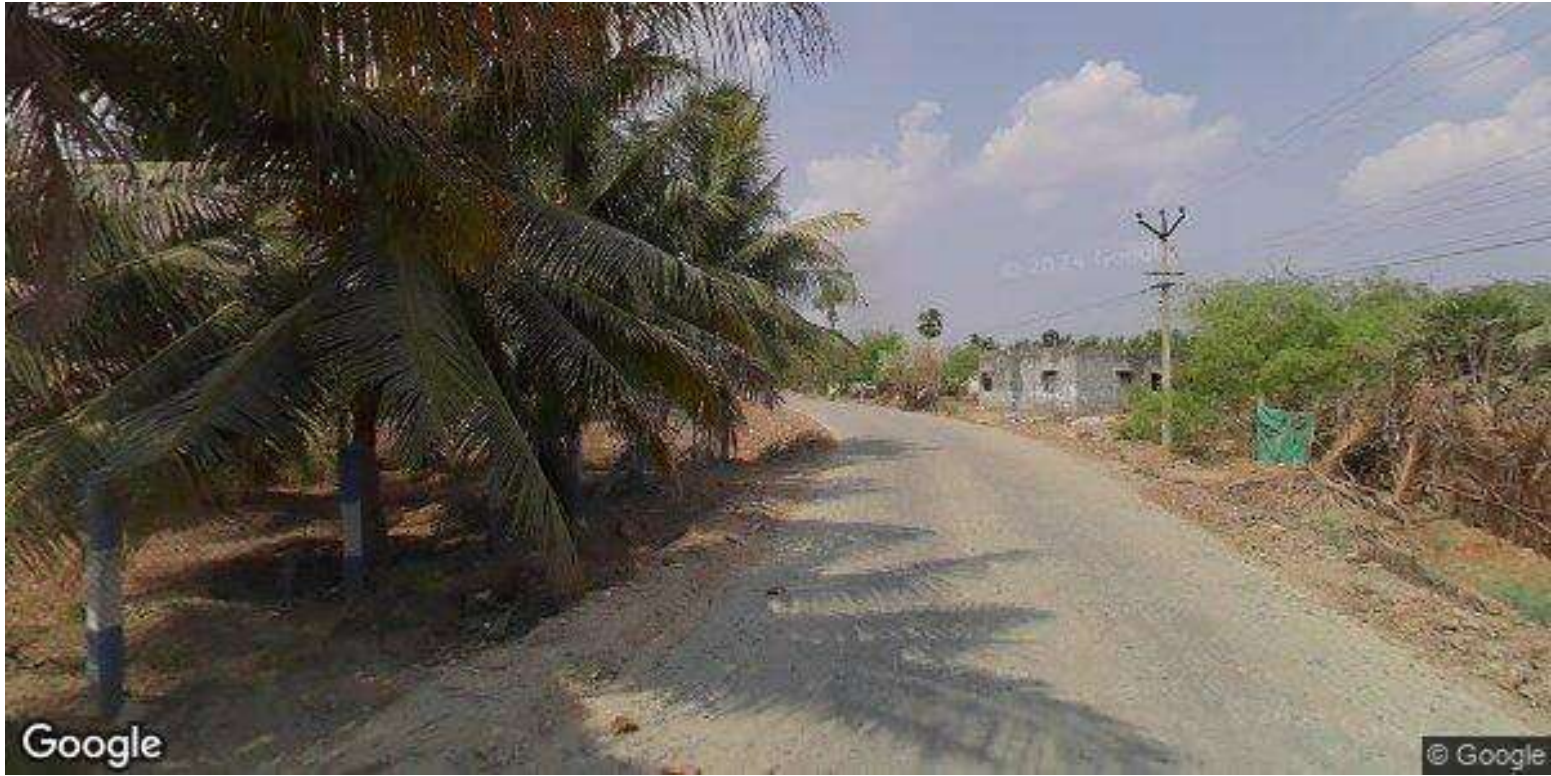
**Risk Type:** Turn  
**Risk Level:** Medium  
**Speed Limit:** 30 KM/Hr  
**Coordinates:** 11.27096, 77.87034

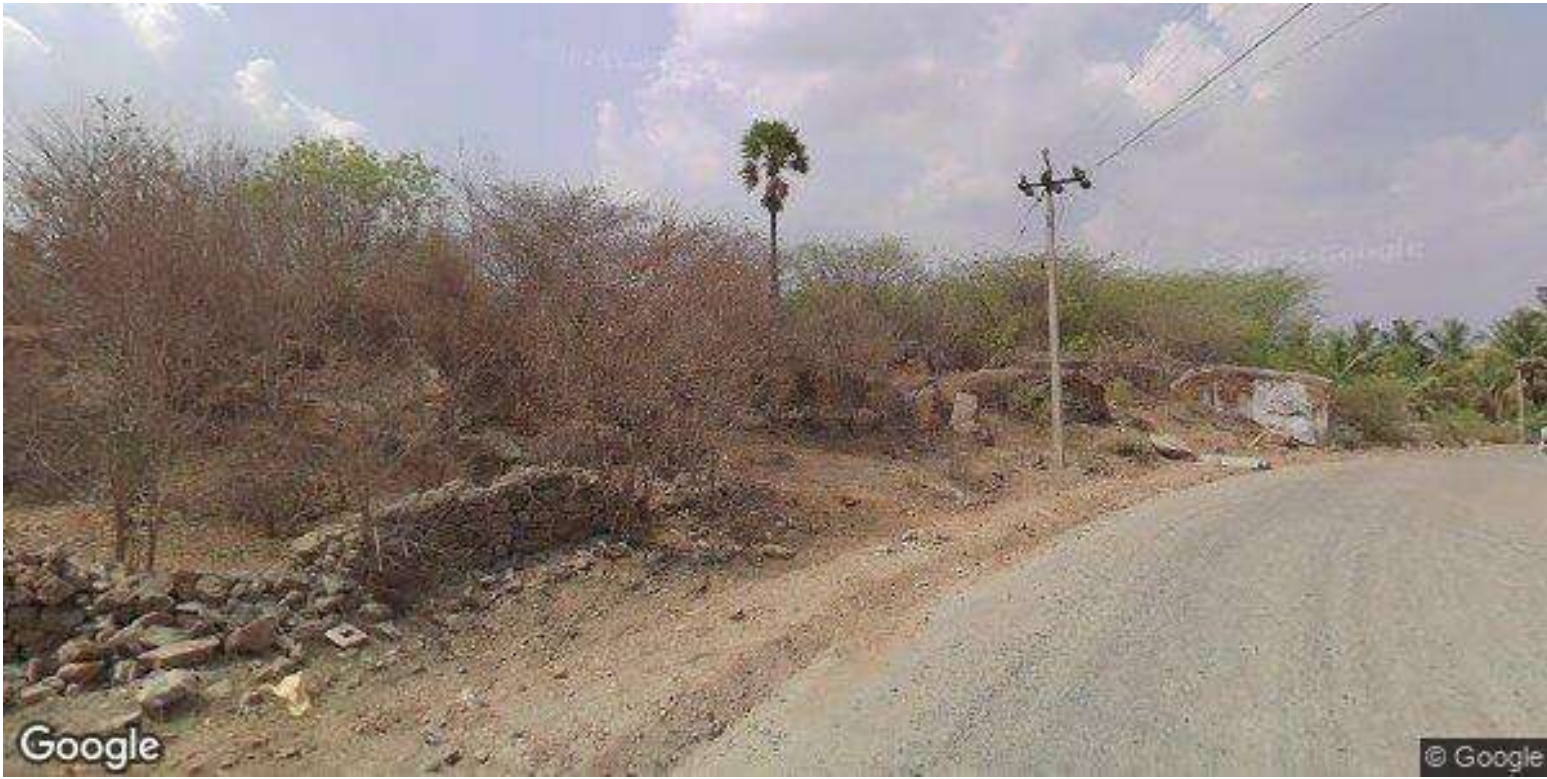
**Risk Type:** Turn  
**Risk Level:** Medium  
**Speed Limit:** 30 KM/Hr  
**Coordinates:** 11.27057, 77.86827

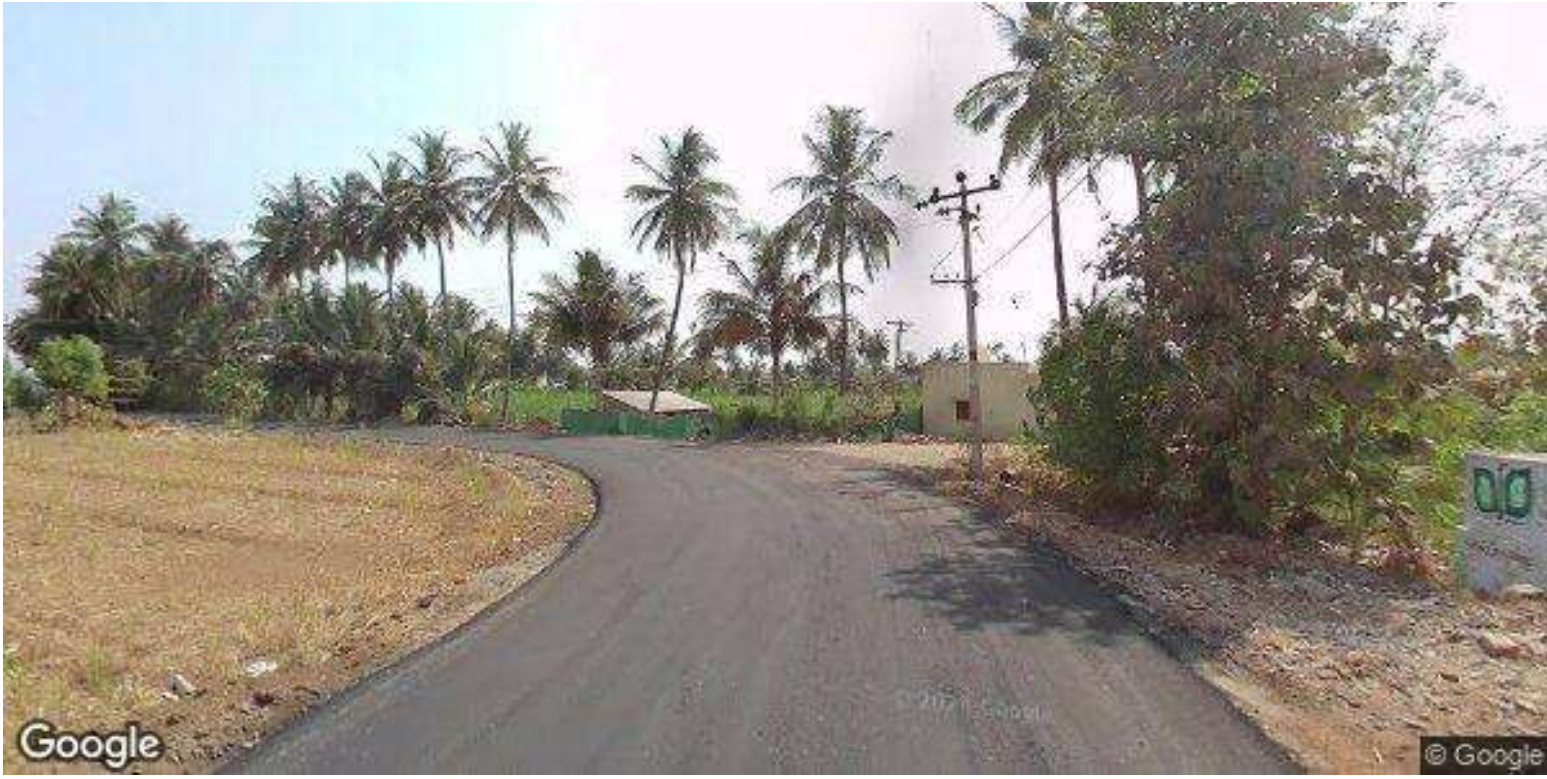
**Risk Type:** Turn  
**Risk Level:** High  
**Speed Limit:** 15 KM/Hr  
**Coordinates:** 11.26028, 77.85633

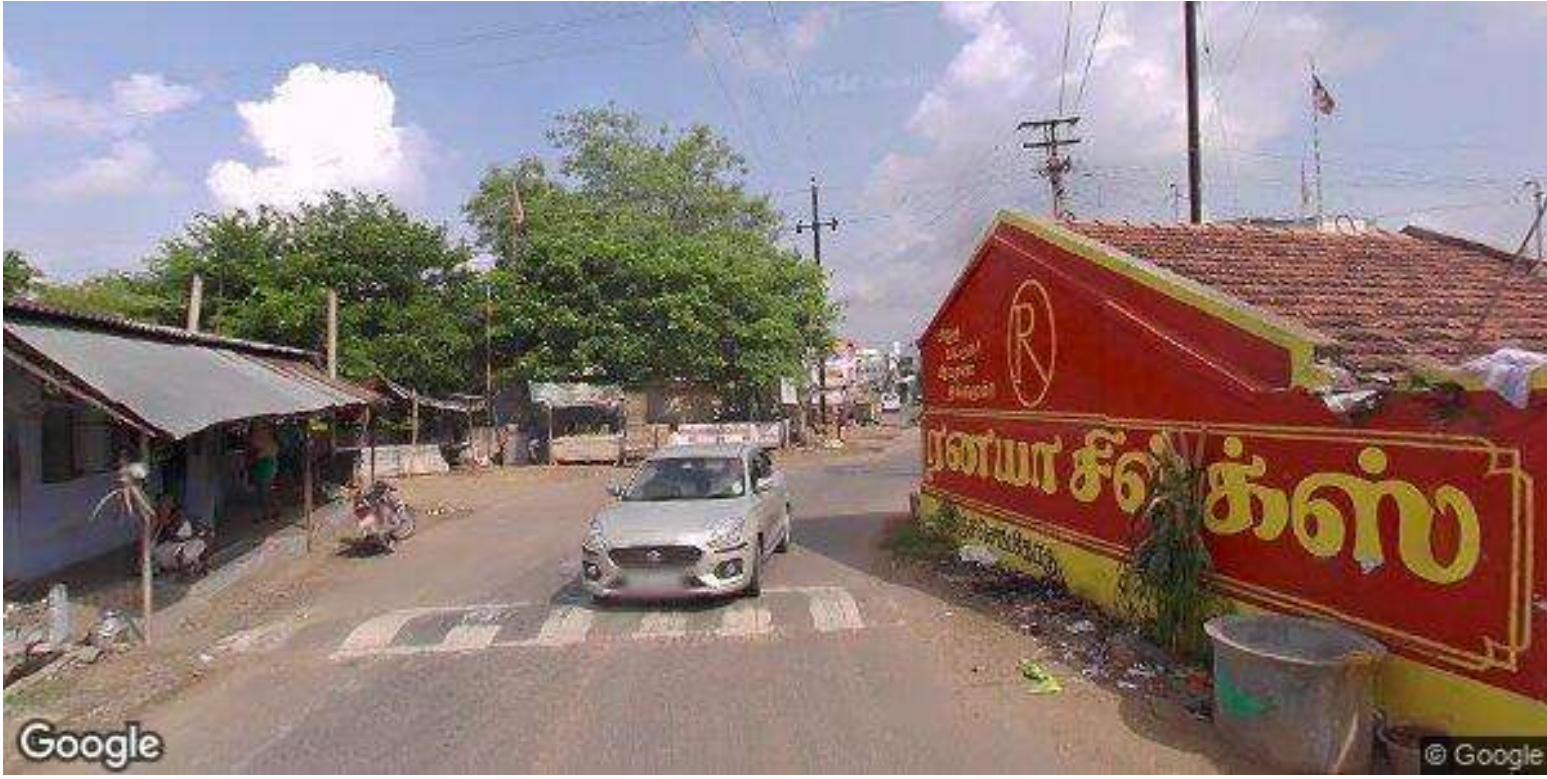
**Risk Type:** Turn  
**Risk Level:** High  
**Speed Limit:** 15 KM/Hr  
**Coordinates:** 11.25791, 77.85522

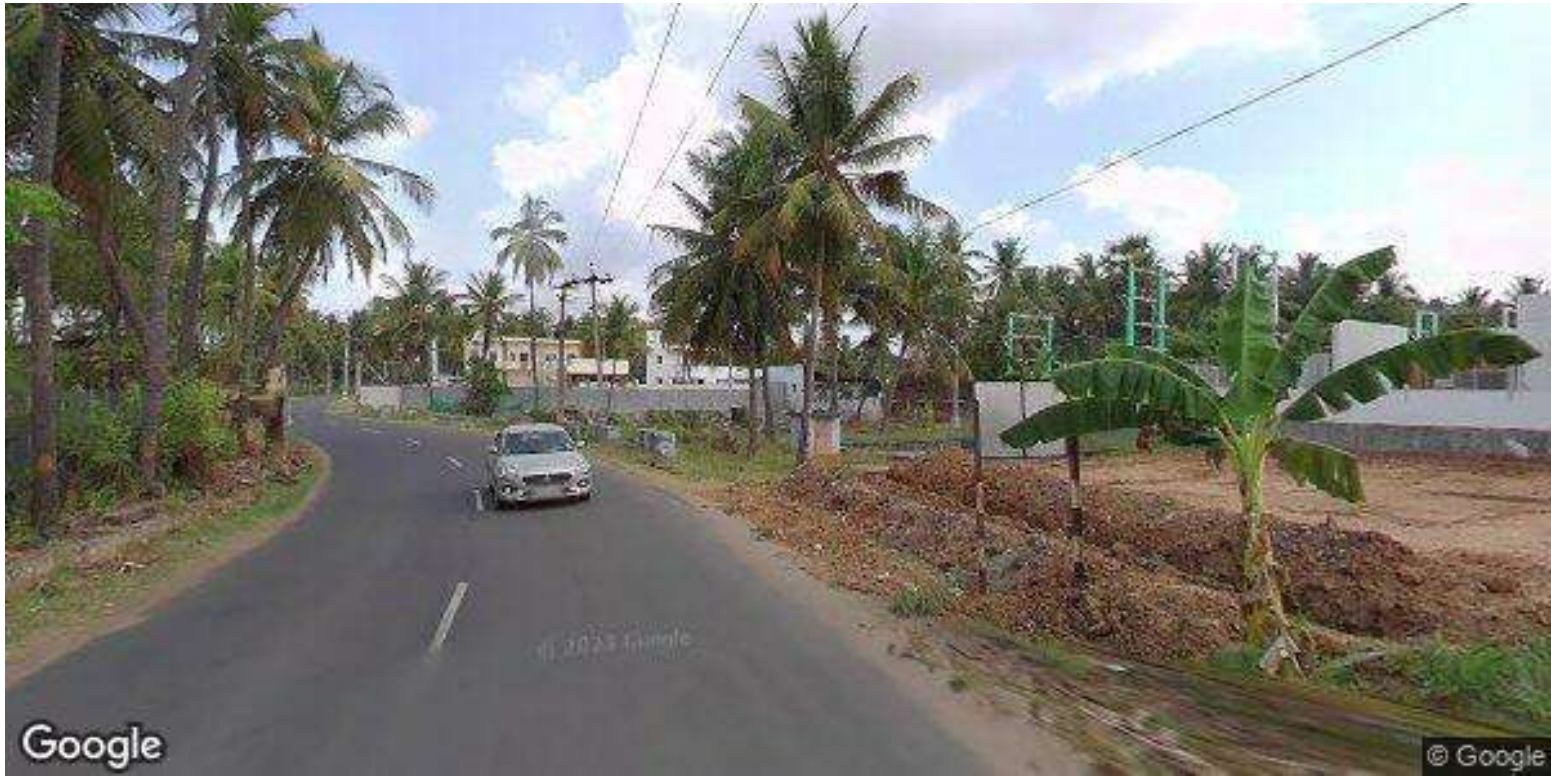
**Risk Type:** Turn  
**Risk Level:** Medium  
**Speed Limit:** 30 KM/Hr  
**Coordinates:** 11.25287, 77.86220

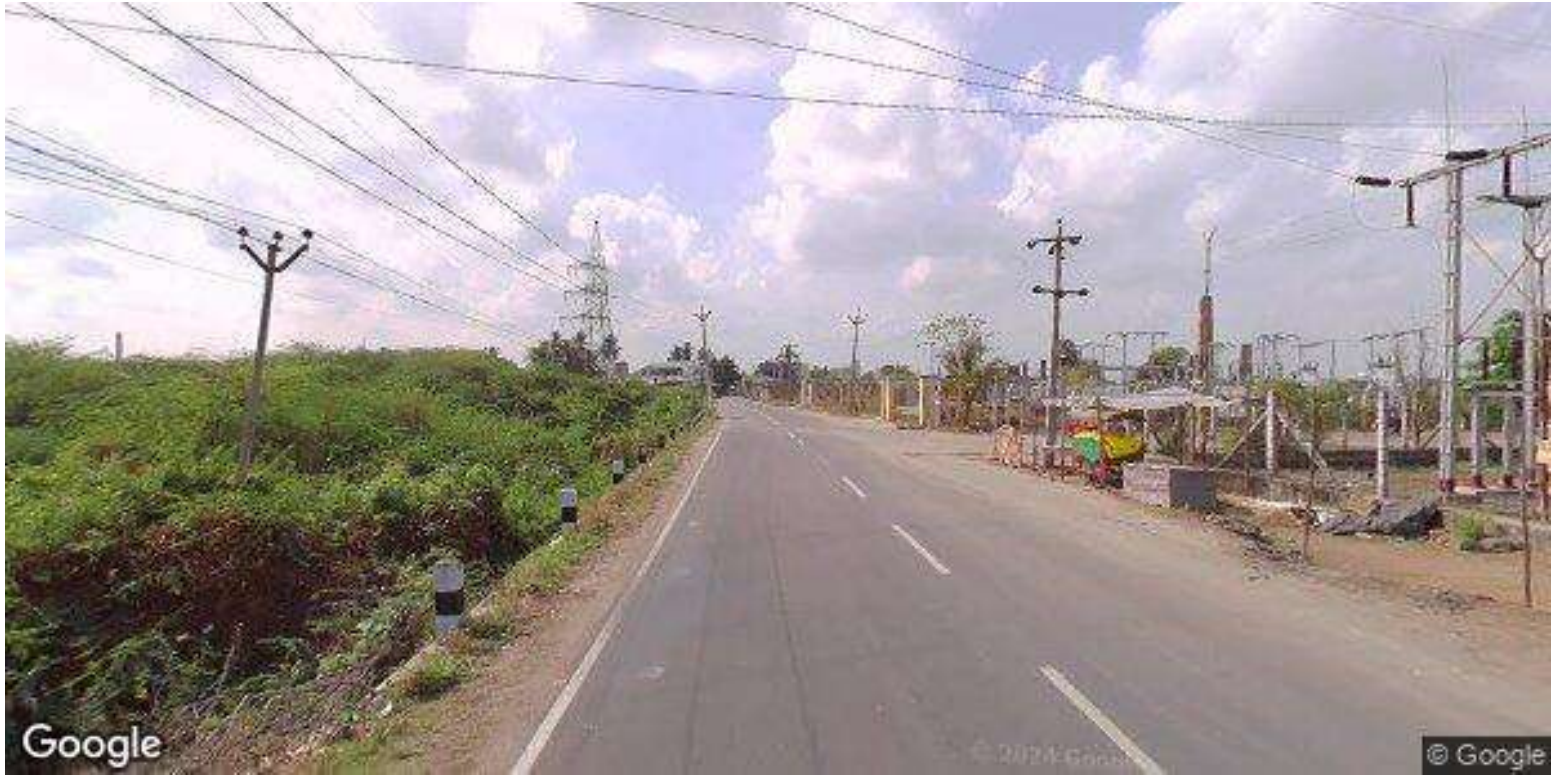
**Risk Type:** Turn  
**Risk Level:** Medium  
**Speed Limit:** 30 KM/Hr  
**Coordinates:** 11.24410, 77.86671

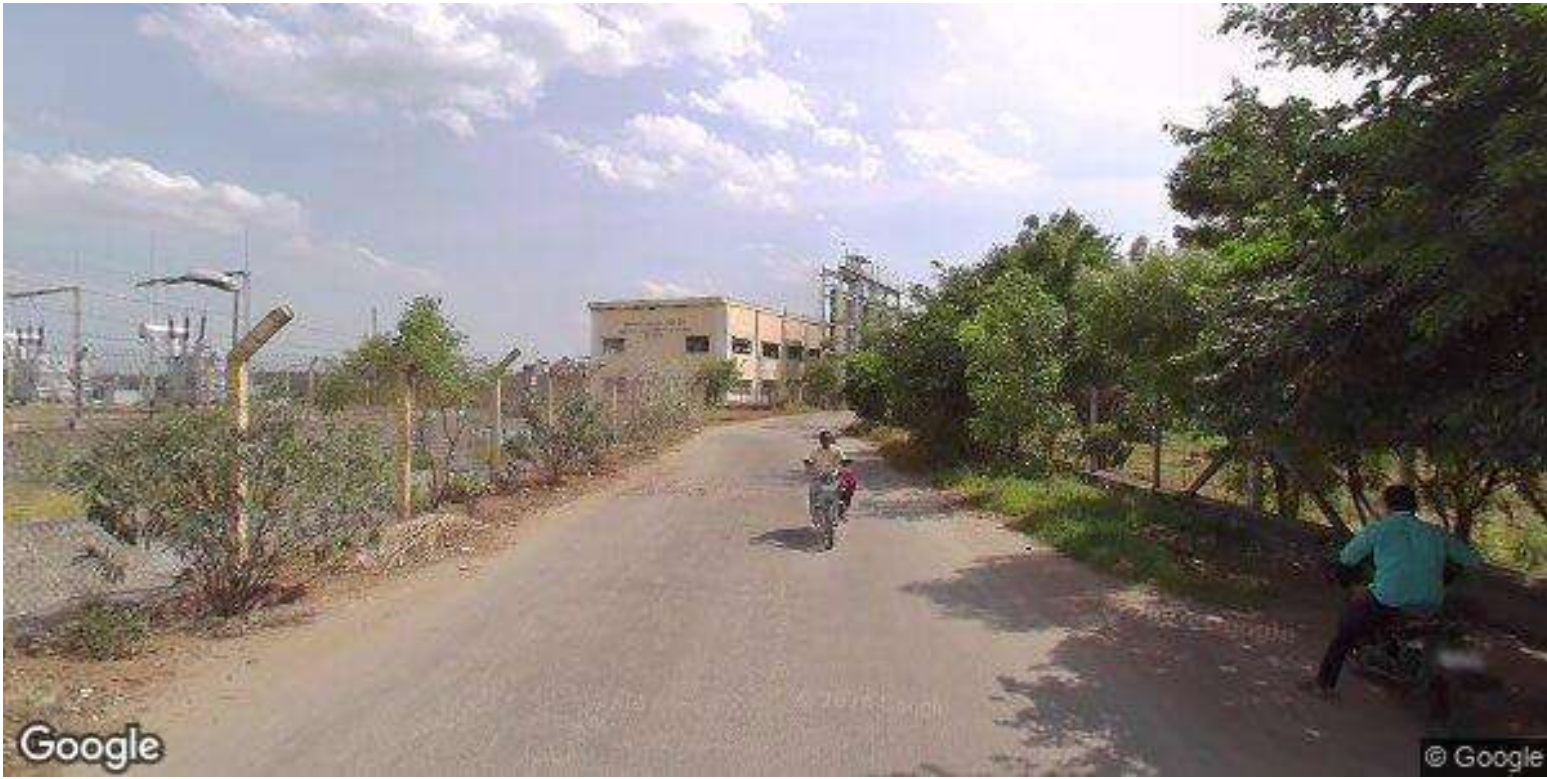
**Risk Type:** Turn  
**Risk Level:** High  
**Speed Limit:** 15 KM/Hr  
**Coordinates:** 11.24365, 77.86668

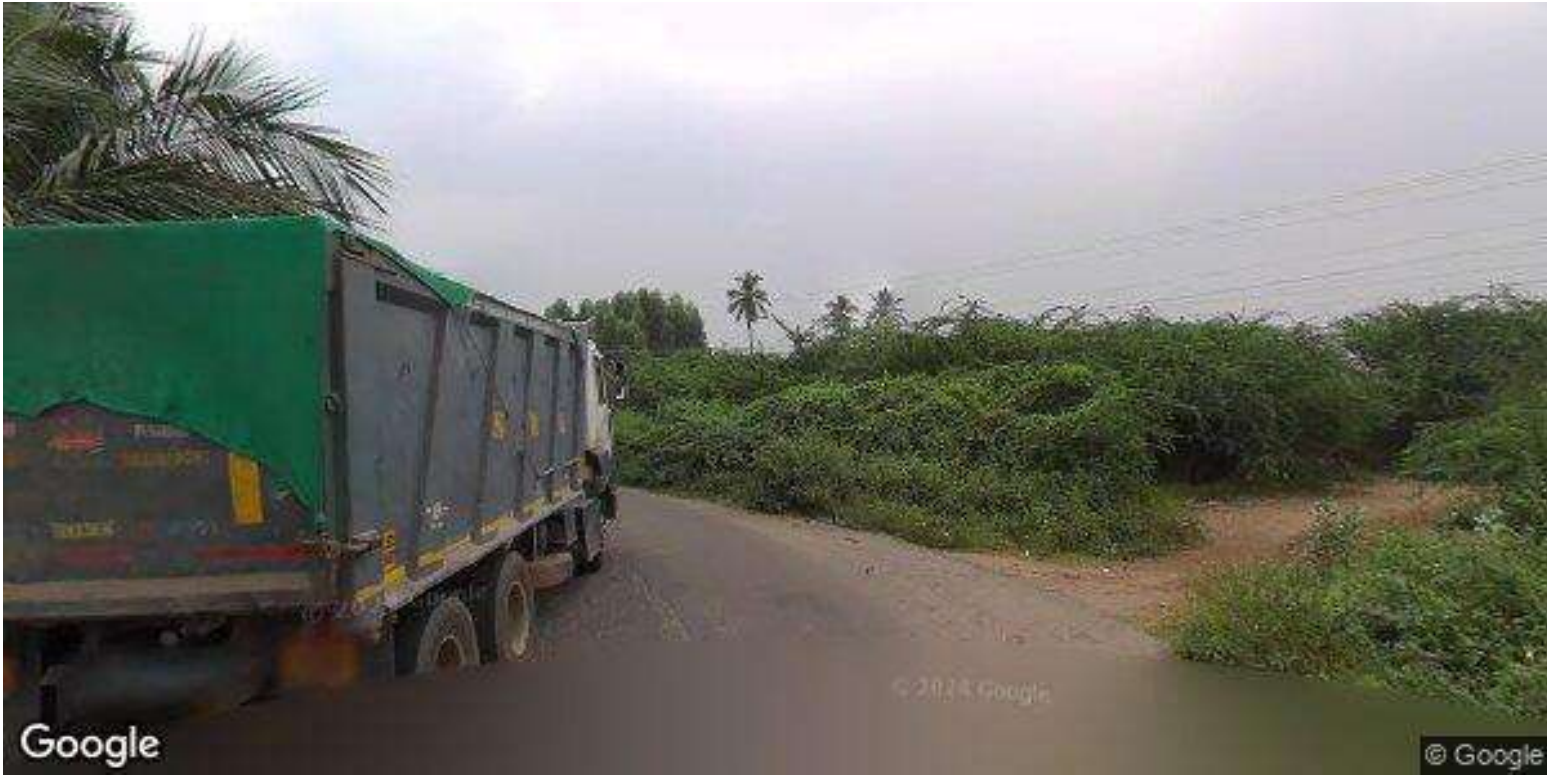
**Risk Type:** Turn  
**Risk Level:** High  
**Speed Limit:** 15 KM/Hr  
**Coordinates:** 11.24100, 77.86030

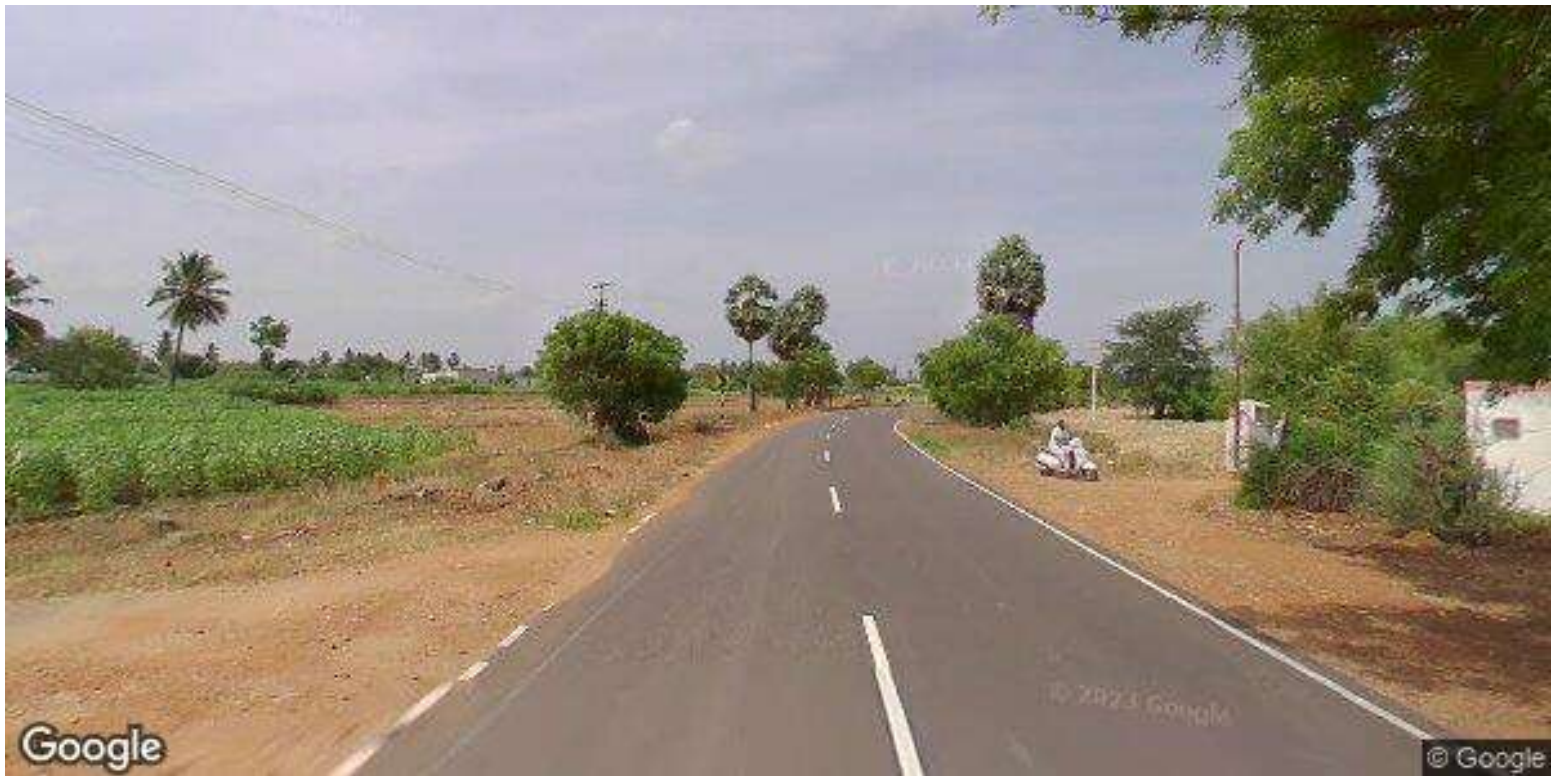
**Risk Type:** Turn  
**Risk Level:** Medium  
**Speed Limit:** 30 KM/Hr  
**Coordinates:** 11.21398, 77.81408

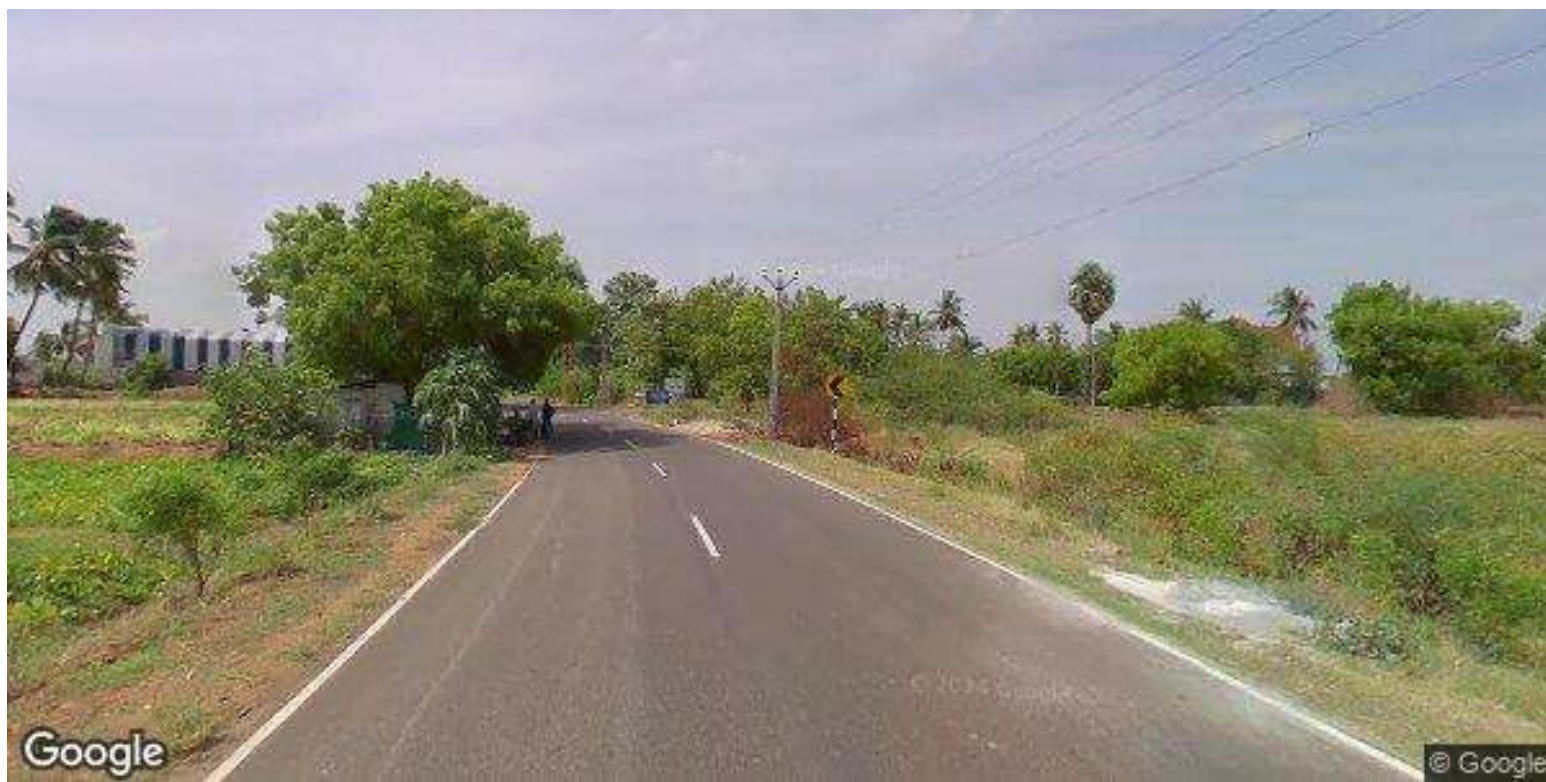
**Risk Type:** Turn

**Risk Level:** Medium

**Speed Limit:** 30 KM/Hr

**Coordinates:** 11.20949, 77.81173

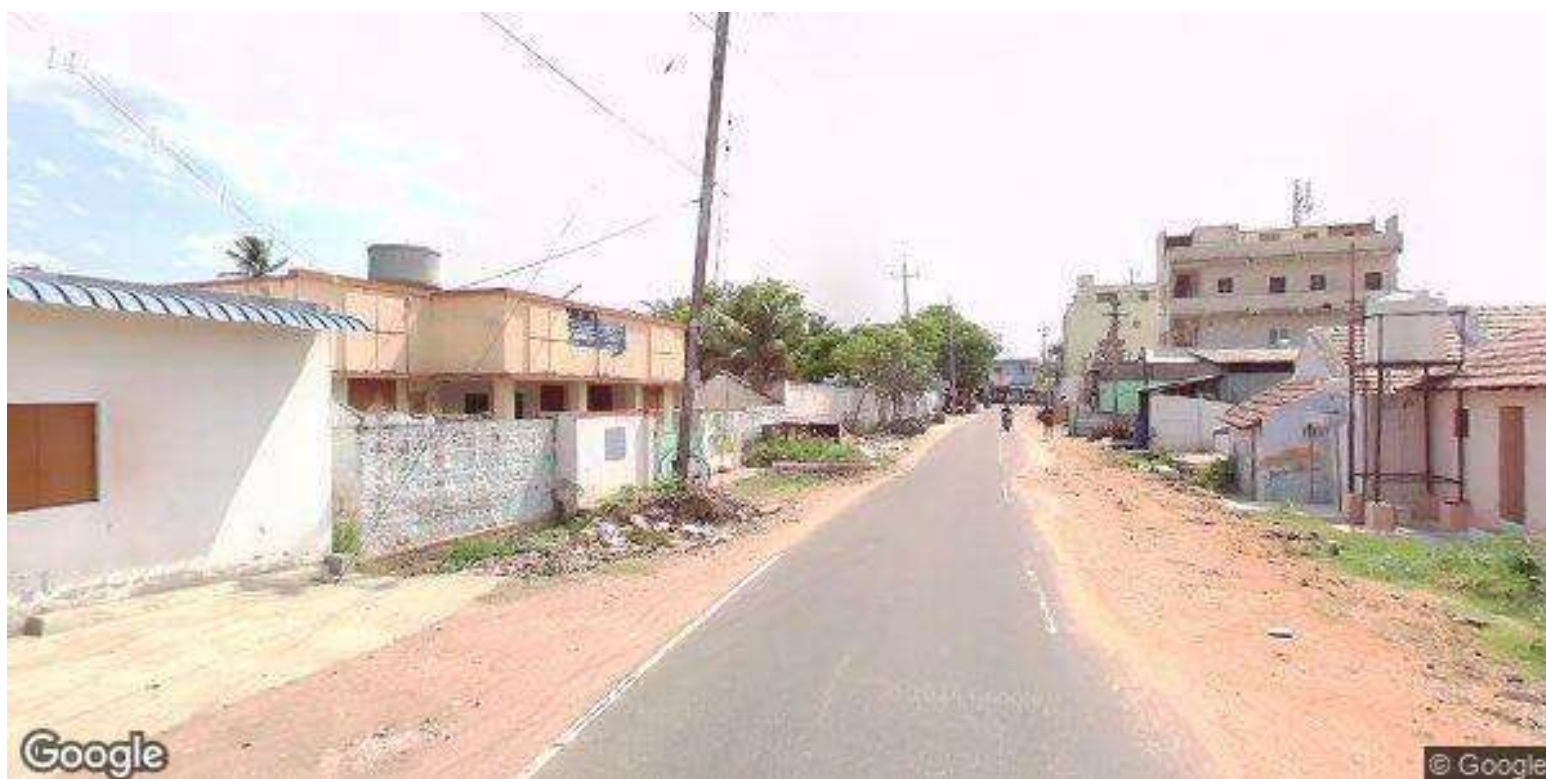
**Risk Type:** Turn

**Risk Level:** Medium

**Speed Limit:** 30 KM/Hr

**Coordinates:** 11.18875, 77.77206

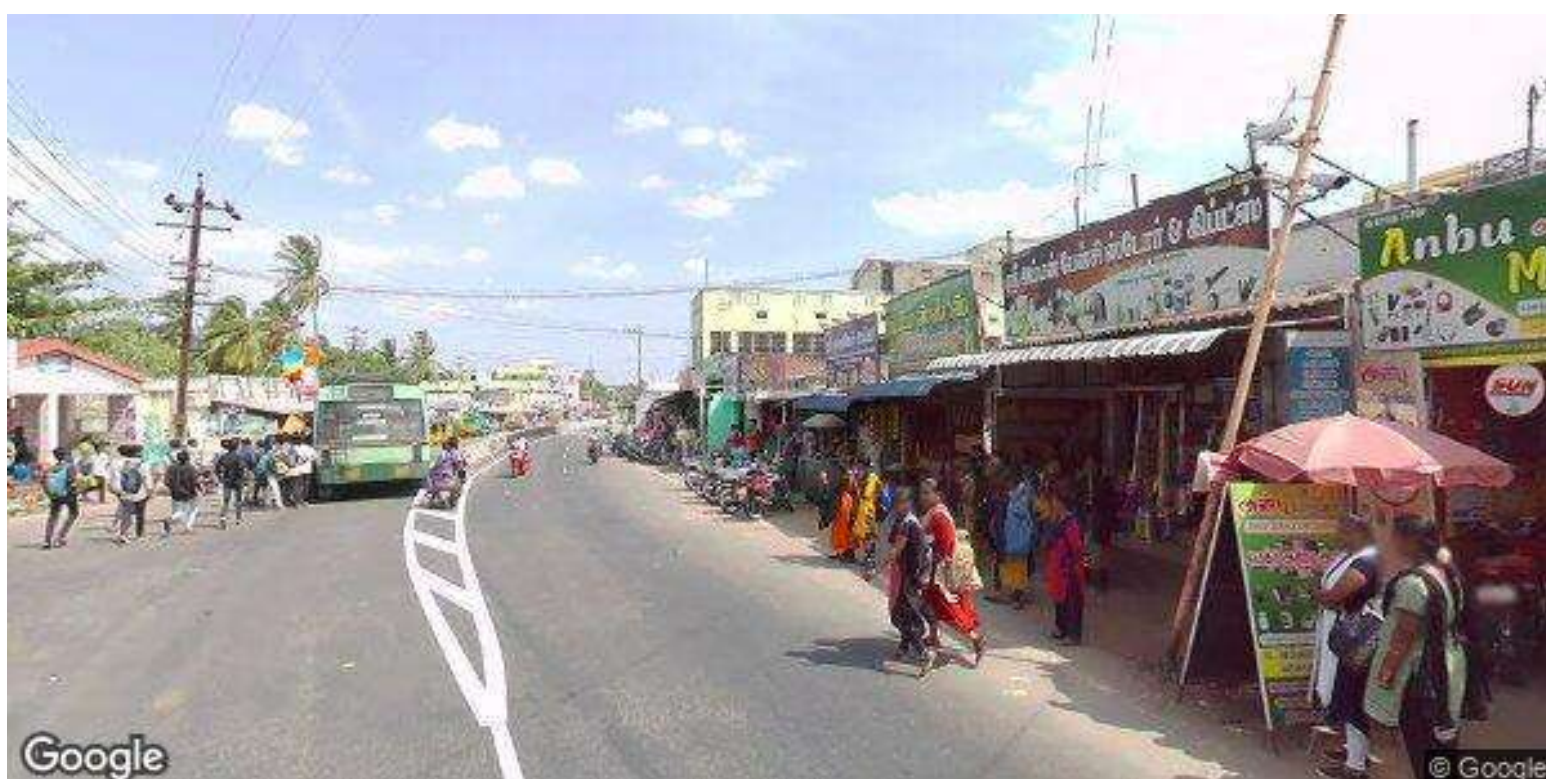
**Risk Type:** Blind Spot  
**Risk Level:** Blind Spot  
**Speed Limit:** 10 KM/Hr  
**Coordinates:** 11.18861, 77.77108

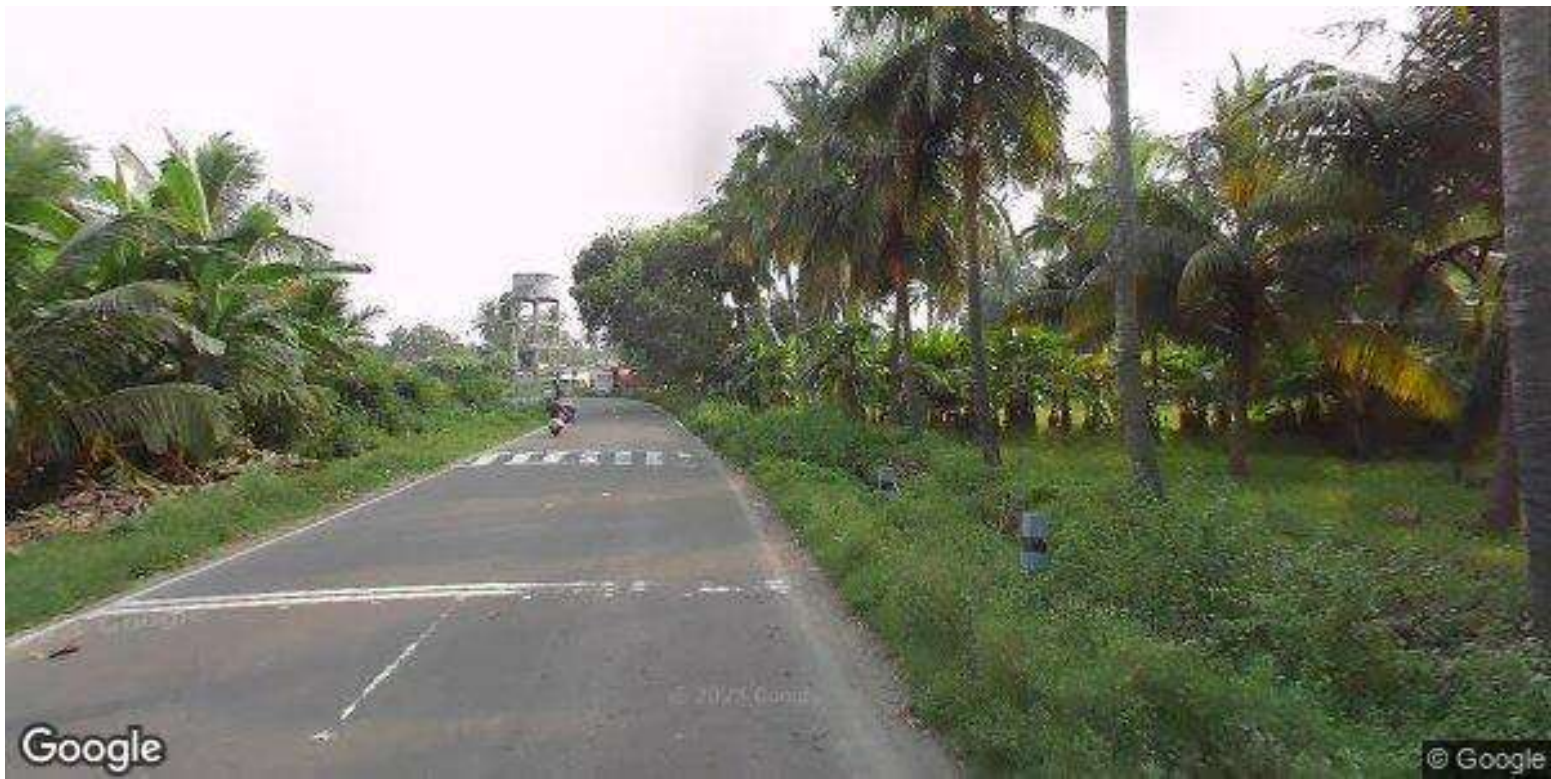
**Risk Type:** Turn  
**Risk Level:** Medium  
**Speed Limit:** 30 KM/Hr  
**Coordinates:** 11.16466, 77.77354
