# IndianOil

## JOURNEY RISK MANAGEMENT (JRM) STUDY

### Salem Terminal TO KANAGAMANI AGENCIES

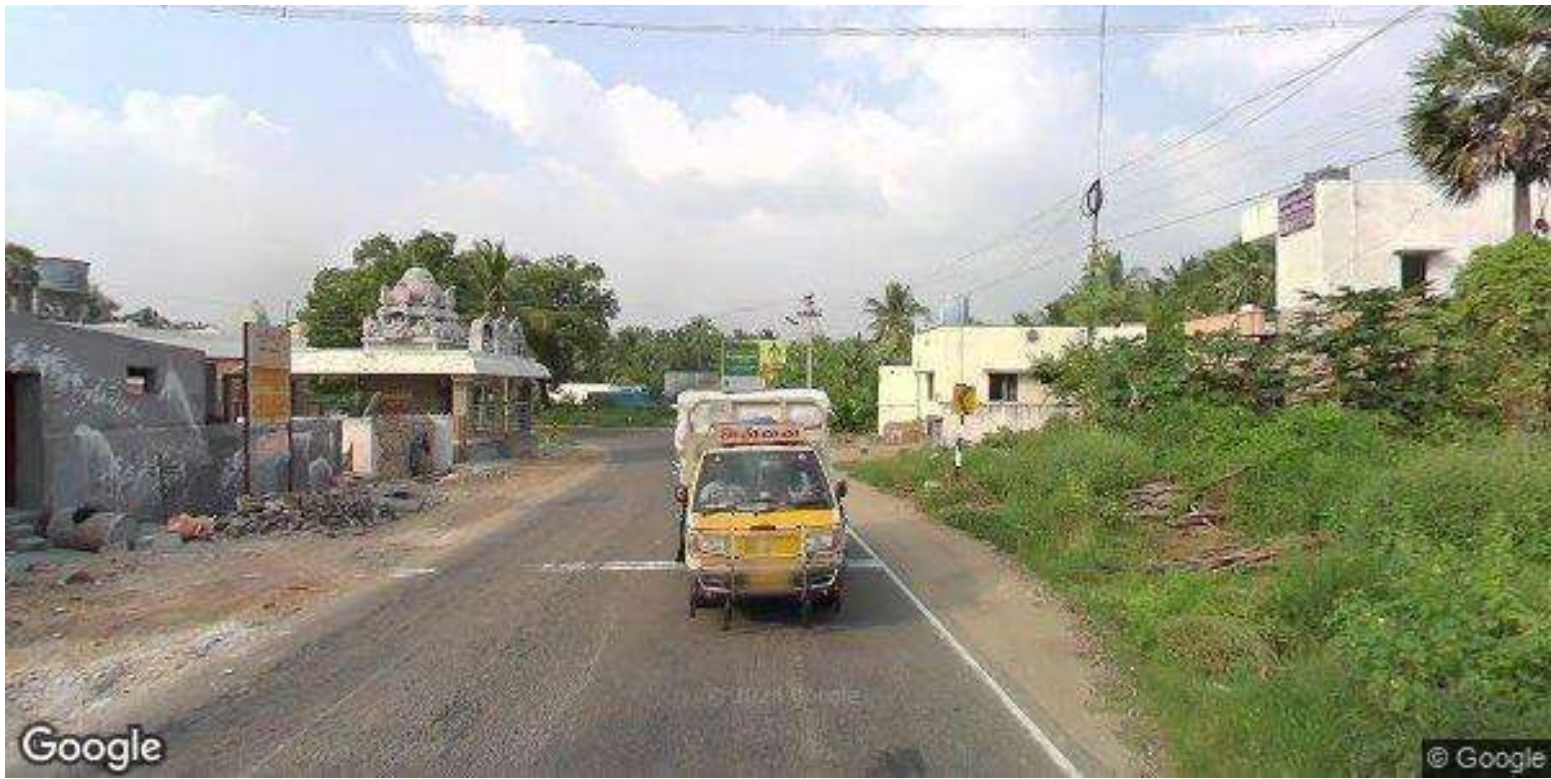
**Risk Type:** Turn  
**Risk Level:** Medium  
**Speed Limit:** 30 KM/Hr  
**Coordinates:** 11.16321, 77.77438

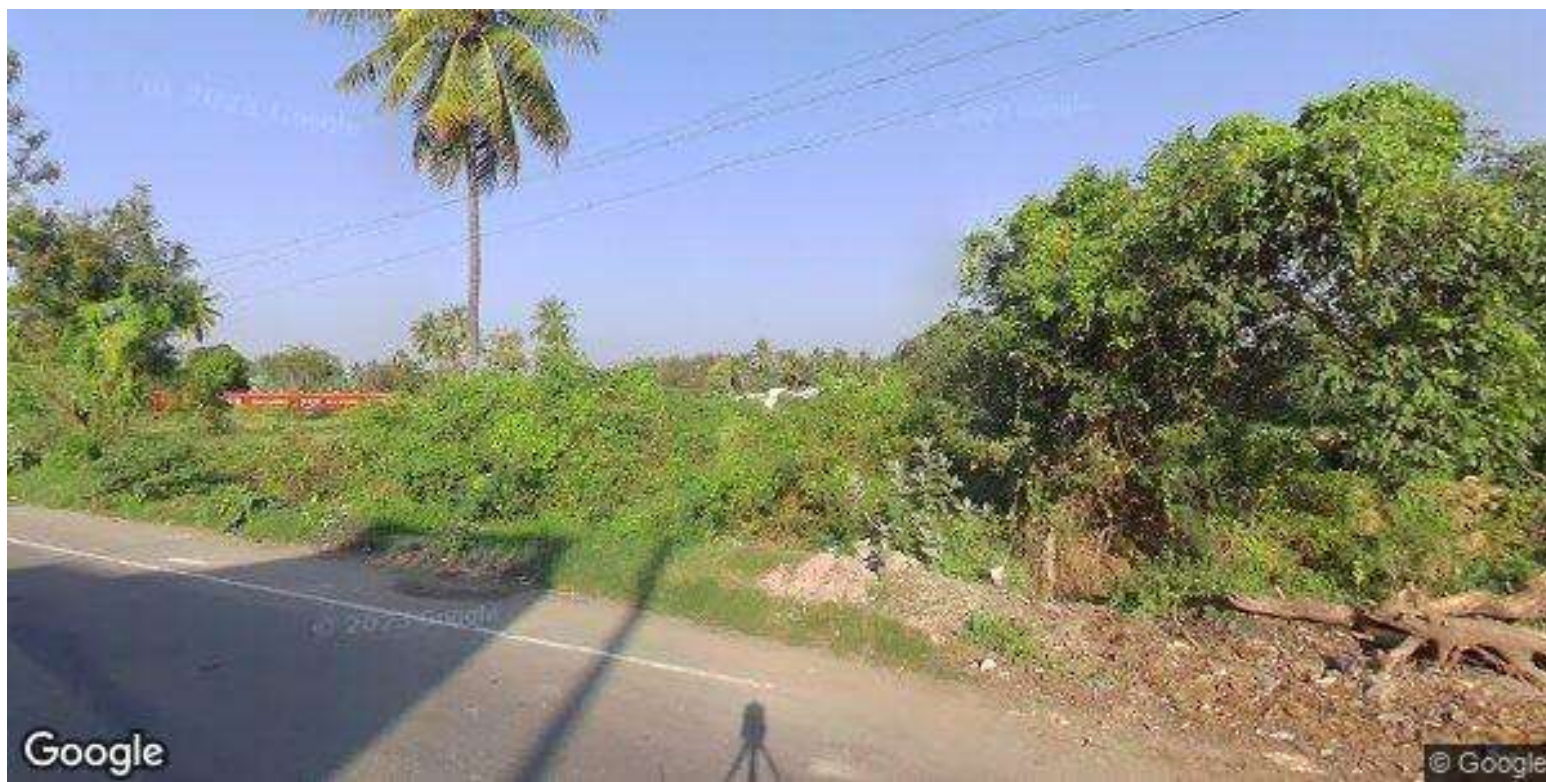
**Risk Type:** Turn

**Risk Level:** High

**Speed Limit:** 15 KM/Hr

**Coordinates:** 11.13693, 77.76539

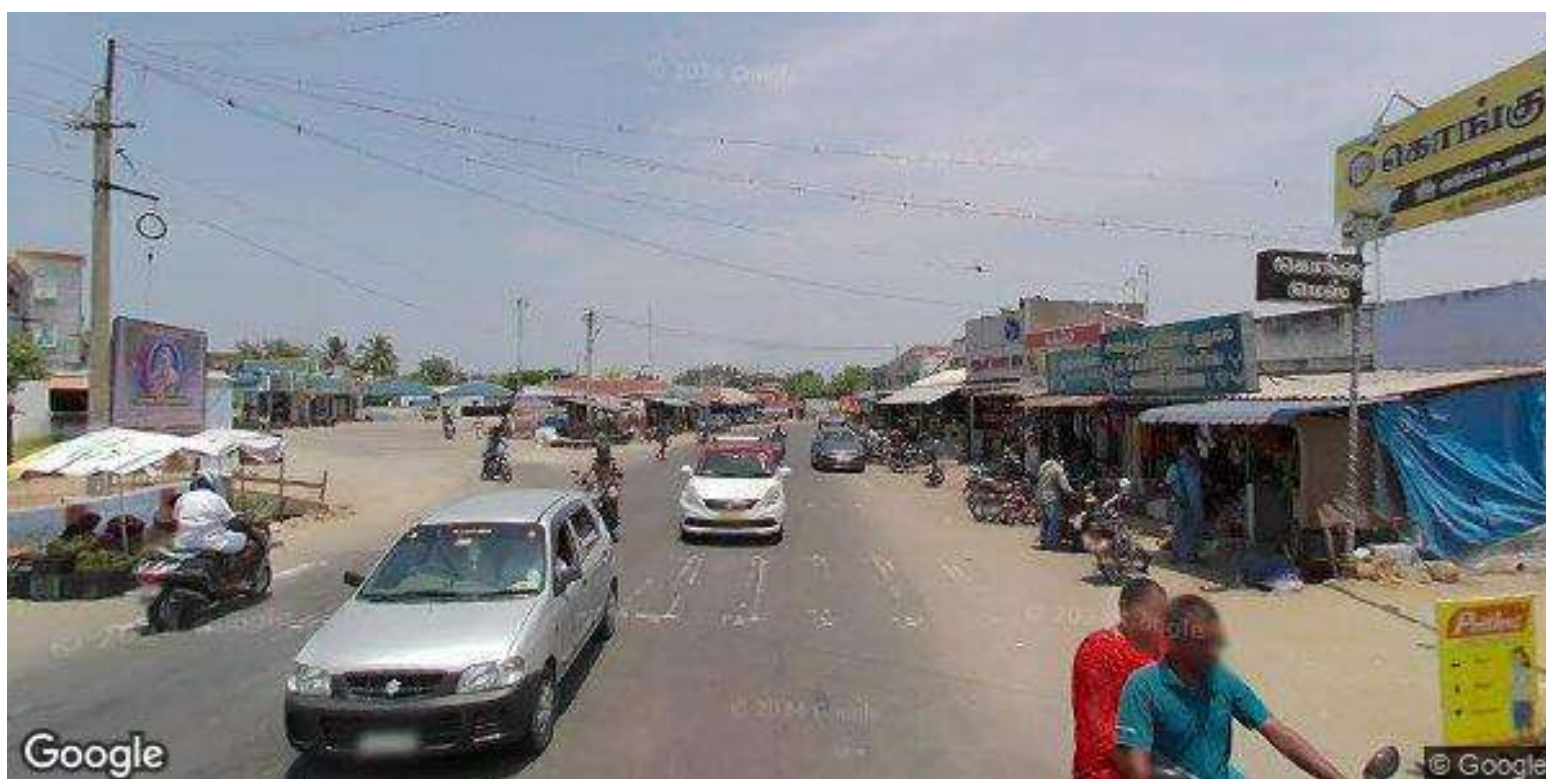
**Risk Type:** Turn

**Risk Level:** High

**Speed Limit:** 15 KM/Hr

**Coordinates:** 11.04545, 77.73638

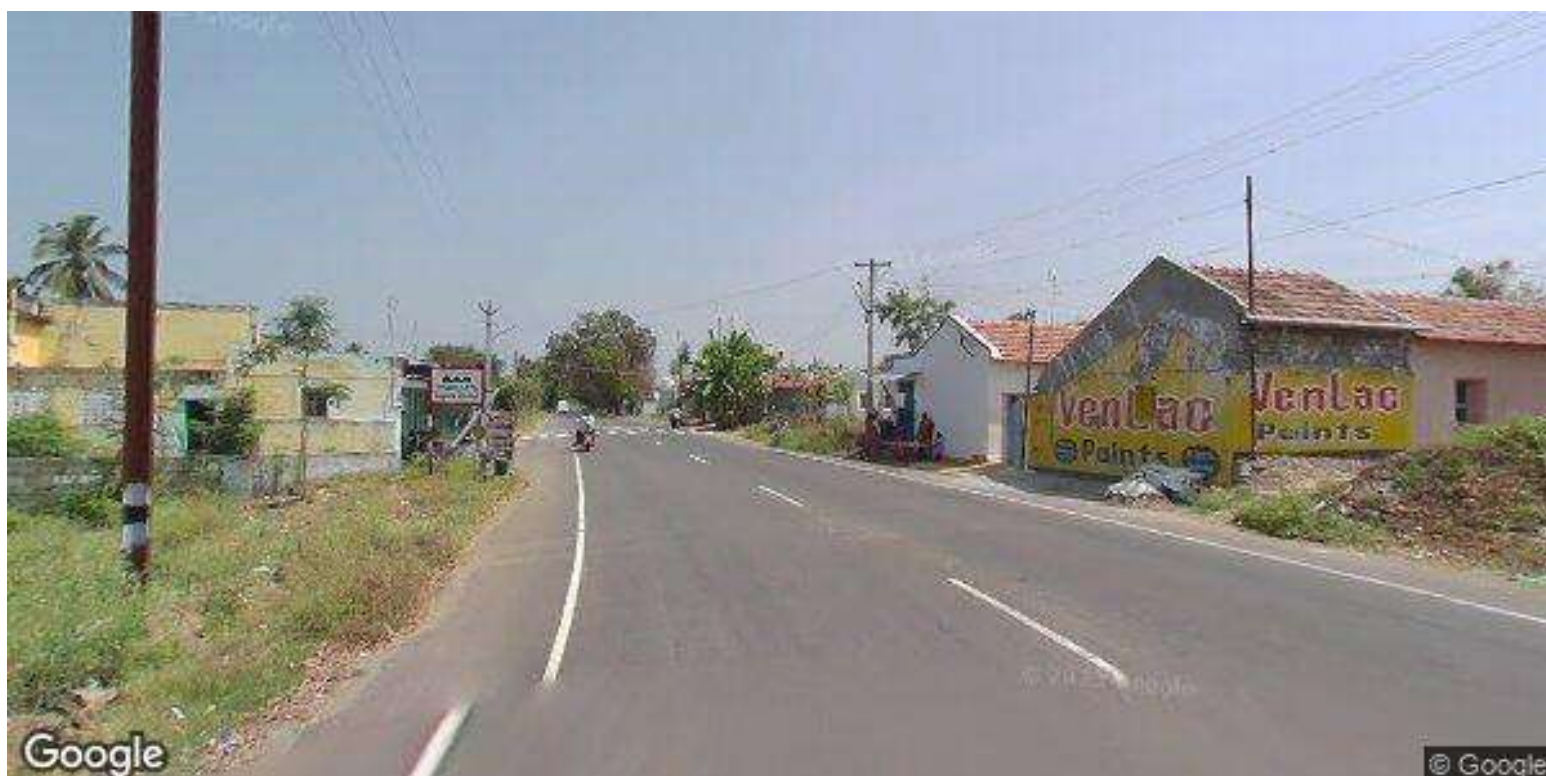
**Risk Type:** Turn  
**Risk Level:** High  
**Speed Limit:** 15 KM/Hr  
**Coordinates:** 10.99038, 77.72518

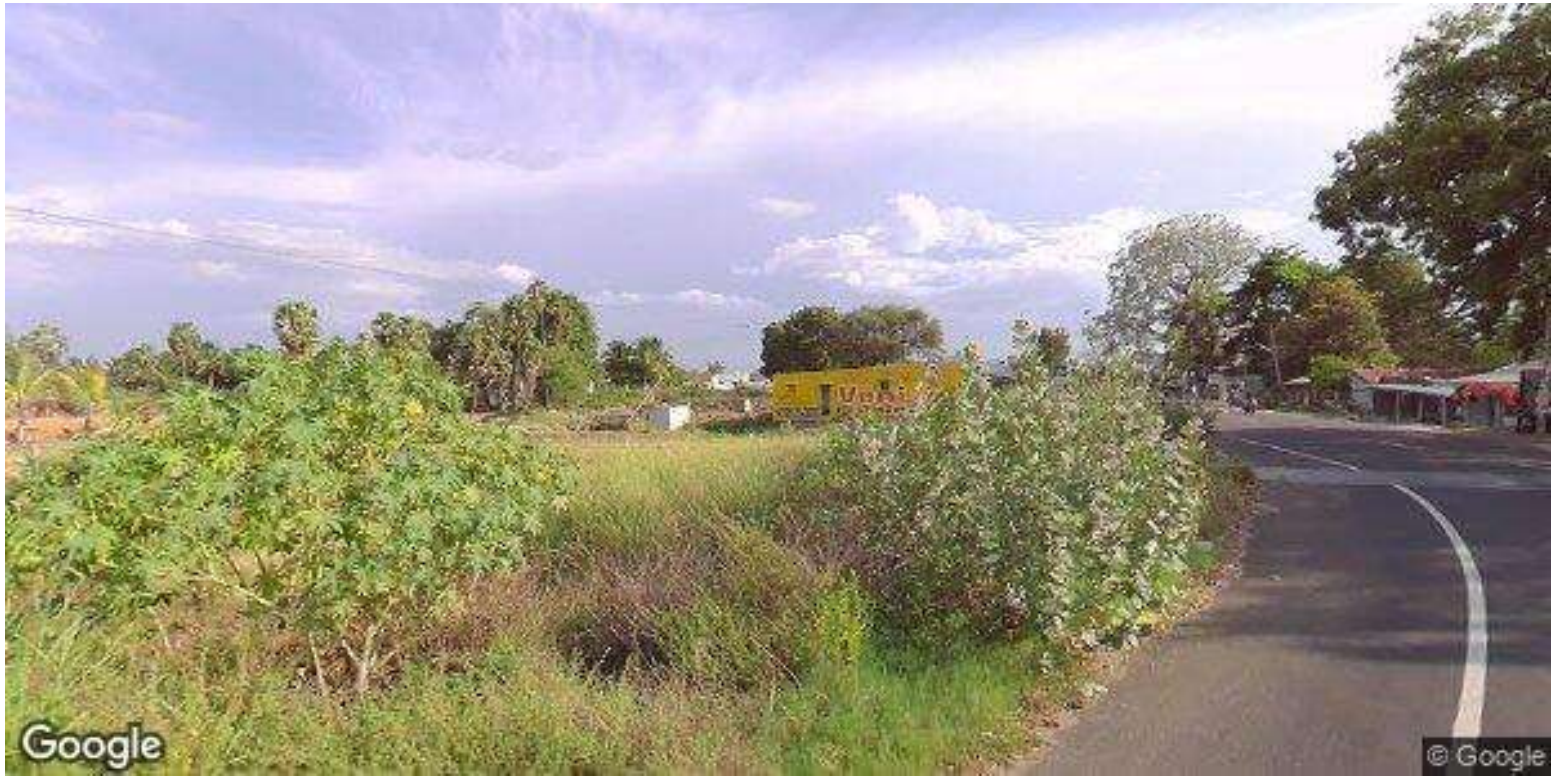
**Risk Type:** Turn  
**Risk Level:** High  
**Speed Limit:** 15 KM/Hr  
**Coordinates:** 10.98970, 77.72385

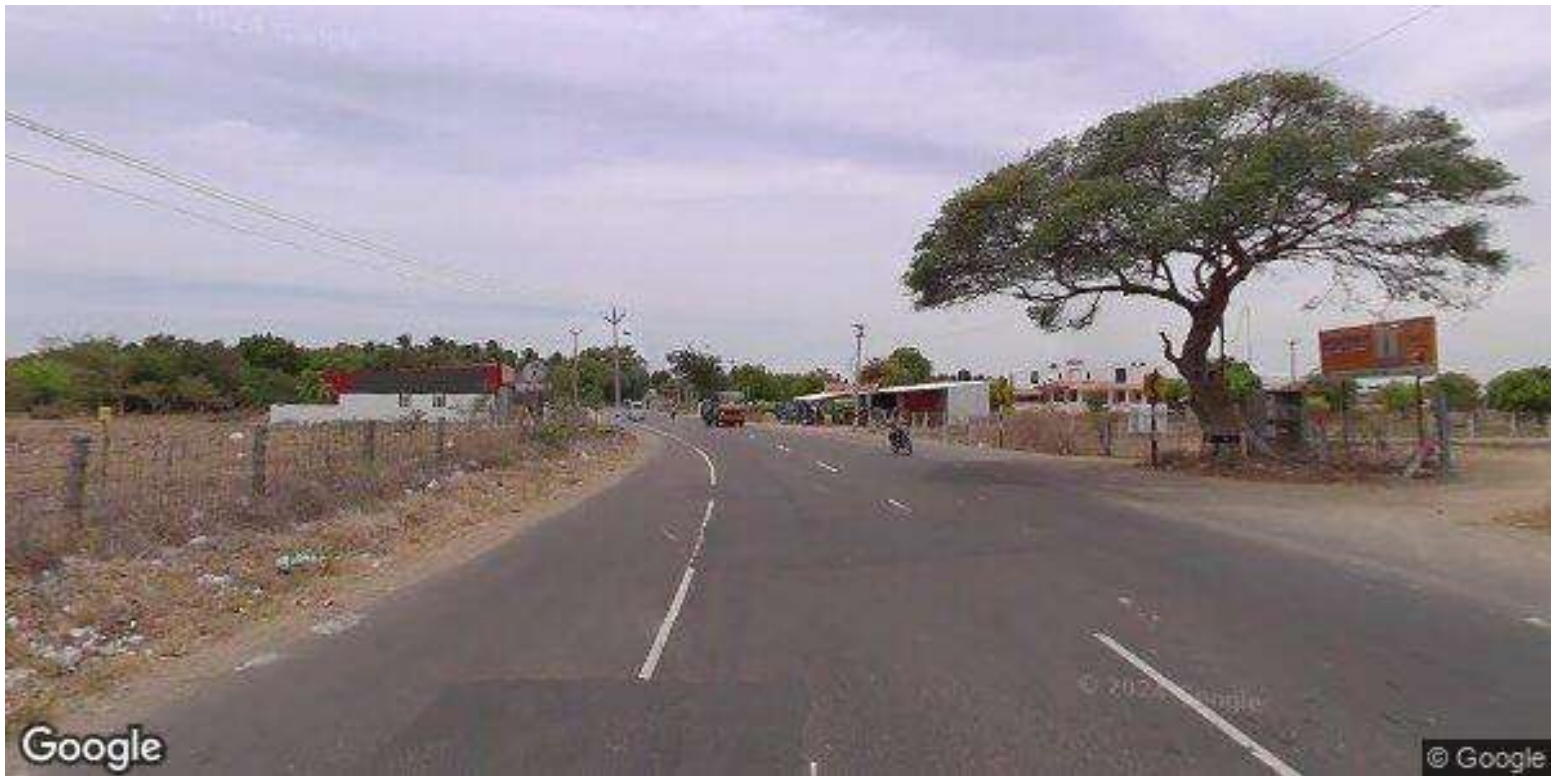
**Risk Type:** Turn  
**Risk Level:** Medium  
**Speed Limit:** 30 KM/Hr  
**Coordinates:** 10.96614, 77.71685

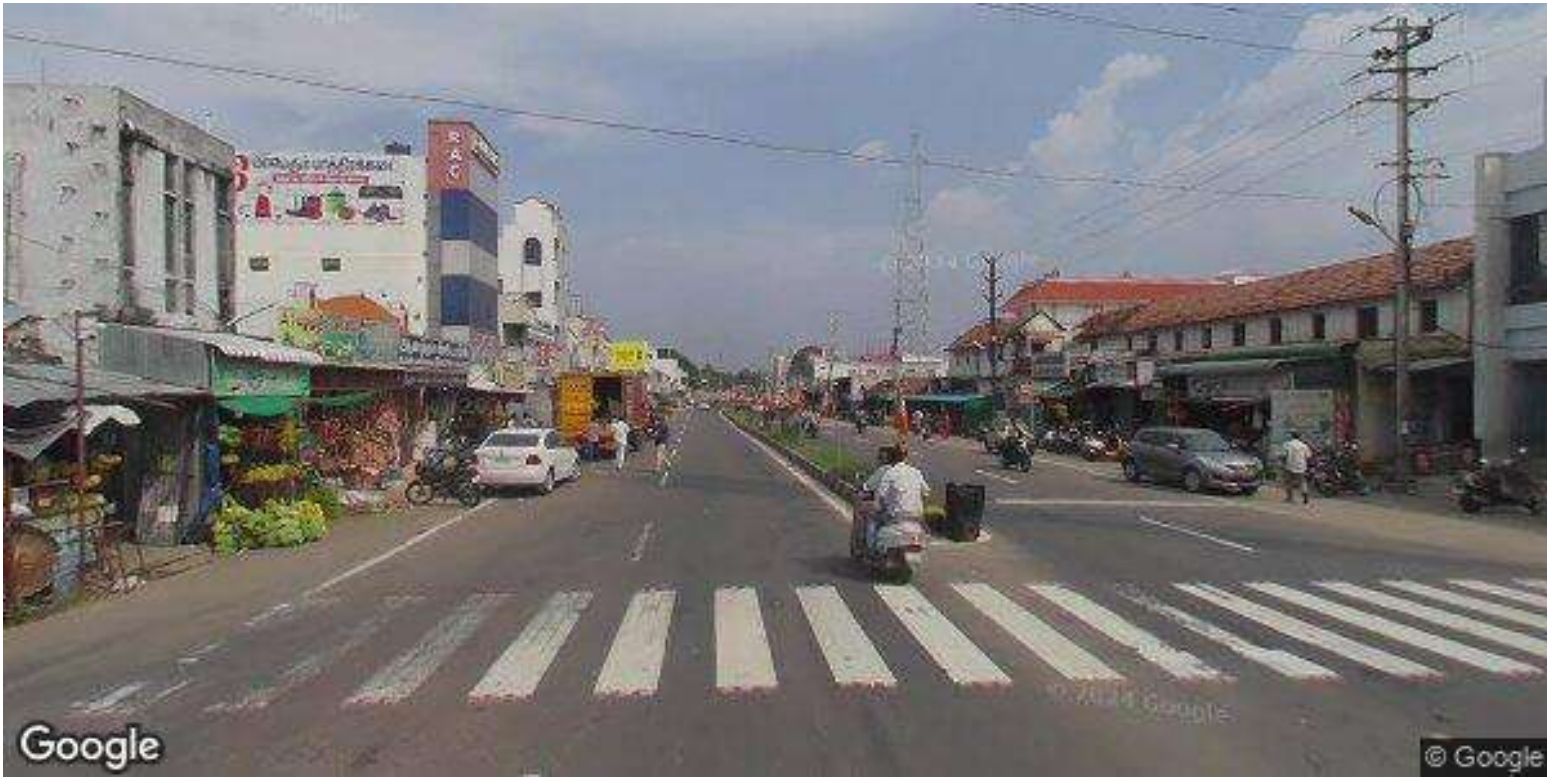
**Risk Type:** Turn  
**Risk Level:** High  
**Speed Limit:** 15 KM/Hr  
**Coordinates:** 10.94597, 77.71319

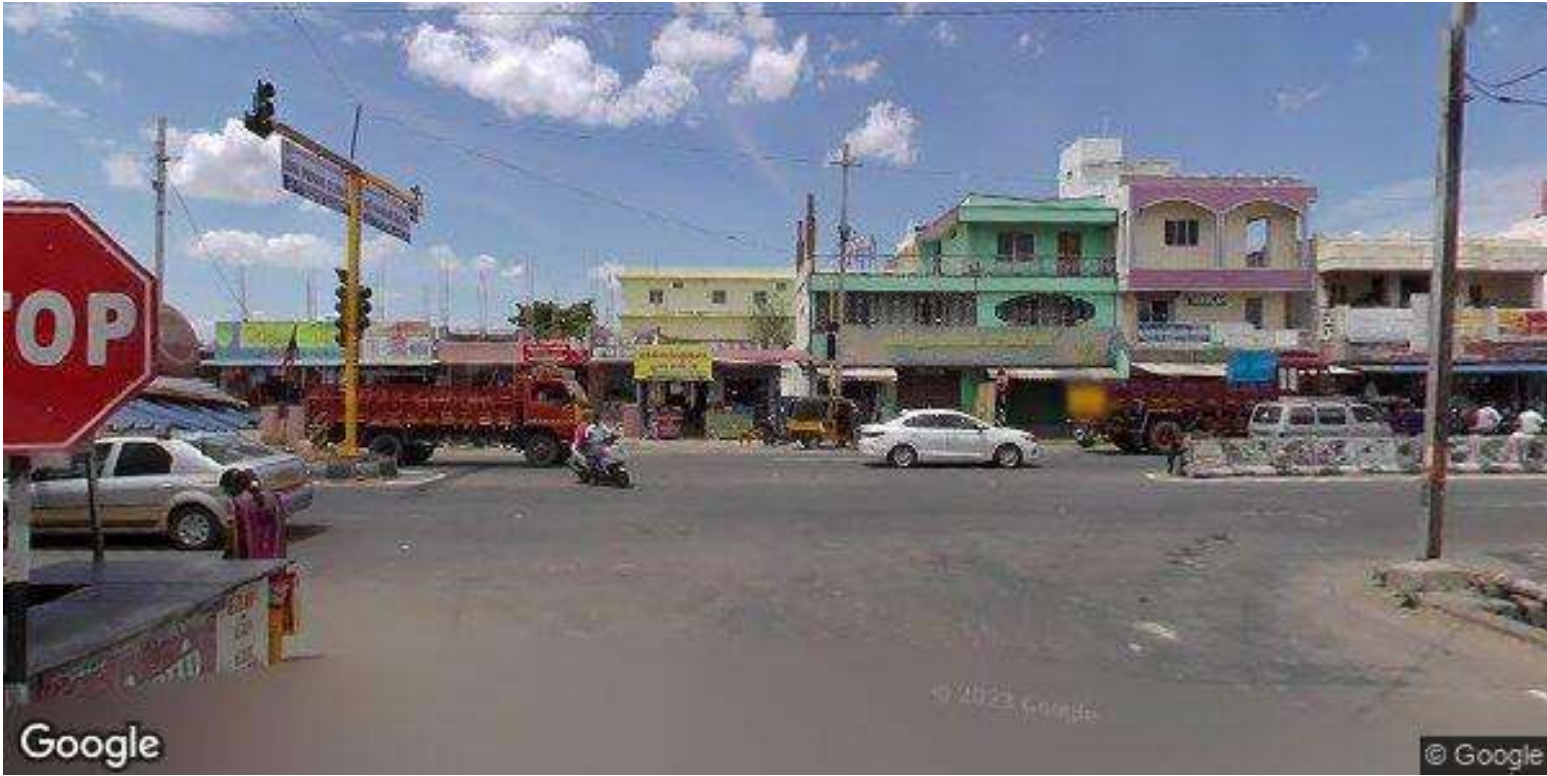
**Risk Type:** Turn  
**Risk Level:** High  
**Speed Limit:** 15 KM/Hr  
**Coordinates:** 10.94582, 77.71257

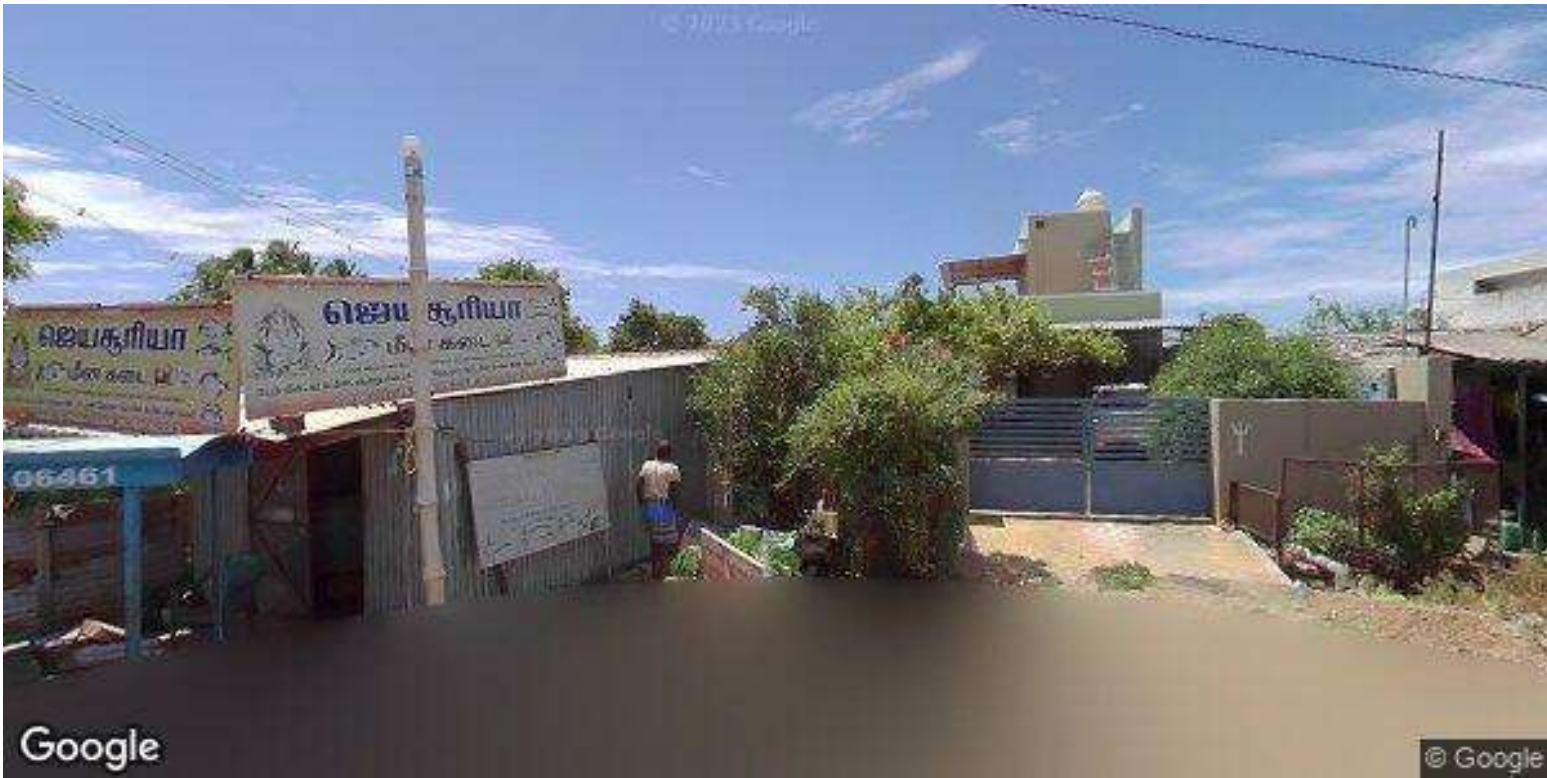
**Risk Type:** Turn  
**Risk Level:** Medium  
**Speed Limit:** 30 KM/Hr  
**Coordinates:** 10.94256, 77.71174

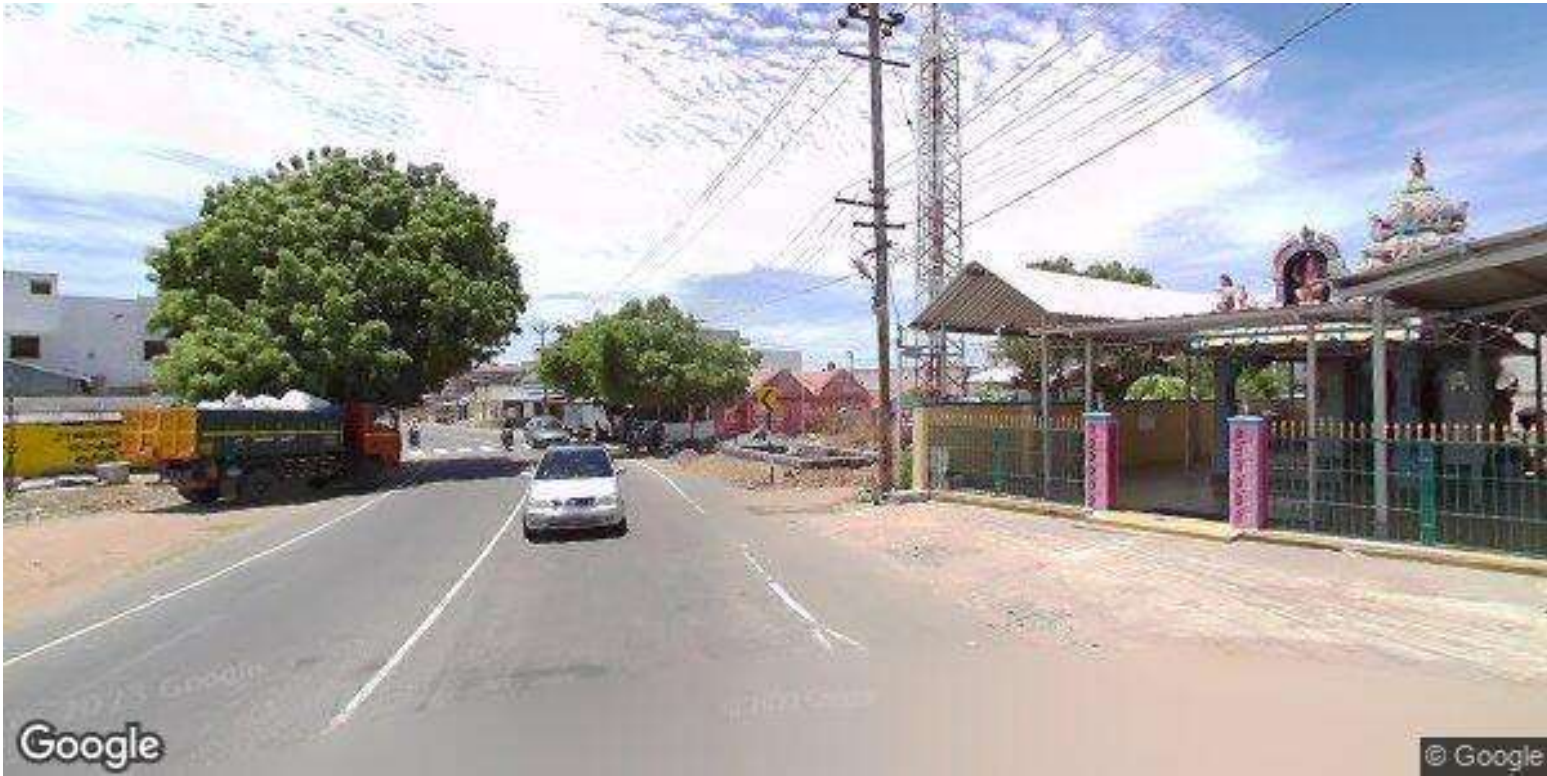
**Risk Type:** Turn  
**Risk Level:** Medium  
**Speed Limit:** 30 KM/Hr  
**Coordinates:** 10.93834, 77.70347

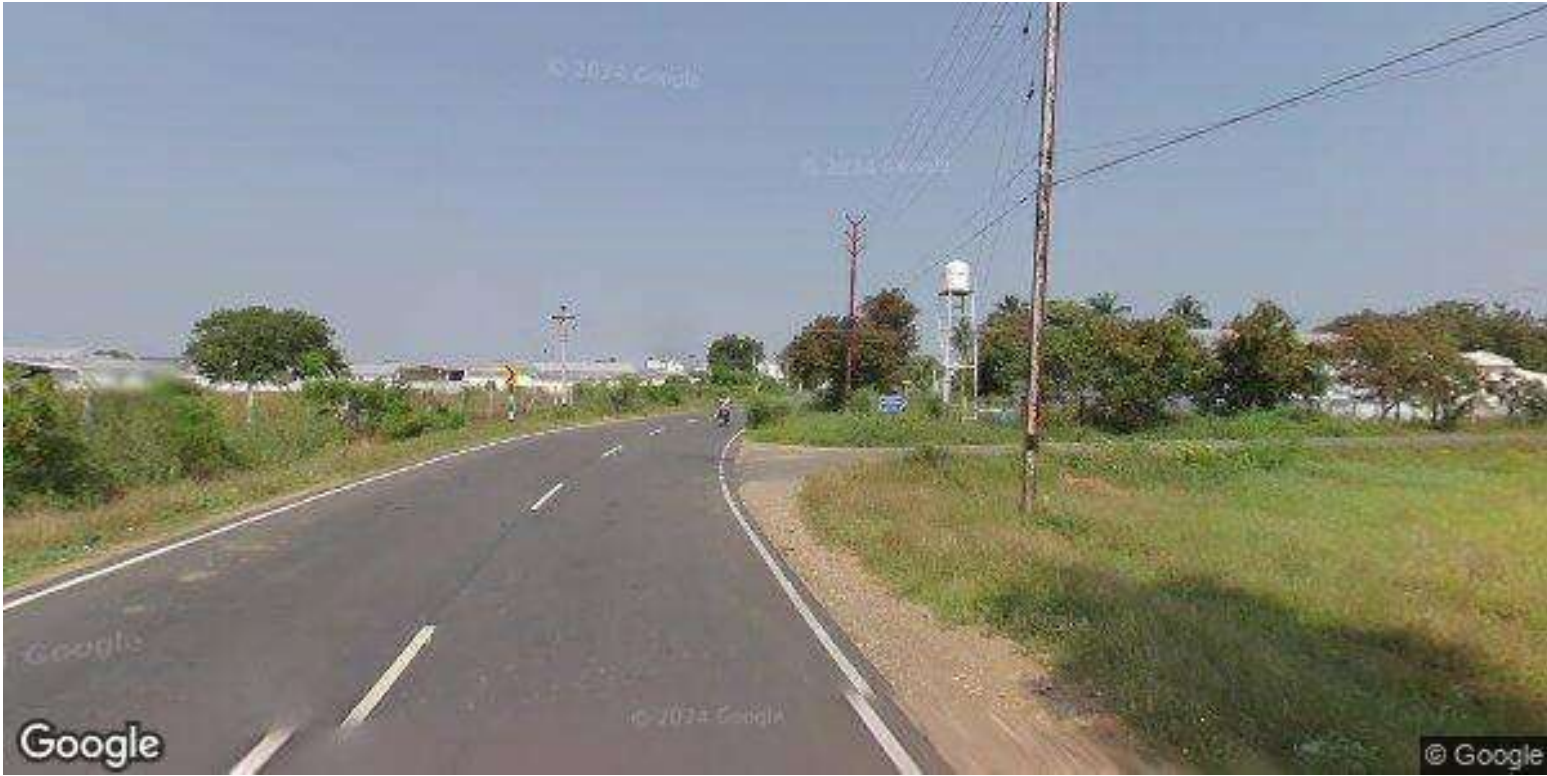
**Risk Type:** Turn  
**Risk Level:** Medium  
**Speed Limit:** 30 KM/Hr  
**Coordinates:** 10.92356, 77.69226

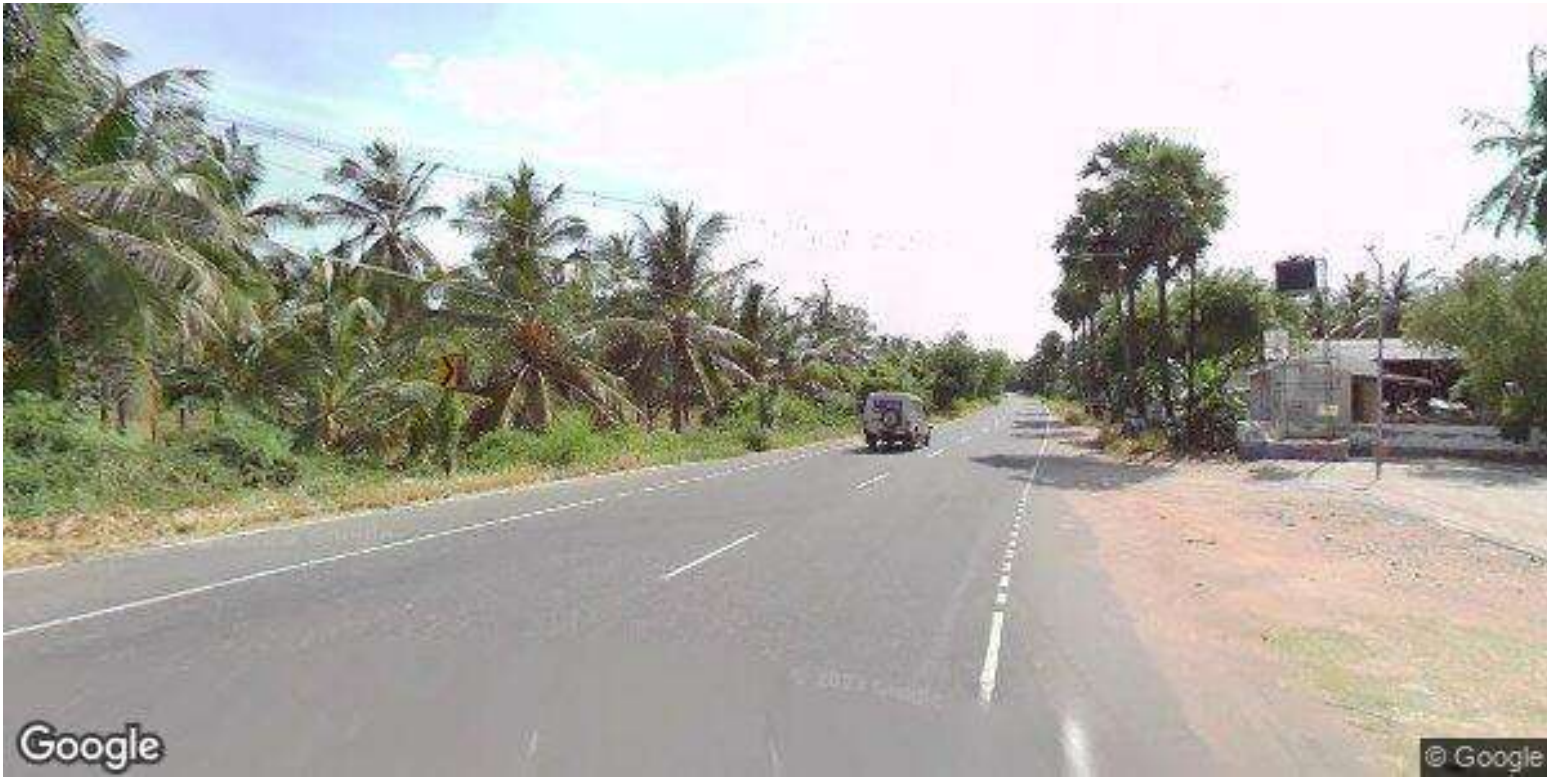
**Risk Type:** Turn  
**Risk Level:** High  
**Speed Limit:** 15 KM/Hr  
**Coordinates:** 10.87230, 77.64953

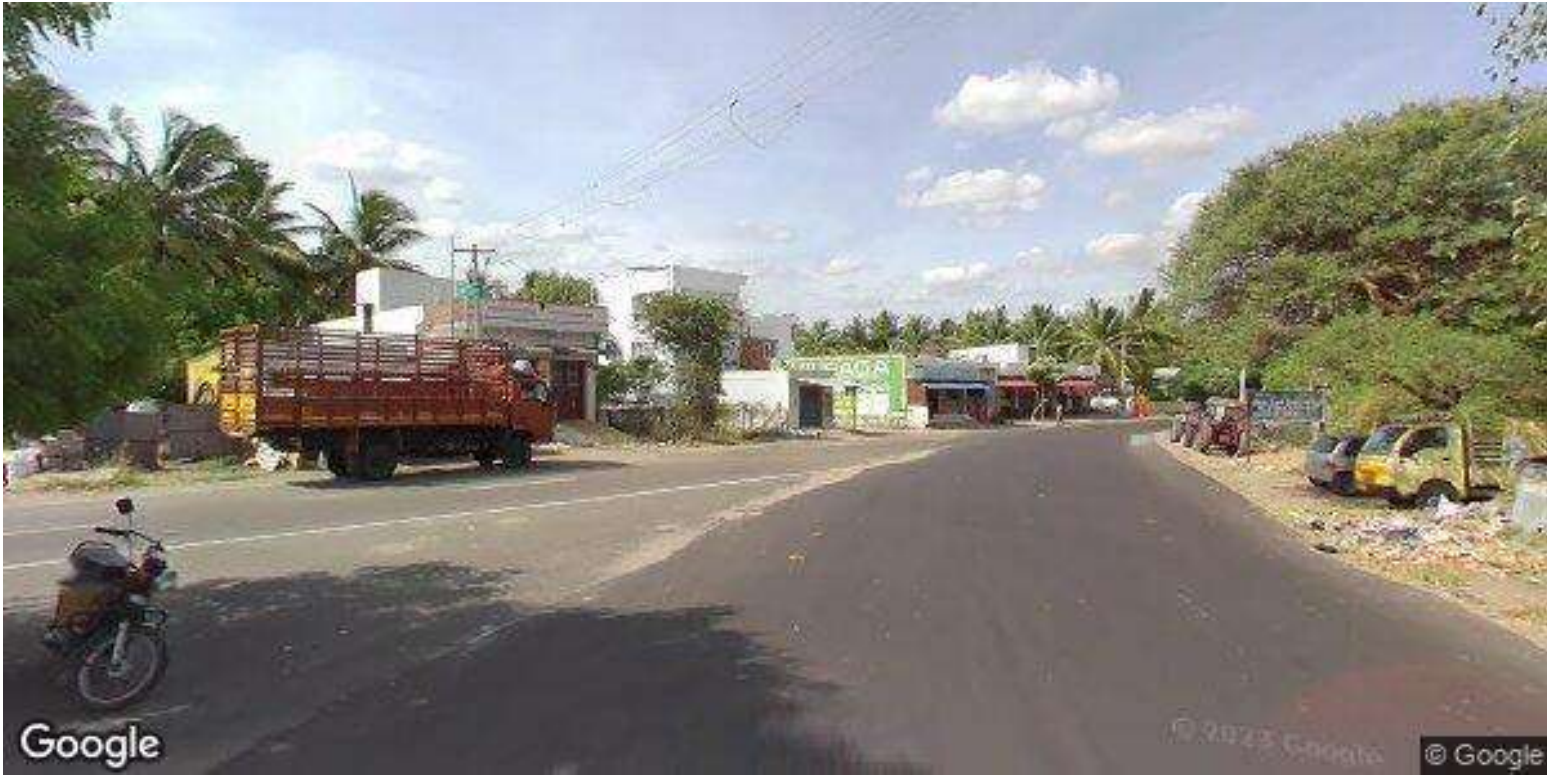
**Risk Type:** Turn  
**Risk Level:** High  
**Speed Limit:** 15 KM/Hr  
**Coordinates:** 10.87207, 77.64474

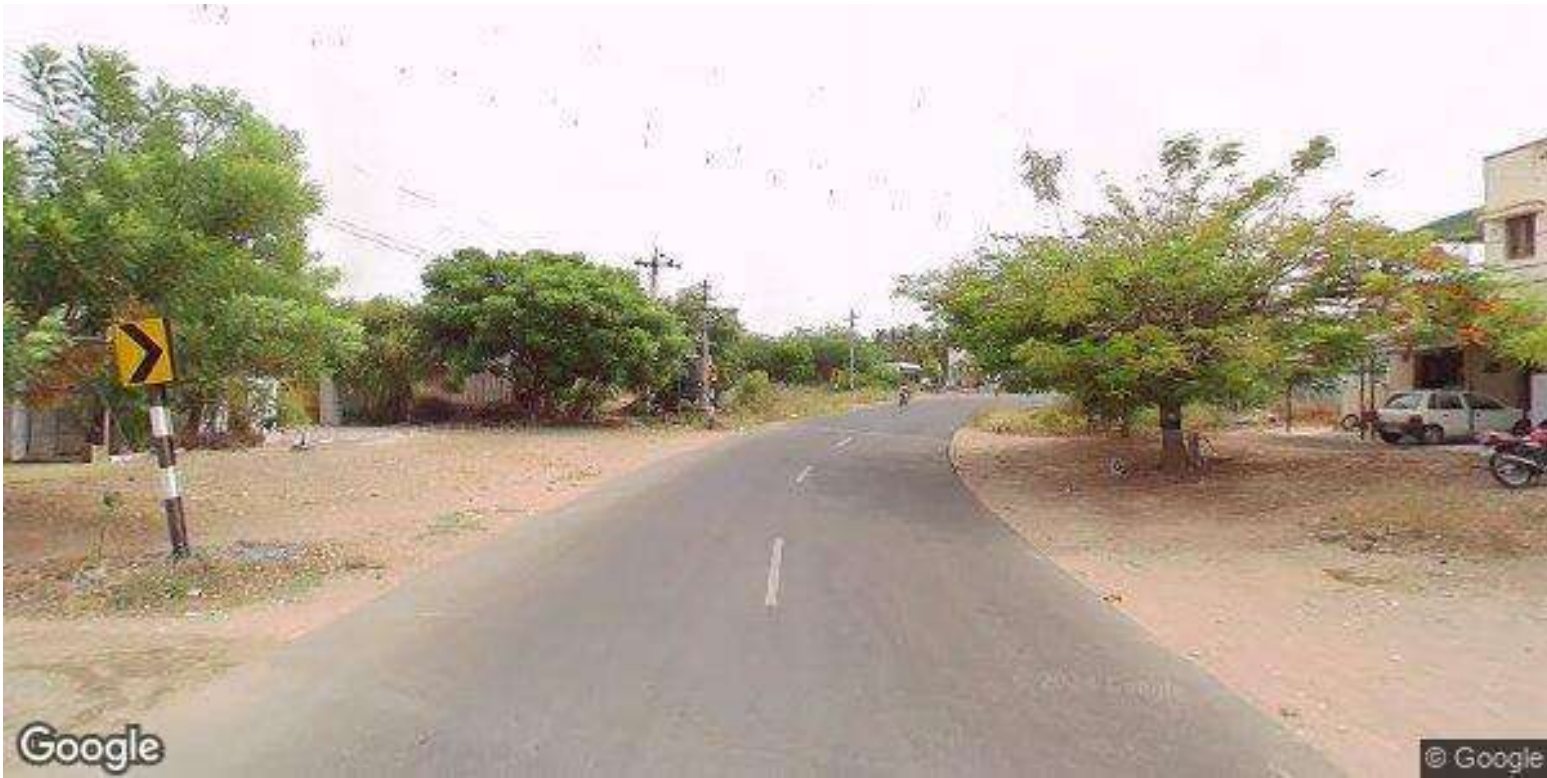
**Risk Type:** Turn  
**Risk Level:** Medium  
**Speed Limit:** 30 KM/Hr  
**Coordinates:** 10.87110, 77.64415

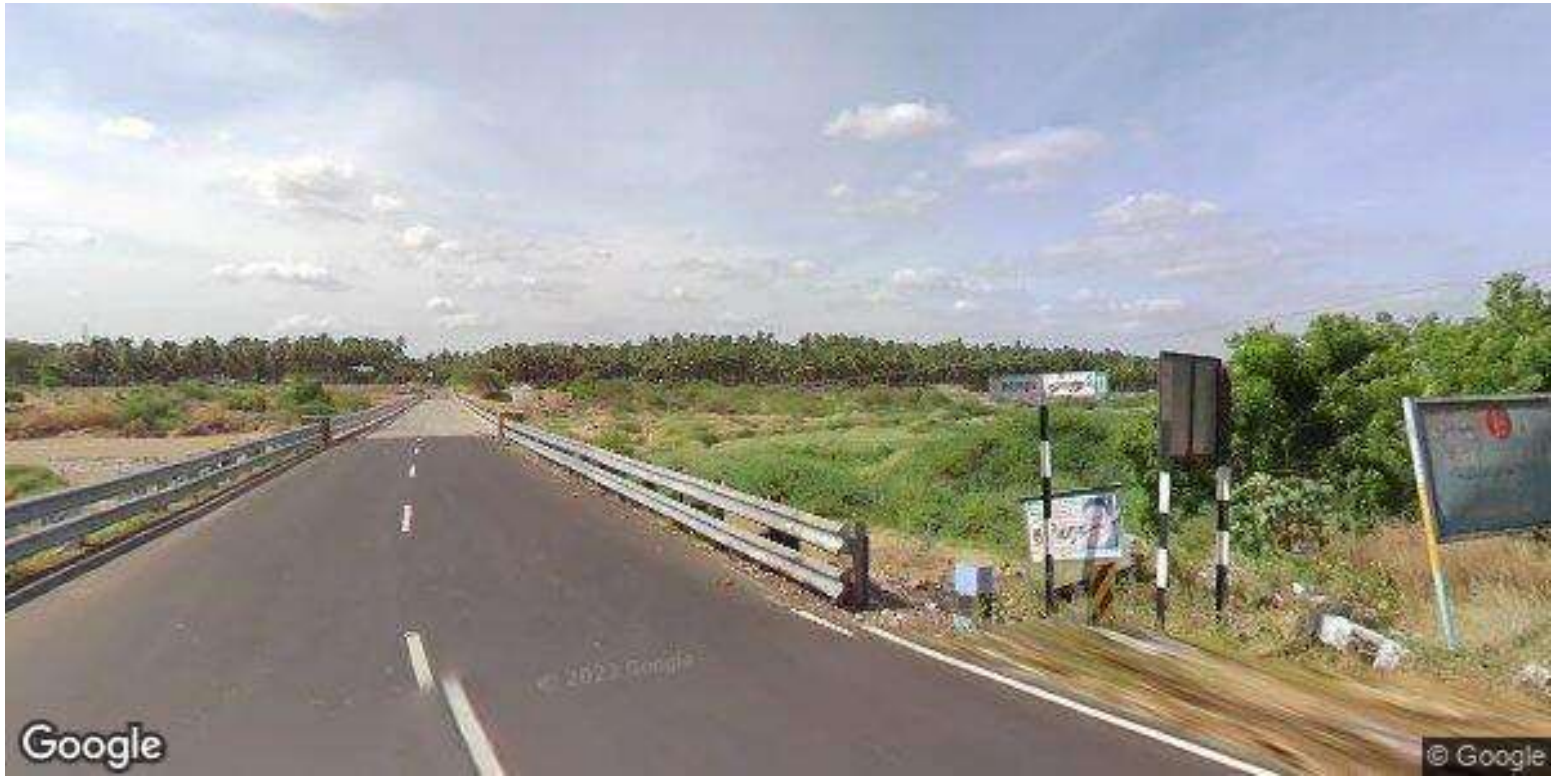
**Risk Type:** Turn  
**Risk Level:** High  
**Speed Limit:** 15 KM/Hr  
**Coordinates:** 10.86447, 77.64345

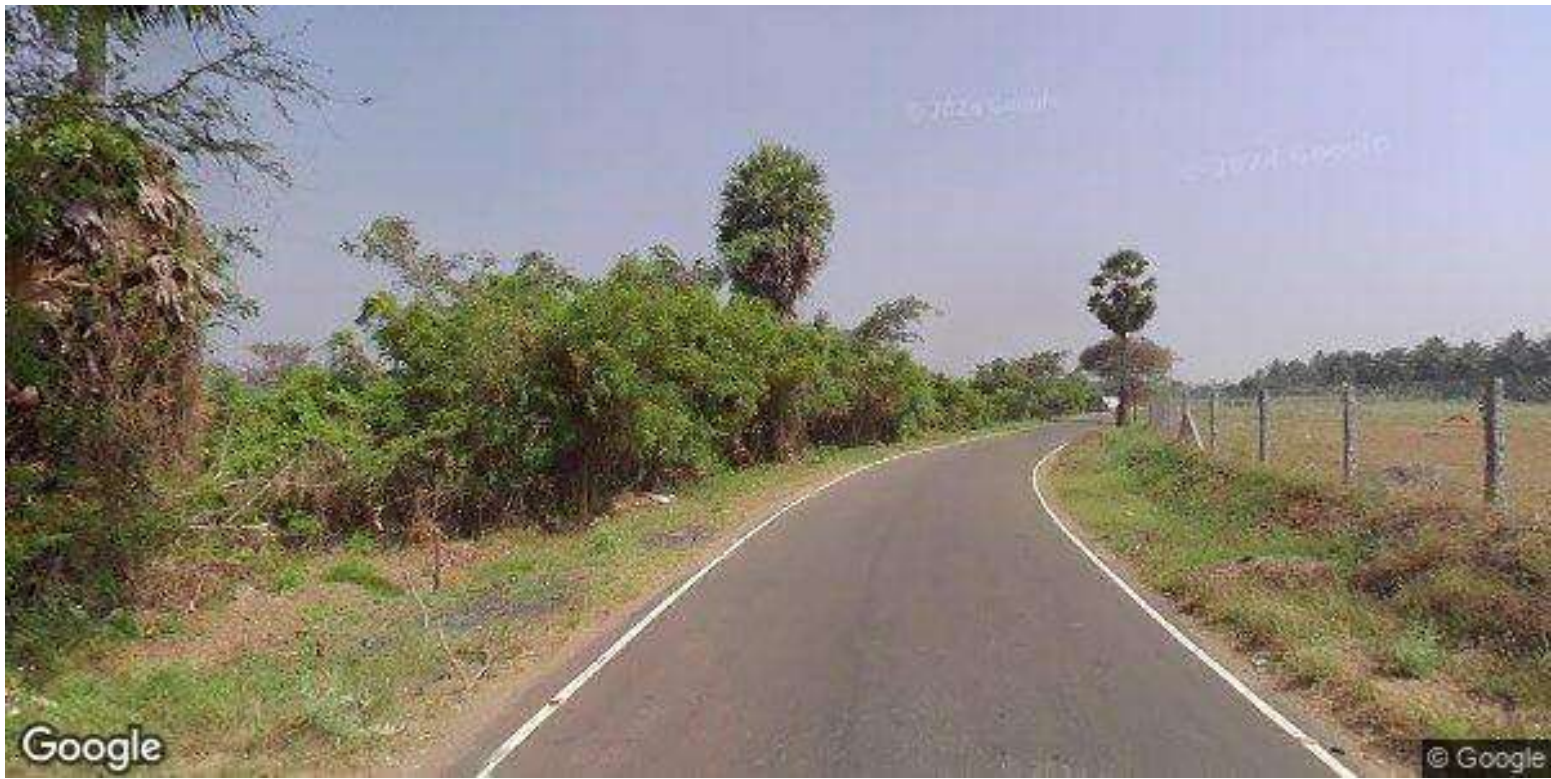
**Risk Type:** Turn  
**Risk Level:** Medium  
**Speed Limit:** 30 KM/Hr  
**Coordinates:** 10.86191, 77.63340

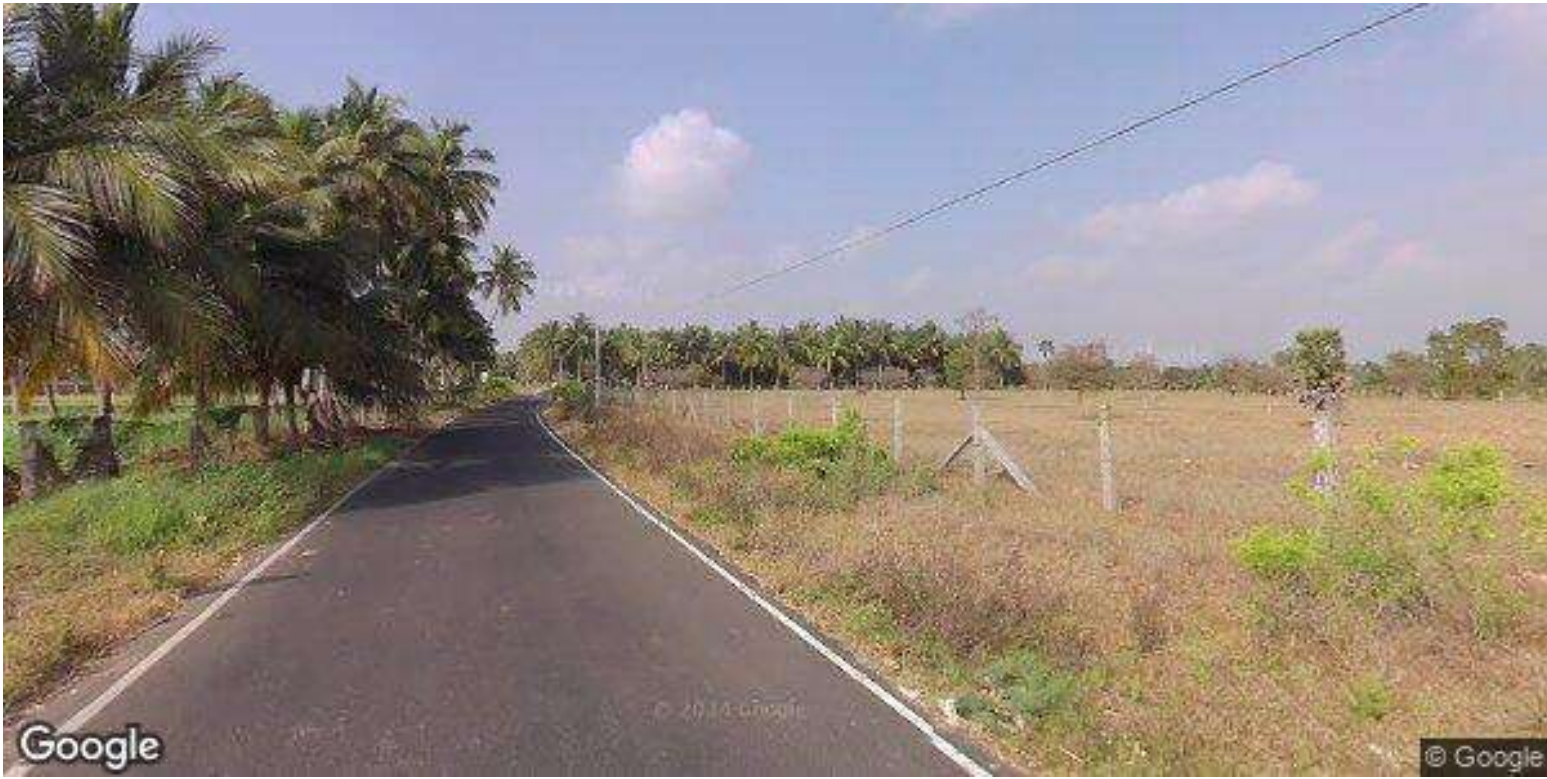
**Risk Type:** Turn  
**Risk Level:** High  
**Speed Limit:** 15 KM/Hr  
**Coordinates:** 10.85748, 77.63339

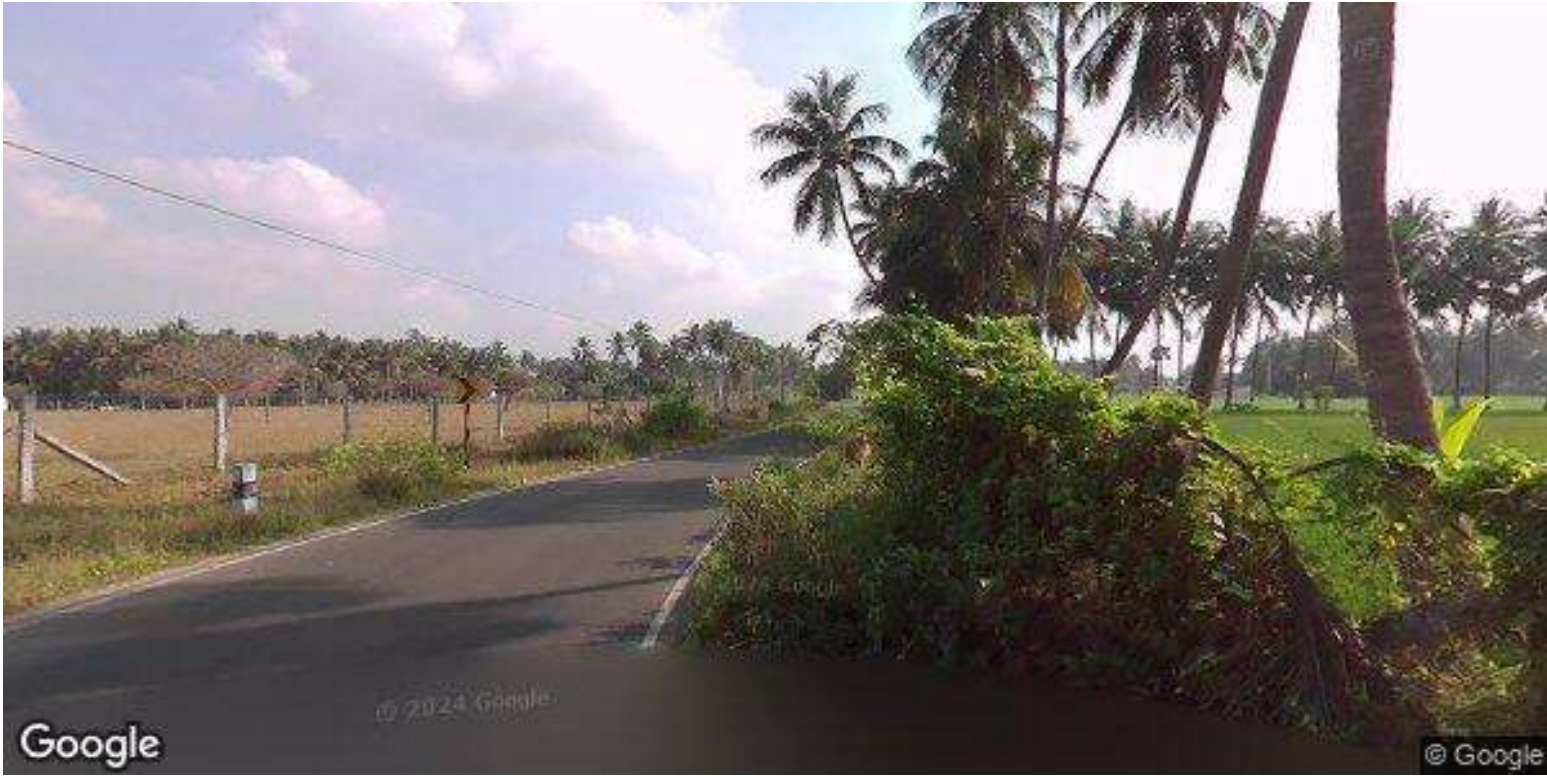
**Risk Type:** Turn  
**Risk Level:** High  
**Speed Limit:** 15 KM/Hr  
**Coordinates:** 10.85691, 77.63242
