# IndianOil

## JOURNEY RISK MANAGEMENT (JRM) STUDY

### Salem Terminal TO KANAGAMANI AGENCIES

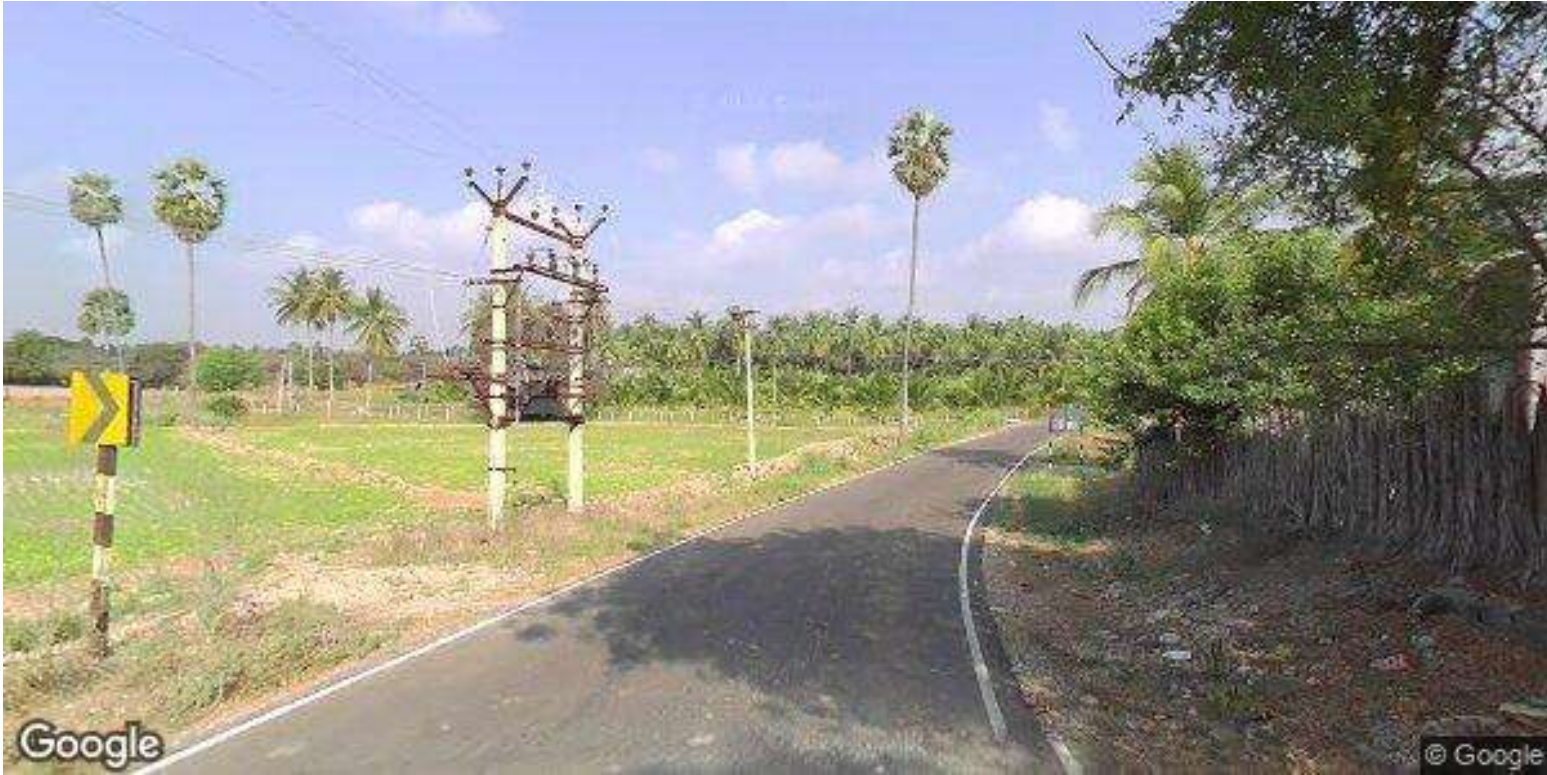
**Risk Type:** Turn  
**Risk Level:** Medium  
**Speed Limit:** 30 KM/Hr  
**Coordinates:** 10.85306, 77.63348

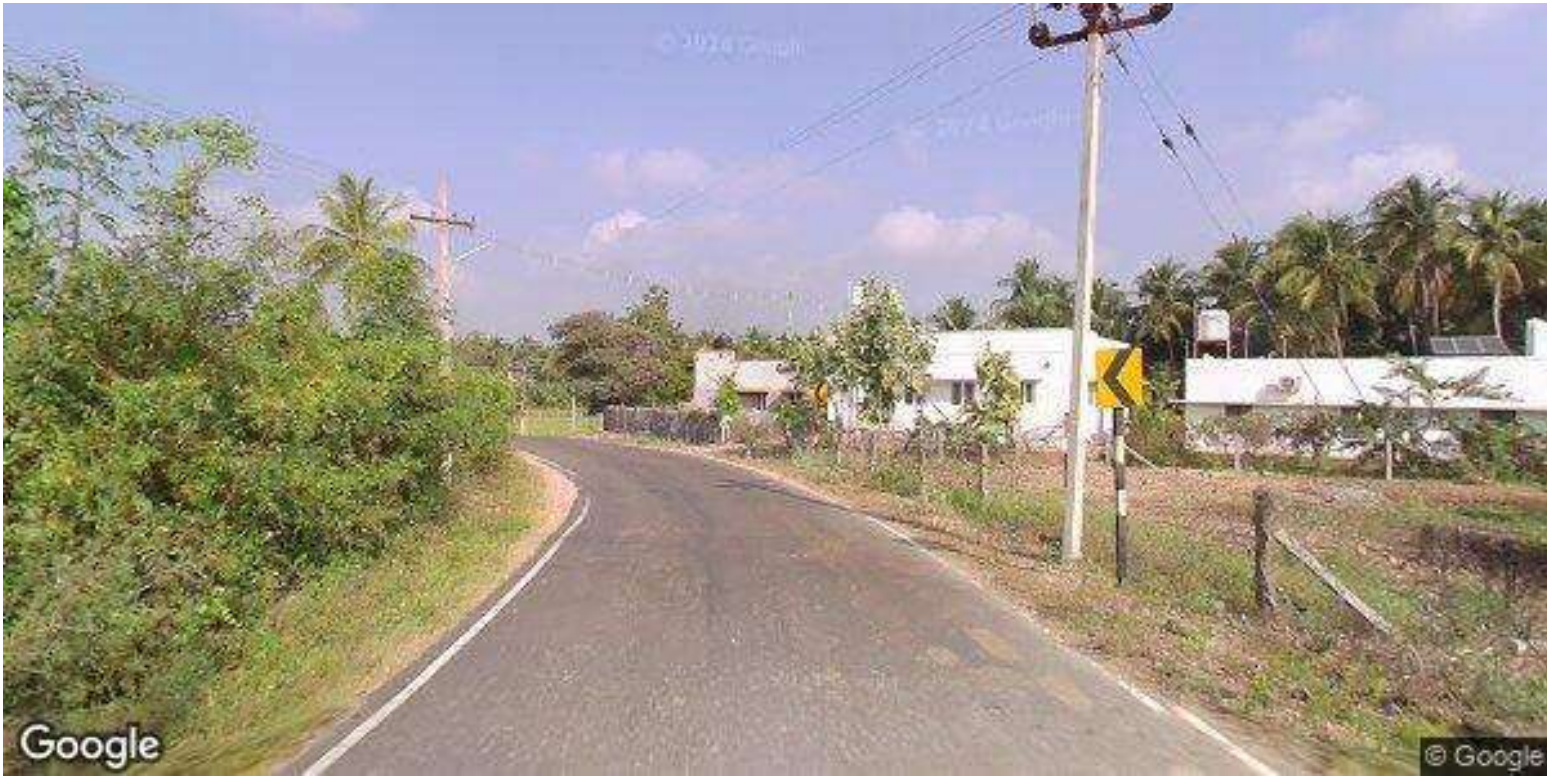
**Risk Type:** Turn  
**Risk Level:** Medium  
**Speed Limit:** 30 KM/Hr  
**Coordinates:** 10.85273, 77.63395

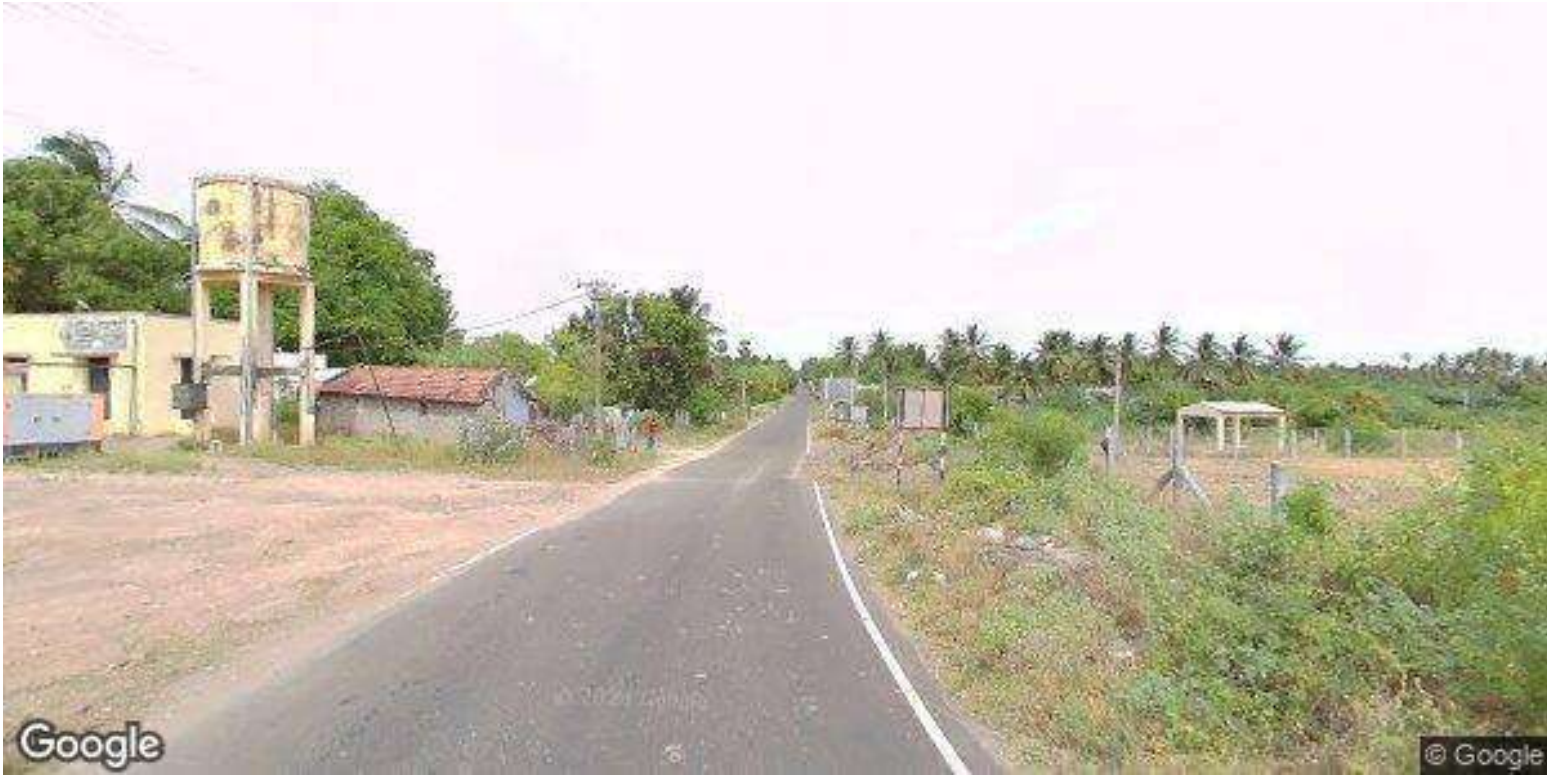
**Risk Type:** Turn  
**Risk Level:** Medium  
**Speed Limit:** 30 KM/Hr  
**Coordinates:** 10.84087, 77.63395

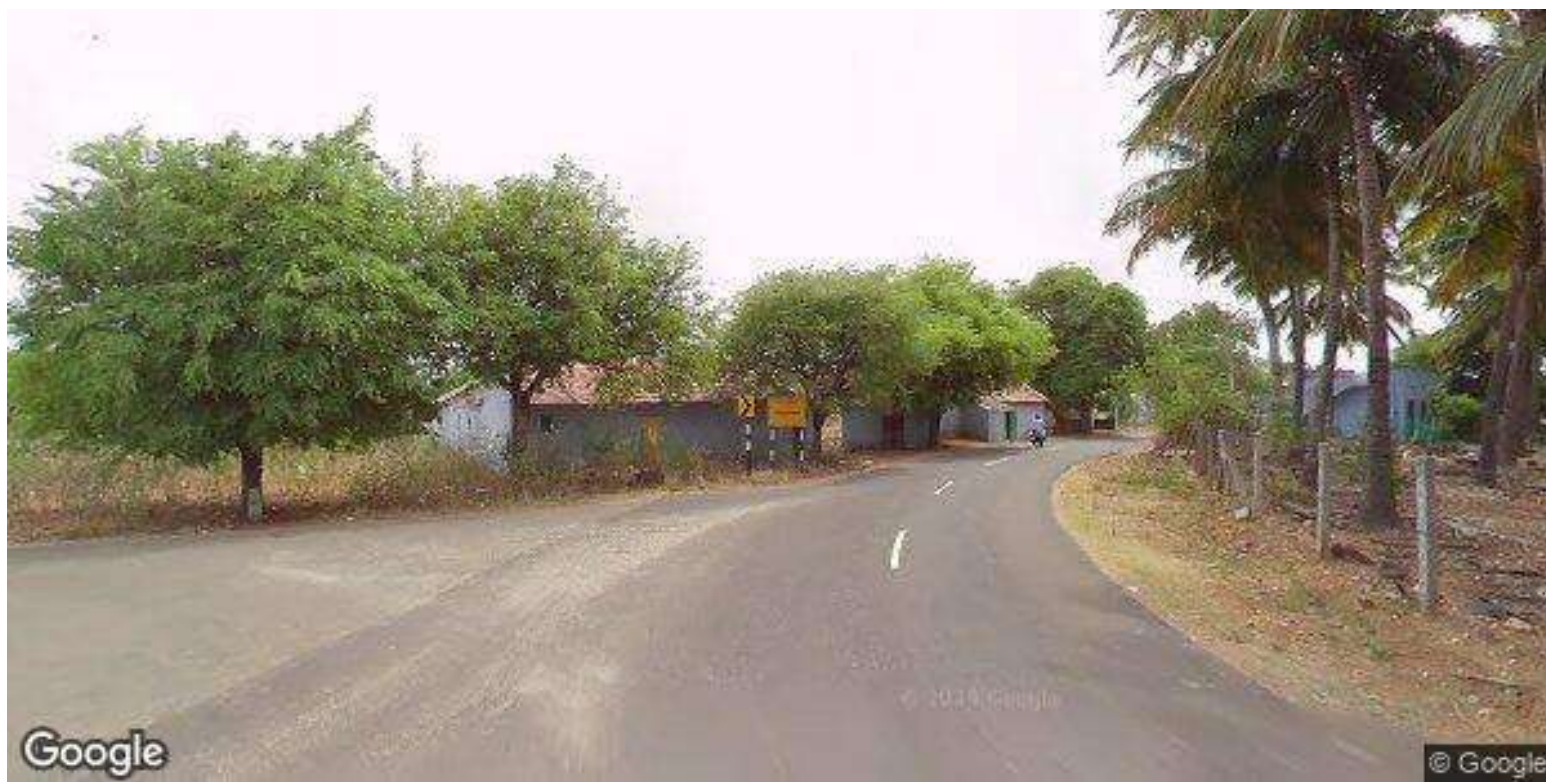
**Risk Type: Turn**

**Risk Level: High**

**Speed Limit: 15 KM/Hr**

**Coordinates: 10.83995, 77.62962**

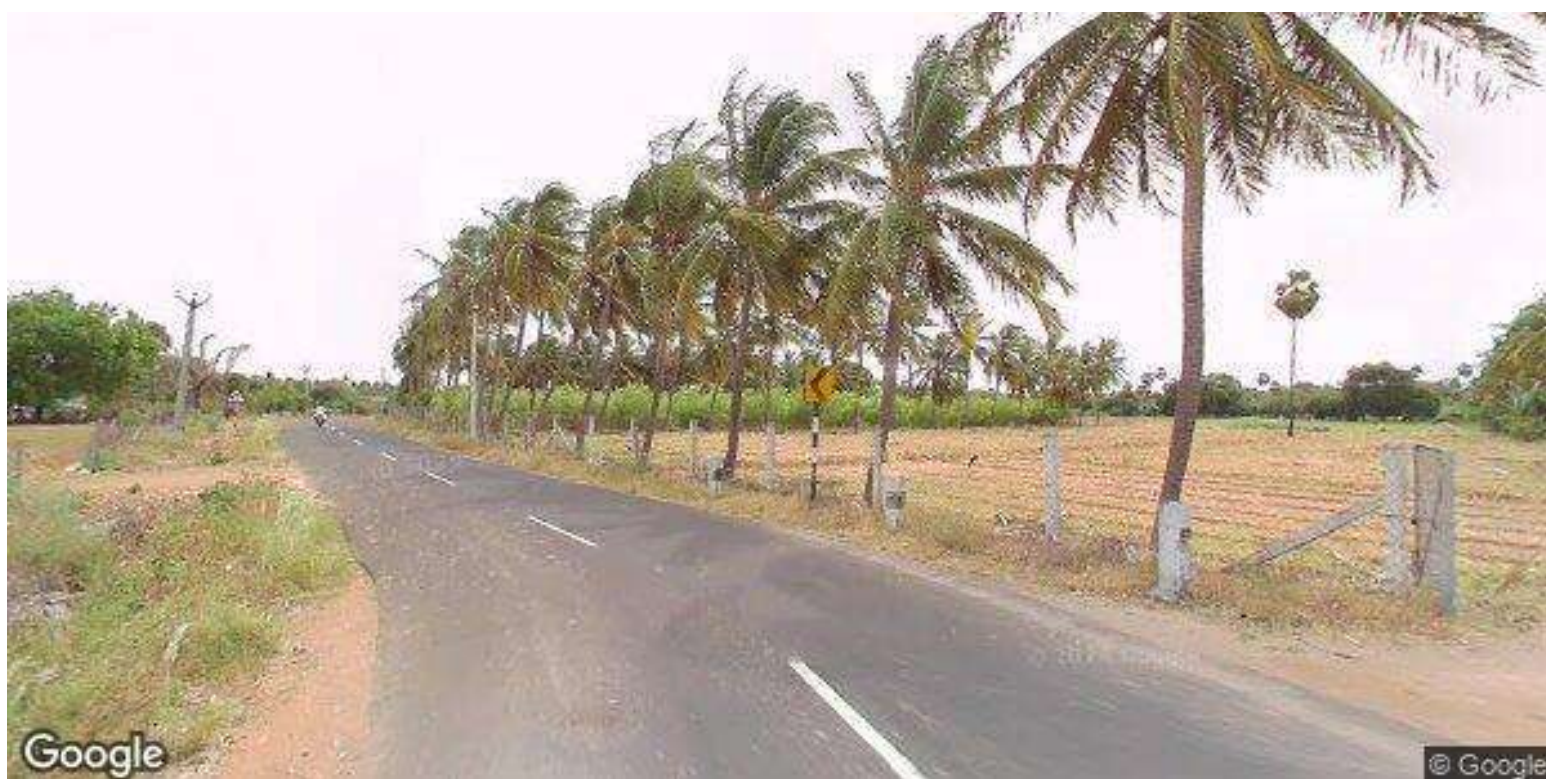
**Risk Type: Turn**

**Risk Level: High**

**Speed Limit: 15 KM/Hr**

**Coordinates: 10.83832, 77.62940**

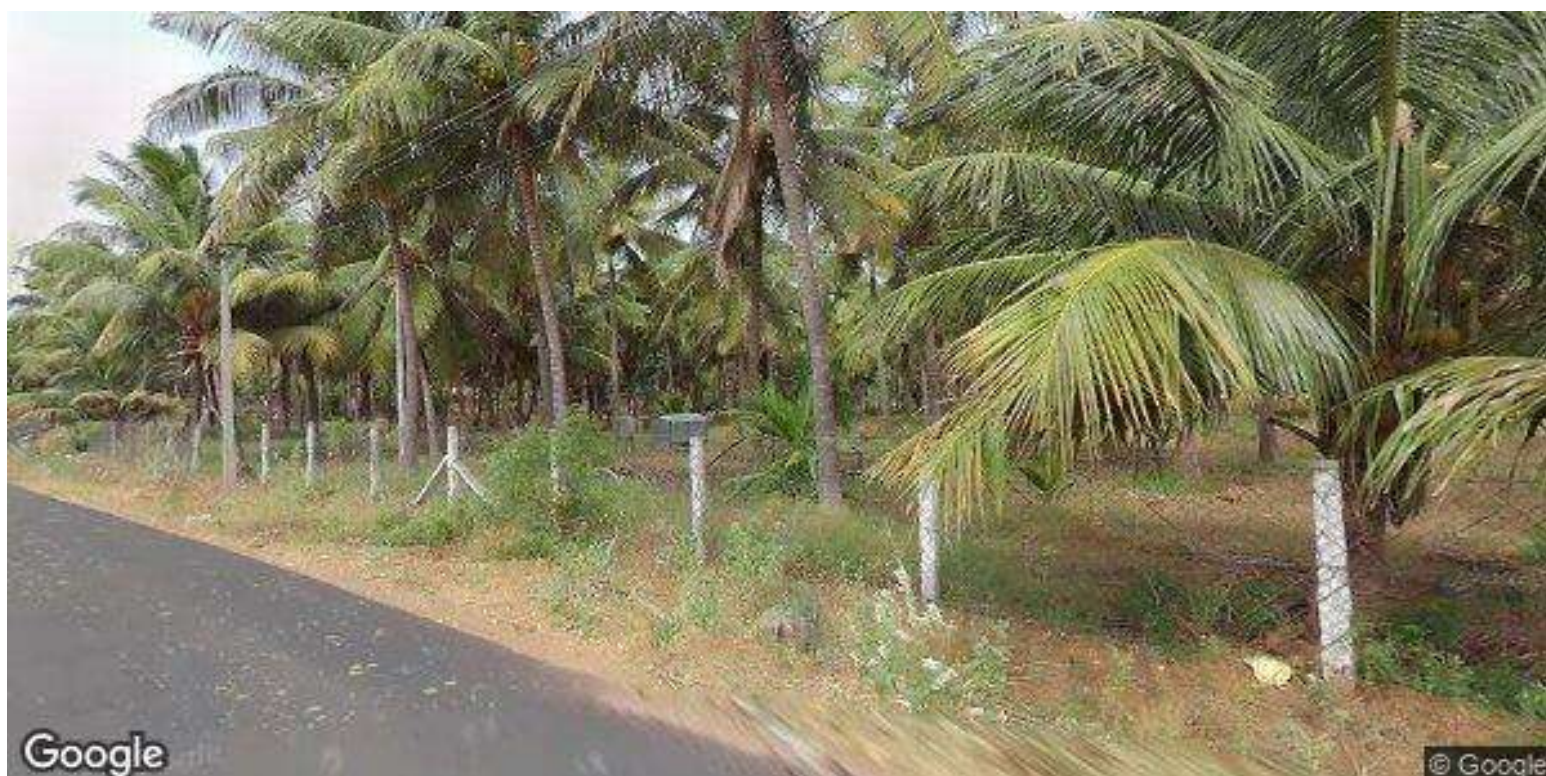
**Risk Type:** Turn  
**Risk Level:** Medium  
**Speed Limit:** 30 KM/Hr  
**Coordinates:** 10.83770, 77.62869

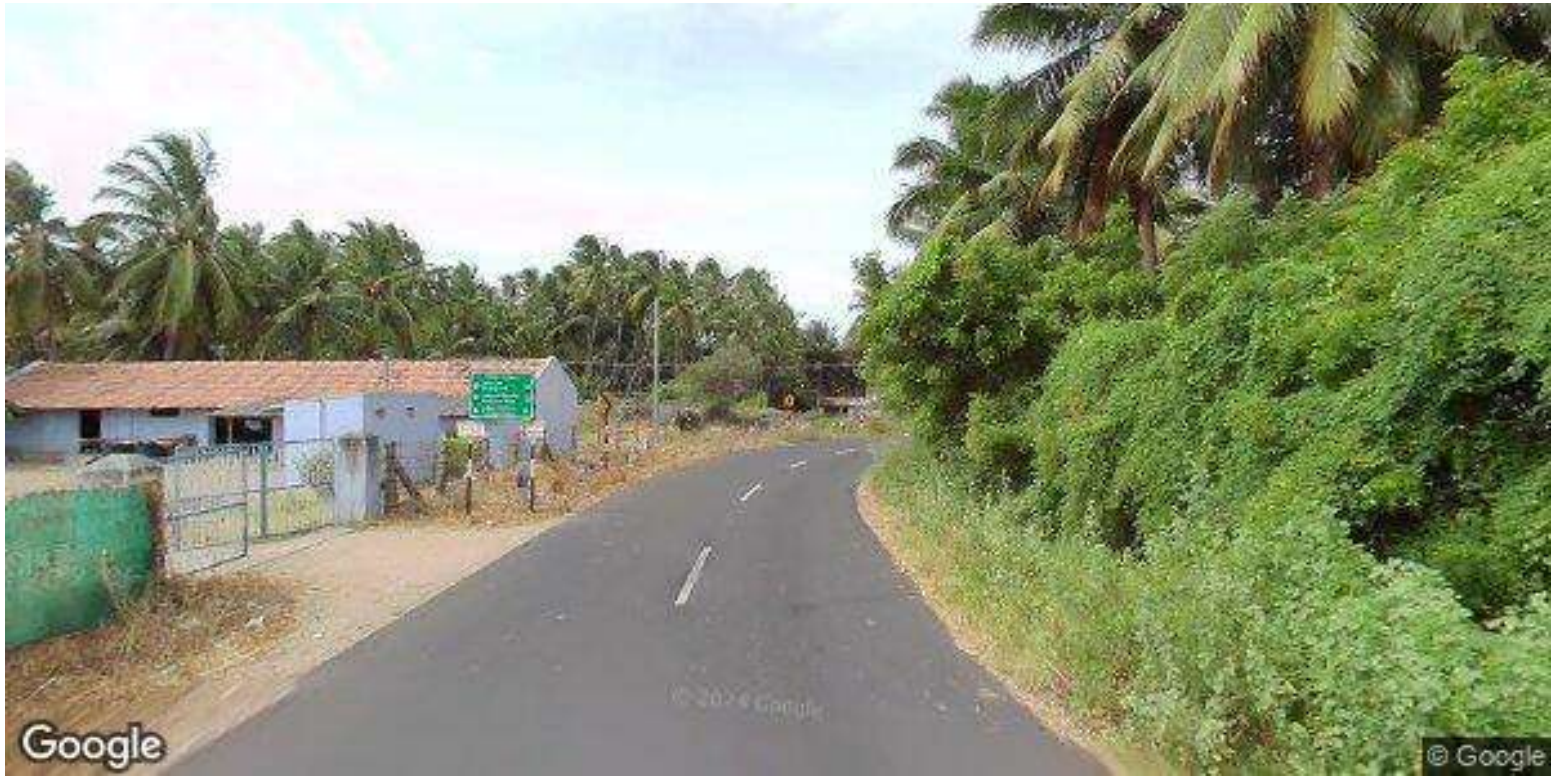
**Risk Type:** Turn  
**Risk Level:** Medium  
**Speed Limit:** 30 KM/Hr  
**Coordinates:** 10.81734, 77.62883

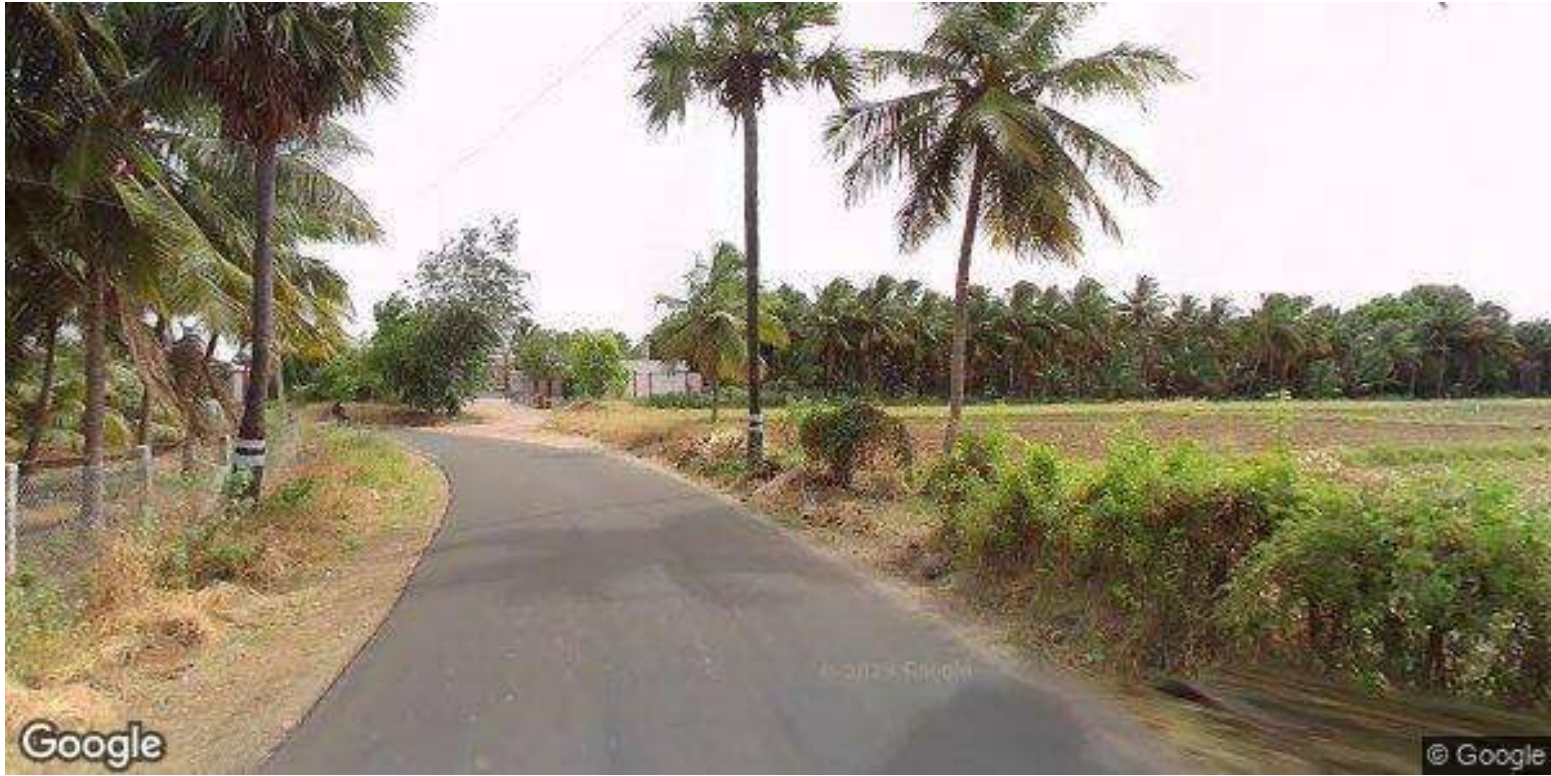
**Risk Type:** Turn  
**Risk Level:** Medium  
**Speed Limit:** 30 KM/Hr  
**Coordinates:** 10.80957, 77.62858

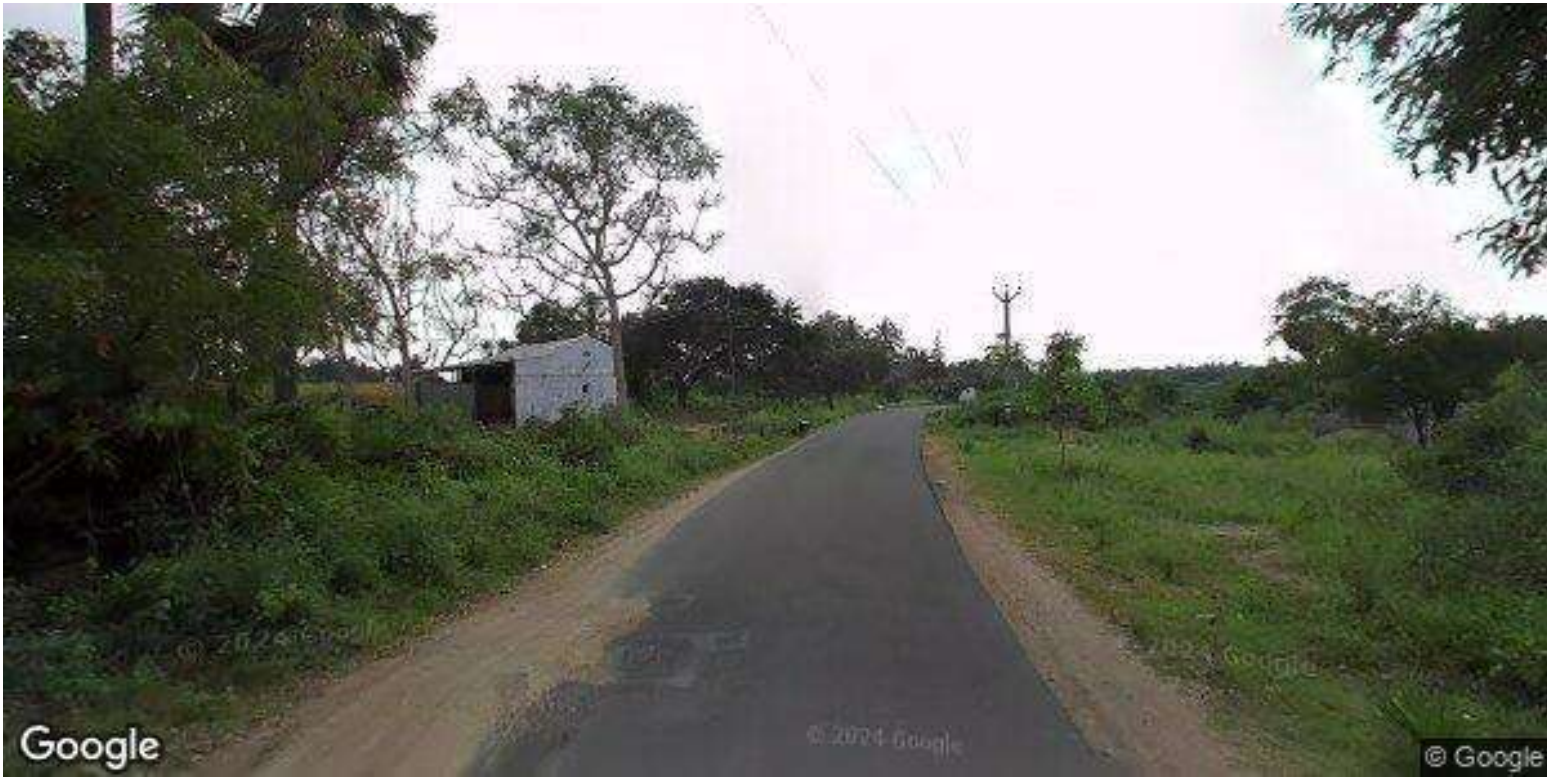
**Risk Type:** Turn  
**Risk Level:** Medium  
**Speed Limit:** 30 KM/Hr  
**Coordinates:** 10.79001, 77.61948

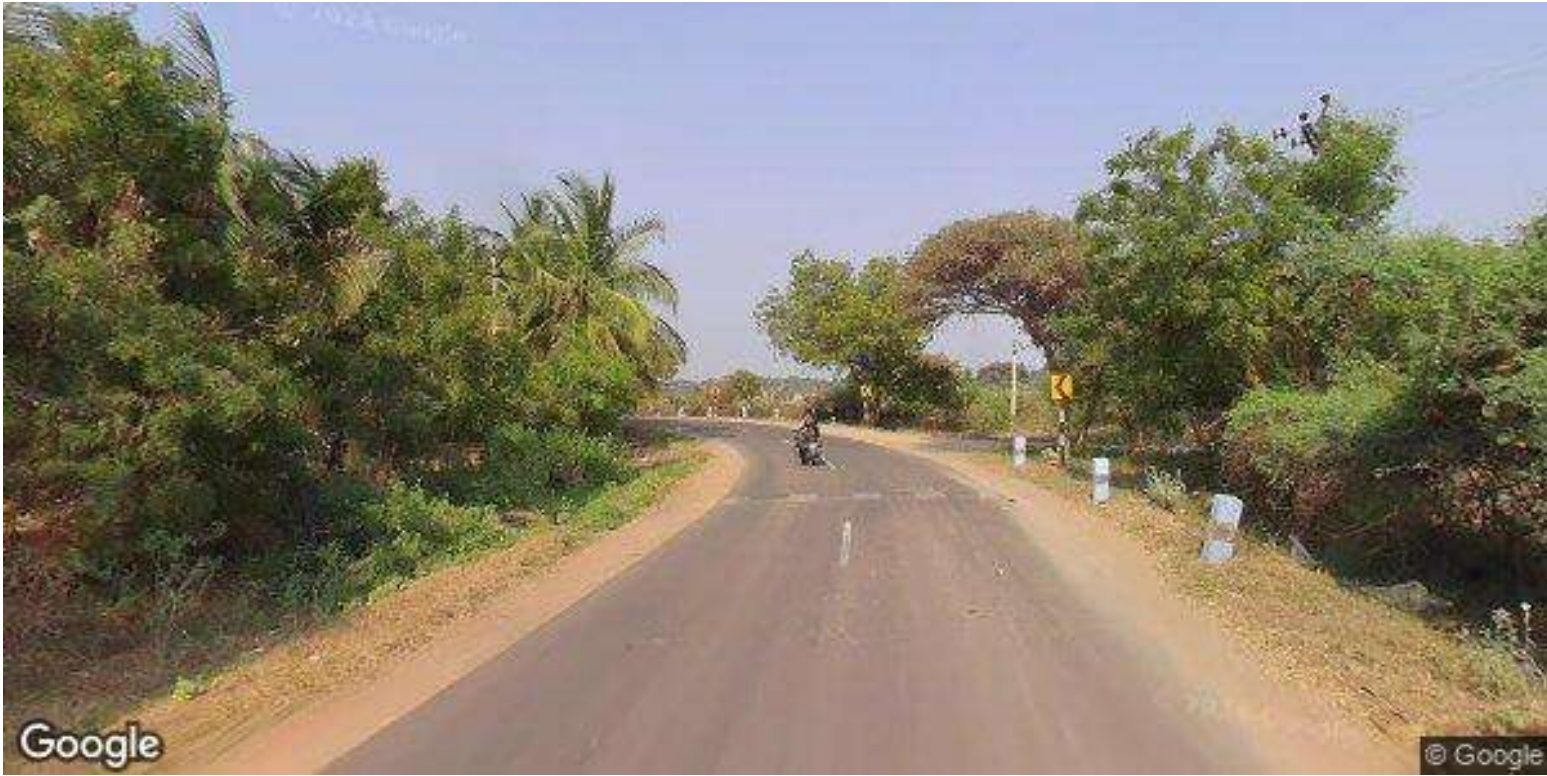
**Risk Type:** Turn  
**Risk Level:** Medium  
**Speed Limit:** 30 KM/Hr  
**Coordinates:** 10.78284, 77.61251

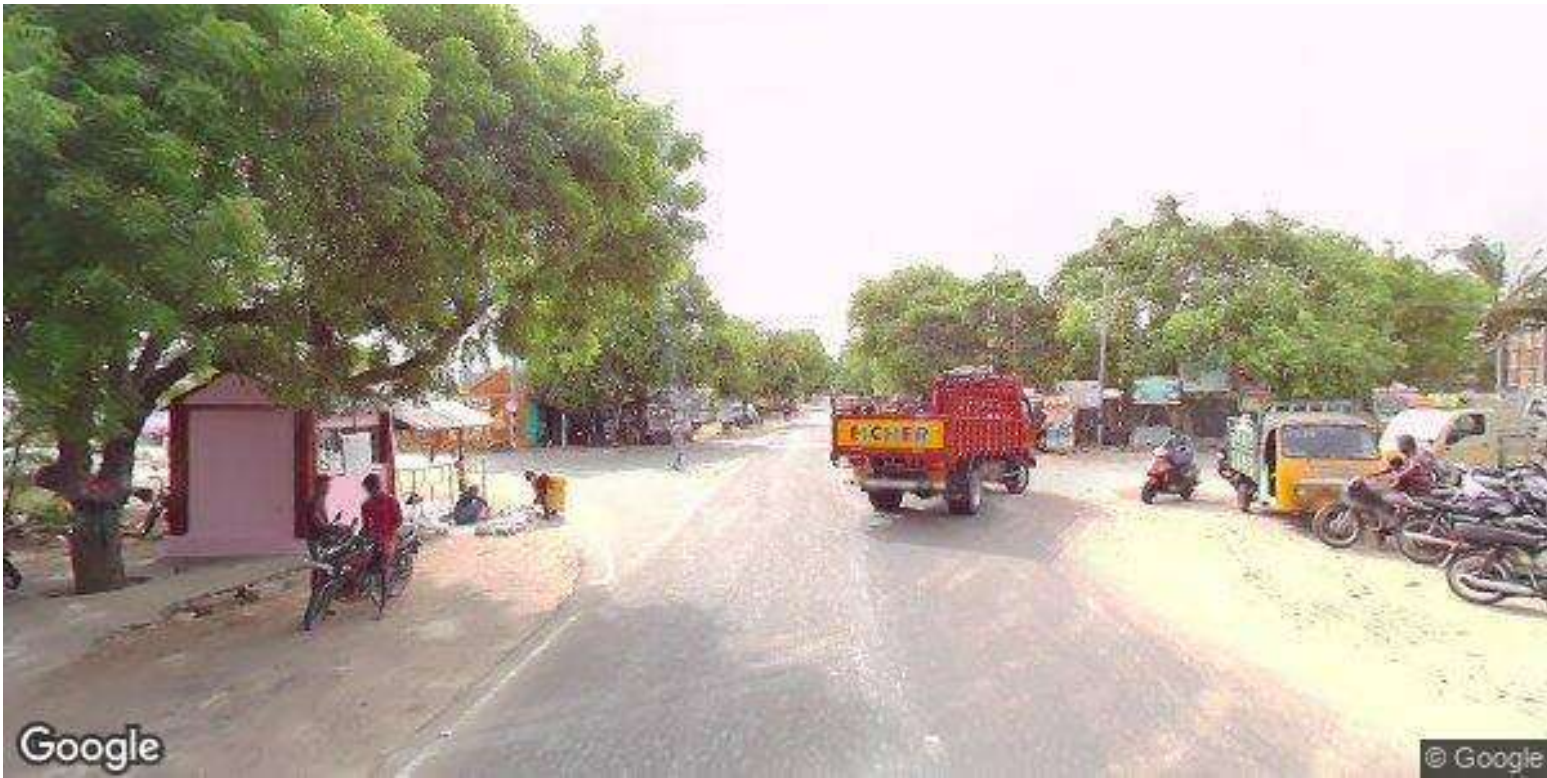
**Risk Type:** Turn  
**Risk Level:** High  
**Speed Limit:** 15 KM/Hr  
**Coordinates:** 10.76663, 77.60179

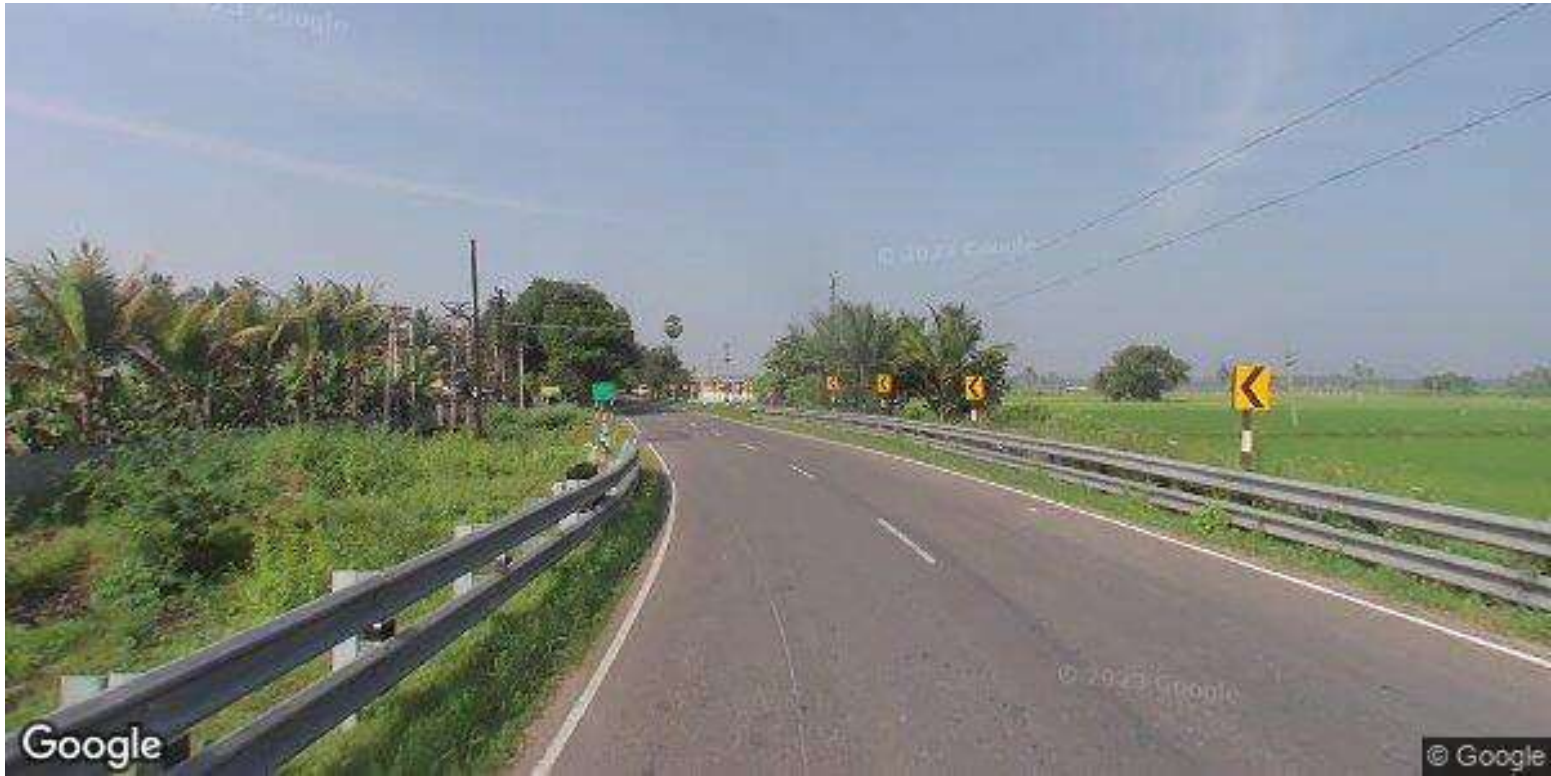
**Risk Type:** Turn  
**Risk Level:** Medium  
**Speed Limit:** 30 KM/Hr  
**Coordinates:** 10.76745, 77.59641

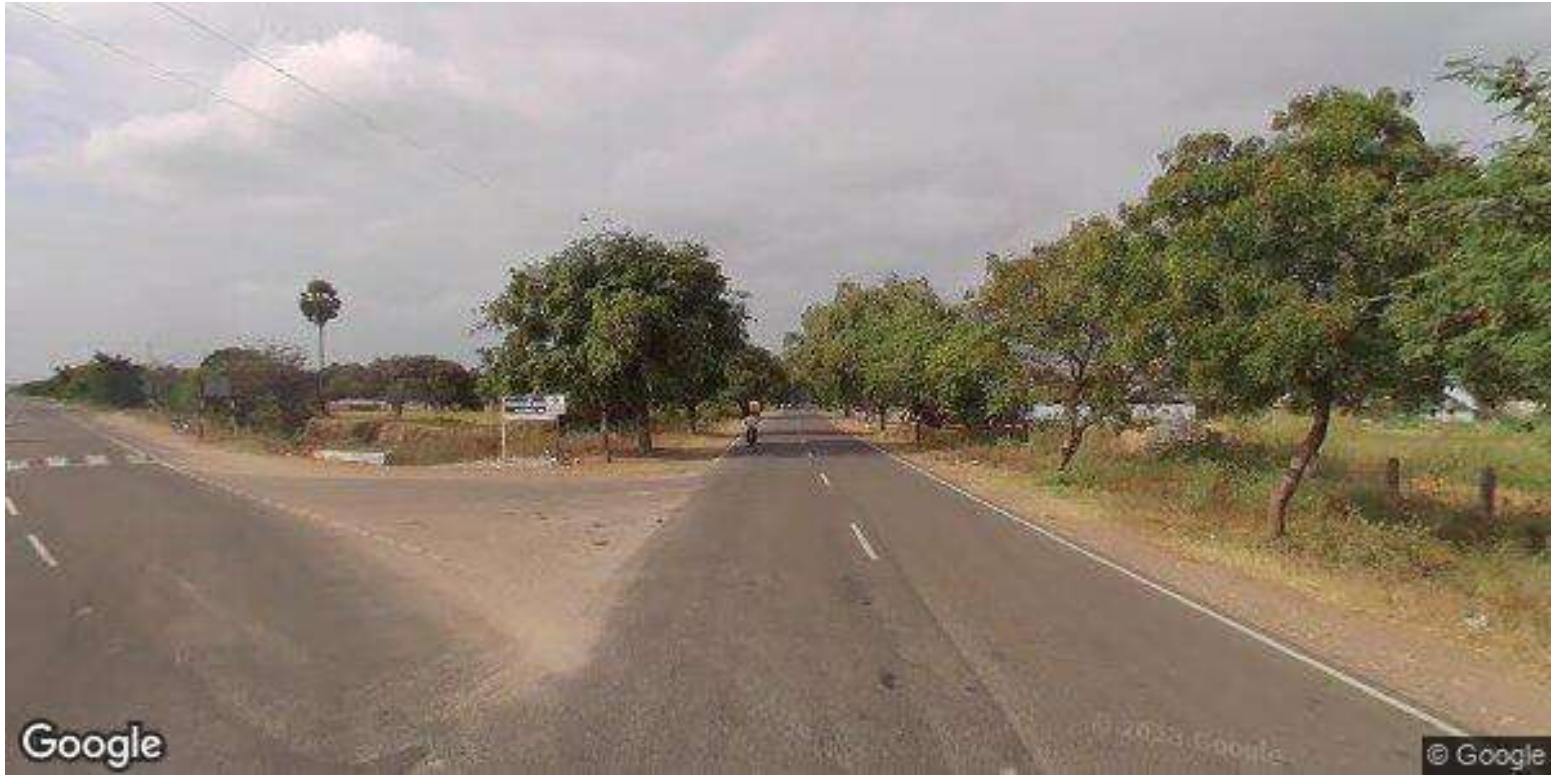
**Risk Type:** Turn  
**Risk Level:** High  
**Speed Limit:** 15 KM/Hr  
**Coordinates:** 10.74735, 77.54864
