# IndianOil

## JOURNEY RISK MANAGEMENT (JRM) STUDY

### Salem Terminal to NAMAKKAL TK LORRY OWNERS ASSN

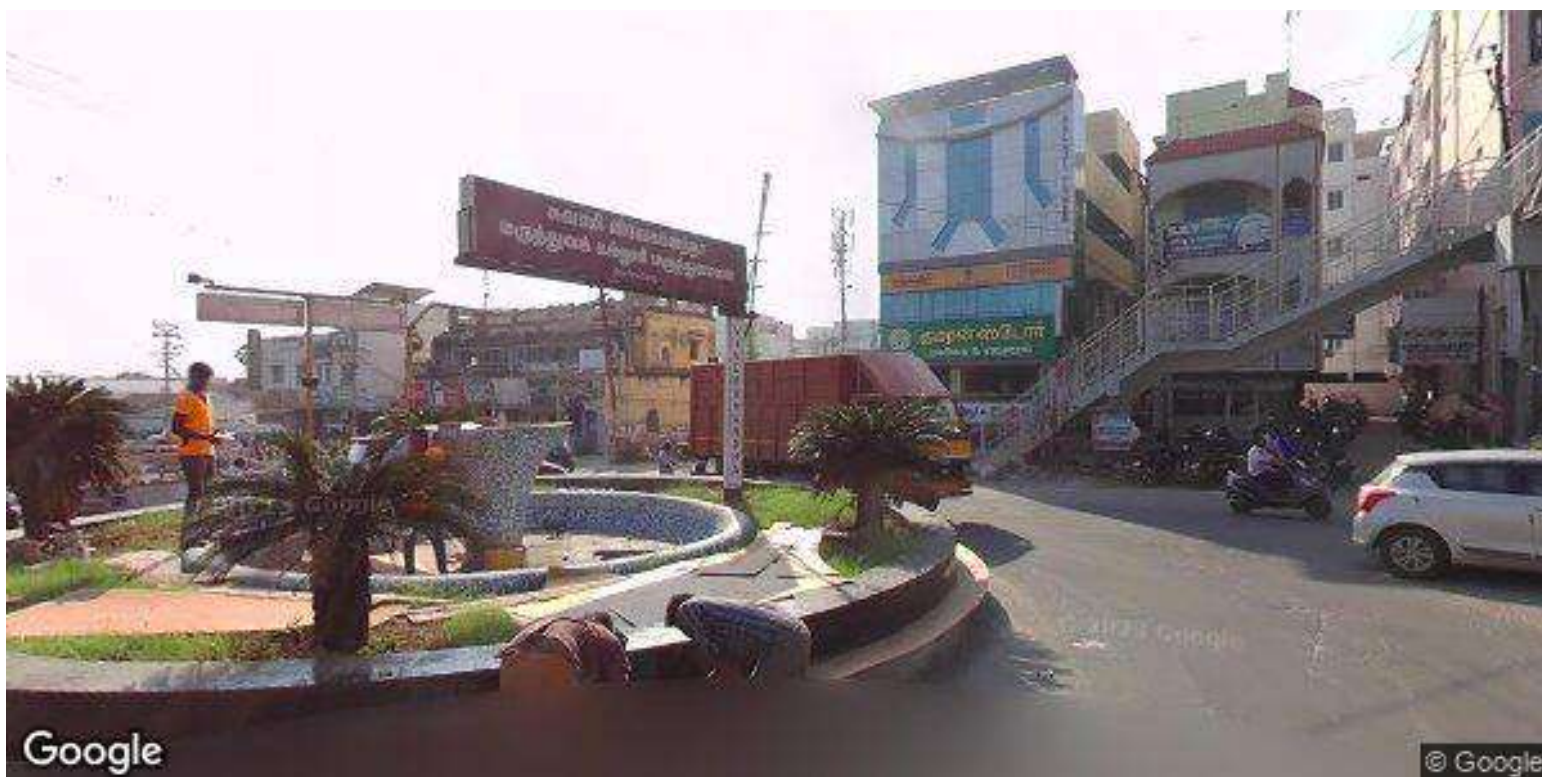
**Coordinates:** 11.38395, 77.89480

**Risk Type:** Roundabout

**Risk Level:** High

**Speed Limit:** 15 KM/Hr

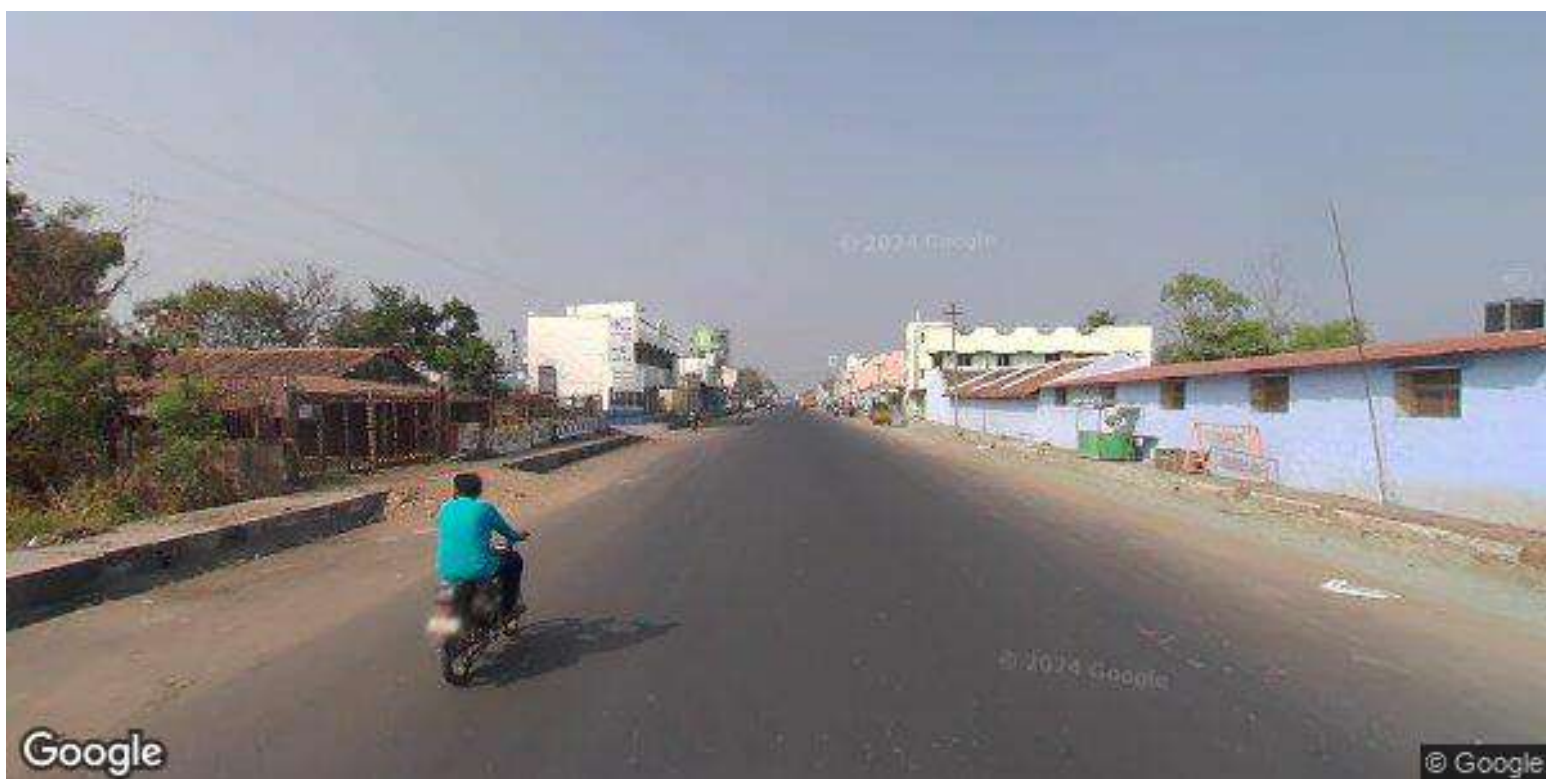
**Coordinates: 11.2164807, 78.1511632**

**Risk Type: U-Turn**

**Risk Level: High**

**Speed Limit: 10 KM/Hr**

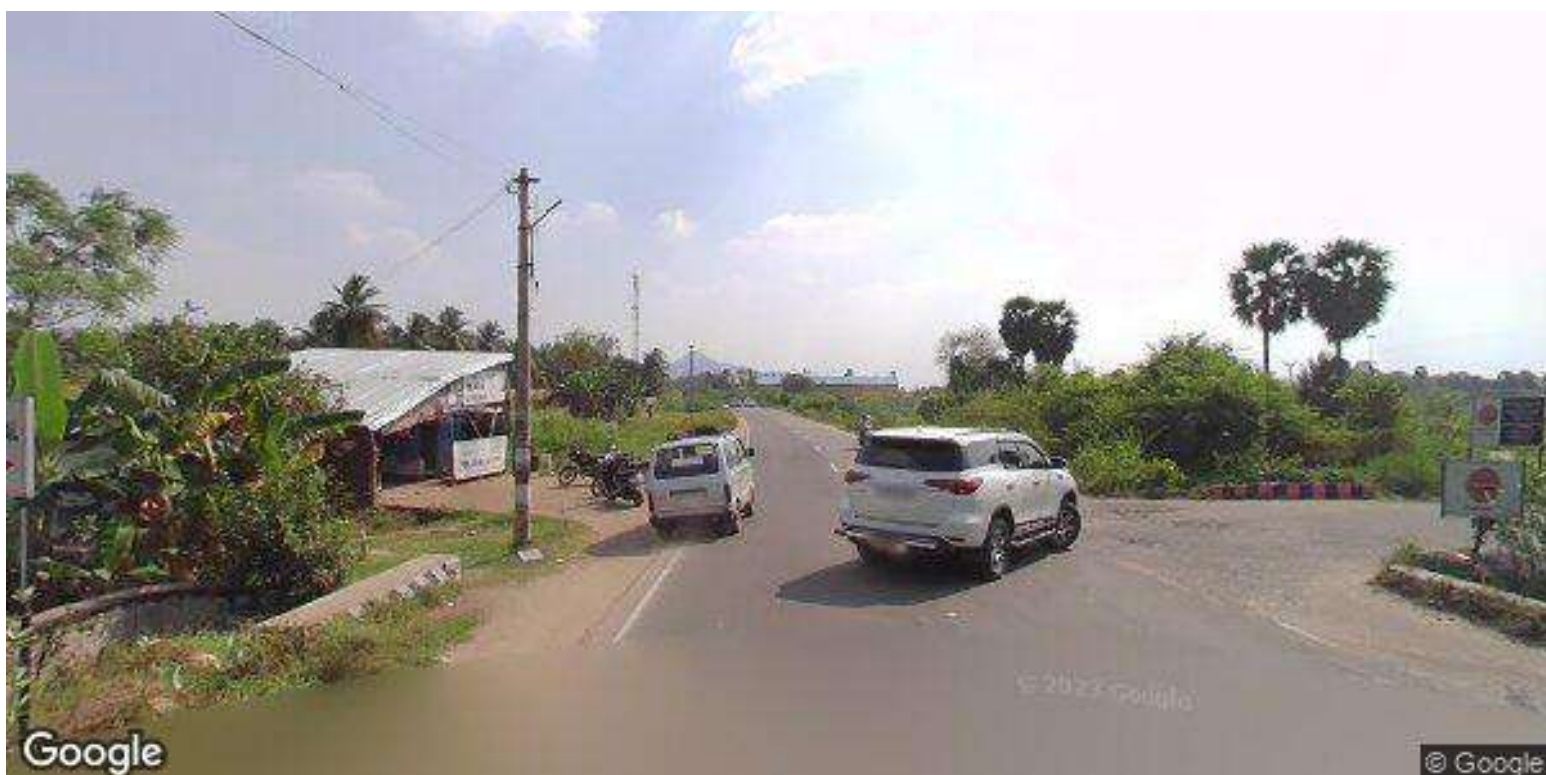
**Risk Type:** Blind Spot  
**Risk Level:** Blind Spot  
**Speed Limit:** 10 KM/Hr  
**Coordinates:** 11.44029, 77.87544

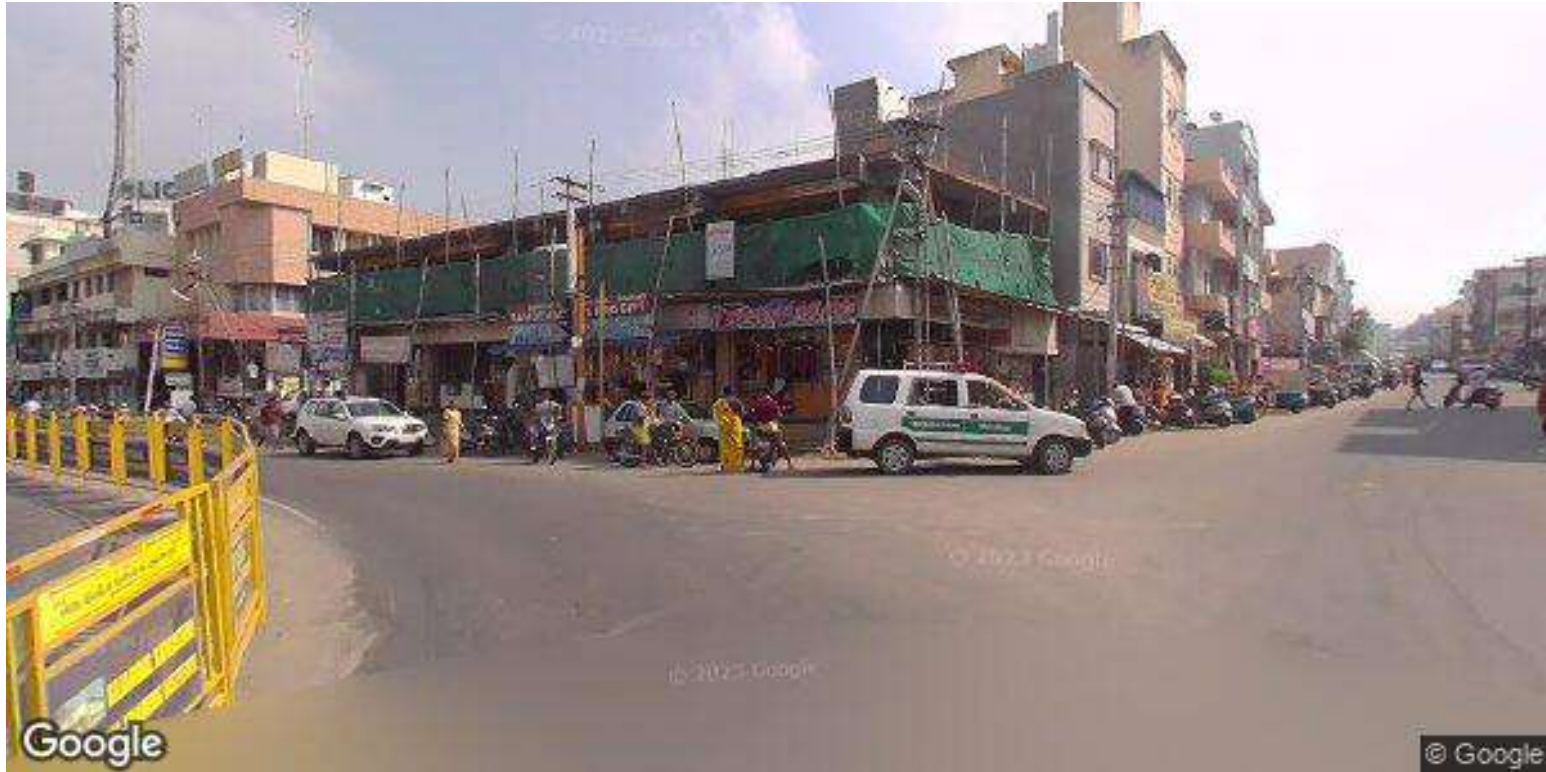
**Risk Type:** Turn  
**Risk Level:** High  
**Speed Limit:** 15 KM/Hr  
**Coordinates:** 11.37868, 77.89498

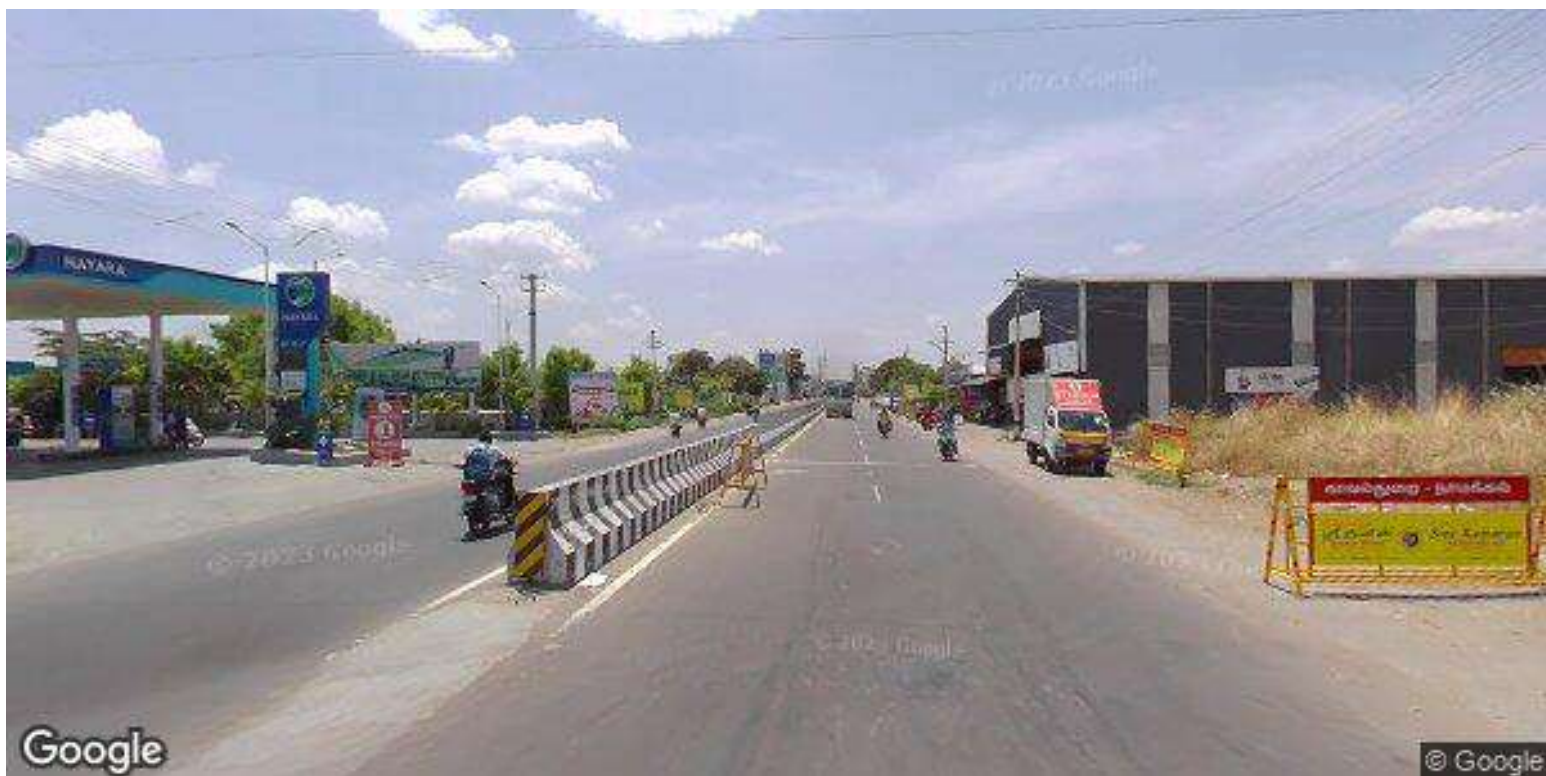
**Risk Type:** Blind Spot  
**Risk Level:** Blind Spot  
**Speed Limit:** 10 KM/Hr  
**Coordinates:** 11.23446, 78.15458

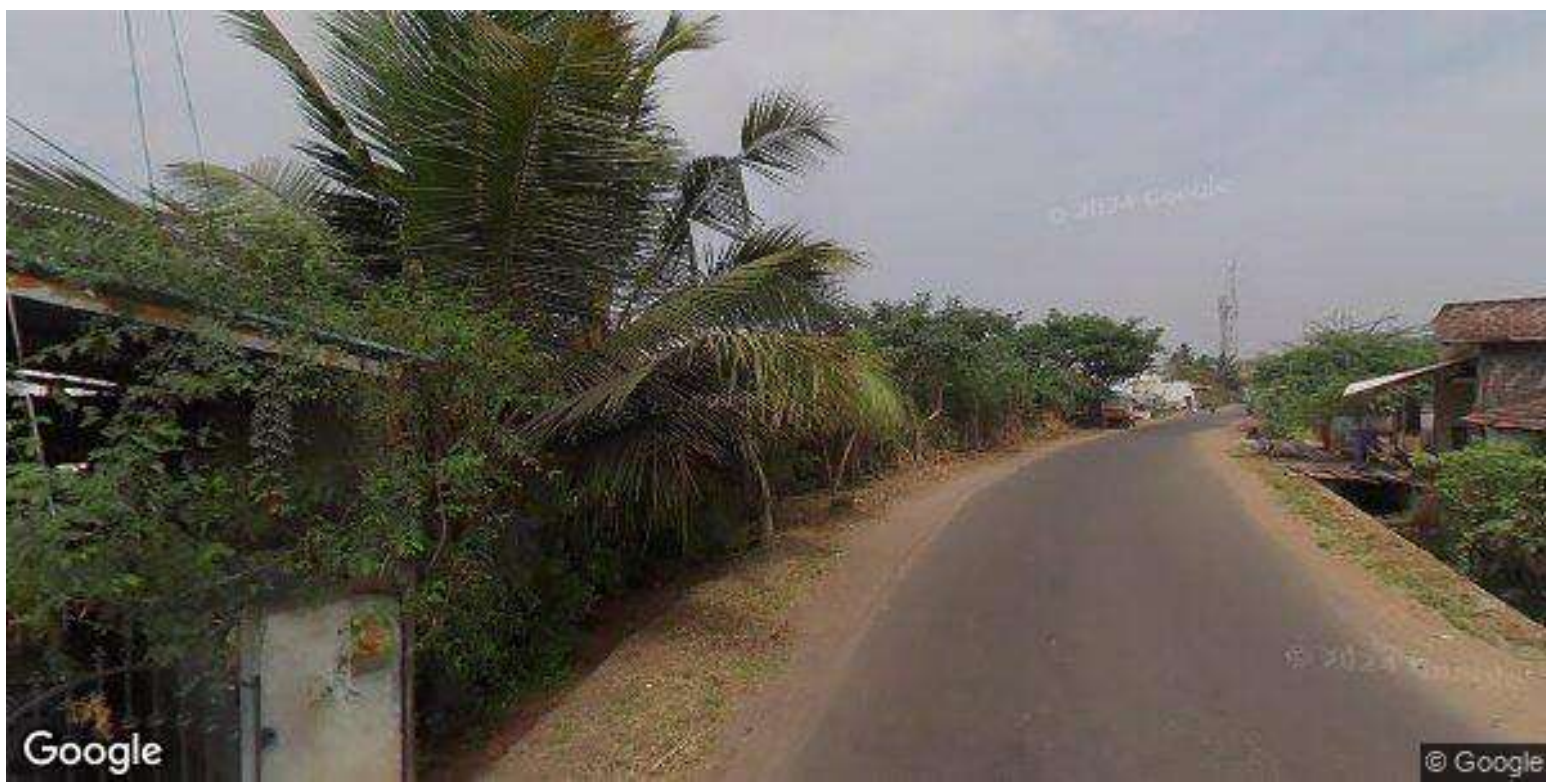
**Coordinates:** 11.22243, 78.15379

**Risk Type:** Turn

**Risk Level:** Medium

**Speed Limit:** 30 KM/Hr

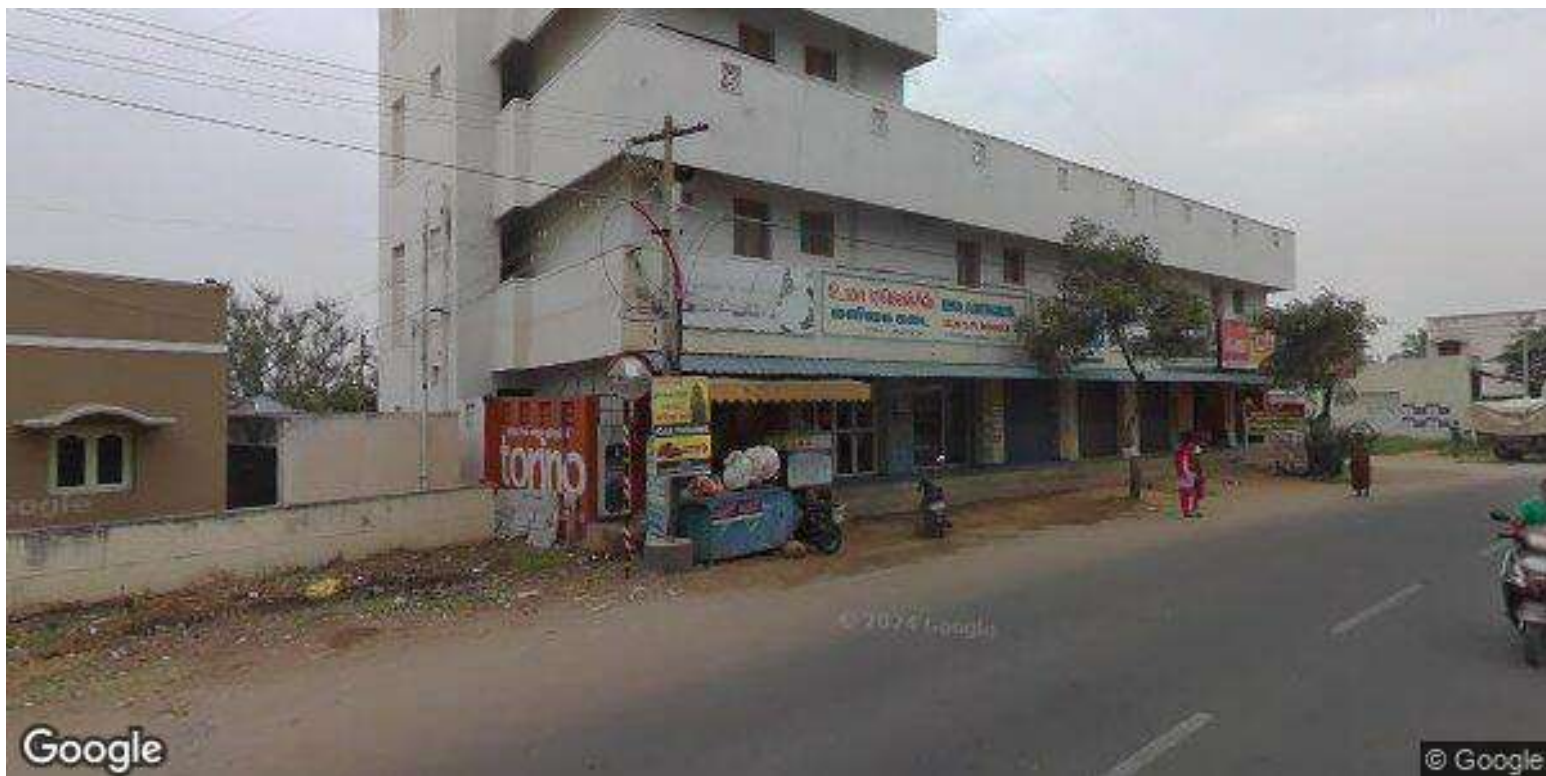
**Coordinates:** 11.22081, 78.15944

**Risk Type:** Turn

**Risk Level:** High

**Speed Limit:** 15 KM/Hr

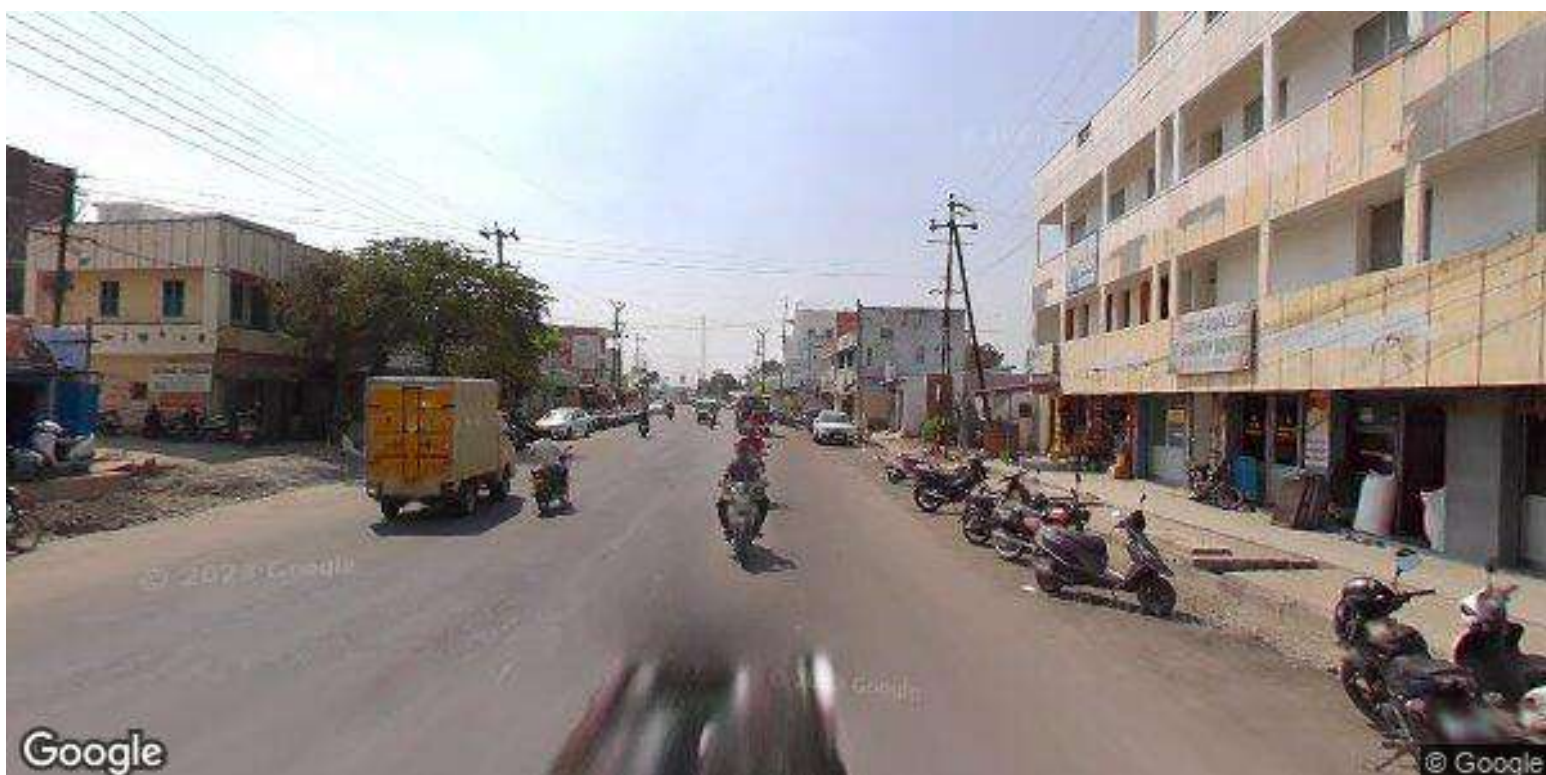
**Risk Type:** Blind Spot  
**Risk Level:** Blind Spot  
**Speed Limit:** 10 KM/Hr  
**Coordinates:** 11.21910, 78.15911

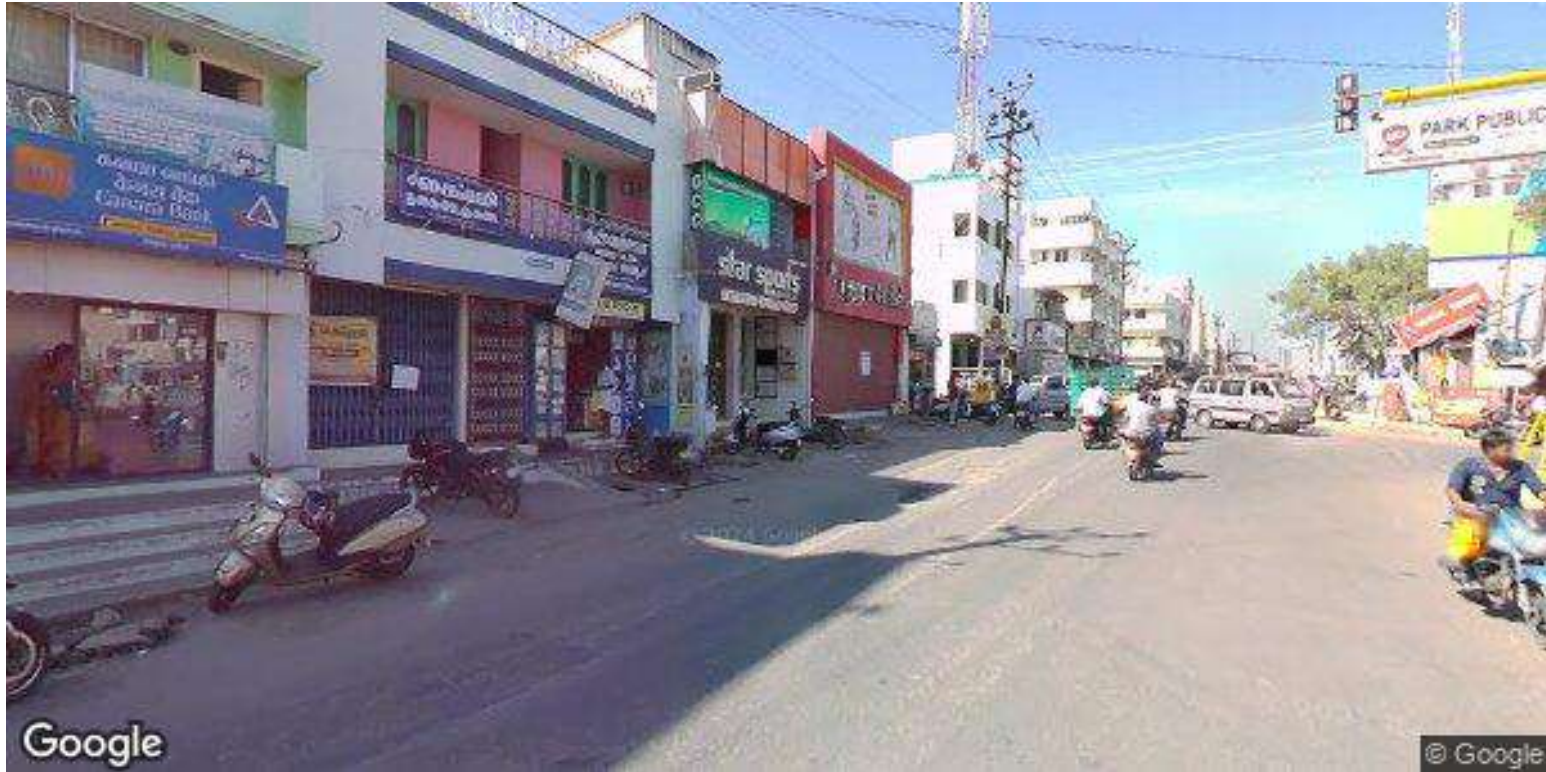
**Risk Type:** Turn  
**Risk Level:** High  
**Speed Limit:** 15 KM/Hr  
**Coordinates:** 11.21847, 78.16357

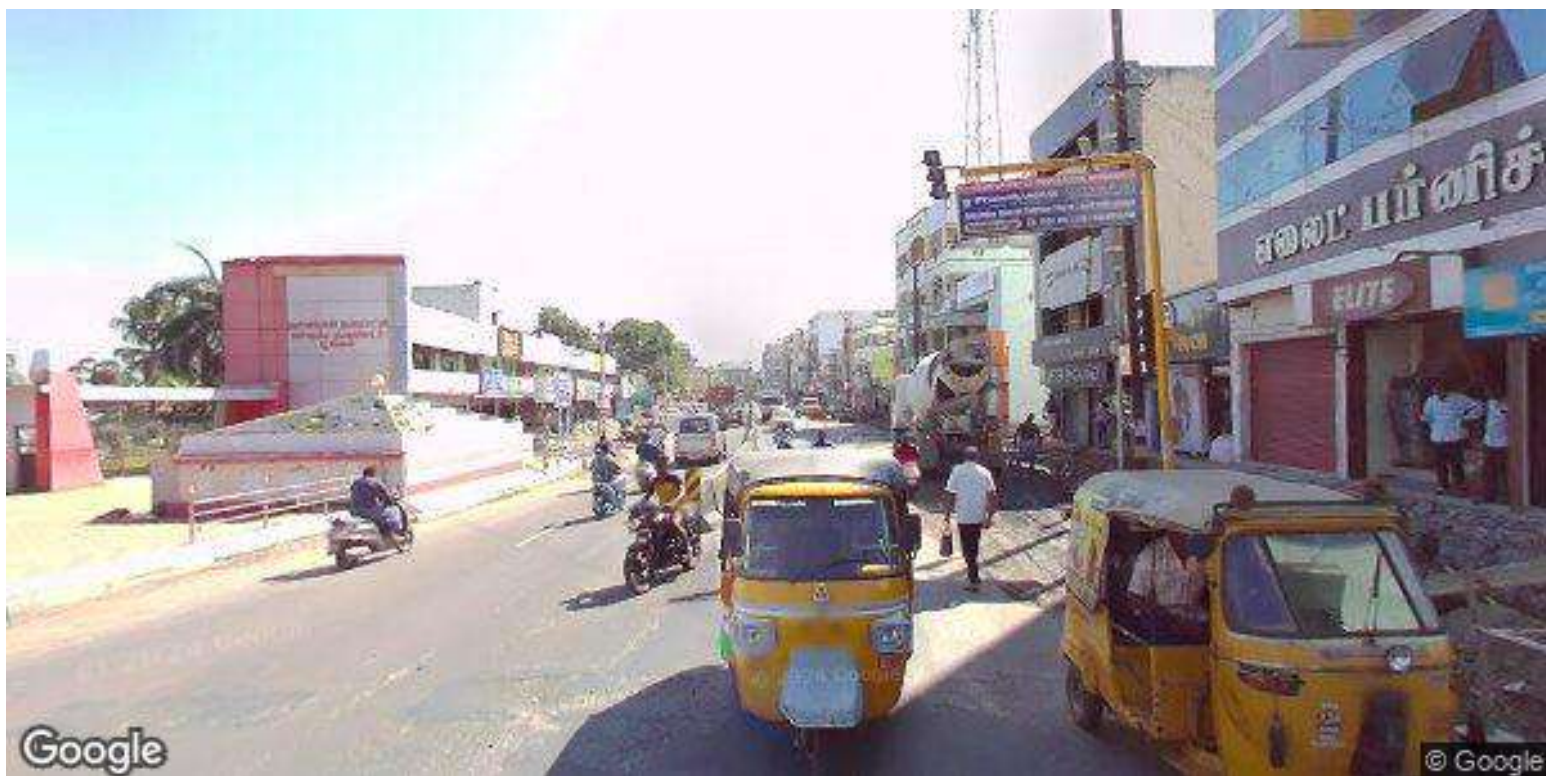
**Risk Type:** Blind Spot  
**Risk Level:** Blind Spot  
**Speed Limit:** 10 KM/Hr  
**Coordinates:** 11.21841, 78.16359

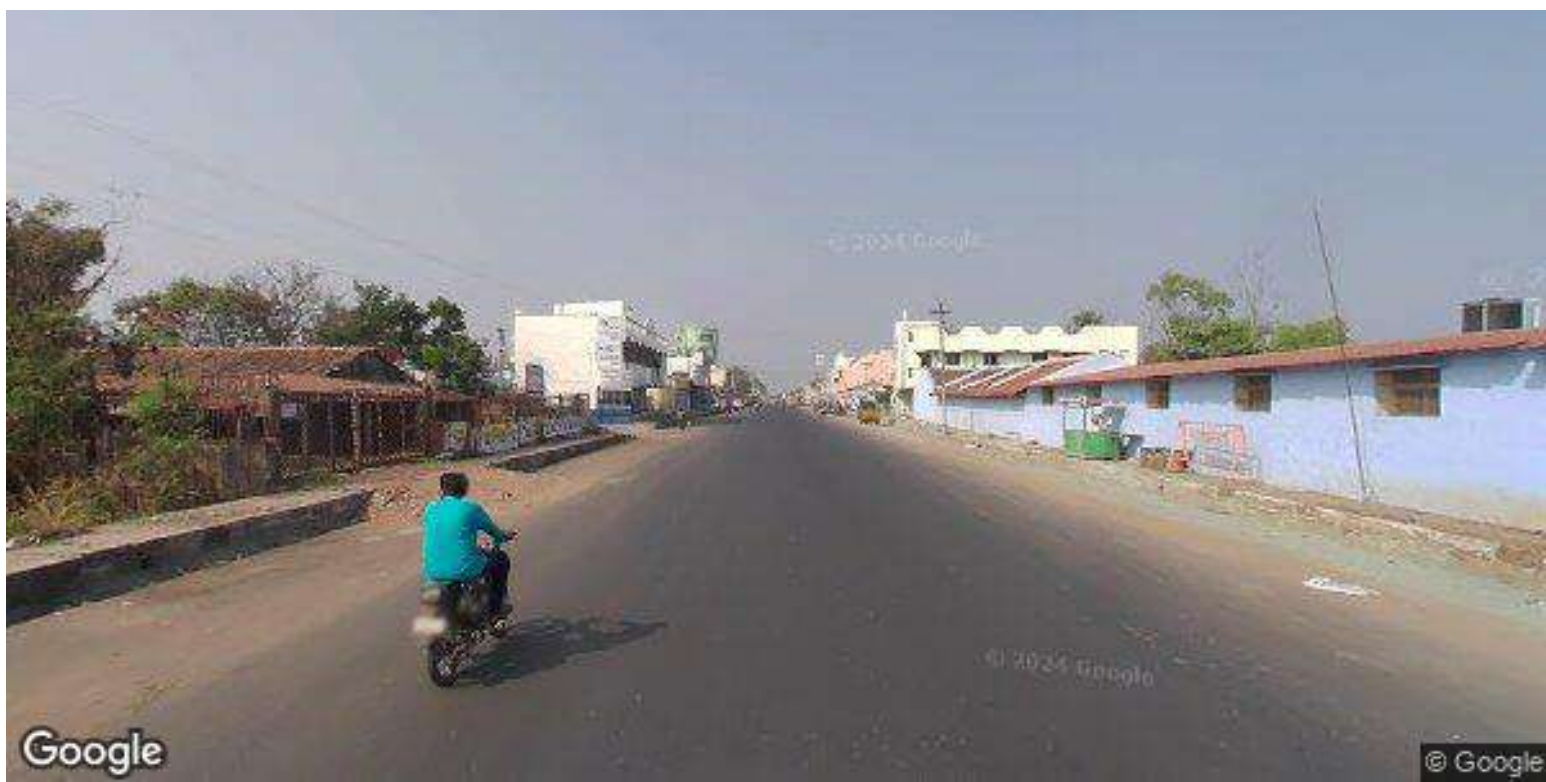
**Risk Type:** Blind Spot  
**Risk Level:** Blind Spot  
**Speed Limit:** 10 KM/Hr  
**Coordinates:** 11.21648, 78.15116

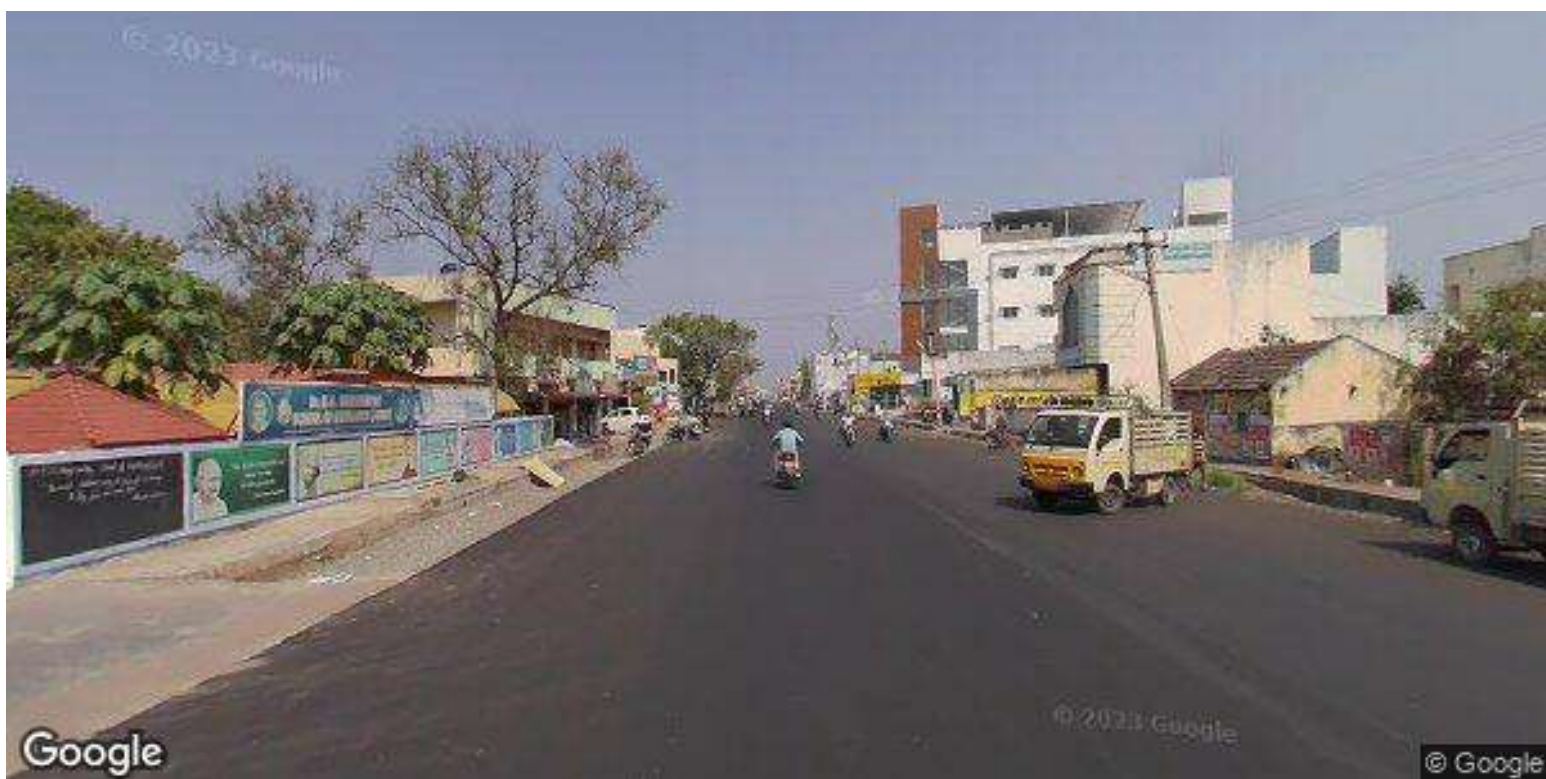
**Risk Type:** Turn  
**Risk Level:** High  
**Speed Limit:** 15 KM/Hr  
**Coordinates:** 11.21655, 78.15114

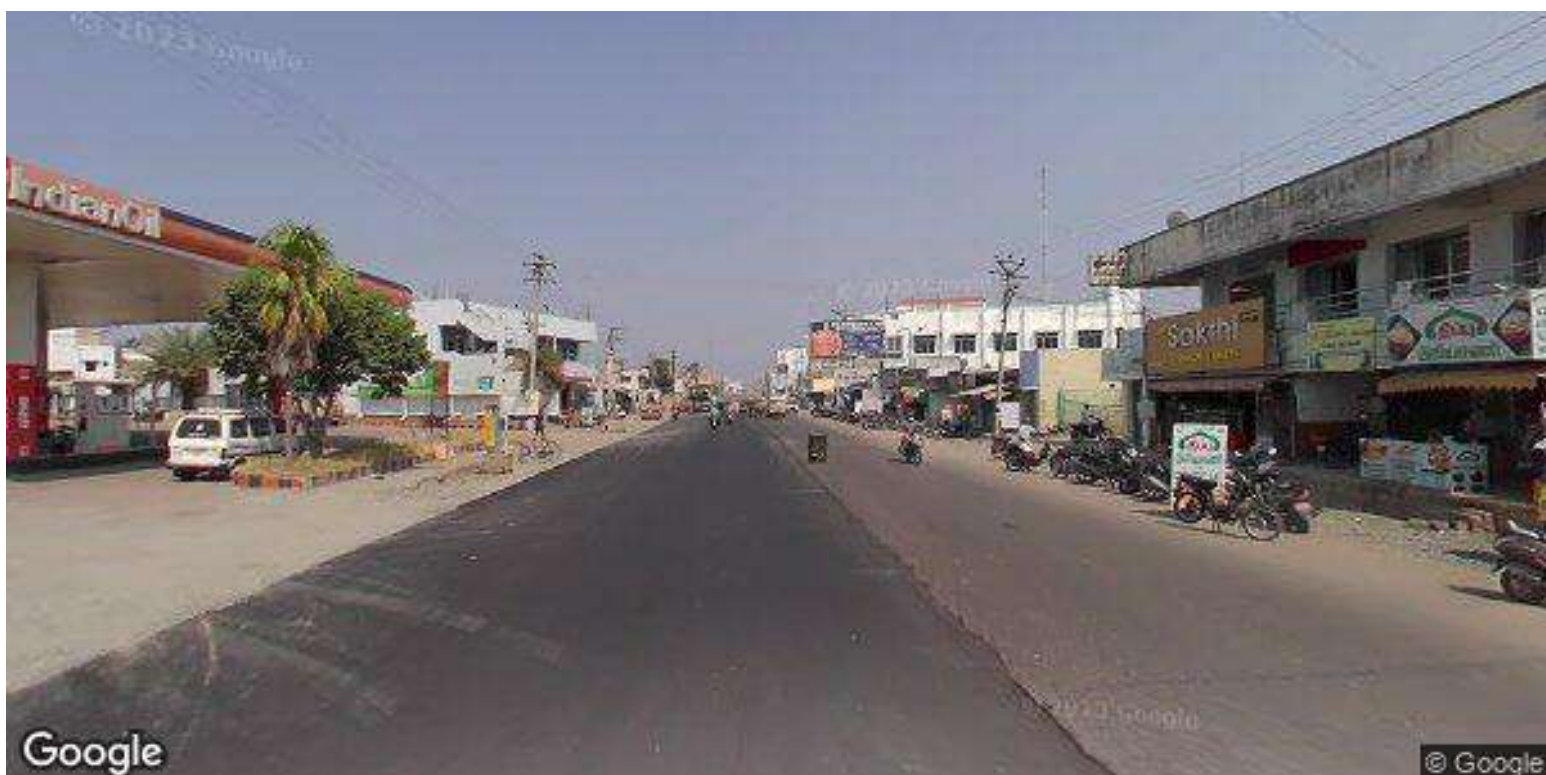
**Coordinates:** 11.21765, 78.15430

**Risk Type:** Turn

**Risk Level:** High

**Speed Limit:** 15 KM/Hr
