## JOURNEY RISK MANAGEMENT (JRM) STUDY

### Salem Terminal to VEESUMANI TRANSPORTS

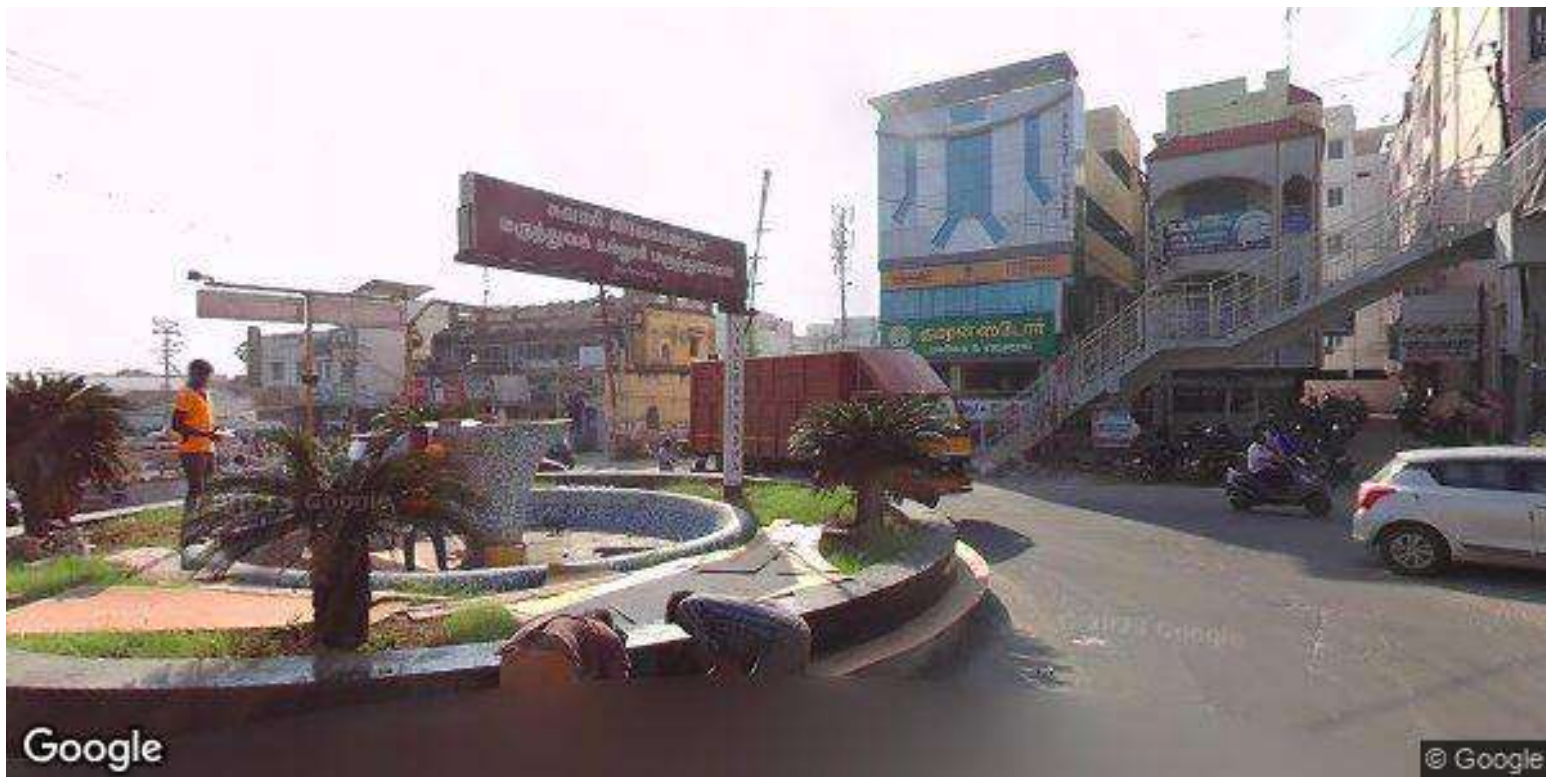
**Coordinates:** 11.38395, 77.89480

**Risk Type:** Roundabout

**Risk Level:** High

**Speed Limit:** 15 KM/Hr

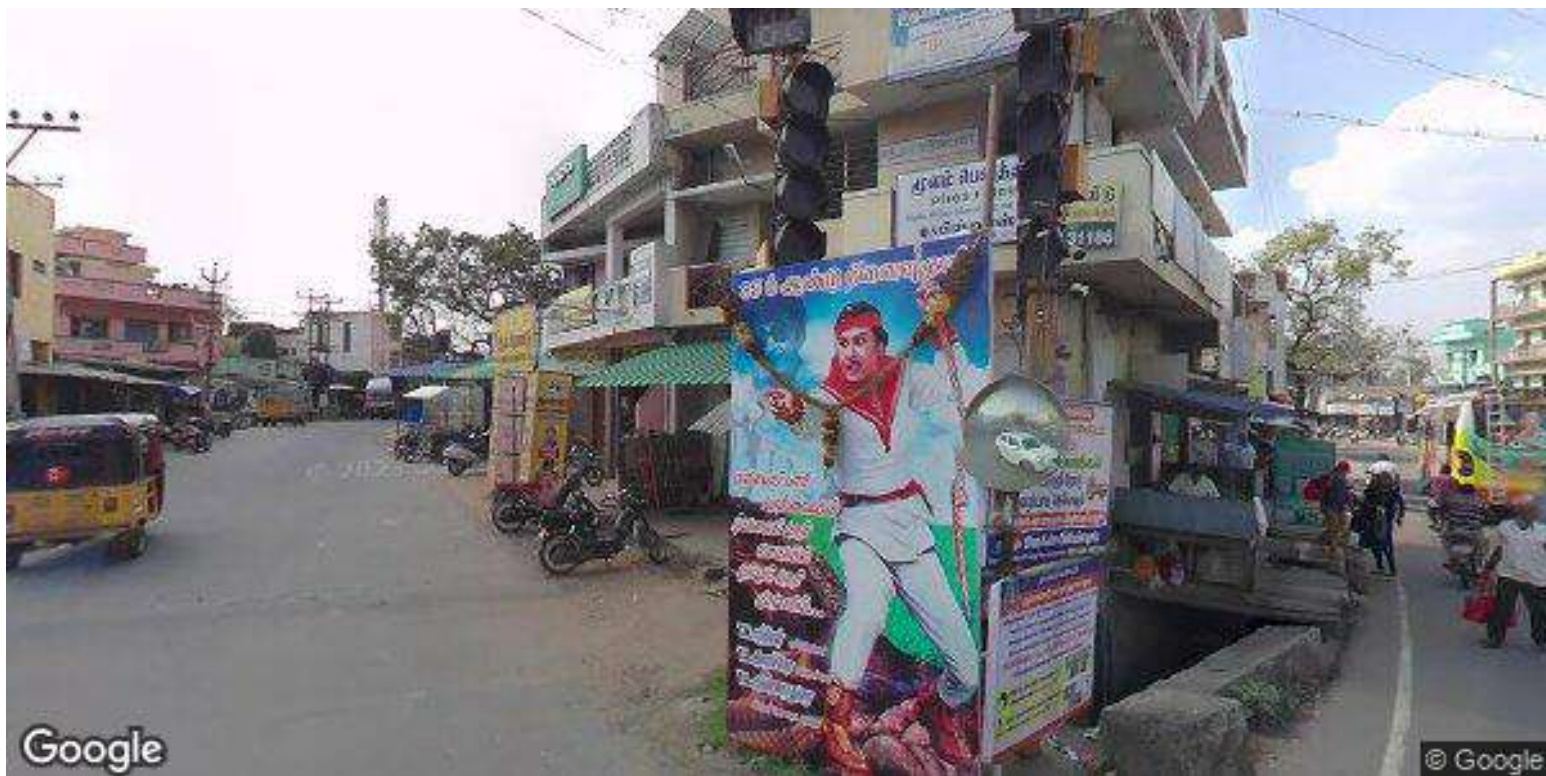
**Risk Type:** Turn  
**Risk Level:** Medium  
**Speed Limit:** 30 KM/Hr  
**Coordinates:** 11.38342, 77.89975

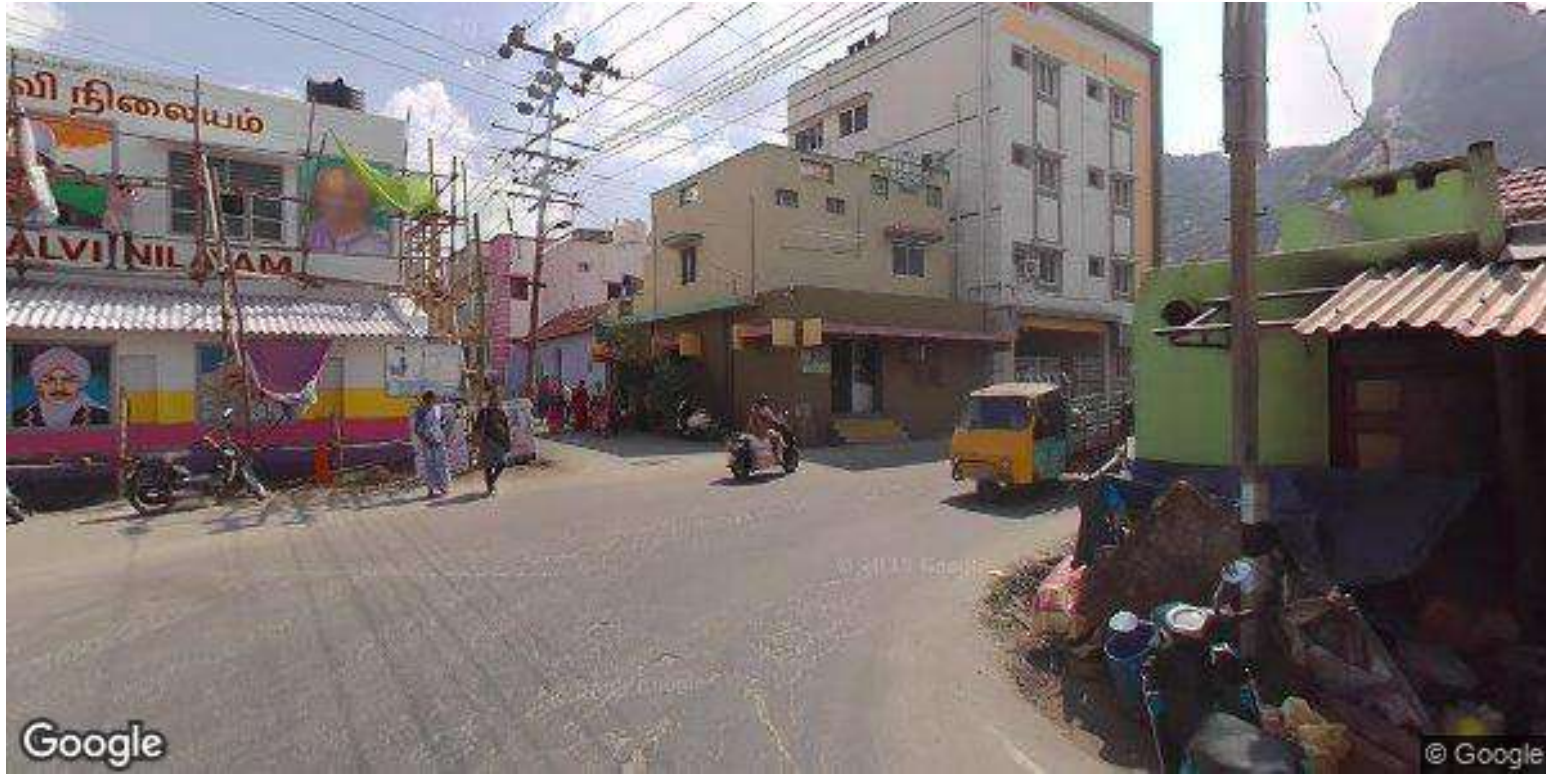
**Coordinates: 11.38186, 77.90258**

**Risk Type: Turn**

**Risk Level: High**

**Speed Limit: 15 KM/Hr**

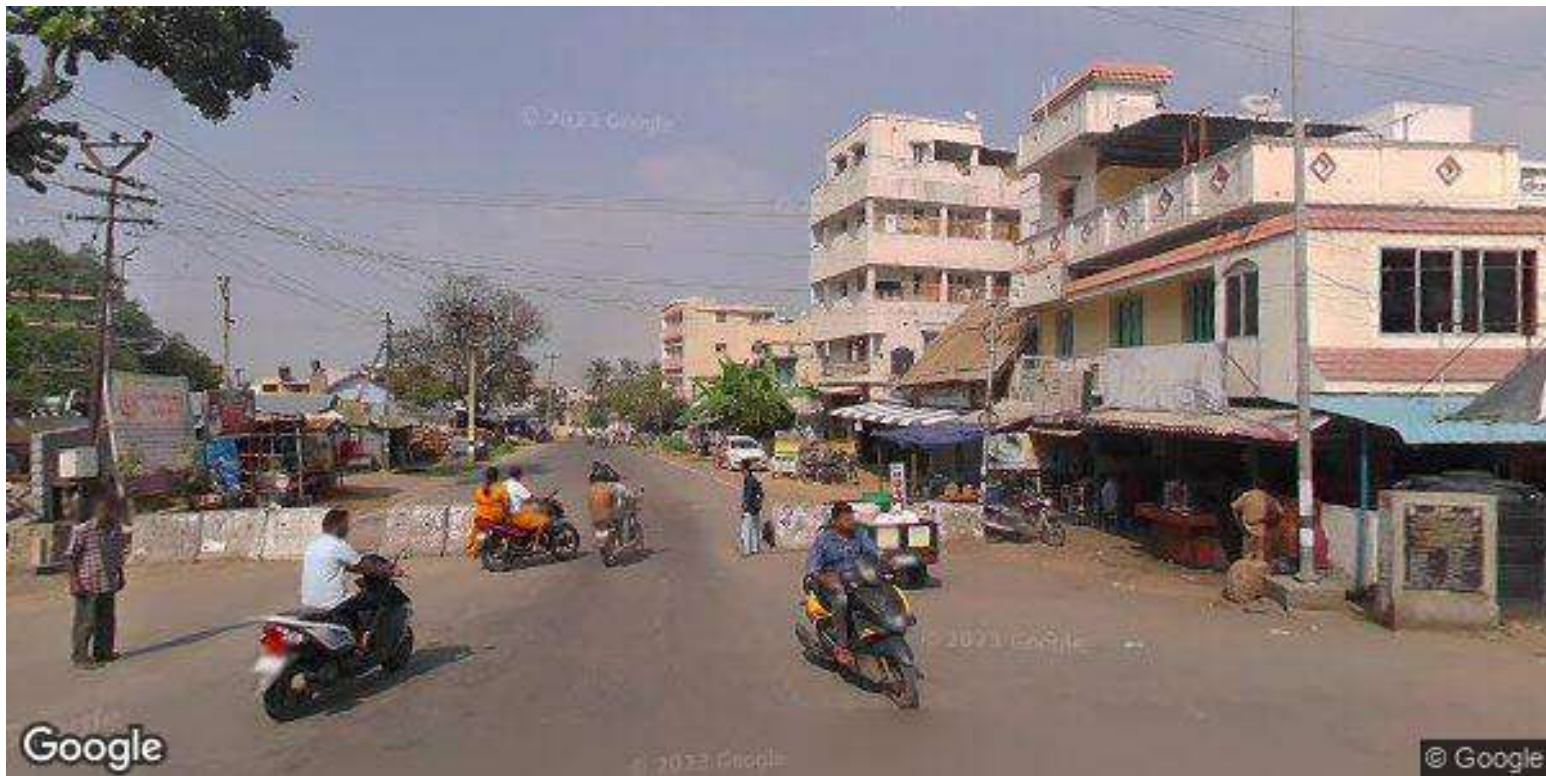
**Coordinates: 11.37841, 77.90140**

**Risk Type: Blind Spot**

**Risk Level: Blind Spot**

**Speed Limit: 10 KM/Hr**

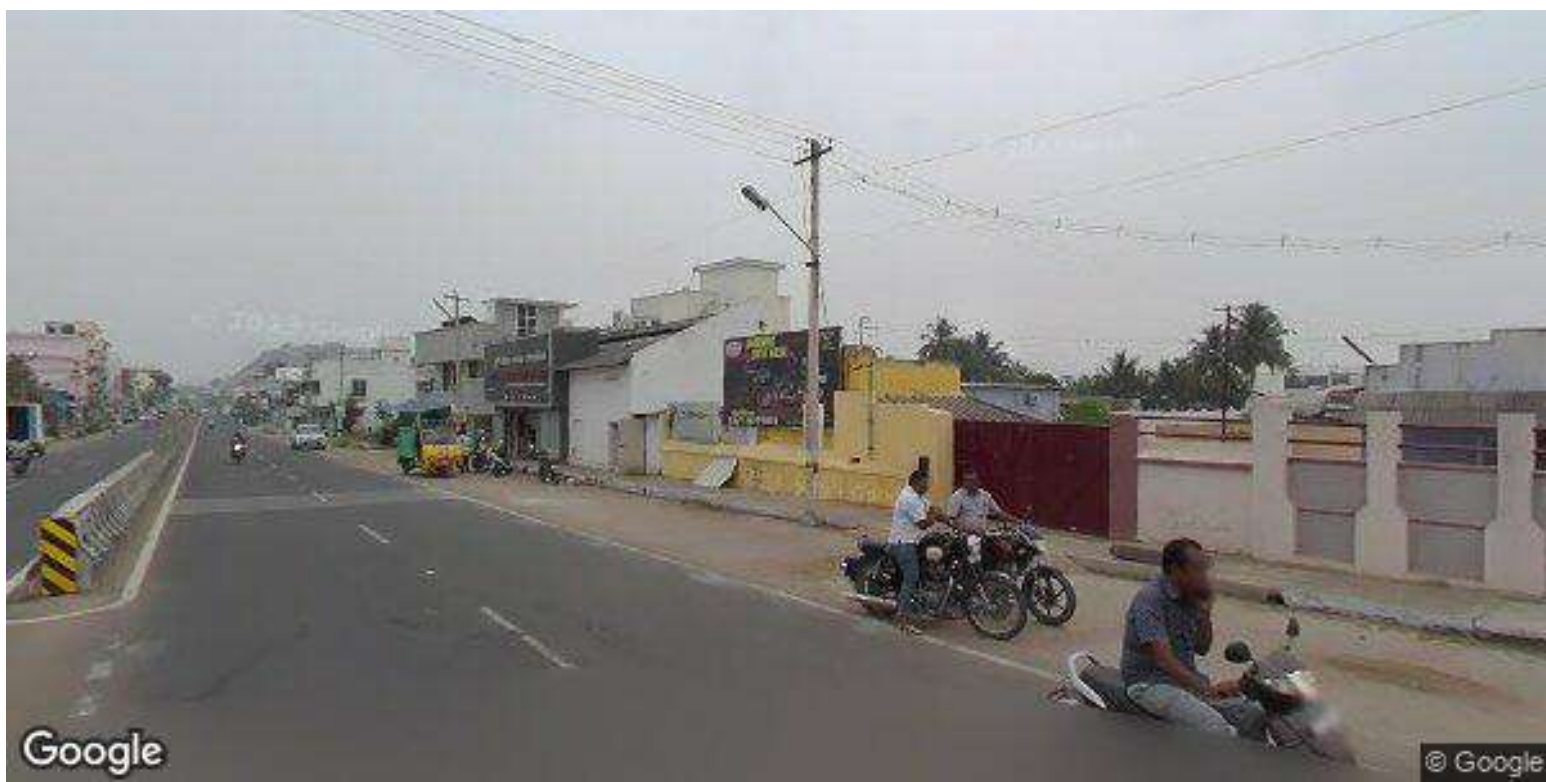
**Coordinates:** 11.23044, 78.15943

**Risk Type:** Blind Spot

**Risk Level:** Blind Spot

**Speed Limit:** 10 KM/Hr

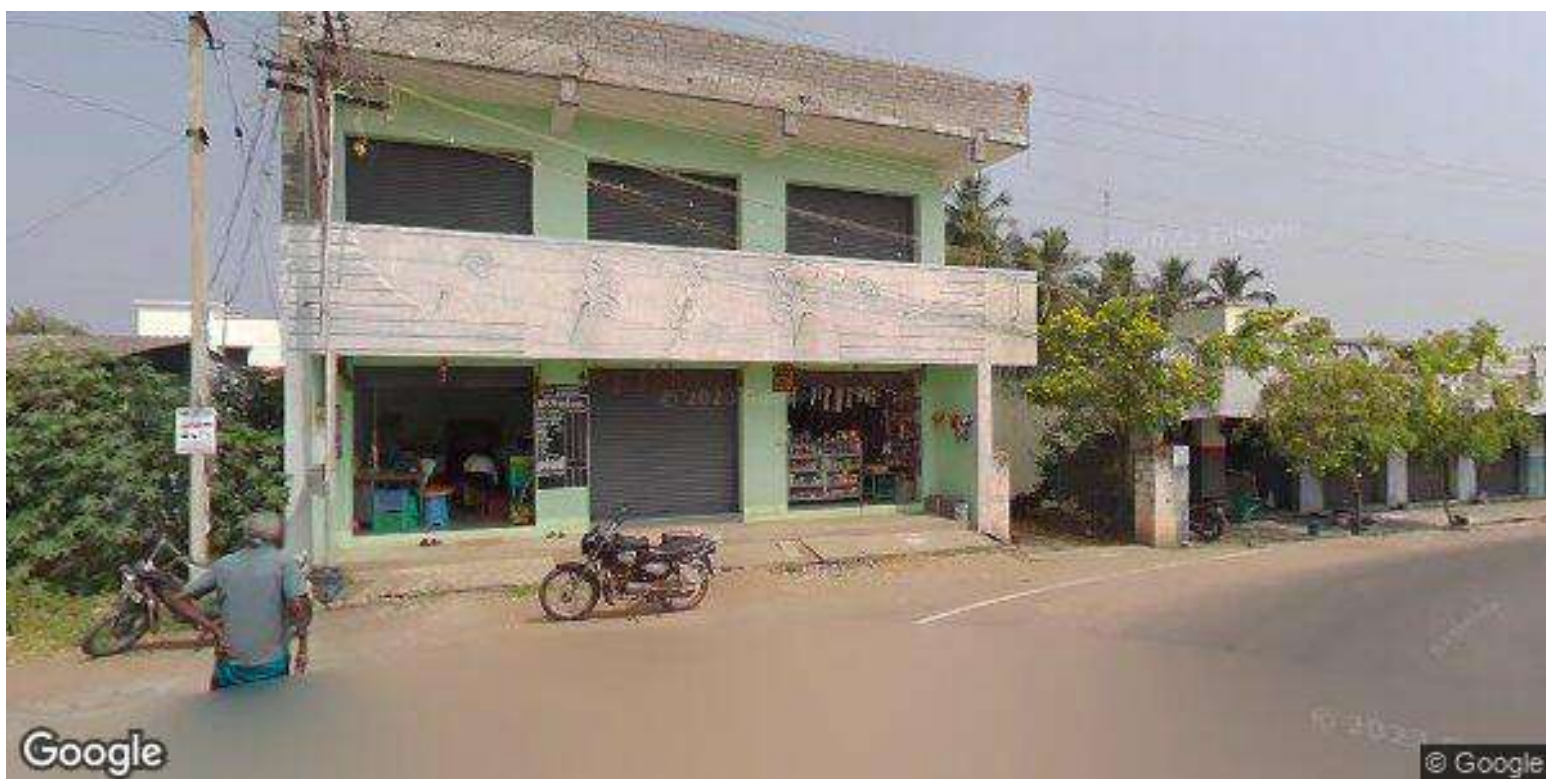
**Coordinates:** 11.23678, 78.16438

**Risk Type:** Turn

**Risk Level:** High

**Speed Limit:** 15 KM/Hr

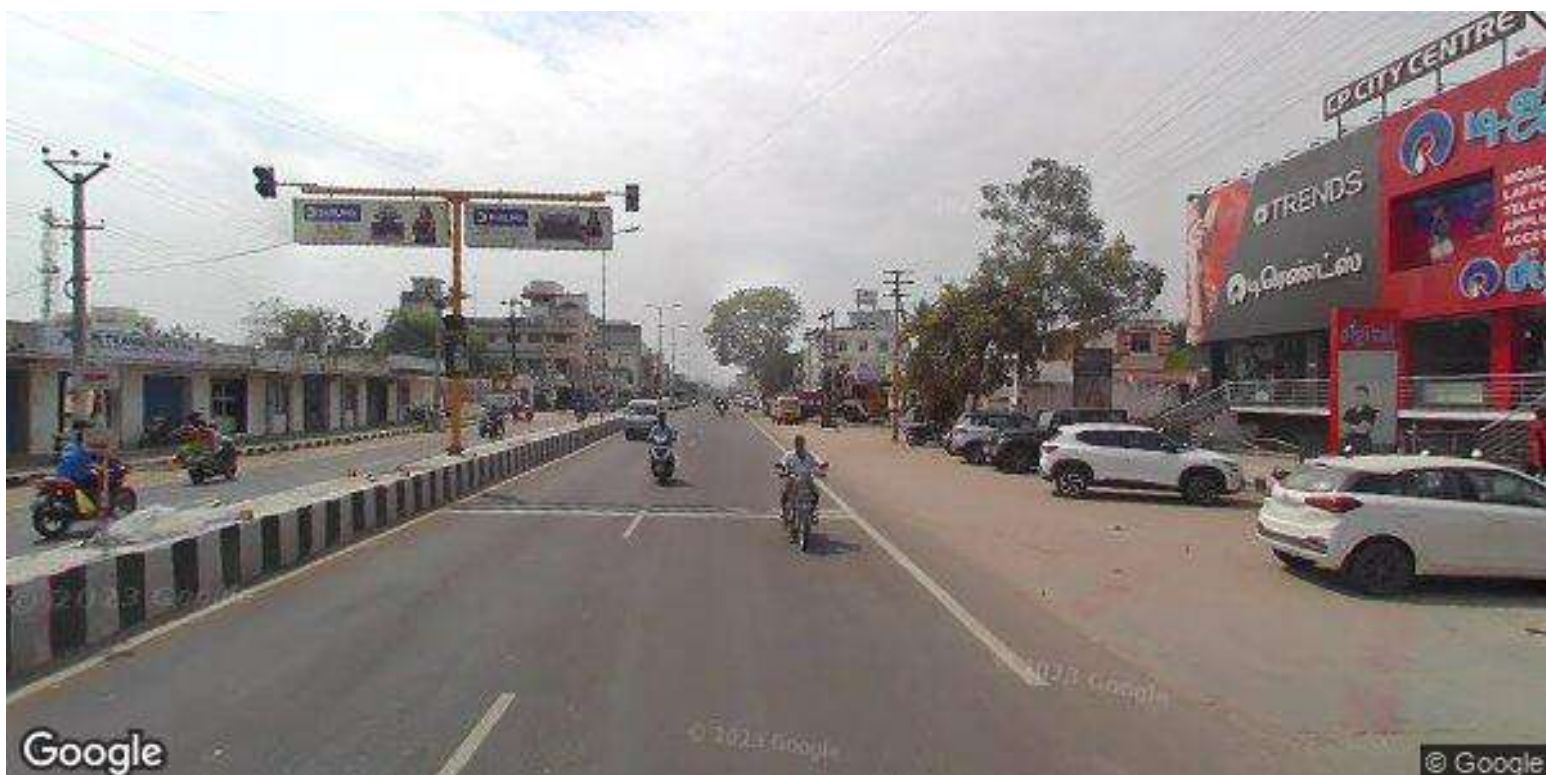
**Coordinates:** 11.23661, 78.16558

**Risk Type:** Blind Spot

**Risk Level:** Blind Spot

**Speed Limit:** 10 KM/Hr
