# IndianOil

## JOURNEY RISK MANAGEMENT (JRM) STUDY

### Salem Terminal to UDAYAM AUTO CARE

### Route Safety Analysis: Sangagiri to Kangeyam

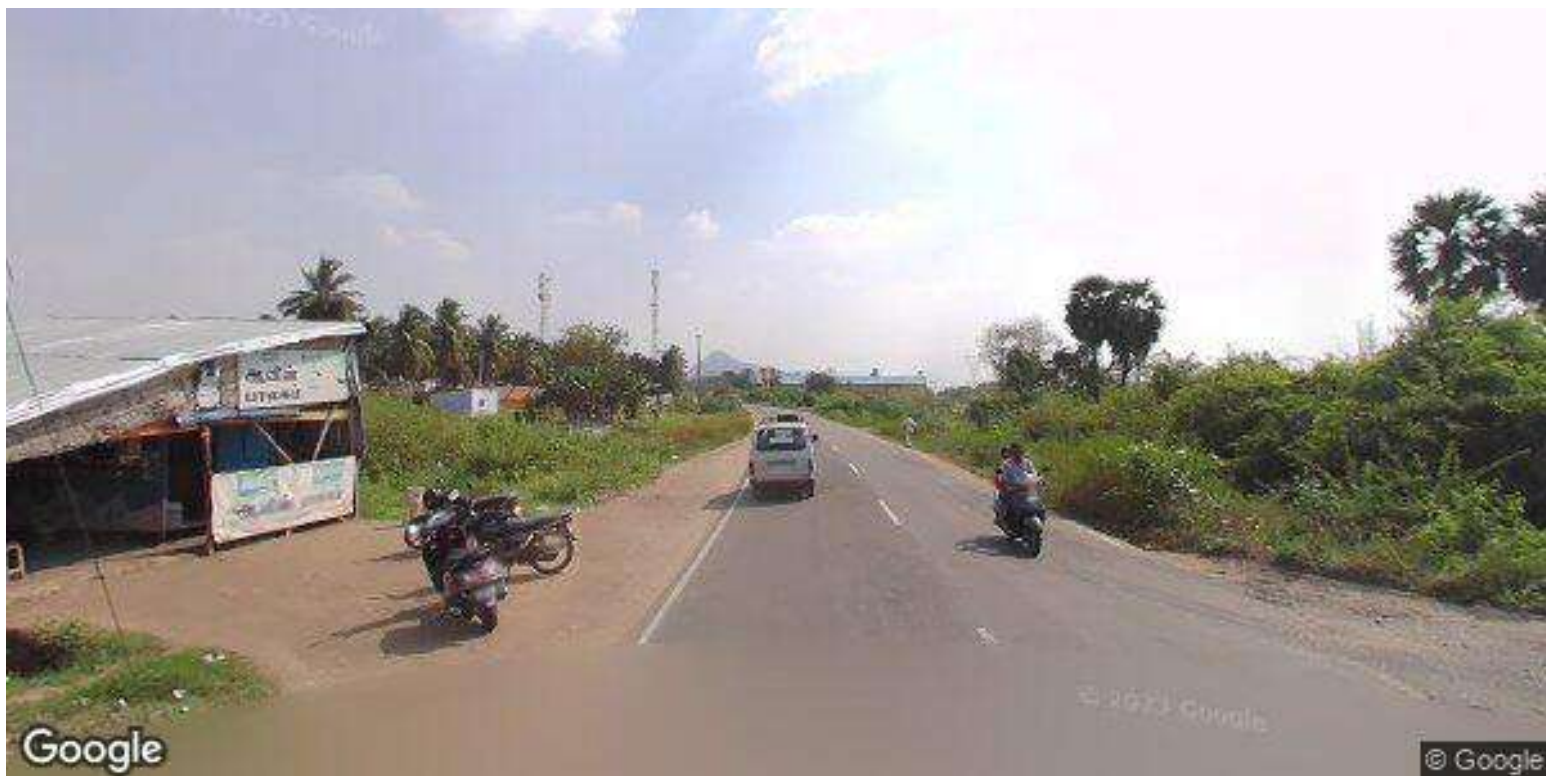
**Coordinates:** 11.44022, 77.87546

**Risk Type:** Turn

**Risk Level:** High

**Speed Limit:** 15 KM/Hr

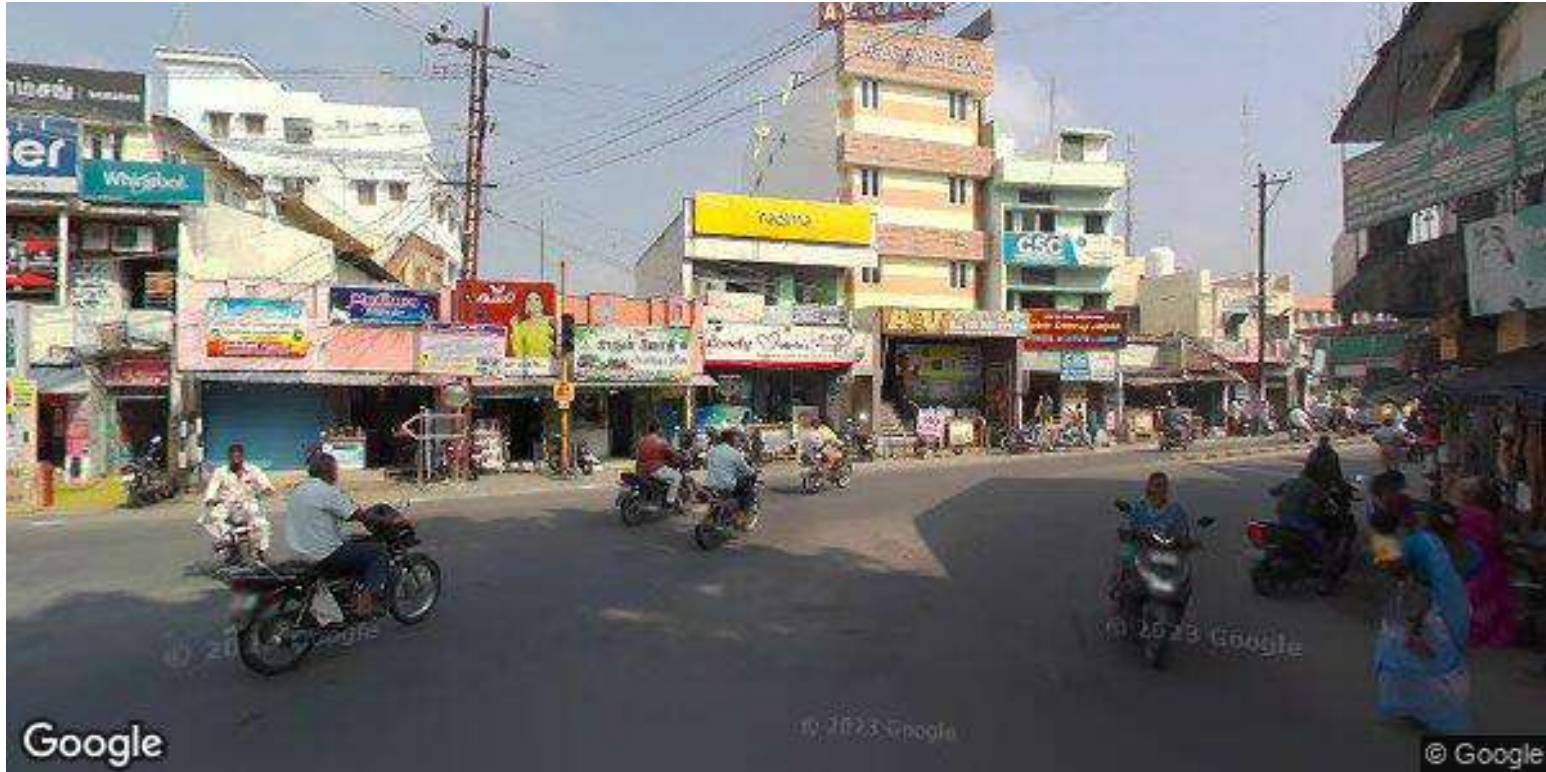
**Coordinates:** 11.37842, 77.89452

**Risk Type:** Turn

**Risk Level:** Medium

**Speed Limit:** 30 KM/Hr

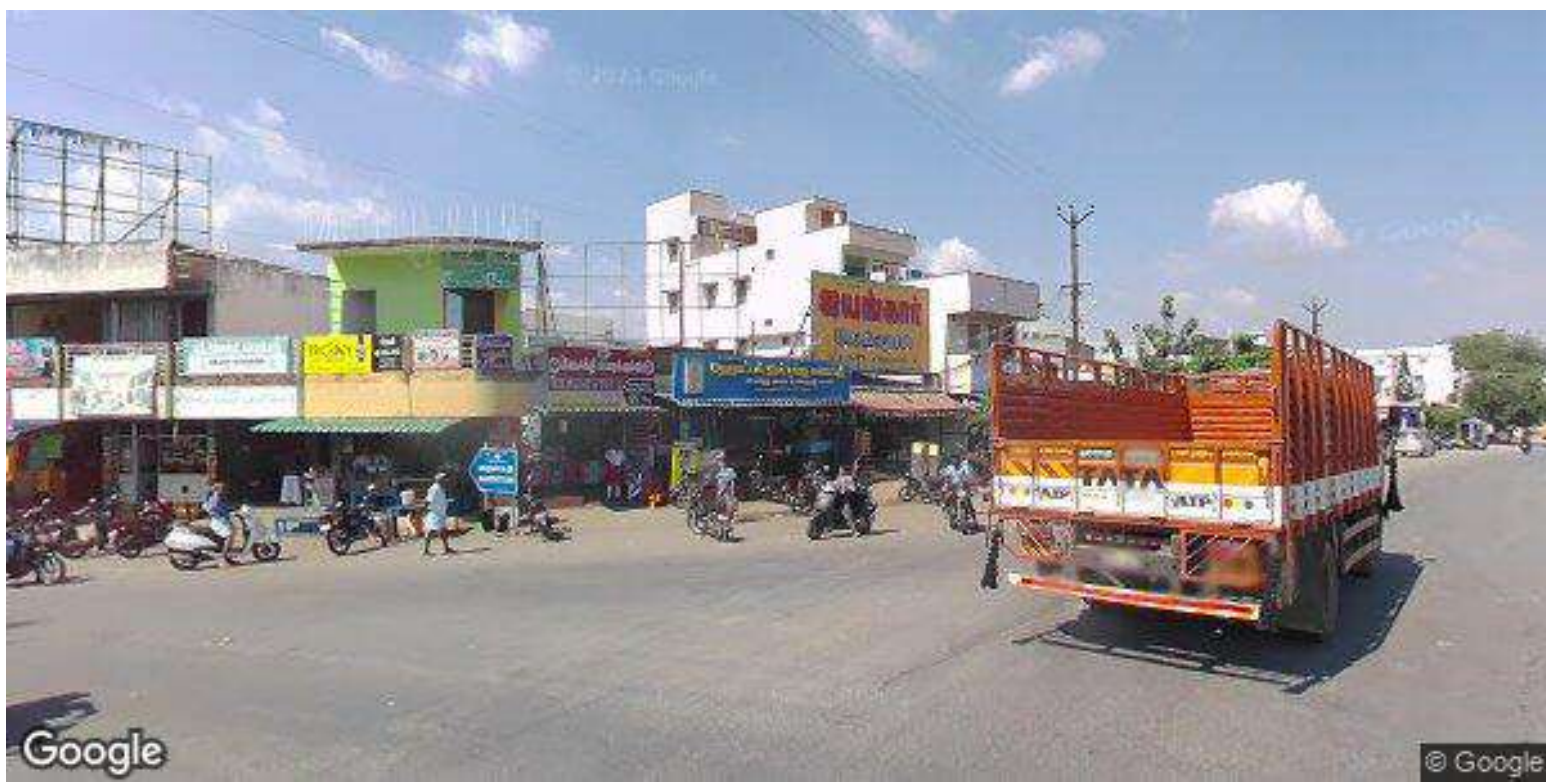
**Coordinates:** 11.36602, 77.88875

**Risk Type:** Turn

**Risk Level:** Medium

**Speed Limit:** 30 KM/Hr

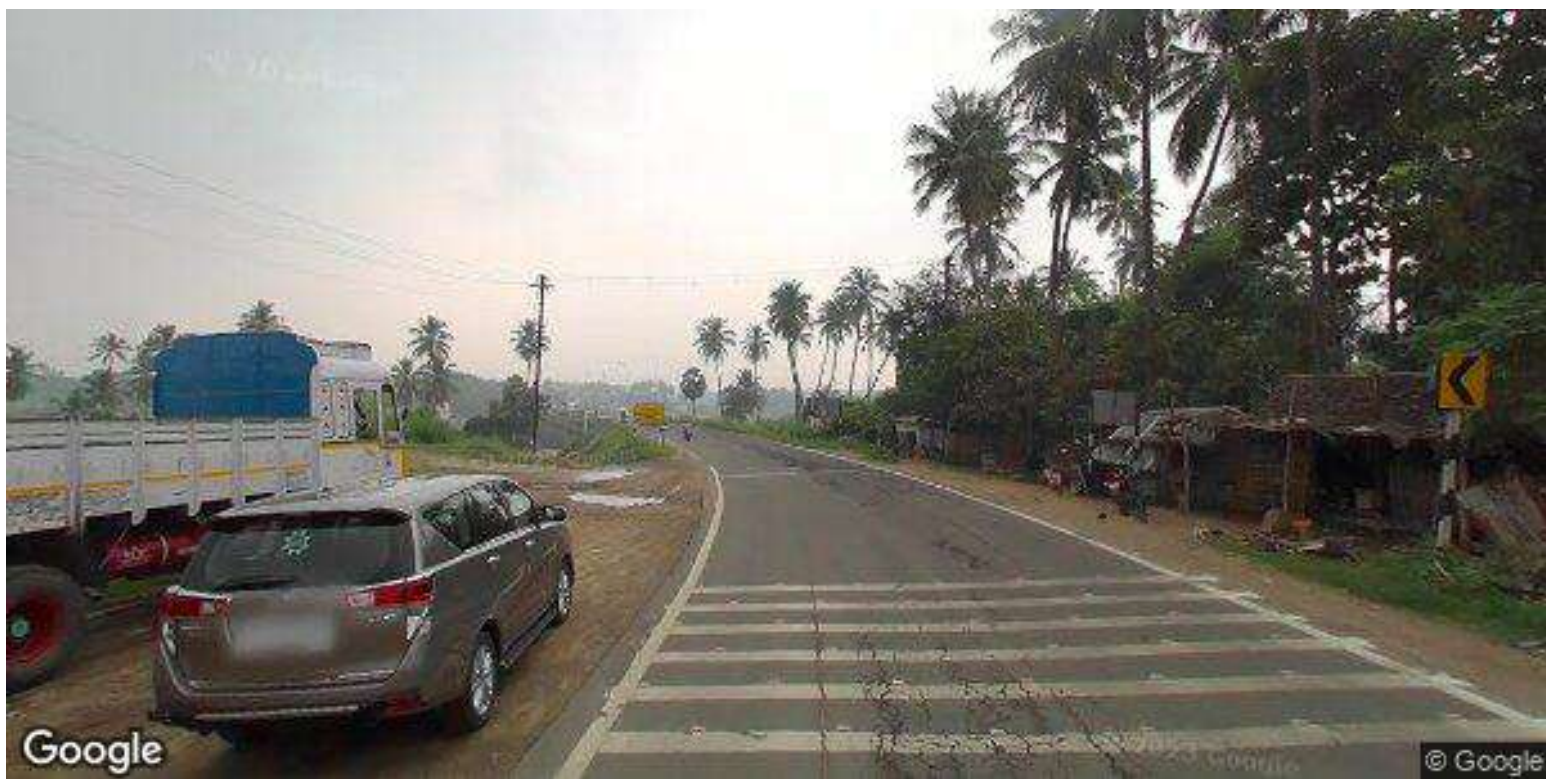
**Risk Type:** Turn  
**Risk Level:** Medium  
**Speed Limit:** 30 KM/Hr  
**Coordinates:** 11.30952, 77.77587

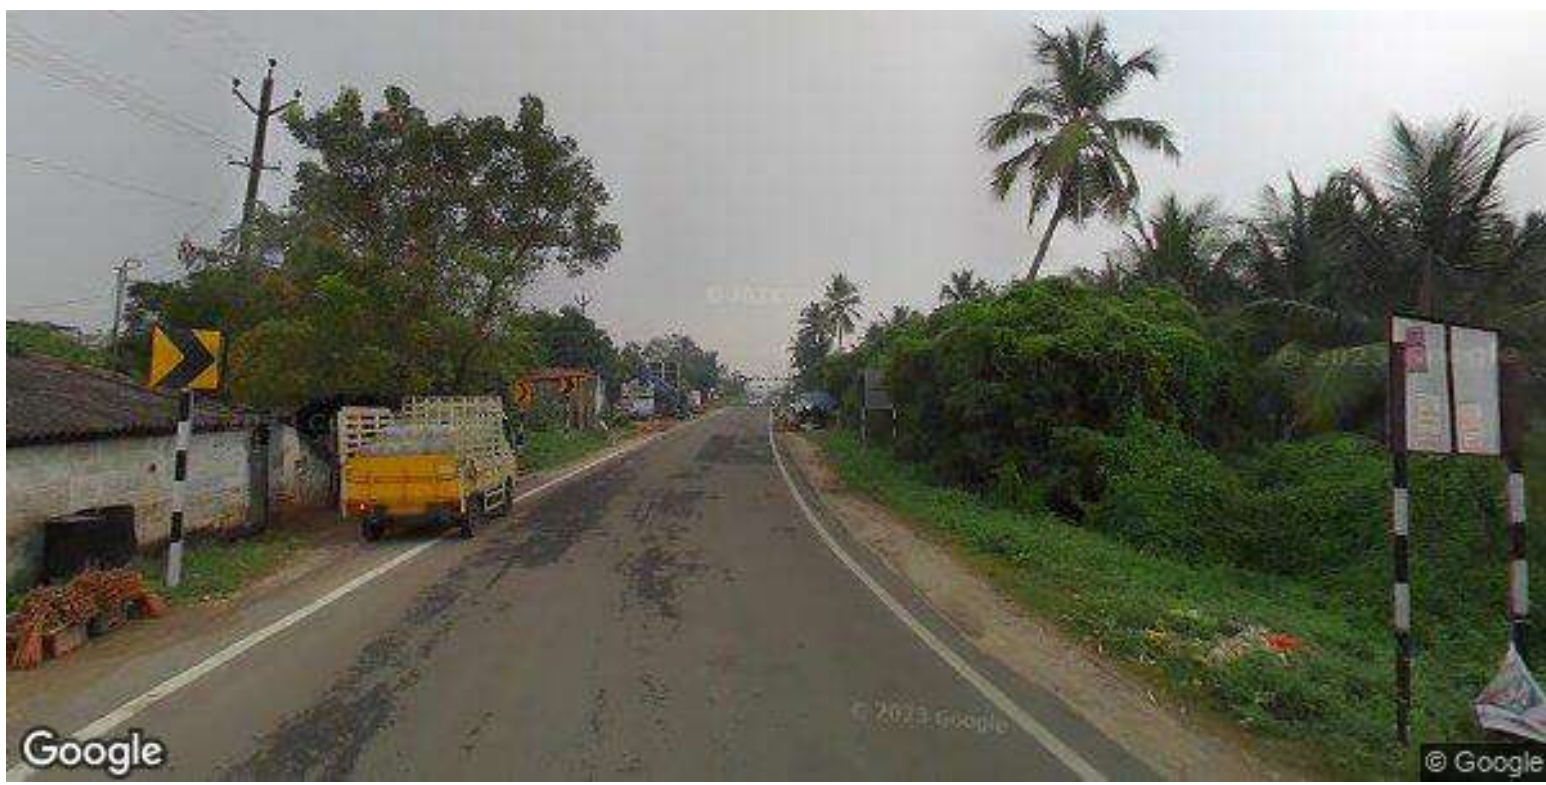
**Coordinates:** 11.30973, 77.76712

**Risk Type:** Turn

**Risk Level:** Medium

**Speed Limit:** 30 KM/Hr

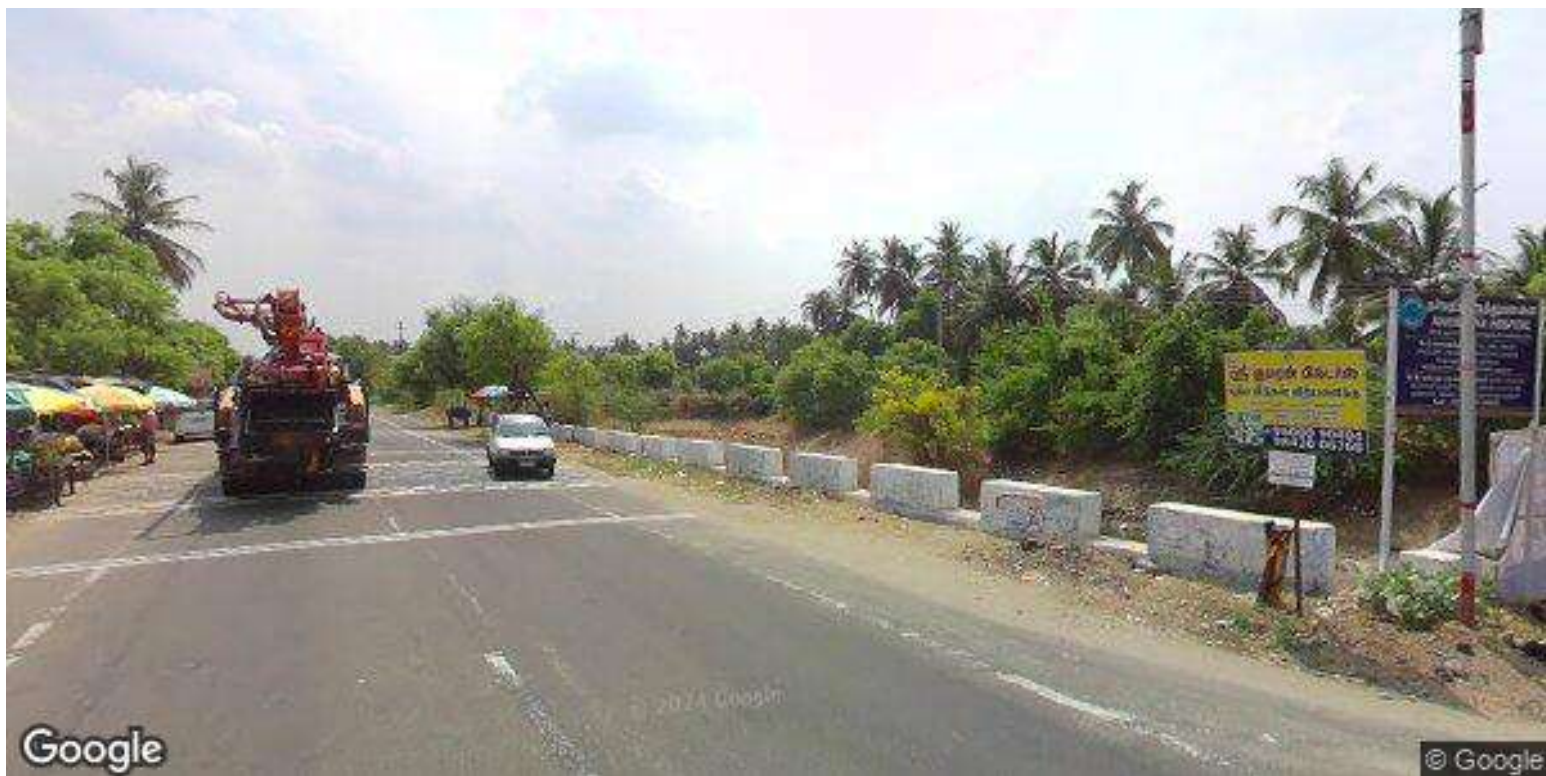
**Coordinates:** 11.29490, 77.74685

**Risk Type:** Turn

**Risk Level:** High

**Speed Limit:** 15 KM/Hr

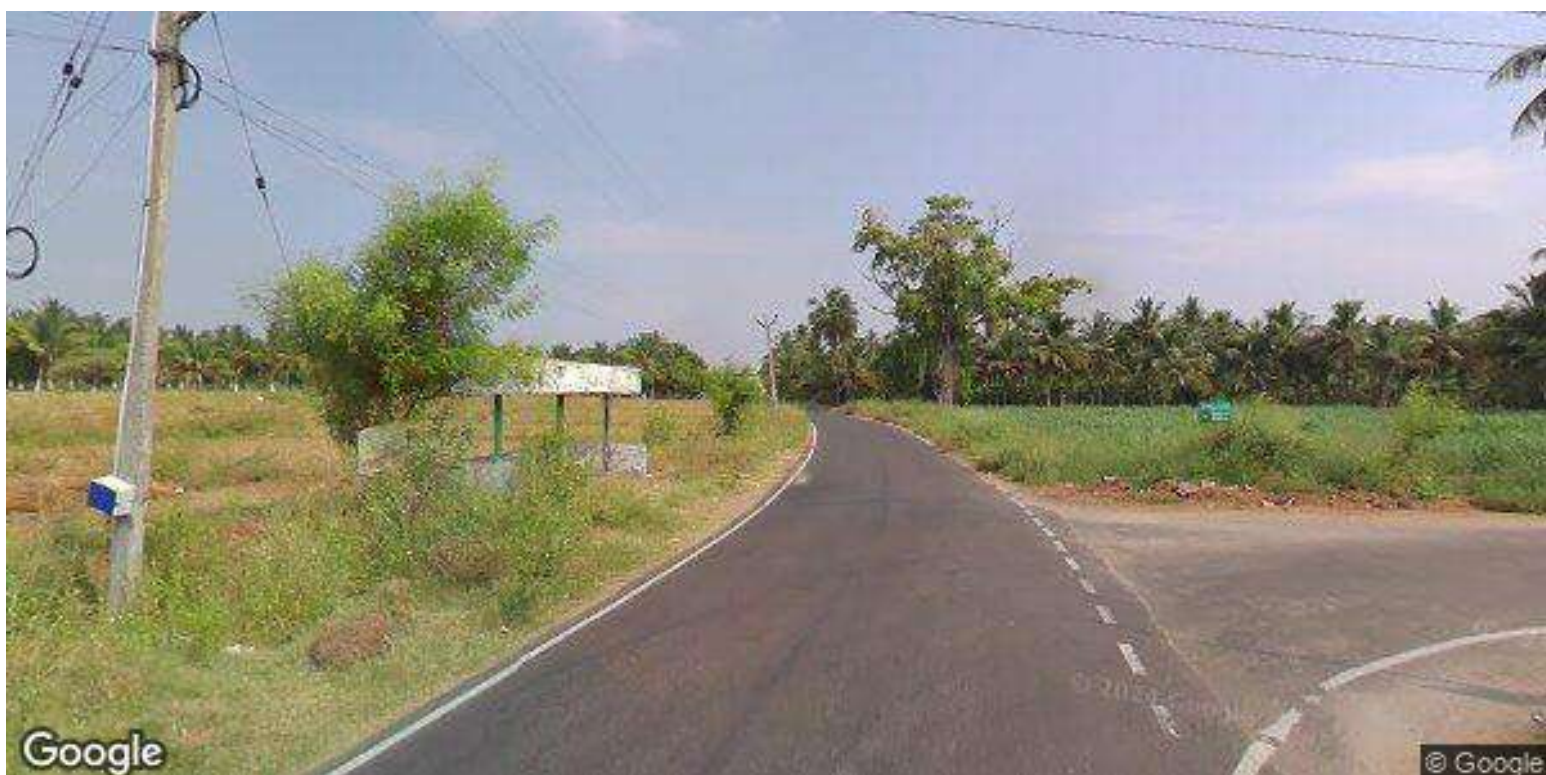
**Risk Type:** Turn  
**Risk Level:** High  
**Speed Limit:** 15 KM/Hr  
**Coordinates:** 11.29141, 77.74662

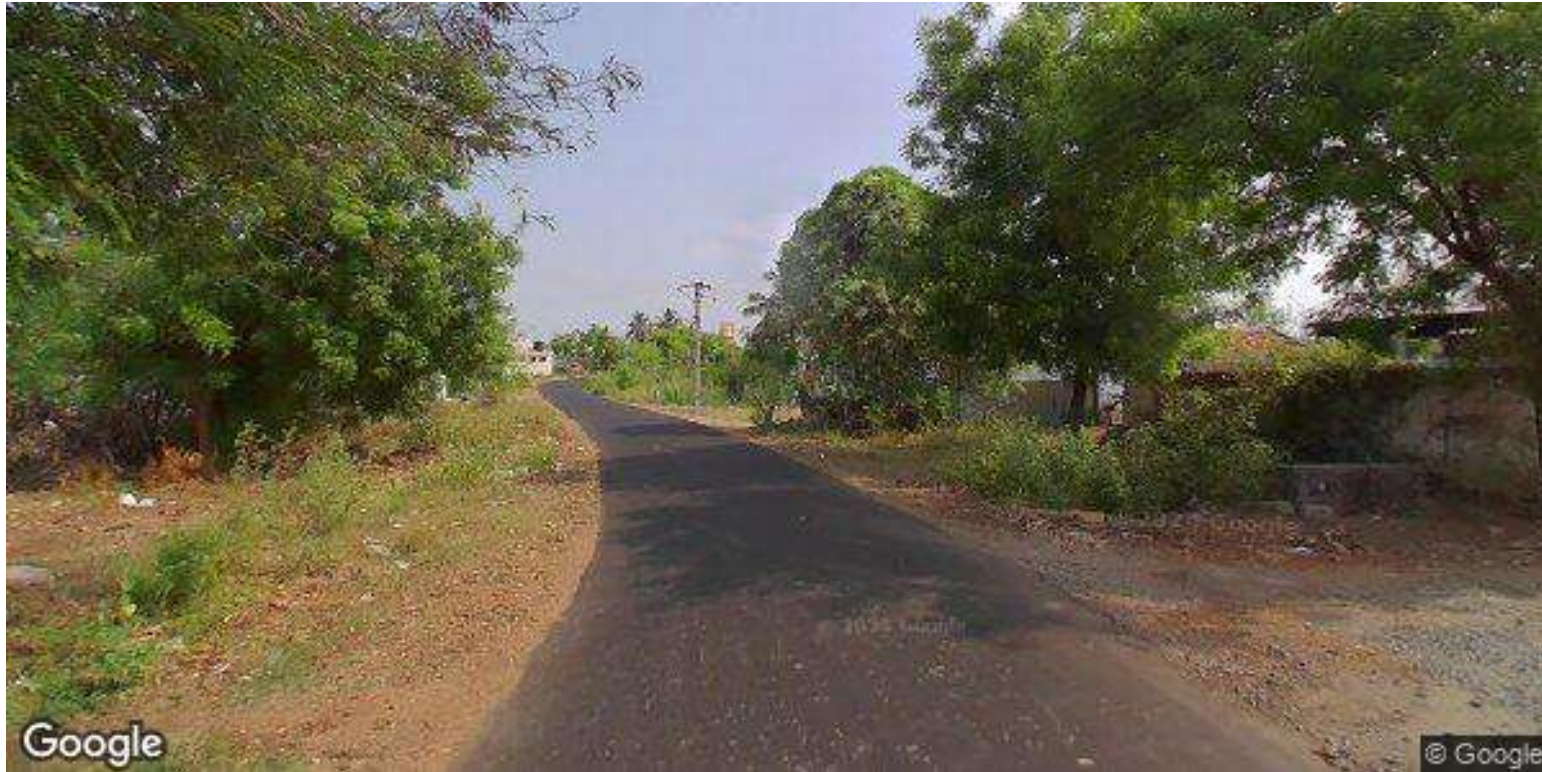
**Risk Type:** Turn  
**Risk Level:** Medium  
**Speed Limit:** 30 KM/Hr  
**Coordinates:** 11.28844, 77.74319

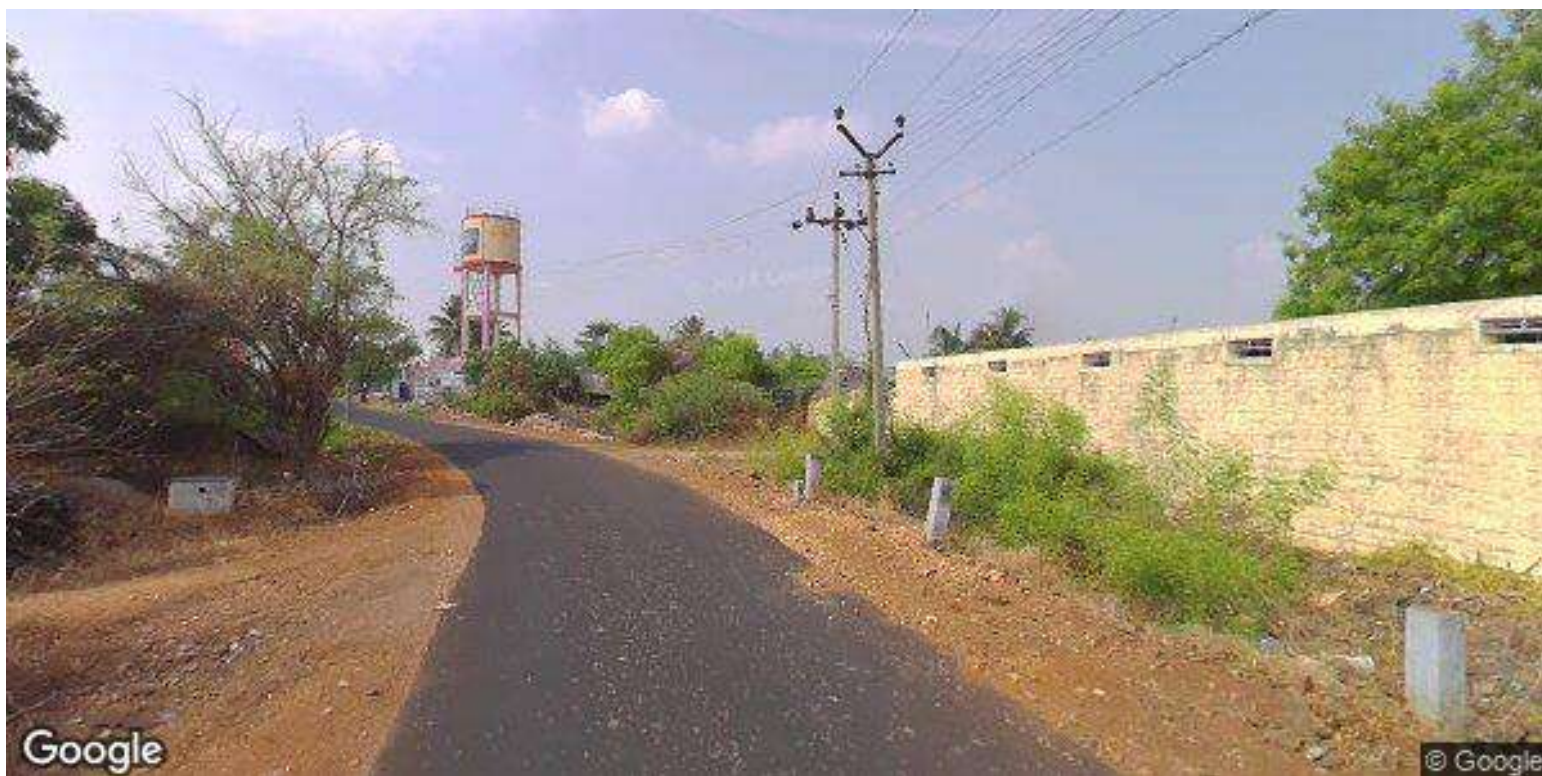
**Risk Type:** Turn  
**Risk Level:** Medium  
**Speed Limit:** 30 KM/Hr  
**Coordinates:** 11.28573, 77.74281

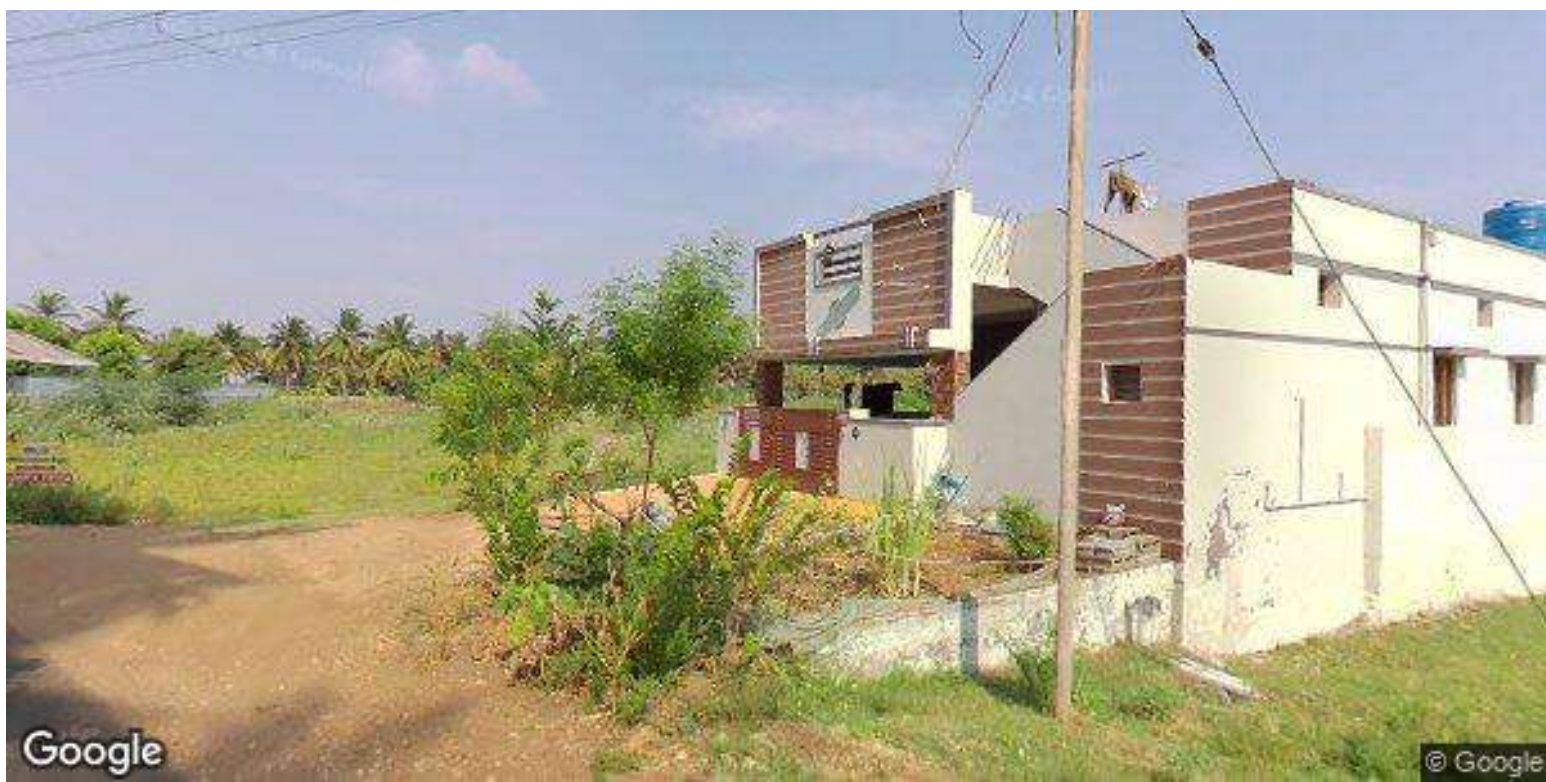
**Coordinates:** 11.27319, 77.72981

**Risk Type:** Turn

**Risk Level:** High

**Speed Limit:** 15 KM/Hr

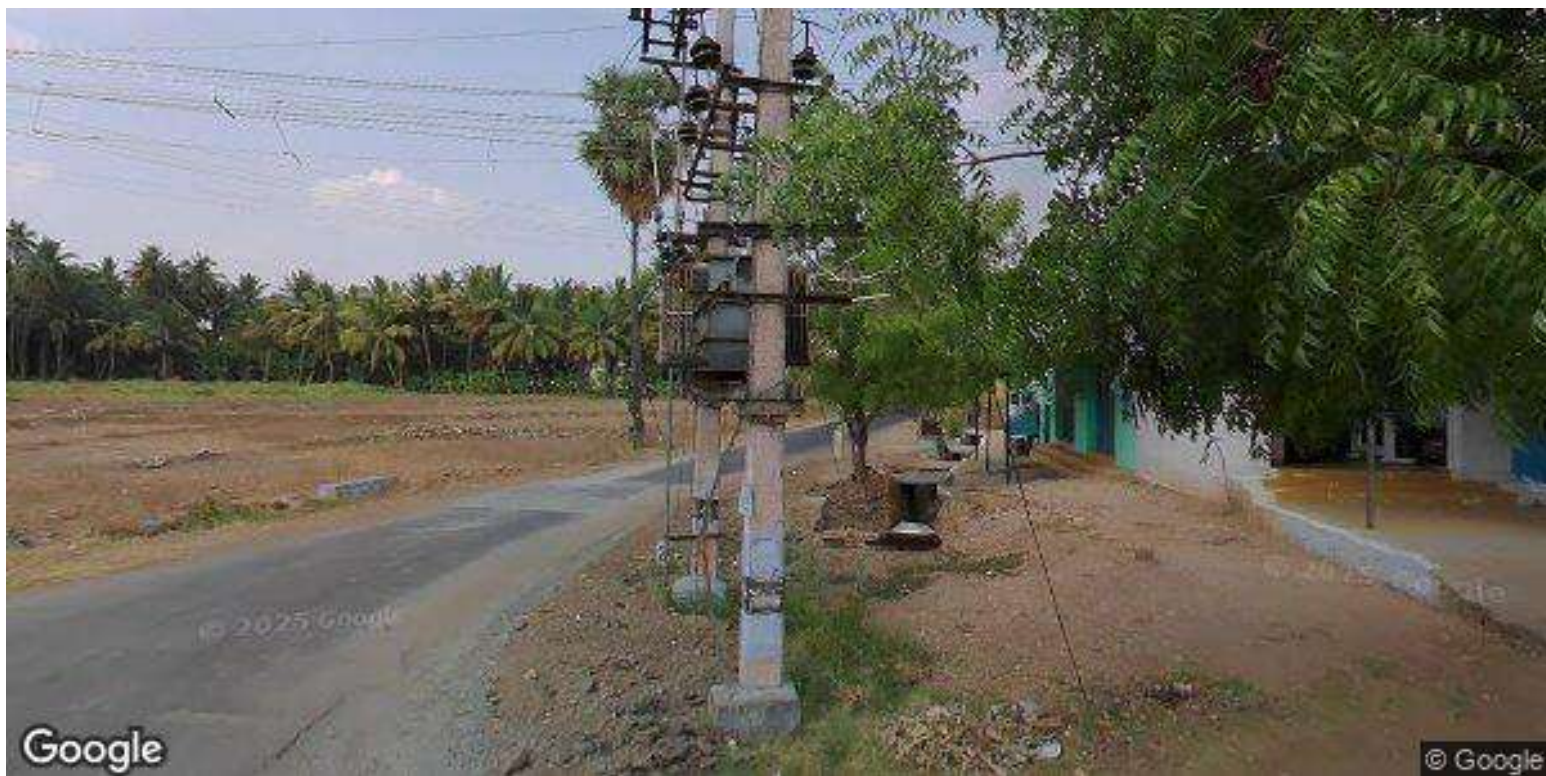
**Coordinates:** 11.27330, 77.72715

**Risk Type:** Blind Spot

**Risk Level:** Blind Spot

**Speed Limit:** 10 KM/Hr

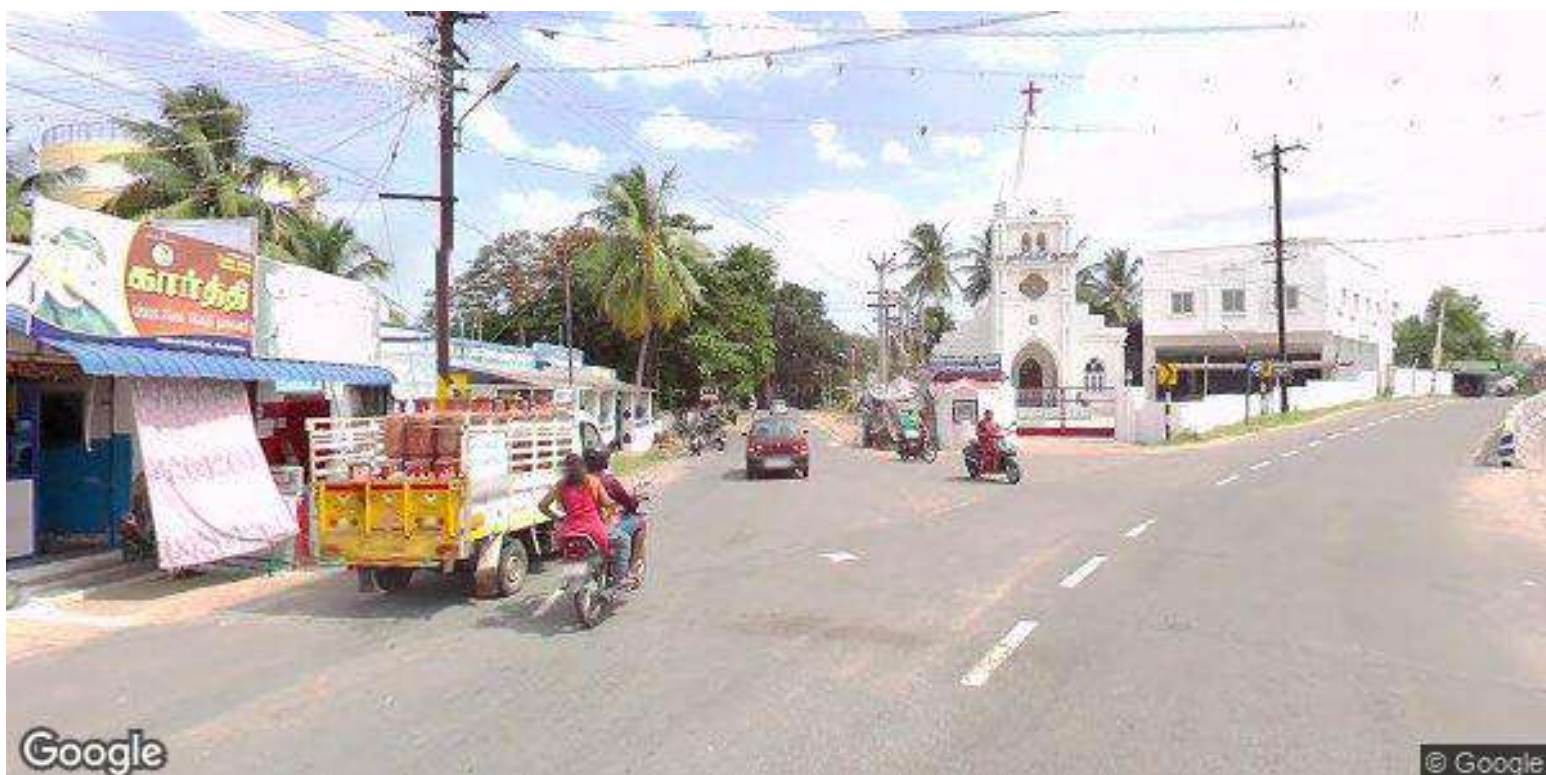
**Coordinates:** 11.23054, 77.71796

**Risk Type:** Turn

**Risk Level:** Medium

**Speed Limit:** 30 KM/Hr

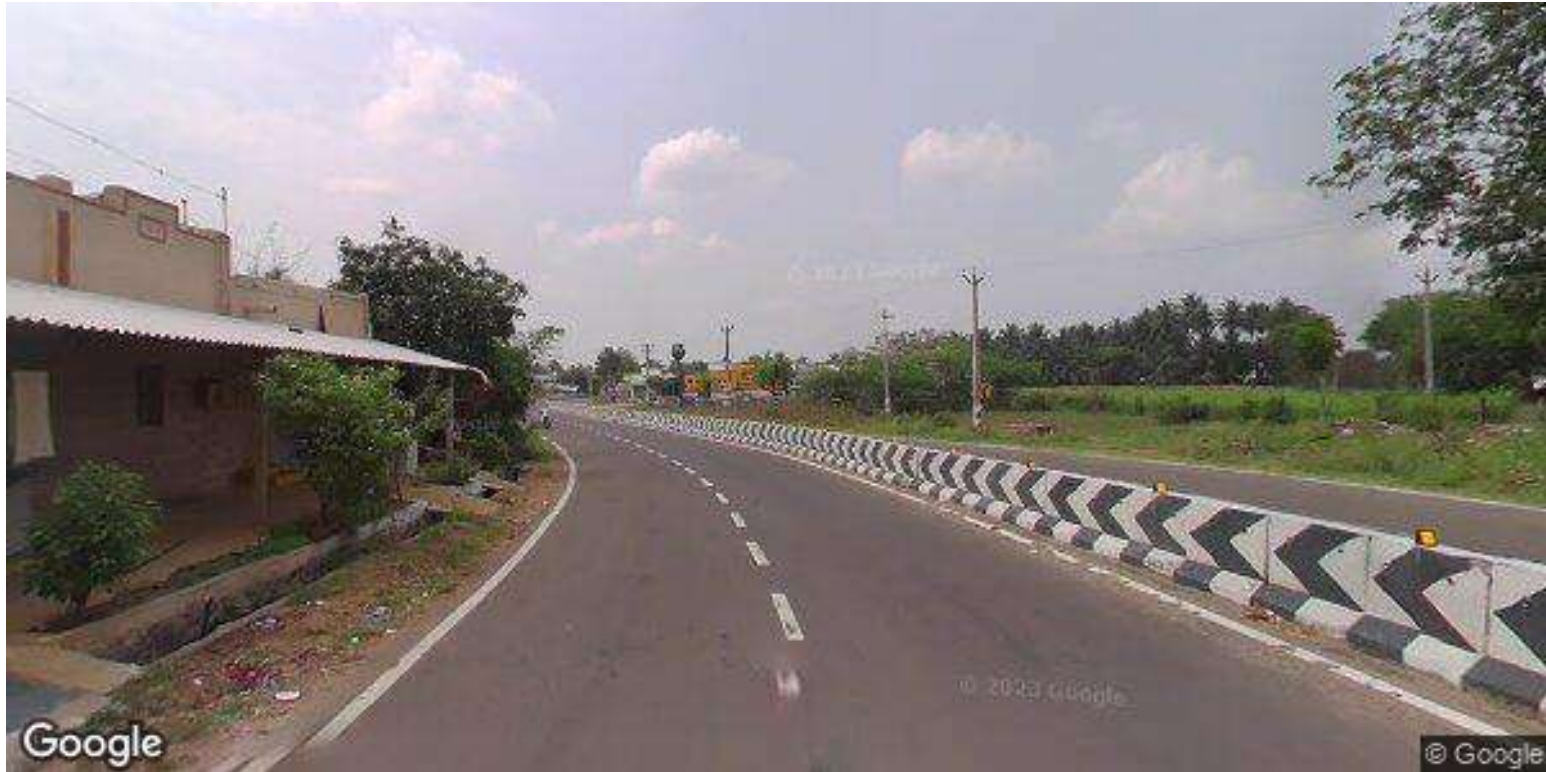
**Coordinates:** 11.22387, 77.71385

**Risk Type:** Turn

**Risk Level:** Medium

**Speed Limit:** 30 KM/Hr

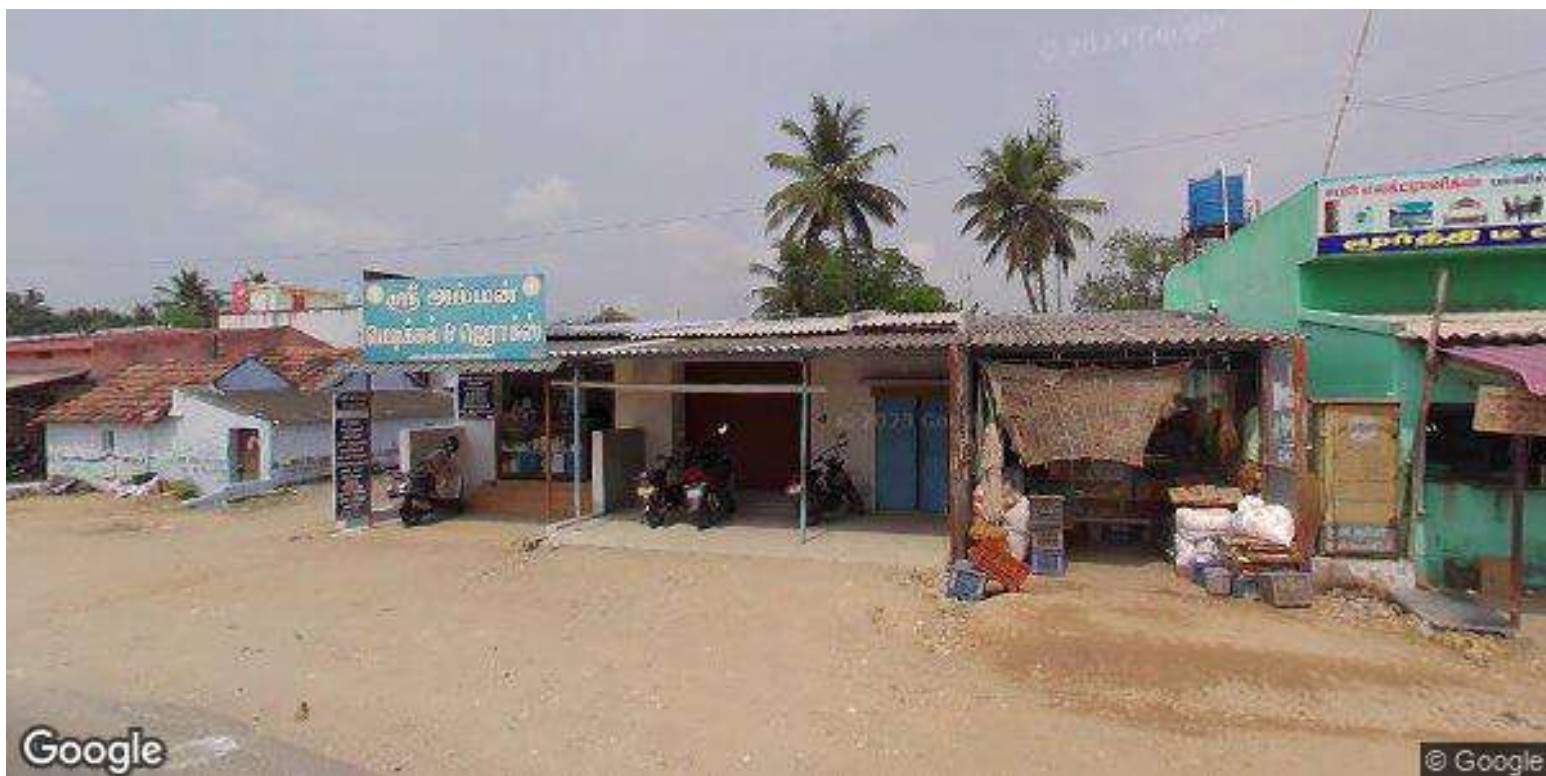
**Coordinates:** 11.20776, 77.70916

**Risk Type:** Turn

**Risk Level:** Medium

**Speed Limit:** 30 KM/Hr

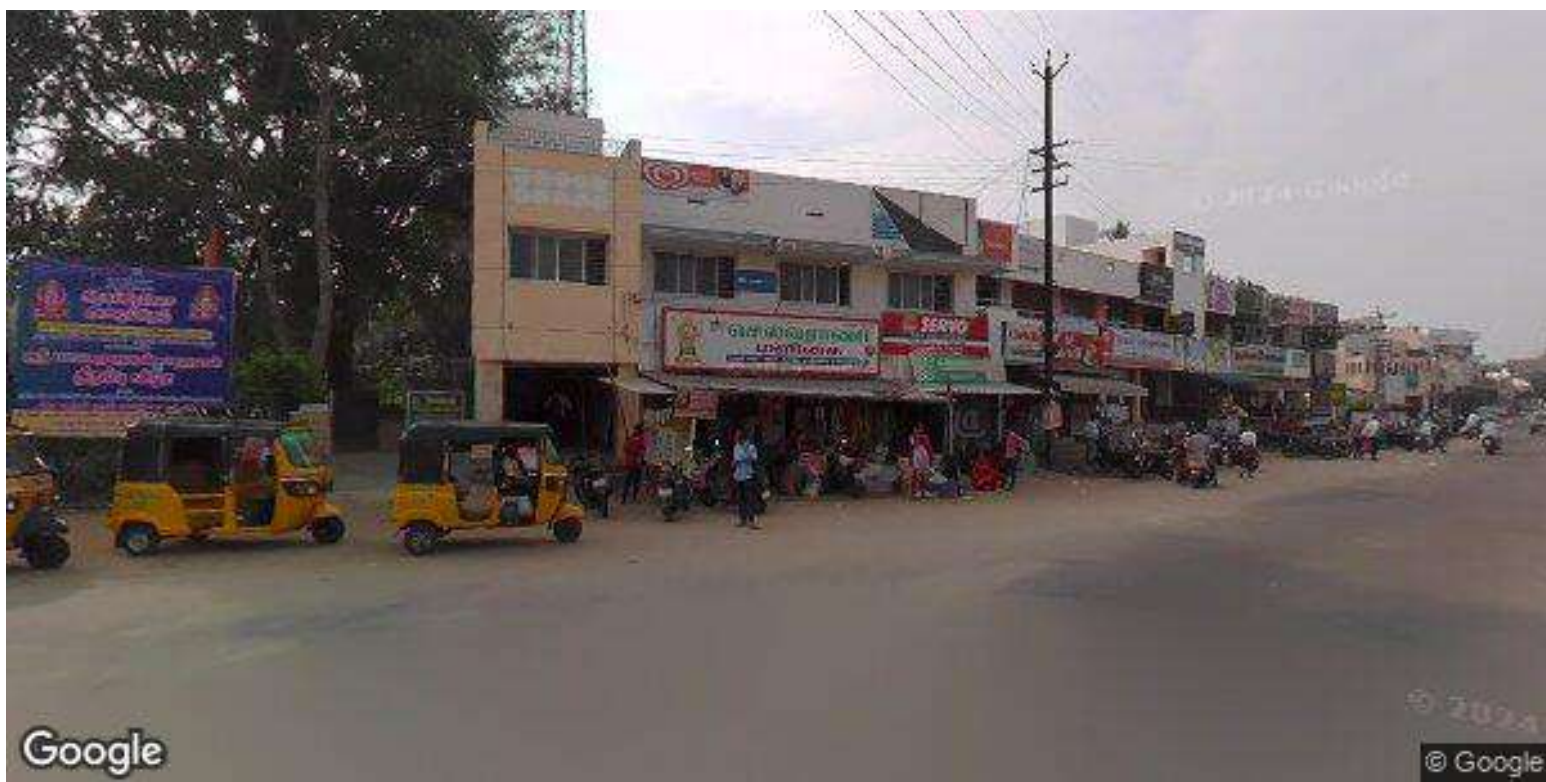
**Coordinates:** 11.15942, 77.70068

**Risk Type:** Turn

**Risk Level:** High

**Speed Limit:** 15 KM/Hr

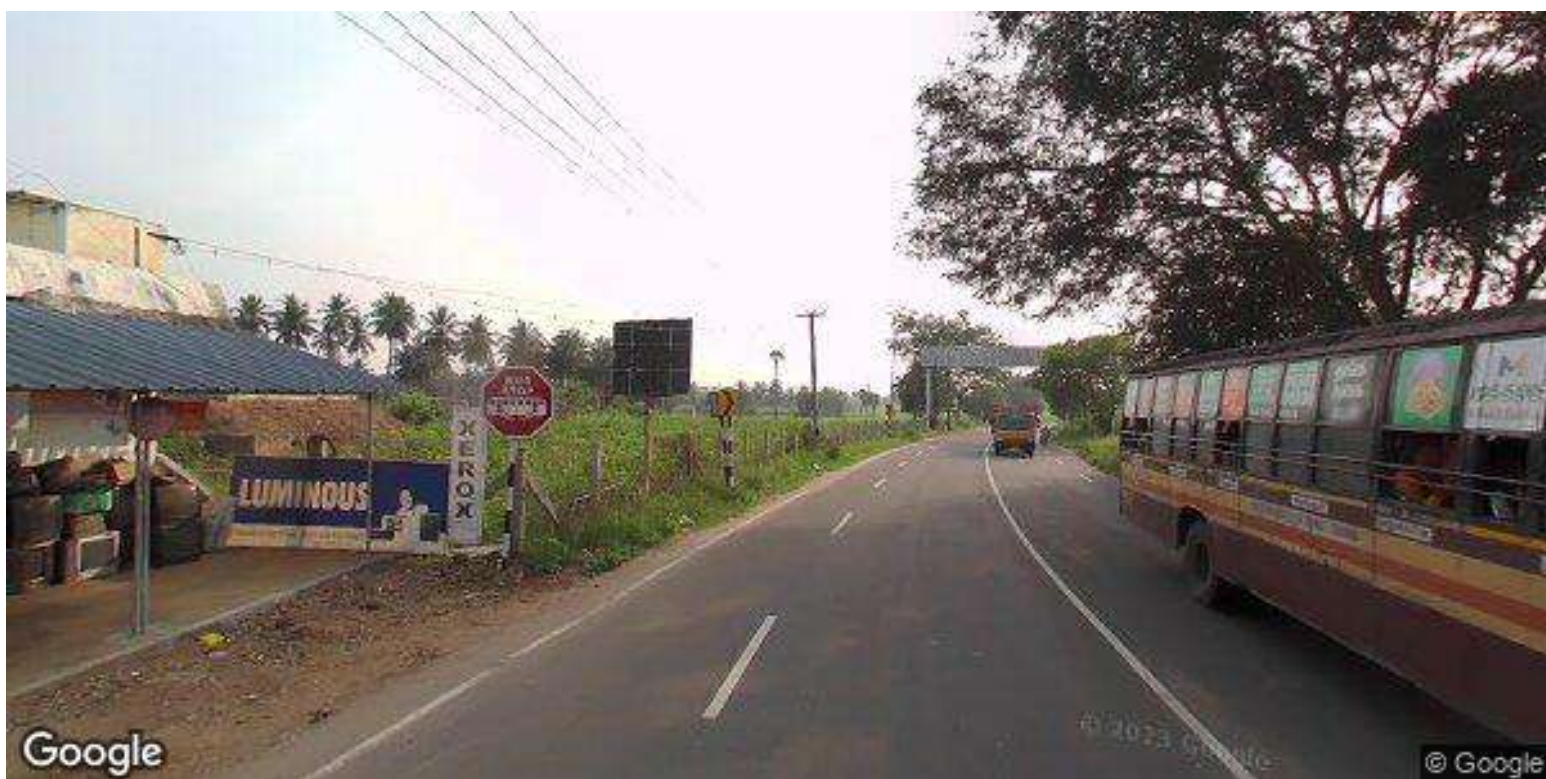
**Coordinates:** 11.12102, 77.67919

**Risk Type:** Turn

**Risk Level:** Medium

**Speed Limit:** 30 KM/Hr

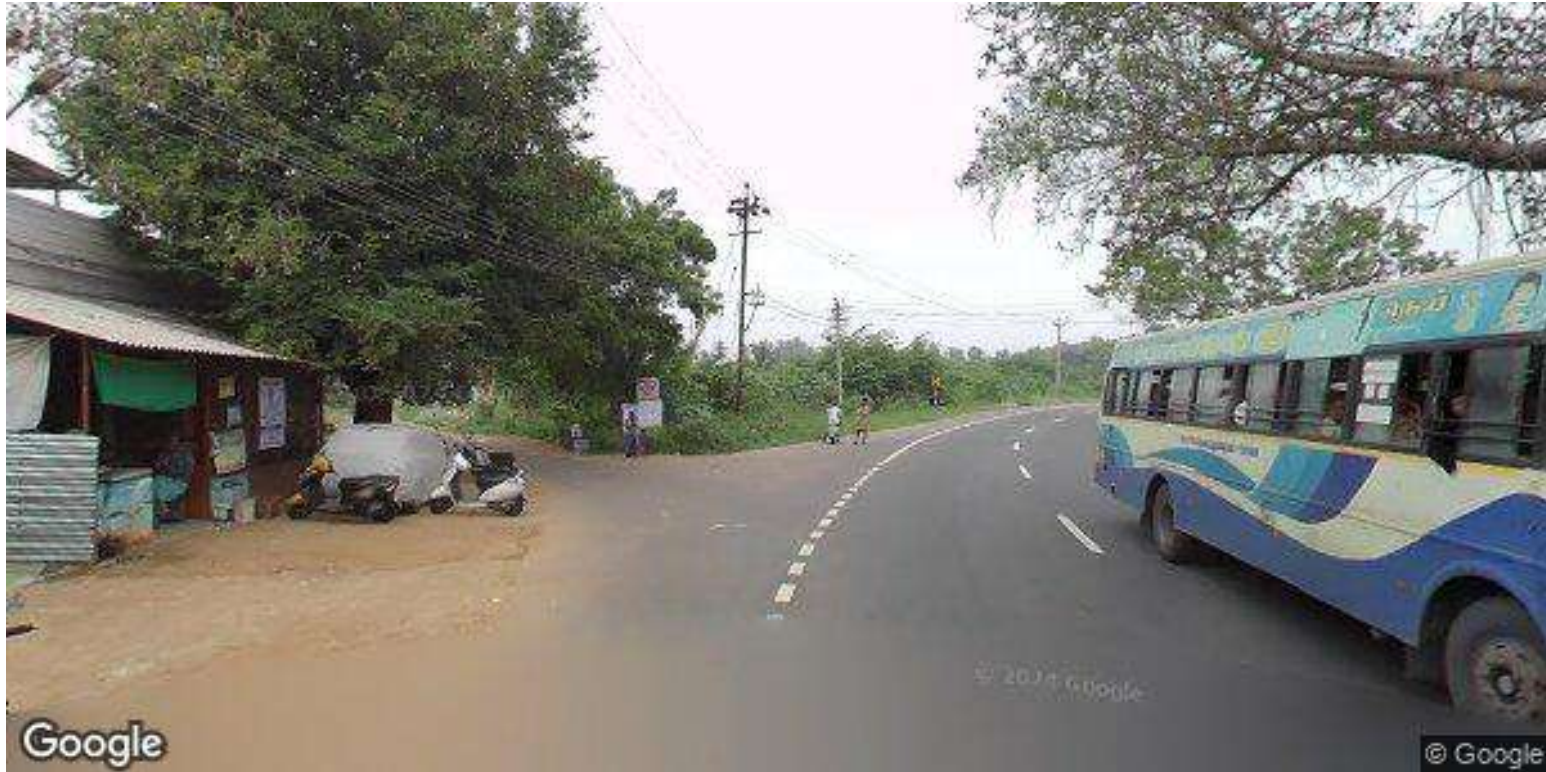
**Risk Type:** Turn  
**Risk Level:** Medium  
**Speed Limit:** 30 KM/Hr  
**Coordinates:** 11.11710, 77.67175

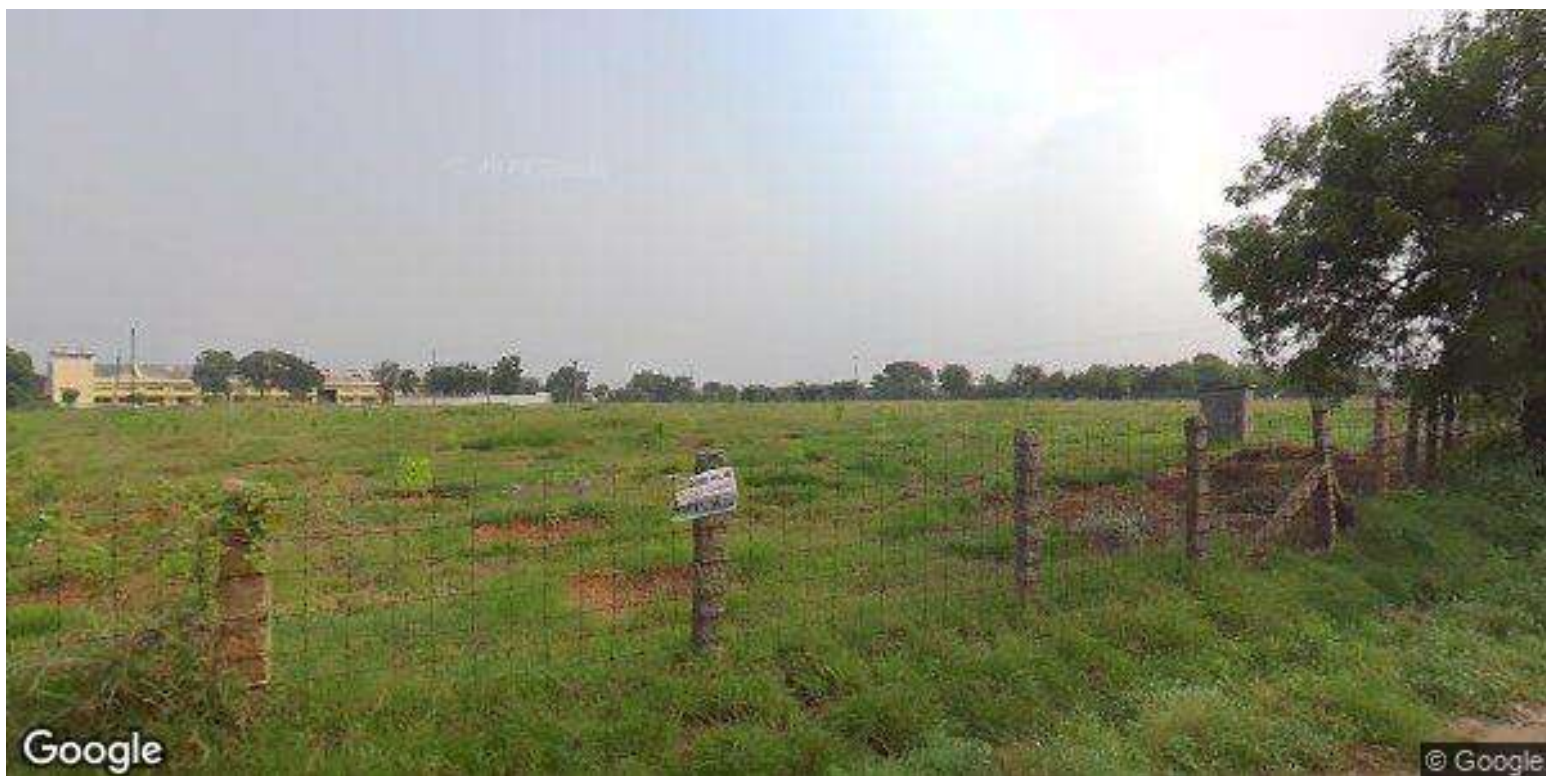
**Risk Type:** Turn  
**Risk Level:** Medium  
**Speed Limit:** 30 KM/Hr  
**Coordinates:** 11.09491, 77.66603

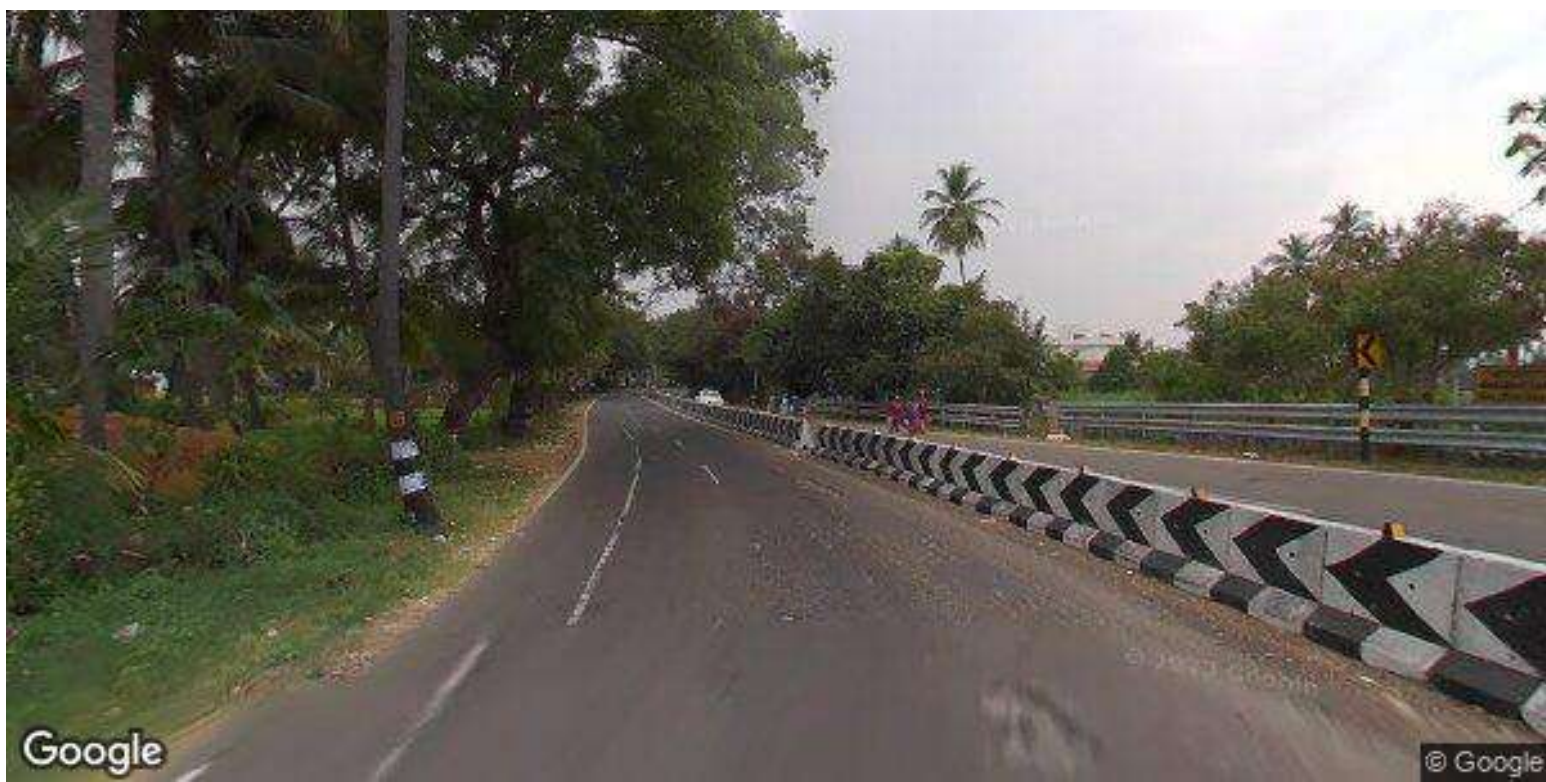
**Coordinates:** 11.08282, 77.65837

**Risk Type:** Turn

**Risk Level:** Medium

**Speed Limit:** 30 KM/Hr
