# IndianOil

## JOURNEY RISK MANAGEMENT (JRM) STUDY

### Salem Terminal to UDAYAM AUTO CARE

### Route Safety Analysis: Sangagiri to Kangeyam

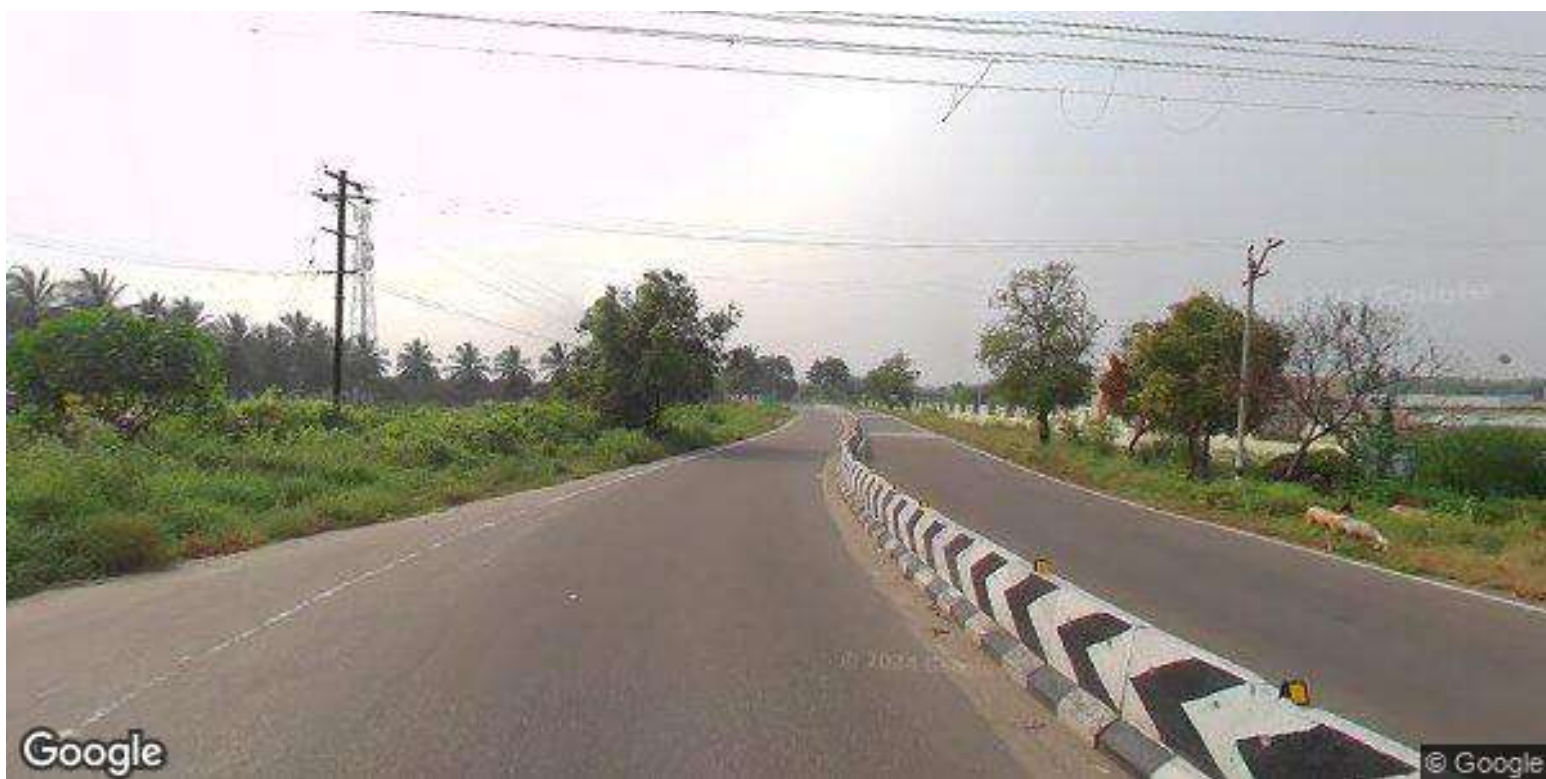
**Coordinates:** 11.06183, 77.63924

**Risk Type:** Turn

**Risk Level:** Medium

**Speed Limit:** 30 KM/Hr

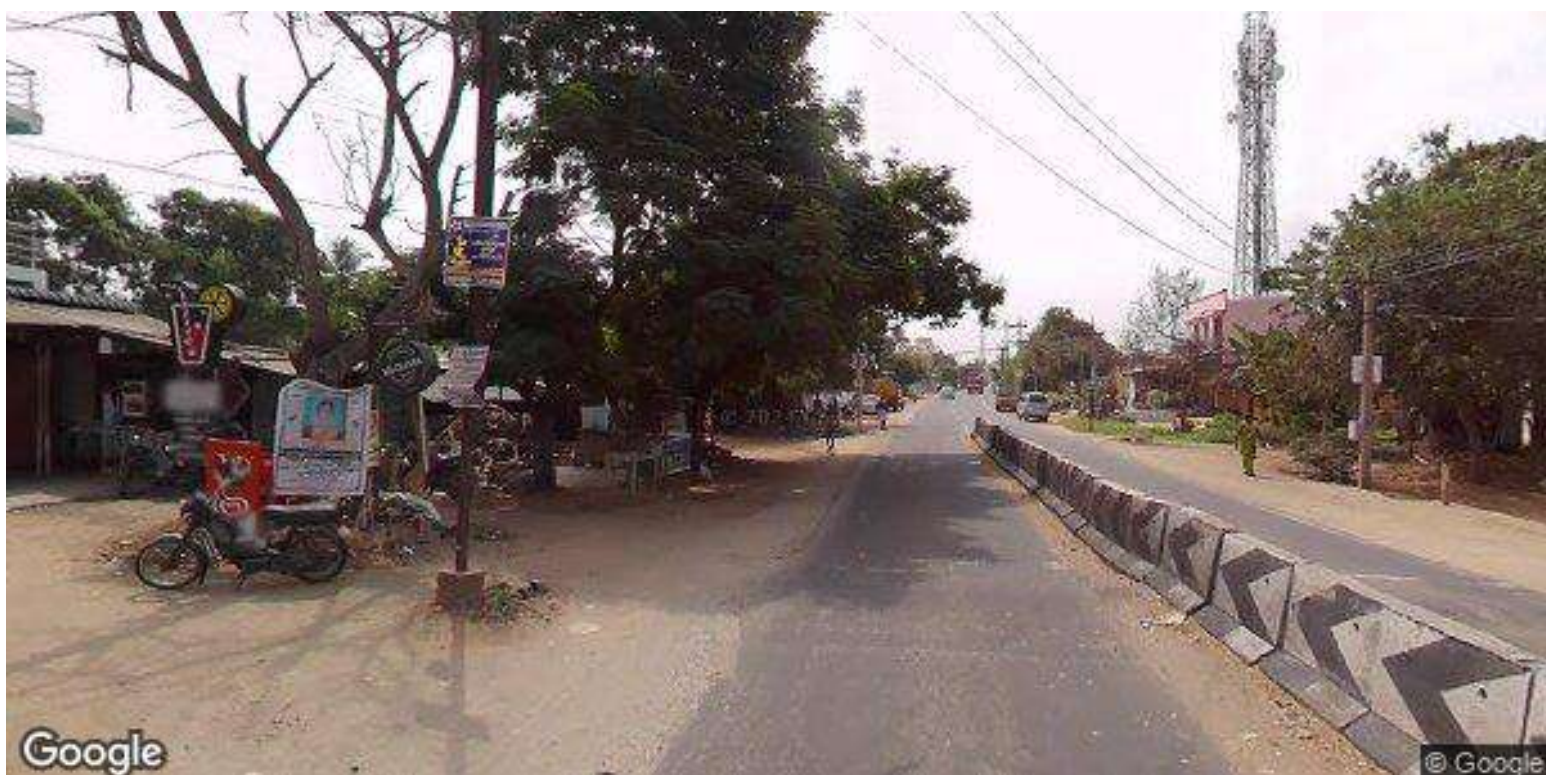
**Coordinates:** 11.00826, 77.56962

**Risk Type:** Turn

**Risk Level:** High

**Speed Limit:** 15 KM/Hr

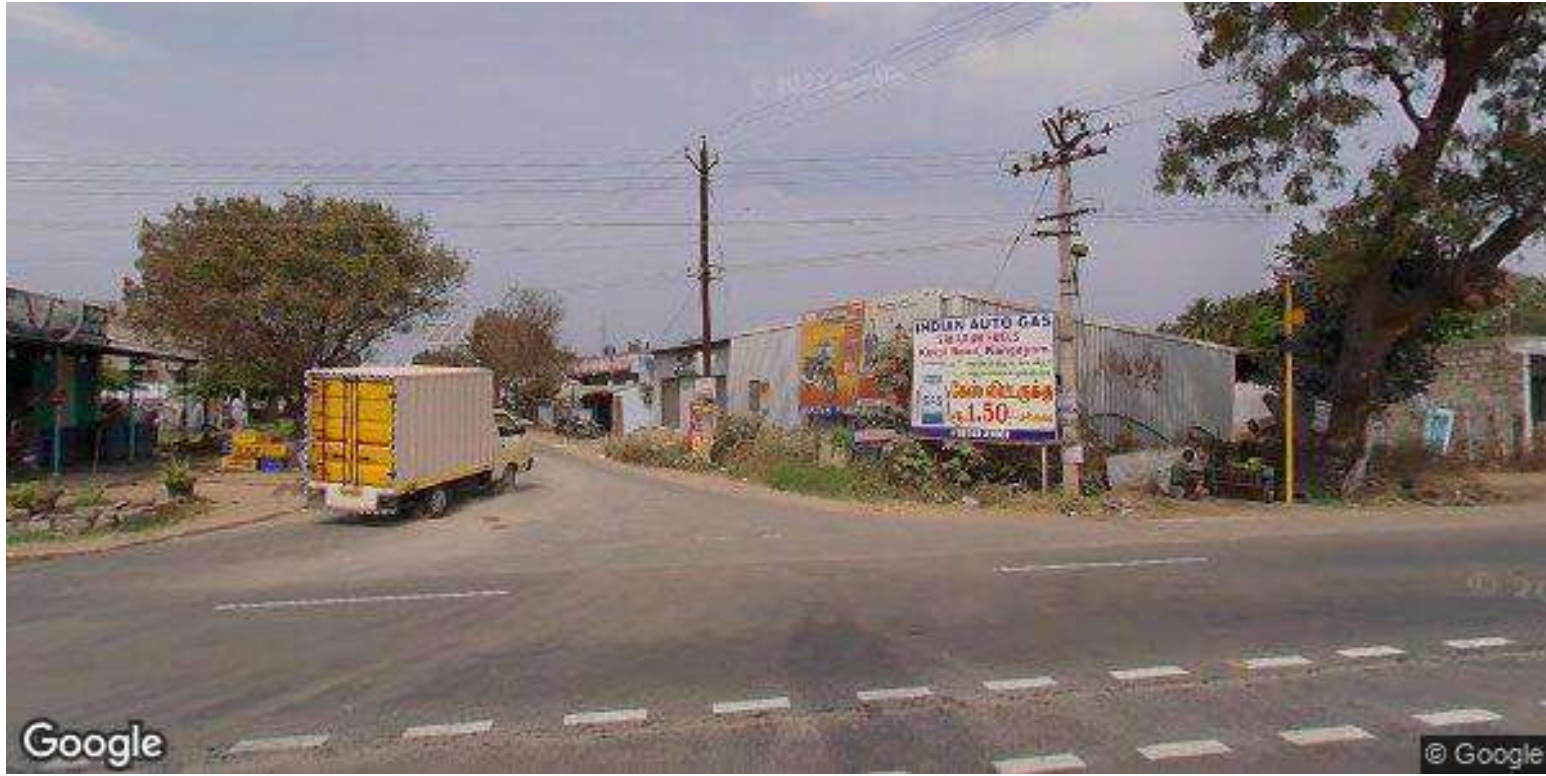
**Coordinates:** 11.00058, 77.56882

**Risk Type:** Blind Spot

**Risk Level:** Blind Spot

**Speed Limit:** 10 KM/Hr

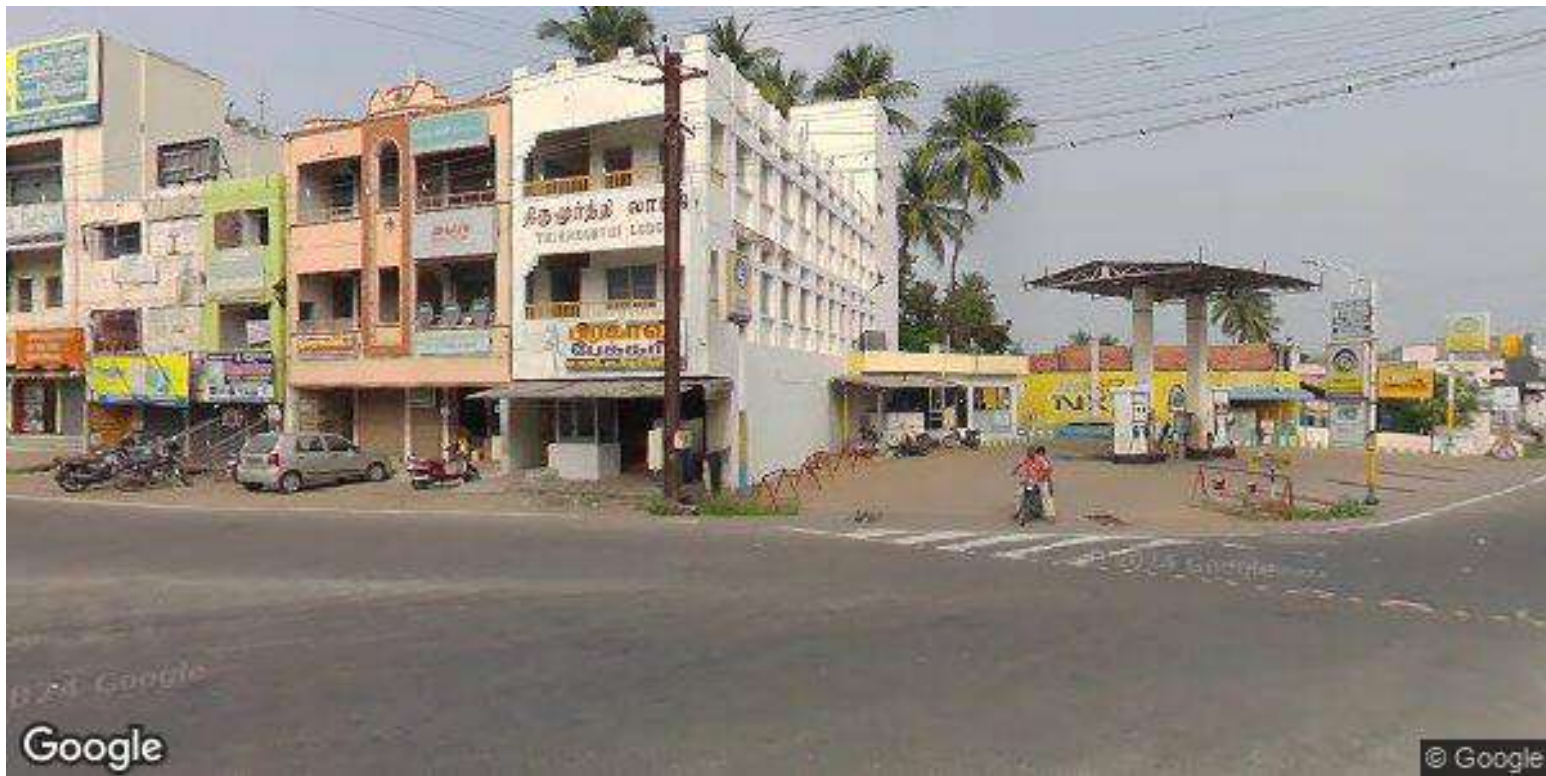
**Coordinates:** 11.00172, 77.56268

**Risk Type:** Turn

**Risk Level:** High

**Speed Limit:** 15 KM/Hr

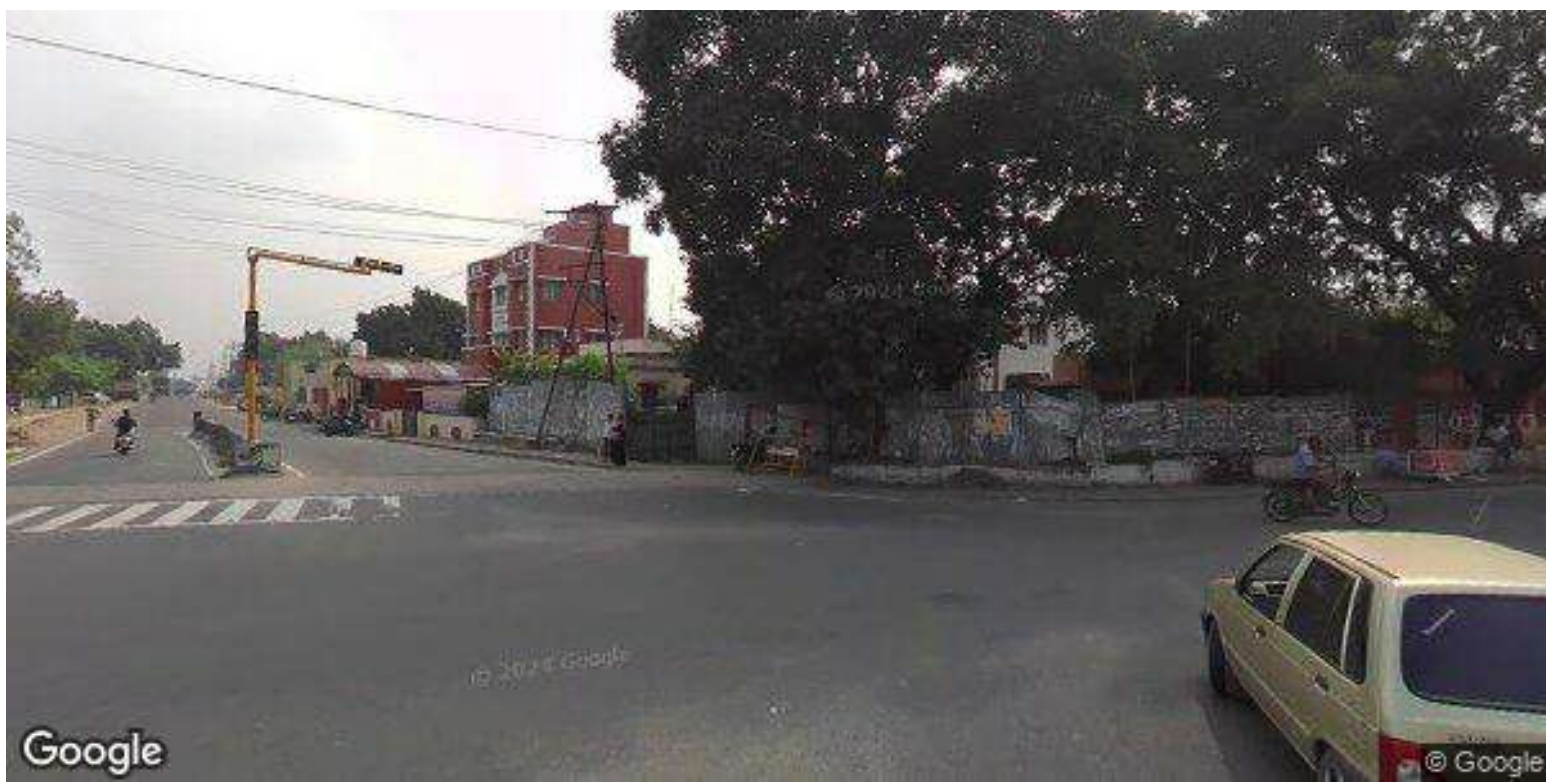
**Coordinates:** 11.00170, 77.56267

**Risk Type:** Turn

**Risk Level:** Medium

**Speed Limit:** 30 KM/Hr

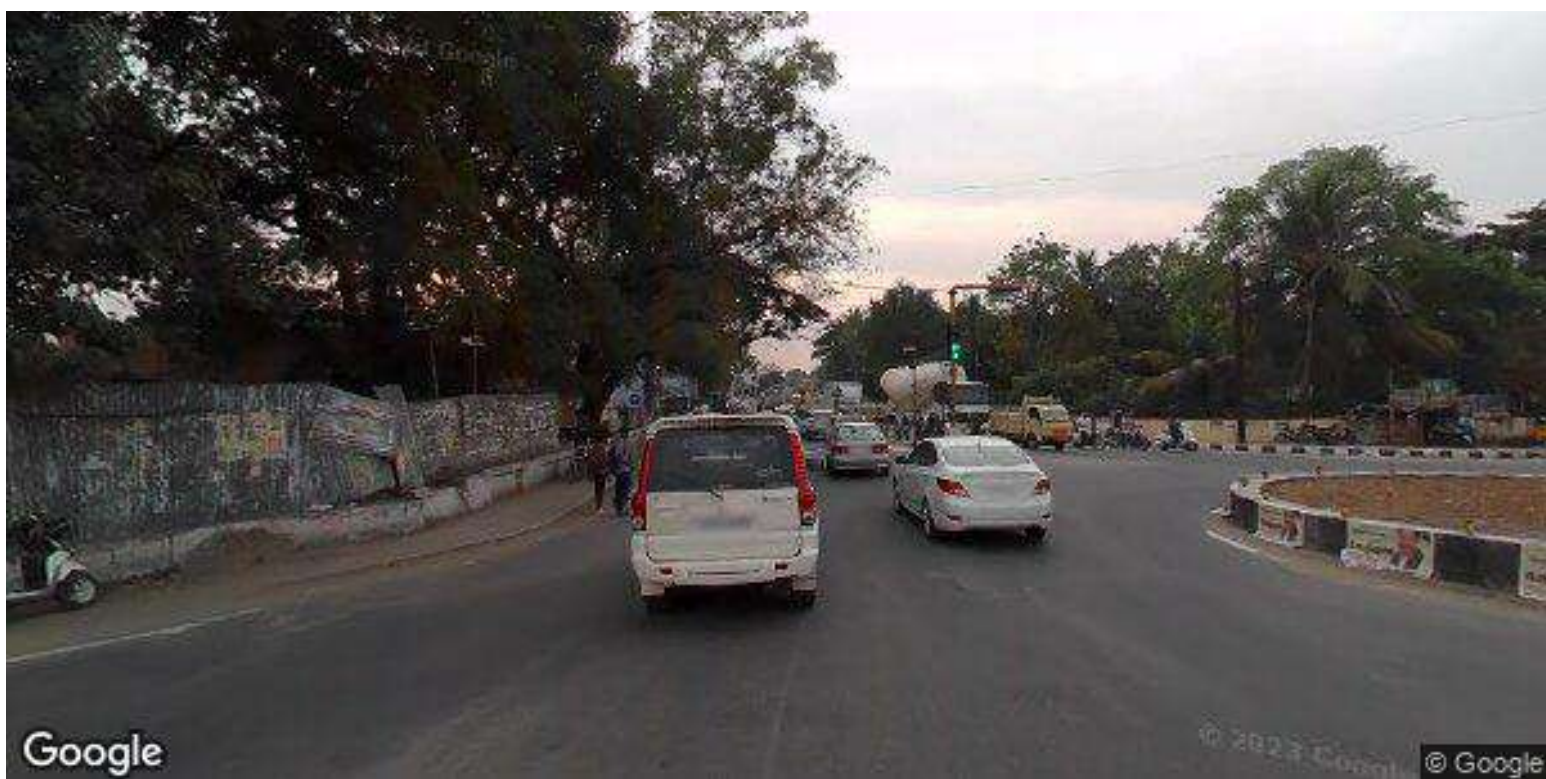
**Coordinates:** 11.00168, 77.56264

**Risk Type:** Turn

**Risk Level:** Medium

**Speed Limit:** 30 KM/Hr

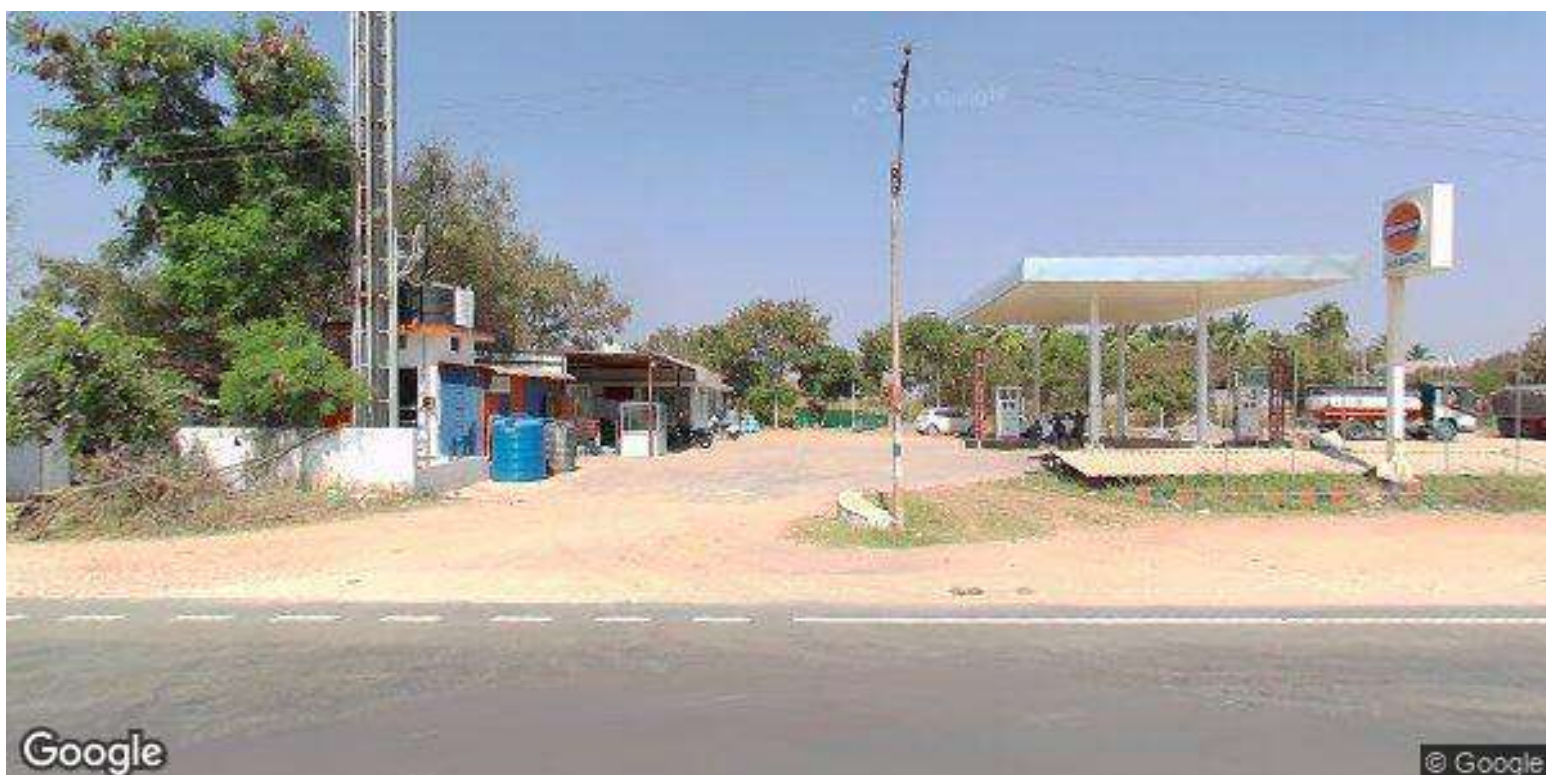
**Coordinates:** 10.99763, 77.54603

**Risk Type:** Turn

**Risk Level:** High

**Speed Limit:** 15 KM/Hr
