# IndianOil

## JOURNEY RISK MANAGEMENT (JRM) STUDY

### Salem Terminal to ALAMU AGENCIES

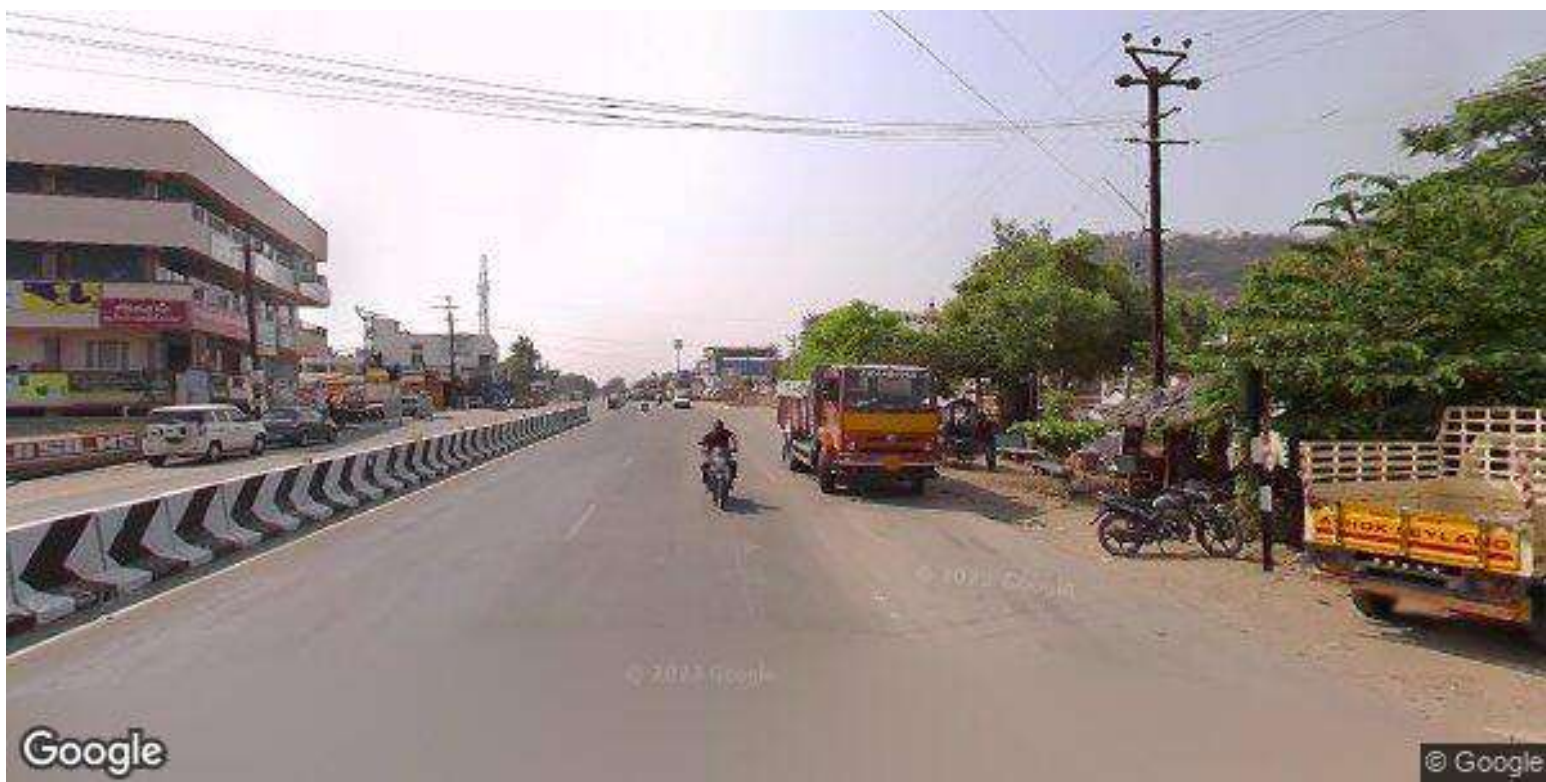
**Coordinates:** 11.39685, 77.88861

**Risk Type:** Turn

**Risk Level:** Medium

**Speed Limit:** 30 KM/Hr

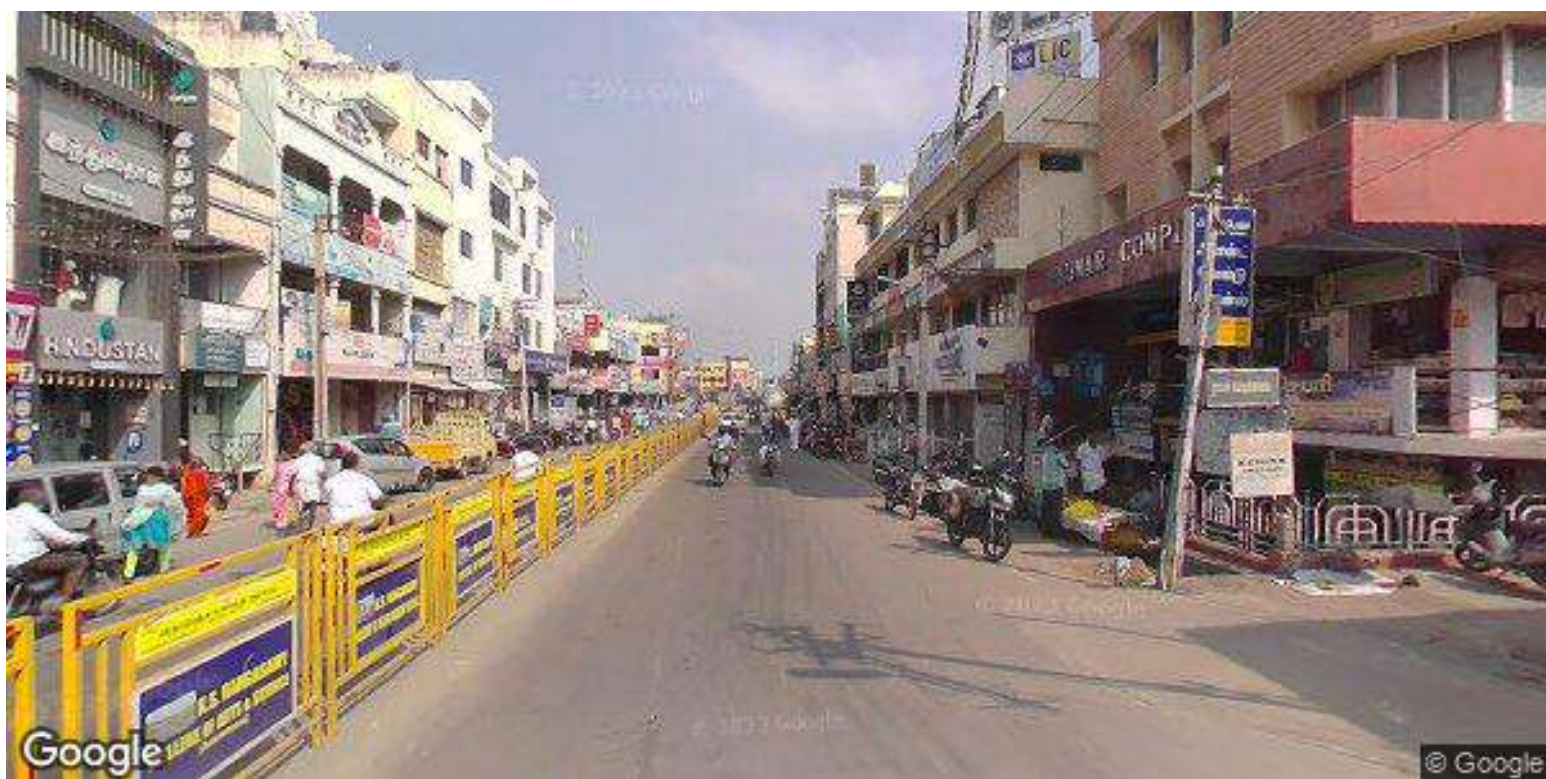
**Coordinates:** 11.37902, 77.89500

**Risk Type:** Turn

**Risk Level:** Medium

**Speed Limit:** 30 KM/Hr

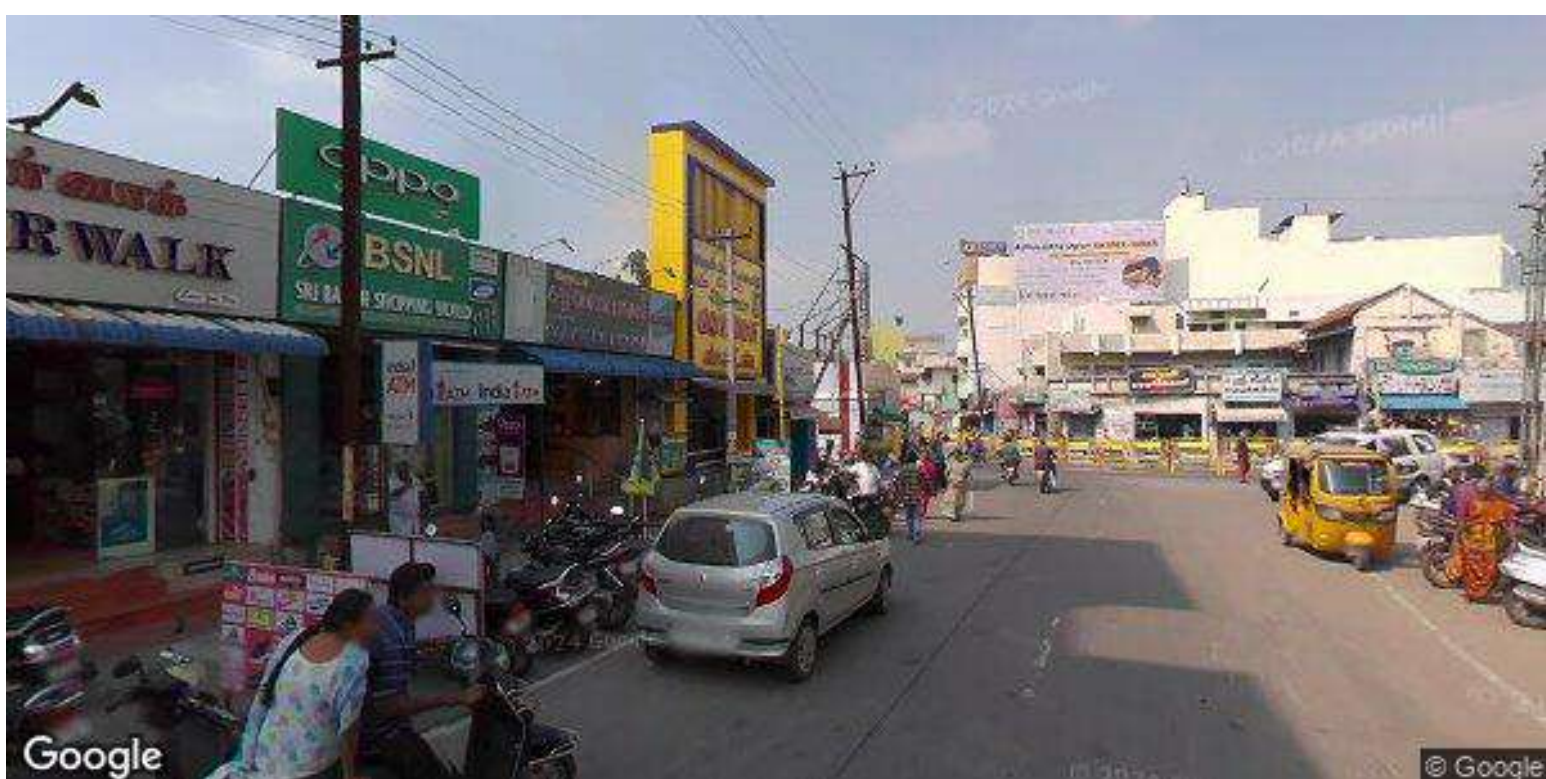
**Risk Type:** Turn  
**Risk Level:** High  
**Speed Limit:** 15 KM/Hr  
**Coordinates:** 11.37862, 77.89524

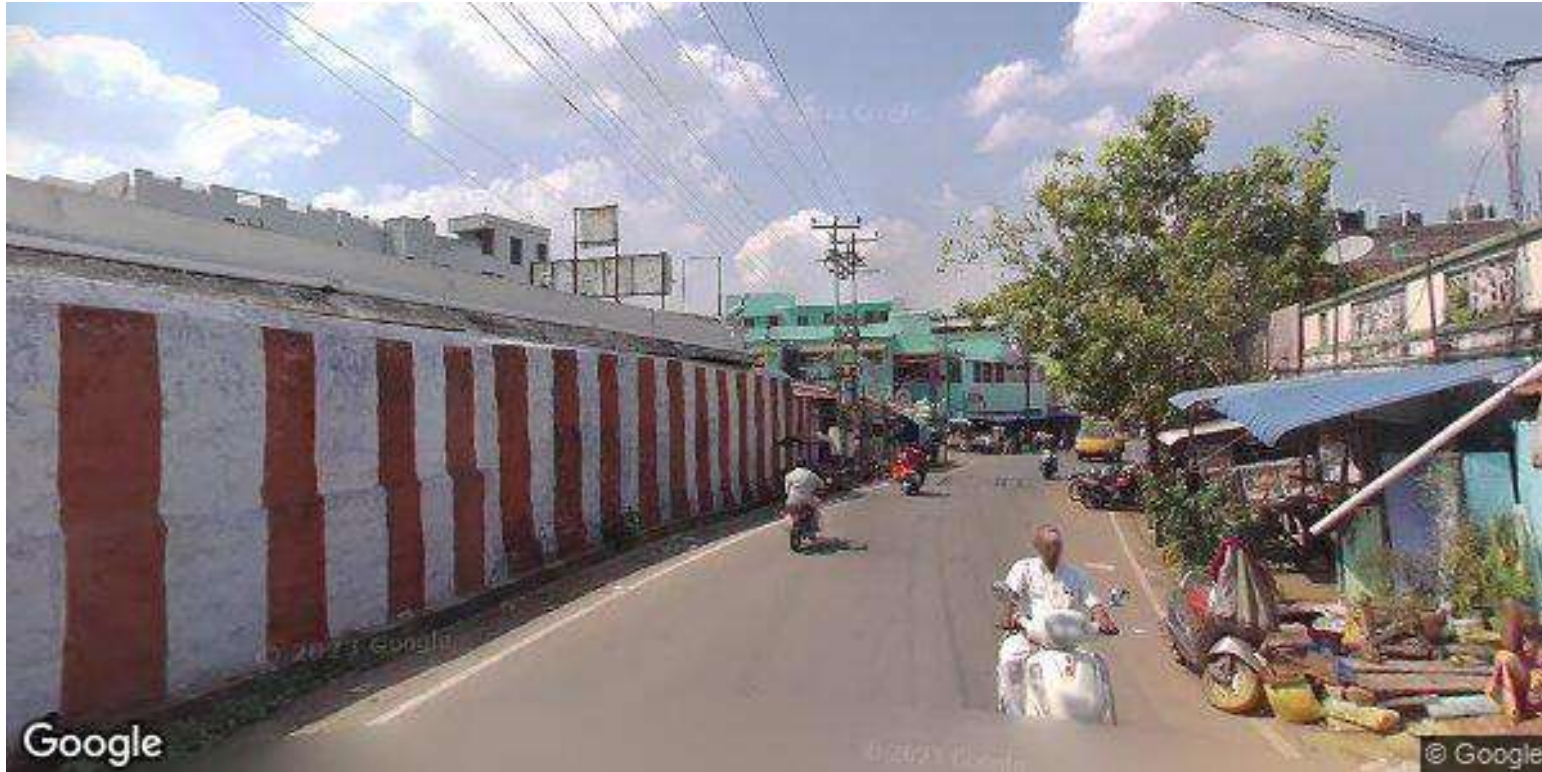
**Risk Type:** Turn  
**Risk Level:** Medium  
**Speed Limit:** 30 KM/Hr  
**Coordinates:** 11.37809, 77.89834

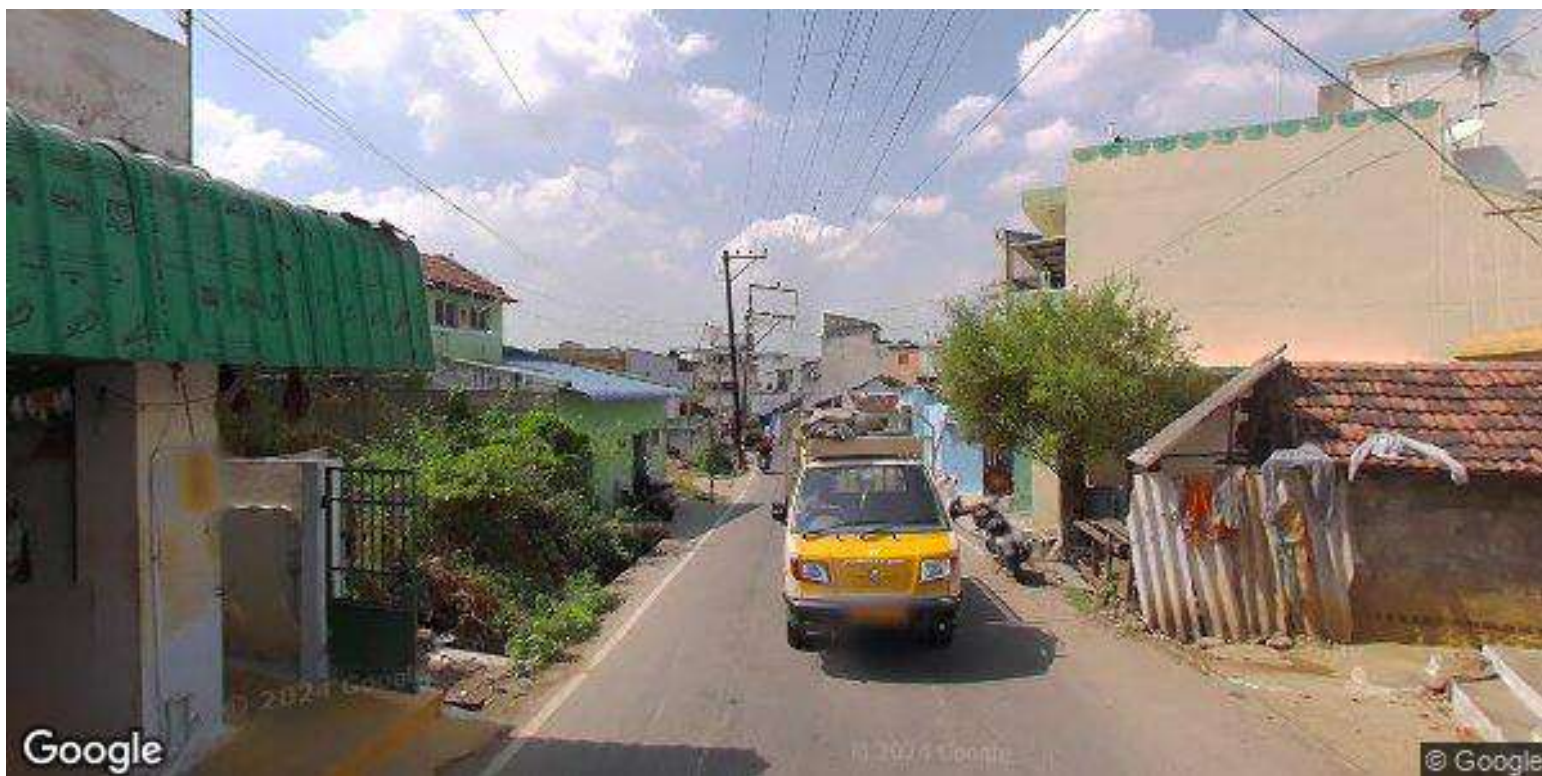
**Risk Type:** Turn  
**Risk Level:** Medium  
**Speed Limit:** 30 KM/Hr  
**Coordinates:** 11.37885, 77.89989

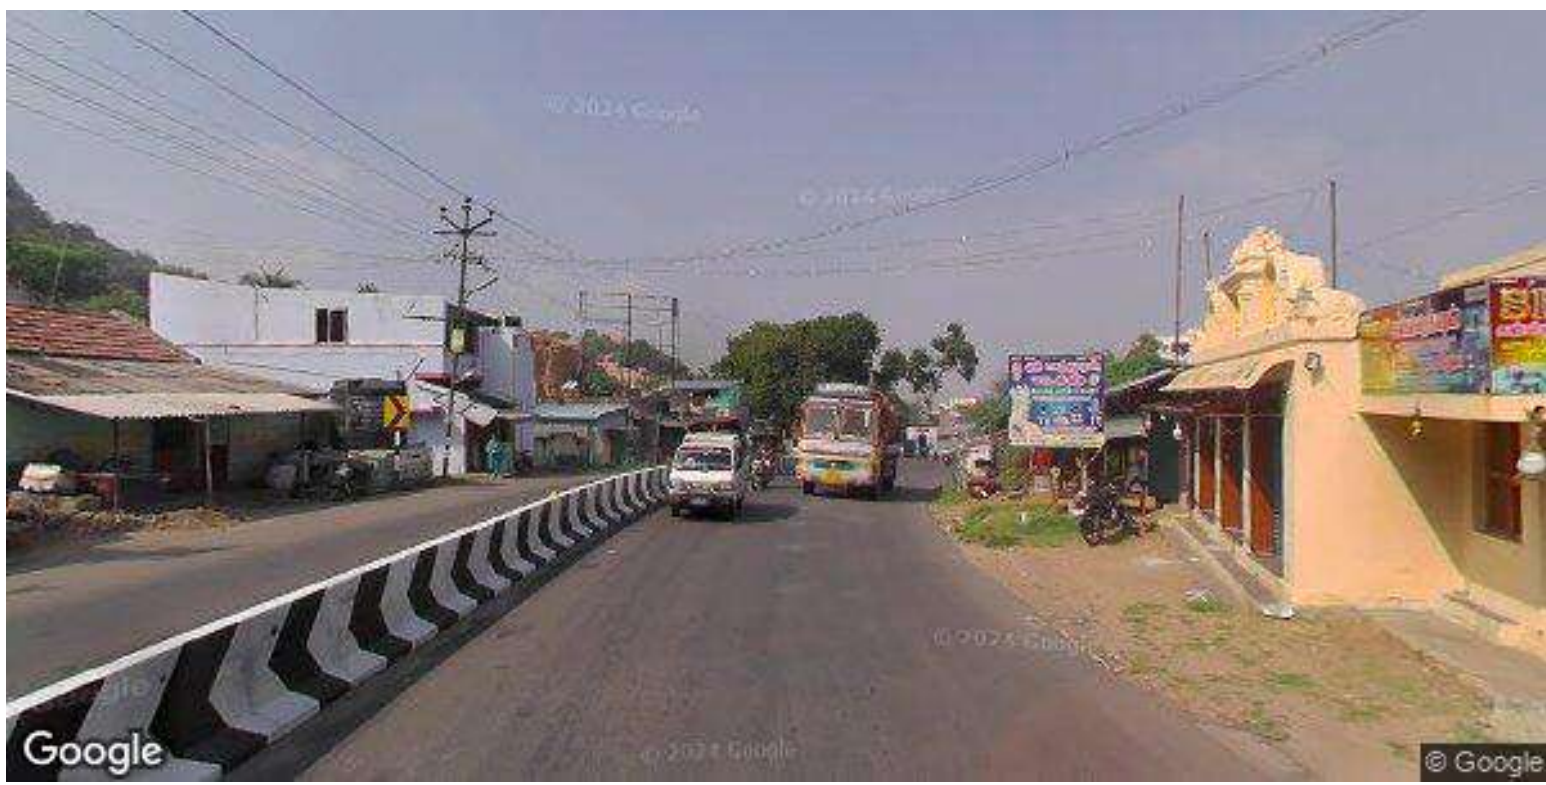
**Coordinates:** 11.37820, 77.90220

**Risk Type:** Turn

**Risk Level:** Medium

**Speed Limit:** 30 KM/Hr

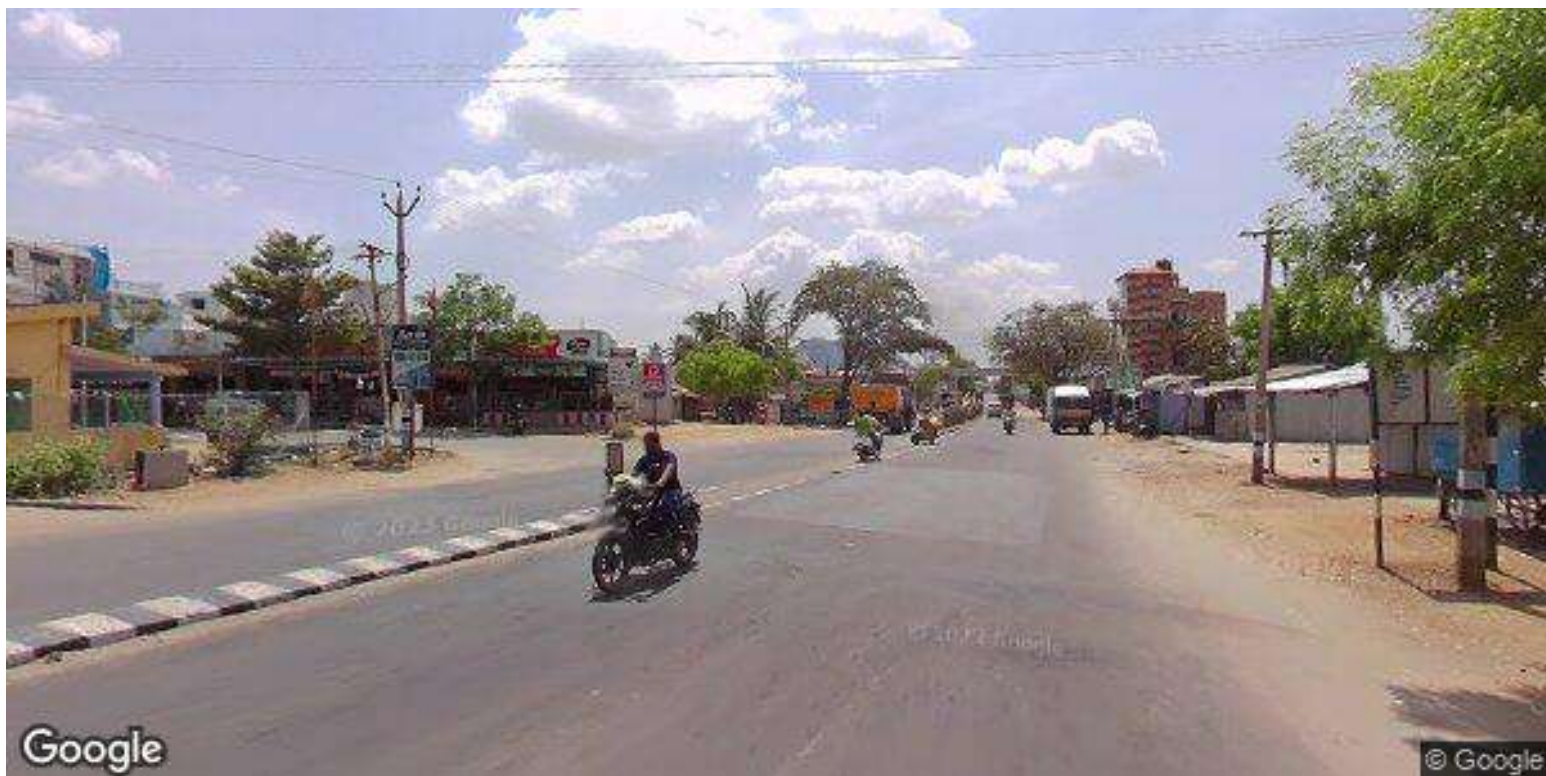
**Coordinates:** 11.36748, 77.93938

**Risk Type:** Turn

**Risk Level:** Medium

**Speed Limit:** 30 KM/Hr

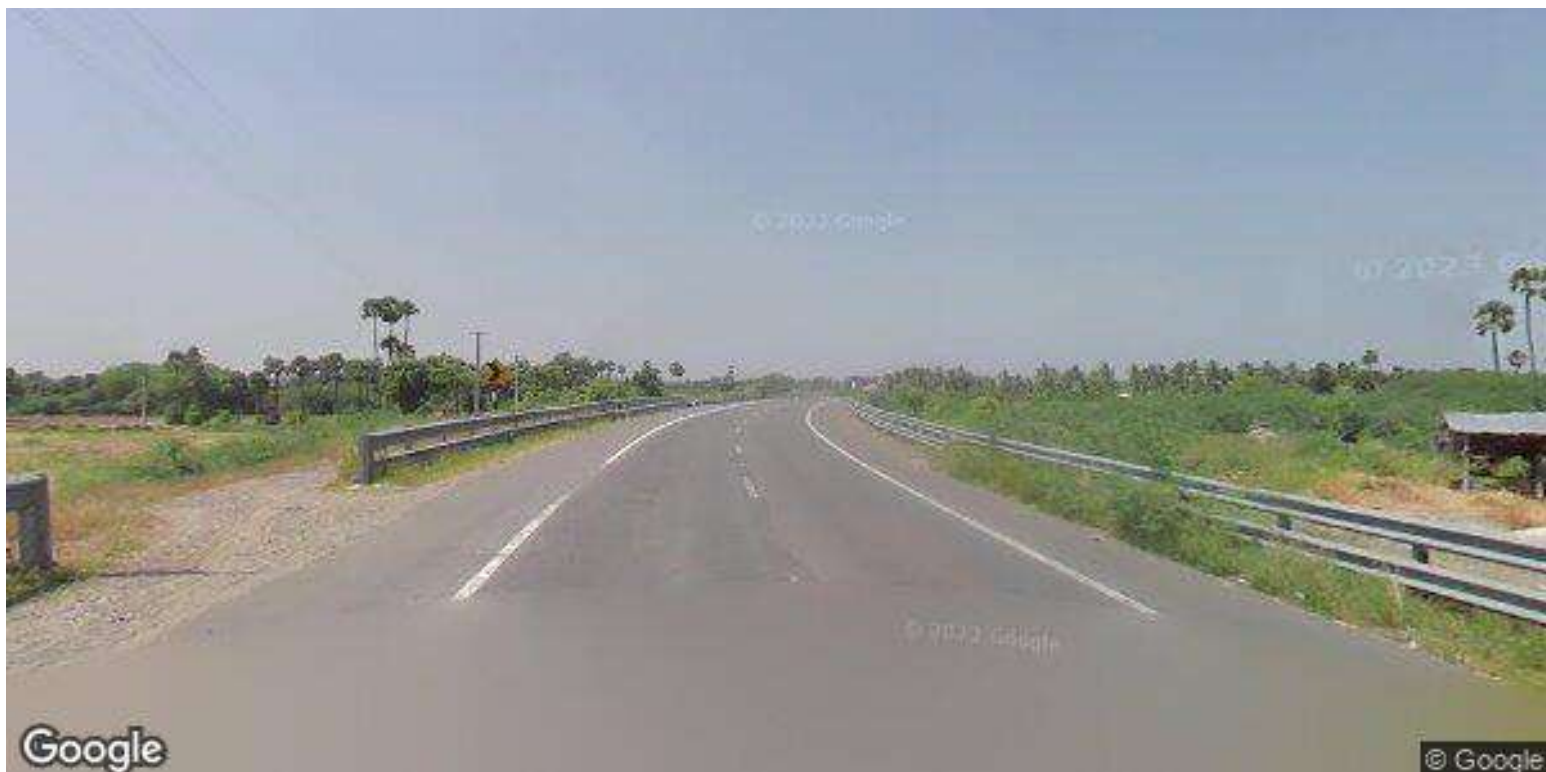
**Coordinates: 11.38968, 78.02925**

**Risk Type: Turn**

**Risk Level: Medium**

**Speed Limit: 30 KM/Hr**

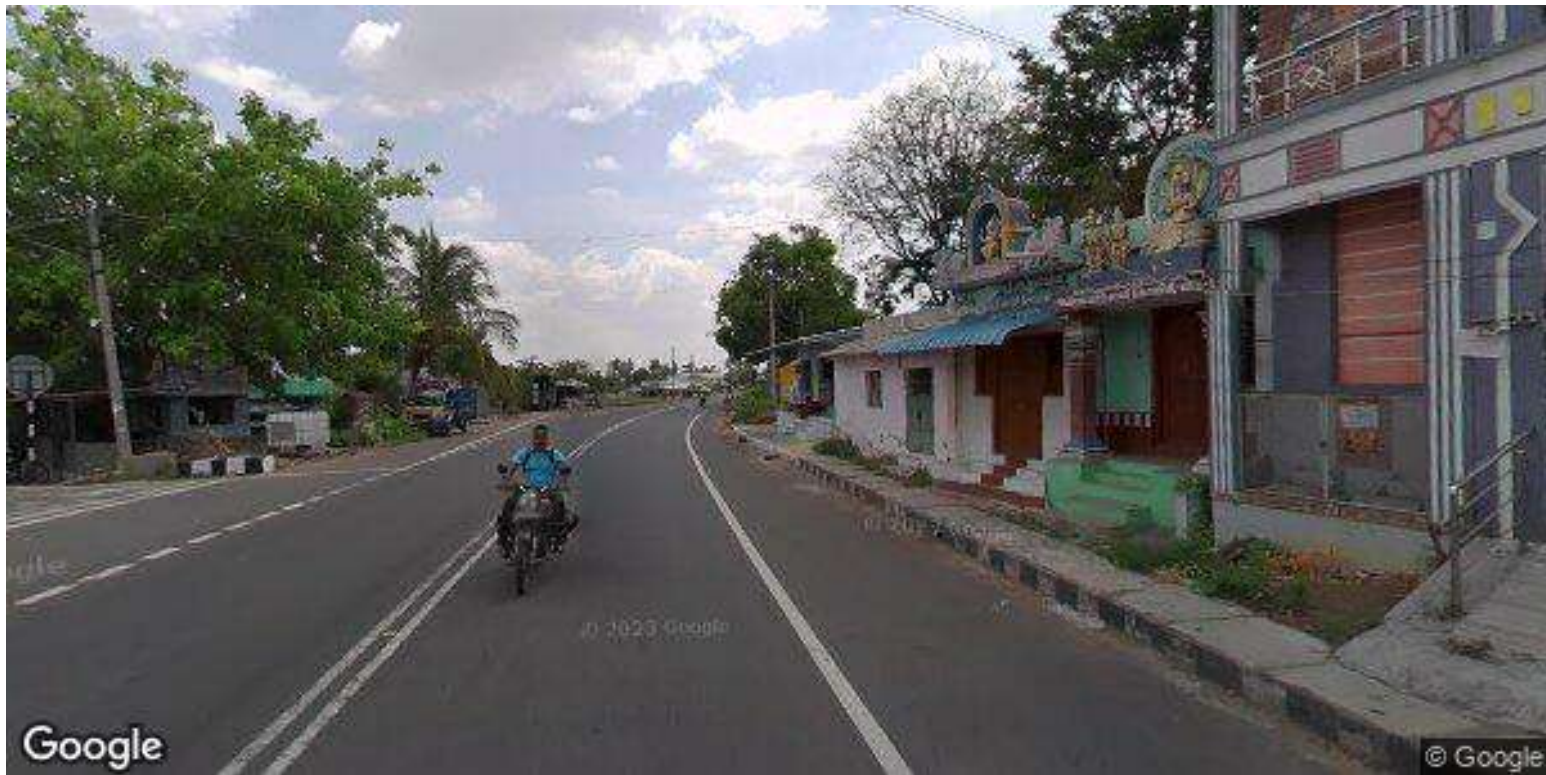
**Coordinates: 11.41288, 78.08045**

**Risk Type: Turn**

**Risk Level: Medium**

**Speed Limit: 30 KM/Hr**

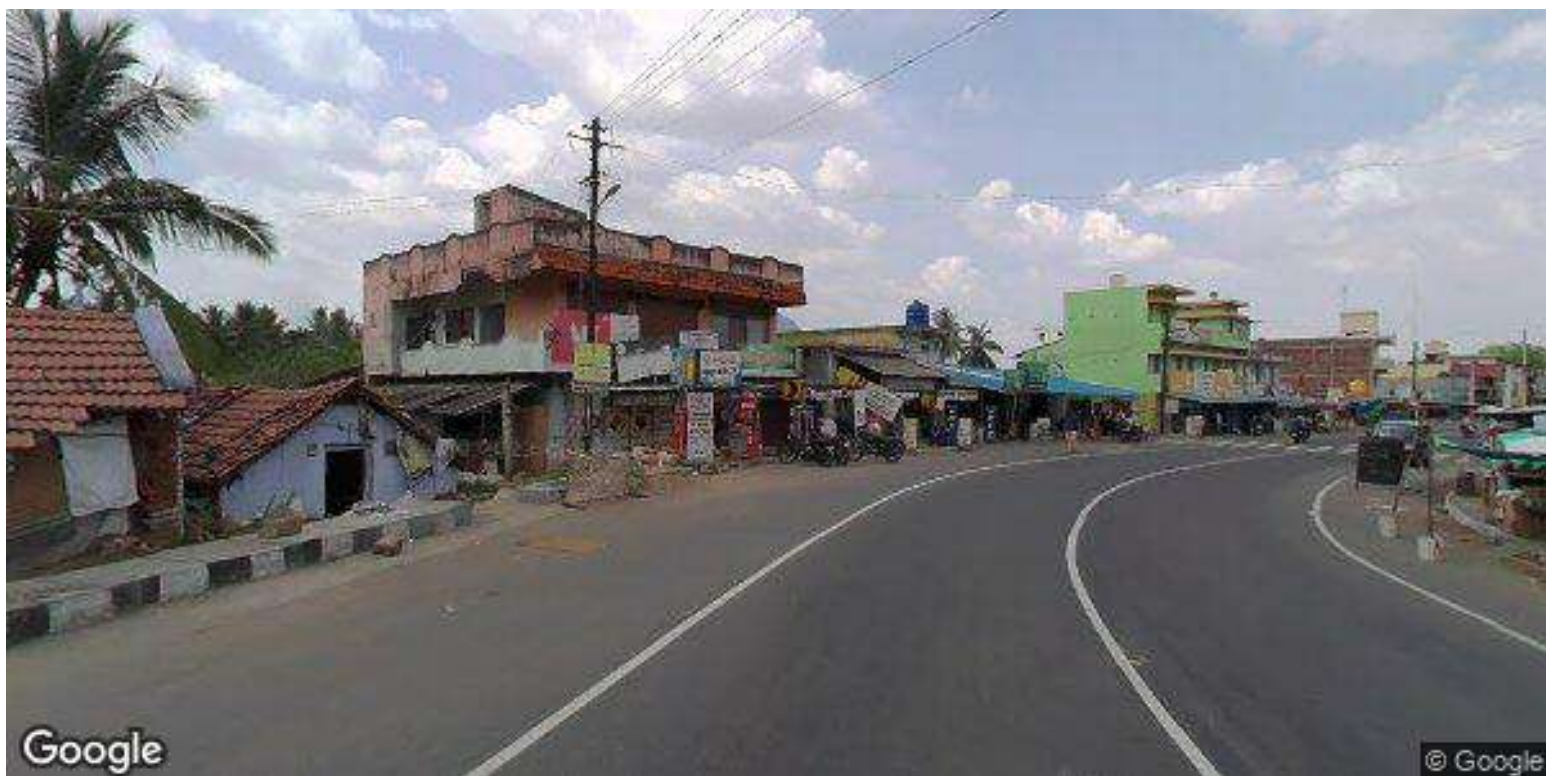
**Coordinates: 11.41466, 78.08070**

**Risk Type: Turn**

**Risk Level: High**

**Speed Limit: 15 KM/Hr**

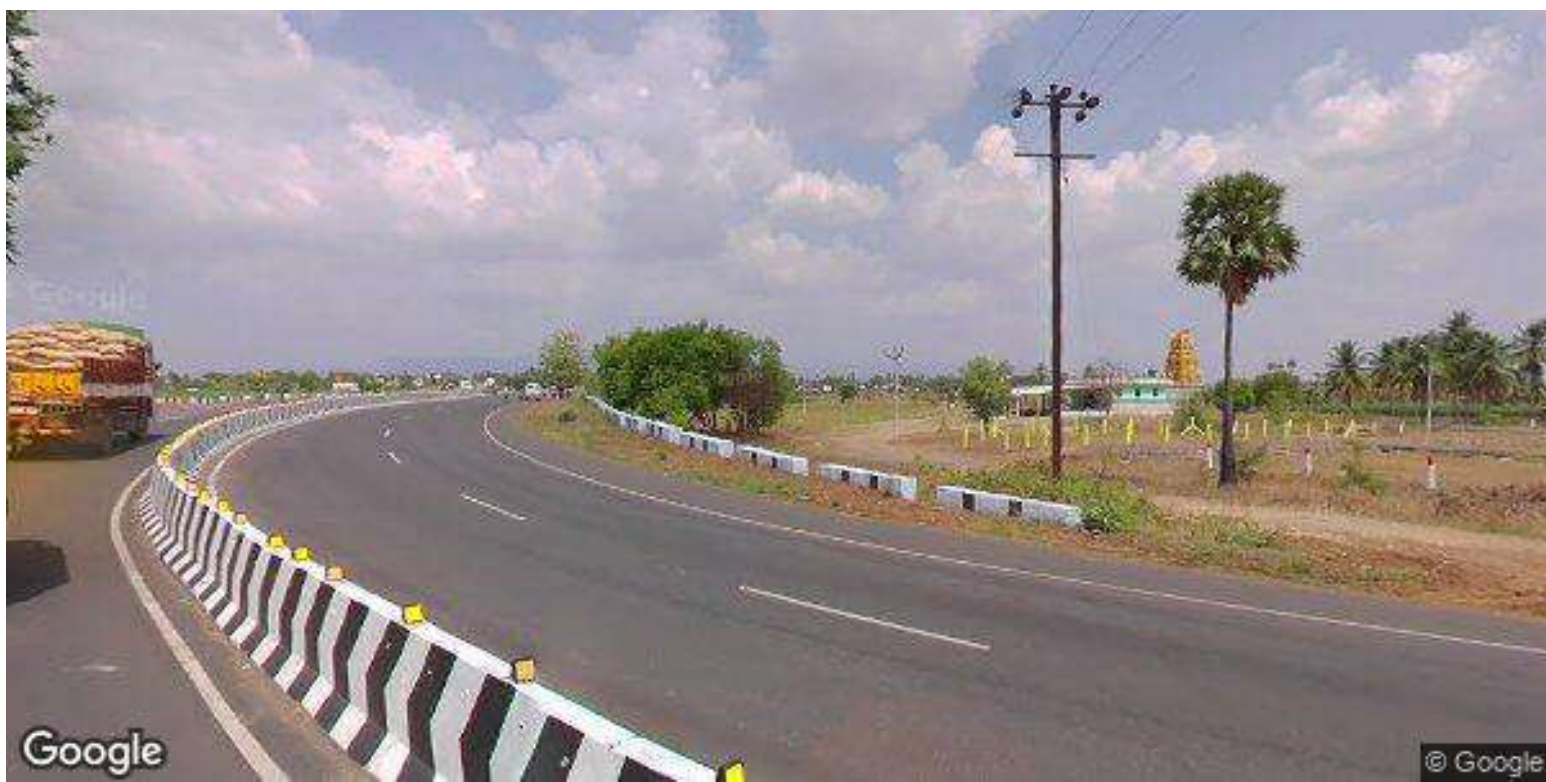
**Coordinates:** 11.43253, 78.12084

**Risk Type:** Turn

**Risk Level:** High

**Speed Limit:** 15 KM/Hr

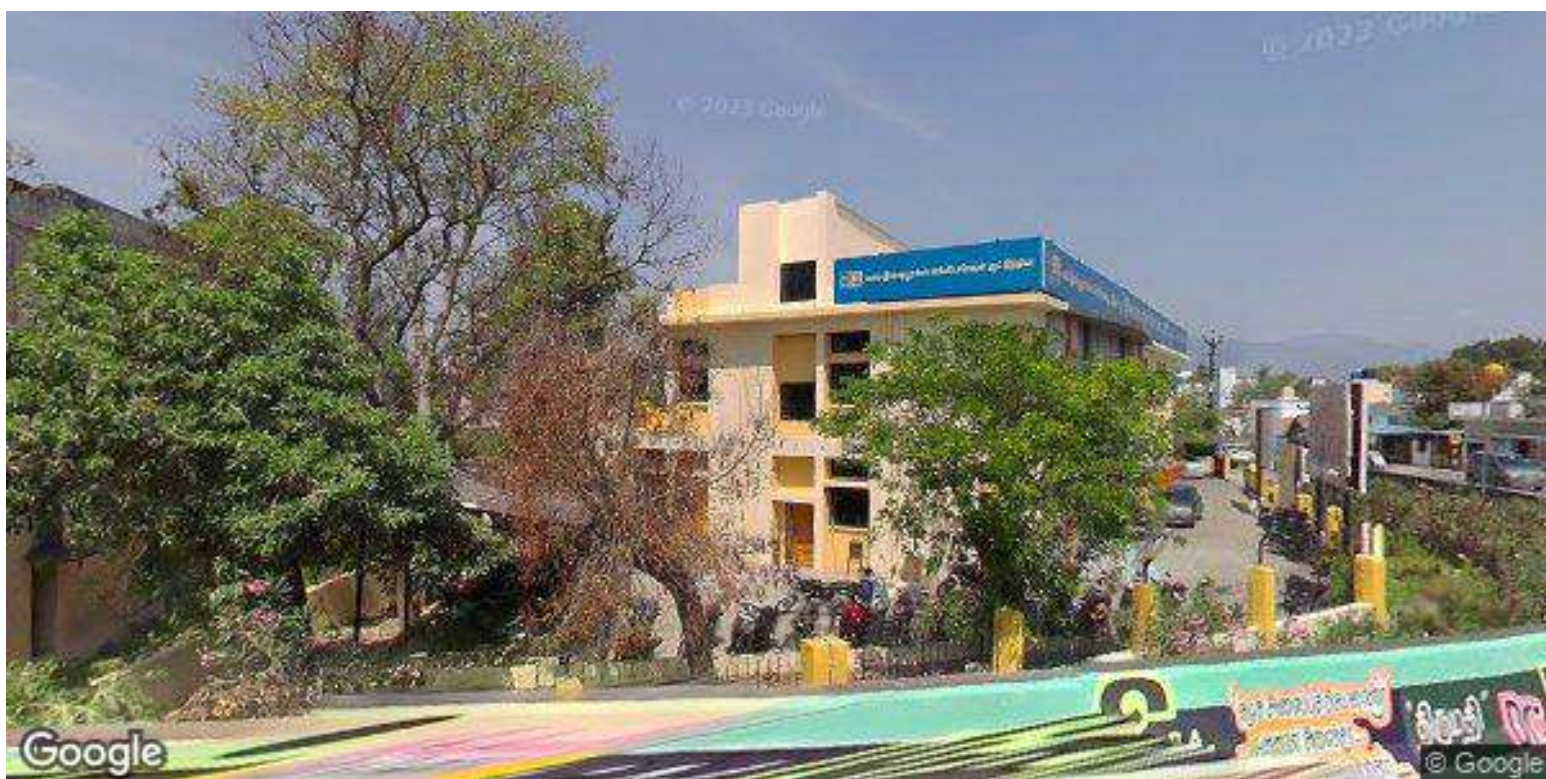
**Coordinates:** 11.45587, 78.18054

**Risk Type:** Turn

**Risk Level:** High

**Speed Limit:** 15 KM/Hr

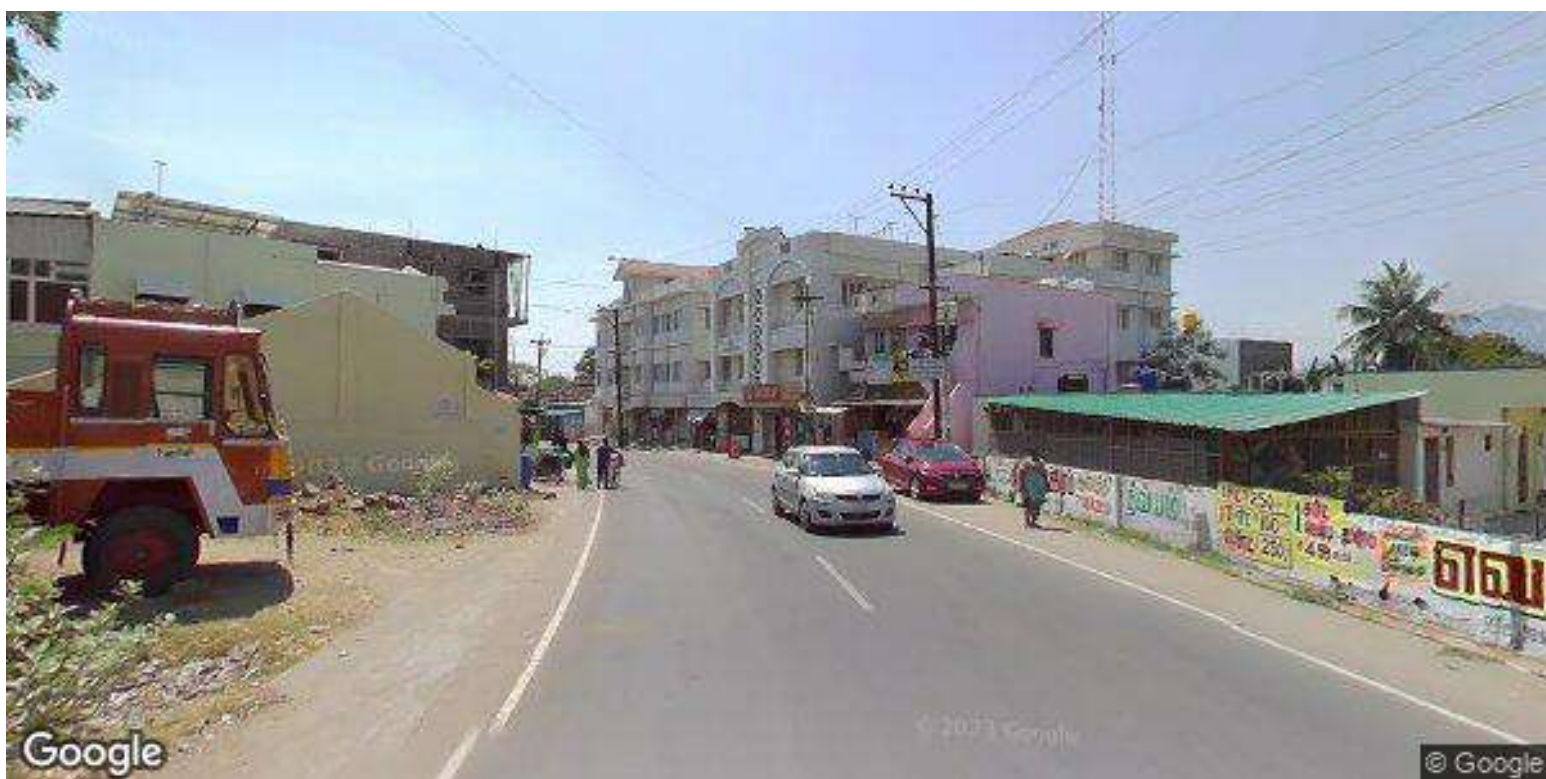
**Coordinates: 11.45757, 78.18137**

**Risk Type: Turn**

**Risk Level: Medium**

**Speed Limit: 30 KM/Hr**

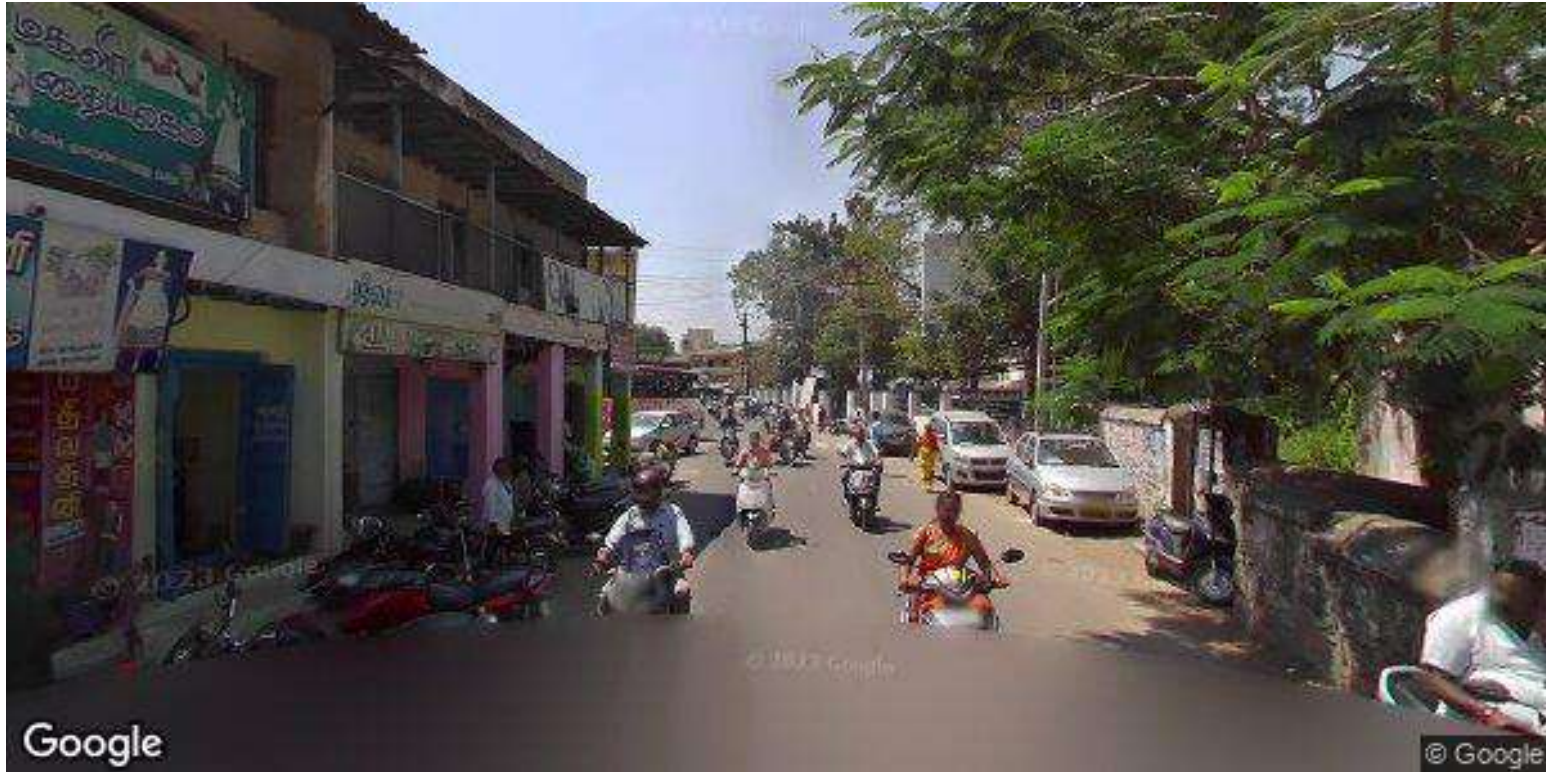
**Coordinates: 11.46032, 78.18514**

**Risk Type: Blind Spot**

**Risk Level: Blind Spot**

**Speed Limit: 10 KM/Hr**

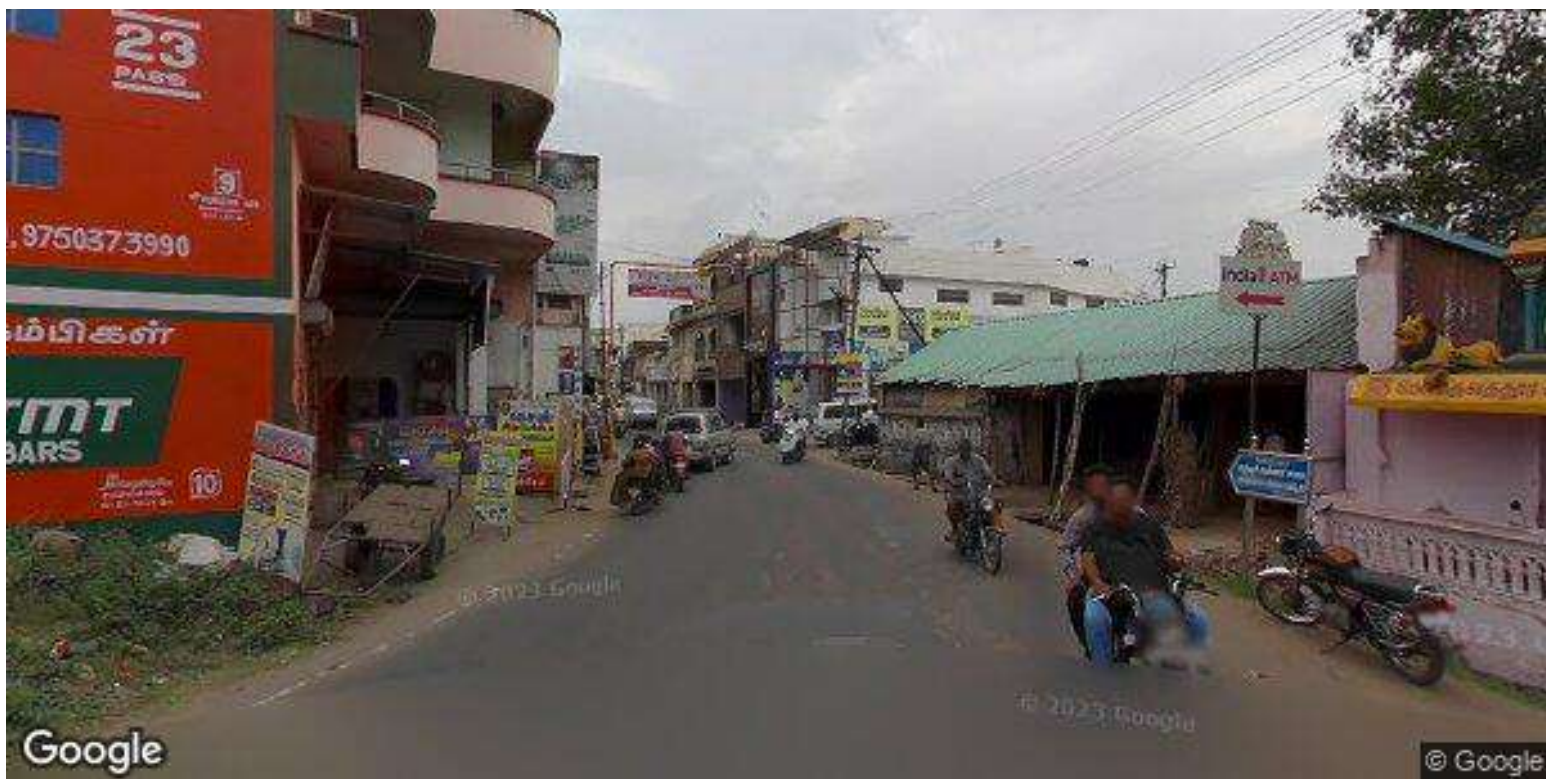
**Coordinates: 11.45898, 78.18564**

**Risk Type: Turn**

**Risk Level: High**

**Speed Limit: 15 KM/Hr**

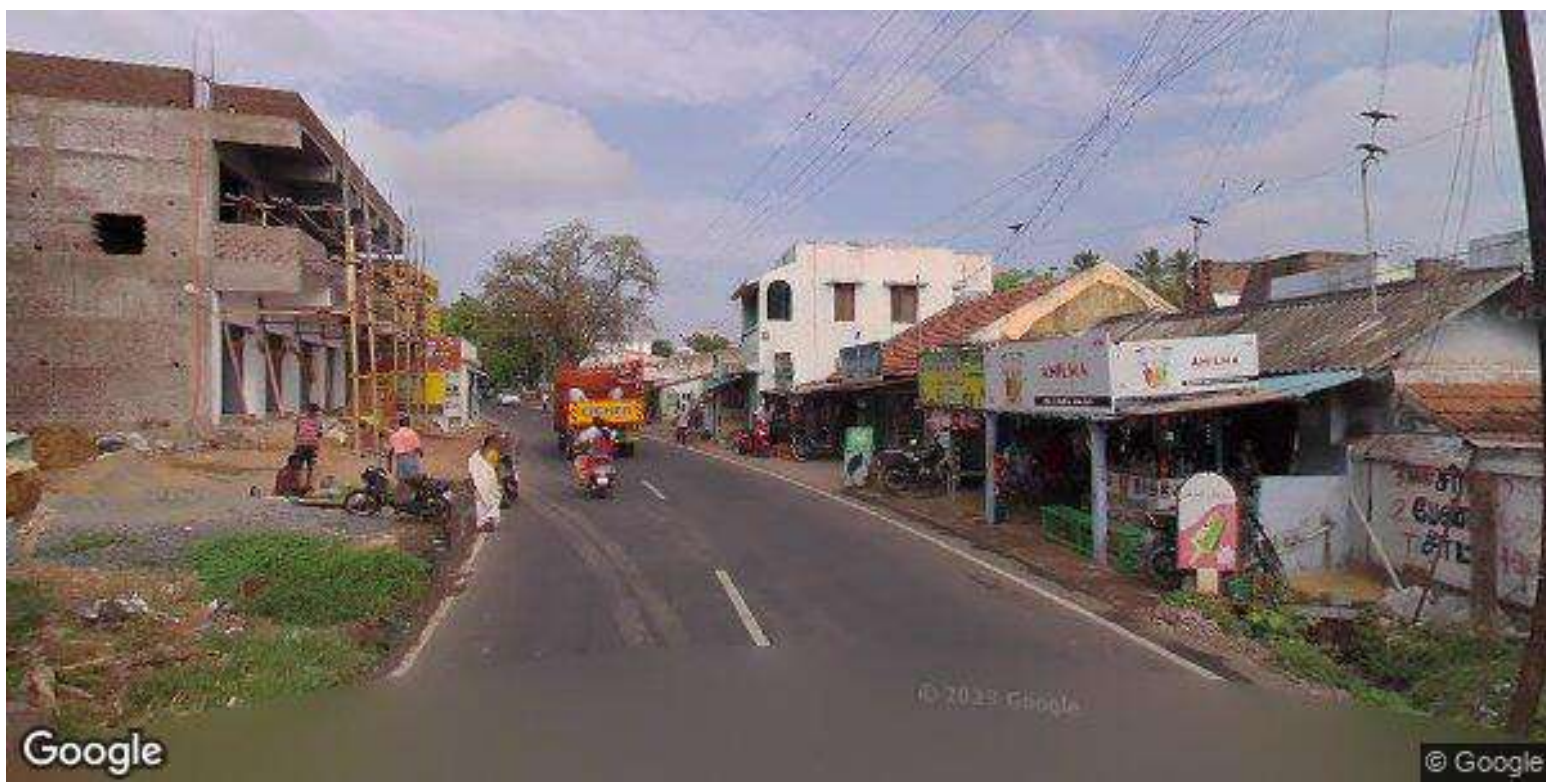
**Coordinates:** 11.44993, 78.22152

**Risk Type:** Turn

**Risk Level:** Medium

**Speed Limit:** 30 KM/Hr

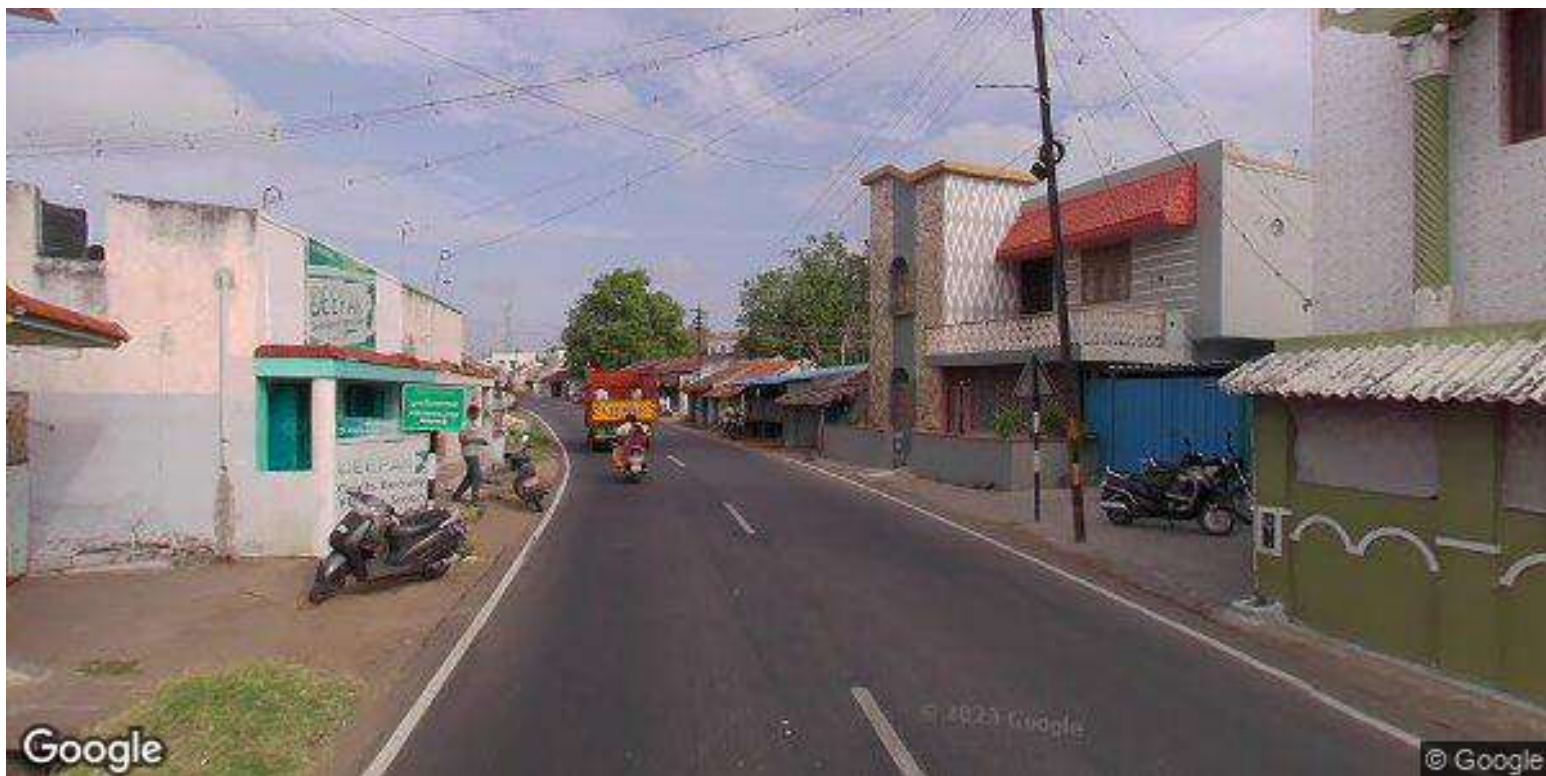
**Coordinates:** 11.44951, 78.22263

**Risk Type:** Turn

**Risk Level:** High

**Speed Limit:** 15 KM/Hr

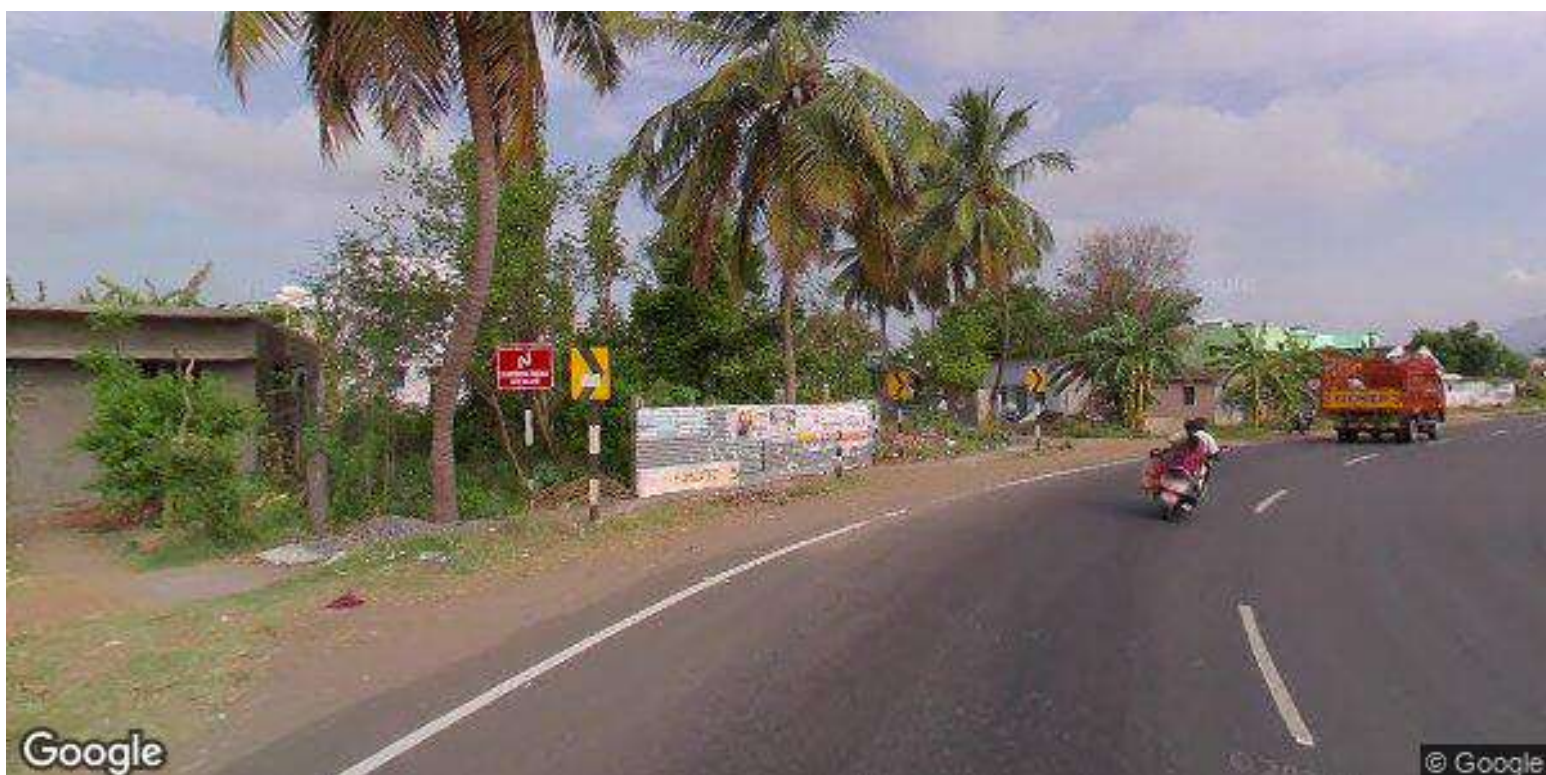
**Risk Type:** Turn  
**Risk Level:** High  
**Speed Limit:** 15 KM/Hr  
**Coordinates:** 11.44797, 78.22314

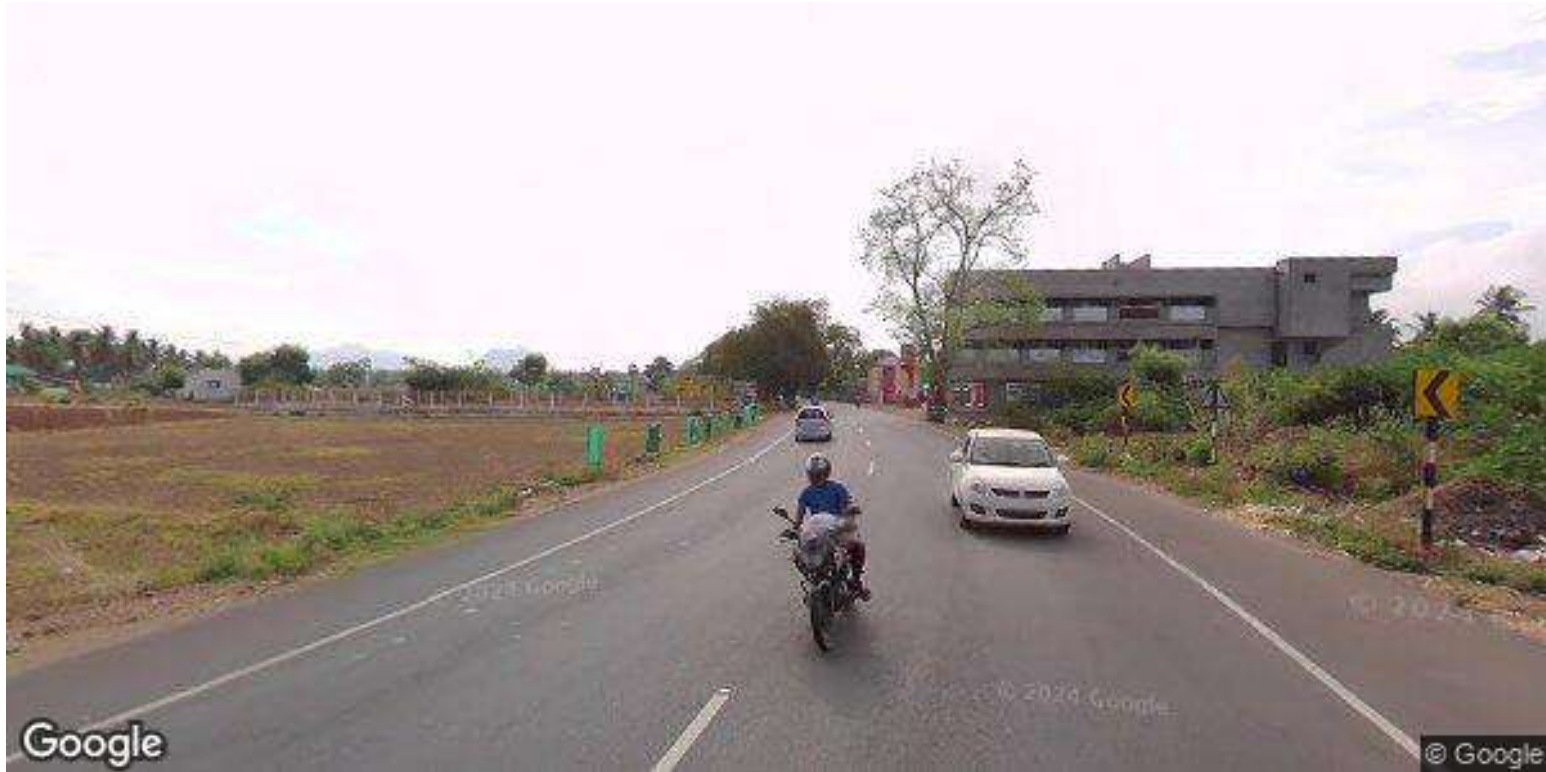
**Risk Type:** Turn  
**Risk Level:** Medium  
**Speed Limit:** 30 KM/Hr  
**Coordinates:** 11.44756, 78.22414
