# IndianOil

## JOURNEY RISK MANAGEMENT (JRM) STUDY

### Salem Terminal to ALAMU AGENCIES

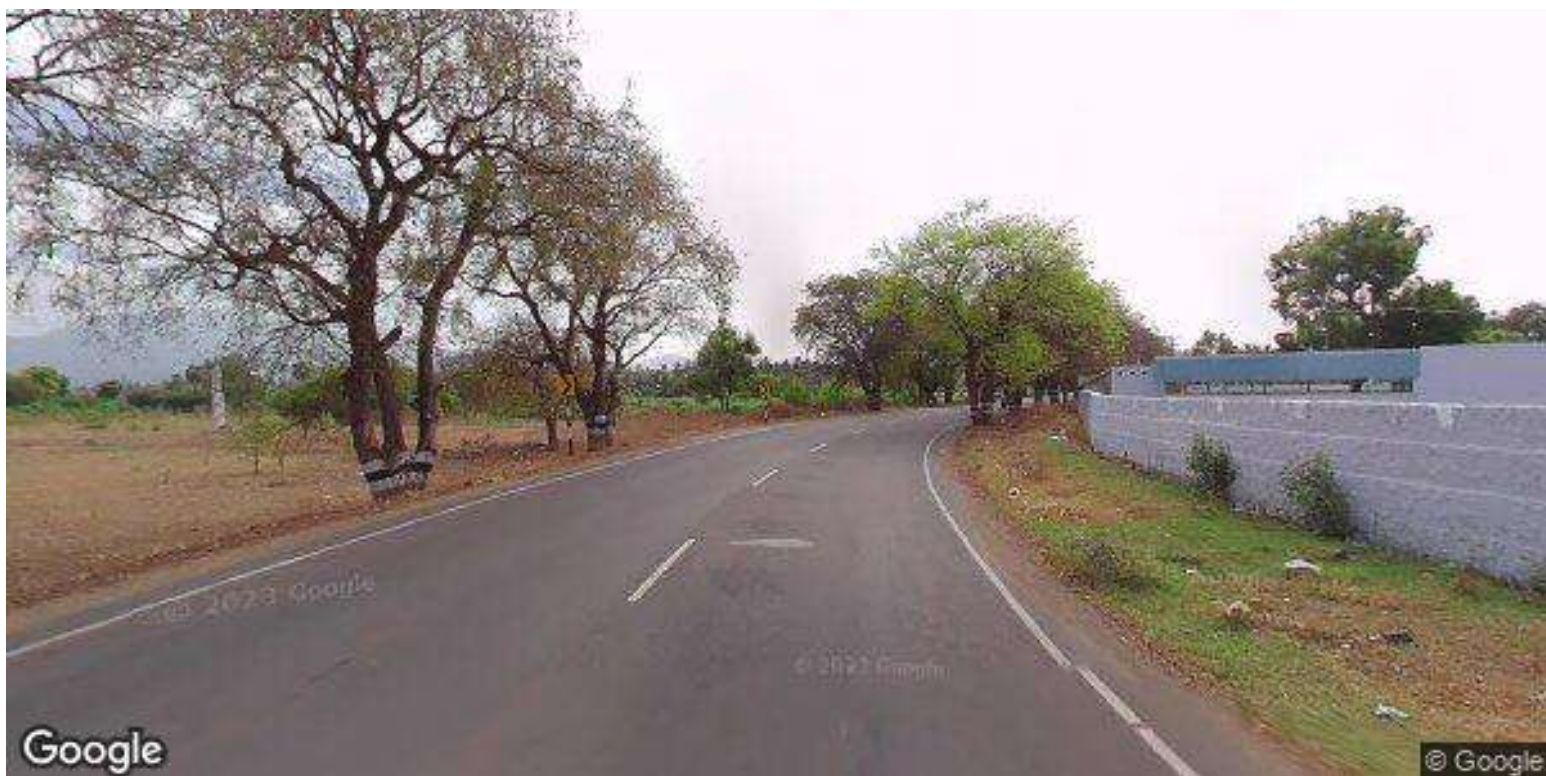
**Risk Type:** Turn  
**Risk Level:** Medium  
**Speed Limit:** 30 KM/Hr  
**Coordinates:** 11.45353, 78.23584

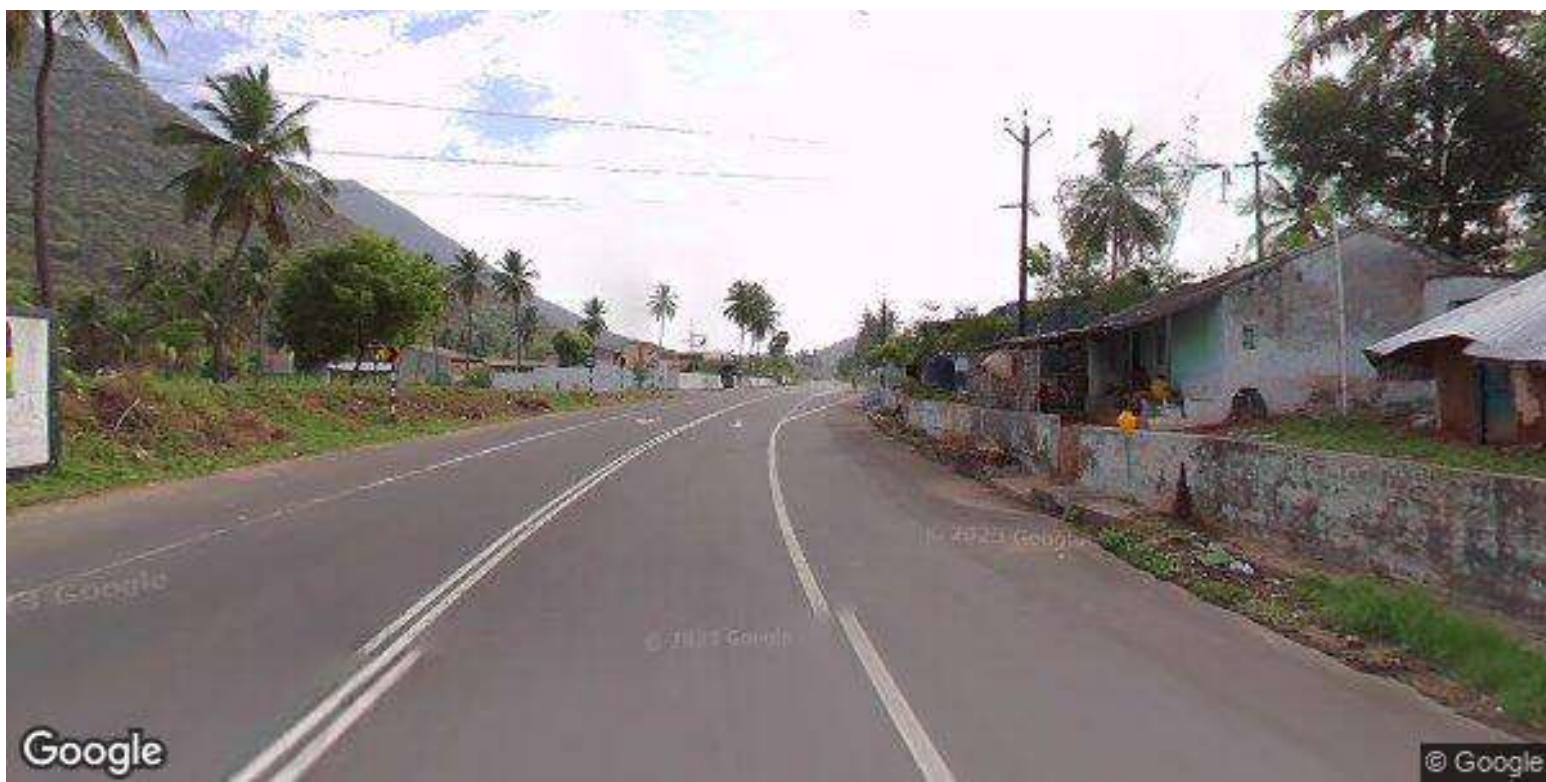
**Coordinates:** 11.49835, 78.32417

**Risk Type:** Turn

**Risk Level:** Medium

**Speed Limit:** 30 KM/Hr

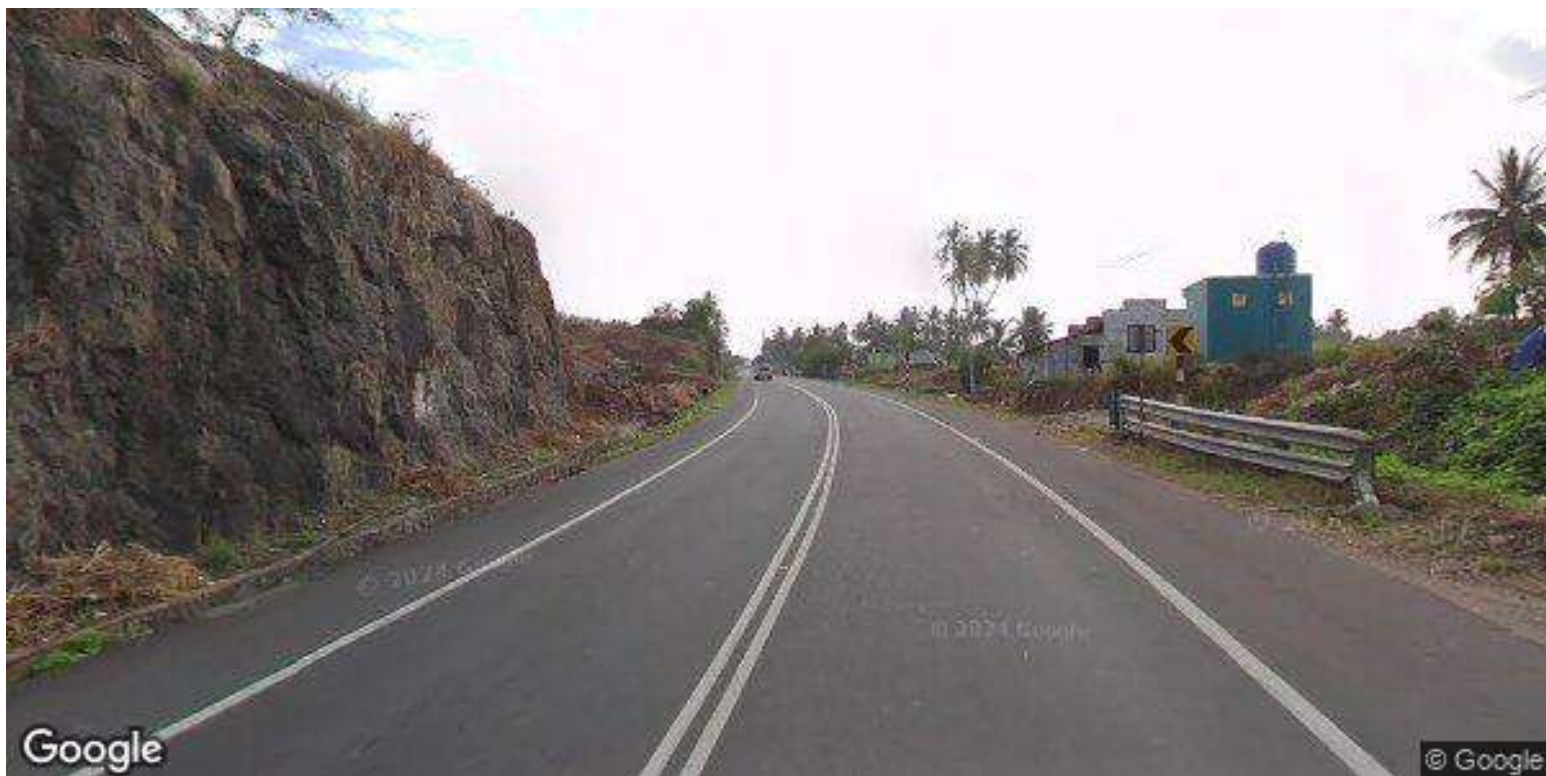
**Coordinates:** 11.50865, 78.33966

**Risk Type:** Turn

**Risk Level:** Medium

**Speed Limit:** 30 KM/Hr

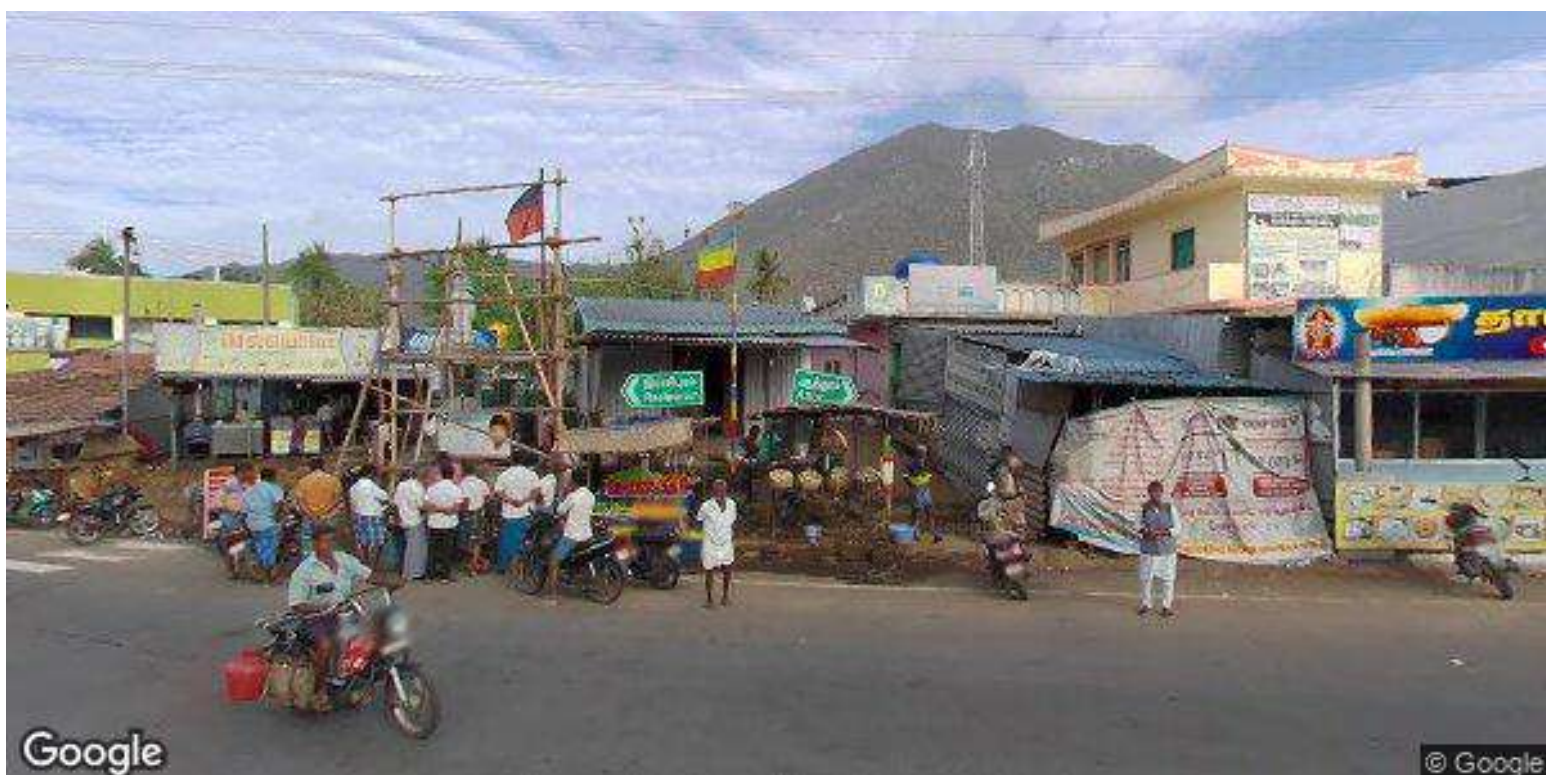
**Risk Type:** Turn  
**Risk Level:** Medium  
**Speed Limit:** 30 KM/Hr  
**Coordinates:** 11.51183, 78.34416

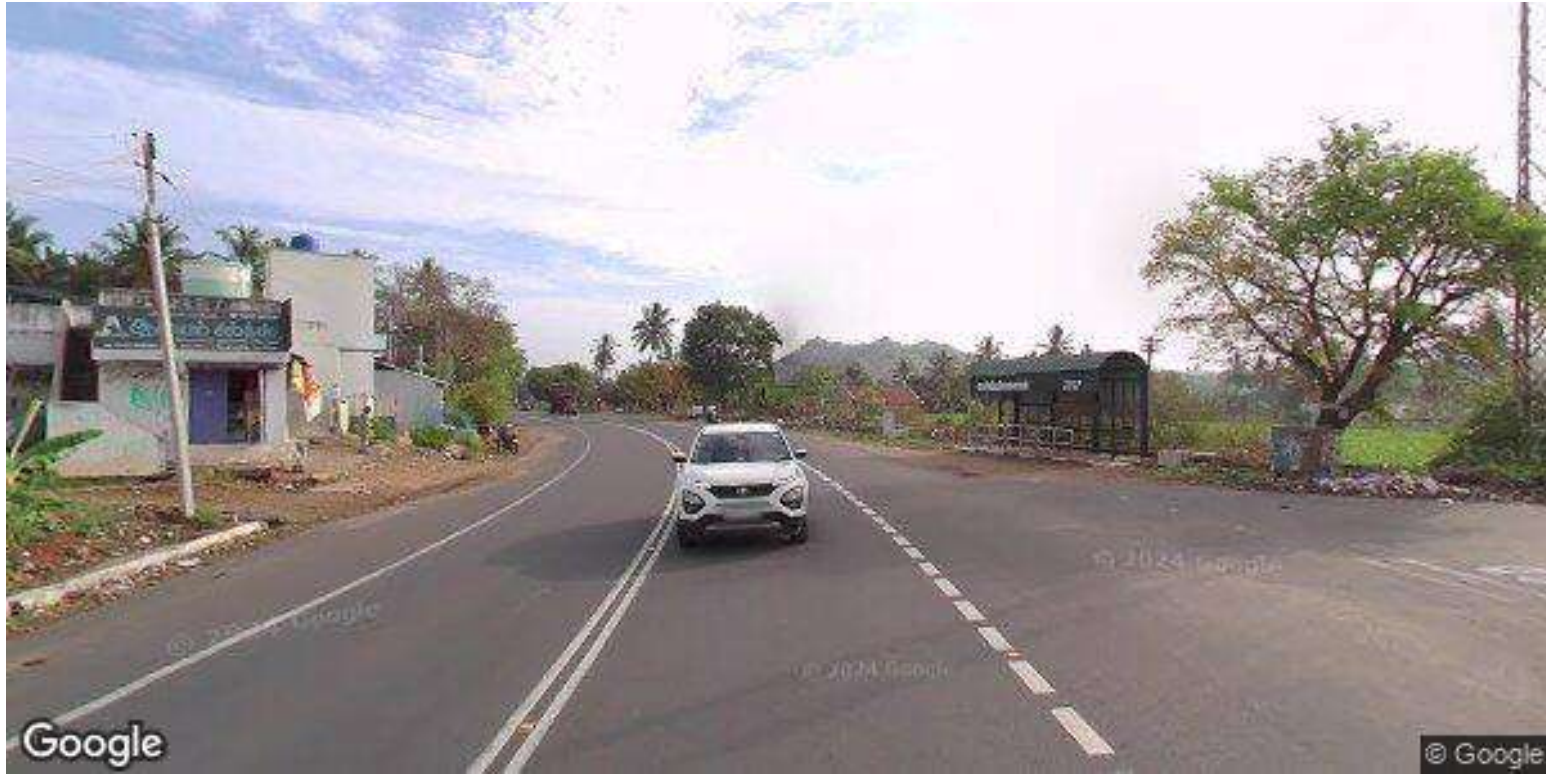
**Risk Type:** Turn  
**Risk Level:** Medium  
**Speed Limit:** 30 KM/Hr  
**Coordinates:** 11.51870, 78.34816

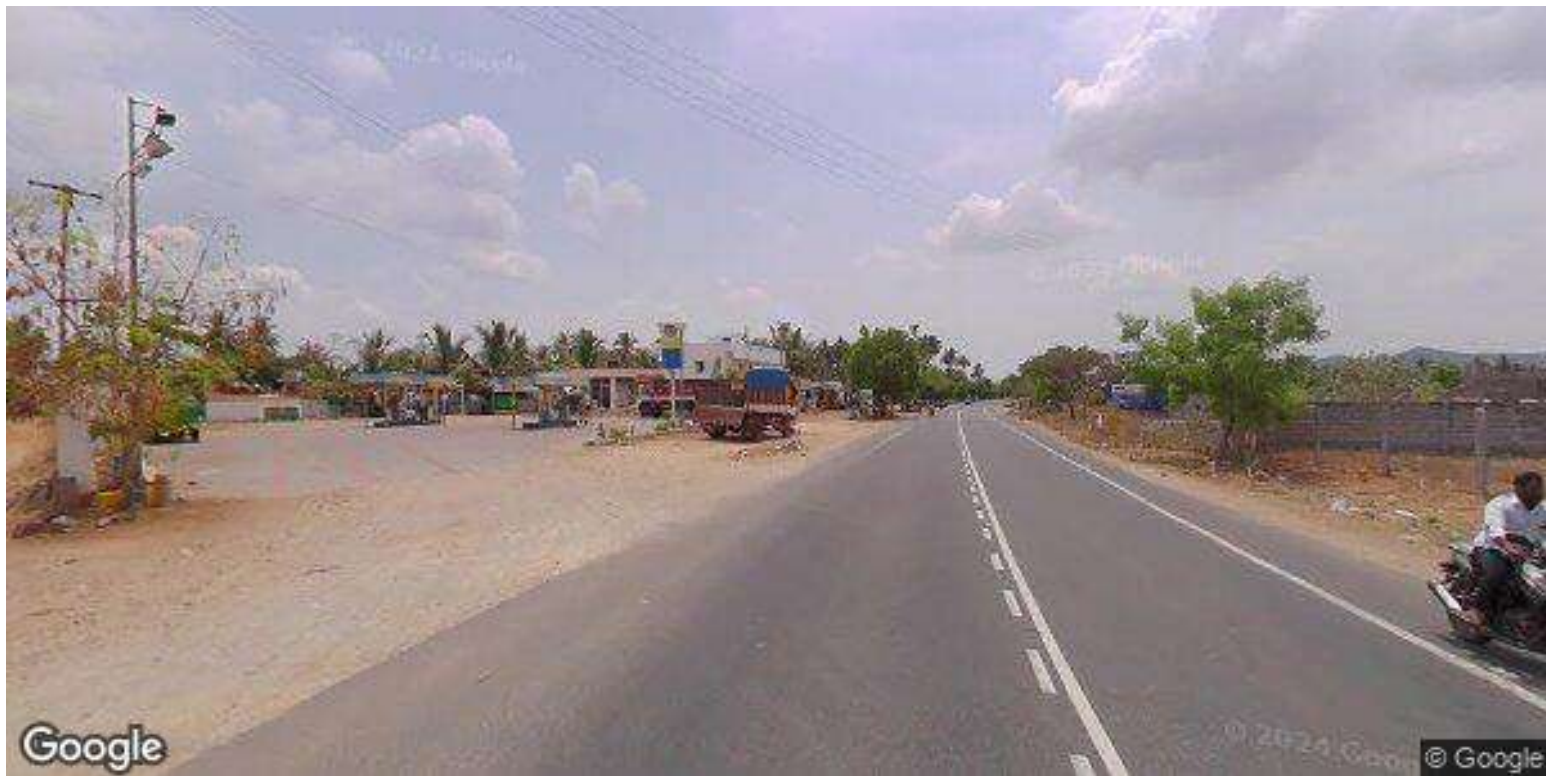
**Risk Type:** Turn  
**Risk Level:** Medium  
**Speed Limit:** 30 KM/Hr  
**Coordinates:** 11.54842, 78.35627

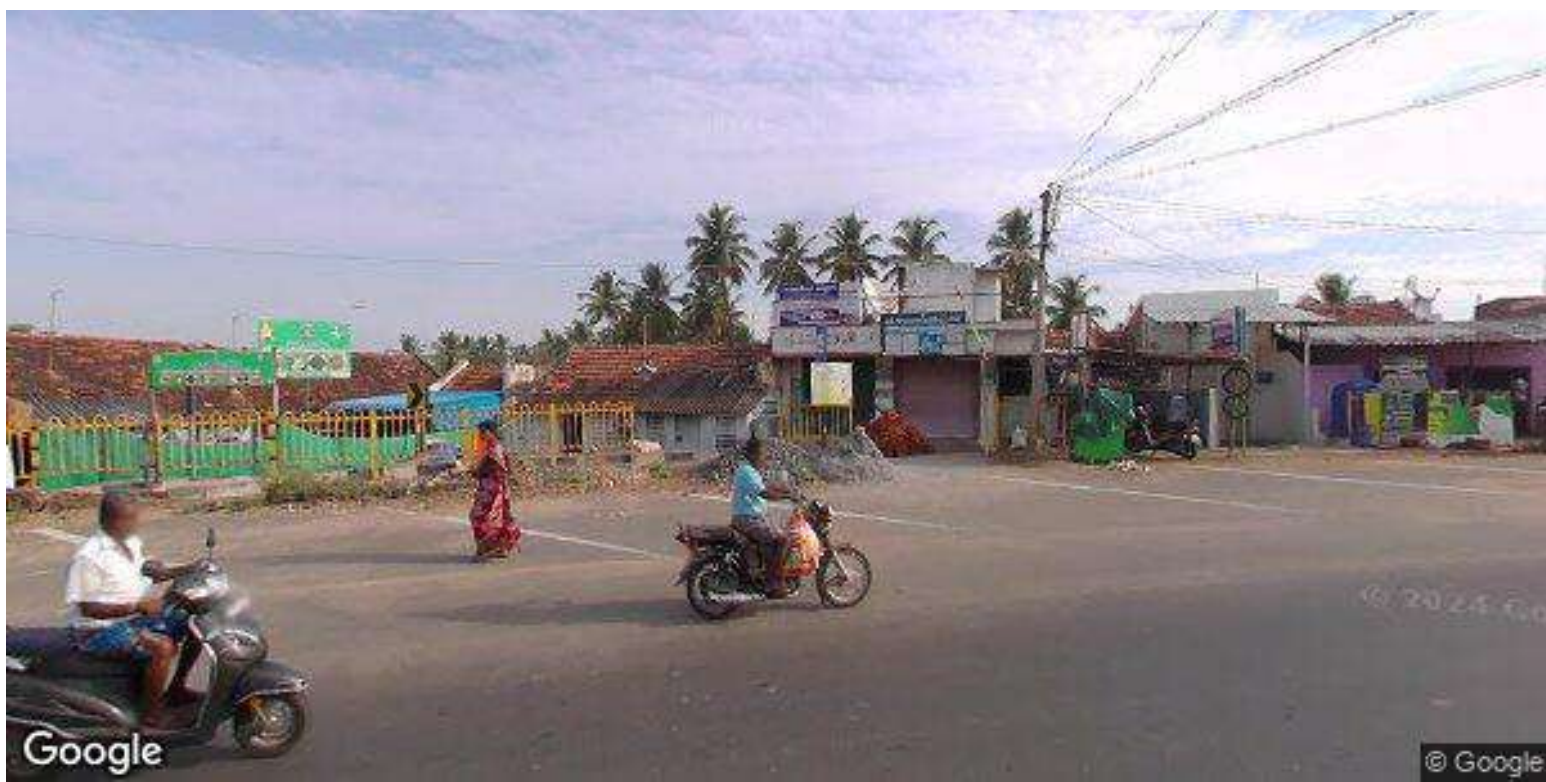
**Coordinates:** 11.56719, 78.37813

**Risk Type:** Turn

**Risk Level:** Medium

**Speed Limit:** 30 KM/Hr

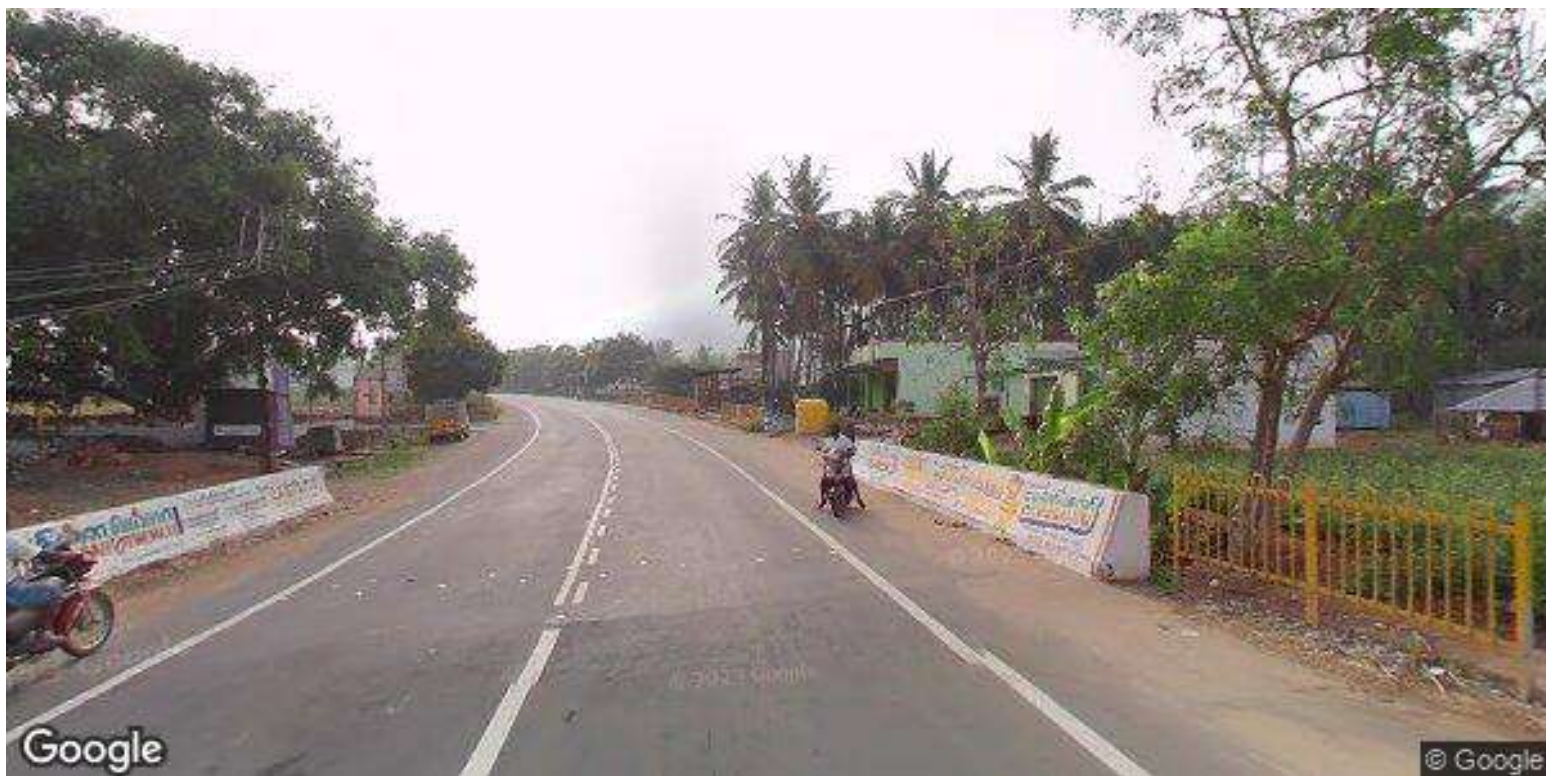
**Coordinates:** 11.56940, 78.39856

**Risk Type:** Turn

**Risk Level:** Medium

**Speed Limit:** 30 KM/Hr

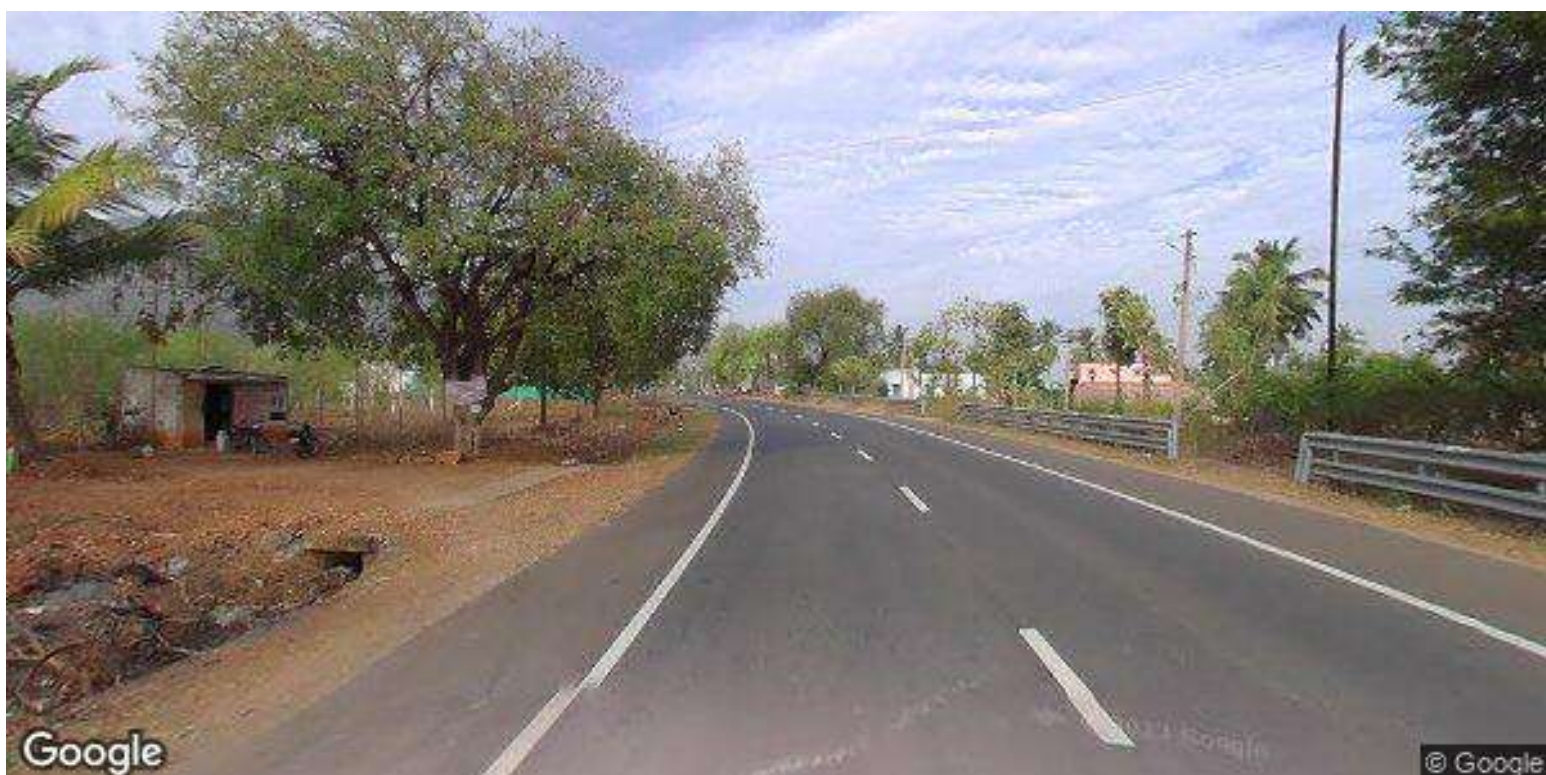
**Coordinates:** 11.58180, 78.41812

**Risk Type:** Turn

**Risk Level:** Medium

**Speed Limit:** 30 KM/Hr

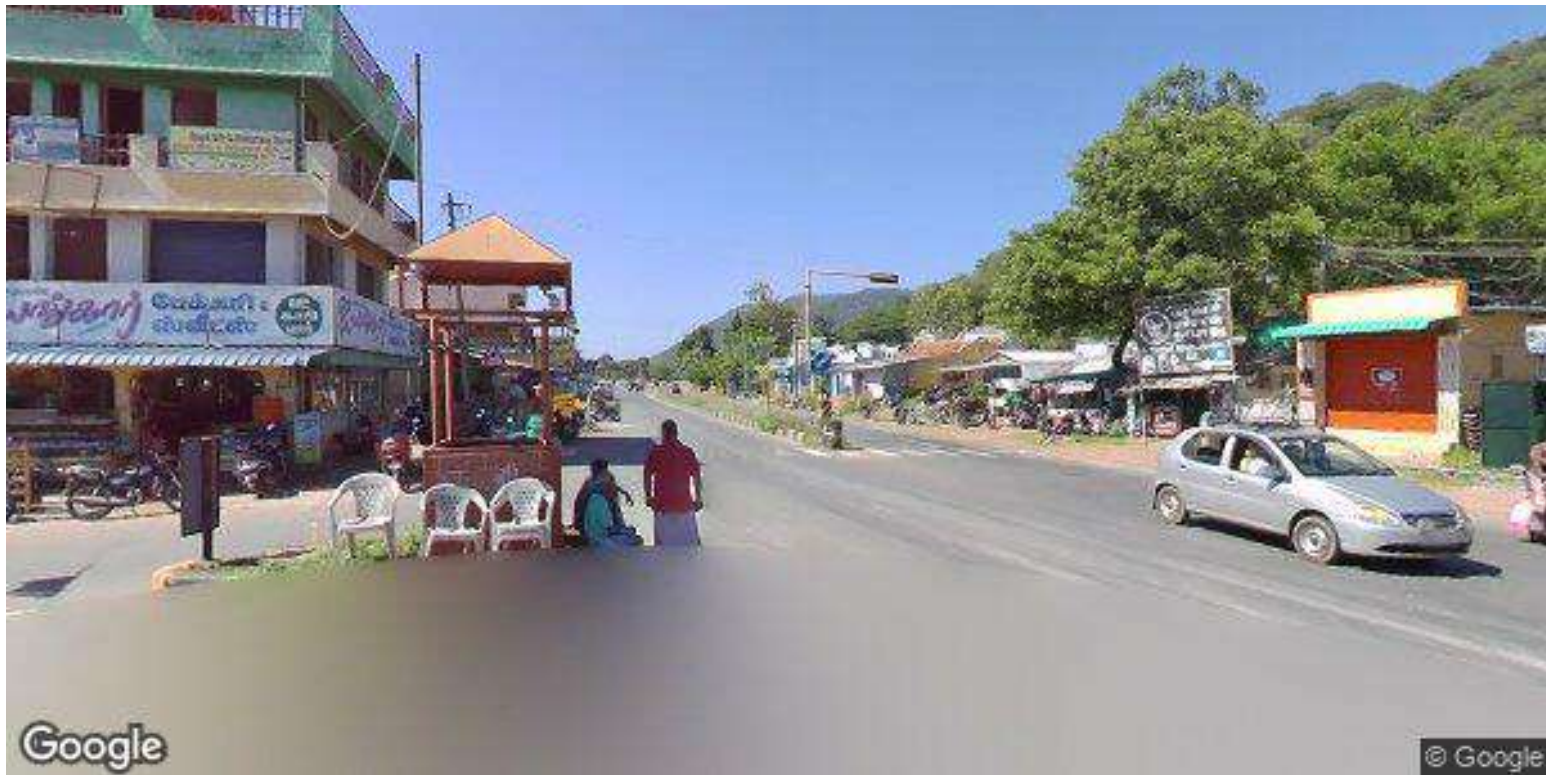
**Coordinates:** 11.57108, 78.49917

**Risk Type:** Turn

**Risk Level:** Medium

**Speed Limit:** 30 KM/Hr

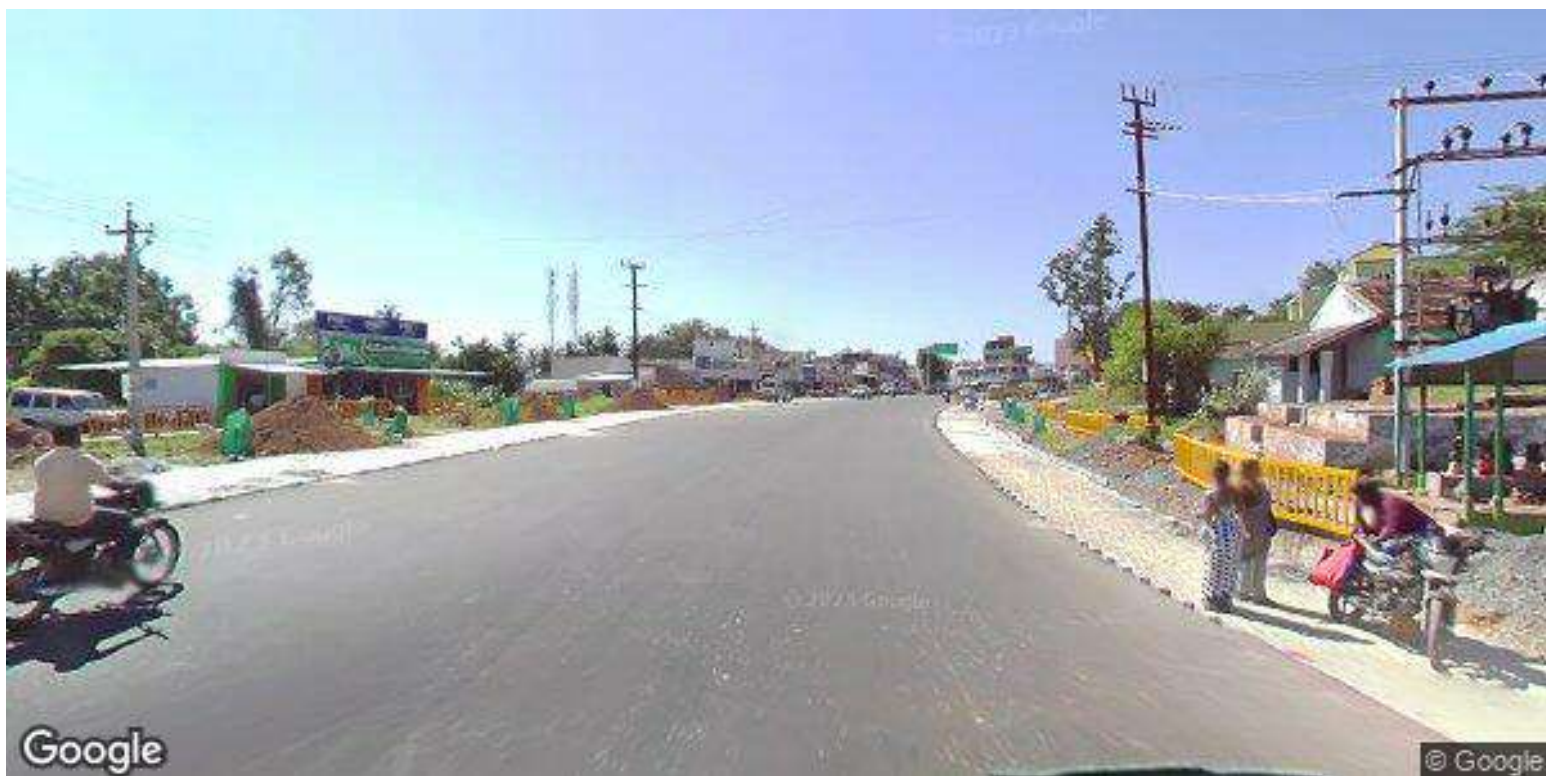
**Coordinates:** 11.57105, 78.50084

**Risk Type:** Turn

**Risk Level:** Medium

**Speed Limit:** 30 KM/Hr

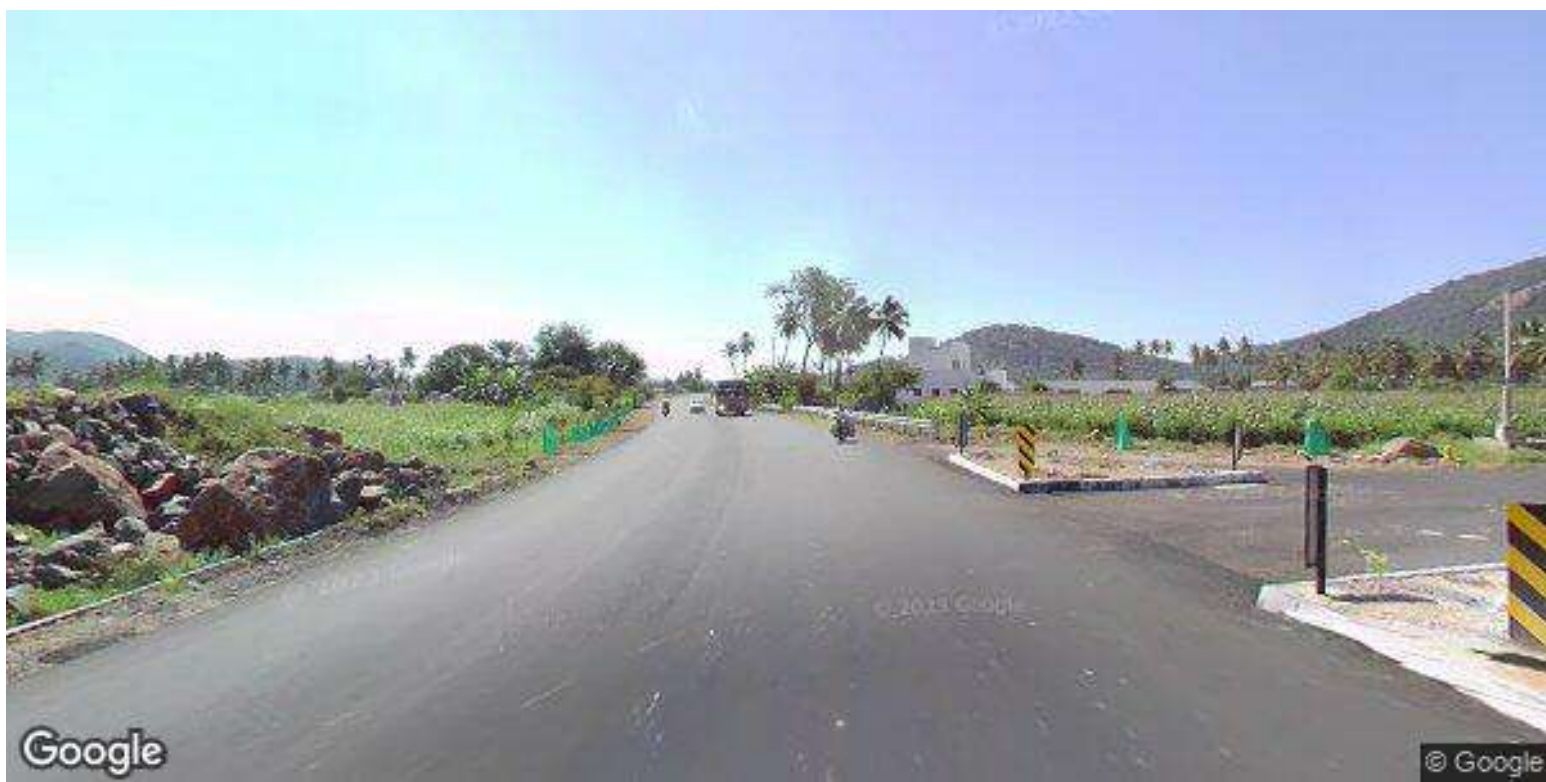
**Coordinates:** 11.57829, 78.51245

**Risk Type:** Turn

**Risk Level:** Medium

**Speed Limit:** 30 KM/Hr

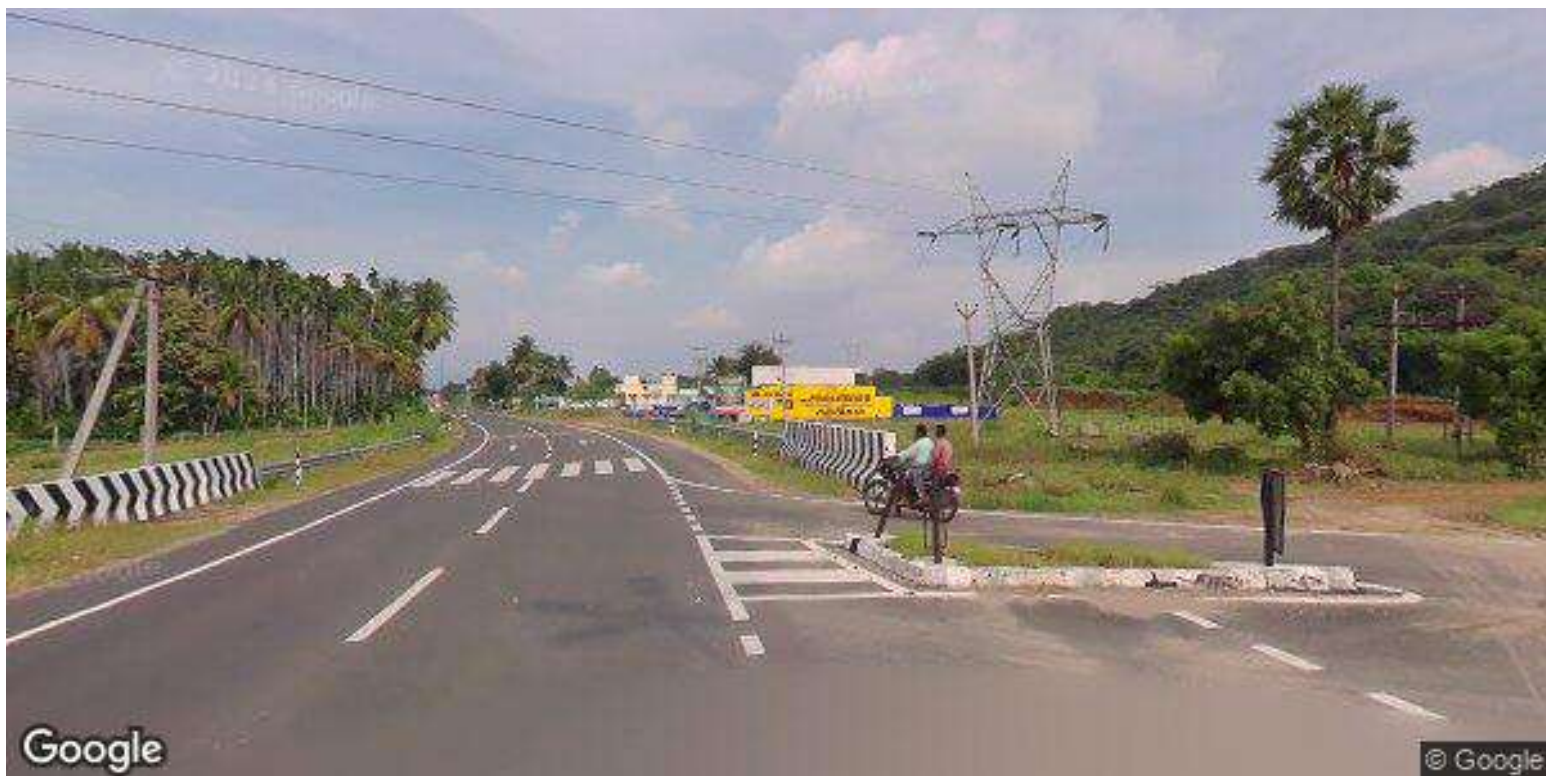
**Coordinates:** 11.58679, 78.54553

**Risk Type:** Turn

**Risk Level:** Medium

**Speed Limit:** 30 KM/Hr

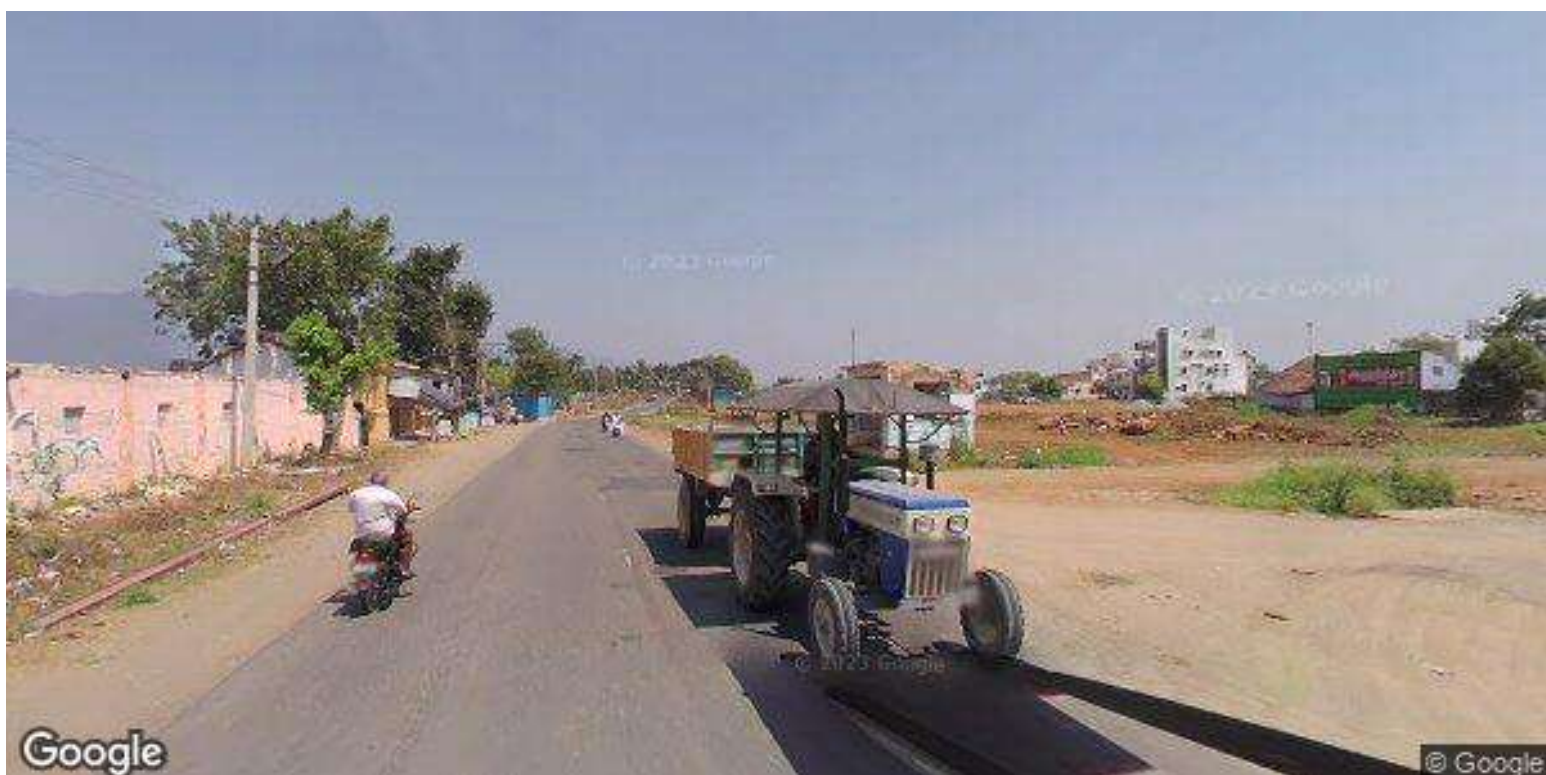
**Risk Type:** Turn  
**Risk Level:** High  
**Speed Limit:** 15 KM/Hr  
**Coordinates:** 11.59744, 78.57347

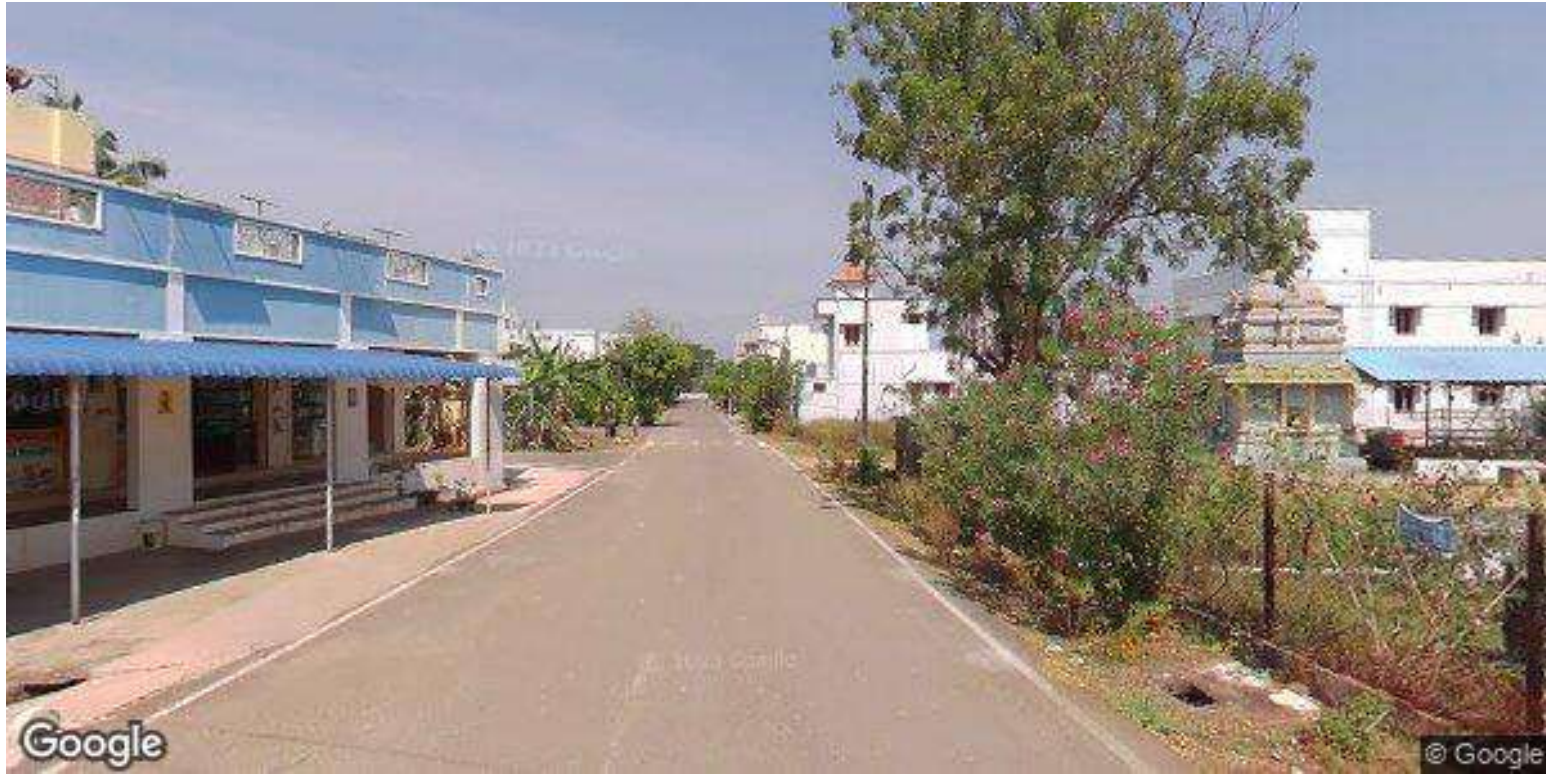
**Risk Type:** Turn  
**Risk Level:** High  
**Speed Limit:** 15 KM/Hr  
**Coordinates:** 11.59553, 78.57461

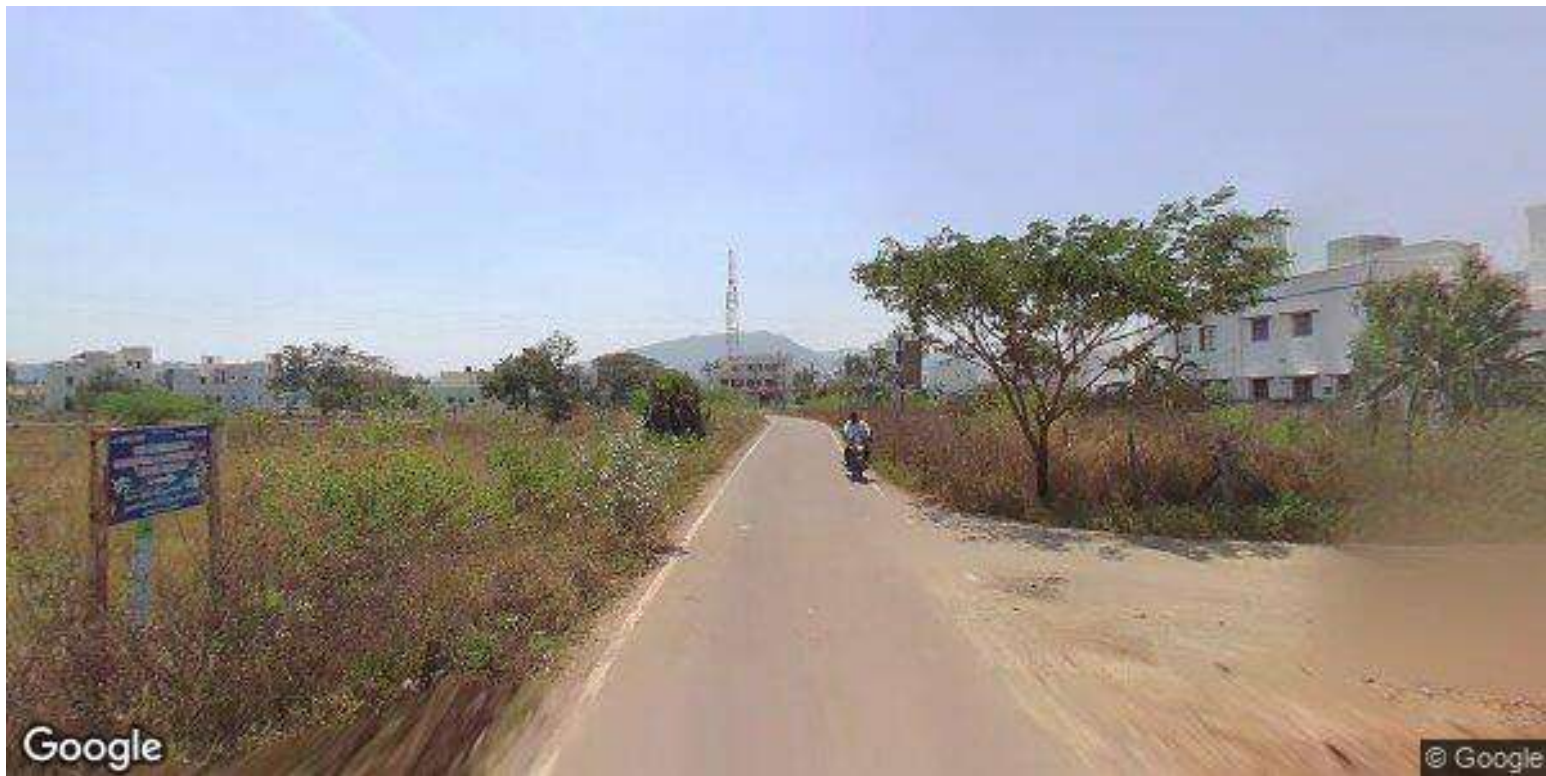
**Risk Type:** Turn  
**Risk Level:** High  
**Speed Limit:** 15 KM/Hr  
**Coordinates:** 11.59538, 78.57598

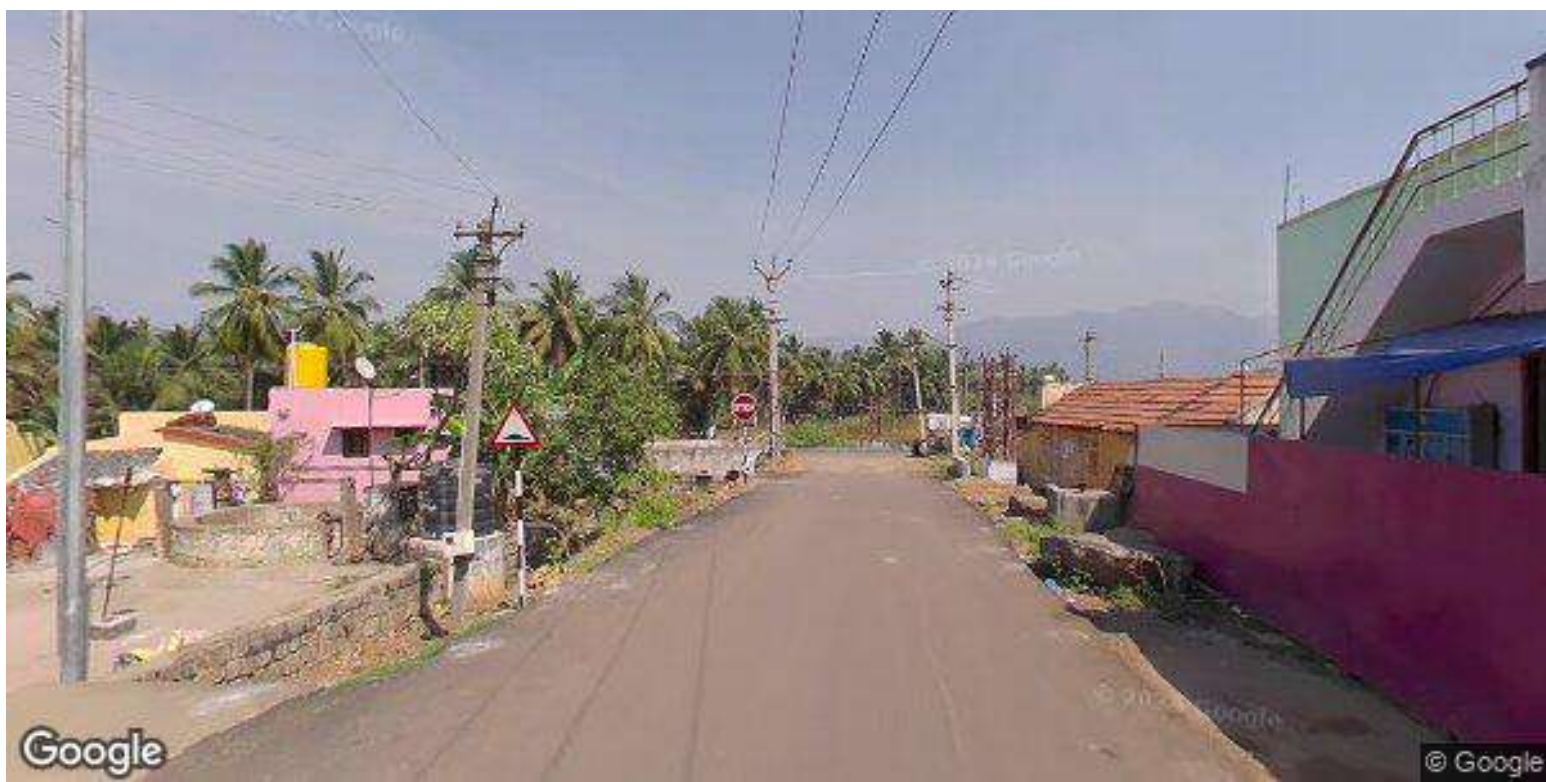
**Coordinates:** 11.59861, 78.57703

**Risk Type:** Turn

**Risk Level:** High

**Speed Limit:** 15 KM/Hr

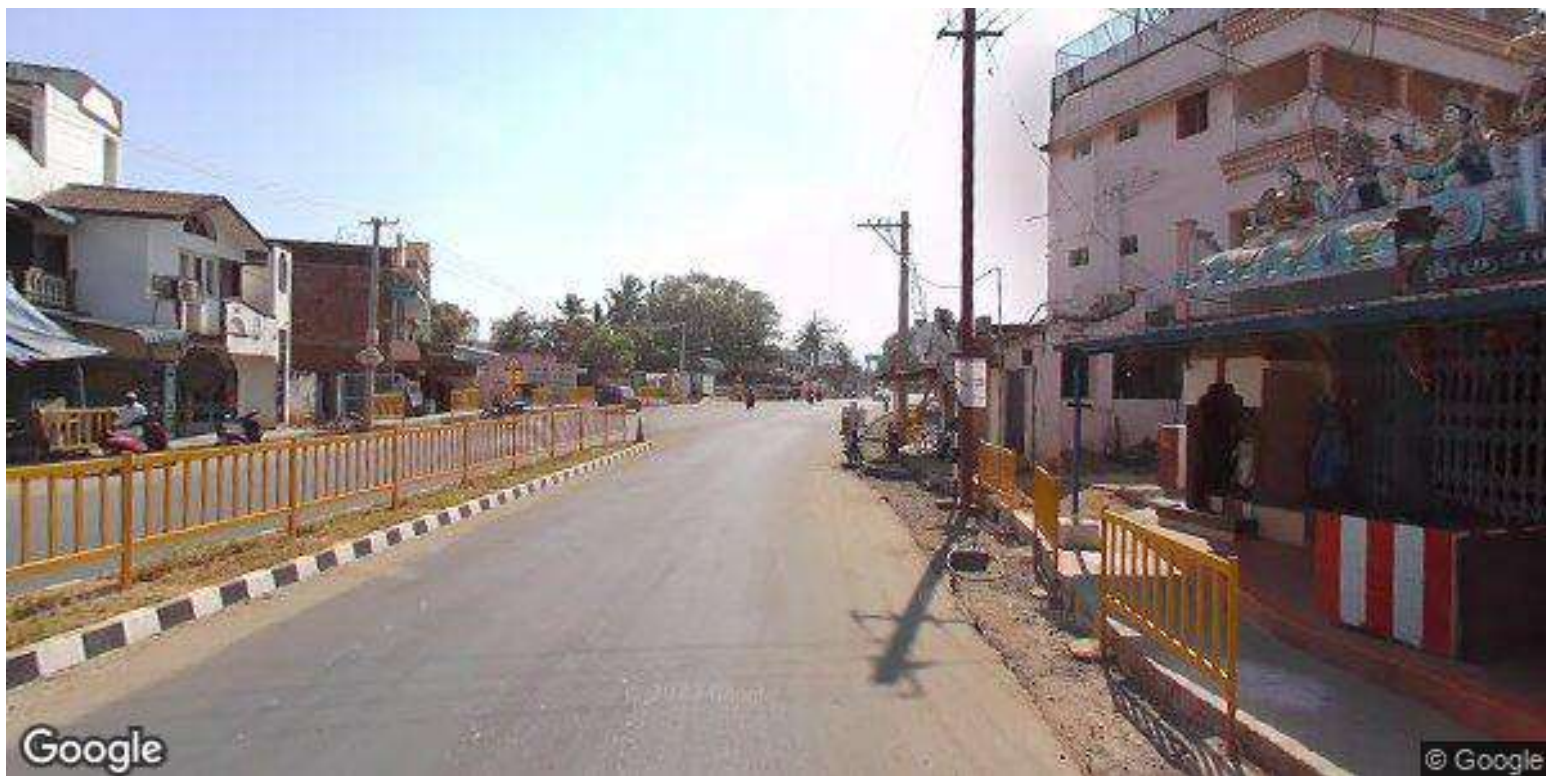
**Coordinates:** 11.60109, 78.58219

**Risk Type:** Blind Spot

**Risk Level:** Blind Spot

**Speed Limit:** 10 KM/Hr

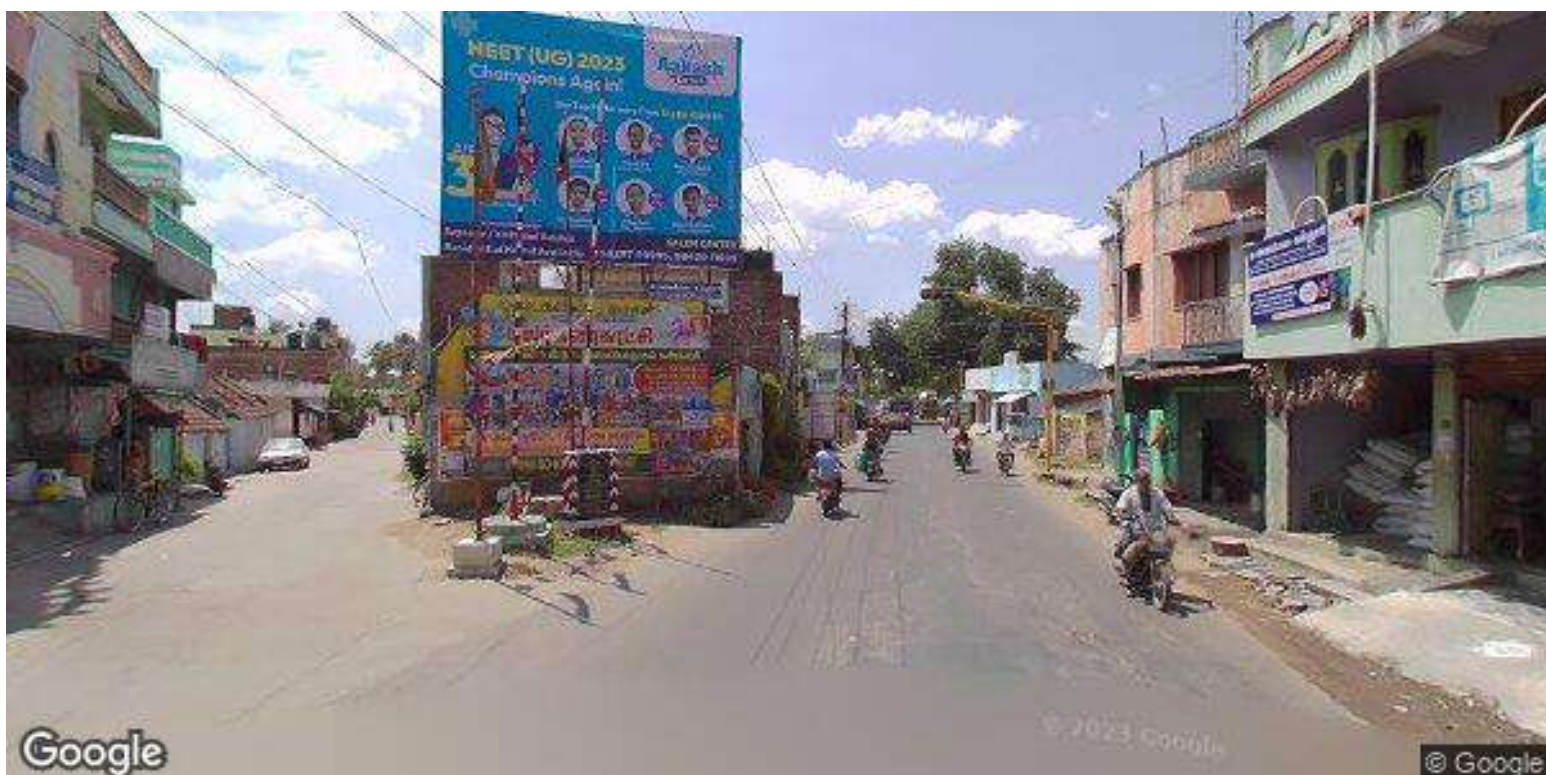
**Risk Type:** Turn  
**Risk Level:** Medium  
**Speed Limit:** 30 KM/Hr  
**Coordinates:** 11.60434, 78.57636
