# IndianOil

## JOURNEY RISK MANAGEMENT (JRM) STUDY

### Salem Terminal to ALAMU AGENCIES

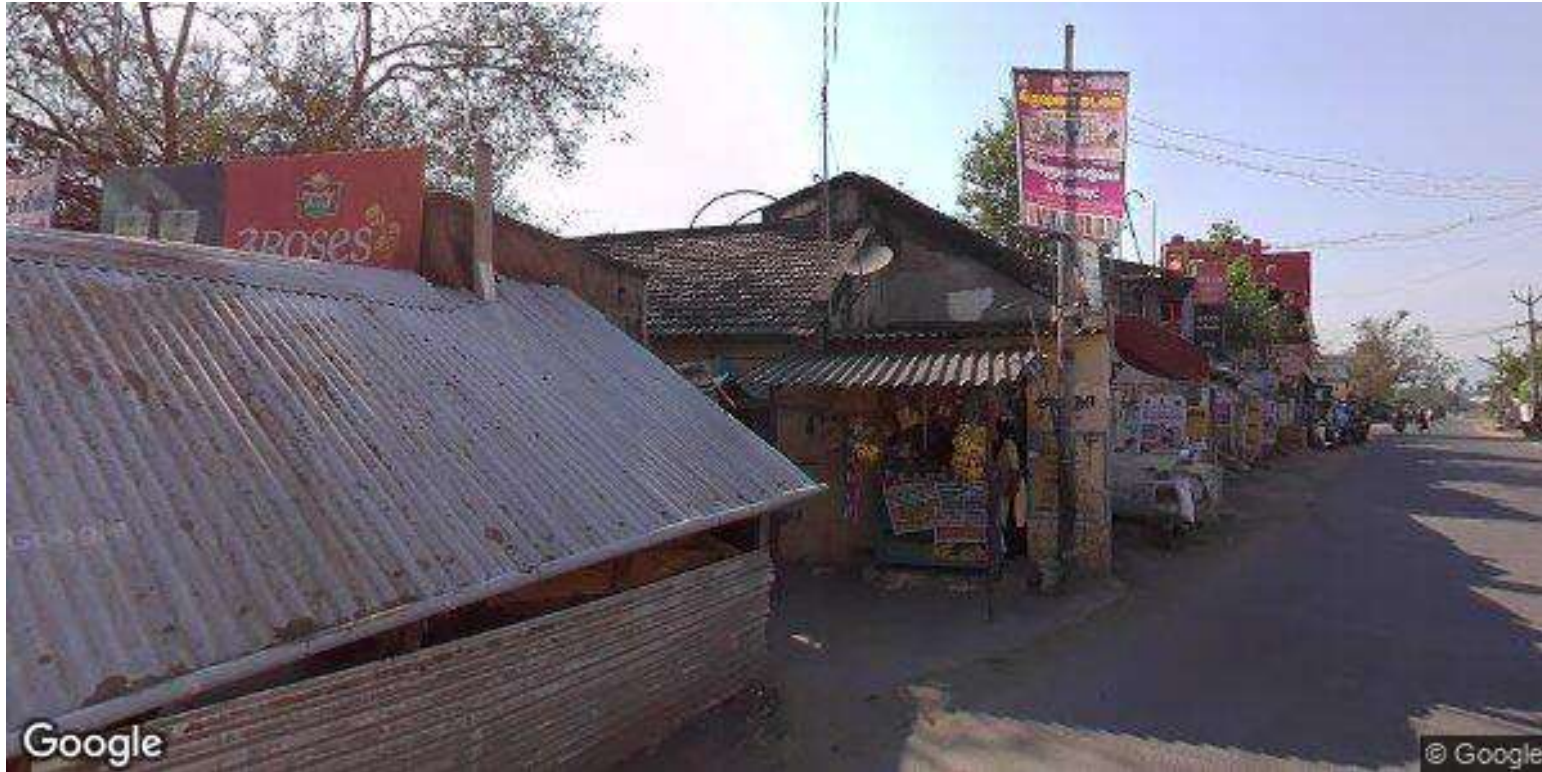
**Risk Type:** Turn  
**Risk Level:** High  
**Speed Limit:** 15 KM/Hr  
**Coordinates:** 11.60491, 78.57377

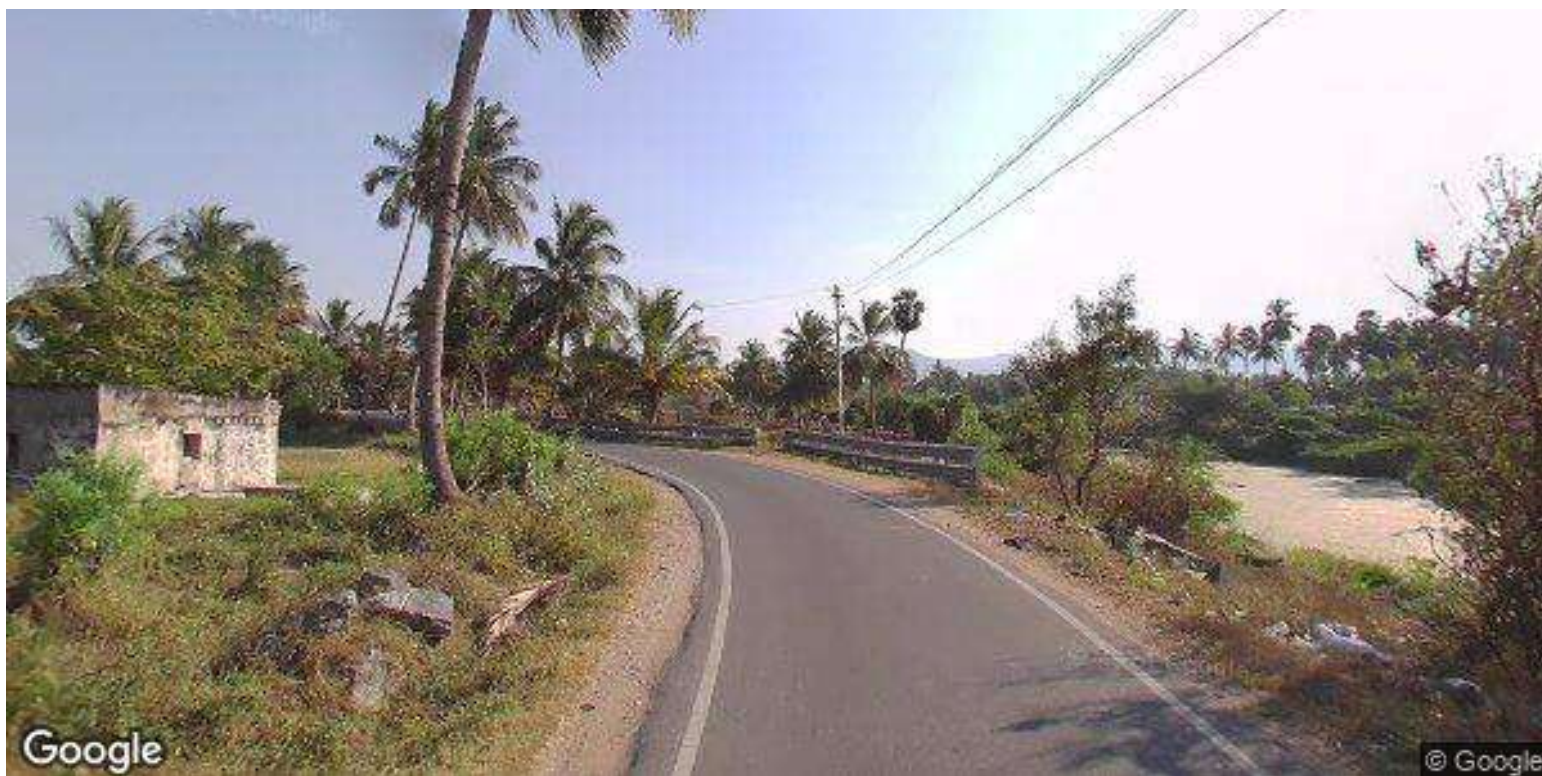
**Risk Type:** Turn  
**Risk Level:** Medium  
**Speed Limit:** 30 KM/Hr  
**Coordinates:** 11.61294, 78.57255

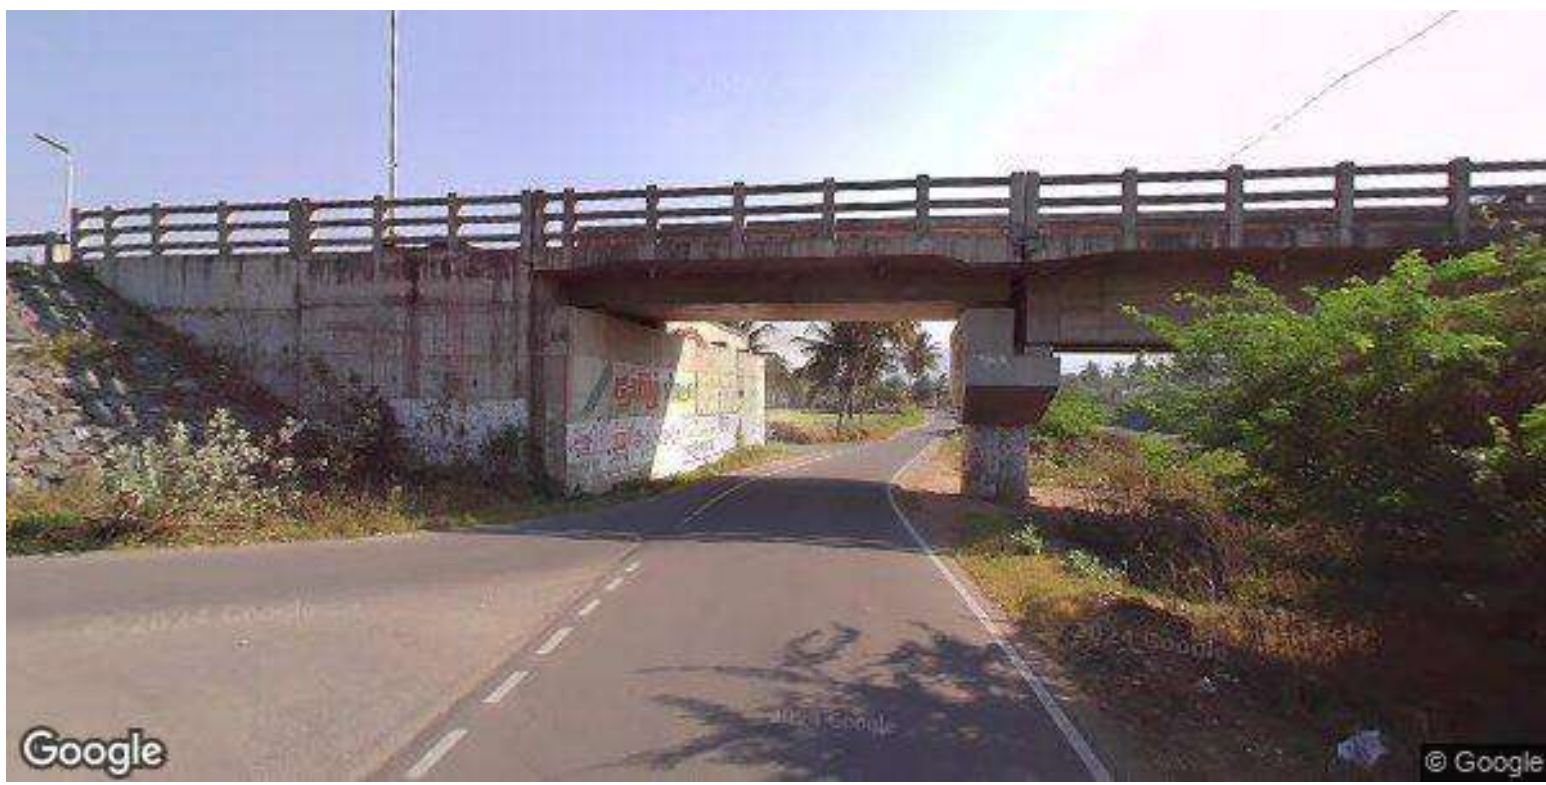
**Coordinates:** 11.61426, 78.57274

**Risk Type:** Turn

**Risk Level:** High

**Speed Limit:** 15 KM/Hr

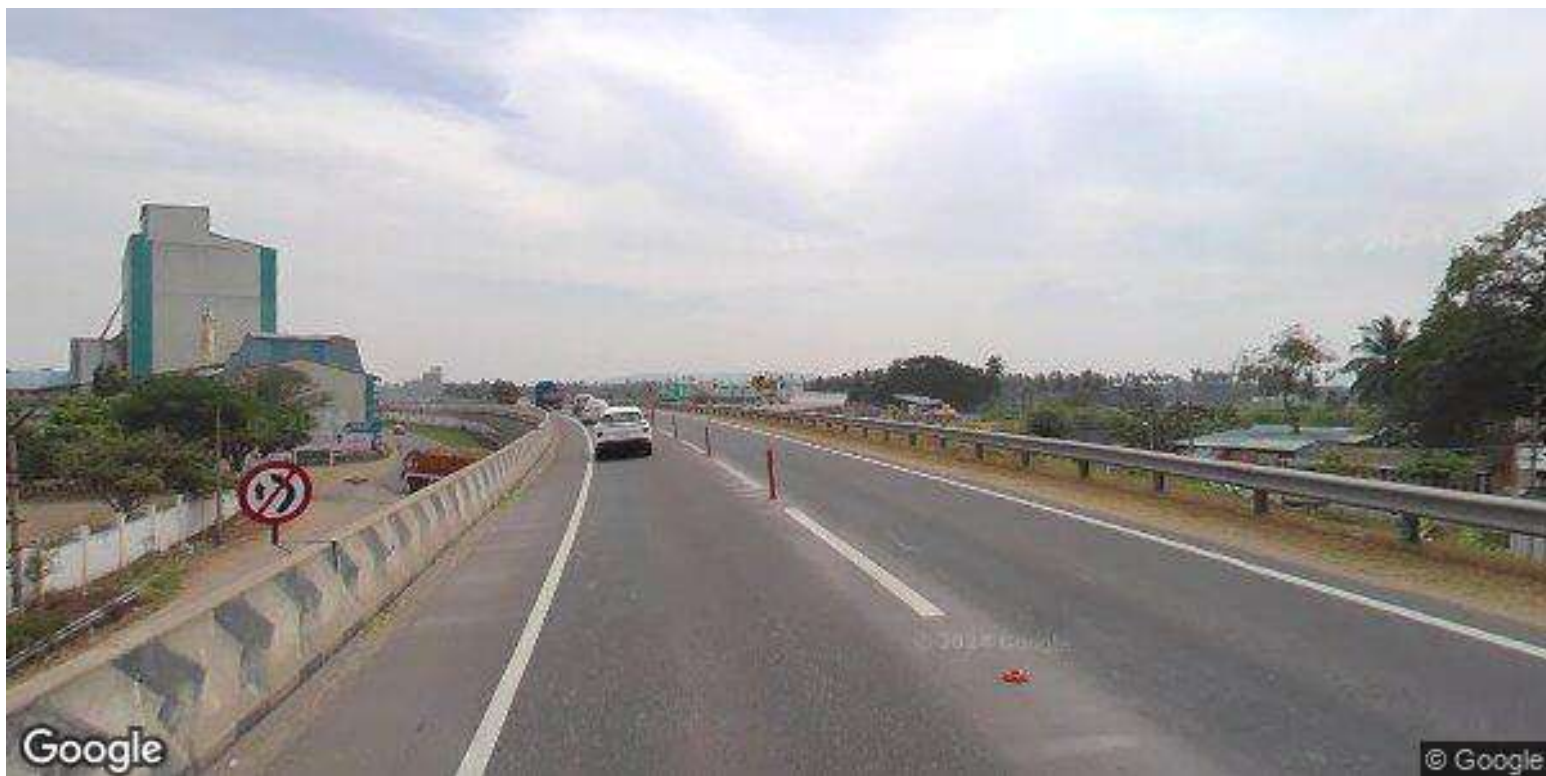
**Coordinates:** 11.59340, 78.62042

**Risk Type:** Turn

**Risk Level:** Medium

**Speed Limit:** 30 KM/Hr
