## **JOURNEY RISK MANAGEMENT (JRM) STUDY**

### **Salem Terminal To SRI KRISHNA AGENCIES**

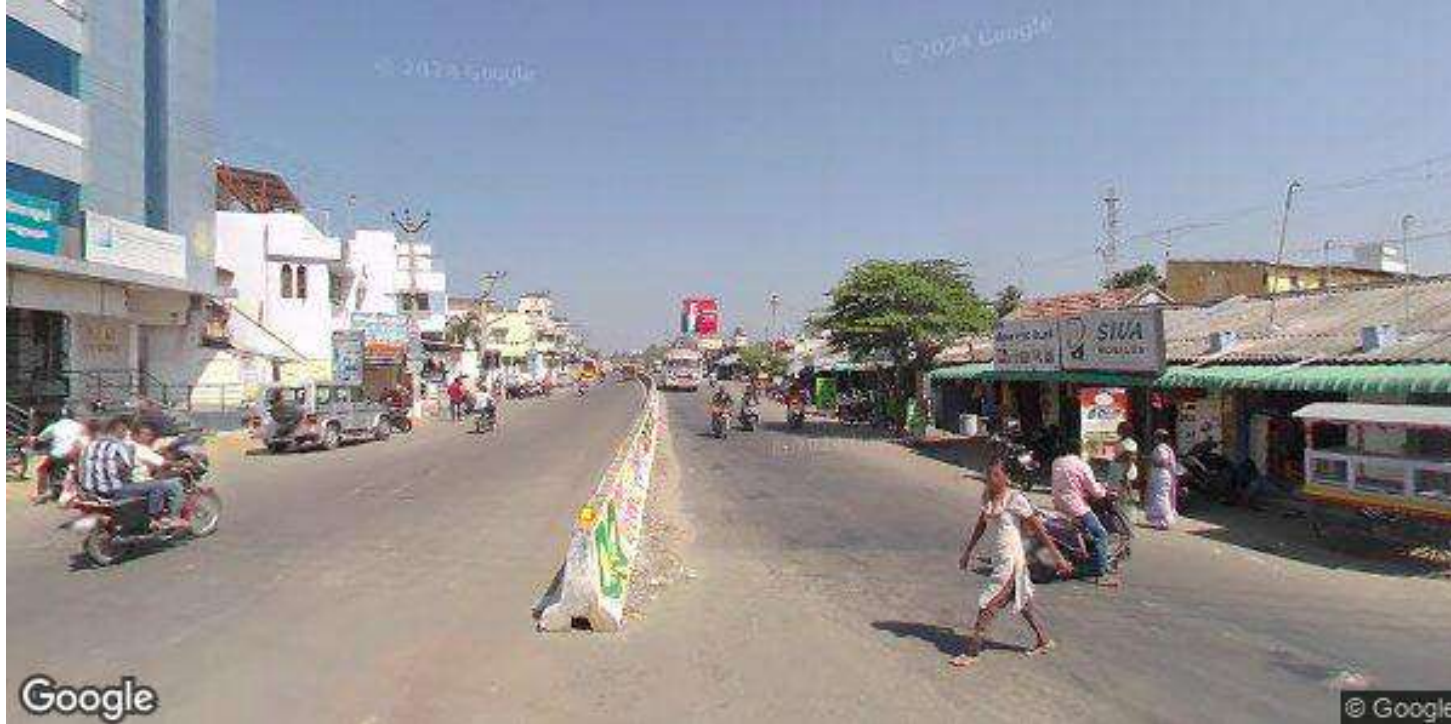
| | Risk Type | Risk Level | Coordinates | Speed Limit |
|---|---|---|---|---|
| 0 | Roundabout | High | 11.37086, 77.74828 | 15 KM/Hr |

**Risk Type:** Roundabout  
**Risk Level:** High  
**Speed Limit:** 15 KM/Hr  
**Coordinates:** 11.37086, 77.74828

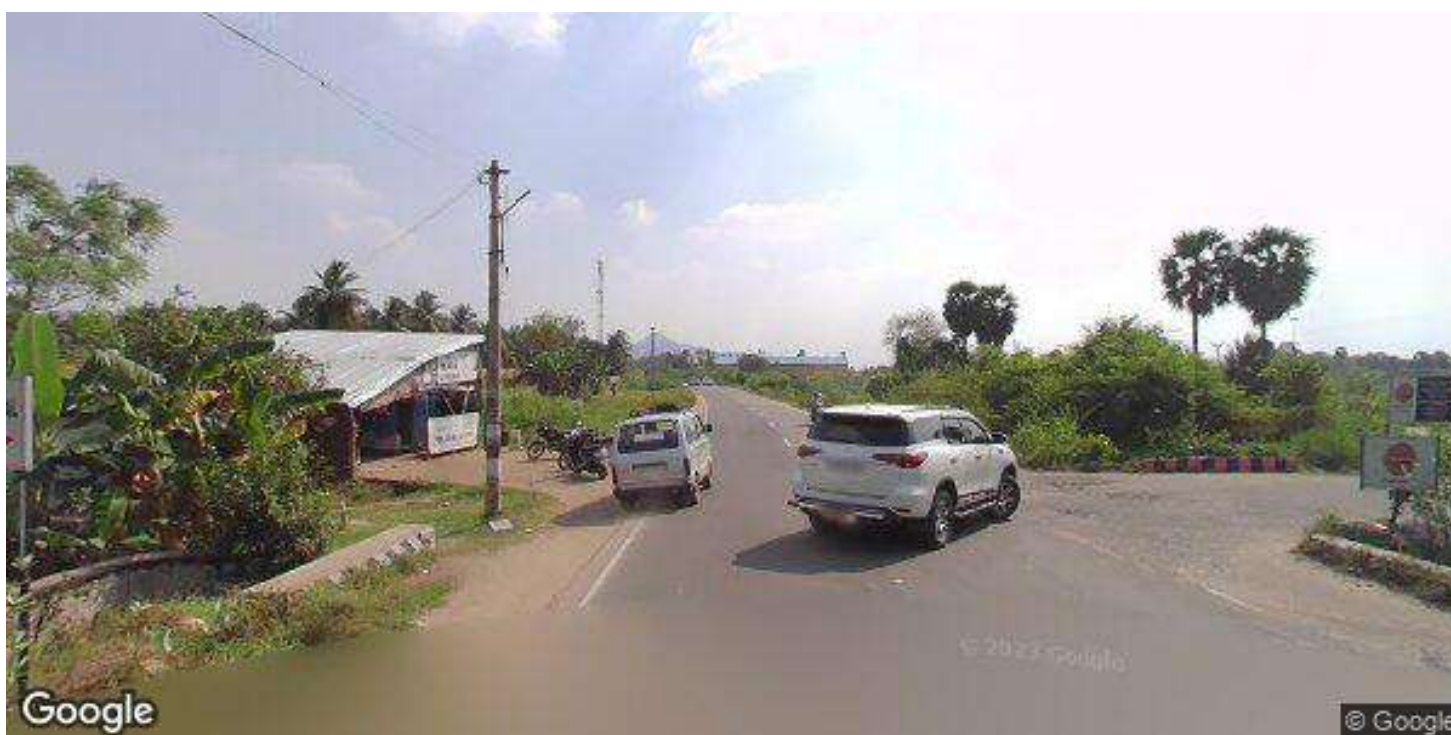
| | Risk Type | Risk Level | Coordinates | Speed Limit |
|---|---|---|---|---|
| 4 | Turn | High | 11.44029, 77.87544 | 15 KM/Hr |

**Risk Type:** Turn  
**Risk Level:** High  
**Speed Limit:** 15 KM/Hr  
**Coordinates:** 11.44029, 77.87544

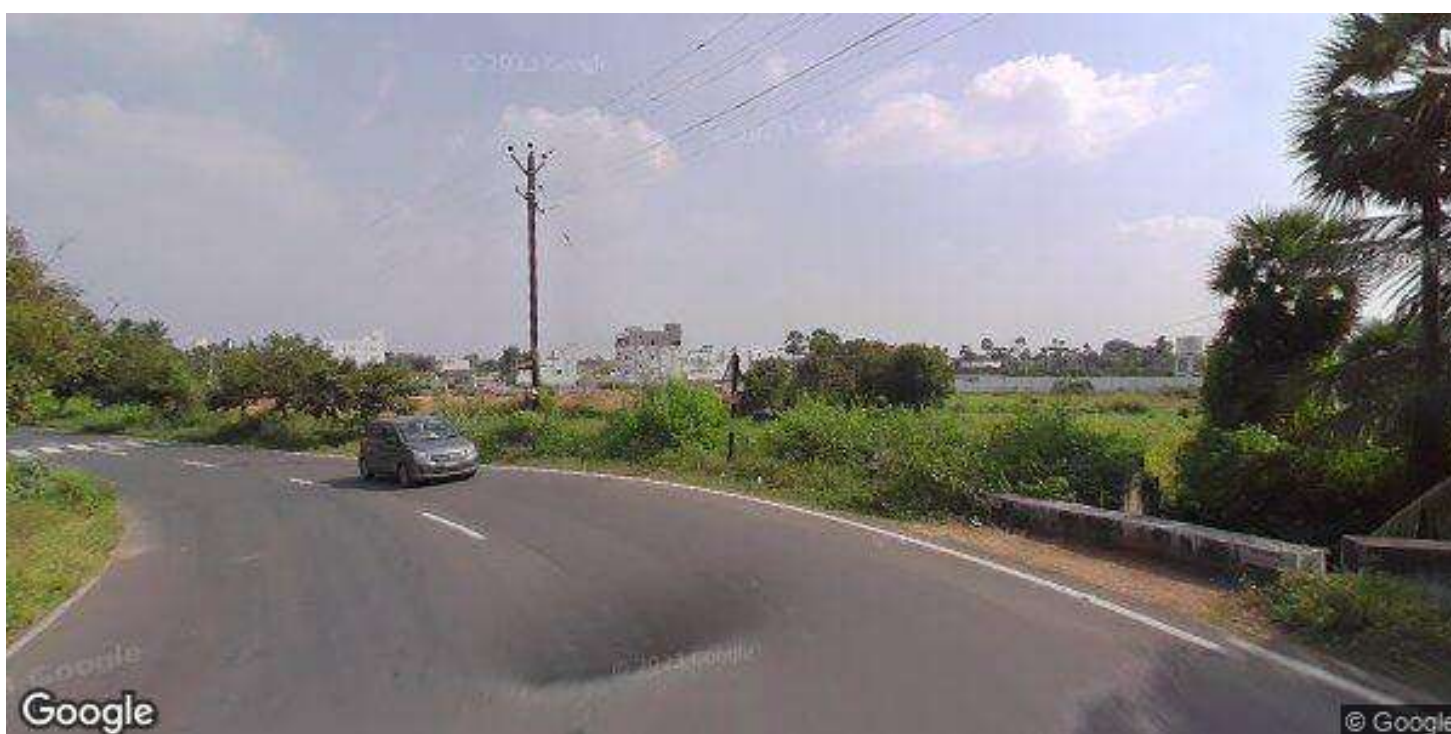
**Coordinates: 11.45350, 77.85700**

| | Risk Type | Risk Level | Coordinates | Speed Limit |
|---|---|---|---|---|
| 5 | Turn | Medium | 11.45350, 77.85700 | 30 KM/Hr |

**Risk Type:** Turn  
**Risk Level:** Medium

**Speed Limit: 30 KM/Hr**

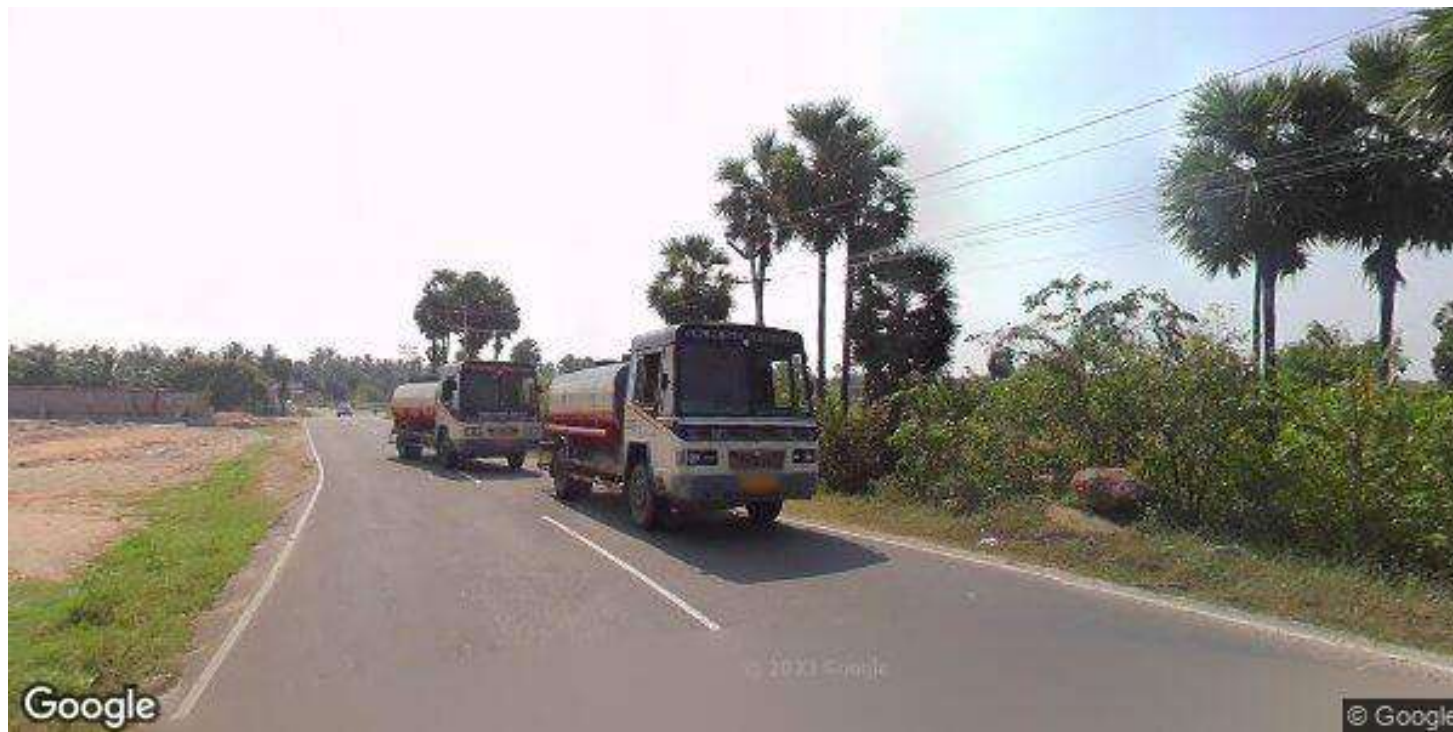
**Coordinates: 11.45833, 77.85146**

| | Risk Type | Risk Level | Coordinates | Speed Limit |
|---|---|---|---|---|
| 6 | Turn | Medium | 11.45833, 77.85146 | 30 KM/Hr |

**Risk Type: Turn**

**Risk Level: Medium**

**Speed Limit: 30 KM/Hr**

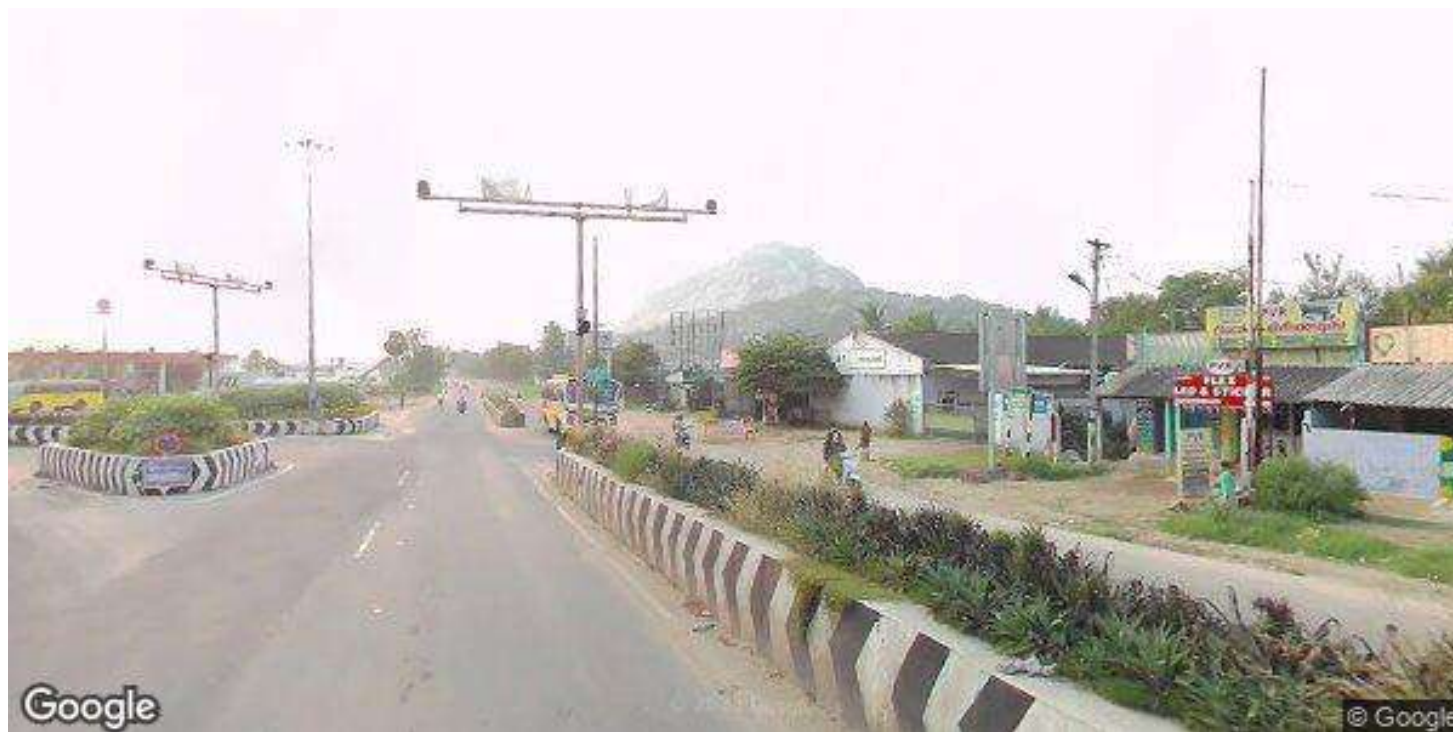
**Coordinates: 11.46312, 77.84886**

| | Risk Type | Risk Level | Coordinates | Speed Limit |
|---|---|---|---|---|
| 7 | Turn | Medium | 11.46312, 77.84886 | 30 KM/Hr |

**Risk Type: Turn**

**Risk Level: Medium**

**Speed Limit: 30 KM/Hr**

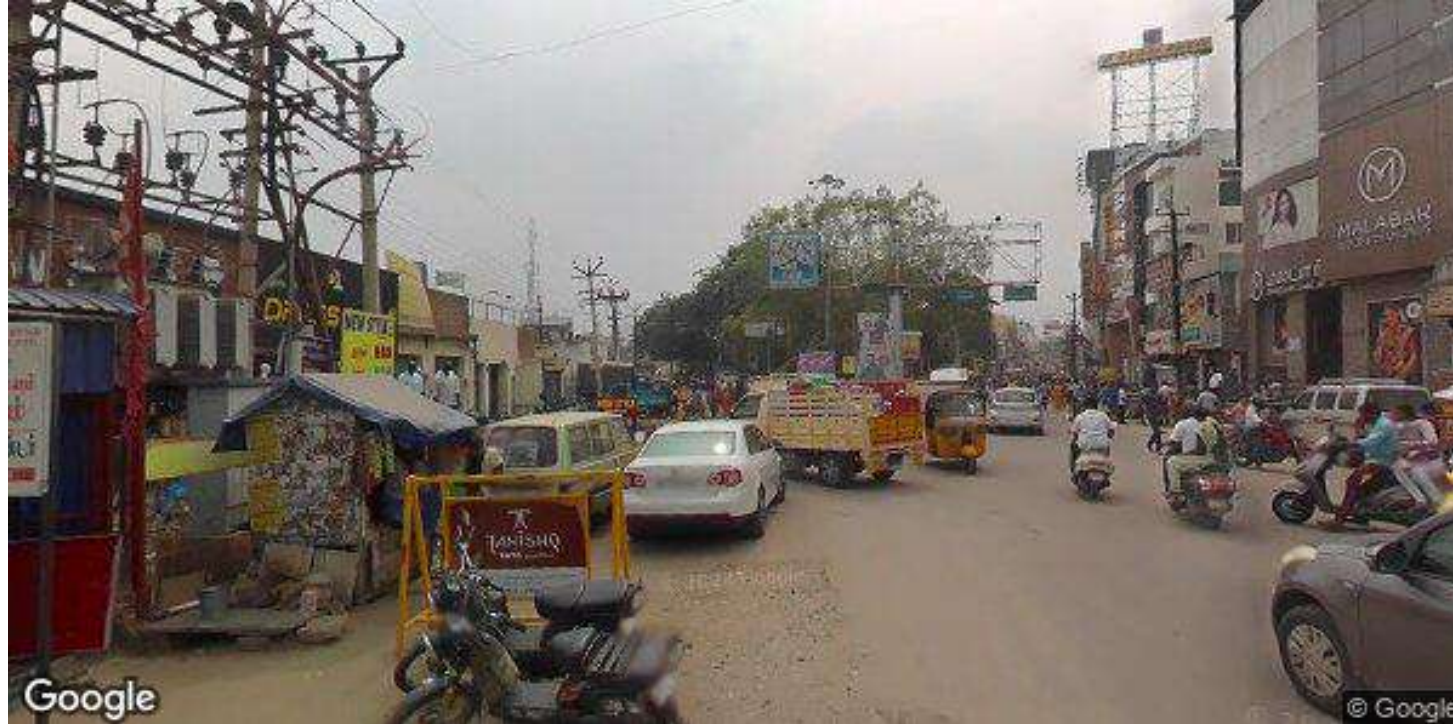
**Coordinates:** 11.34493, 77.73032

| | Risk Type | Risk Level | Coordinates | Speed Limit |
|---|---|---|---|---|
| 8 | Turn | Medium | 11.34493, 77.73032 | 30 KM/Hr |

**Risk Type:** Turn

**Risk Level:** Medium

**Speed Limit:** 30 KM/Hr

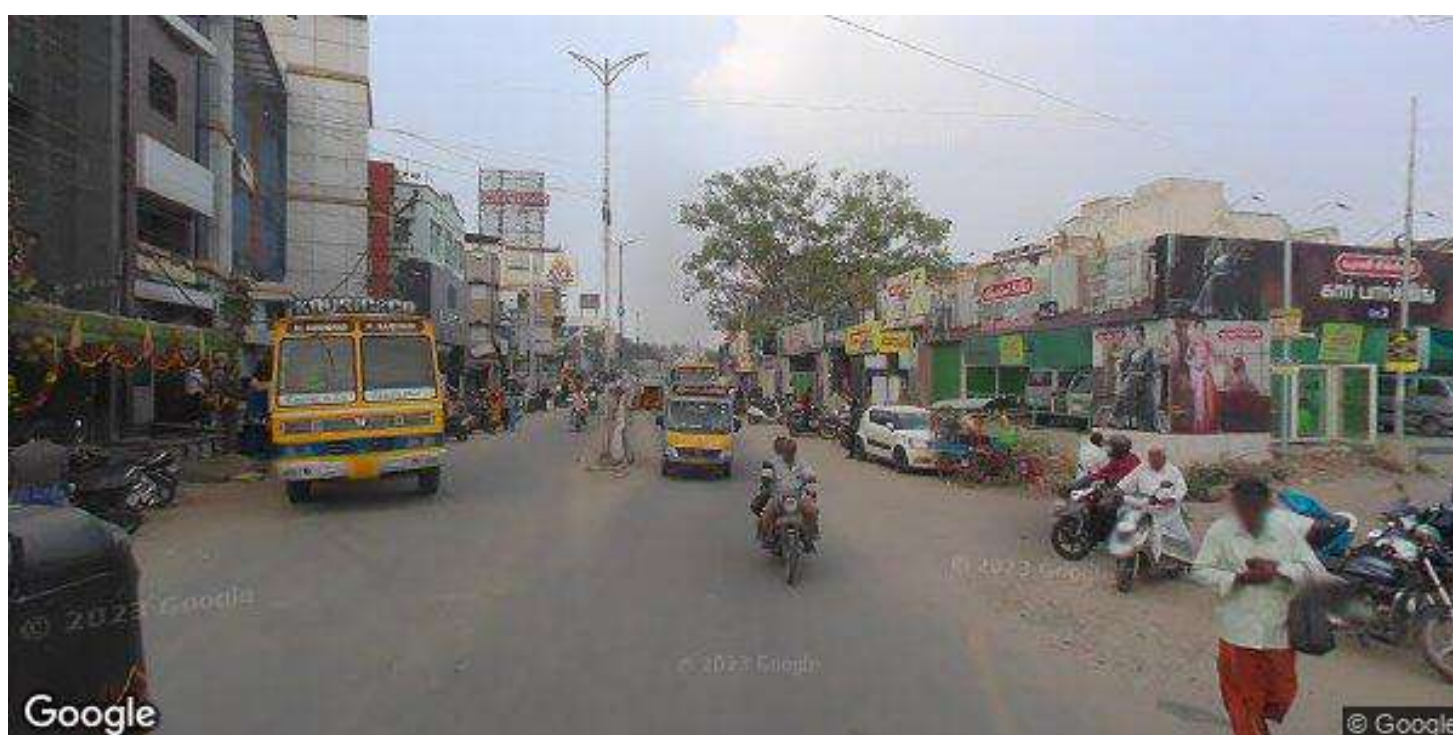
**Coordinates:** 11.34487, 77.73024

| | Risk Type | Risk Level | Coordinates | Speed Limit |
|---|---|---|---|---|
| 9 | Turn | Medium | 11.34487, 77.73024 | 30 KM/Hr |

**Risk Type:** Turn

**Risk Level:** Medium

**Speed Limit:** 30 KM/Hr

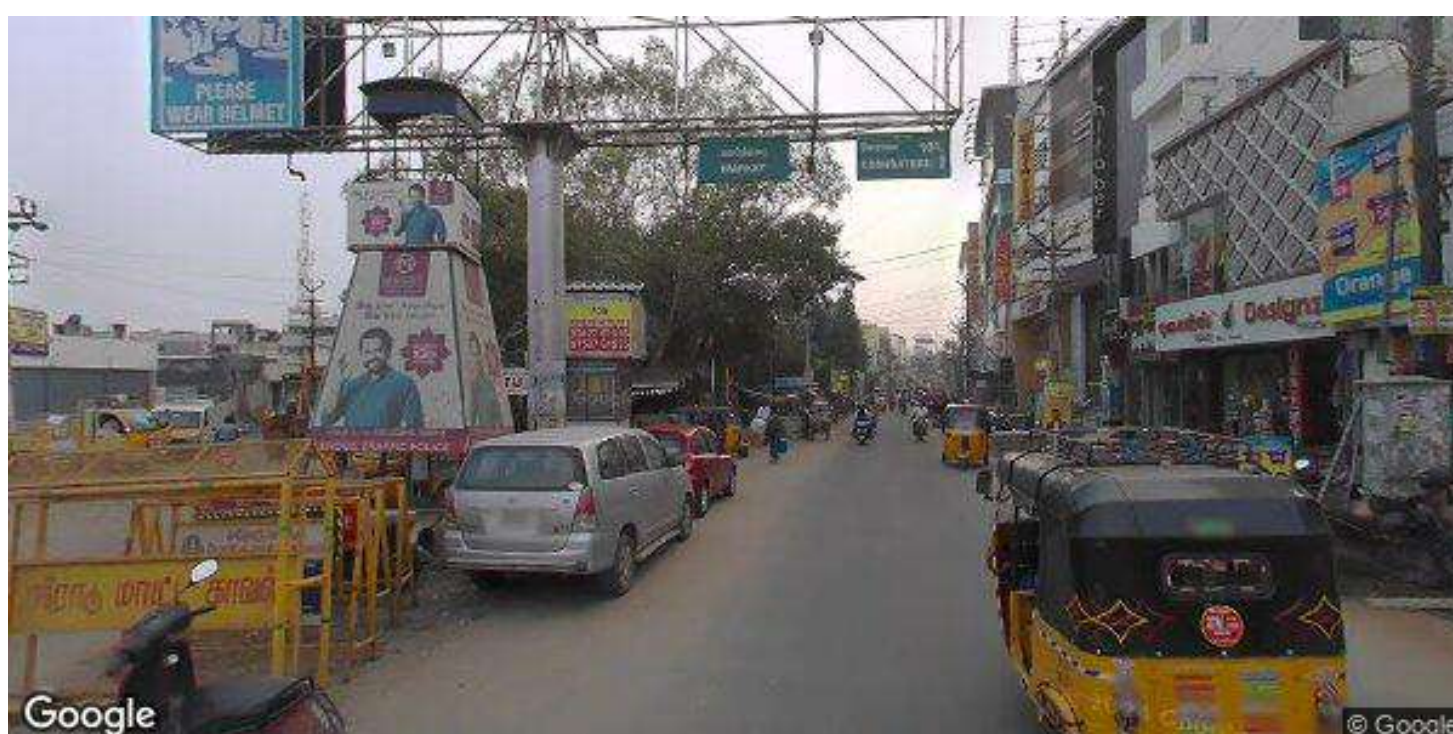
Coordinates: 11.34470, 77.73018

| | Risk Type | Risk Level | Coordinates | Speed Limit |
|---|---|---|---|---|
| 10 | Turn | Medium | 11.34470, 77.73018 | 30 KM/Hr |

**Risk Type:** Turn

**Risk Level:** Medium

Speed Limit: 30 KM/Hr

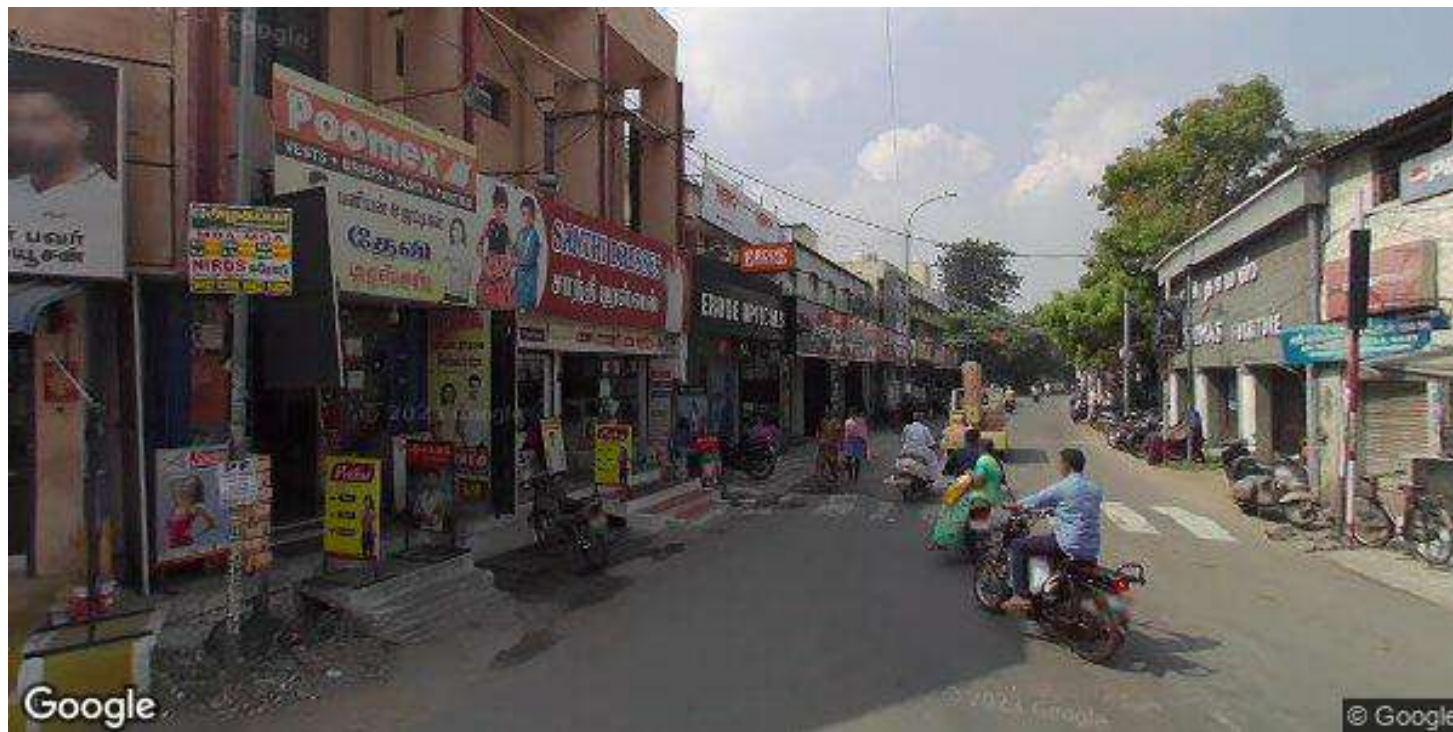
Coordinates: 11.33920, 77.72902

| | Risk Type | Risk Level | Coordinates | Speed Limit |
|---|---|---|---|---|
| 11 | Blind Spot | Blind Spot | 11.33920, 77.72902 | 10 KM/Hr |

Risk Type: Blind Spot

Risk Level: Blind Spot

Speed Limit: 10 KM/Hr

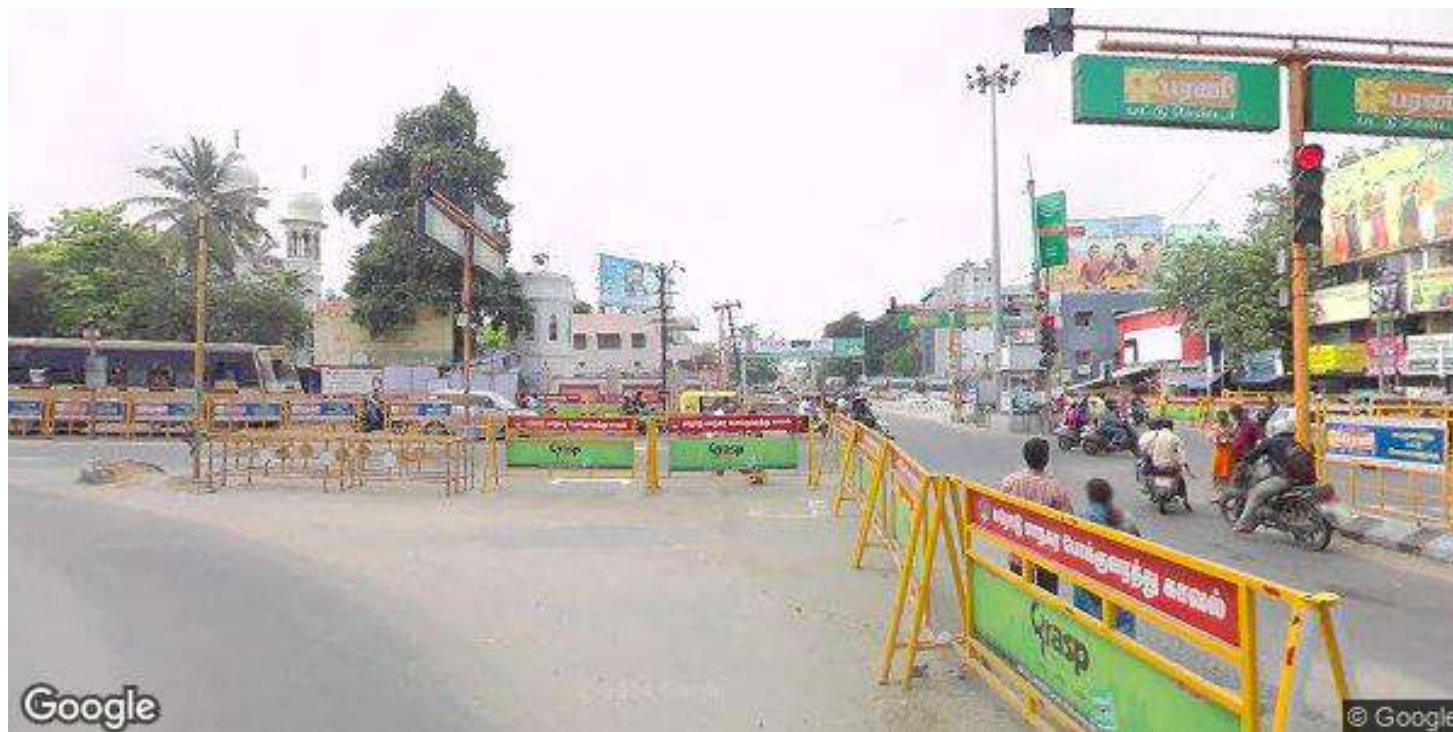
Coordinates: 11.33914, 77.72659

| | Risk Type | Risk Level | Coordinates | Speed Limit |
|---|---|---|---|---|
| 12 | Turn | Medium | 11.33914, 77.72659 | 30 KM/Hr |

Risk Type: Turn

Risk Level: Medium

Speed Limit: 30 KM/Hr

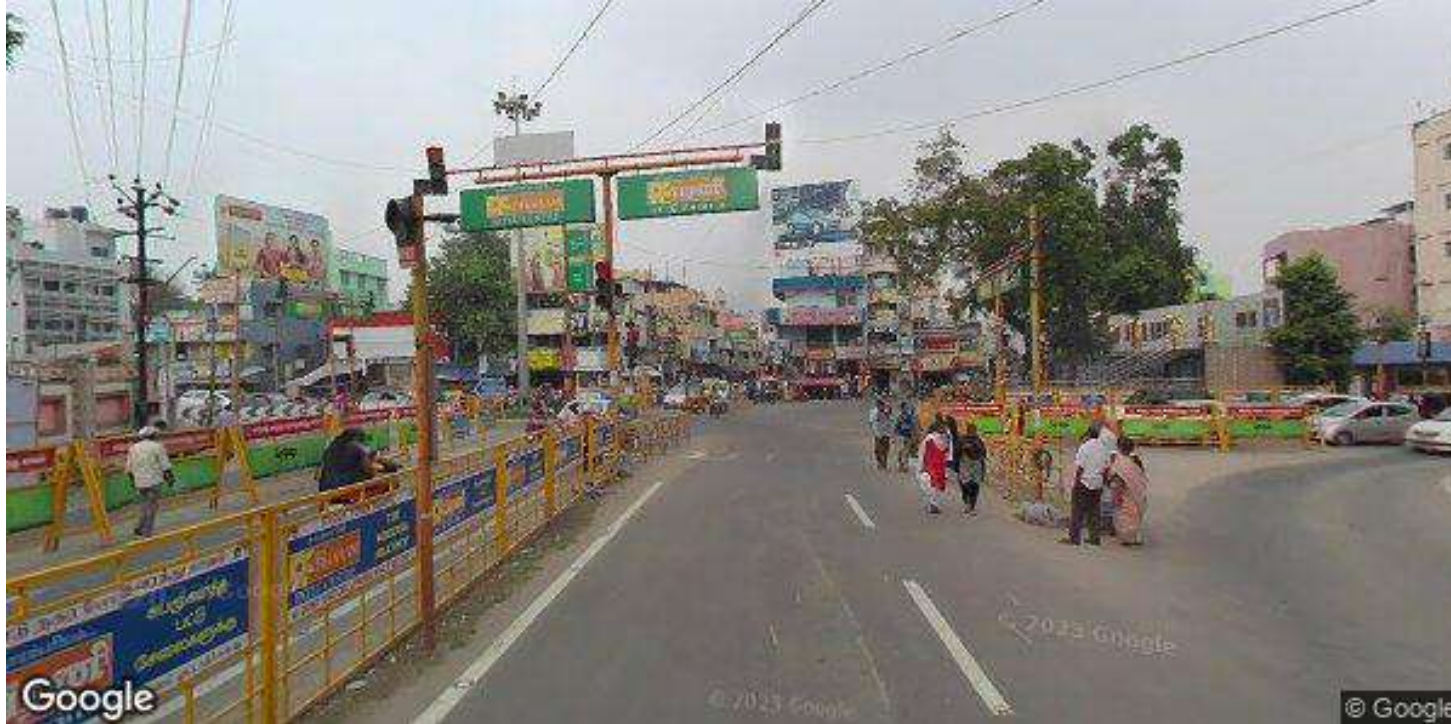
**Coordinates:** 11.33890, 77.72637

| | Risk Type | Risk Level | Coordinates | Speed Limit |
|---|---|---|---|---|
| 13 | Turn | High | 11.33890, 77.72637 | 15 KM/Hr |

**Risk Type:** Turn

**Risk Level:** High

**Speed Limit:** 15 KM/Hr

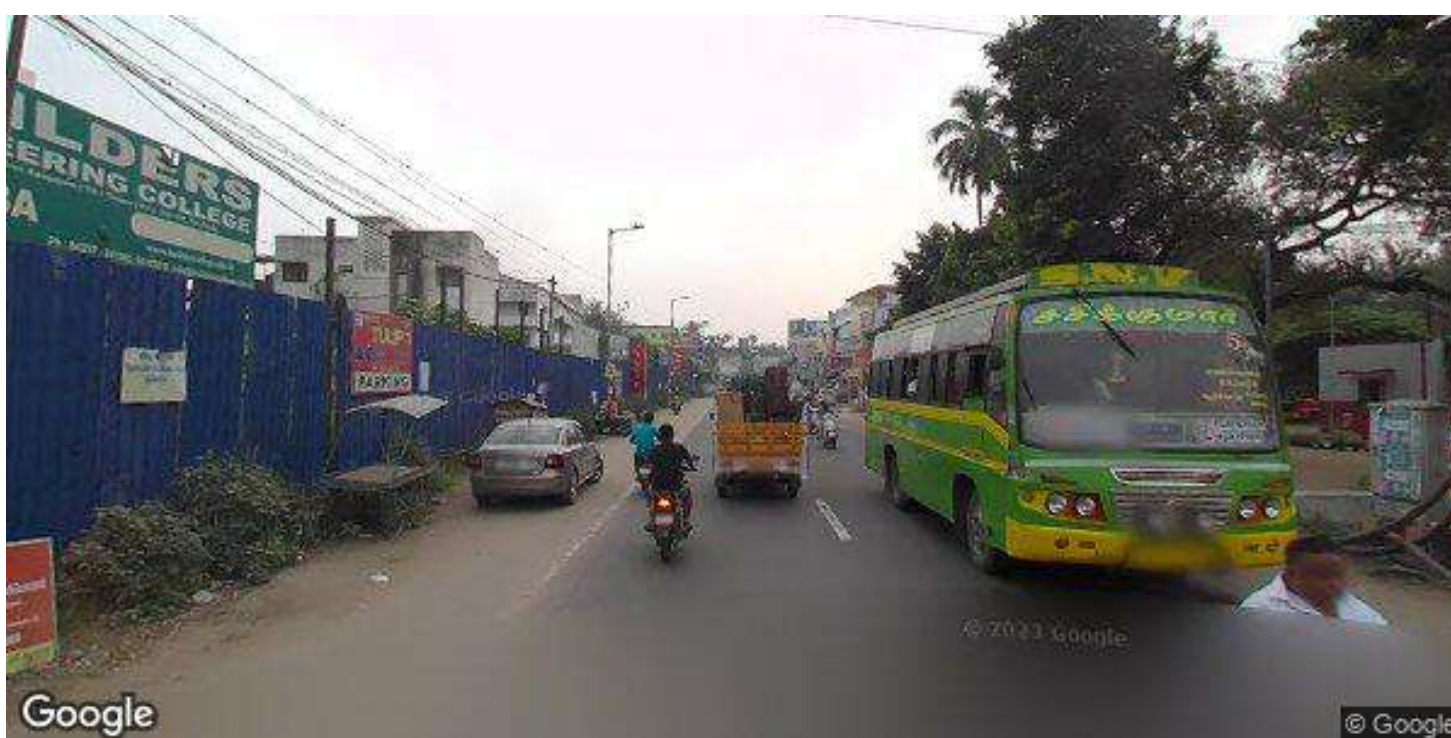
**Coordinates:** 11.33281, 77.72755

| | Risk Type | Risk Level | Coordinates | Speed Limit |
|---|---|---|---|---|
| 14 | Turn | High | 11.33281, 77.72755 | 15 KM/Hr |

**Risk Type:** Turn

**Risk Level:** High

**Speed Limit:** 15 KM/Hr
