# IndianOil

## JOURNEY RISK MANAGEMENT (JRM) STUDY

### Salem Terminal to RJNS TRADERS

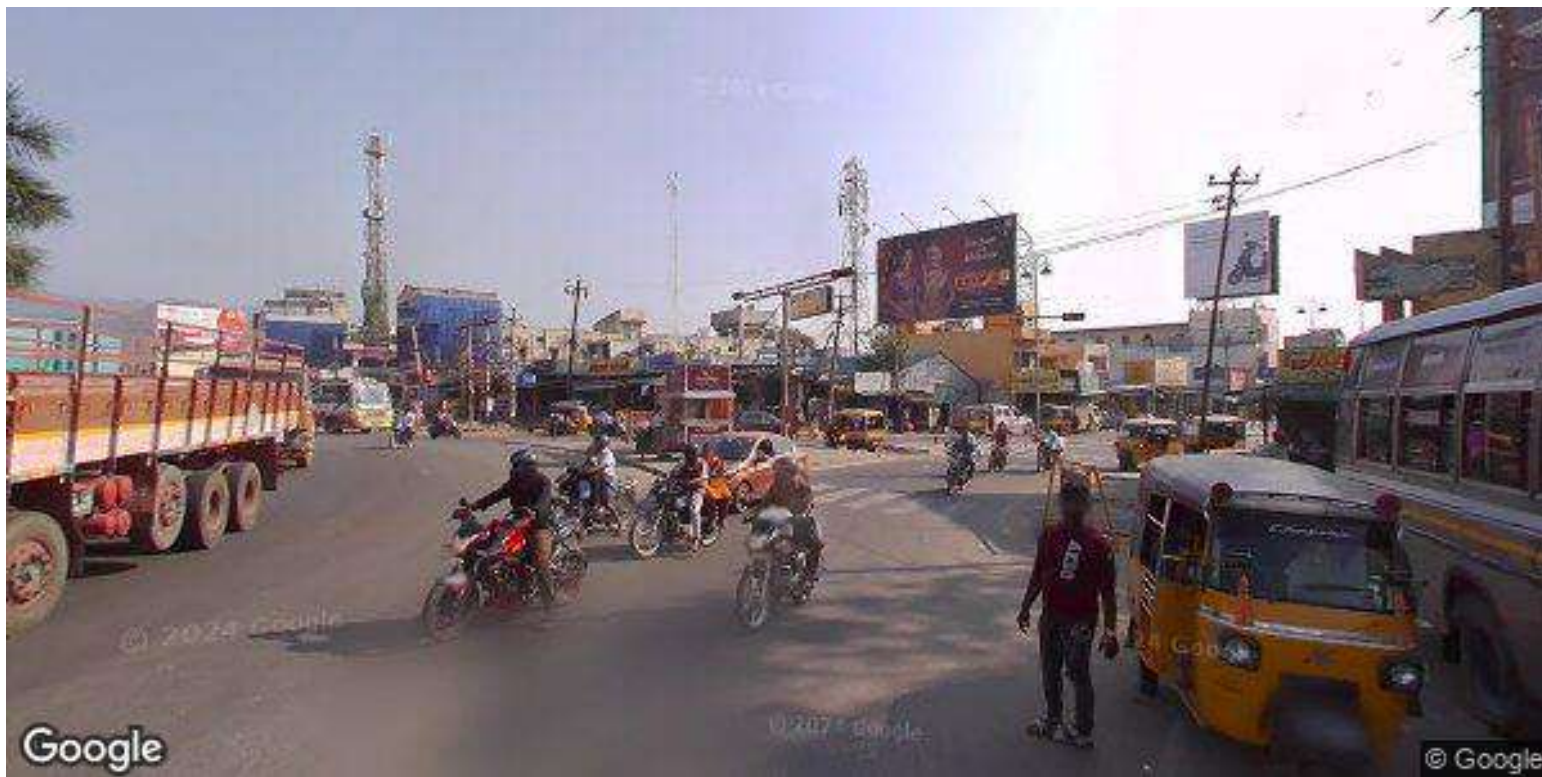
**Coordinates:** 11.63266, 78.12699

**Risk Type:** Roundabout

**Risk Level:** High

**Speed Limit:** 15 KM/Hr

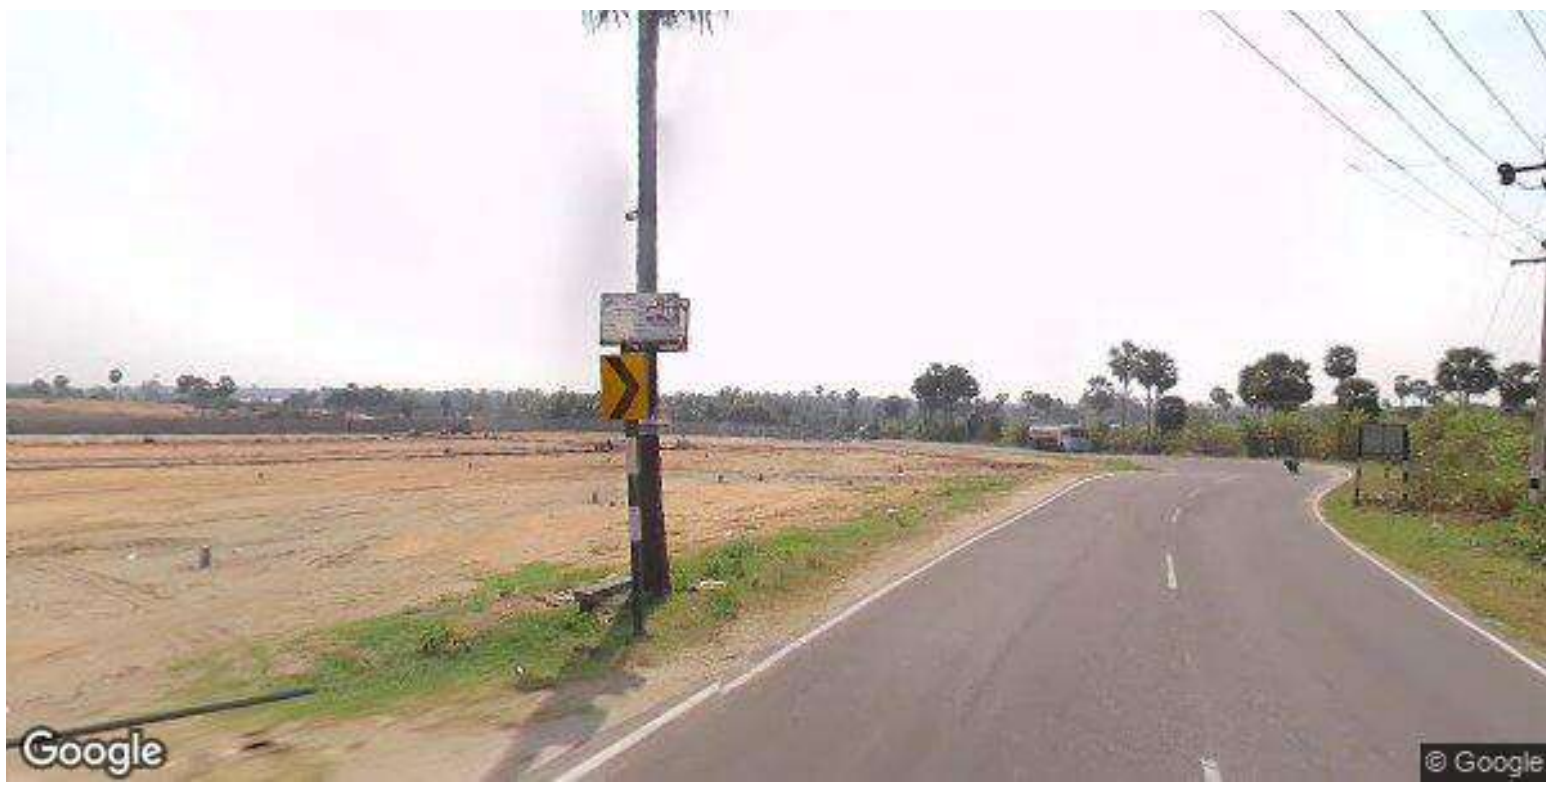
**Coordinates:** 11.45898, 77.85135

**Risk Type:** Turn

**Risk Level:** Medium

**Speed Limit:** 30 KM/Hr

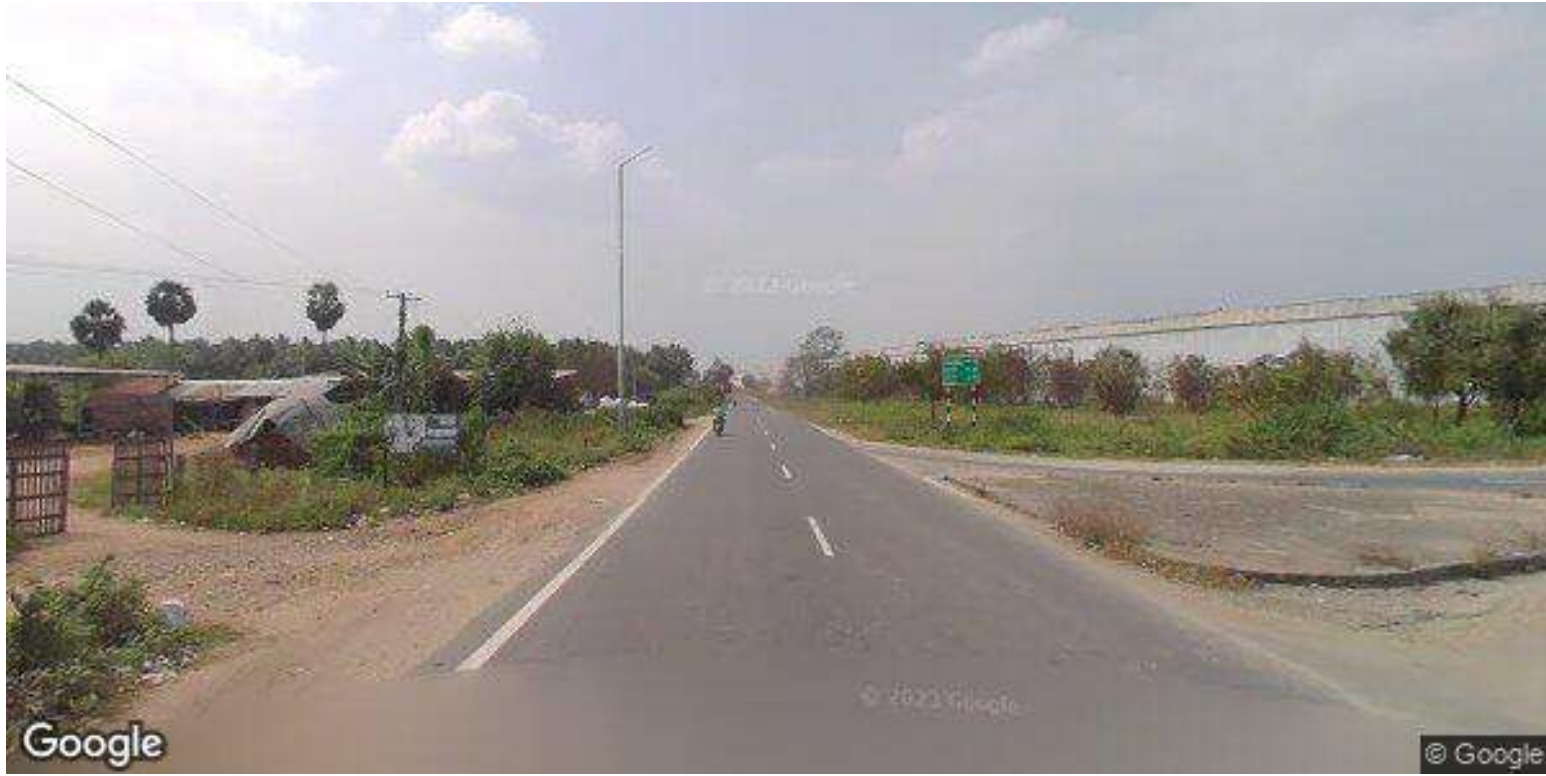
**Coordinates: 11.45542, 77.81725**

**Risk Type: Turn**

**Risk Level: High**

**Speed Limit: 15 KM/Hr**

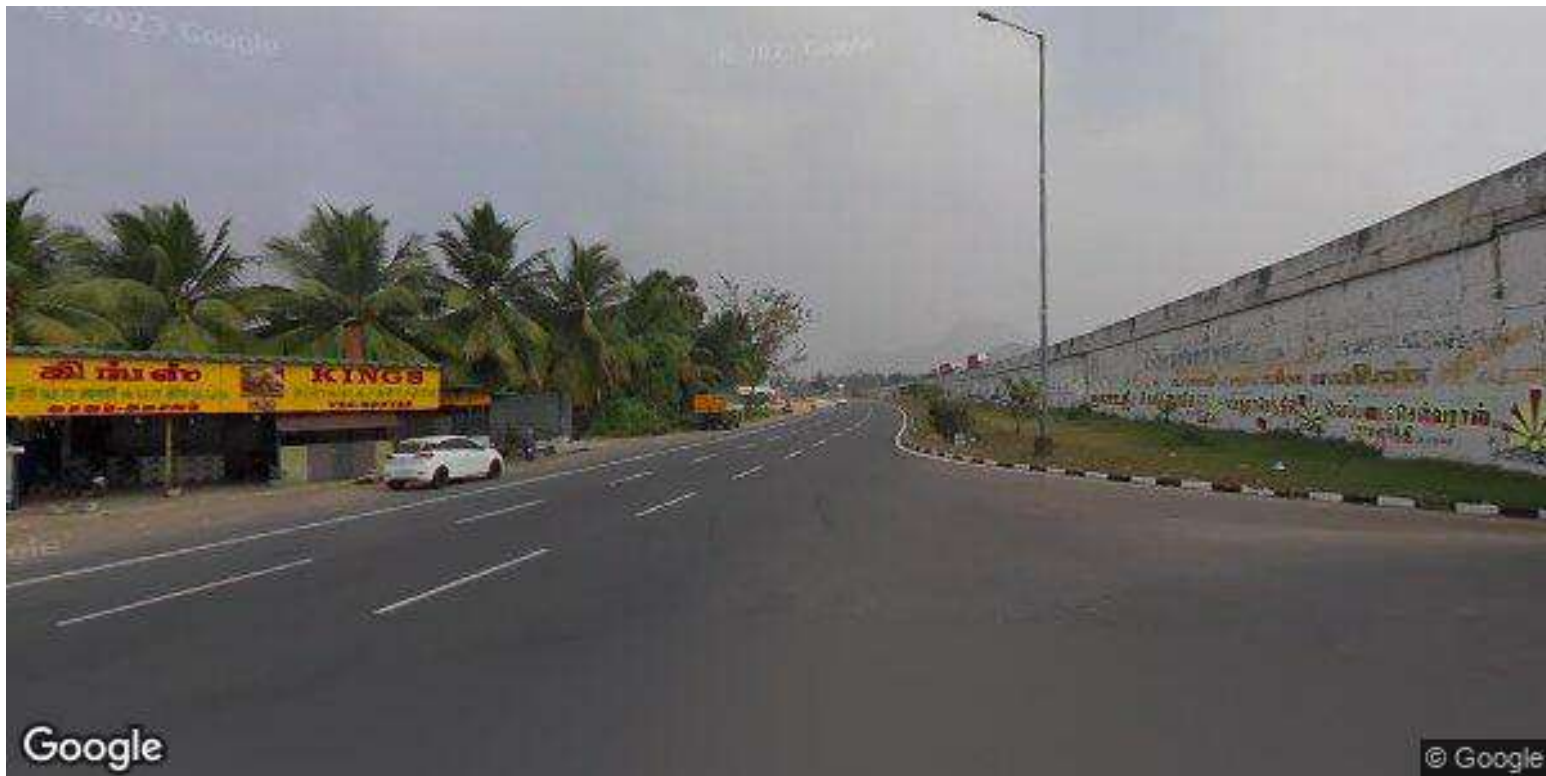
**Coordinates: 11.45634, 77.81673**

**Risk Type: Turn**

**Risk Level: High**

**Speed Limit: 15 KM/Hr**

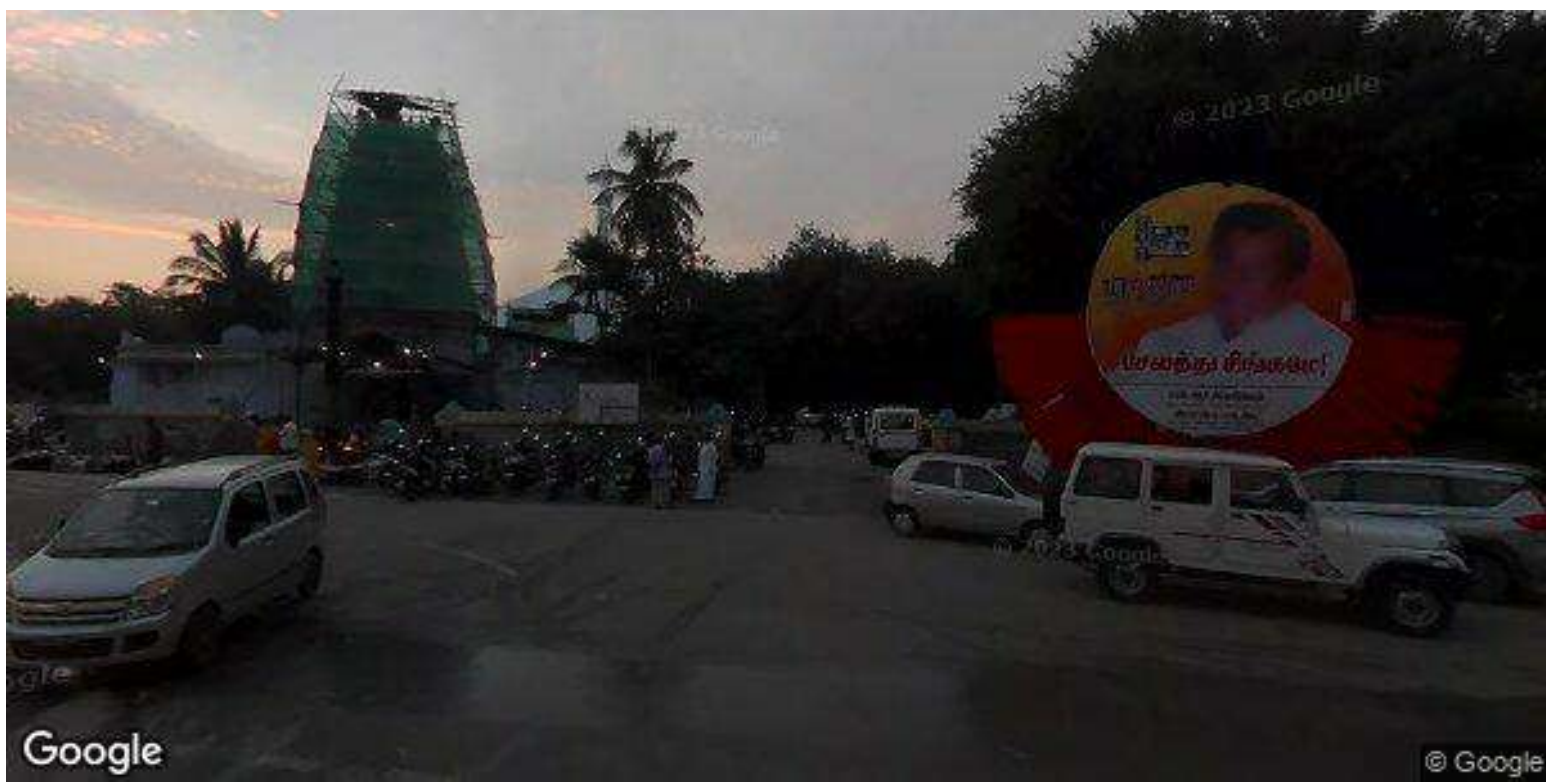
**Coordinates:** 11.61233, 78.10397

**Risk Type:** Turn

**Risk Level:** High

**Speed Limit:** 15 KM/Hr

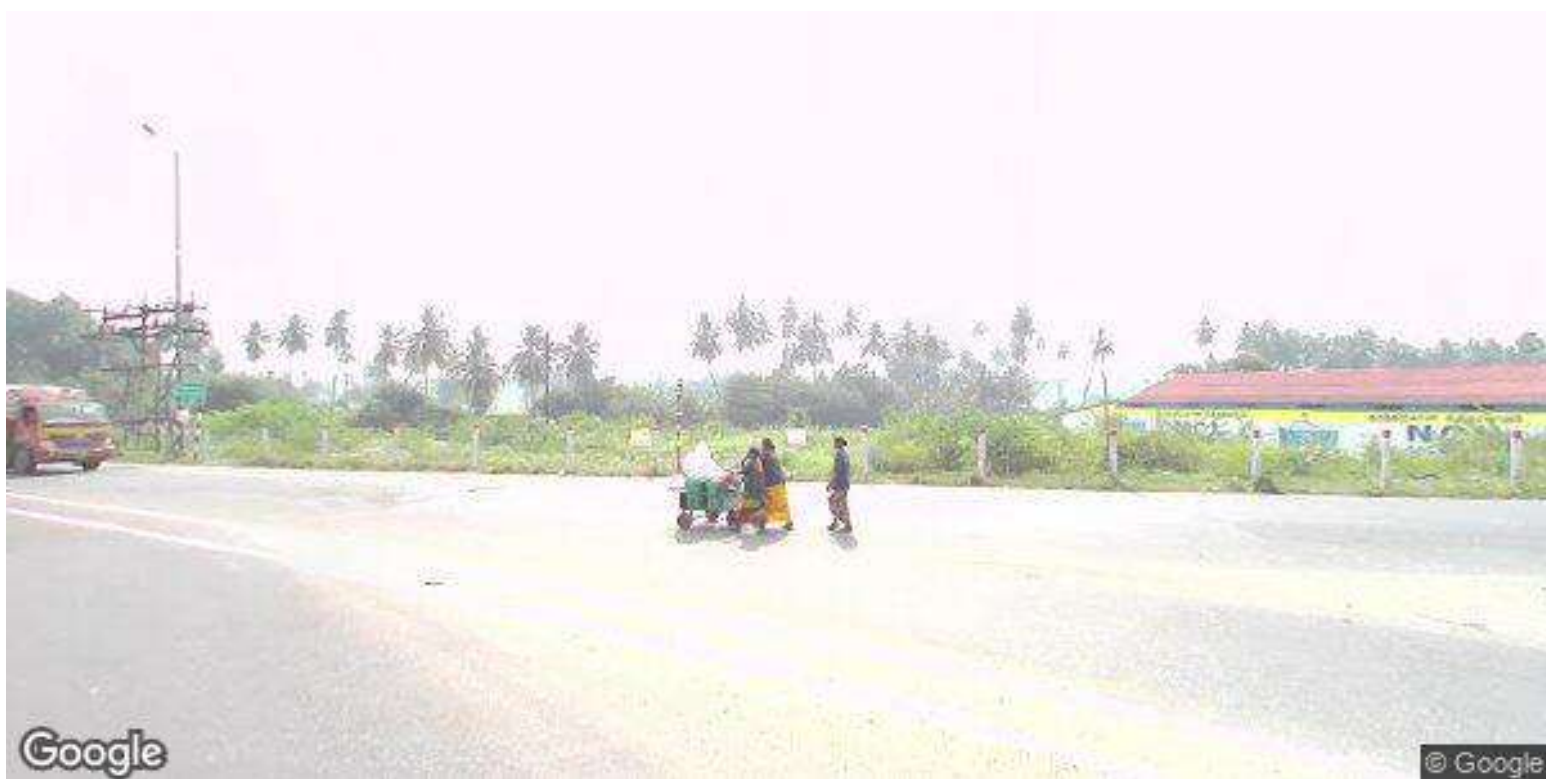
**Coordinates:** 11.61216, 78.10423

**Risk Type:** Turn

**Risk Level:** High

**Speed Limit:** 15 KM/Hr

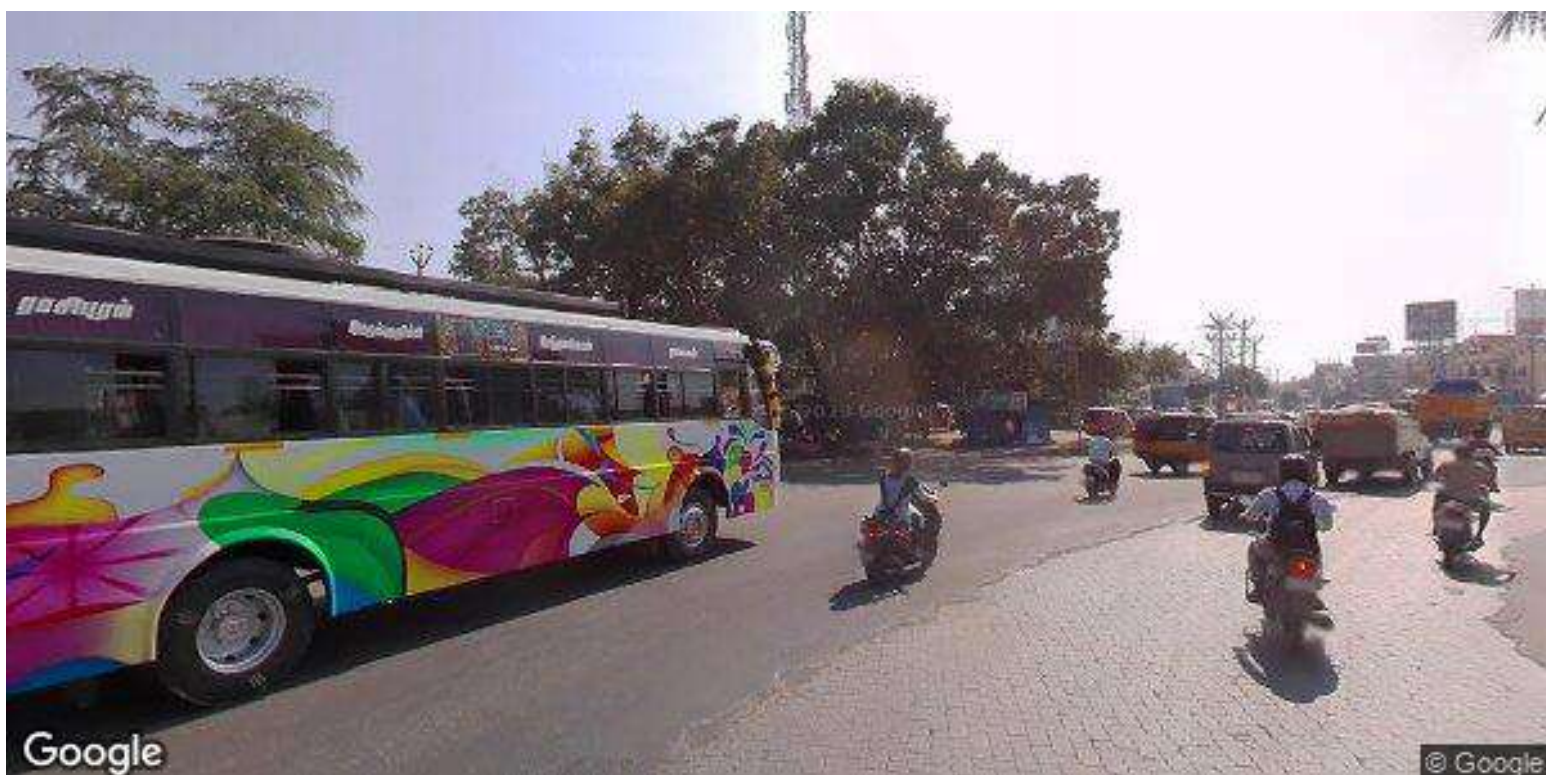
**Risk Type:** Turn  
**Risk Level:** High  
**Speed Limit:** 15 KM/Hr  
**Coordinates:** 11.63300, 78.12746

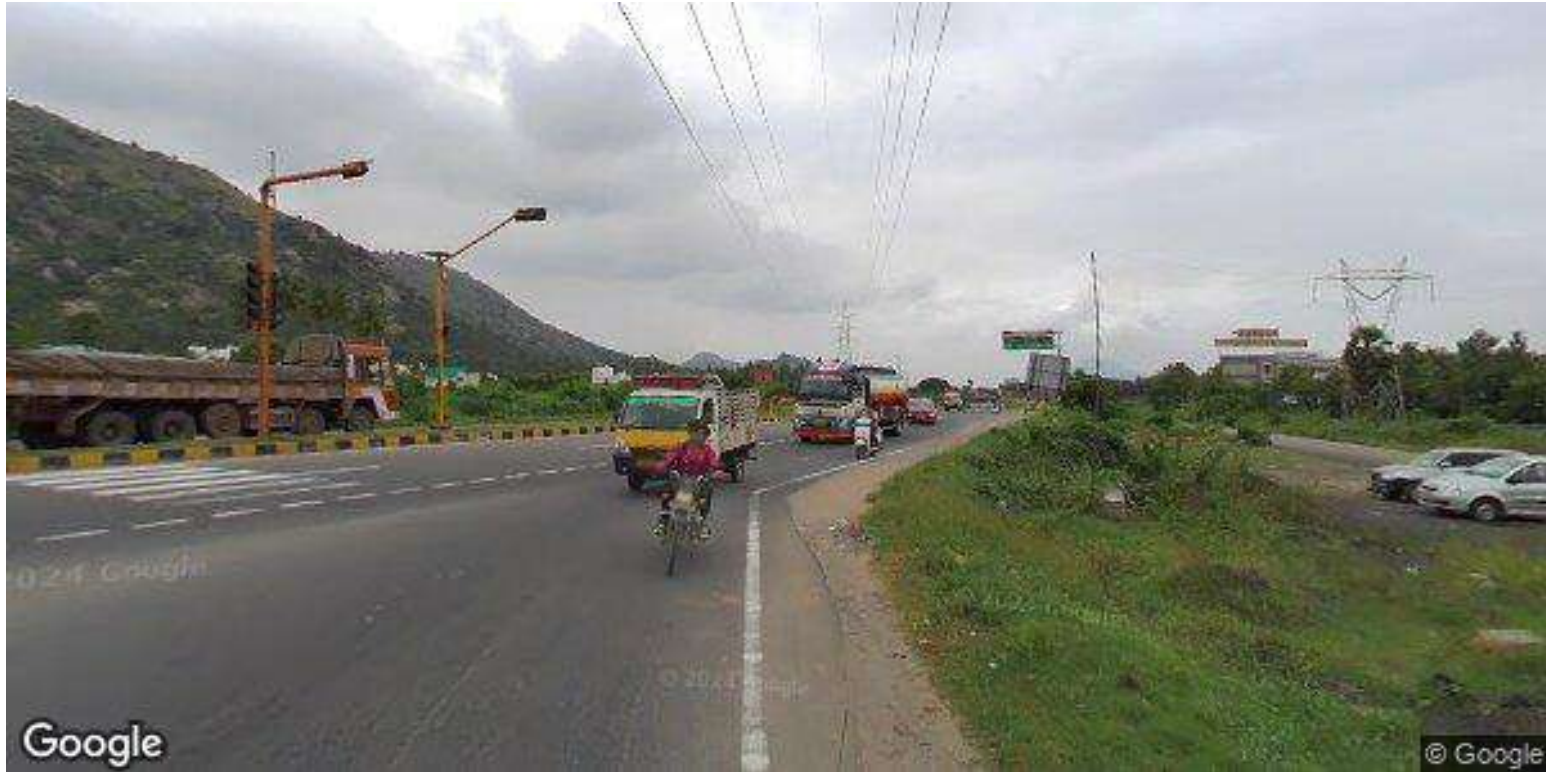
**Risk Type:** Turn  
**Risk Level:** Medium  
**Speed Limit:** 30 KM/Hr  
**Coordinates:** 11.65627, 78.20215

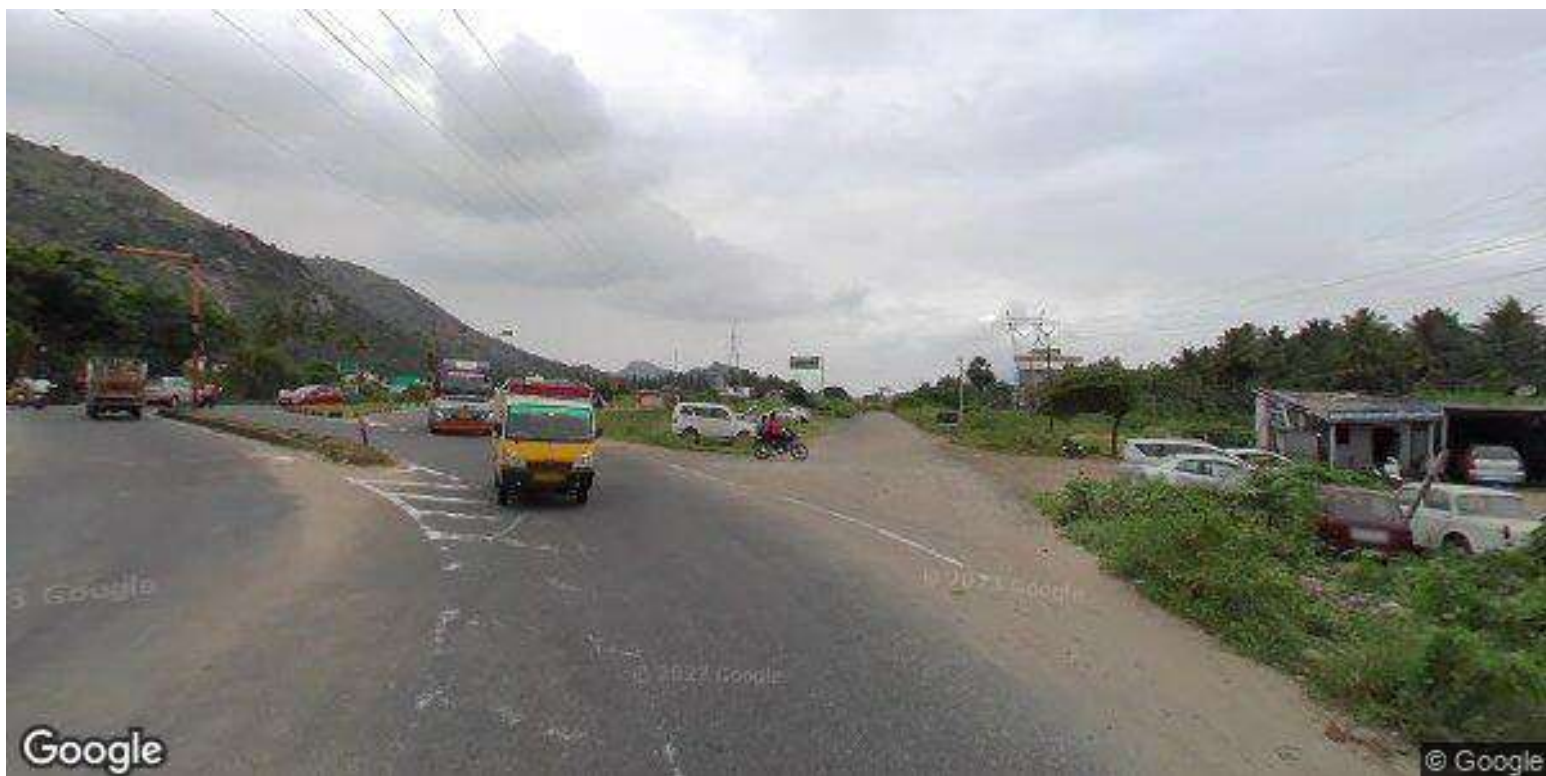
**Risk Type:** Turn  
**Risk Level:** Medium  
**Speed Limit:** 30 KM/Hr  
**Coordinates:** 11.65664, 78.20240

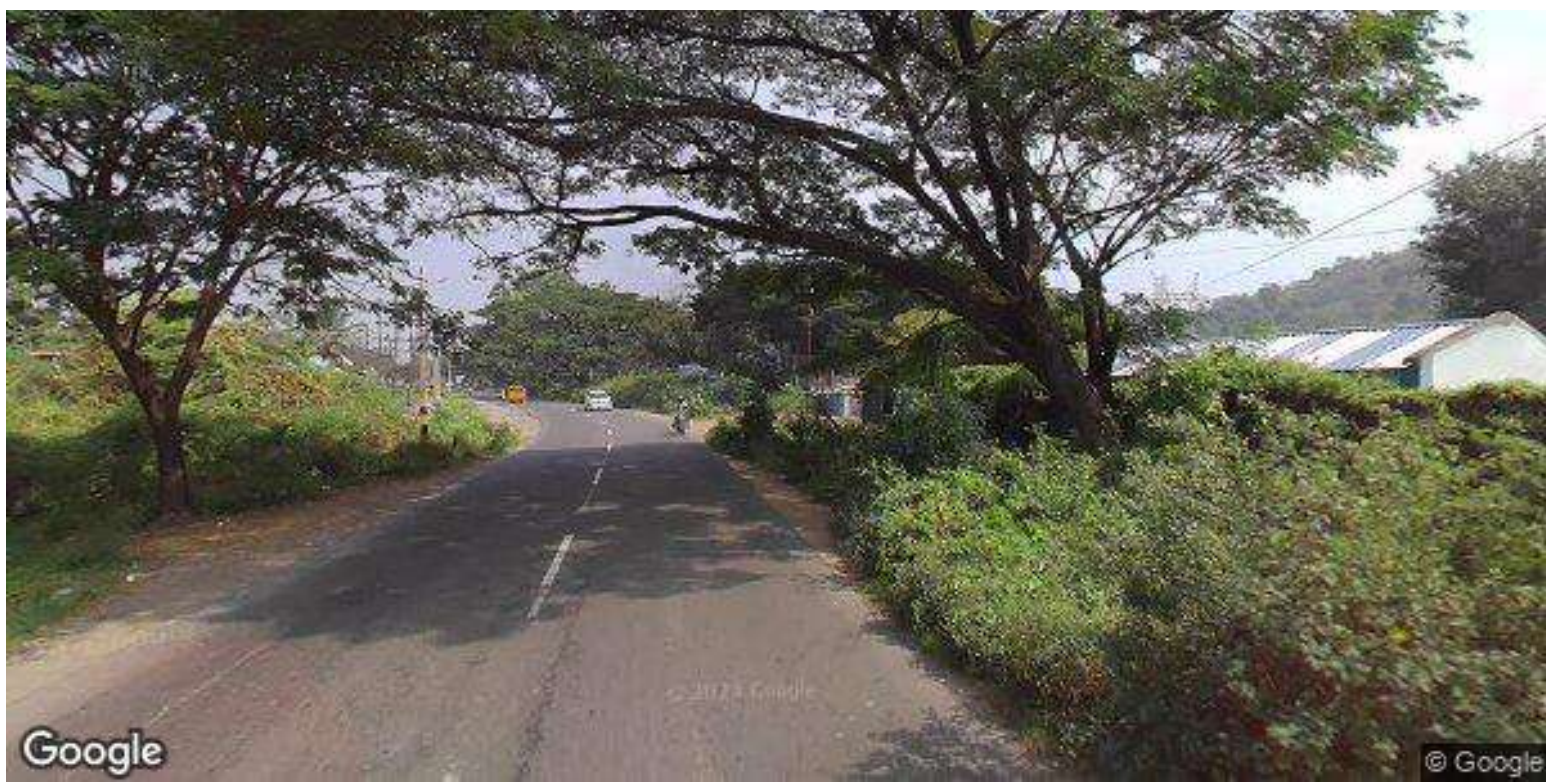
**Coordinates:** 11.65825, 78.20469

**Risk Type:** Turn

**Risk Level:** Medium

**Speed Limit:** 30 KM/Hr

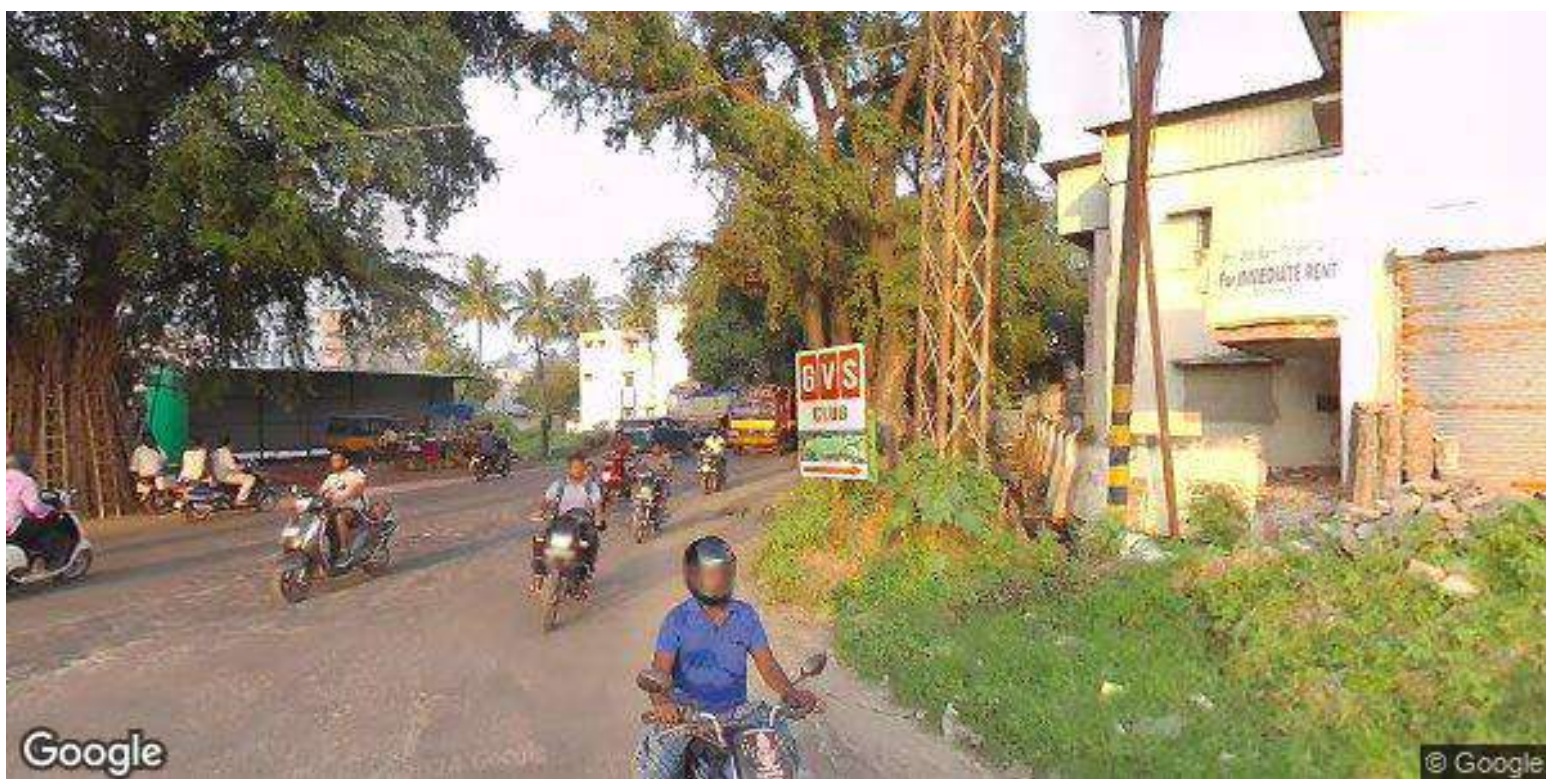
**Coordinates:** 11.66366, 78.20649

**Risk Type:** Turn

**Risk Level:** Medium

**Speed Limit:** 30 KM/Hr

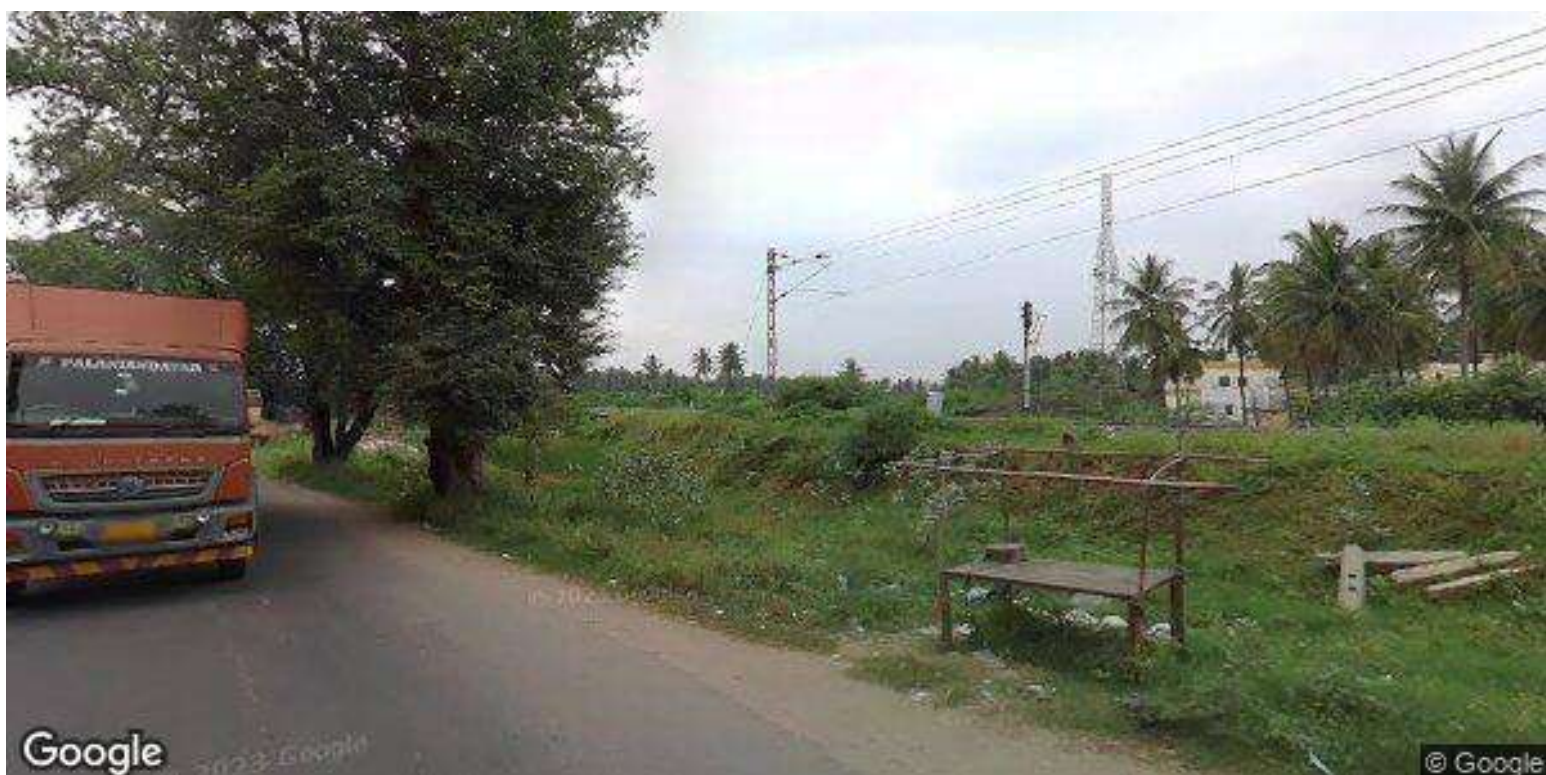
**Coordinates: 11.67128, 78.22971**

**Risk Type: Turn**

**Risk Level: Medium**

**Speed Limit: 30 KM/Hr**

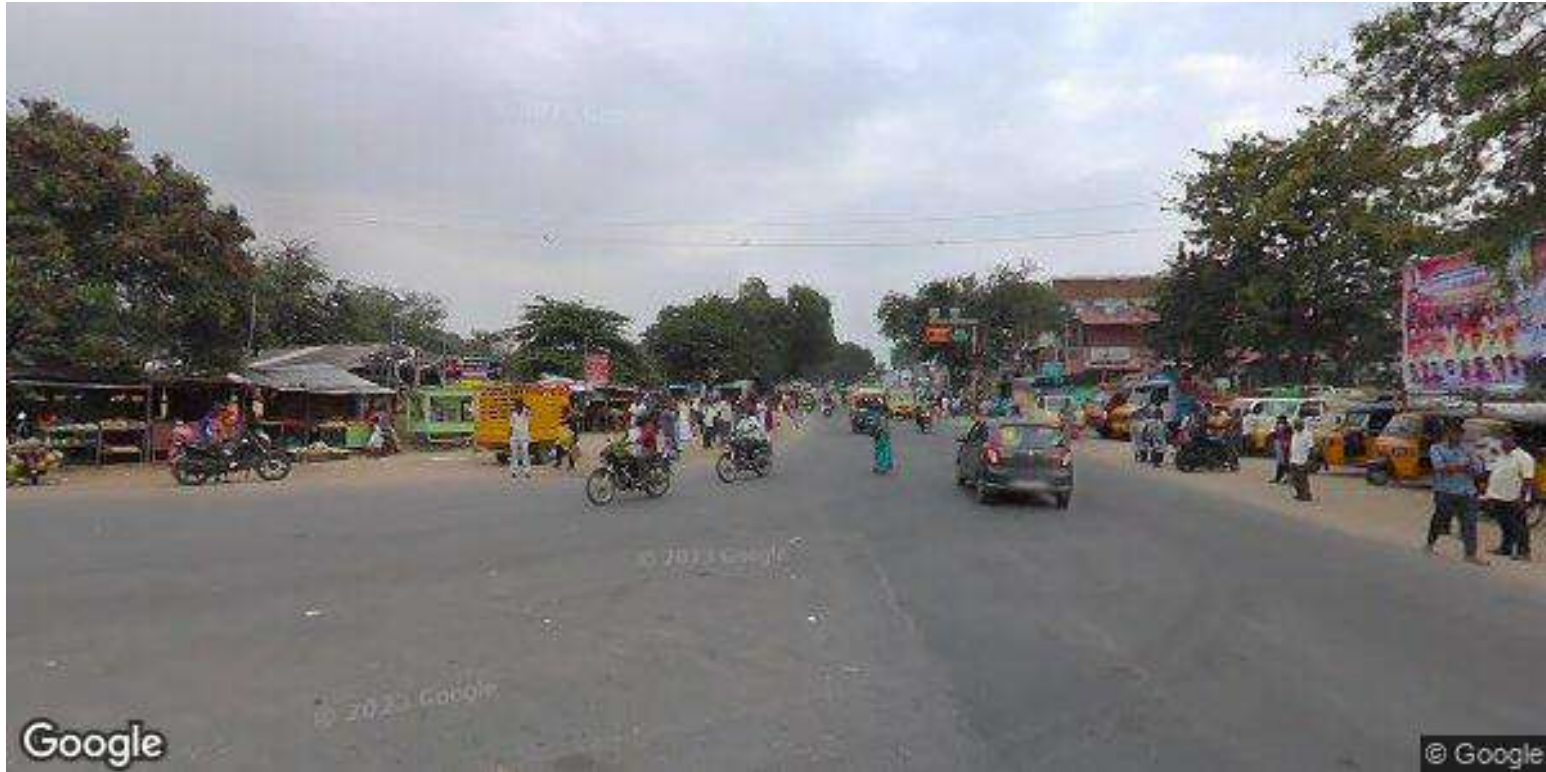
**Coordinates: 11.67111, 78.23134**

**Risk Type: Turn**

**Risk Level: High**

**Speed Limit: 15 KM/Hr**

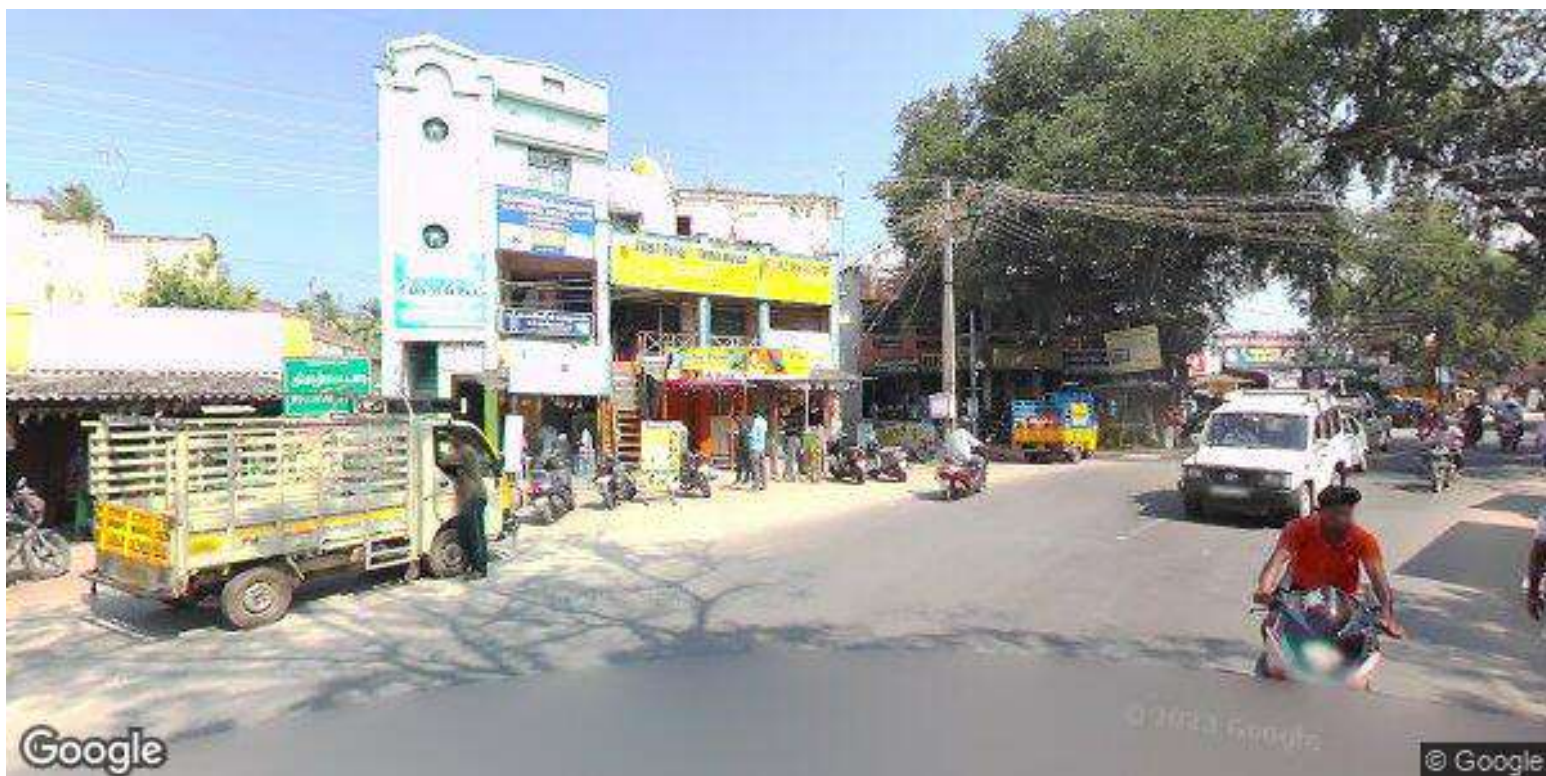
**Coordinates: 11.67195, 78.23146**

**Risk Type: Turn**

**Risk Level: Medium**

**Speed Limit: 30 KM/Hr**

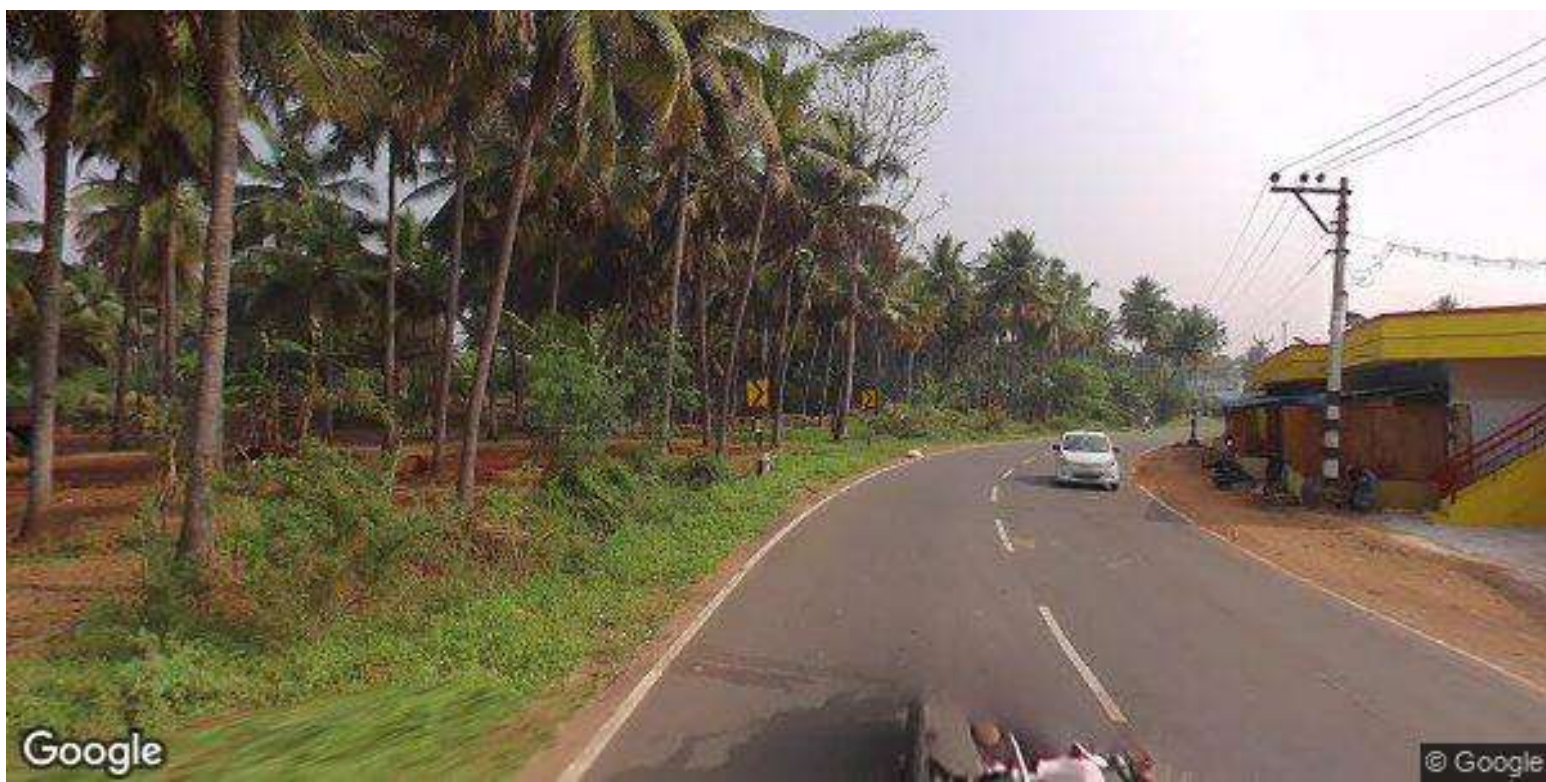
**Coordinates:** 11.68490, 78.26190

**Risk Type:** Turn

**Risk Level:** Medium

**Speed Limit:** 30 KM/Hr

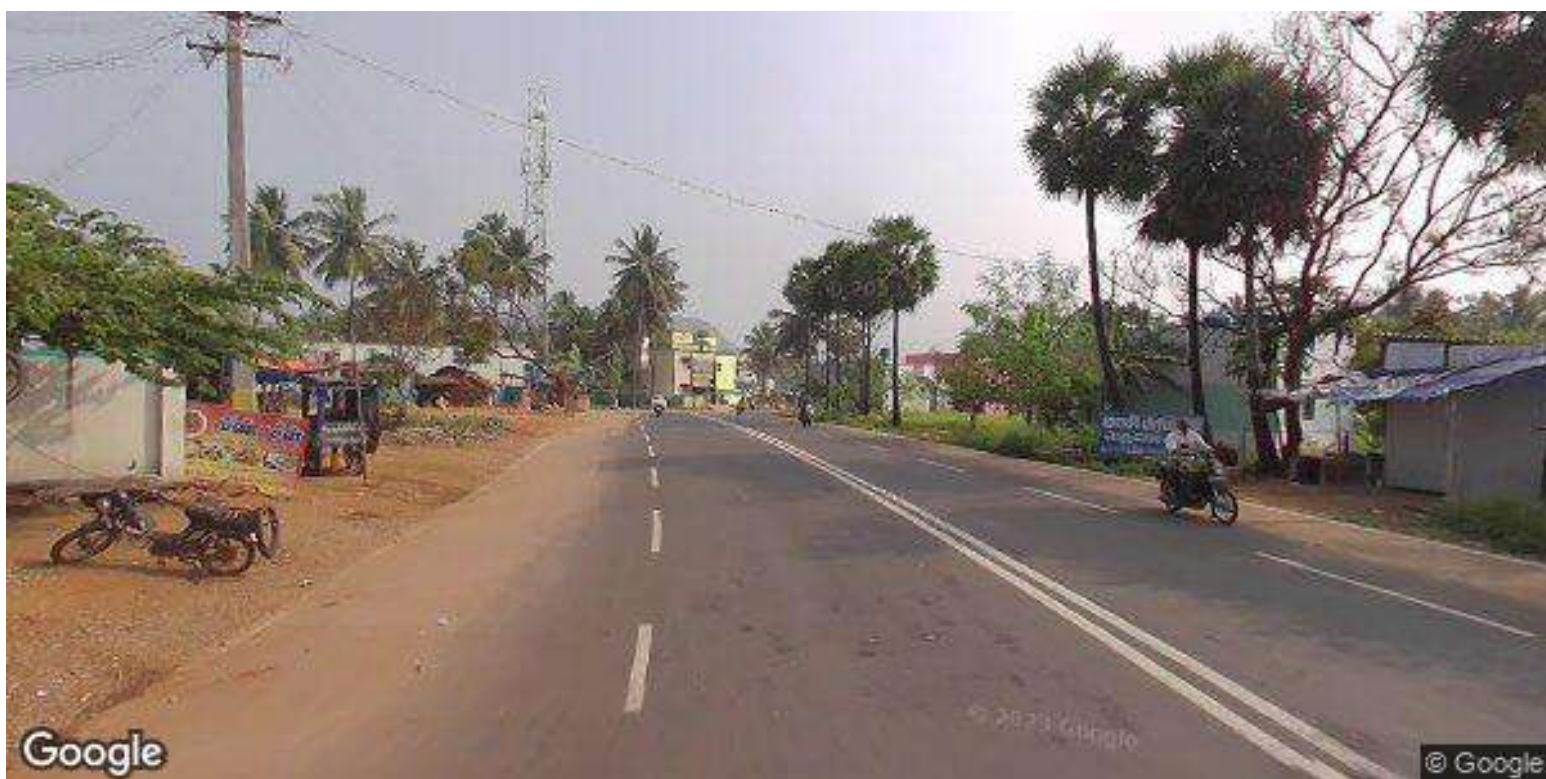
**Coordinates:** 11.68562, 78.26787

**Risk Type:** Turn

**Risk Level:** Medium

**Speed Limit:** 30 KM/Hr

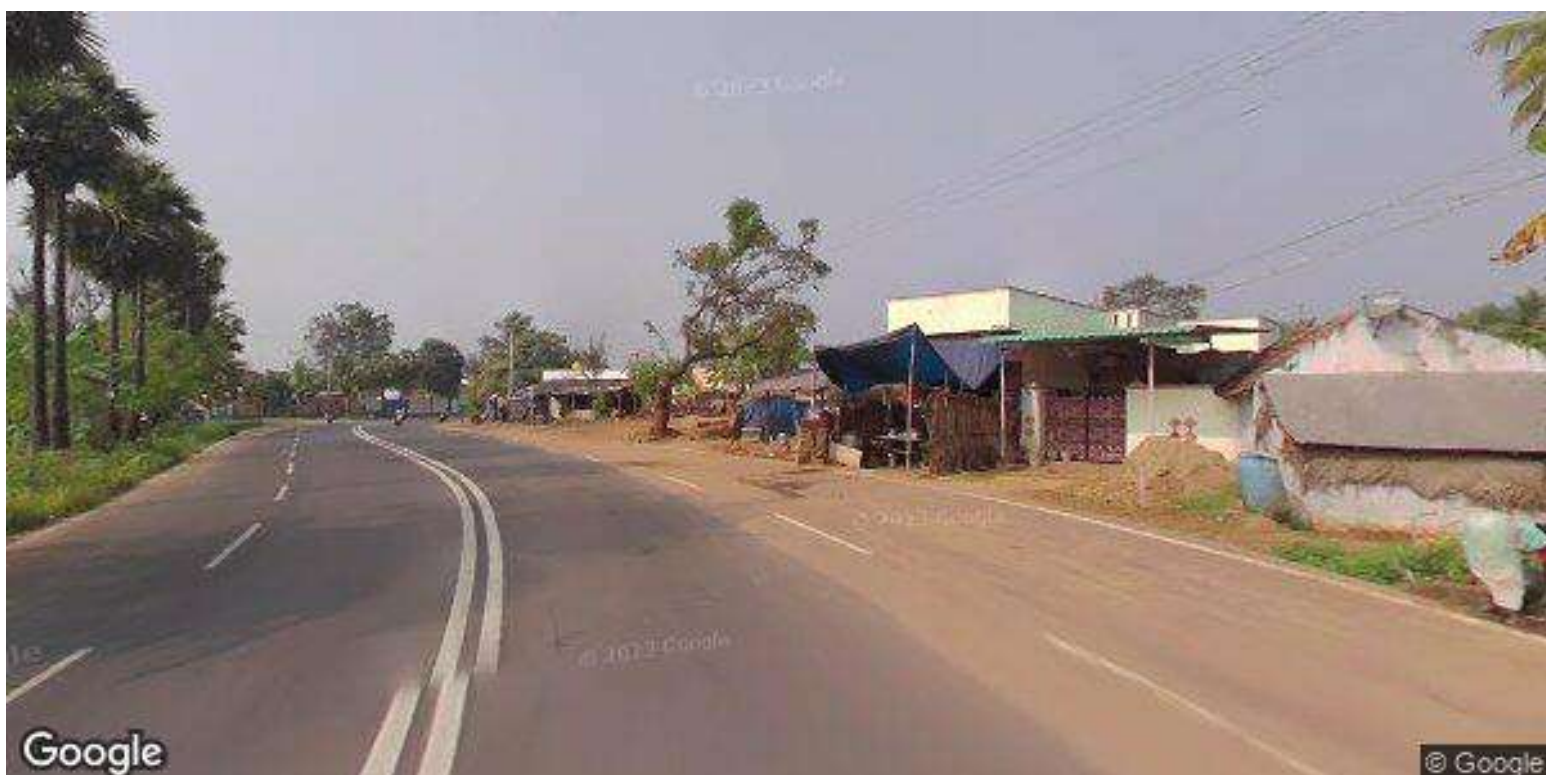
**Risk Type:** Turn  
**Risk Level:** Medium  
**Speed Limit:** 30 KM/Hr  
**Coordinates:** 11.68604, 78.26834

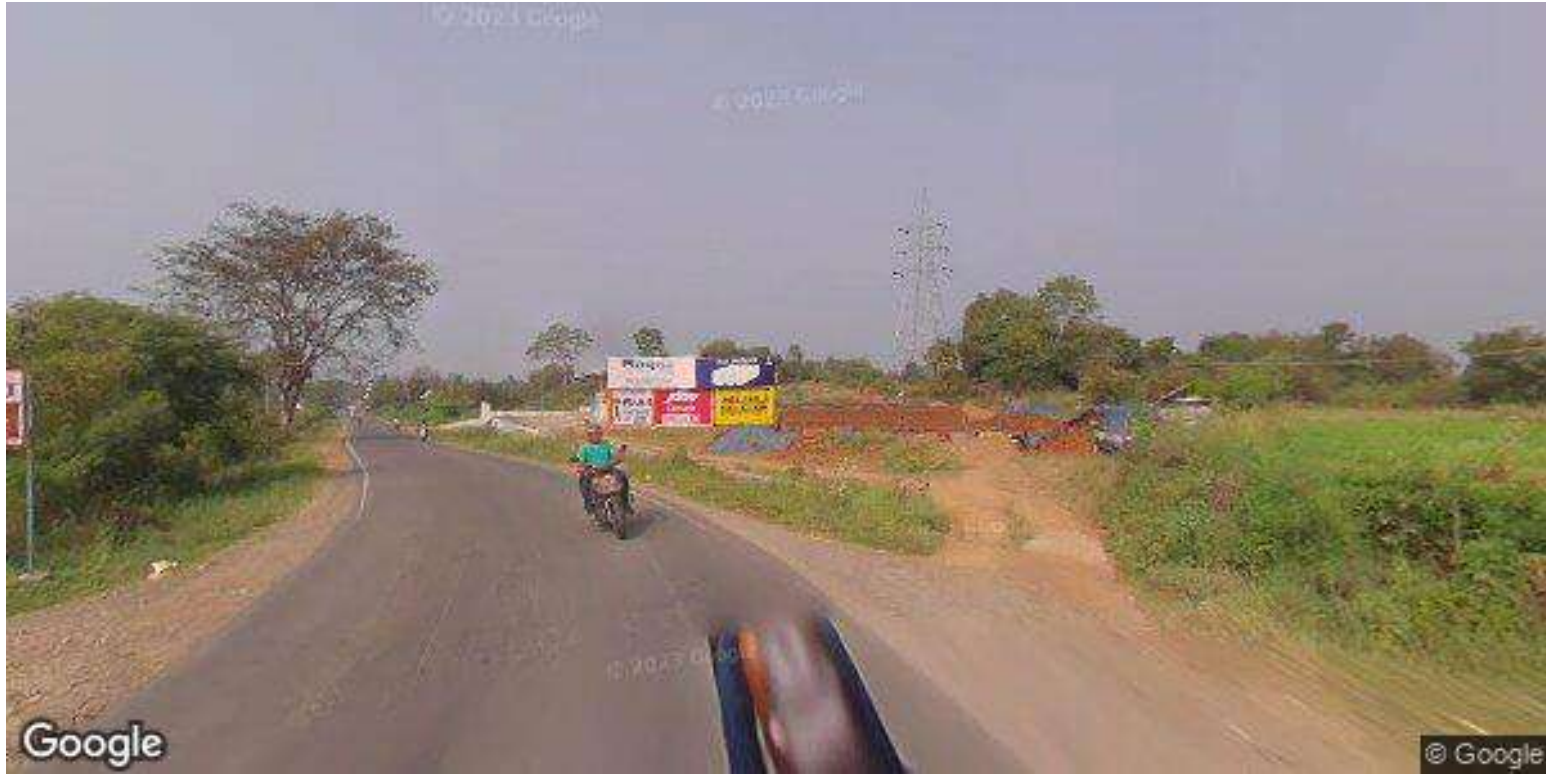
**Risk Type:** Turn  
**Risk Level:** Medium  
**Speed Limit:** 30 KM/Hr  
**Coordinates:** 11.68753, 78.27612

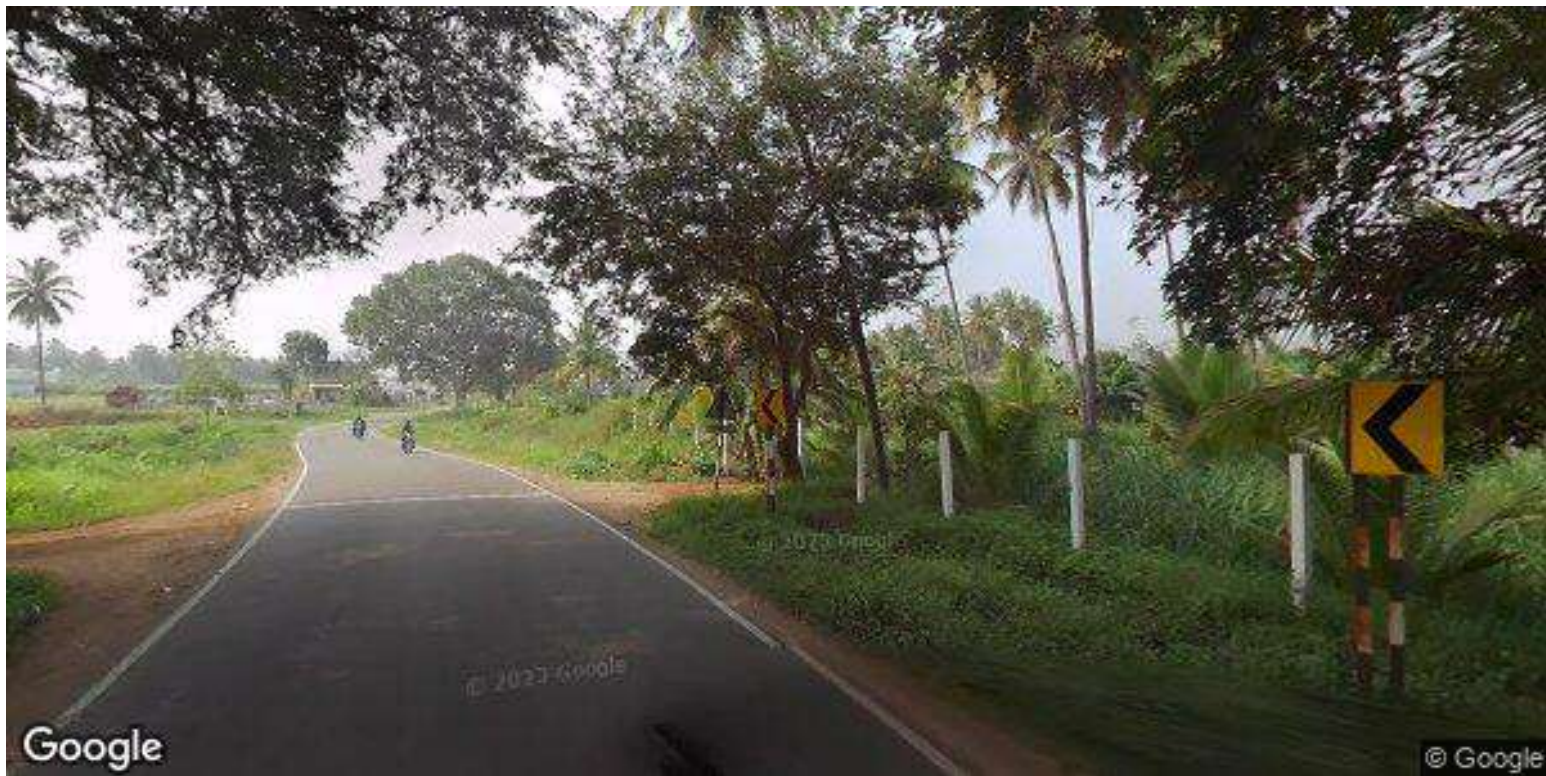
**Risk Type:** Turn  
**Risk Level:** Medium  
**Speed Limit:** 30 KM/Hr  
**Coordinates:** 11.70546, 78.31554
