# IndianOil

## JOURNEY RISK MANAGEMENT (JRM) STUDY

### Salem Terminal to RJNS TRADERS

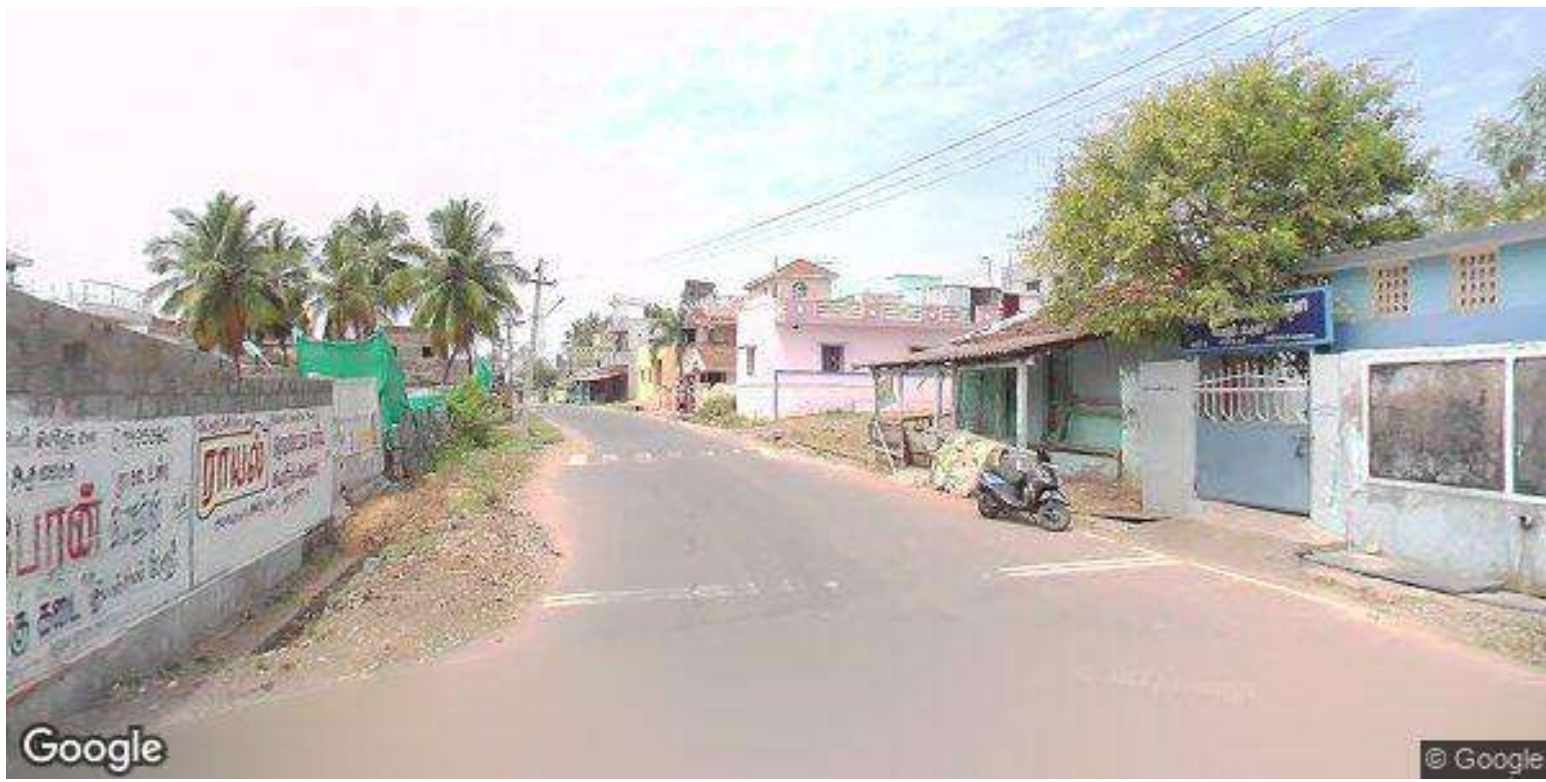
**Coordinates:** 11.70761, 78.41639

**Risk Type:** Turn

**Risk Level:** High

**Speed Limit:** 15 KM/Hr

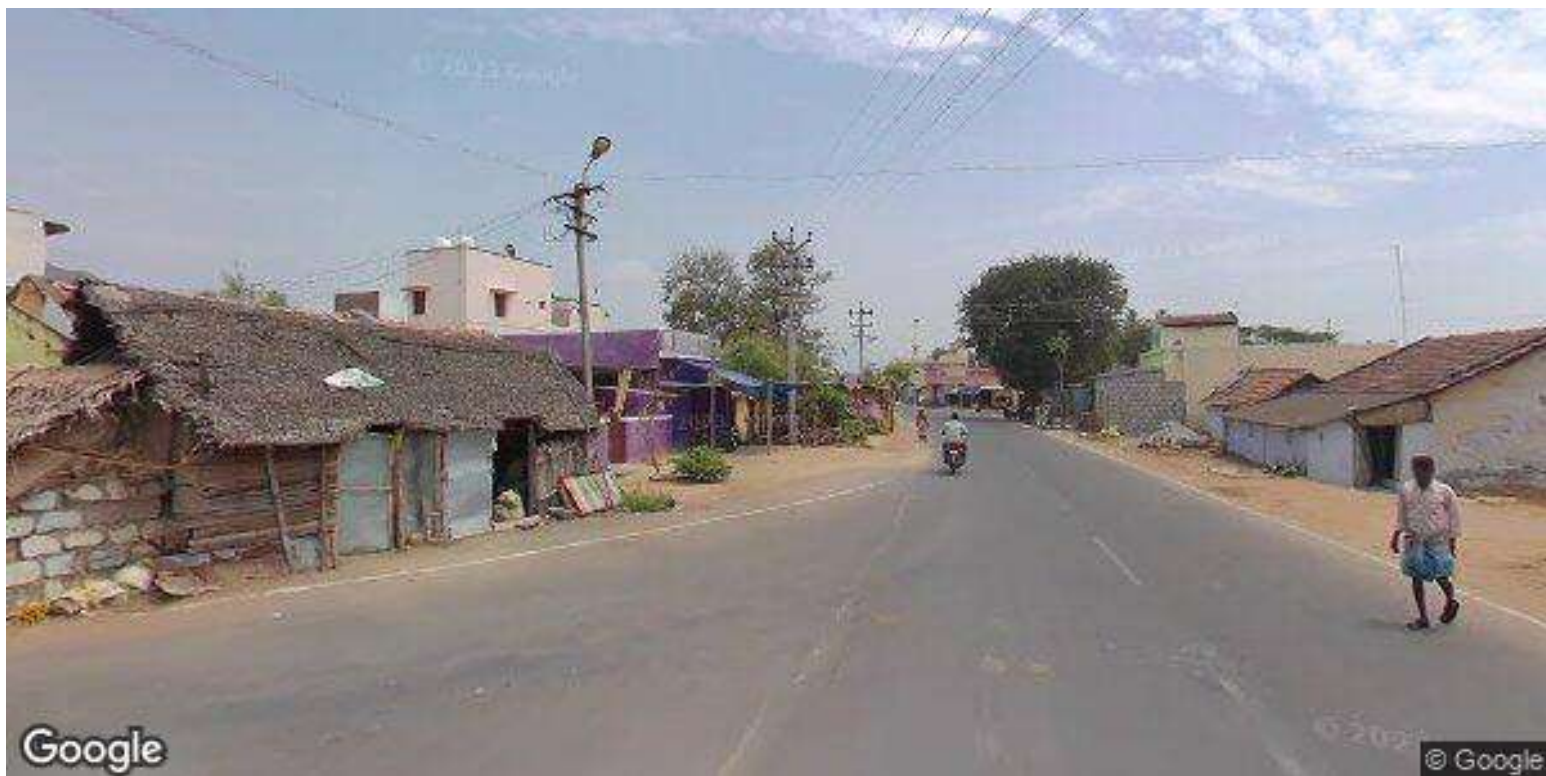
**Coordinates:** 11.70674, 78.41686

**Risk Type:** Turn

**Risk Level:** High

**Speed Limit:** 15 KM/Hr
