# IndianOil

## **JOURNEY RISK MANAGEMENT (JRM) STUDY**

### **Salem Terminal TO BAGIRATHI AUTO NEEDS**

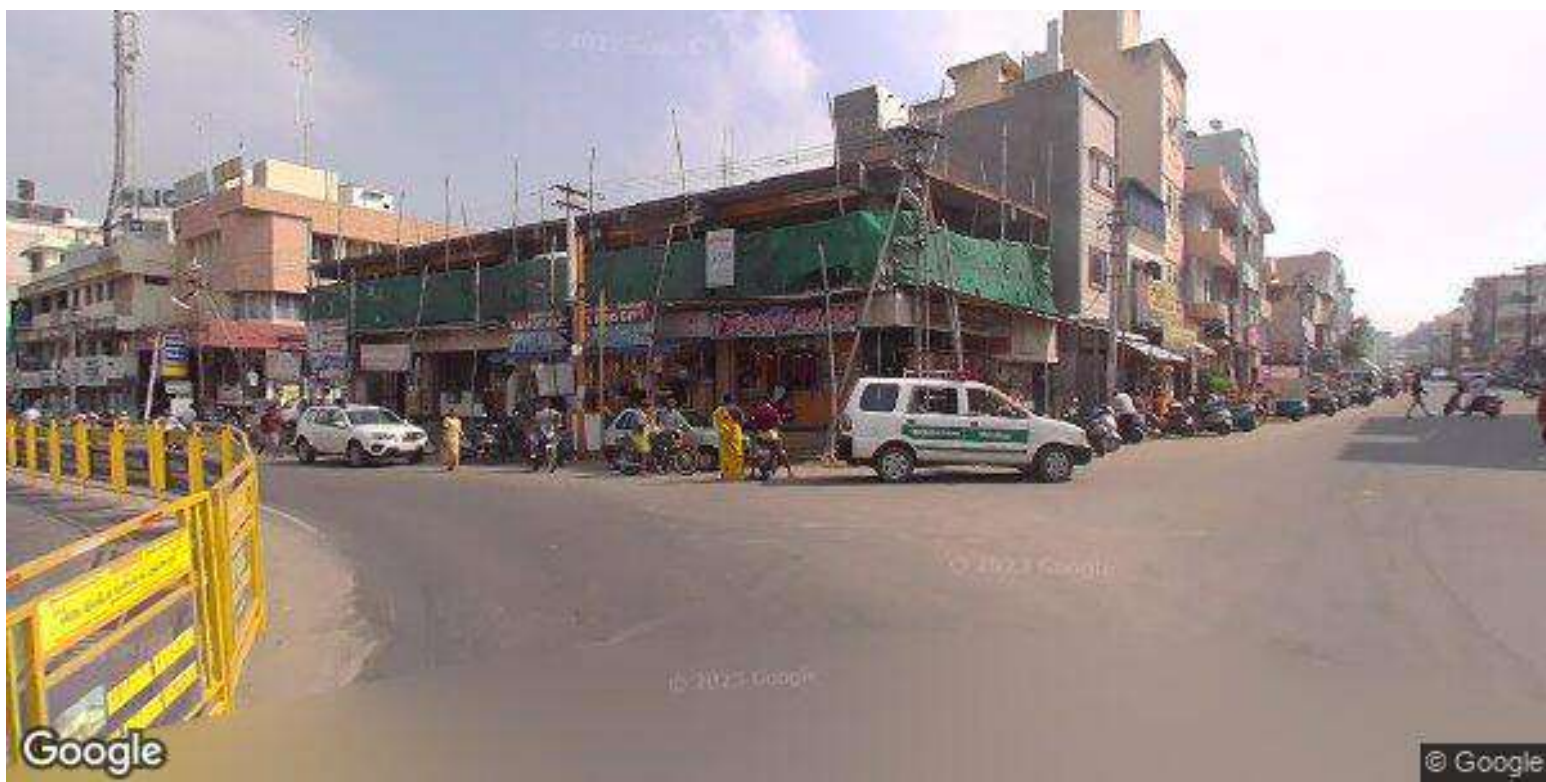
**Coordinates:** 11.37868, 77.89498

**Risk Type:** Turn

**Risk Level:** High

**Speed Limit:** 15 KM/Hr

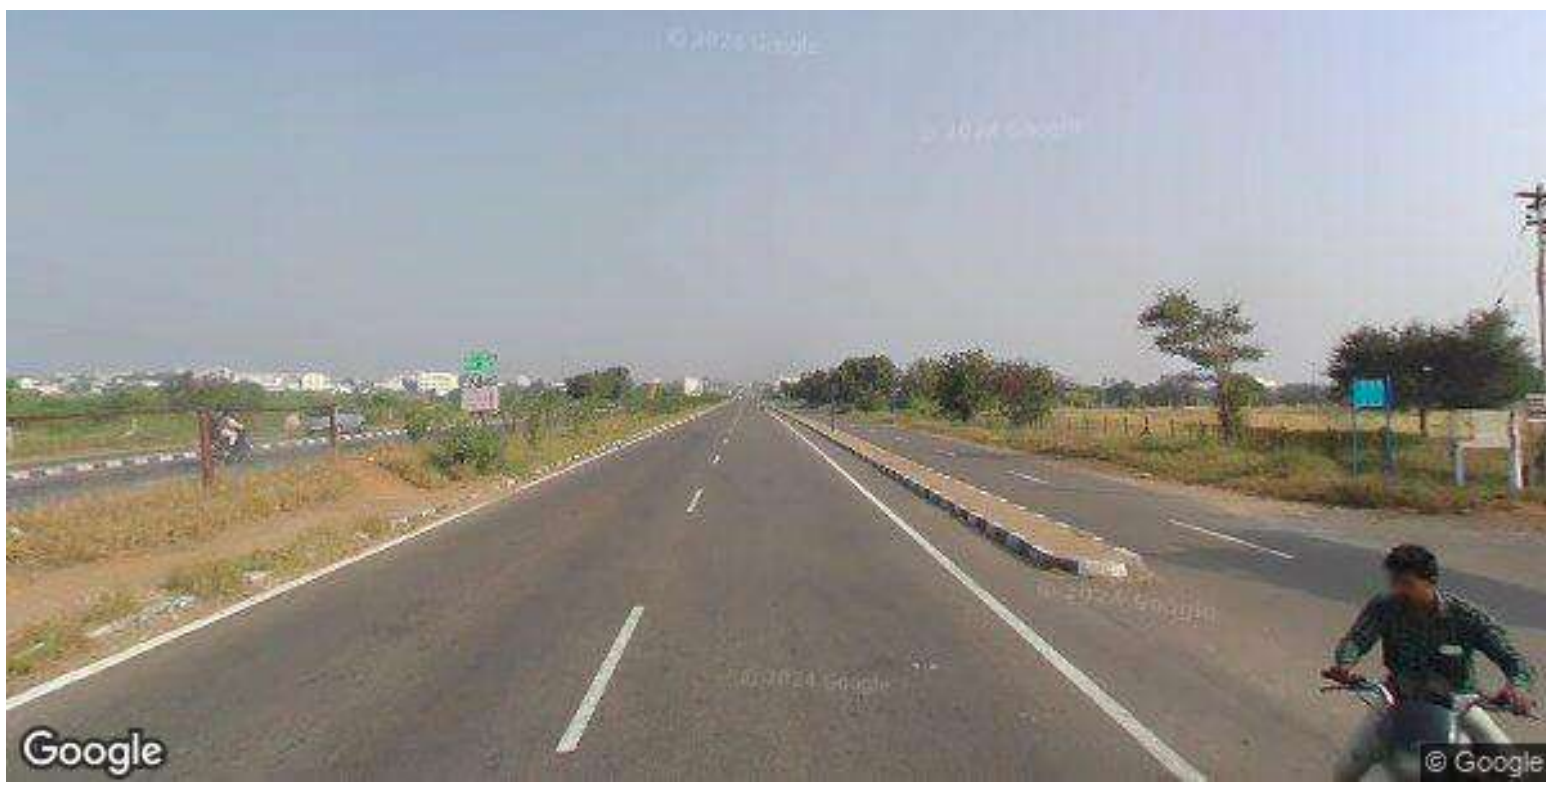
**Coordinates:** 10.99285, 78.06634

**Risk Type:** Blind Spot

**Risk Level:** Blind Spot

**Speed Limit:** 10 KM/Hr

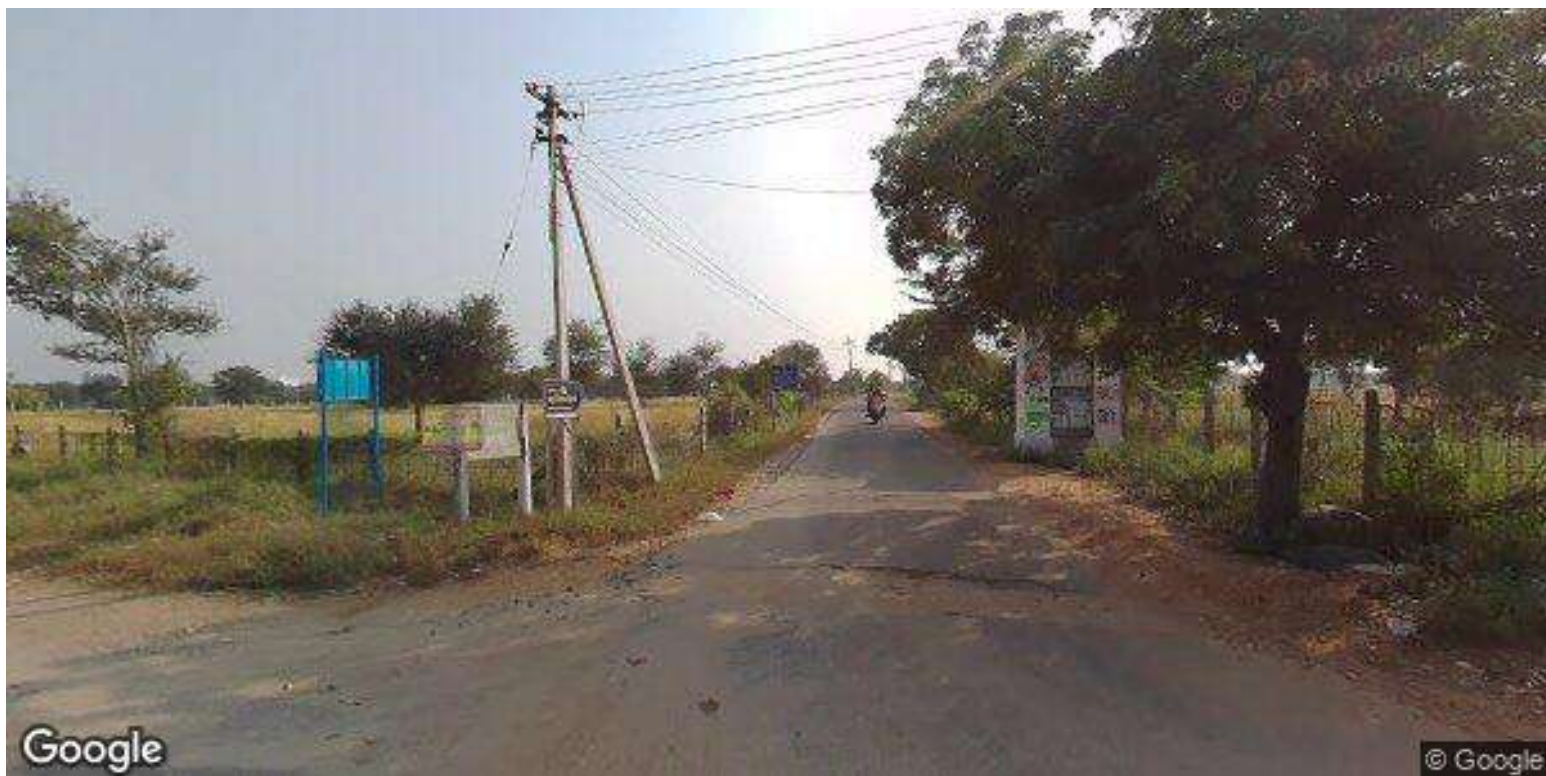
**Coordinates:** 10.99286, 78.06643

**Risk Type:** Blind Spot

**Risk Level:** Blind Spot

**Speed Limit:** 10 KM/Hr
