# IndianOil

## JOURNEY RISK MANAGEMENT (JRM) STUDY

### Salem Terminal to SUMI AGENCIES

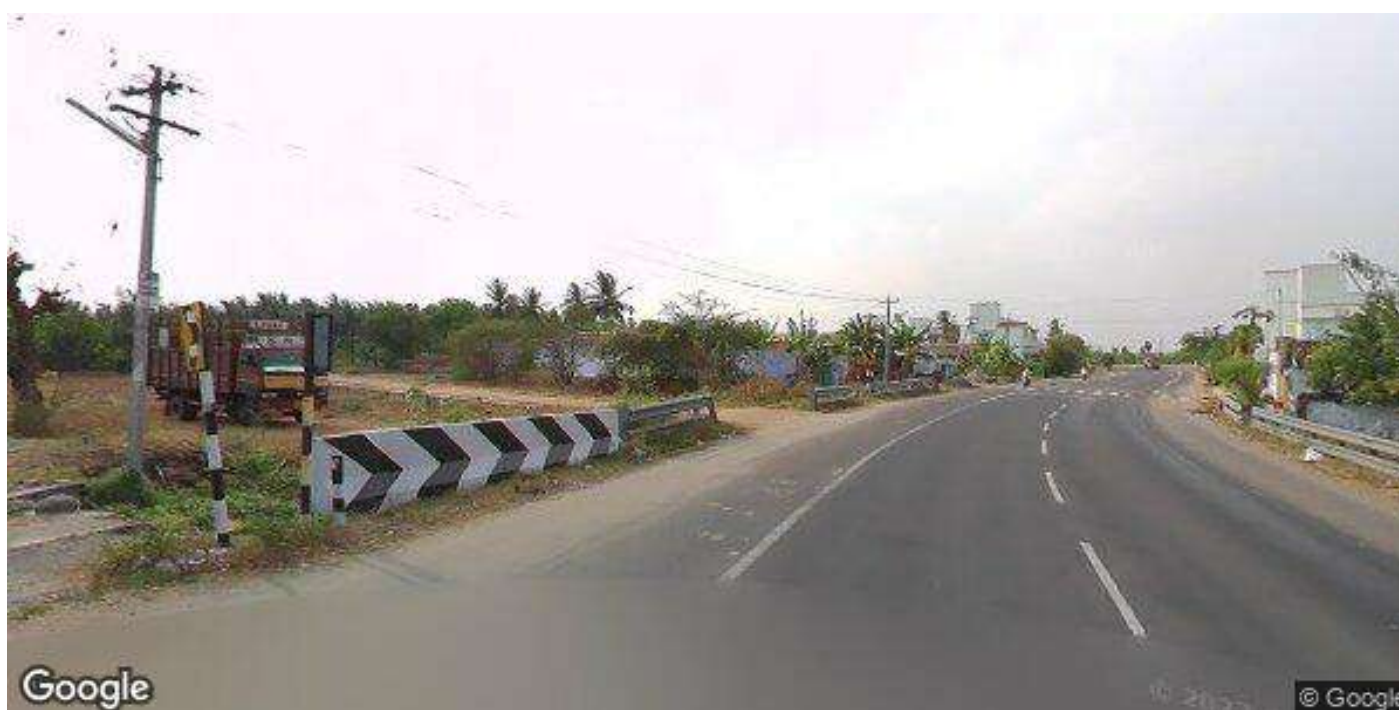
**Risk Type:** Turn  
**Risk Level:** Medium  
**Speed Limit:** 30 KM/Hr  
**Coordinates:** 11.16755, 78.01568

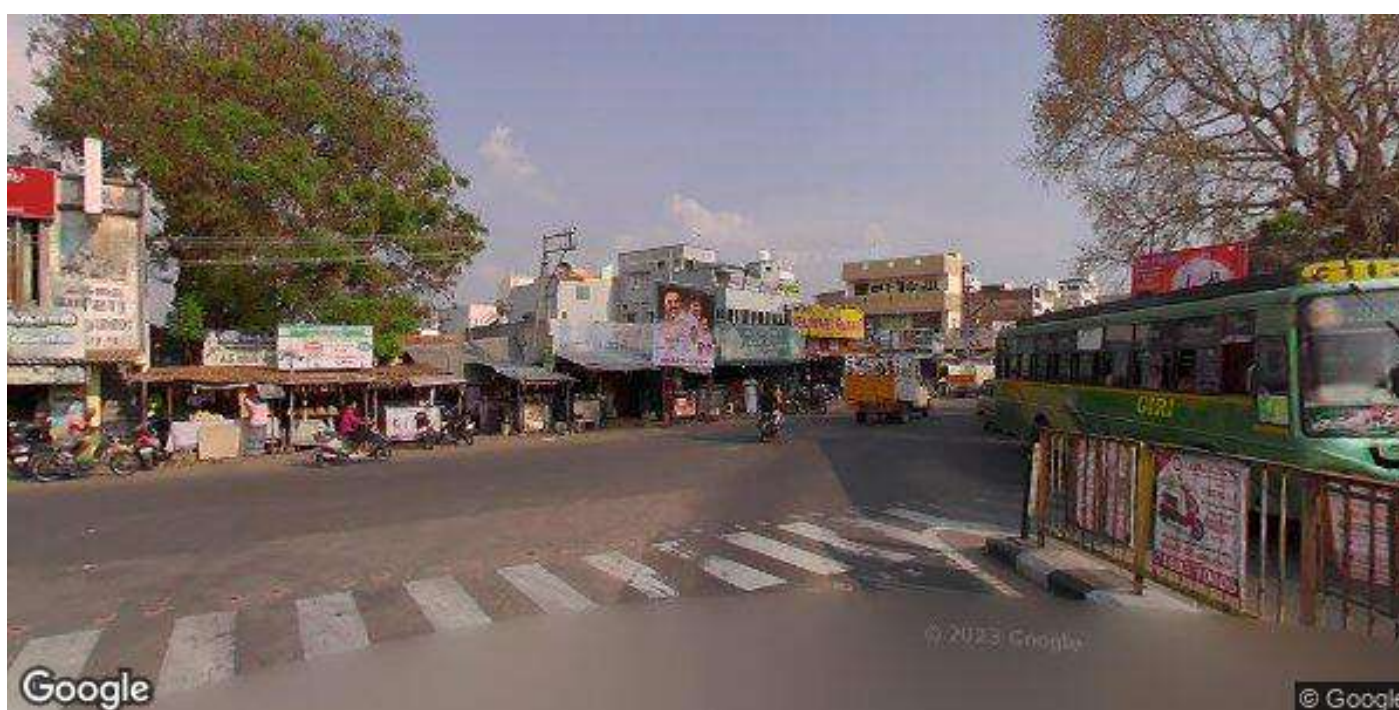
**Risk Type:** Turn  
**Risk Level:** Medium  
**Speed Limit:** 30 KM/Hr  
**Coordinates:** 11.15579, 78.02169

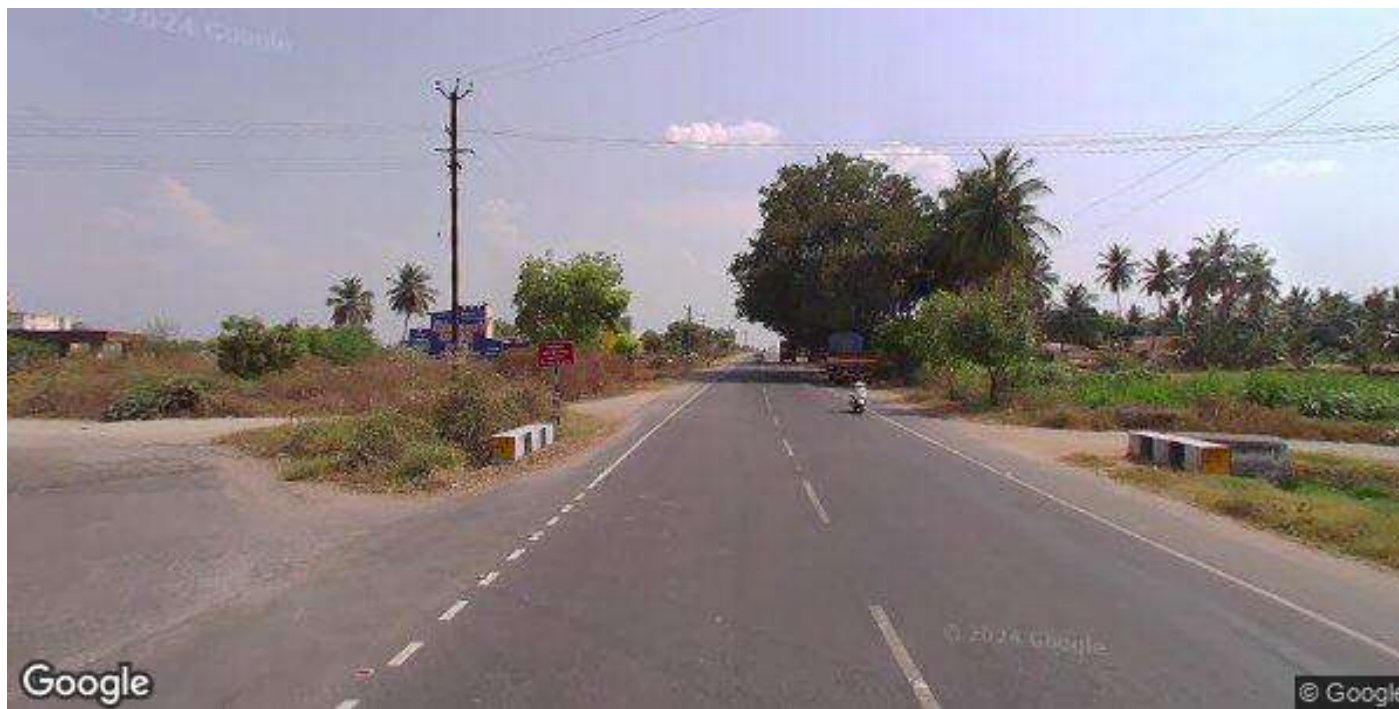
**Risk Type:** Turn  
**Risk Level:** High  
**Speed Limit:** 15 KM/Hr  
**Coordinates:** 11.14545, 78.02208

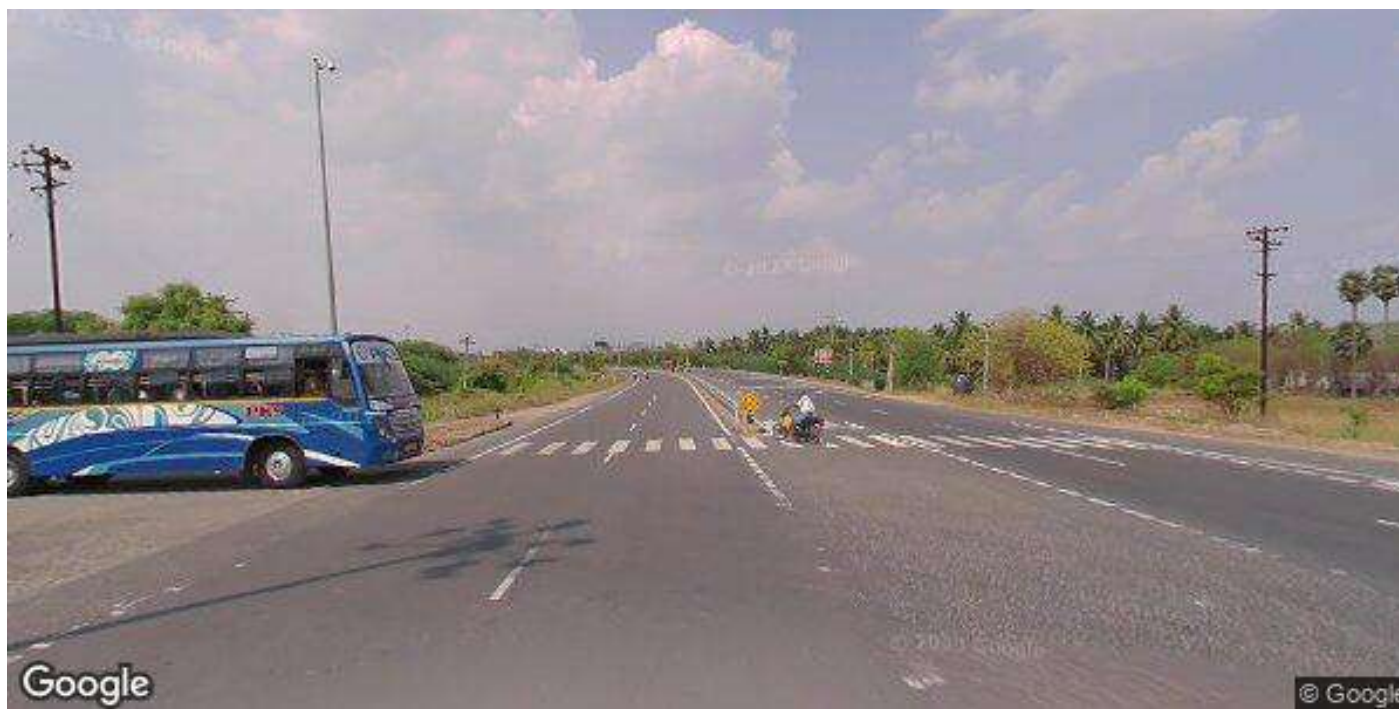
**Risk Type:** Turn  
**Risk Level:** High  
**Speed Limit:** 15 KM/Hr  
**Coordinates:** 11.14485, 78.02282

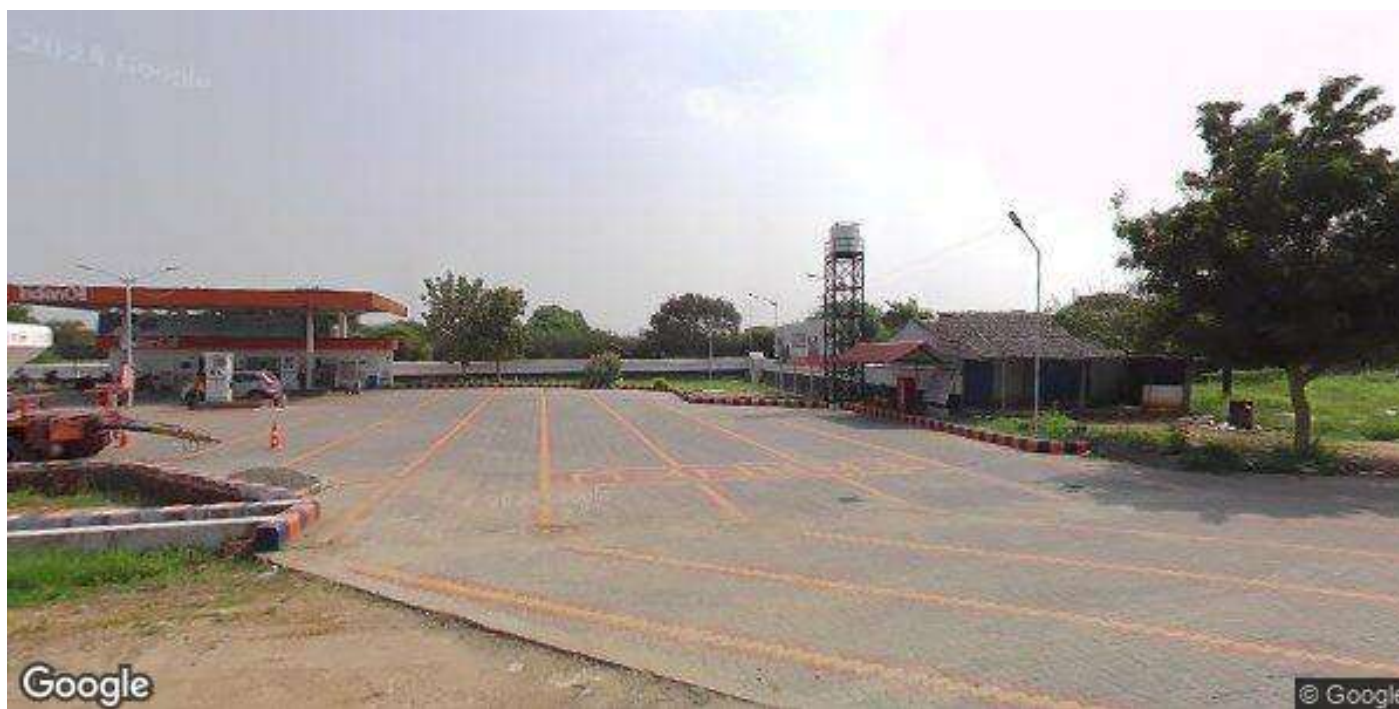
**Risk Type:** Blind Spot  
**Risk Level:** Blind Spot  
**Speed Limit:** 10 KM/Hr  
**Coordinates:** 10.75511, 77.91217
