# IndianOil

## JOURNEY RISK MANAGEMENT (JRM) STUDY

### Salem Terminal to P S K AGENCIES

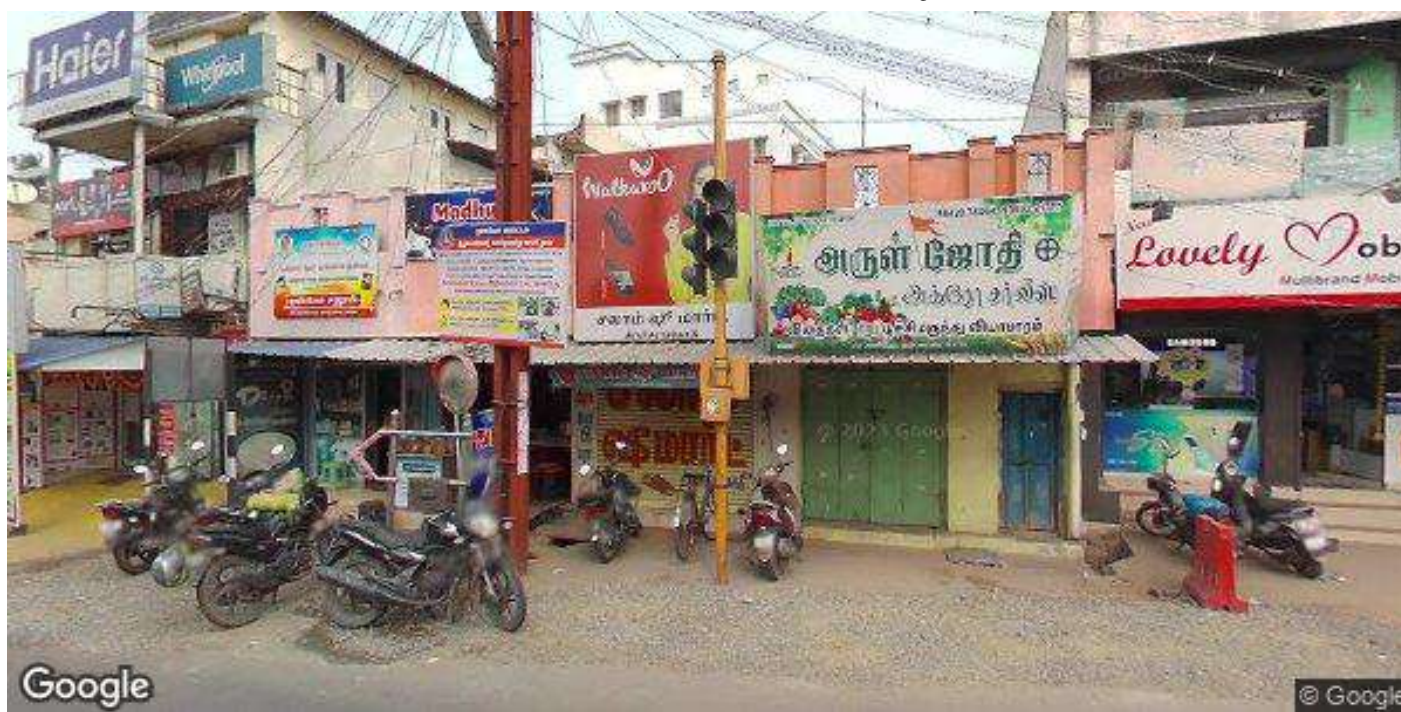
**Risk Type:** Turn  
**Risk Level:** High  
**Speed Limit:** 15 KM/Hr  
**Coordinates:** 11.37850, 77.89453

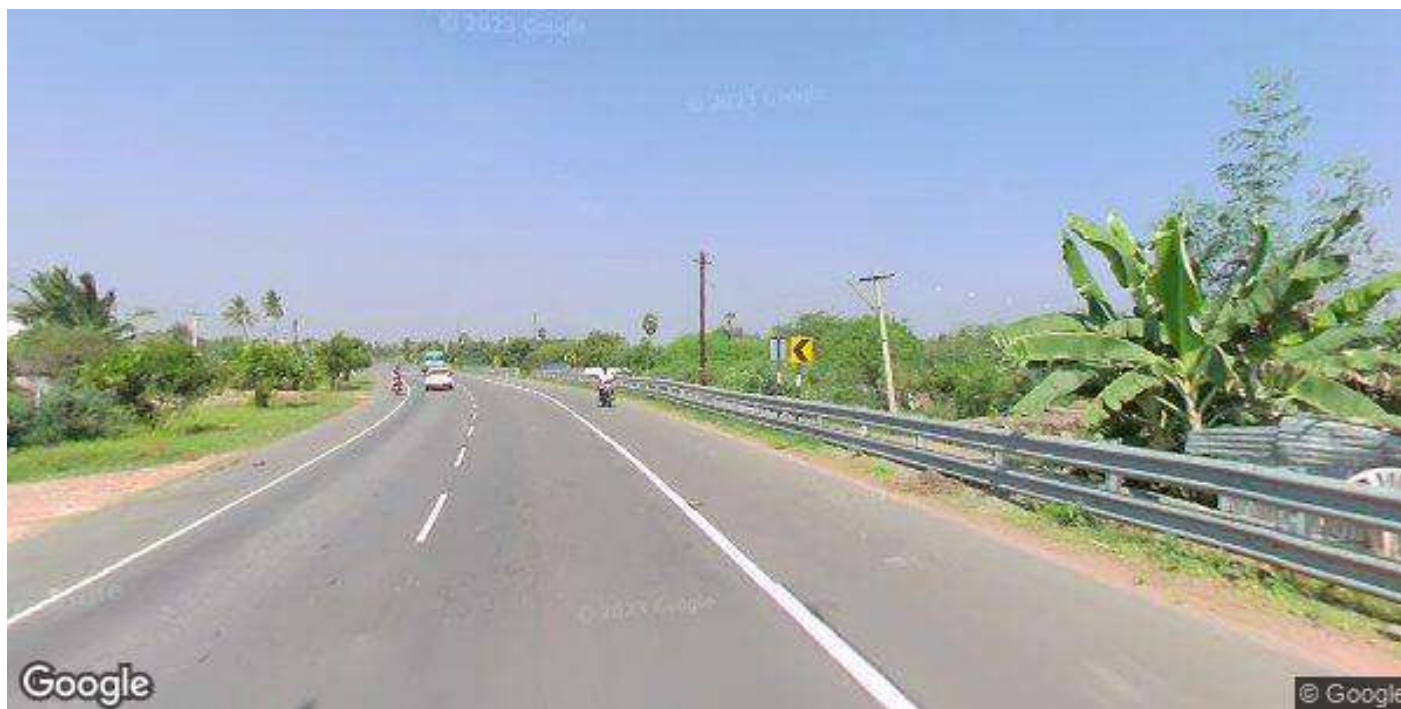
**Risk Type:** Turn  
**Risk Level:** Medium  
**Speed Limit:** 30 KM/Hr  
**Coordinates:** 11.16950, 78.01544

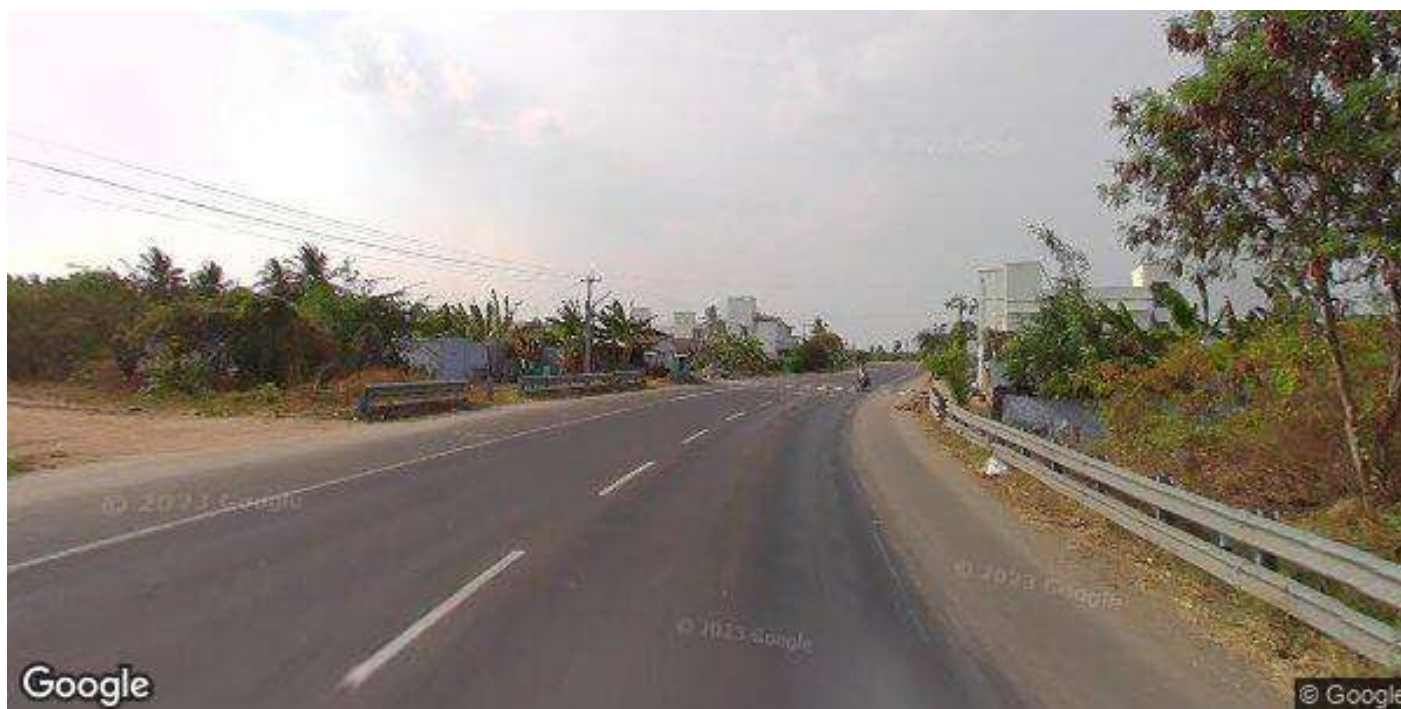
**Risk Type:** Turn  
**Risk Level:** Medium  
**Speed Limit:** 30 KM/Hr  
**Coordinates:** 11.16764, 78.01565

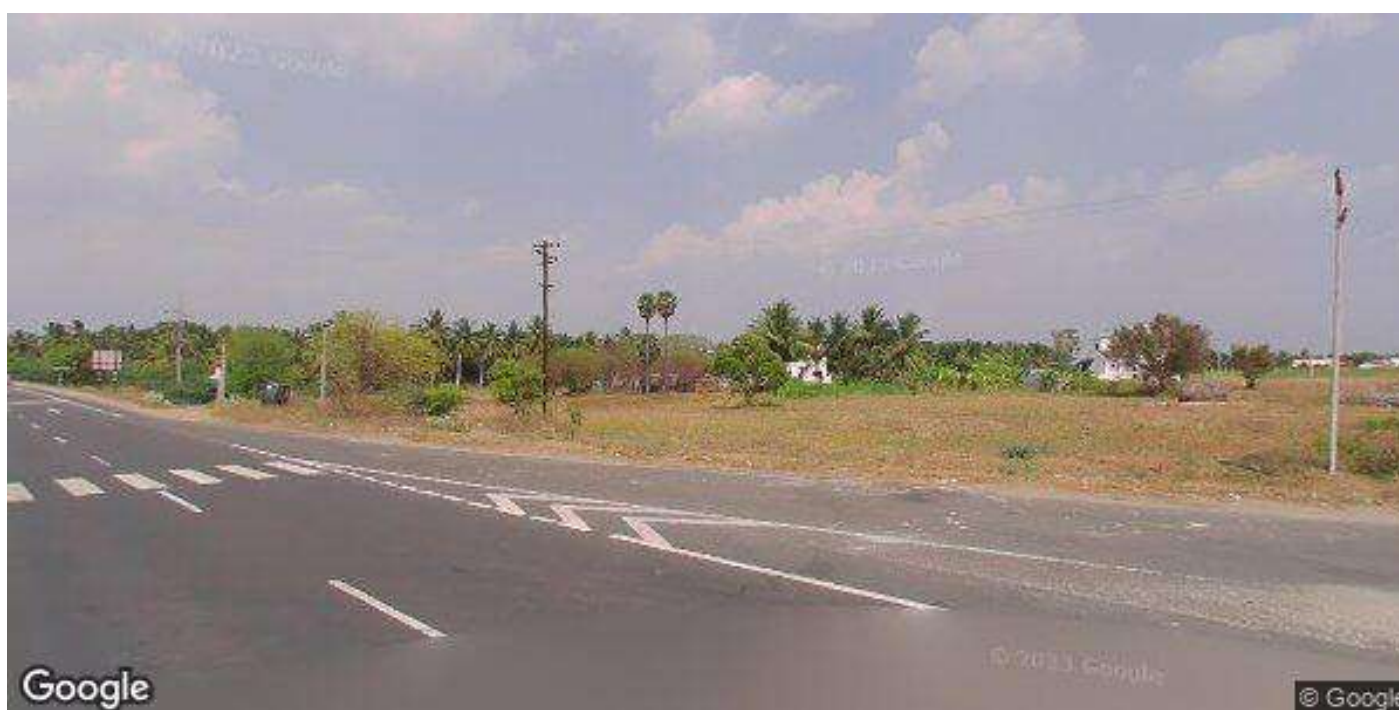
**Risk Type:** Turn  
**Risk Level:** High  
**Speed Limit:** 15 KM/Hr  
**Coordinates:** 11.14480, 78.02291

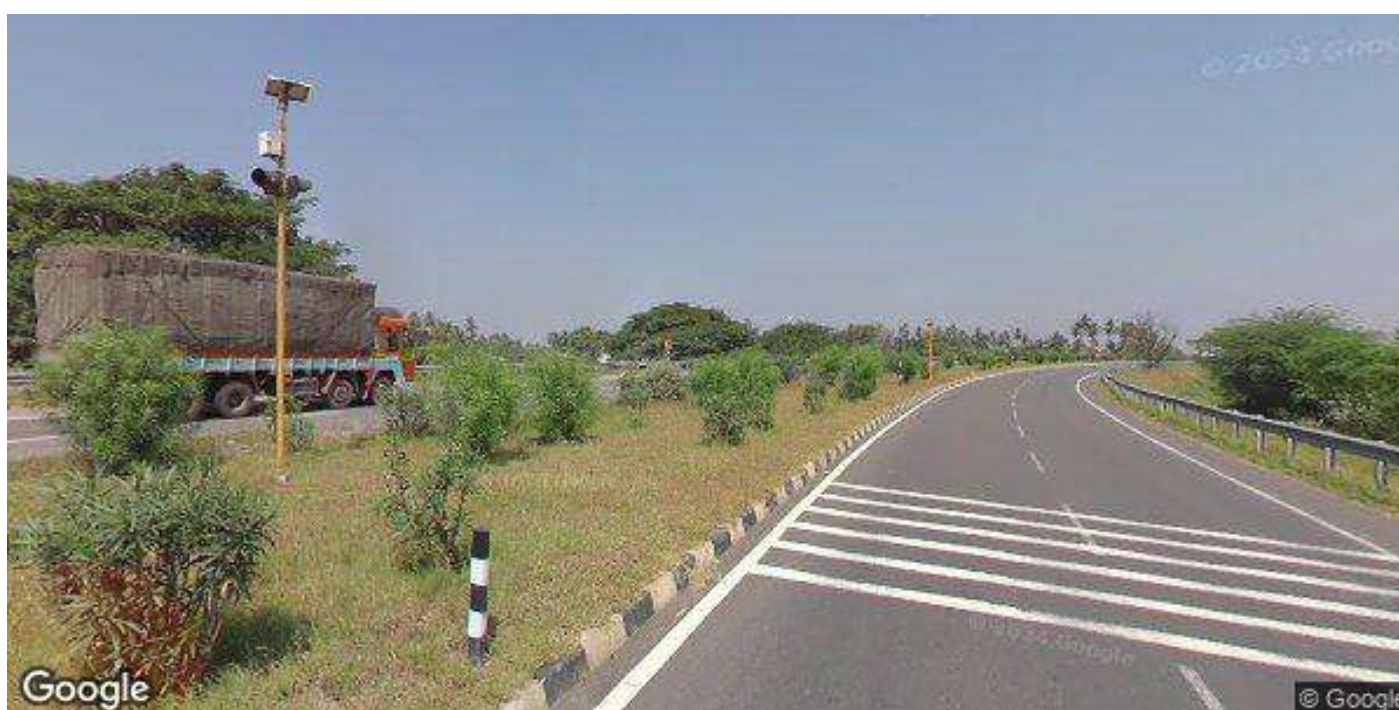
**Risk Type:** Turn  
**Risk Level:** Medium  
**Speed Limit:** 30 KM/Hr  
**Coordinates:** 11.10102, 78.00572

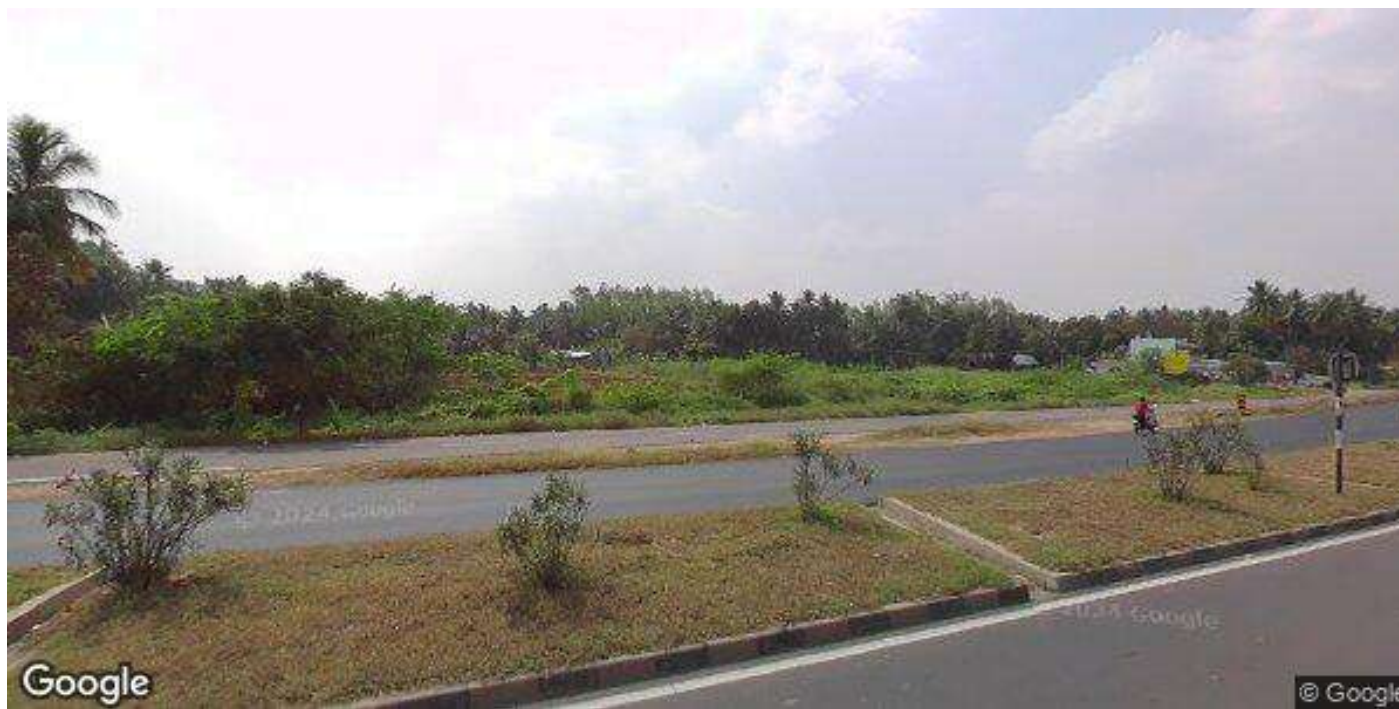
**Risk Type:** Turn  
**Risk Level:** Medium  
**Speed Limit:** 30 KM/Hr  
**Coordinates:** 11.05261, 78.05138

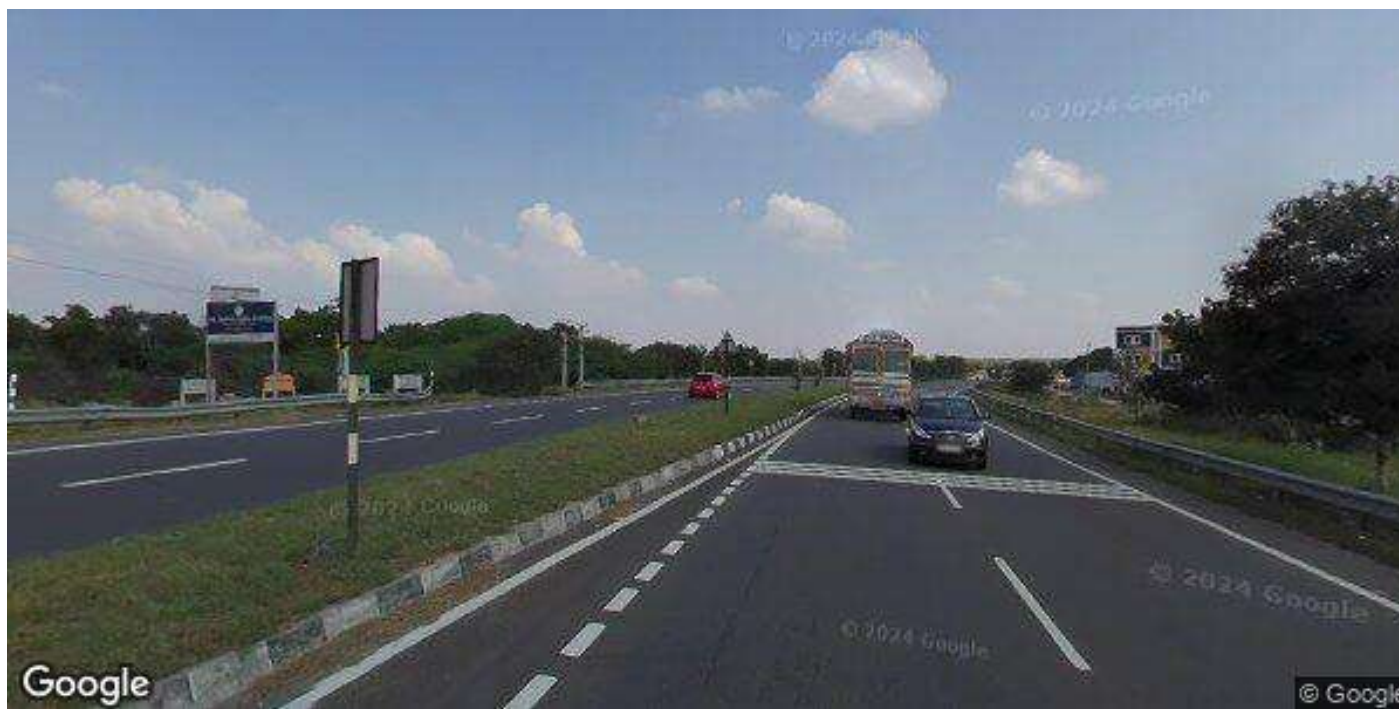
**Risk Type:** Turn  
**Risk Level:** Medium  
**Speed Limit:** 30 KM/Hr  
**Coordinates:** 10.89913, 78.03032

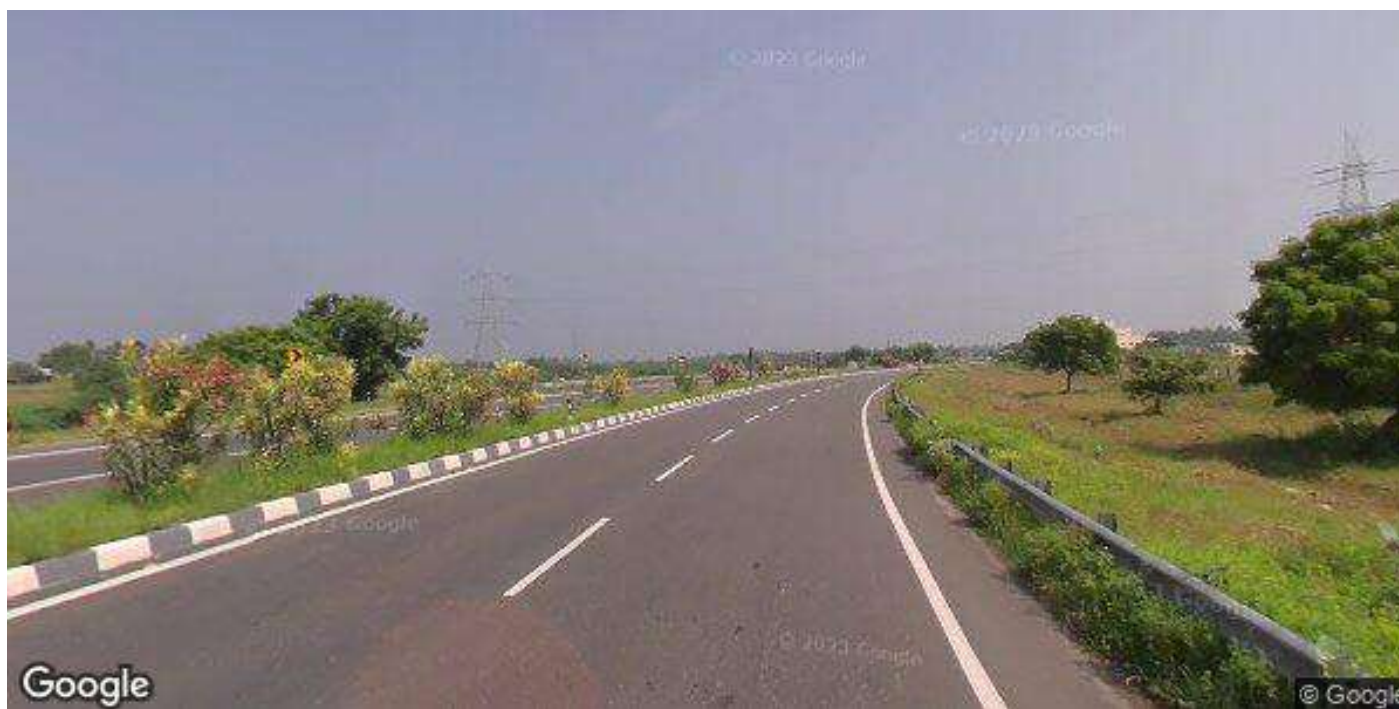
**Risk Type:** Turn  
**Risk Level:** Medium  
**Speed Limit:** 30 KM/Hr  
**Coordinates:** 10.79857, 77.92714

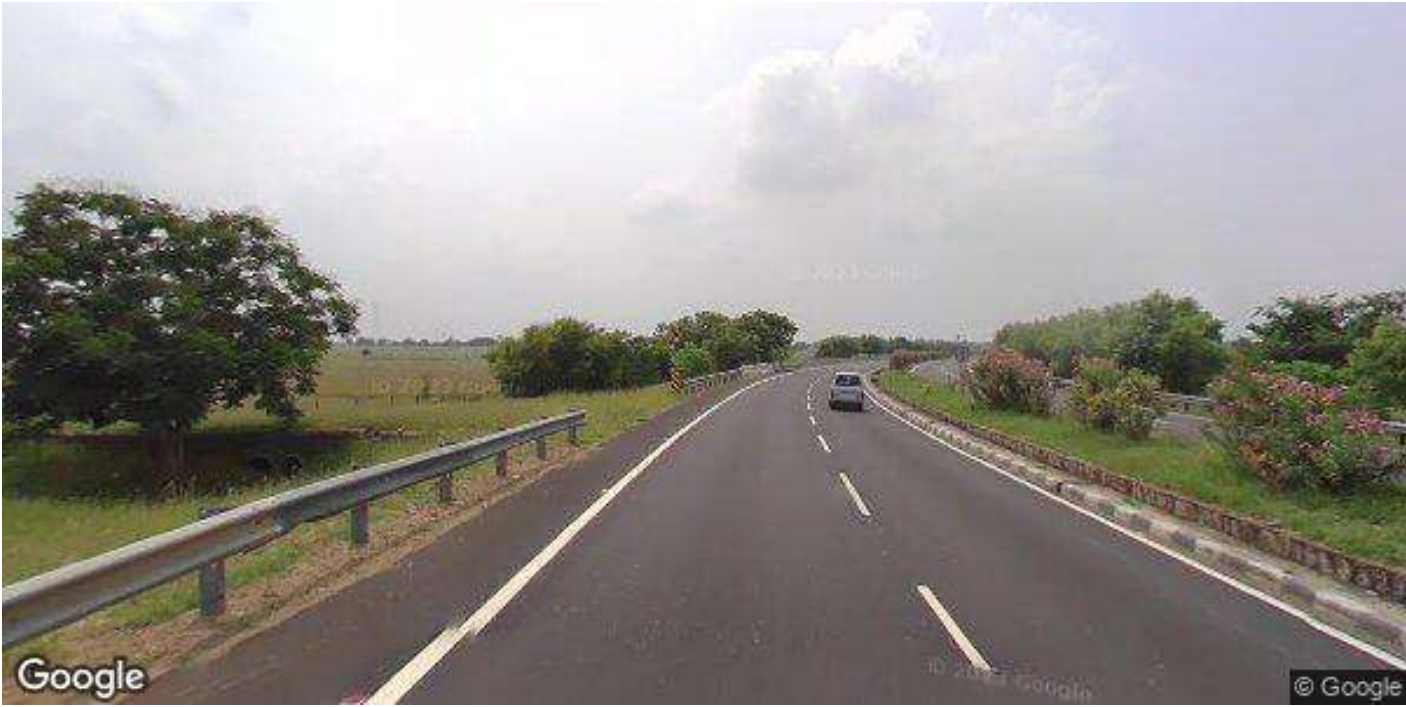
**Risk Type:** Turn  
**Risk Level:** Medium  
**Speed Limit:** 30 KM/Hr  
**Coordinates:** 10.78576, 77.92670

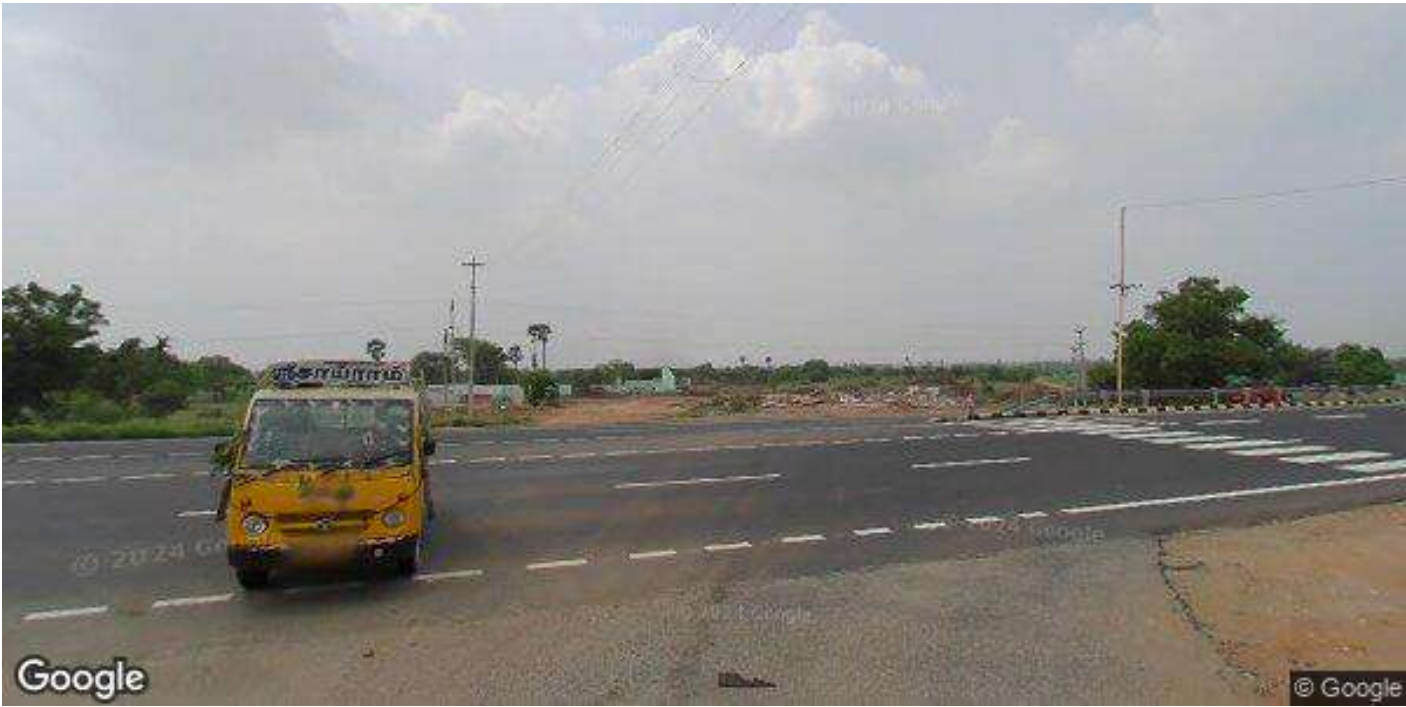
**Risk Type:** Turn  
**Risk Level:** High  
**Speed Limit:** 15 KM/Hr  
**Coordinates:** 10.72341, 77.92805

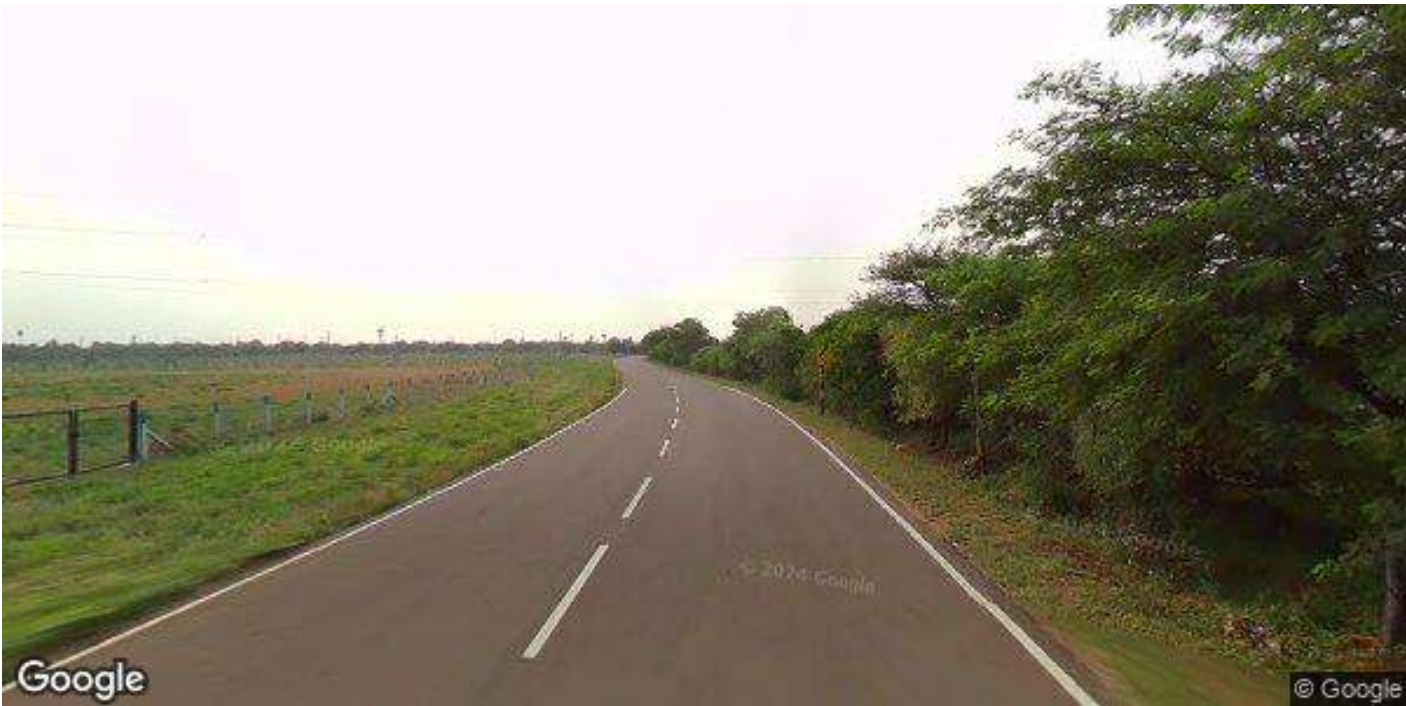
**Risk Type:** Turn  
**Risk Level:** High  
**Speed Limit:** 15 KM/Hr  
**Coordinates:** 10.72296, 77.93309

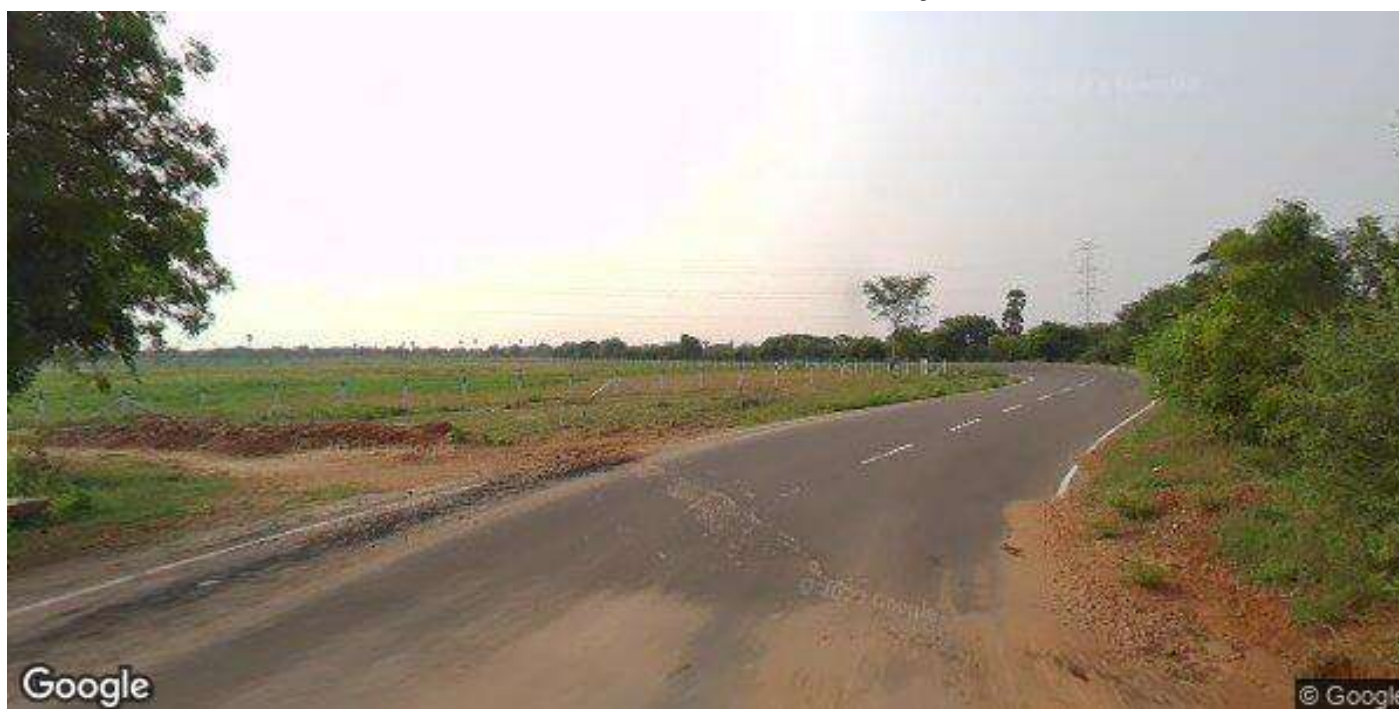
**Risk Type:** Turn  
**Risk Level:** Medium  
**Speed Limit:** 30 KM/Hr  
**Coordinates:** 10.72242, 77.93367

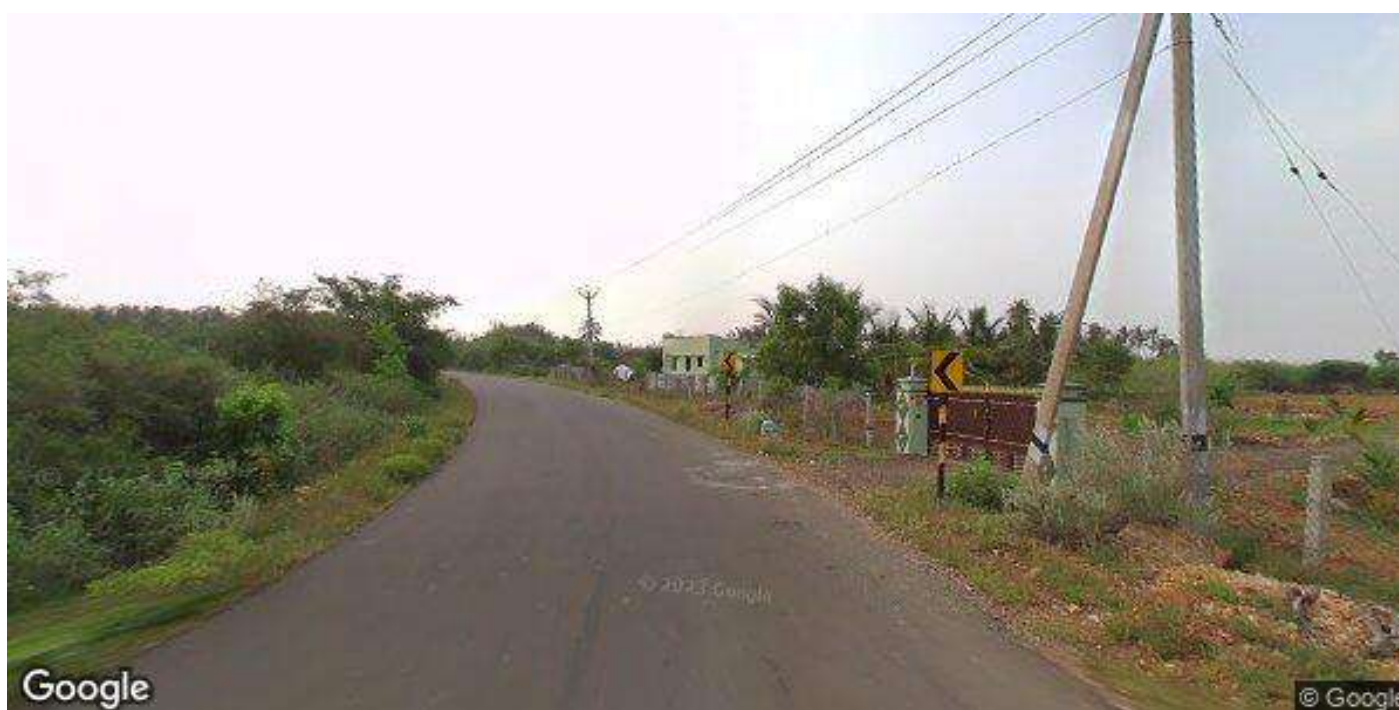
**Risk Type:** Turn  
**Risk Level:** Medium  
**Speed Limit:** 30 KM/Hr  
**Coordinates:** 10.71598, 77.95672

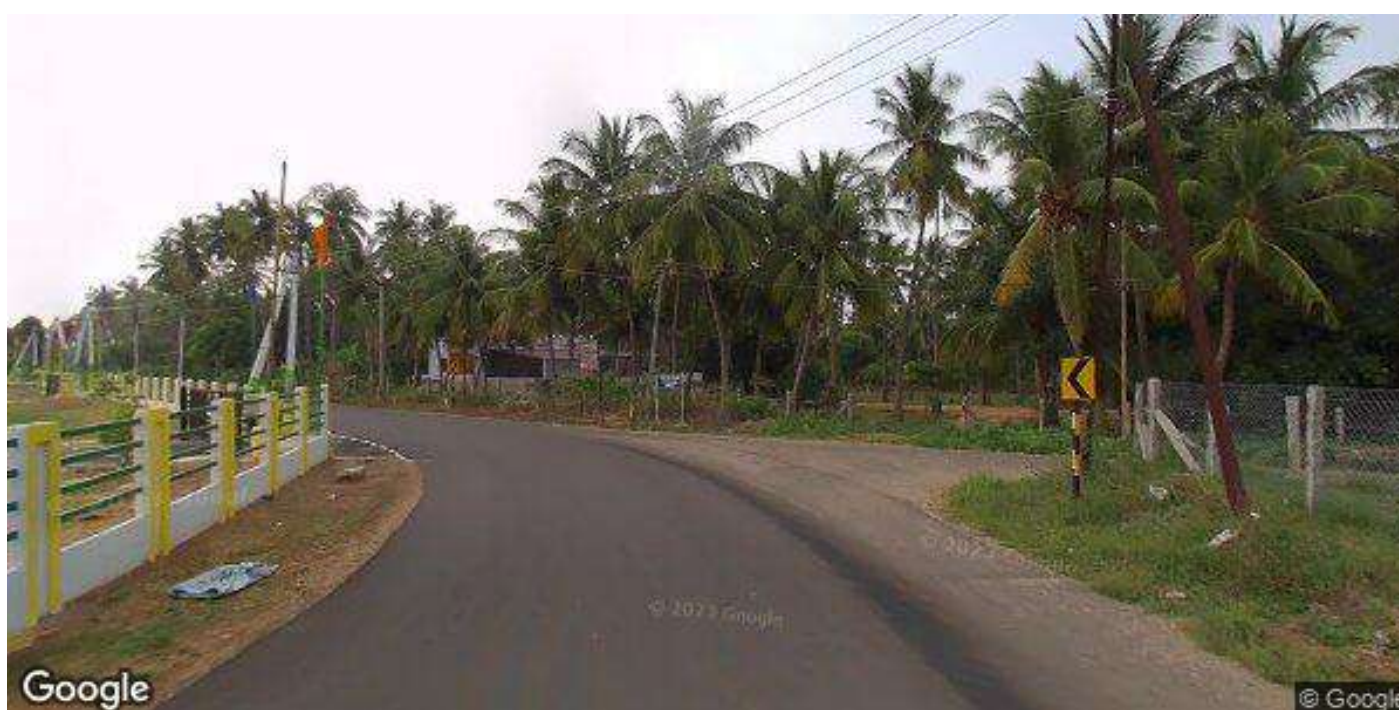
**Risk Type:** Turn  
**Risk Level:** High  
**Speed Limit:** 15 KM/Hr  
**Coordinates:** 10.71153, 77.96780

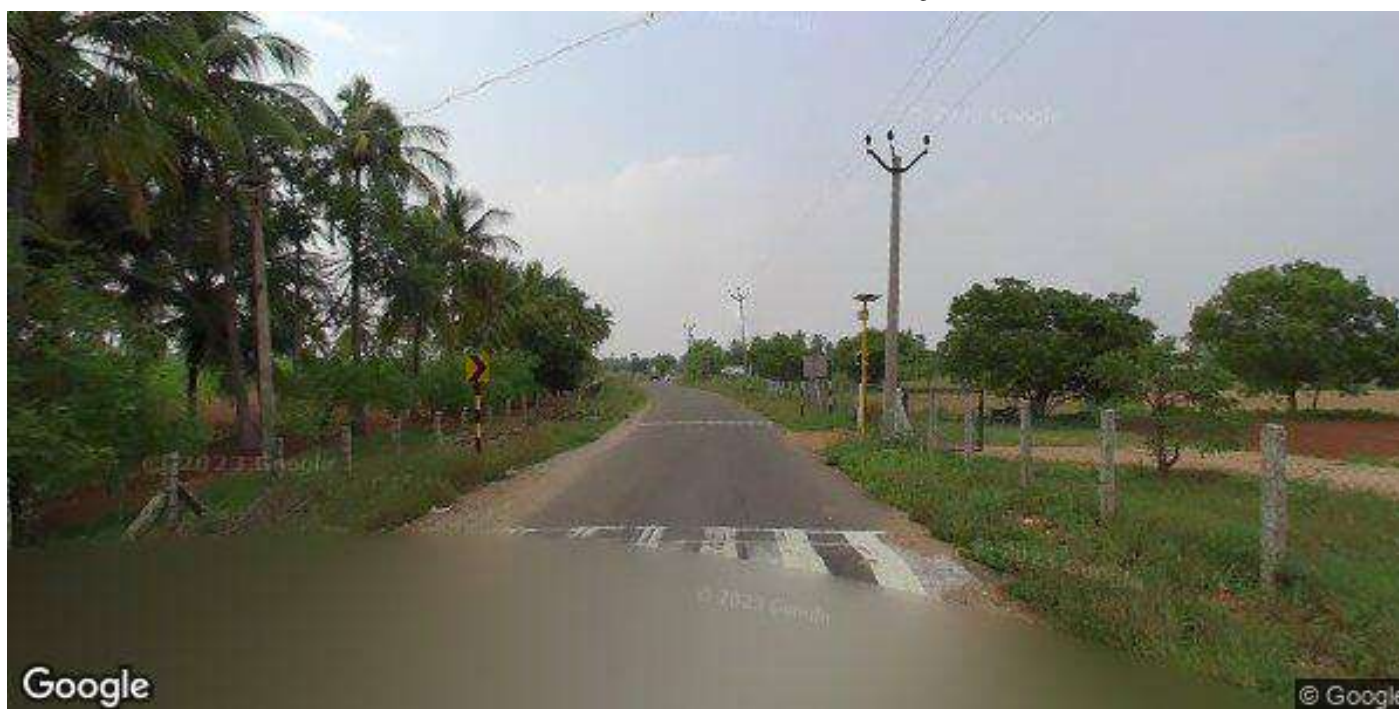
**Risk Type:** Turn  
**Risk Level:** Medium  
**Speed Limit:** 30 KM/Hr  
**Coordinates:** 10.70434, 77.96938

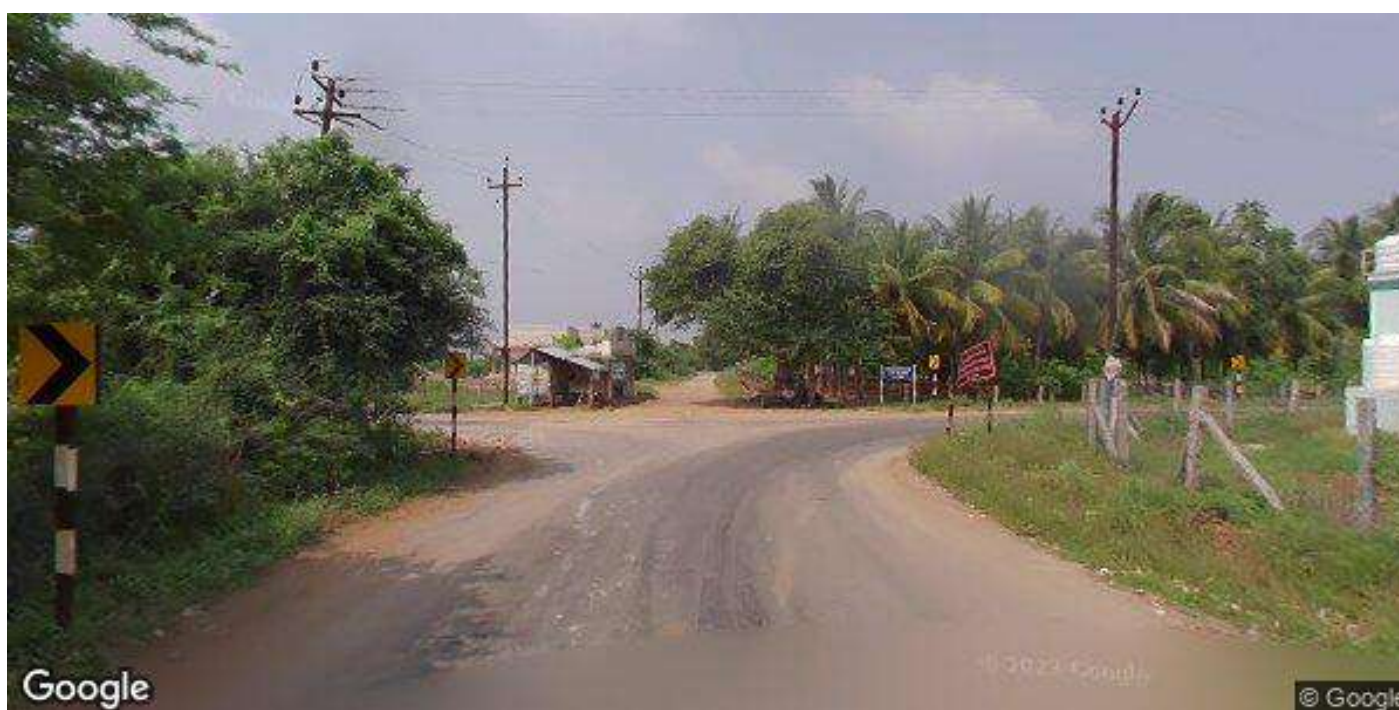
**Risk Type:** Turn  
**Risk Level:** High  
**Speed Limit:** 15 KM/Hr  
**Coordinates:** 10.70405, 77.96965

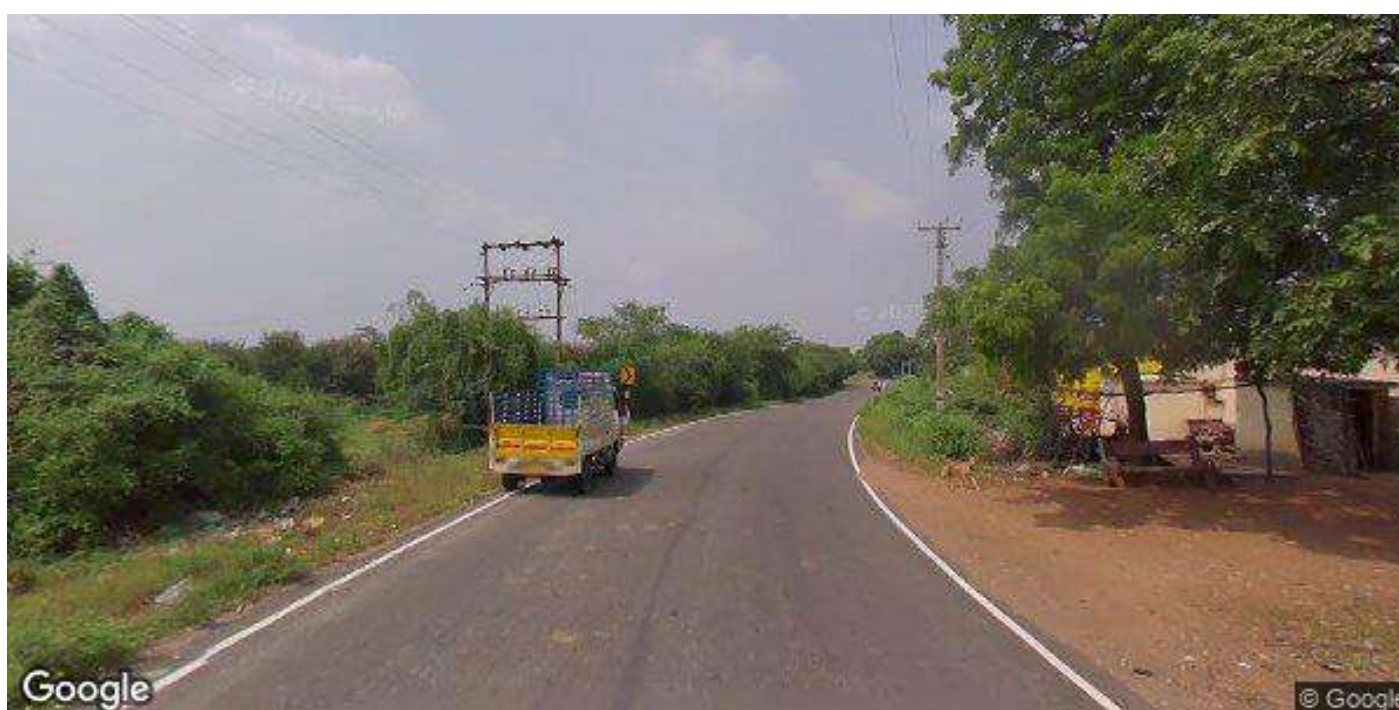
**Risk Type:** Turn  
**Risk Level:** Medium  
**Speed Limit:** 30 KM/Hr  
**Coordinates:** 10.70341, 77.97475

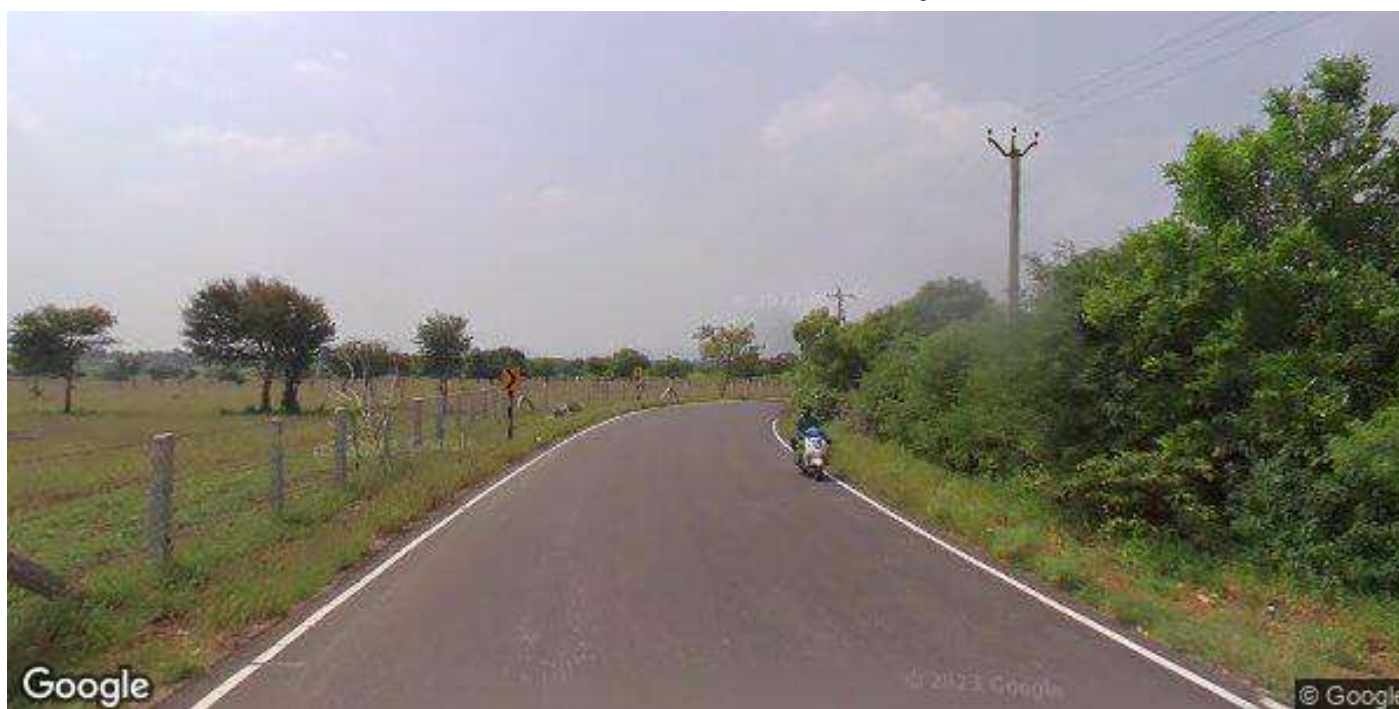
**Risk Type:** Turn  
**Risk Level:** Medium  
**Speed Limit:** 30 KM/Hr  
**Coordinates:** 10.70567, 77.97849

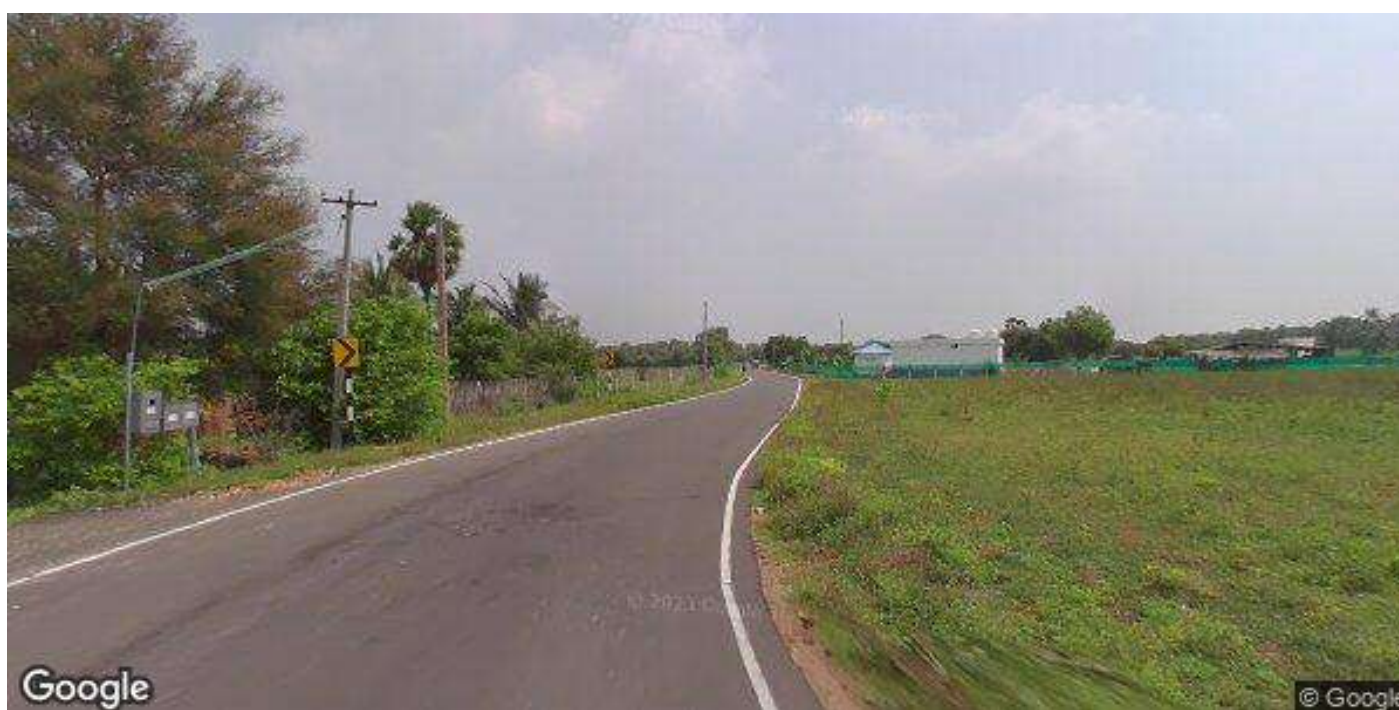
**Risk Type:** Turn  
**Risk Level:** Medium  
**Speed Limit:** 30 KM/Hr  
**Coordinates:** 10.70653, 77.97903

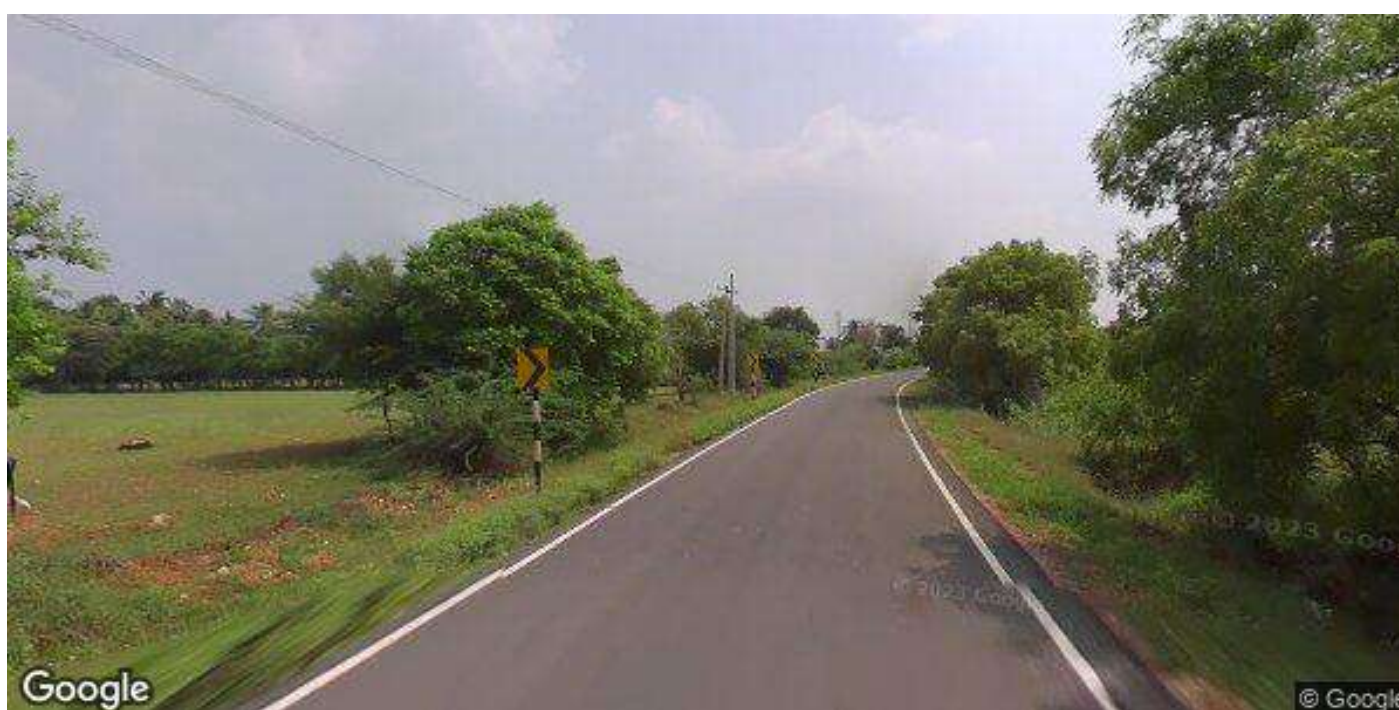
**Risk Type:** Turn  
**Risk Level:** Medium  
**Speed Limit:** 30 KM/Hr  
**Coordinates:** 10.70781, 77.98181

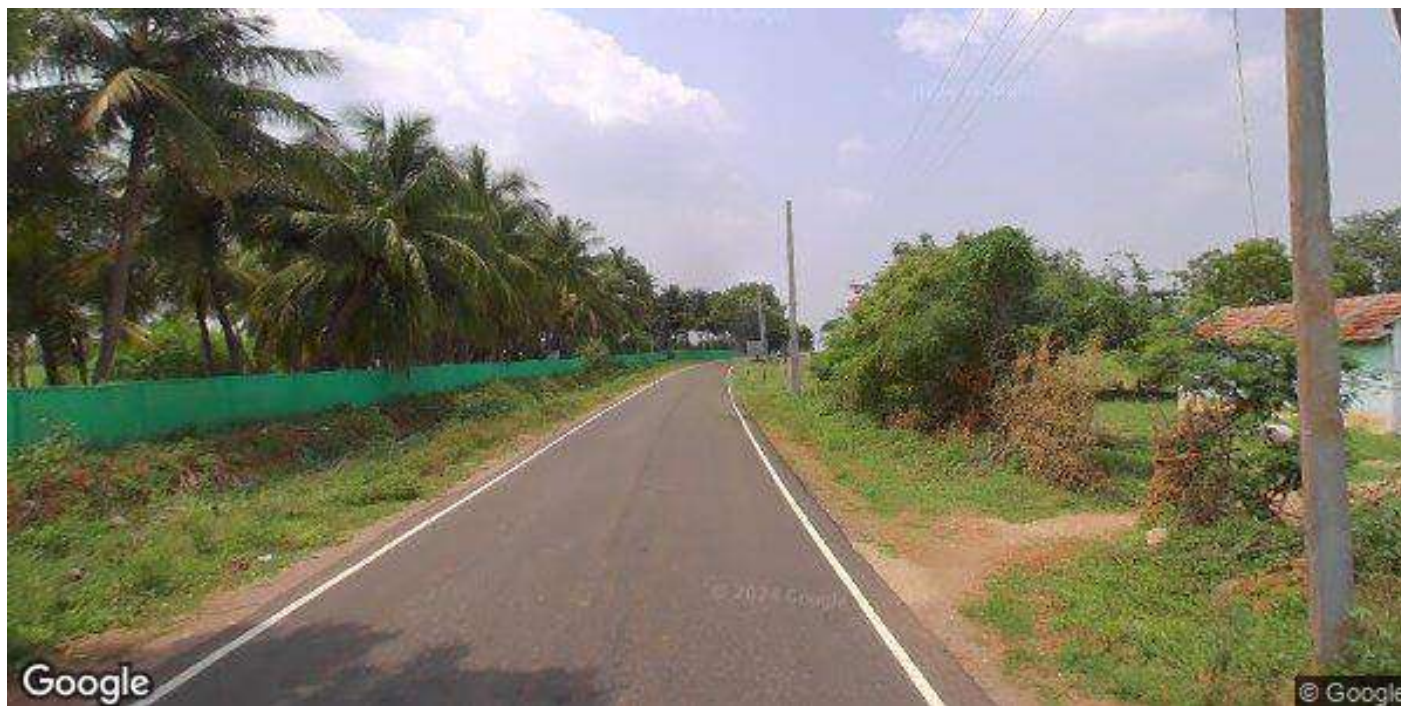
**Risk Type:** Turn  
**Risk Level:** Medium  
**Speed Limit:** 30 KM/Hr  
**Coordinates:** 10.70644, 77.99157

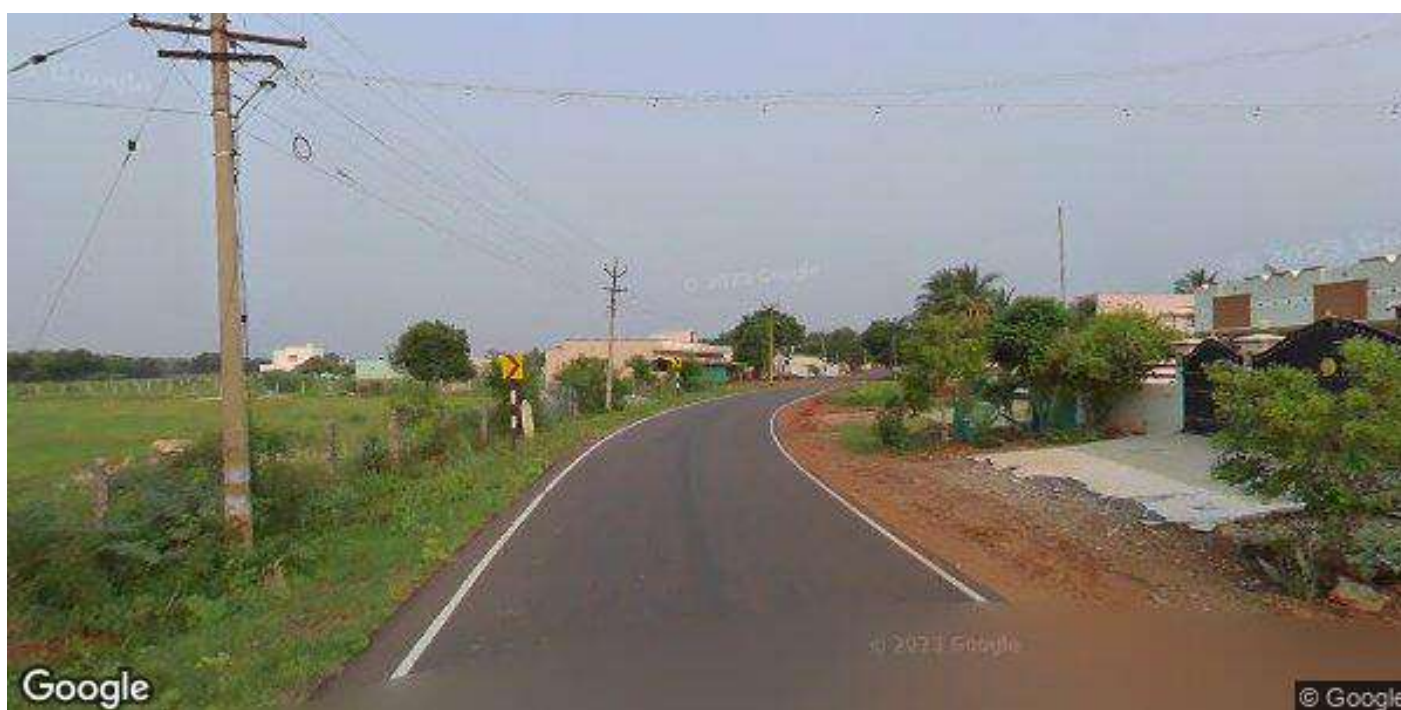
**Risk Type:** Turn  
**Risk Level:** Medium  
**Speed Limit:** 30 KM/Hr  
**Coordinates:** 10.70742, 77.99465
