# IndianOil

## JOURNEY RISK MANAGEMENT (JRM) STUDY

### Salem Terminal to P S K AGENCIES

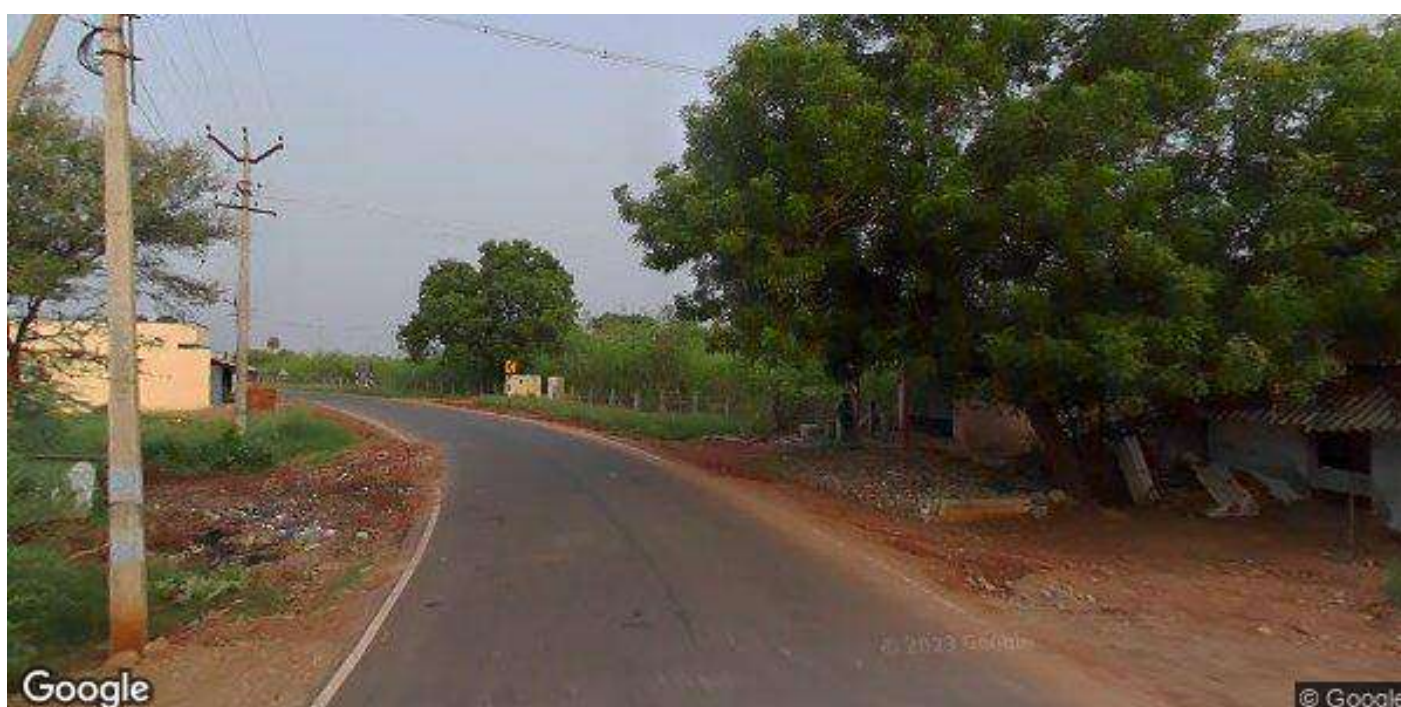
**Risk Type:** Turn  
**Risk Level:** Medium  
**Speed Limit:** 30 KM/Hr  
**Coordinates:** 10.70637, 77.99669

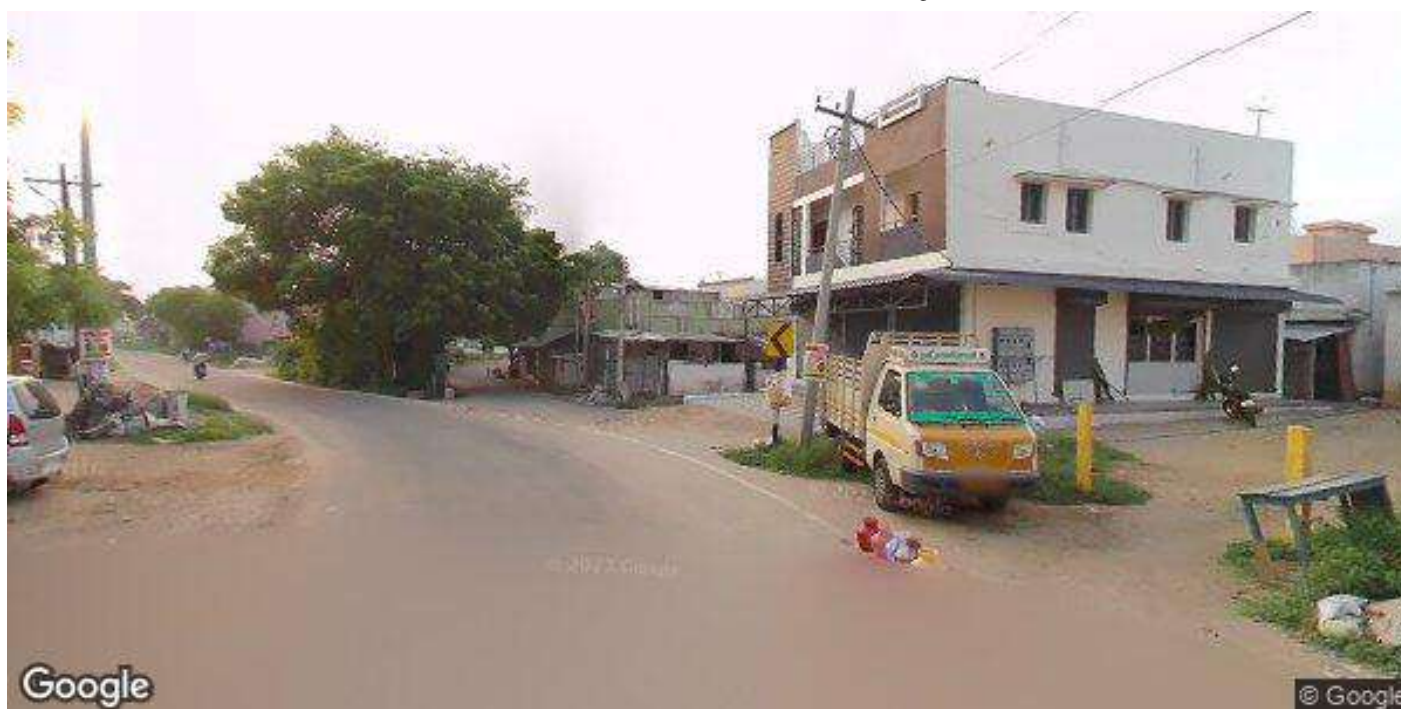
**Risk Type:** Turn  
**Risk Level:** Medium  
**Speed Limit:** 30 KM/Hr  
**Coordinates:** 10.70797, 78.00188

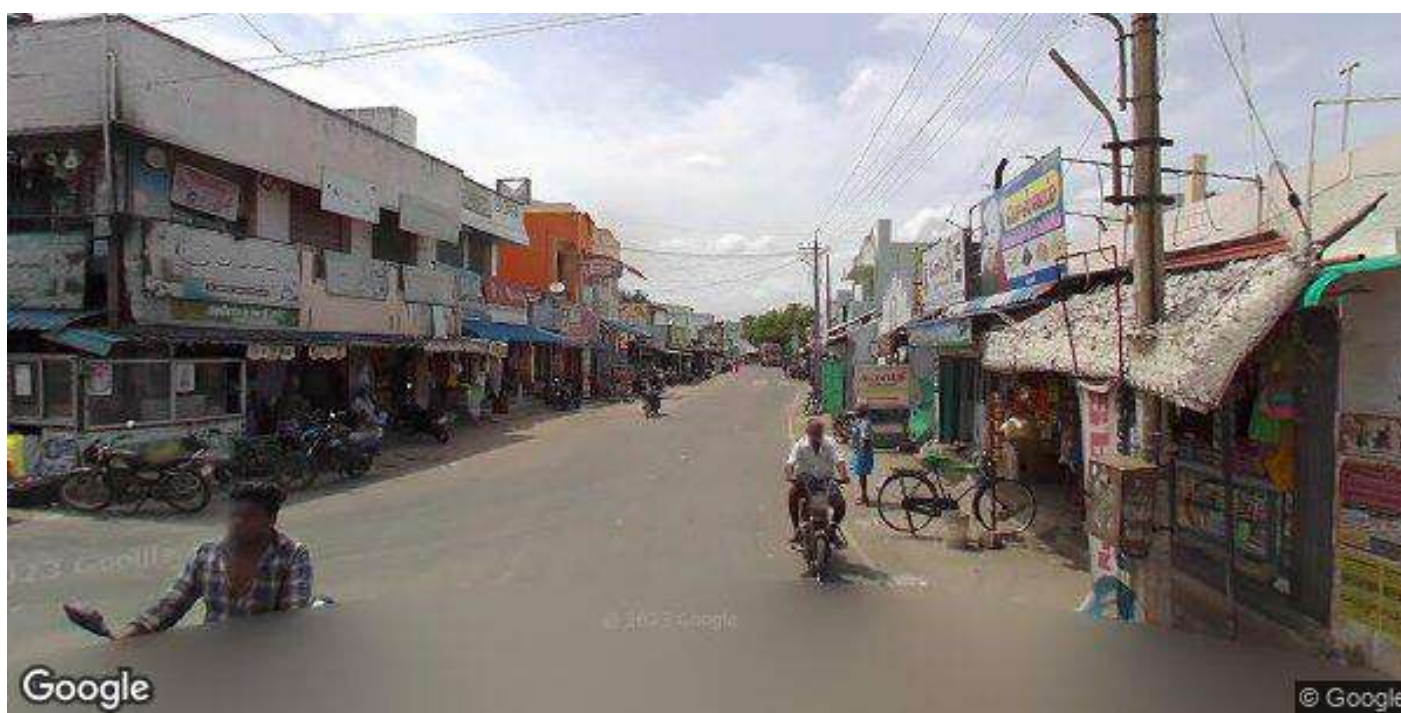
**Risk Type:** Turn  
**Risk Level:** High  
**Speed Limit:** 15 KM/Hr  
**Coordinates:** 10.70766, 78.00275
