## **JOURNEY RISK MANAGEMENT (JRM) STUDY**

### **Salem Terminal To SRI KARTHIKEYA AGENCIES**

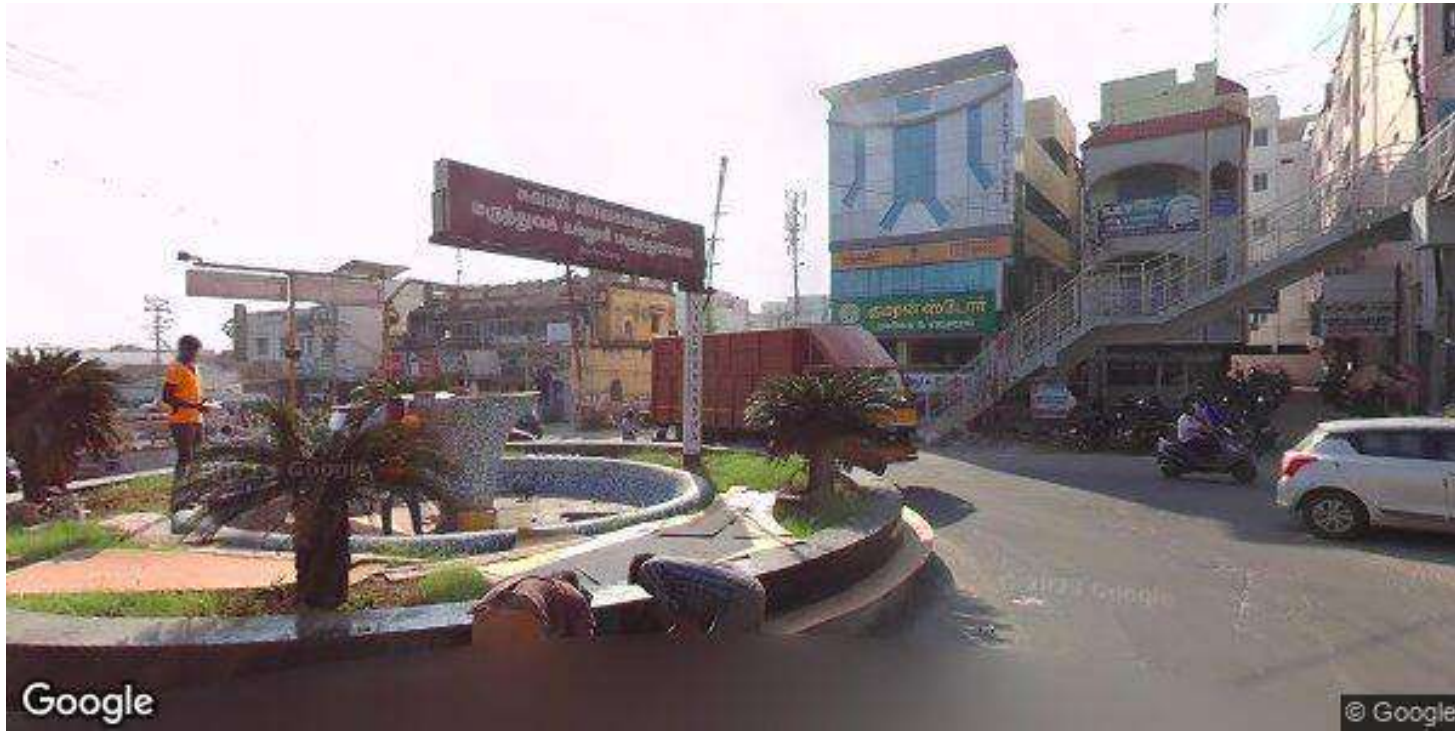
**Coordinates:** 11.38395, 77.89480

**Risk Type:** Roundabout

**Risk Level:** High

**Speed Limit:** 15 KM/Hr

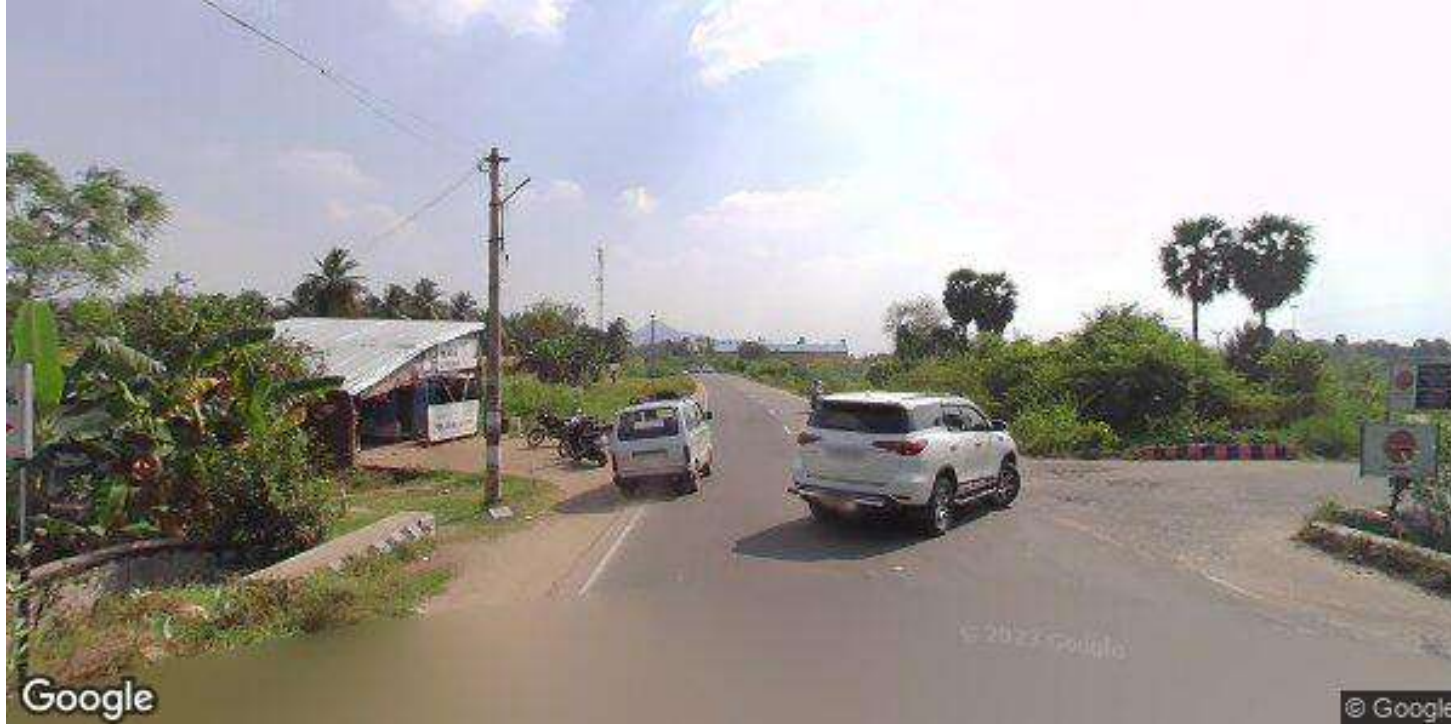
**Coordinates:** 11.44029, 77.87544

**Risk Type:** Turn

**Risk Level:** High

**Speed Limit:** 15 KM/Hr

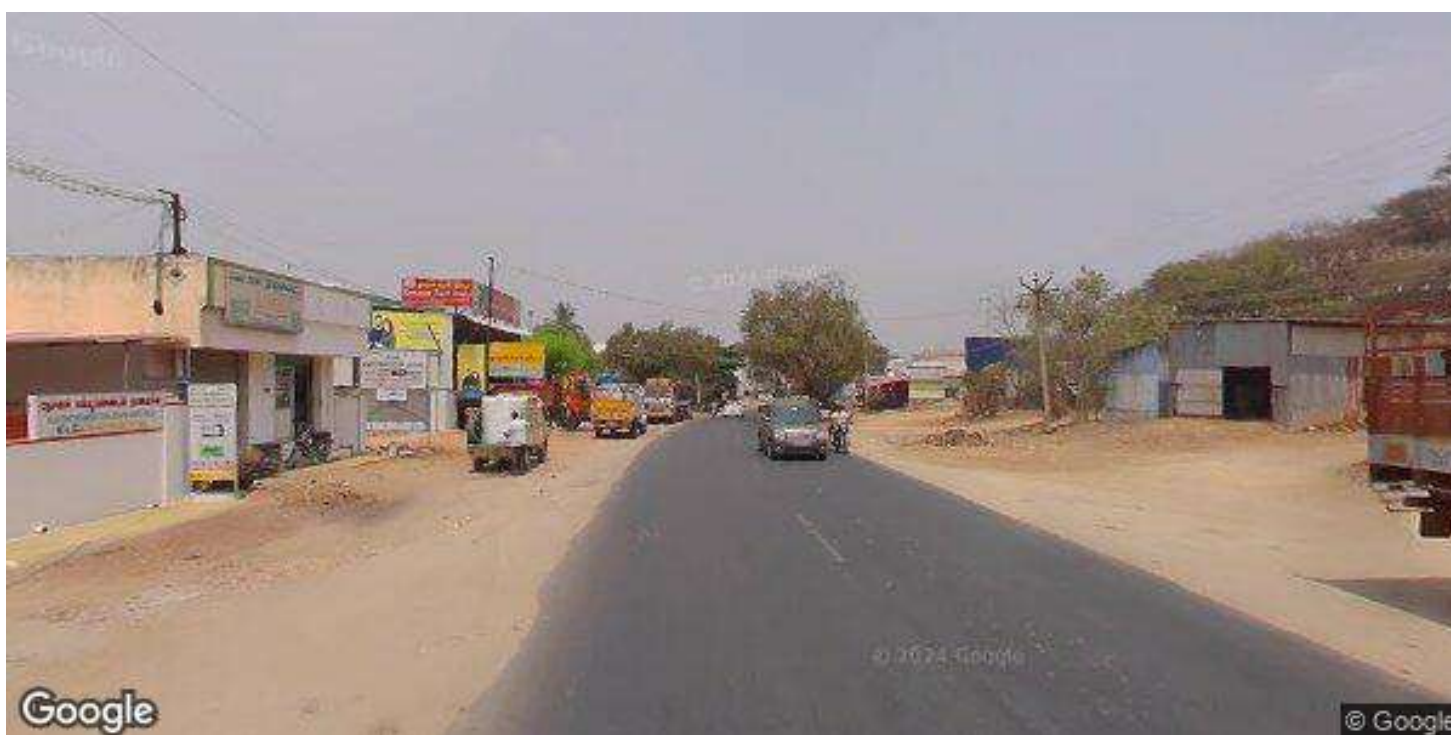
**Coordinates:** 11.39983, 77.88377

**Risk Type:** Turn

**Risk Level:** Medium

**Speed Limit:** 30 KM/Hr

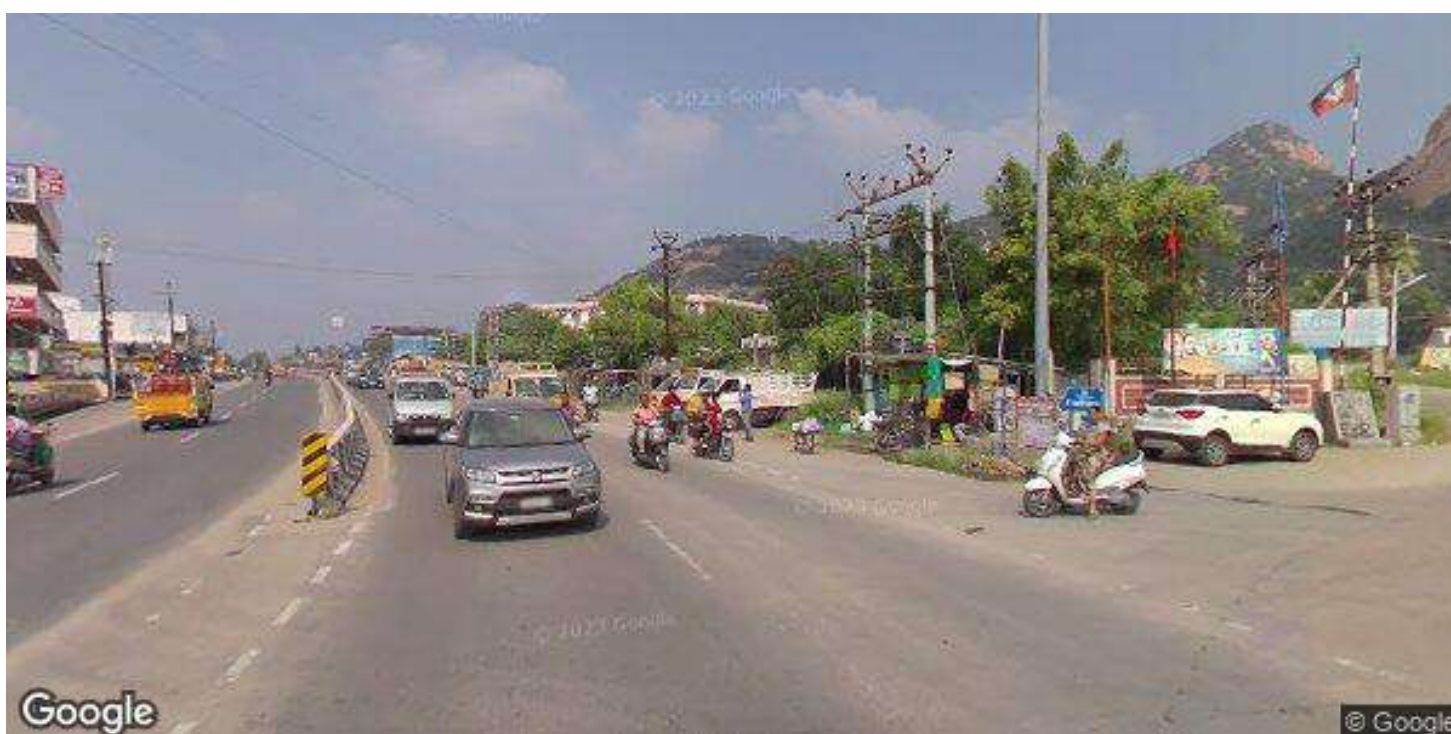
Coordinates: 11.39671, 77.88878

**Risk Type:** Turn

**Risk Level:** Medium

Speed Limit: 30 KM/Hr

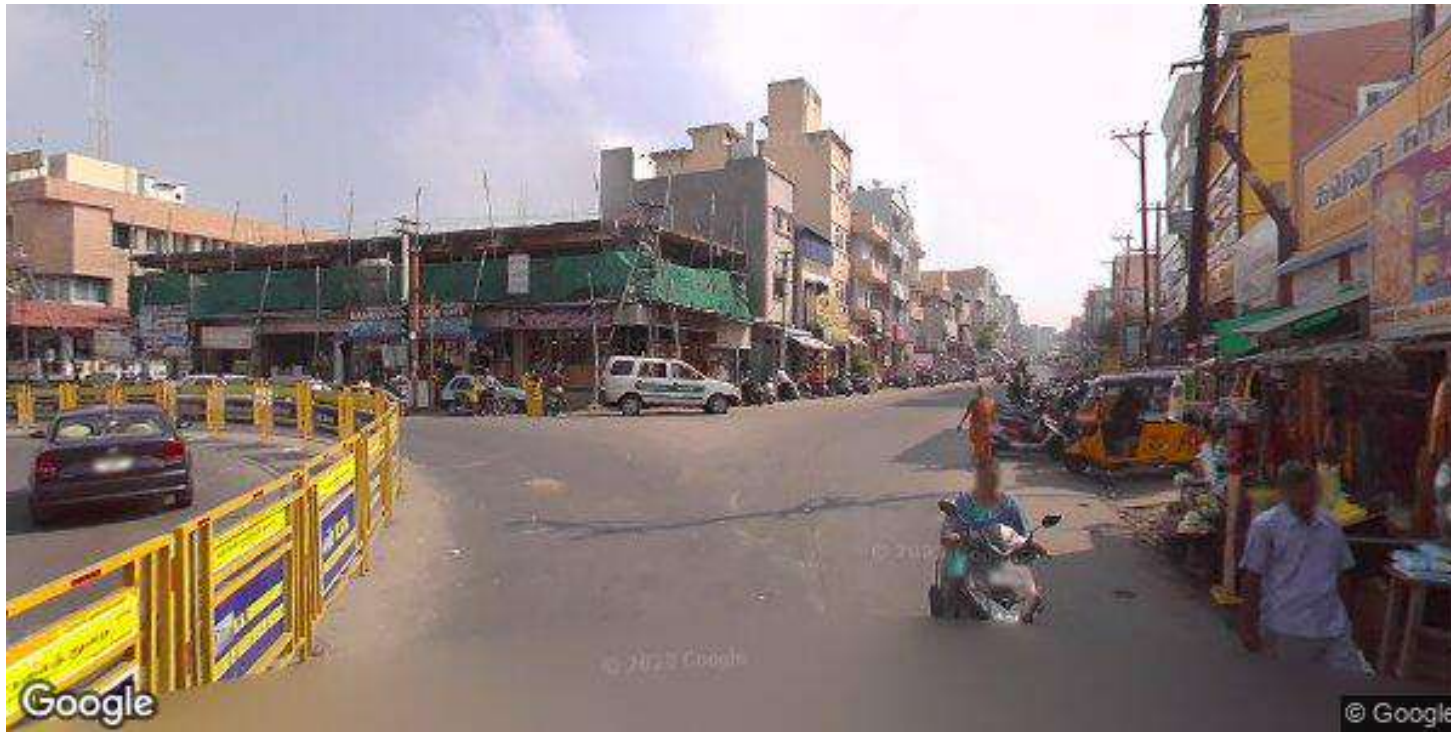
Coordinates: 11.37862, 77.89488

Risk Type: Turn

Risk Level: Medium

Speed Limit: 30 KM/Hr

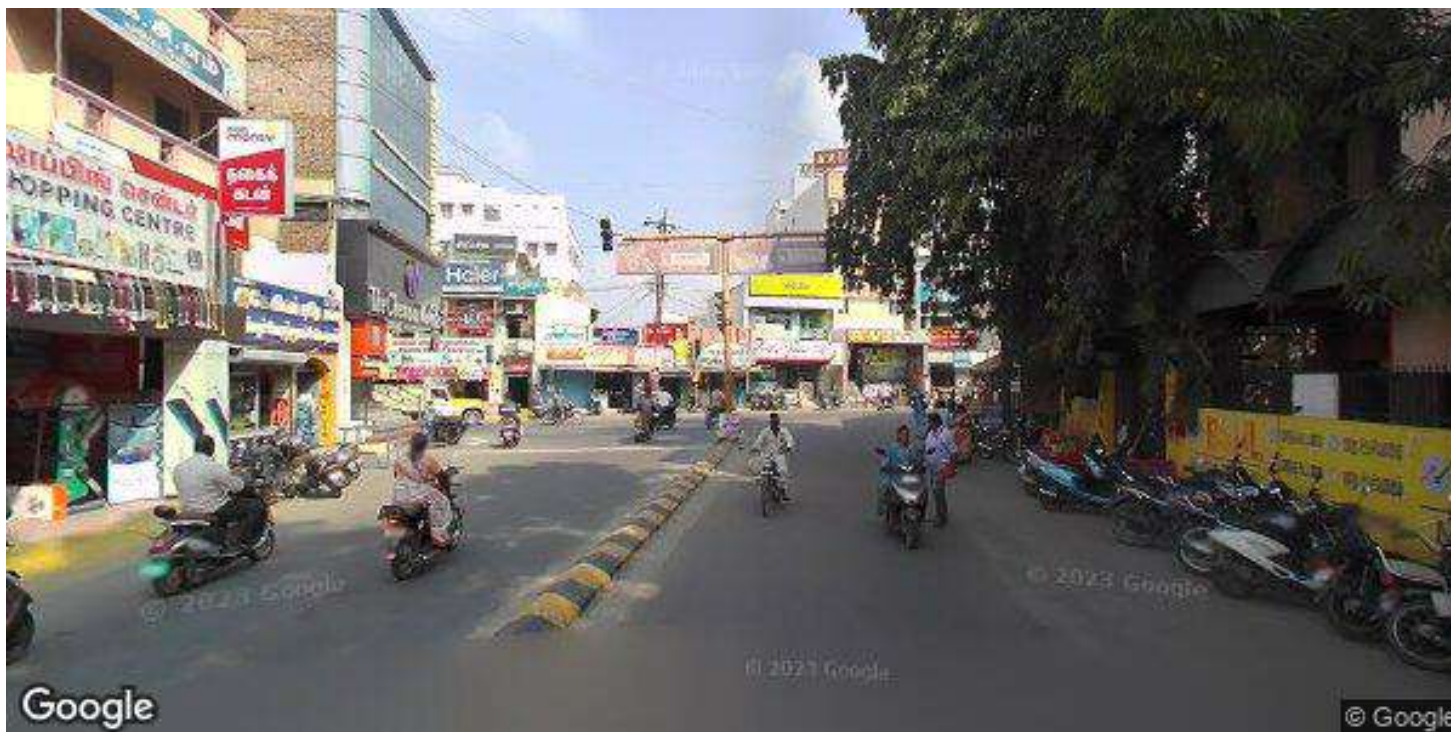
Coordinates: 11.37823, 77.89448

Risk Type: Turn

Risk Level: Medium

Speed Limit: 30 KM/Hr

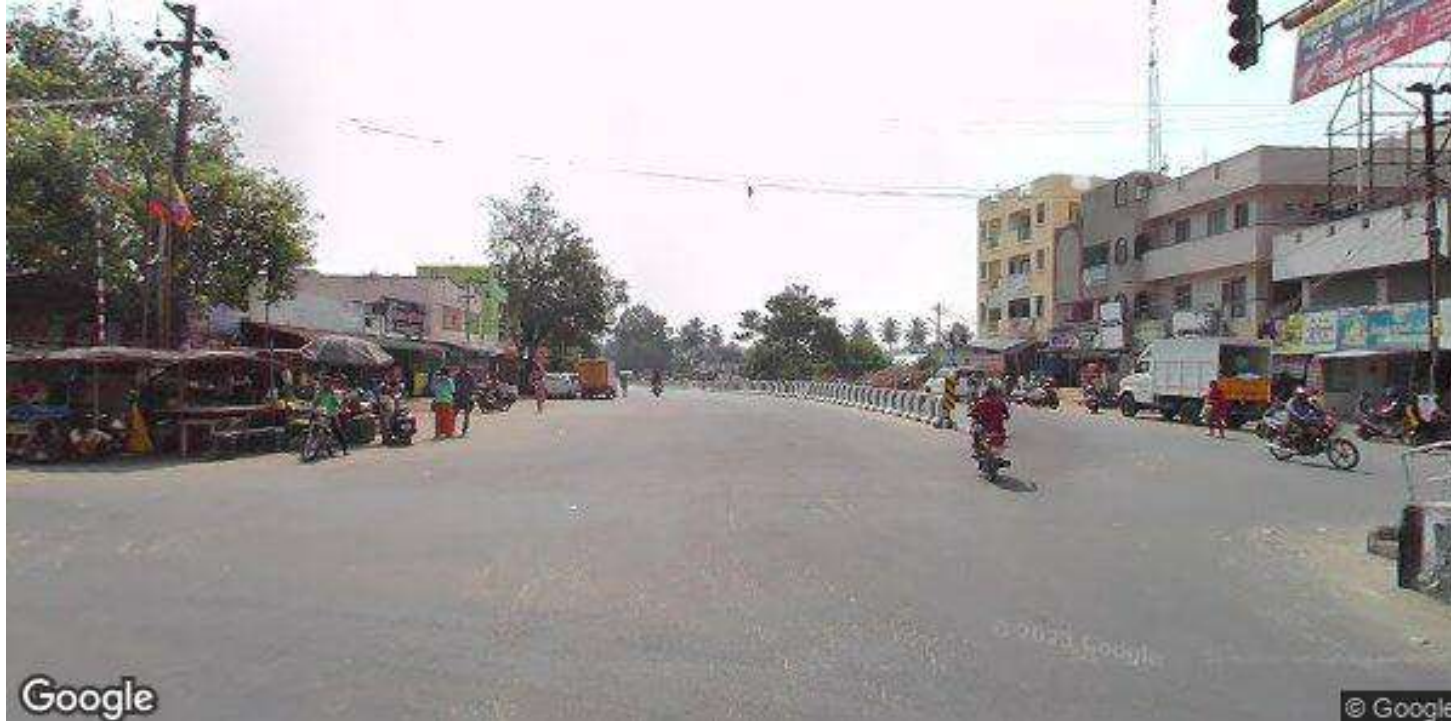
**Risk Type:** Turn  
**Risk Level:** High  
**Speed Limit:** 15 KM/Hr  
**Coordinates:** 11.36604, 77.88887

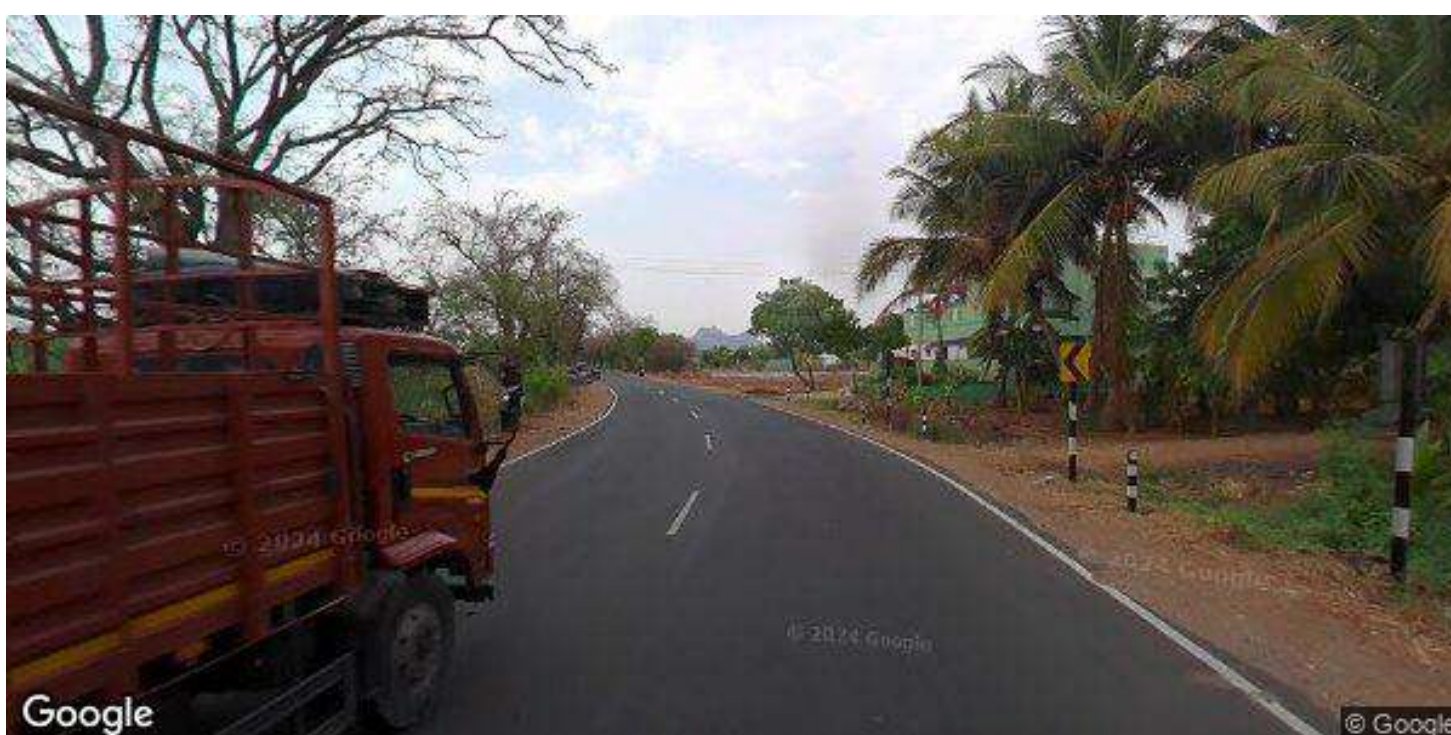
**Risk Type:** Turn  
**Risk Level:** Medium  
**Speed Limit:** 30 KM/Hr  
**Coordinates:** 11.34105, 77.86426

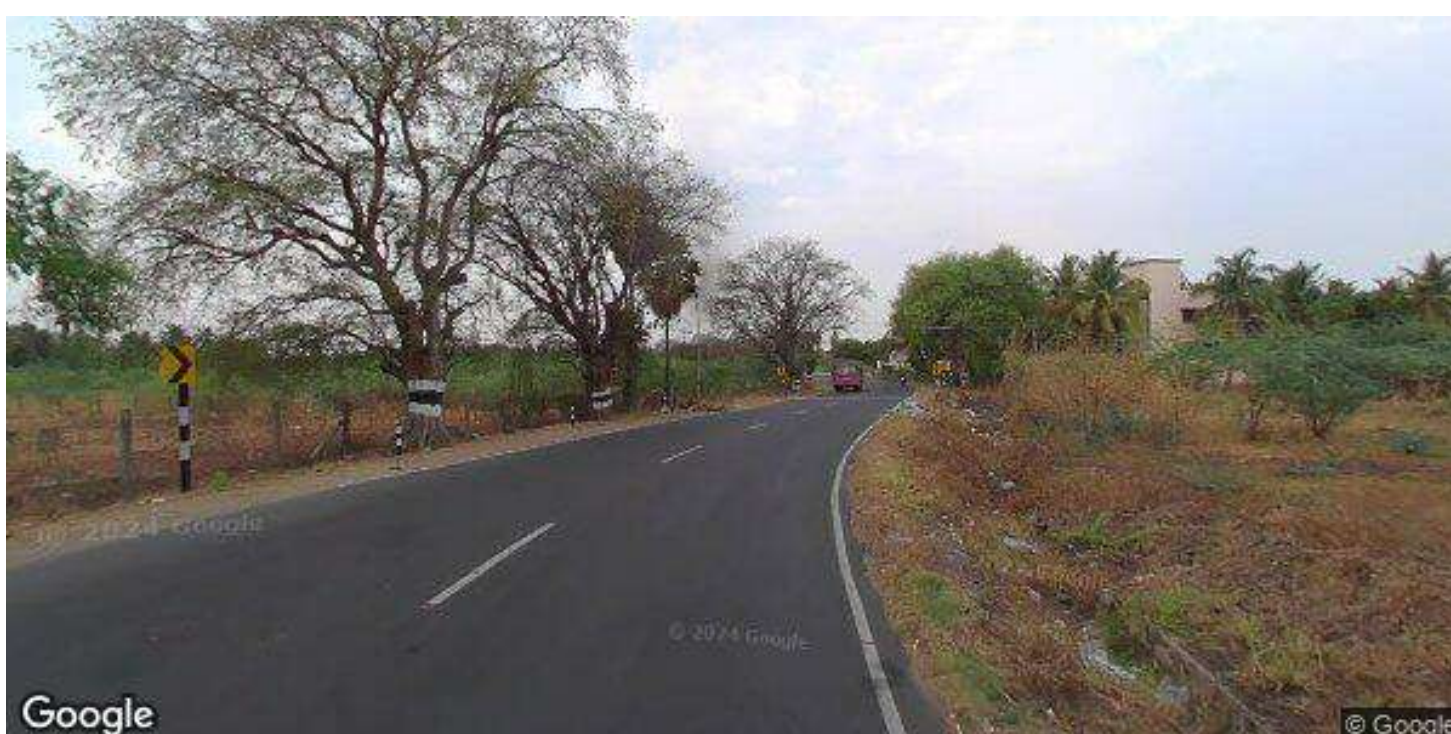
**Coordinates: 11.34074, 77.86356**

**Risk Type:** Turn  
**Risk Level:** Medium

**Speed Limit: 30 KM/Hr**

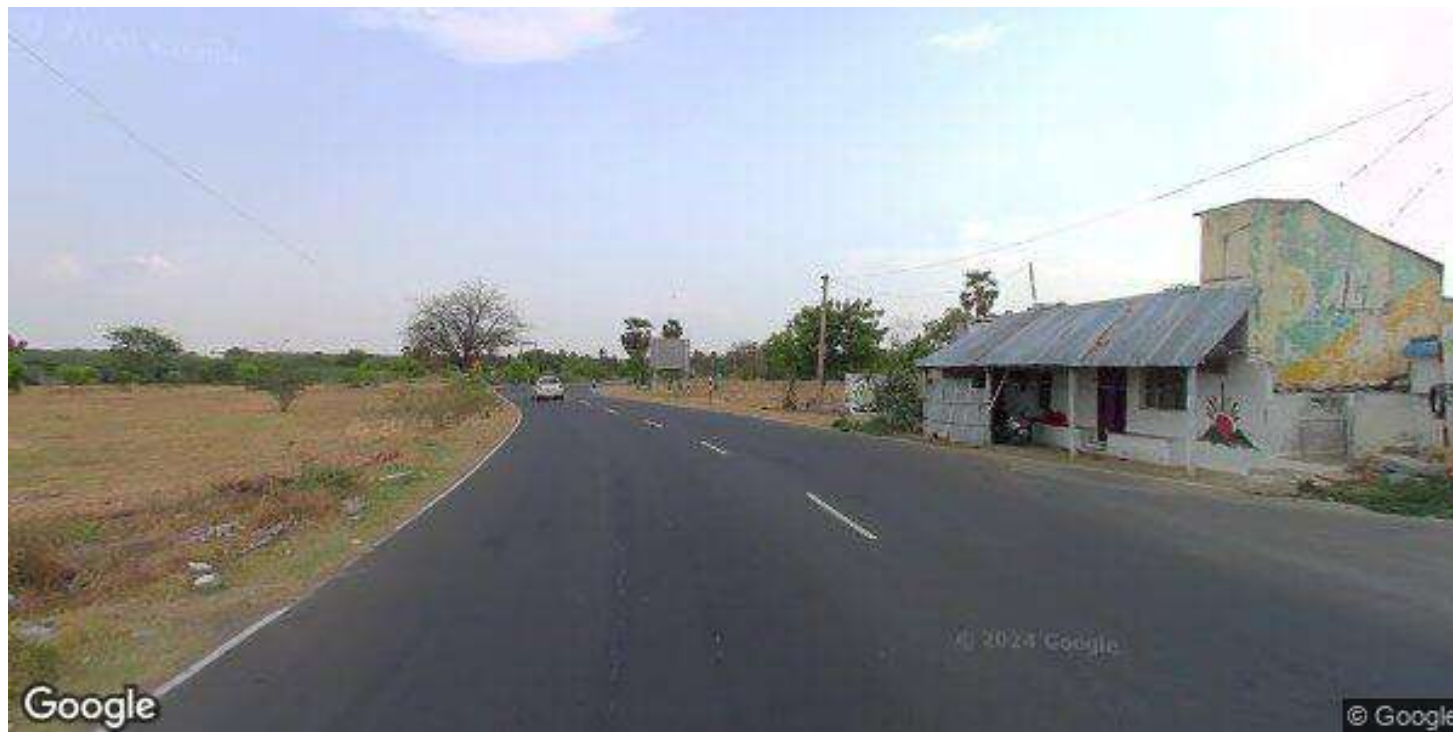
**Coordinates: 11.33865, 77.86216**

**Risk Type: Turn**

**Risk Level: High**

**Speed Limit: 15 KM/Hr**

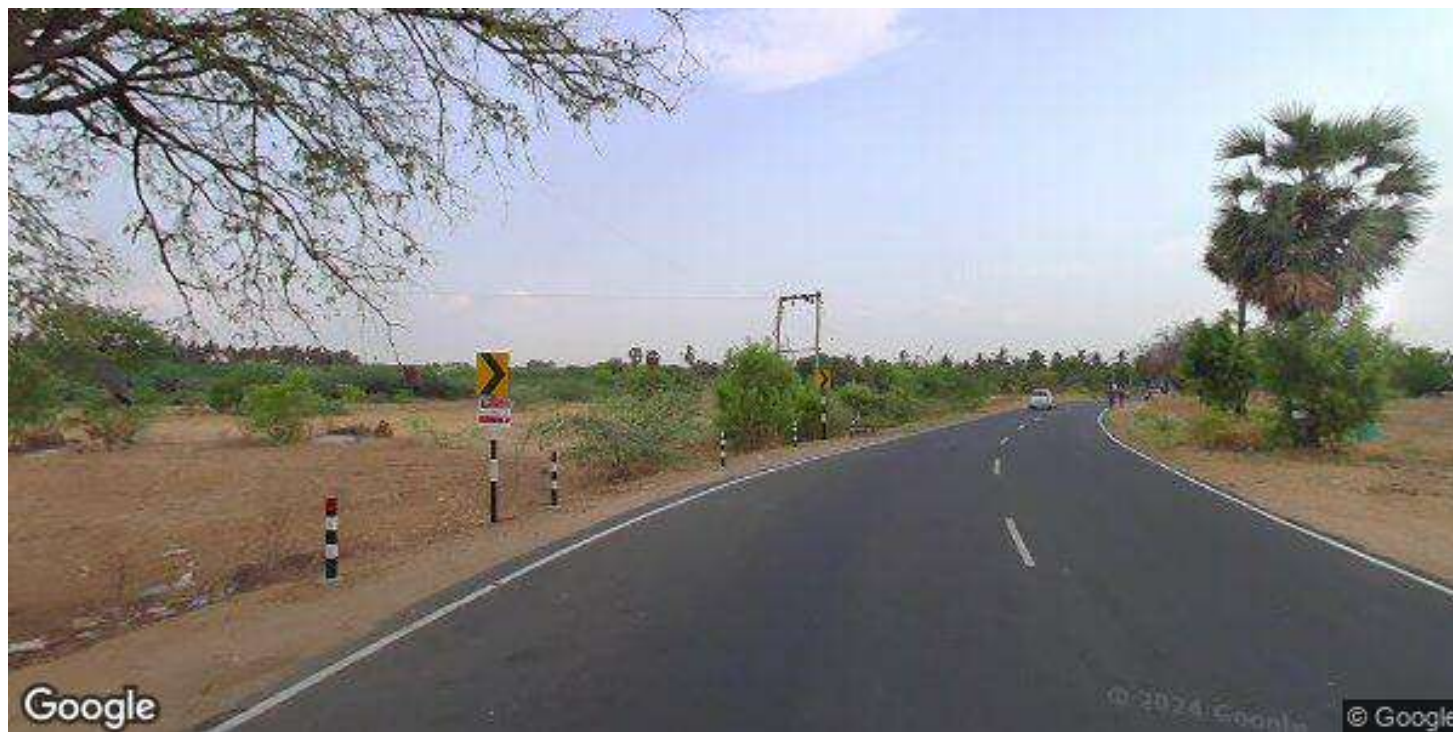
**Coordinates: 11.33794, 77.86235**

**Risk Type: Turn**

**Risk Level: Medium**

**Speed Limit: 30 KM/Hr**

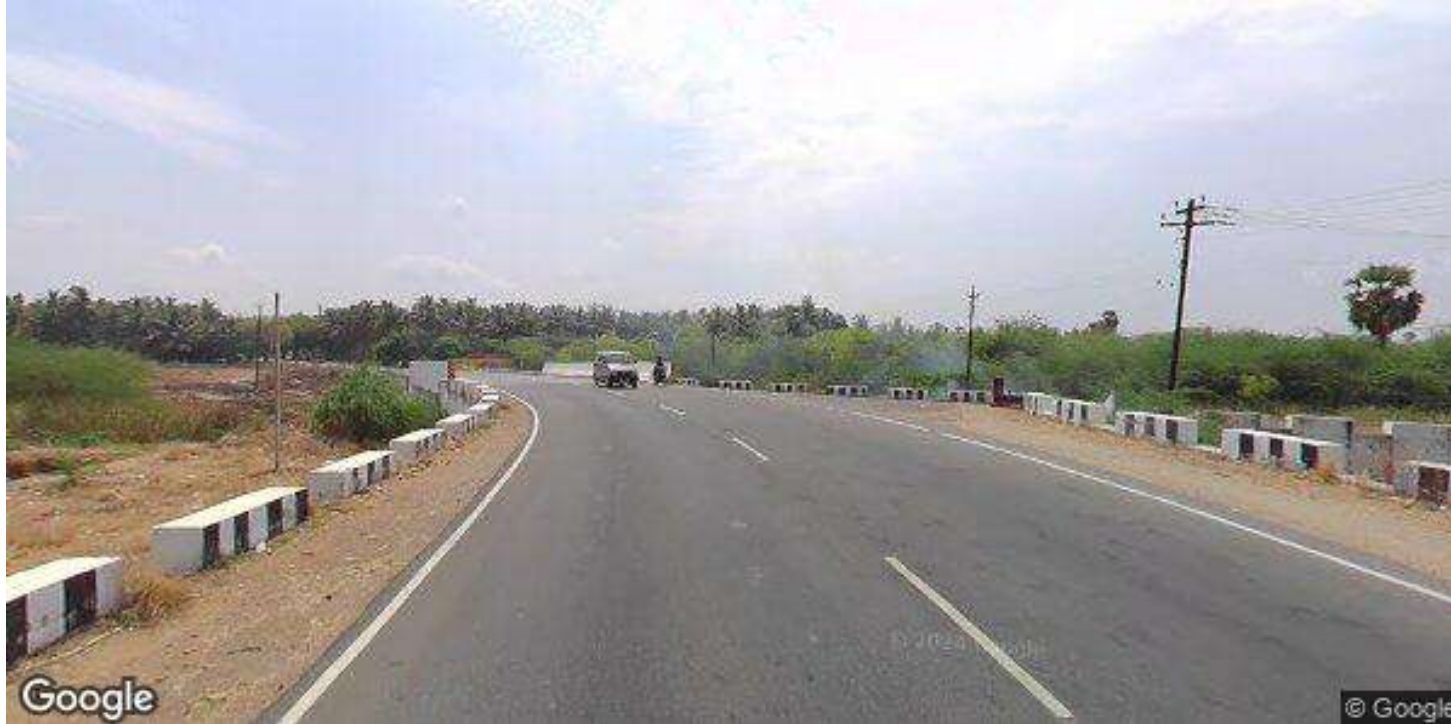
**Risk Type:** Turn  
**Risk Level:** Medium  
**Speed Limit:** 30 KM/Hr  
**Coordinates:** 11.31746, 77.84231

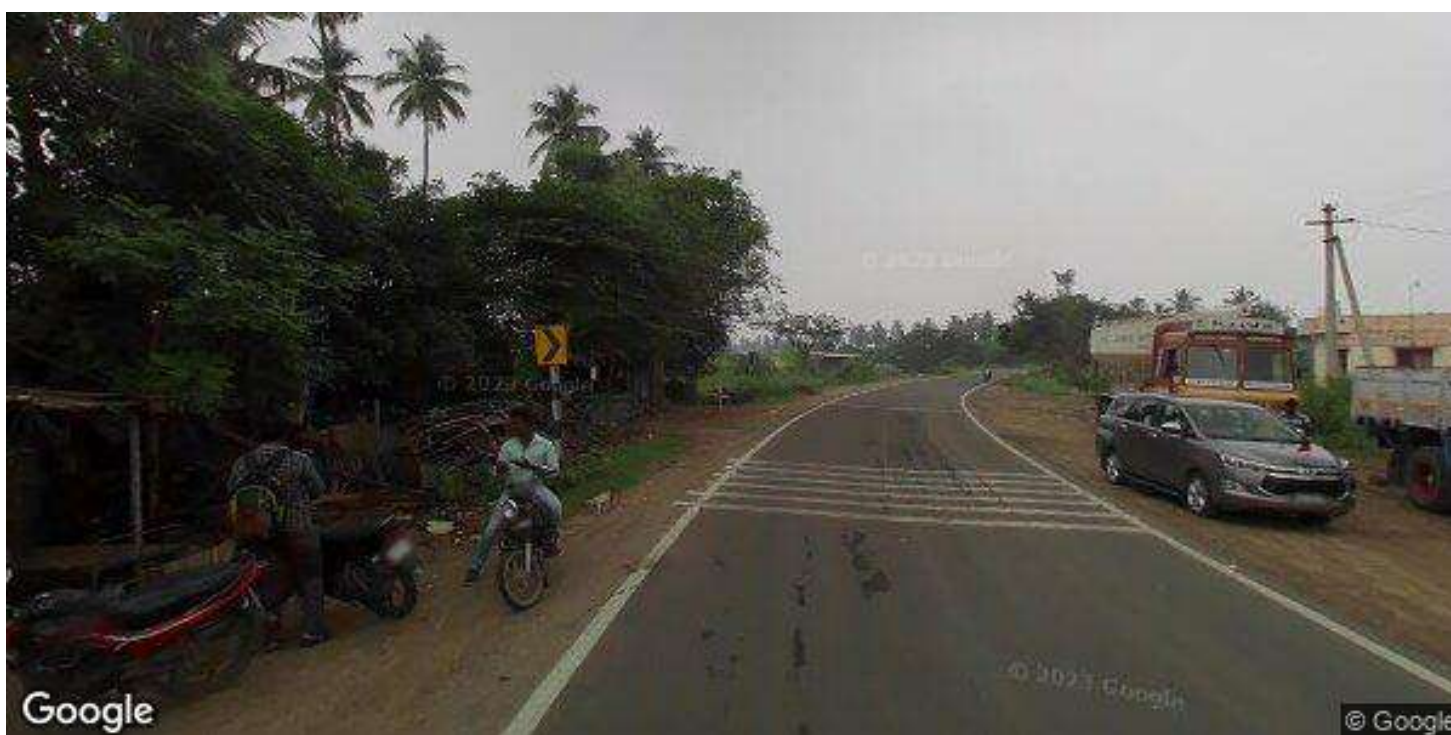
**Risk Type:** Turn  
**Risk Level:** Medium  
**Speed Limit:** 30 KM/Hr  
**Coordinates:** 11.30951, 77.77598

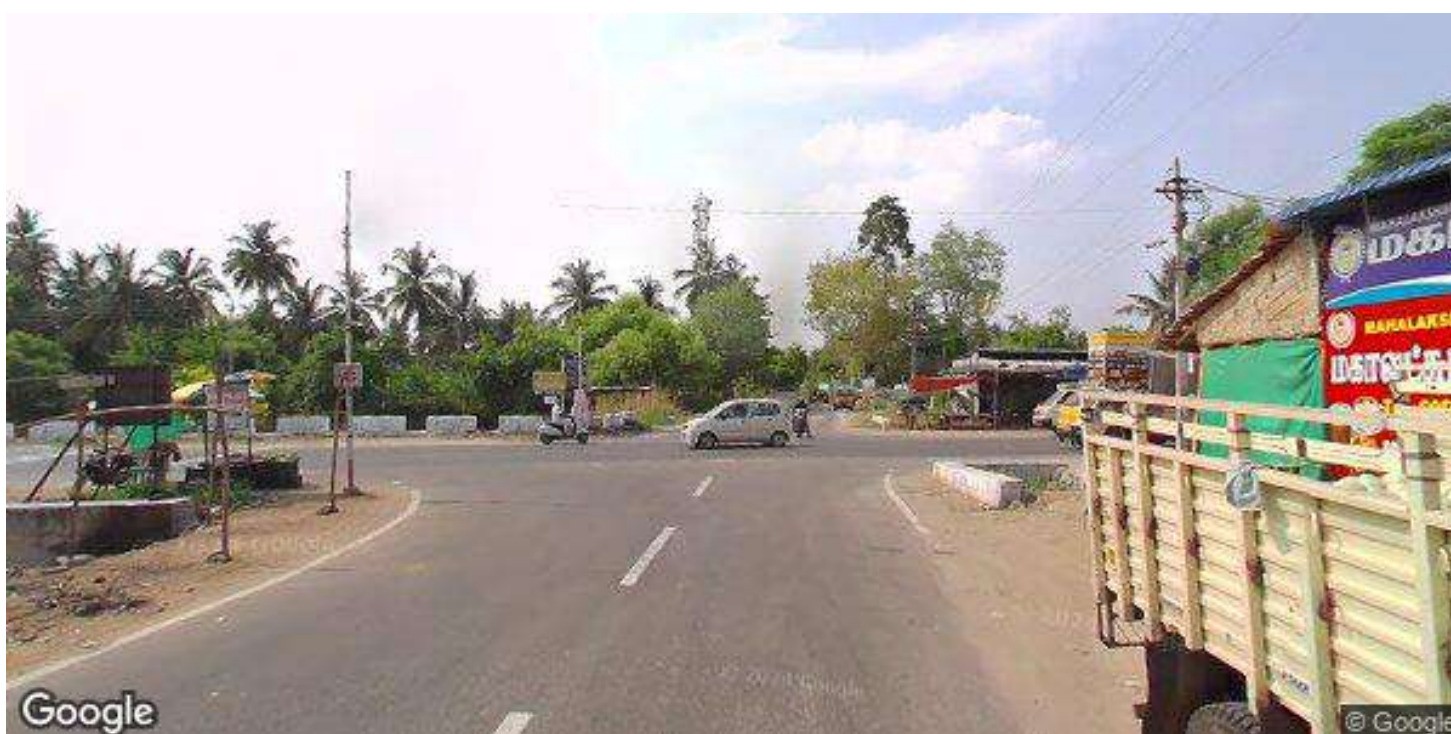
**Coordinates: 11.29473, 77.74685**

**Risk Type:** Turn  
**Risk Level:** High

**Speed Limit: 15 KM/Hr**

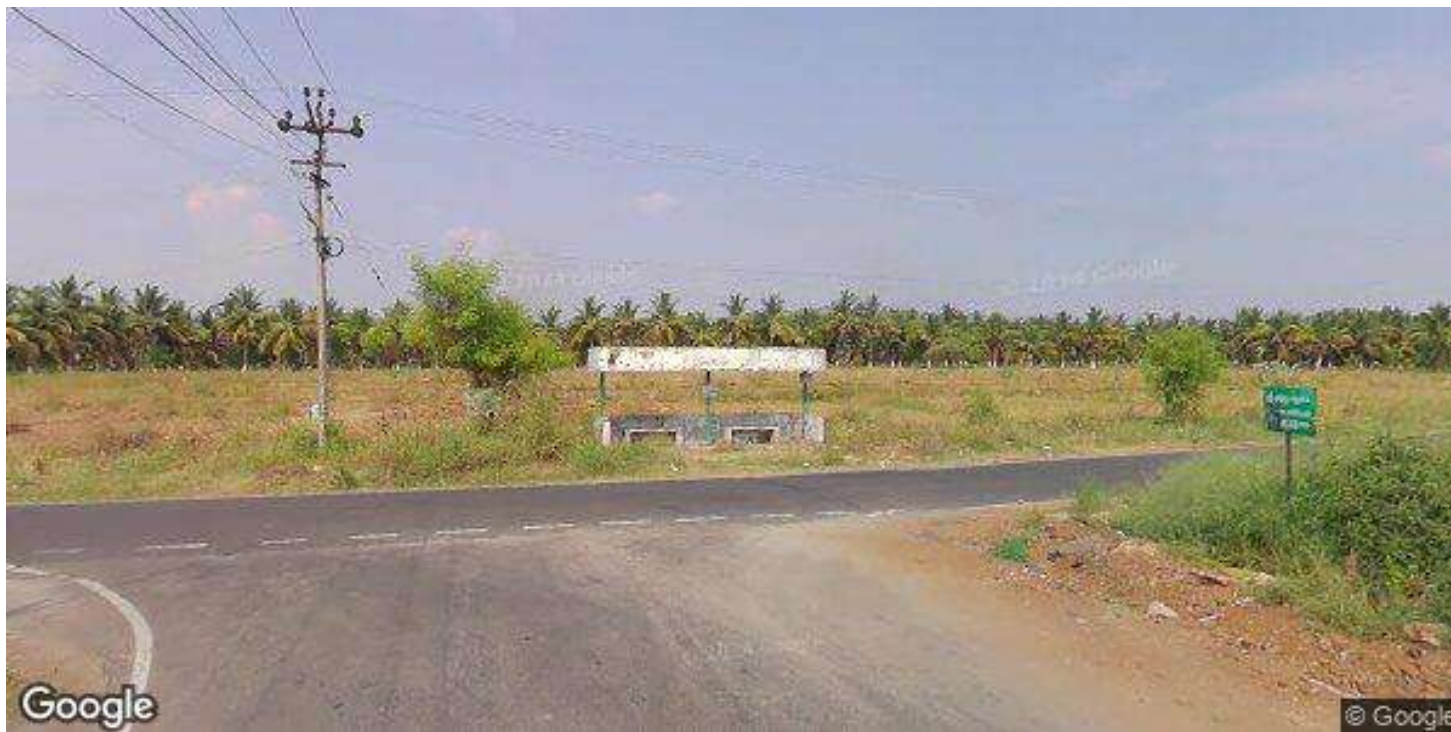
**Coordinates: 11.29128, 77.74656**

**Risk Type: Turn**

**Risk Level: High**

**Speed Limit: 15 KM/Hr**

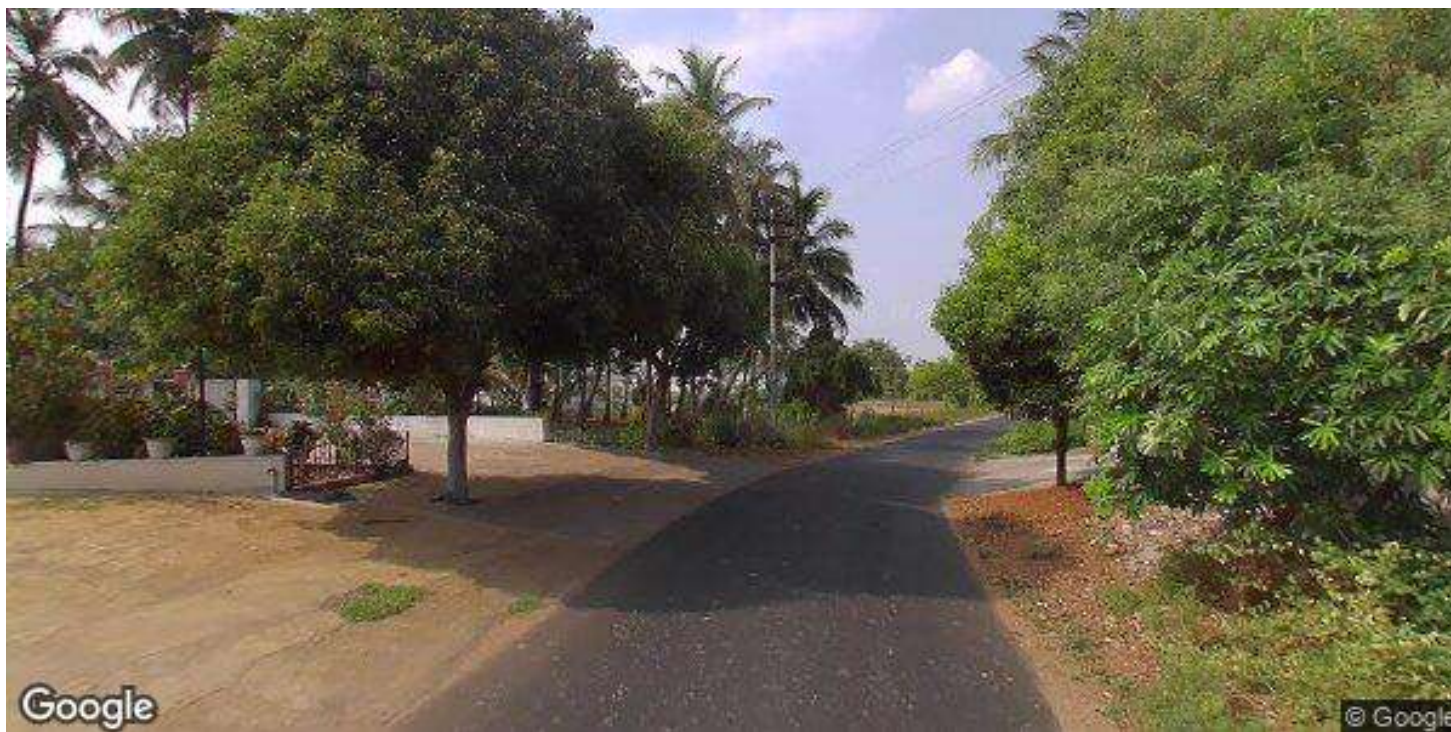
**Coordinates: 11.28859, 77.74323**

**Risk Type: Turn**

**Risk Level: Medium**

**Speed Limit: 30 KM/Hr**

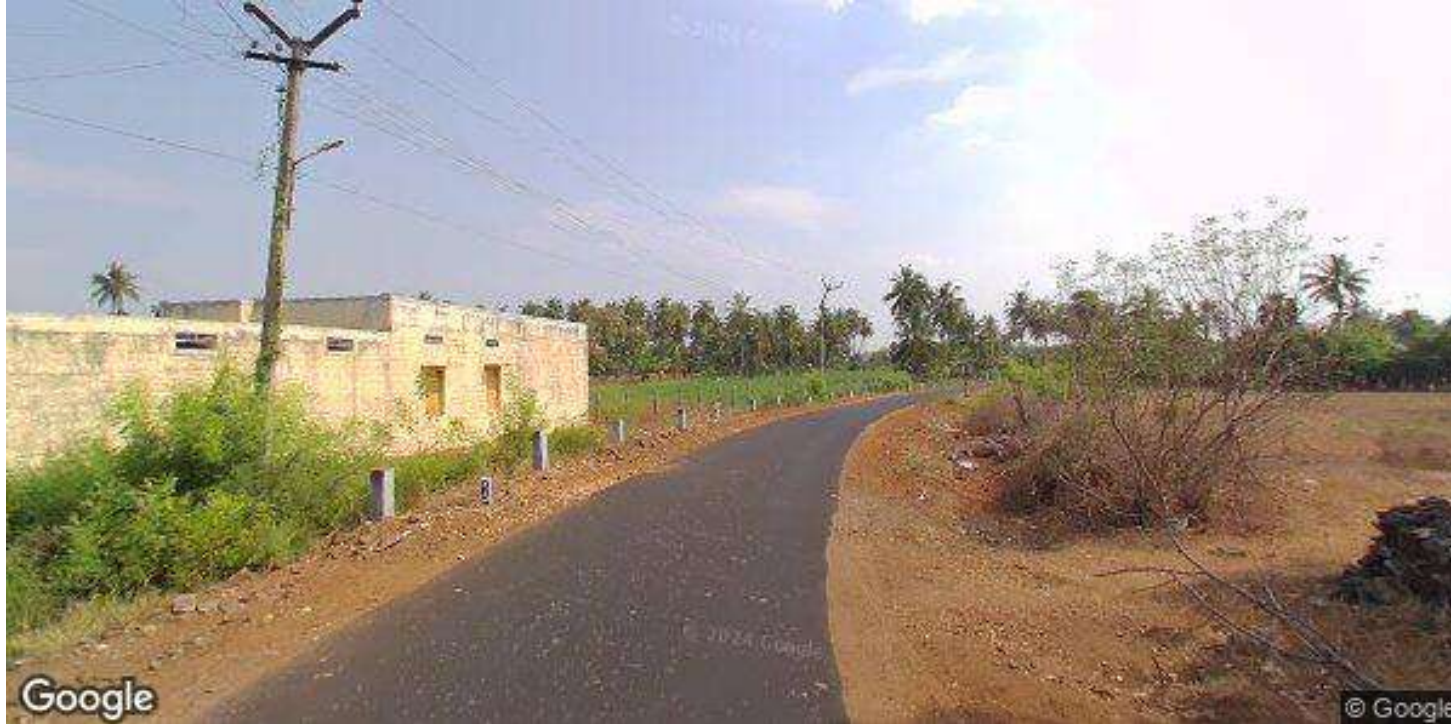
**Risk Type:** Turn  
**Risk Level:** Medium  
**Speed Limit:** 30 KM/Hr  
**Coordinates:** 11.28588, 77.74287

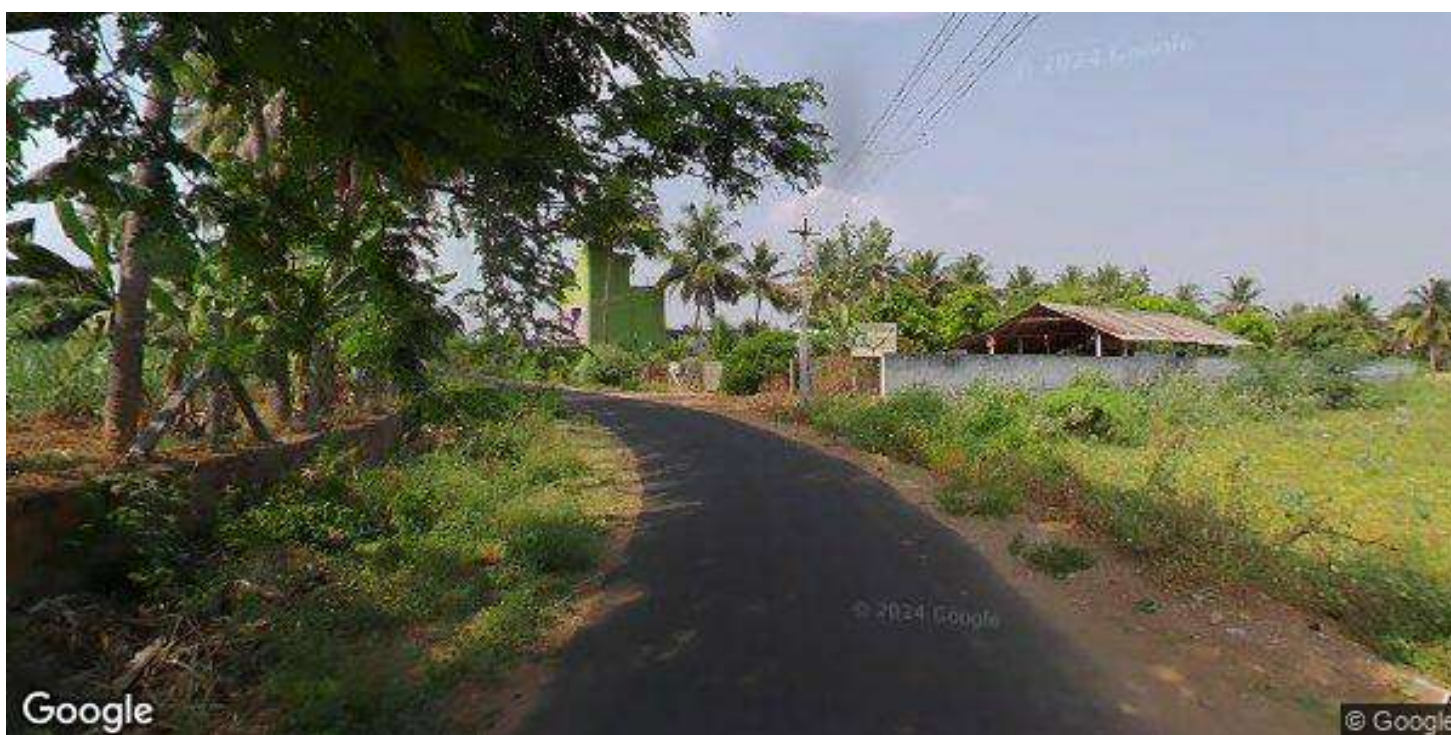
**Risk Type:** Turn  
**Risk Level:** High  
**Speed Limit:** 15 KM/Hr  
**Coordinates:** 11.27326, 77.72991

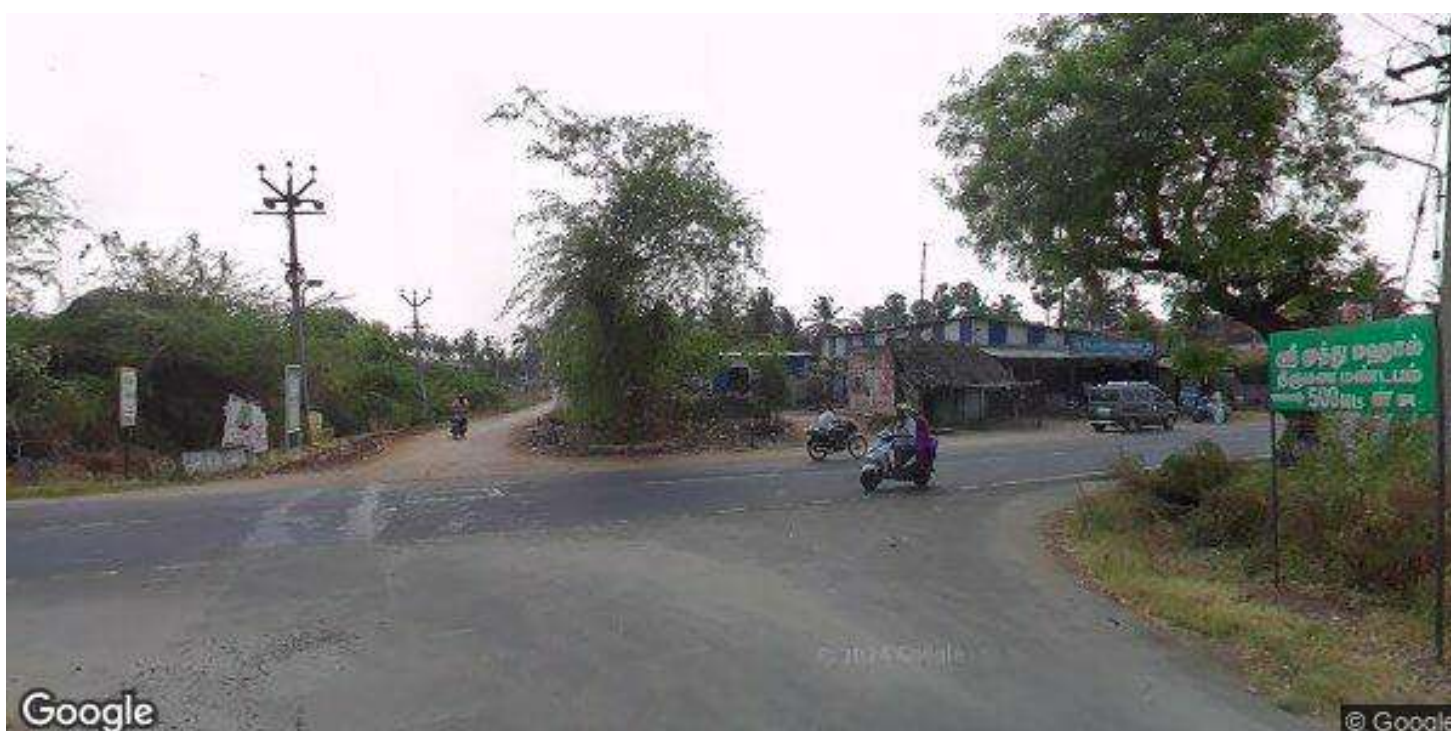
**Coordinates: 11.27330, 77.72720**

**Risk Type:** Turn  
**Risk Level:** High

**Speed Limit: 15 KM/Hr**

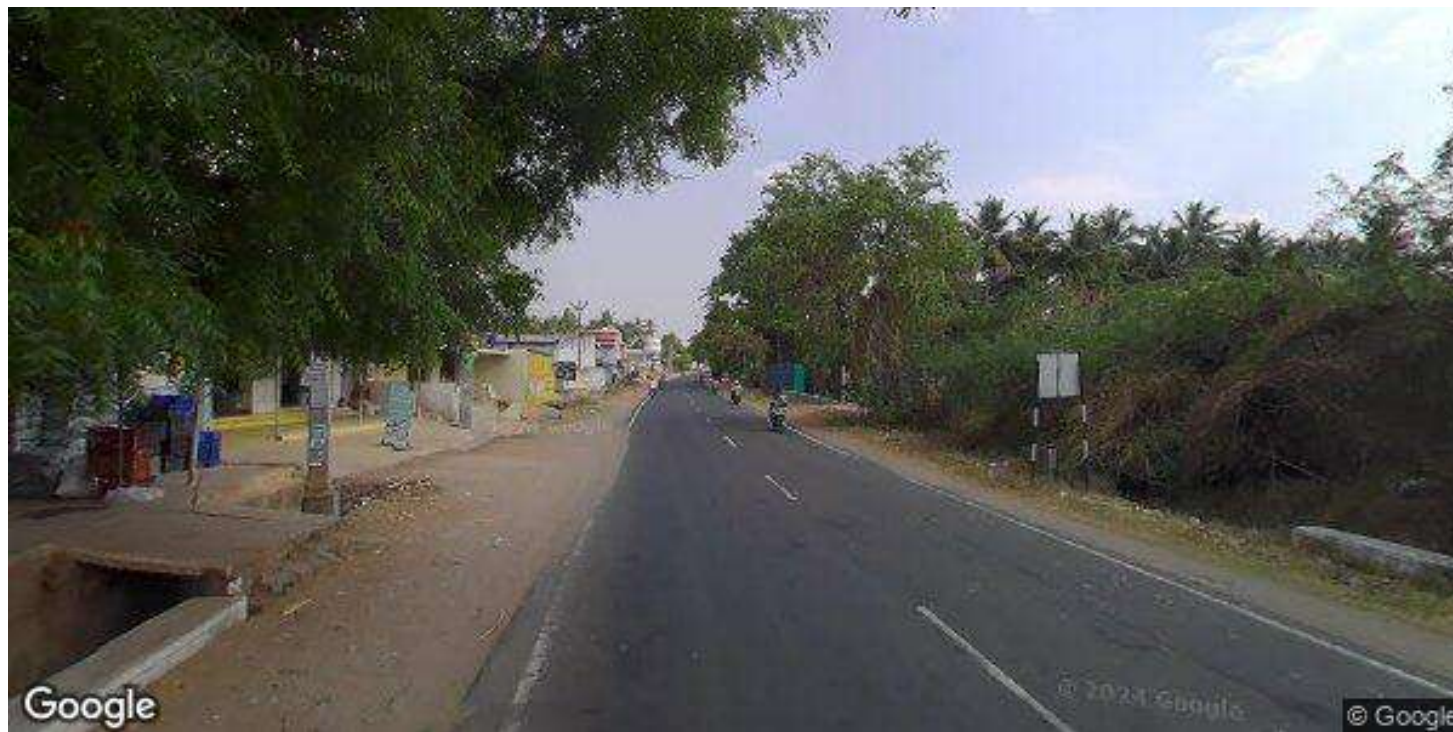
**Coordinates: 11.27319, 77.72706**

**Risk Type: Turn**

**Risk Level: High**

**Speed Limit: 15 KM/Hr**

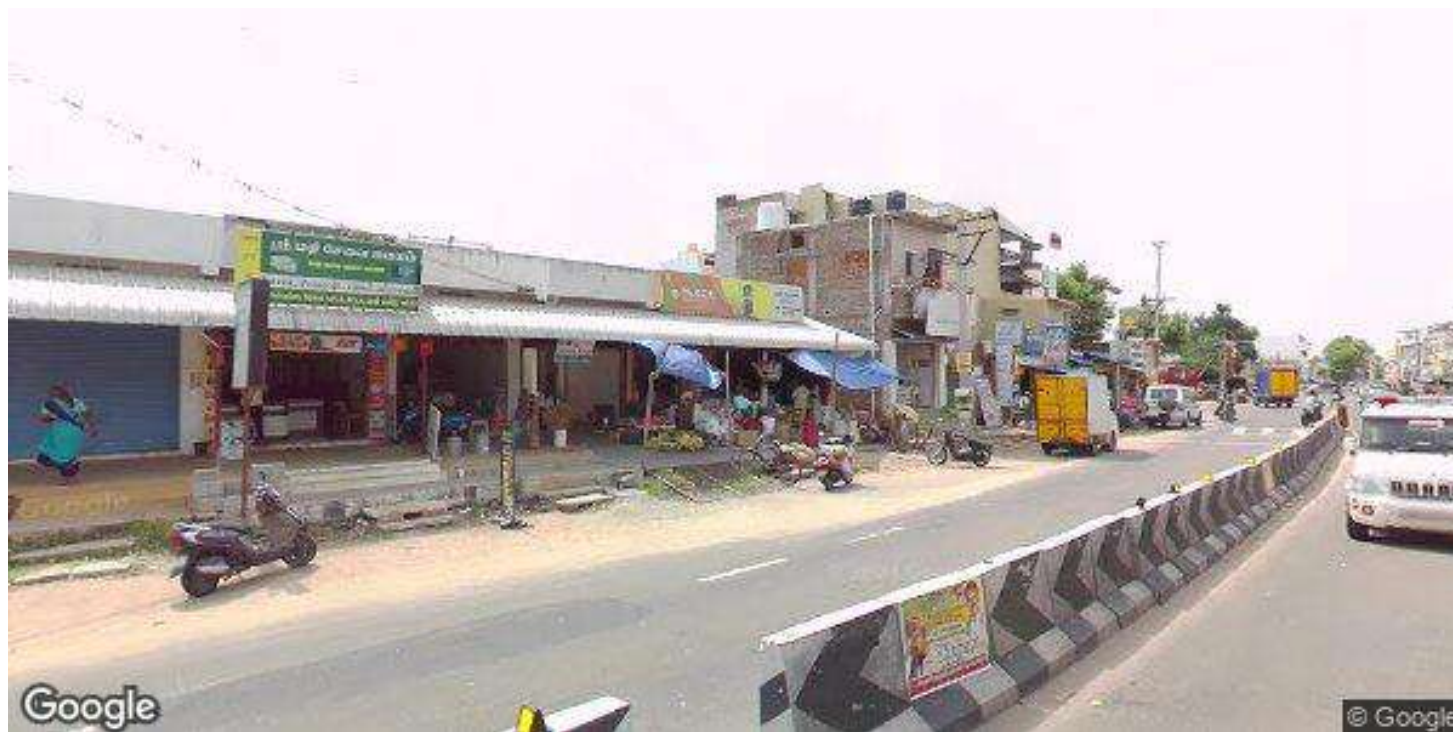
**Coordinates: 11.23073, 77.71802**

**Risk Type: Turn**

**Risk Level: Medium**

**Speed Limit: 30 KM/Hr**
