## **JOURNEY RISK MANAGEMENT (JRM) STUDY**

### **Salem Terminal To SRI KARTHIKEYA AGENCIES**

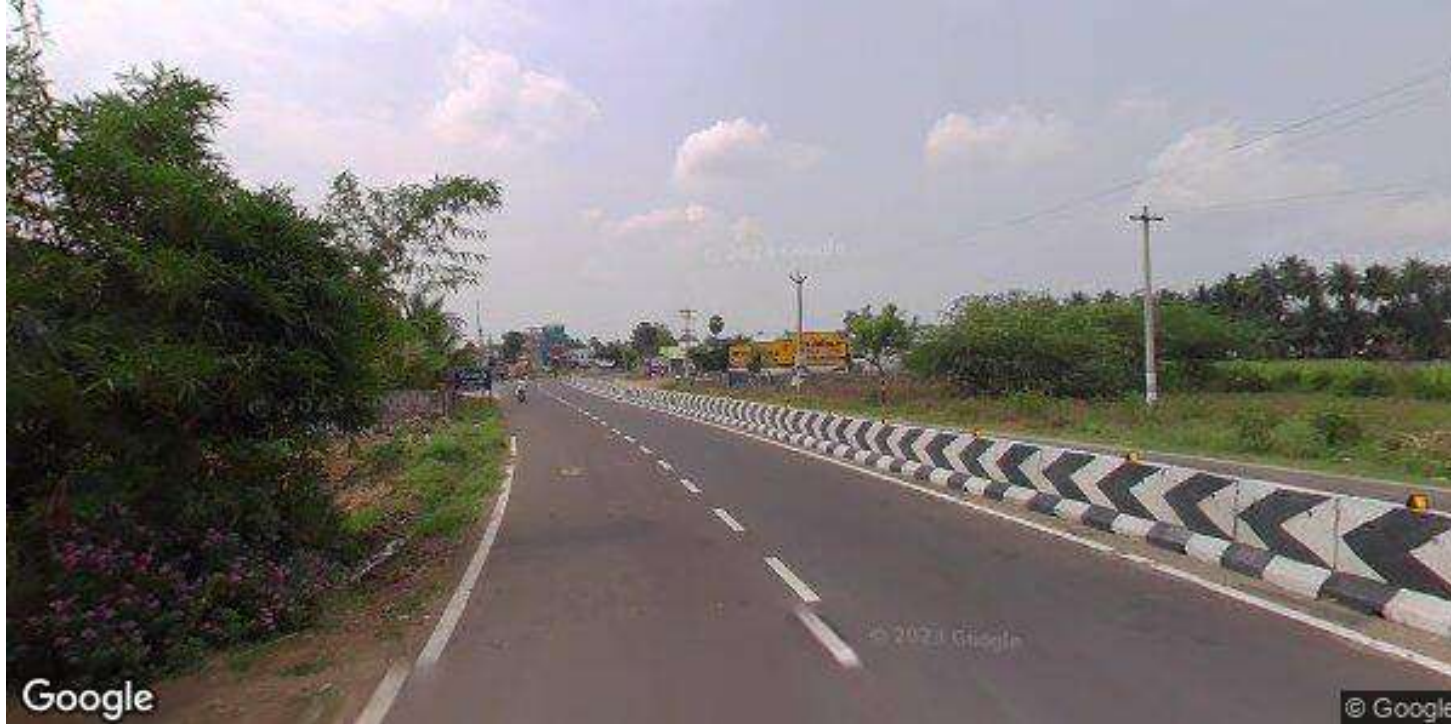
**Risk Type:** Turn  
**Risk Level:** Medium  
**Speed Limit:** 30 KM/Hr  
**Coordinates:** 11.22367, 77.71384

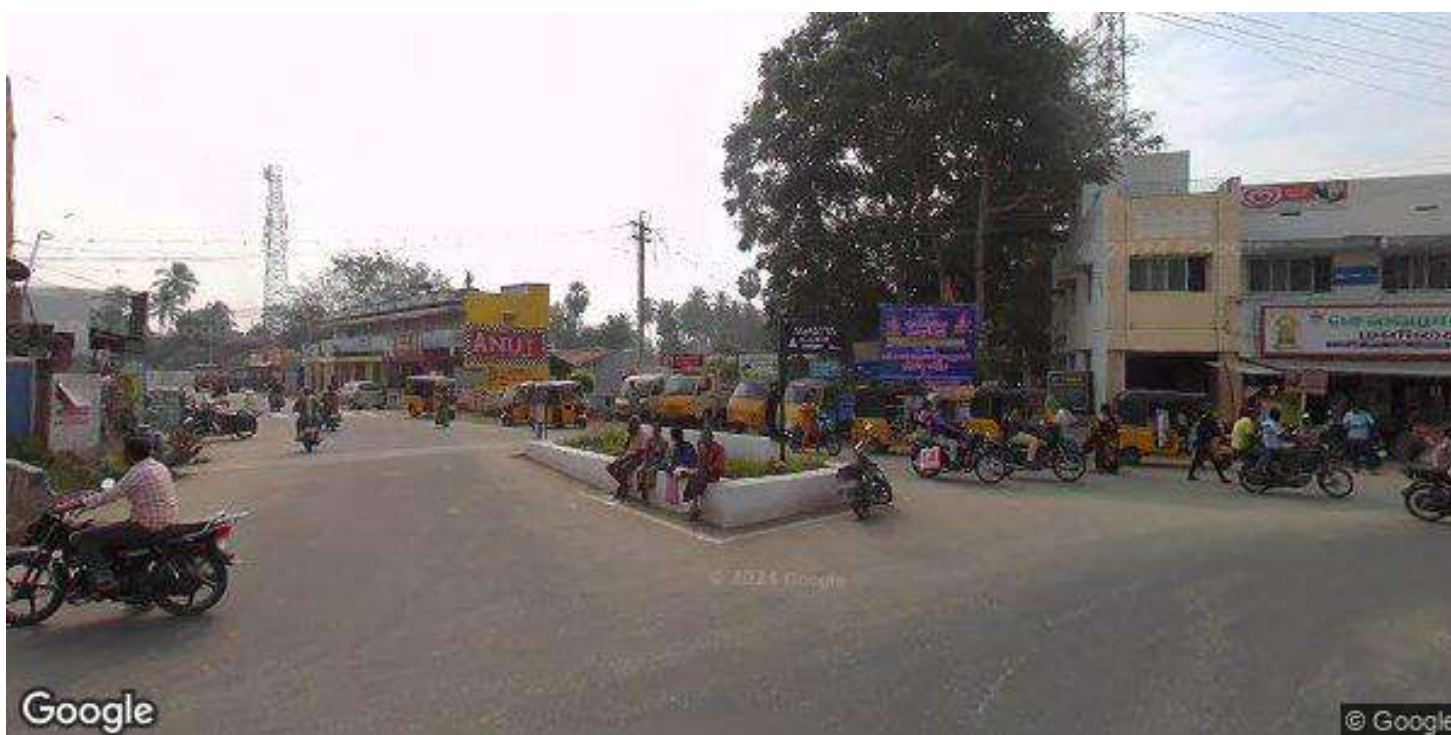
**Risk Type:** Turn  
**Risk Level:** Medium  
**Speed Limit:** 30 KM/Hr  
**Coordinates:** 11.15952, 77.70067

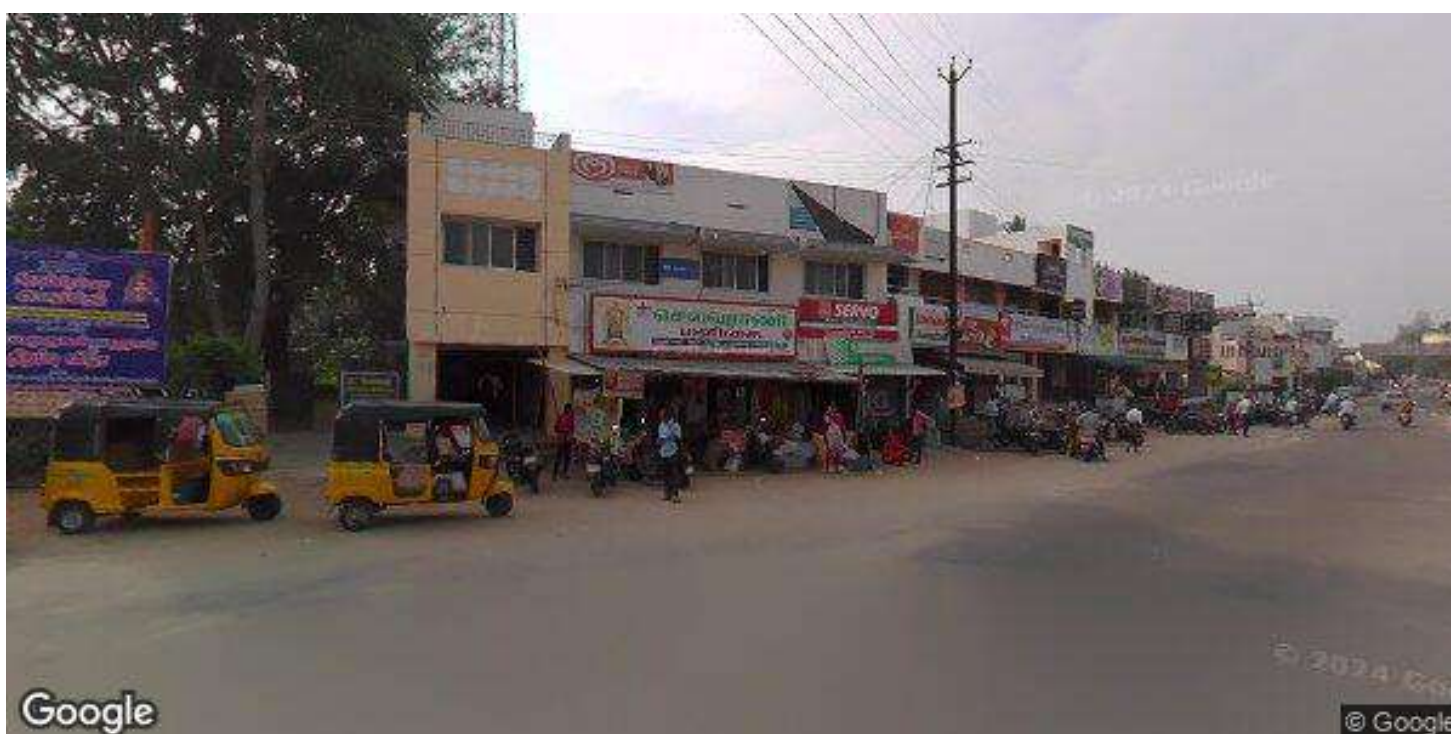
**Coordinates: 11.15943, 77.70068**

**Risk Type:** Turn  
**Risk Level:** High

**Speed Limit: 15 KM/Hr**

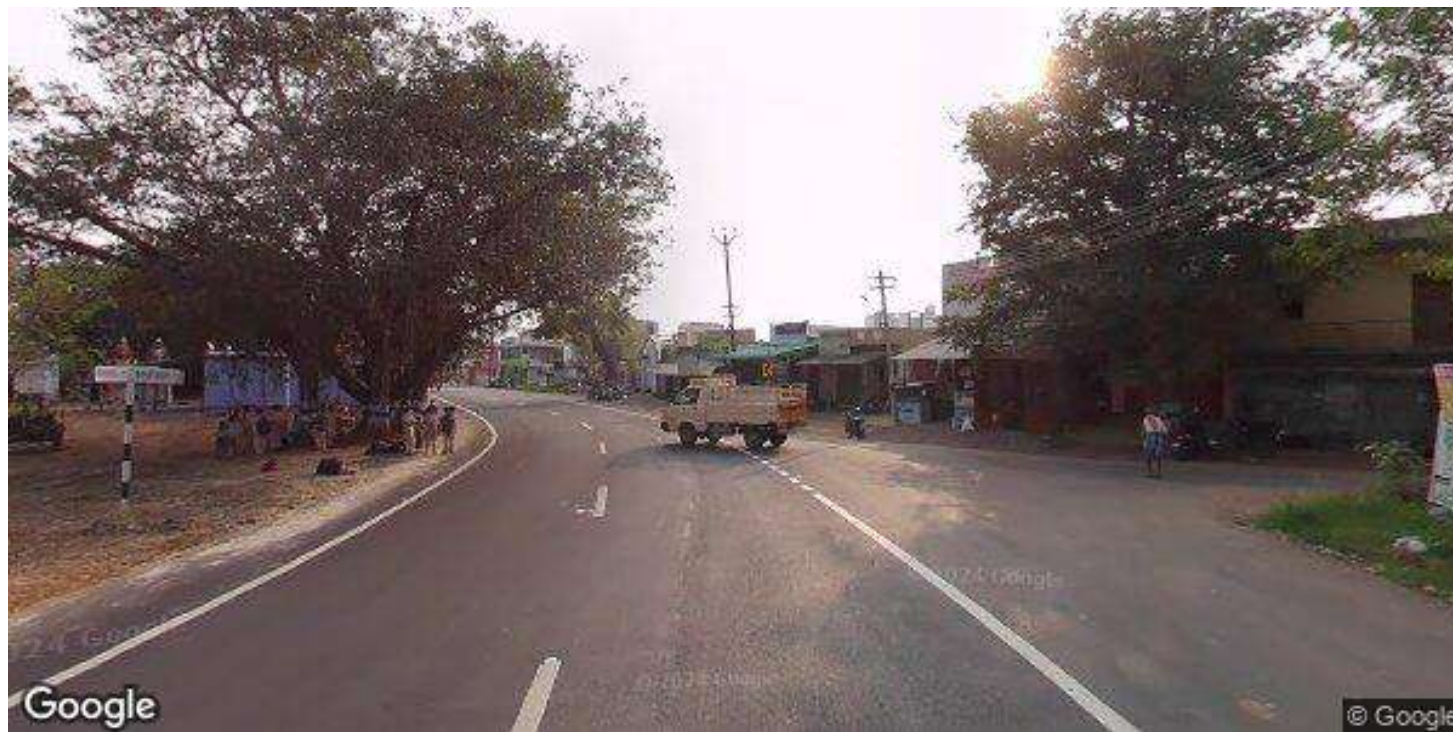
**Coordinates: 11.11730, 77.67189**

**Risk Type: Turn**

**Risk Level: Medium**

**Speed Limit: 30 KM/Hr**

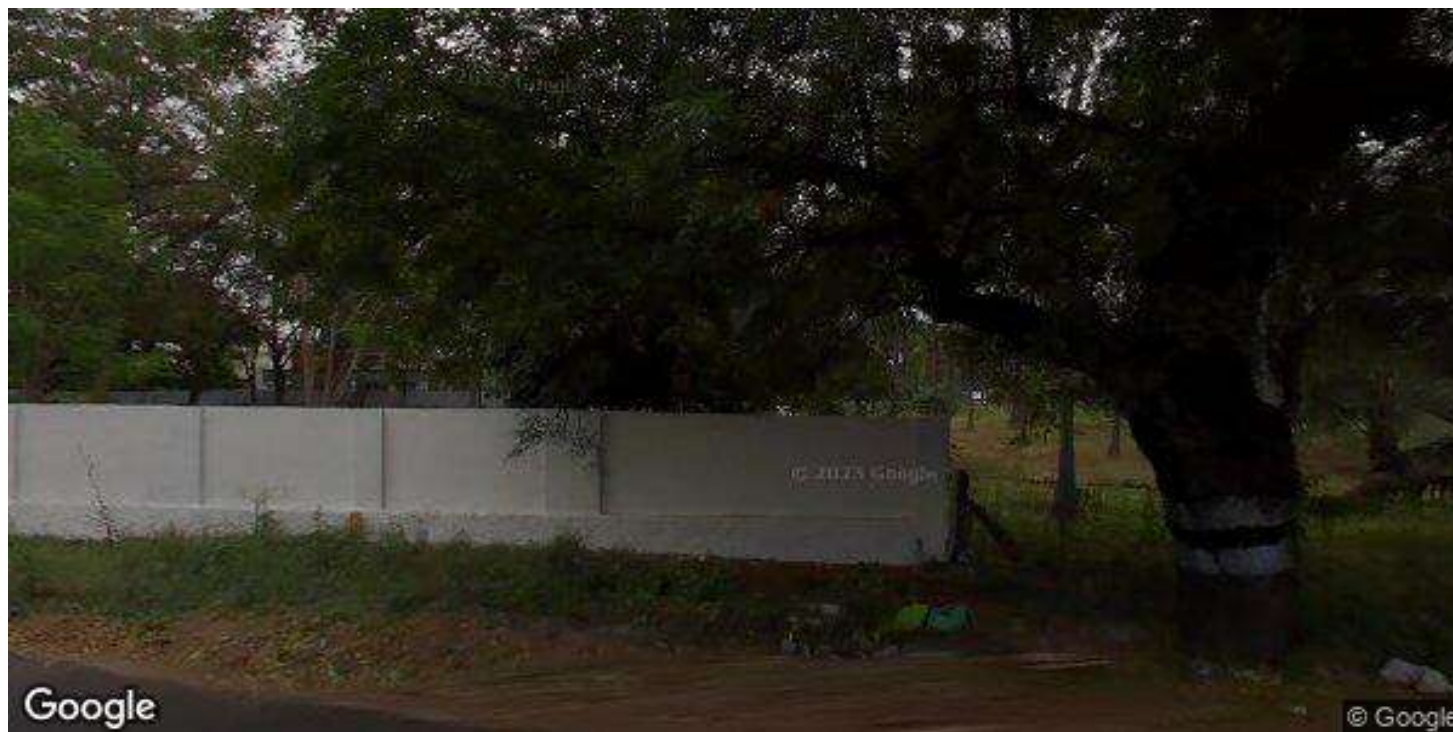
**Coordinates: 11.10466, 77.67057**

**Risk Type: Turn**

**Risk Level: Medium**

**Speed Limit: 30 KM/Hr**

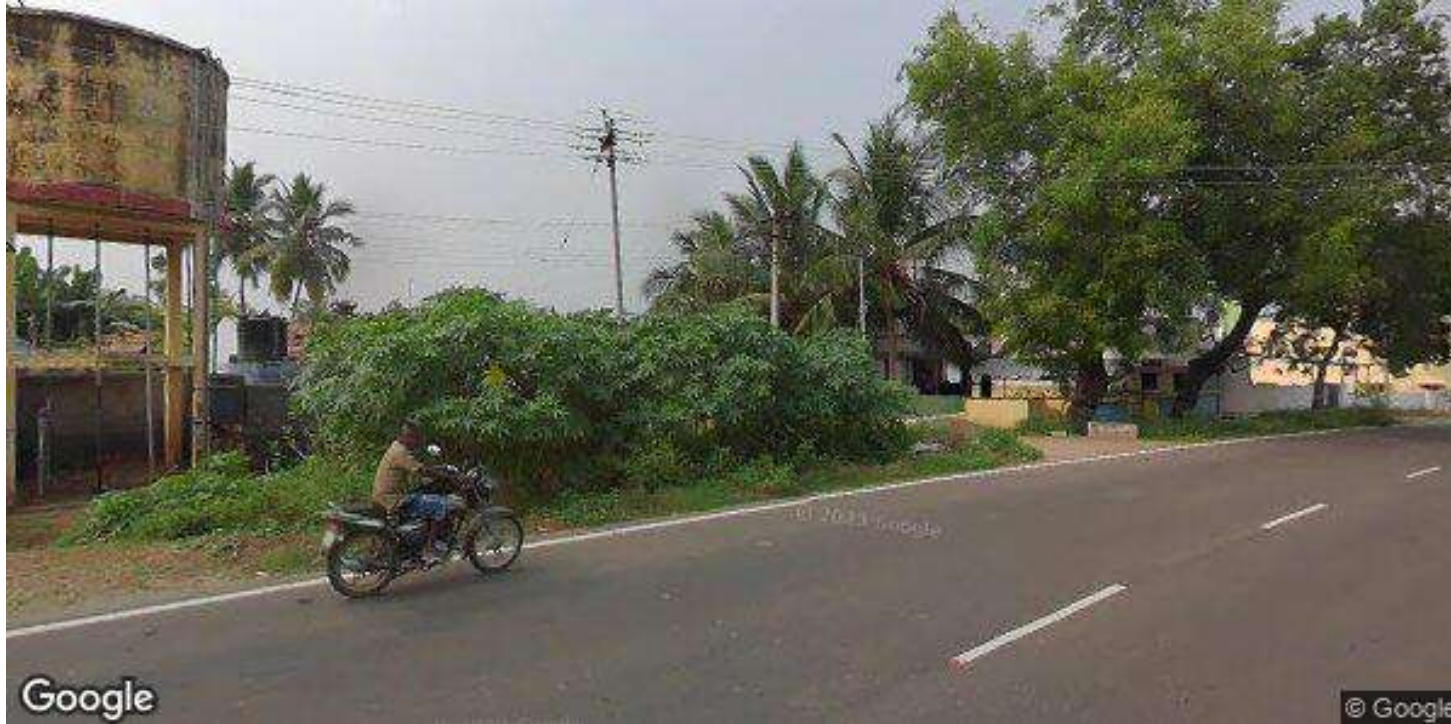
**Coordinates:** 11.09500, 77.66607

**Risk Type:** Turn

**Risk Level:** Medium

**Speed Limit:** 30 KM/Hr

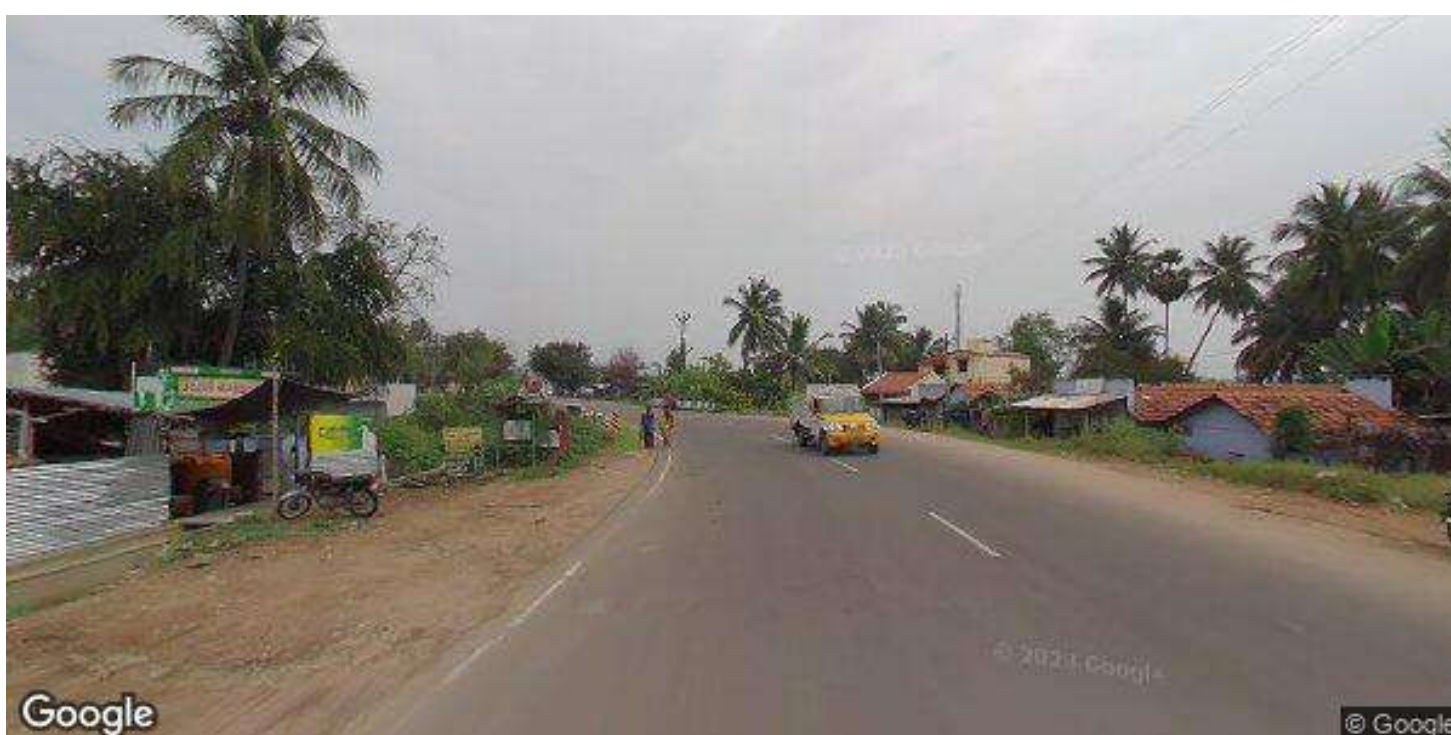
**Coordinates:** 11.08712, 77.66422

**Risk Type:** Turn

**Risk Level:** Medium

**Speed Limit:** 30 KM/Hr

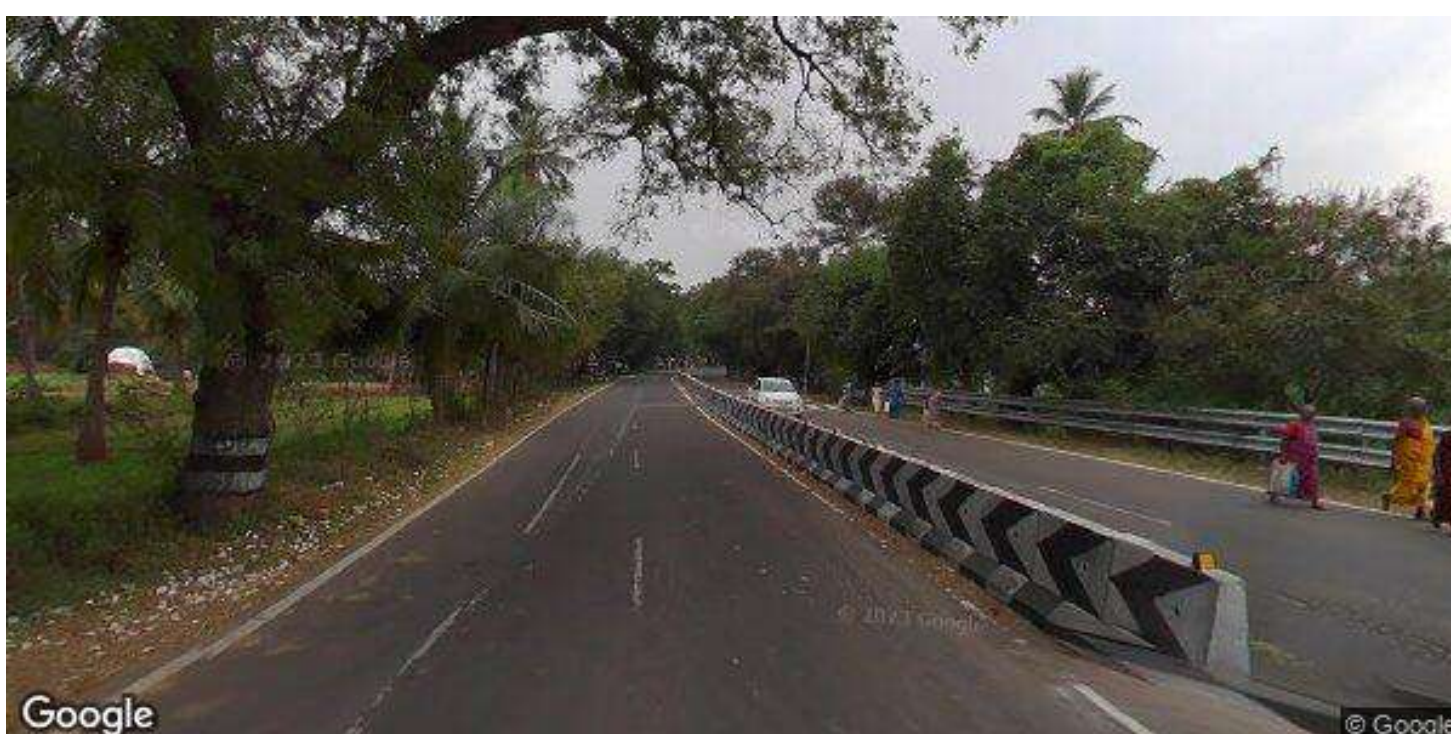
**Coordinates: 11.08264, 77.65828**

**Risk Type:** Turn

**Risk Level:** Medium

**Speed Limit: 30 KM/Hr**

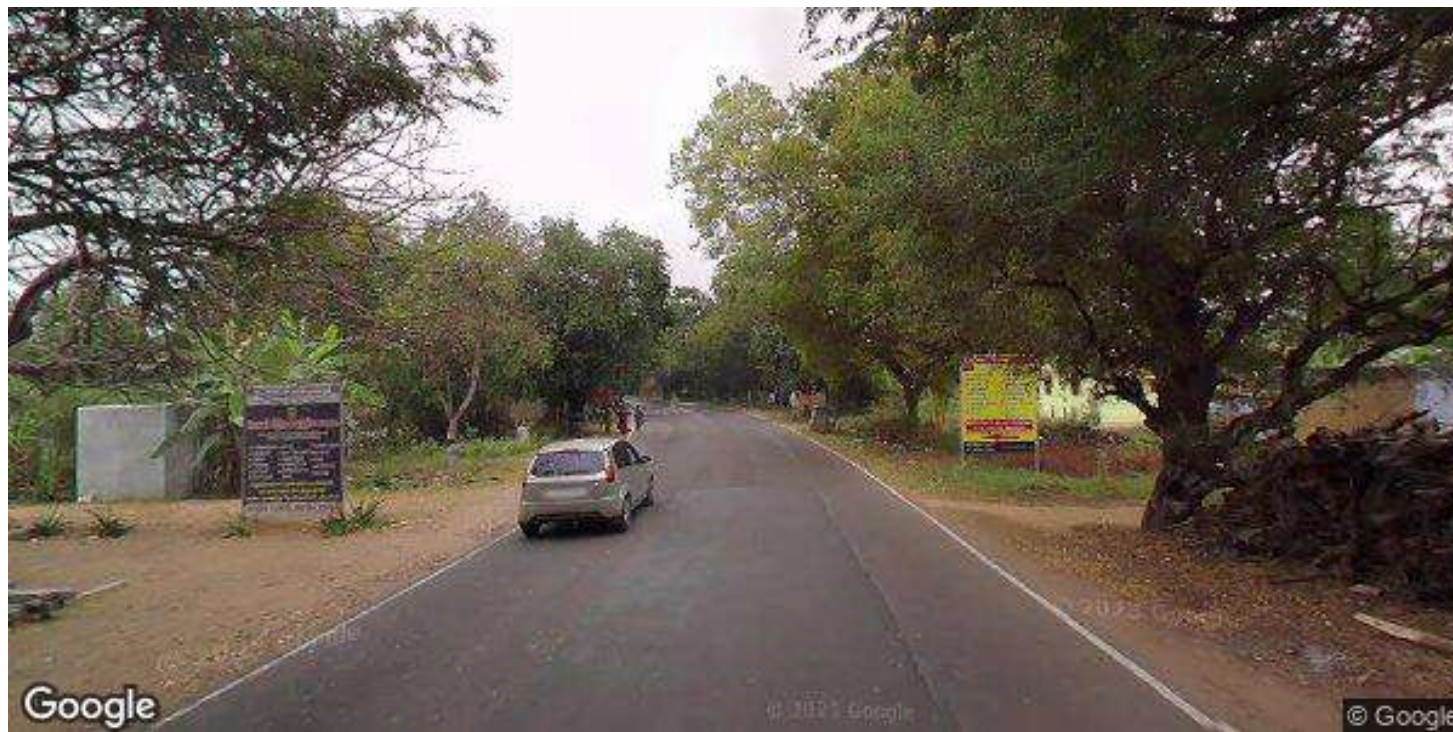
**Coordinates: 11.08104, 77.65762**

**Risk Type: Turn**

**Risk Level: Medium**

**Speed Limit: 30 KM/Hr**

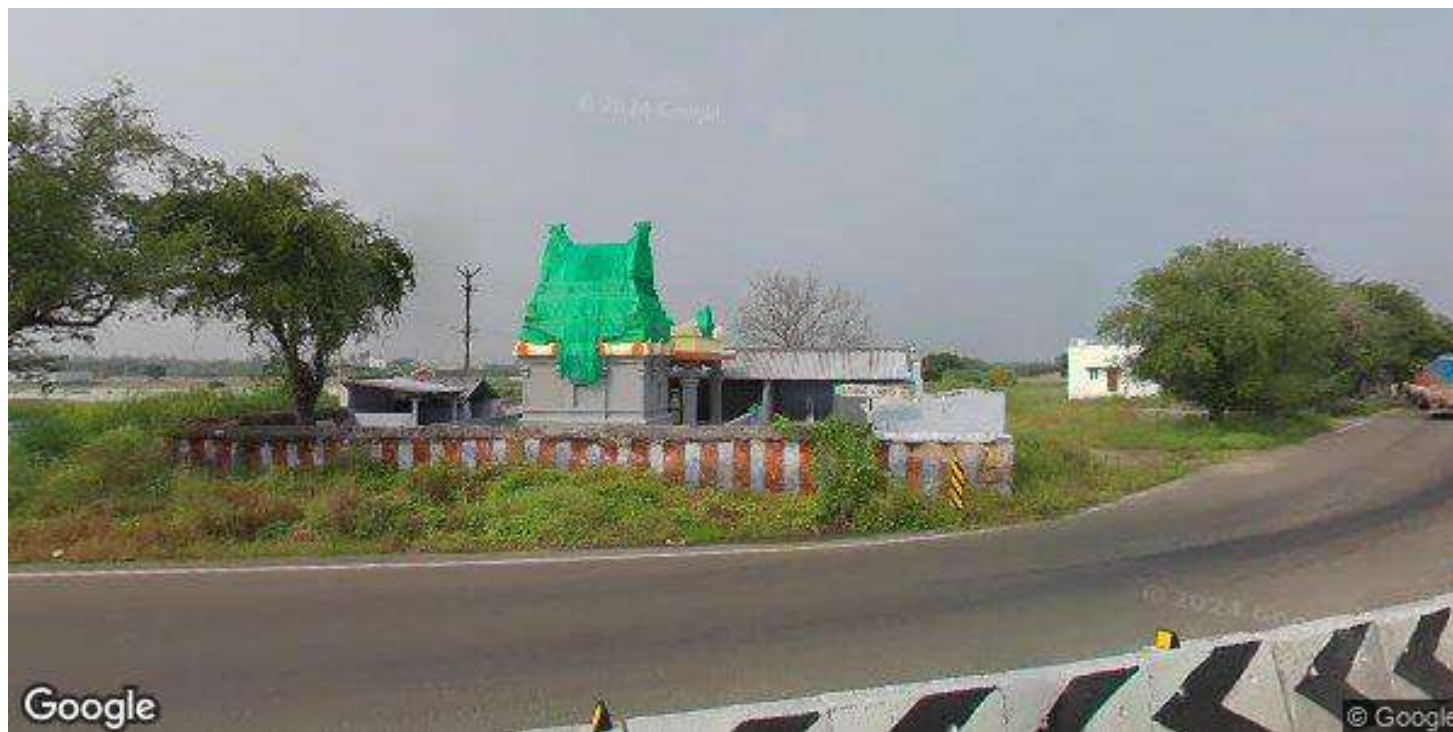
**Coordinates: 11.06185, 77.63934**

**Risk Type: Turn**

**Risk Level: High**

**Speed Limit: 15 KM/Hr**

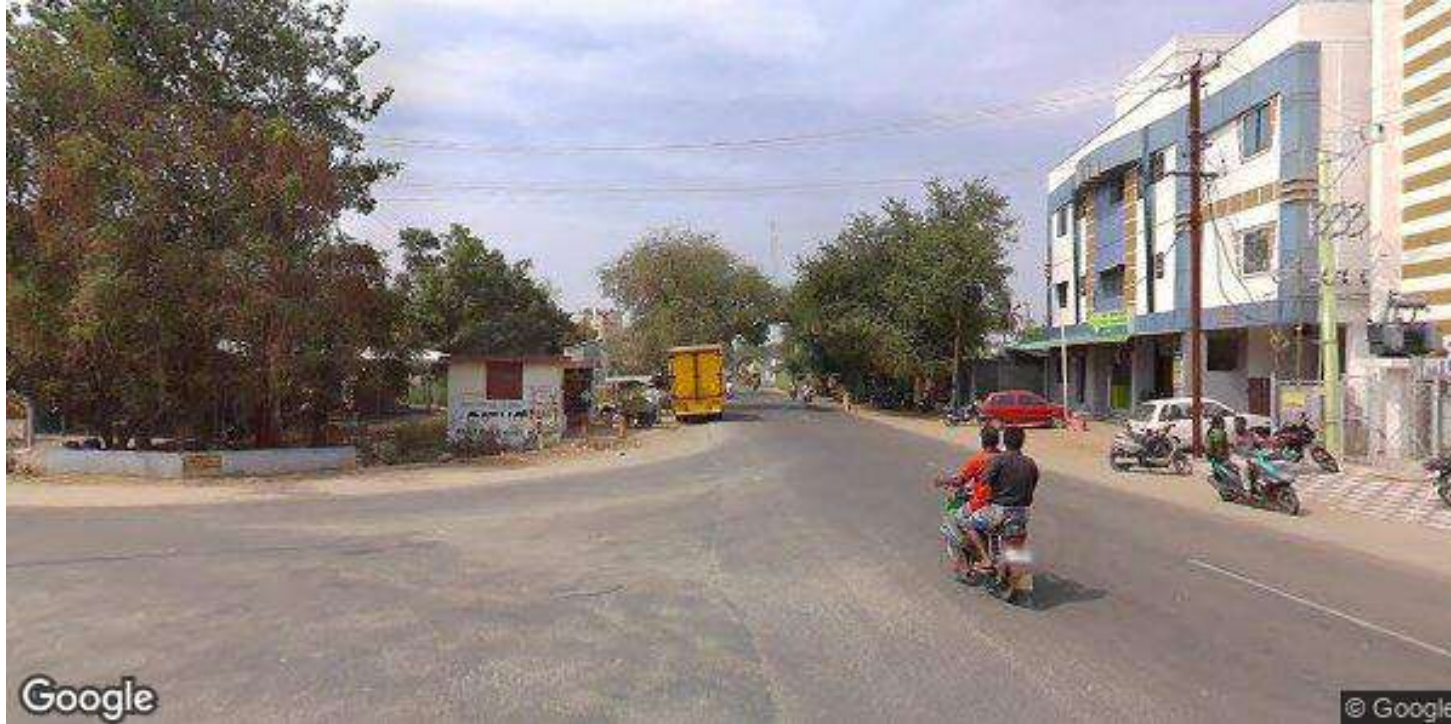
**Coordinates:** 11.00840, 77.56963

**Risk Type:** Turn

**Risk Level:** High

**Speed Limit:** 15 KM/Hr

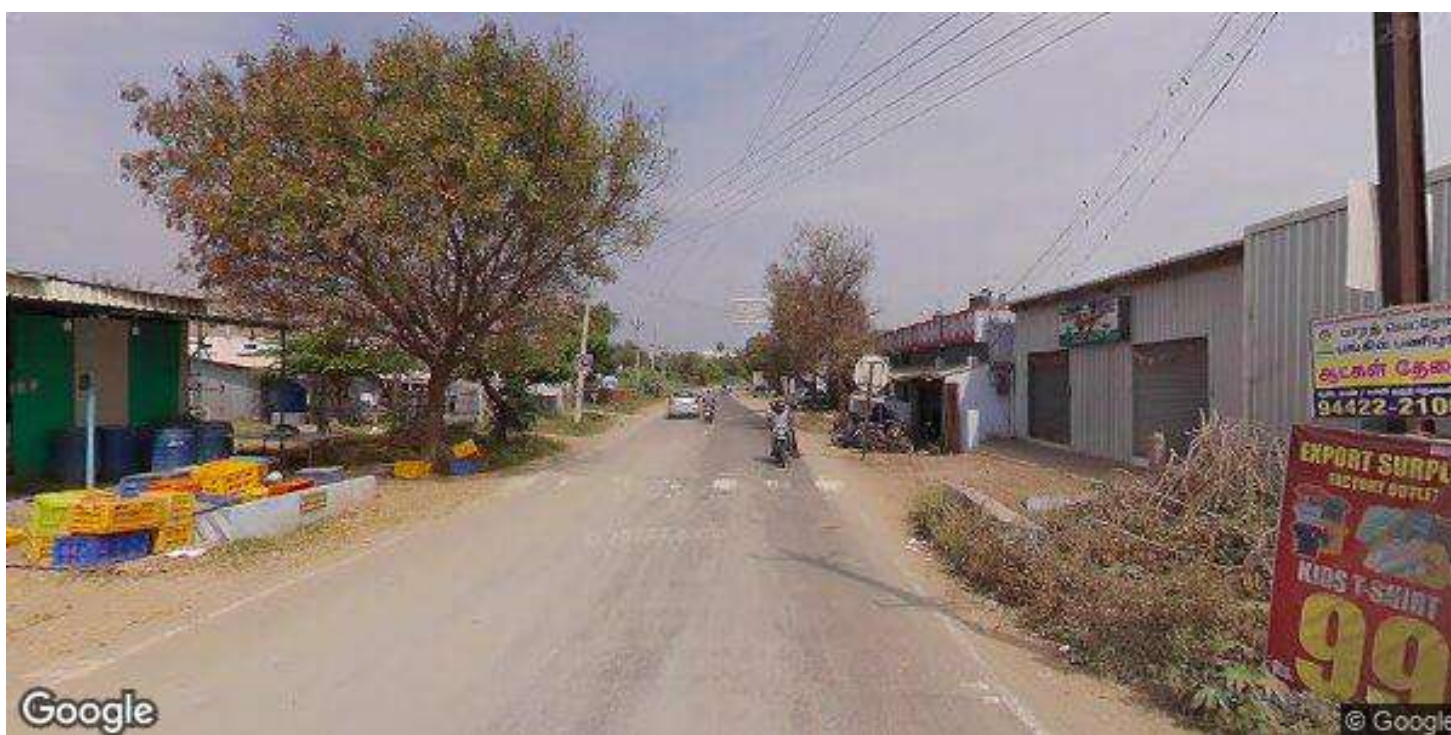
**Coordinates:** 11.00074, 77.56886

**Risk Type:** Blind Spot

**Risk Level:** Blind Spot

**Speed Limit:** 10 KM/Hr

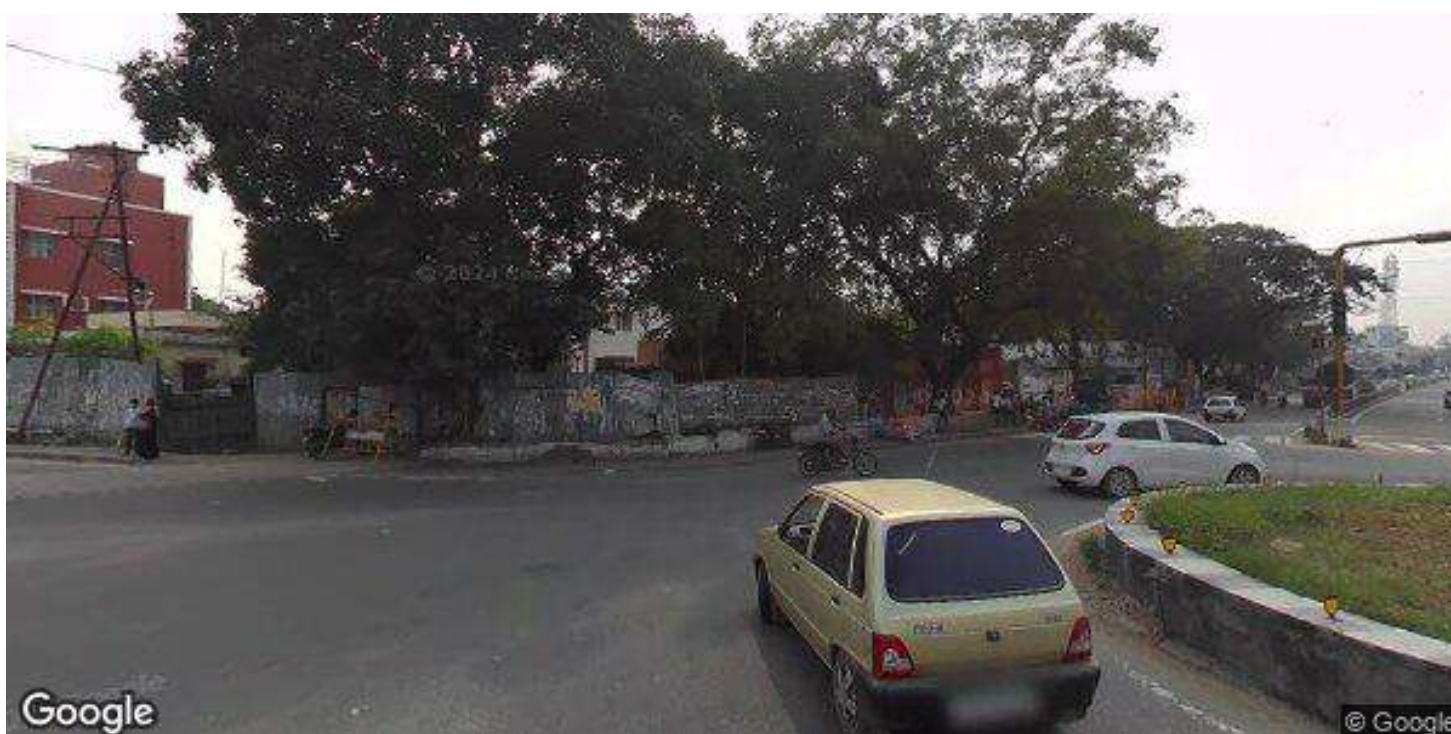
**Coordinates: 11.00171, 77.56267**

**Risk Type:** Turn

**Risk Level:** High

**Speed Limit: 15 KM/Hr**

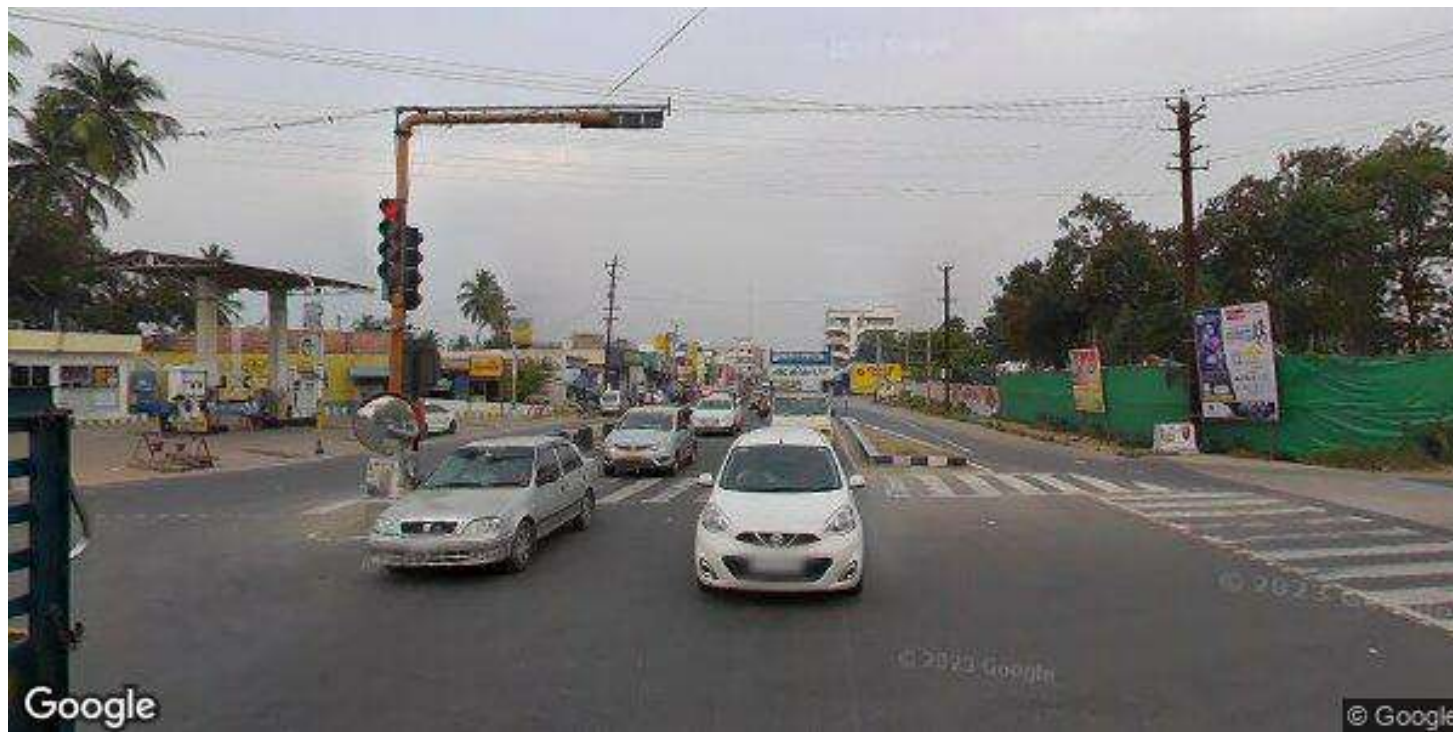
**Coordinates: 11.00168, 77.56265**

**Risk Type: Turn**

**Risk Level: Medium**

**Speed Limit: 30 KM/Hr**

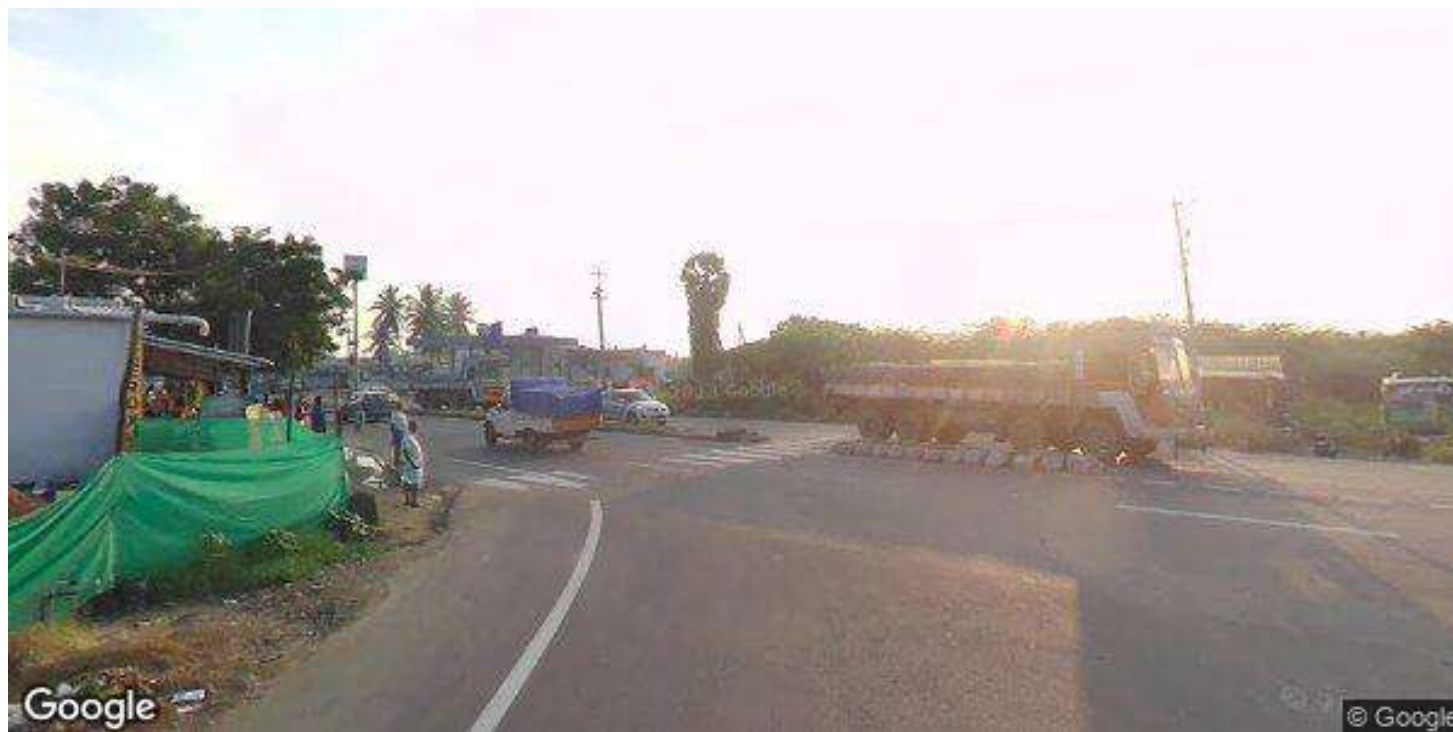
**Coordinates: 10.97027, 77.42726**

**Risk Type: Turn**

**Risk Level: High**

**Speed Limit: 15 KM/Hr**

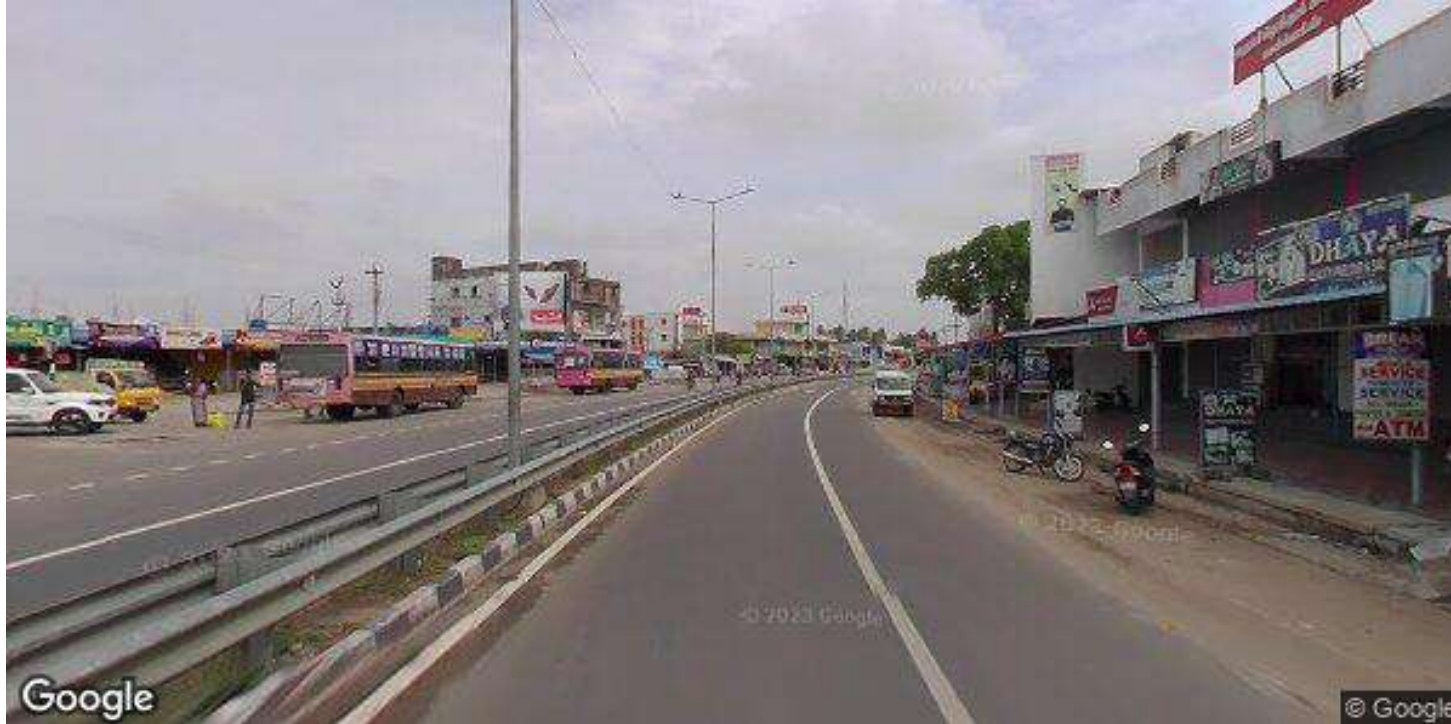
**Coordinates:** 10.94381, 77.43639

**Risk Type:** Turn

**Risk Level:** Medium

**Speed Limit:** 30 KM/Hr

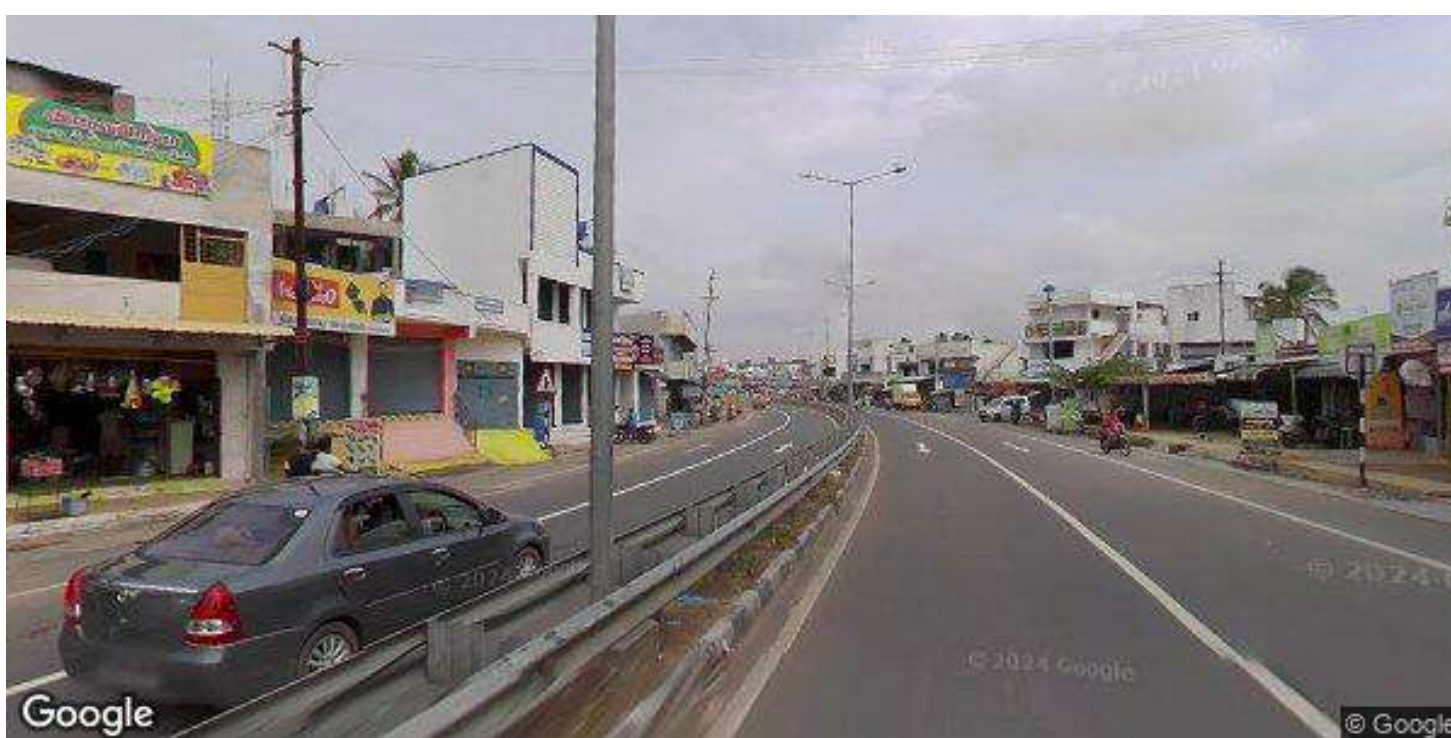
**Coordinates:** 10.94243, 77.43815

**Risk Type:** Turn

**Risk Level:** Medium

**Speed Limit:** 30 KM/Hr
