## JOURNEY RISK MANAGEMENT (JRM) STUDY

### Salem Terminal to SREE VENKATESHWARA FUEL STATION

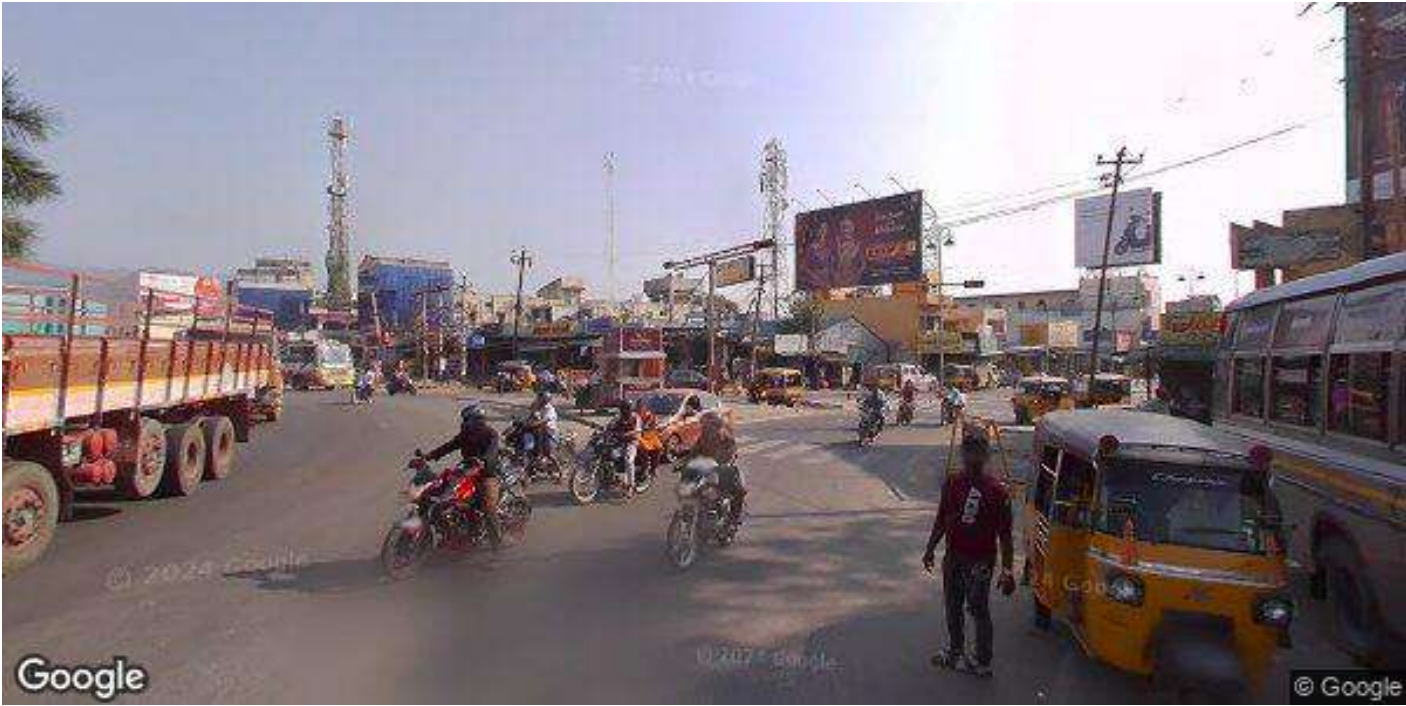
Risk Type: Roundabout  
Risk Level: High  
Speed Limit: 15 KM/Hr  
Coordinates: 11.63266, 78.12699

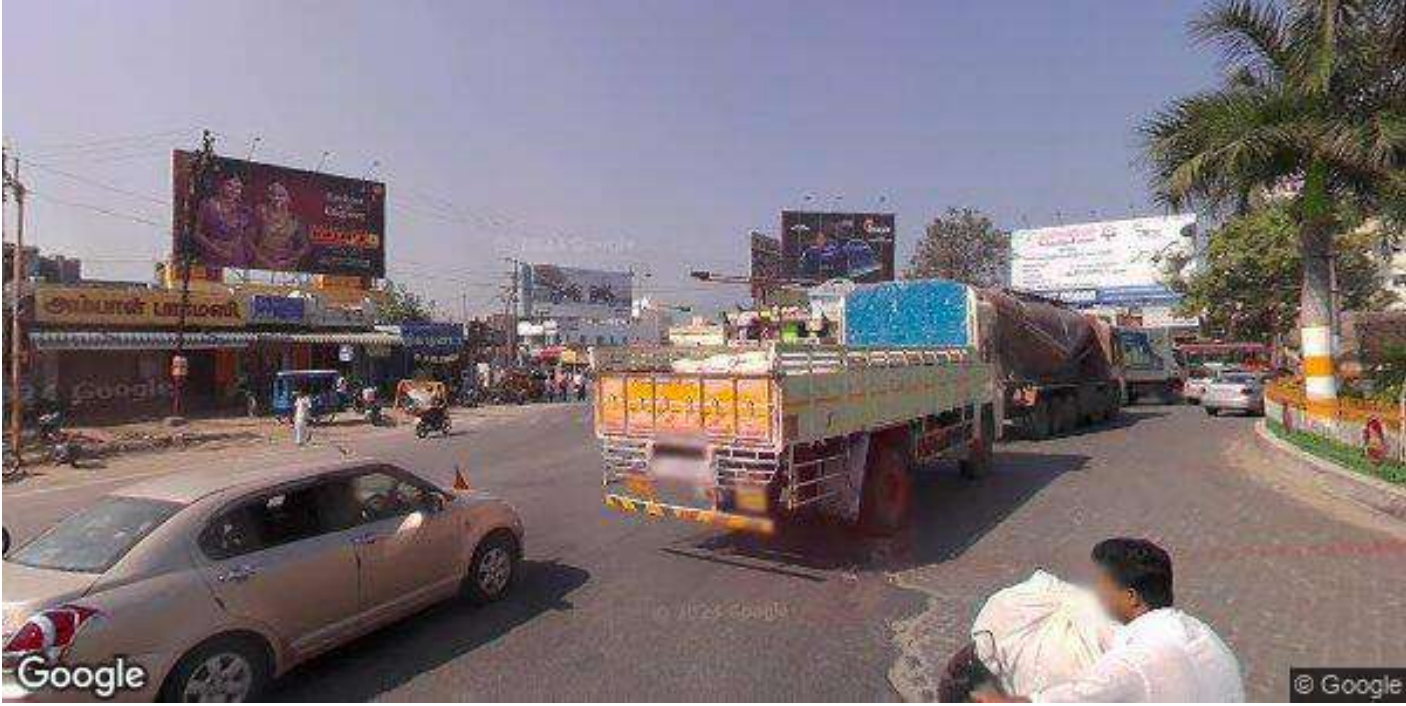
Risk Type: Roundabout  
Risk Level: High

**Speed Limit: 15 KM/Hr**  
**Coordinates: 11.63247, 78.12734**

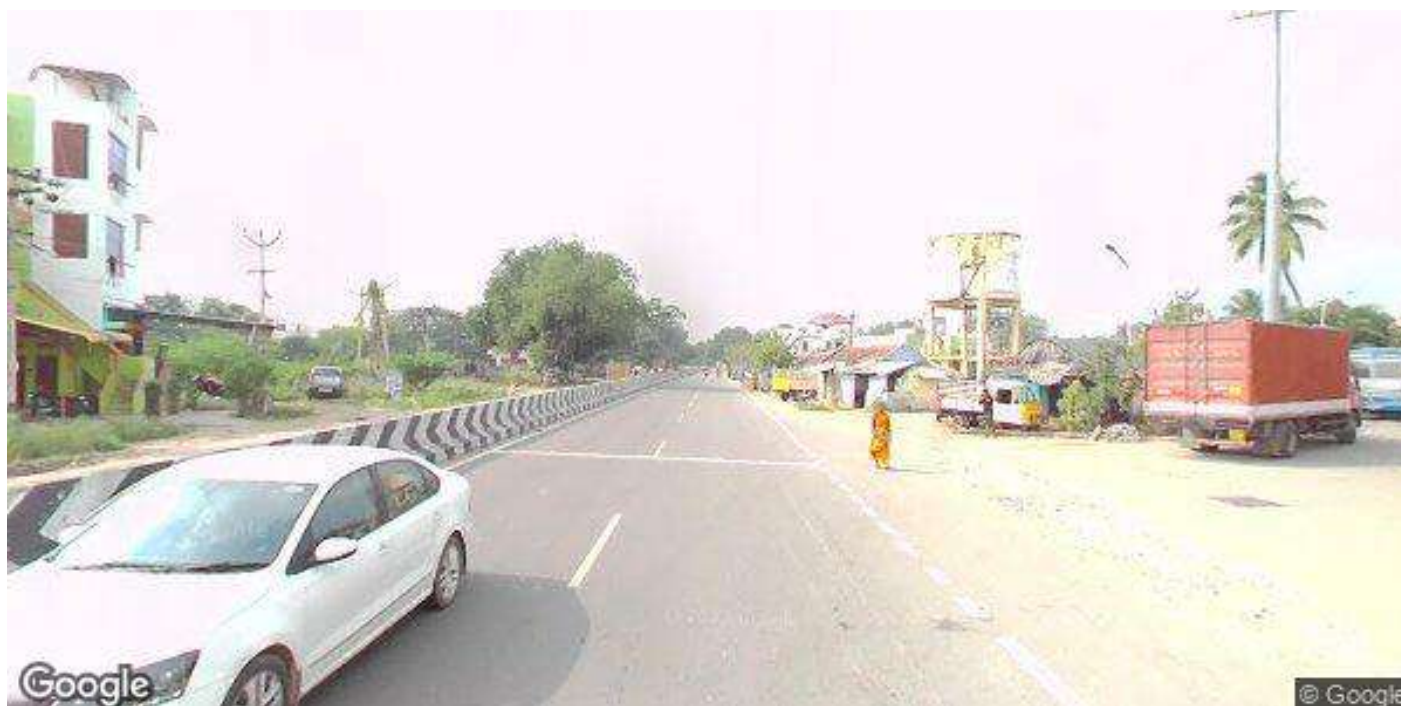
**Risk Type: U-Turn**  
**Risk Level: High**  
**Speed Limit: 10 KM/Hr**  
**Coordinates: 11.6193714, 78.1124012**

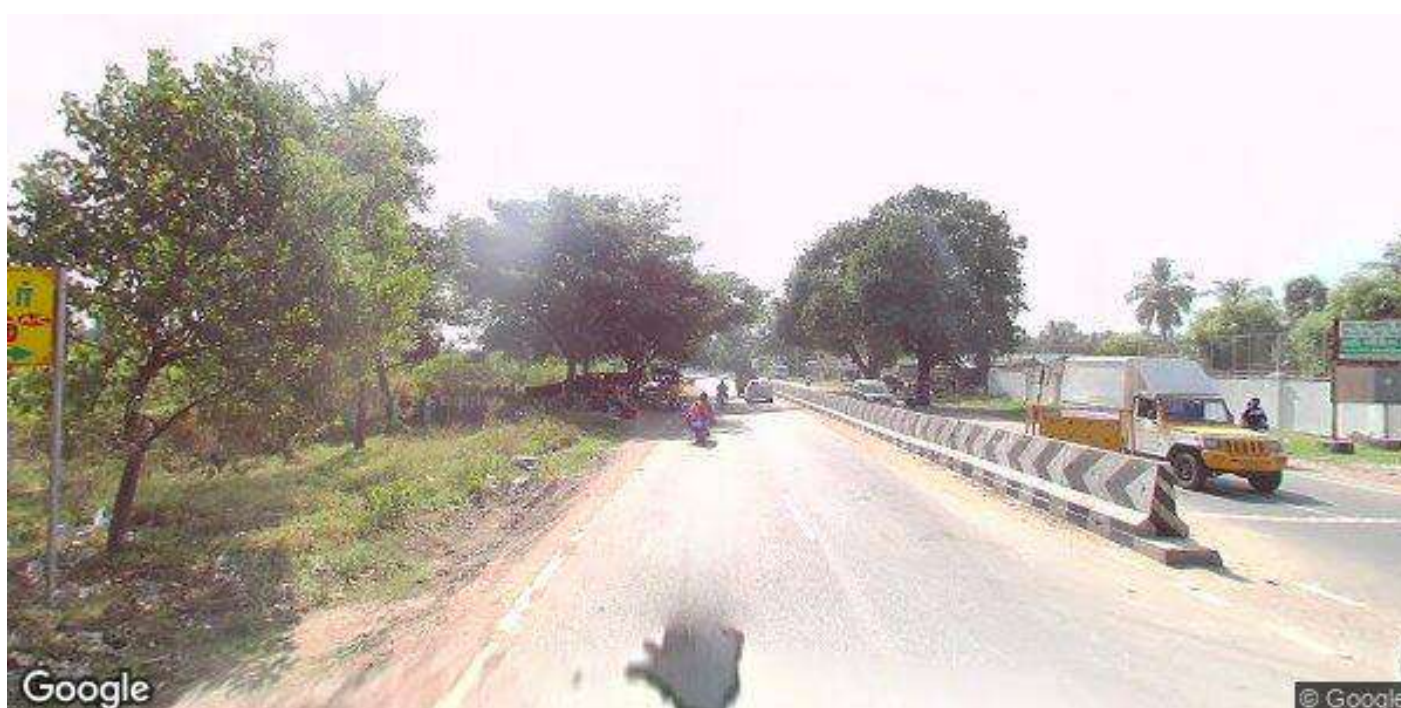
**Risk Type: U-Turn**  
**Risk Level: High**  
**Speed Limit: 10 KM/Hr**  
**Coordinates: 11.618013, 78.1109532**

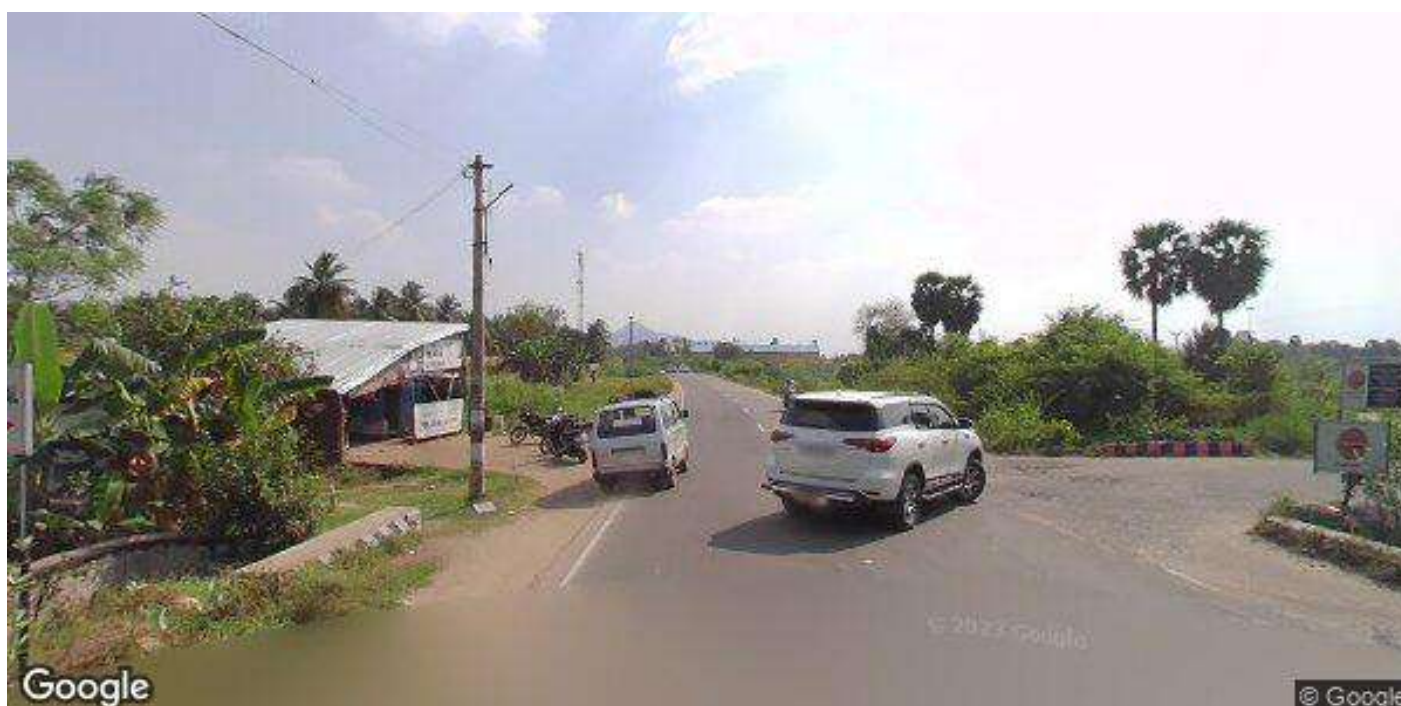
**Risk Type:** Turn  
**Risk Level:** High  
**Speed Limit:** 15 KM/Hr  
**Coordinates:** 11.44029, 77.87544

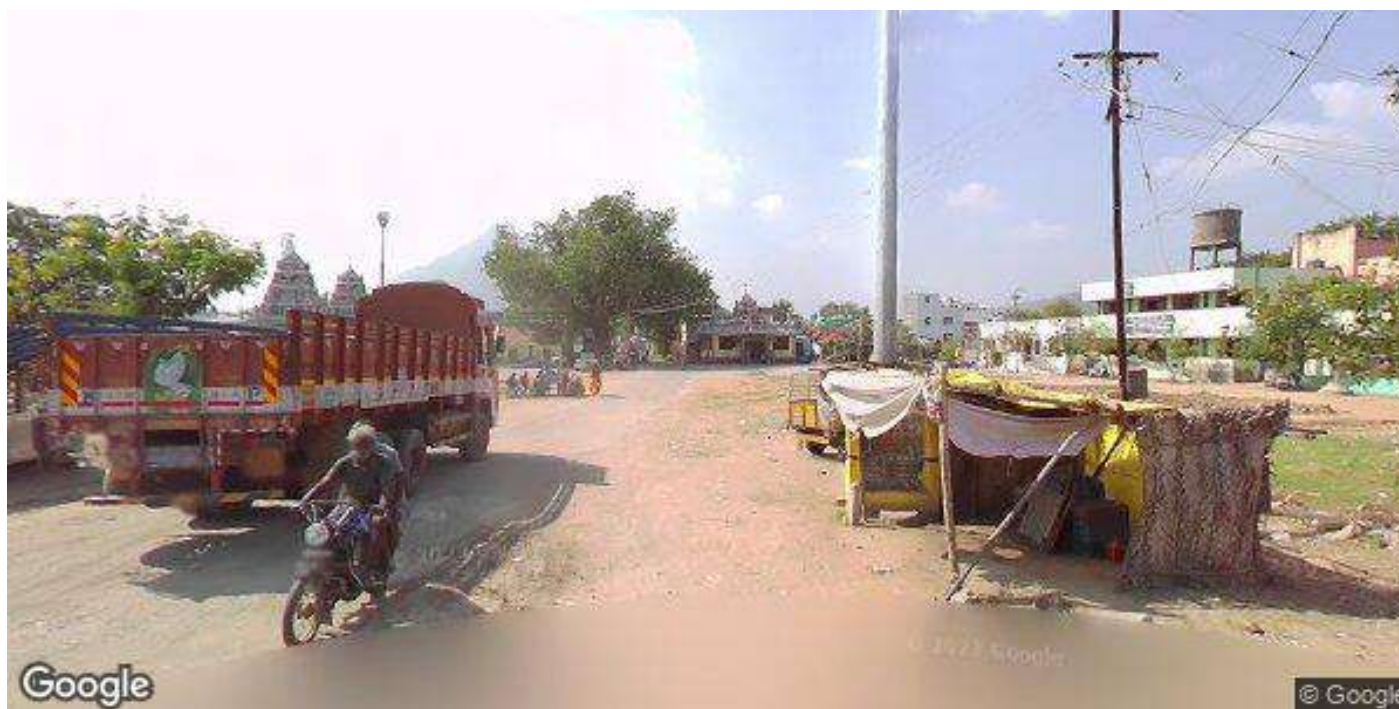
**Risk Type:** Blind Spot  
**Risk Level:** Blind Spot  
**Speed Limit:** 10 KM/Hr  
**Coordinates:** 11.62145, 78.10740

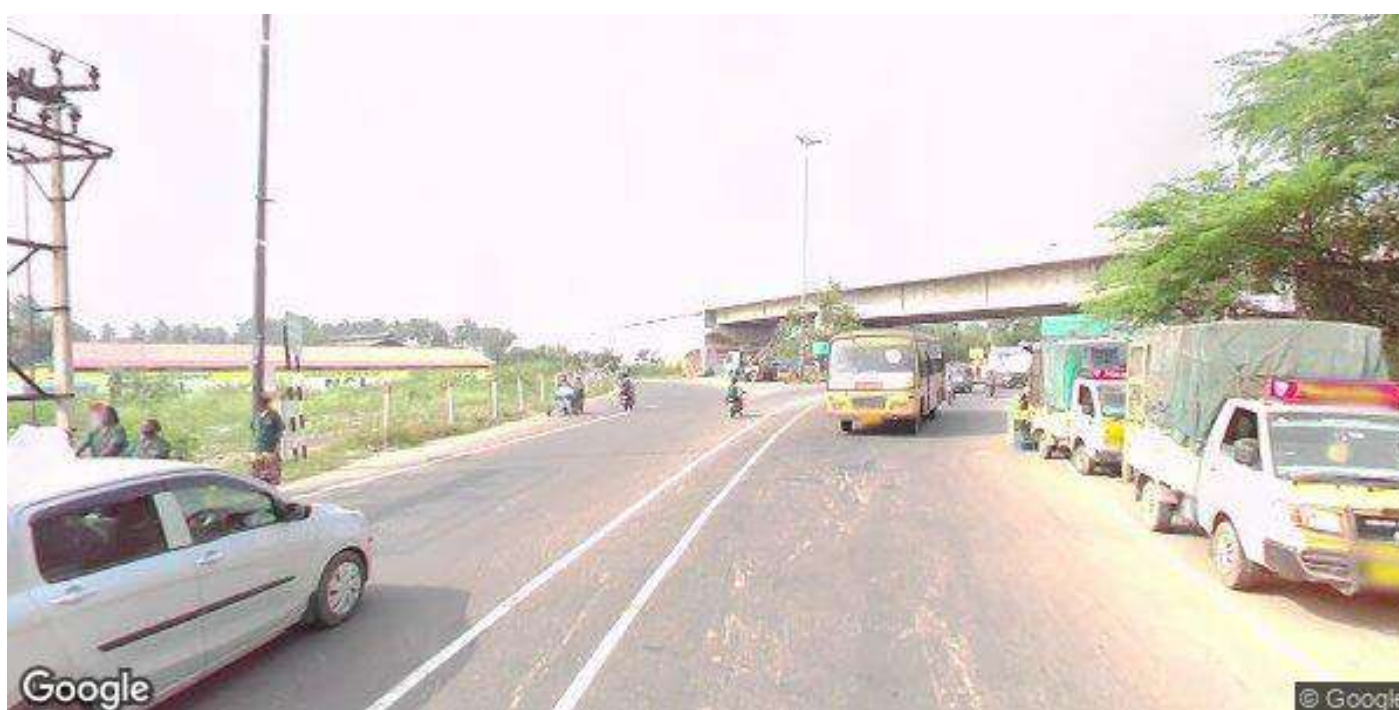
**Risk Type:** Turn  
**Risk Level:** Medium  
**Speed Limit:** 30 KM/Hr  
**Coordinates:** 11.61224, 78.10469

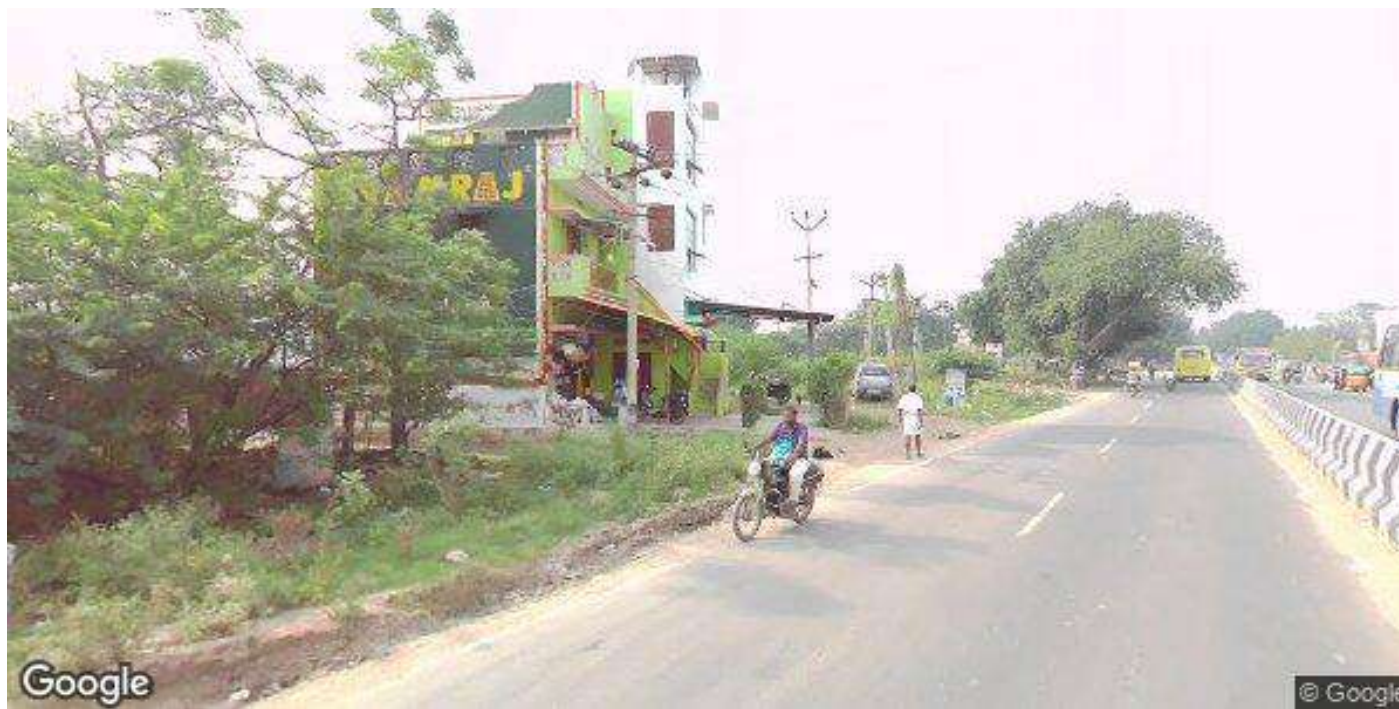
**Risk Type:** Blind Spot  
**Risk Level:** Blind Spot  
**Speed Limit:** 10 KM/Hr  
**Coordinates:** 11.61928, 78.11242

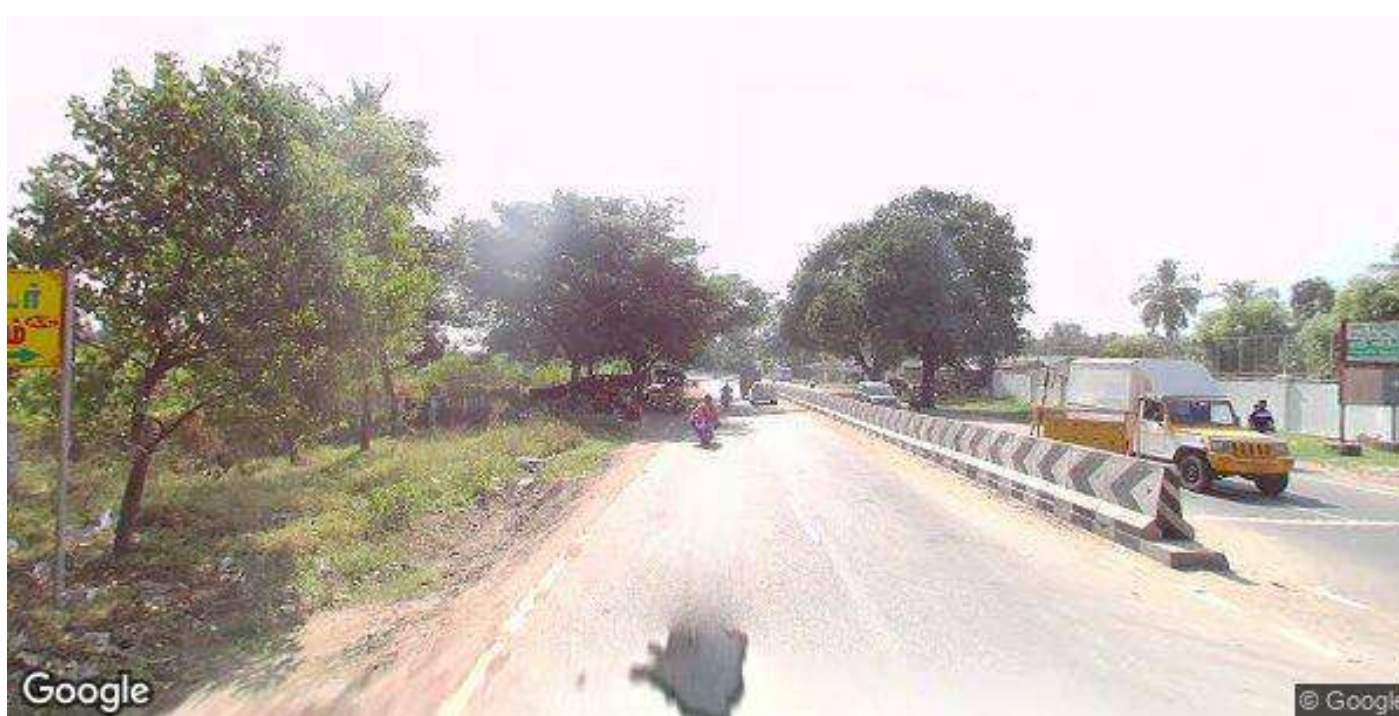
**Risk Type:** Blind Spot  
**Risk Level:** Blind Spot  
**Speed Limit:** 10 KM/Hr  
**Coordinates:** 11.61801, 78.11095

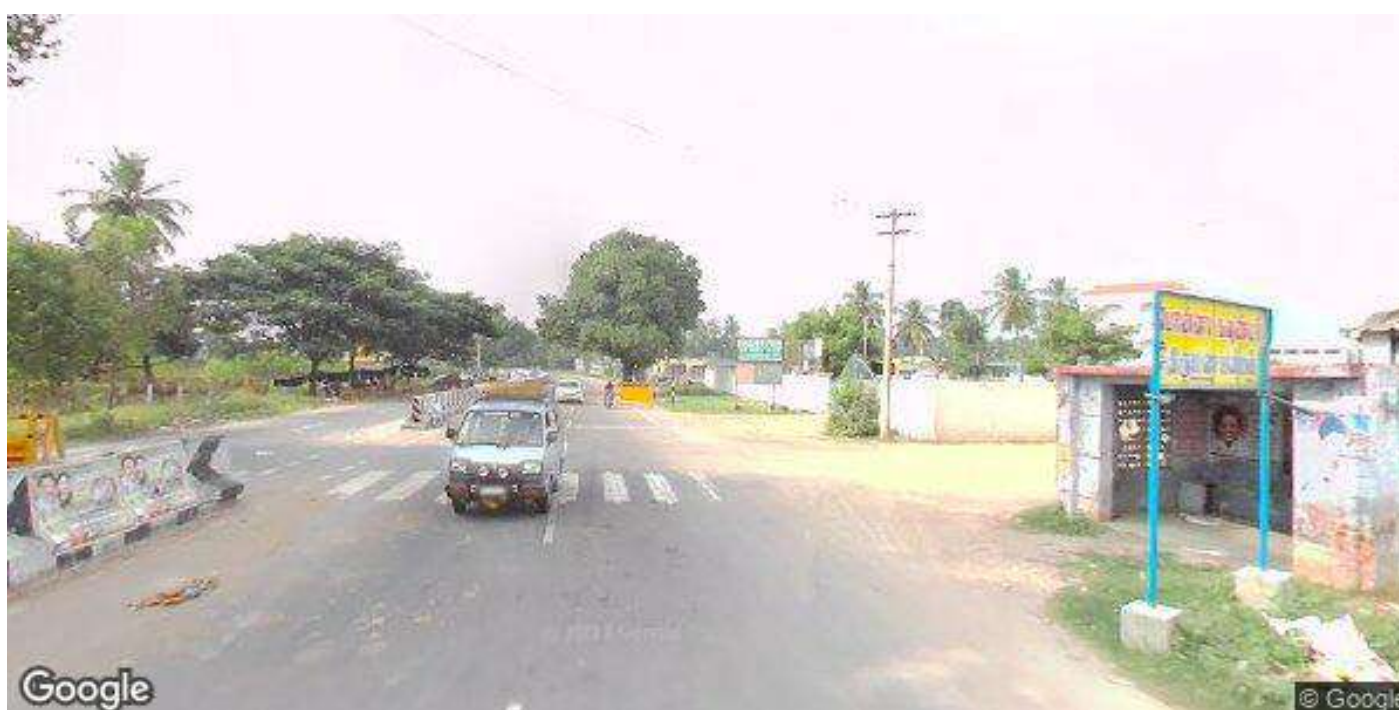
**Risk Type:** Turn  
**Risk Level:** Medium  
**Speed Limit:** 30 KM/Hr  
**Coordinates:** 11.61817, 78.11102

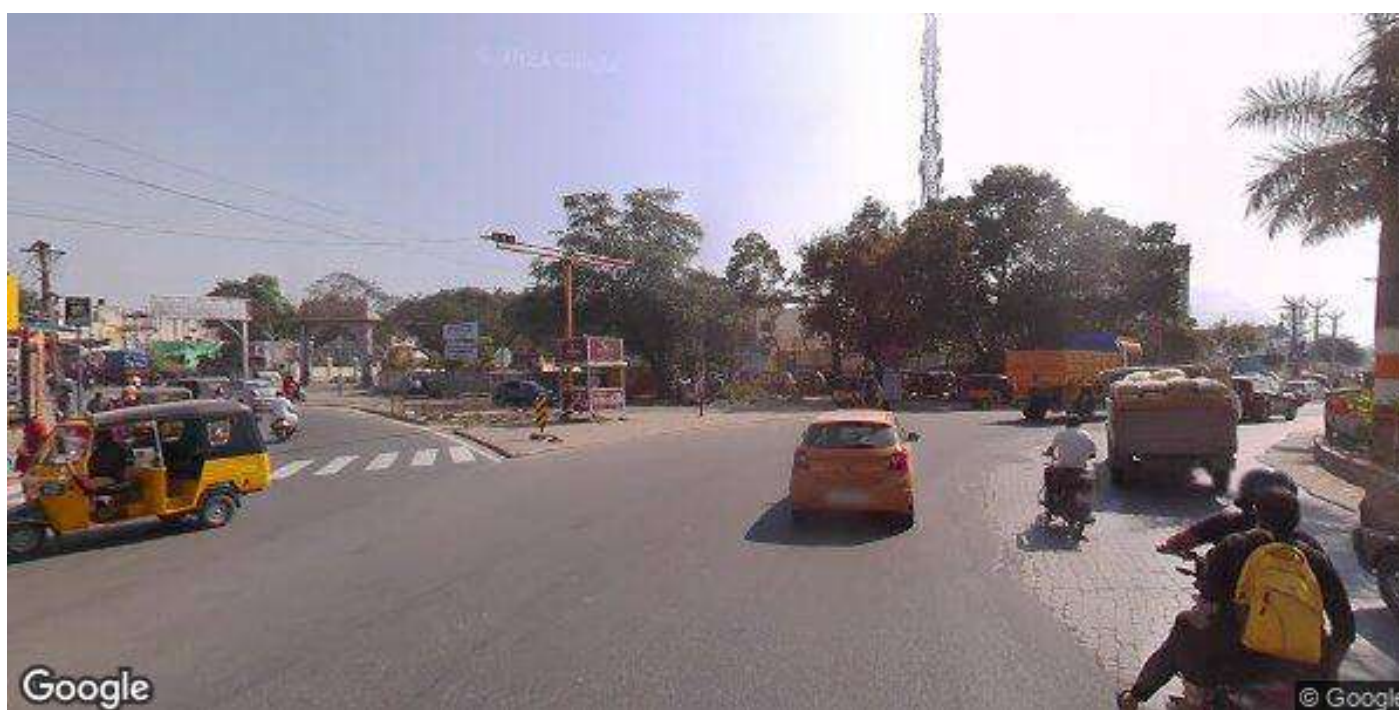
**Risk Type:** Turn  
**Risk Level:** High  
**Speed Limit:** 15 KM/Hr  
**Coordinates:** 11.63306, 78.12731

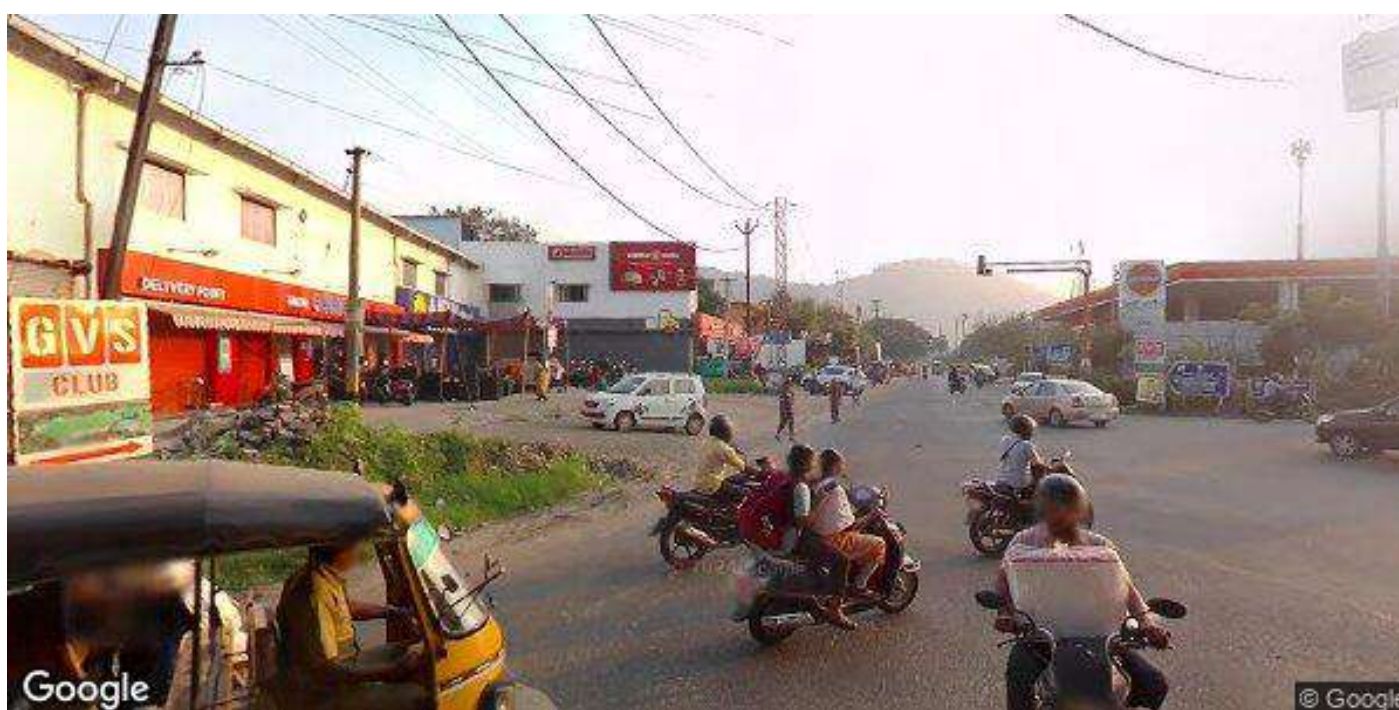
**Risk Type:** Turn  
**Risk Level:** Medium  
**Speed Limit:** 30 KM/Hr  
**Coordinates:** 11.66372, 78.20649

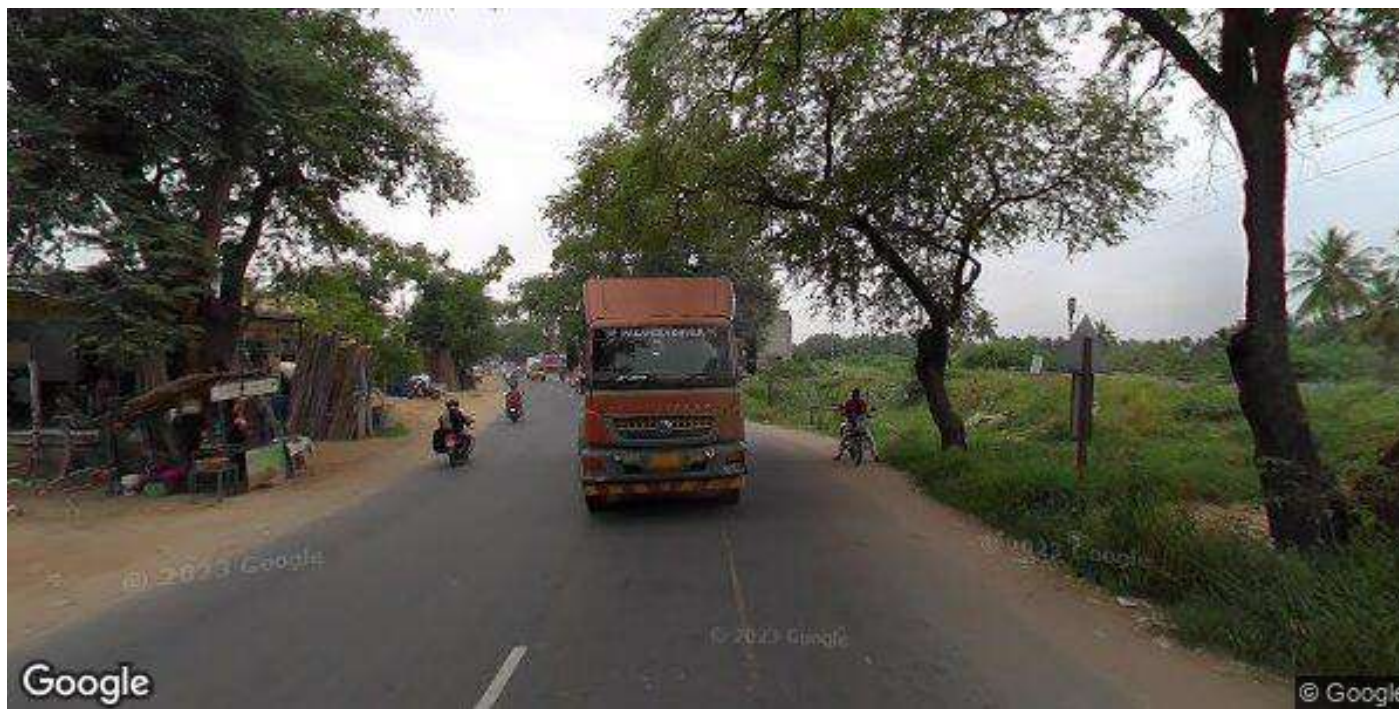
**Risk Type:** Turn  
**Risk Level:** Medium  
**Speed Limit:** 30 KM/Hr  
**Coordinates:** 11.67130, 78.22990

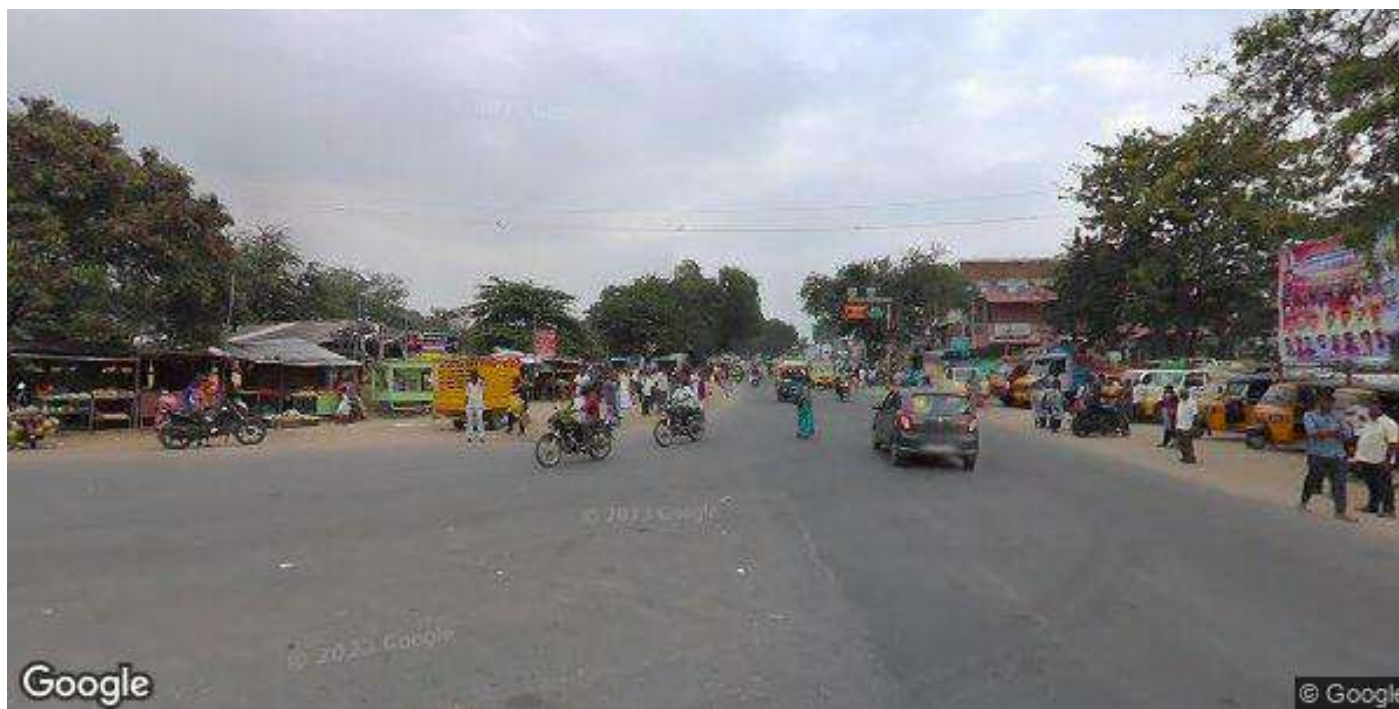
**Risk Type:** Blind Spot  
**Risk Level:** Blind Spot  
**Speed Limit:** 10 KM/Hr  
**Coordinates:** 11.67111, 78.23134

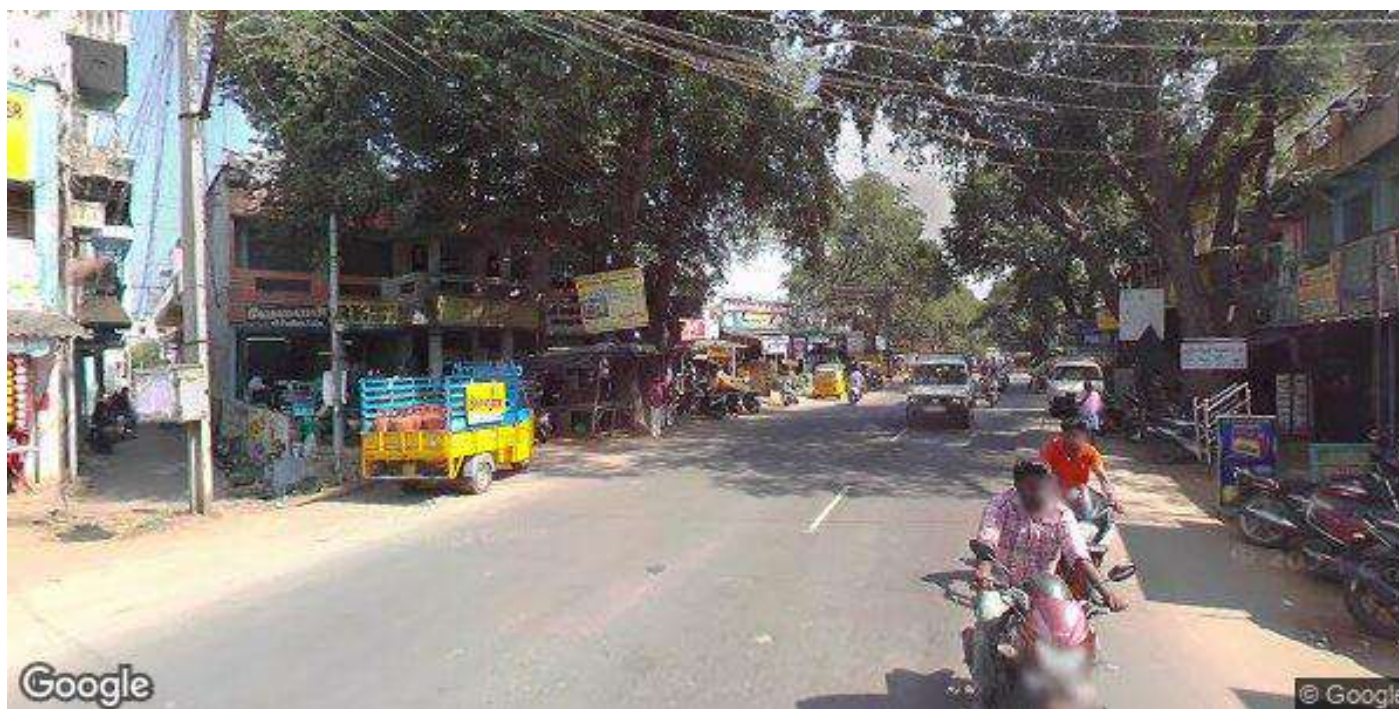
**Risk Type:** Turn  
**Risk Level:** High  
**Speed Limit:** 15 KM/Hr  
**Coordinates:** 11.67203, 78.23152

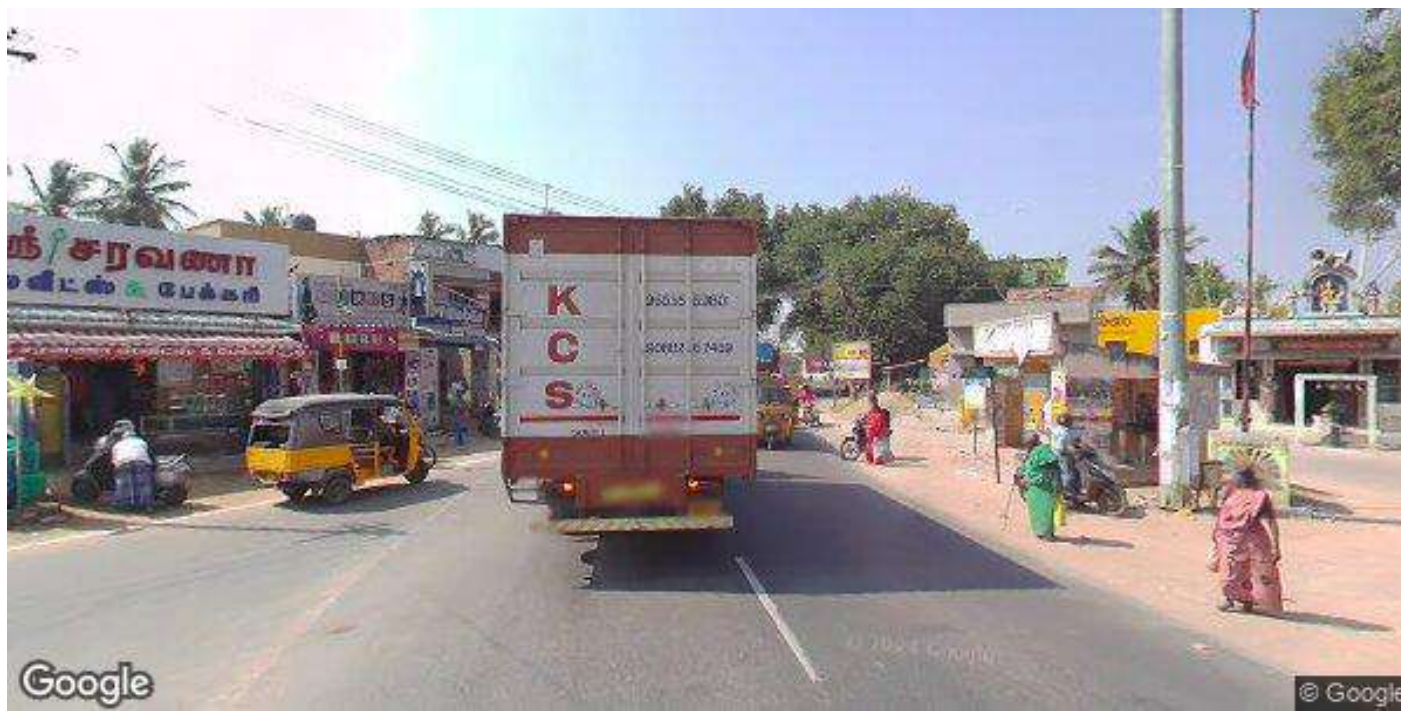
**Risk Type:** Turn  
**Risk Level:** Medium  
**Speed Limit:** 30 KM/Hr  
**Coordinates:** 11.67445, 78.23920

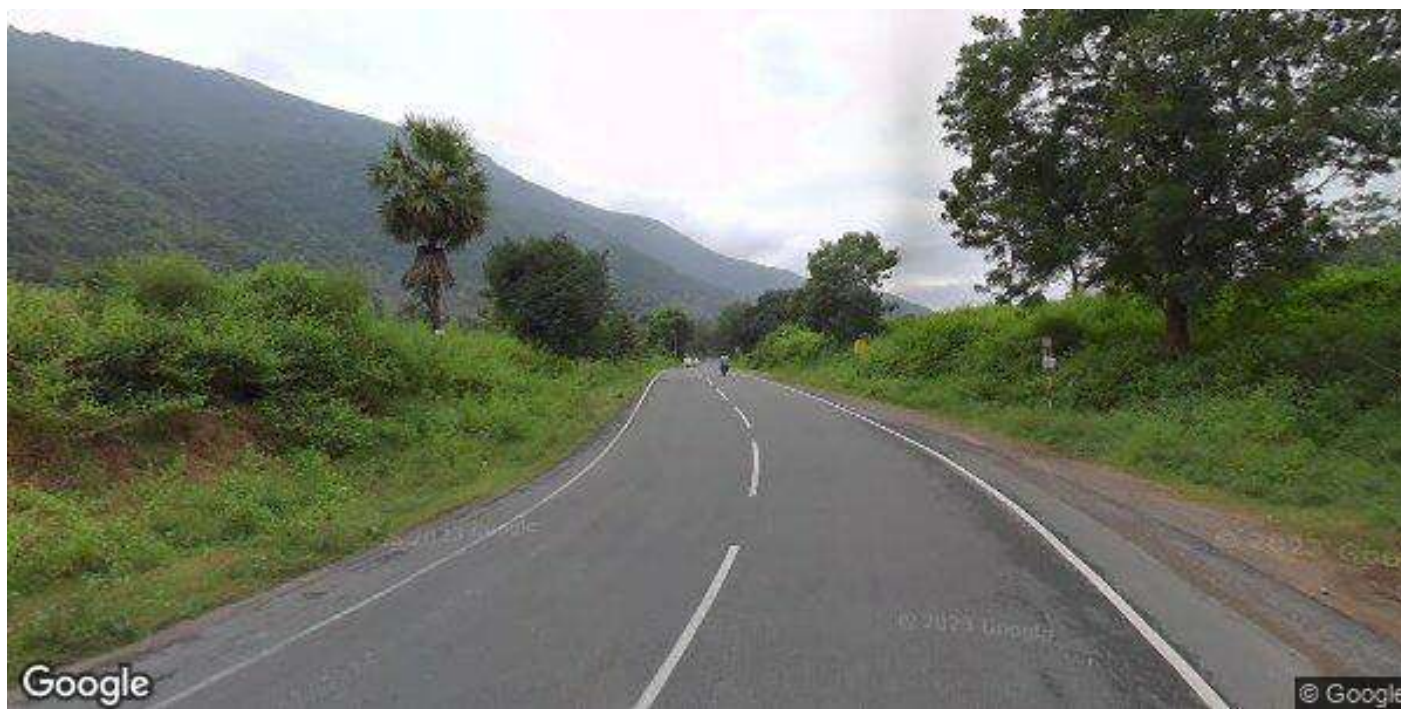
**Risk Type:** Turn  
**Risk Level:** Medium  
**Speed Limit:** 30 KM/Hr  
**Coordinates:** 11.80448, 78.33329

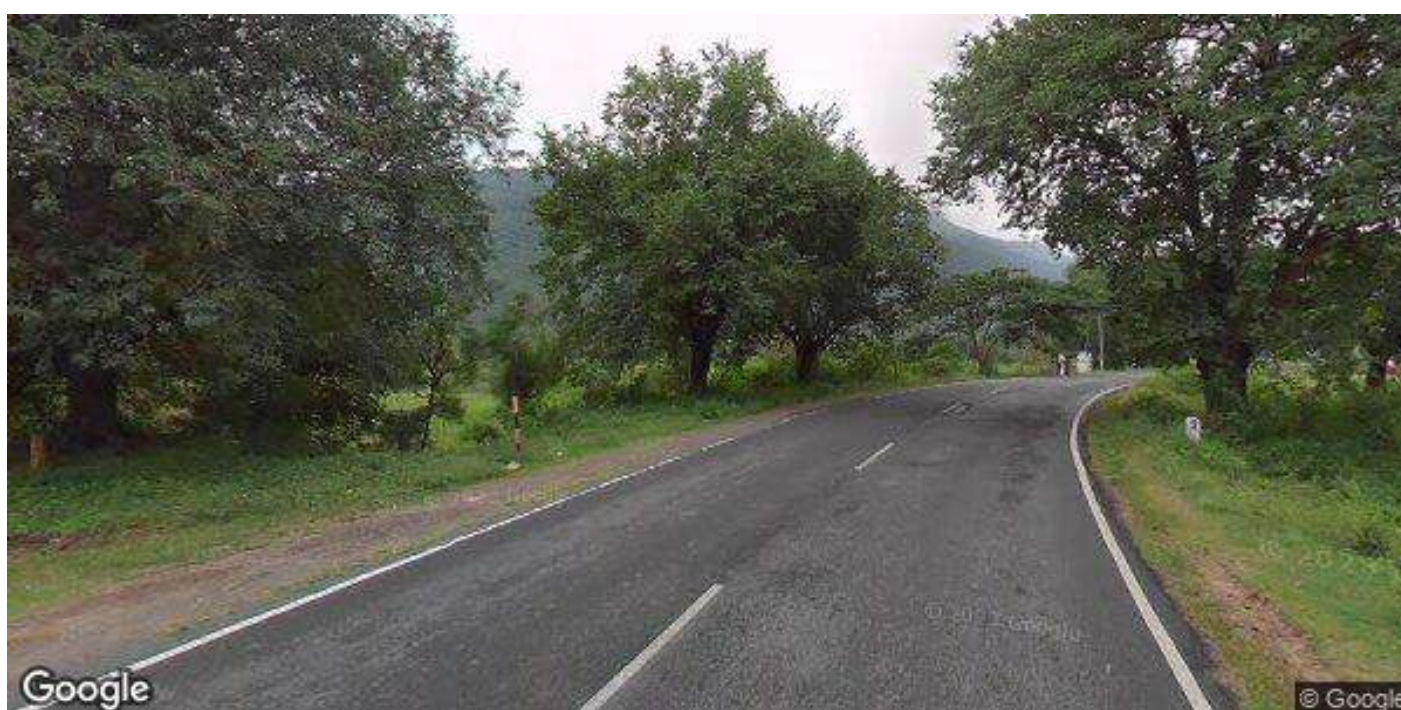
**Risk Type:** Turn  
**Risk Level:** Medium  
**Speed Limit:** 30 KM/Hr  
**Coordinates:** 11.81243, 78.34087

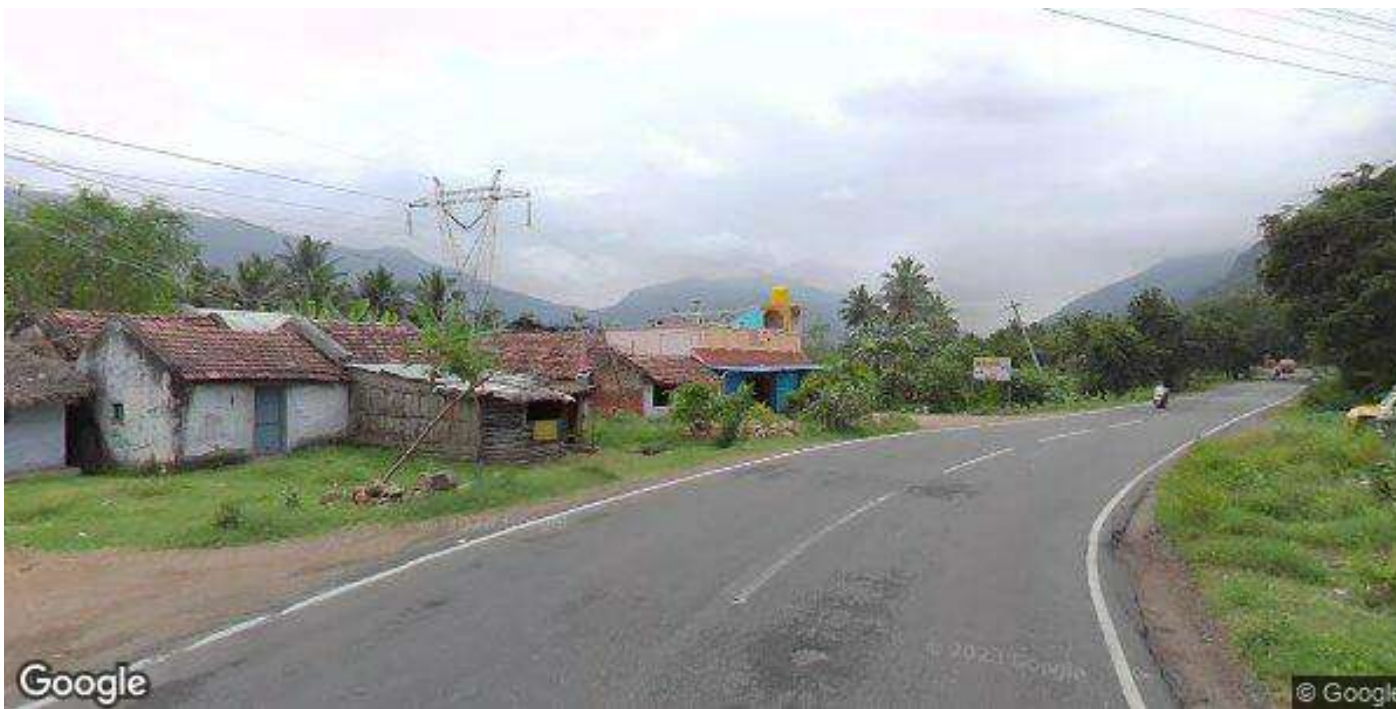
**Risk Type:** Turn  
**Risk Level:** Medium  
**Speed Limit:** 30 KM/Hr  
**Coordinates:** 11.83483, 78.35295

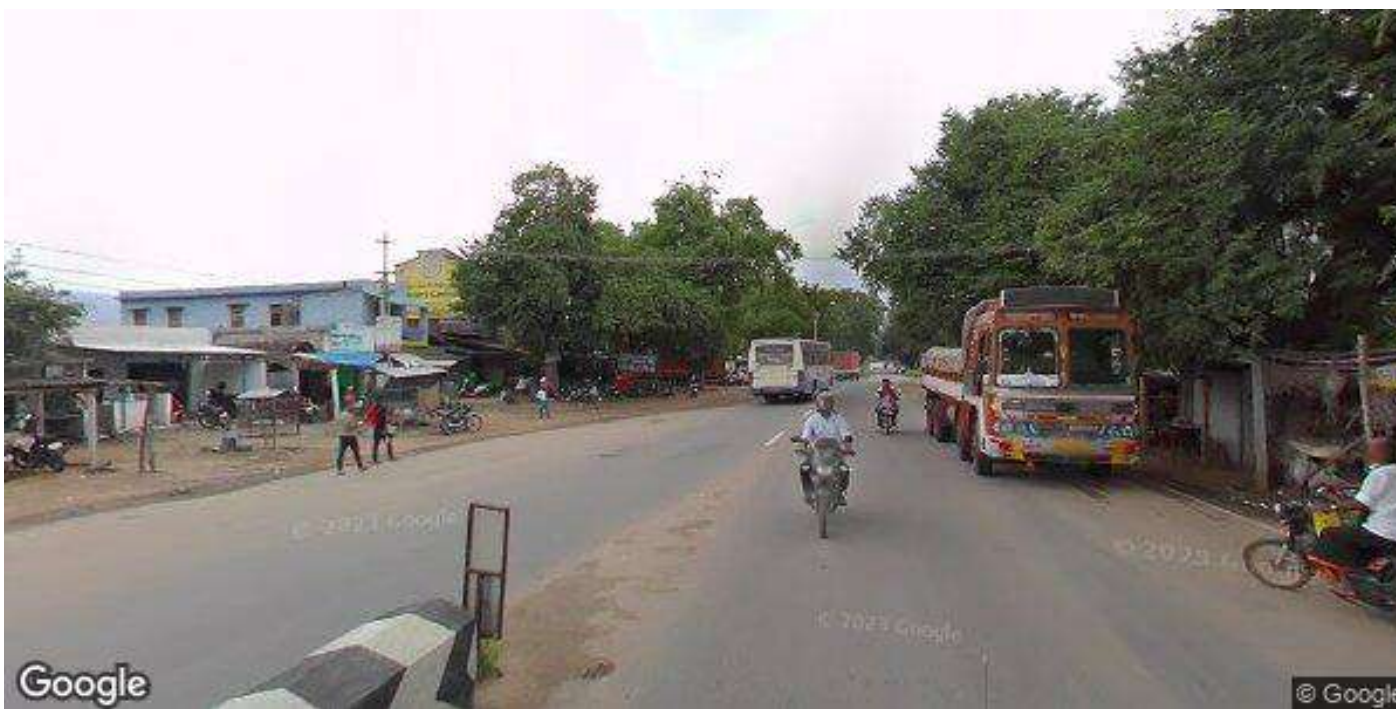
**Risk Type:** Turn  
**Risk Level:** Medium  
**Speed Limit:** 30 KM/Hr  
**Coordinates:** 11.88901, 78.37646

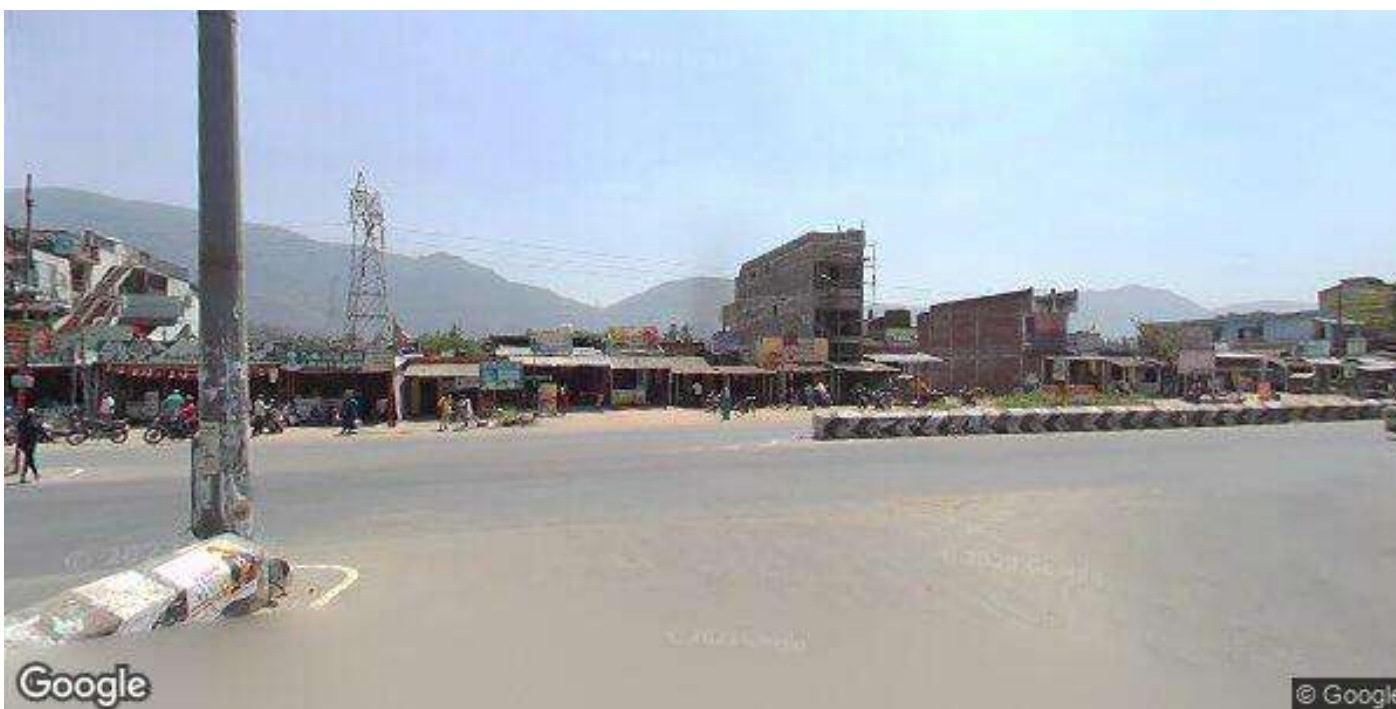
**Risk Type:** Turn  
**Risk Level:** Medium  
**Speed Limit:** 30 KM/Hr  
**Coordinates:** 11.88930, 78.37653
